Warton Crag Hilltop Enclosure, Warton, Lancashire: Aerial Mapping and Analytical Field Survey

Research Report Series 033-2017

Aerial Mapping and Analytical Field Survey

NGR: SD 4922 7288

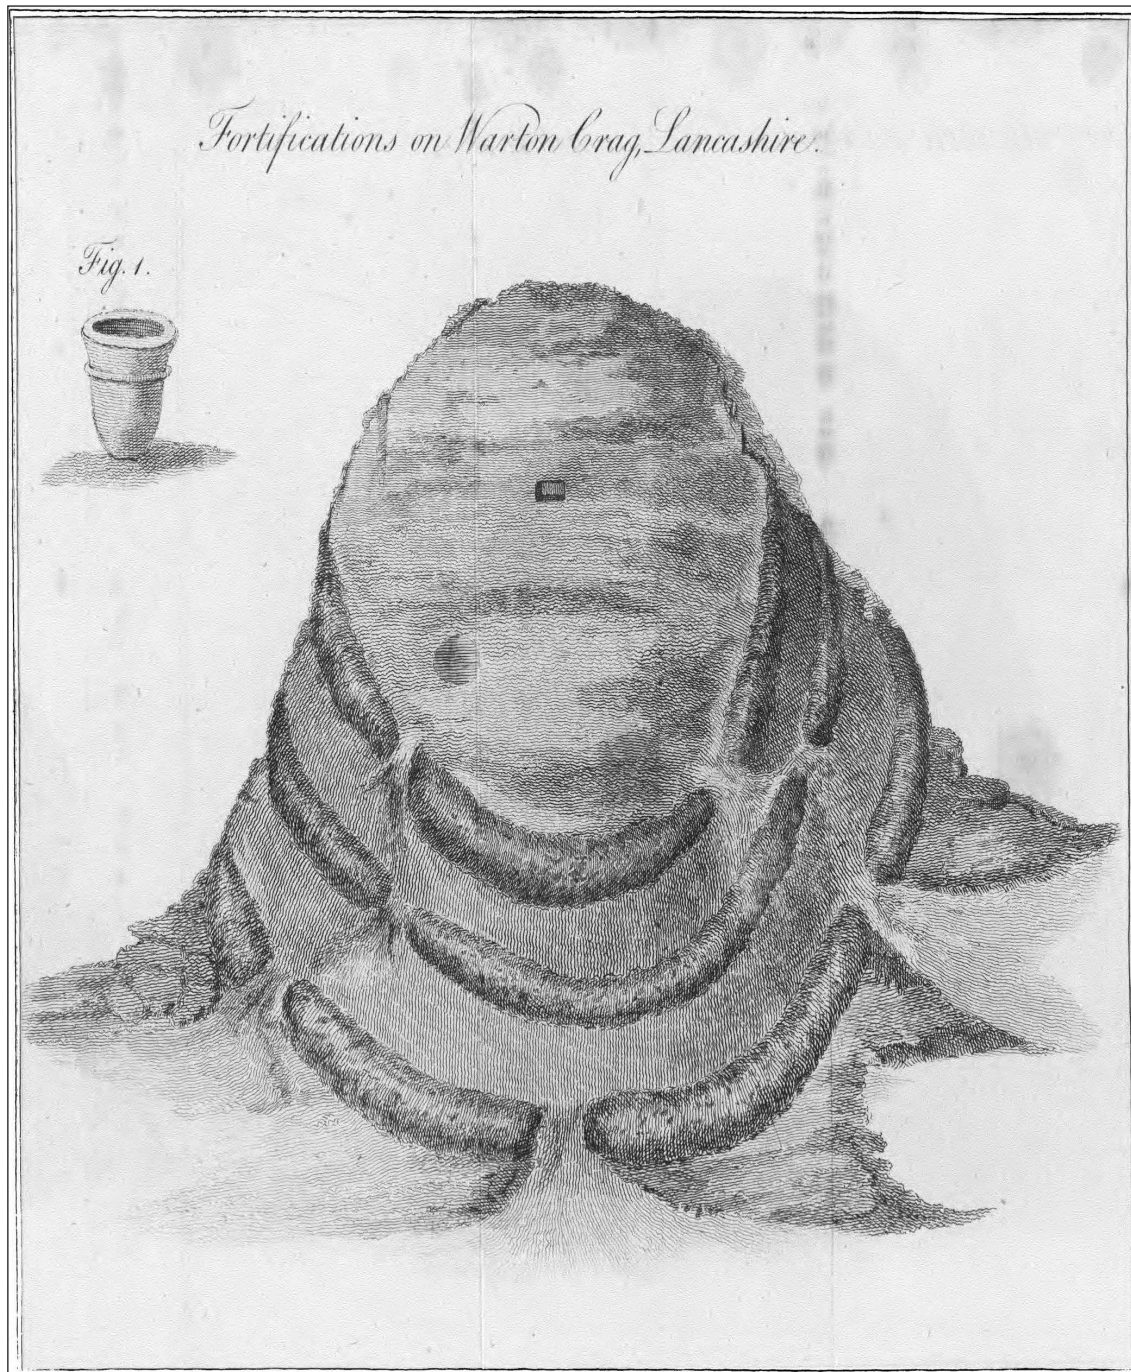
Figure 2. Hutchinson's bird's-eye sketch of Warton Crag. (Reproduced from *Archaeologia* 9, 1789).

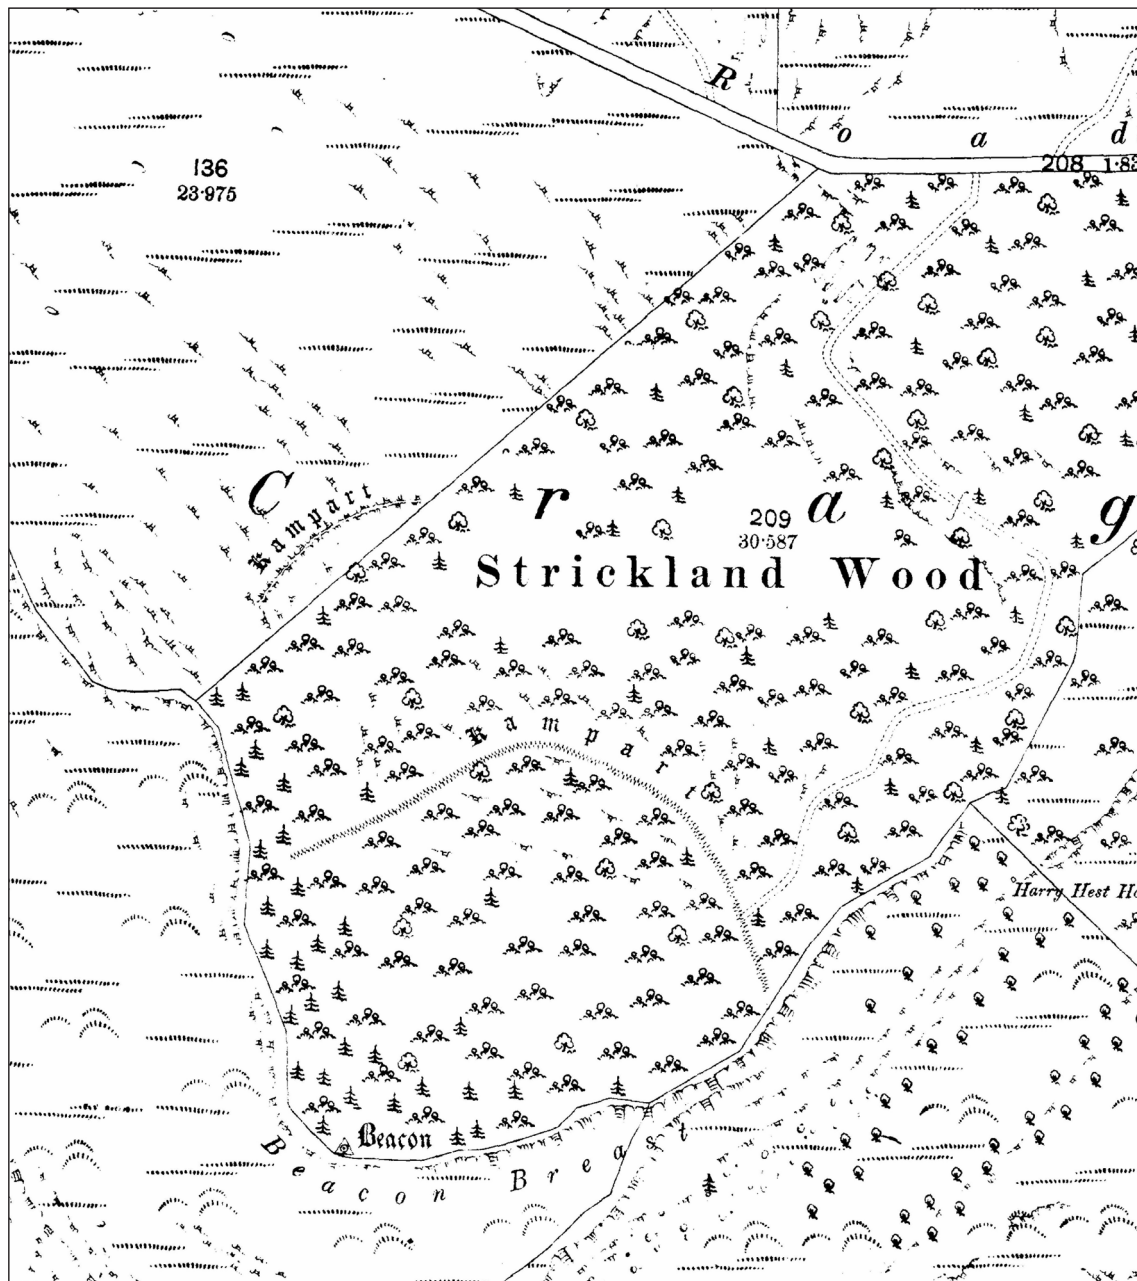
Figure 3. Warton Crag hilltop enclosure as mapped at 1:2500 scale in 1889. (Reproduced from the 1891 Ordnance Survey map).

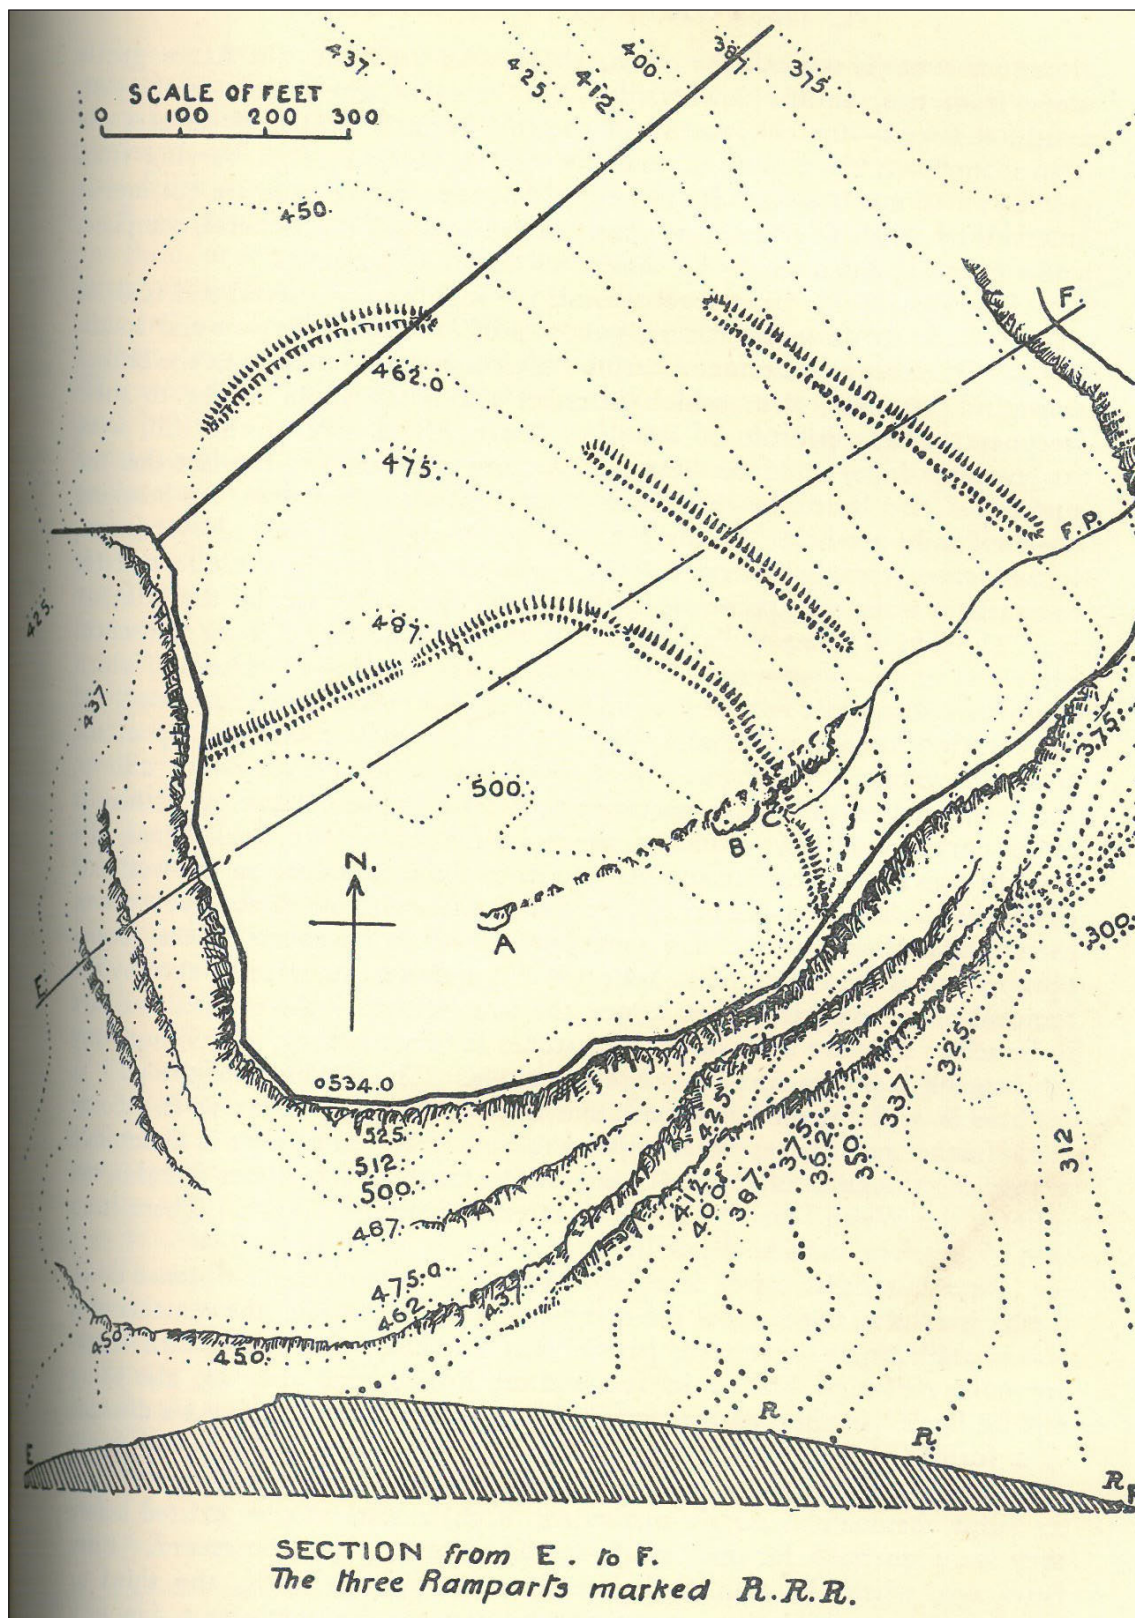
Figure 4. Warton Crag hilltop enclosure as mapped by the VCH. Line E – F diagonally across the middle of the plan is the line of the section drawing shown below the plan. (Reproduced from Farrer and Brownbill (ed) 1908).

No trace was seen of either the square hut mentioned by Hutchinson at the centre of the enclosure or the small pen at ‘A’ on the VCH plan (Figure 4), ie at the west end of the scar that leads away east from the dewpond.

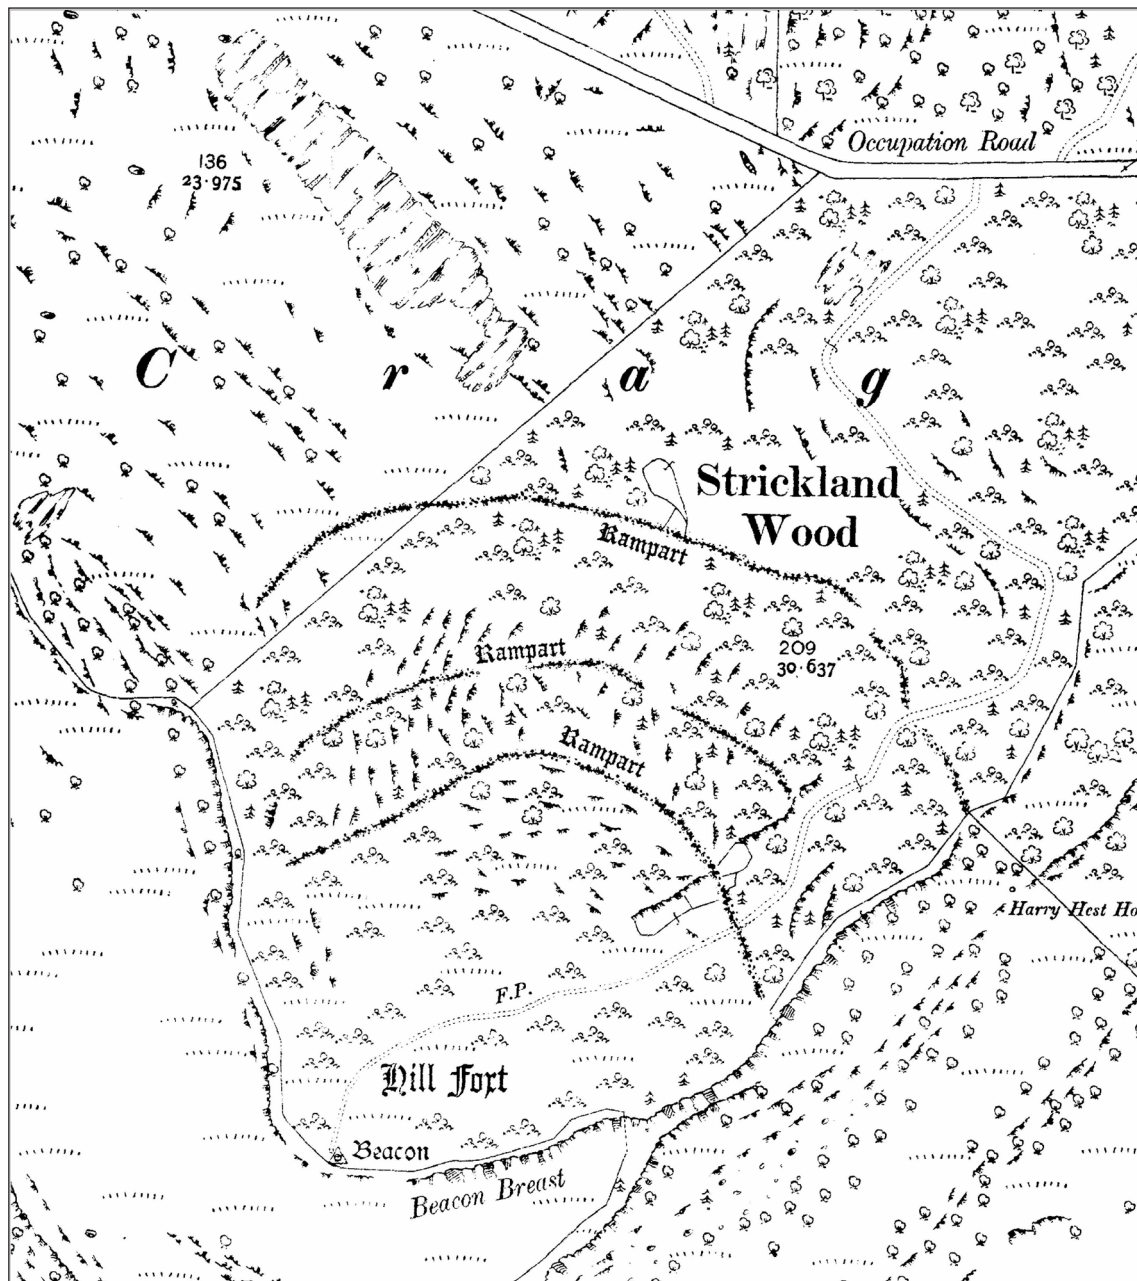
Figure 5. Warton Crag hilltop enclosure as revised at 1:2500 scale in 1911. (Reproduced from the 1913 Ordnance Survey map).

The map depicts a number of breaks in the middle and outer circuits but it is not clear if the OS surveyor thought these were original entrances. Both the 1891 and 1913 maps depict the Enclosure-period stone field wall that cuts across the west end of the outer wall of the monument. The 1891 map shows the hilltop south of this field wall (*ie*, much of the monument interior) as covered by mixed woodland (an extension of Strickland Wood), but by 1913 tree cover on the summit within the line of the enclosure's inner circuit had thinned to more open scrub; the area north of the field wall is depicted as rough open or semi-open pasture on both maps.

The wall thereafter passes into an area of light deciduous tree cover but is still clearly traceable on the ground. After a further 30m (*ie* just prior to the point where it is crossed by the Enclosure-period field wall) there is a 1.5m-wide break in its course. The east side of the break is marked by a transverse upright stone suggesting the gap is probably an original entrance (Figure 28); certainly the break already existed when the outer circuit was mapped by the OS in 1913 (Figure 5).

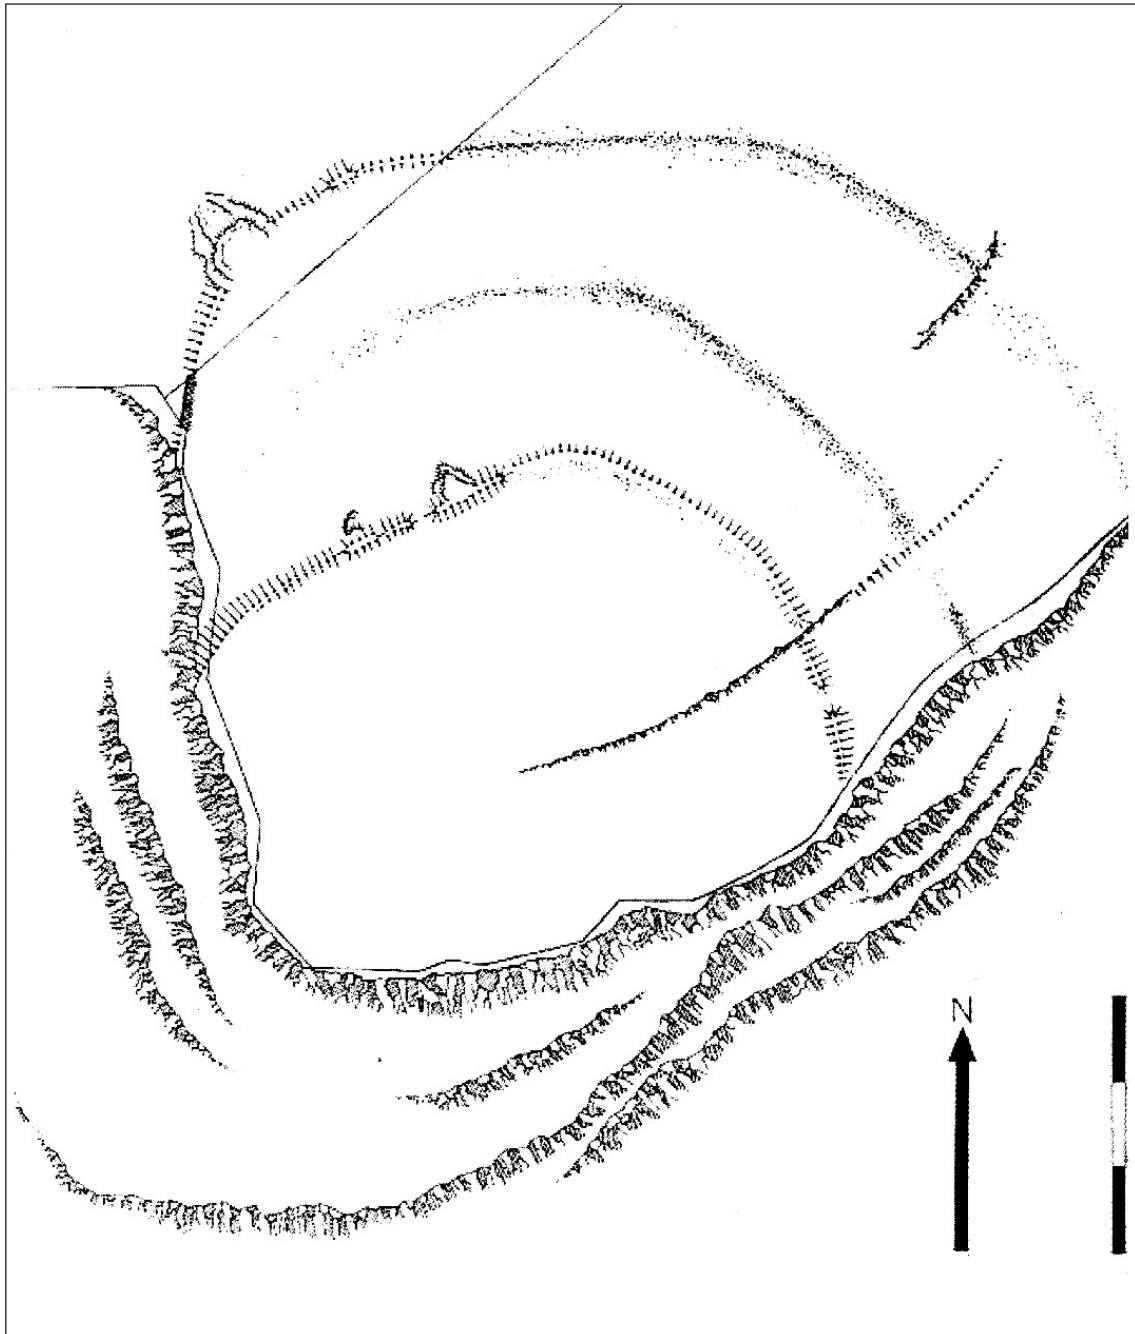
Figure 6. Warton Crag hilltop enclosure as mapped by James Forde-Johnstone.
(Reproduced from Forde-Johnstone 1962).

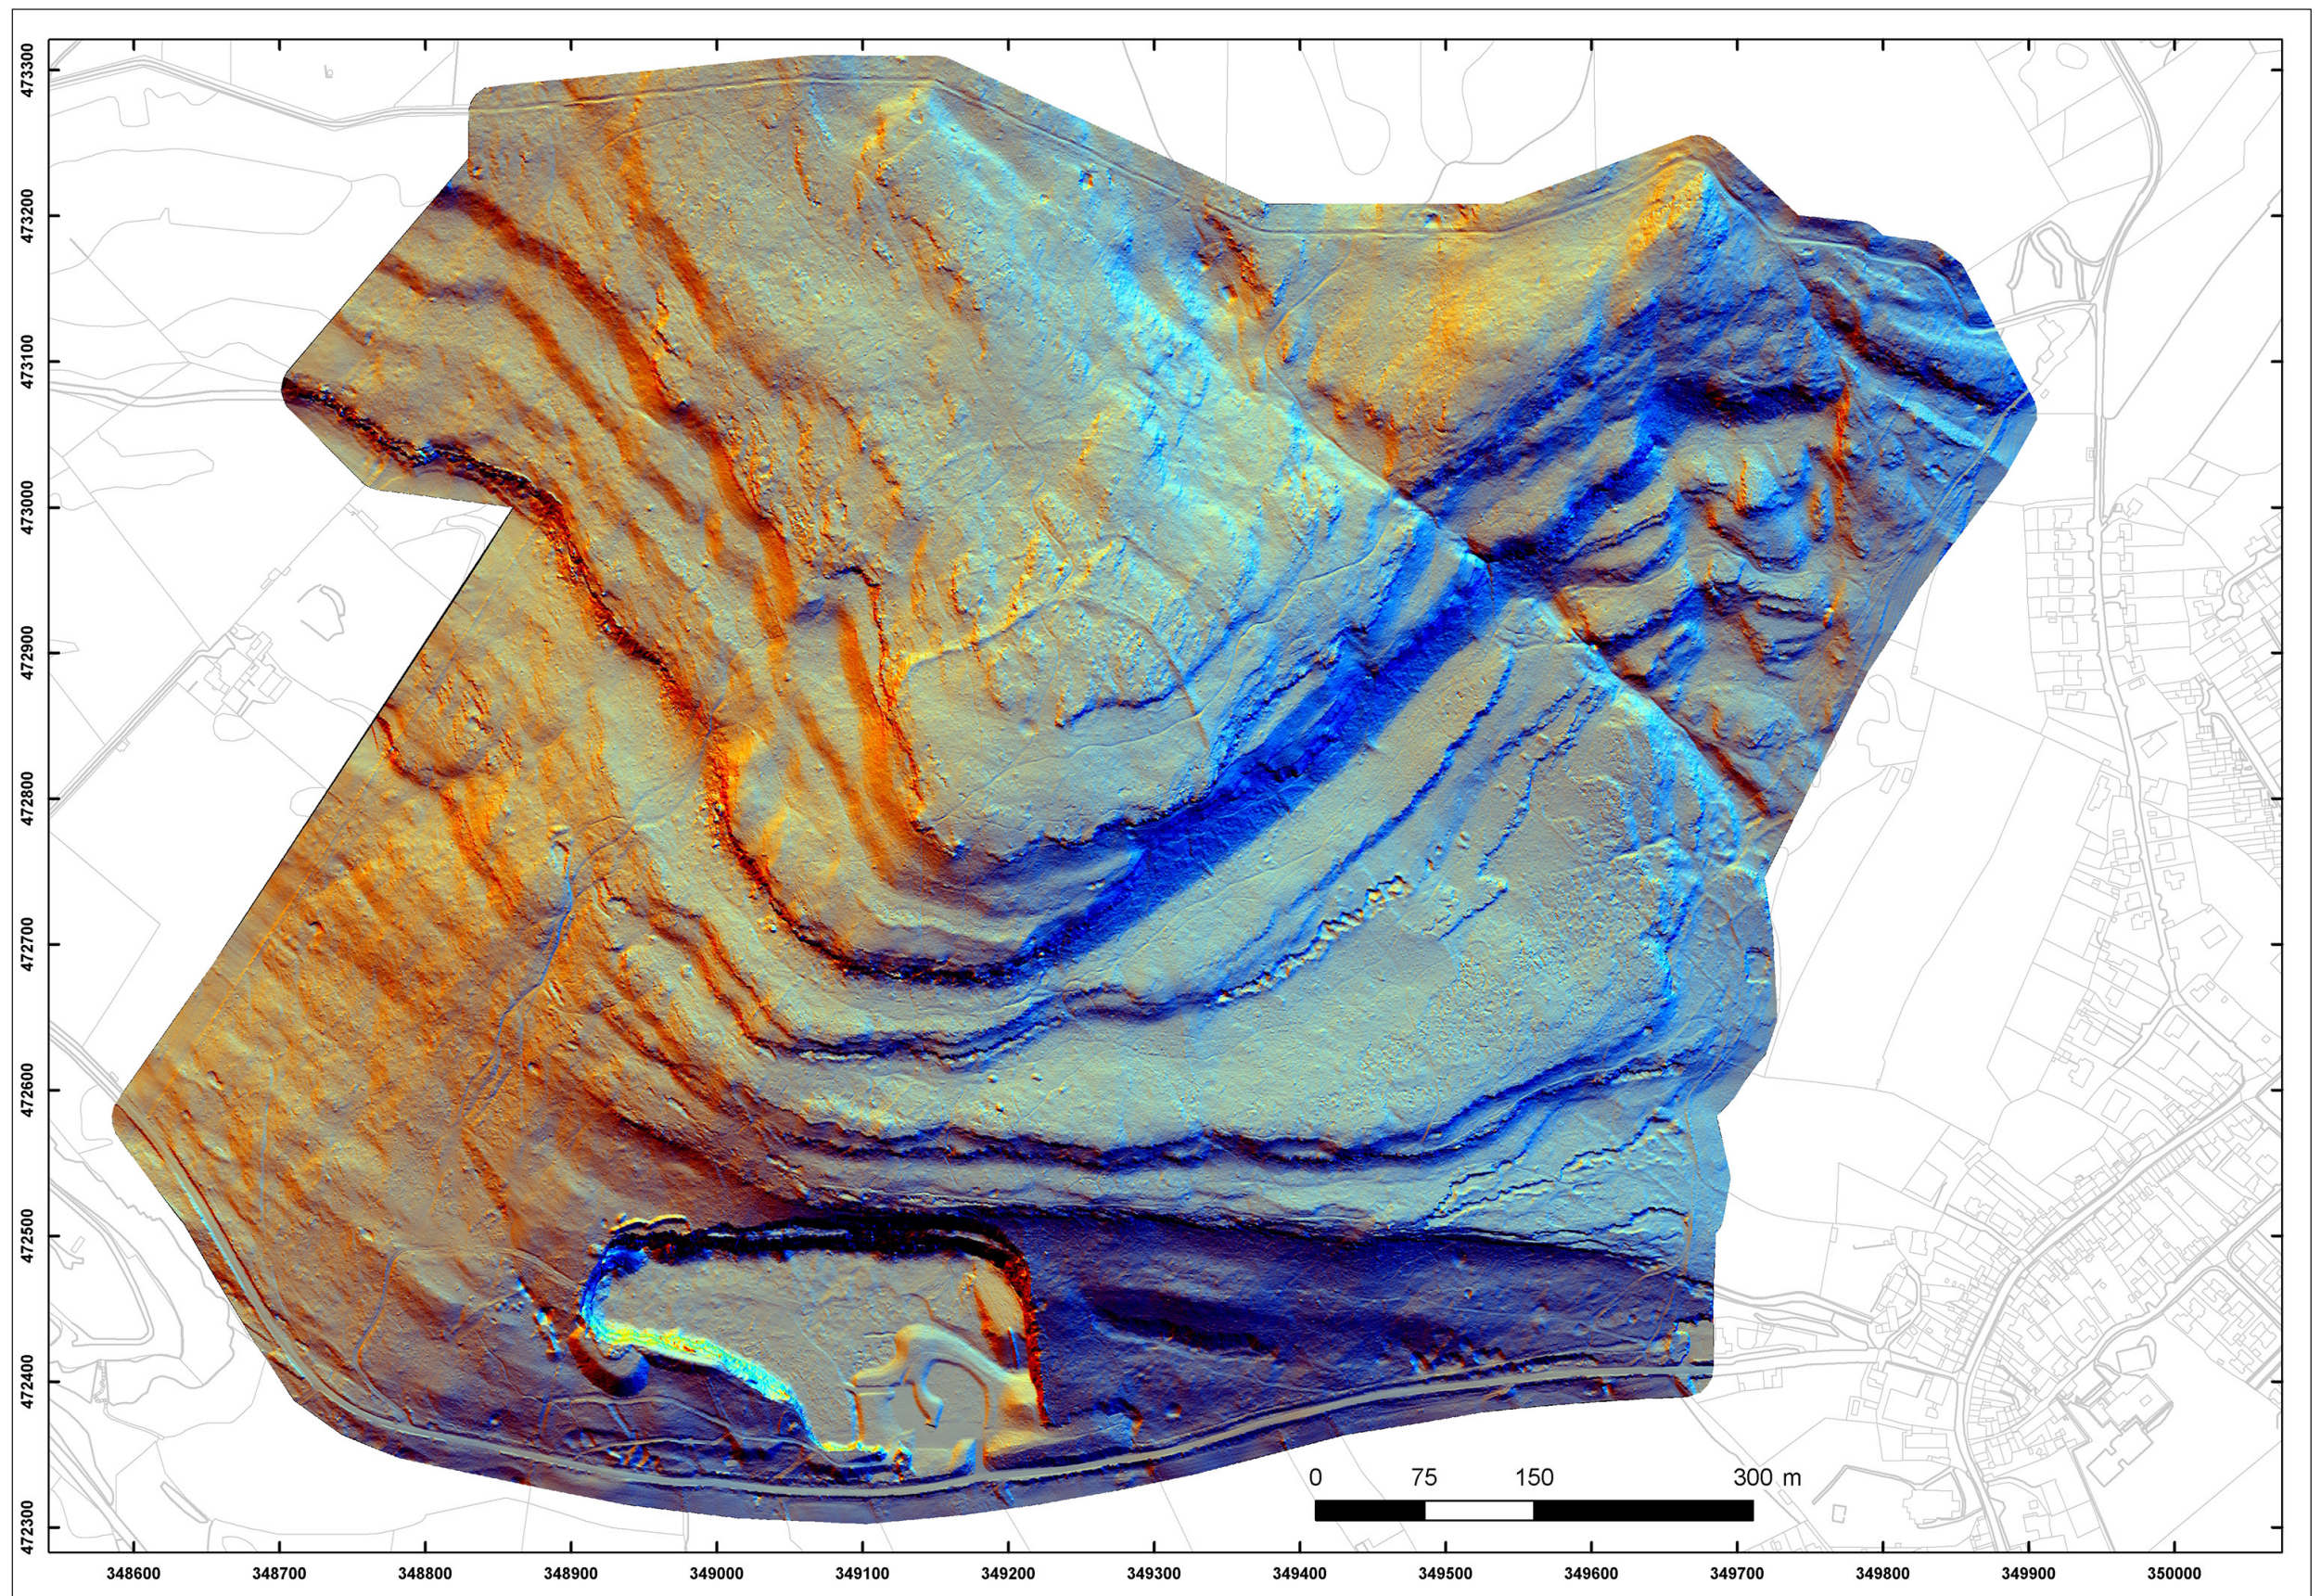
Figure 8. A 16-direction hillshade DTM model of the commissioned lidar overlaid against OS digital mapping. (D0040620, Sally Evans 2016 © Historic England).

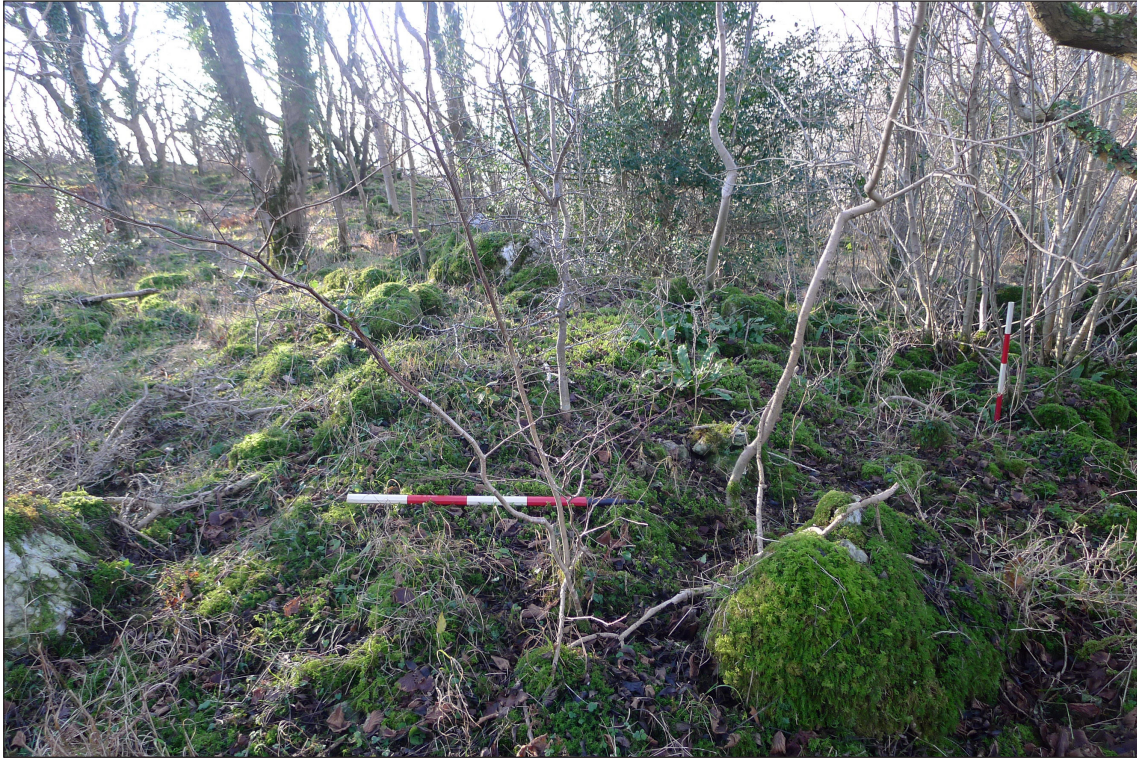
On the Crag summit above bank 'f', the inner wall survives between Beacon Breast and the western footpath as a low, curving, discontinuous bank composed of moss-covered boulders and smaller stones with seemingly very little or no soil matrix between and beneath. It appears better preserved close to the path and less substantial towards the escarpment edge, but in places is heavily infested with small saplings and the occasional more mature tree making detailed observation problematic. As best as can be observed, all surviving stonework directly overlies limestone pavement, with no intervening buried ground surface. The 64-direction hillshade visualisation of the lidar suggests this stretch of wall survives up to 5m wide, but field inspection reveals that the impression of 'bankiness' on the lidar is attributable to the fact that the wall runs along the crest of a slight north-facing declivity in the underlying limestone pavement, and that its true width - as indicated by intermittent lines of boulders set on edge, suggestive of *in-situ* inner and outer facing stones - is closer to 1.8m. A loose scatter of mostly smaller stones that lies between and beyond the facing stones presumably represents the *in-situ* and *ex-situ* remains of core material. Some of the facing stones stand up to 0.8m tall, but a more typical height for the wall in this section is 0.4m or less (Figure 11).

Figure 11. Looking west along the inner circuit towards Beacon Breast from near the western footpath. The vertical ranging rod at right of frame marks the base of the natural declivity; the rods are marked in 0.2m intervals. (Image 00406001, Marcus Jecock 2017 © Historic England).

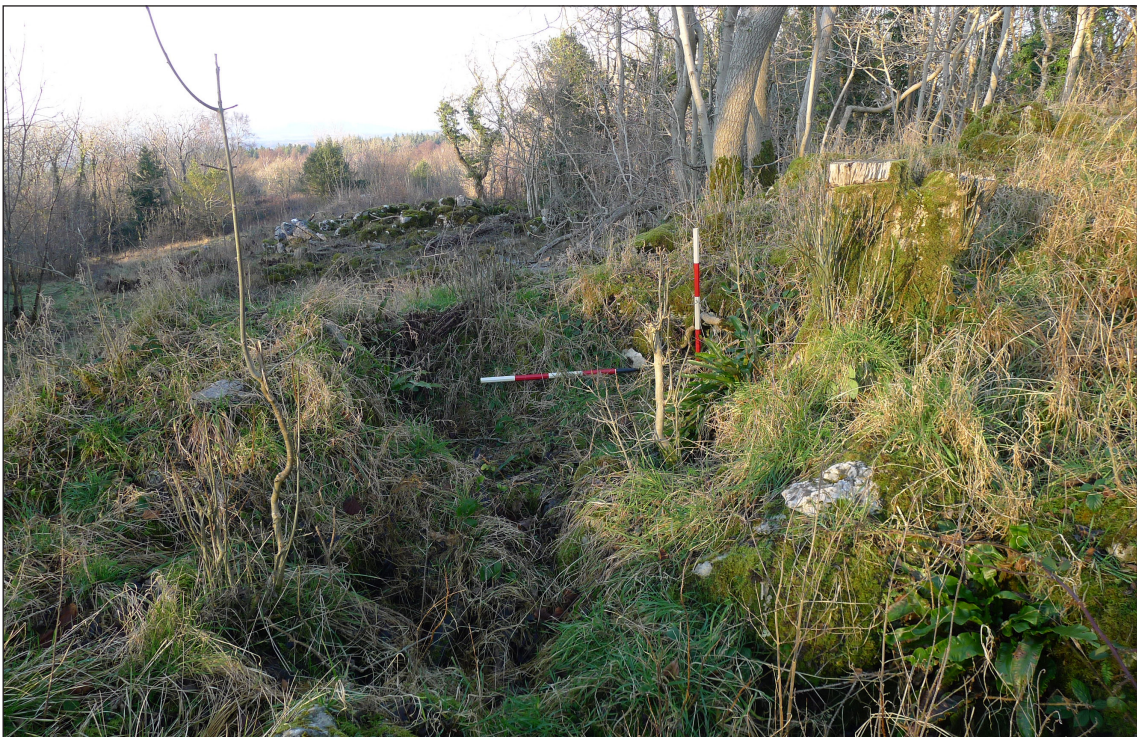
Figure 12. Far view of possible guard chamber in the inner circuit, east of the western footpath. Looking north from the interior of the enclosure. (Image 00406004, Marcus Jecock 2017 © Historic England).

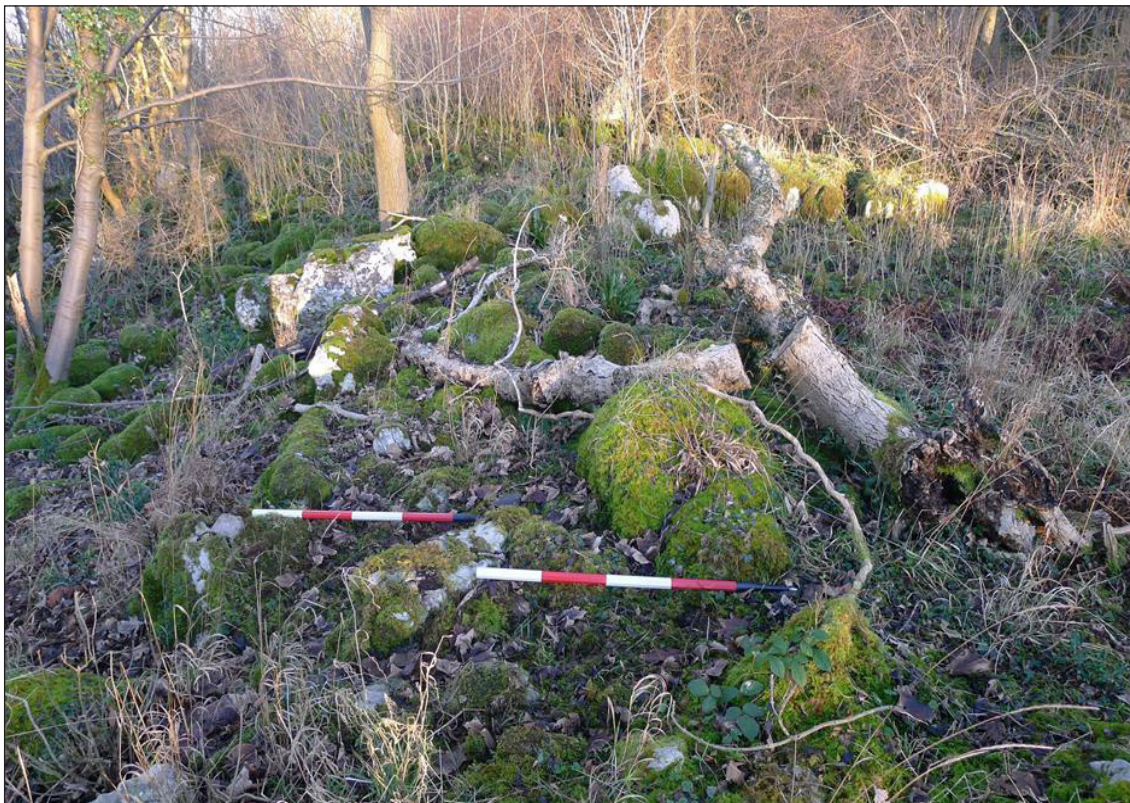
Figure 13. View north-east along the inner circuit from just east of the 'guard chamber' (Image 00406007, Marcus Jecock 2017 © Historic England).

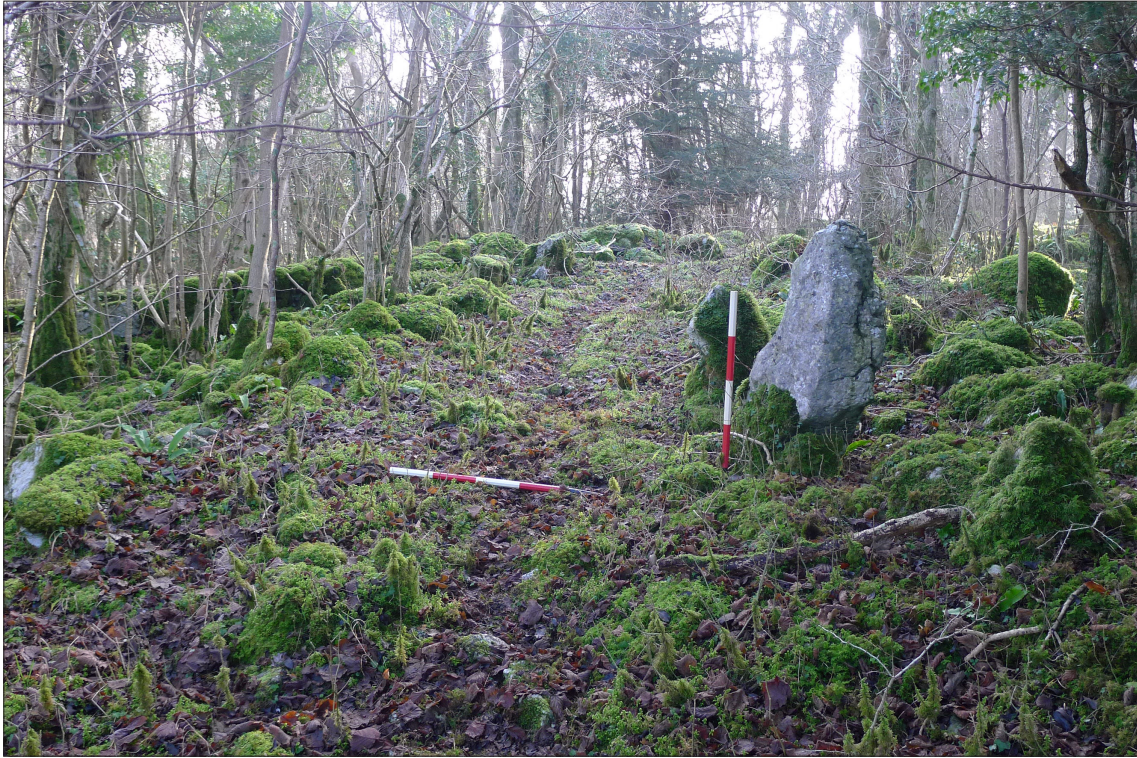
Figure 14. View south-east along the line of the (?robbed) inner circuit close to the upright stone, showing the very different earthwork form of the wall in this sector (Image 00406009, Marcus Jecock 2017 © Historic England).

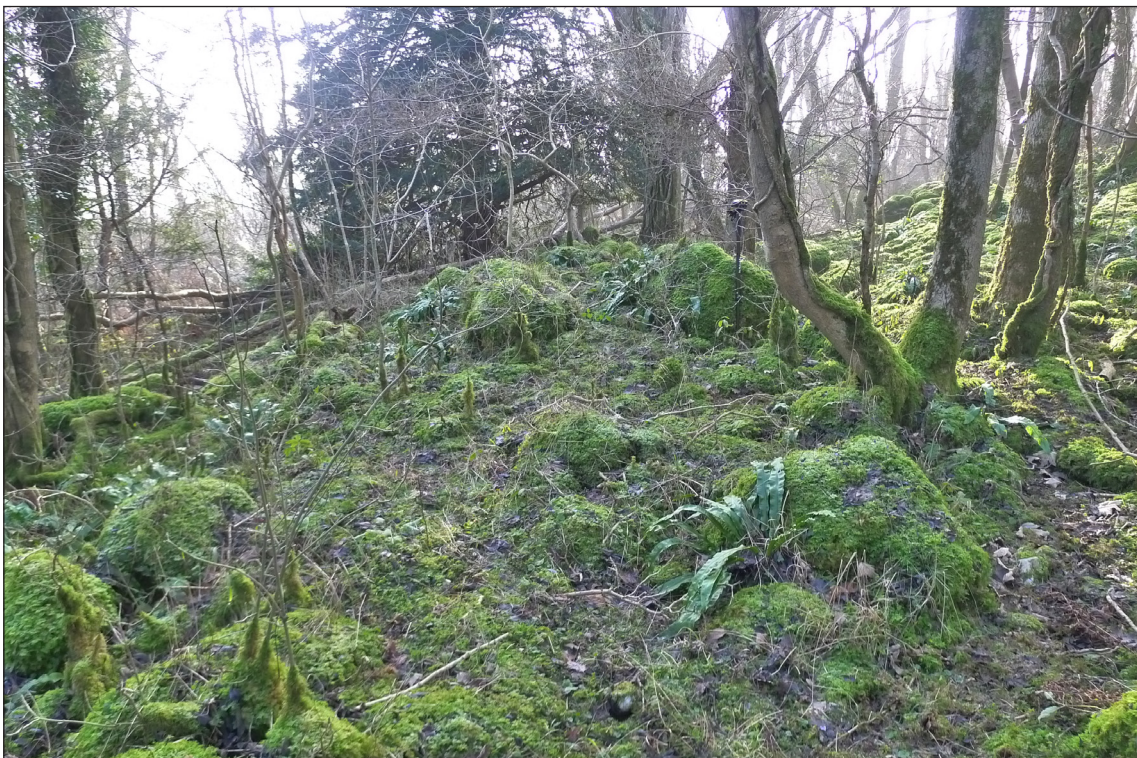
At SD 49312 72896, the form of the inner wall suddenly changes back to a low rubble spread between intermittent facing stones (Figure 15). From this point as far

Figure 15. View almost due south along the inner circuit. The GNSS controller on its pole is set at a height of 1.1m and marks the south-eastern end of the 'terraced' section of the inner circuit where it reverts to a stony bank at NGR SD 49312 72896. (Image 00406033, Marcus Jecock 2017 © Historic England).

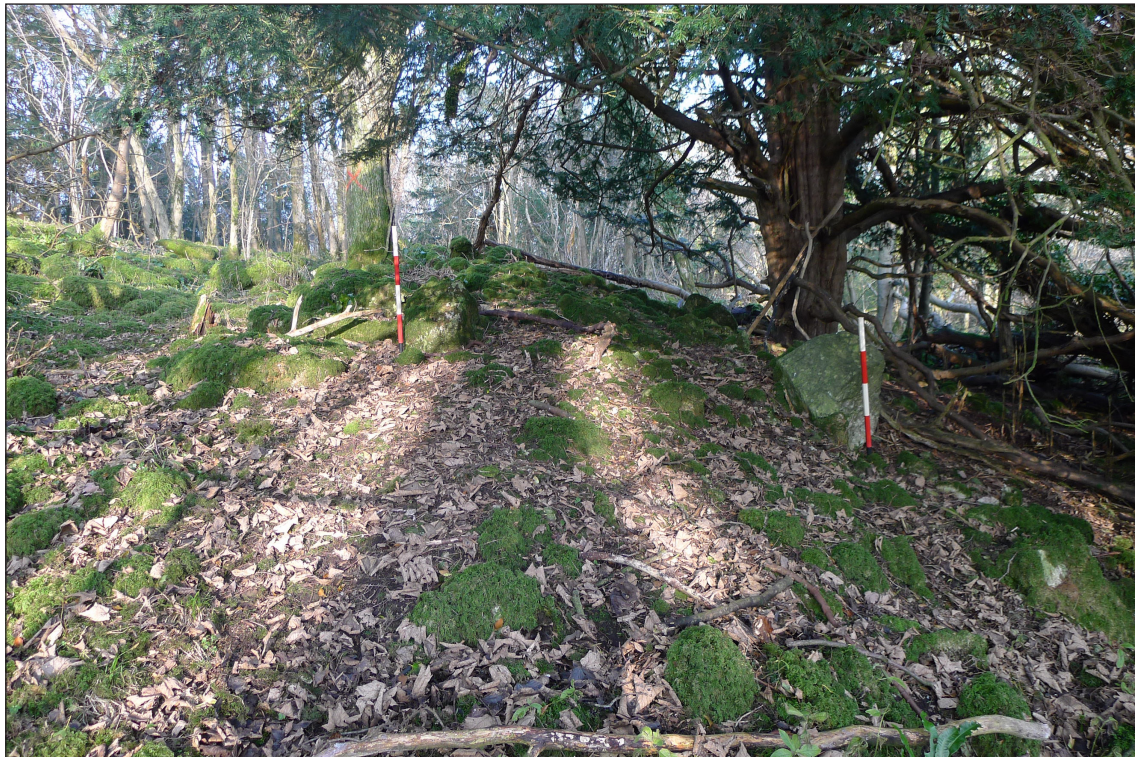
as a localised but *circa* 4m-high east-west scar that runs parallel to and some 50m back from Beacon Breast (*ie* the area north of the eastern footpath), the base of the wall is again well preserved. As it drops down over the localised scar, the feature becomes more massive, changing in form and increasing in size from a rubbly spread to more of an earthwork bank some 4.3m wide by up to 0.6m high. This may, however, be simply an impression caused by the accumulation of soil and leaf litter over and against stone-faced wall: the tops of large boulders visible within the bank are suggestive of facing stones, in which case the underlying structure and width of the wall is comparable to that of the circuit further west (Figure 16).

Figure 16. View north-west along the inner circuit as it drops down over the localised scar north of Beacon's Breast. The vertical ranging rods indicate the possible inner and outer wall facing stones within the overall width of the bank. (Image 00406015, Marcus Jecock 2017 © Historic England).

A number of mature trees are rooted in the wall-line in this sector, especially between the localised scar and eastern footpath. These should be felled before they

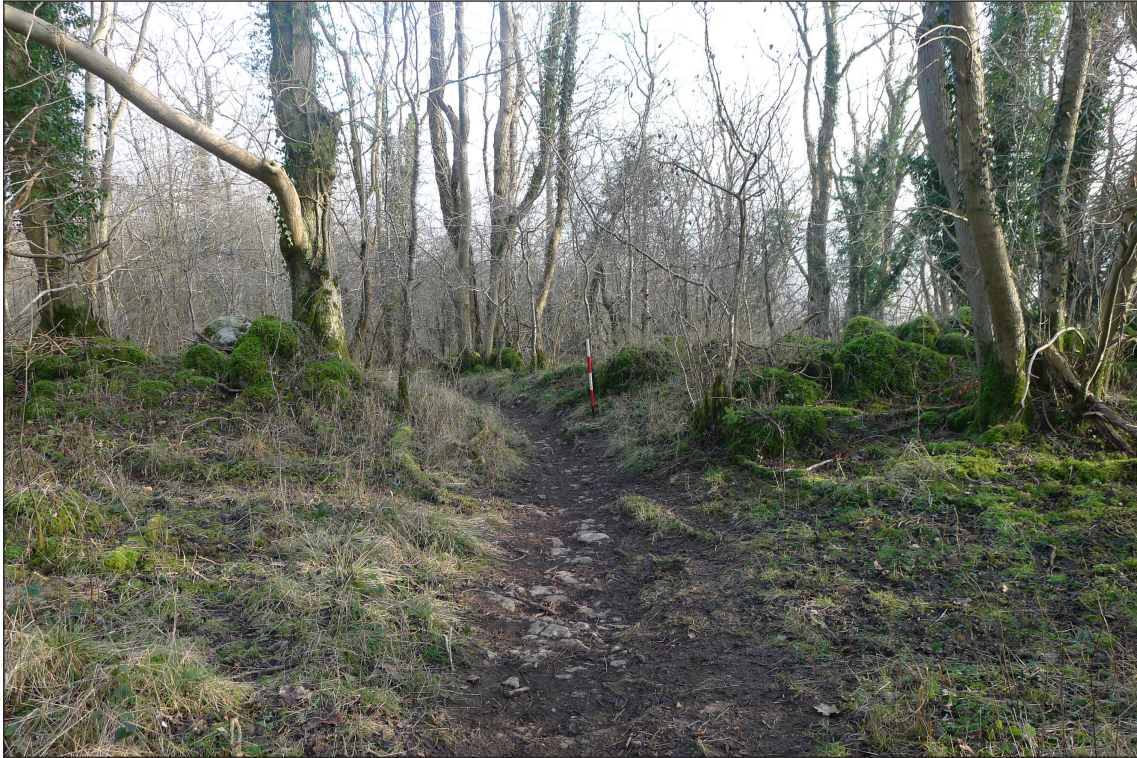
Figure 17. View east from within the monument of the probable eastern entrance in the inner circuit, now followed by the eastern footpath. (Image 00406016, Marcus Jecock 2017 © Historic England).

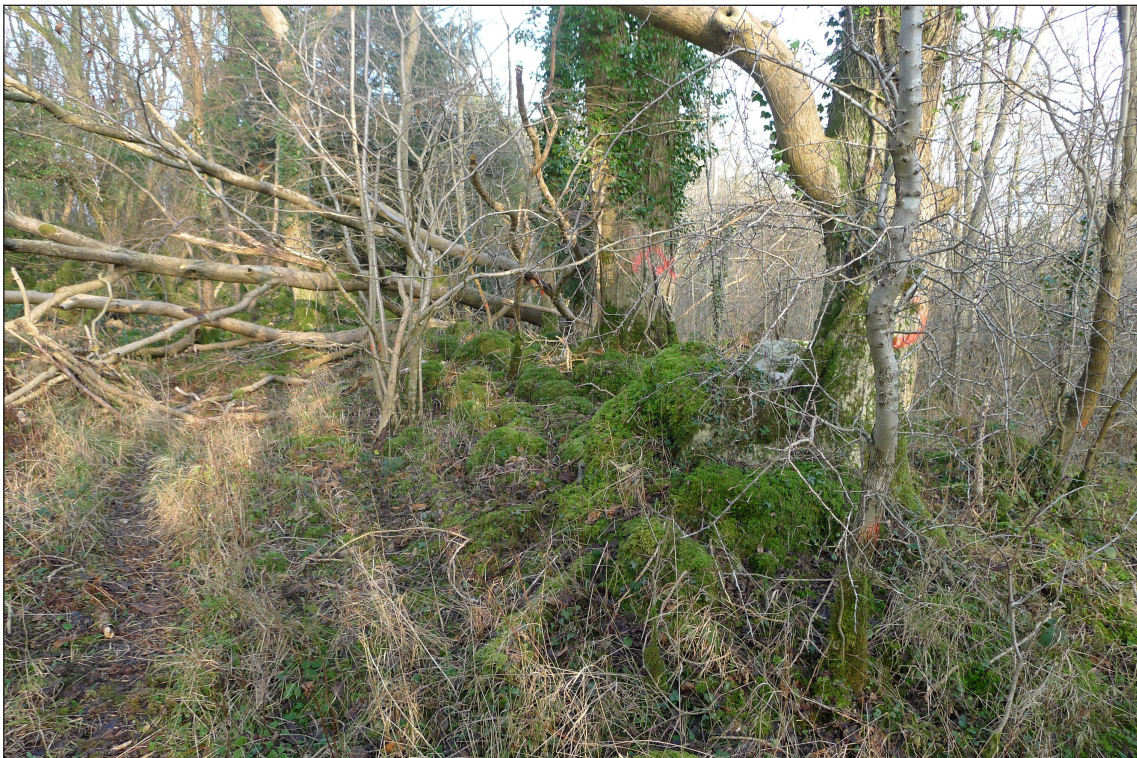
Figure 18. The inner circuit just north of the eastern entrance, showing one of the wind-thrown trees and other mature trees marked up for felling. Looking north. (Image 00406017, Marcus Jecock 2017 © Historic England).

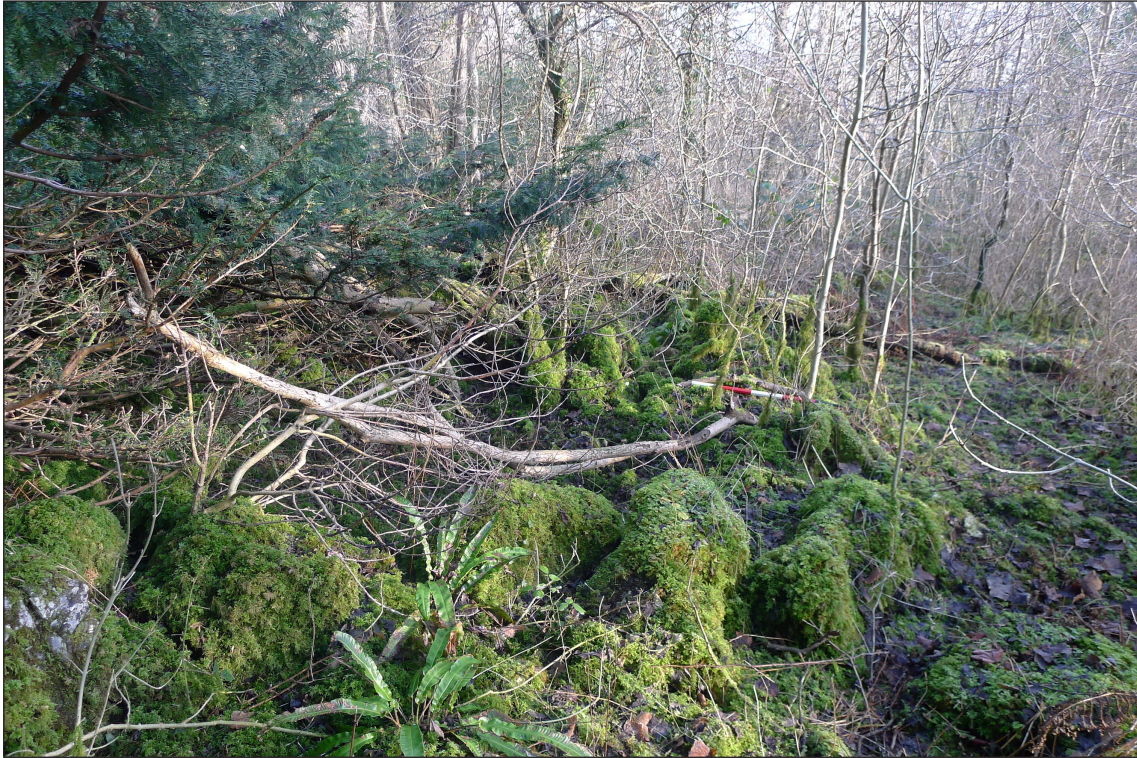
Figure 19. The easternmost of the three boulder-walled stock pens adjacent to the inner circuit. Note the fallen yew tree at left of frame that has prevented the feature being picked up by lidar. (Image 00406011, Marcus Jecock 2017 © Historic England).

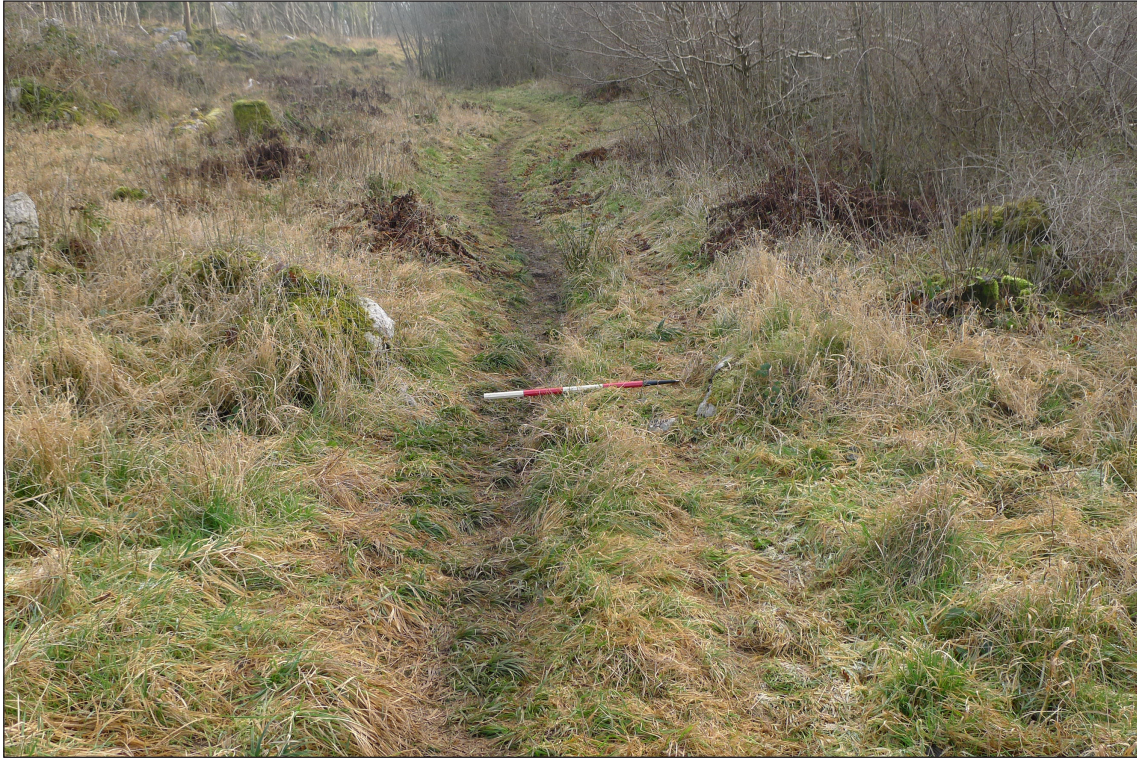
In common with previous surveys of the monument, the present investigation has found little or no trace of the middle wall immediately above the western escarpment edge. Suggestions of wall (a few grass- and moss-covered boulders vaguely in line) are discernible either side of the western footpath, but it is only *circa* 13m east of the path as it rises up over a localised low north-south scar (the same scar that forms the east side of the ‘guard-chamber’ in the inner circuit) that the middle wall becomes particularly evident on the ground. The western footpath passes through a *circa* 1.7m-wide gap in the line of the wall so defined (Figure 20), while approximately

Figure 20. View south towards the enclosure interior through the gap in the middle circuit followed by the western footpath. (Image 00406025, Marcus Jecock 2017 © Historic England).
