Warton Crag Hilltop Enclosure, Warton, Lancashire: Aerial Mapping and Analytical Field Survey

Research Report Series 033-2017

Aerial Mapping and Analytical Field Survey

NGR: SD 4922 7288

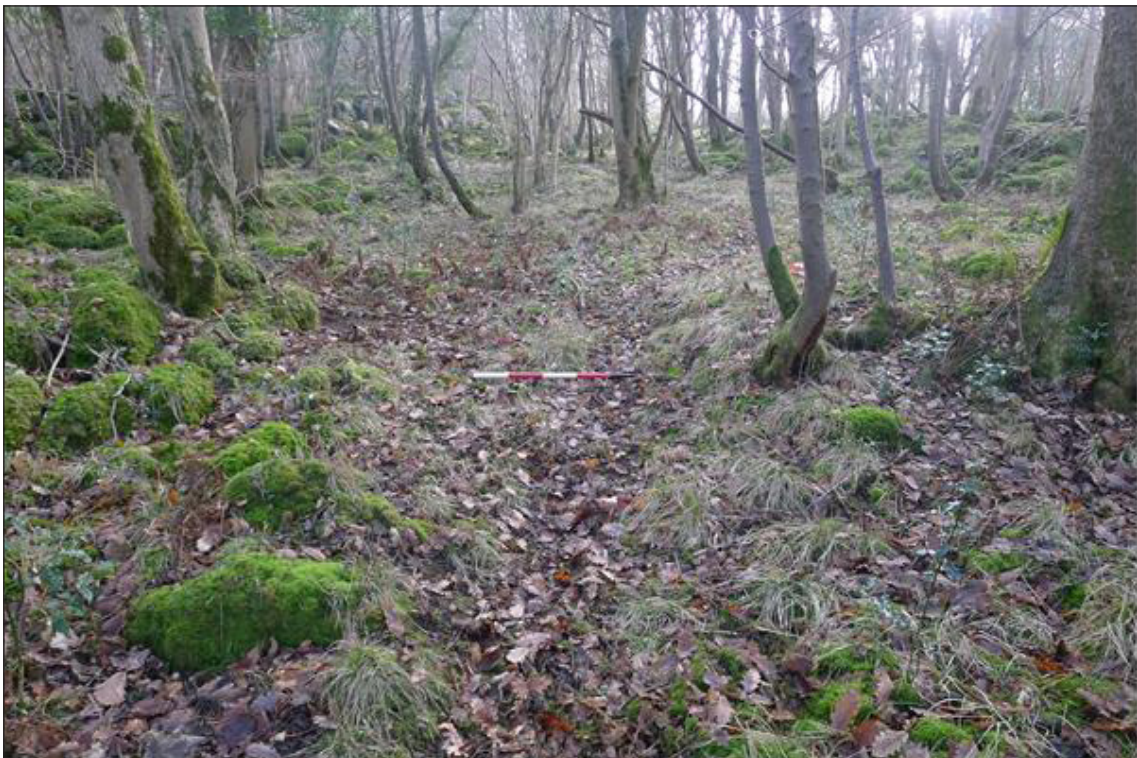
Figure 21. View south towards the enclosure interior through the gap in the middle circuit followed by the disused footpath at NGR SD 49198 72964. (Image 00406024, Marcus Jecock 2017 © Historic England).

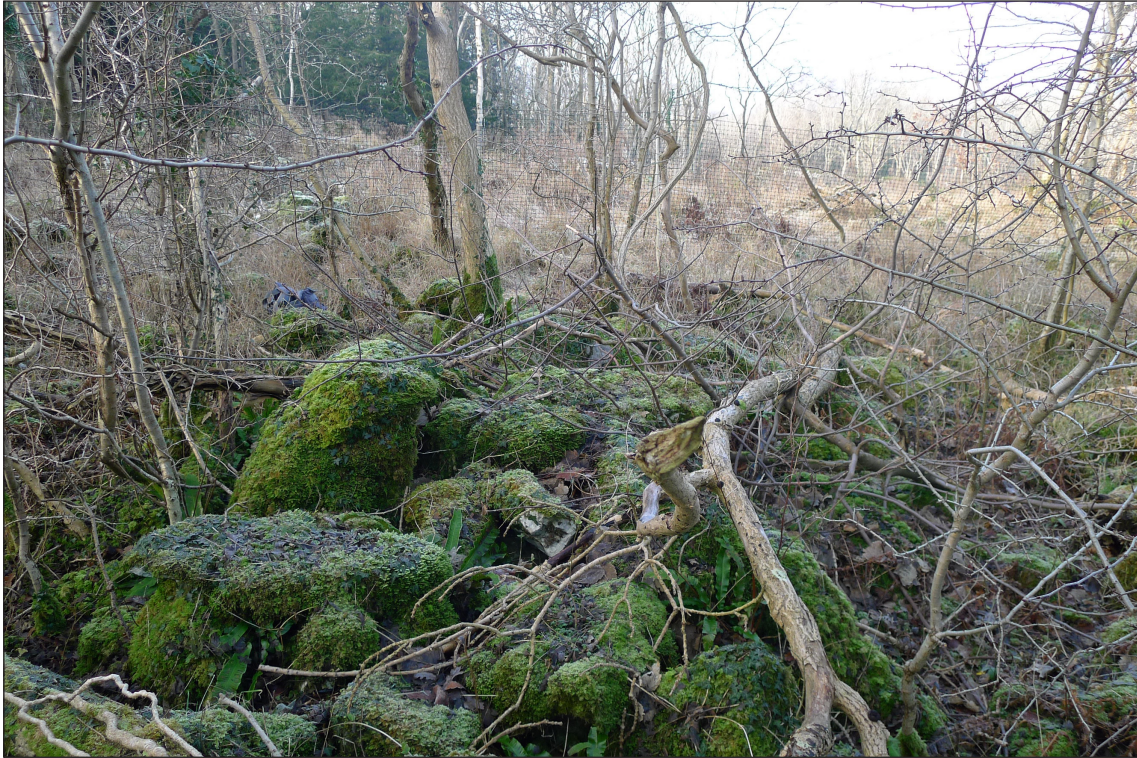
Figure 22. The middle circuit immediately east of the butterfly-ride fence. Looking west towards the fence. (Image 00406023, Marcus Jecock 2017 © Historic England).

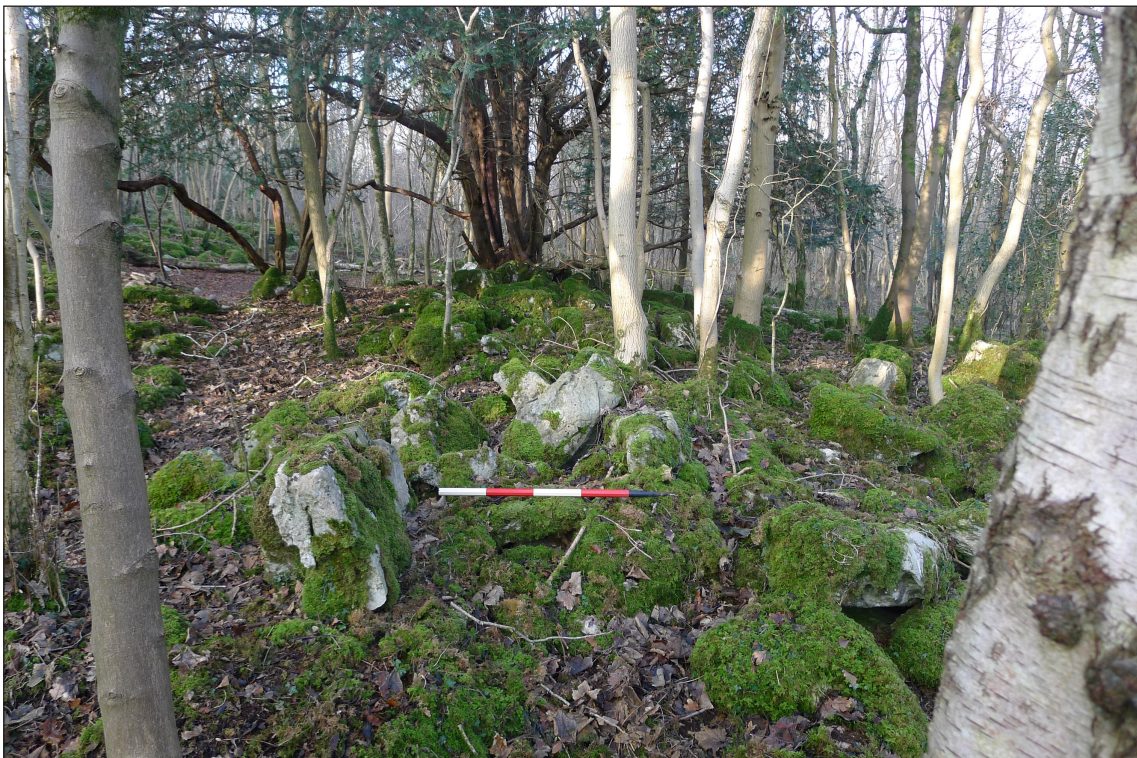
Figure 23. View north-west along the middle circuit at NGR SD 49333 72950. (Image 00406021, Marcus Jecock 2017 © Historic England).

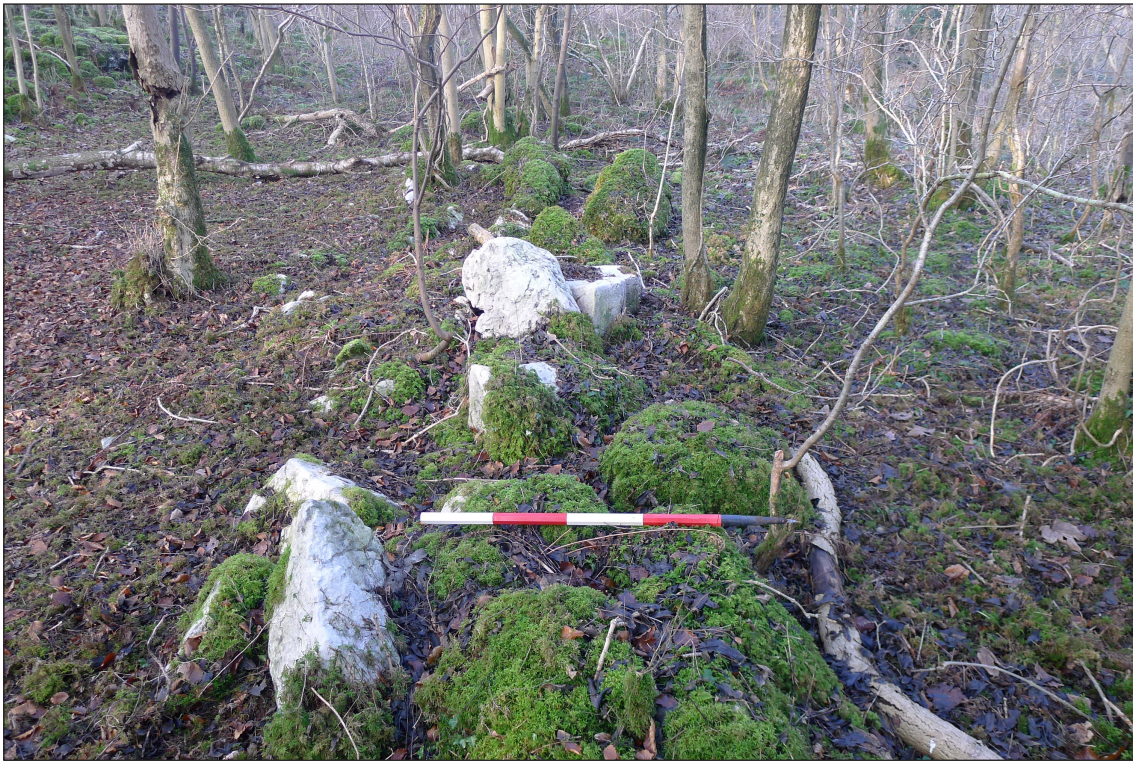
Figure 24. View north-west along the middle circuit at NGR SD 49320 72954 (Image 00406022, Marcus Jecock 2017 © Historic England).

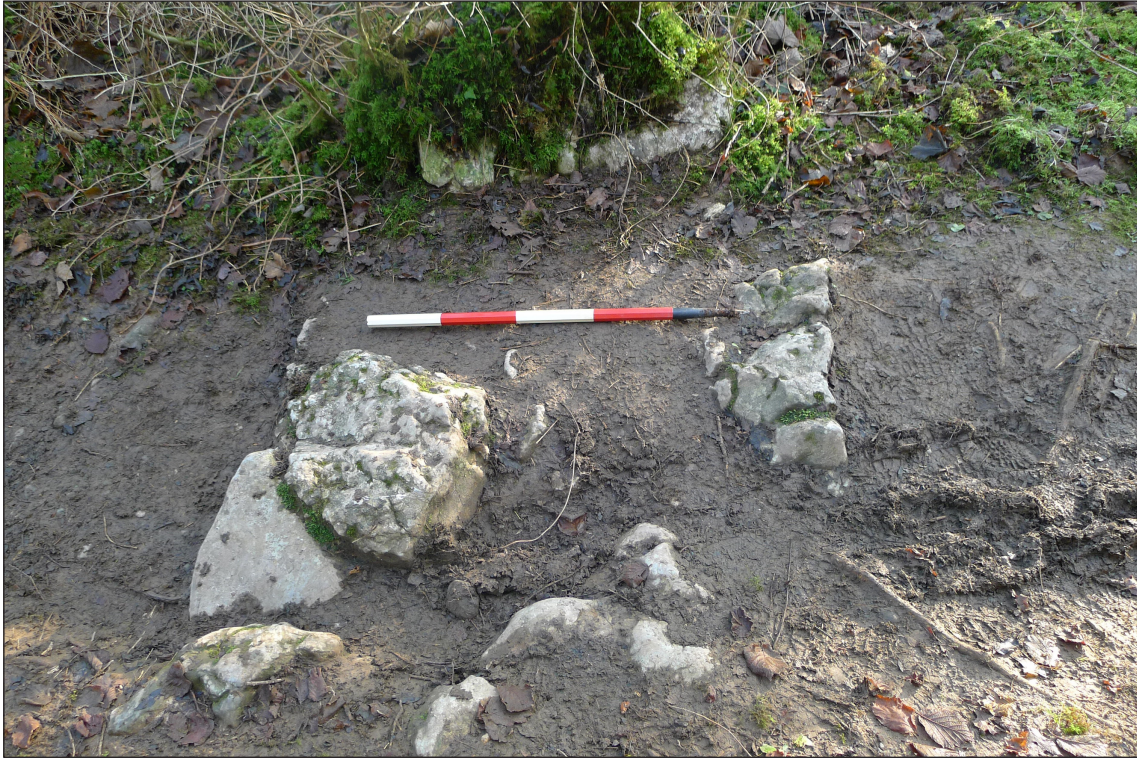
Figure 25. Close-up of the base of the middle circuit continuing through the floor of the eastern footpath (Image 00406019, Marcus Jecock 2017 © Historic England).

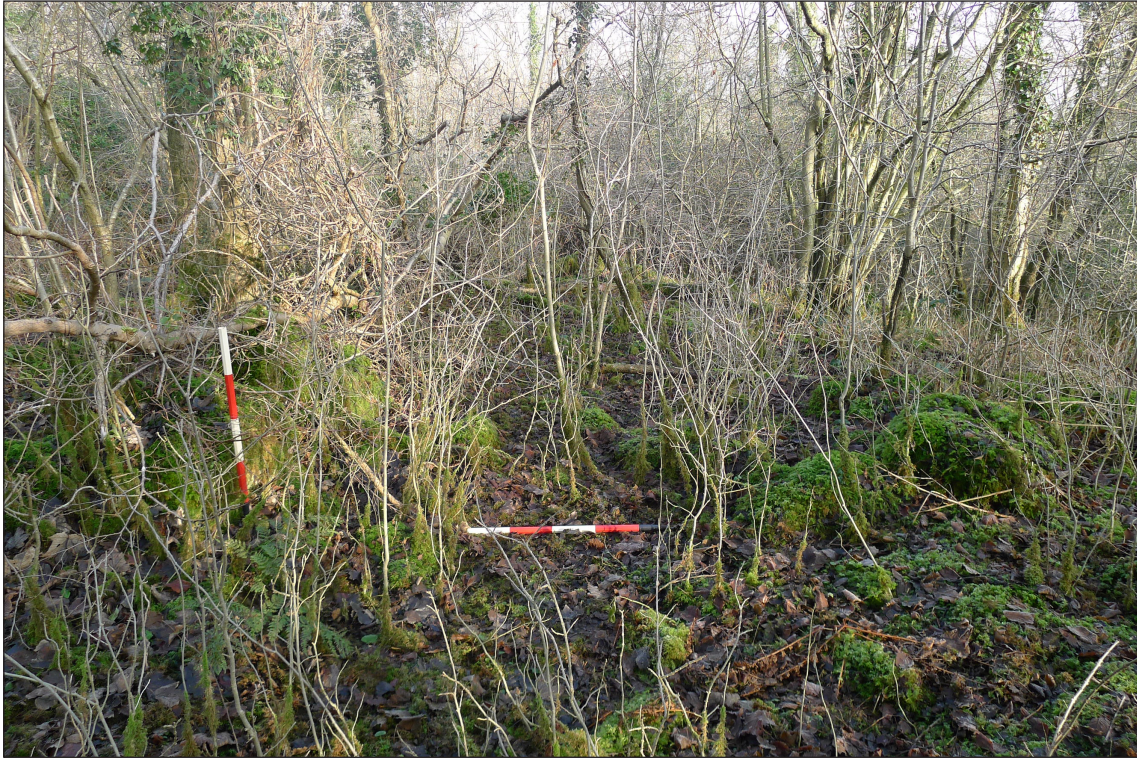
Figure 26. View north-east through the eastern entrance in the middle circuit (that just south of the eastern footpath). The vertical ranging rod at left of frame marks a tranverse orthostat that probably denotes the actual north side of the entrance passage. (Image 00406020, Marcus Jecock 2017 © Historic England).

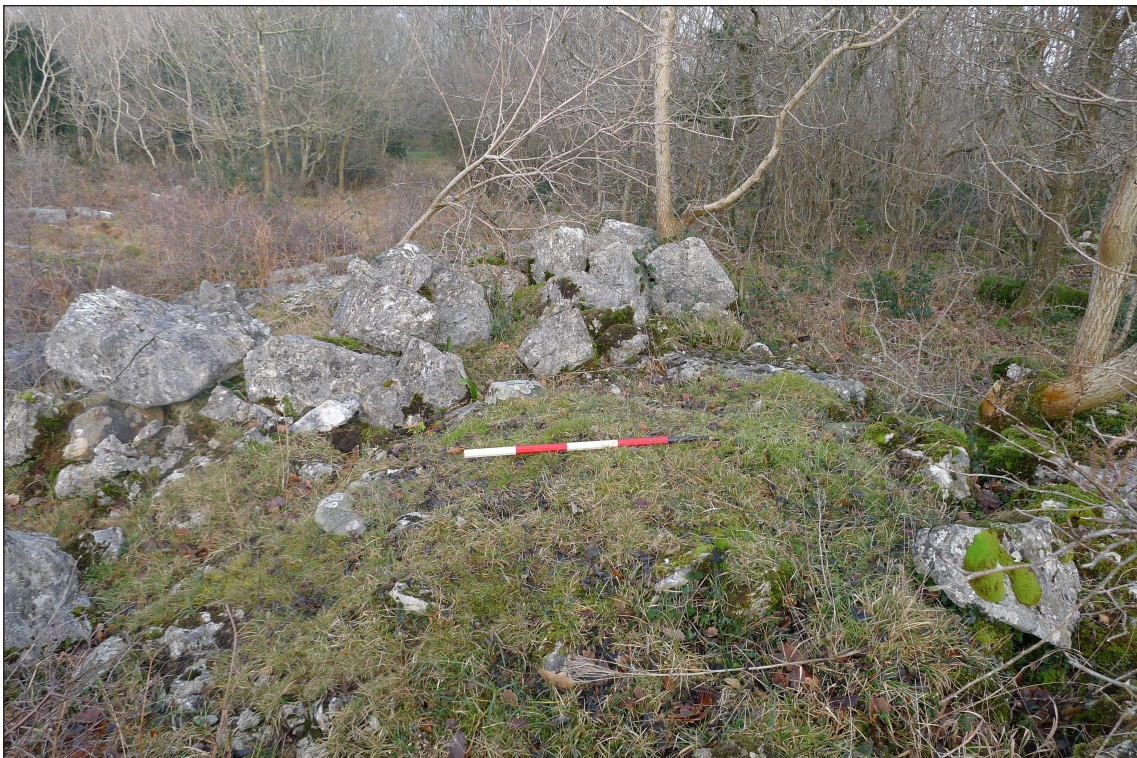
Figure 27. View of the disturbed stony bank defining the outer circuit about 30m in from the western escarpment. Looking north. (Image 00406026, Marcus Jecock 2017 © Historic England).

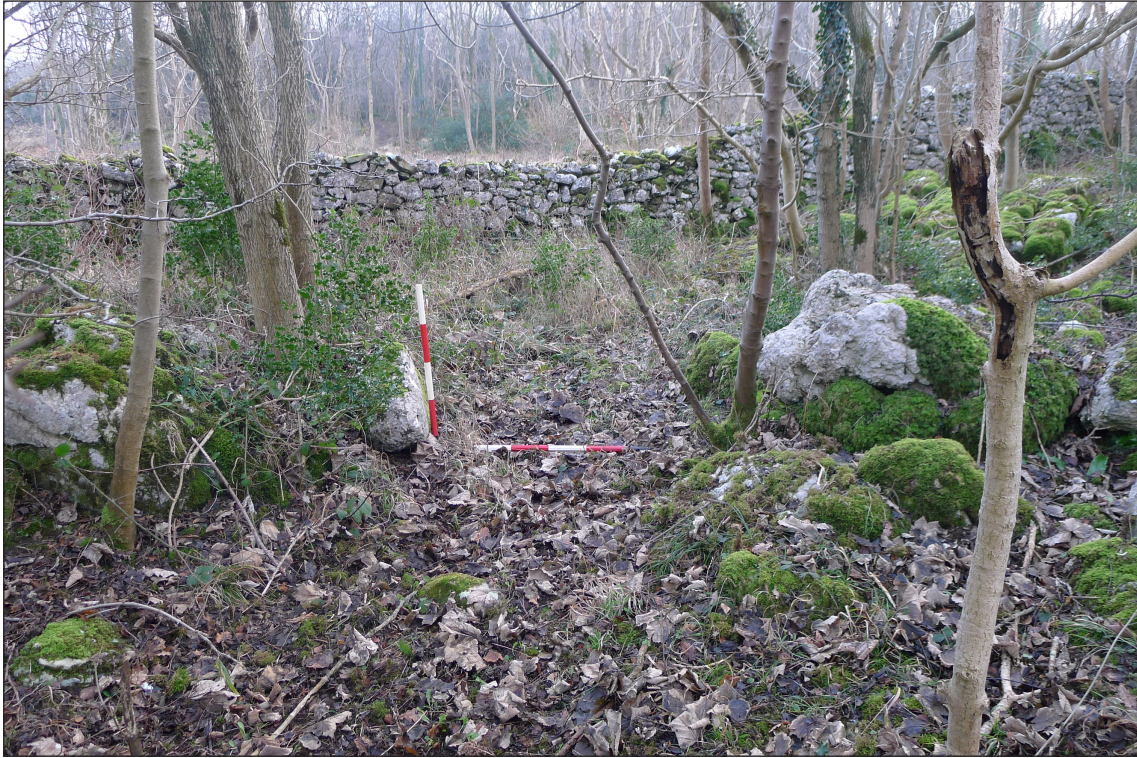
Figure 28. View south through the western entrance in the outer circuit (that in the woods north of the field wall). The vertical ranging rod at left of frame marks a possible transverse orthostat forming the east side of the entrance passage. (Image 00406027, Marcus Jecock 2017 © Historic England).

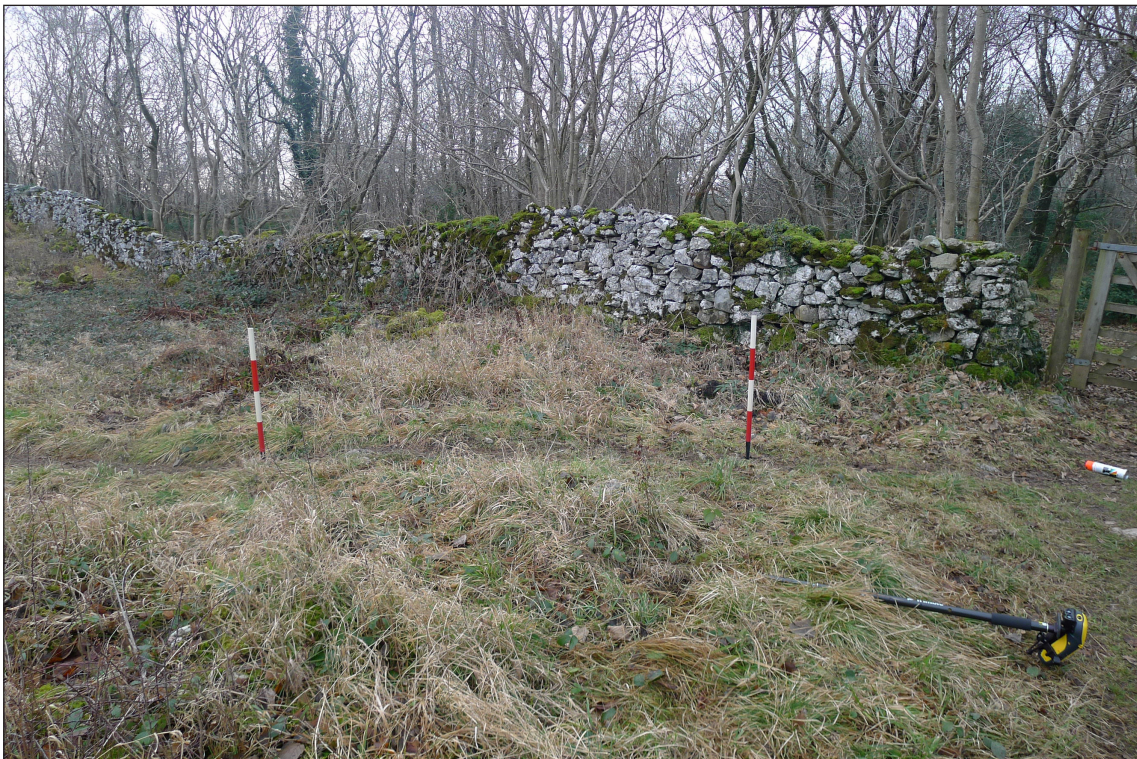
Figure 29. The outer circuit visible as a grass-covered bank immediately south of the field wall. Note how the field wall rises up and over the line of the prehistoric wall. (Image 00406028, Marcus Jecock 2017 © Historic England).

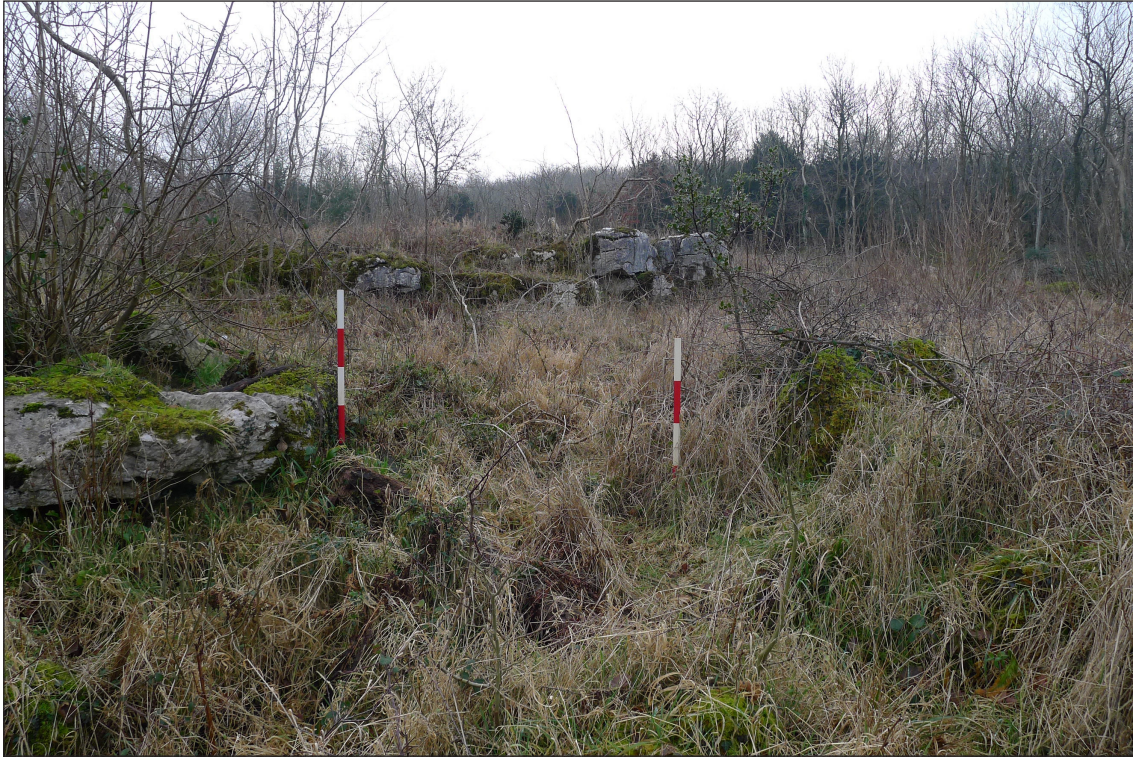
Figure 30. View south through the possible entrance in the outer circuit at NGR SD 49250 73046. The ranging rod at left of frame marks a possible fallen transverse orthostat. (Image 00406030, Marcus Jecock 2017 © Historic England).

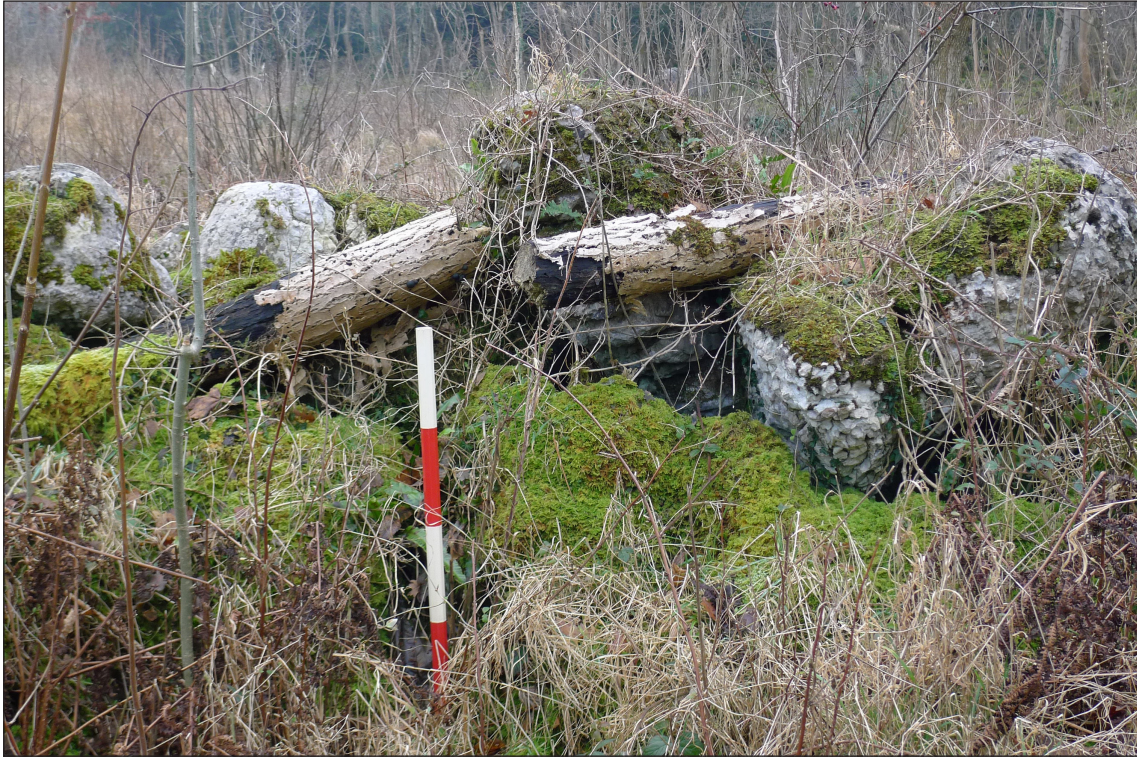
Figure 31. Detail of the external face of the highest-standing stretch of the outer circuit at NGR SD 49241 73048. (Image 00406029, Marcus Jecock 2017 © Historic England).

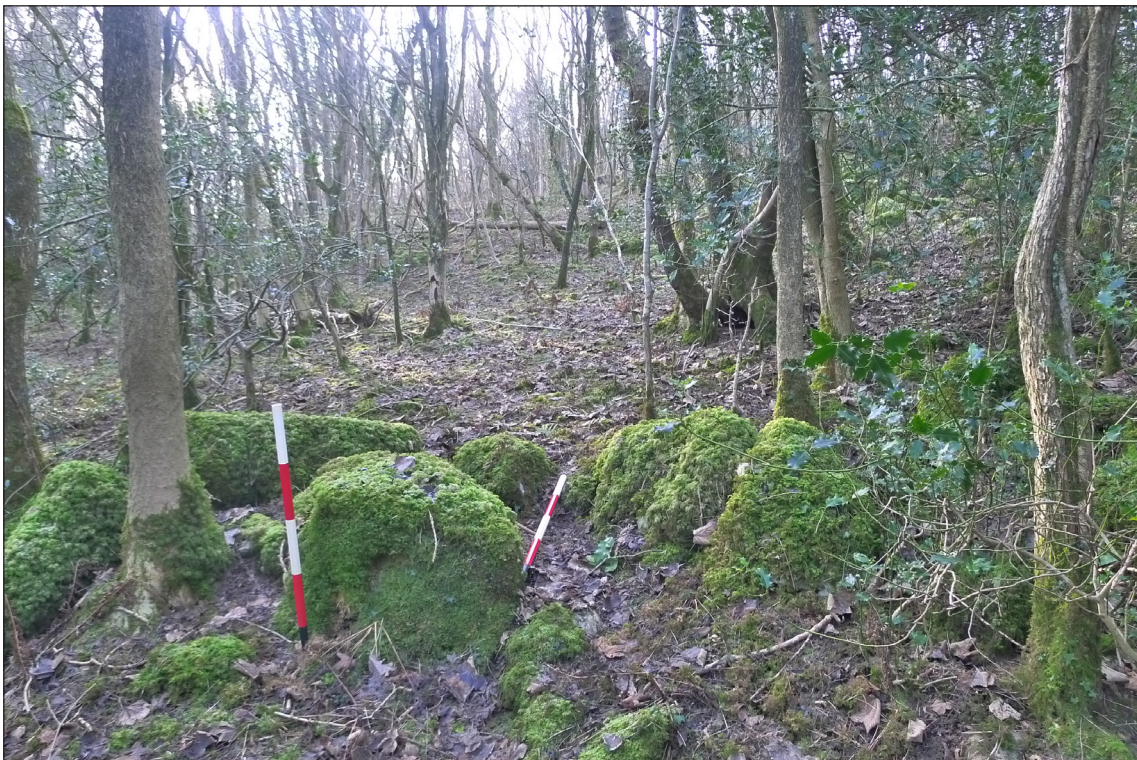
Figure 32. Looking south-west over the outer circuit into the interior of the enclosure from NGR SD 49327 73028 (just east of the boulder-walled stock pens). Note the level terrace immediately behind the wall with the ground rising up in the middle distance beyond. (Image 00406035, Marcus Jecock 2017 © Historic England).

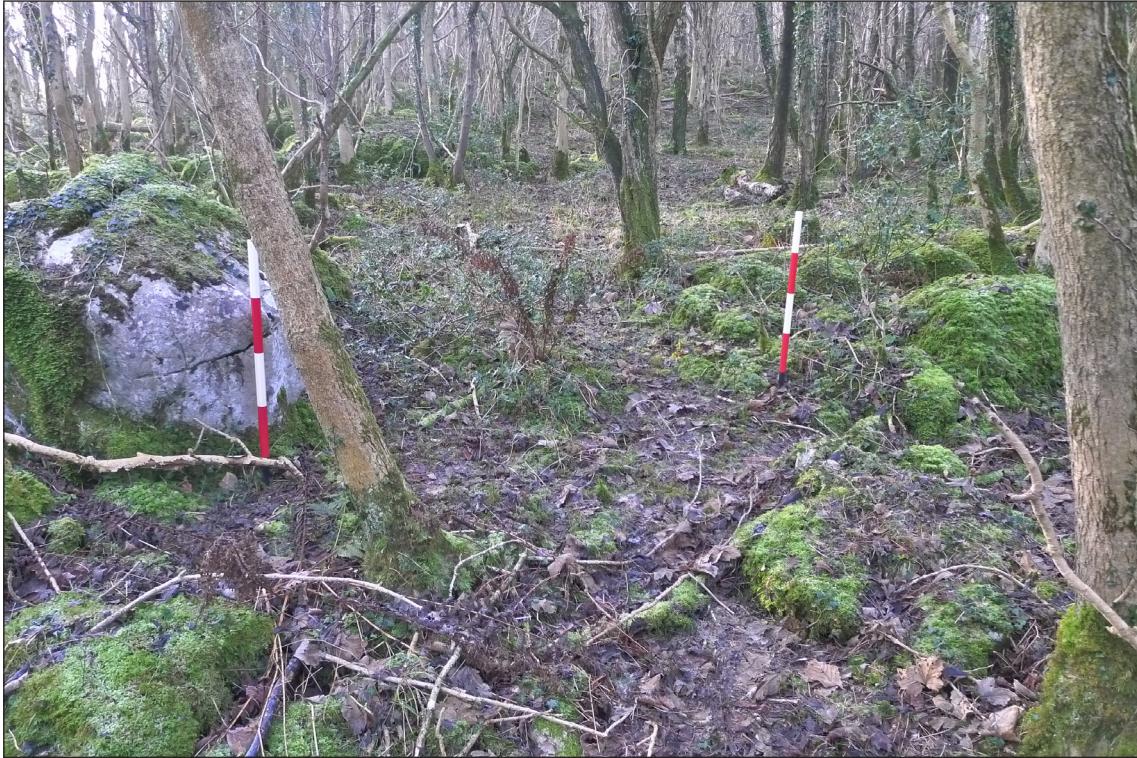
Figure 33. View south through the gap - a probable entrance - in the outer circuit at NGR SD 49375 73016. Note the large boulder 1.5m high at left of frame (behind the vertical ranging rod), which probably marks one side of the entrance passage. (Image 00406036, Marcus Jecock 2017 © Historic England).

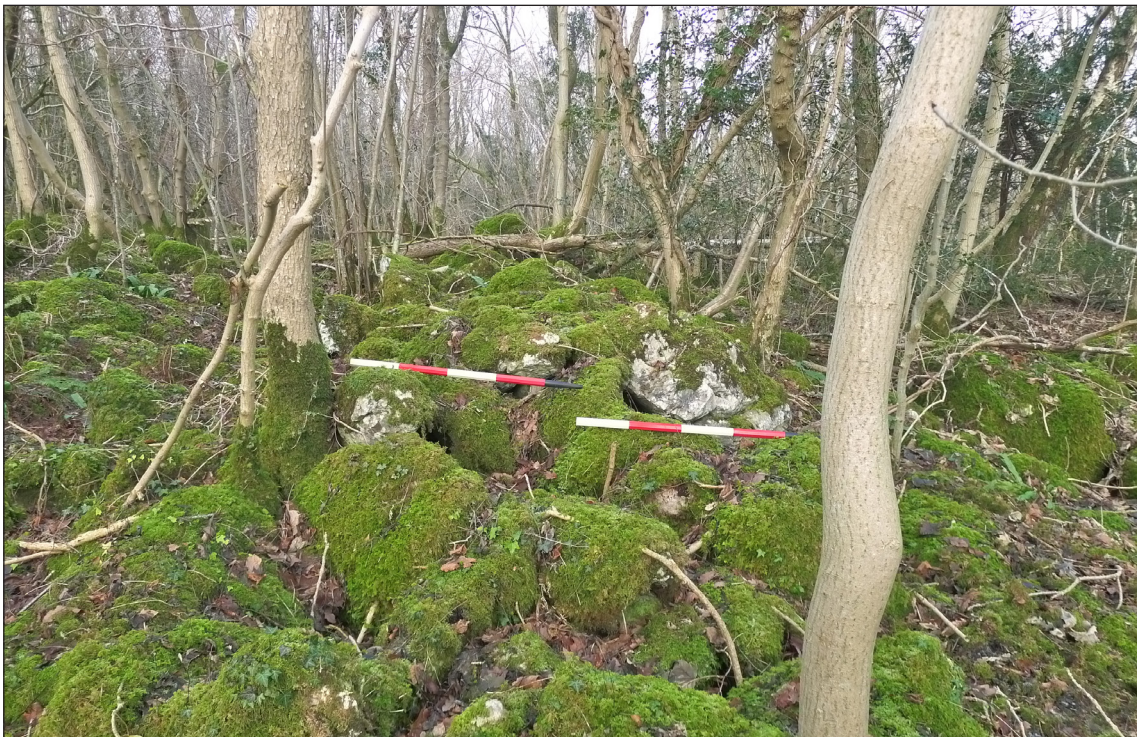
Figure 34. View south-east along the line of the outer circuit from NGR SD 49401 72976. (Image 00406037, Marcus Jecock 2017 © Historic England).

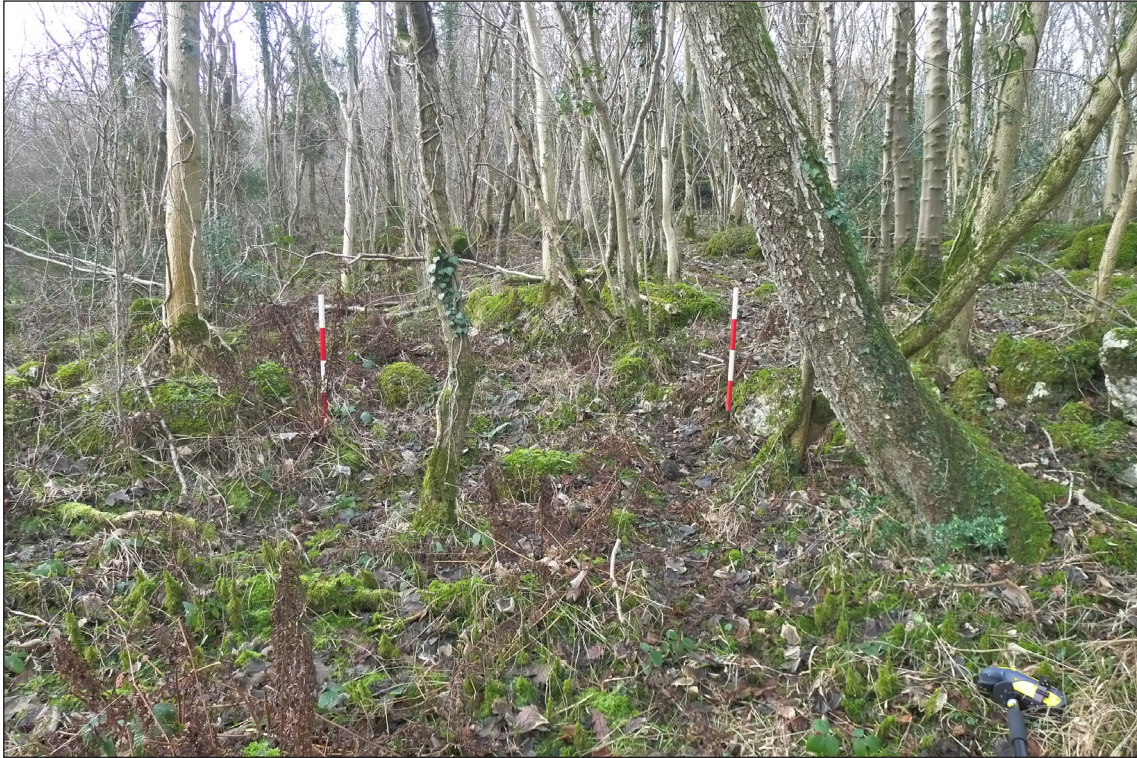
Figure 35. View south-west through the easternmost gap or possible entrance in the outer circuit at NGR SD 49407 72963. towards the interior of the monument. The vertical ranging rods mark the edges of the gap. (Image 00406038, Marcus Jecock 2017 © Historic England).

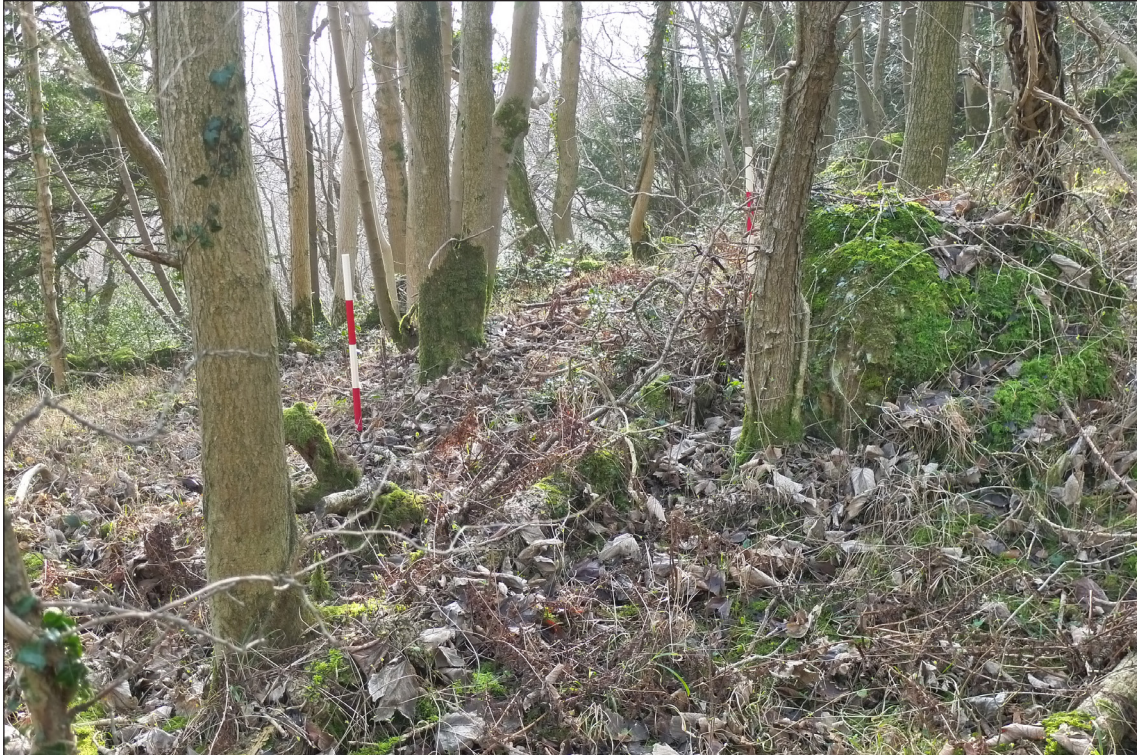
Figure 36. View south towards Beacon Breast of the outward-facing scarp marking the southern end of the outer circuit. (Image 00406040, Marcus Jecock 2017 © Historic England).
