THE SPAB RESEARCH REPORT 1.

U-VALUE REPORT

REVISED NOVEMBER 2012.

Caroline Rye and Cameron Scott

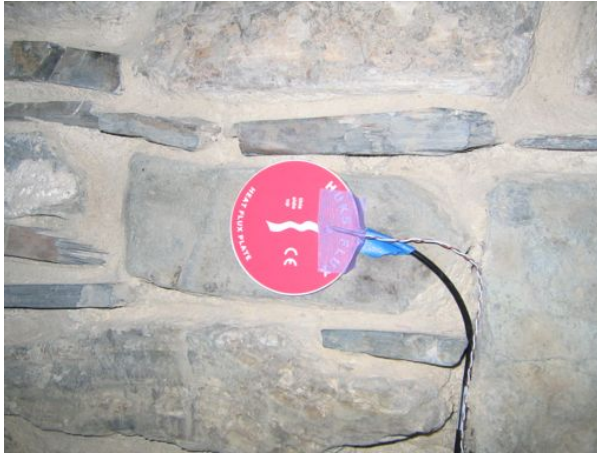
A Hukseflux HFP01 heat flux sensor is attached to the interior surface of the wall under investigation (Fig. 1). The sensors are 80mm in diameter and 5mm thick. The sensors were mounted by firstly applying a layer of double-sided adhesive tape to the back of the sensor. Secondly, low tack masking tape was applied to the wall. Finally, the heat flux sensor was applied firmly to the masked area. This arrangement was generally satisfactory for two or more weeks monitoring on painted or plastered surfaces. Wallpapered surfaces were not generally used in case of damage. On occasion, if a wall surface was uneven, such as a bare stone or limewashed rubble wall, it was necessary to attach the sensors using a small quantity of silicon sealant.

Figure 1. Heat Flux Sensor and surface temperature thermocouple.

Sensor locations were chosen to avoid probable thermal bridge locations near to windows, corners, etc., with the sensor ideally located about halfway between window and corner, and floor and ceiling. In addition, a thermographic camera was used to survey the internal face of the wall to ensure a general uniformity of surface temperature and thus establish a representative site for the placement of the sensor (Fig. 2). The heat flux data was logged on a Campbell Scientific CR1000 data logger. The Campbell data logger also recorded the surface temperature of the same wall using a type-T thermocouple taped onto the surface of the heat flux sensor (Fig. 1).

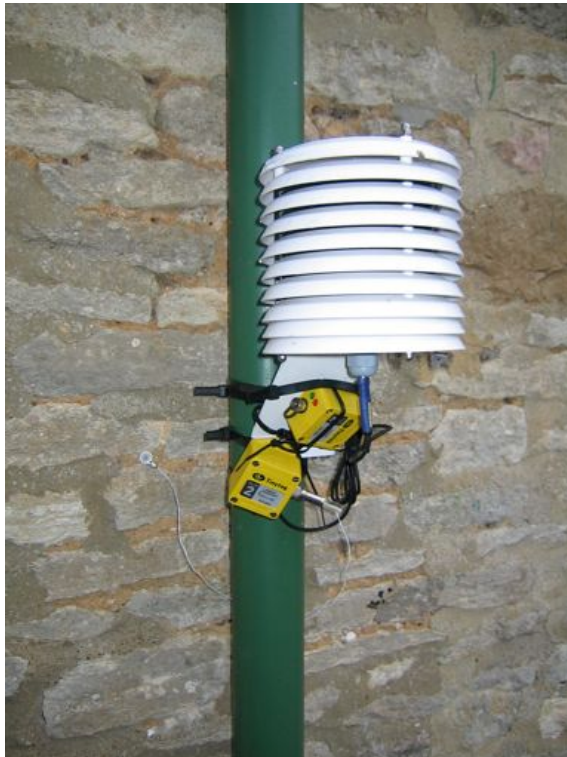
External temperatures were measured using a separate Gemini TinyTag Plus 2 TGP-4520 data logger which could be mounted outdoors. Thermistor probes were used to measure external air temperature and, generally, external wall surface temperature. Each external air temperature sensor was placed in a radiation shield which was secured, for example, onto a drainpipe (Fig. 3). Crimp-on terminals were used to fix surface temperature sensors to mortar joints, by drilling and plugging joints. Figure 3 shows the method of mounting external surface temperature sensors. In some cases external surface temperature sensors were not used either to avoid damaging the exterior surface of the building, for example, a rendered finish, or owing to difficult access.

Figure. 3. Air and surface temperature sensors.

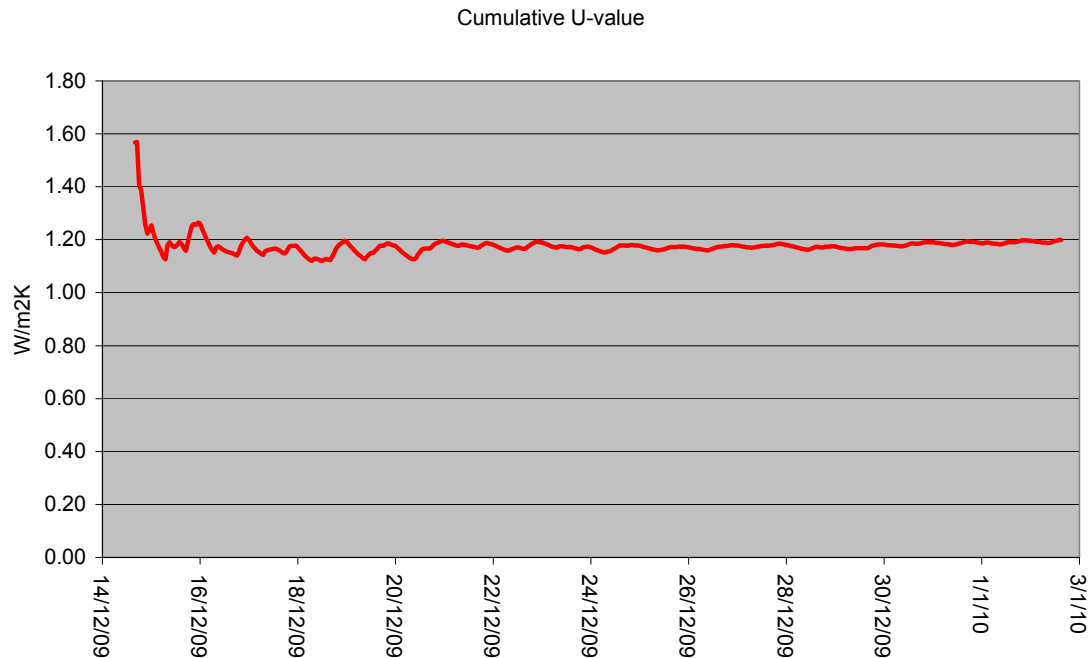
The U-value figure can then be plotted against time to check the quality of the data, i.e. variations should damp down and the value should approach an asymptote. Figure 4 shows the effect of increasing the length of the

monitoring period on the estimate of the U-value using the averaging procedure as described above. A period of at least a week is required before the U-value estimate stabilises to within $\pm 5\%$ of the final value determined from about 27 days data.

Figure 4. The stabilising effect of durational monitoring. (from Baker, 2010.³)

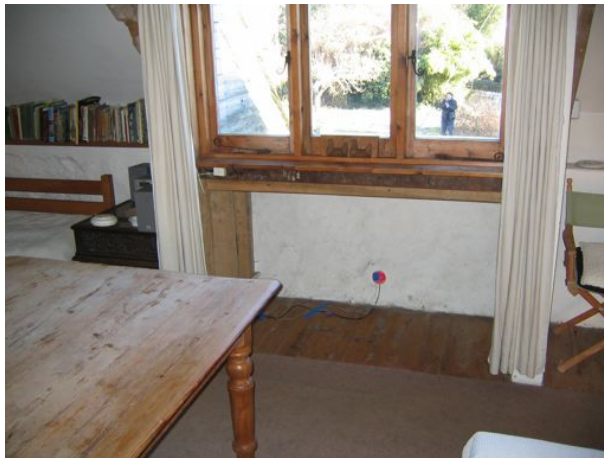
There are three *in situ* U-value results which are widely divergent from those measured on similar materials in the study. The U-value of $0.76 \text{ W/m}^2\text{K}$ for a 615mm thick granite wall recorded at Higher Uppacott (5c) seems extremely low. Conversely, the value $2.26 \text{ W/m}^2\text{K}$ for a 510mm cob wall recorded at Oxenholm Farm (7b) seems high and at this location there is the possibility of thermal bridging affecting the final result due to poor sensor placement in close proximity to an intermediate floor (Fig. 5). Example 9b from a house in Farrington in Oxfordshire gives a figure of $1.05 \text{ W/m}^2\text{K}$ for a limestone rubble wall. When plotted against similar wall types this figure does not conform to an overall trend and therefore may possibly be treated as an outlier or is the result of a high proportion of mortar and voids within that particular wall construction (Fig. 6).

Figure 5. Cob sensor placement at Oxenholm Farm (7b).

Previously it had been thought that the figure for the cob wall from Oxenholm (7b - 2.26 W/m²K @ 510mm) was questionable due to possible sensor placement error (see page 17.). Subsequently, more *in situ* U-value data has

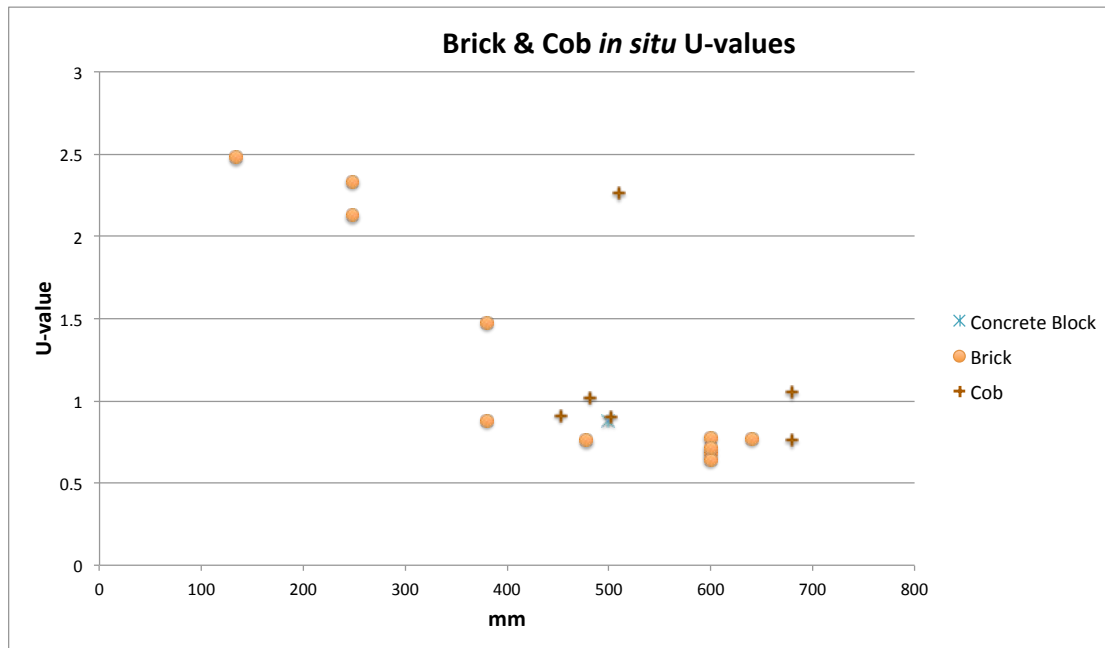
Figure 9. Brick and Cob *in situ* U-values 2012.

been gathered for cob walls, both earth and chalk, and this would seem to confirm the 7b Oxenholm U-value as erroneous (Fig. 9).

The U-values plotted for brick walls shown in Figure 9 once again demonstrate the relationship between increased wall thickness and declining U-values where the highest U-value, $2.48 \text{ W/m}^2\text{K}$ is actually for a brick infill panel within a timber-frame, effectively a wall half a brick thick (1c, Blewbury). Conversely, lower U-values are achieved from a group of much thicker walls measured at New Court, Trinity College, Cambridge. These walls are in total 600mm thick (consisting of 22.5" brick walls with a variety of internal and external finishes) and measured U-values of between $0.64 - 0.78 \text{ W/m}^2\text{K}$ (26a - 26e). With the addition of these measurements from the walls at Trinity College it may be possible to see a range for brick walls emerging (Fig. 10).

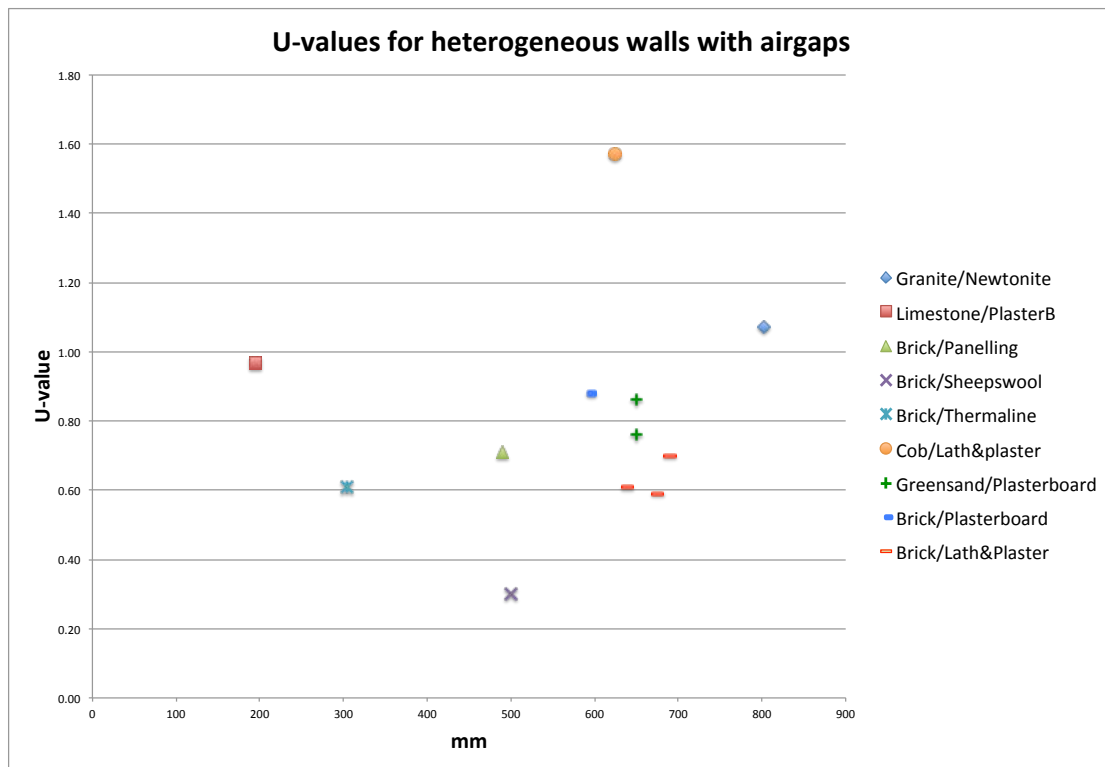
Figure 12. *In situ* U-values for lightweight heterogeneous walls with air gaps 2012.

The historic examples of brick wall linings (timber paneling at Spital Square, 12b = 0.71 W/m²K and lath and plaster at New Court, 26f = 0.59 W/m²K & 26g = W/m²K) all measure fractionally lower U-values than un-lined equivalent walls at the same locations and in general represent some of the lower U-values given in Figure 12. By referring to the U-value ranges plotted for Limestone and Granite walls shown in Figure 8 it is possible to see that the addition of a plasterboard drylining for the limestone wall at Bradford on Avon

There are some walls which have received an additional treatment without the incorporation of an air gap or cavity where brick walls have been subject to either external or internal insulation using expanded polystyrene, insulating lime render, reedboard, woodfibre board or hemcrete. Some of the walls that do not incorporate any form of air gap combine two materials as panel infills for timber-frames; one being the traditional treatment of wattle and daub and others more modern interventions such as the addition of reedboard or hemcrete to existing brick and timber stud work or another example where the original panel infill material has been replaced with sheep's wools combined with a woodfibre board (Fig. 12).
