# UB-31 Folkestone, Kent

Archaeological Report

Ref: 83803.32  
December 2014

**Prepared for:**  
English Heritage

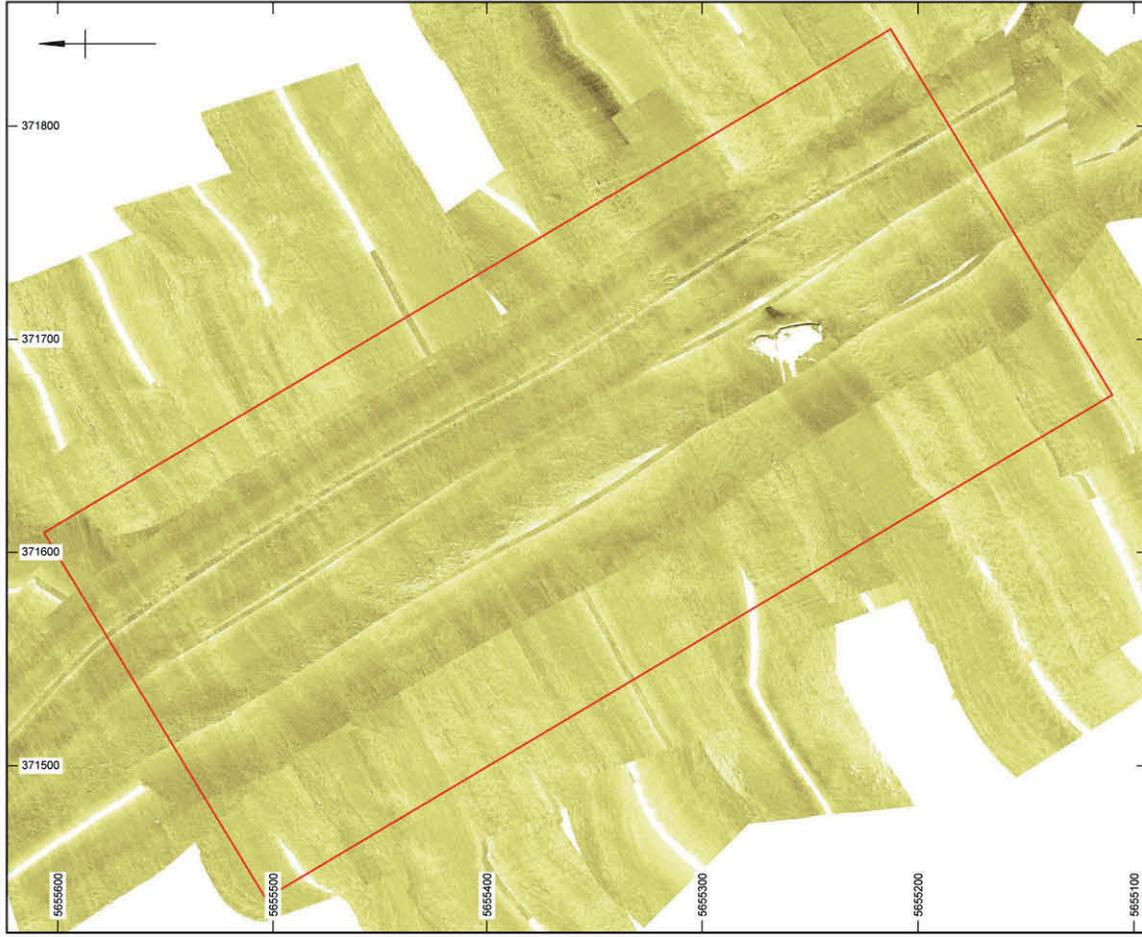
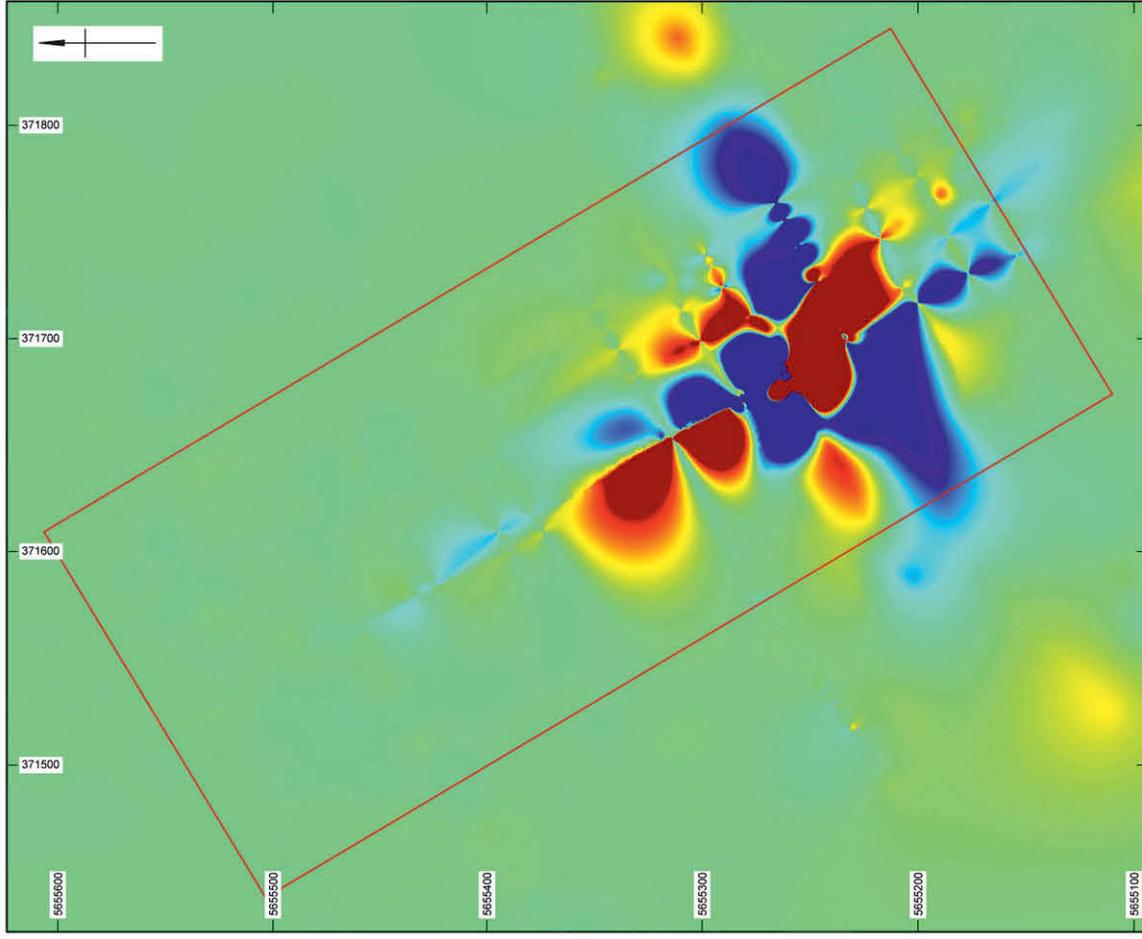
Figure 2

Sidescan Sonar Mosaic

Gridded Magnetometer Data (+/-50nT)

Sidescan Sonar Mosaic and Gridded Magnetometer Data

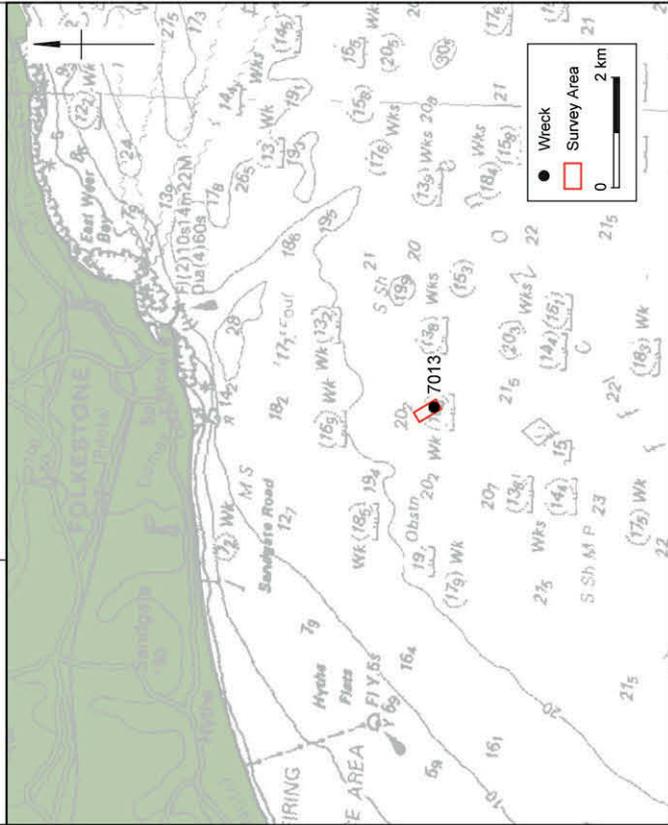
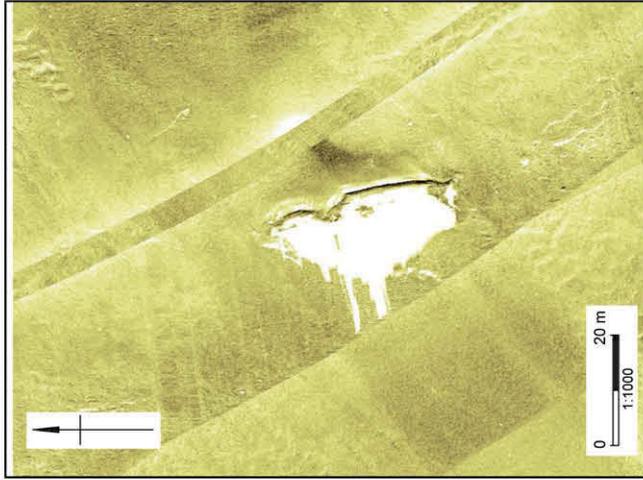
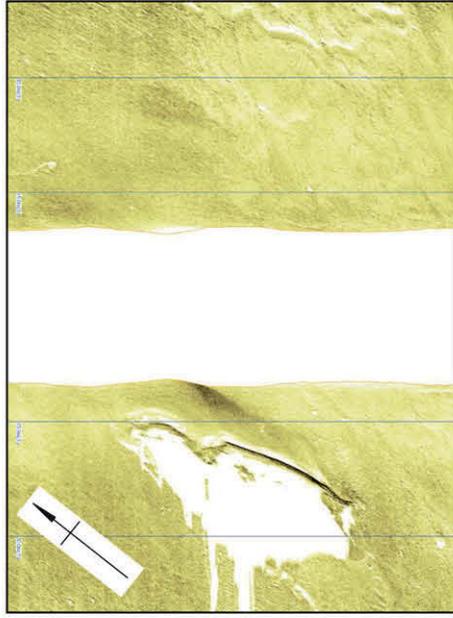
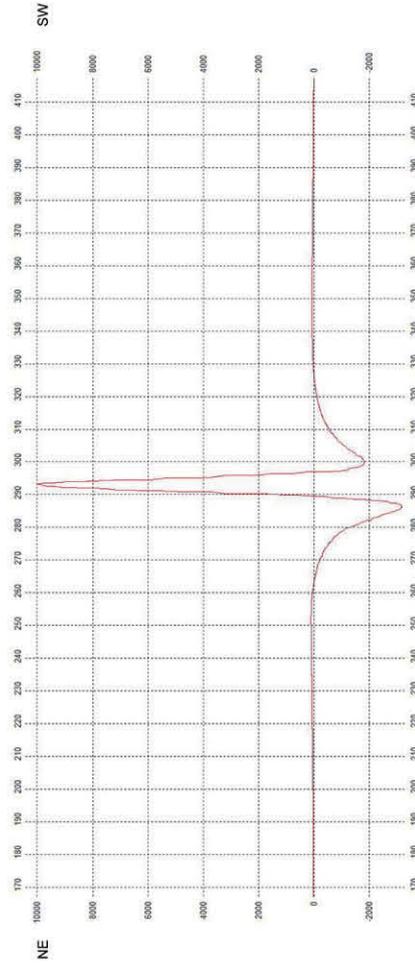
Figure 3

<b>Location</b>		371702 E, 5655261 N (UTM31N) 51° 02.074' N, 001° 10.211' E (WGS84)
<b>Geophysical survey dimensions and notes</b>		Dimensions: 40.7m x 8.6m x 4.5m. Distinct outline of a mainly coherent structure, exhibiting significant height. Appears relatively intact, though a large bend/hole in the hull visible on one side. Little associated debris, and very little sediment scouring. Associated with a very large (13161nT) magnetic anomaly.
<b>Build</b>	<b>Type</b>	Submarine
	<b>Construction</b>	
	<b>Dimensions</b>	
	<b>Shipyard</b>	
<b>Loss</b>	<b>Cause</b>	Reportedly lost after being depth charged and then detonating a mine whilst on patrol in the Straits of Dover in 1918
<b>Extent of Survival</b>		The UKHO record this wreck with a minimum depth of 16.6m, last surveyed in 1997. The wreck is noted to be generally intact but listing to port and with a large hole in the hull forward of the conning tower. Wreck is interpreted as being the UB-31, though it has not been definitively identified.

7013: Sidescan sonar mosaic

7013: Sidescan sonar waterfall

7013: Magnetometer profile over UB-31, 13161nT

- 4.2.2 Wreck *UB-31* is located in approximately 20m depth of water and has been identified approximately 15m NNW of the UKHO recorded location (assuming the interpreted conning tower as the surveyed position). Subsequent diver survey has indicated that the bow is located to the north. The main body of the wreck (**7013**) appears relatively intact and upright, and has been found orientated approximately NNW-SSE and measuring approximately 40.7 x 8.6 x 4.6m (**Fig 2-3**). A large shadow in the centre suggests the conning tower is intact and in place. However, the forward starboard side of the wreck appears damaged, with a significant bend (or possible hole) in the hull being easily visible in the data (**Fig 4 - Sheet**). This again has been confirmed as significant damage to the hull by diver survey. The wreck is associated with a very large (13,161nT) magnetic anomaly.

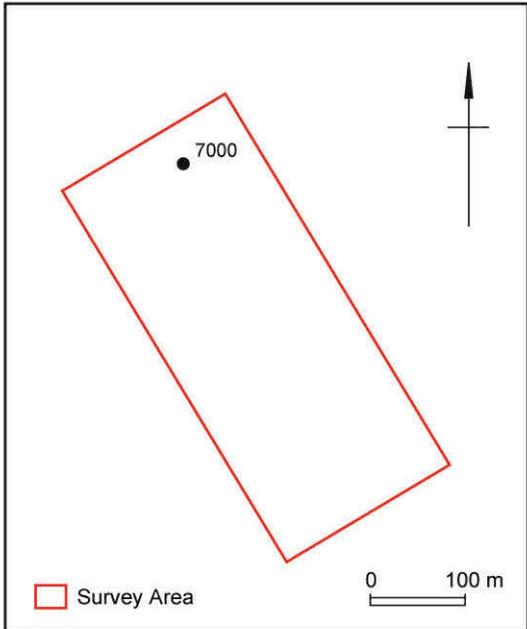
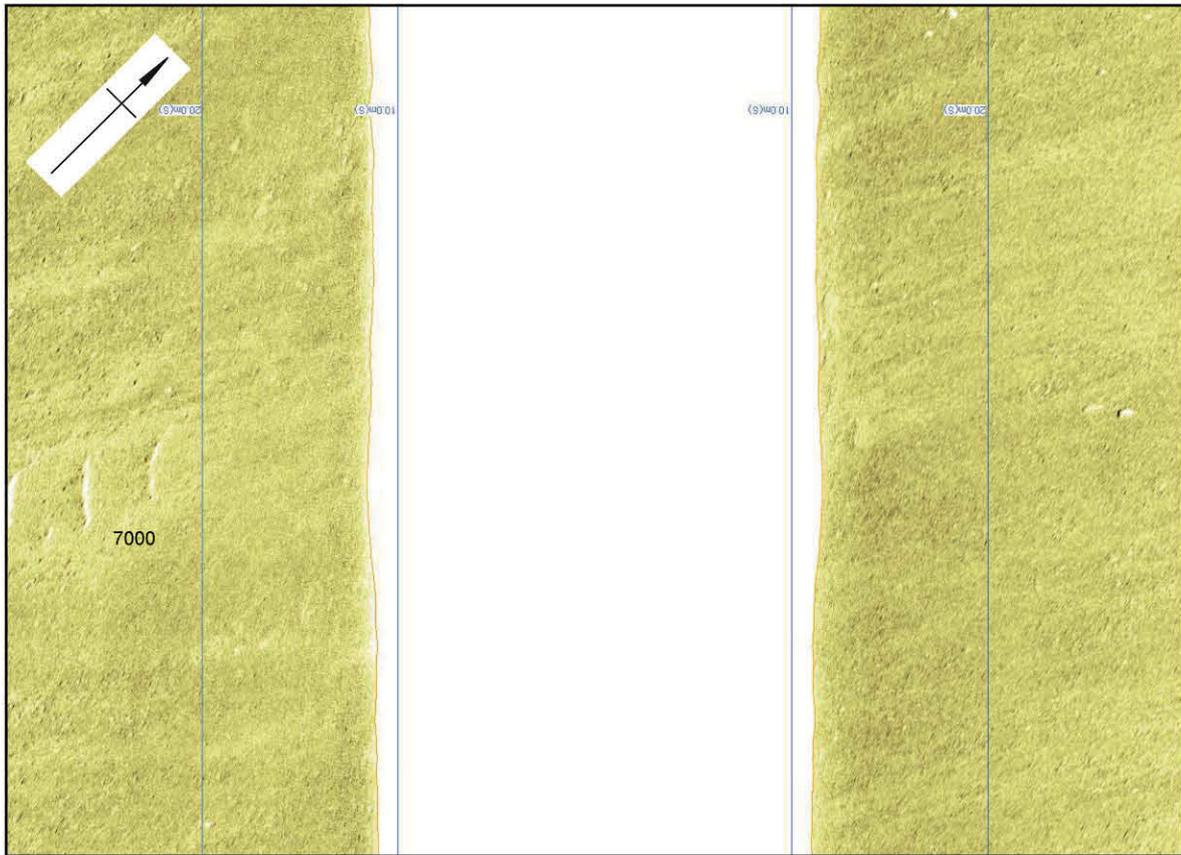
Figure 5

Sidescan Sonar Data Example of 7000

- 4.2.11 Of greater potential interest is anomaly **7000**, identified approximately 65m NNW of the recorded location of UKHO 13486, interpreted as a possible debris field. This feature is characterised by three short, linear, parallel bright reflectors within a small area of possible disturbed seabed sediment (**Fig 4**). This could be three parallel pieces of non-ferrous debris, such as wood, and as such could represent the remains of a degraded structure. However, it could also be an isolated natural accumulation of seabed sediment.

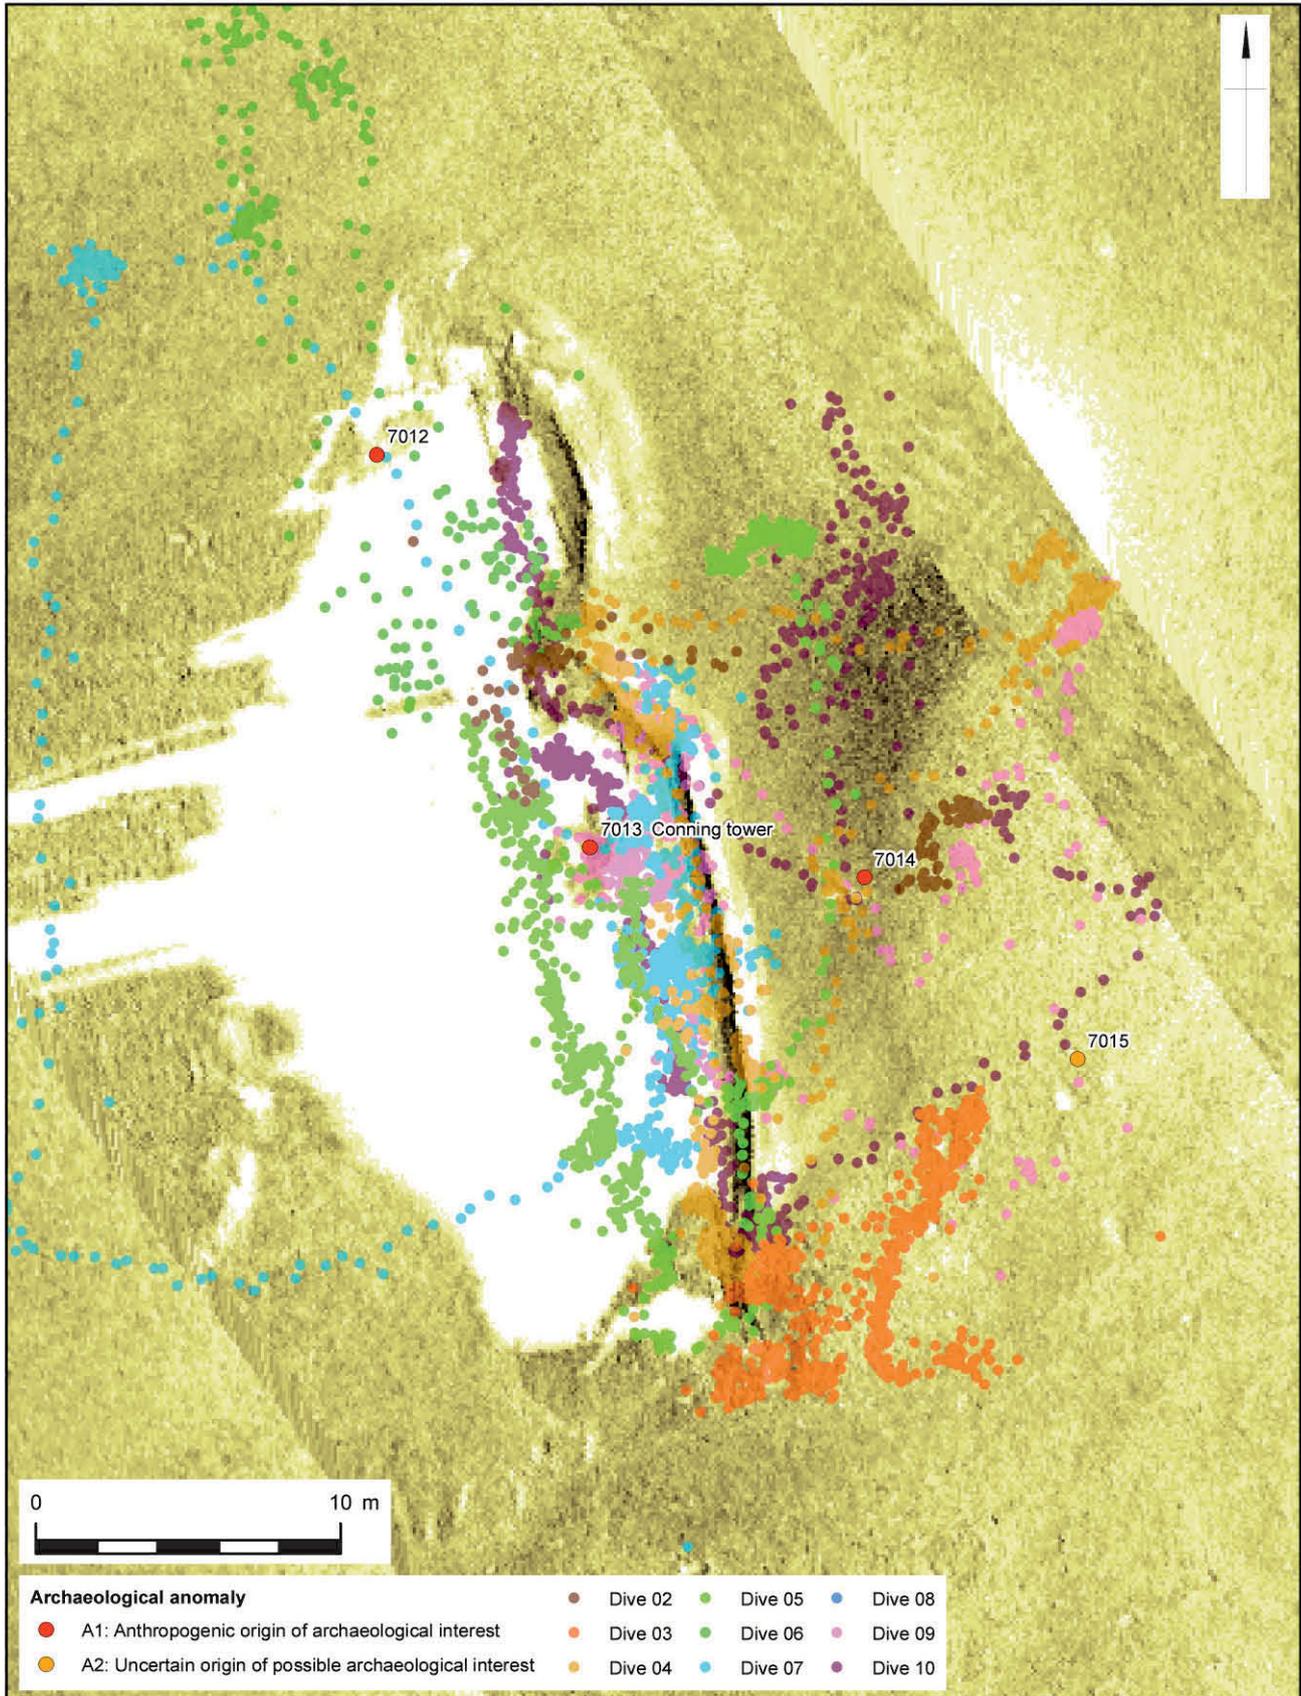
Figure 6

4.7.6 As shown by the SSS image (**Fig 6**) the bow is slightly displaced, the plating is missing and the pressure hull damaged. On the starboard side just fore of the gun mount there is

Sidescan sonar with dive tracks and archaeological anomalies

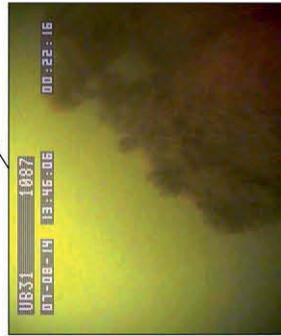
1037

- 4.7.11 As stated previously, forward of the gun signs of severe damage that compromise the pressure hull are visible and are consistent with an explosion. The torpedo loading hatch was not located and considering that the area forward the gun deck is severely damaged it is possible that it had been displaced at the time of the sinking. However, the hinge of the crew deck hatch just above the torpedo loading hatch is visible in the diver's footage and appears to be closed (**Plate 1 – 1037**).

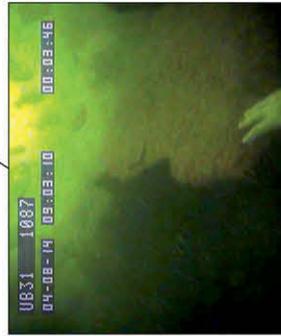
1023

the southern edge of the damaged area corresponding with a large cavity further forward with considerable amounts of debris and twisted metal (**Plate 1 – 1023**).

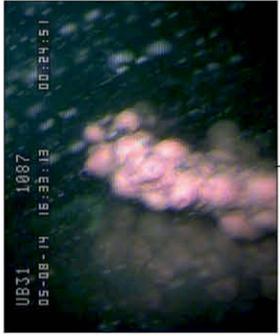
1024

- 4.7.22 On the pressure hull at the centreline toward the stern, remains of the exhaust system of the two 142ps Benz diesel engines can be found. They consist of pipework of c. 120mm diameter attached to a large cylinder with one flat face whilst the other appears to be flanged to a conical tube. The exhaust piping and terminal are covered by white anemones (**Plate 3 – 1024, 1025, 1026**).

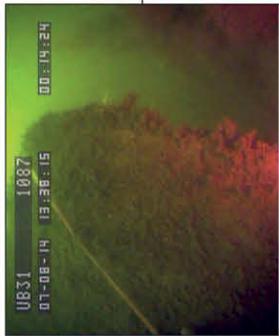
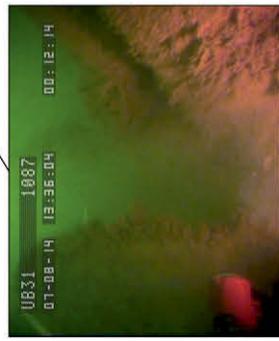
1032

- 4.7.23 The inspection of the stern revealed it to be largely complete and well exposed with the aft hydroplanes *in situ* and in diving position at a 45 degree angle (**Plate 3 - 1032, 1033**). It is unclear if the position of the hydroplanes is the position selected at the time the boat sunk or due to disturbances post-deposition. The port hydroplane is partially buried and modern debris such as a rope was found nearby. No other debris was found further to the south.
- 4.7.24 The plating of the rudder itself is gone and the shape of the rudder is indicated only by three horizontal braces that are still in place and pivoting on the rudder post. The rudder post appears to be good condition and the upper pintle that attached the rudder block onto the stern was observed (**Plate 3 – 1012**).

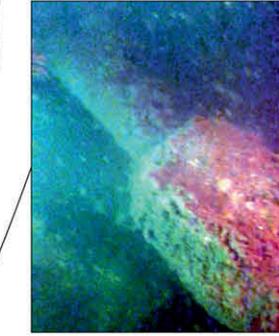
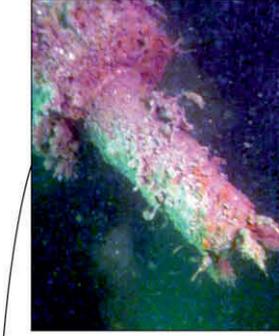
1010

- 4.7.25 The two bronze propellers were not found and the stub of the shaft of the starboard propeller suggests that they are likely to have been salvaged (**Plate 3 – 1010, 1011**). The lateral fin that protected the propeller is damaged. The survey for locating the portside propeller was inconclusive due to lack of visibility during the dive but it is very likely that it had been salvaged as well.

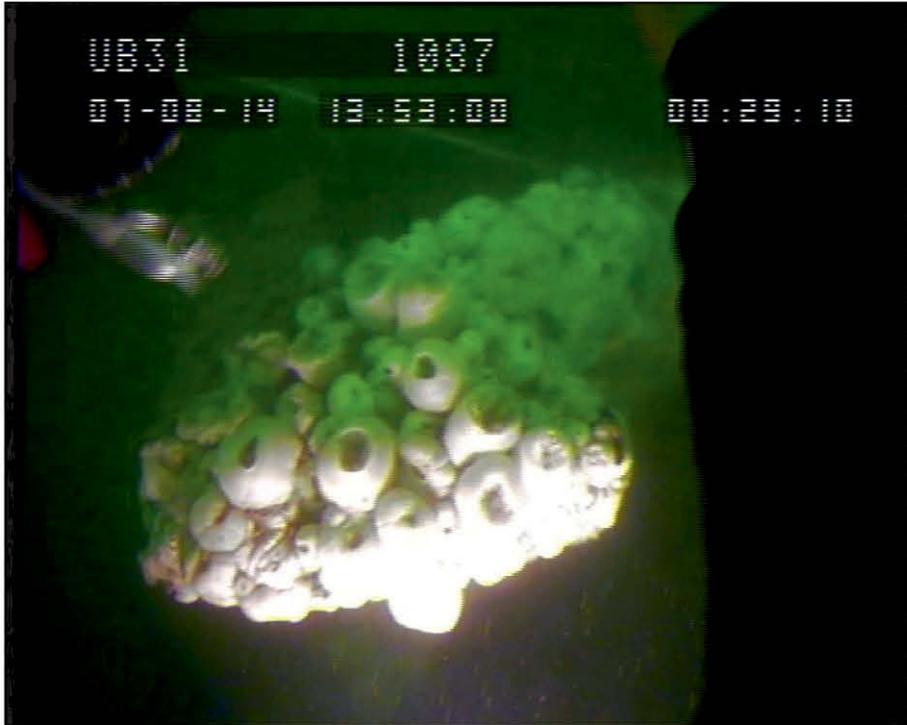
Plate 4: Anomaly 7014 – Anchor

- 4.7.26 An anchor was found E of the wreck. The extant shank measures *c.* 1m and from the video footage it seems to have a rounded section; the exposed curved arm is estimated *c.* 700mm long. The remaining arm is buried in the seabed and no stock was found attached to the shank although it is unclear whether the shank is surviving on its entirety or it is damaged. The anchor was not positively identified although the fluke is similar to an Admiralty Pattern anchor fluke (**Plate 4**). It is very likely that the anchor corresponds to the anomaly **7014** as their positions coincide.
