# NO. 75 PORTLAND PLACE CITY OF WESTMINSTER

*The Historical Significance of the Rear Staircase*

*Reports and Papers 58*

## 75 Portland Place, Westminster: Notes and observations following site visit 13<sup>th</sup> November 2001

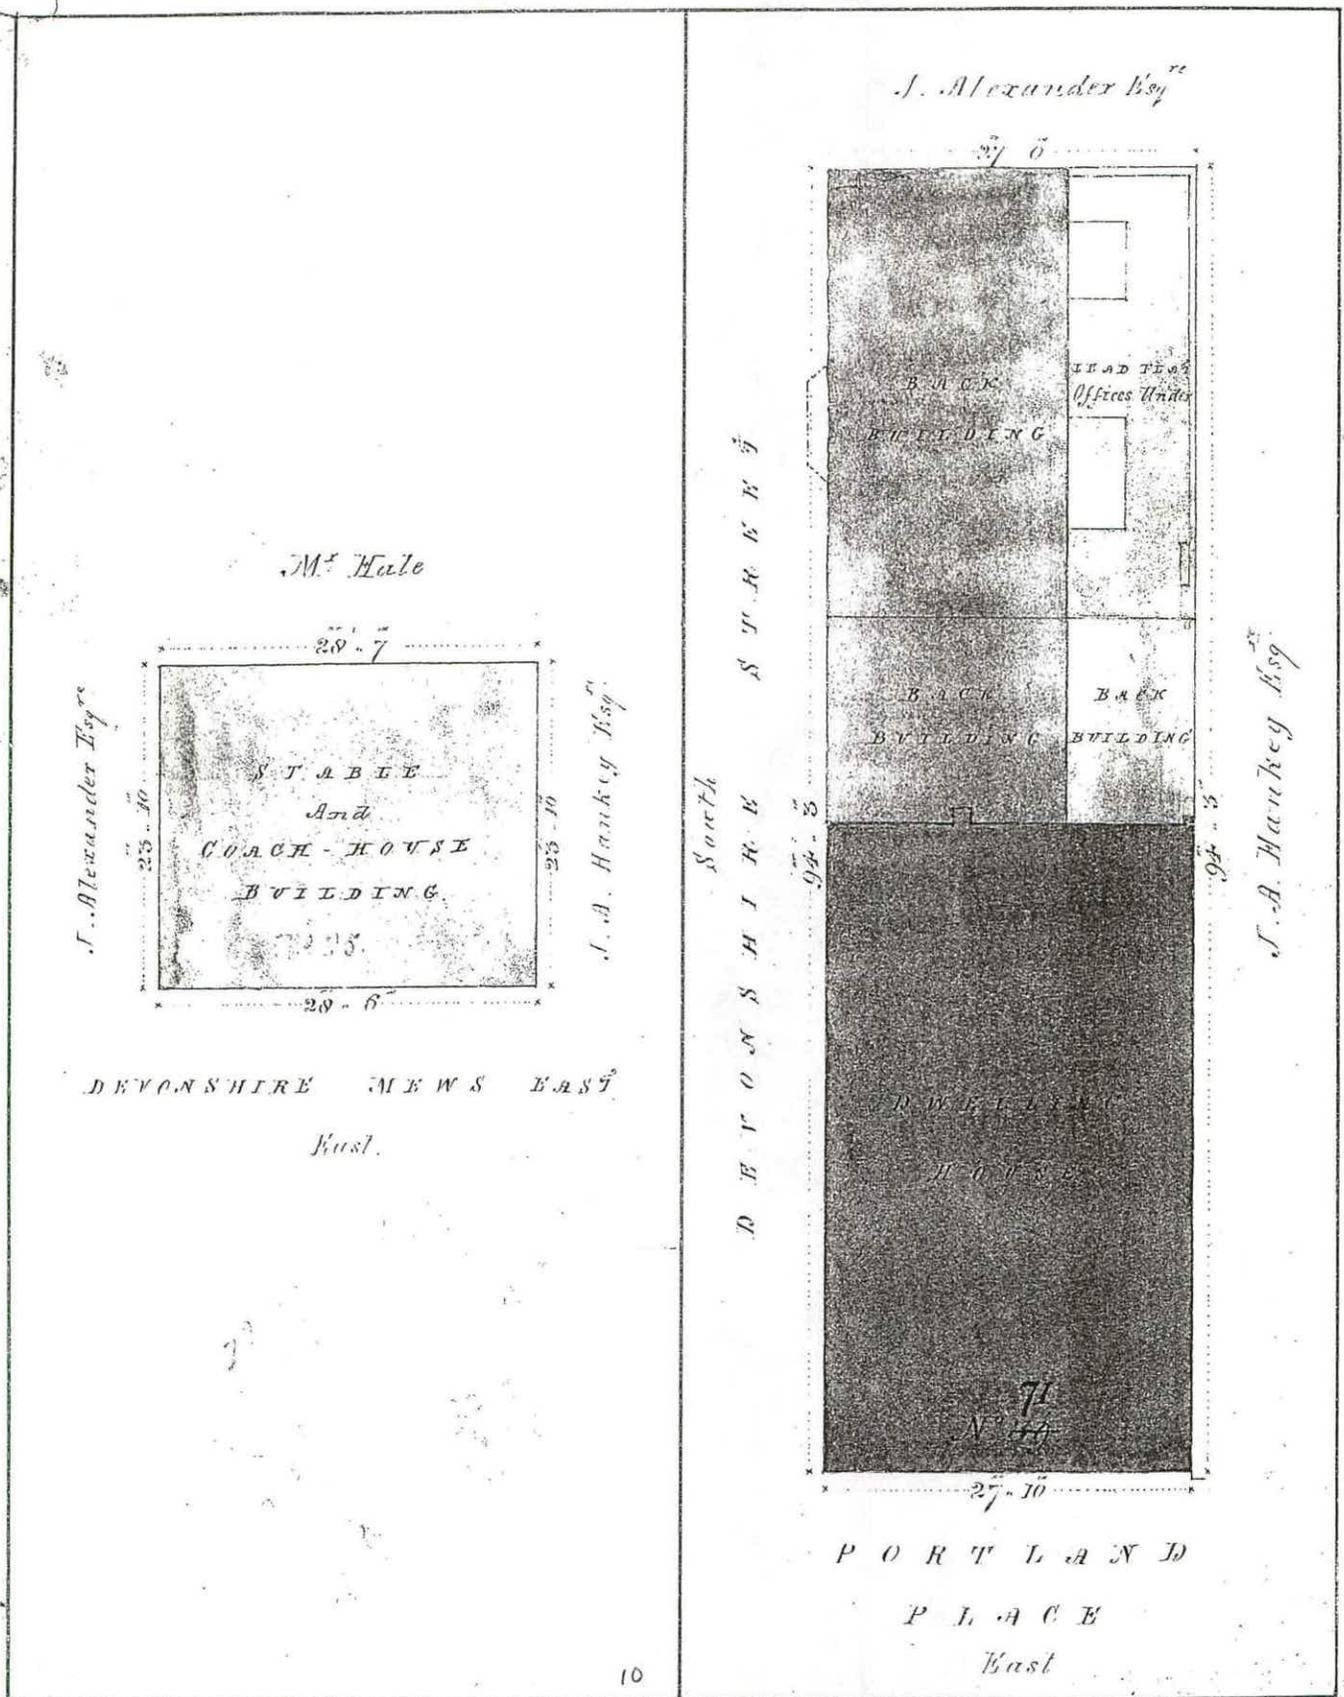
E.T. 10. <sup>71 form<sup>9</sup></sup> West side of Portland Place & North side of Devonshire Street, & Stable & Coachhouse Building West side of Devonshire Mews East. [1866] Block plan of 71 Portland Place, showing the original flat back wall ~~Northward Manuach~~ W. Tebb Esq<sup>r</sup> 2211

Clearly the historian has checked through early documents relating to the building of the house, including a thorough trawl of the Middlesex Deeds Registry volumes to identify the house and to find any plans. The one attached to the new assignment of the lease in 1865 is perhaps the most helpful piece of evidence which shows the

original flat back wall, (MDR 1865/21/463). This corresponds with the plan shown on Horwood's map of 1799, and the revised map of 1819. The 1865 plan also clearly shows the addition of the circular stair compartment at the back of the house, and an even later addition which was probably a billiard room, but which has since been demolished.

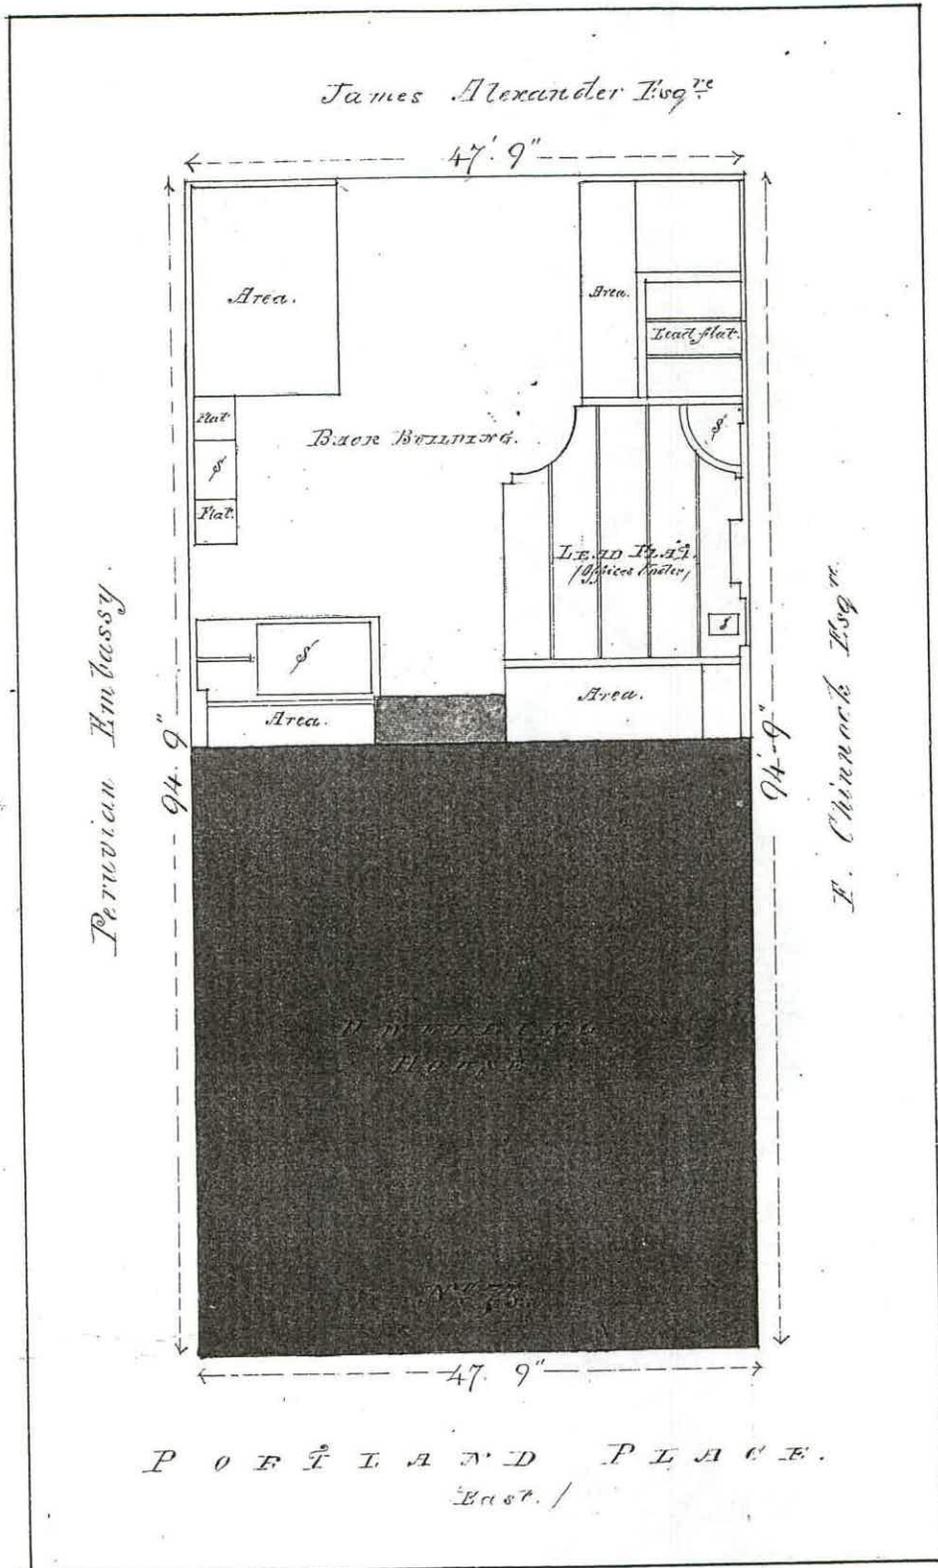
Block plan of 73 Portland Place, showing the original flat back wall

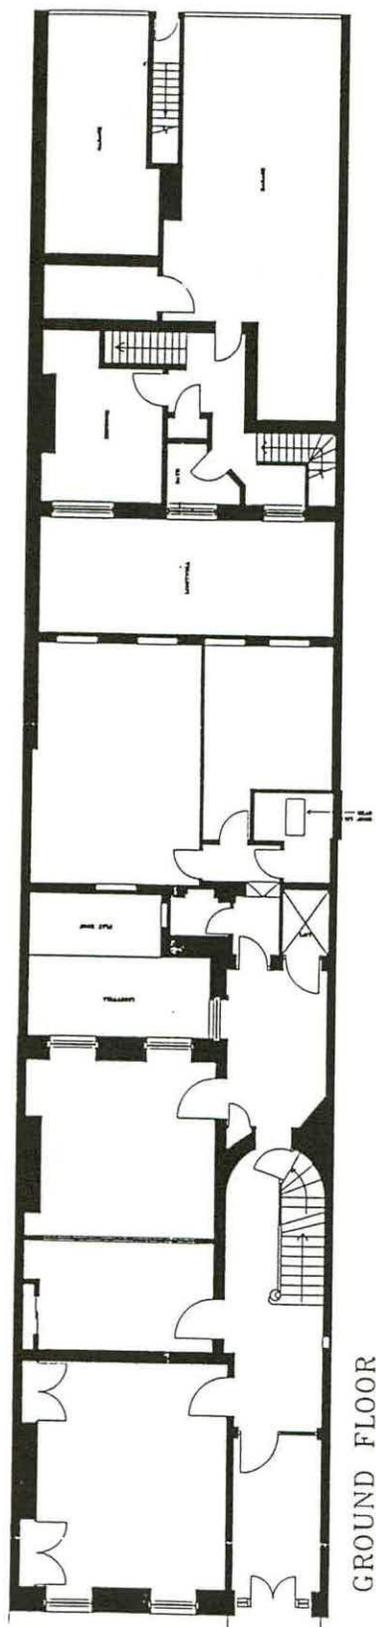
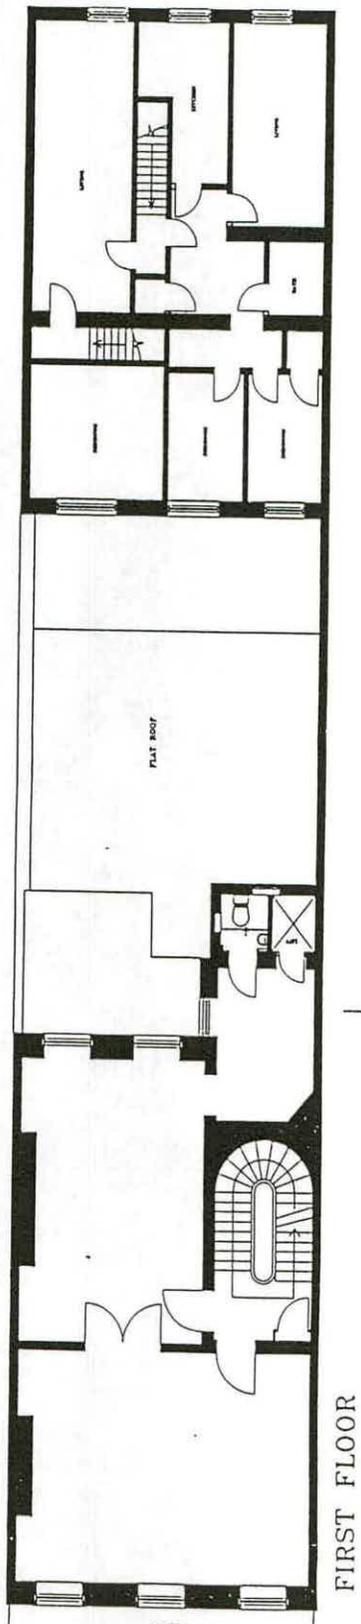
*No. 40 Portland Place, plans of the ground and first floor*

Plan of 40 Portland Place with added wing, now housing lift and toilets

William Woolcott built three houses in the development. The first to be constructed was the present No 40, which survives and has some Adam decoration. It was begun in 1776, completed in 1779 and the first tenant was the Hon Edward Foley. The plan of the house is typical of the period, having two main rooms per floor with the staircase to one side (top lit), and a small closet behind the staircase. There was no evidence of a back staircase having ever been built. If Woolcott did not put in a back staircase at No 40, then it is possible that he did not put one at 75, which would explain the addition of the somewhat awkwardly placed service stair that partially survives.

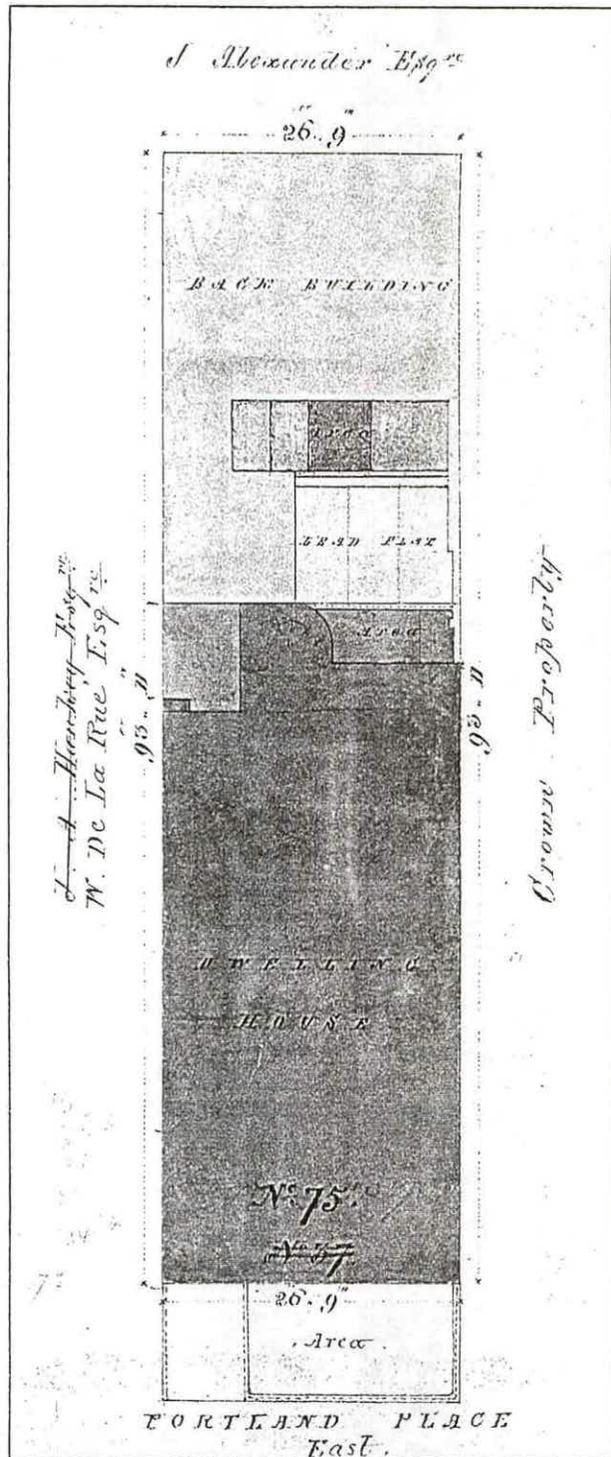
E. 6. 12. N<sup>o</sup> 75. formerly N<sup>o</sup> 57. West side of Portland Place

Block plan of 75 Portland Place, which first appeared with the assignment of lease in 1866, and revised in 1883

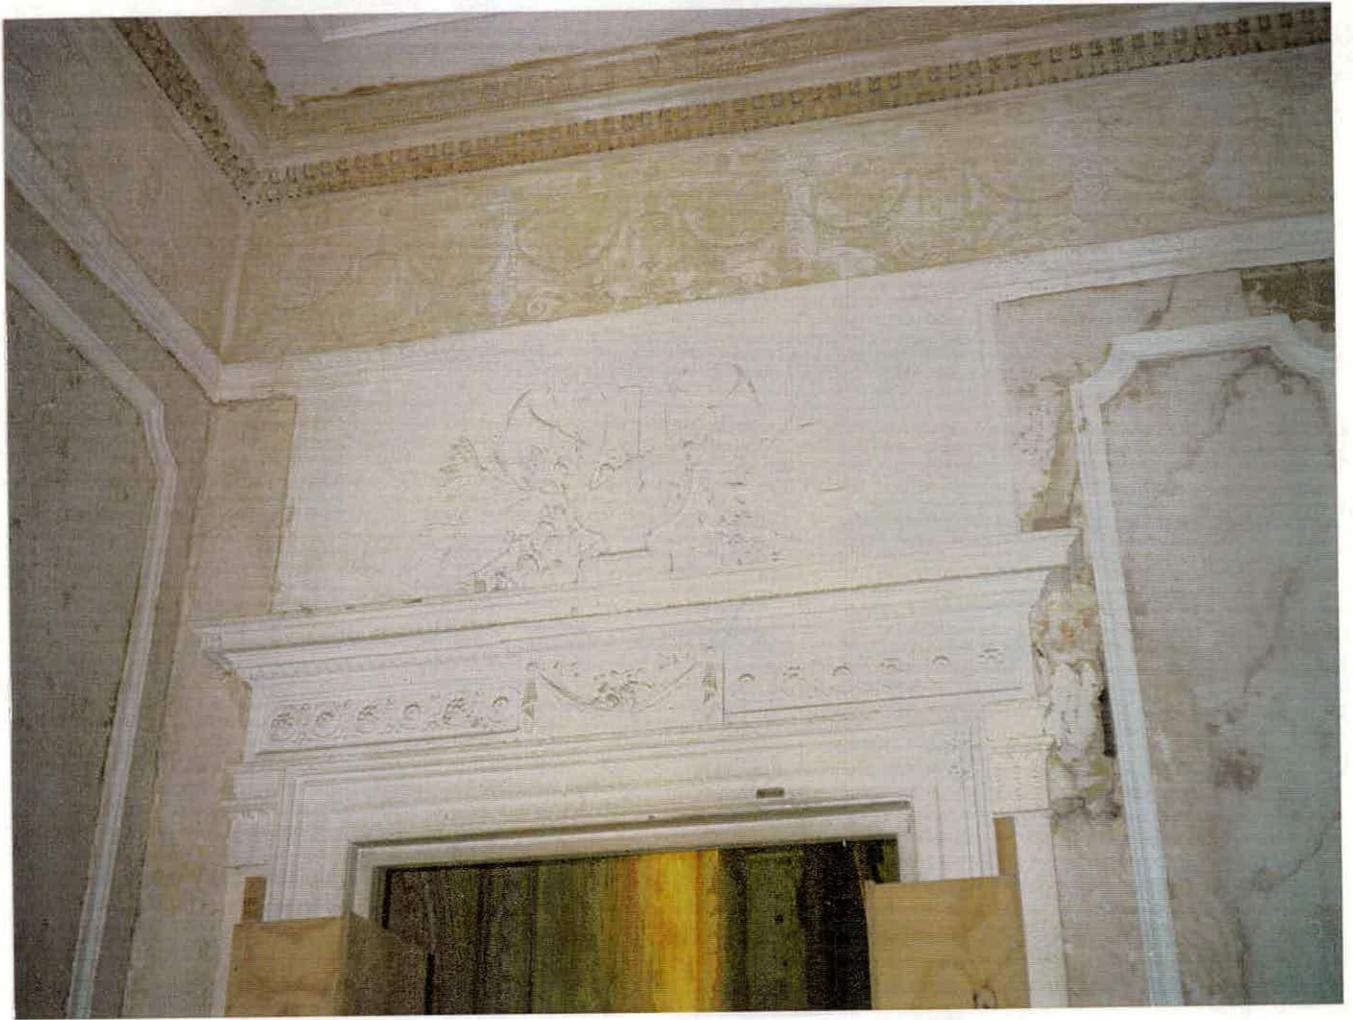
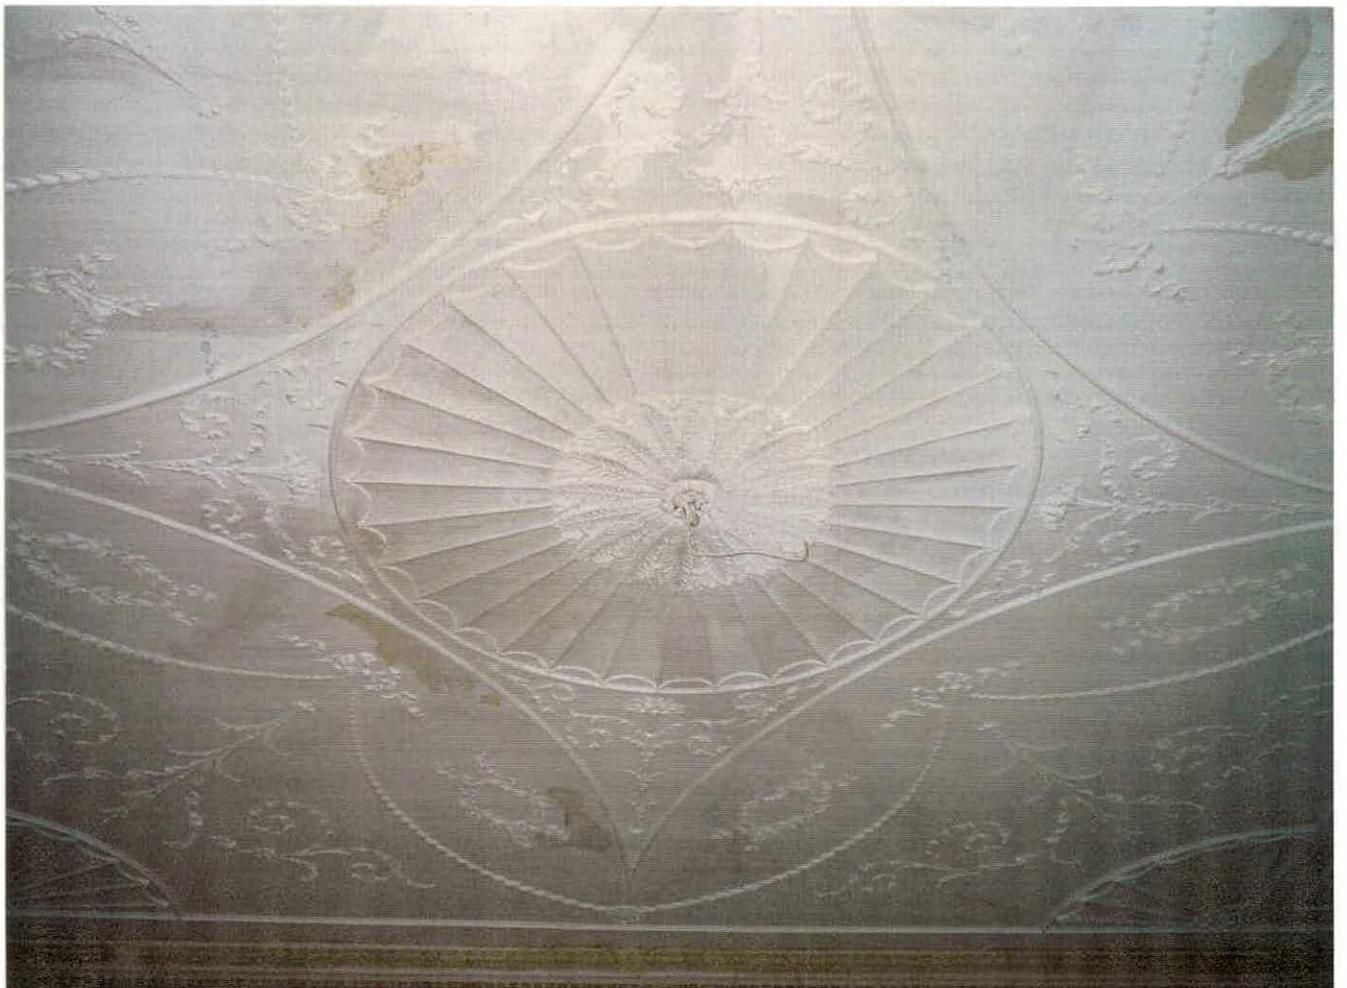
Photographs, November 2001, showing door surround from the first floor front room, and Adamesque plaster ceiling

Another question raised by the AHP report is the question of authenticity of the Adam decoration in the first floor rooms. The report makes a convincing case for the fact that these rooms were altered in the 1880s. The case rests partly on the fact that the plaster decoration follows round the back room into the bay which we now agree not to be the original back wall, therefore must date from after the pushing out of the back wall sometime after 1812. The ceiling in the front room may date from c.1790, but Tara Draper was not convinced that it was an Adam design, but was instead a copy from one of the other house in the street, probably No 65, (see her note, appended). The scale of the frieze under the cornice was larger than one would find under an Adam ceiling, with classical motifs that he would not have used. The wooden mouldings forming panels on the walls, the dado rail, the door case into the front

room, and the jambs of the enlarged opening made between the front and rear rooms, all accord with joinery of a late-nineteenth century rather than a late-eighteenth century date. All this would tie in with the documentary evidence seen by the AHP that shows that a Mr Stanley Bird was making alterations to the house in 1883.

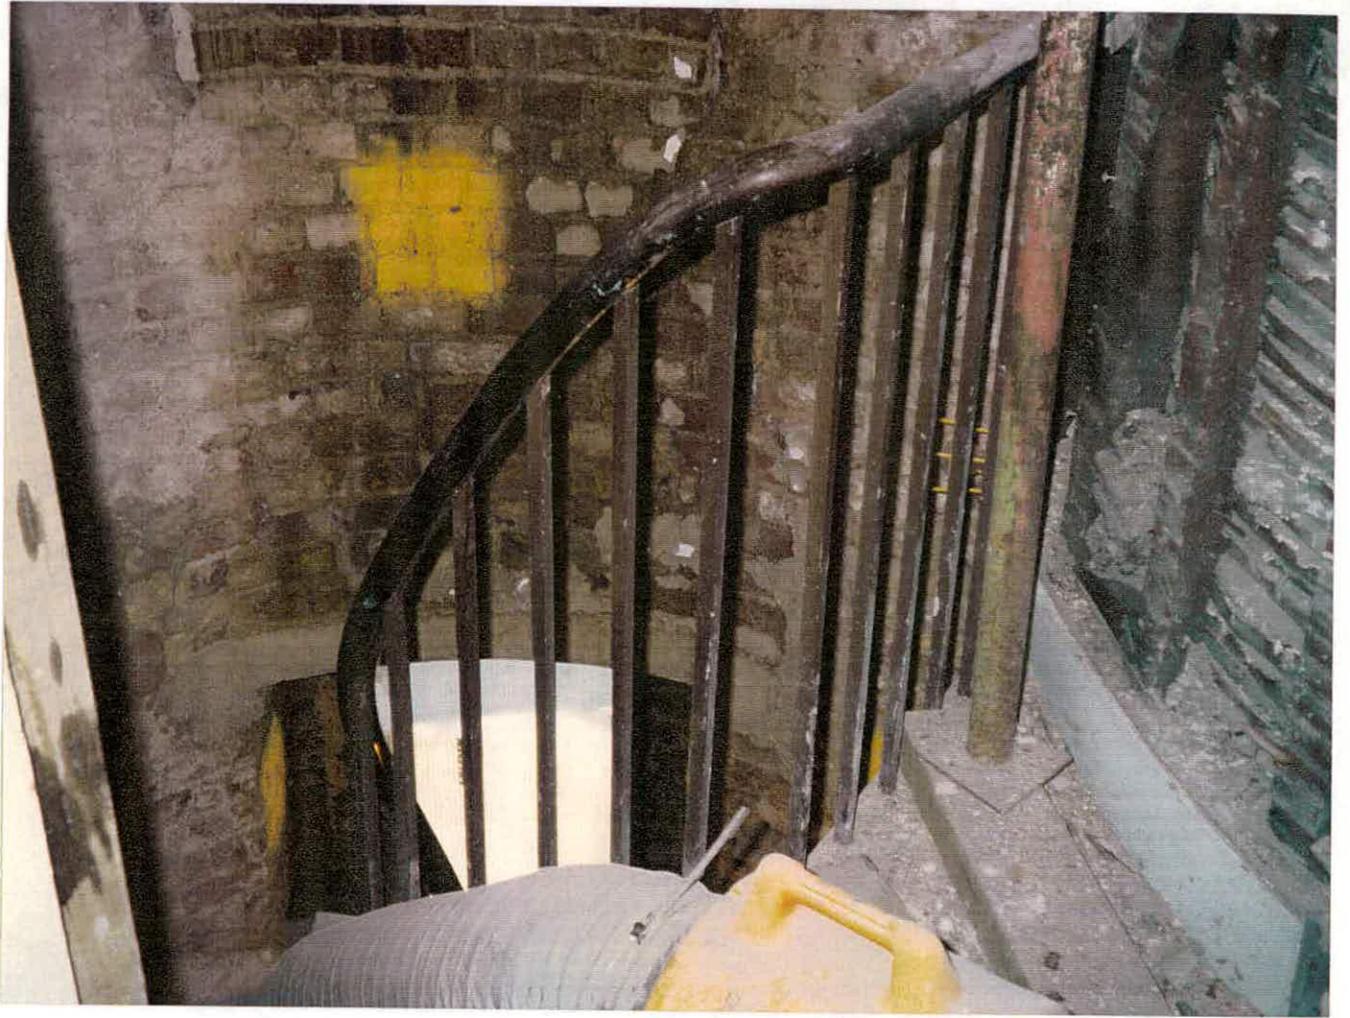
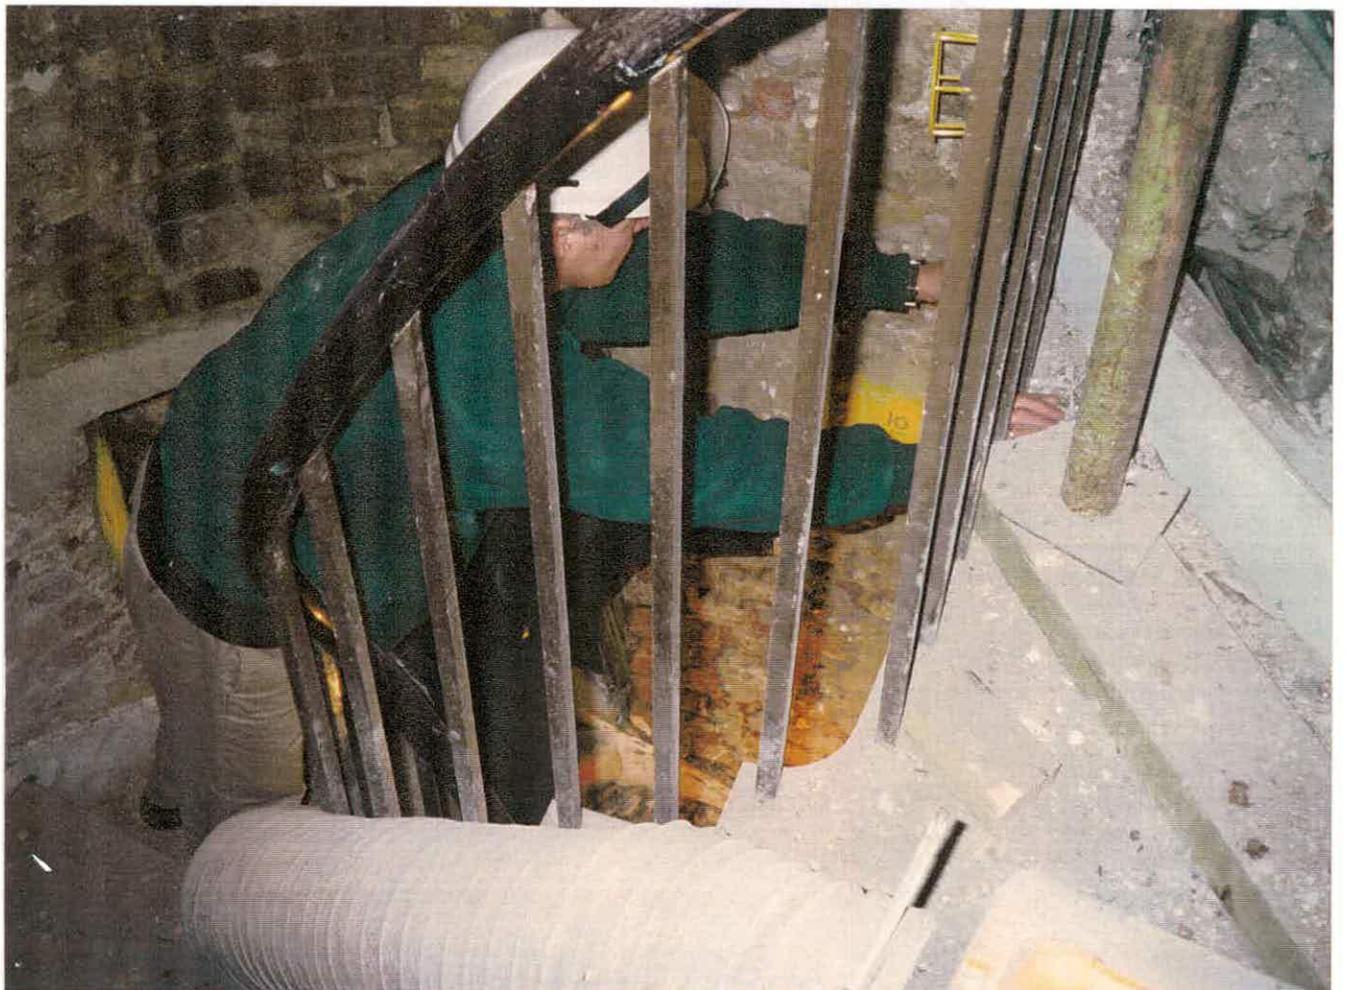
Photographs November 2001, showing the rear staircase and brick staircase compartment

The back stair probably dates from some time around 1820; it is a simple, elegant and modest, certainly of intrinsic architectural, as well as historic, interest, and it is a shame that the lower half (handrail, balusters and treads) has been removed because it is rotten. In general, rear or service stairs in a listed building would be retained as a matter of course, and, anecdotally, this would account for a reasonably high survival rate. In this case, it is a matter of judgement whether, on balance, the loss of the added rear stairs, with retention of the brick compartment to house a lift, is offset by the general restoration of the house fit for domestic use after years of neglect. In our view, although the loss is to be regretted, the degree of loss of historic fabric is, on balance, not so great as to outweigh the benefits of overall thorough repair and restoration.

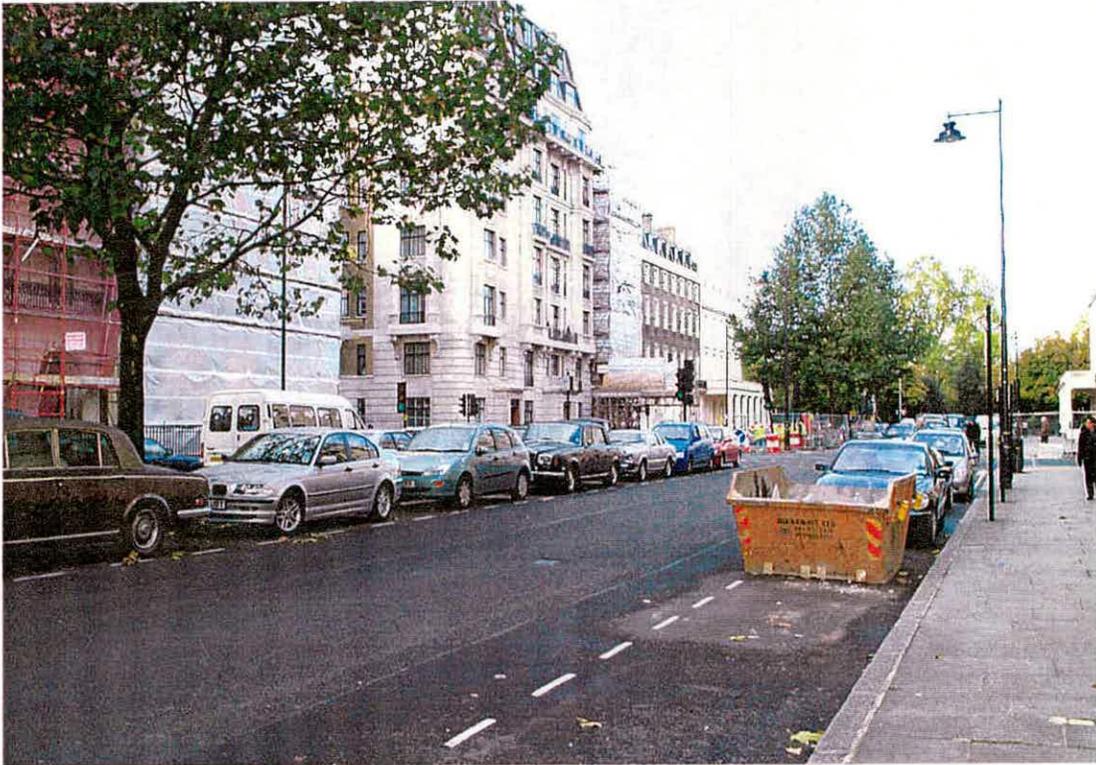
**Figure 1**

View of west side of Portland Place, looking north. Group shot showing no.75 (third building from the far end, its façade hidden behind plastic sheeting) with later terraced row by Nash standing beyond it to the right.

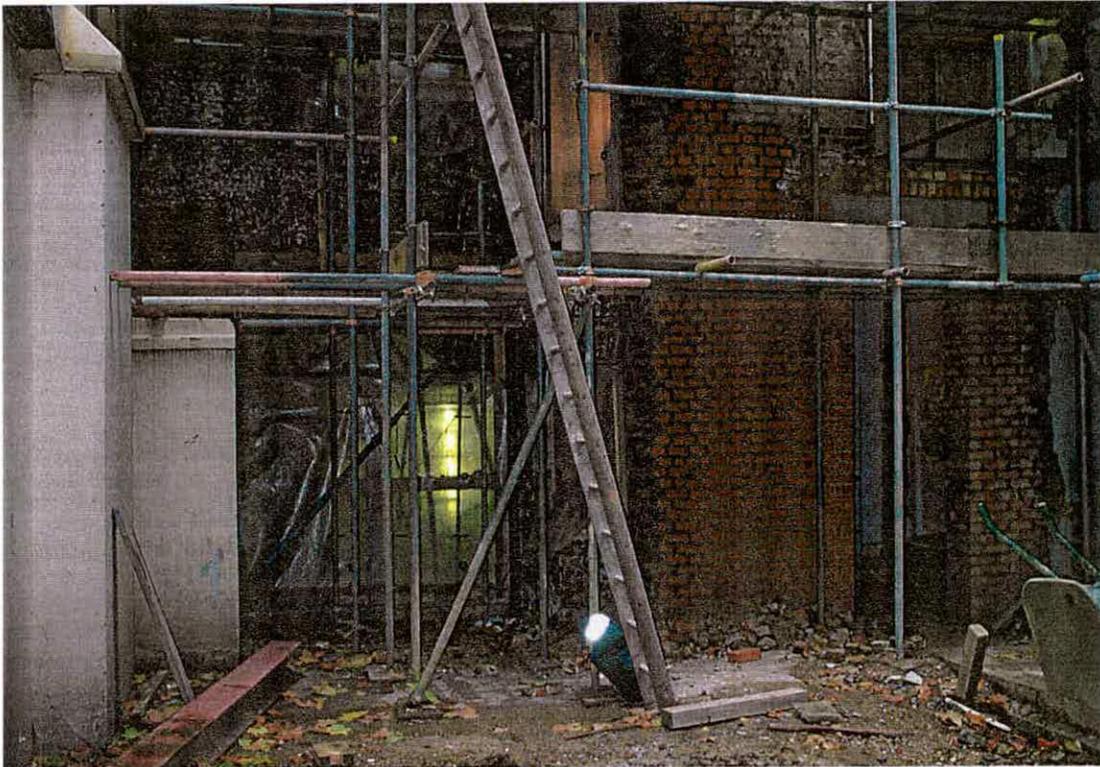
**Figure 2**

View of the exterior elevation of the rear wall at basement level, looking east.

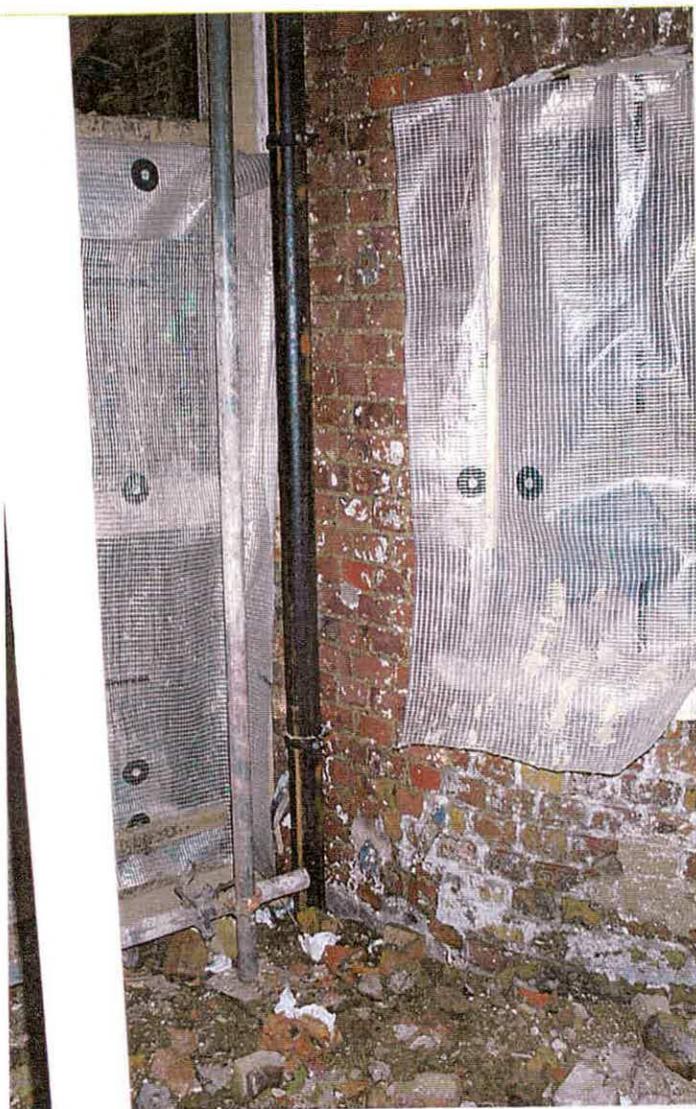
**Figure 3**

Photograph of the exterior elevation of the rear wall at basement level, showing the junction of the 19<sup>th</sup> century staircase extension and rear wall. A new door opening has been inserted in the rear wall and consequently much of the original brickwork has been lost. However the close bonding of the brickwork at the angle of the rear wall and projecting staircase wall (hidden behind the drainpipe in the above photograph) and use of the same type of bricks and mortar shows clearly that the wall and staircase were built at the same time.

- The brickwork of the projecting staircase compartment and rear wall is, by contrast, all of one piece, with the exterior face bricks forming the internal angle all properly bonded together and the coursing lines carried through from one side to the other. The staircase and wall are therefore both of the same date and built during a single period of alteration. The evidence is clearest at basement level in the exposed brickwork at the bottom of the exterior wall face.

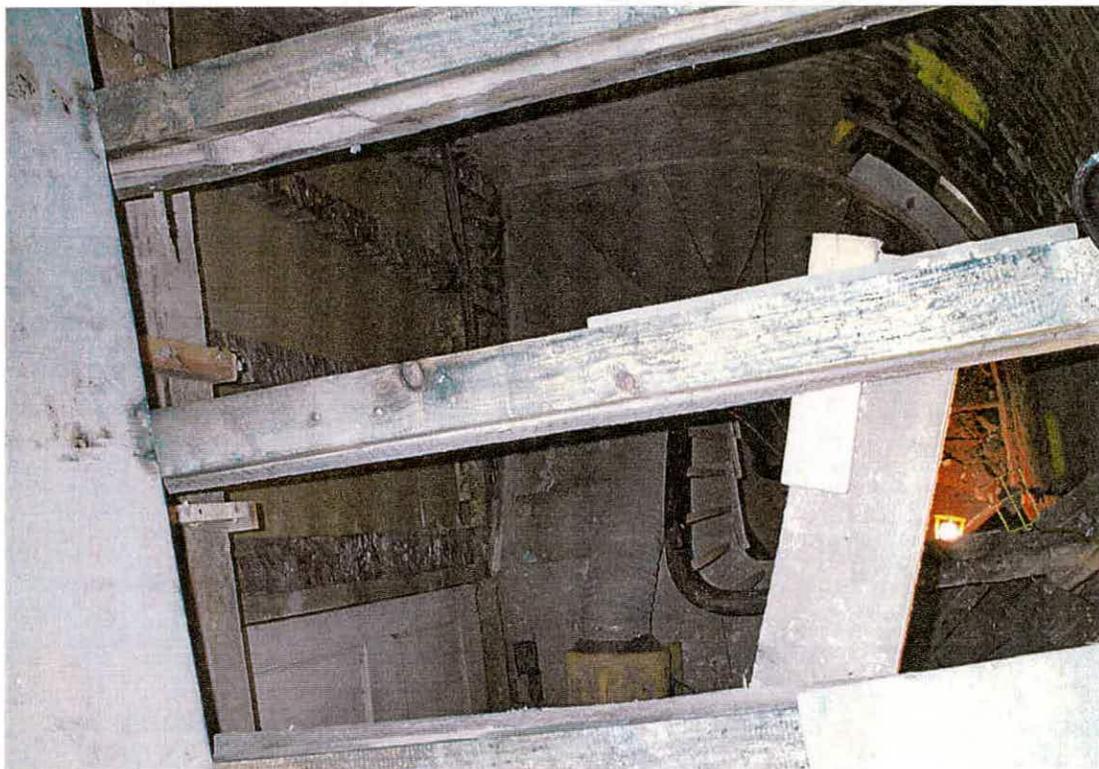
**Figure 4**

View of the inside of the rear staircase compartment, looking down towards the basement from third floor. The staircase extended up to second floor only, and was accessed via the main staircase (via doorways at mezzanine, or half-landing level), and from the rear rooms. The brick shell of the staircase compartment was extended upwards to form a closet for the rear room at third floor. The uppermost of the doorways leading off the main staircase can be seen at the lower left hand corner of the photograph.

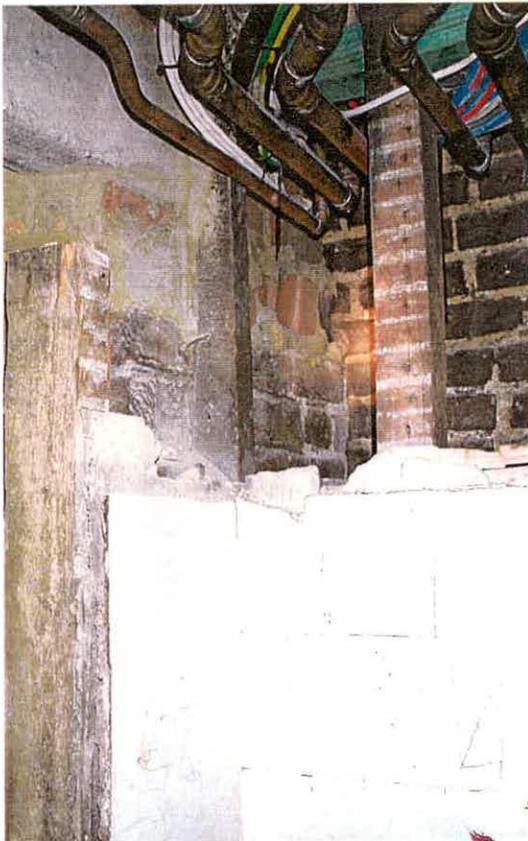
**Figure 5**

Photograph taken inside the rear room at basement level, showing the junction of the 19<sup>th</sup> century rear wall of no. 75 (to the left) and the c.1790 party wall dividing the house from the adjoining house on the north side, no.77 Portland Place. As can clearly be seen in the photograph, the brickwork of the later rear wall abuts, but is not bonded into, the brickwork of the earlier party wall. Prior to the construction of the rear wall on a line some five or six feet to the west of the original rear wall line of no.75, the section of party wall shown here was external, and perhaps formed part of an original garden wall.

- There is a vertical construction joint in the brickwork, visible at ground floor both inside the house and externally, at the junction between the northern end of the exterior rear wall and the party (formerly garden?) wall dividing the house from the adjacent property, no. 77 Portland Place. The walls were built using different types of brick, and are not bonded together. The face brickwork of the party/garden wall can be seen extending eastwards behind the brickwork of the rear wall, and therefore pre-dates the construction of the rear wall of no.75. Consequently the 'earliest possible' date for the construction of the rear wall/staircase is c.1810, i.e. some time after the construction of the adjoining row of terraced houses, designed by John Nash. The 'latest possible' date for the alterations is 1883, the date of a plan drawn up to accompany a new lease taken out on the property, and which clearly shows in outline the both the rear staircase and area of the rear extension.

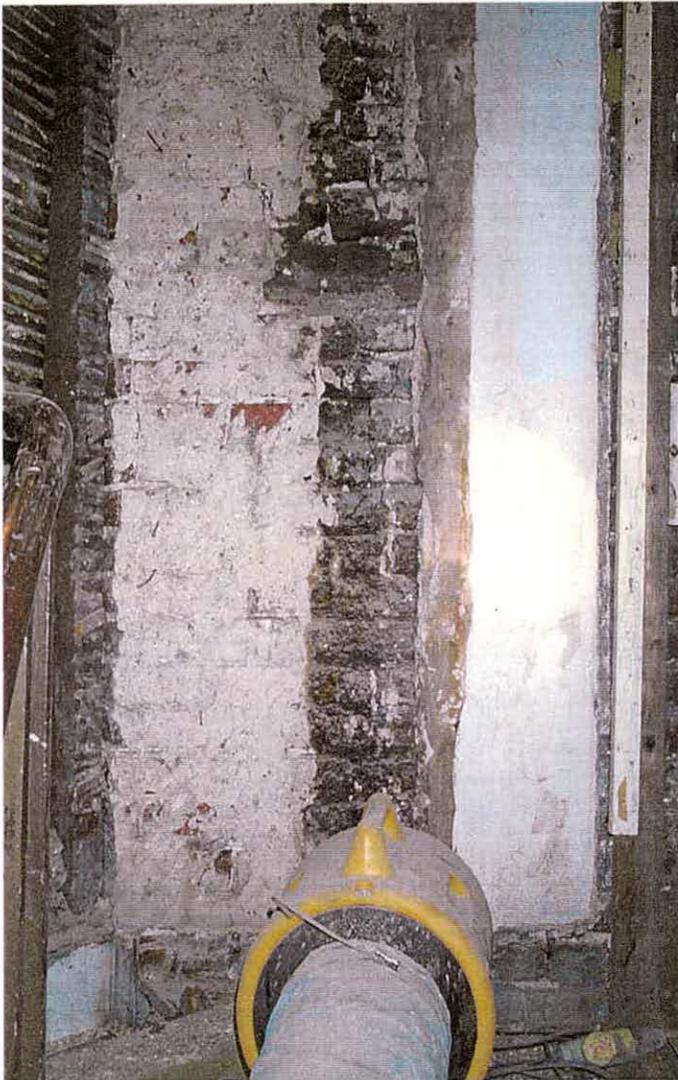
**Figure 6**

Photograph taken inside rear staircase compartment at second-third floor mezzanine level, looking eastwards (i.e. towards the interior of the house) at the west face of the original rear wall of the house. Following the addition of the rear staircase and rebuilding of the rear wall, this section of the wall became an internal wall. As can be seen in the above photograph, where the later plaster has been removed, the surface of the brickwork is heavily stained with soot.

- Inside the rear staircase compartment at second floor level can be seen a section of what was originally the exterior rear wall face. The formerly external surface of brickwork is sooted and somewhat eroded through exposure to the elements, and has struck mortar joints between the brick courses. The wall face was plastered over and made into an interior wall following the addition of the rear staircase.

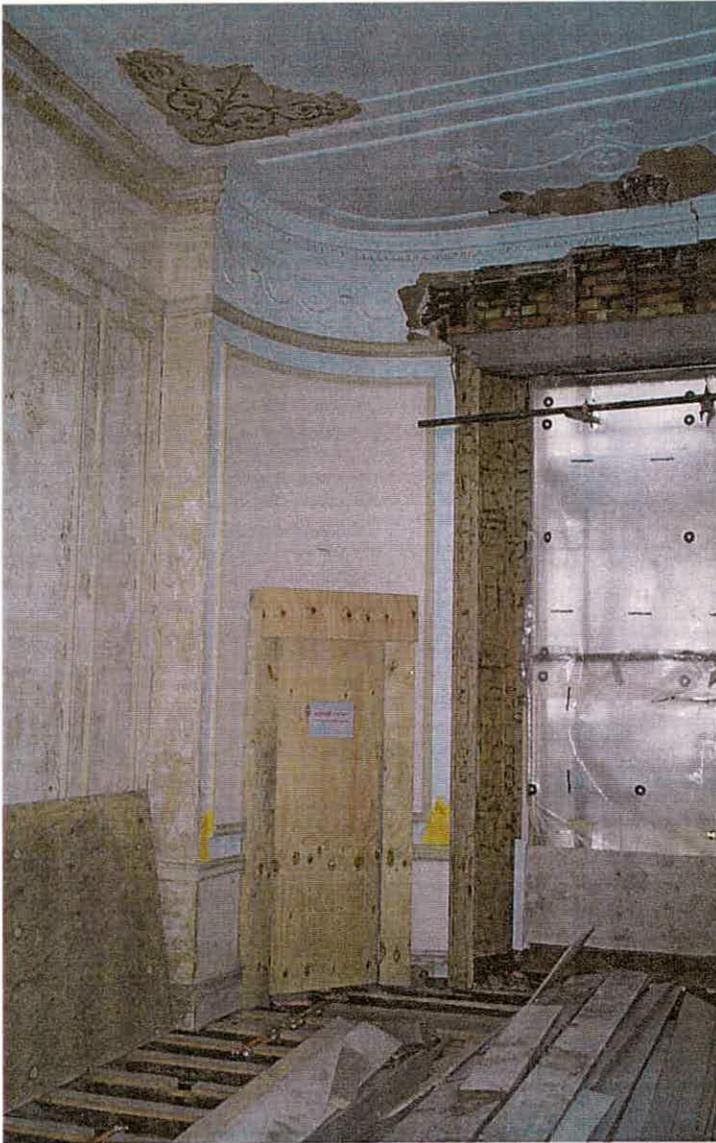
**Figure 7**

View of the rear room at first floor, looking west towards the rear wall. The plaster ceiling and frieze extend into and across the area of the additional curved bay, and must therefore be contemporary with (or post-date) the construction of the present rear staircase and rear wall.

- The plaster frieze presently extending around the front and rear rooms at first floor level also continues into the window bay in the rear wall lighting the rear room. Since the window bay was constructed when the rear wall was extended and rear staircase added, the plaster frieze (and by implication, the plaster ceilings, also) must also date to after 1810. It has already been established that there originally existed a much smaller communicating doorway (probably a double door opening) between the front and rear rooms at first floor, and that this was at some time removed and replaced with the present enlarged opening. Whether or not this work was carried out at the
