TUDOR HOUSE SOUTHAMPTON

PRELIMINARY NOTES ON THE HISTORICAL
DEVELOPMENT OF THE BLUE ANCHOR LANE AND
GEORGIAN WINGS

Richard Lea

Historical Analysis & Research Team
Reports and Papers 66
2002

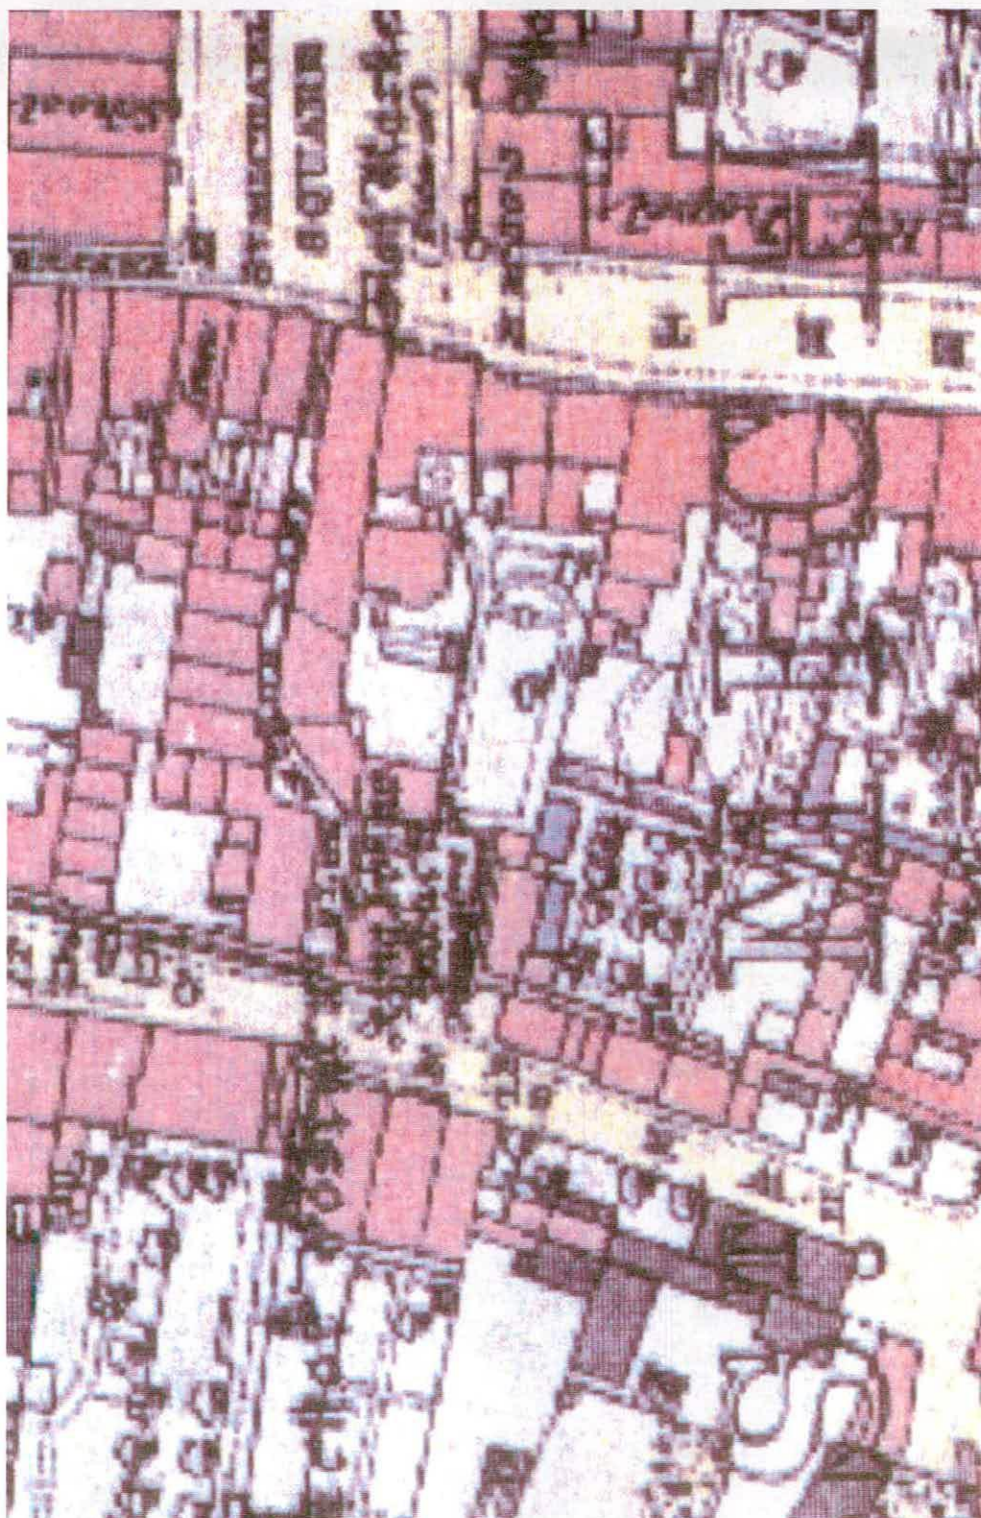
Figure 1, a detail from the 1st edition of the Ordnance Survey map of Hampshire, 1848. Reproduced here with east at the top (Southampton Record Office).

The first edition Ordnance Survey map of 1848 shows the site subdivided by simplified property boundaries, Figure 1. The east frontage, excluding the cottage, is divided into two. The northern property is shown extending along Blue Anchor Lane, beyond the 'Georgian Wing' which is shown as a separate entity.

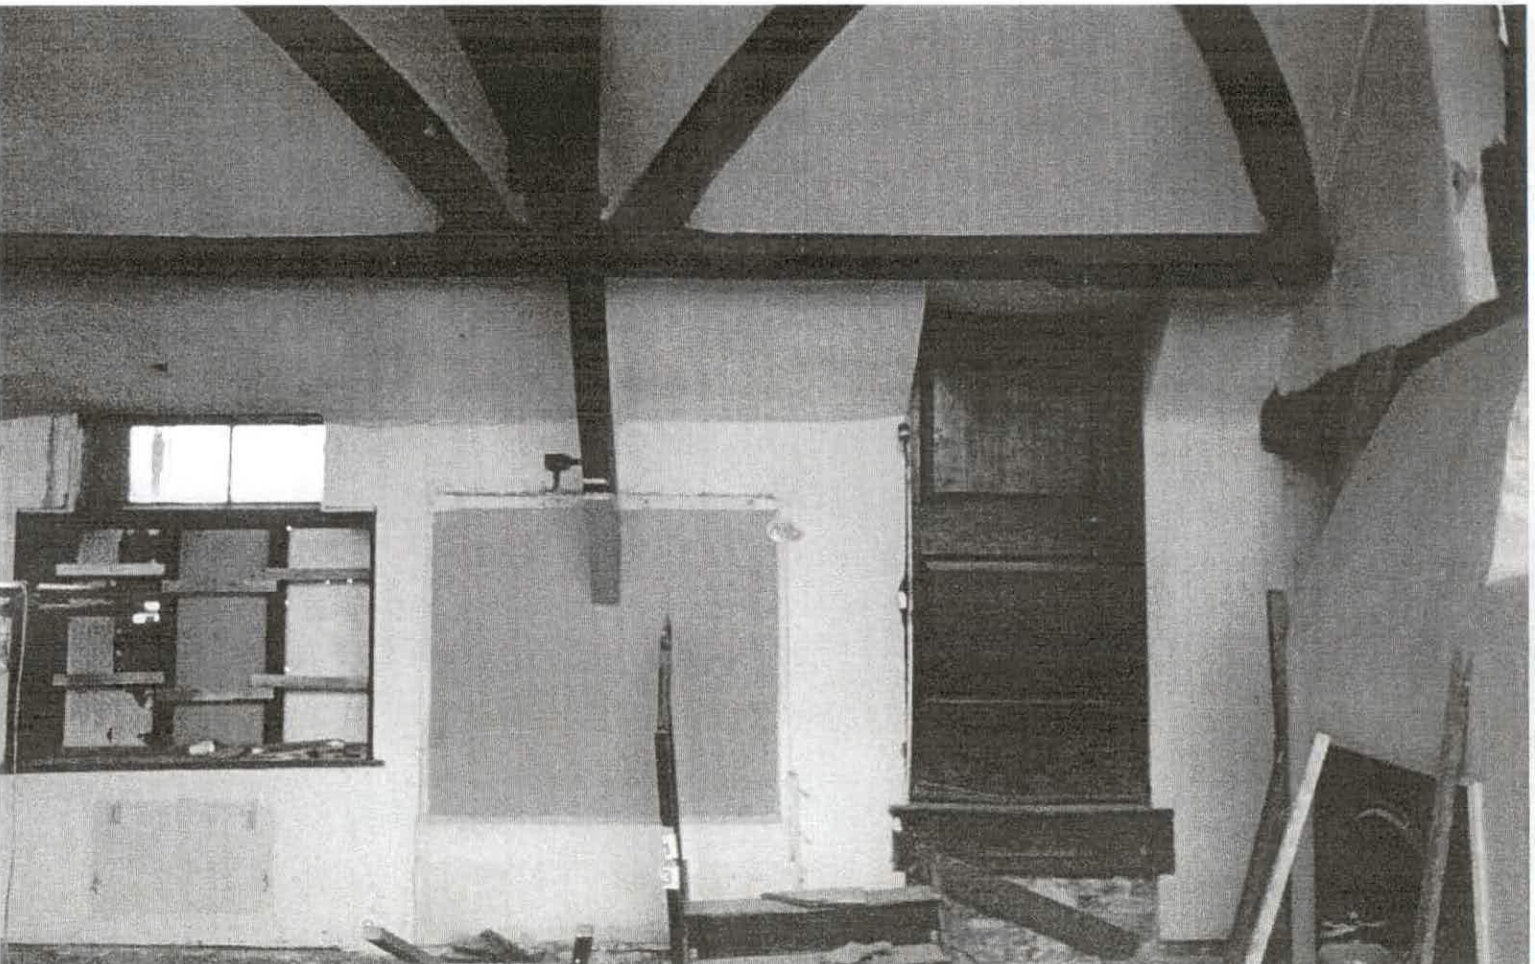
Figure 16, Room 23, east of central stack, looking south, during restoration works of 1984-5 (Conservation Manager, Southampton Council).

The photographs taken in 1984/5 show the floorboards removed and some of the roof covering at the east end of the Blue Anchor Lane Wing, Figure 16 and Figure 17. It seems that in Room 23, during these works, the wall plate, the roof truss tiebeam and the window were replaced, Figure 55, Figure 56 and Figure 57.

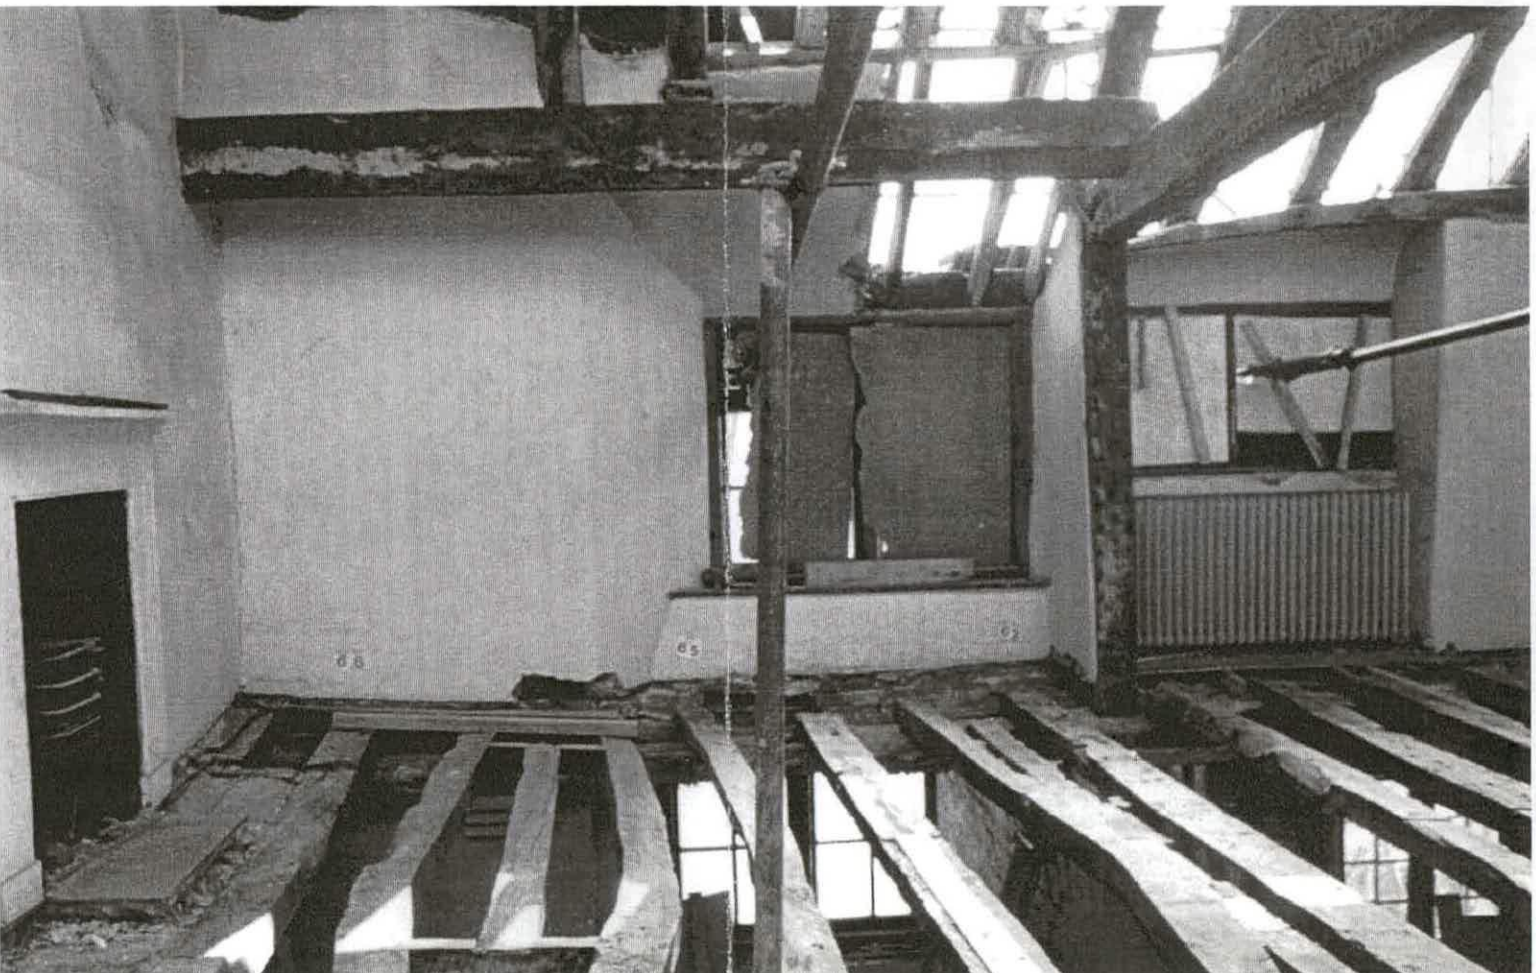
Figure 17, Room 23, west of the central stack, looking south during restoration works of 1984-5 (Conservation Manager, Southampton Council).

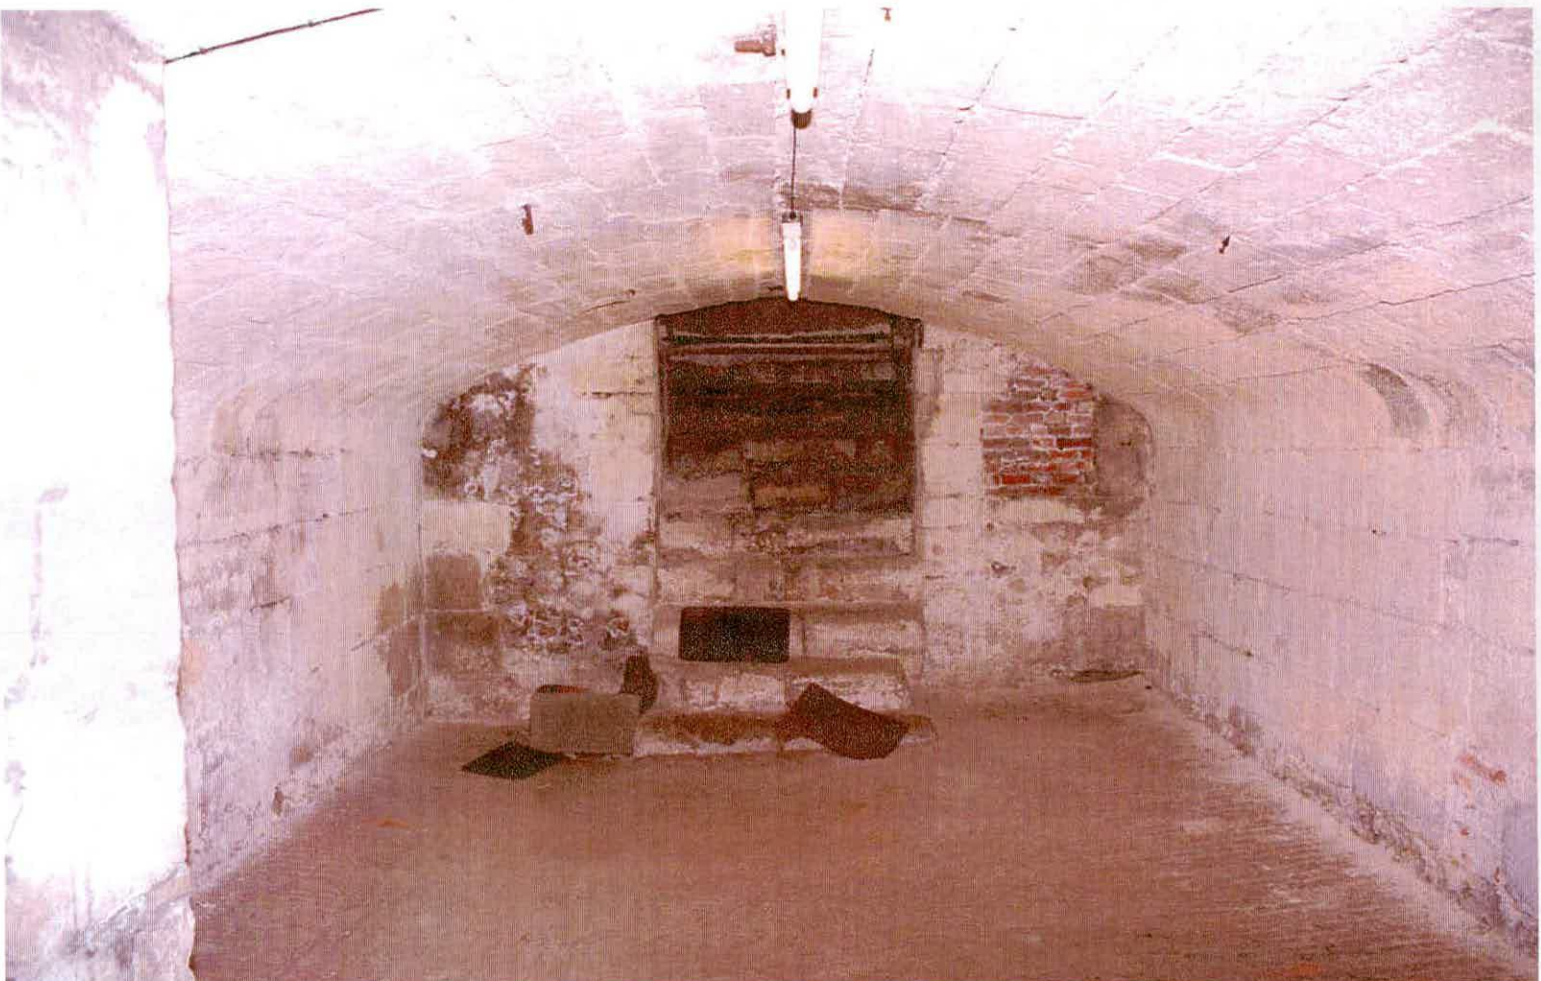
Figure 29, the undercroft beneath 59 Bugle Street, known as The Cottage, Room 1, looking east.

The southern undercroft, Room 1, has a low four-centred tunnel vault and is constructed with neatly coursed ashlar, Figure 29 and Figure 30. This contrasts significantly with the construction of the undercrofts lying to the north, which are built with uncoursed rubble and show no sign of any vaulting. The undercrofts contain very little datable fabric. The doorways in the southern vault, Room 7, Figure 30, and between the long north undercroft and its southern extension, Figure 32, provide the primary stylistic dating evidence. Faulkner assigns them to the early fifteenth-century.¹²

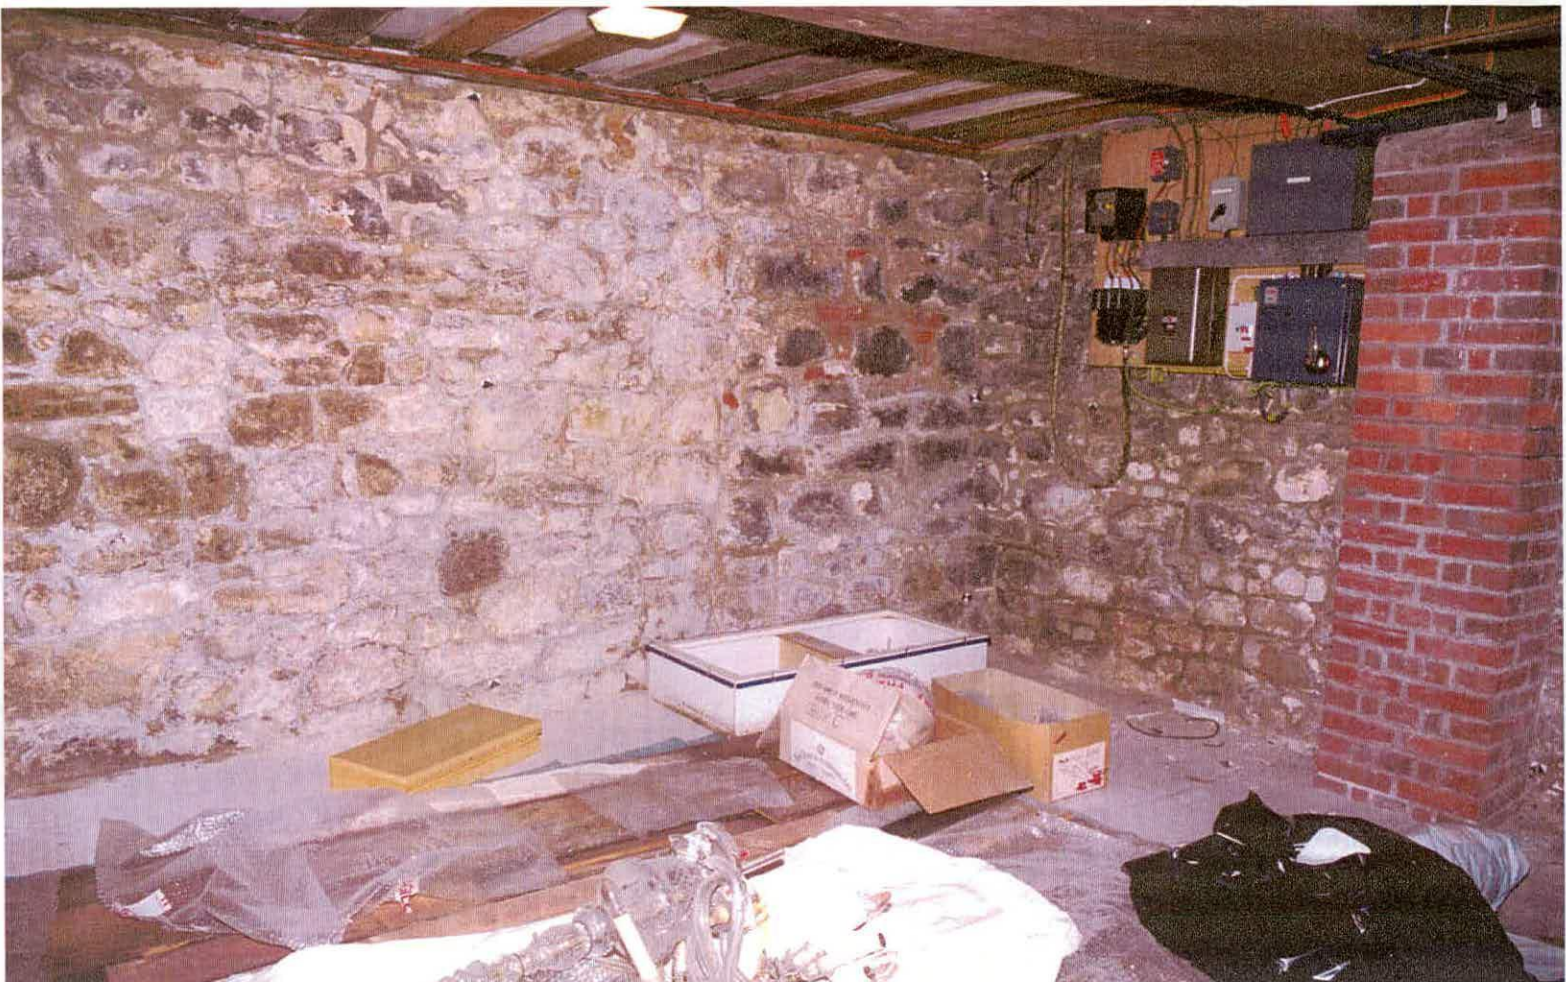
Figure 31, the north-east corner of the northern undercroft, Room 5. A possible building break in the north wall appears about two meters from the north-east corner.

A possible building break in this construction is visible in the north-east corner of the northern undercroft, Room 5, Figure 31. This could perhaps relate to the reference to John Dawtrey's documented enlargement of his house seven feet 'into the Strete' in 1492-3.¹³ A better understanding of the construction of these structures may become apparent when the drawn survey of the cellar walls is analysed.

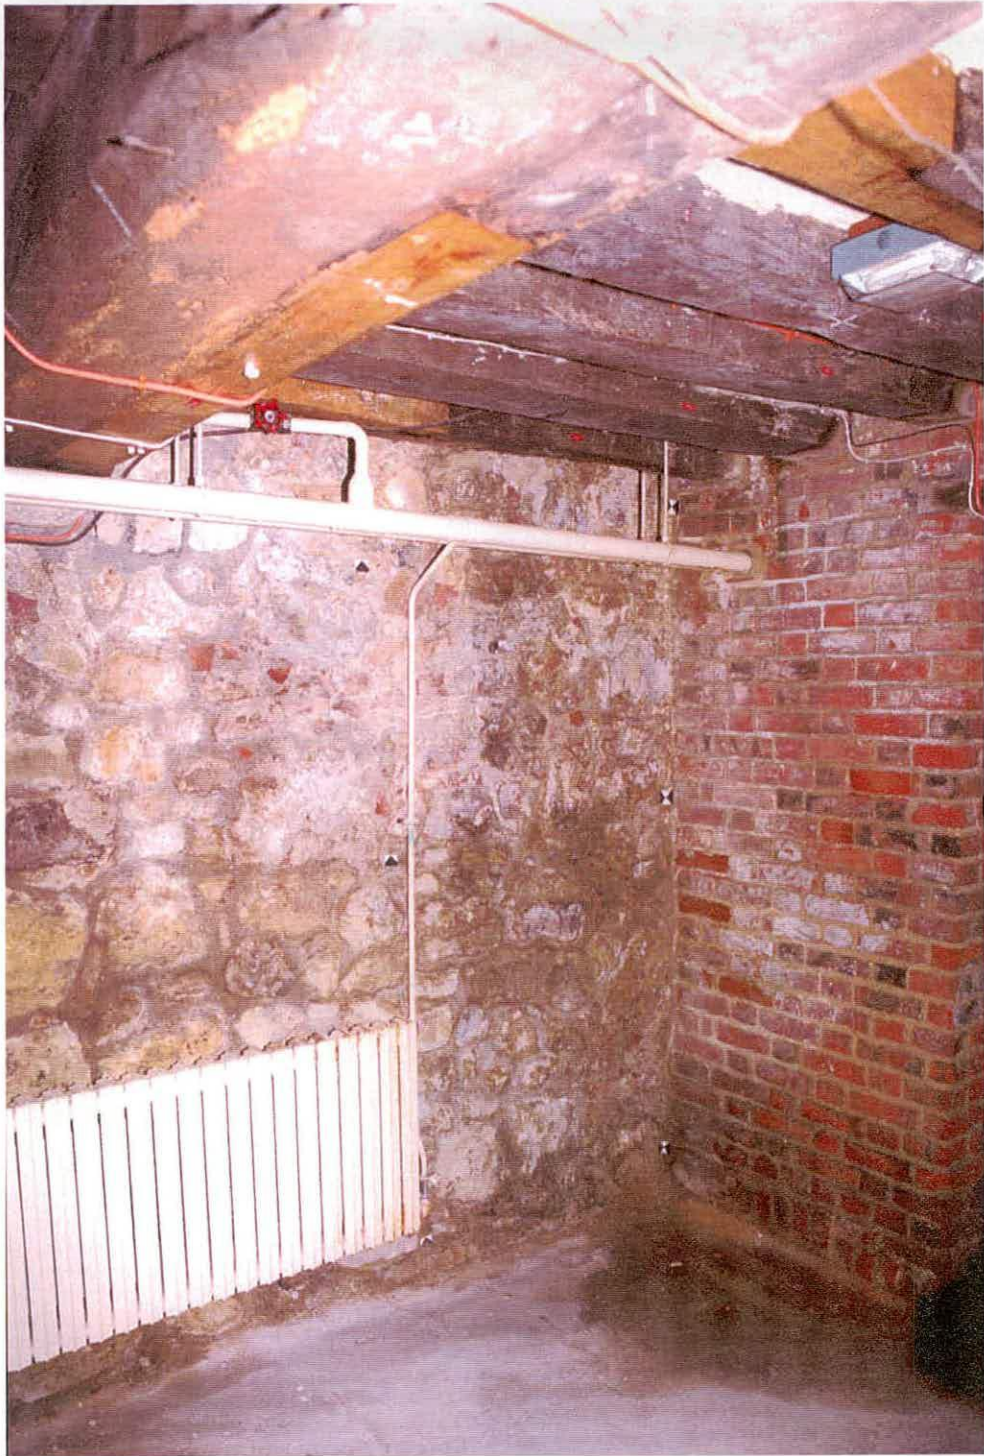
Figure 33, the south wall of the undercroft, Room 7. The larger blocks of stone above the radiator suggest an alteration or repair when compared with the blocks to the west.

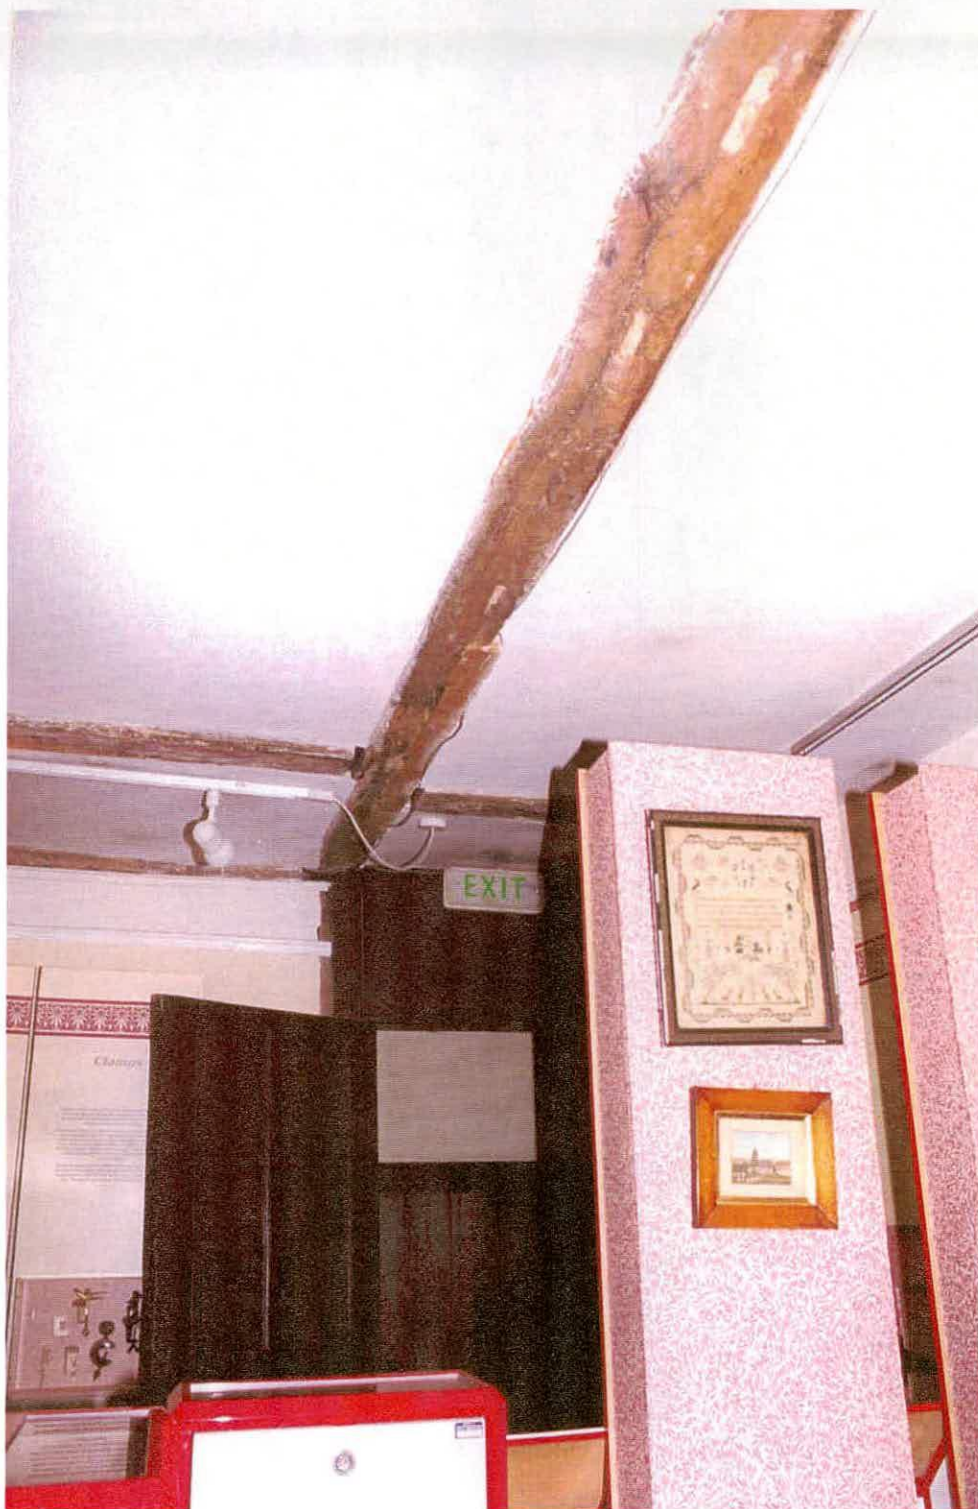
Figure 34, the ceiling of Room 13 looking north. The large beam, running north south is on the line of the roof truss and is morticed for an internal partition.

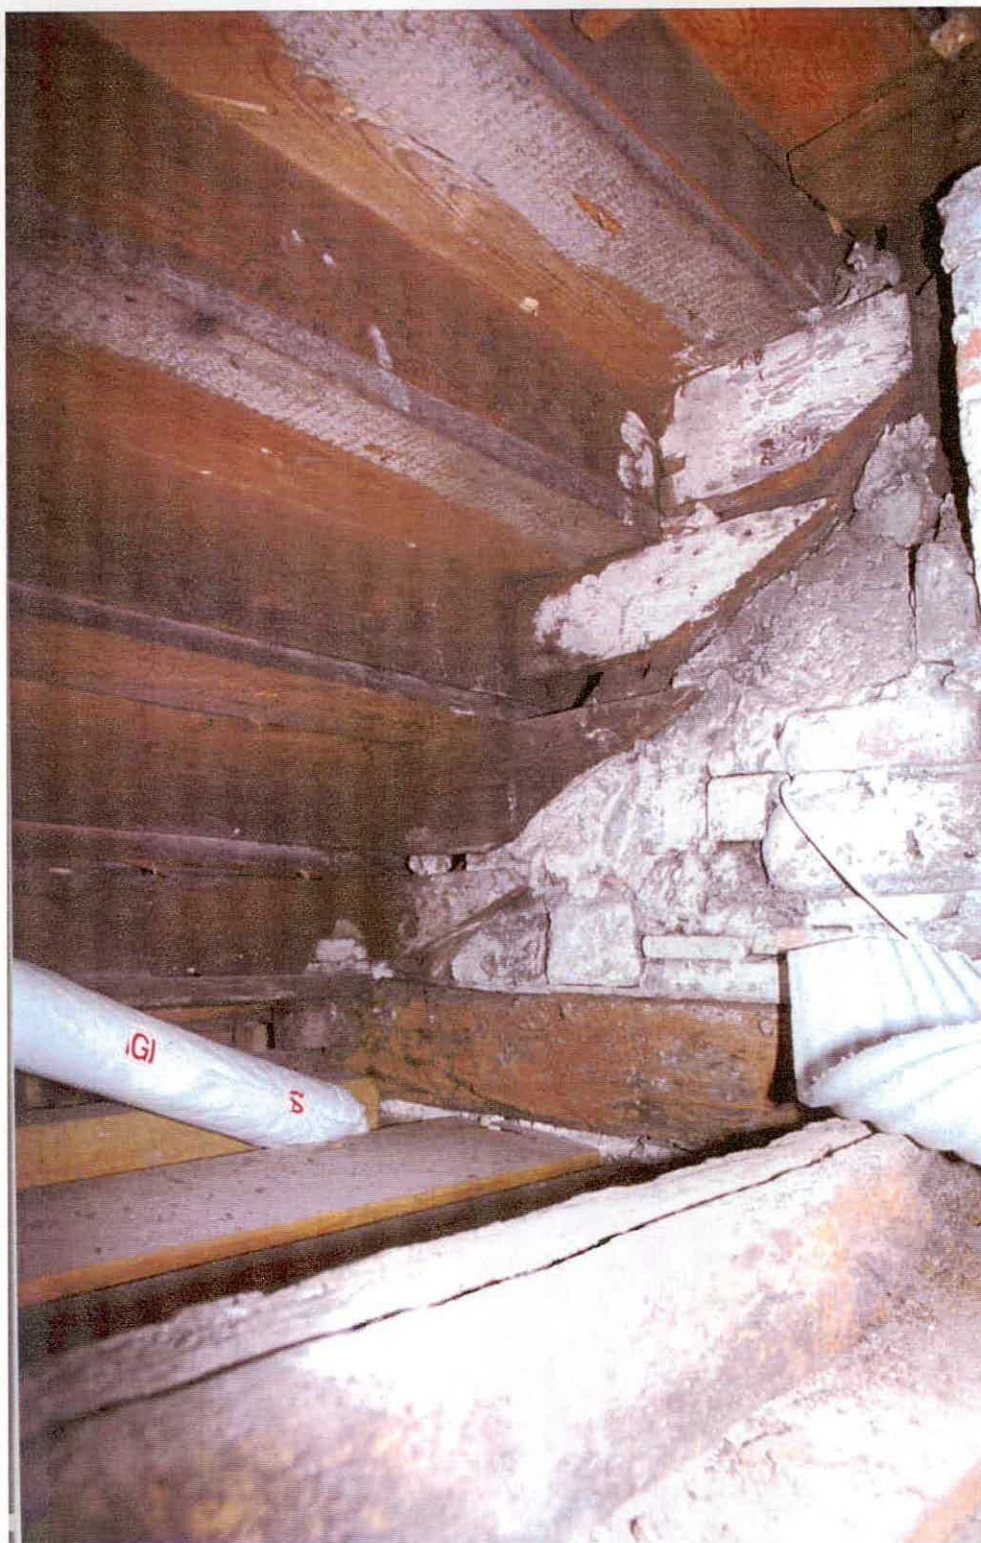
Figure 35, the area under the stairs looking east. The horizontal timber at the foot of the wall has a peg set in it. The horizontal timber in the foreground is grooved to receive a wattle and daub infill.

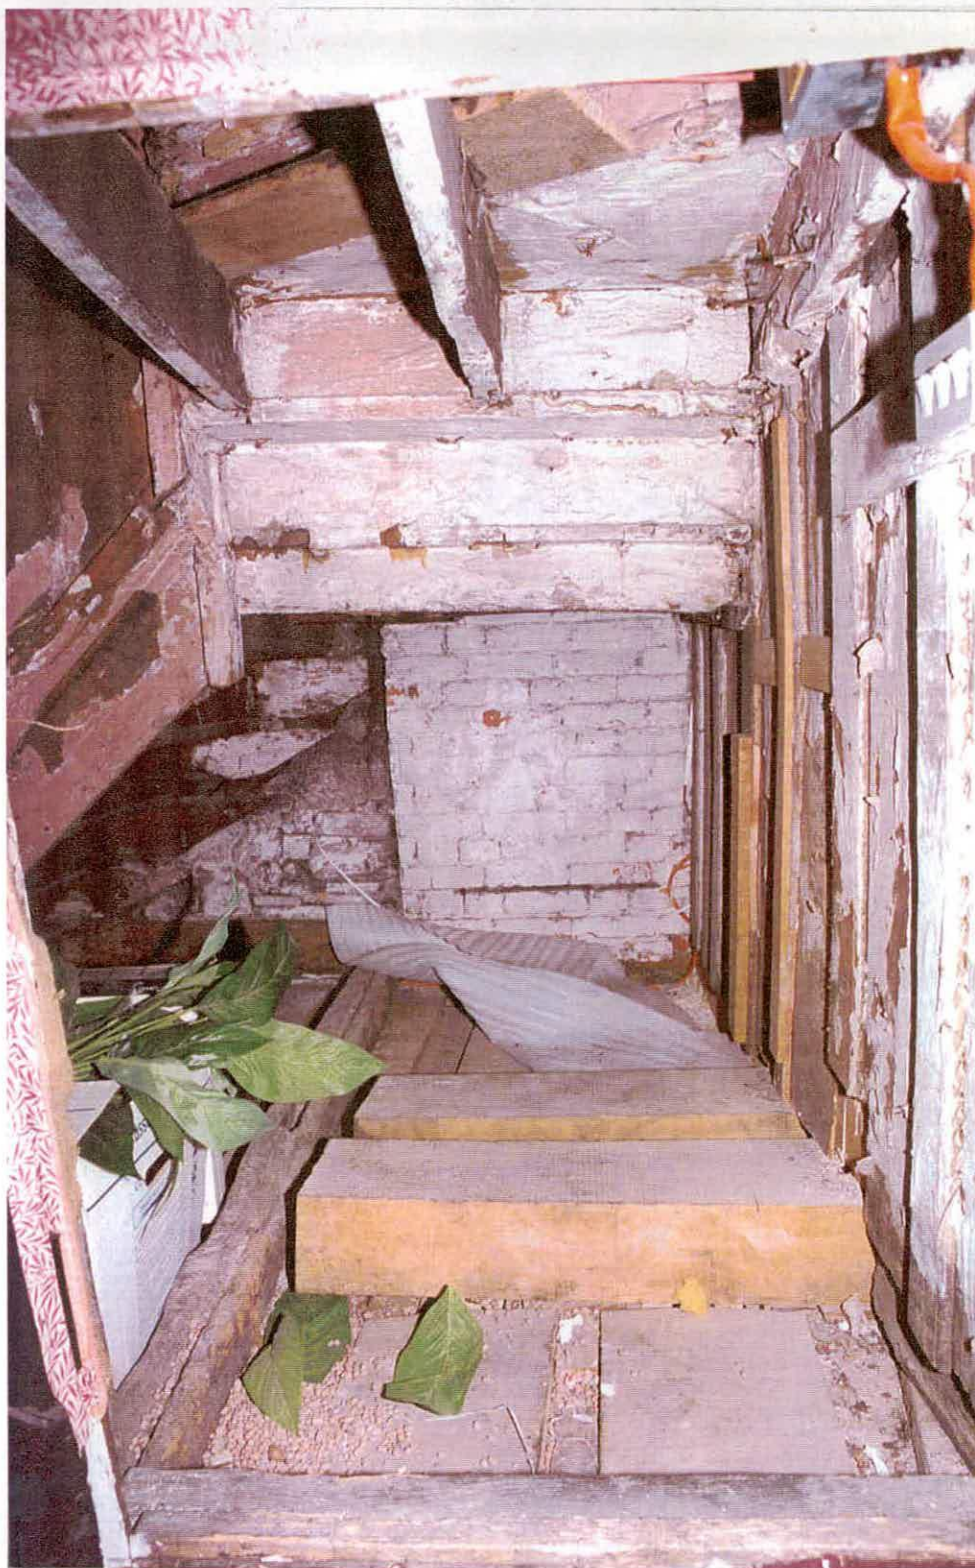
Figure 36, the understair cupboard in Room 13 looking east. The horizontal timber set on the floor and running east west has a mortice in its upper surface for an upright and a groove for wattle and daub infill.

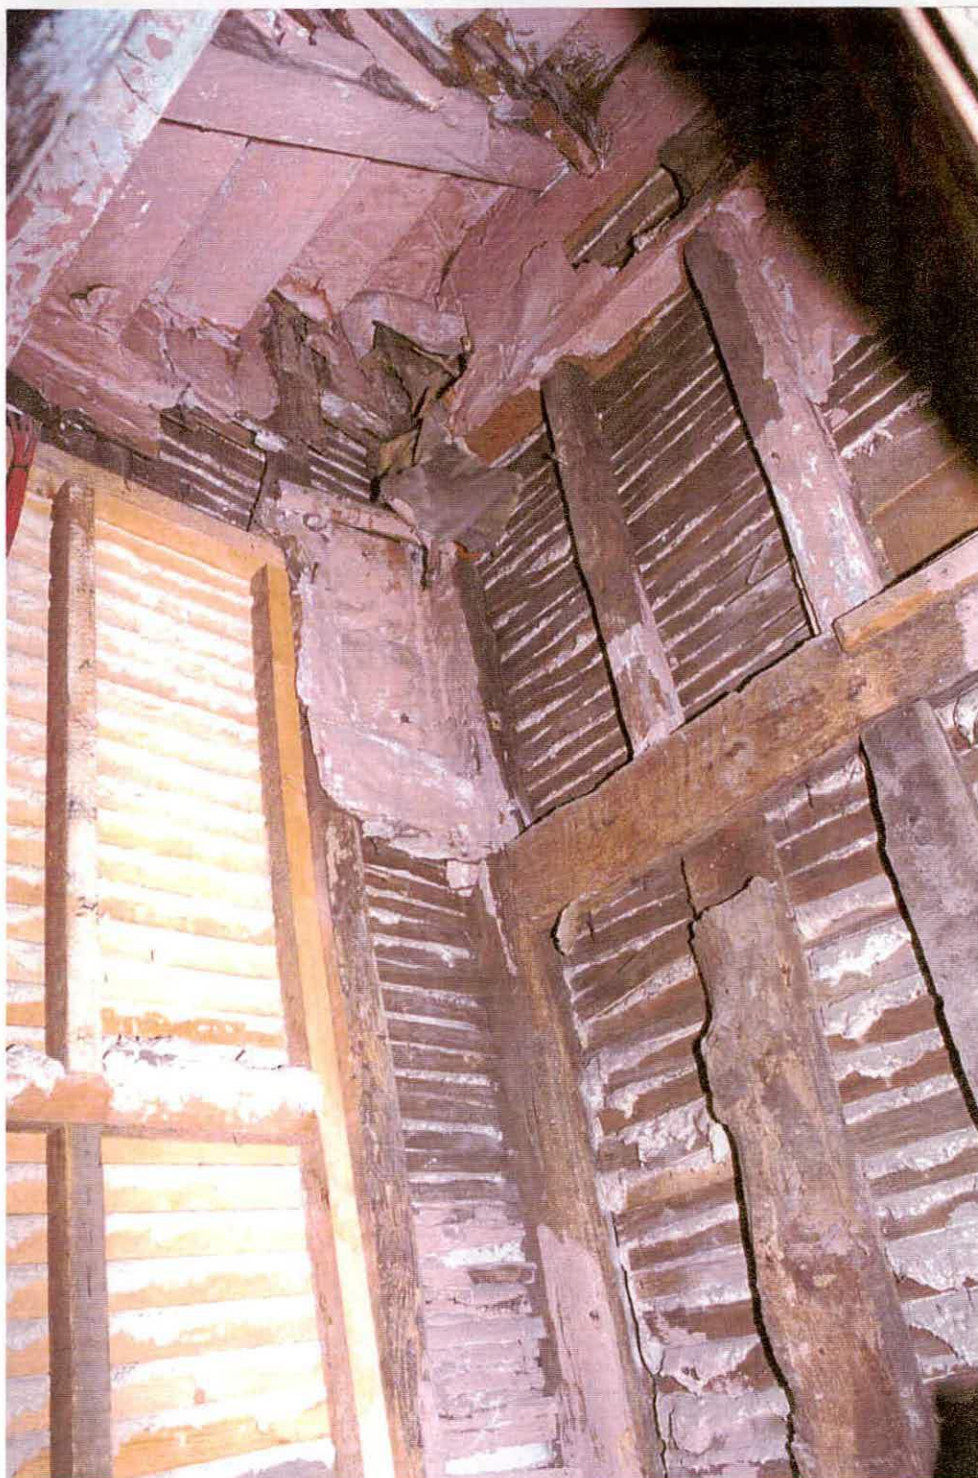
Figure 48, under the stairs at the east end of the Blue Anchor Lane Wing, looking north-west. Note the recently blocked door sized opening to the left and the staircase panelling extending for a short distance below the treads of the upper flight.

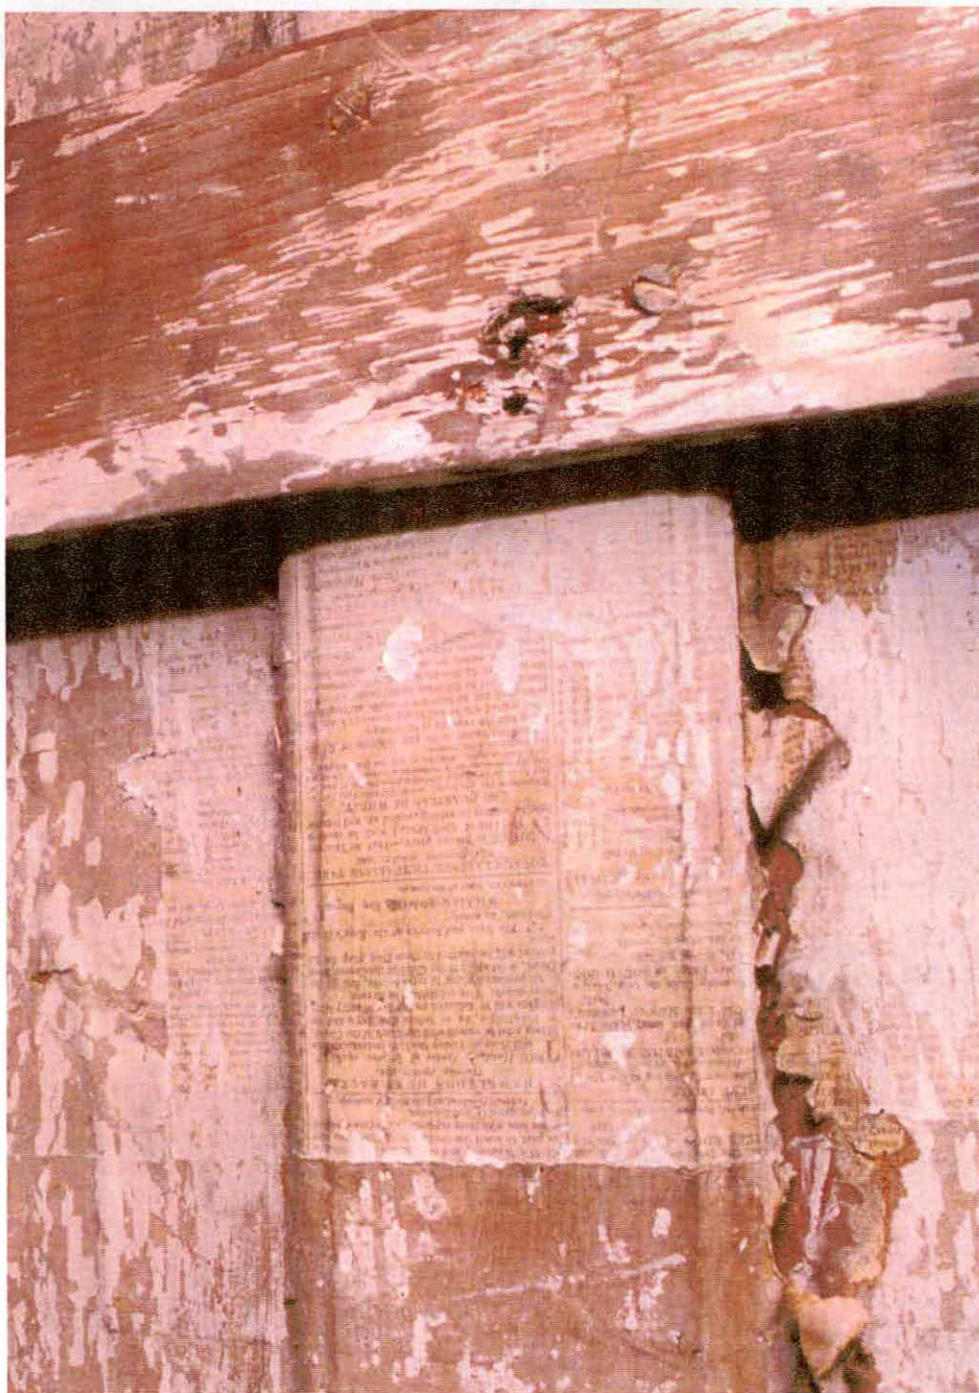
Figure 54, a detail of the newspaper, dated 1836, glued to the panelled south wall of the staircase, underneath the stairs at the east end of the Blue Anchor Lane Wing.

The stair and the panelled staircase walls are of pine construction, which suggests a seventeenth-century date or later. All exposed timber details but not those under the stairs, are stripped of historic paint and coated with a brown stained varnish. This appears to have been applied in at least two stages because, where the central section of each riser was left bare for a stair carpet, it has since been coated with a slightly darker brown stain varnish. The treads are currently carpeted with a beige carpet and the nosing of each tread is covered with protective rubber. The understair area is rough finished and clearly not designed to be seen, Figure 48. The absence of traces of plaster and lath applied to the underside of the stairs suggests that the space under the stairs has always been contained. The paper and limewash applied to the underside of the stairs appears to date from the 1830s, see below.

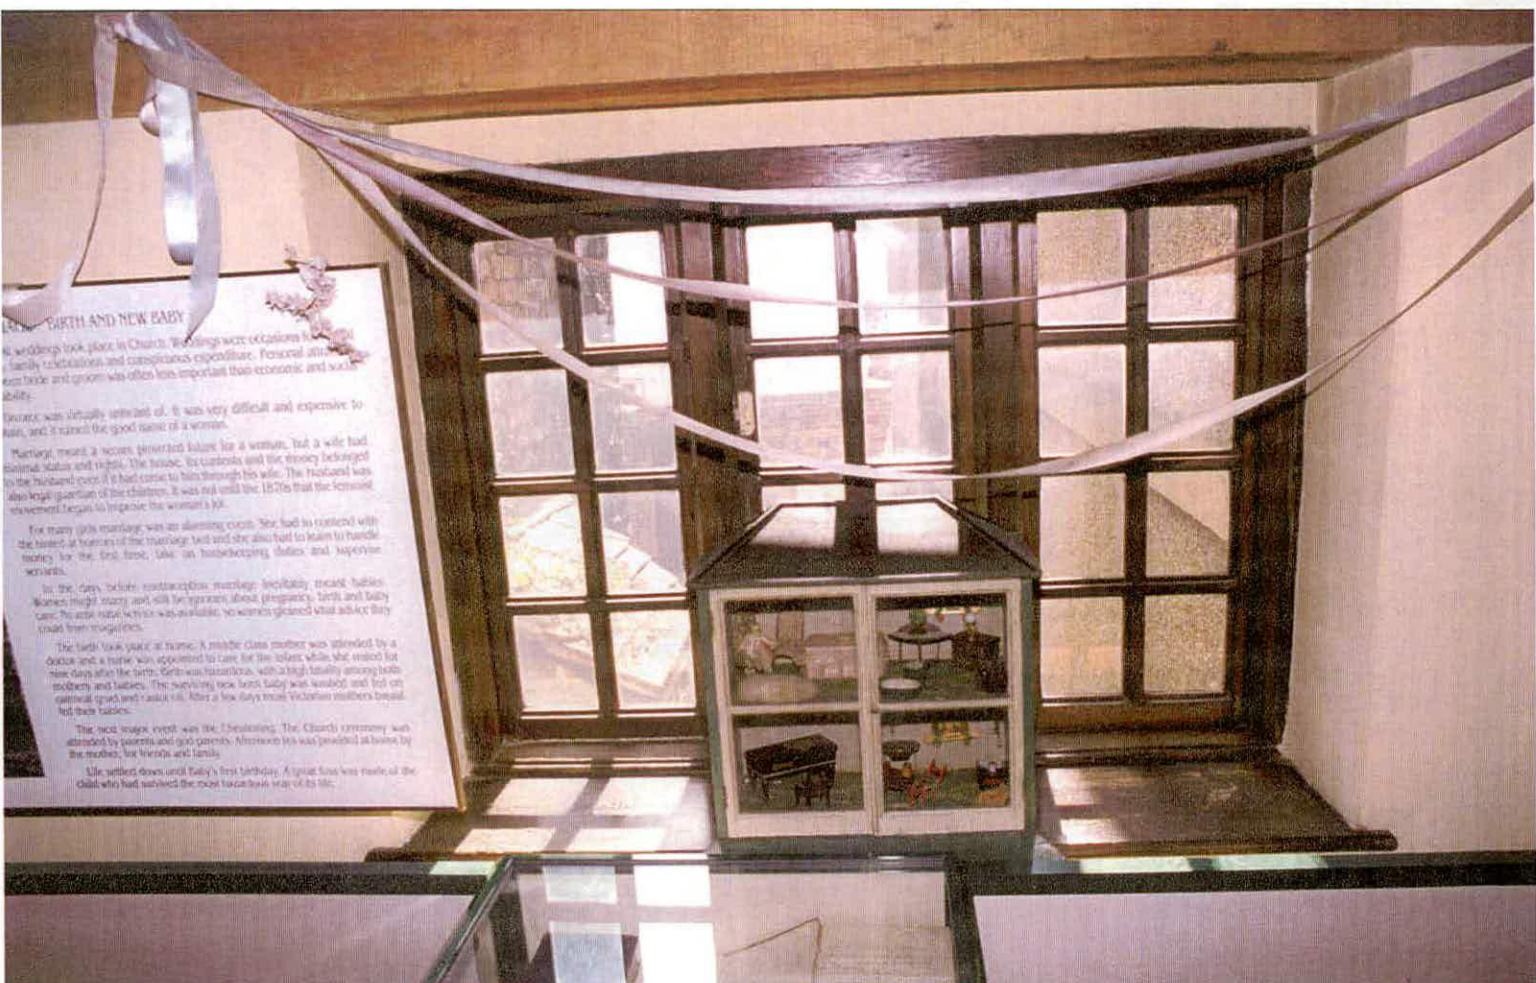
Figure 56, the new window in the south wall of Room 23.

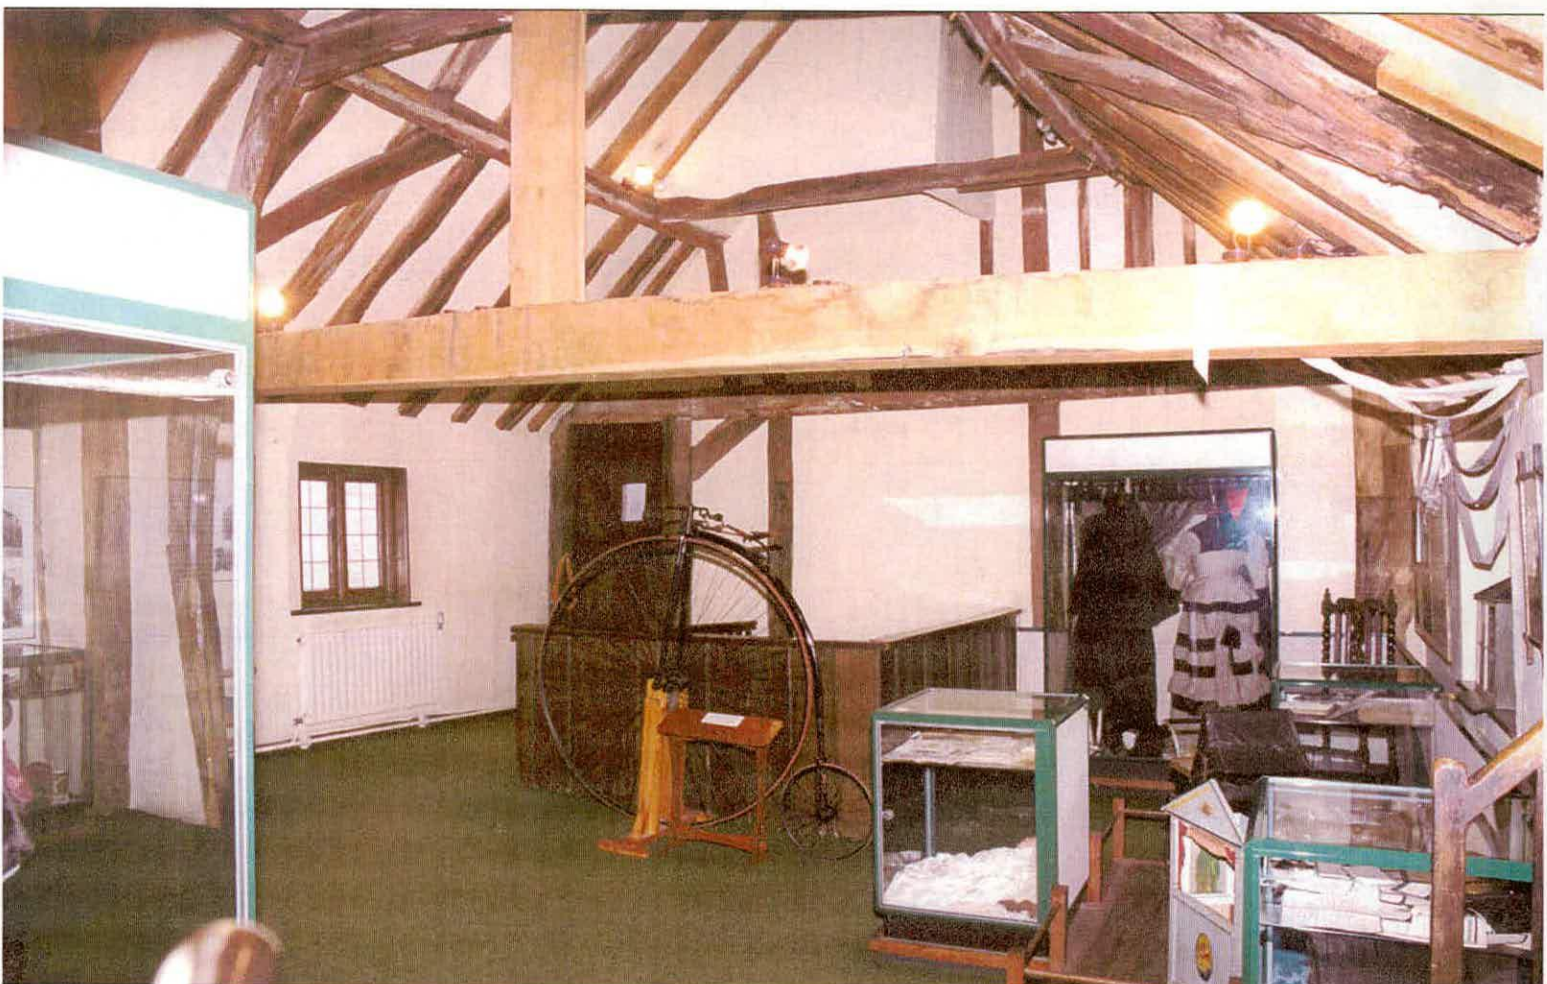
Figure 57, Room 23 looking east with the replaced tie beam in the foreground.
