ICE HOUSE AT
NO.1 BELVEDERE DRIVE,
WIMBLEDON

London Borough of Merton

Emily Cole

Reports and Papers 53

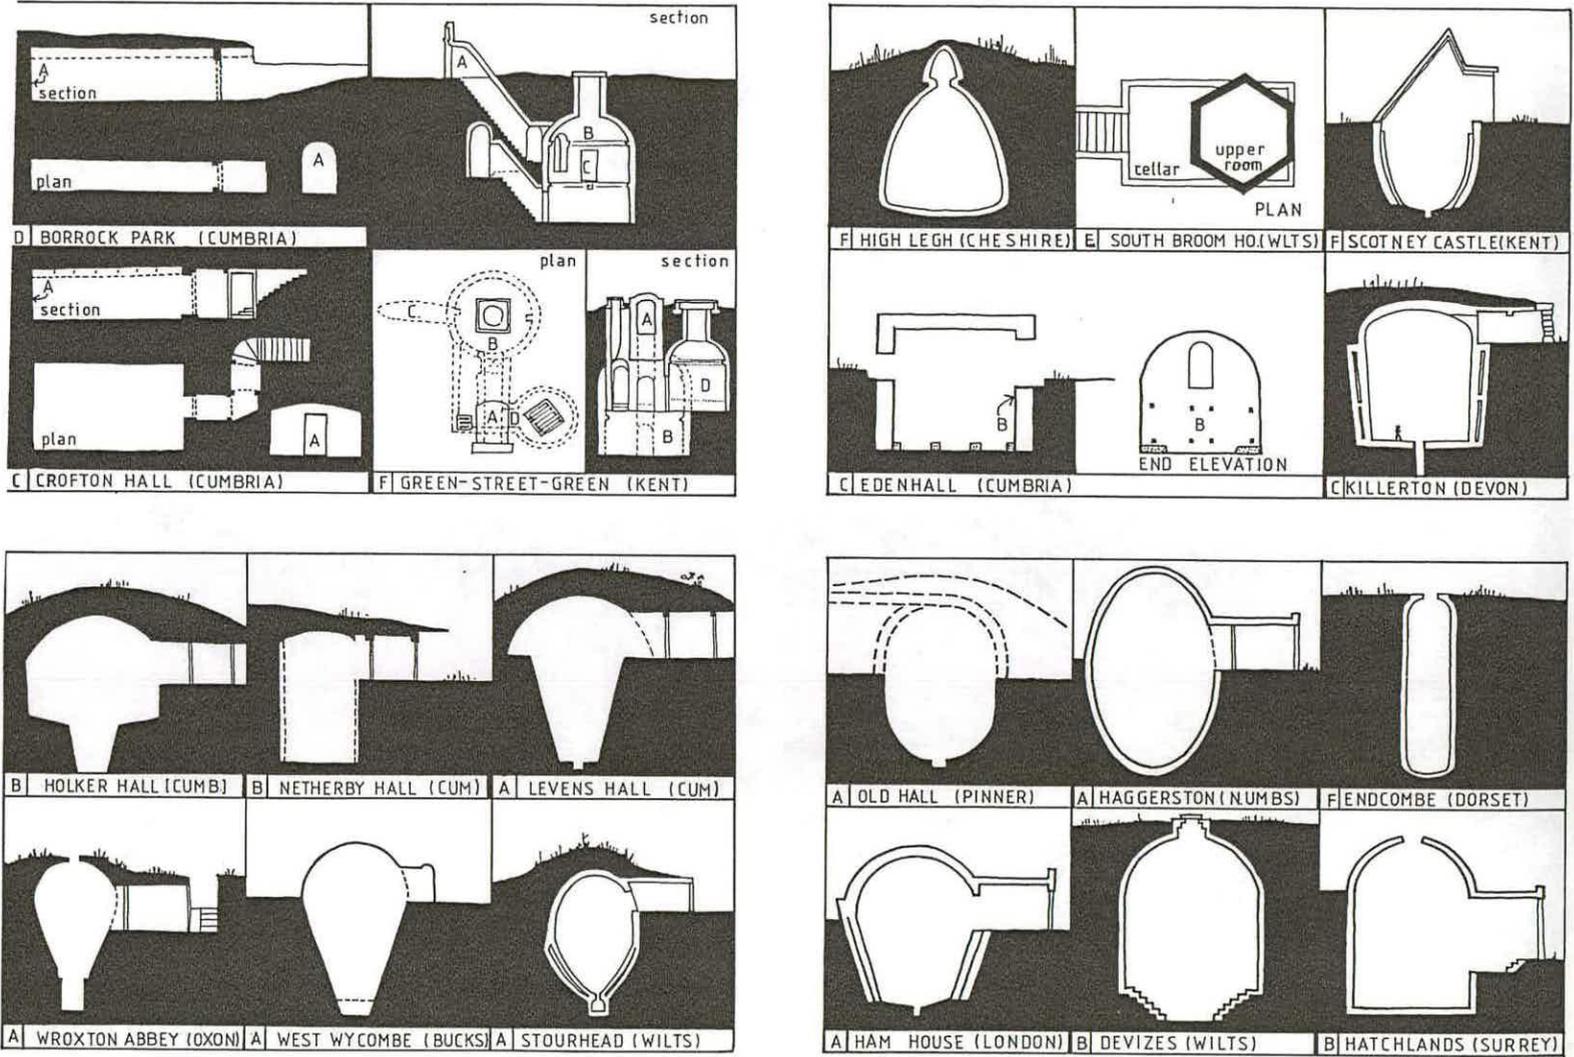
Figure 1: Drawing showing various forms of ice houses, taken from Sylvia P. Beamon and Susan Roaf's *The Ice-Houses of Britain*, (1990). The letter A shows ice houses of the 'cup and dome' form.

Ice houses were built in a variety of forms, sizes and materials, but almost all conformed to general principles in having an entrance, a passage, an ice chamber and a vault or dome (Fig. 1). From the outside entrance ran a paved passage, intended to improve insulation and protection (Fig. 2). This often contained a number of doors, all set in solid wooden frames or masonry openings. The passage opened, via another door, onto the top half of the ice chamber itself, which was typically of masonry, and built down into the earth. The bottom half was filled with ice, and a sump or drain was provided to discharge the melting water. Most were connected via a drain to the base of a nearby lake or pond. At the top of the dome or vault was placed a ventilator, most often covered with a cap; noxious gases were a problem with ice houses, and ventilators not only removed them, but could prevent the gases from forming at all.²

The most common form of free-standing ice house to be built on country estates was the 'cup and dome' variety, also known as globe-shaped or egg-shaped (see Figs 1 and 2). This consisted of a dome or vault, usually of masonry, covering an ice chamber or well, the sides of which sloped downwards into the earth towards a sump or drain. Although this form was expensive, it was extremely strong and durable, and many cup and dome ice houses have survived over two hundred years. The external face of the dome or vault was often rendered, and was then covered with earth (see Fig. 2). J. C. Loudon wrote in 1833

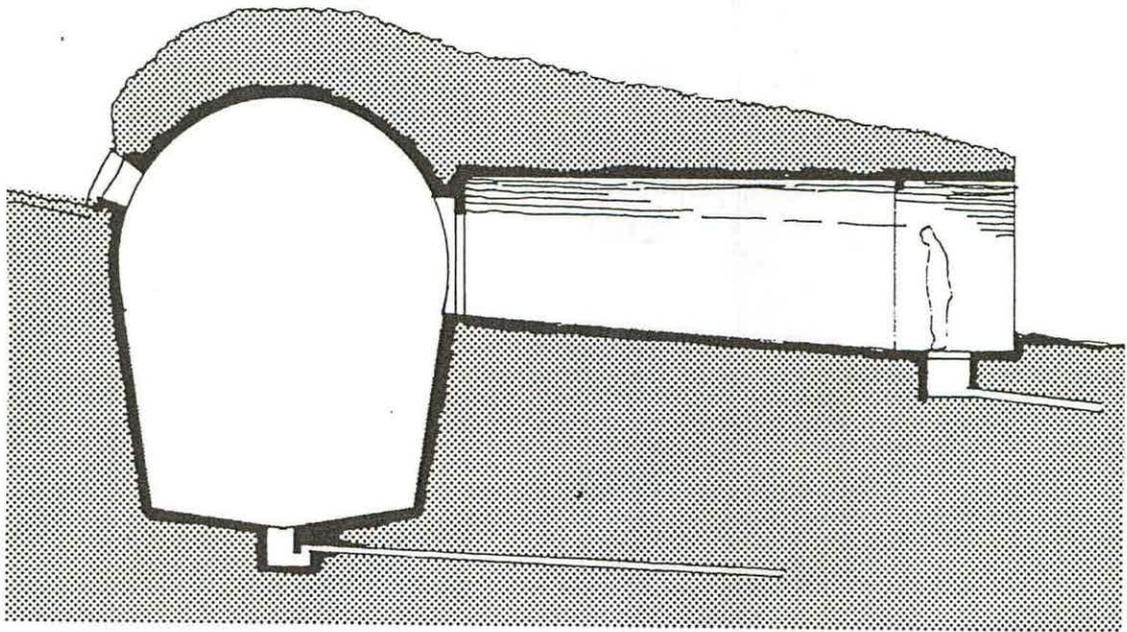
Figure 2; Drawing from Tim Buxbaum's *Icehouses* (1992), showing the form of the cup and dome ice house at Hanbury Hall, Worcestershire, built around 1730

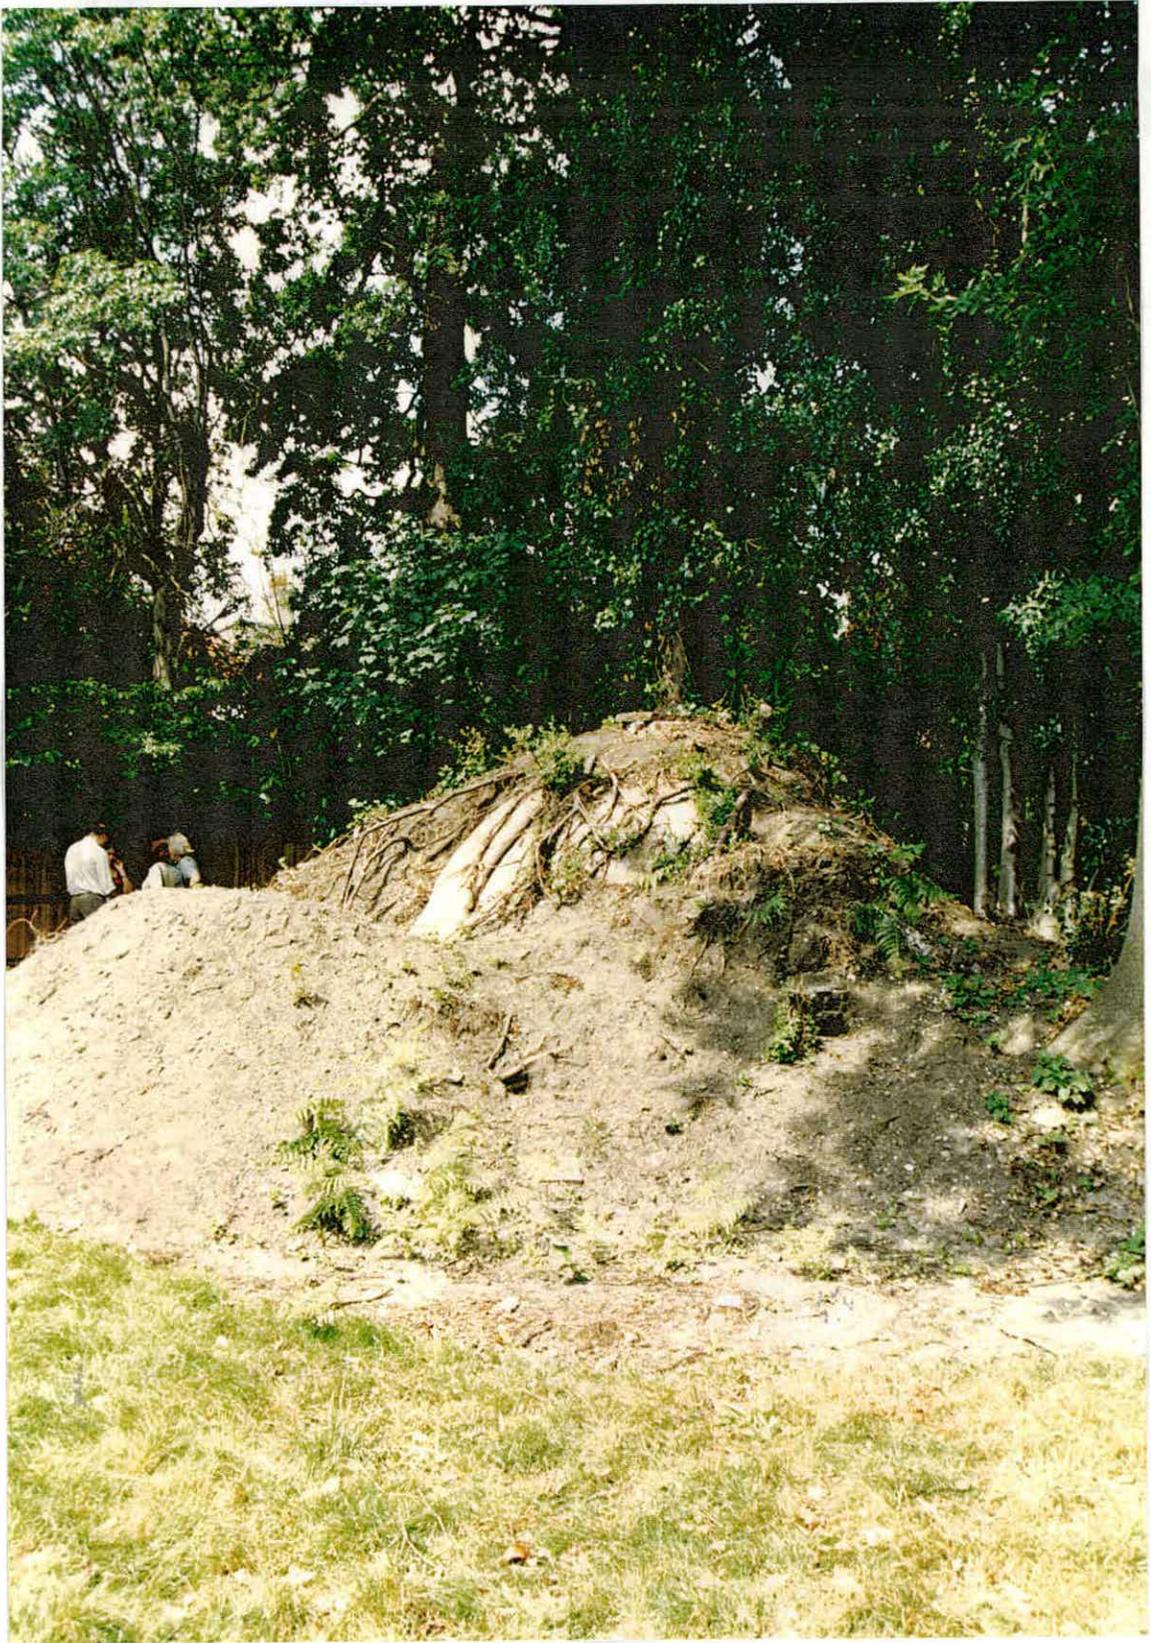
Figure 3; Photograph showing the ice house at the rear of 1 Belvedere Drive, from the south

The ice house under consideration here stands at the north corner of the rear garden of 1 Belvedere Drive, a grade II listed Edwardian house, built in 1901 to the designs of Ernest George and Yeates. The ice house has only recently been rediscovered, having been completely covered with earth for some number of years (Fig. 3). 1 Belvedere Drive is in close proximity to Wimbledon's historic High Street, and falls within a Conservation Area.

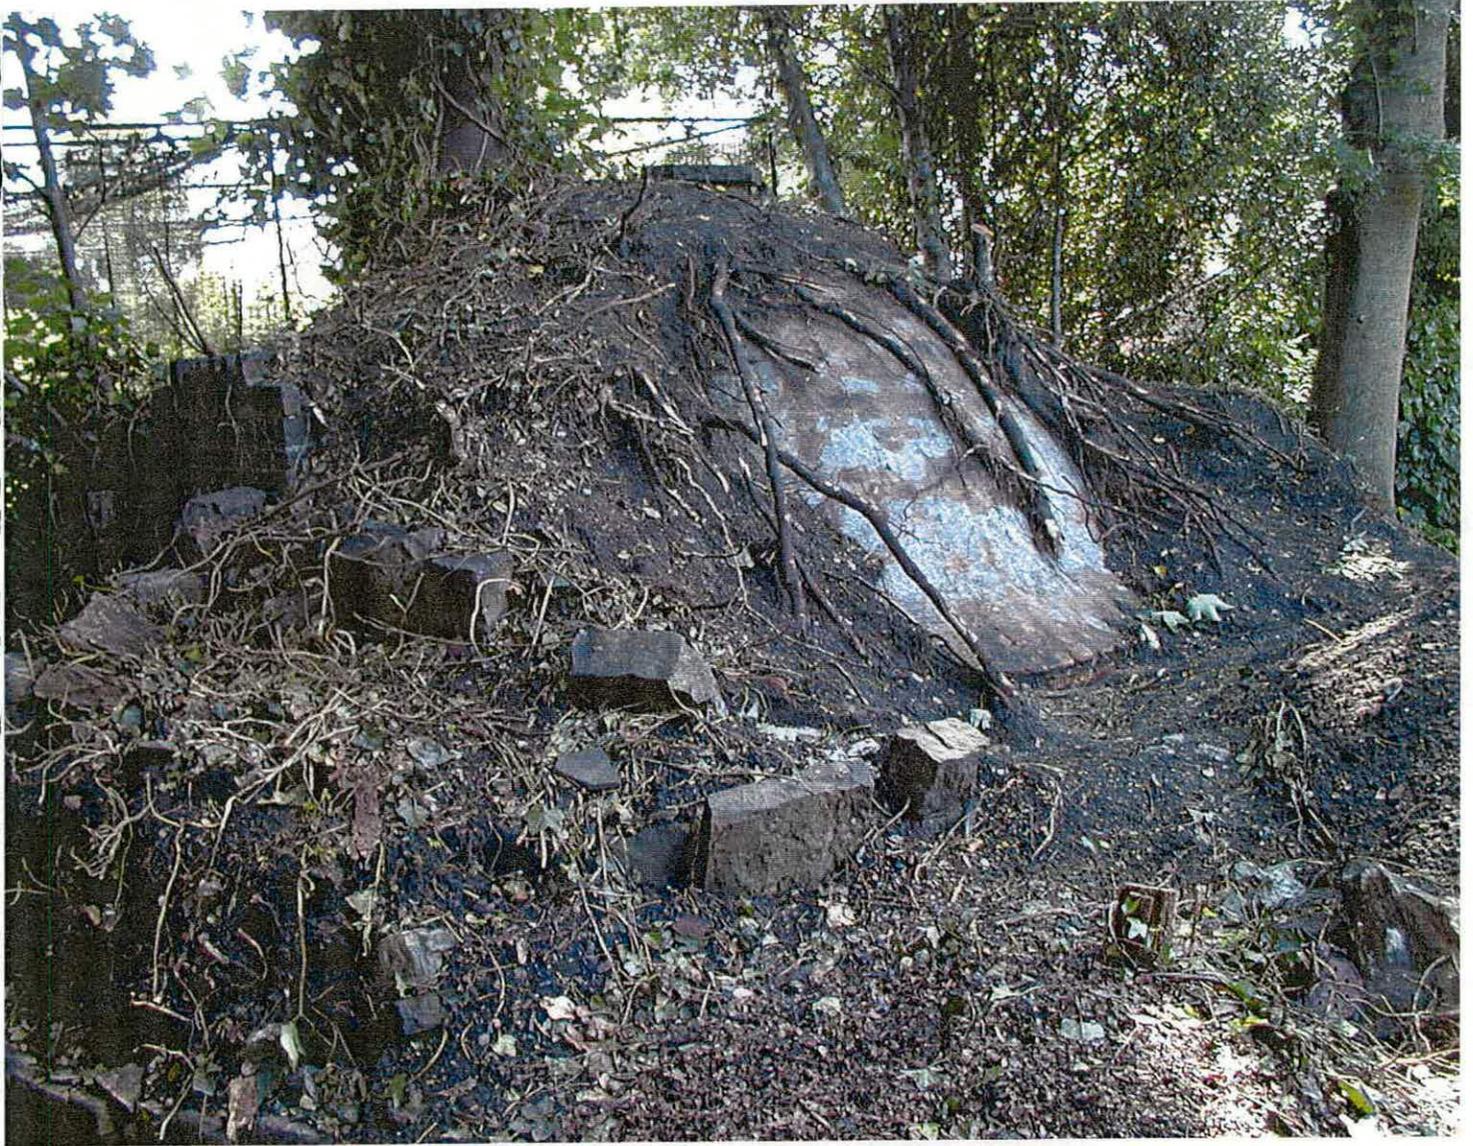
The ice house, of a considerable size, is of the free-standing cup and dome type which, as mentioned above, was the most widely built variety. It has a domed roof, built of red brick and rendered externally, which has a ventilation hole at its summit (Fig. 4). The entrance, on the building's north-west side, now enters straight onto the ice chamber. Externally, the entrance is of brick and is topped by bricks on end, a crude attempt at castellation (Fig. 5). The bricks of this entrance are of a different size and colour from those of the main ice chamber, and seem to belong to a later date. Originally, the ice house – as was standard – would have had its own entrance passageway, a feature which has been removed, with the innermost doorway being made the main entrance. A low wall of cement blocks sweeps around the outside of the earth mound on the entrance side, curving away from the door (Fig. 6). It is probable that these blocks were added when the passageway was removed, so as to provide an alternative support for the earth superstructure. The date of these alterations cannot be given with any certainty, though the bricks of the present entrance way appear to date from some time after the mid-nineteenth century.

Figure 4; Photograph of the ice house from the west, showing an exposed area of its rendered brick dome

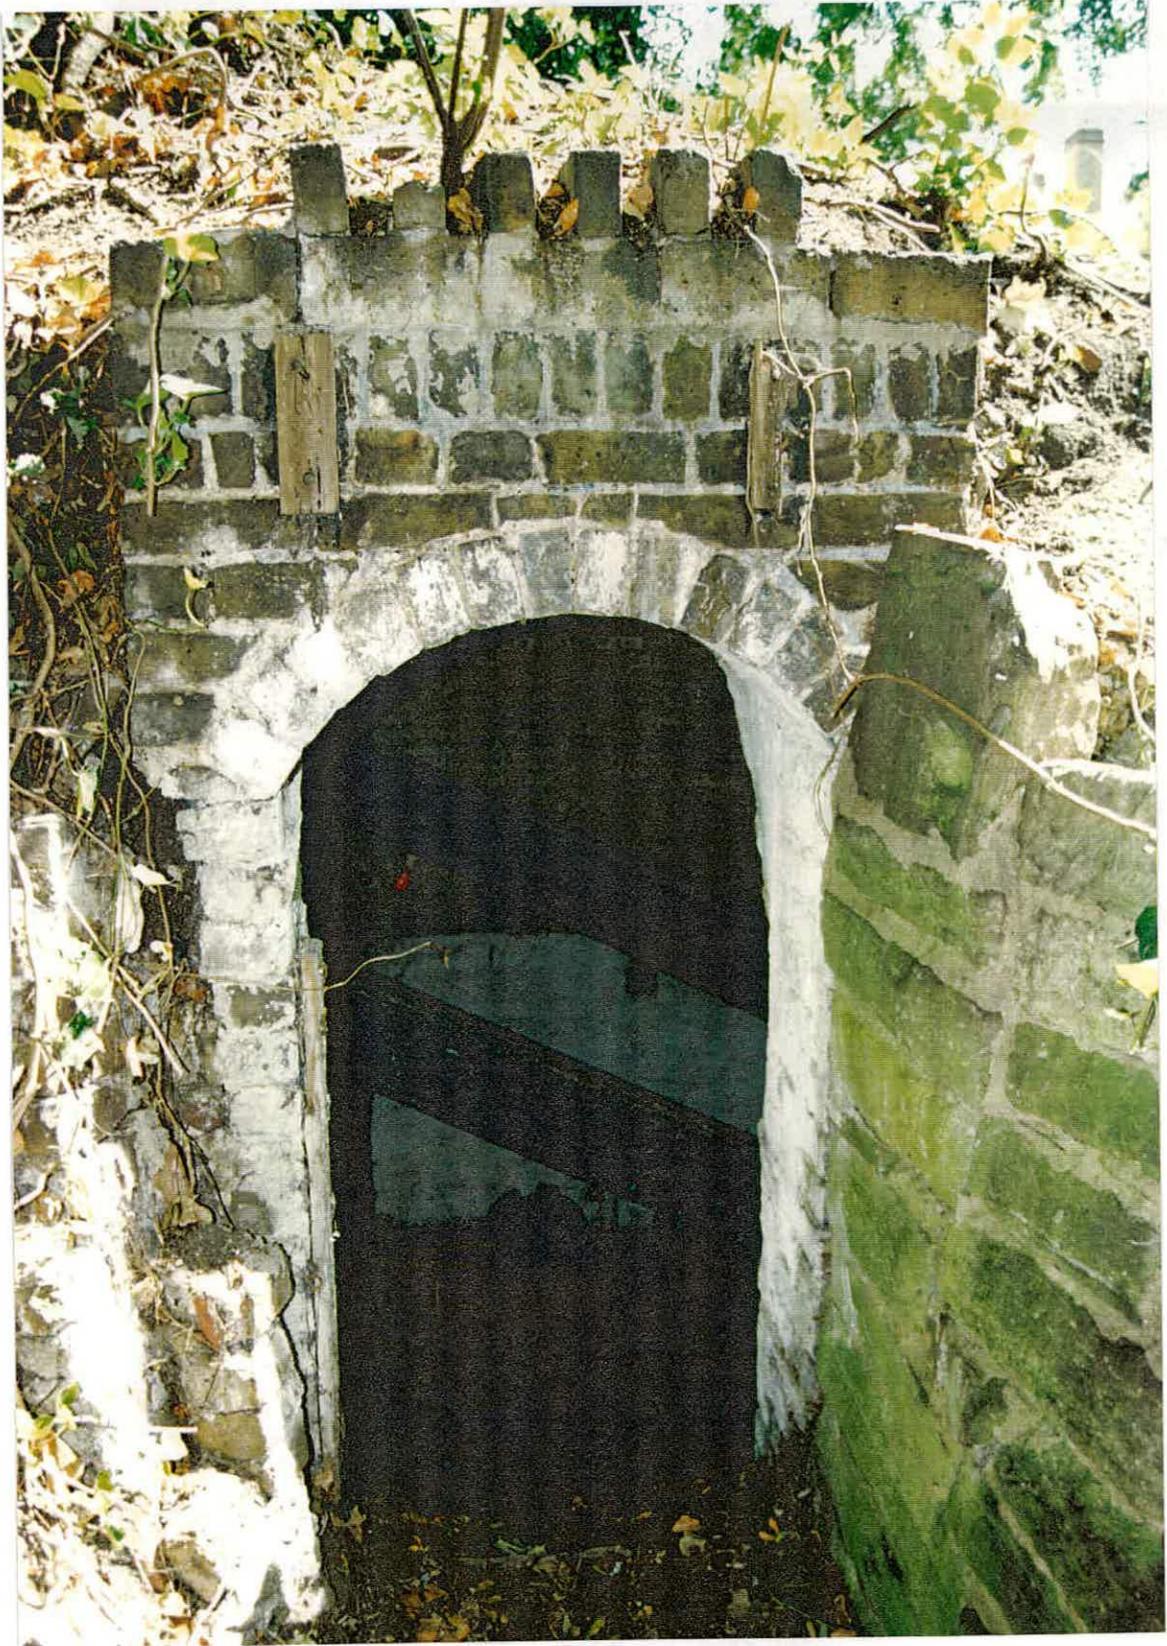
Figure 5; View of the present brick entrance to the ice house

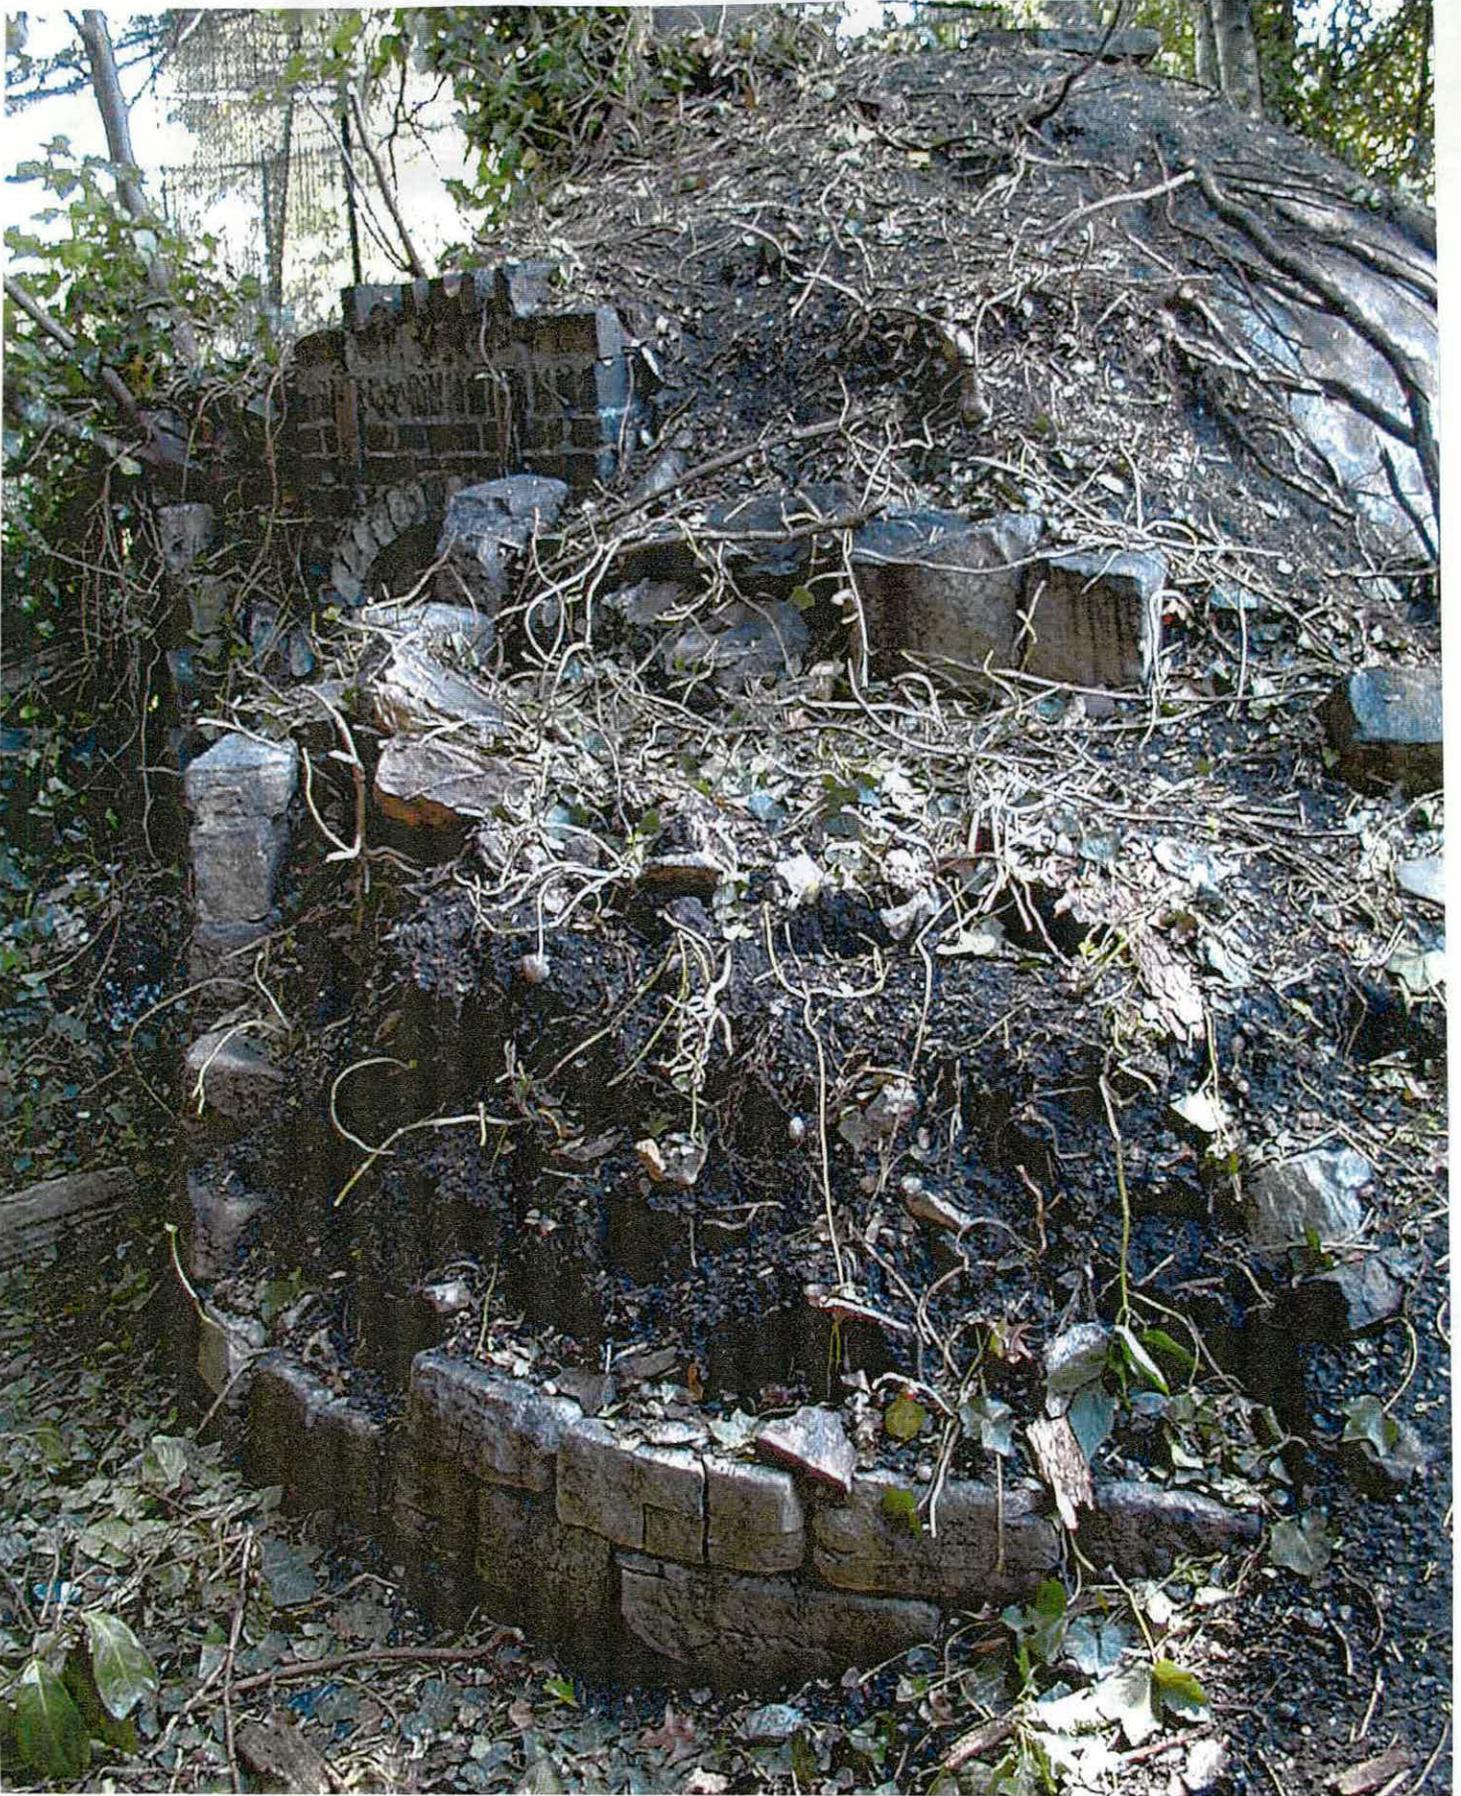
Figure 6; The ice house from the west, showing the wall of cement blocks which sweeps around the entrance side of the mound

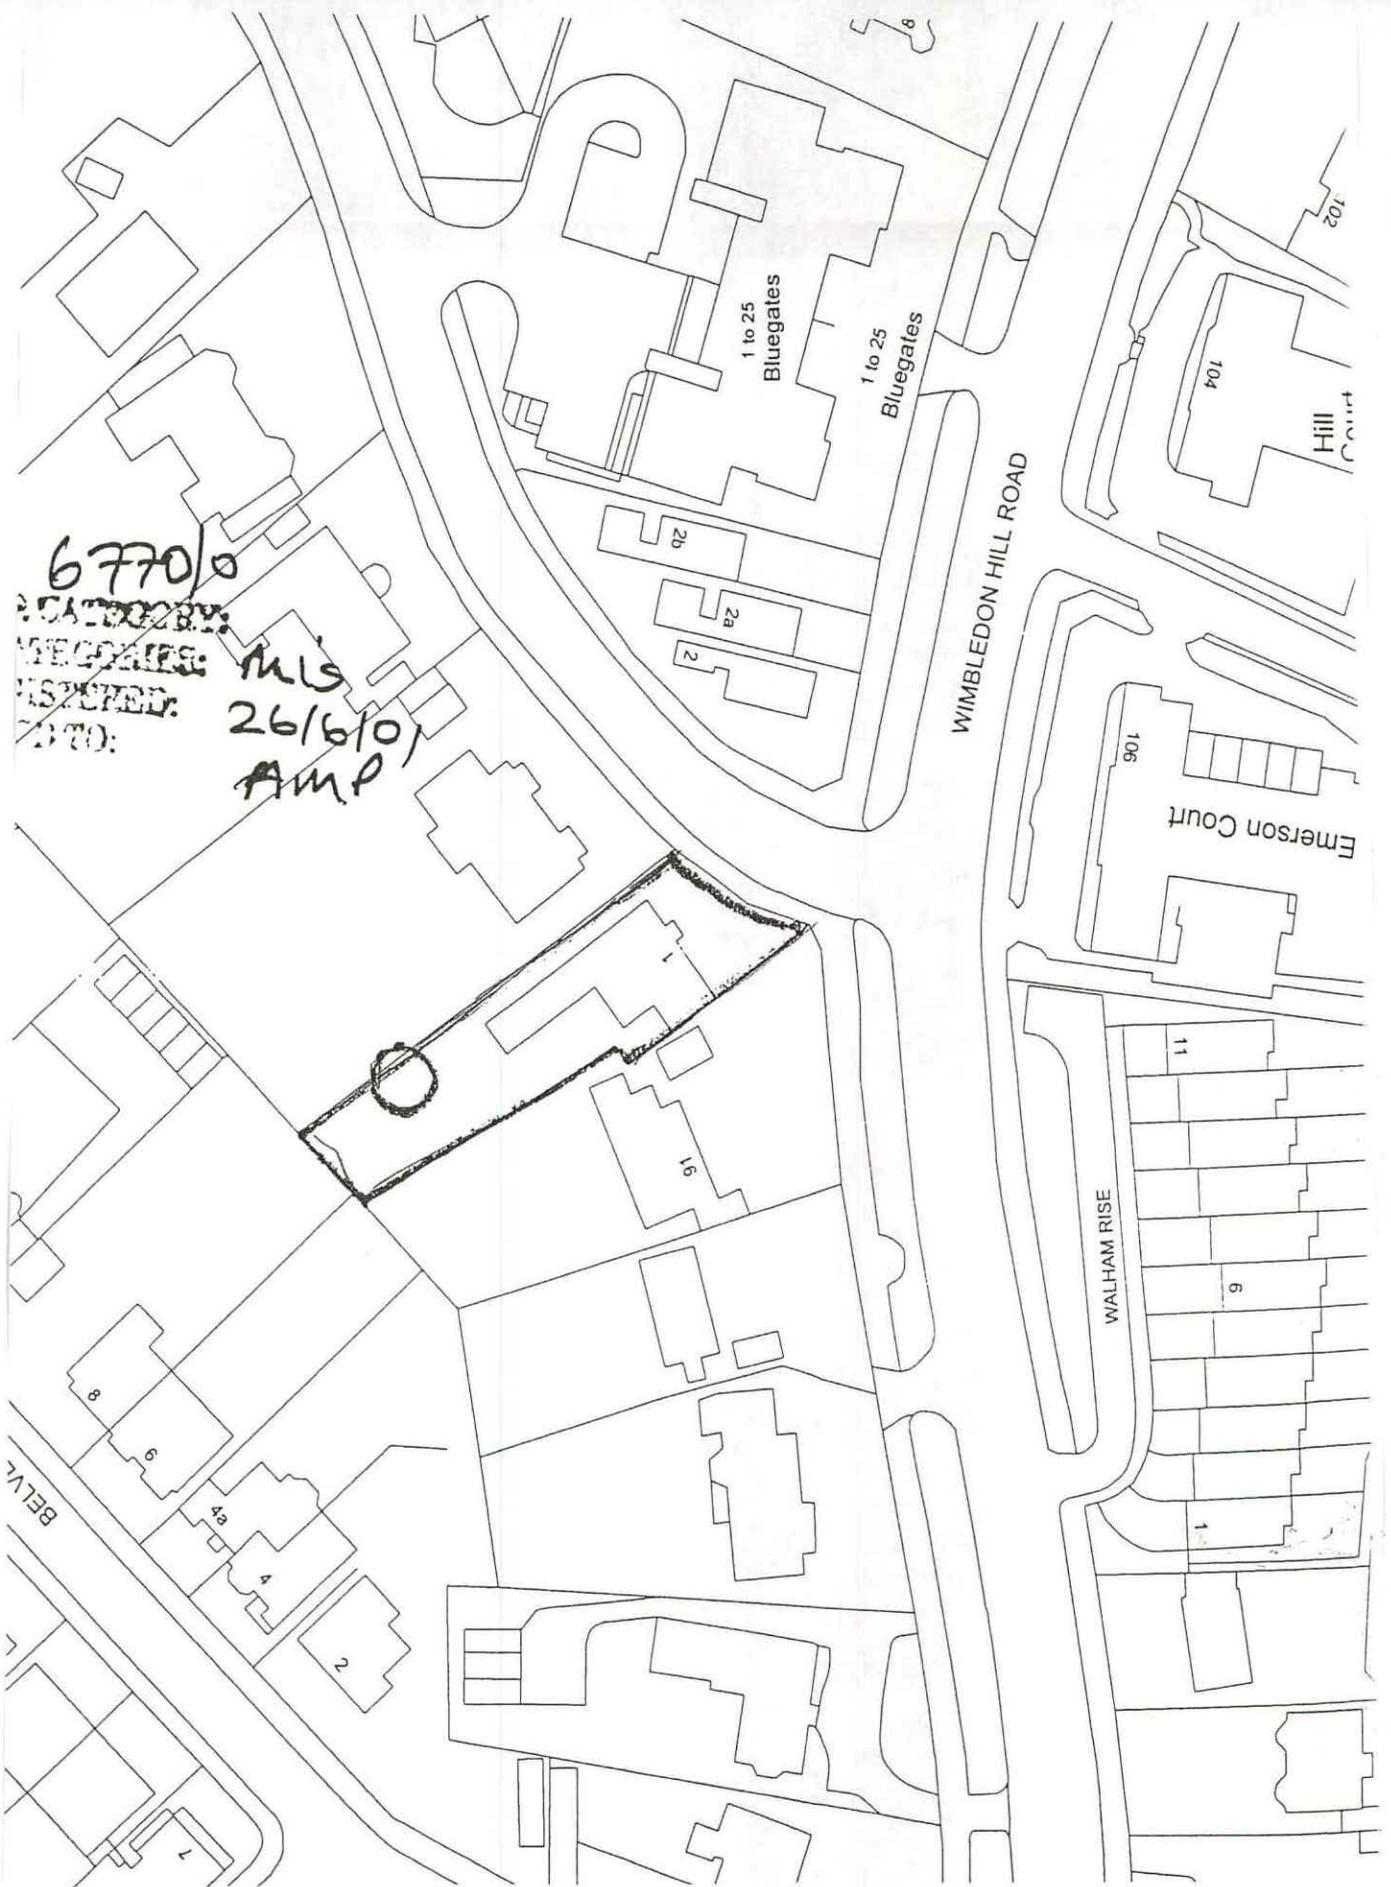
The nature of the property boundaries designated at the turn of the twentieth century meant that the ice house had to be divided in two; the majority of the building lies within the grounds of 1 Belvedere Drive, but at least a quarter falls within the grounds of the neighbouring property, 3 Belvedere Drive (Fig. 7). At an unspecified date in the past, the owners of 3 Belvedere Drive decided to demolish their section of the ice house. The result is that the interior of the ice house is somewhat confusing. A vertical wall forms the building's north-east termination, rather than the graceful curve of the dome and well which one would expect (Fig. 8). The vertical wall, constructed of brick, is supported by unattractive timber shoring. The base of the ice chamber is covered with debris, and it is not possible to see either sump or drain (Fig. 9).

Figure 7; Modern map showing the position of the ice house. The area of the ice house shown as falling within 3 Belvedere Drive has been demolished

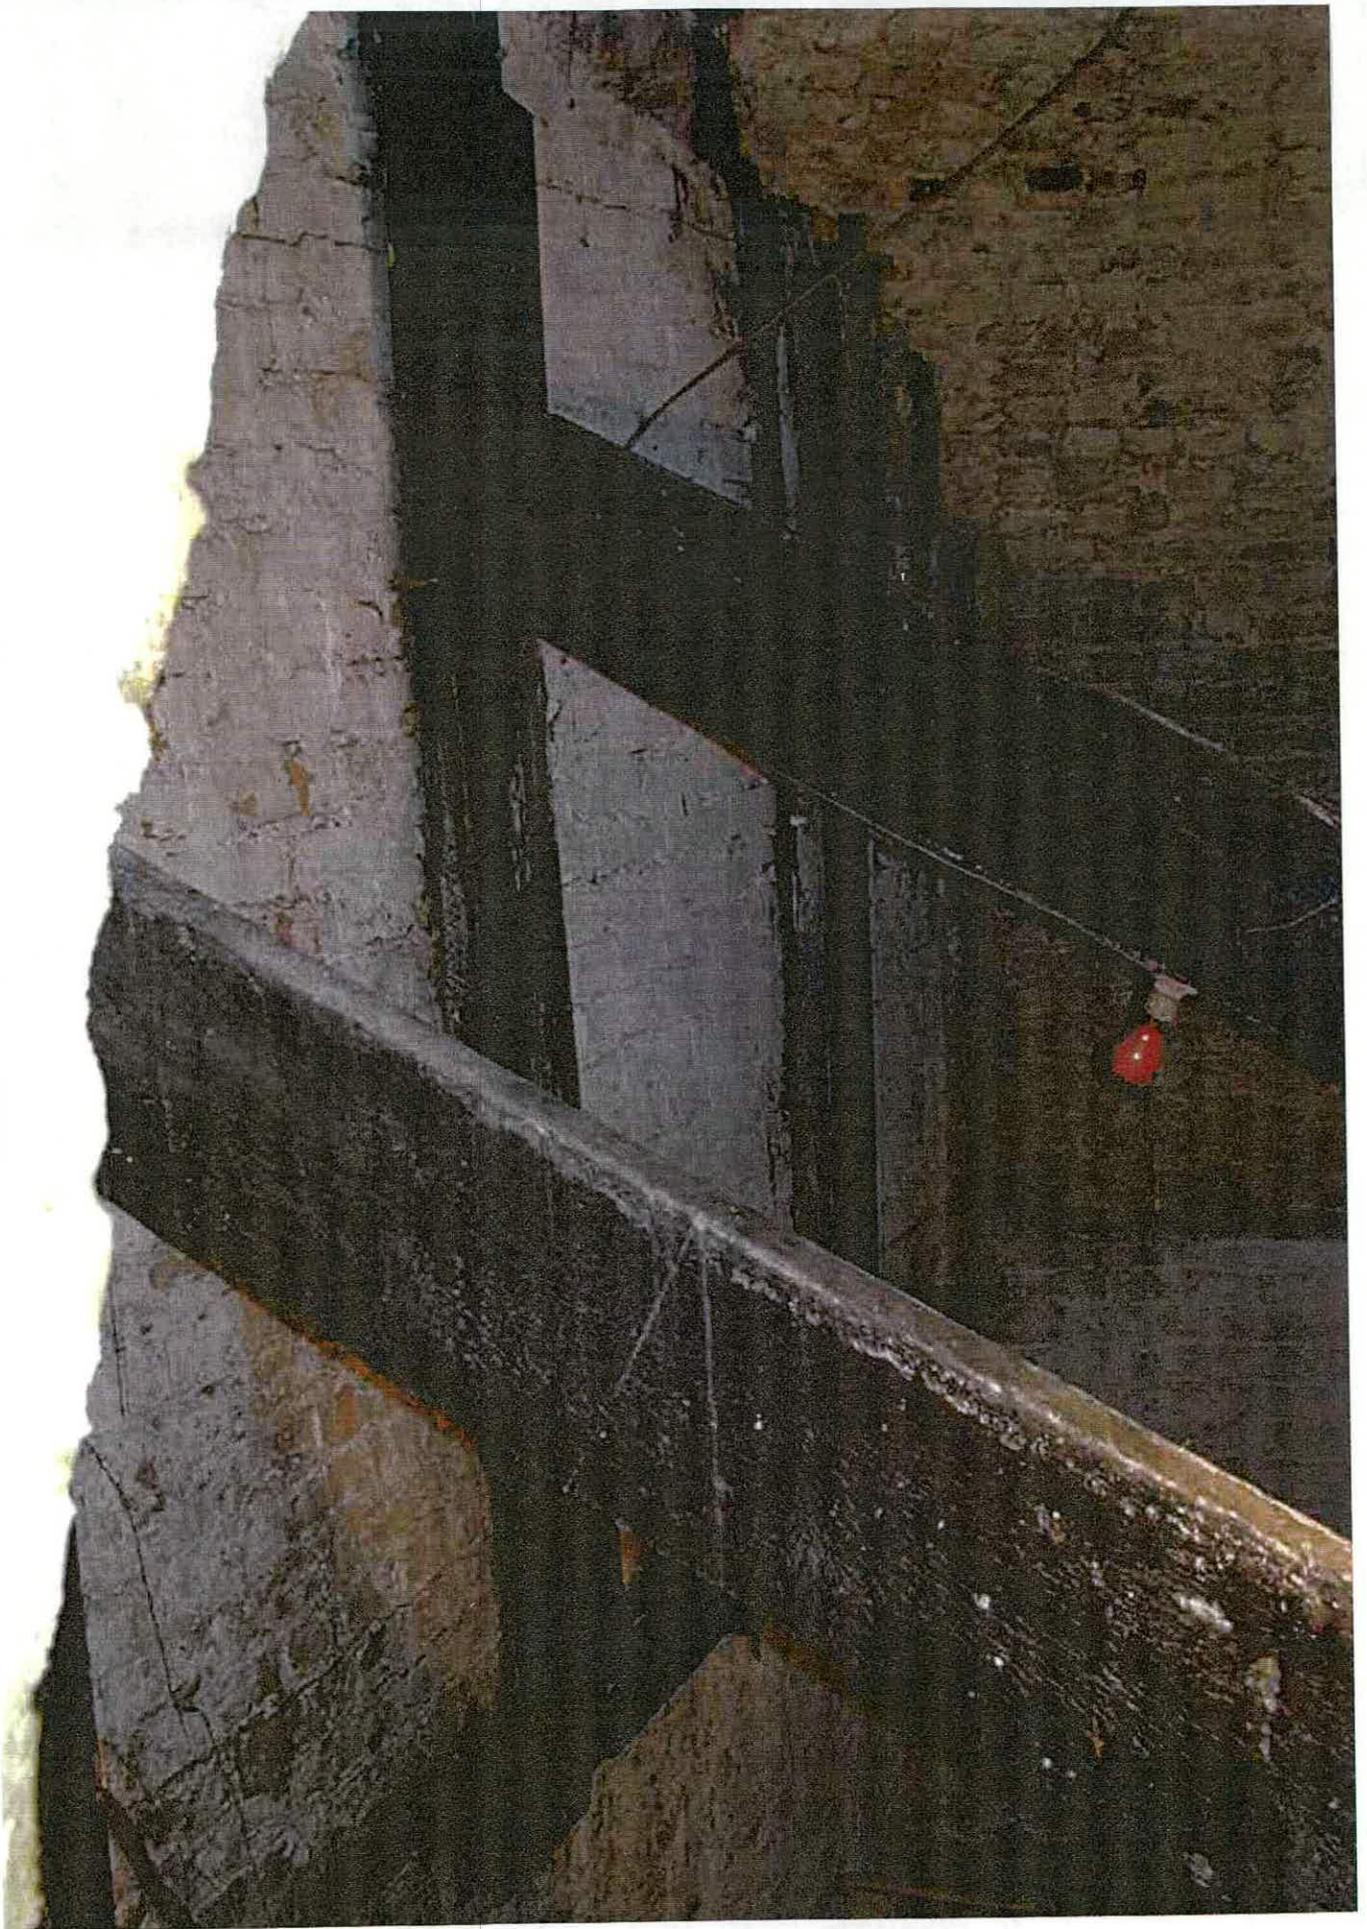
The ice house is, on the whole, in poor repair. The vertical wall mentioned above has come away from the bricks of the dome, and the roots of a large tree – which is growing on top of the superstructure – have begun to cause damage.

Figure 8; Photograph of the vertical wall which was added at the north-east of the ice house when it was part demolished

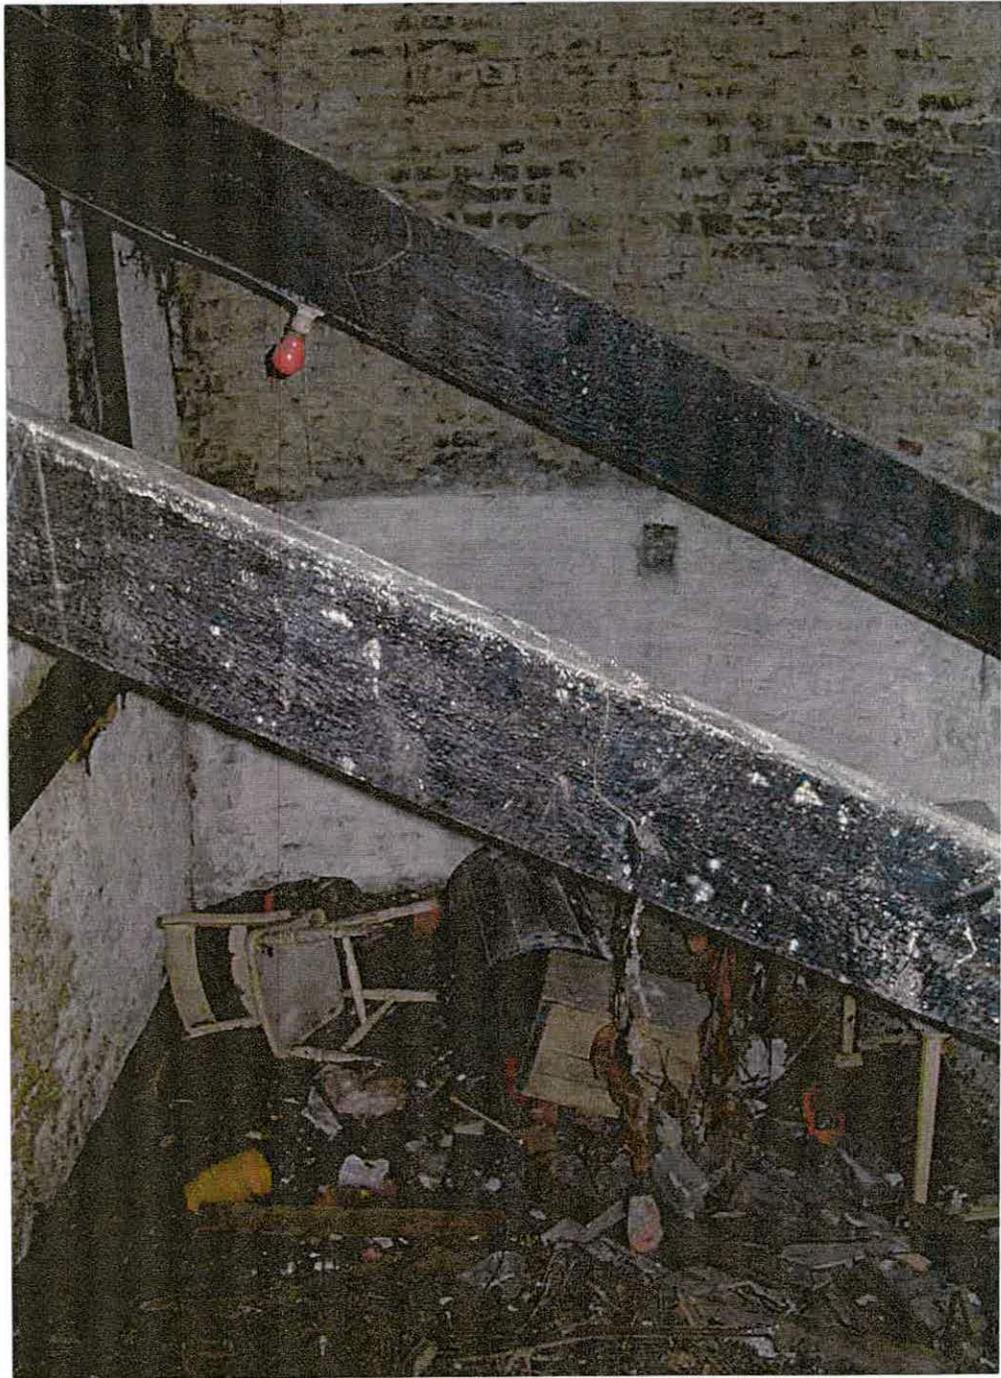
Figure 9; The interior of the ice house, showing the base of the well of the ice chamber full of debris

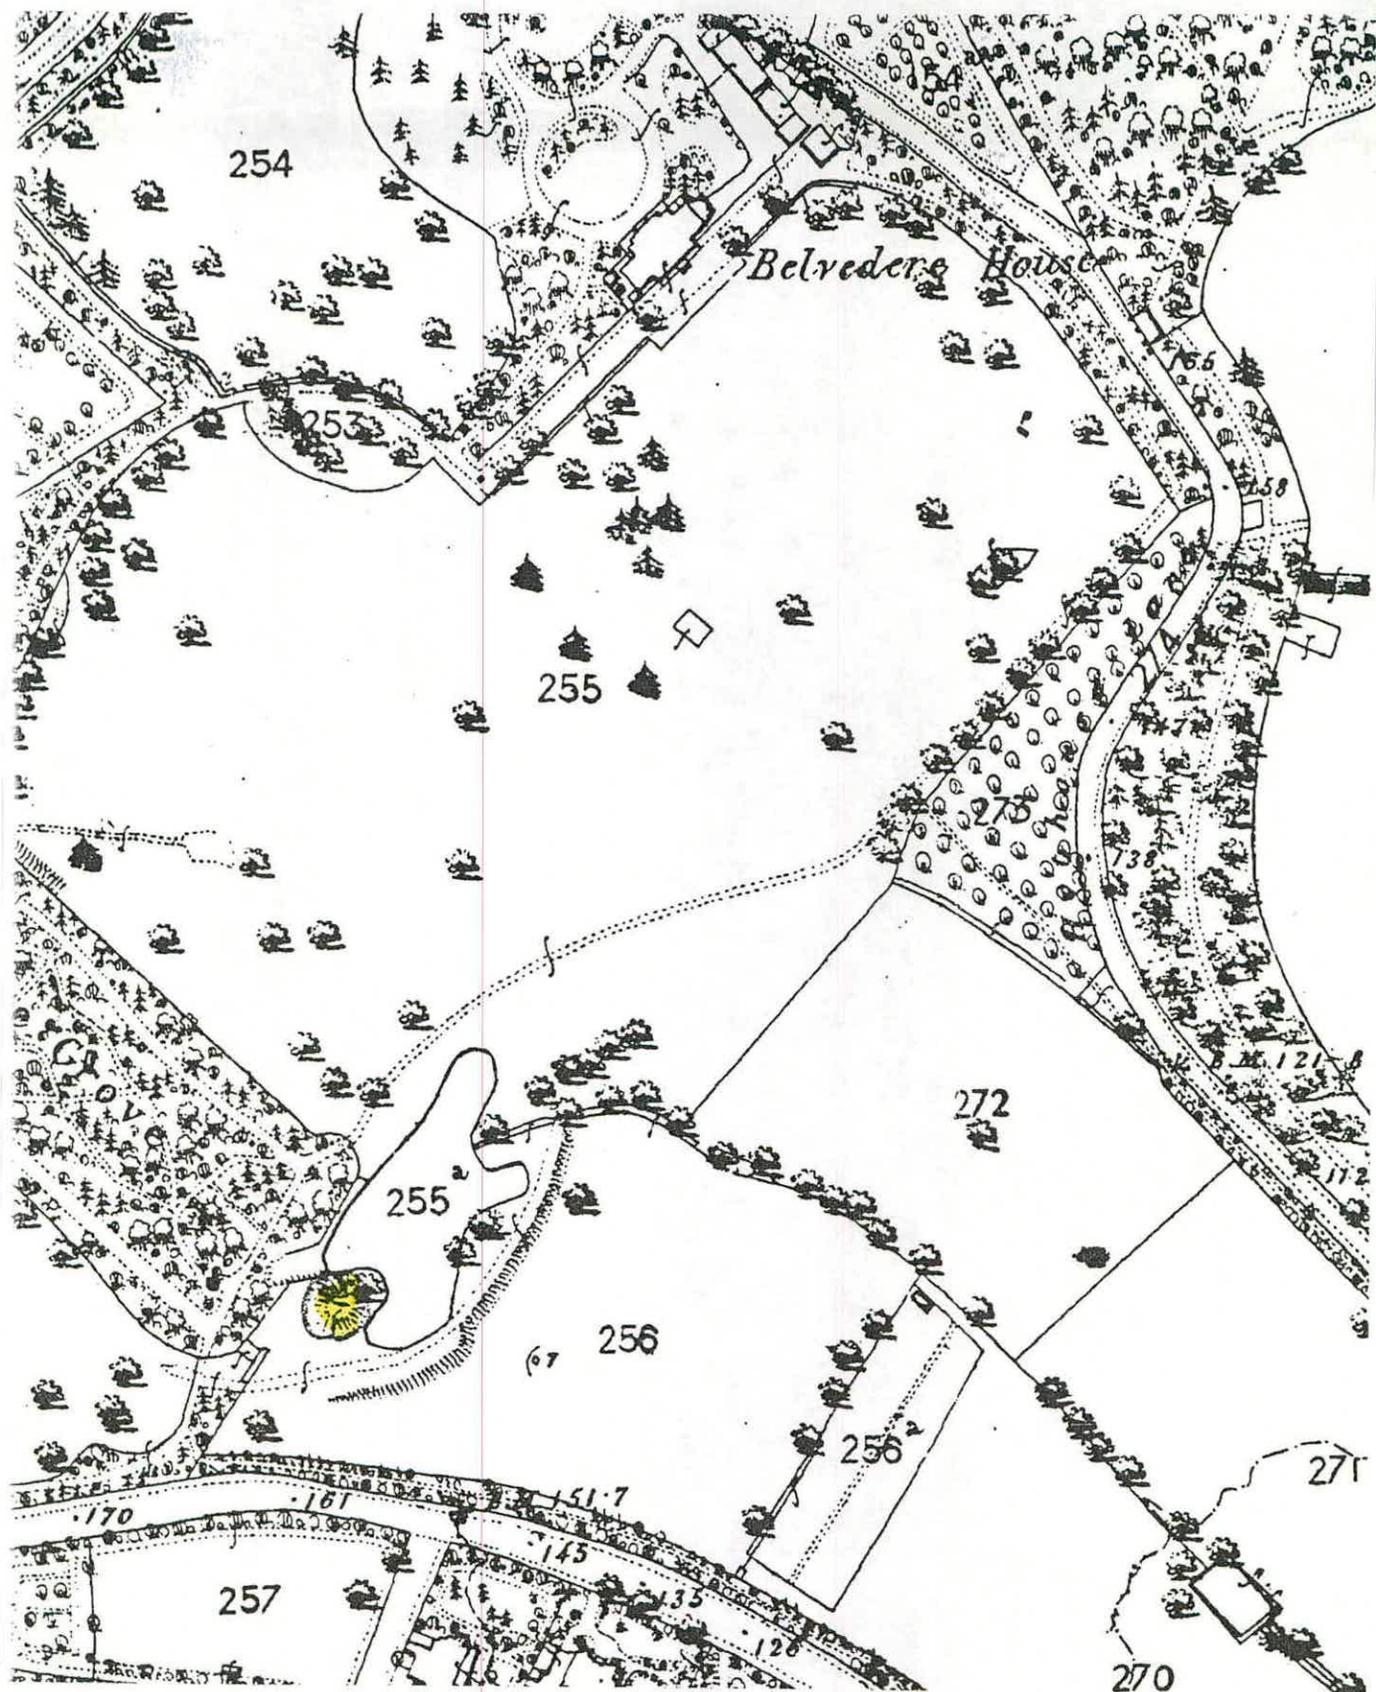
There can be no doubt that this ice house once stood in the grounds of one of Wimbledon's most important houses, Belvedere House. In the first edition Ordnance Survey map, dating from the 1870s, the land now occupied by Belvedere Drive is shown to be within the house's boundary. Furthermore, a mound appears in a position which corresponds with that of the ice house (Fig. 10). The mound is set adjacent to a landscaped lake, a situation that was – as we have seen – that most favoured for ice houses, and is close to the public highway.

Figure 10; Detail of first edition Ordnance Survey map, drawn in the 1870s. The ice house appears as a mound at the foot of a lake
