ICE HOUSE AT
NO.1 BELVEDERE DRIVE,
WIMBLEDON

London Borough of Merton

Emily Cole

Reports and Papers 53

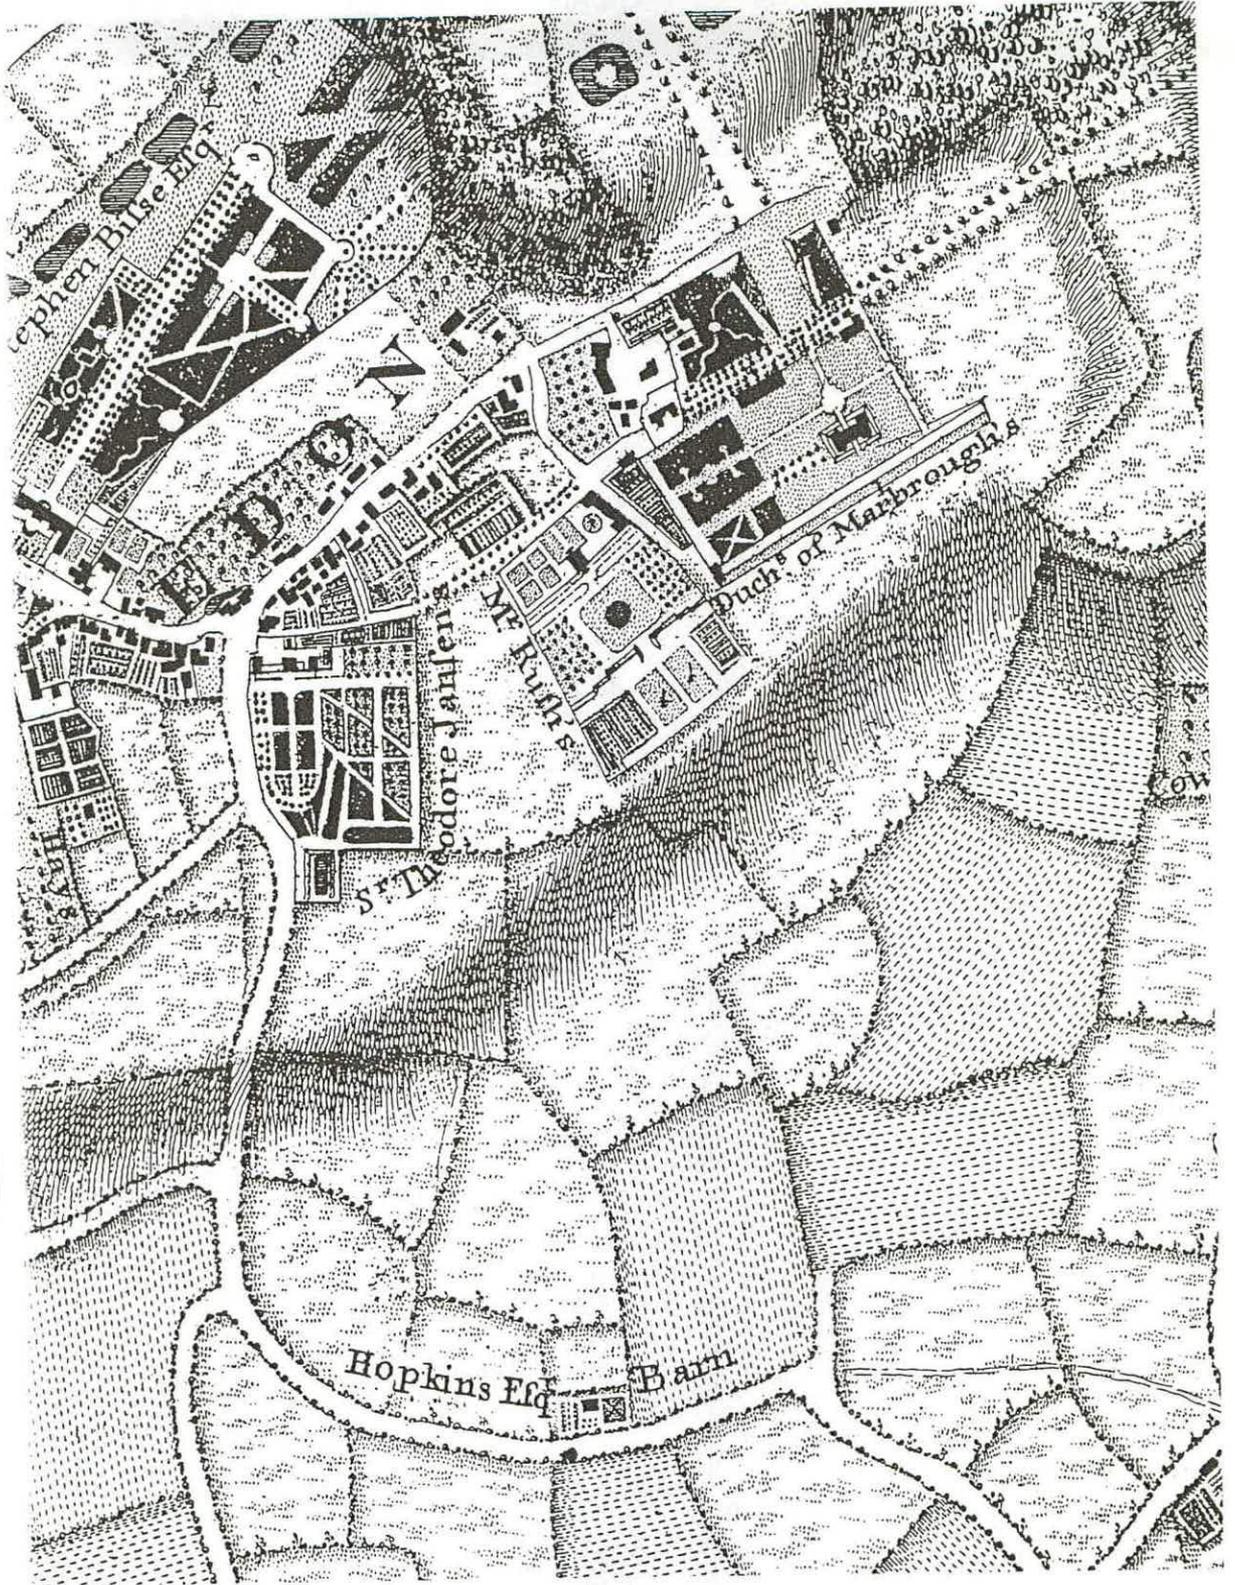
It seems most likely that the ice house now at 1 Belvedere Drive was constructed during one of the more major landscapings of the estate grounds. At the time John Rocque's map was drawn in 1746, it appears that the grounds of Belvedere House had been little landscaped, and there is no sign of an ice house (Fig. 13). It was under the Rushes, from 1748 to 1834, that the greatest work was done, in particular under Sir William Rush, after 1783. By the nineteenth century, the grounds of Belvedere House extended as far south as Woodside and across to Wimbledon Hill Road.¹⁰

Figure 13; Detail of John Rocque's map of 1746. The landscaping of the grounds of Belvedere House did not then extend to the area now occupied by Belvedere Drive
