**OLD WISLEY,  
CRANBROOK, KENT**

Historical Analysis & Research Team  
*Reports and Papers 25*  
2000

## OLD WILSLEY, CRANBROOK, KENT

### *Introduction and scope of study*

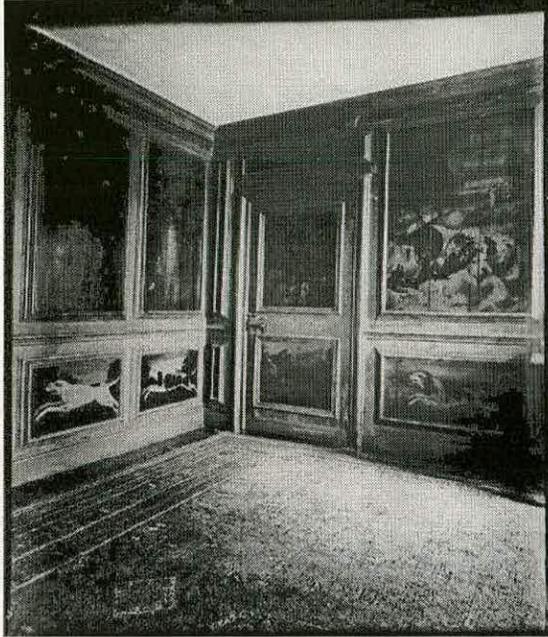
**Figure 2** Photographic plate of C17th painted panelling in former service wing. Nathaniel Lloyd Collection. NMR Swindon

The skewed plan of the northern extension wing of 1998-9, and presence of what may be *in situ* reused stone foundations at its western end, suggest the existence of a former rear extension wing at the service end of the house<sup>6</sup> (see *plan drawing at rear of this report*). The main service accommodation was probably relocated to the rear of the wing following the construction of a new kitchen block behind the hall in the seventeenth century (see below). The original site of the buttery and pantry was converted to a parlour in c.1700 (*fig 2*).

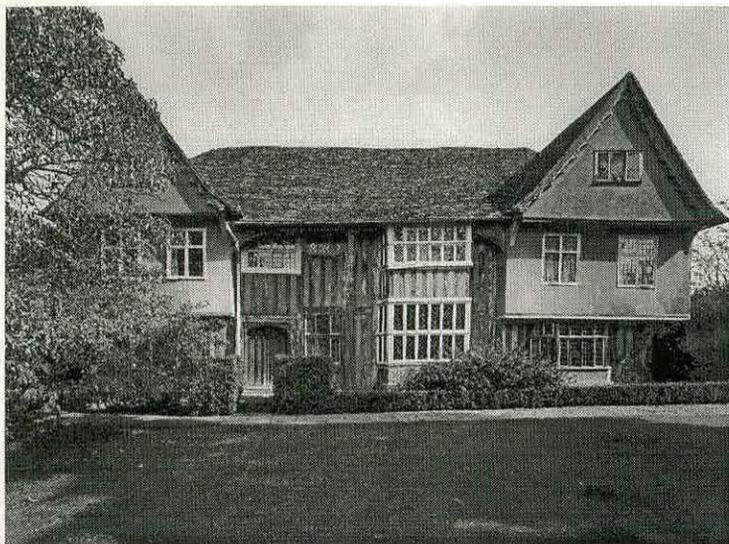
**Figure 3 West (original front) elevation**

The original house faced towards the west (*fig 3*), with the 'upper' end of the house, consisting of a ground floor parlour with solar above, situated to the south of the hall (*fig 4*), and the 'lower' end, i.e. the buttery and pantry, to the north. The hall was entered via two diagonally opposing doorways. The front door was situated in the conventional medieval position next to the service rooms at the lower end of the hall. The rear door was in the opposite corner of the hall and opened into a short staircase bay, which lay behind the parlour (see below).<sup>5</sup> There was no cross passage, and the buttery and pantry were entered directly from the hall.

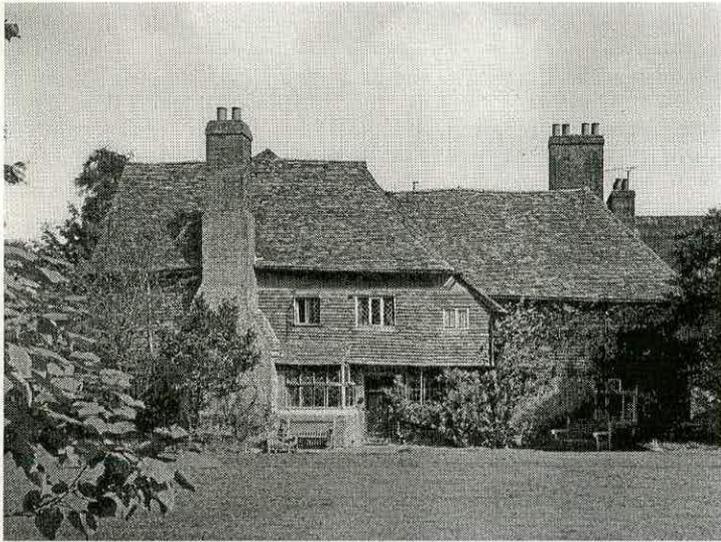
**Figure 4 South (side) elevation**

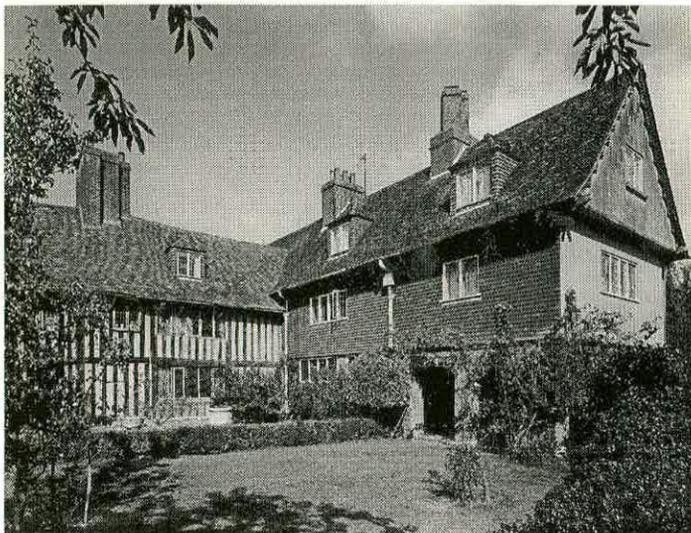
**Figure 5** East (rear) elevation with wing of 1898-9 and 1915 at right

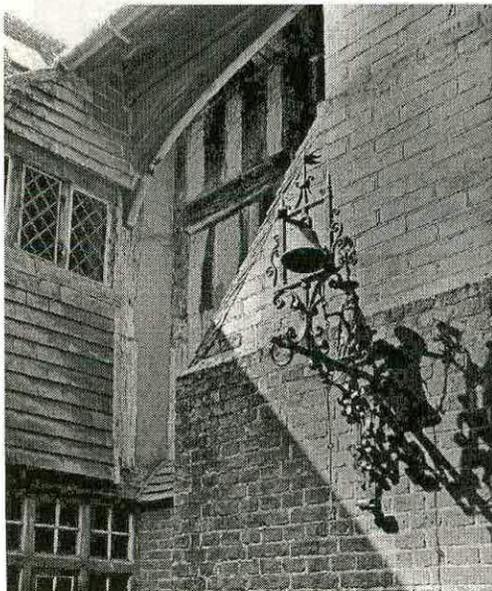
**Figure 6** Courtyard. Junction of hall and S wing. The horizontal timber forming the head of the sixteenth century hall window (now blocked) can be seen to the right of the first floor window of the adjoining wing

A tall, narrow window in the rear wall of the building lit the dais at the upper end of the hall (*fig 6*). The window was blocked following the insertion of an upper floor into the hall range, probably during the seventeenth century. The window forms an integral part of the timber frame of the hall, and dates from the original construction of the house. The timbers forming the jambs to the opening are decorated with carved ogee mouldings.

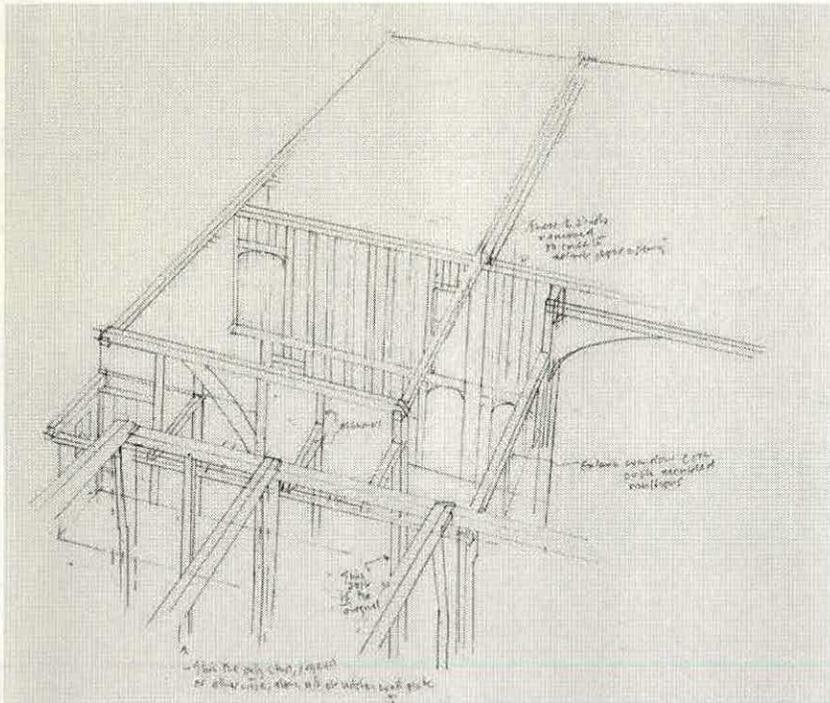
Figure 15 Sketch showing the relationship of the west staircase wing to the south (solar) wing

The plan of the rear wing at the south (solar) end of the house has been substantially altered, however there still remains sufficient evidence to reconstruct the basic layout of the sixteenth century staircase (*figs 15 & 16*). The roof over the main part of the rear projection wing (marked 'A' and 'B' in figure 16) may date from the original construction of the house, or alternatively may have been rebuilt when the existing clasped purlin cross wing roofs were added in the late-sixteenth or seventeenth centuries.

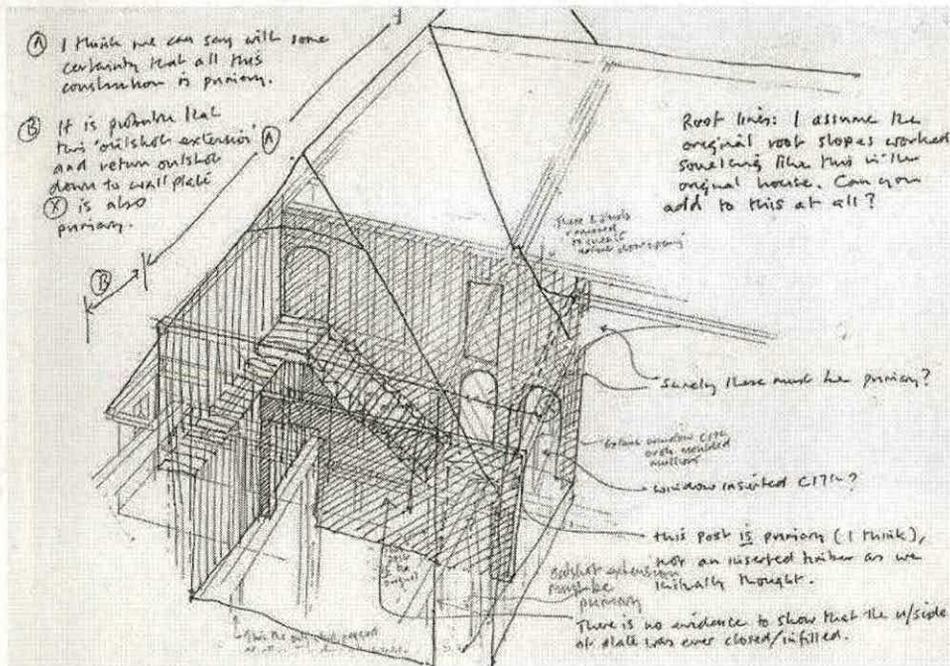
Figure 16 Sketch reconstruction showing the probable original staircase arrangement at the southern (solar) end of the house

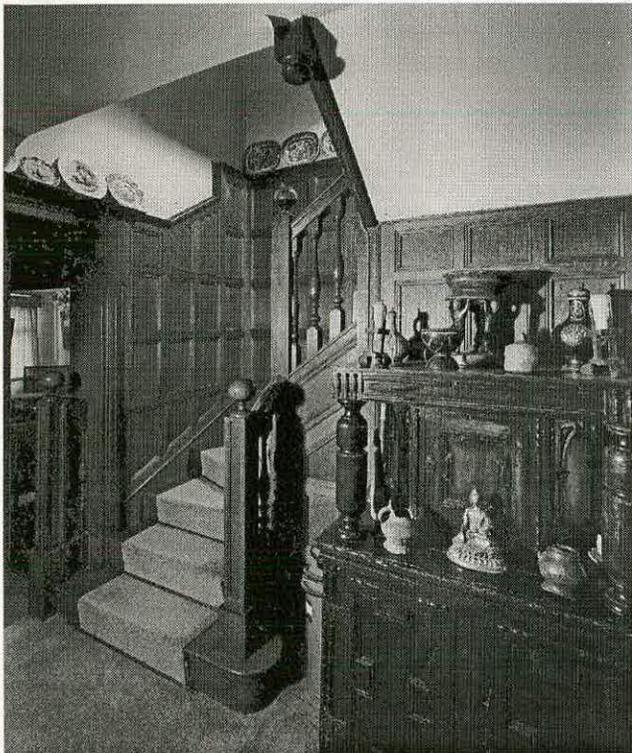
**Figure 17 South wing. Ground floor. Present staircase**

The wing was extended and a new access passageway created on its northern (courtyard) side at the same time as the kitchen block was constructed at the rear. The rebuilt north side wall includes an original ovolo-moulded window at first floor (possibly of the same type as the former frieze windows within the kitchen block) which looks out onto the small rear courtyard. The existing staircase dates from the restoration of 1898-9, but it may replace an earlier staircase of a similar form in the same position (*fig 17*).

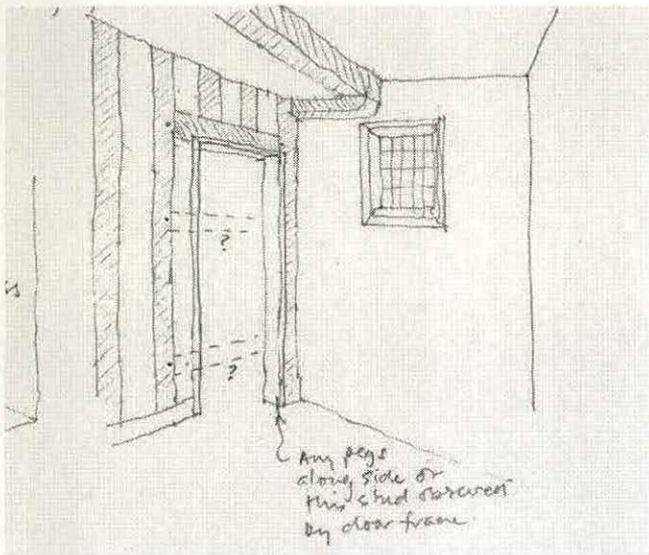
**Figure 18 North wing. First floor. Sketch showing the position of the sixteenth century window opening (now blocked) which lit the former staircase bay at the northern (service) end of the house**

As constructed, the house included a short staircase wing serving the solar at the southern end of the hall. At the northern opposite end of the house, the staircase was probably situated within a narrow bay within the northern bay itself, and was lit by a window in the rear wall (*fig 18*).

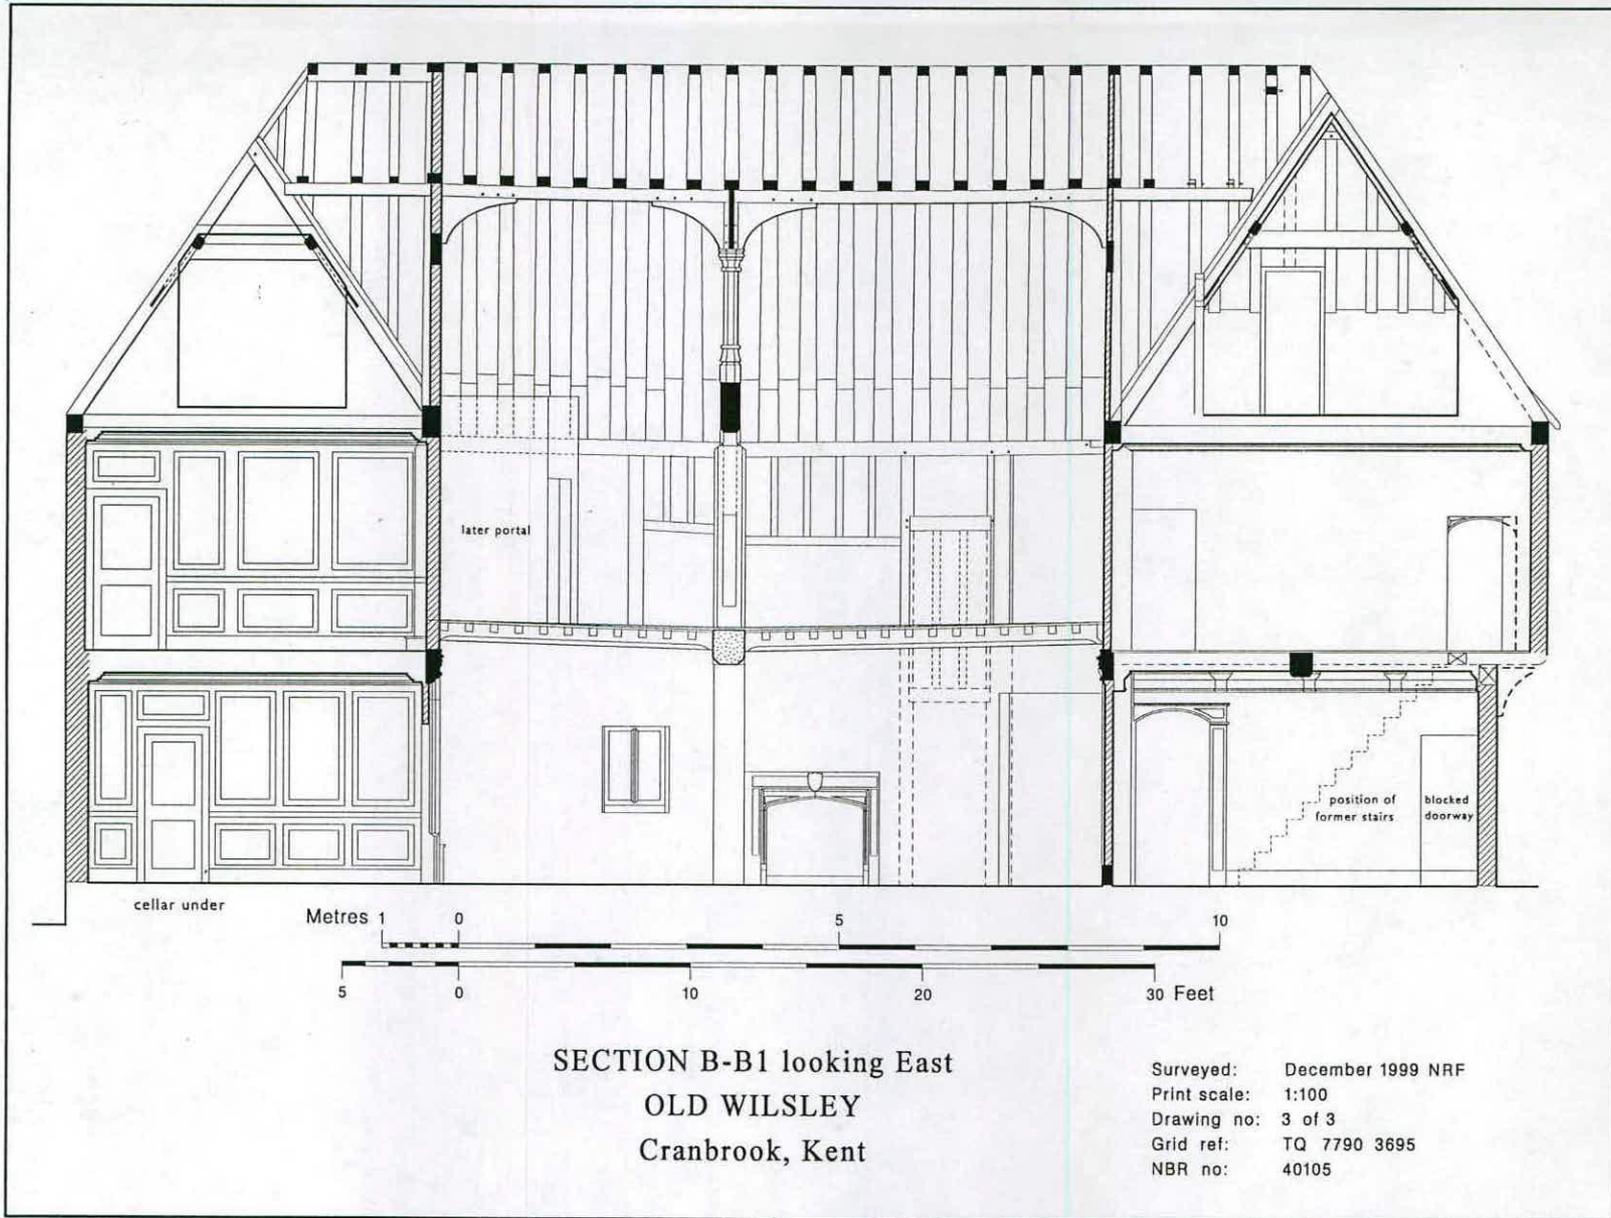
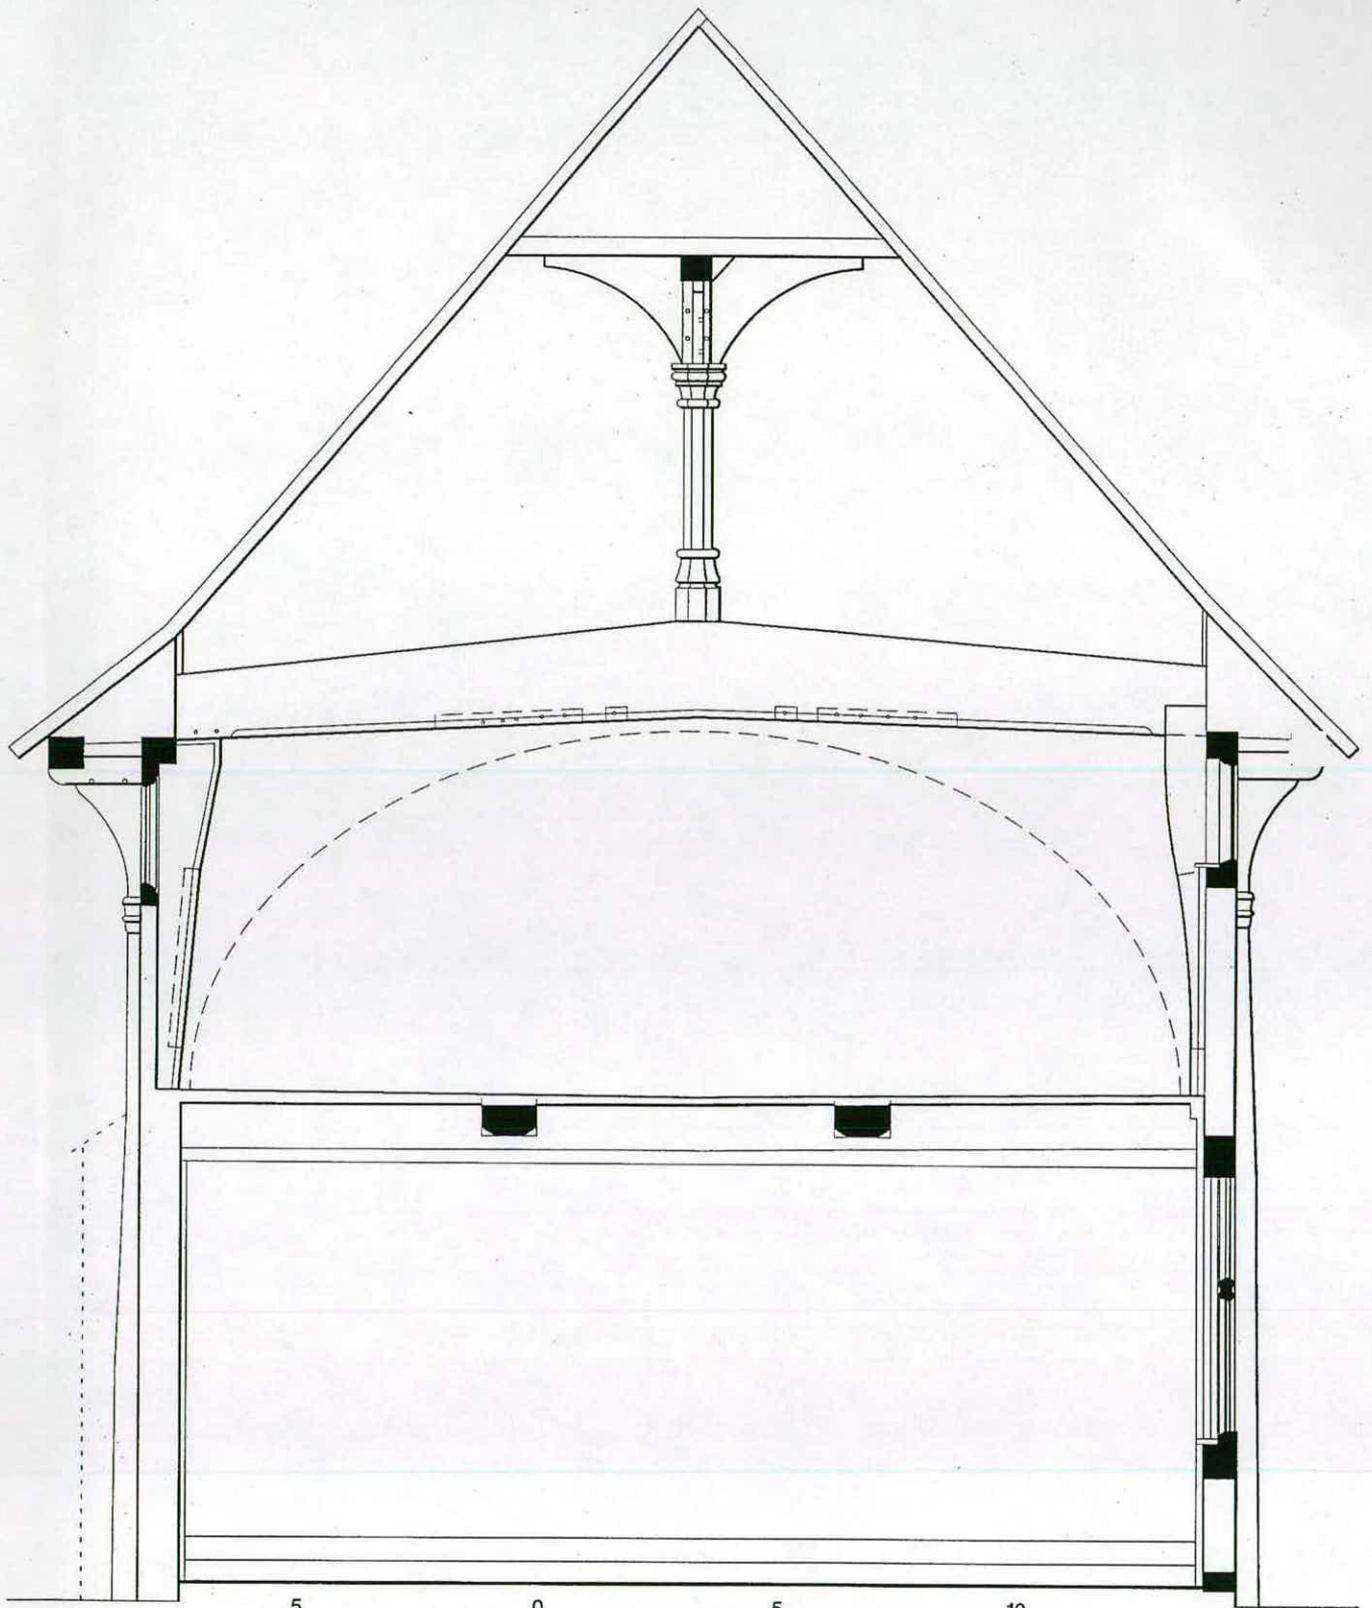
**SECTION A - A1 of Hall truss looking South**

As constructed, the hall was open from ground floor to the roof, and was dominated by the splendid decorative crown post truss (*see section drawing at rear of this report*). The central tie beam has long since lost its original deep arch braces<sup>7</sup> which would formerly have extended downwards to the side walls. The crown post itself has an octagonal-section shaft, and a roll-moulded capital and base. The longitudinal crown plate (which the crown post supports) extends up to and beyond the line of the end partition walls of the hall.
