NO. 34 CHEYNE ROW

KENSINGTON AND CHELSEA

*Report on a Proposal to Change
the Existing Door Surround*

Reports and Papers 12

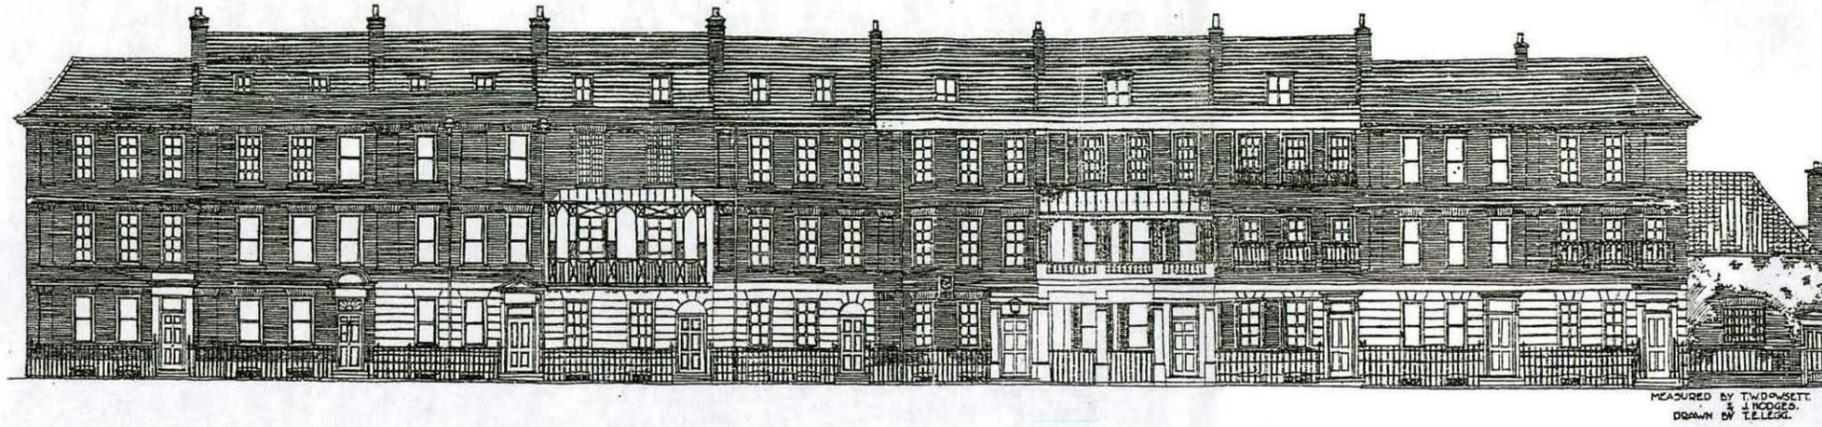
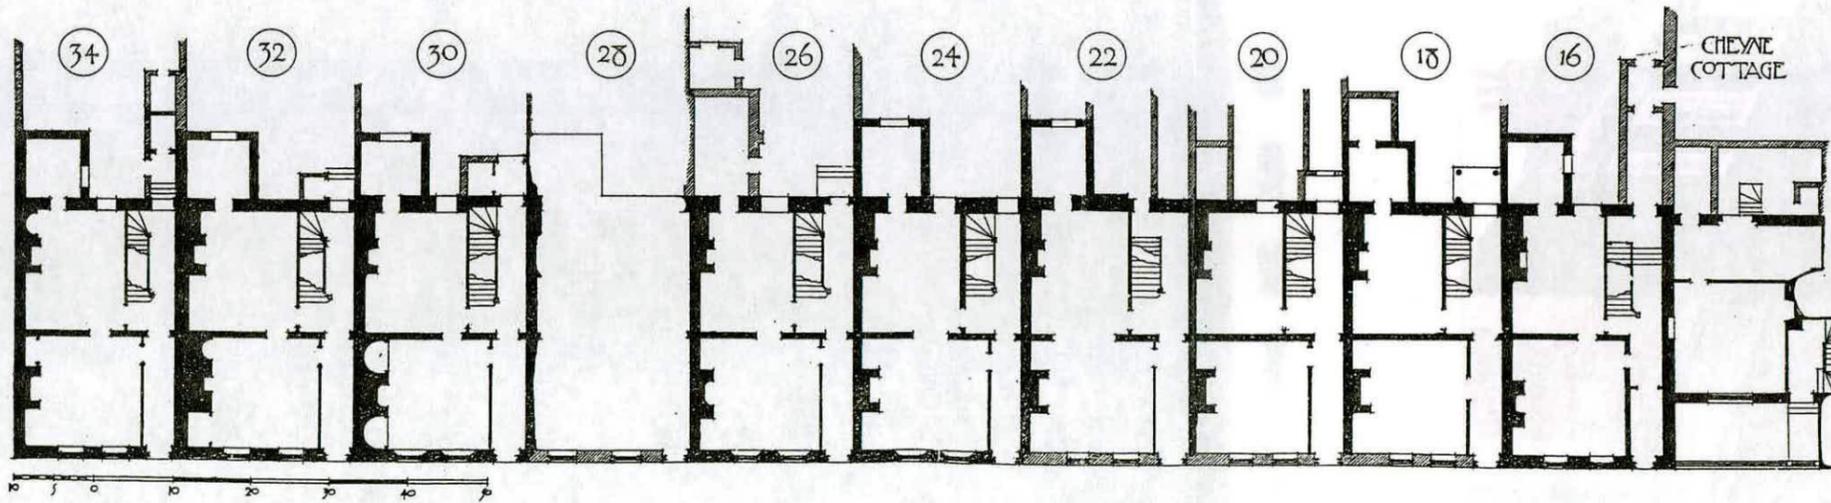
CHEYNE COTTAGE AND NOS. 16 TO 34, CHEYNE ROW

Fig. 2 Elevation and plan of Cheyne Row, taken from the Survey of London (1913).

The well-known, highly attractive, and always fashionable terrace of houses on the east side of Cheyne Row in Chelsea was built on land leased from William, Lord Cheyne, lord of the manor, in the early part of the eighteenth century (figs. 1 and 2). There is a date plaque or tablet surviving on No. 16, inscribed '*This is Cheyne Row 1708*'. Indeed, there is nothing in the design or layout of the houses to suggest that their building was prolonged over any great period. Among the notable residents in the nineteenth century were the essayist and historian, Thomas Carlyle (1795–1881), and the potter and tile-manufacturer, William de Morgan (1839–1917), a close friend and supplier to William Morris. Not surprisingly, as a comparatively rare and important group of Queen Anne (1702–14) houses, the whole of Cheyne Row is listed as grade II*.

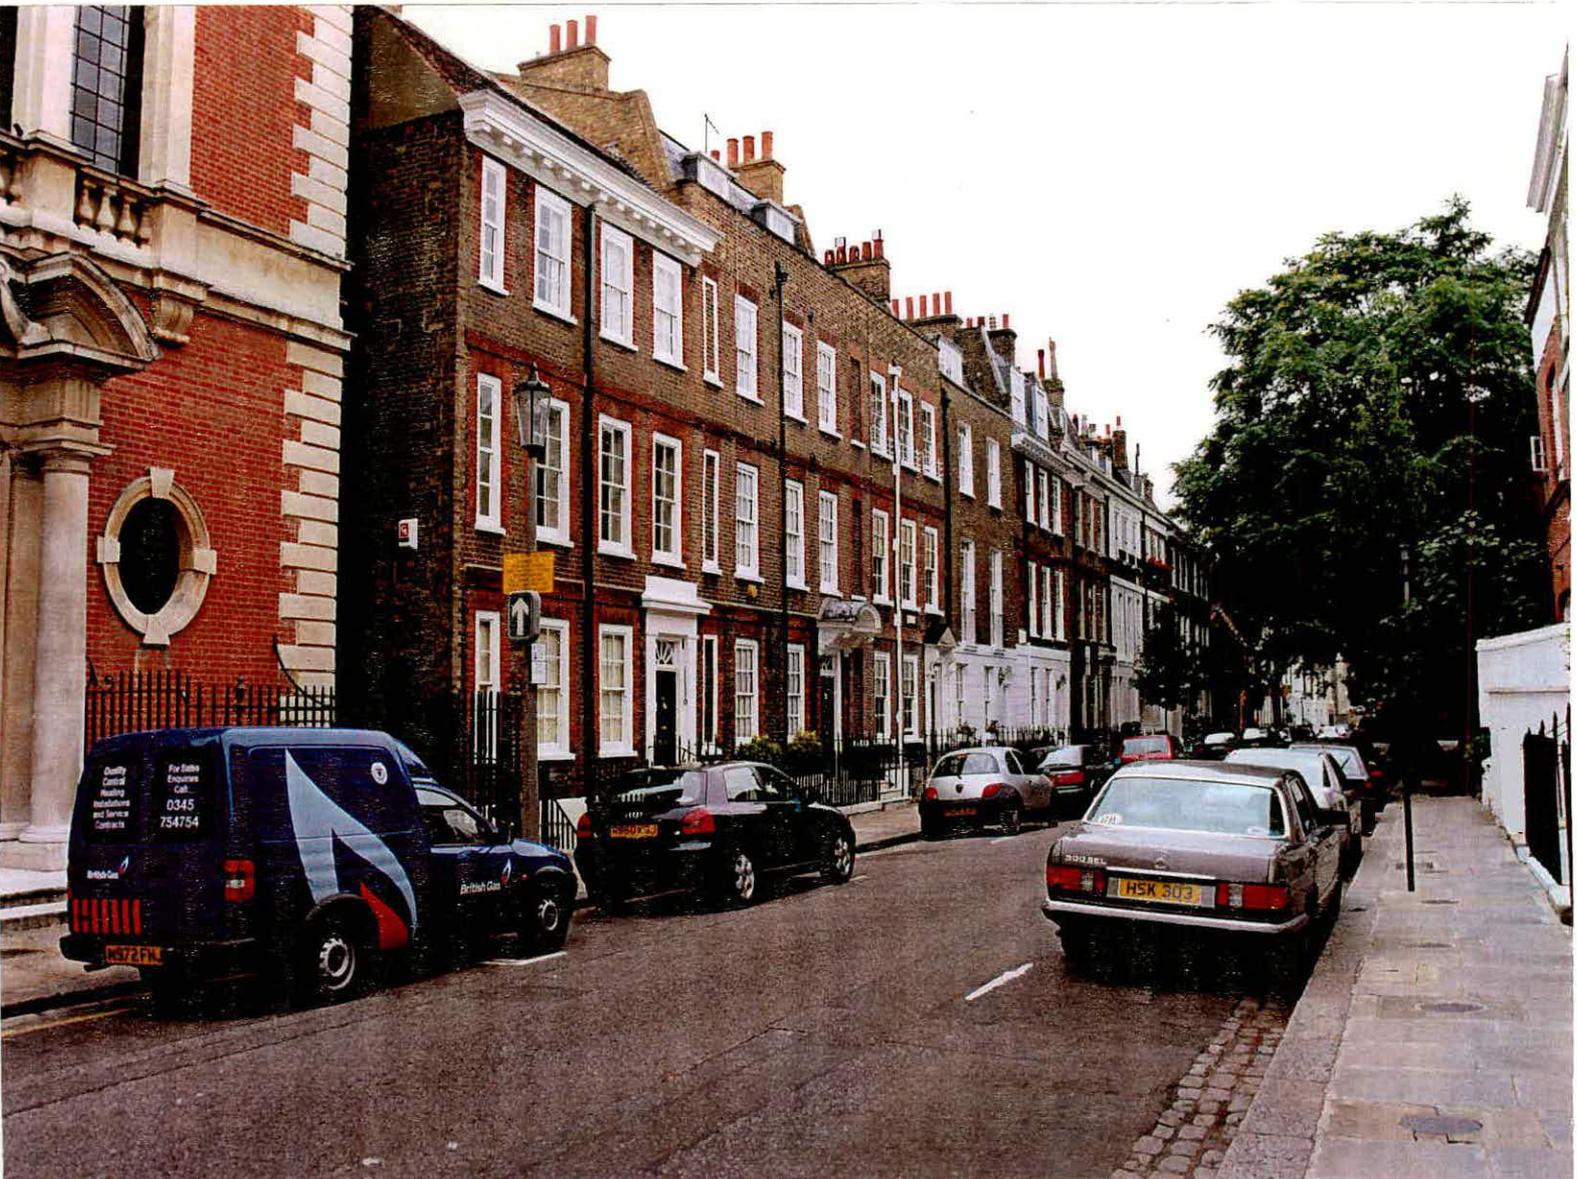
Fig. 1 A general view of Cheyne Row, SW 3, seen from the north-west. No. 34 is the house in the foreground. To the left is the Roman Catholic Church of the Most Holy Redeemer and St Thomas More (1895), which replaced a further house ('Orange House') at the original end of the terrace.

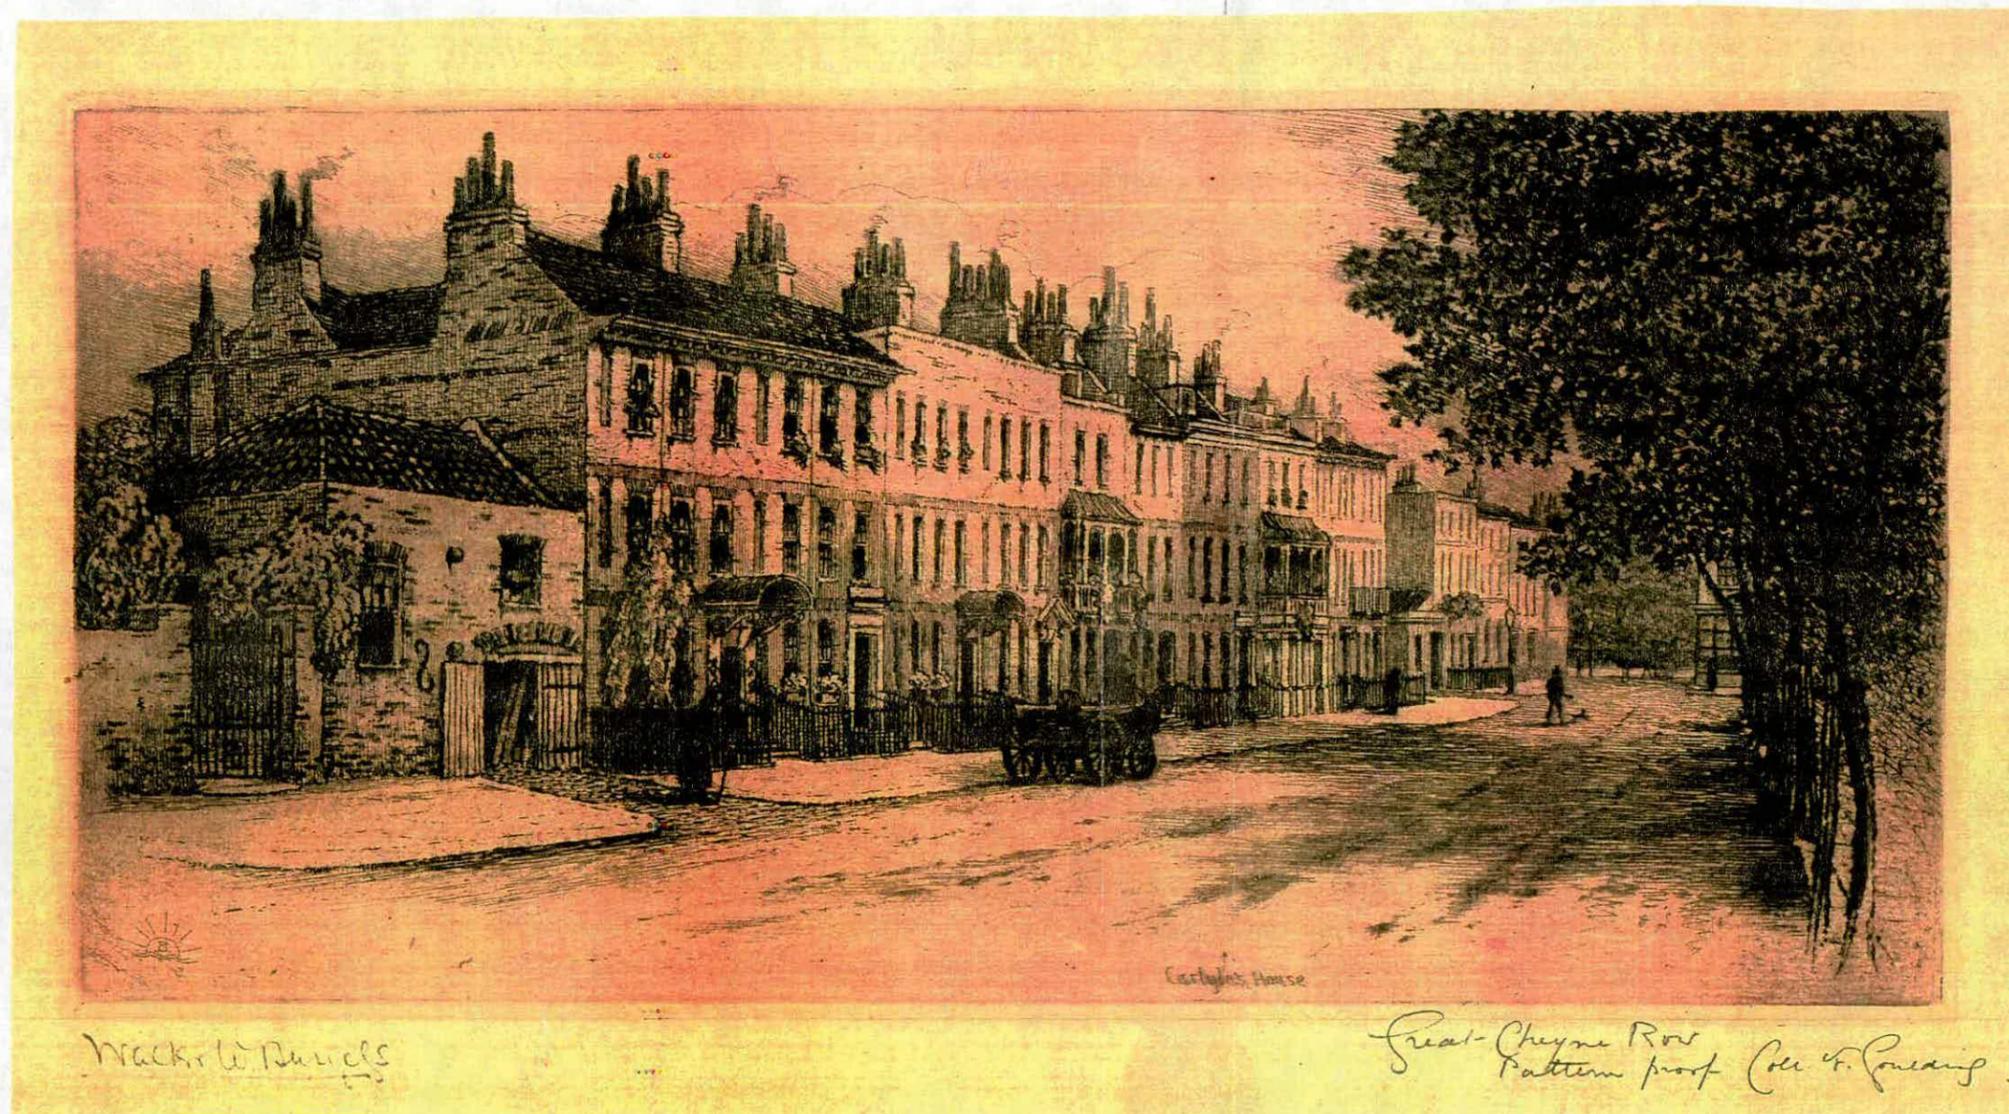
Fig. 3 Cheyne Row seen from the north-west, engraved by Walter Burgess, published in 1891. The drawing was prepared before the destruction of 'Orange House' at the end of the terrace.

That shell-hoods resting on ornate brackets were not unknown is indicated by the survival of one example at No. 32 (fig. 6). Moreover, from two prints — one executed in 1887 (fig. 4) and one in the early 1890s (fig. 3) — it is clear that the now lost house, No. 36, also featured a shell-hood canopy. Indeed, this example looks to have been particularly elaborate, projecting well forward of the door surround. Two other houses, Nos. 18 (fig. 7) and 30 (fig. 8), have carved brackets supporting smaller hoods, though in both cases the hoods themselves may not be the originals.

Even though there is a distinct possibility that an earlier door-hood existed at No. 34, and that it might well have been of shell-hood form, the extant surround is by no means undervalued, nor should its qualities be underestimated (fig. 11). It has been suggested that the context for this elegant feature is to be sought in the trend among late eighteenth-century architects to experiment with a form of 'stripped down' Classical. As was usual, as the fashion gained greater currency, it began to make its way into smaller domestic structures, with modifications to doorways one way of introducing up to date features for a comparatively small cost. The earliest representation of the No. 34 surround *in situ* comes from a print by Walter Burgess, dating from 1891 (fig. 3), though the sketch from which this is taken was probably made in the 1880s.

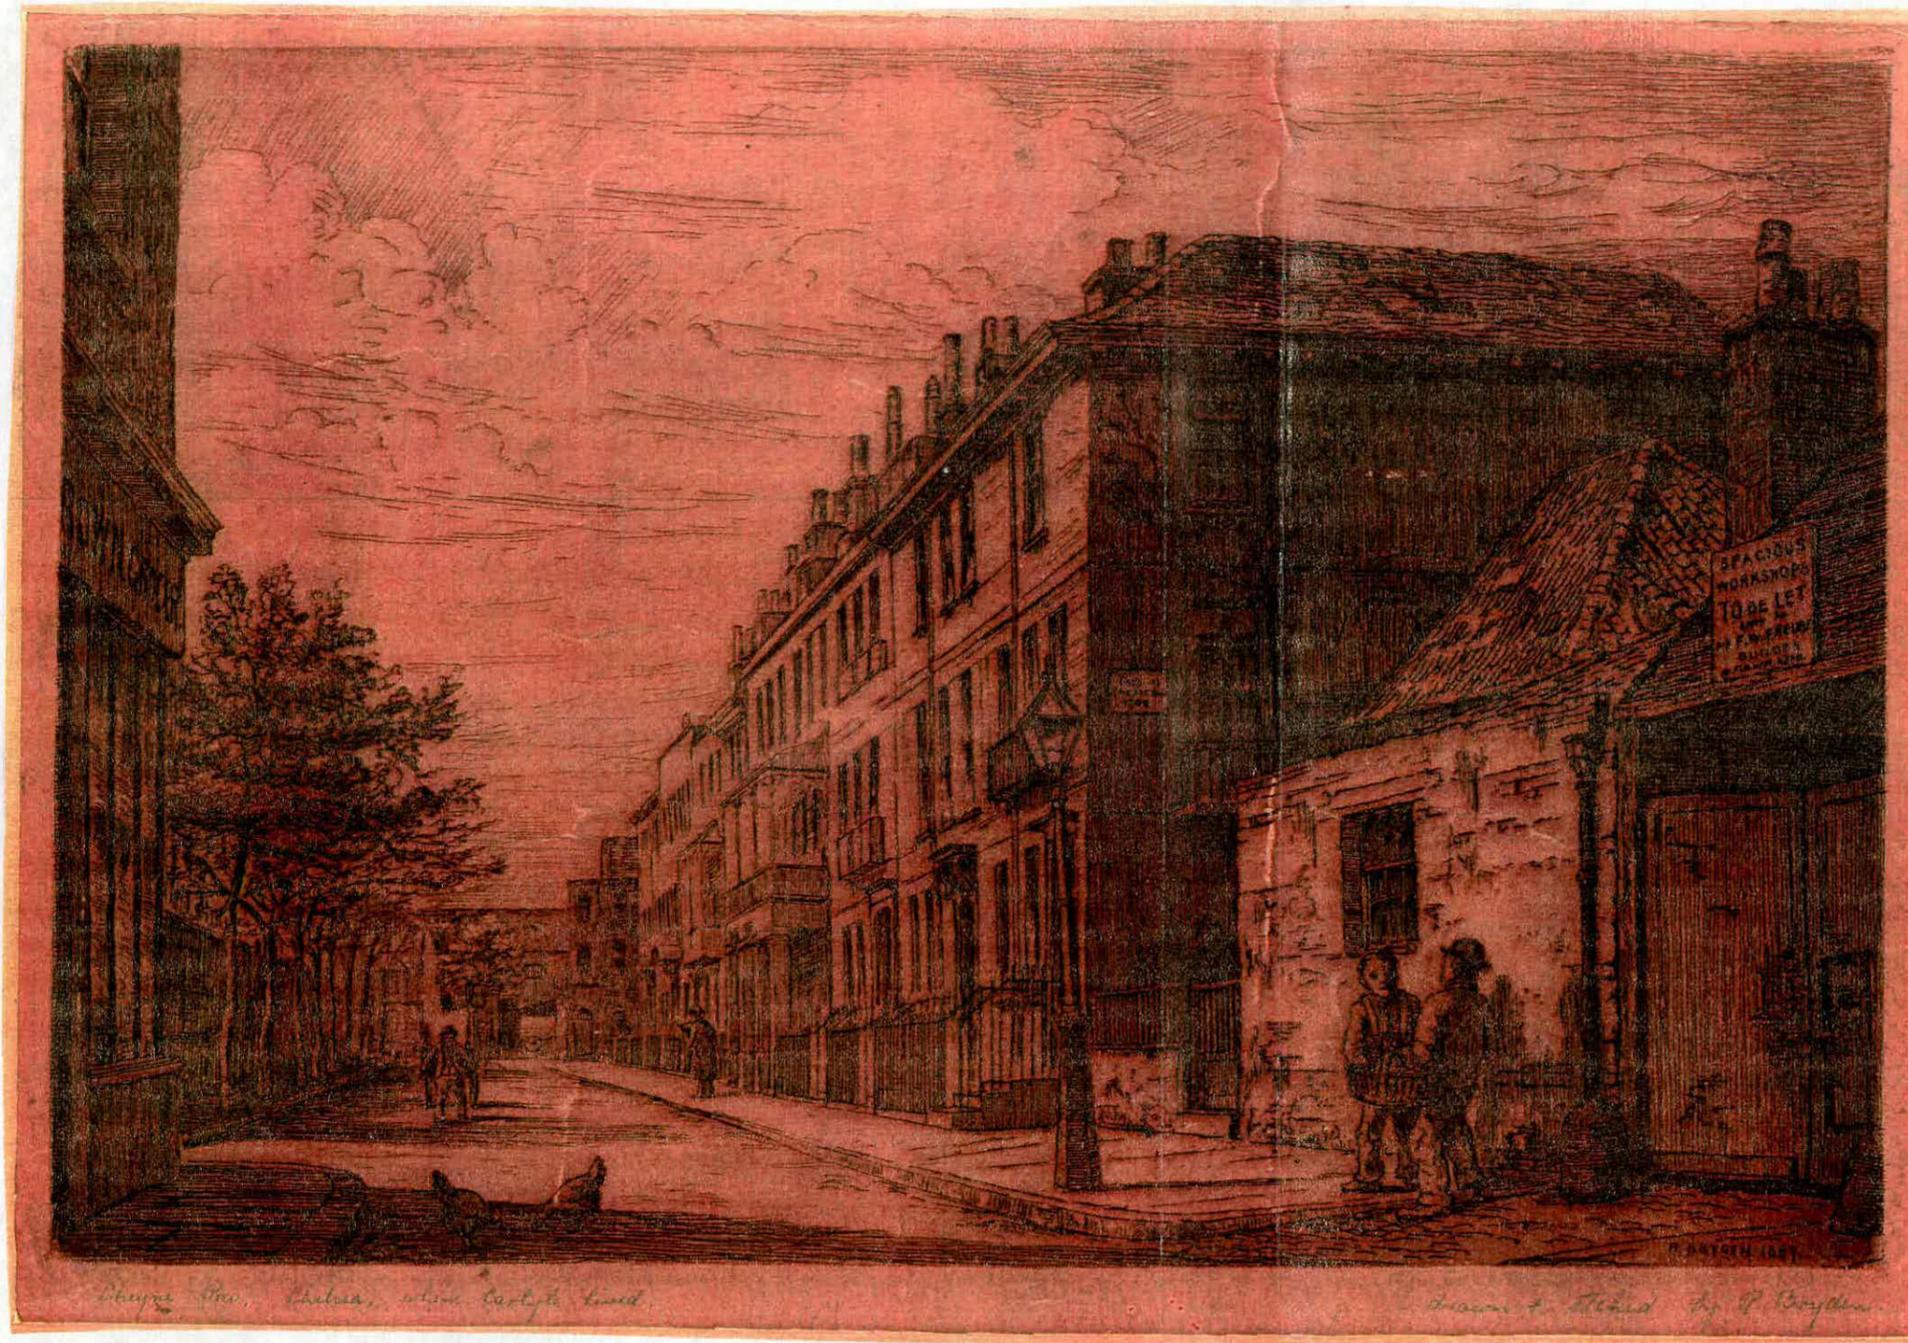
Fig. 4 Cheyne Row from the south, drawn and etched by R. Bryden, 1887.

In so far as generalization is possible, Cheyne Row has much in common with the essential character of London terrace houses of the period from the very late seventeenth century through to about 1720. Similar to the near-contemporary if somewhat grander pattern found at Queen Anne's Gate (1704) in Westminster, the Cheyne Row houses were raised as three-storey constructions set over basements; all of them with the same internal plan (fig. 2). The façades are of brownish stock brick, with red brick dressings to the jambs of the windows, and expensive rubbers to the heads, and with two horizontal red brick bands marking the first- and second-floor levels. The somewhat curious rhythm to the elevations, with one narrow bay to the left, followed by three full window bays, and with the doorway set in all cases to the right, is again found at Queen Anne's Gate. The positioning of the sashes close to the outer wall is typical of the years before 1720, even if here they are almost certainly all replacements. The initial unity of the terrace would have been further bound by an overhanging eaves cornice of wood, in the form of a modillion frieze. This had largely disappeared before the end of the nineteenth century (fig. 3), though its form — if not its original fabric — appears to survive at Nos. 16 and 18 (fig. 4). It is also imitated at No. 26, and it has been rebuilt at No. 34 (fig. 5).

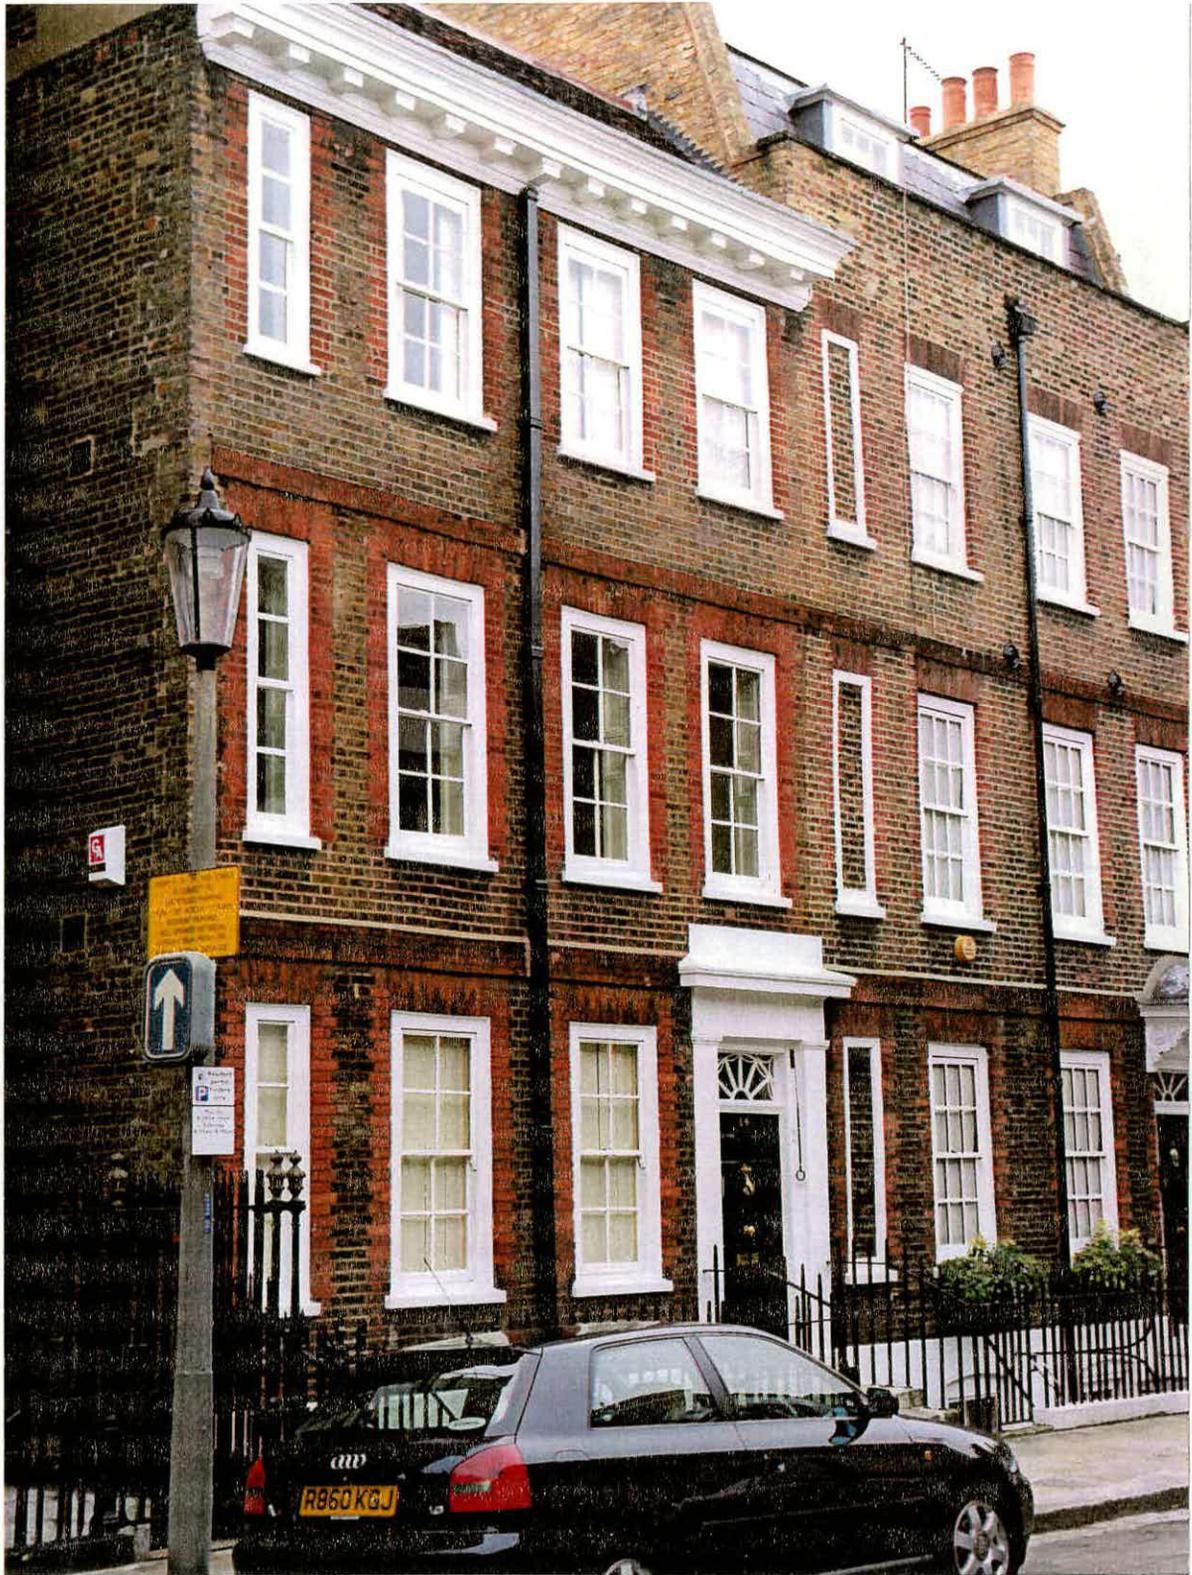
Fig. 5 No. 34 Cheyne Row, front elevation.

In many ways, the elevation at No. 34 retains its early eighteenth-century character better than most other houses in the terrace (fig. 5). This is in no small part due to the handsome eaves cornice, and to the way its brick detailing continues to reflect the original conception. And yet there have been significant changes to the fabric over the course of its history.

But it is the upper storey where the historic fabric has probably been most altered. This becomes clearer when we learn that bombs fell on No. 34 Cheyne Row on the 17 April 1941, starting an extensive fire which apparently caused much damage. From a superficial examination of the brickwork (fig. 5), there is a strong suggestion that the entire upper level has been extensively rebuilt, presumably as a result of this bomb damage. The cornice is also likely to represent a rebuild, though it is clearly based on the original form. Whether the damage caused by the bombs spread to No. 32 is unclear, though the brickwork in the upper two storeys there is not of the character of the early eighteenth-century fabric.

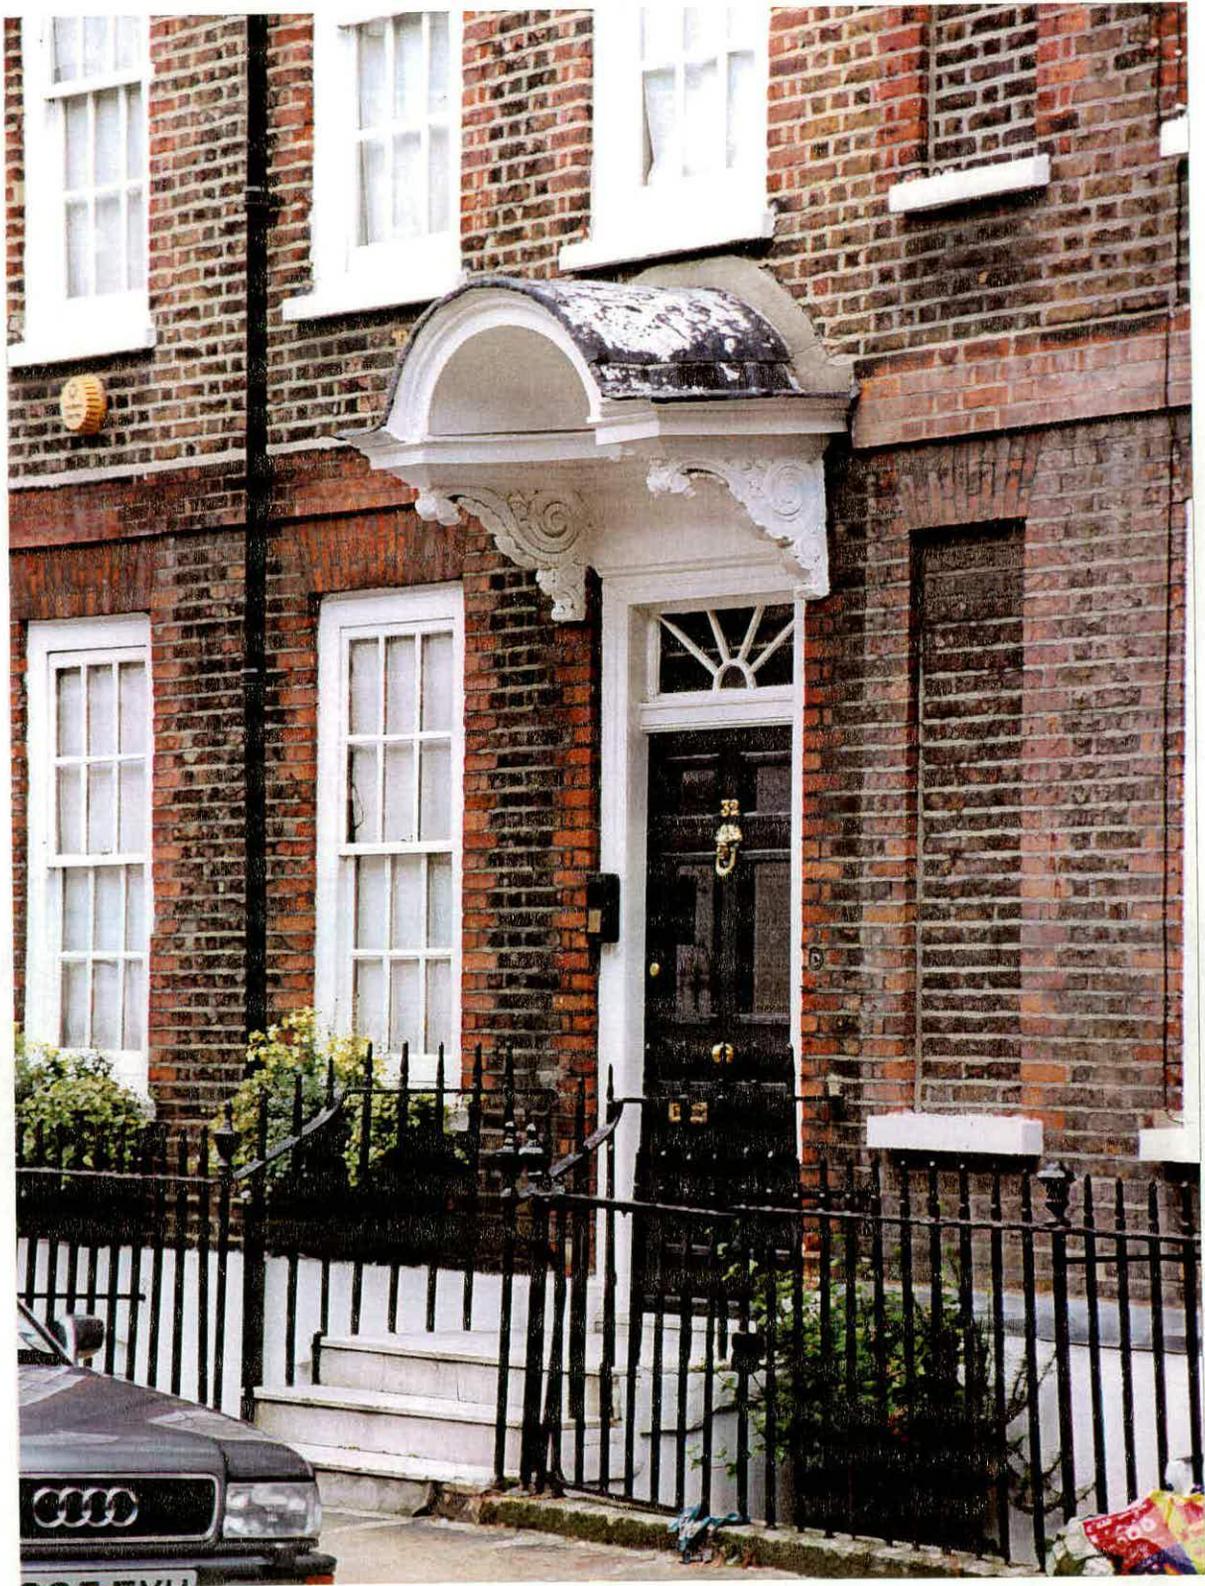
Fig. 6 Shell-hood porch at No. 32 Cheyne Row.

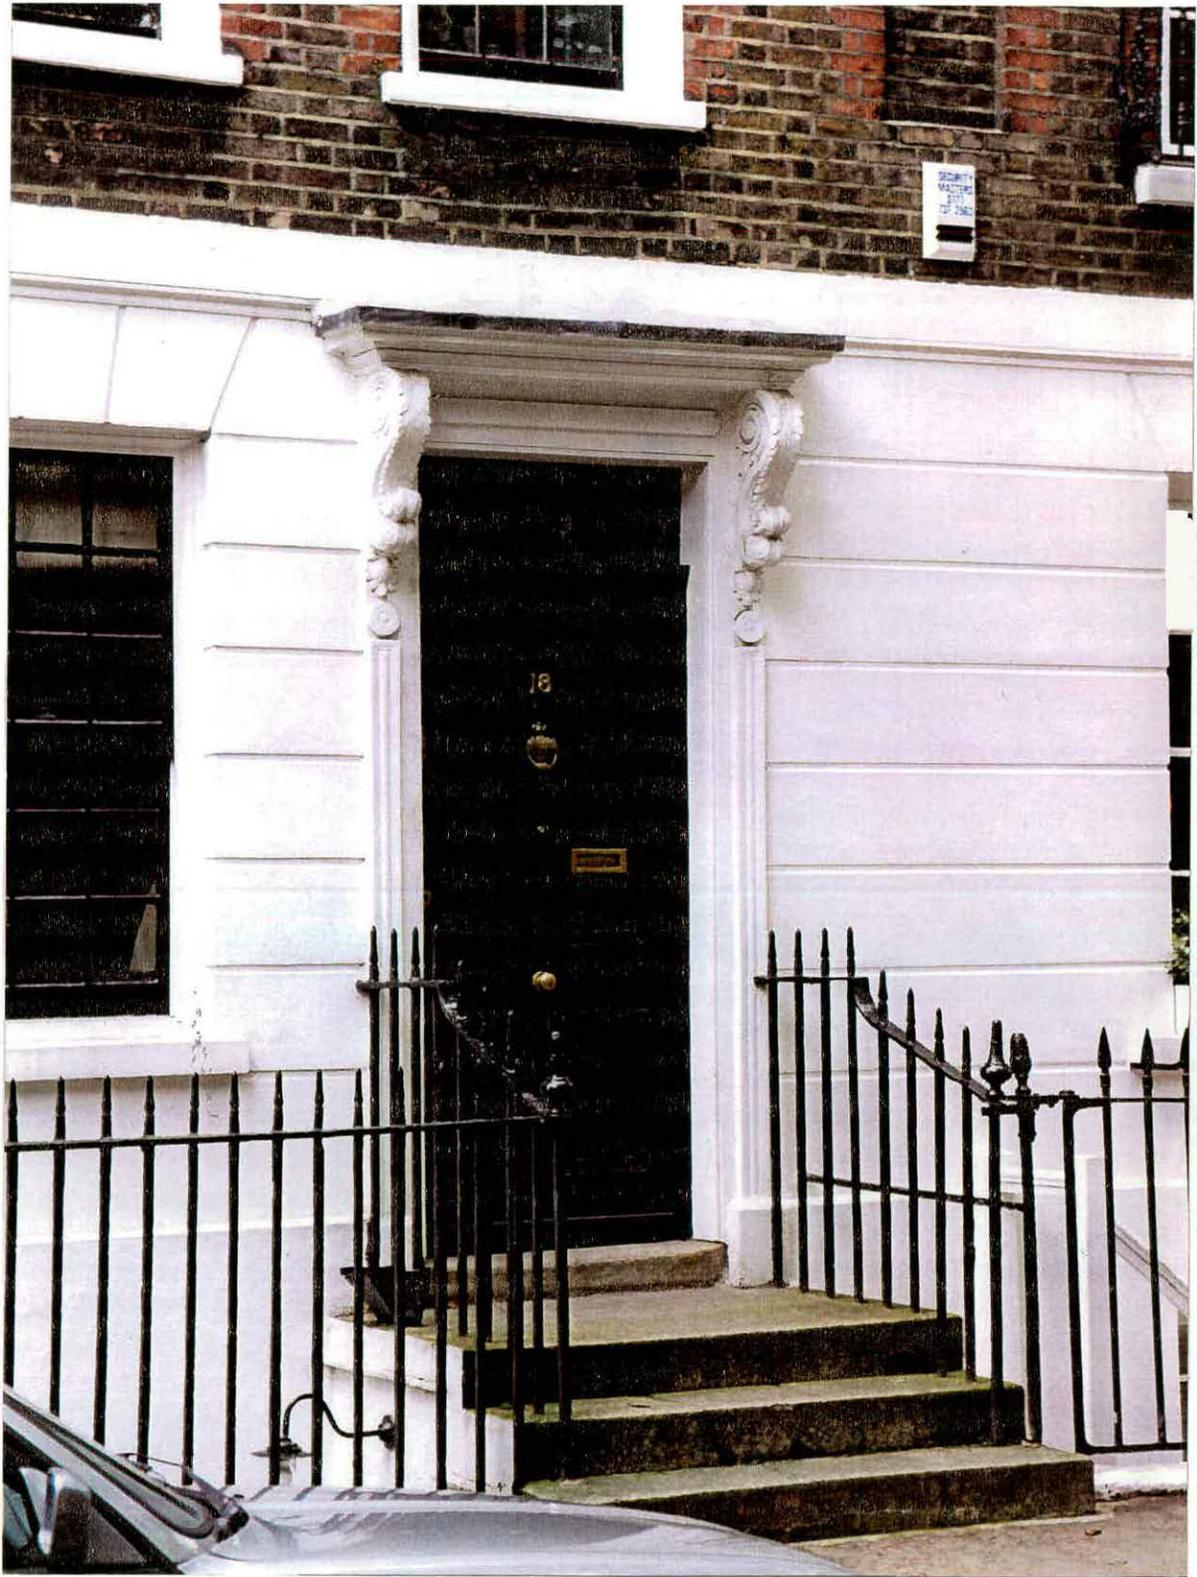
Fig. 7 Door-hood with scroll brackets at No. 18 Cheyne Row.

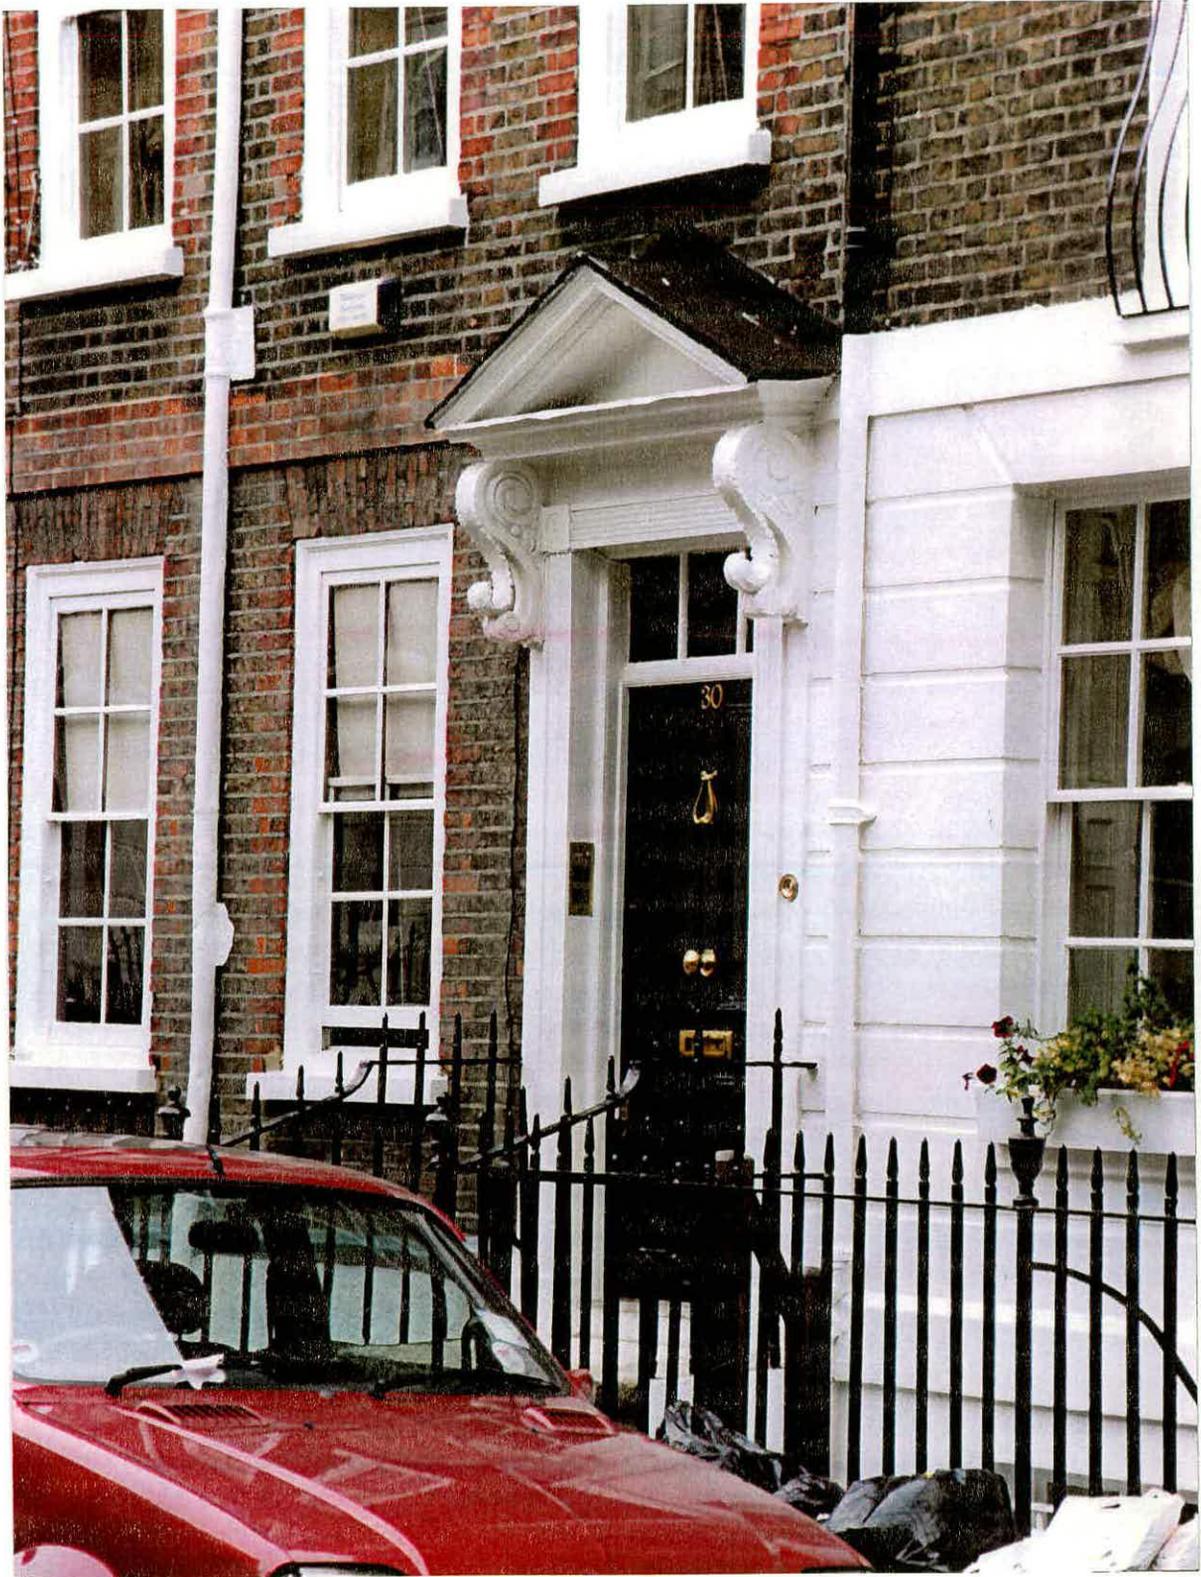
Fig. 8 Door-hood with scroll brackets at No. 30 Cheyne Row.

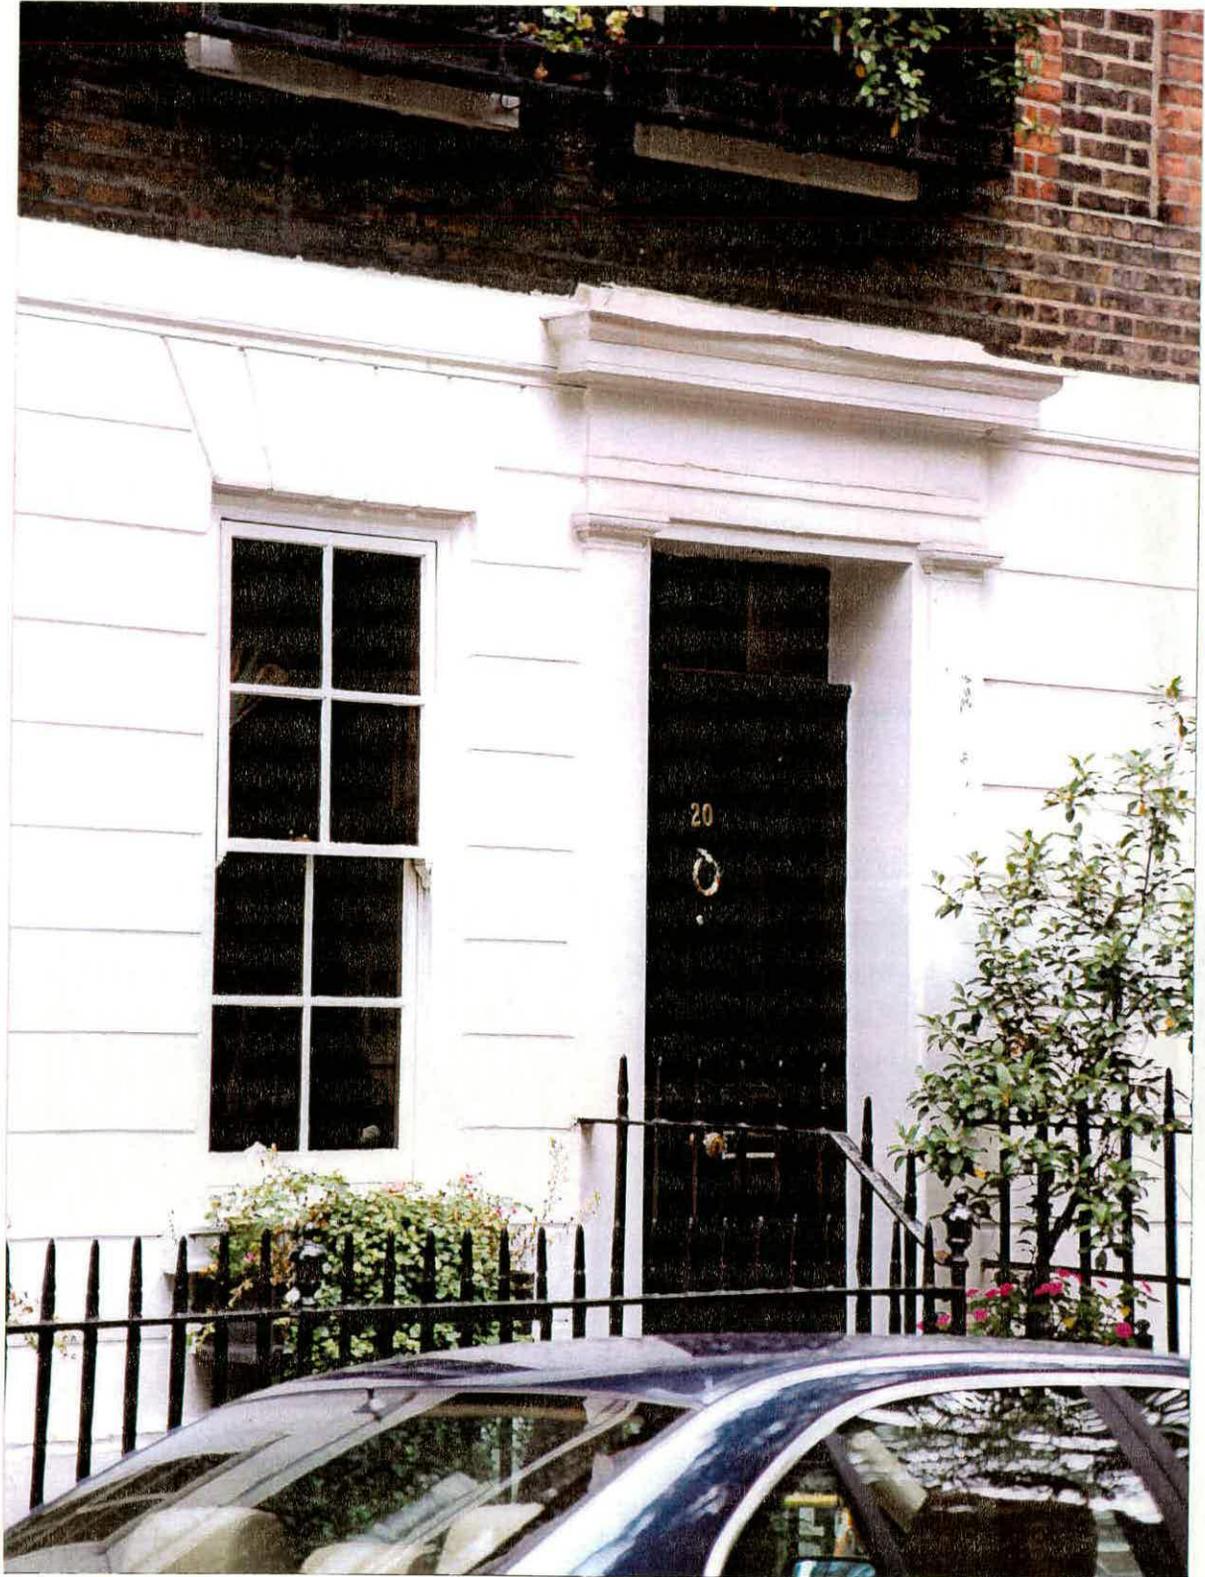
Fig. 9 Door-surround of stripped down neo-classical inspiration at No. 20 Cheyne Row.

It was probably during the nineteenth century that a number of the houses in the row had their door surrounds modified, perhaps in conjunction with other changes such as window detailing. The most common pattern, almost certainly introduced before 1850, was to add pilasters to the outer door jambs, with a small projecting hood of greater or lesser neo-classical authenticity. There are good examples at Nos. 16 and 20 (fig. 9), and another at Carlyle's house, No. 24 (fig. 10).

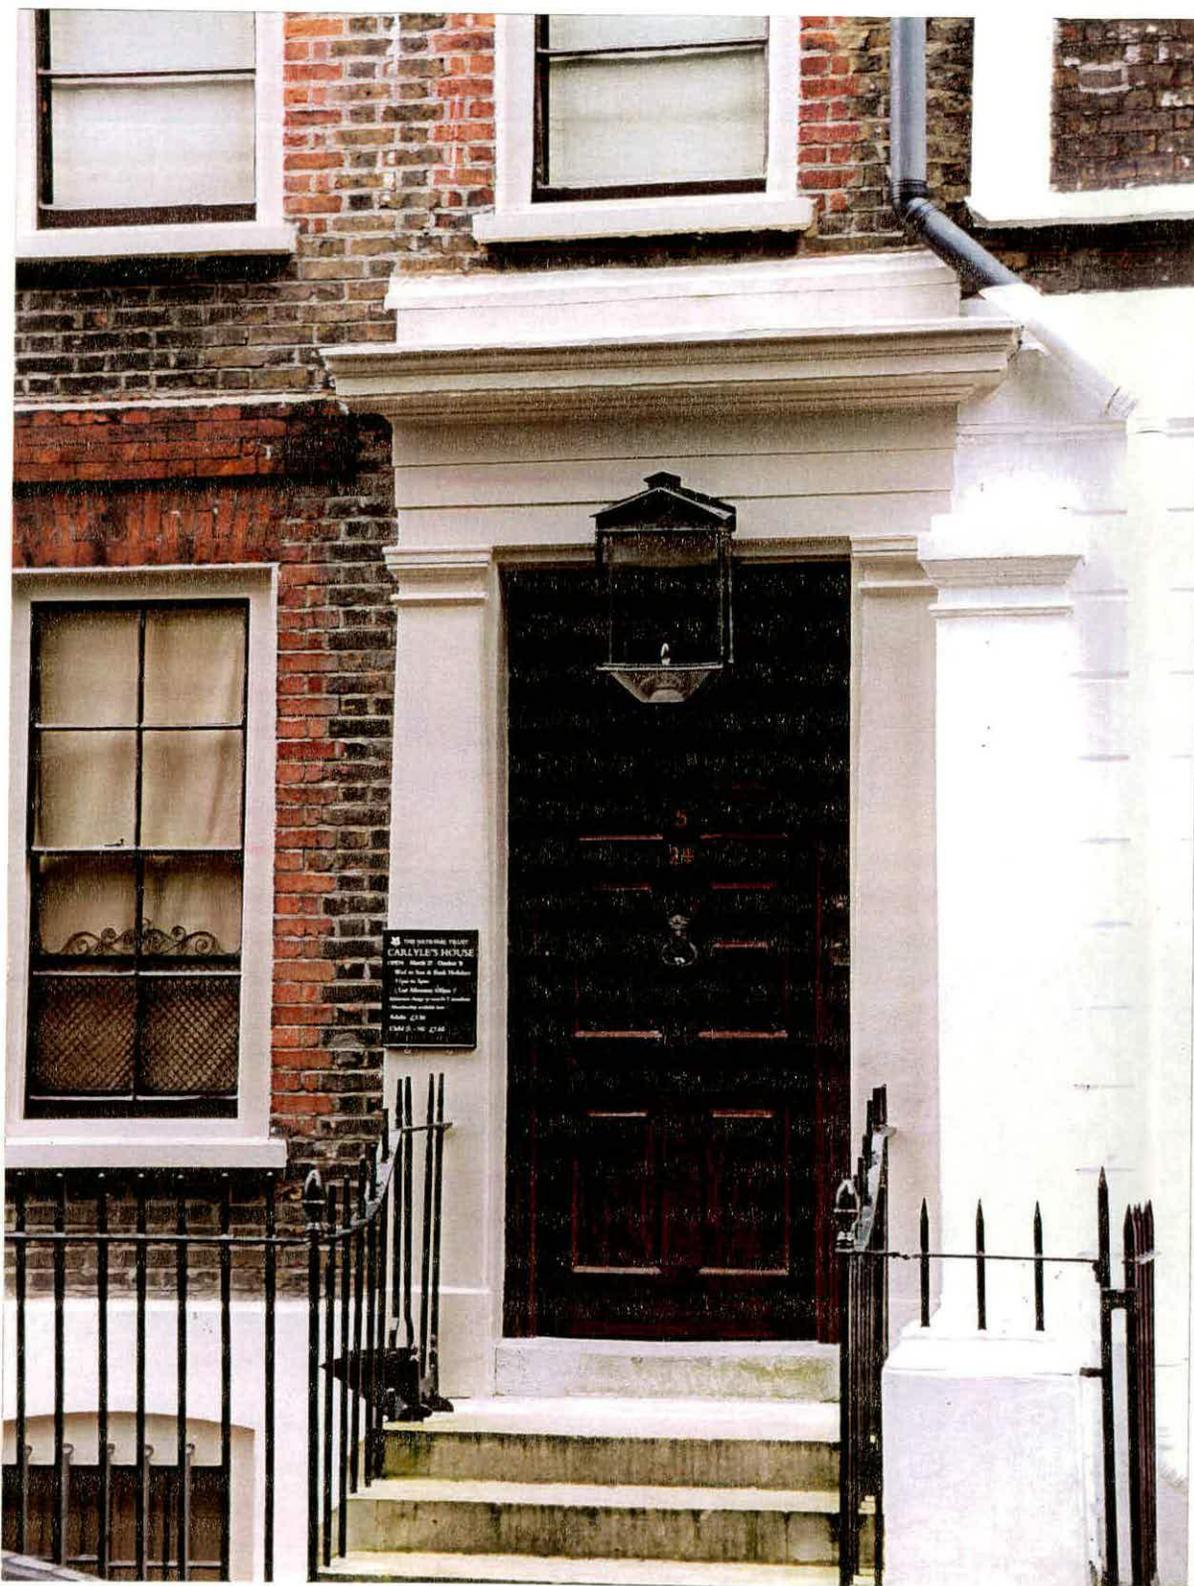
Fig. 10 Door-surround of stripped down neo-classical inspiration at No. 24 Cheyne Row.

The surround at No. 34 Cheyne Row is of stucco, and does indeed seem to betray a filtering down of a standard body of Greek revival architectural work by the 1820s. Below the entablature, this is emphasized by the absence of entasis in the shallow pilasters, contrasting incidentally with the form seen at No. 24 (fig. 10). Above the moulded capitals, the entablature itself combines the standard frieze and architrave, though the diminutive cornice is typical of the style. The 'hawk's-beak' undercut moulding is especially diagnostic of work in the second and third decades of the nineteenth century. And in this context, we might note the precedents that were published and made available to a wider readership in the new edition of *The Antiquities of Athens*, by James Stuart and Nicholas Revett, appearing in four volumes between 1825 and 1830. The proportions of the entablature at No. 34 may be compared to those recorded by Stuart and Revett at the Choragic Monument of Thrasyllos (fig. 12), with the hawk's-beak moulding particularly close to that observed on the Athens structure (fig. 13).
