NO. 34 CHEYNE ROW

KENSINGTON AND CHELSEA

*Report on a Proposal to Change
the Existing Door Surround*

Reports and Papers 12

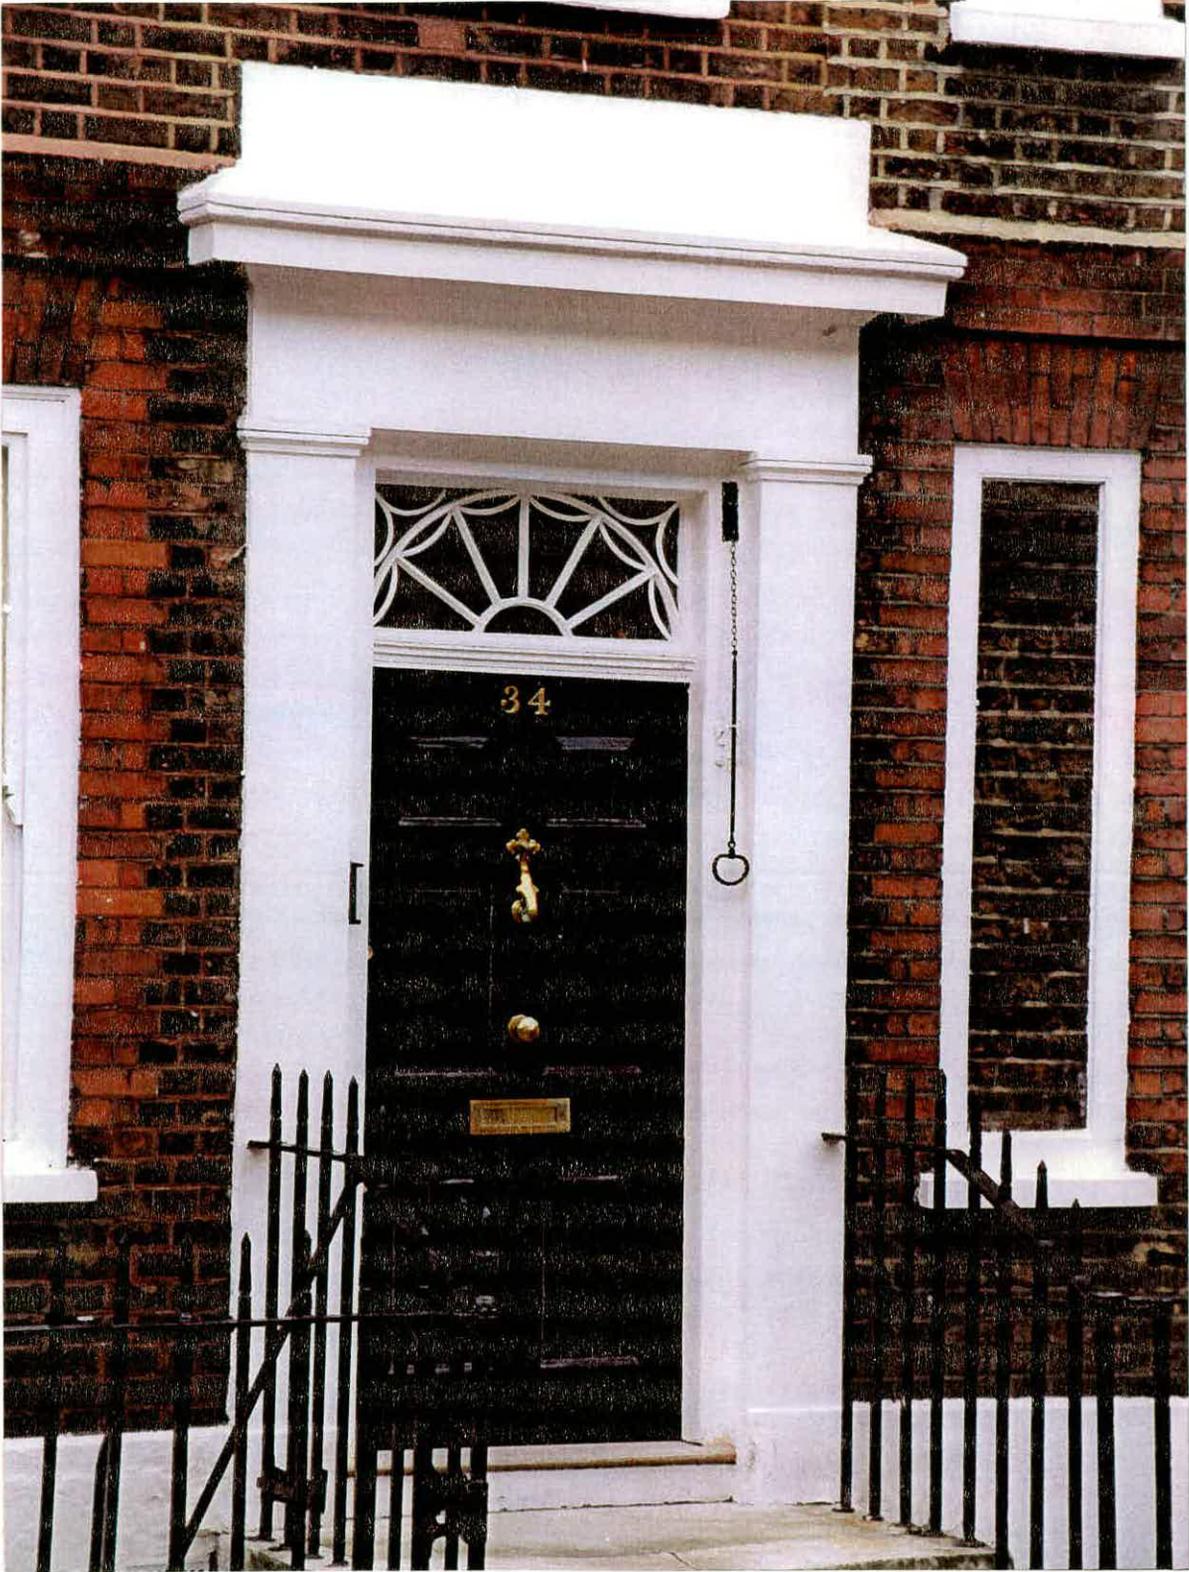
Fig. 11 The door-surround at No. 34 Cheyne Row.

Even though there is a distinct possibility that an earlier door-hood existed at No. 34, and that it might well have been of shell-hood form, the extant surround is by no means undervalued, nor should its qualities be underestimated (fig. 11). It has been suggested that the context for this elegant feature is to be sought in the trend among late eighteenth-century architects to experiment with a form of 'stripped down' Classical. As was usual, as the fashion gained greater currency, it began to make its way into smaller domestic structures, with modifications to doorways one way of introducing up to date features for a comparatively small cost. The earliest representation of the No. 34 surround *in situ* comes from a print by Walter Burgess, dating from 1891 (fig. 3), though the sketch from which this is taken was probably made in the 1880s.

The surround at No. 34 Cheyne Row is of stucco, and does indeed seem to betray a filtering down of a standard body of Greek revival architectural work by the 1820s. Below the entablature, this is emphasized by the absence of entasis in the shallow pilasters, contrasting incidentally with the form seen at No. 24 (fig. 10). Above the moulded capitals, the entablature itself combines the standard frieze and architrave, though the diminutive cornice is typical of the style. The 'hawk's-beak' undercut moulding is especially diagnostic of work in the second and third decades of the nineteenth century. And in this context, we might note the precedents that were published and made available to a wider readership in the new edition of *The Antiquities of Athens*, by James Stuart and Nicholas Revett, appearing in four volumes between 1825 and 1830. The proportions of the entablature at No. 34 may be compared to those recorded by Stuart and Revett at the Choragic Monument of Thrasyllos (fig. 12), with the hawk's-beak moulding particularly close to that observed on the Athens structure (fig. 13).

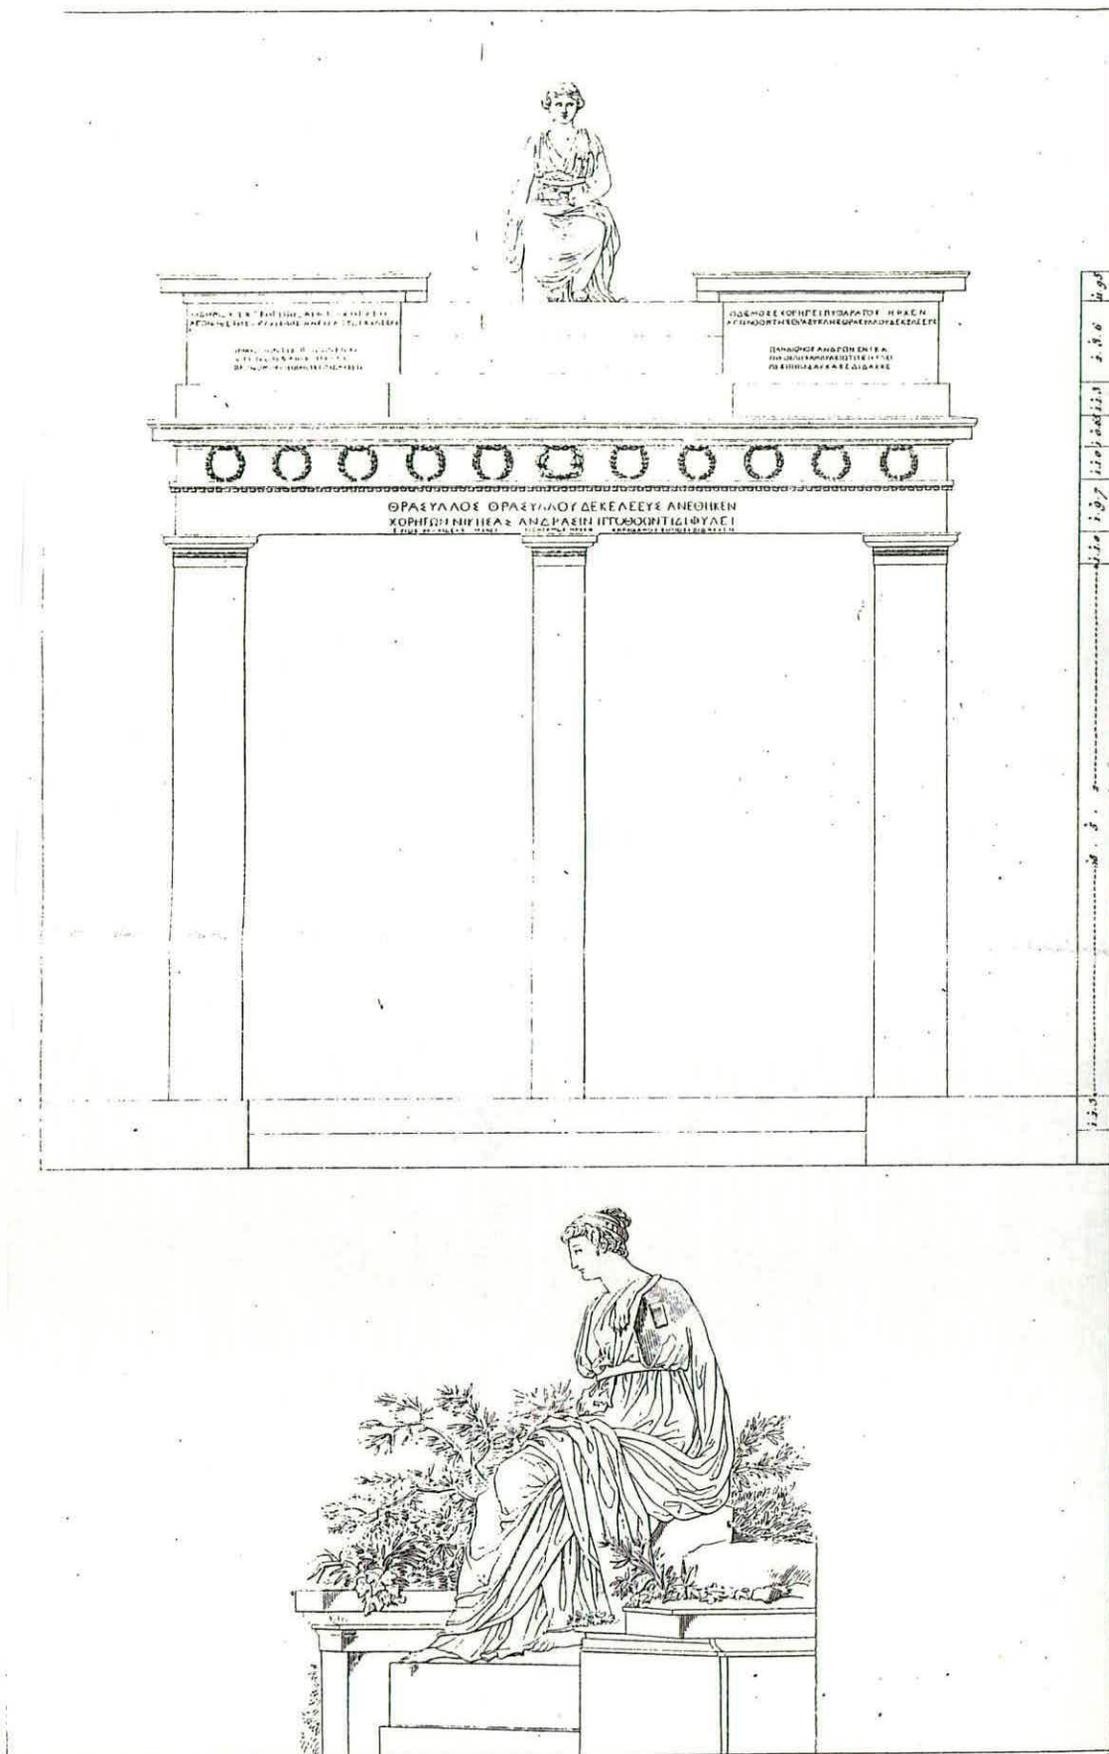
Fig. 12 Elevation of the Choragic Monument of Thrasyllos, Athens, taken from Stuart and Revett, ii (1825).
