ISAAC LORD

Fore Street, Ipswich

A Report on the Historical Development of the Site

Reports and Papers 7
1999 (Revised 2002)

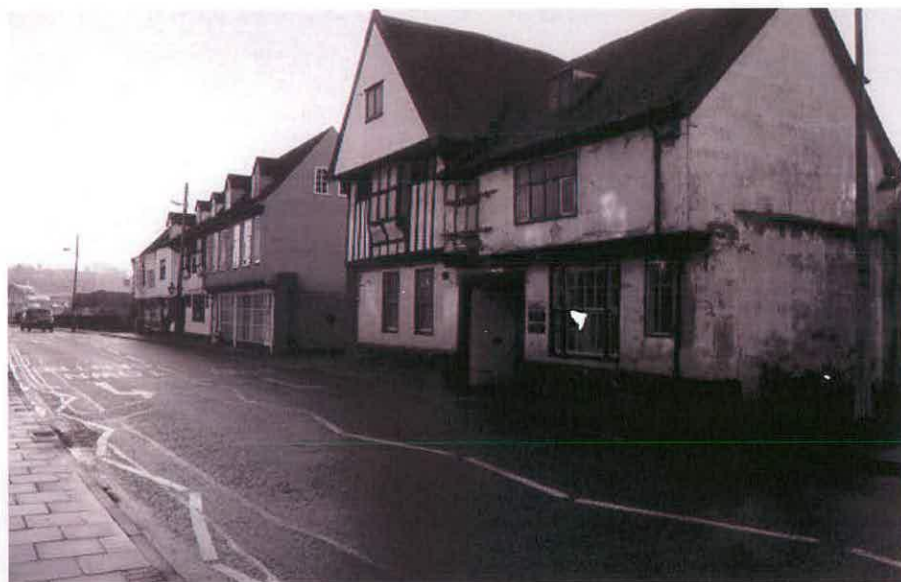
Figure 10 Fore street frontage of the merchant's house, ranges 1 & 2, as it appears today

- 3.1.2 Although outwardly the house appears to have been designed as a single unified structure, the two ranges in fact belong to two separate periods of construction, with No.80 (range 1) probably dating from between c.1418 and c.1449, and No.80a (range 2) dated 1636. The central carriageway between the two ranges dates from the original construction of range 1 but was originally narrower, the opening having been widened probably when range 2 was constructed in the early-mid seventeenth century.

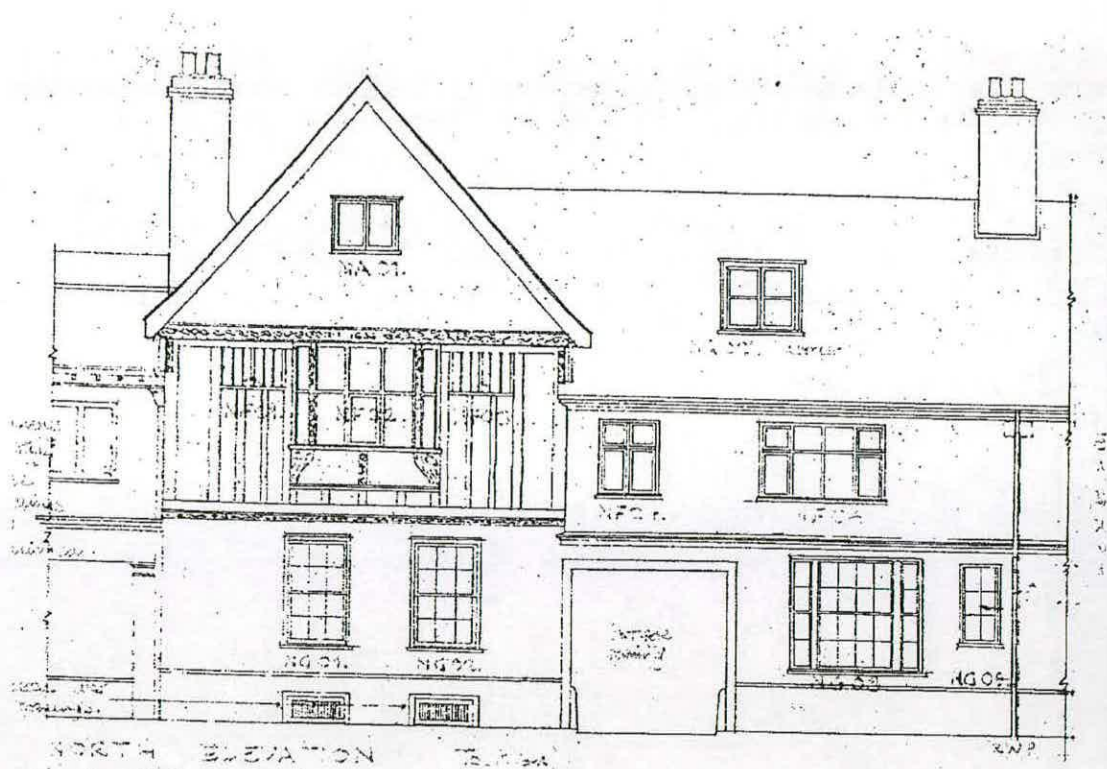
Figure 12 Fore Street elevation of ranges 1 & 2 (drawing courtesy of Mr. Andrew Rossi)

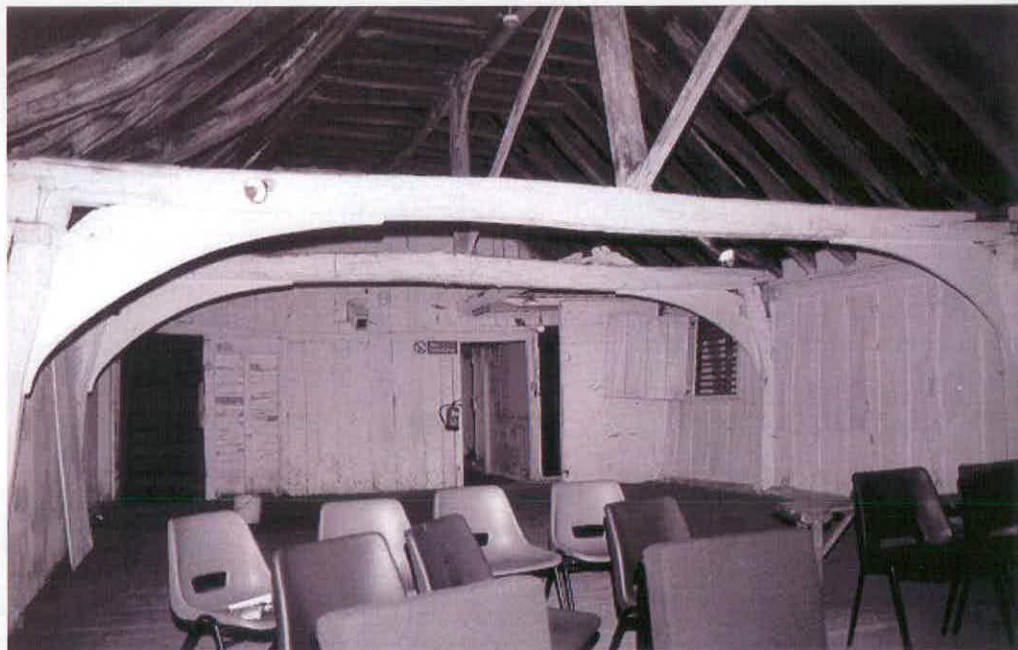
Figure 22 Range 3 (Sale Room). View of first floor looking south

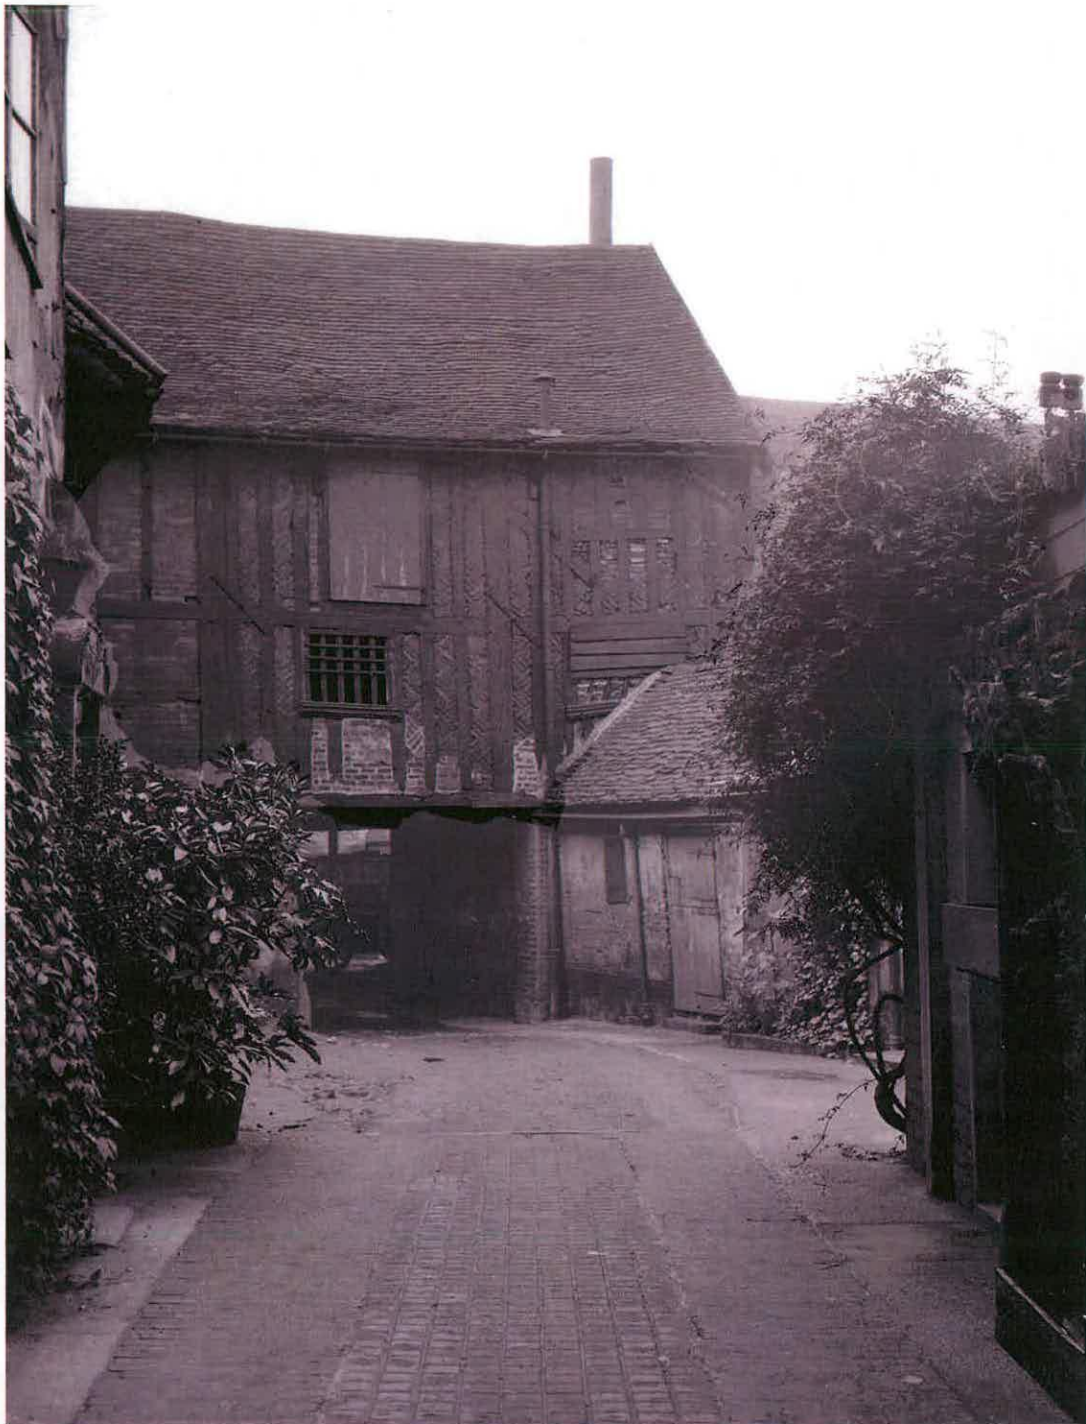
Figure 26 Pre-war photograph of Crossway, showing single-storey outhouse destroyed by enemy bombing

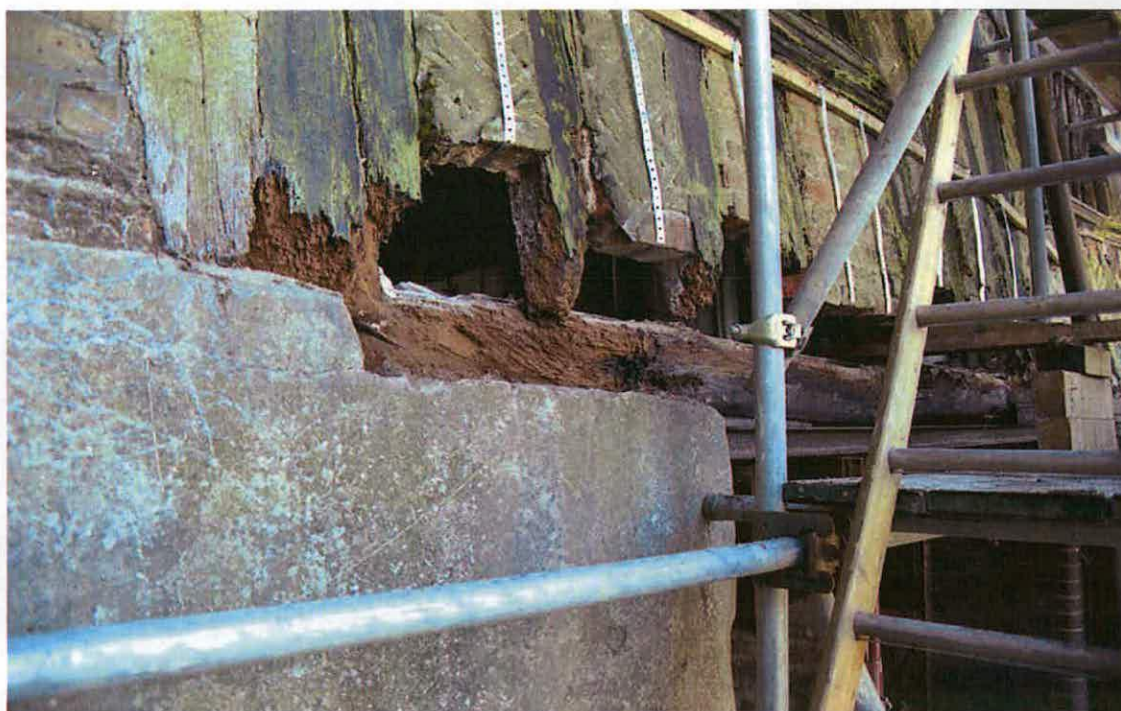
Figure 27 Detail of north wall of the Crossway, showing decayed feet of timbers at first floor level

- 3.4.7 Although the precise sequence of alterations is unknown, it is clear that there has been a long history of small-scale repairs and alterations to both the timber frame and brick infill panels of the north wall of the Crossway. In a number of areas at first floor level, where the feet of the timbers have either rotted away or been forced out of their original alignment, the brickwork panels between the framing members have had to be repaired or else completely renewed.

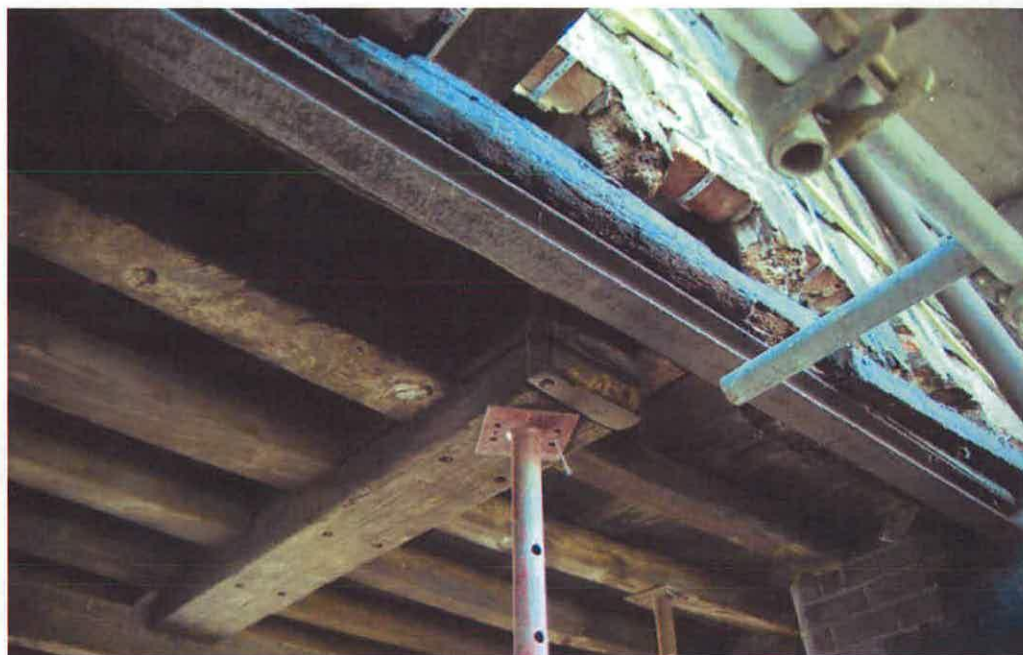
Figure 28 Detail of underside of carriageway through the Crossway

- 3.4.4 The central carriageway through the Crossway was originally a much narrower opening, with timber-framed walls on either side. The wall on the west side has been rebuilt in brick but remains roughly in its original position. That on the east side was taken down when the carriageway was widened, and replaced with the present brick wall on a line further to the east. The timber head piece (i.e. first floor plate) of the original timber-framed west side wall is still *in situ*, set back a little distance from the present brick wall. In the soffit of the beam is a series of empty mortices for a row of closely spaced wall studs with centres of approximately 15" (375mm). Running parallel to this beam along the centre of the carriageway is a second N-S beam, representing the head piece of the original timber-framed wall on the east side. The underside of the timber has been cut away, thereby losing any evidence for mortices in the soffit of the beam.⁶ Between the two head pieces is a series of first floor joists running E-W, all with plain chamfers and cyma run-out stops. The joists are all clearly primary, *in situ* timbers, that were meant to be visible from within the carriageway when the Crossway was first built. The first floor joists to the west (visible from inside the adjoining ground floor room) and to the east (over the extended part of the present carriageway, but internal timbers originally) are not chamfered.

⁶ The remains of a tenon can still be seen on the north end of the beam. The tenon was sawn off, and its corresponding mortice lost, when the lower mid-rail (with which it originally intersected) was reduced in depth (in similar fashion to the N-S beam itself) and raised, probably when the carriageway was widened in the early twentieth century.

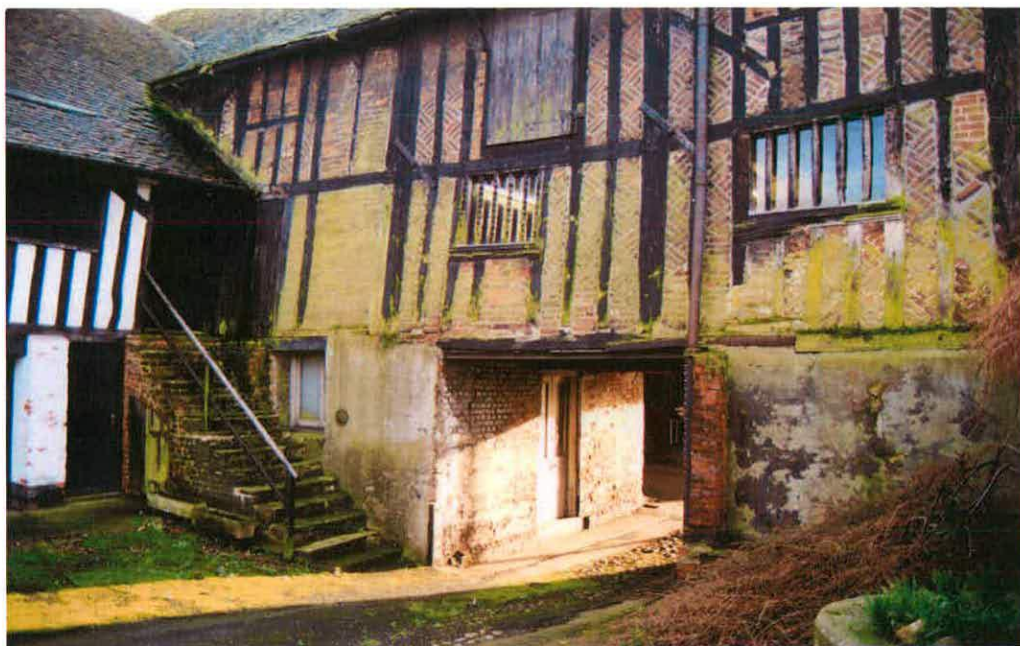
Figure 31 North elevation of Crossway as existing

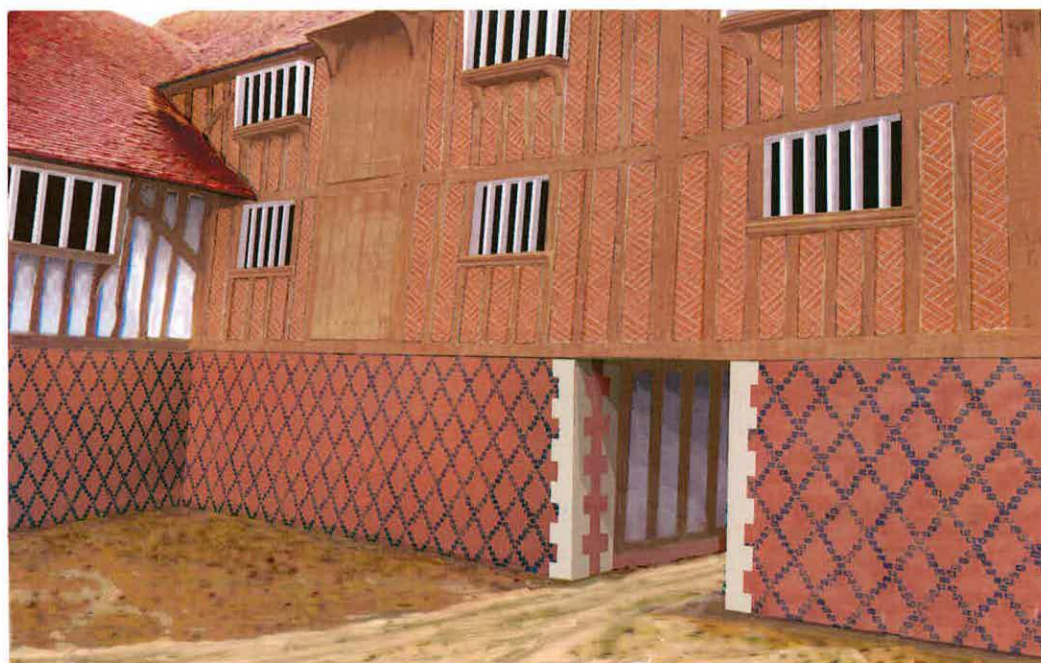
Figure 32 North elevation of the Crossway as it may have appeared in the mid-sixteenth century, incorporating information relating to the exterior decoration of sixteenth-century Suffolk houses provided by Timothy Easton. Digital photo-based reconstruction drawing by the author

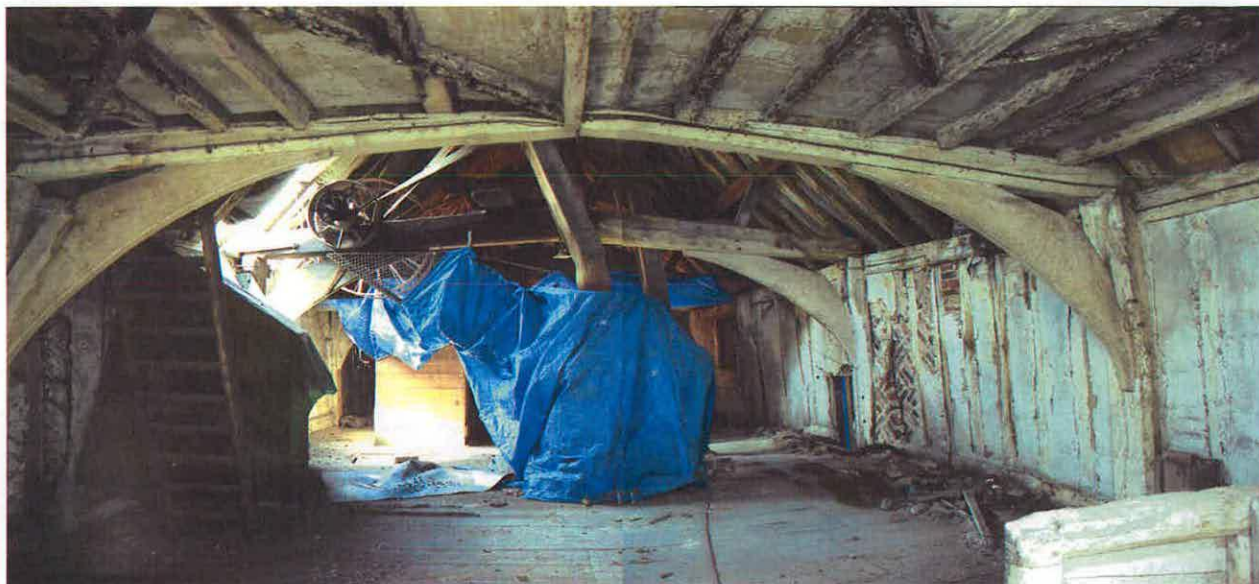
Figure 34 Interior of the east end of the Crossway at second floor (looking west)

- 3.4.11 At the eastern end of the Crossway a pigeon loft has been created by constructing a floor at wall plate level and making a closed partition screen on the line of the internal roof truss next to the east gable. The floor of the pigeon loft is constructed of poor quality salvaged timbers, many showing evidence of earlier fire damage and a number with carpenter's marks relating to their previous use. The floor frame abuts, and clearly post-dates the eighteenth century inserted lath and plaster roof linings. It seems probable that the pigeon loft was built at the same time as the east gable was given its existing weatherboarded cladding, i.e. during the early twentieth century. The boards are of softwood (as opposed to elm or oak as is traditional) and there is a row of neatly cut pigeonholes in one of the boards close to the apex of the gable.

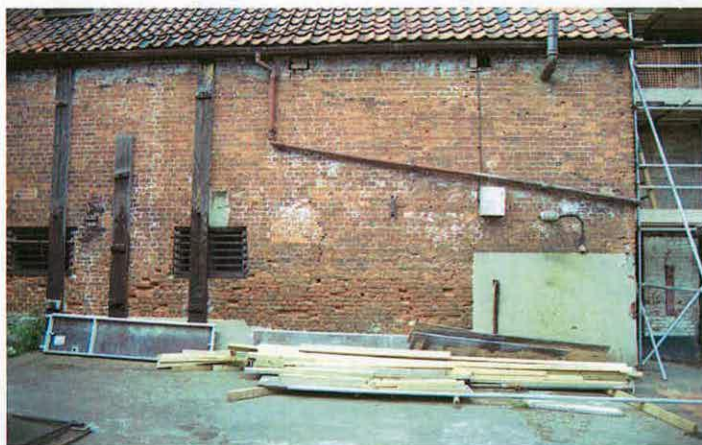
Figure 24 South wall of range 5, showing change in brickwork

- 3.5.2 The bottom 4' 6" (1350mm) section of brickwork in the southern exterior wall is built of smaller, possibly older bricks, than the upper section. Thus nine courses of bricks in the lower section total only some 1ft 11" (575mm) in height, as compared with a height of 2ft 3" (650mm) for the same number of courses above this level. This change may indicate the replacement of a timber-framed wall, suggesting that range 5 originally had an appearance similar to ranges 3, 4 and 8. The first floor comprises four transverse beams, each 13" (325mm) square, and a fifth beam inserted over the point where range 6 begins. At this point there is a straight joint formed by the ragged end of range 5 and the straight beginning of range 6. This confirms that range 5 predates range 6 and was cut back with the addition of the latter.

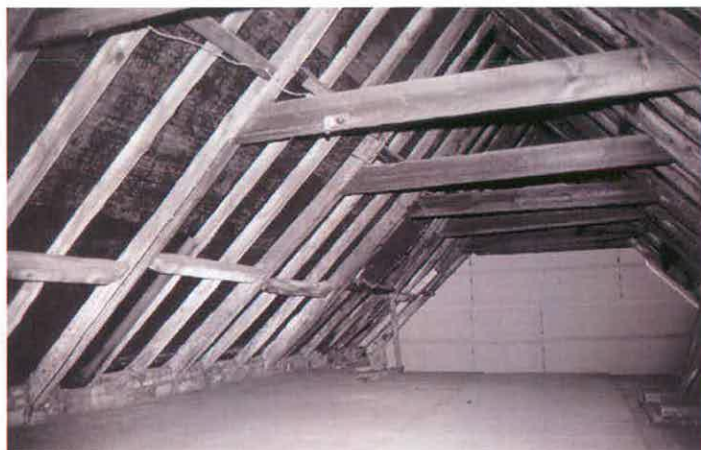
Figure 25 Range 5. View of roof construction

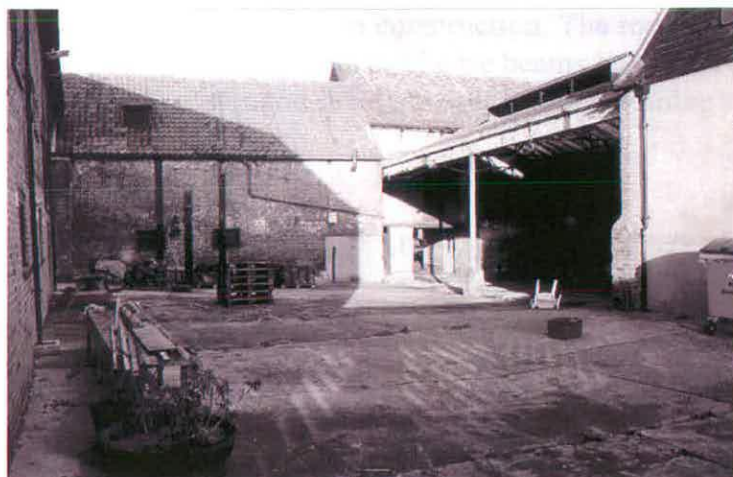
Figure 26 View of south courtyard, looking northwards towards range 5.

- 3.5.3 There are relatively few window openings in range 5 (three on the ground floor, none at first floor and a single dormer window in the attic) and just one loading door at first floor level at the east end of the south wall.

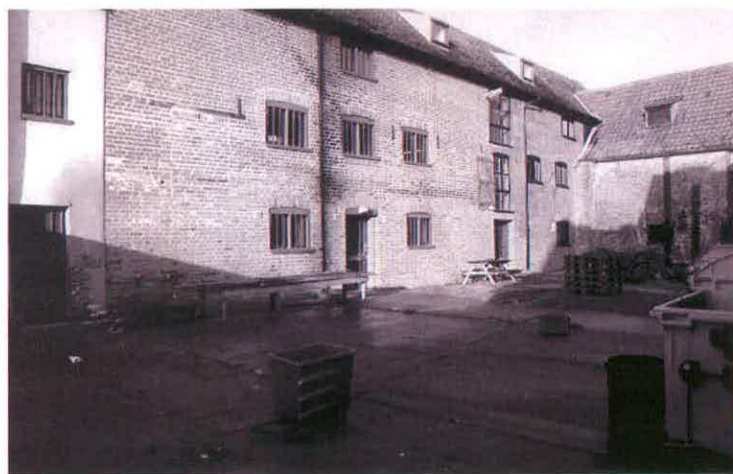
Figure 27 East elevation of Range 6, viewed from south courtyard

3.6.1 This three and a half storey range is built across the western end of range 5 and is some 90ft (27m) long by 19ft (5.7m) wide. To the west it shares a wall with range 7 but its eastern wall displays similar vertical discrepancies to these of the southern wall of range 5. The lowest 5ft 6" (1650mm) section is built in English bond of smaller bricks than the upper section, which is built in Flemish bond. The difference in depth of nine courses is some 4" (100mm). As in range 5, this change may indicate the rebuilding in brick of an earlier, possibly timber-framed, wall.

- 3.6.2 The roof is of softwood and clasped-purlin construction. The roof trusses have high collars and in this case there is a ridge piece. The tie beams have iron clamps connecting them to the wall plates and the tie beams of the adjoining range, range 7.

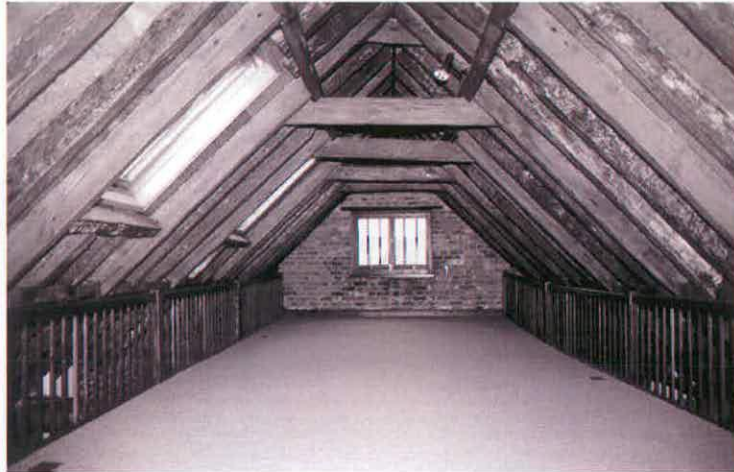
Figure 28 Range 6. View of attic showing construction of roof

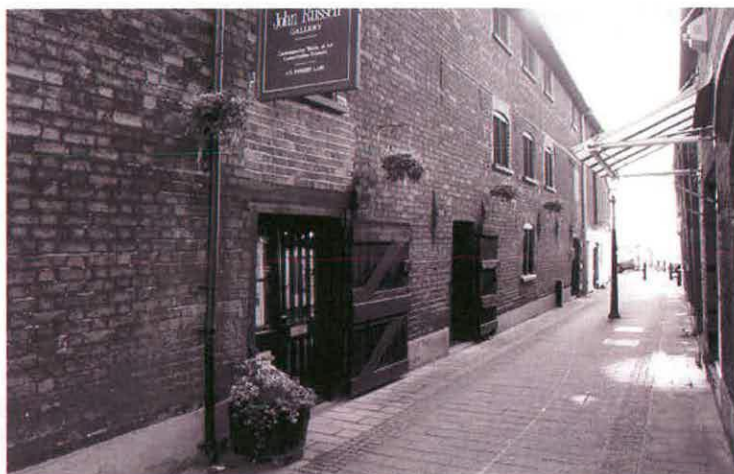
Figure 30 West elevation of range 7, looking southwards towards Common Quay

- 3.7.1 This range is built parallel to range 6 but extends further to the south. The roof appears to be identical to that of range 6 and the dormers to the west appear to be original. The small windows on the upper floor had top hinged internal shutters and the northern eleven bays (each measuring 6ft 10" / 1750mm in length) pre-date the four southern bays. The later bays totalling some 36ft (10.8m) were probably added when the quay was moved southwards with the construction of the wet dock in 1840. An internal transverse wall at this point was thus probably originally external.
- 3.7.2 Around the middle of the twentieth century range 7 was used as a warehouse for the storage of coal. The ground floor of ranges 6 and 7 are now used as an art gallery.

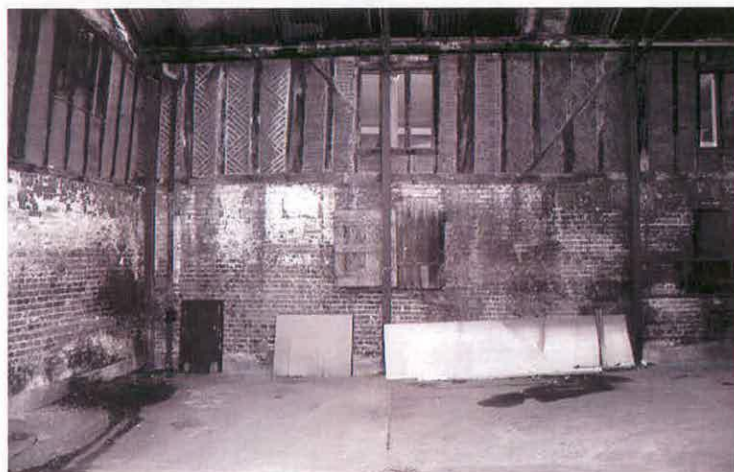
- 3.8.1 A three-storey range extending southwards from the south side of range 4 along the eastern side of the rear courtyard. The east exterior wall is of brick, and the west wall (facing onto the courtyard) is of brick at ground floor with timber framing above. The wall framing comprises vertical studs interrupted by diagonal braces (i.e. 'primary bracing) and is infilled with brick nogging. Internally, the first and second floor frames are divided into twelve bays by eleven transverse floor beams, supported on timber posts built into the walls. Second floor level is approximately 2ft (600mm) below wall plate level, and the floor frame includes upper (hanging) and lower knee braces. The roof is divided into twenty bays by nineteen principal rafter roof trusses. The roof is of staggered butt purlin construction. The roof trusses have straight collars.

Figure 31 West elevation of range 8 showing exposed timber-framing at first floor

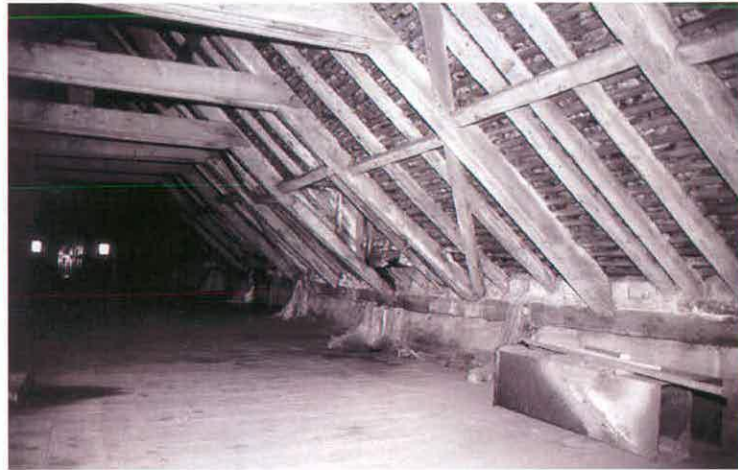
Figure 32 Range 8. Interior of attic showing roof construction

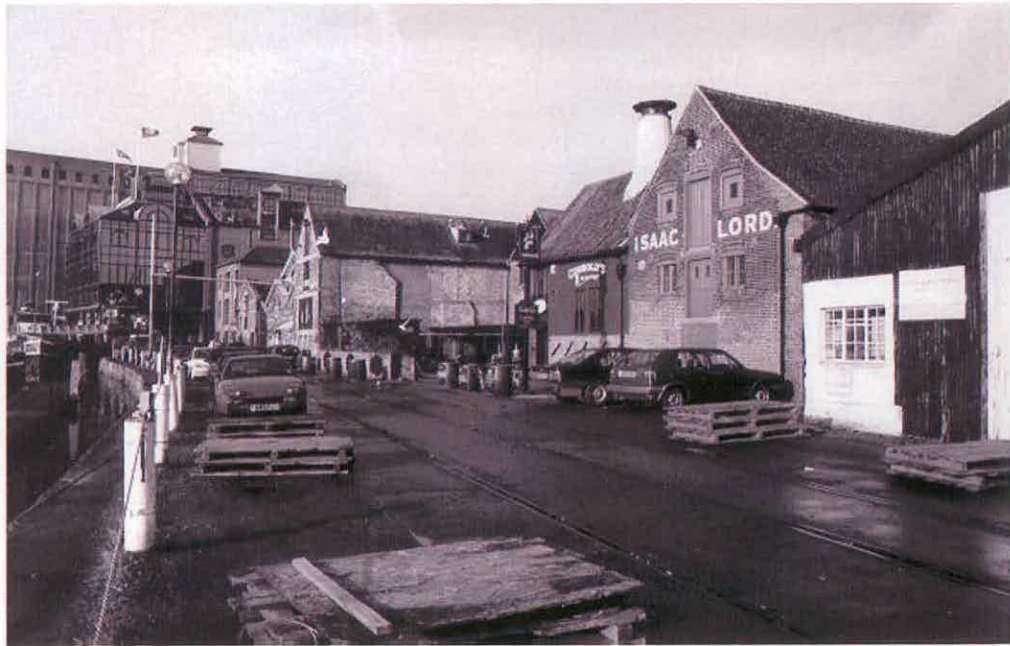
Figure 35 General view of quayside showing part of ranges 7, 8 and 11

This appears to be a separate building attached to the western side of range 8 at its southern end. The circular kiln may date in part from the late eighteenth or early nineteenth century when much of the complex was used as a maltings. The kiln itself has a furnace with two fire holes and a baffle constructed of metal framing with perforated tiles. The kiln floor is also of perforated tiles while the kiln hood is of lath and plaster on a light wooden frame suspended from the roof of the building. This suggests that the kiln was inserted into an existing building and reinforces the suggestion that conversion to a maltings caused much piecemeal rebuilding and some demolition. Thus the archway through the kiln block cuts what may have been the timber-framed wall of the transverse range which formerly closed off the rear of the yard from the quay. Some courses of small bricks survive at a low level in the west wall of the kiln block.
