ARCHITECTURAL SURVEY REPORT

MUMFORD'S FLOUR MILL

23-25 GREENWICH HIGH ROAD

Surveyed: August 1999
Report by Jonathan Clarke
Drawings by Andrew Donald
Photographs by Sid Barker

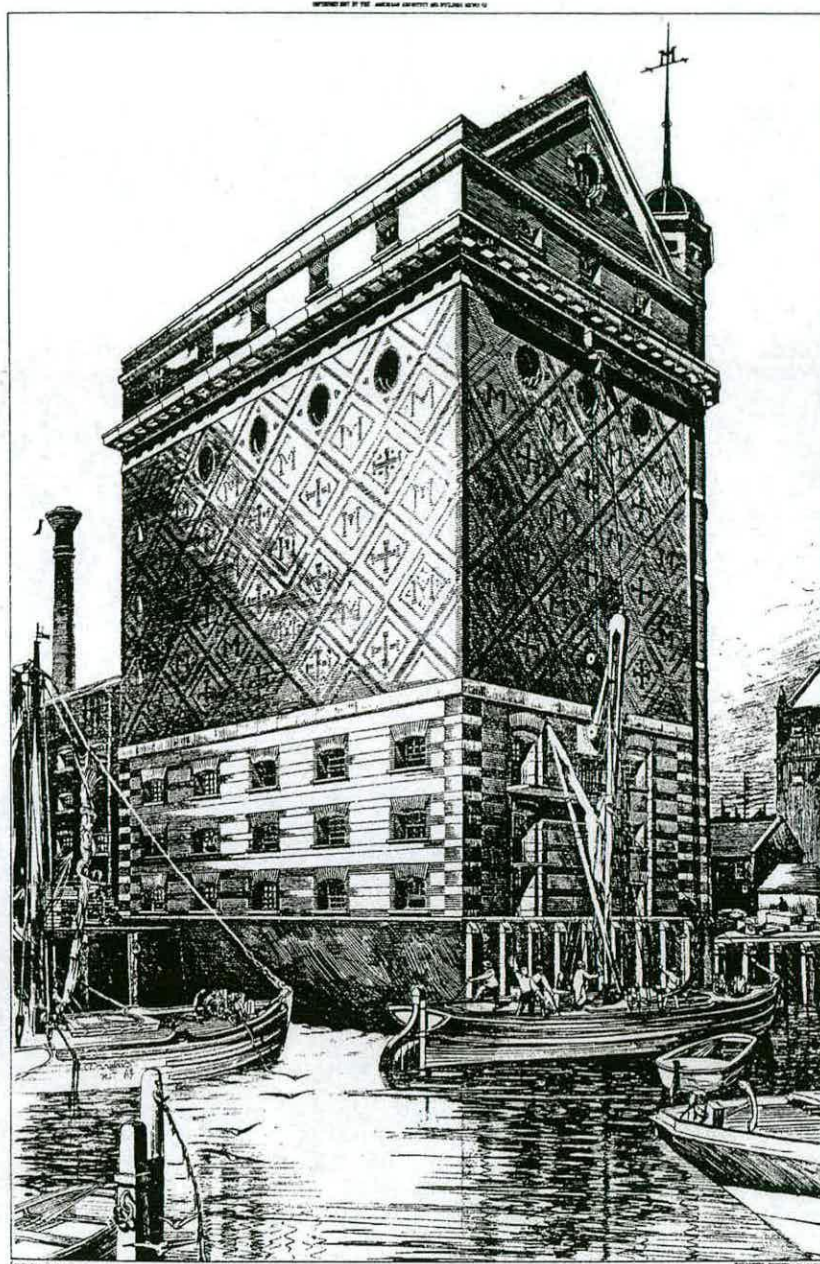
Fig. 1 – Grain silo at Mumford's Mill, Aston Webb, architect, from the north east, as depicted in the The Builder and American Architect and Building News in 1897.

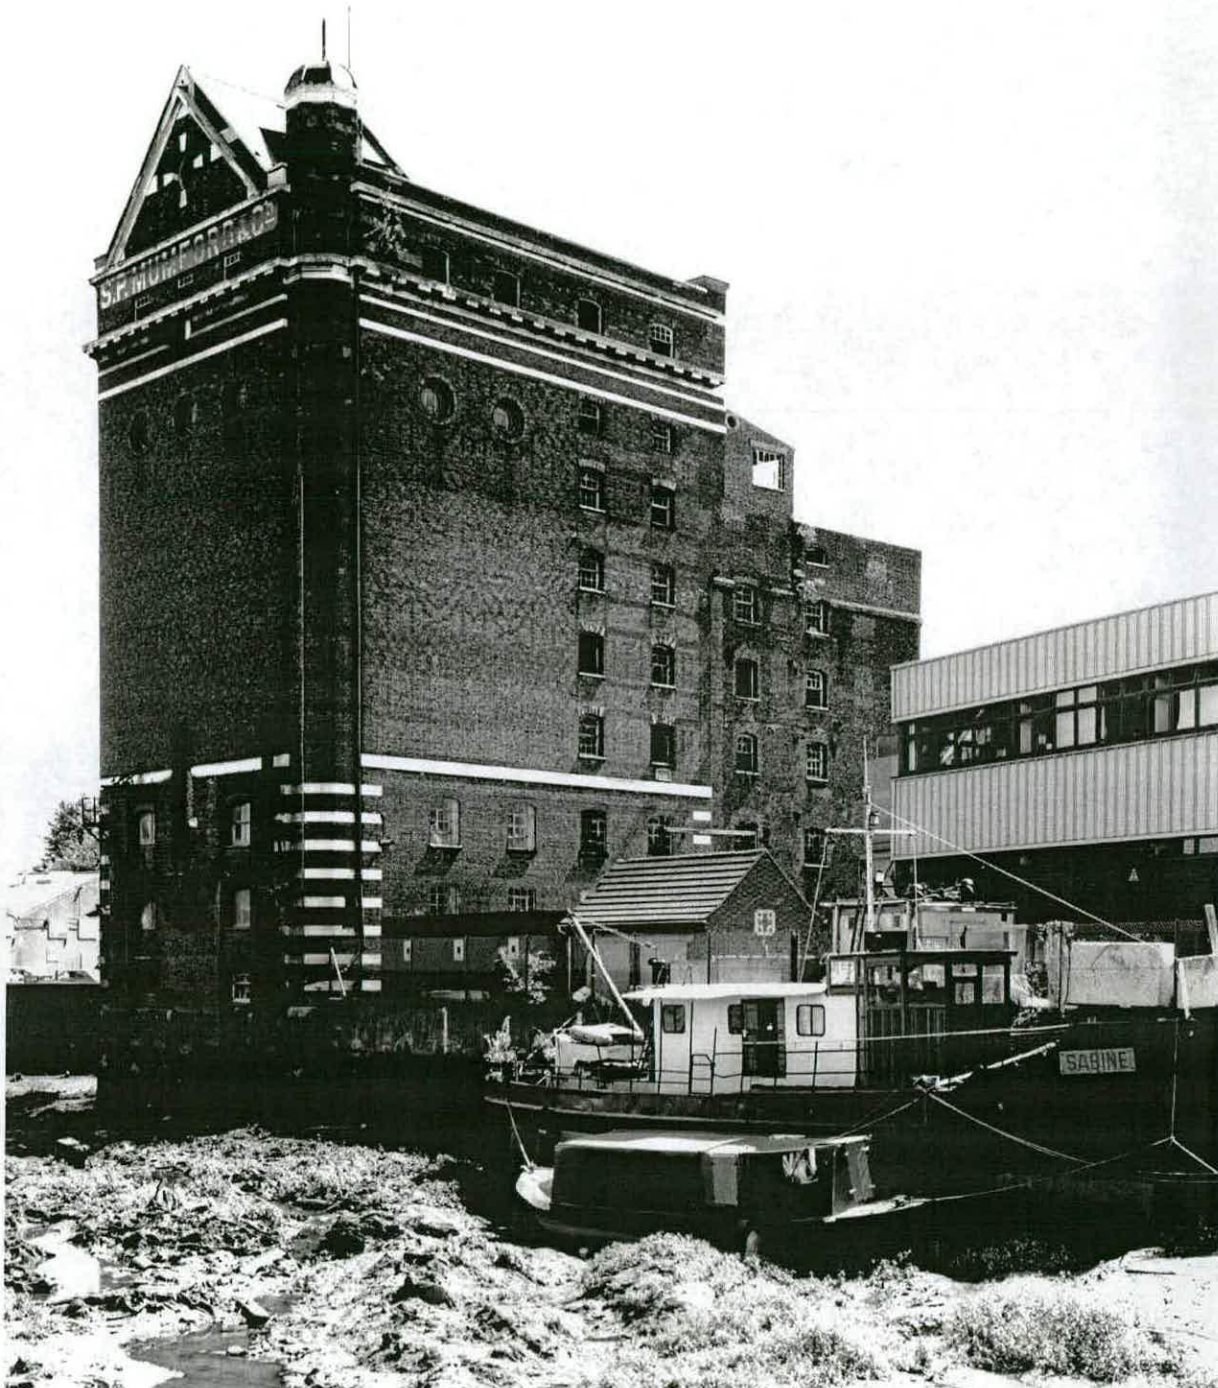
Fig. 4 – The Silo as it appeared in 1999, viewed from the north-west (EH, 07/09/99).

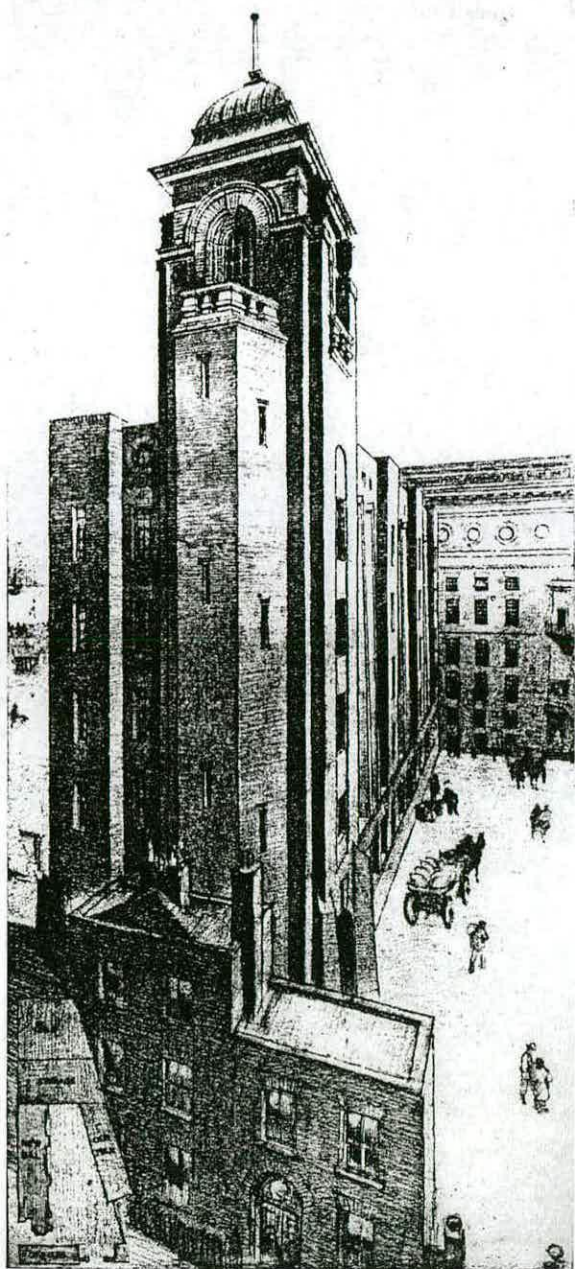
Fig. 5 – Aston and Maurice Webb's proposed (1919) addition to Mumford's flour mill, as illustrated in *The Builder* in 1919.

Webb's involvement with the Mumford enterprise did not end with the construction of the grain silo at Deptford. In 1919 drawings depicting proposed additions to Mumford's Flour Mills were exhibited at the Royal Academy, and in the following year at the Royal Scottish Academy. Contrived by Sir Aston Webb - President of the R.A. in 1919-24 - and his son, Maurice E. Webb, this ambitious scheme (Fig. 5) was never executed.

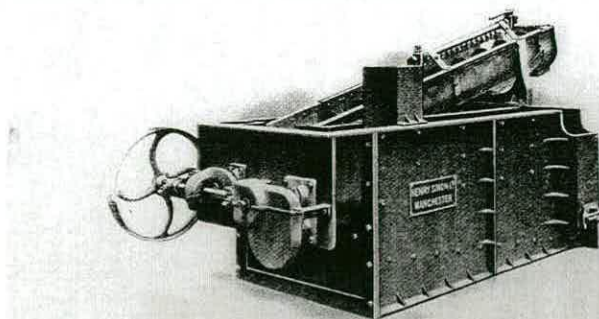
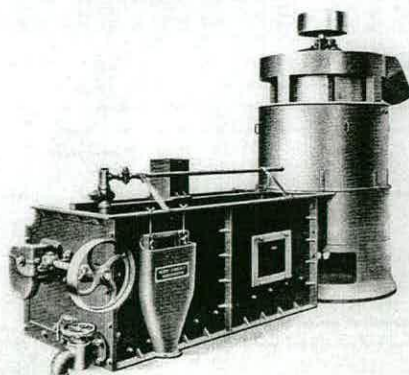
THE "REFORM" WHIZZERLESS WASHER AND STONER
(MUMFORD PATENT).

THE "REFORM"
COMBINED WASHER, STONER, AND WHIZZER
(MUMFORD PATENT).

Fig. 6 – Two wheat cleaning machines devised by a Mumford and manufactured by Henry Simon Ltd.

S.P. Mumford & Co.'s (unfulfilled) expansionist plans were perhaps matched by their seeming involvement in improving milling machinery at this time. The sixteenth edition (1920) of Henry Simon Ltd.'s 'Modern Flour Mill Machinery' catalogue featured two machines designed to be employed in the preliminary cleaning stages of the milling process, each with a 'Mumford Patent'. These comprised 'The "Reform" Combined Washer, Stoner, and Whizzer', and 'The "Reform" Whizzerless Washer and Stoner' - the latter sagaciously devised for those millers who already had whizzers, could be easily linked-up via an inclined rinsing worm (Fig. 6).

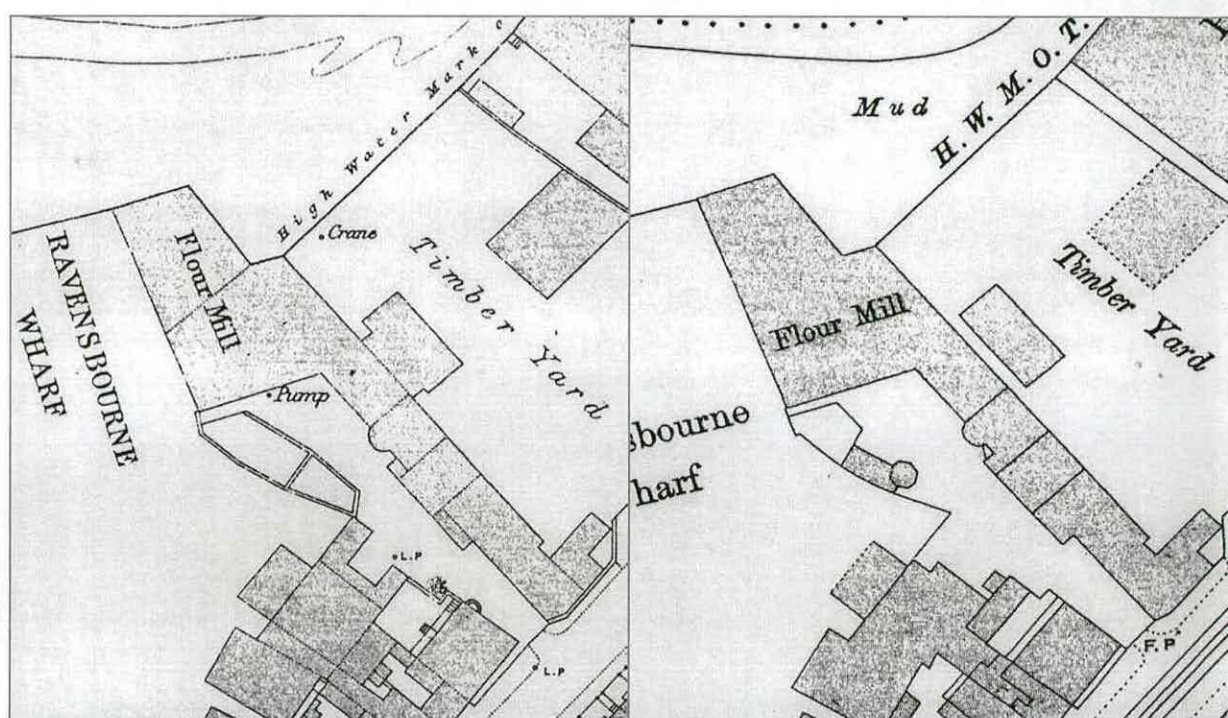
Fig. 7 – 1st and 2nd edn. 1:1250 Ordnance Survey maps: left hand side surveyed 1867; right hand side surveyed 1894.

The majority of the buildings flanking the west side of the yard still survive (Fig. 9). These one and two-storeyed, largely unembellished sheds evidently functioned as a mess room, smithy, garage, general store, engineering shop and oil store. Stylistically they are of early-20th-century appearance, and comparison with the 1894 OS map shows that they replaced an assortment of 19th-century buildings (Fig.7).

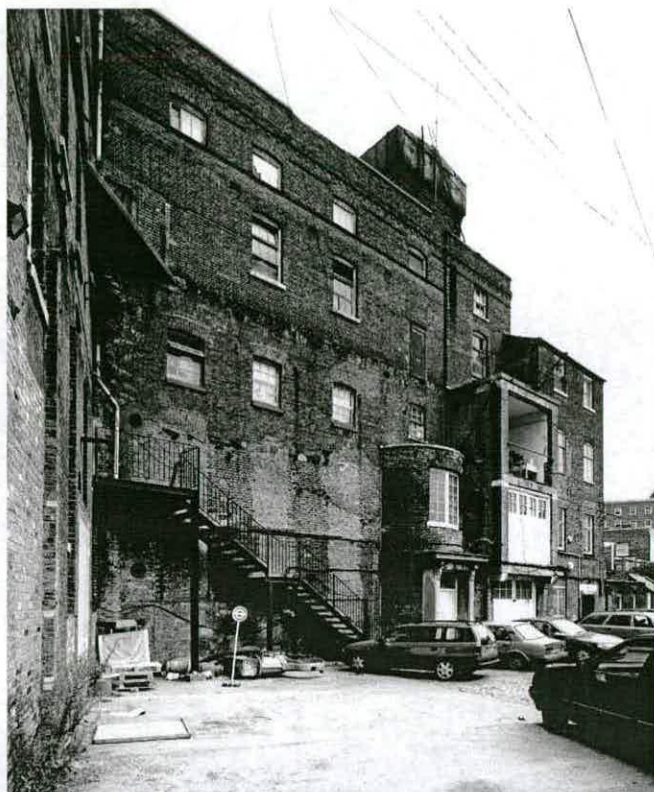
Fig.8 – The East Mill from the West (EH, BB99/09864).

The earlier of the two blocks is the East Mill (Fig. 8). That the East Mill is earlier than the West Mill is demonstrated by both the brickwork of the lower storeys of the south elevation, which is closed up in respect of the western elevation of the east

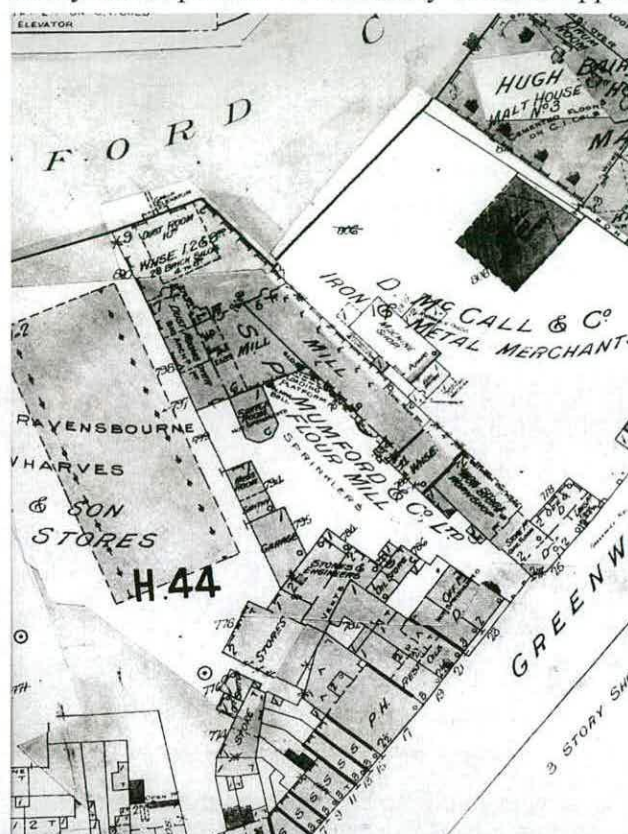
Fig.9 – Mumford's flour mill as depicted on Goad's fire insurance map of 1942 (resurveyed from 1891 original).

The earliest surviving component of the mill complex seems to be the L-shaped block abutting the south elevation of the grain silo, gabled approximately east-west and north-south (Figs 7 and 8). A date of c.1817, when Charles Ritchie was rated for a Greenwich mill, seems entirely consistent with the appearance of the east and west elevations. The Goad fire insurance map of 1942 (Fig. 9) clearly

delineates this as a long, narrow mill building abutting the grain silo to its north, the West Mill to its west, and a warehouse block to the south. Viewed from the yard, the south and west elevations of this five-storey block present an ostensibly uniform appearance, despite a plethora of blocked and inserted

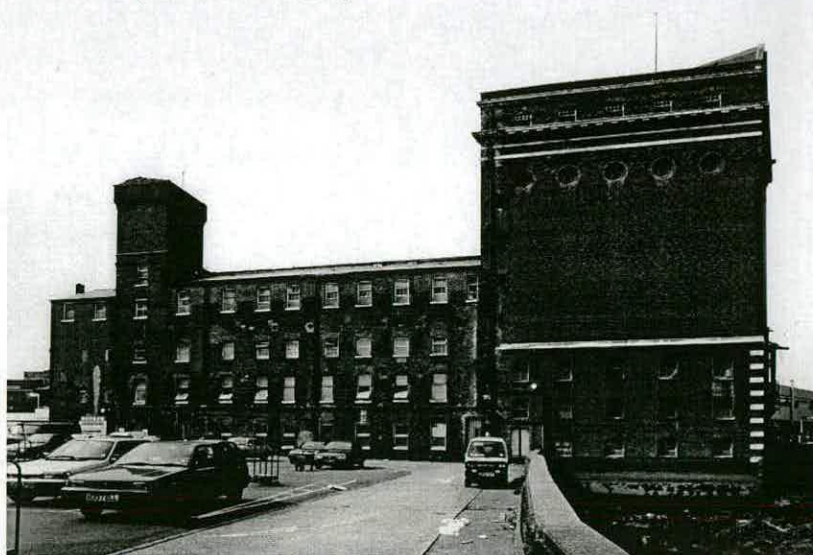
Fig. 10 – The east elevation of the East Mill, truncated to the north by the 1897 Silo, and raised to the south to create a water tower (EH,BB99/09872).

The four-storey east elevation (Fig. 10) is one storey shorter than the west elevation. The eaves line of the east elevation is marked by rectangular spreader plates, set between the windows. These are mirrored on the west elevation, and the brickwork above this, incorporating shallow fifth-floor windows, and enlivened by string and dentil courses, is perceptibly lighter in colour. Examination of the interior of this attic space confirms that the western side of this space was raised to permit additional windows (see below). This alteration may have been made at the same time as the construction of the West Mill and the construction of the adjoining water tower block to the south, all of which are unified by identical string and eaves courses (see below). On the evidence of spreader plates alone, and of window heights and window-head form, it is likely that the fourth storey itself may be a later addition. The lower three storeys are characterised, on both elevations, by circular spreaders and by segmental window heads with heads of a stretcher-and-a-half depth (and gauged flat arches on the ground floor, only partially preserved on the west elevation). In itself this is a weak indicator of a separate phase, but coupled with the disproportionately greater height of the fourth floor windows (whose window heads are a single stretcher in depth), there is a more compelling case.

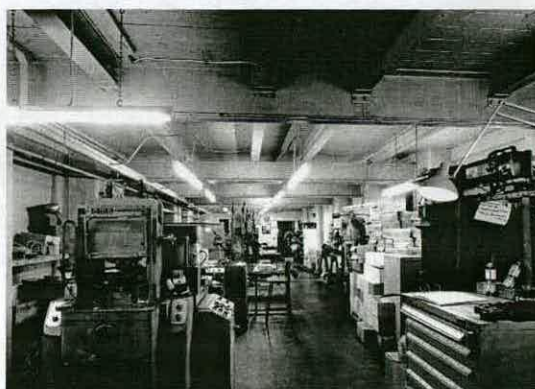
Fig. 11 – Ground floor of the East Mill looking north (EH, BB99/09862).

The original structure probably consisted of non-fireproof timber floors, formed from transverse timber beams supporting longitudinal joists on which the floorboards were laid. The narrow internal width of the building [(20.7ft (6.3m))] probably obviated the need for a central row of props, and ensured that the interior was fully lit by the windows. The principal change has been the replacement of the original timber floors by robust steel-framed floors. These were probably inserted in 1897, to accommodate the possible refitting of larger, heavier roller-milling machinery. Throughout, the judicious use of heavy steel girders bypassed the need for intermediary vertical support, thus preserving the presumed open plan of the floors.³⁸

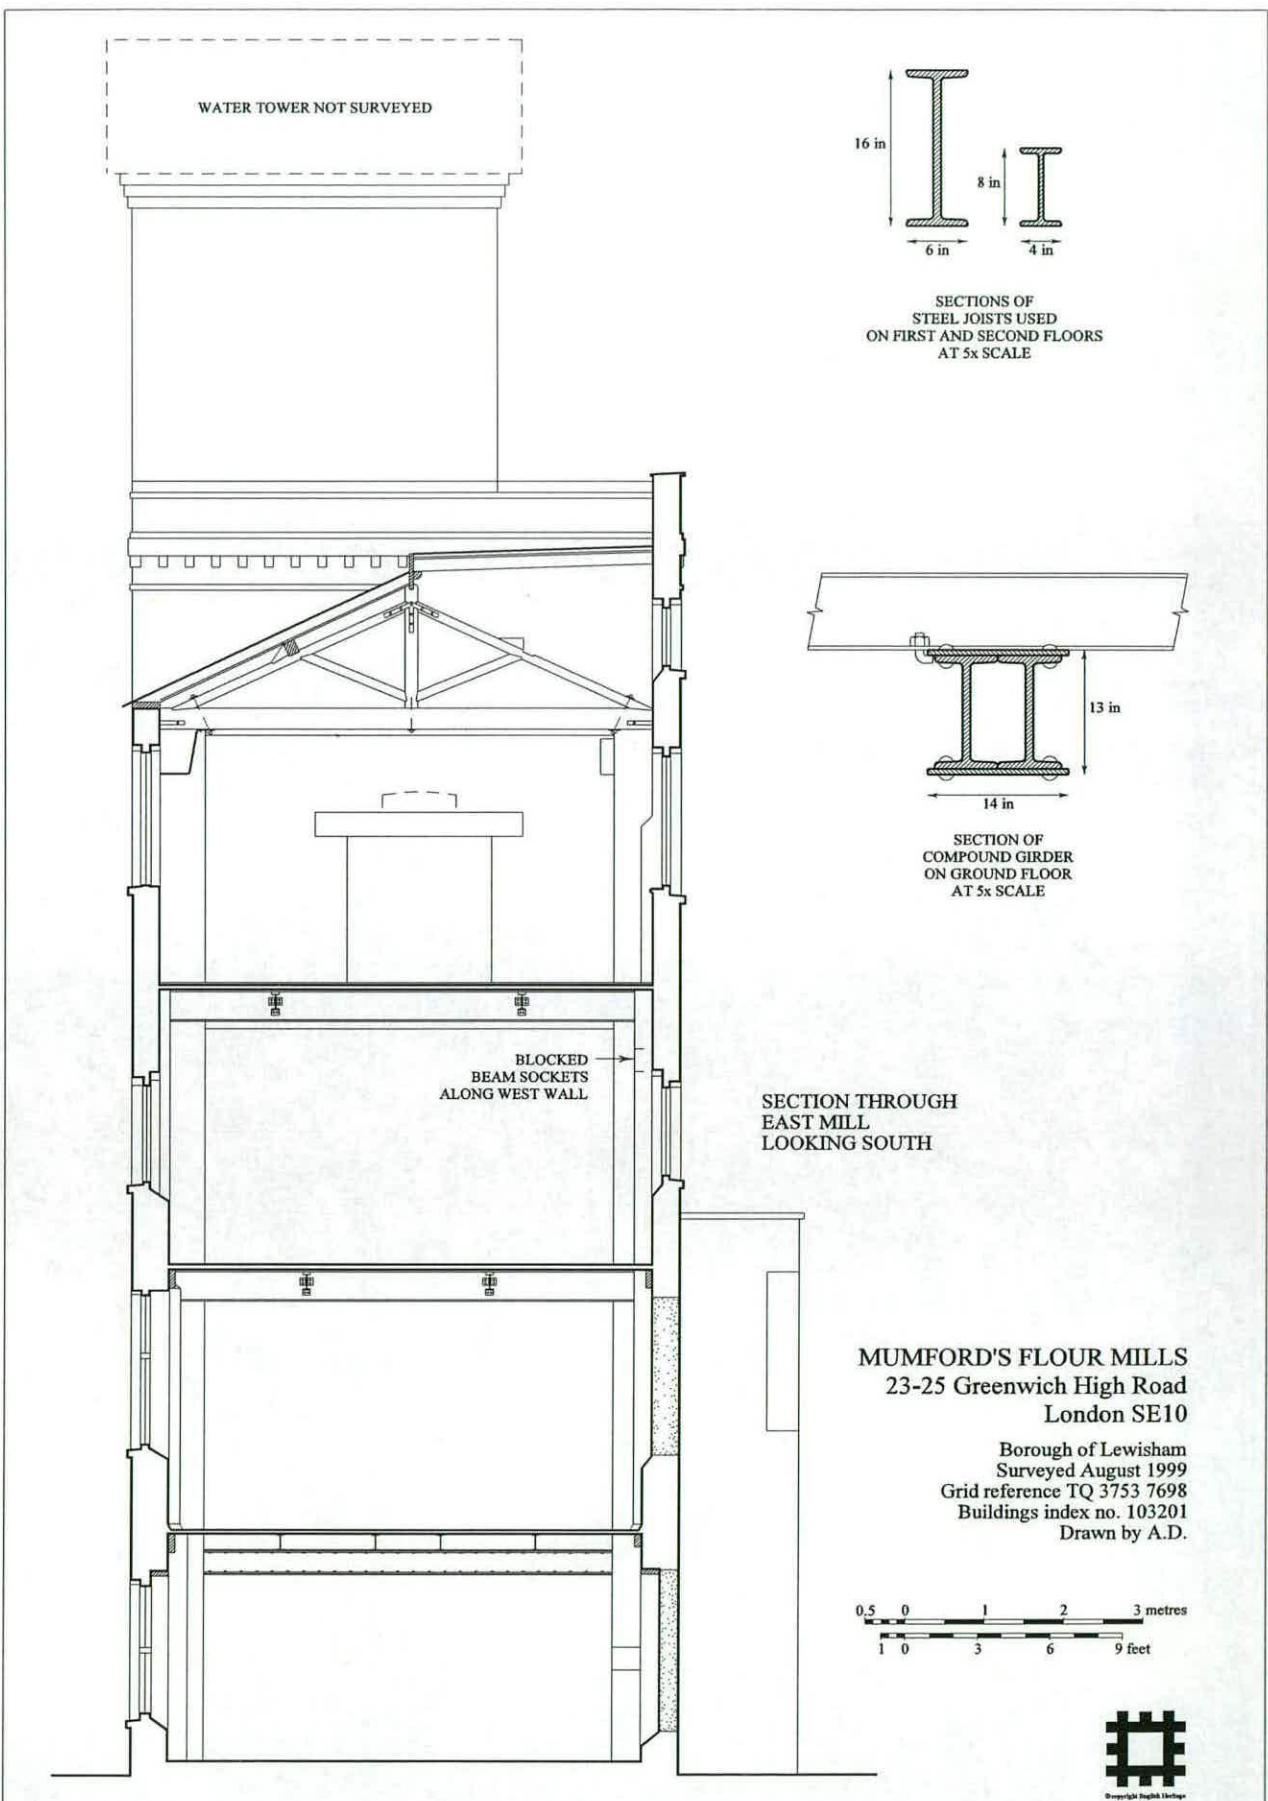
Fig. 12 – East Mill, section looking south and structural details.

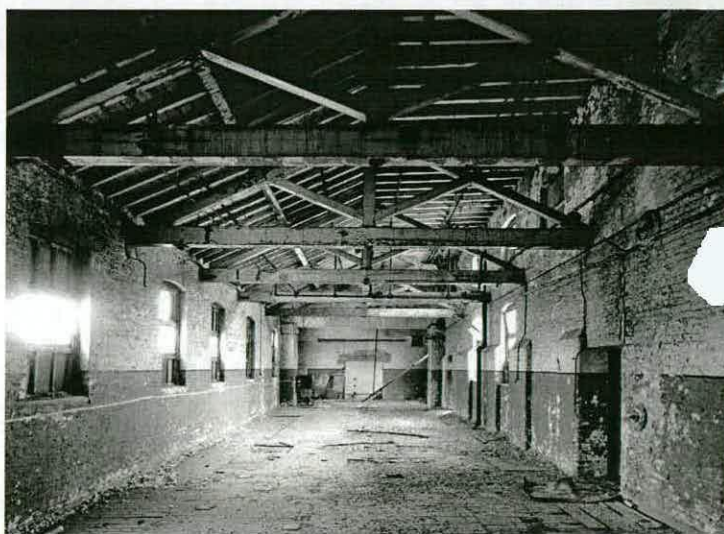
Fig. 13 – Fourth floor of the East Mill, view from north (EH, BB99/09857).

The added fourth floor, still preserves what is probably the original king-post roof, possibly re-sited from the floor below (Fig. 13). When the western wall was raised to permit additional windows, the western purlins, rafters and roof covering were removed. It is unclear what advantages accrued from this alteration, since a new floor level was not created. It may have improved the lighting of the floor - a requirement perhaps of a new process introduced into storage space, and/or additional height for new plant. There is no evidence to suggest that the same wall was ever fenestrated in the northern portion, either on fourth-floor level or in the raised upper part. This suggests that the fourth floor was added with, or perhaps just following, the construction of the West Mill, which adjoins to the west. Cast-iron pipes, suspended from the original and raised sides of the roof form the remains of a sprinkler system which may have been introduced when the water-tower block, was created from the south end (see below). The south wall, separating the water-tower block has been knocked through leaving stub walls. These support a reinforced-concrete lintel, which spans the opening. The northern end wall is presumably formed from the south wall of Webb's grain silo. It is not perpendicular to the long walls, running at a slight angle that, when built, necessitated the truncation of one of the northern

trusses. This 'half truss' remains curiously embedded in the west wall, despite being structurally redundant.

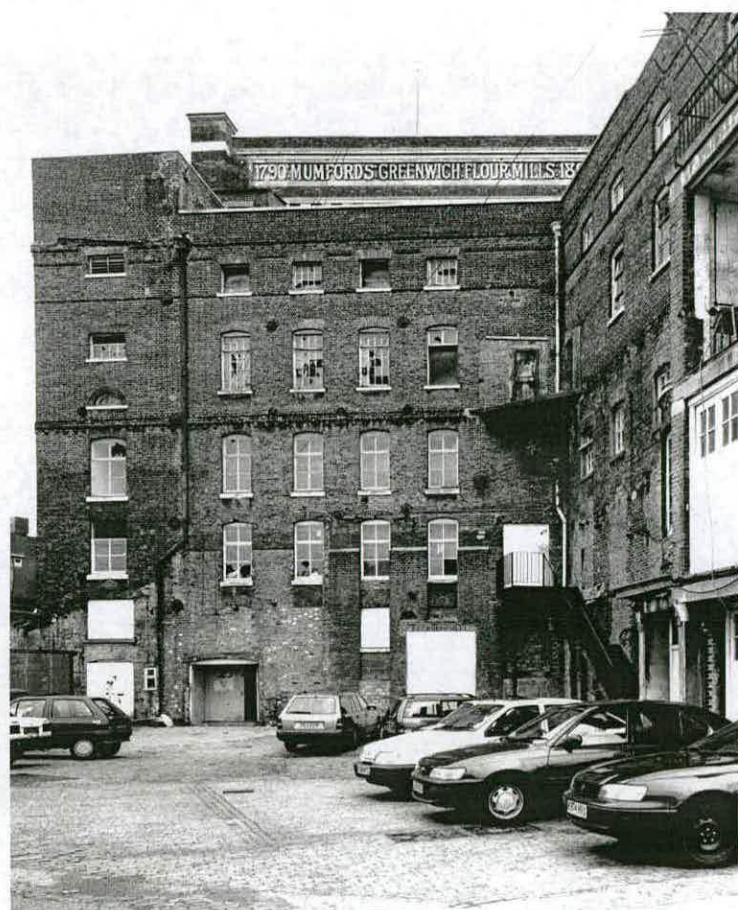
Fig. 14 – South elevation of the West Mill, showing the wheat cleaning wing at the far left (EH, BB99/09873).

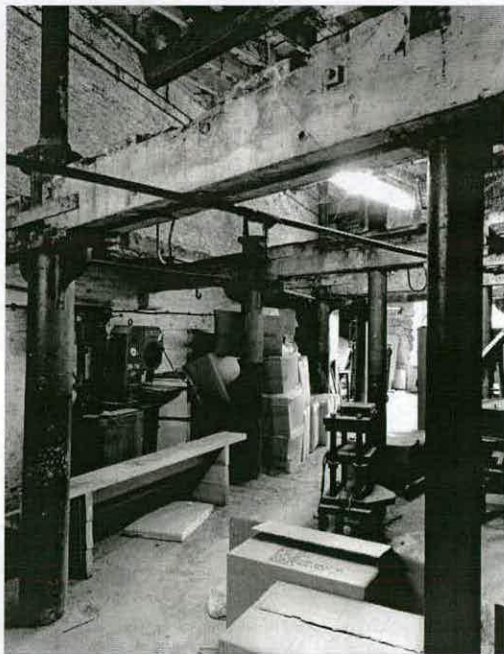
Fig. 16 – Lower ground floor of the West Mill, from the south-east (EH, BB99/10977).

The beams are joined together below the column 'capitals' by iron straps, their ends resting on lugged brackets reinforced by sizeable ribs. The diminutive column 'capitals', which rise above the beams, are socketed to accept the base castings of the columns above, the two in effect creating a single column that extend two storeys. The ground-floor columns, which are considerably more slender, are cast with a square capital, the flat upper surface of which is also socketed to receive a shallow cylindrical projection cast on the soffit of the beams. In cross section these cast-iron beams are of inverted T-shape, with a narrow bottom flange but no top flange. At their mid-point, the flange enlarges into a square shape with a projecting cylindrical lug -

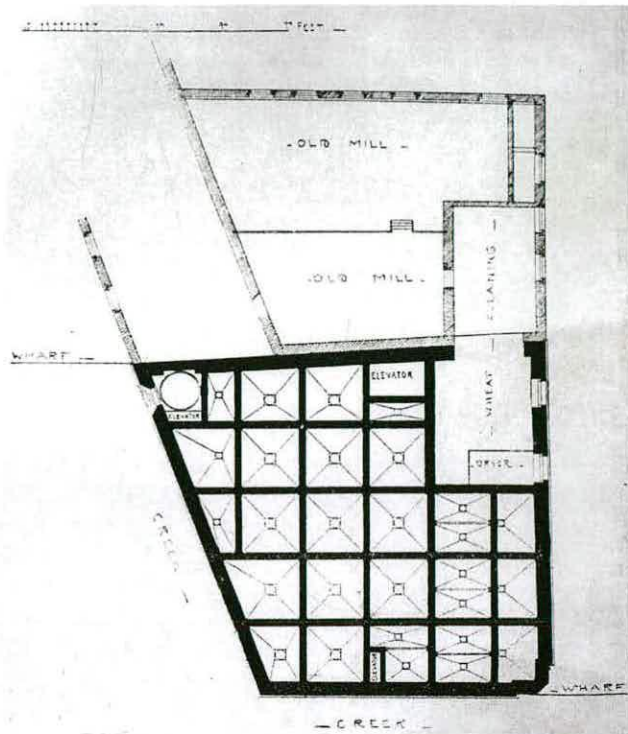
Fig. 15 – Webb's first-floor plan for the Silo, also showing the West Mill. (The Builder, 1 May 1897, 400).

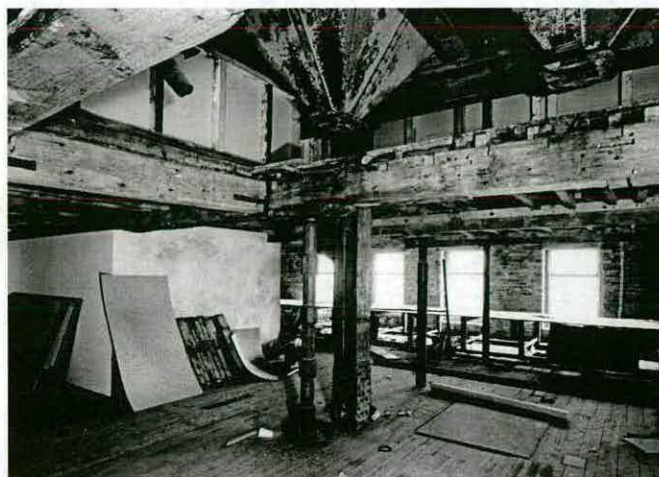
Fig. 17 – First floor of West Mill, looking south, showing reused props and steel hopper-bottoms (EH, BB99/09896).

The internal construction of the first and second floors also comprises heavy timber floors supported by intermediate metal props. On the first floor a whole assortment of reused ironmongery has been brought into structural service to support the beams: axles and driving shafts from steam-powered machinery, and, more conventionally, a variety of slender cast-iron columns, one with an elaborate foliate capital, removed, perhaps, from a Victorian theatre or music hall (Fig. 17). Those on the floor above are

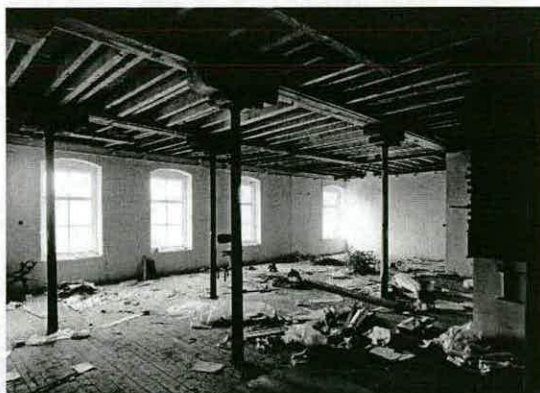
Fig. 18 – Second floor of West Mill, looking southwest (EH, BB99/09894).

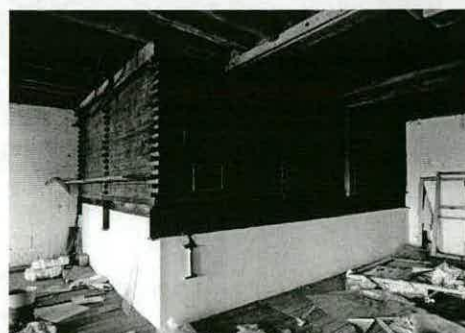
Fig. 19 – Lower portion of wood-wall silo visible on second floor (EH, BB/09893).

The most tangibly functional surviving component of this block is a wood-wall silo,³⁹ situated on the east side of the wall dividing the ‘Wheat Cleaning’ block and the ‘Old Mill’ (Fig. 15). Owing to the inaccessibility of the upper floors, the true height of this is uncertain, but the lower portion of the timber walls of the bin compartments is visible on the second floor (Fig. 19), and the steel hopper-bottoms are visible on the floor below (Fig. 17). The weight of this silo, comprising six compartments or bins, is supported by a steelwork frame made up of a grid of Dorman Long I-section beams that ‘grip’ the hopper-bottoms. This frame is itself supported by steel stanchions and the flanking wall. In view of the ‘Dorman Long’ rolling marks visible on the larger [6in. by 14in. (15.2cm x 35.6cm)] I-beams of the framework, the earliest this silo could have been introduced is the late 1880s, when the company began production. It seems likely that it was added in c.1897, as an adjunct to the main silos. Unlike those, which received ‘crude’ or dirty wheat, this probably acted as a secondary storage receptacle for turning over or mixing different consignments of wheat, or for supplying the dirty wheat mixture to the cleaning department wing next door.

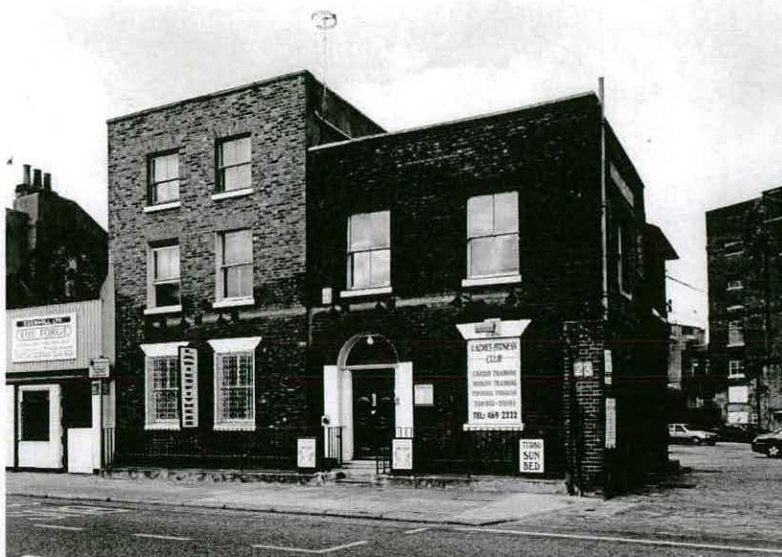
Denoted (Fig. 7) as a single large block in 1867, No.23 Greenwich High Road consists of three adjoined, yet chronologically discrete dwellings that may intercommunicate internally. On stylistic grounds, the earliest is probably the two-bay, two-storey (with basement) building that both overlooks the site entrance and faces Greenwich High Road (Fig. 20). Although modest in scale, it is well-proportioned with interesting details that enliven the Flemish brickwork, including a decorative panelled door (formerly with fanlight) and a ground-floor round window on the side elevation. This may be the

house Charles Ritchie was rated for from 1802. The two-storey (with basement) building behind this has lost its original door, but still preserves the corbelled door-arch and hornless twelve-sash windows. This probably dates from the 1820s or the 1830s. The tall, deep and narrow building to the west of these two buildings seemingly dates from the early-mid 19th century. Because it was not provided with a front door, it was reached either from the earlier building, from the back door that opens onto the yard, or possibly from a side door prior to the construction of the third building.

Fig. 20 – The Site Offices facing Greenwich High Road, looking North (EH, BB99/09854).

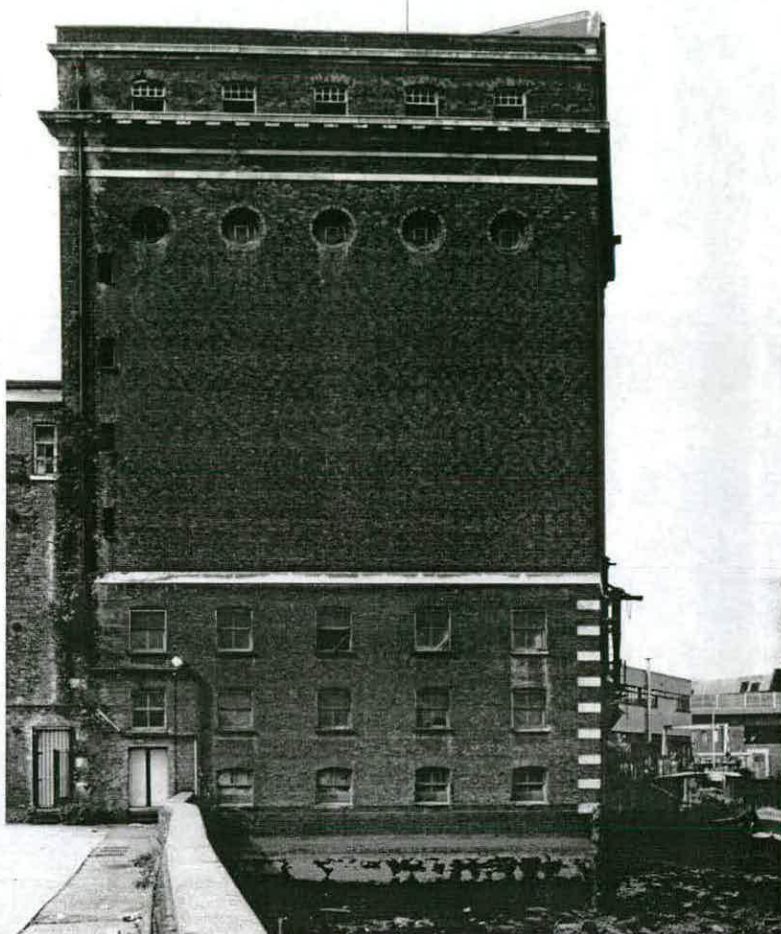
Fig. 21 – The Silo from the east (EH, BB99/09866).

The round windows, which almost fully encircle the building above vast expanses of unfenestrated brickwork, are perhaps the only architectural feature to express the interior use: they light the outer ranks of brick bins, which when full would (on close inspection) have displayed the grain pressed against the glass. The tourelle, capped by a pinnacled octagonal dome, is purely decorative, enclosing one of the capacious brick bins. The triangular pediment facing the creek forms the front elevation of the aspirator room, lit by a circular window (a modification of an original segmental-headed design). The three lower floors, and the uppermost floor are all fenestrated and open, effectively 'sandwiching' the silos between. The central portion of the eastern elevation is however fenestrated for two bays; this is the wheat-cleaning wing which continues southwards into the West Mill.

To withstand the great pressures exerted by stored grain, the building was constructed in chain bond (where embedded long stones, iron bars or chains are used to strengthen the brickwork), using cement mortar. The river wall is faced with blue bricks, and the upper portions with stocks enlivened with red brick dressings and diaper ornament. The contractors for the whole work, including the foundations, (which were built in the Creek during periods of low tide) were Jerrard & Son, of Lewisham. The steam elevator, the remains of which remain affixed to the riverfront, and the rest of the machinery, was erected and fitted by Henry Simon Ltd.

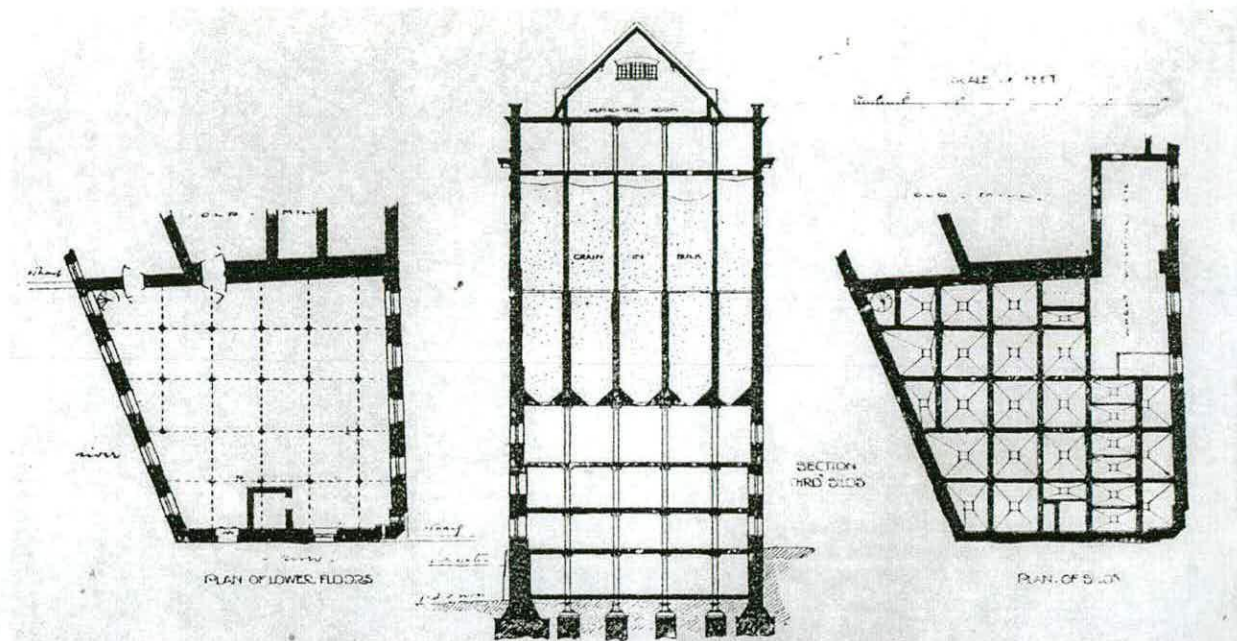
Fig. 22 – Webb's plan and section of the Silo building. (from *Academy Architecture No.12* (1897), 82).

The internal construction of the Silo exhibits a robustness and technological sophistication paralleled on this site only by that of the East Mill. A grid of longitudinal and transverse primary beams, formed from rolled-steel and supported at their intersections by hefty cast-iron columns support the lower (fireproof) concrete floors, and transmit most of the colossal weight of the grain bins directly to the foundations (Figs 22 and 24). This method of interior framing, whilst reliant on the walls to carry the outer ends of the beams, nevertheless virtually eliminated the horizontal thrust into the walls generated by the cumulative floor weight: a problem with earlier fireproof systems reliant on jack-arching.

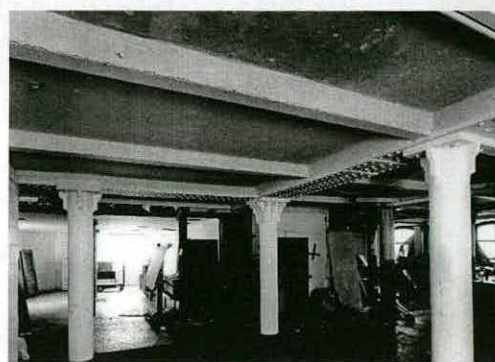
Fig. 23 – First floor interior, looking north-west. (EH, BB99/09901).

In the basement and on the ground floor, the fireproof floor system uses lighter, rolled-steel joists, whereas the first floor incorporates, in addition to these, heavily rivetted plate or compound girders - presumably a reflection of different live loadings. On all these floors, the webs of the primary members forming the grid, and those secondary members serving to strengthen the floor still further, and the connections, are concealed by concrete. This technique of fireproofing, resulting in a 'troughed panel' appearance to the ceiling (Fig. 23), was employed by Webb elsewhere.⁴³

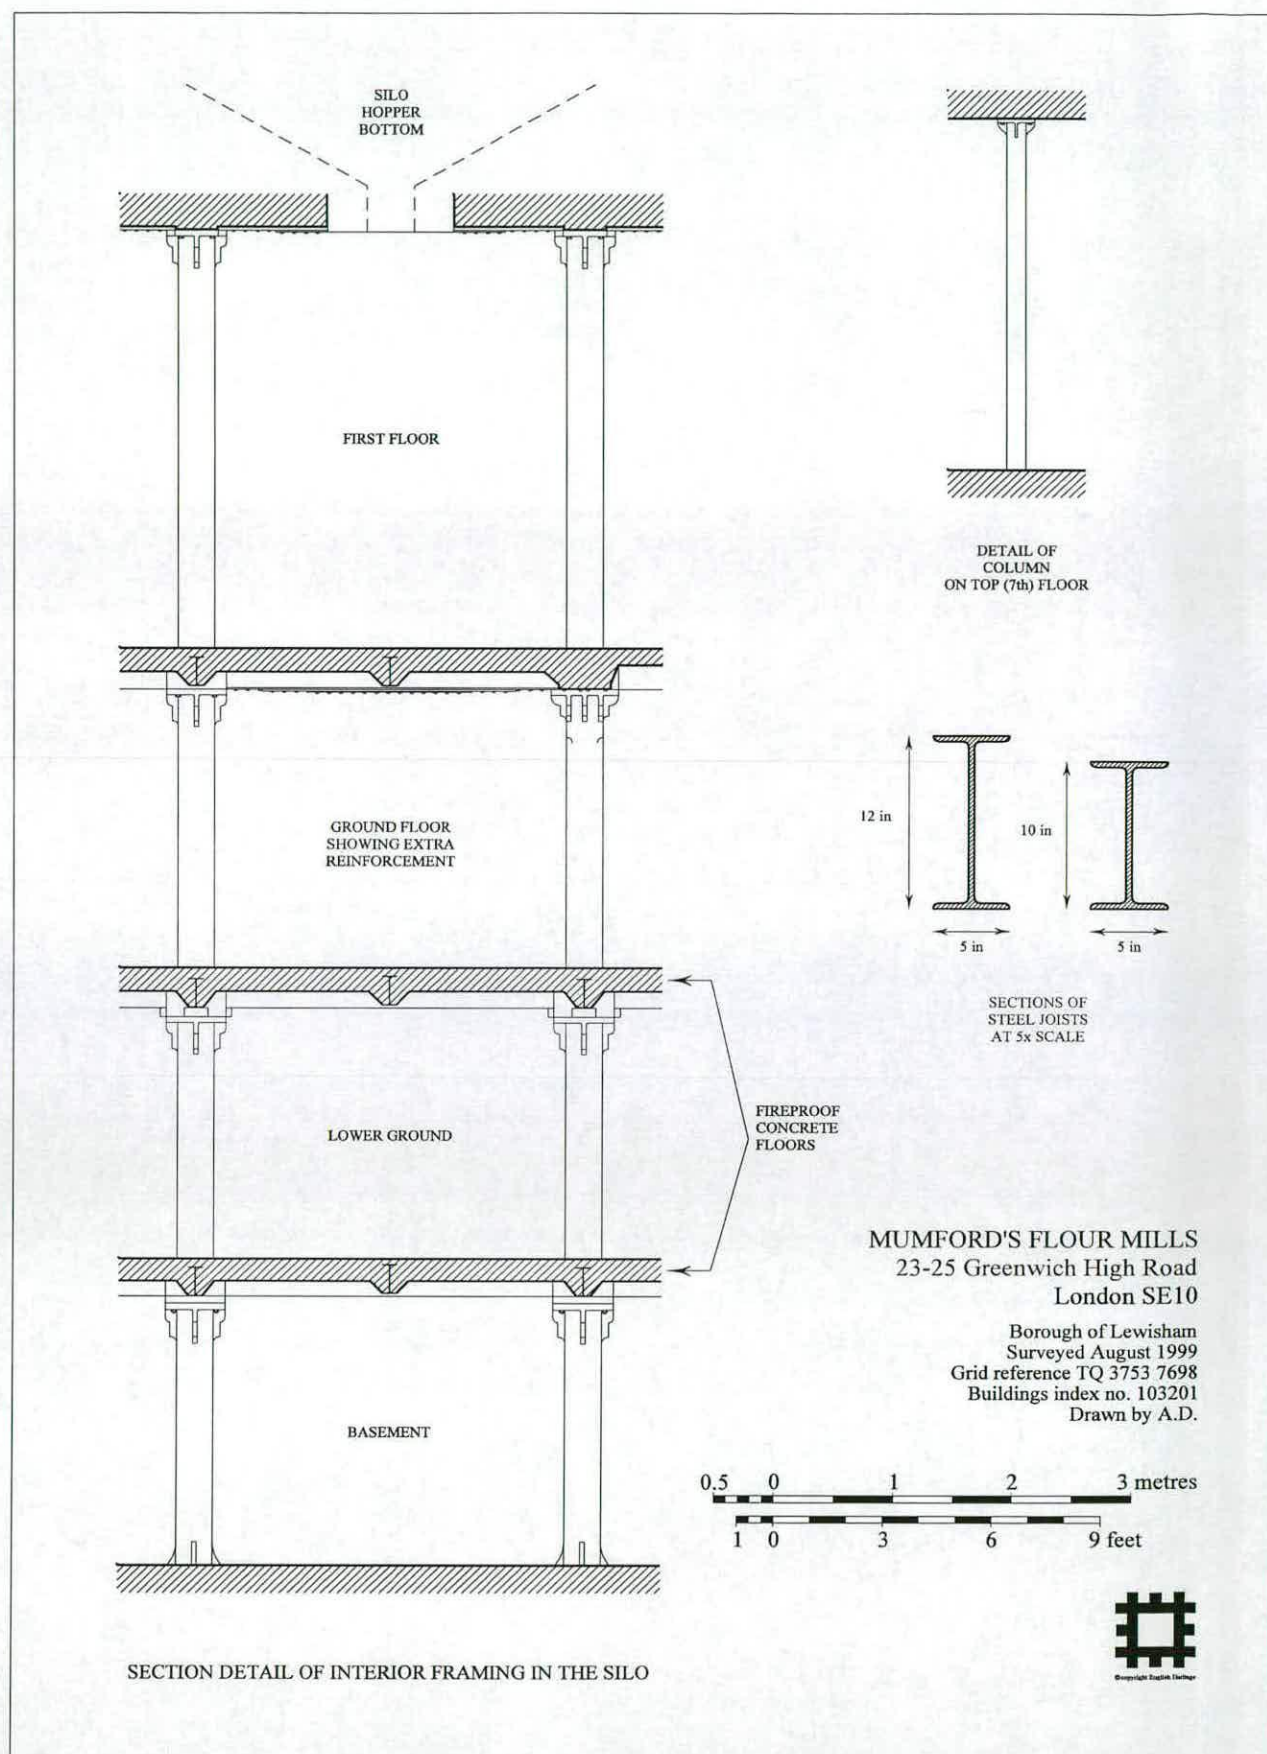
Fig. 24 – The Silo, section showing framing of lower floors and structural details.

The second floor, which supports the 47ft (14.3m) high walls of the brick bins, is more heavily reinforced still, the grid exclusively formed from compound or plate girders. Secondary beams 'grip' the hopper bottoms which partially project below the concrete ceiling (Fig. 24). The seventh floor, which only supports the roof and aspirator house is frail by comparison, with slim columns supporting slender joists (Fig. 25). Although rolling marks testifying to the source of this steelwork may lie concealed by concrete, it seems likely that Dorman Long steel was used here given its use elsewhere in the complex, and elsewhere in some of his Tooley Street buildings. Some of the columns in the lower floors bear the maker's plate 'H.EDIE & Co. BOW'.

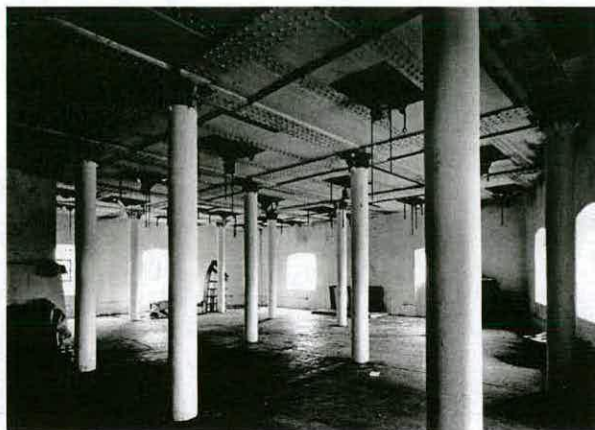
Fig. 24– Second floor of grain silo, looking north-west (EH, BB99/09898).

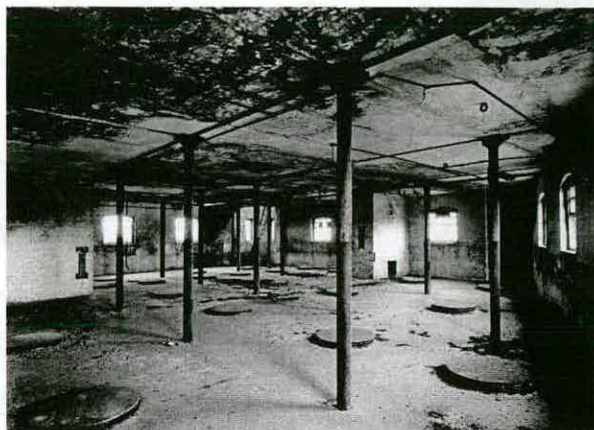
Fig. 25– Seventh floor of grain silo, looking north-west (EH, BB99/09901).

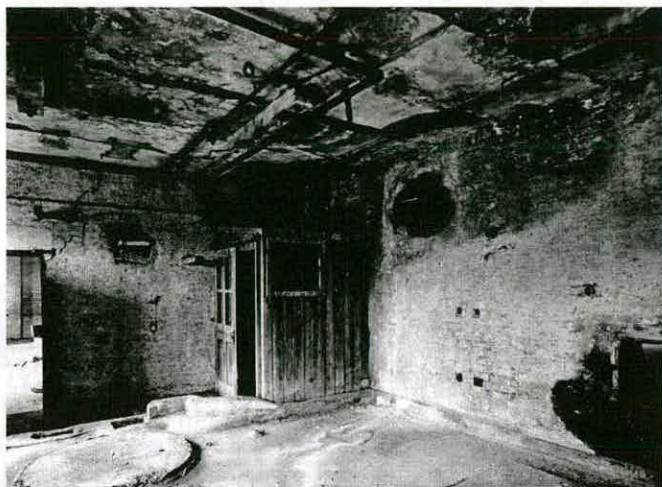
Fig. 27 – Top (7th) floor of wheat cleaning portion of the silo, from south-west (EH, BB99/09889).

timber hut in the corner of the room probably protected a supervisor from water spray (Fig. 27). The lower floors, which are plank floored, probably housed the drying and conditioning plant. Numerous openings through these floors, including trap doors in the north-west corner indicate the importance of vertical conveyance of wheat in varying states of cleanliness and moisture content. One distinctive large opening consisting of two paired holes that runs through virtually all the floors (Fig. 28) may mark the

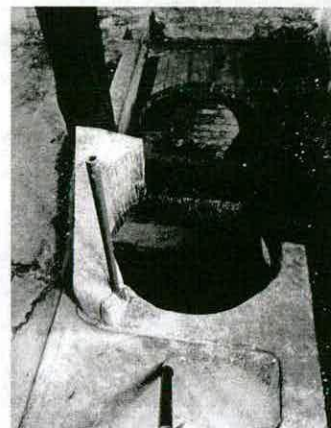
Fig. 28 – Aperture for (possible) wheat conditioner machine (EH, BB99/09892).

position of a former conditioner. These machines often consisted of two vertical cylinders of perforated metal through which the grain descended, with hot and cold air currents providing gradual drying and conditioning.

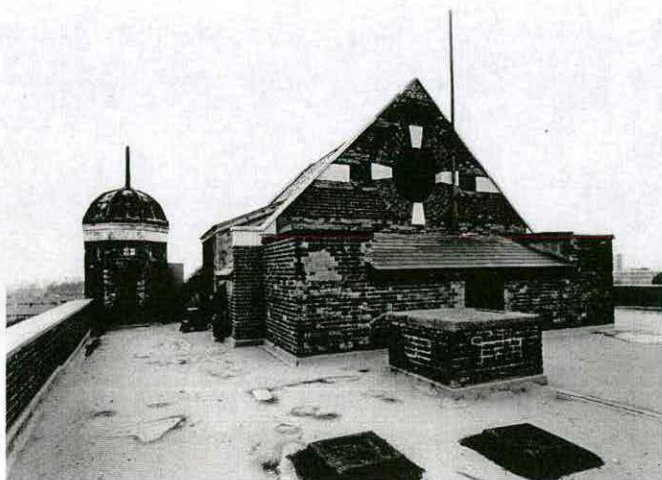
Fig. 29 – The Aspirator House from the south (EH, BB99/09881).

like that separating the southern portion of this space from the West Mill, was the ‘gearing wall’; with wall boxes surviving *in situ* on each floor throughout the height of the building.

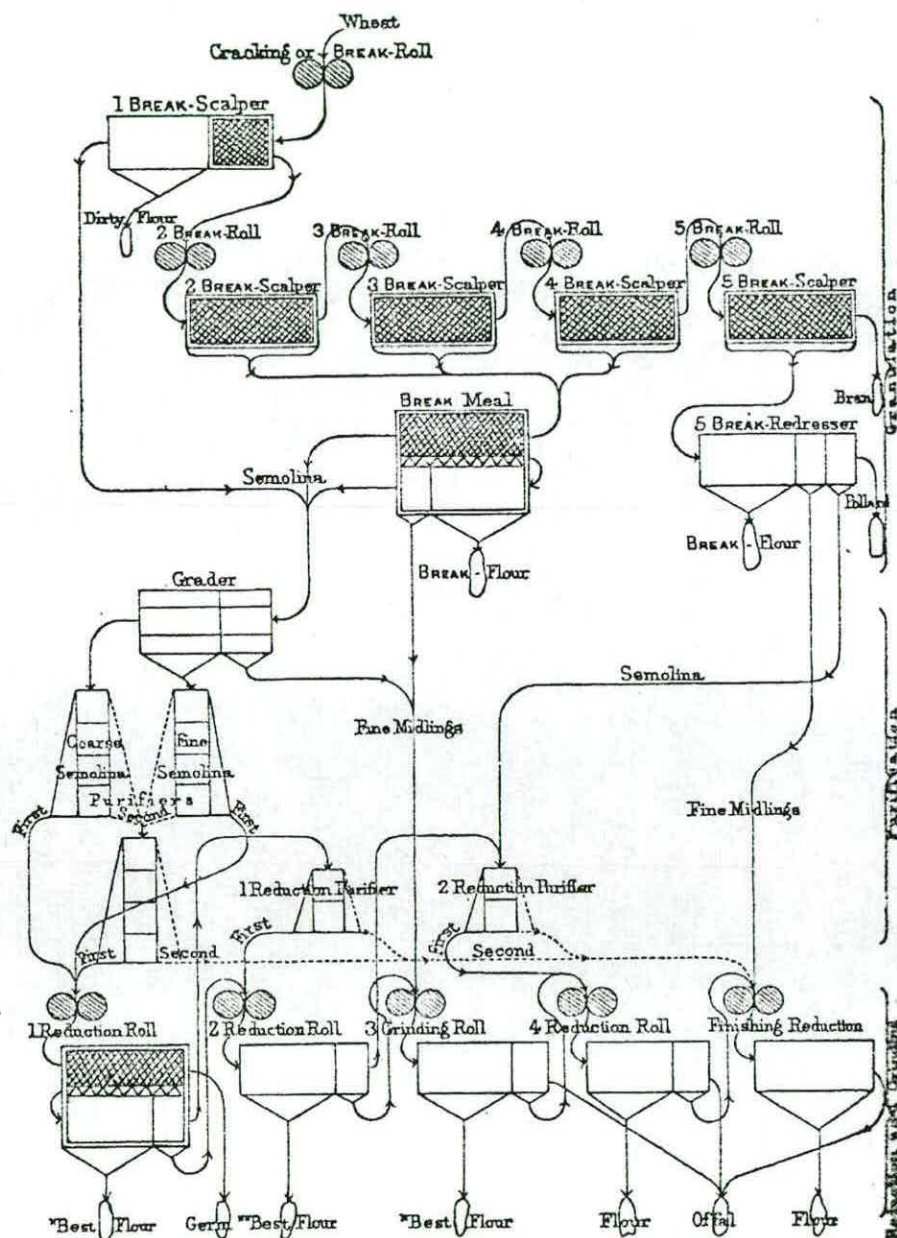
Fig. 30 – Diagram illustrating the three stages of the (Simon) system of gradual reduction
