ARCHITECTURAL SURVEY REPORT

MUMFORD'S FLOUR MILL

23-25 GREENWICH HIGH ROAD

Surveyed: August 1999
Report by Jonathan Clarke
Drawings by Andrew Donald
Photographs by Sid Barker

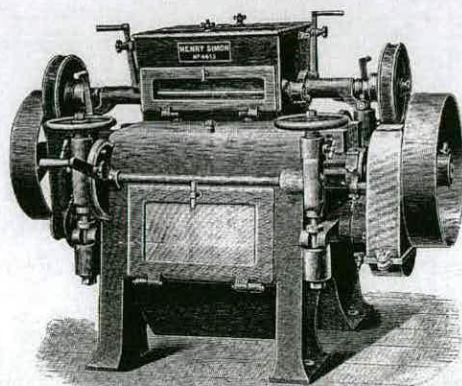
THE "SIMON" FOUR-ROLLER MILL LIGHT PATTERN

This machine is similar in design and construction to the heavier 9' and 10' roller mill, and has the same accurate adjustments and high finish. It has been specially designed to meet the requirements of those millers who require a plant of moderate capacity.

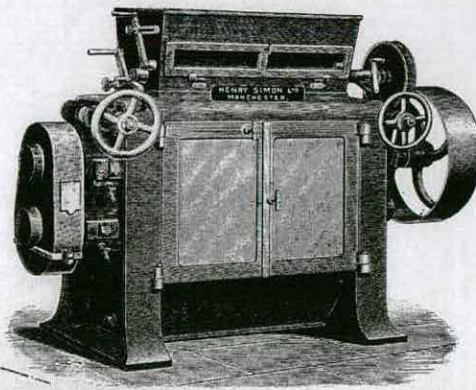
THE "SIMON" TWO-HIGH ROLLER MILL

This mill, like the foregoing, has been specially designed for plants of small capacity. It is easy to adjust, accessible at all parts, compact, durable, and in all other points in material and construction equal to the larger four-roller mills.

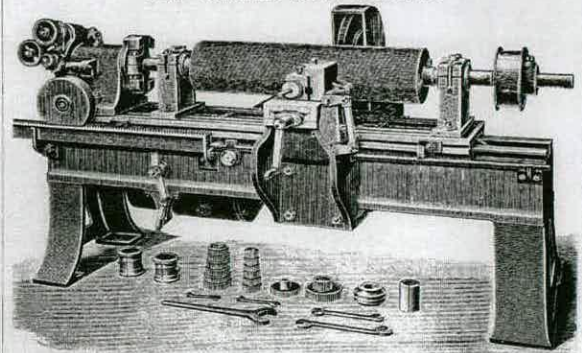
COMBINED GRINDING & FLUTING MACHINE FOR CHILLED IRON ROLLERS

This machine, which is simple in construction, and easily worked, is specially adapted for the use of mill-owners. It is provided with an emery disc for grinding and polishing the rolls, and a tool for cutting the grooves.
