A full list of Research Reports, with abstracts and information on how to obtain copies, may be found on www.HistoricEngland.org.uk/researchreports

The Research Report Series incorporates reports by the expert teams within the Research Group of Historic England, alongside contributions from other parts of the organisation. It replaces the former Centre for Archaeology Reports Series, the Archaeological Investigation Report Series, the Architectural Investigation Report Series, and the Research Department Report Series

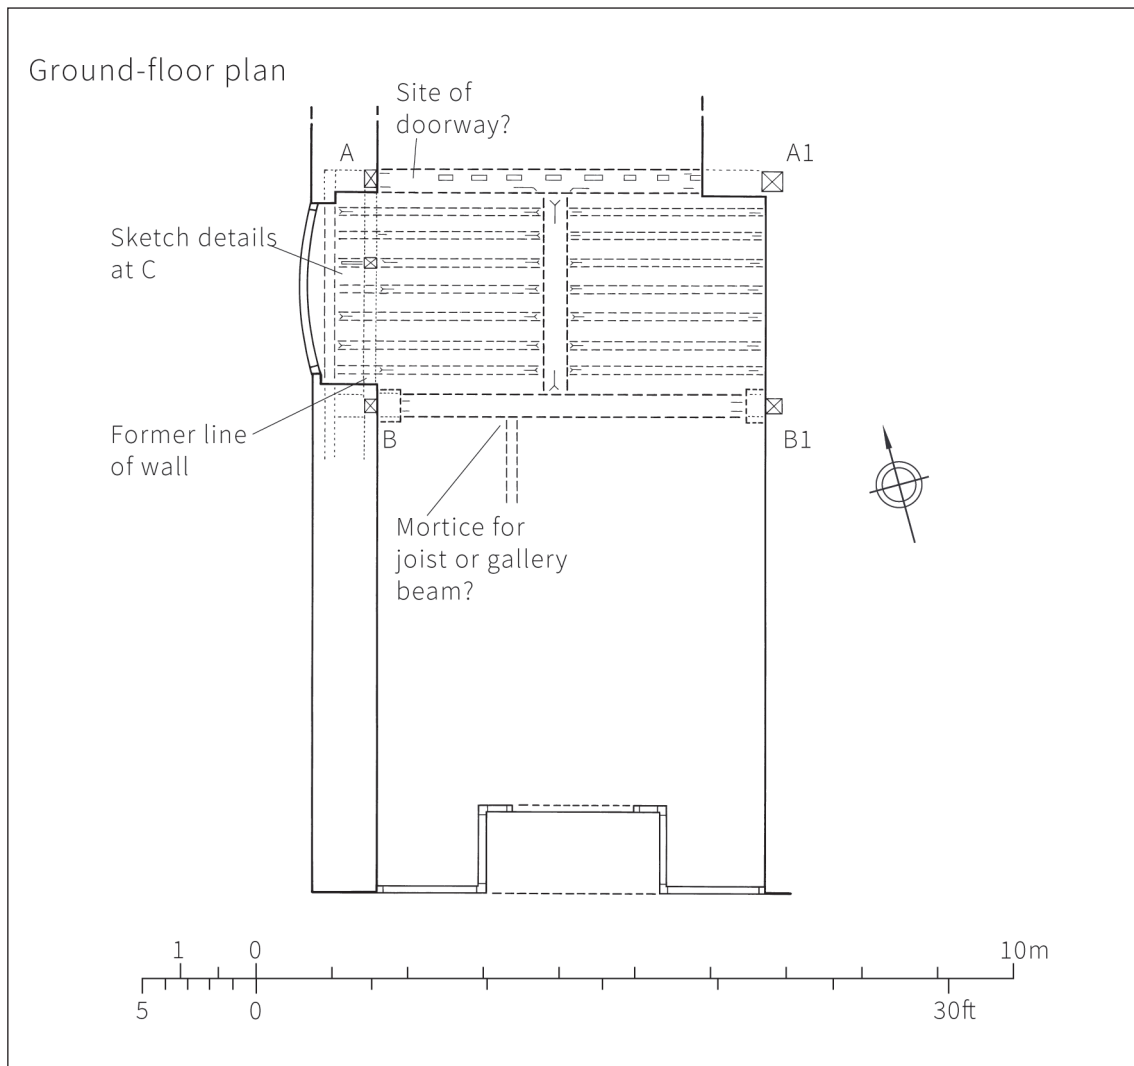
Figure 81 33 High Street, ground-floor plan (Drawing Allan Adams © Historic England).

The overall proportions of the surviving bay suggest that there were two bays to the south of this. One of these is the putative open hall, as described above, possibly incorporating a gallery or stair (Figure 82 shows a suggested reconstruction). Further south again there was almost certainly a further bay, which would have brought the building up to its current street front position on what is now the High Street. The form of this front bay is completely unknown, but evidence from similar urban buildings identified elsewhere, for example Sandwich (Clarke *et al* 2004, 172), suggests that this may have formed a further storied range, possibly with shop units on the ground floor and chambers above. The putative gallery over the main hall would then have linked the two storied areas of the building. Alternatively they may both have been accessed via separate stairs from the open hall. Some of these features are speculative, but the sequence of (from north to south) service

area, parlour, open hall, and a further bay possibly containing a shop, is possible to extrapolate from the surviving evidence.

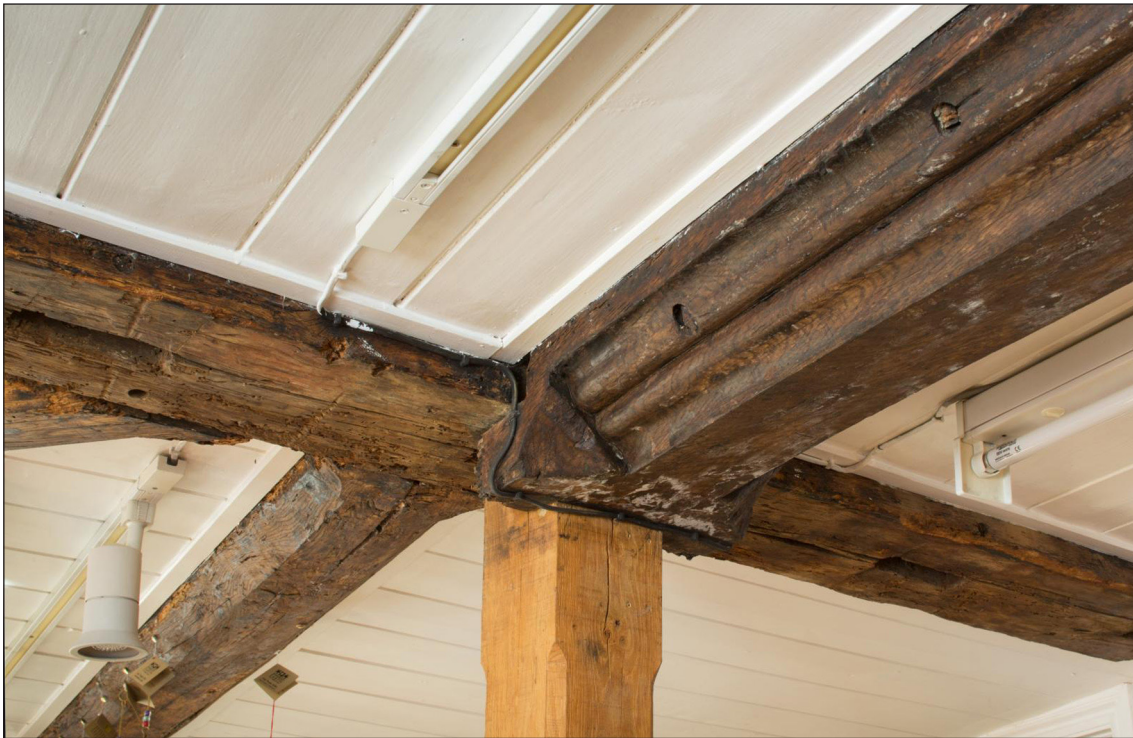
Figure 83 3a High Street Passage, detail of 16th century beam lapped onto the earlier cross beam (DP173792).

The first phase of this building was described in a previous section, and comprised two bays of a potentially longer building, with the surviving two bays representing a double-jettied shop unit with chamber over, and an open hall to the north (see Figure 50 and 51). A significant phase of alteration to the building appears to have been undertaken in the 16th century. This saw a floor inserted into the open hall, and the creation of a chimney stack on the western side of the building. There is a surviving 16th century beam which has been affixed to the underside of the earlier transverse beam running east to west through the building (Figure 83). This is chamfered with scrolled stops. To the west is an extant fireplace with brick jambs and a timber bressumer. The bressumer is degraded, but there is some evidence of a chamfer to the underside.

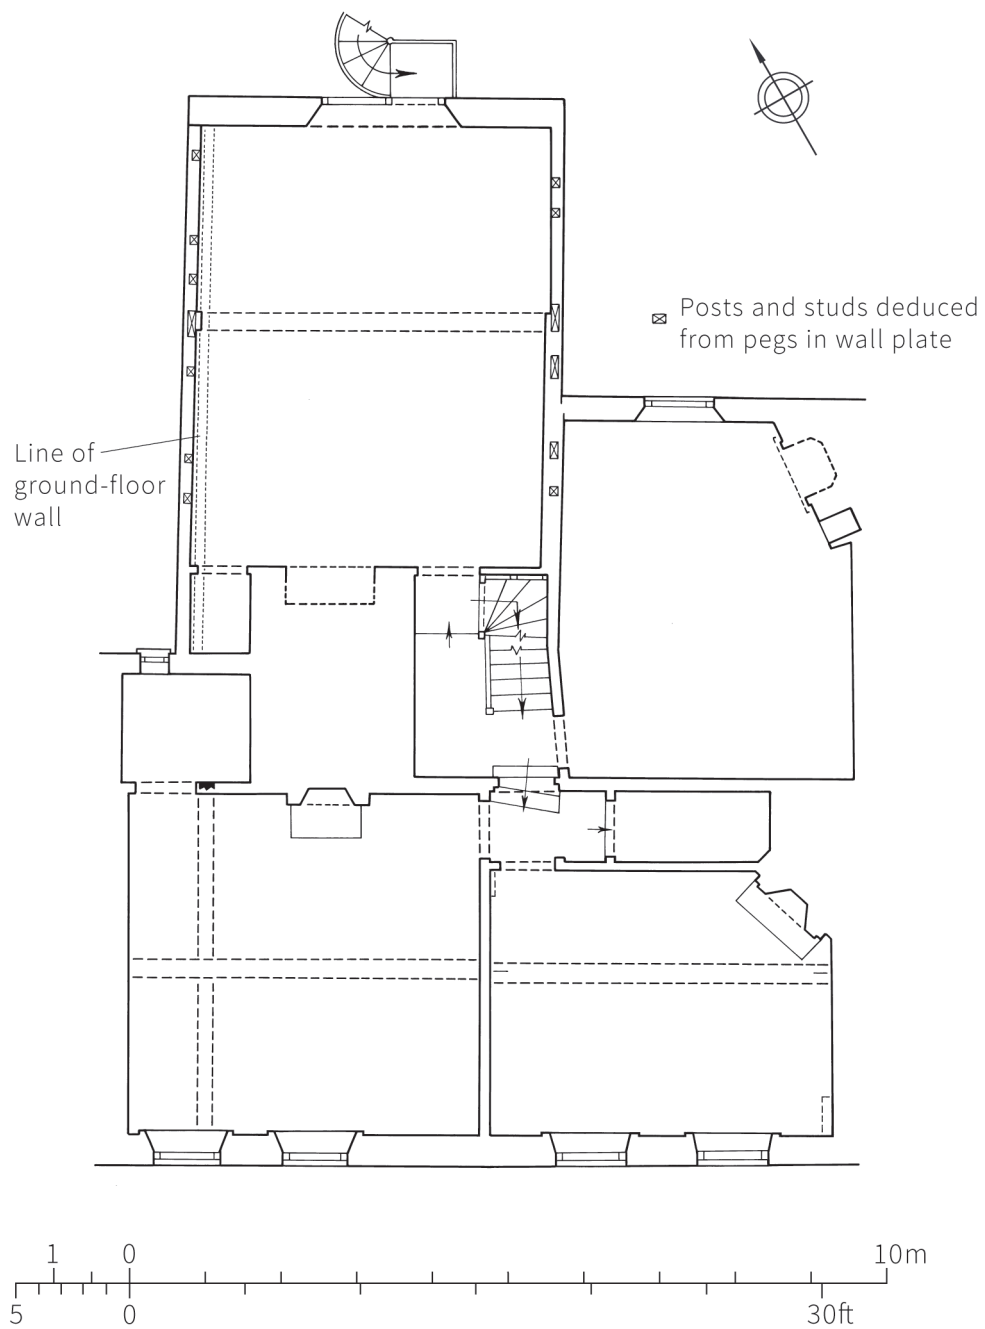
First-floor plan

Figure 85 5 Market Place, plan of first floor (Drawing Allan Adams © Historic England).

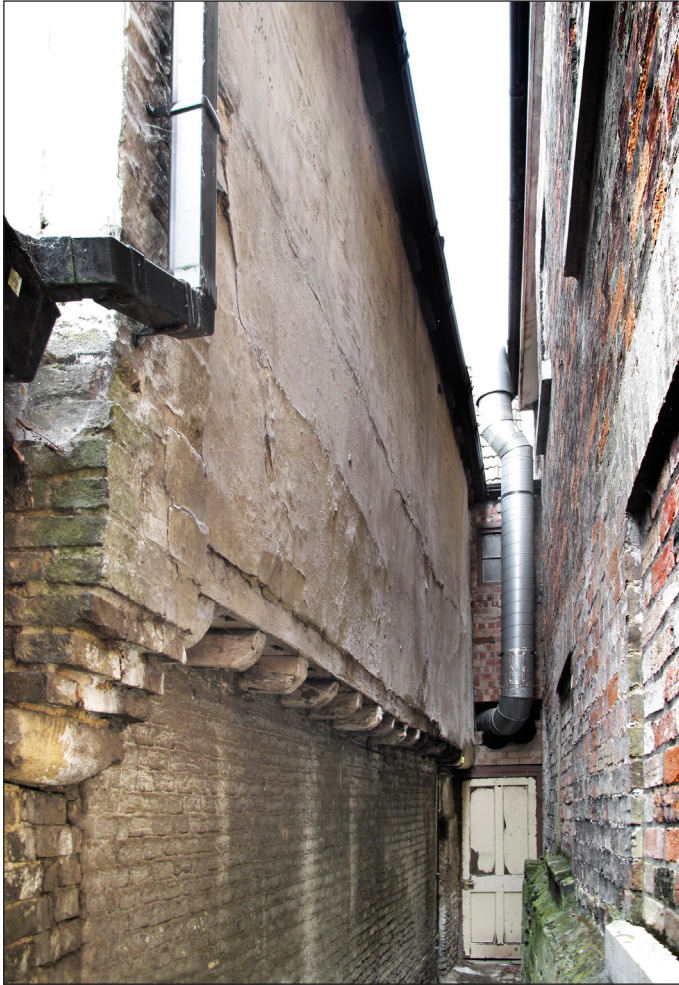
Figure 86 5 Market Place, view of jettied rear range from the northwest (Photograph Rebecca Lane © Historic England).

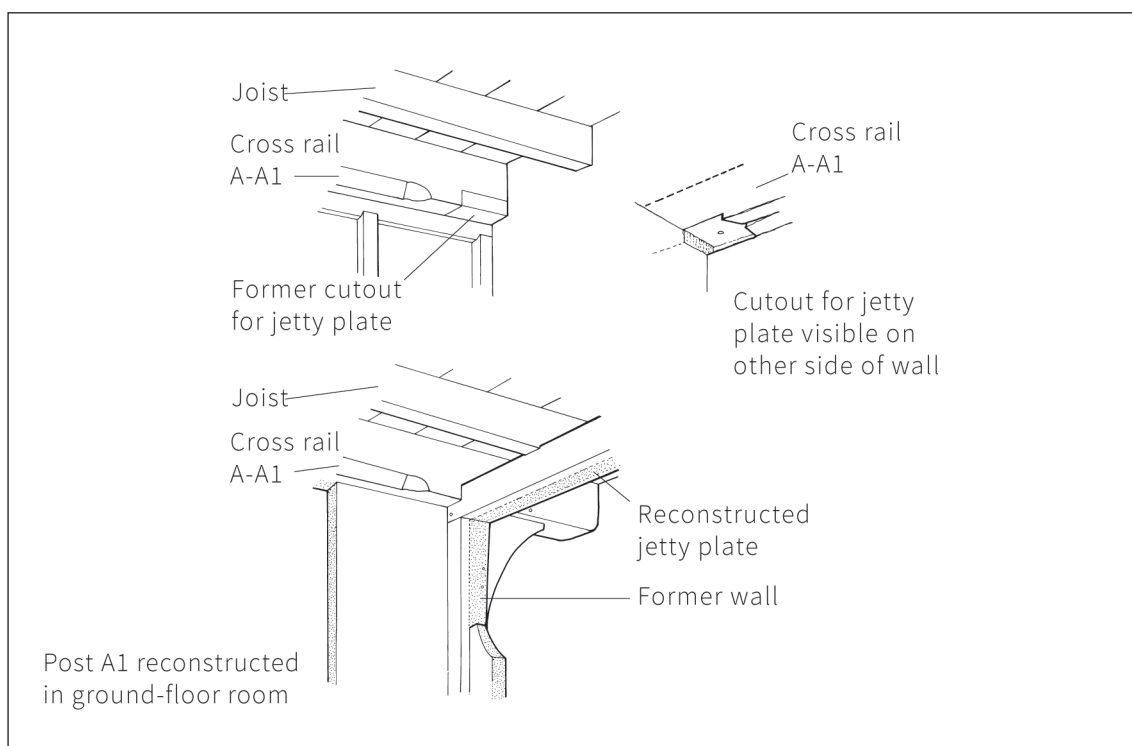
Figure 96 2 Waterside, detail of the ground-floor post (A1) showing cut out for jetty (Drawing Allan Adams © Historic England).

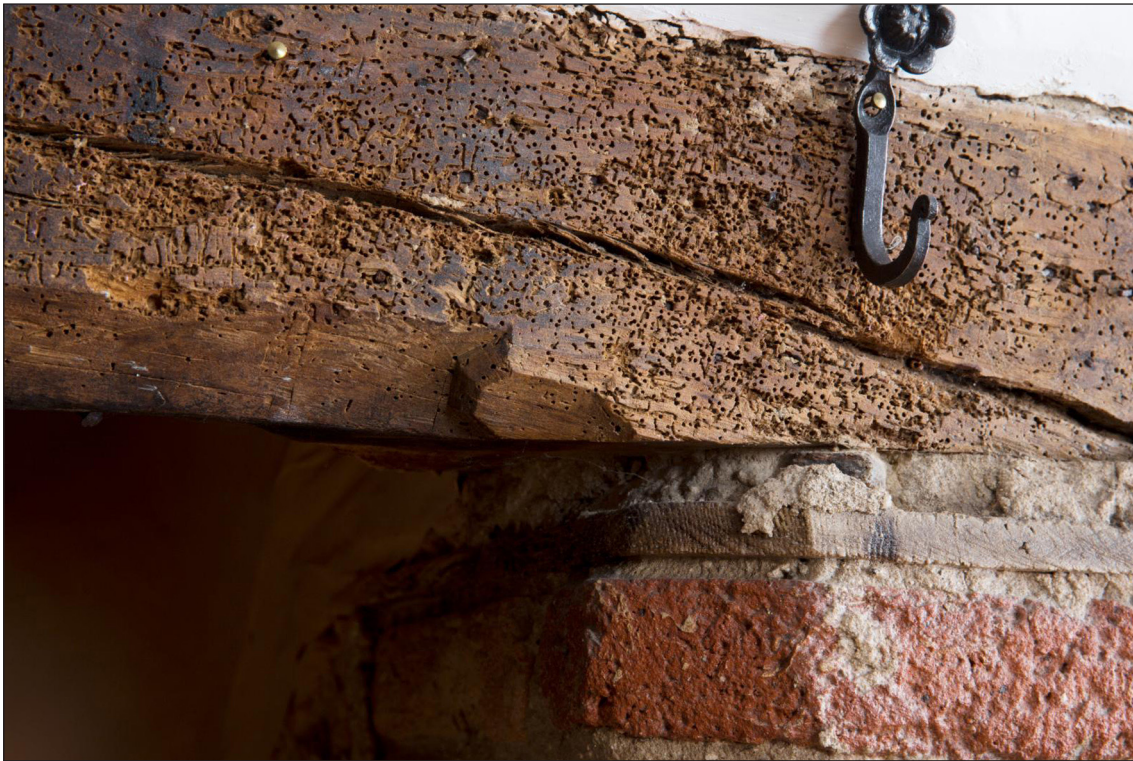
Figure 97 2 Waterside, detail of chamfer stop to fireplace bressumer in the west bay (DP173823).

next to this. Many of the principal framed elements have chamfer mouldings with simple run out stops. The roof structure has been largely replaced, but the tie beams survive, with mortices indicating that braces rose from the principal posts to the bases of the tie beams.

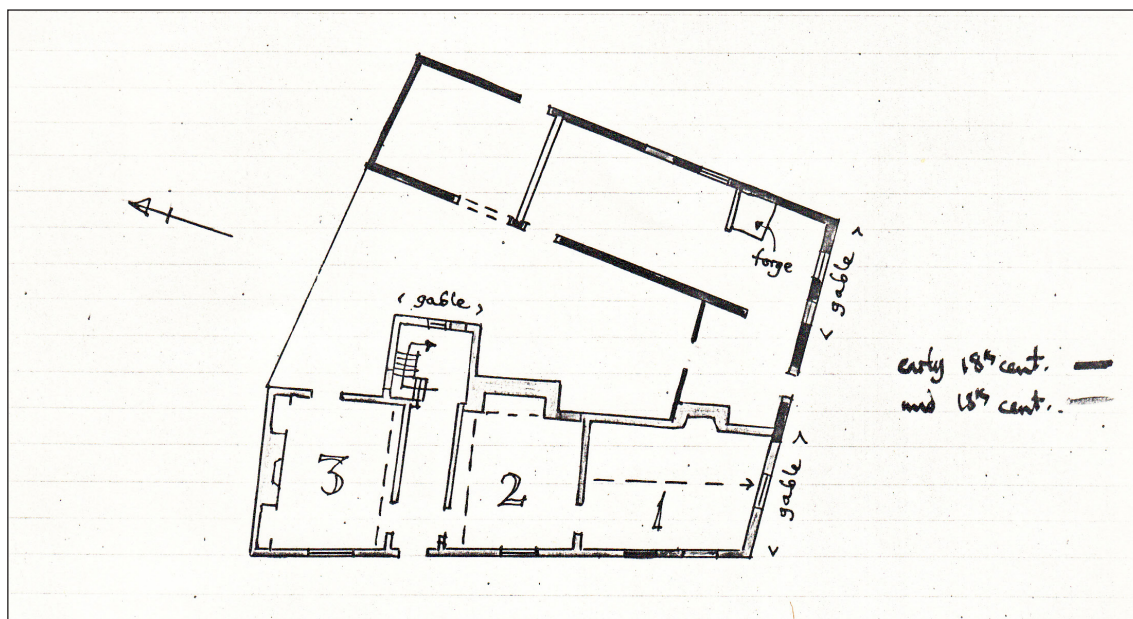
Figure 100 33 Waterside, plan as drawn by the RCHME (HEA BF029795).

33 Waterside sits on the junction of Waterside with a back road running up to Lisle Lane and thus occupies a prominent site (Figure 99). It was examined by the RCHME in the 1970s (HEA BF029795). They concluded that it was of 18th century date, on the basis of most of the internal fittings including the stair. However, they noted that the stair was inserted against an earlier doorway, and the plan form of the building appears to suggest it is instead a 17th -century building with a three room plan running parallel with the street (Figure 100). It is entered via a cross passage, with one room to the west of this and two to the east, including a larger central room. This appears to have been heated via a projecting stack in the north wall with a further stack in the west gable end. Given the early 18th century date assigned to the (inserted) stair, the building may be of the late 17th century.

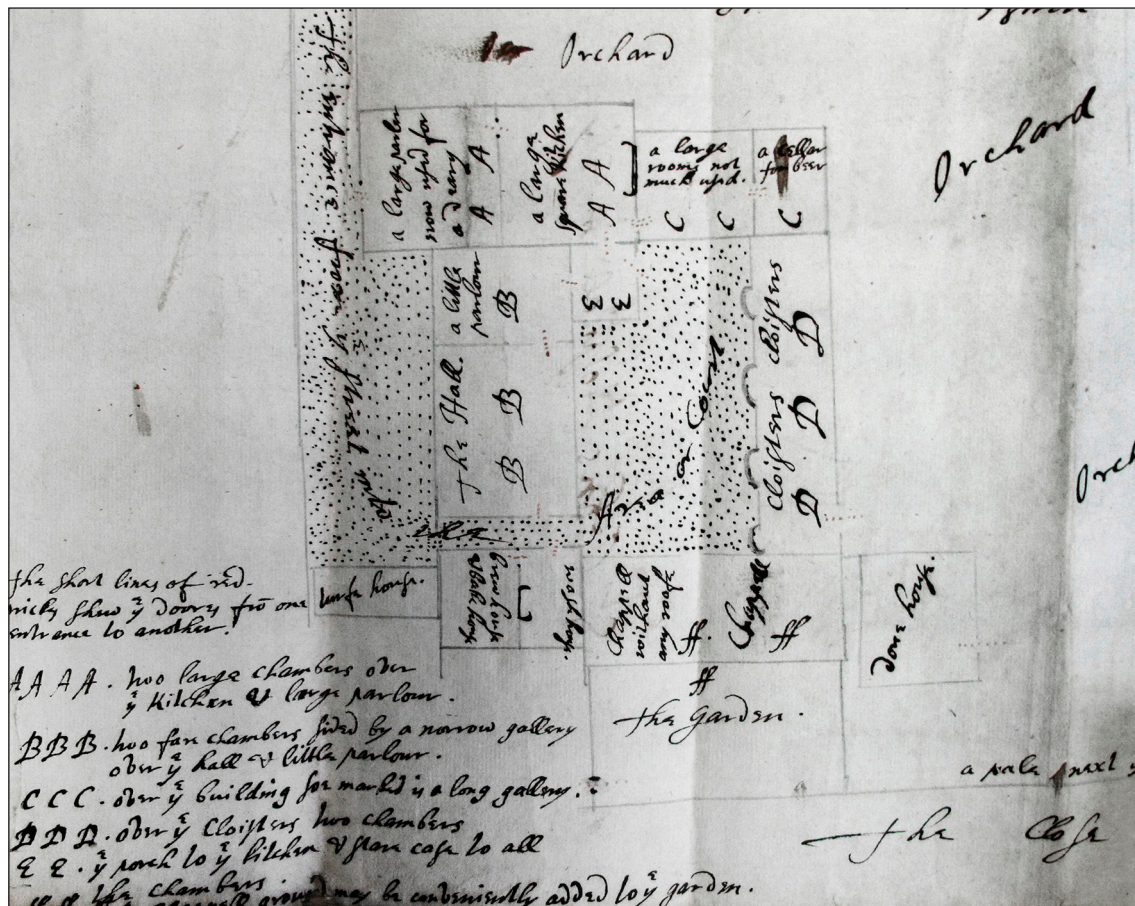
Figure 107 St John's Farm, sketch plan showing the hospital complex as converted into a residential complex in the 16th century. (Reproduced courtesy of Clare College Archive, CCAD3/3/32/2/4/2.)

There is clear evidence that a significant consolidation of the buildings was undertaken at around this date, although whether this took place before or after the dissolution of the hospital is not clear. The main evidence for this is in the surviving stone service building. This however is supplemented by the documentary evidence,

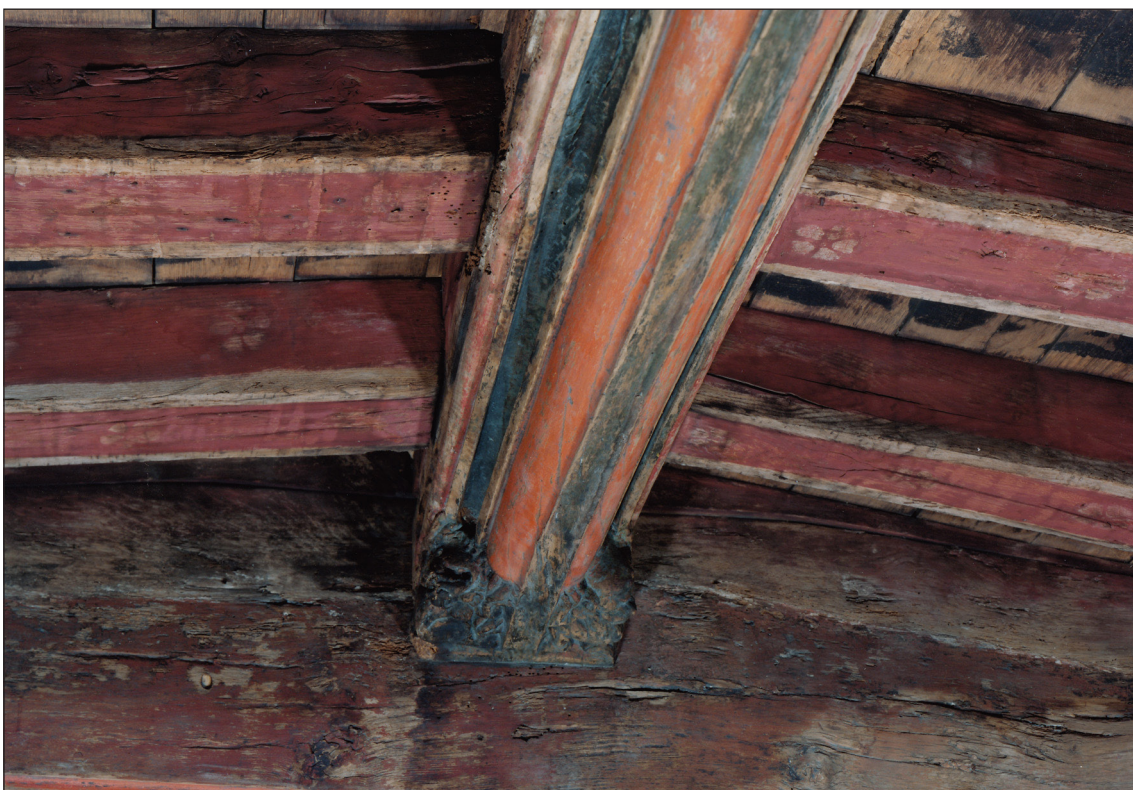
Figure 113 The roof over the west range of Walsingham House, one of the separate complexes constructed in the monastic infirmary in the 14th and 15th centuries (BB92/04458).

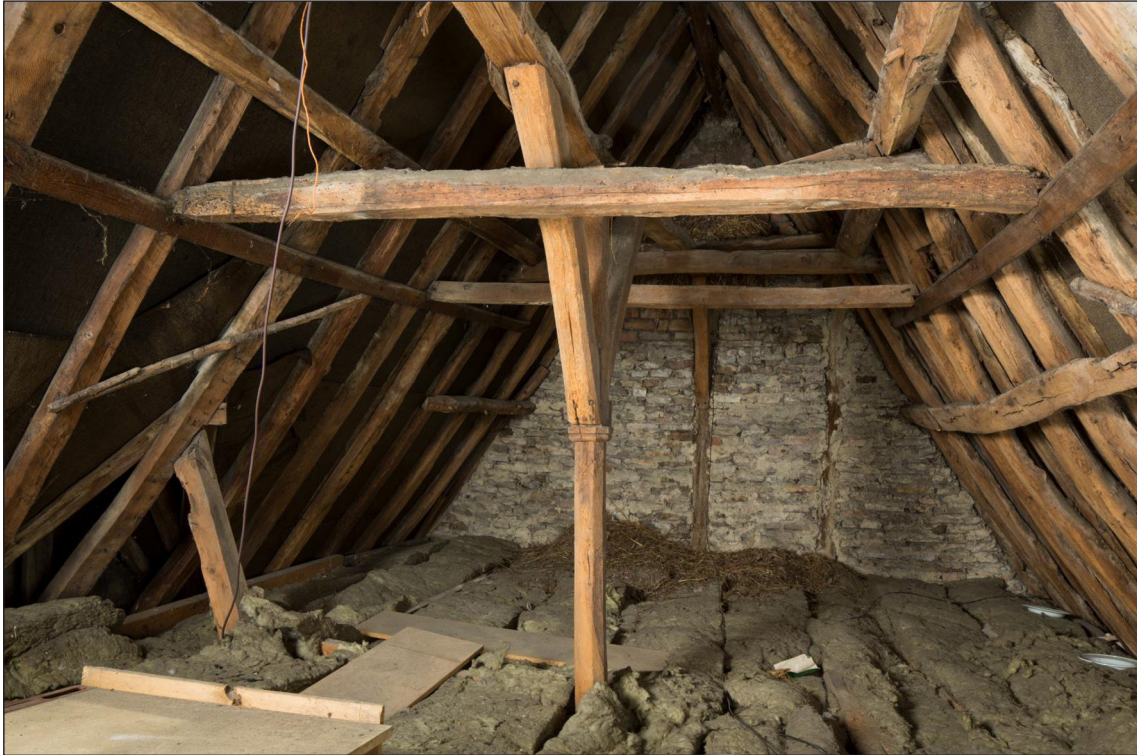
Figure 133 The 14th century roof at 23 Broad Street which incorporates some original pine rafters (DP173787).

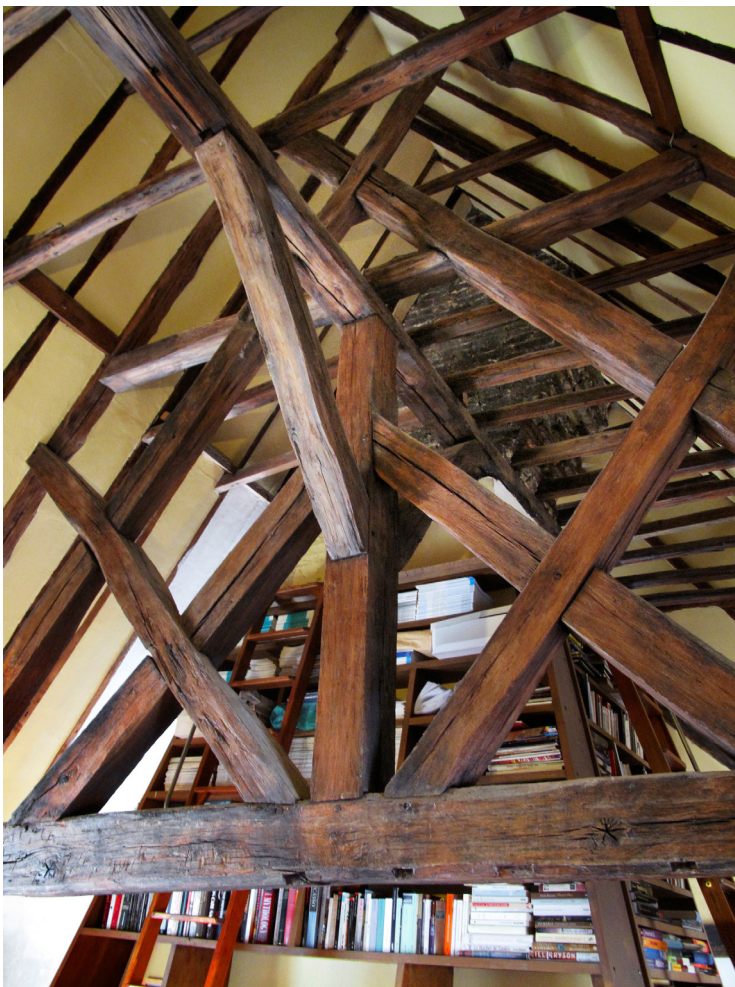
Figure 134 The roof at 41 Broad Street (The Three Blackbirds) showing the use of timbers which are uncharacteristically large for surviving Ely roofs (Photo Rebecca Lane © Historic England).

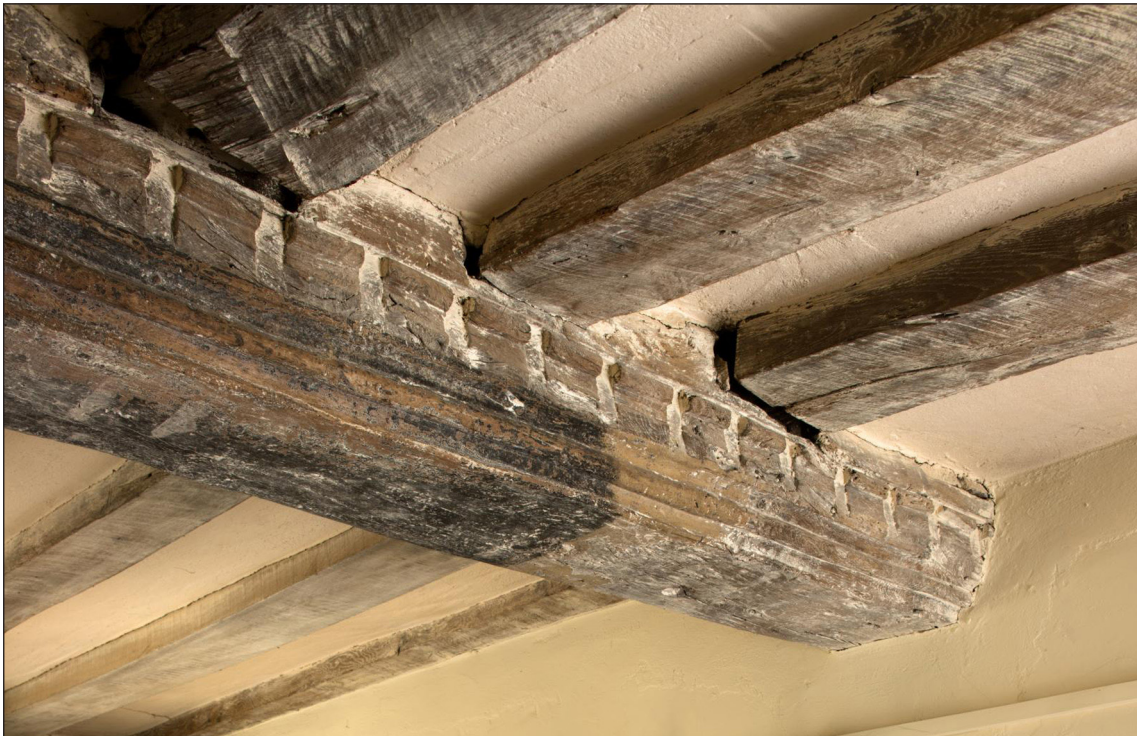
Figure 138 7-11 Silver Street, detail of the decorative treatment of the post supporting the central open truss (BB91/1887).

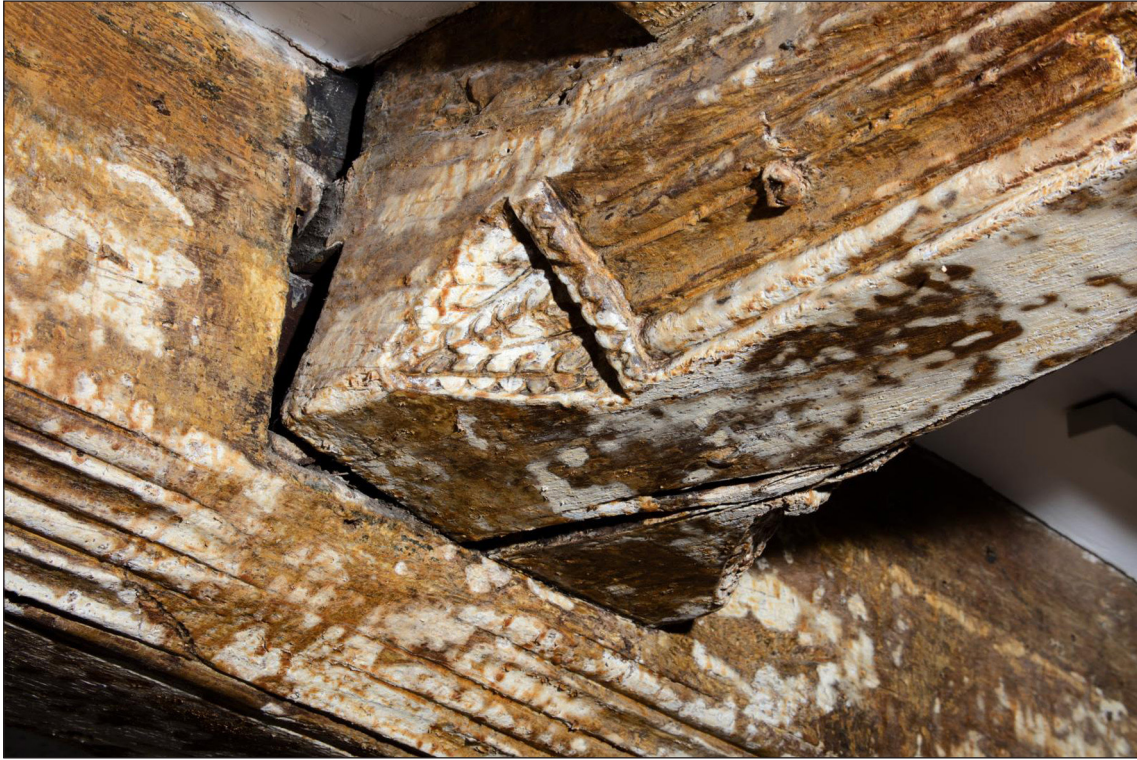
Figure 141 33 High Street, detail of the foliate design on the chamfer stops (DP187931).

The principal dating evidence for the building is the form of the mouldings of the beams, which include distinctive foliate chamfer stops typical of the 16th century. Open halls were largely being replaced by fully storied buildings by this date, and this may represent a relatively archaic plan form, albeit using contemporary decorative detailing.

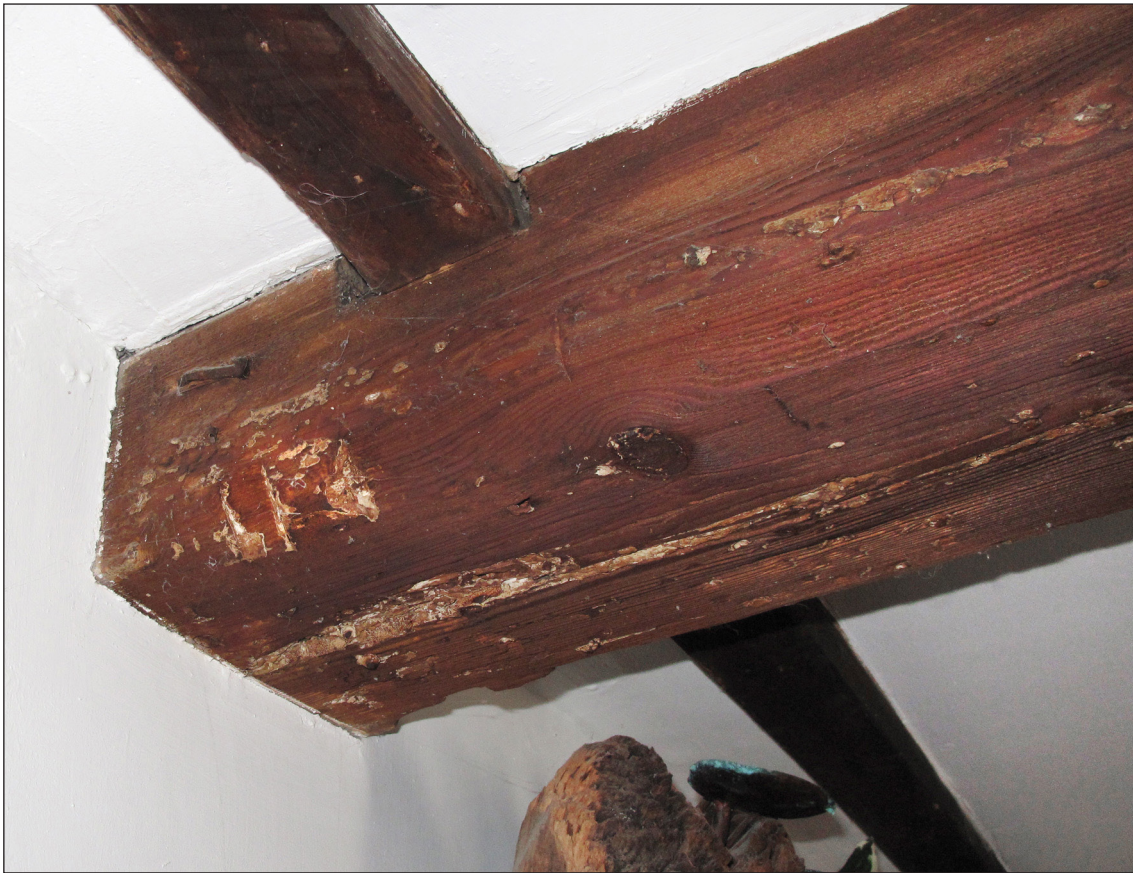
Figure 142 11 Waterside, detail of jewel stop (Photograph Rebecca Lane © Historic England).

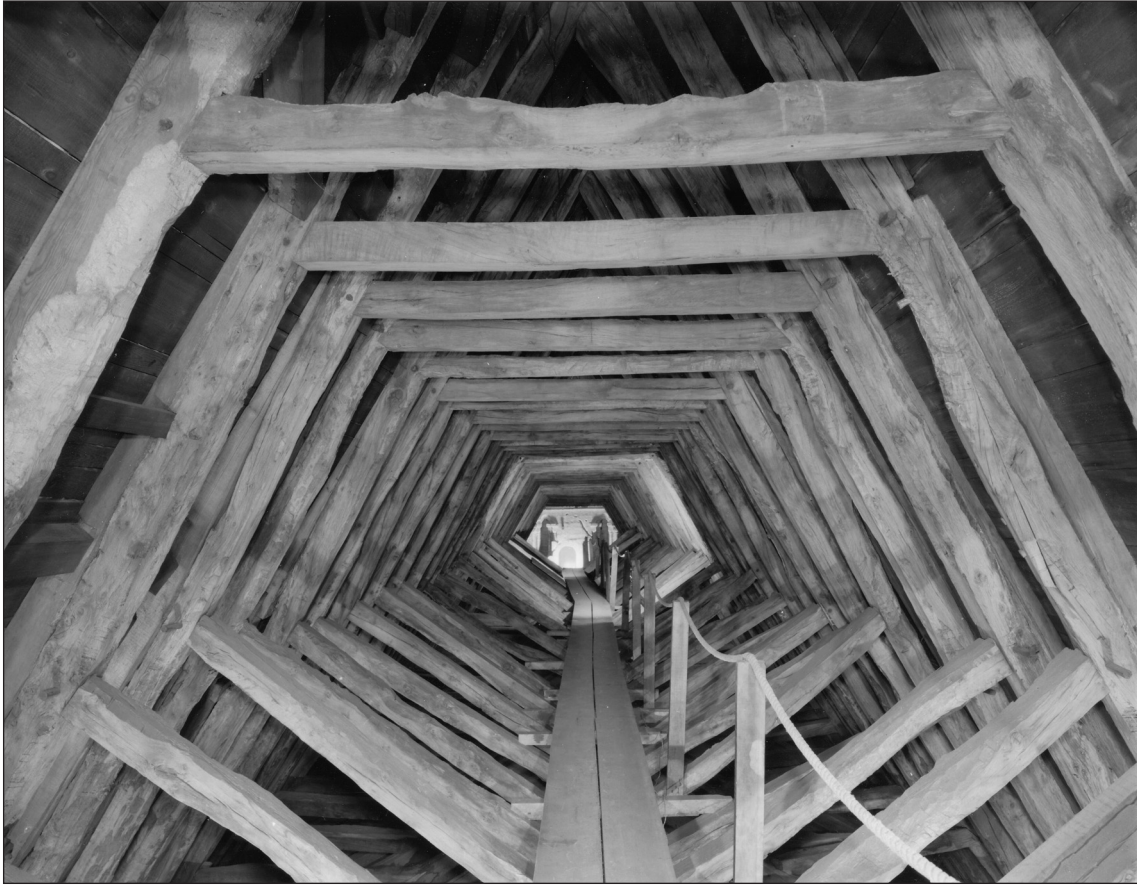
Figure 144 Ely Cathedral, the roof over the nave (BB87/7303).

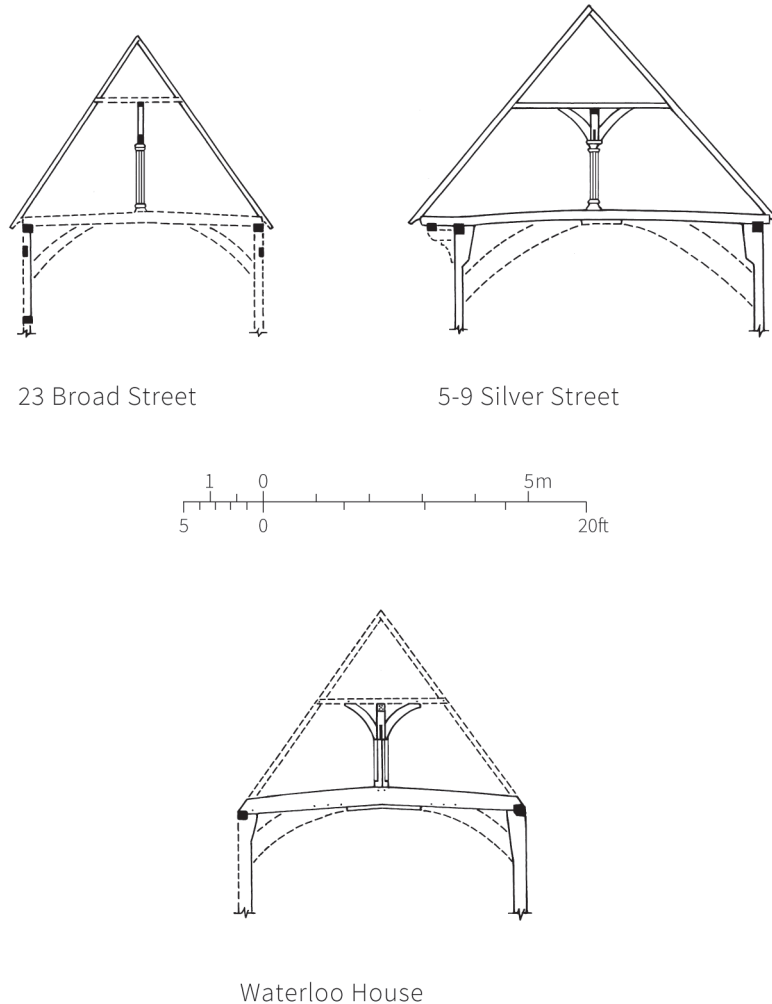
Figure 145 Comparative drawing of some of Ely's crown-post roofs (Drawing Allan Adams © Historic England).

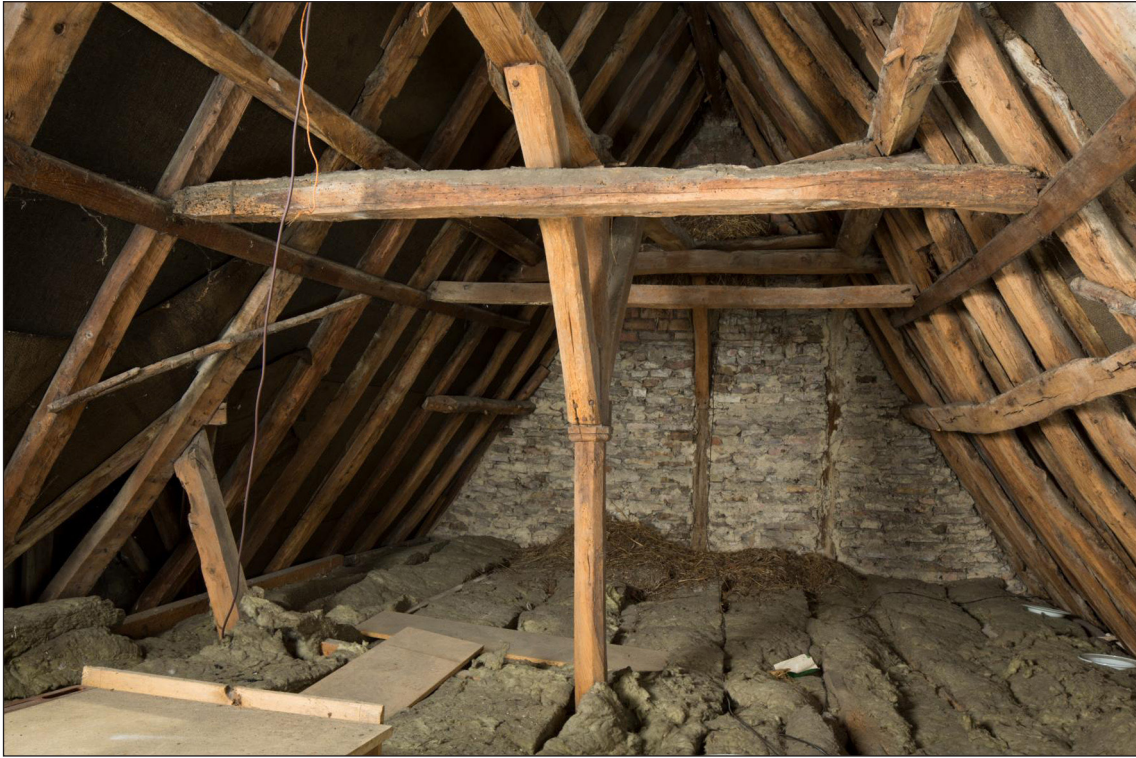
Figure 146 The 14th-century crown-post roof at 23 Broad Street (DP173787).

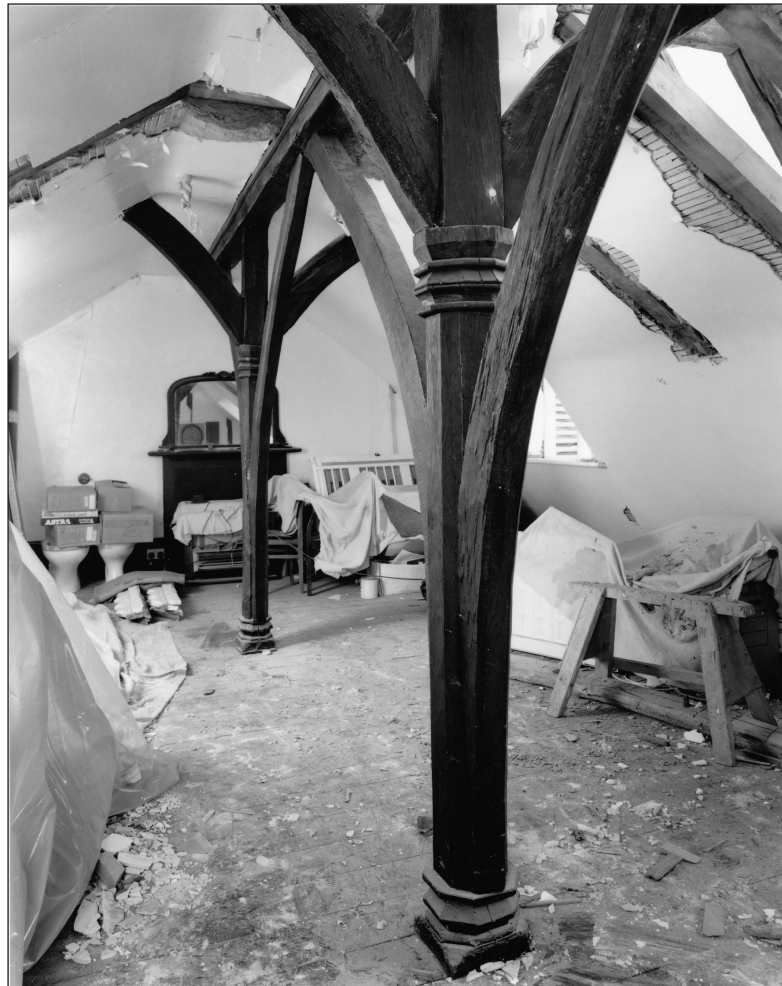
Figure 147 The crown-post roof of the Black Hostelry, within the monastic precinct (BB91/15528).

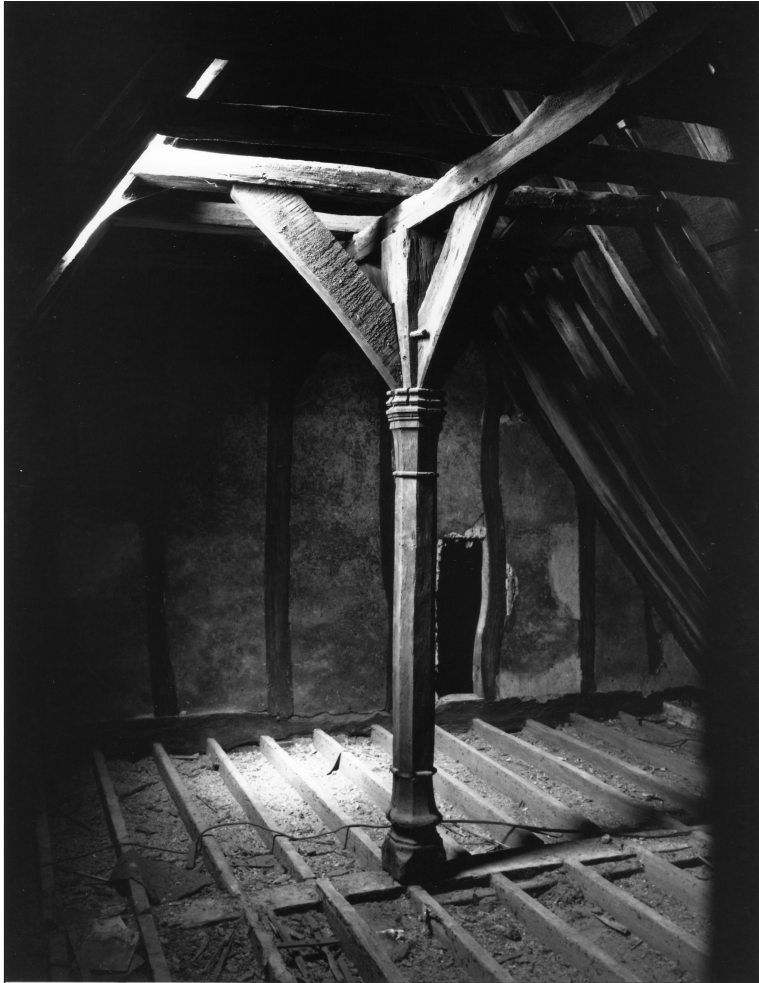
Figure 148 The crown post at 7-11 Silver Street (BB91/1889).

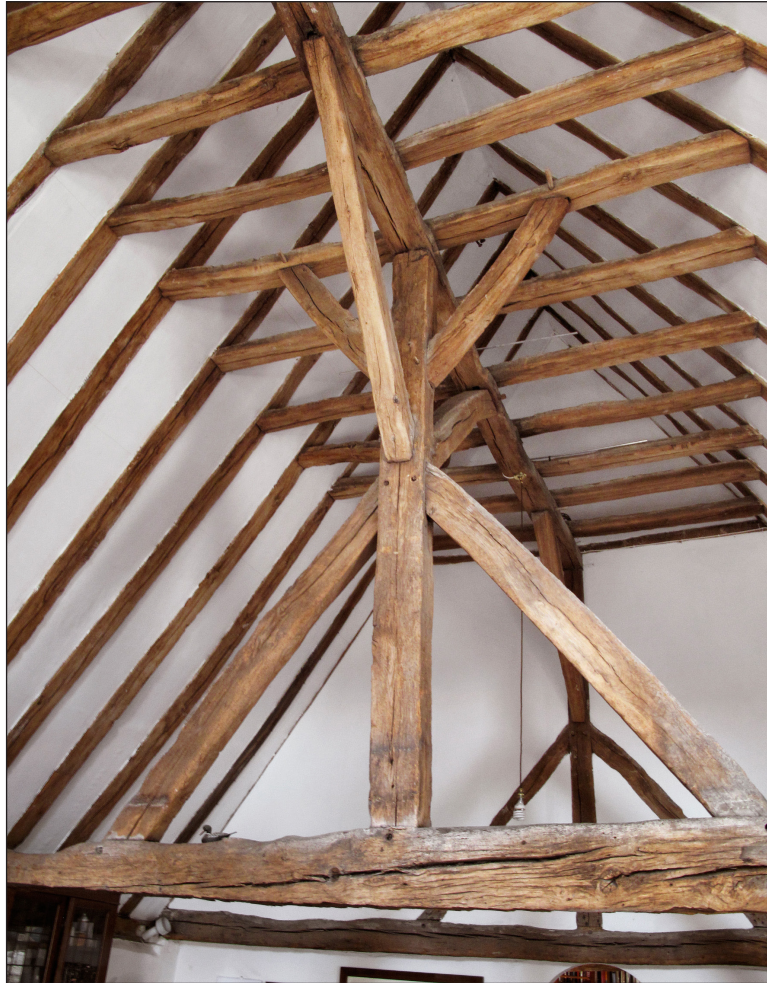
Figure 149 The crown-post roof at 41 Broad Street; The Three Blackbirds (Photograph Rebecca Lane © Historic England).

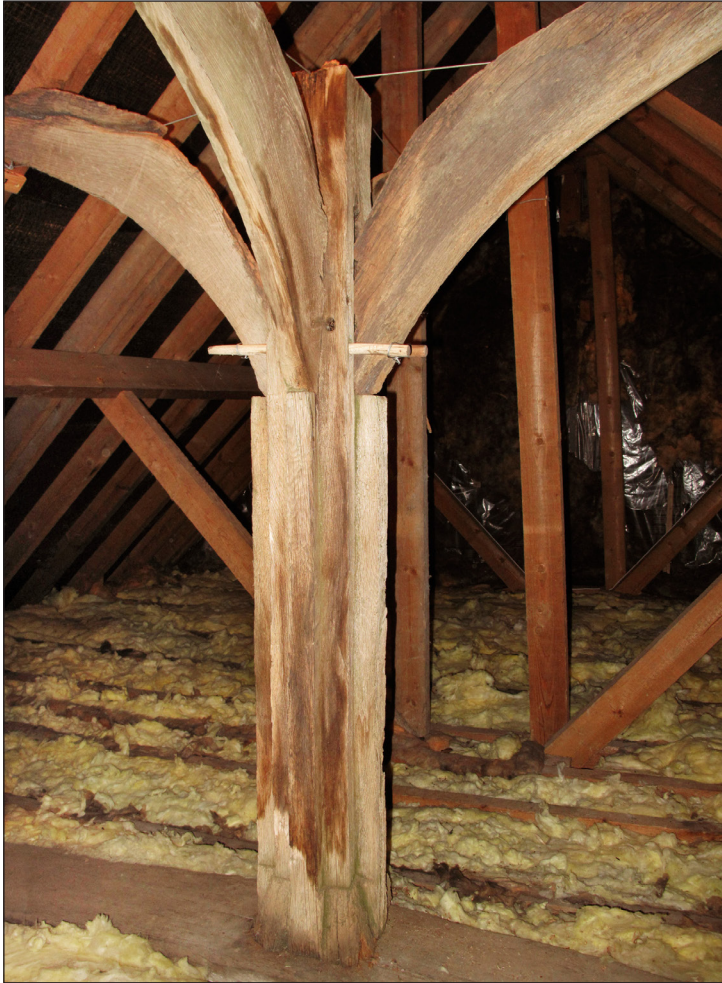
Figure 150 The surviving crown post at Waterloo House, West Fen Road (DP196872).

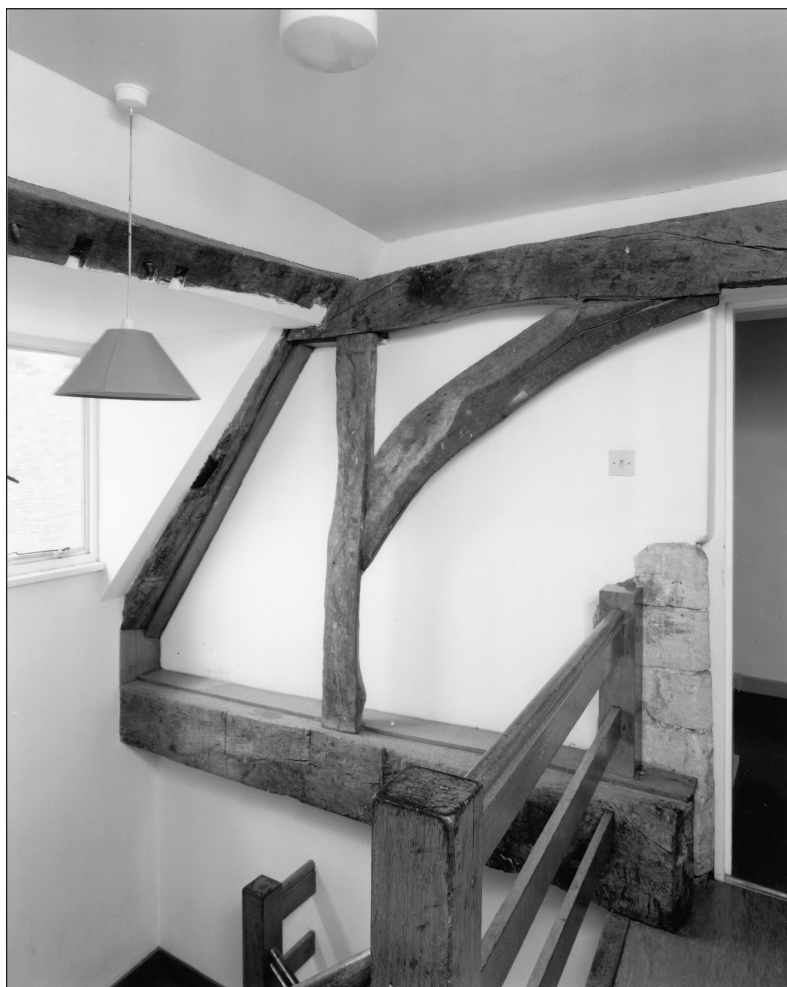
Figure 152 Detail of the roof of Walsingham House, in the monastic precinct (BB92/04458).
