ARCHITECTURAL SURVEY REPORT

BOORD & SON'S DISTILLERY OFFICES

115-121 TOOLEY STREET LONDON BOROUGH OF SOUTHWARK GREATER LONDON

Surveyed: April 1999 Report by Jonathan Clarke Photographs by Derek Kendall

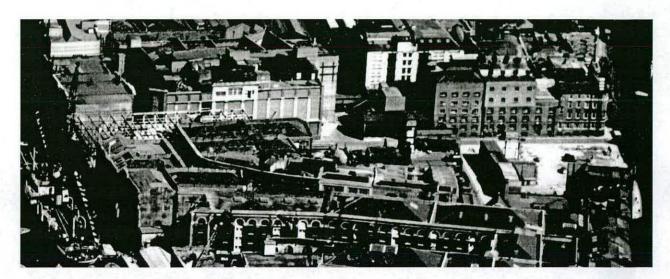
Fig. 3 – An aerial photograph looking north showing the The Boord & Son's Distillery complex in 1957. From left to right are the Wharf and Bonded Stores, Methylating House, Cooperage, Distillery, Duty Paid Warehouse and General Office. © copyright Aerofilms Ltd.

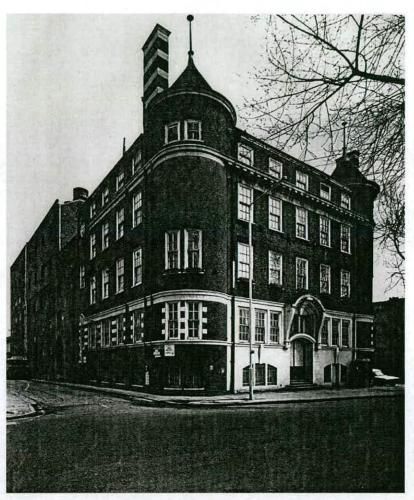
Fig. 4 - The General Office (EH 3/87)

The General Office building, facing Tooley Street, formed the most conspicuous block of the complex and was accordingly clothed in the most lively architectural dress (Fig. 4). Executed in high quality

yellow stocks with red-brick dressings and liberal use of stone for the entrance frontispiece, cornice and details, it is conceived in a Free Classical style. Distinction resides in the commanding rounded corner tourelles rising from ground to pointed conical slate roofs - a reference to Norman Shaws' New Scotland Yard, as well as in the brawny, banded slab chimneys, the modillion cornice below the attic and the segmental-headed entrance surmounted by an open pediment. All this distracts from the bulk of the essentially cubic large-scale block, five storeys in height, with a mezzanine above the ground floor, a full attic storey and a subbasement, and five bays width between the tourelles. The original double-panelled wood doors, segmental-headed tripartite groundfloor windows, and square-headed flush-framed sashes above this, all survive intact.

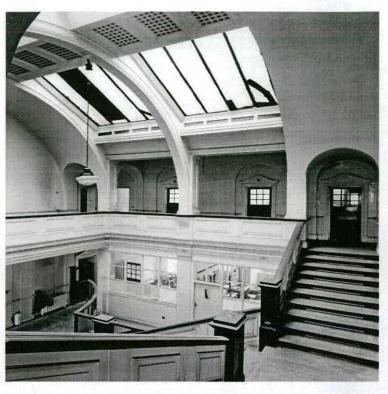
Fig. 5 – General Office atrium, from the North East (EH, BB99/09034)

The pitched, glazed atrium roof is supported principally by three slender arched ribs spanning the perimeter of the gallery (Fig. 5). These arches also support wood-framed ventilation grilles aligned below the roof apex. Given their slenderness (30cm soffits) and span (7.63m), it seems likely that they are formed from curved steel members encased for aesthetic reasons in plaster and/or wood. They spring from square-section piers which support three beams arranged around the gallery perimeter in a U-shape. These beams and piers, again probably encasing steel beams and stanchions respectively, support the interior walls of the upper two storeys. They continue downwards to the floor below (and the central pair, to the basement - see technical details), either as continuous stanchions, or in two butted and spliced lengths. Groined vaults, probably brick, sited above the four corners of the gallery, and thick walls behind the front range and to the rear, accommodate the rest of the upper-floor interior loading.

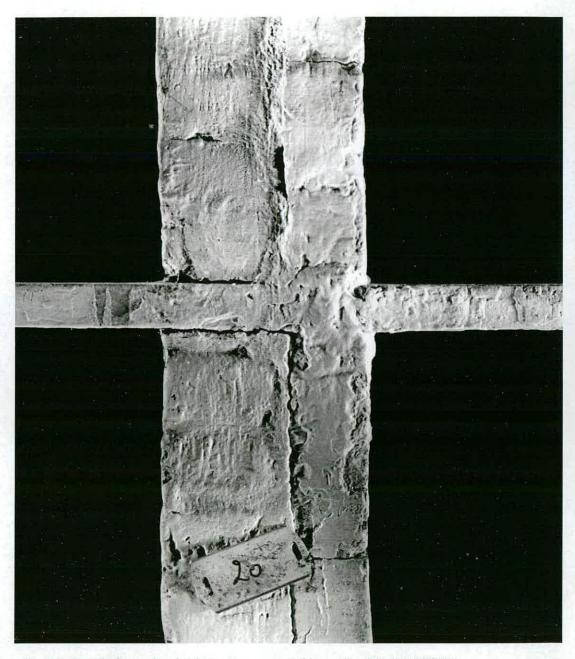
Fig. 10 - Detail of secondary brick insertion to original bin walls. (EH, BB99/09021).

slender (8cm) walls of the original brick bins, formed from frogged bricks stamped 'Eastwood' laid on their sides, were thickened a further 12cm by another tier of bricks laid conventionally (Fig. 10). These were used to support additional steel beams which spanned the gangways at right angles to the original joists which they in turn supported; the 2-3cm gap between the two filled by steel packing pieces rammed into place. The webs of the inserted beams exhibit 'Earl of Dudley Steel 6 x 4½ BSB 109', which provides a *terminus ante quem* of 1932 for their insertion.¹⁷

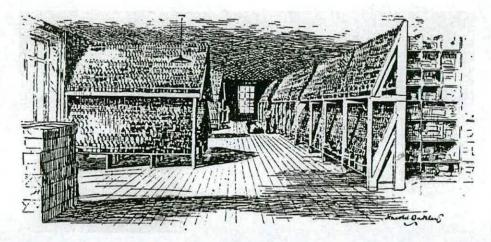
The front room, occupying the full width of the building to the south of the cross wall, was the Sample Room (Fig. 13). Nothing survives of the original timber-framed shelving but a large porcelain sink and mahogany draining board remain *in situ* in the northeast corner. This was presumably used to rinse out

Fig. 13 - The Sample Room, c. 1905, looking west.

the glass sample vessels. The original function of two blocked openings in the cross wall is unclear. Each has a segmental head, formed by a double row of header bricks, and both are set very low. The eastern one, which is set slightly higher, within the chimney breast, is probably a blocked fireplace. In the mid-to-late twentieth century, this room may have been converted to be a canteen, and the western end bay a kitchen, the two divided by a thin partition fitted with a steel shuttered serving hatch. The latter still retains a large smoke extraction funnel and gas burners.

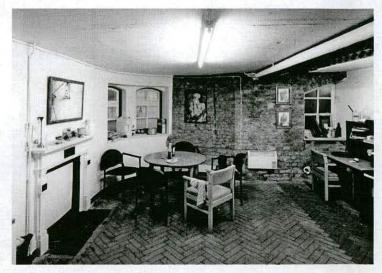
The caretaker's apartment (Fig. 14) was relatively well appointed, with a parquet floor identical to that in the General Office, plastered walls (partly removed in recent years), a large fireplace with glazed tiles and a neo-classical surround, and four casement windows. The toilet block, lined with green glazed brick

Fig. 14 – The caretaker's apartment, looking south., (EH, BB99/09028)

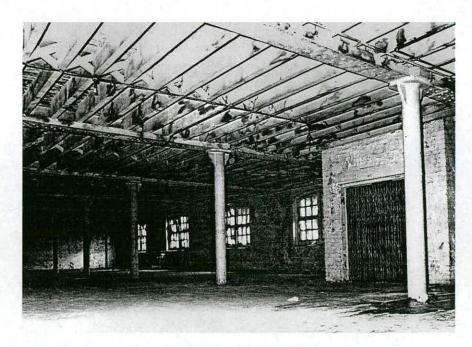
Fig. 17 – An upper floor of the distillery block (EH 3/87).

The five-bay distillery block adjoined to the north of the Duty Paid Warehouse and its north elevation was distinguished by diaper brickwork and circular windows.²⁸ Unlike the firm's former distillery at Bartholomew Close, where manual labour was extensively employed in the horizontal movement of products, this seventy-foot tall tower was designed to exploit gravity as an aid to the manufacturing process. A high-level tank, holding some 25,000 gallons of cold water, positioned on the roof was used to cool the condensers of the galleried Still House, rising through the lower floors. The water was collected in a low-level tank sited on the flat roof of the Duty Paid Warehouse, whereupon it was pumped to the high-level tank. Similarly, gravity was employed in the processing of the distillate: the condensed or 'rectified' spirit was transferred to 'safes' from which copper pipes conveyed it into vats or 'backs'. The plant was steam powered by two large Scotch compound boilers. The lower floors comprised the Filling Floor, where the casks were filled from pipes leading from the vats above, and the Package Floor. The illustration in the contemporary account shows that the Filling Floor at least was provided with a concrete, fireproof ceiling similar to those in the basements of the General Office. More recent interior photographs suggest that the upper floors were formed by unprotected timber joists, braced by cross bridging, resting on rolled-steel joists strengthened with angles and flange plates (Fig. 17). Iron columns, cast with ribs provided intermediary support for the steel members.

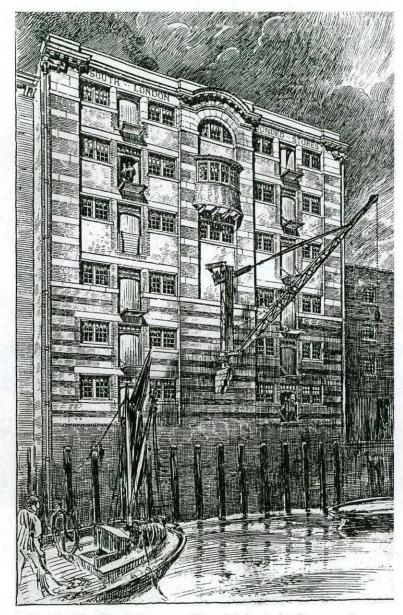
The Thames frontage of the Bonded Stores, although hemmed in on either side by warehouses, provided Webb with an even more prominent opportunity for architectural display than that given by the Tooley Street frontage (Fig.20). The rear of this building appears to have been similarly detailed; before the construction of the new warehouse in the early twentieth century (see below) it was visible from Tooley Street (Fig. 1). Crates of wines and spirits were moved between the stores and river vessels by a large

Fig. 20 – The Thames frontage of Boord & Son's distillery complex, c.1905.

hydraulic jib crane mounted on the central wall panel of the Thames façade. An operator seated in a curved lookum cum oriel window above this controlled the movement of the jib via three levers, transferring cases - forty being packed in a 'cage' at a time - between the twelve loopholes and the vessels. All the floors of this large building, which included an examination floor, a Custom's office, a vat floor, an export bottling floor and cellarage deep underground, were divided in two by a cross wall.

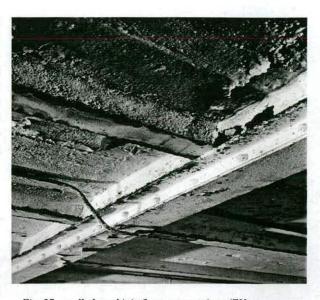
Fig. 27 – rolled-steel joist/beam connections (EH, BB99/09027).

The largest girder, running transversely on the line of the cross wall, is made up of two or more lengths of I-section beams arranged side by side, connected via 24in. wide plates rivetted (staggered) to their upper (concealed) and lower flanges. The four axial beams to the north of this, each formed by I-section beams strengthened by 12in.-thick top and bottom plates, are connected

to it by angle stools, side and (presumably) top cleats. The secondary transverse beam to the north of the main one, appears similar in form and dimensions to the four axial ones. The manufacturer of these heavy structural members was not visible on the webs, but it seems likely that they too were rolled by Dorman Long & Co.

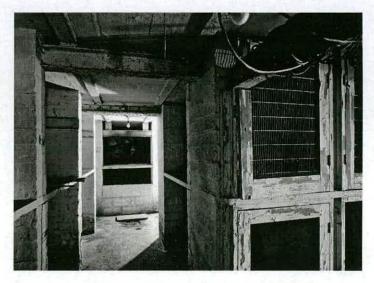
The rolled-steel joists spanning between the beams and either wall are of similar form to those employed in the basement, and they are connected in identical fashion, resting on lengths of unequal angles rivetted in the lower part of the web of the beams. The principal difference appears to be their degree of spacing: 45in. as opposed to 30in.

Fig. 28 – View from west along east-west passage of sub-basement. Inserted British Standard Beams provide additional support to the original rolled steel joists. (EH, BB99/09020).
