Chapel Street, King's Lynn, Norfolk: The History and Archaeology of the Chapel Street Car Park

Research Report Series 002-2018

**CHAPEL STREET
KING'S LYNN
NORFOLK**

**THE HISTORY AND ARCHAEOLOGY OF
THE CHAPEL STREET CAR PARK**

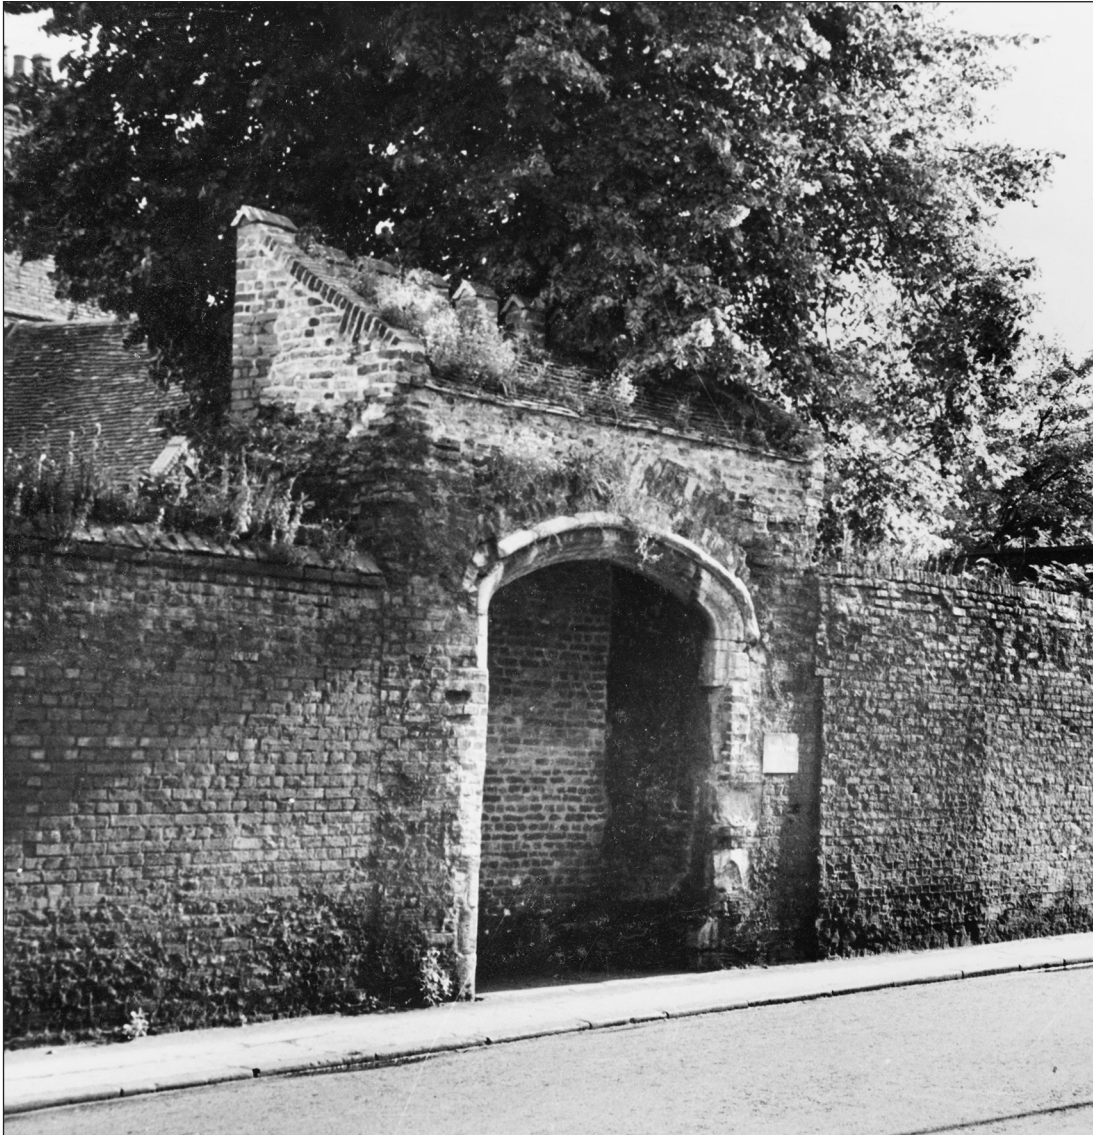
Figure 5: The 15th-century gateway on the south side of Austin Street, thought to be the northern entrance into the Austin Friary precinct, photographed in the early to mid-1970s. [Detail of Historic England Archive OP35027©Crown Copyright]

According to historical sources, the friary was established on the east side of Chapel Street, south of Austin Street (27 on Bell's *Groundplat of King's Lynn*, Fig 14). Despite the implied survival of the precinct wall into the 18th century (Mackerell 1738, 176), the only fragment of the friary surviving above ground is thought to be the 15th-century gateway on the south side of Austin Street (NHER 1025; NHLE 1291449; Fig 5). Other historical documents and antiquarians mention parts of the friary, such as the cloister, lavatory and chapter house (Harrod 1870, 102-3), but provide no information as to where these were located. The site probably consisted of a church, claustral ranges, cemetery, kitchen gardens, orchards and fishponds (O'Sullivan 2013, 8). Lucas (1993, 483) notes that one benefactor requested to be buried in the 'chapel under the bell tower'.

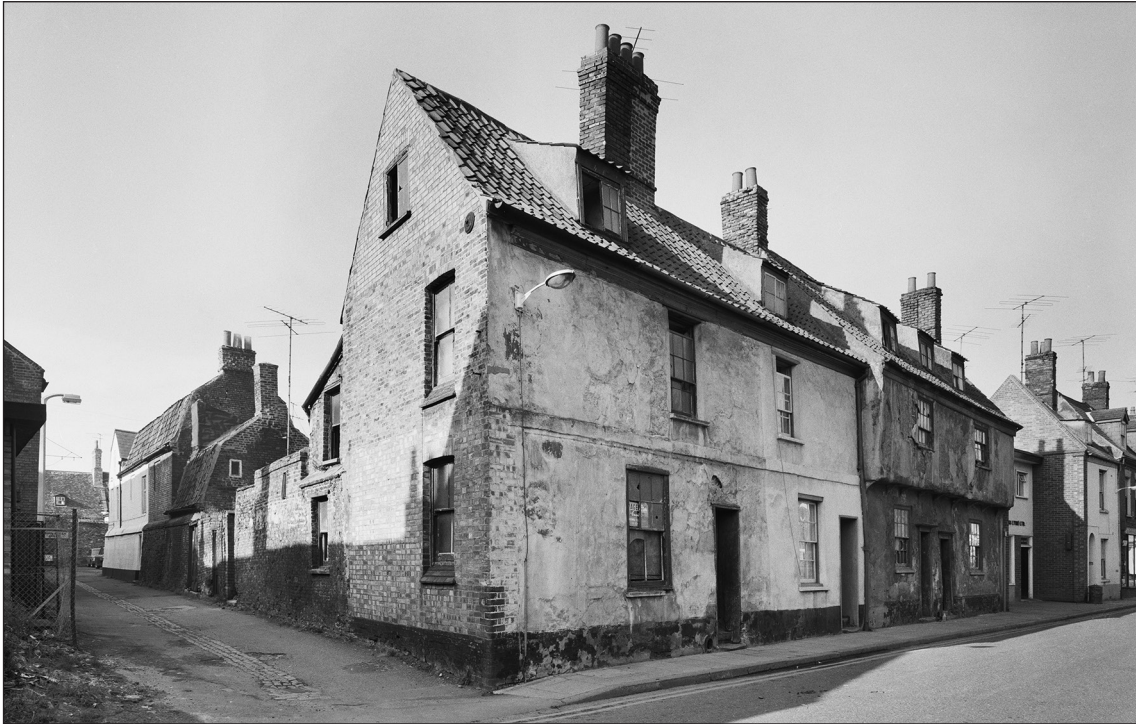
Figure 7: 43-45 Chapel Street in October 1966. Ravenshaw House can be seen to the rear (west) and 47-49 Chapel Street to the right (north). Both buildings were formerly listed and are now demolished. [HEA BB67/00360 Hallam Ashley ©Historic England]

A photograph of the now demolished 43-45 Chapel Street, surviving to the north of the entrance to Ravenshaw's Yard in 1972, does seem to fit with Parker's observation about the nature of the buildings on Chapel Street, as it appears to be of two main storeys and one room deep (Fig 7), though it is possible that the dormers visible on the photograph are original. Though much altered, the steepness of the roof pitch and the insertion of a central chimney suggest that the building could have originated as early as the 16th century and hidden a timber frame. Original chimneys would have been located at the gable ends, suggesting the building originated before chimneys became fashionable. A possible plat-band running horizontally between the ground and first floors may be a piece of surviving timber-frame or a later decorative feature (HEA BB99/05781; BB67/00360). The assertion that the building had a timber frame, or was at least of an early date, is also supported by the fact that it was added to the List of Buildings of Special Architectural or Historic Interest on 1 December 1951 (Chesterton 1964, 3; Ministry of Housing and Local Government 1951).

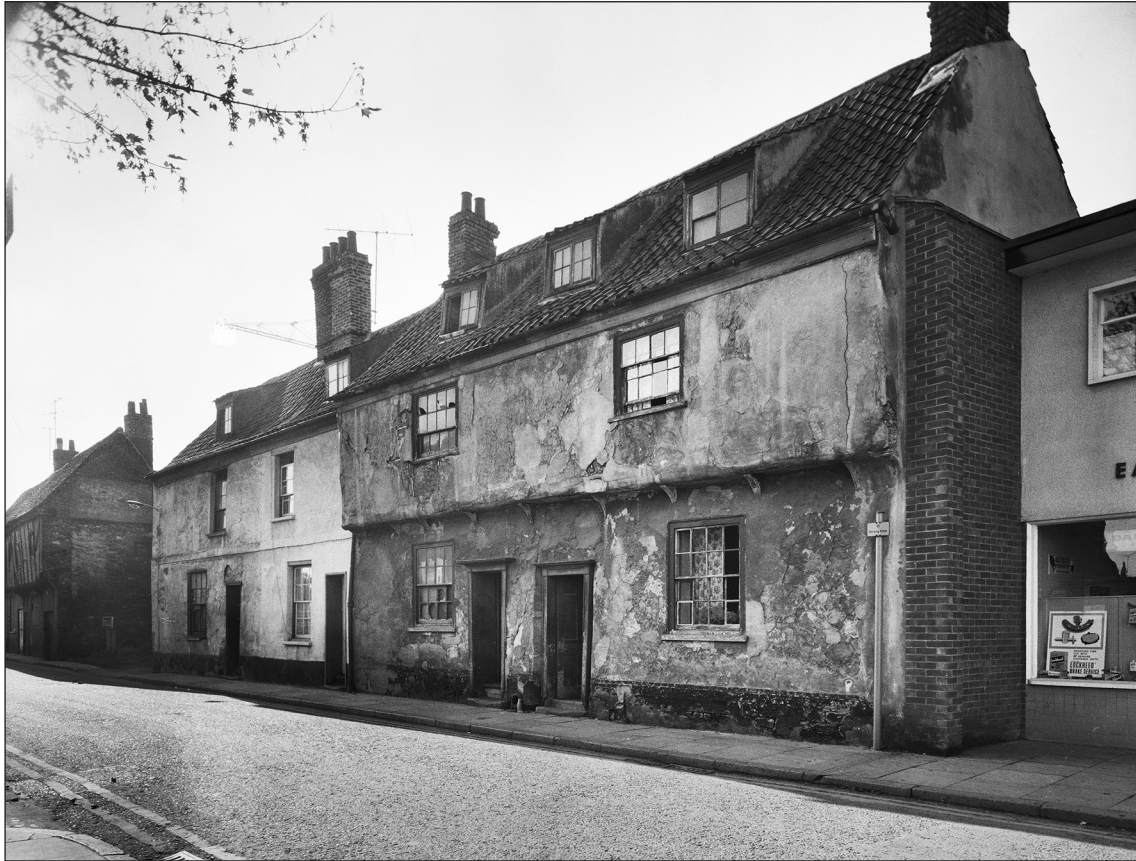
Figure 8: 47-49 Chapel Street in October 1966. To the south (left) 43-45 Chapel Street is visible with the north gable of Lattice House beyond and to the north (right) a small section of the Eastern Counties Utilities building is visible. [HEA BB67/00359 Hallam Ashley ©Historic England]

A distinct crack and the survival of what appears to be coving infilling the jetty at the north end of the eastern elevation may support this interpretation, as the coving may have survived better where it was adhered to the stone wall (Fig 8). The date and purpose of these niches is unclear but they are unusual in a non-ecclesiastical context for a building of 16th-century date. Other examples, thought to be piscinae, have been noted at Lattice House and properties on King Street in King's Lynn (Rose 1982) but this needs further exploration. Parker (1971, 77) may have been referring to these features when discussing stone windows in King's Lynn, where she describes windows in a 'recently demolished building in Chapel Street, with cusped heads'.

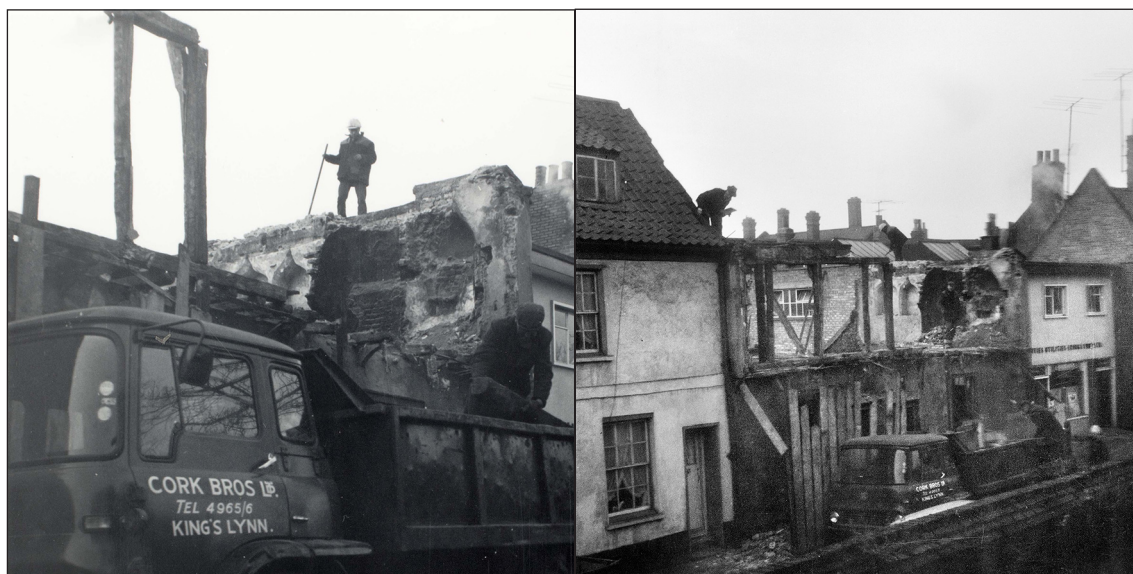
Figure 9: Two images of 47-49 Chapel Street under demolition in January 1967 showing the ogee-headed niches or windows in the north gable-end wall [Source: Norfolk Museums Service (Lynn Museum) KILLM 1992.217.19; Image: HEA DP219386]; [Source: Norfolk Museums Service (Lynn Museum), Image: HEA Red Boxes 4259/52 (4259/130) January 1967]

If the wall that contains the ogee-headed recesses is of stone (or indeed brick), it suggests that it was part of an earlier building. In Ely examples such as 26 Lynn Road and 38a St Mary's Street survive of brick and stone walls incorporated into later timber-framed buildings (Rebecca Lane pers comm), a situation that may have occurred because the surviving fabric was a party wall and could not be demolished when the building was redeveloped. Parker (1971, 125) mentions 30-32 King Street, King's Lynn, where a gable wall was found to be stone with only timber used from the first floor upwards 'as was usual in Lynn where side walls were of stone to prevent fire'. If the wall containing the recesses was constructed of stone it may suggest ecclesiastical origins. A possible context for the ogee-headed recesses might be an early site for the friary church, which was eventually located on the other side of Chapel Street. O'Sullivan (2013, 7) states that friaries often relocated and this could have happened in King's Lynn as the friars consolidated land that had been gifted to them. The earliest friary churches were undifferentiated buildings (O'Sullivan 2013, 19). A stone house is mentioned in a will of 1307, possibly located somewhere north of Market Lane, but the remains of a stone building have also been found on the south side of Fells Warehouse (Rutledge and Rutledge 1978, 101; Fig 47).

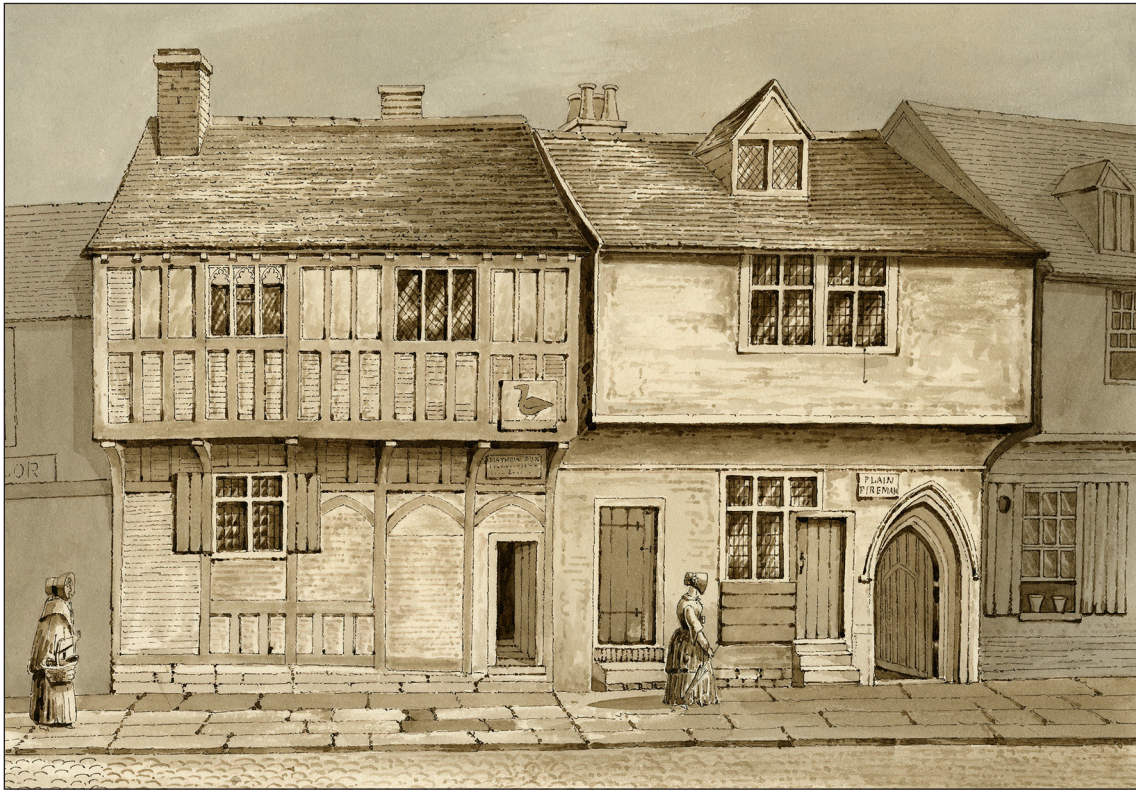
Figure 10: The Black Goose public house by William Taylor c1850. The timber-framing suggests that the building originally had a shop-front. The stone entrance to Bennett's Yard can be seen in the building to the right (west). [Norfolk Museums Service (Norwich Castle Museum & Art Gallery) NWHCM 1951.235.B275]

Through depicted as rendered on Taylor's sketch, the building to the west of Bennett's Yard, now demolished, also appears to have been timber-framed and therefore potentially medieval as indicated by the coving of an infilled jetty which can be seen on the drawing (Fig 10). However, photographs taken in 1907 (Fig 12) and 1972 (HEA BB98/30884) show a brick building to the west of Bennett's Yard. It is possible that a brick façade was added to the front of a timber-framed building, as happened to the ground floor of the Black Goose (Fig 24), or the building was replaced after Taylor completed his sketch.

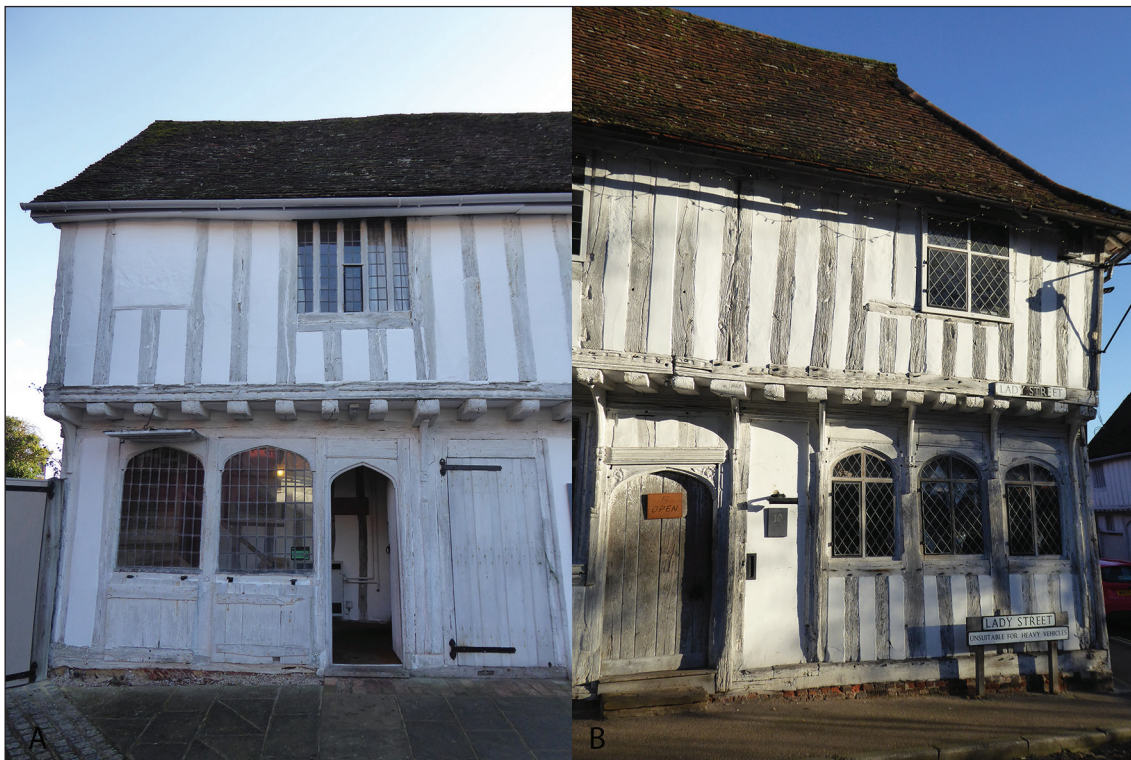
Figure 11: Two medieval shop fronts in Lavenham, Suffolk, both Grade I Listed: A) The 15th-century shop front at the eastern end of the Guildhall Range (NHLE 1181069) B) The 15/16th-century shop front on the building at the corner of Water Lane and Lady Street (NHLE 1351532). Images: Sarah Newsome 7-JAN-2018

afield good comparable examples of similar shop fronts, the Guildhall in Lavenham, Suffolk (Fig 11), and the Woolpack Inn at Great Coggeshall in Essex (Clark 2000, 65), have been dated to the 15th century, suggesting that the Black Goose could have had pre-16th-century origins. Clark (2000, 67) notes that for shops jetties had visual impact, provided shelter and created extra living space above.

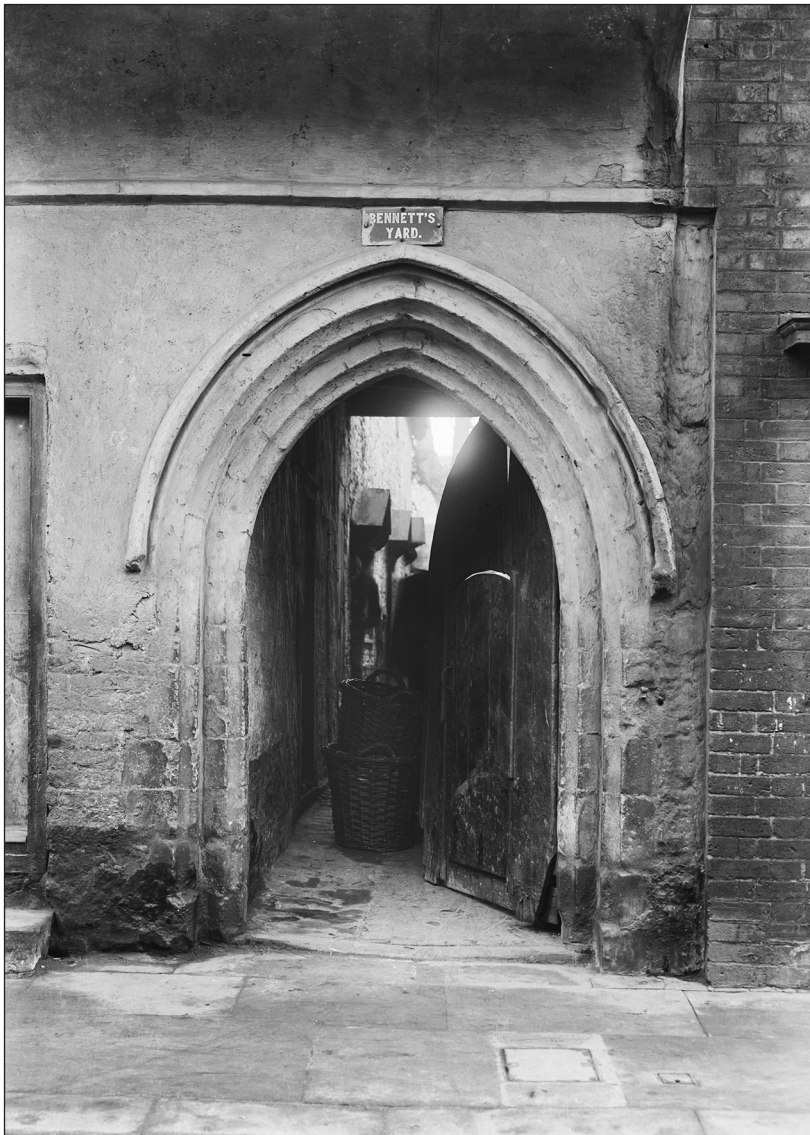
Figure 12: The stone entrance arch to Bennett's Yard, 21 St Nicholas Street, in 1907. The cottages which comprised the 'yard' are visible through the entrance [HEA BB46/01526 1907 ©Historic England]

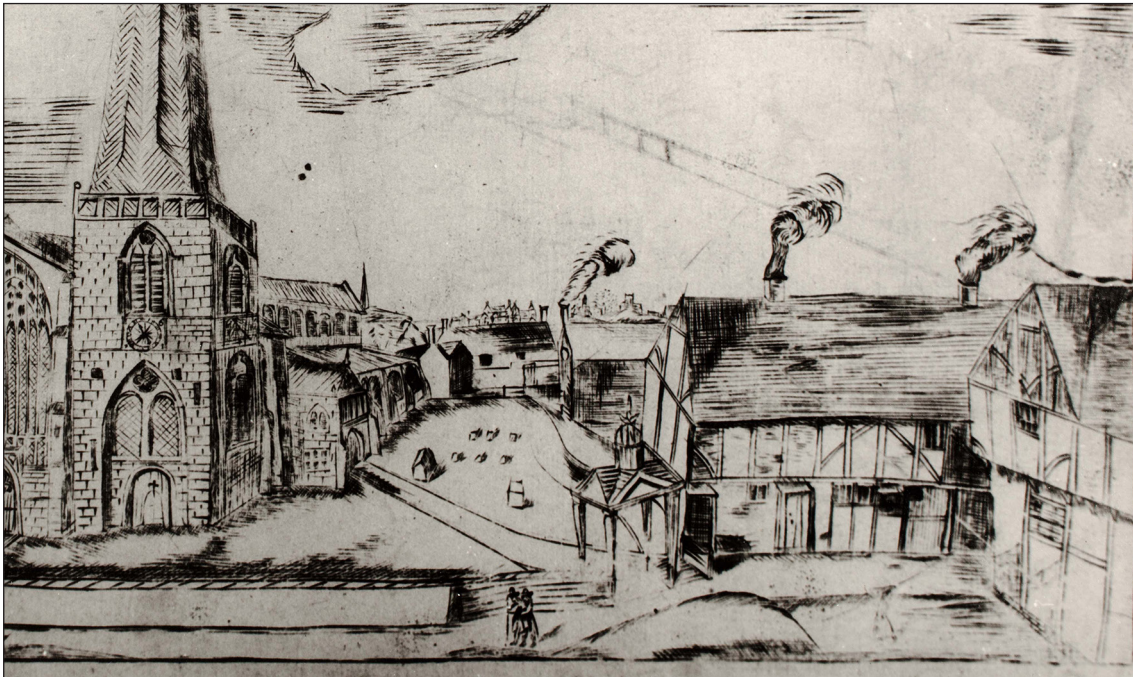
Figure 13: The buildings that stood at 78-80 Chapel Street and 26 St Nicholas Street (see Fig 4, 8) in the late 17th century [Source: Norfolk Museums Service (Lynn Museum) KILLM 2007.143, Image: HEA DP219368].

An etching of St Nicholas Chapel thought to be by Henry Bell from around 1670 (Fig 13) shows a fairly typical timber-framed building opposite the project area where 78 and 80 Chapel Street stand today, with later inserted chimneys. It also shows a timber-framed building with either an end or corner jetty on the corner of Chapel Street and St Nicholas Street, where 26 St Nicholas Street stands today. Both buildings are broadly of 15th- or 16th-century date and suggest that medieval timber-framed buildings once ran the length of the eastern boundary of the car park site. Documentary evidence shows that the buildings at the corner of St Nicholas Street and Chapel Street were owned by St Nicholas Chapel from the 17th to 19th centuries (Sykes 2003, 120) and it is likely that this reflects the earlier, medieval,

Spain'. However, the print of St Nicholas Chapel from c 1670 (Fig 13) and the houses that survived into the 20th century show that many timber-framed buildings were retained in the area despite the growing use of brick in the town as a whole.

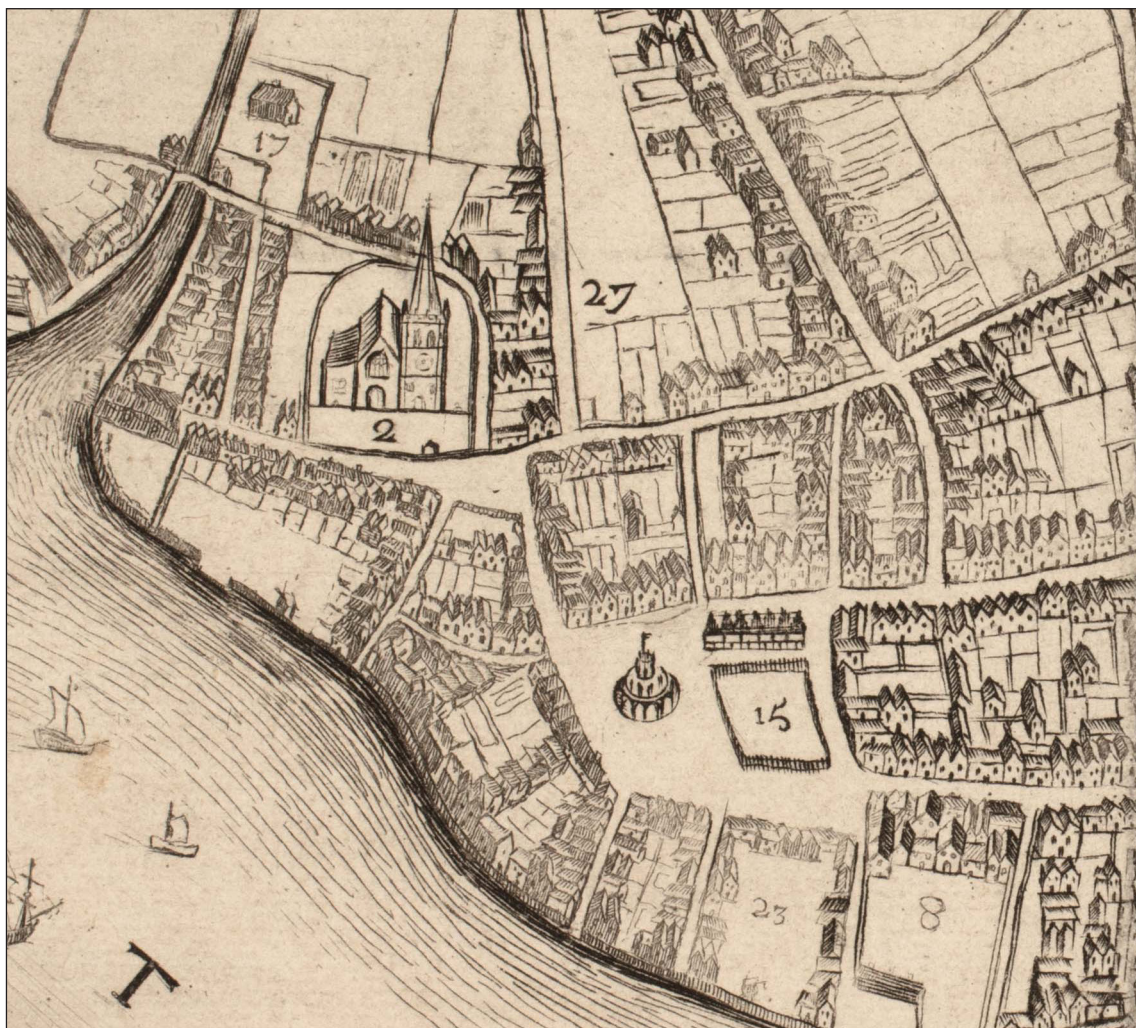
Figure 14: Extract from *The Groundplat of King's Lynn* by Henry Bell c1670 showing the project area located between St Nicholas Chapel (marked '2') and the Tuesday Market Place (marked '15'). North is to the left of the map. [Source: Norfolk Museums Service (Lynn Museum) KILLM 1999.63; Image: HEA DP219398]

The *Groundplat of King's Lynn* by Henry Bell dating to c 1670 shows buildings fronting on to Chapel Street, St Nicholas Street and Tuesday Market Place (Fig 14). Most of the plots run east to west (a pattern persisting from the medieval period) and a building is shown in the middle of the block. Two plots run north-south to the north and south of this building. No buildings are shown along Market Lane at this date.

Rastrick's map of 1725 is very stylised (Fig 15), but shows plots running east to west from Chapel Street, possibly as far west as Bennett's Yard and/or the Black Goose, where a plot runs north-south towards a row of buildings in the same position as those shown on Bell's *Groundplat* (Fig 14). A few more buildings are also shown on Market Lane. William Faden's map of 1797 is also very stylised. It shows buildings along St Nicholas Street and Chapel Street and the entrance into Ravenshaw's Yard but is of little use in understanding the complex history of the Chapel Street Car Park (www.fadensmapofnorfolk.co.uk accessed 3/1/17).

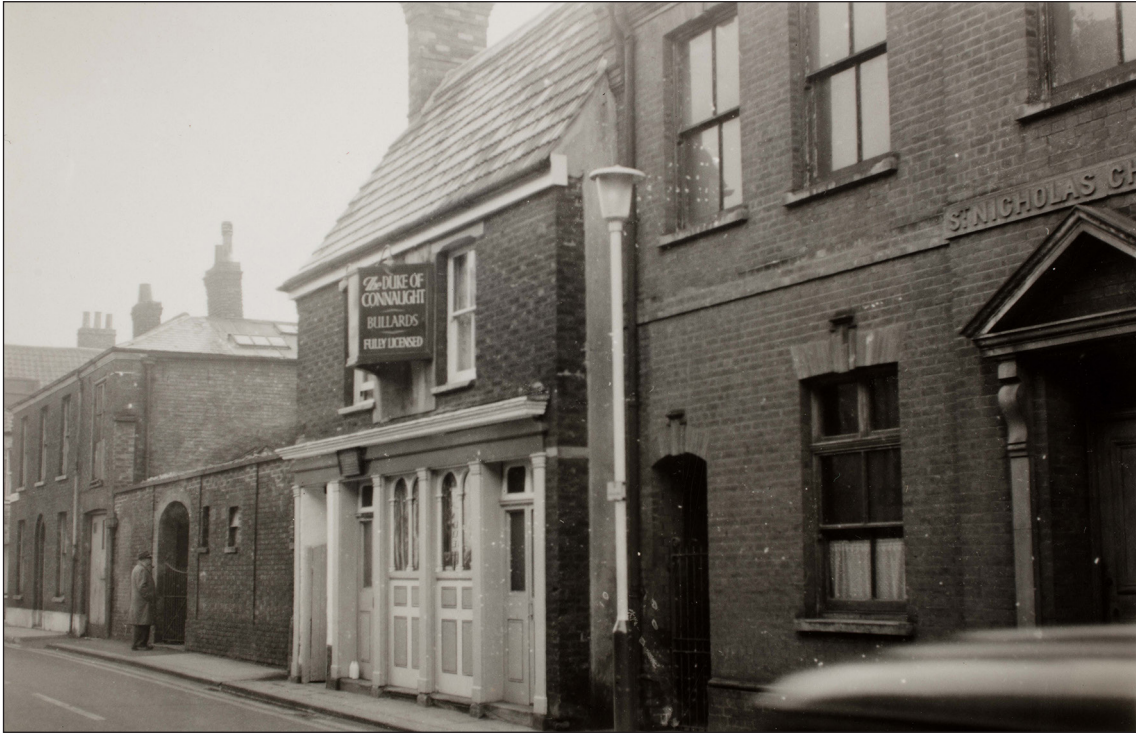
Figure 16: The Duke of Connaught public house, probably photographed in the 1960s. The building is potentially late 18th century in date, though a new ground-floor front was inserted around the early 20th century. [Source: King's Lynn Norfolk Studies Collection. Image: HEA DP219468]

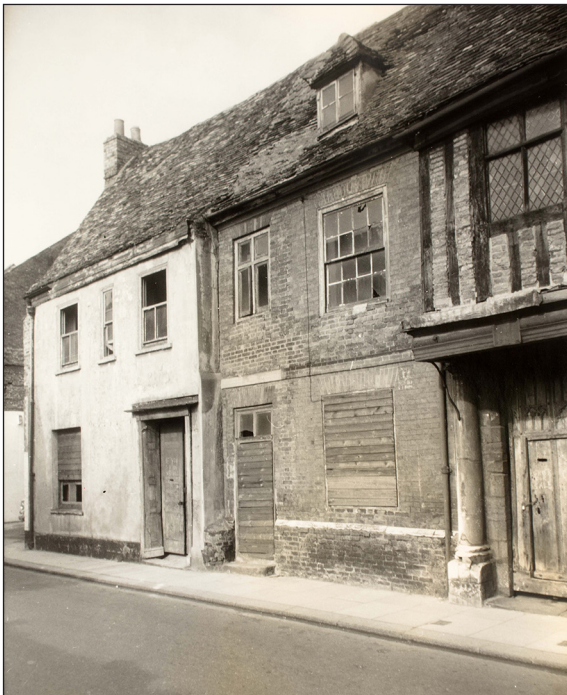
Figure 17: Houses possibly built in the 18th century located to the west of what is now the Tudor Rose Hotel on the north side of St Nicholas Street in 1961. [Source: Norfolk Museums Service (Lynn Museum) KILLM 2007.66. Image: HEA DP219387].

Two houses to the west of the Tudor Rose on the north side of St Nicholas Street (demolished to make way for Lovell House) may also be broadly 18th-century in

date, though their lack of uniformity and similarity in scale to what is now the Tudor Rose Hotel to the east may suggest they are older and were refronted in brick around this date. Photographs held in the Lynn Museum collection give little clue to the construction date of the buildings, but no timber-framing is visible (Fig 17). Both are of two storeys with steeply pitched pantiled roofs, the building to the east being brick-built whilst the other is rendered but presumably brick. A dormer also indicates an attic storey in the eastern building.

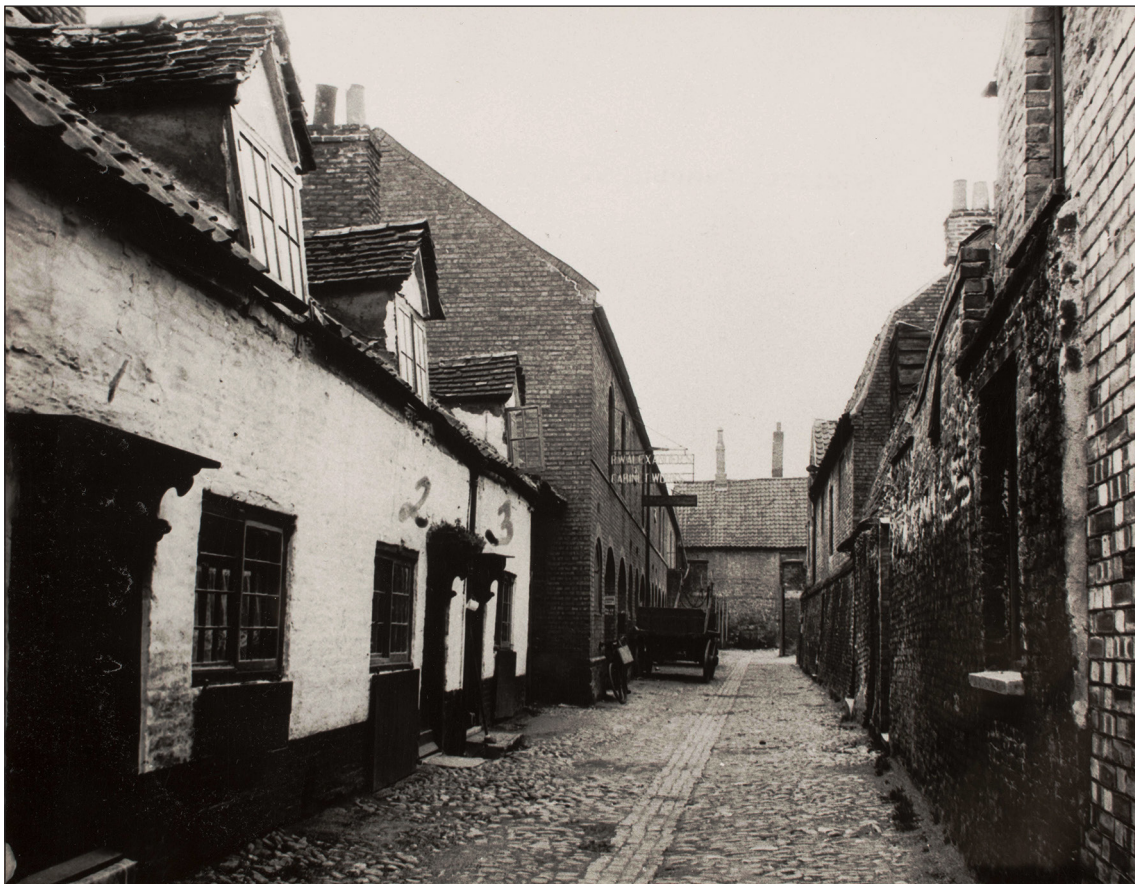
Figure 18: Chapel Buildings, presumably photographed after Fells Warehouse, seen in the background, was remodelled in 1882. The view is looking west along Ravenshaw's Yard with Ravenshaws House to the right (north). [Source: King's Lynn Norfolk Studies Collection; Image: HEA DP219423].

An historic photograph looking west along Ravenshaw's Yard (taken after 1882) shows a row of three cottages known as Chapel Buildings, immediately east of Fells Warehouse and north of Lattice House on the west side of Chapel Street. Now demolished, the appearance of the cottages suggests that they may have been constructed in the late 18th century, particularly the matching ornate door surrounds, which also suggest they were in a single ownership at this date (Fig 18). The cottages have a ground floor and an attic storey (indicated by pitched dormer windows). Each cottage has a single casement window with a wooden shutter hinged at the bottom. A similar shutter can be seen on the Taylor sketch of the Black Goose and Bennett's Yard (Fig 10). A passageway from Ravenshaw's Yard to the rear of Lattice House is also visible at the western end of the row of cottages and can still be seen as a blocked entrance way with a timber lintel in the northern boundary wall of Lattice House. It is possible that the cottages have pre-18th-century origins, but this is not visible from this image alone. A photograph taken in 1978, after demolition, shows that the cottages were brick-built and had a mono-pitch roof, the line of which can be seen on the eastern elevation of Fells Warehouse (Fig 30).

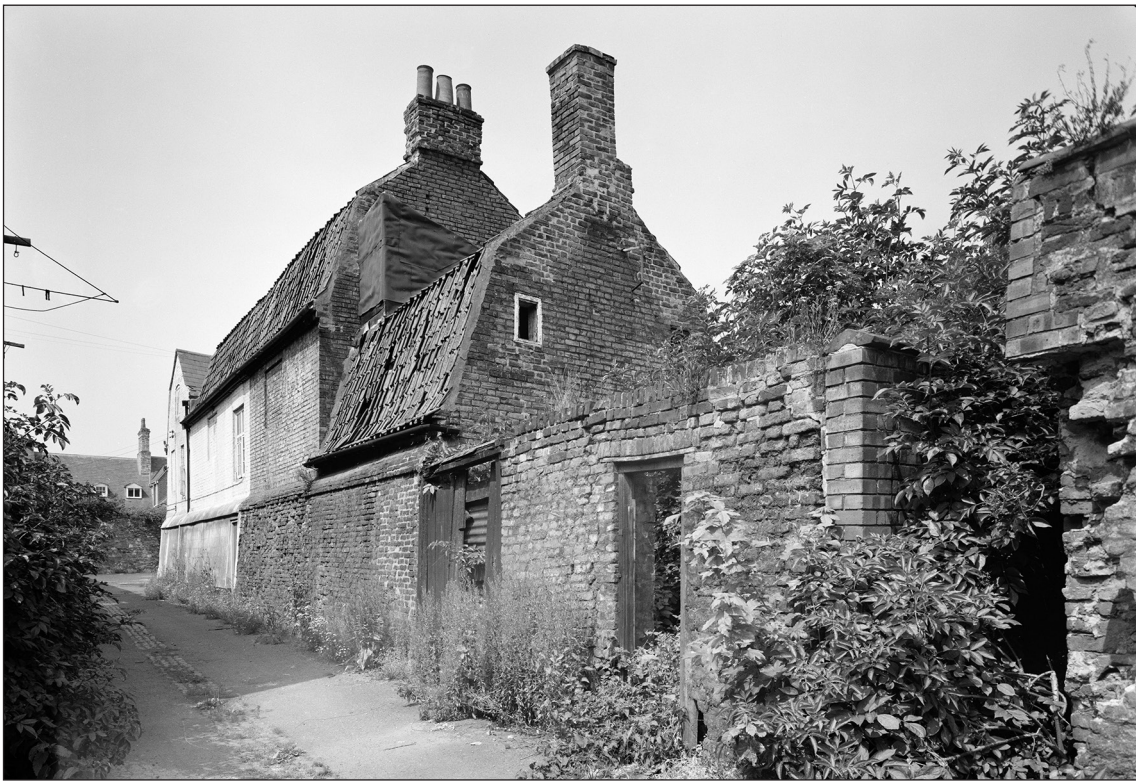
Figure 19: Rear (southern) elevation of Ravenshaws House in 1972, looking north-east [Source: Historic England Archive Hallam Ashley BB99/05780]

Ravenshaws House, thought to have been constructed in the second half of the 18th century, was a two-storey house with an attic storey, with a pantiled mansard roof, and two adjoining extensions, also with mansard roofs, one with pantiles to the east

and one with slate to the west (HEA BF032552 1972; Figs 19 and 25). Comfortable rather than particularly high status, its construction suggests that access to the rear of plots and their uses was changing at this time and its layout suggest that access to the property was from the north. It is also worth noting that the southern elevation of the house appears to have been constructed on or hard up against an existing, and substantial, brick wall of an estimated 2.2m in height and with a decorative rounded brick coping. This suggests the existence of a significant property boundary before the house was built. The only view of the northern elevation of the house appears in an undated photograph in the King's Lynn Norfolk Studies Collection, looking south along Seed's Yard behind the Duke of Connaught (Fig 25). It has been demolished.

Wood's map of 1830, though being described as 'from actual survey' and appearing accurate, does seem to have a number of inaccuracies and the details shown should be treated with caution (Fig 21). For example, the map shows empty plots (possibly gardens) where Ravenshaws House was located by that date (Fig 19) and also where 43-49 Chapel Street were located, 16th-century buildings which survived into the 1960s (Figs 7 and 8). However the map does show the long row of buildings now known as Fells Warehouse, as well as the two buildings which originally abutted it to the south. It also shows a large square building (a possible stable block) to the rear of 8-10 Tuesday Market Place (see Fig 23), Bennett's Yard, Seed's Yard (behind the Duke of Connaught) and also a building on the future site of St Nicholas Drill Hall, close to the eastern end of St Nicholas Street which had been demolished, possibly before 1848 (CULmaps b/77/84/1 Utting) and definitely by 1883 (Ordnance Survey 1:500, surveyed 1883, published 1886). NB the building or its facade appears to be shown on a photograph held in the King's Lynn Norfolk Studies Collection (Fig 24), thought to be circa 1880. On the Wood map this building appears to be much deeper in comparison to surrounding buildings but its date is unclear. Another undated photograph in the same collection looking south along Seed's Yard, behind the Duke of Connaught on St Nicholas Street, shows a substantial boundary wall which may be related to this building or the later hall built on the site in the early 20th century (Fig 25). It is also worth noting that by this date, the north-south

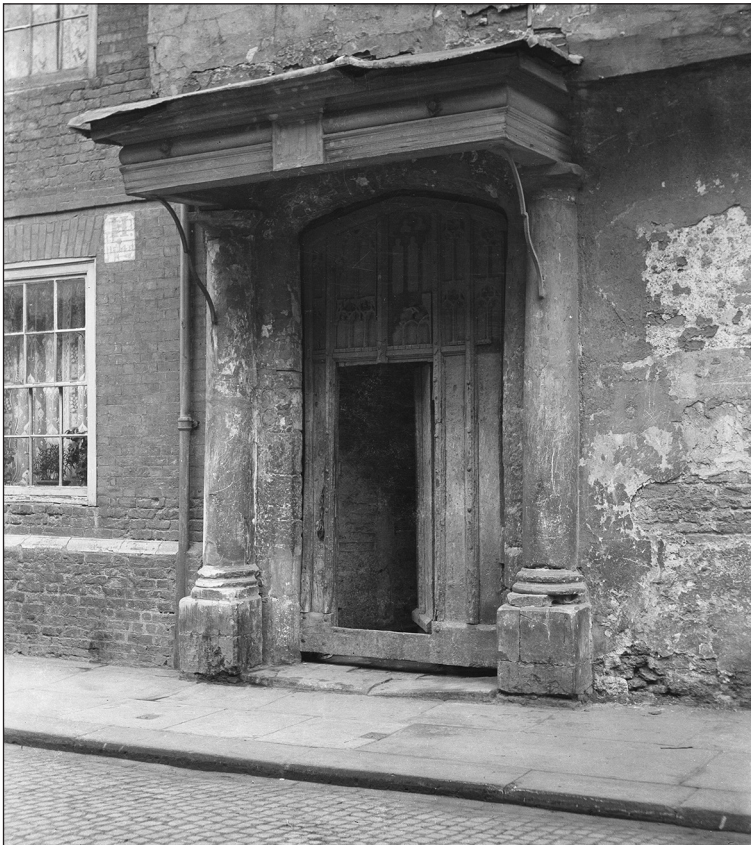
Figure 20: The entrance to the Tudor Rose Hotel in 1907 [Source: Historic England Archive B44/1151 EP4263/47]

Successive owners of 10 St Nicholas Street (now the Tudor Rose Hotel) clearly had money to invest in the post-medieval period, adding much later demi-columns and a canopy, probably in the 18th century, to a stone door surround with a four-centred arch sometime from the mid-15th century (Fig 20). The property has an extremely complex history which is beyond the scope of this report (e.g. Rose 2004; James 2004).

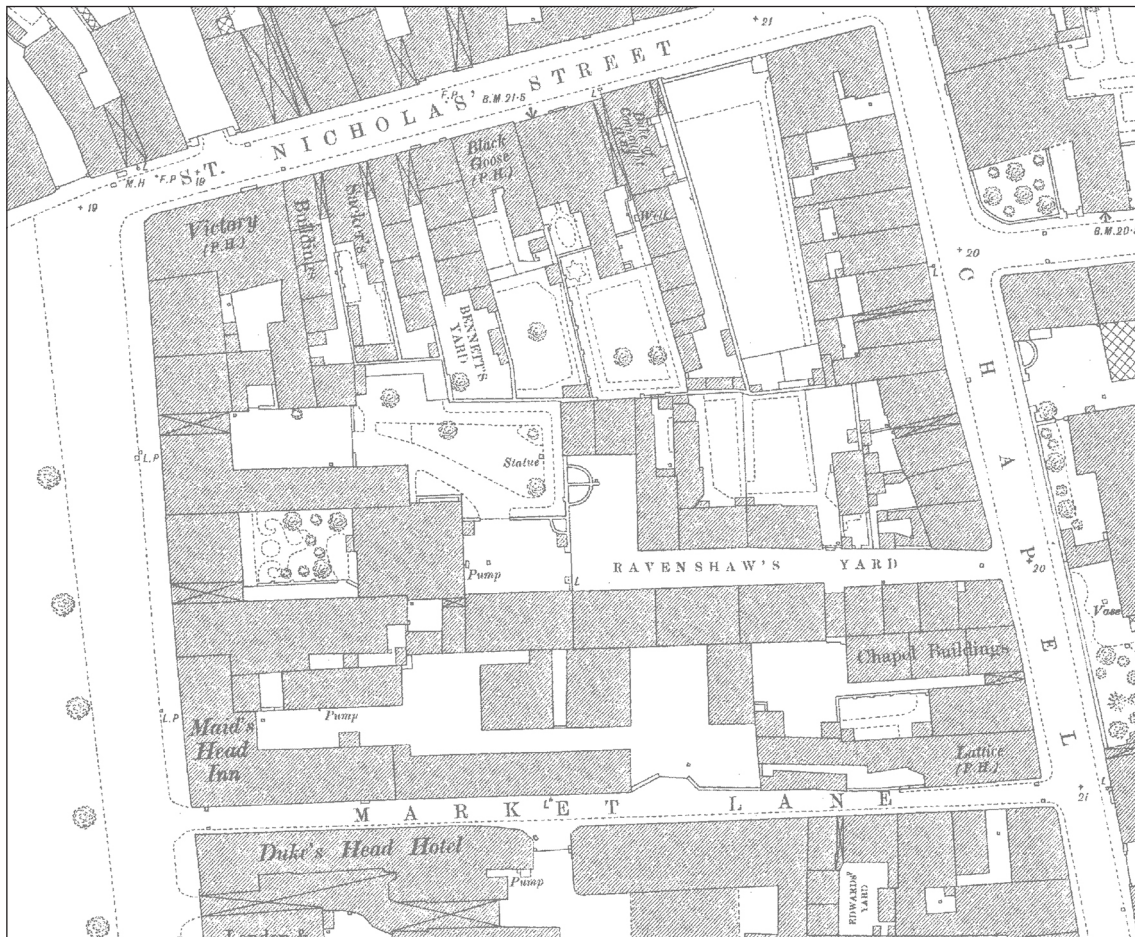
Figure 23: The project area in 1883 from the Ordnance Survey 1:500 Town Plan, surveyed 1883, published 1886. (Historic Ordnance Survey mapping: © and database right Crown Copyright and Landmark Information Group Ltd (All rights reserved 2017) Licence numbers 000394 and TP0024).

The first detailed and presumably accurate map of the project area is the Ordnance Survey 1:500 Town Plan, which was surveyed in 1883 and published in 1886 (Fig 23). A date-stone of 1882 suggests that the stable block and coach house at Ravenshaw's Yard was built at this time and it is shown on this map (HEA BF032552).

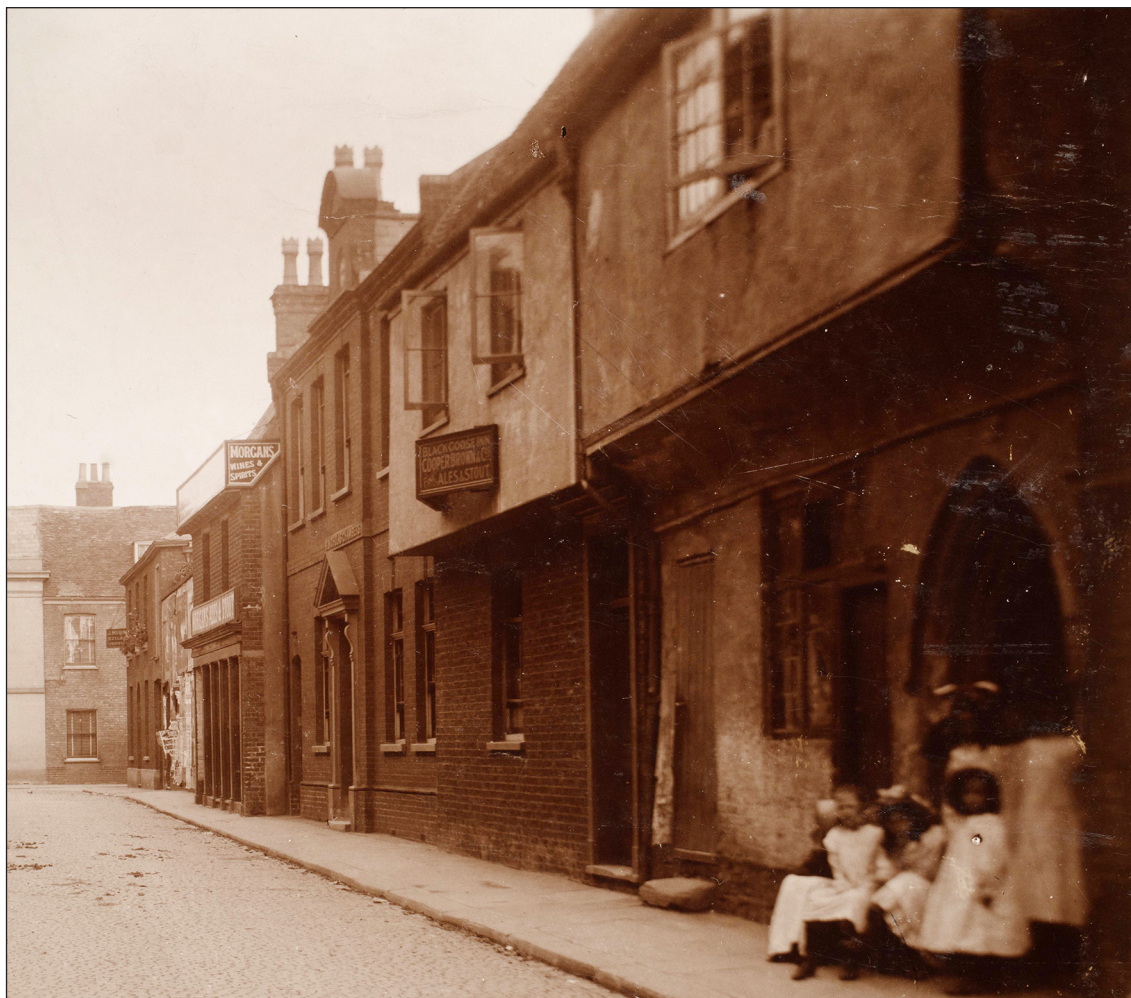
Figure 24: The south side of St Nicholas Street in the late 19th century. The building containing the stone doorway arch to Bennett's Yard is shown in the foreground, followed by the Black Goose public house, St Nicholas Chambers, the Duke of Connaught public house, the (possibly derelict) predecessor to St Nicholas Drill Hall and finally 26 St Nicholas Street in the background of the photograph. [Source: King's Lynn Norfolk Studies Library (St Nicholas Street photograph file); Image: HEA DP219454]

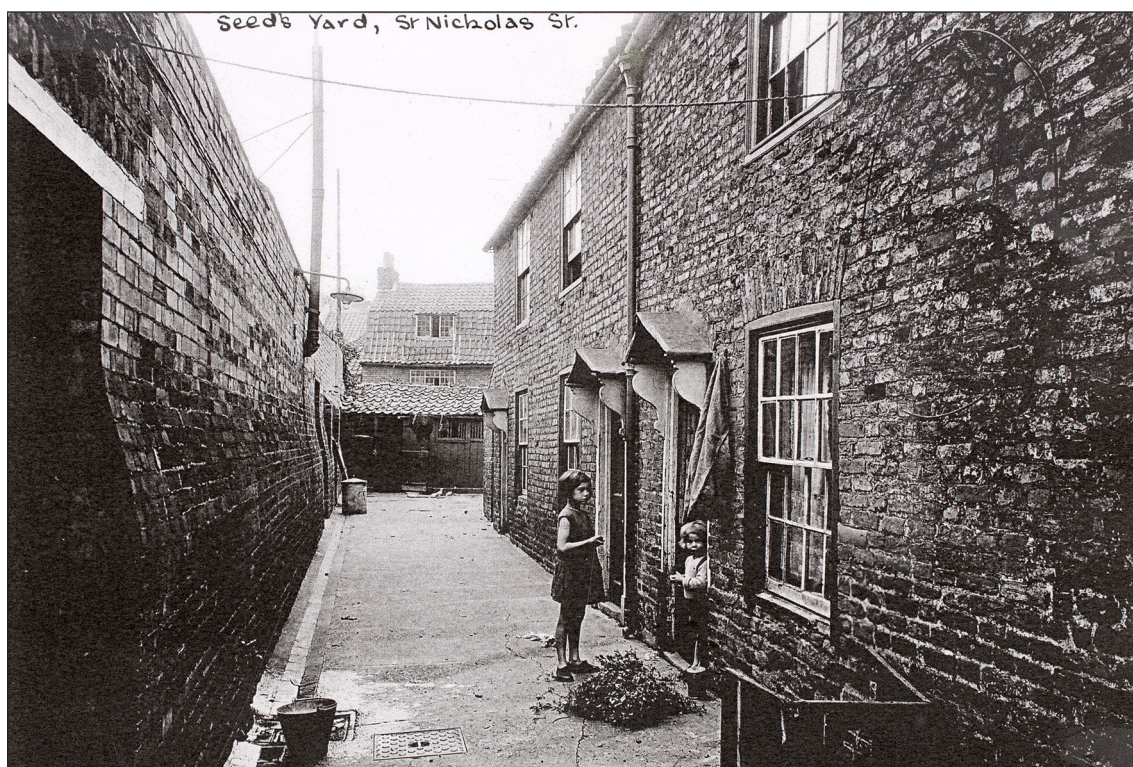
Figure 25: Seed's Yard, located to the rear of the Duke of Connaught public house on the south side of St Nicholas Street (undated). The row of cottages is typical of the 'yards' constructed behind the earlier street frontages and appears to be early to mid- 19th century in date. The building in the distance is the northern elevation of Ravenshaws House. [Source: King's Lynn Norfolk Studies Collection (Yards photographic file); Image: HEA DP219446].

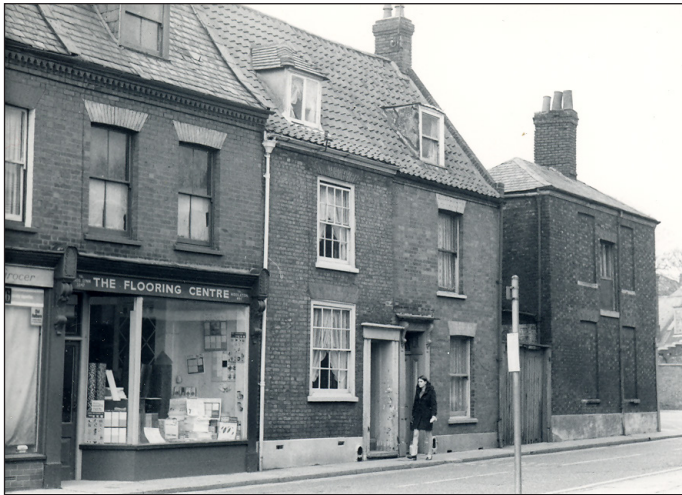
Figure 26: 61-63 Chapel Street with the eastern elevation of 26 St Nicholas Street visible to the north (right) and 59 Chapel Street visible to the south (left). [Norfolk Museums Service (Lynn Museum) KILLM 1995.106.1 n.d.].

Now demolished, 61-63 Chapel Street may have been constructed in the late 18th or early 19th century before their neighbours 26 St Nicholas Street to the north and 57-59 Chapel Street to the south. Both are two-storey with attics lit by dormers in their pantiled roofs, though the eaves line and other details suggest they were built at slightly different dates or were possibly earlier buildings that had been refronted.

Both have flat gauged brickwork heads to their windows though No 61 has four-by-four light sashes whereas No 63 appears to have later plain sashes set in slightly different positions. The adjacent doors of the properties are of slightly different designs (Fig 26).

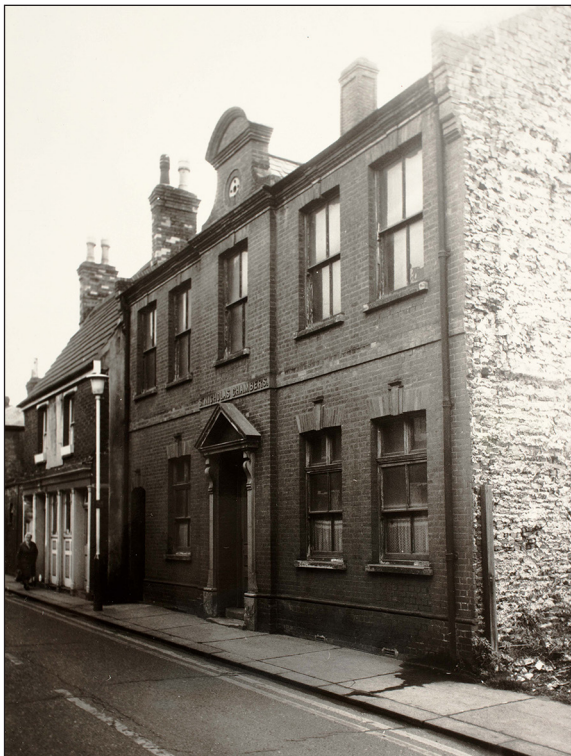
Figure 27: St Nicholas Chambers on the south side of St Nicholas Street. The Duke of Connaught public house can be seen to the extreme left-hand side (east) of the image and the vacant plot where the Black Goose public house has been demolished can be seen to the right-hand side (west). [Source: Norfolk Museums Service (Lynn Museum) KILLM 2007.57 nd – post 1951; Image: HEA DP219369]

A phase of redevelopment in the area seems to have started in the mid- to late 19th century. The building known as St Nicholas Chambers, located on the south side of St Nicholas Street between the Black Goose and Duke of Connaught public houses, was built in the late 19th century, prior to 1883 (Fig 27) and probably after 1850 as it is not shown on the Taylor sketch of the Black Goose (Fig 10).

Now demolished, the large two-storey brick building was almost symmetrical with five bays. At ground-floor level a central door was flanked by two windows to the west and a window and service entrance to the east. The photograph shows these windows to either be triple sash windows or standard sash windows with two hops above, which might indicate a non-domestic function in these rooms. The name 'St Nicholas Chambers' also suggests a non-domestic function in at least some parts of the building. Large sash windows with two-by-two lights are visible at first-floor level. The building had some Classical influences with a segmental headed pediment with a central roundel forming a central rooftop frontispiece, a triangular bracketed pediment above the main doorway and exaggerated keystones in the flat heads above the windows. A string course ran between ground- and first-floor level (Fig 27), on which 'St Nicholas Chambers' was written in relief (see Fig 16).

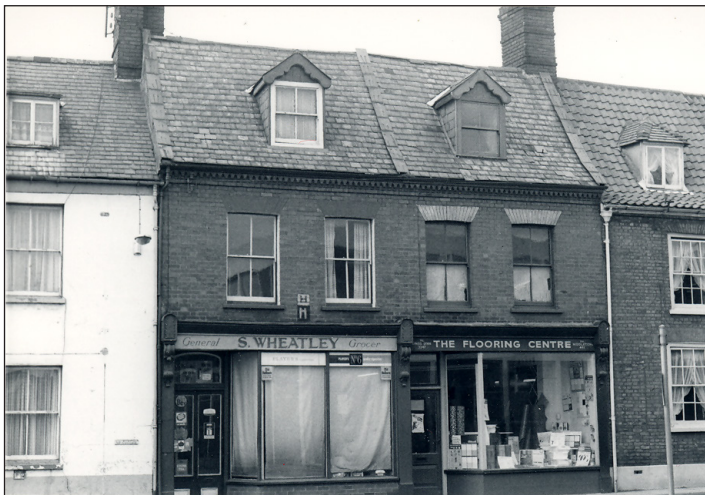
Figure 28: 57-59 Chapel Street with 55 Chapel Street to the south (left) and 61 Chapel Street to the north (right). [Norfolk Museums Service (Lynn Museum) KILLM 1994.327 n.d.]

On the west side of Chapel Street a number of buildings appear to have been built in this period. 57-59 Chapel Street (now demolished) were a pair of shops with accommodation above which appear from historic photographs to be mid- to late 19th-century in date (Fig 28). They were two-storey brick buildings with ground-floor shops with large display windows and attic storeys, each with a single pitched central dormer. The roofs were pitched and appear to have been slate-tiled with slate-topped firebreaks. The sash windows had two-by-two lights and flat gauged heads and a decorative dentilled string course in brick ran across both at eaves level. The house to the south, No 55, does not appear to have been built at the same time but had similar sash windows, a flat-roofed dormer, a round-arched entrance and possibly a slate roof. It may be broadly 19th-century in date (Fig 28; KLNCS Chapel Street Photo File).

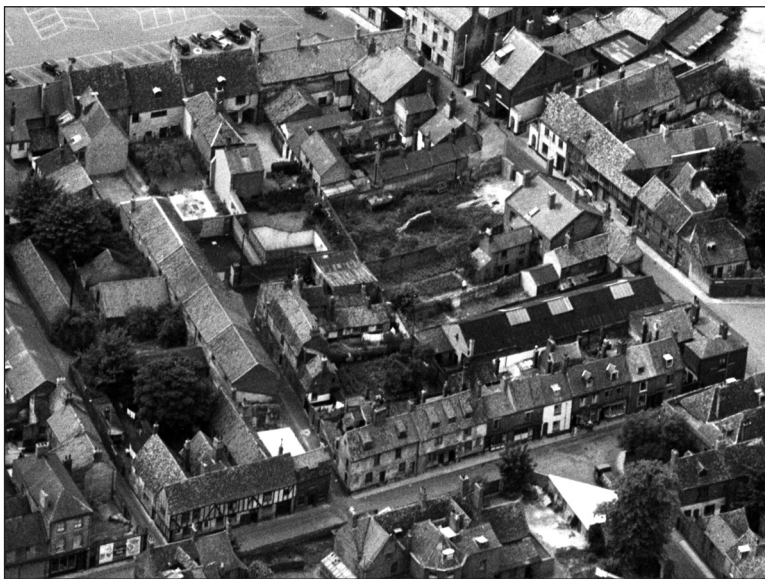
Figure 30: The former stables known as Fells Warehouse, Ravenshaw’s Yard, Chapel Street in 1978. The coach house is located at the far (westernmost) end of the stable block. (Source: Historic England Archive BB031782 14-APR-1978)
