Chapel Street, King's Lynn, Norfolk: The History and Archaeology of the Chapel Street Car Park

Research Report Series 002-2018

**CHAPEL STREET
KING'S LYNN
NORFOLK**

**THE HISTORY AND ARCHAEOLOGY OF
THE CHAPEL STREET CAR PARK**

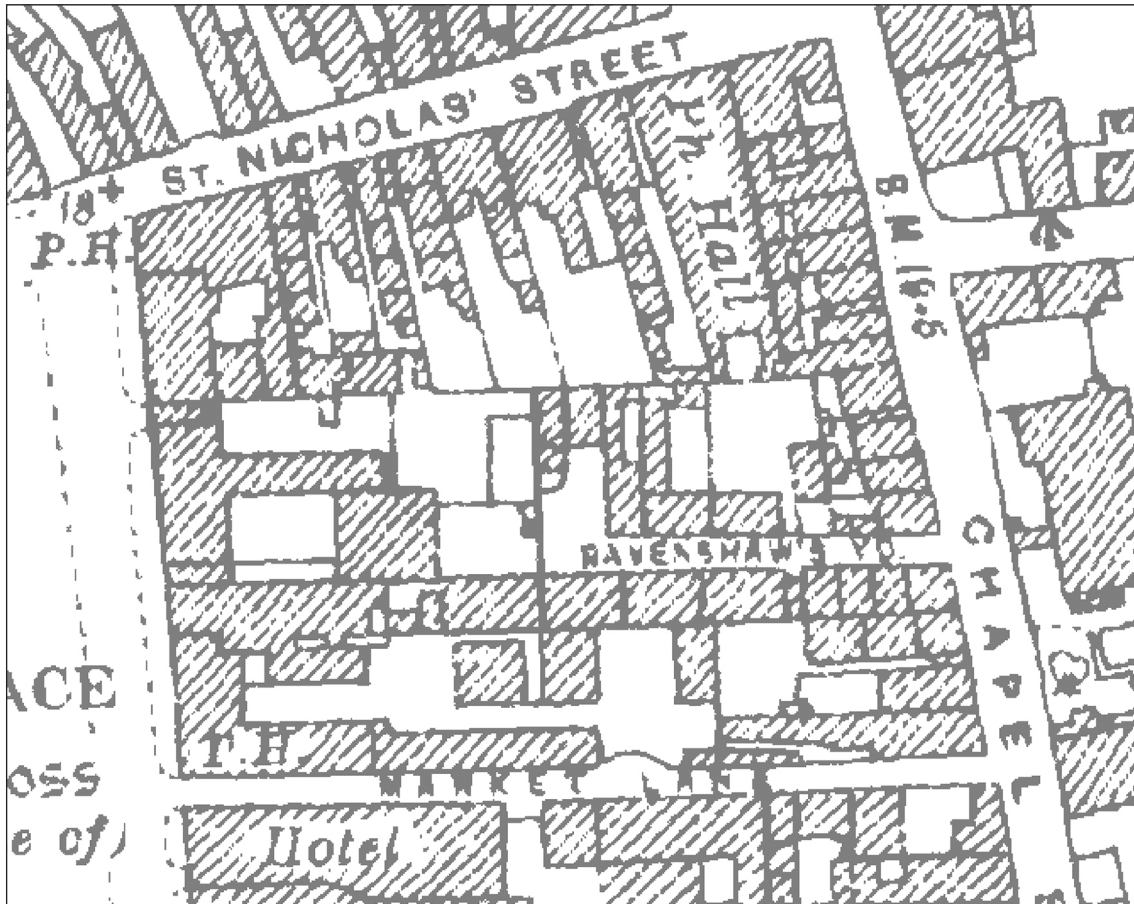
Figure 31: The 1927 Ordnance Survey 3rd Edition 1:2500 map (published 1928) showing the large Parish Hall constructed at the eastern end of St Nicholas Street. (Historic Ordnance Survey mapping: © and database right Crown Copyright and Landmark Information Group Ltd (All rights reserved 2017) Licence numbers 000394 and TP0024).

The Ordnance Survey maps show very little change in the project area from the end of the 19th century until 1927, by which time a large building marked as a Parish Hall had been constructed in the vacant area to the west of 26 St Nicholas Street, sometime between 1904 and 1927 (Fig 31). This is named ‘St Nicholas Drill Hall’ in Booth (1933, 126). The Black Goose pub (6 St Nicholas Street) closed in

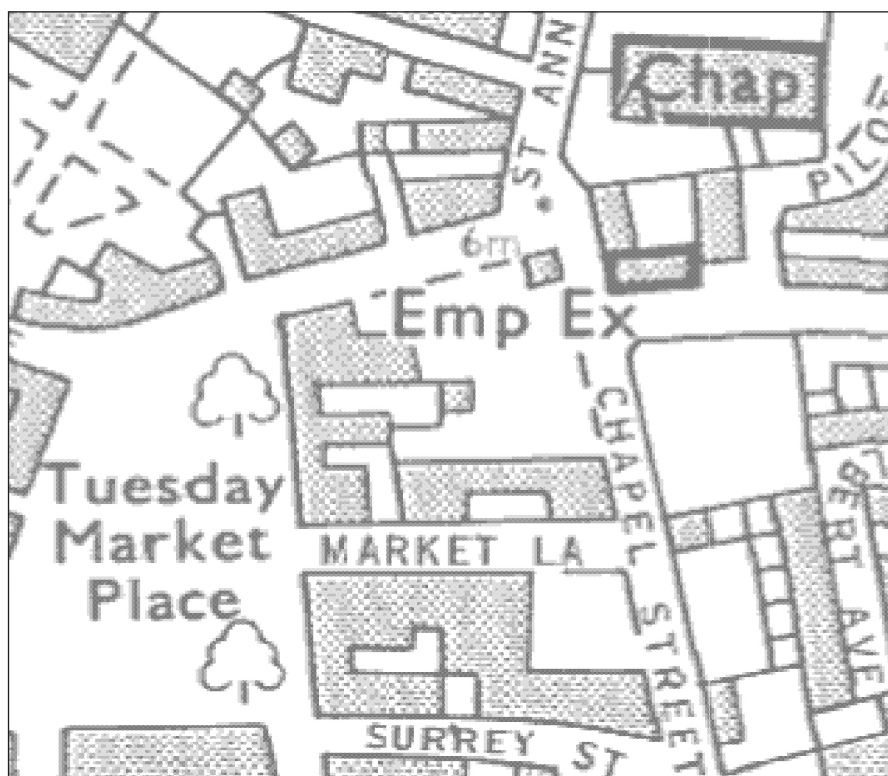
Figure 33: The Ordnance Survey 1:10,000 3rd Edition map from 1976 showing the results of the final clearance of the project area which occurred between 1967 and 1976. (Historic Ordnance Survey mapping: © and database right Crown Copyright and Landmark Information Group Ltd (All rights reserved 2017) Licence numbers 000394 and TP0024).

In 1972 43-45 Chapel Street and Ravenshaws House and its outbuildings were still standing (HEA BB99/05781) but by 1976 the whole site had been cleared bar a small building at the northern end of Ravenshaw's Yard and 26 St Nicholas Street, which survives today (Fig 33). At least part of this final clearance occurred in early 1974 when, according to a newspaper clipping held in the King's Lynn Norfolk Studies Collection, preparations began for a road improvement scheme and office development which never came to fruition; this included extending Austin Street to Tuesday Market Place (KLNSC 'Lynn News & Advertiser 1.2.74' St Nicholas Street file).

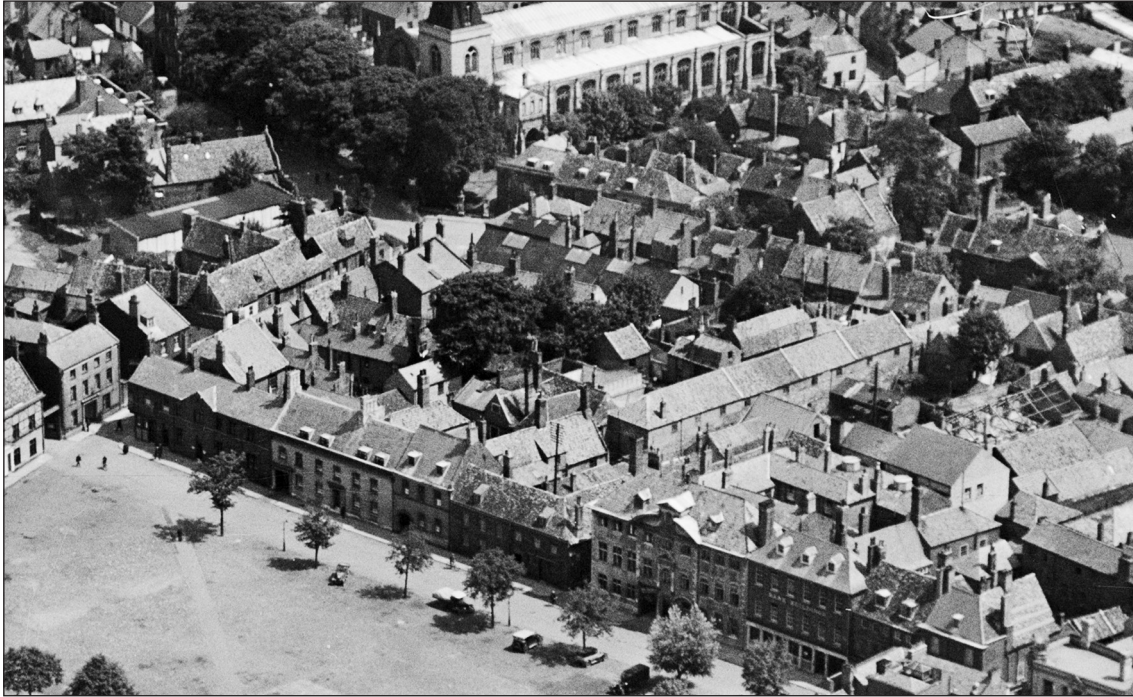
Figure 34: Aerial view looking north-east over the Chapel Street Car Park site towards St Nicholas Chapel in 1928 [Source: Historic England Archive (Aerofilms Collection) AFL60482/EPW021474 JUN-1928] .

An aerial photograph from 1928 shows just how densely occupied the area was at that date and had been for many years. The variety of chimneys, roof lines, outbuildings and extensions reflect the varied dates of construction of the buildings (Fig 34). At this date the area still reflected its earlier, densely occupied character from previous centuries. The buildings on Chapel Street were very narrow, with steep pitches, short backyards and numerous outbuildings and lots of dormer windows lighting attic storeys. In 1942 St Nicholas Street was still cobbled (HEA EP4263/47; A42/3843).

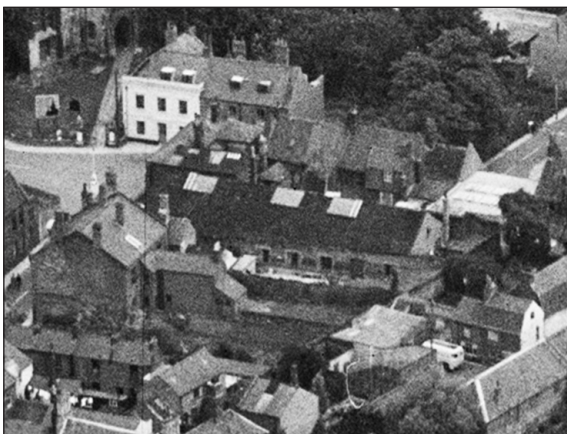
Figure 35: An aerial photograph looking north-east from July 1963 shows the western and southern elevations of the parish/drill hall on St Nicholas Street [Source: Historic England Archive (Aerofilms Collection) ALF62883/EAW116074 8-JUL-1963]

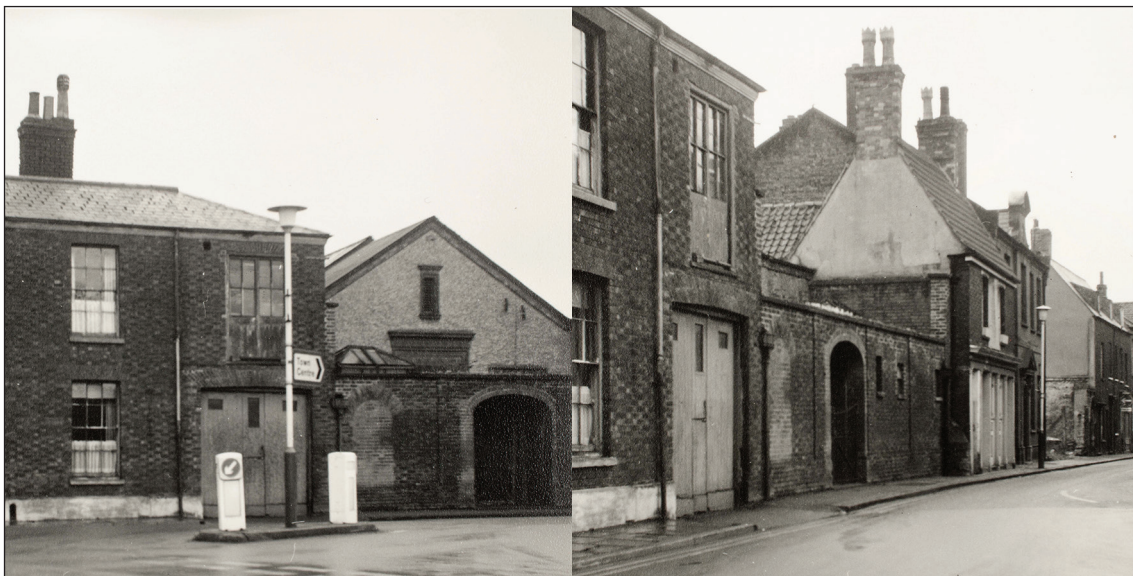
Figure 36: Details from two photographs showing the north elevation of the parish/drill hall on St Nicholas Street. Note: The Ordnance Survey map of 1976 (Fig 33) suggests the catalogued date of 1977 for the photograph on the right-hand side is incorrect. [Source: Norfolk Museums Service (Lynn Museum) KILLM 2007.64.1 nd, KILLM 2007.65.1 1977; Images: HEA DP219388, DP219389]

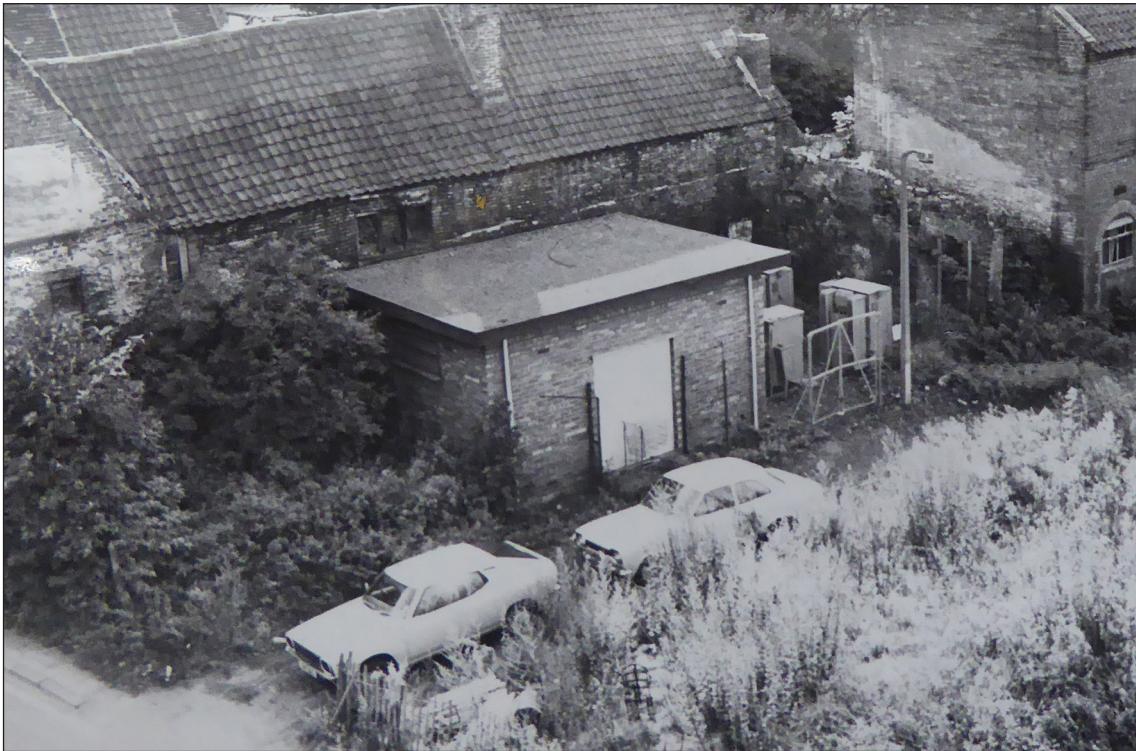
Figure 37: View, looking south-west, of the northern elevation of the electricity sub-station built on the site of the Chapel Buildings. [King's Lynn Norfolk Studies Collection (Chapel Street photograph file, nd)].

An aerial photograph from 1952 (HEA EAW044459 27-JUN-1952) shows the newly constructed flat roof of the electricity sub-station just to the north of Lattice House, on the former site of the Chapel Buildings. This small rectangular building was brick-built with a flat projecting concrete roof, double doors in its north elevation and a small high-level window in its east elevation (Fig 37; KLNSC Fells Warehouse Chapel Street Photo File). It was demolished at some time in the 1970s.

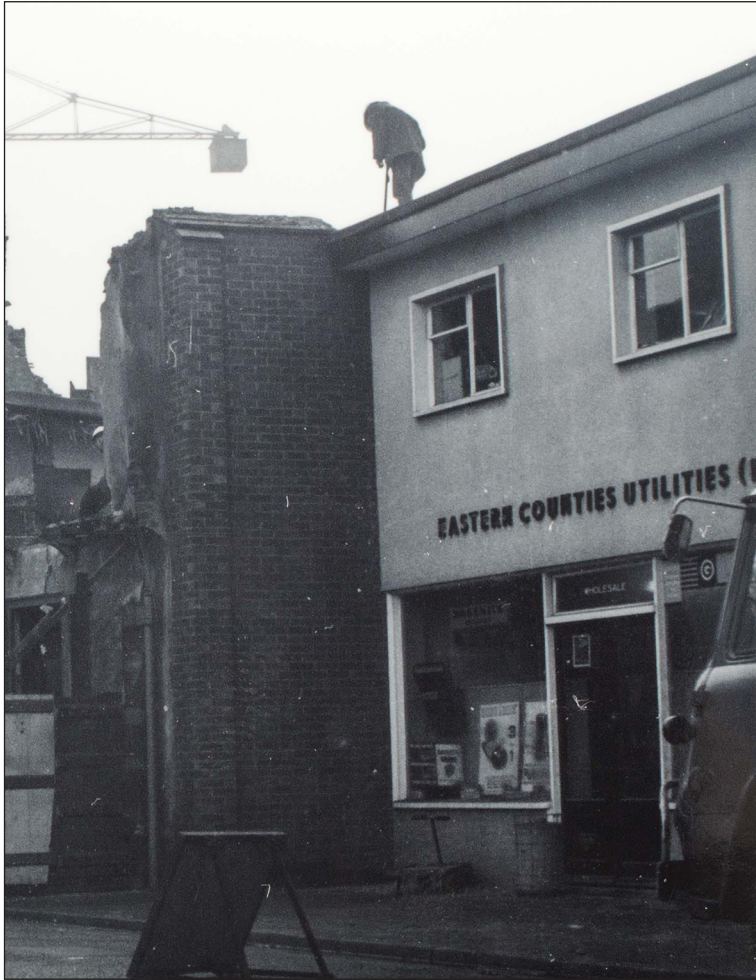
Figure 38: The Eastern Counties Utilities premises at 51-53 Chapel Street (right-hand side of image). To the south (left), 47-49 Chapel Street is under demolition. The date of the photograph must therefore be January 1967 (cf Fig 9). [Source: Norfolk Museums Service (Lynn Museum) KILLM 1992.217.25; Image: HEA DP219390]

The now demolished Eastern Counties Utilities building was set back from the historic street frontage. It replaced an earlier, possibly 19th-century building (Fig 4, 14), at some point between 1955 and 1961. It was a brick two-storey building with a flat projecting roof, a ground-floor shop front and three square recessed windows (the north window is not visible on many photographs) with projecting window surrounds at first-floor level. Tiles are visible below the shop windows at either side of the central, double door and the first floor was rendered. A second door to the north probably gave access to office accommodation on the first floor (HEA BB67/00360; KLNSC Chapel Street Photo File). Brick walls to the north and south may have been built to support the gable ends of 47-49 and 55 Chapel Street (Fig 8) when the original buildings at 51-53 were demolished sometime between 1955 and 1961 (Fig 38).

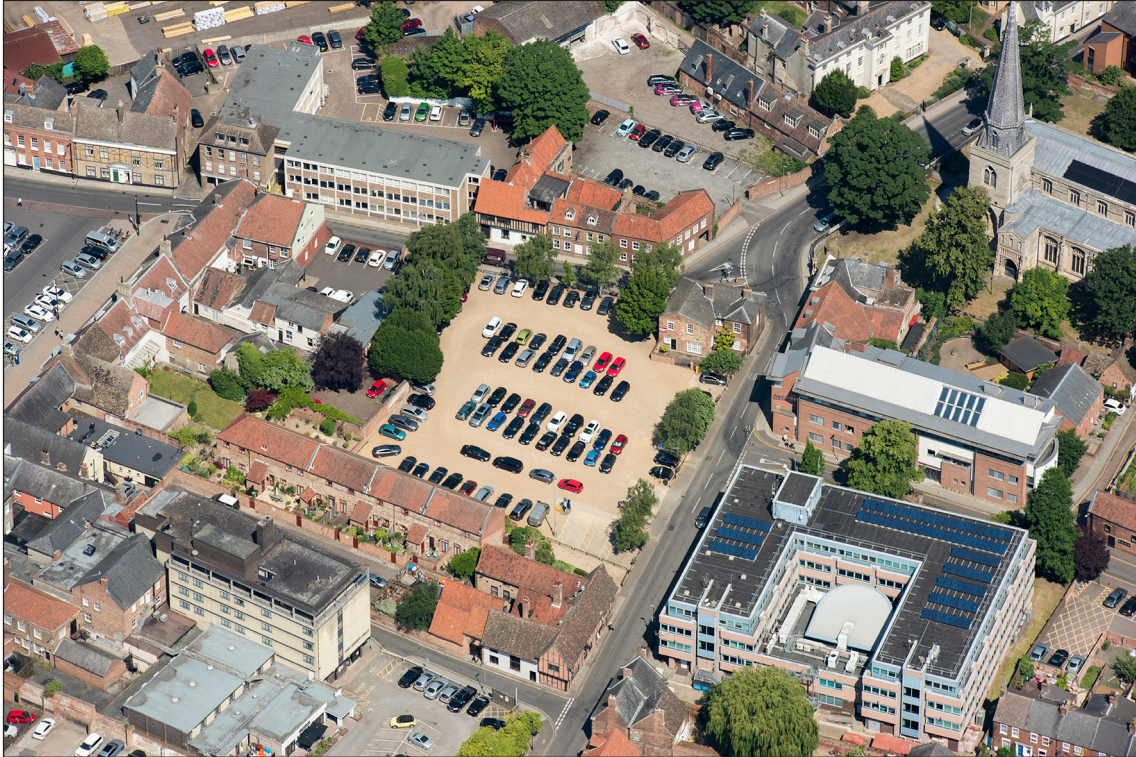
Figure 39: Chapel Street Car Park looking north. Tuesday Market Place can be seen to the west (left), Lovell House and the Tudor Rose Hotel to the north (top), St Nicholas Chapel to the north-east, King's Court to the east (right) and the Fells Warehouse and Duke's Head Hotel extension to the south (bottom). [HEA 33198/011 Damian Grady 19-JUN-2017 ©Historic England]

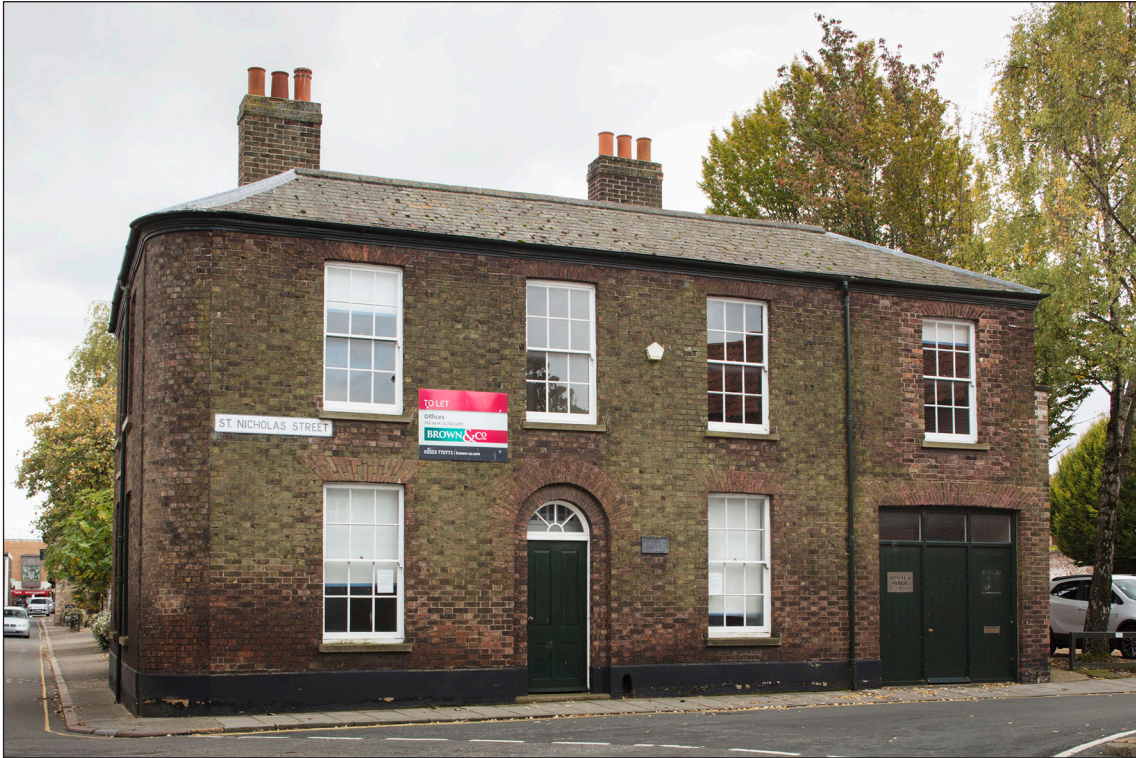
Figure 40: Grade II Listed 26 St Nicholas Street, which survives at the north-eastern corner of the car park. [HEA DP217394 Patricia Payne 20-SEP-2017 ©Historic England]

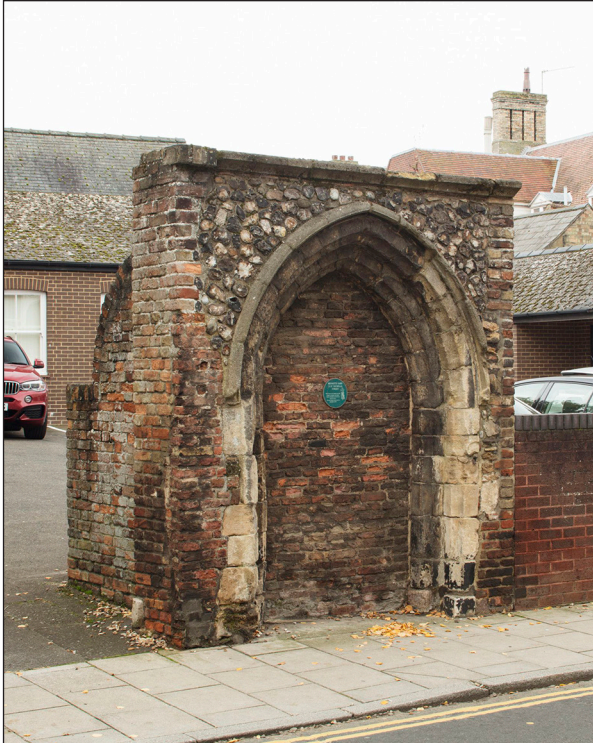
Figure 41: The Grade-II Listed probable 15th-century doorway, former entrance to Bennett's Yard, St Nicholas Street, standing isolated just beyond the north-western corner of the car park. [HEA DP217376 Patricia Payne 20-SEP-2017 ©Historic England]

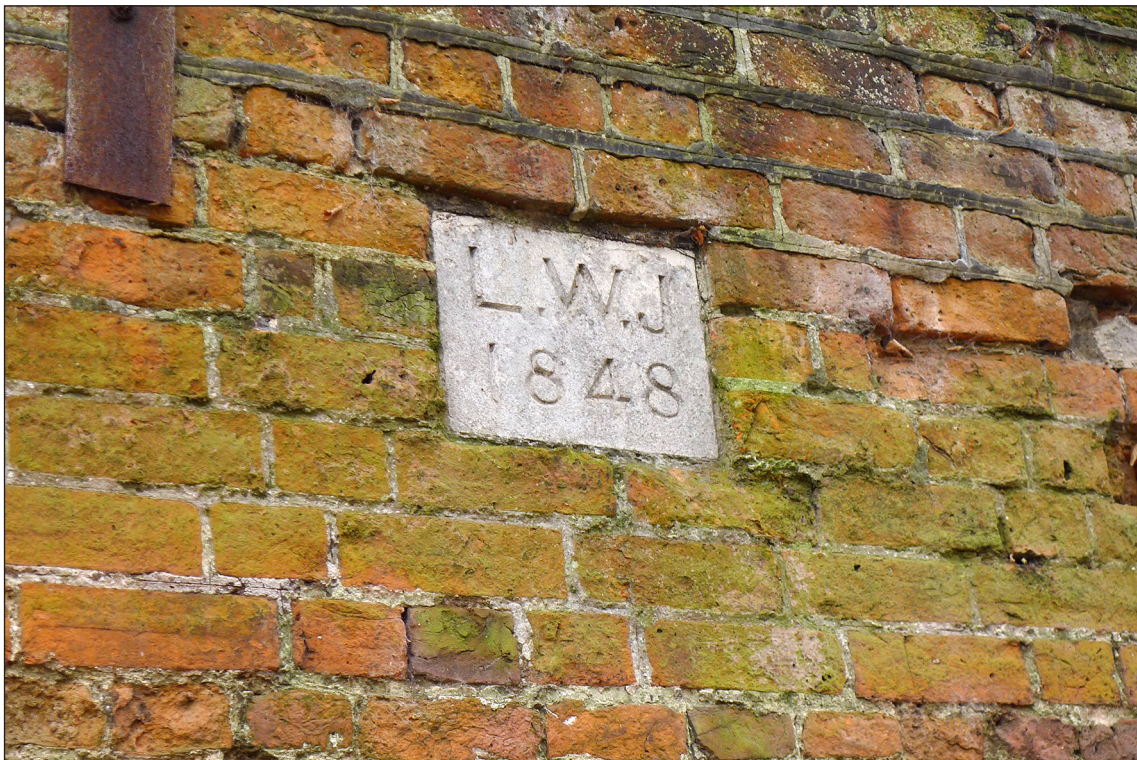
Figure 42 (below): Date-stone relating to Lewis Weston Jarvis, or his son Lewis Whincop Jarvis, located on a north-facing wall towards the north-western corner of the car park. (Photo: Sarah Newsome, Historic England).

Moving south along the western boundary of the site is a roughly 2.8m high red-brick wall containing a stone inscribed 'L.W.J. 1848' which appears to demarcate an area of formal garden, possibly associated with 10 Tuesday Market Place, a house with origins in the 16th century (Fig 42). In this case 'L.W.J' probably denotes Lewis Weston Jarvis, attorney, or his son Lewis Whincop Jarvis, solicitor, one of whom probably built Fells Warehouse. Lewis Weston and Lewis Whincop were aged 74 and 31 respectively in 1848 and lived in adjacent properties on Tuesday Market Place abutting this walled area to the rear (1851 Census, 17-19 Market Place). Documentary evidence from 1849 suggests that the area may have been accessed via Bennett's Yard as it is described as 'down the yard or entry leading out of the Woolmarket' (Sykes 2003, 121). This access may be reflected in the L-shaped plot depicted on some of the historic maps (e.g. Fig 14).

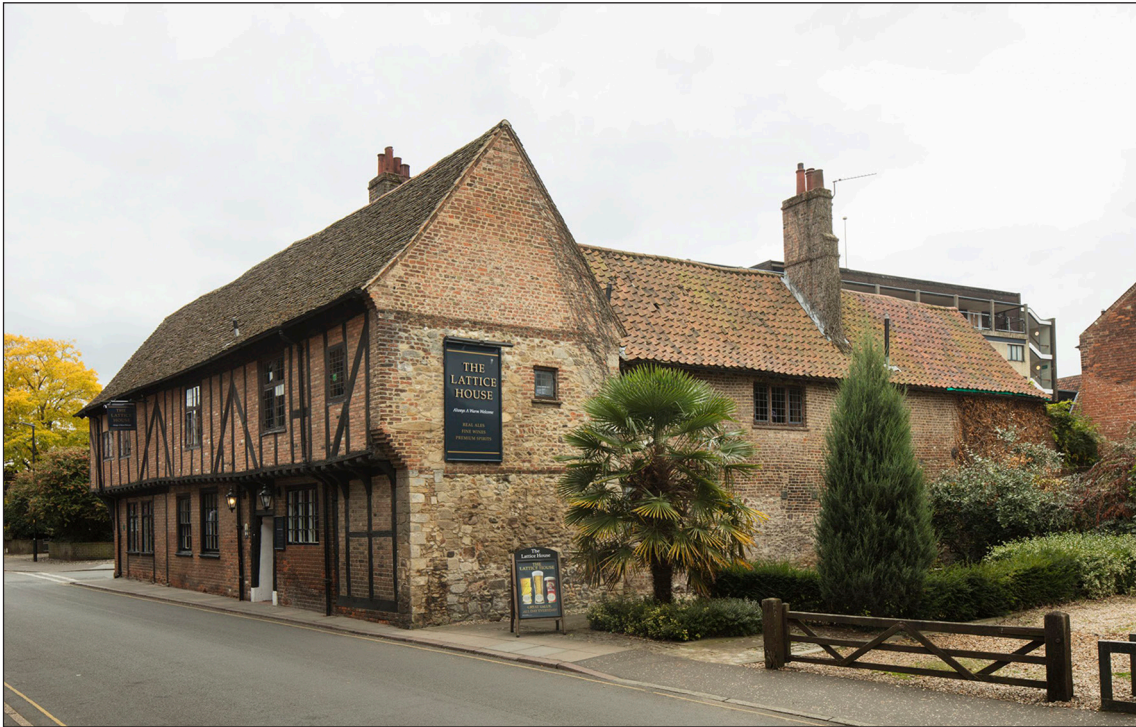
Figure 43: Lattice House, Chapel Street, looking south-west. [HEA DP217395 Patricia Payne 20-SEP-2017 ©Historic England]

To the south the car park is bounded by the Grade II listed 19th-century stable block and coach house at one time known as 'Fell's Warehouse' (NHLE 1298133; NHER 12081), a long two-storey red-brick building which runs along the southern side of the site. To the south-east of this is The Lattice House, a Grade II* Listed timber-framed (with red-brick infill) building now, and historically, a public house (NHLE 1291415; NHER 12005) built around 1480 with later 16th-century cross-wings, which faces on to Chapel Street to the east (Fig 43). The street range represents a rare, mostly unaltered example of 15th-century timber-framing (Parker 1971, 70).

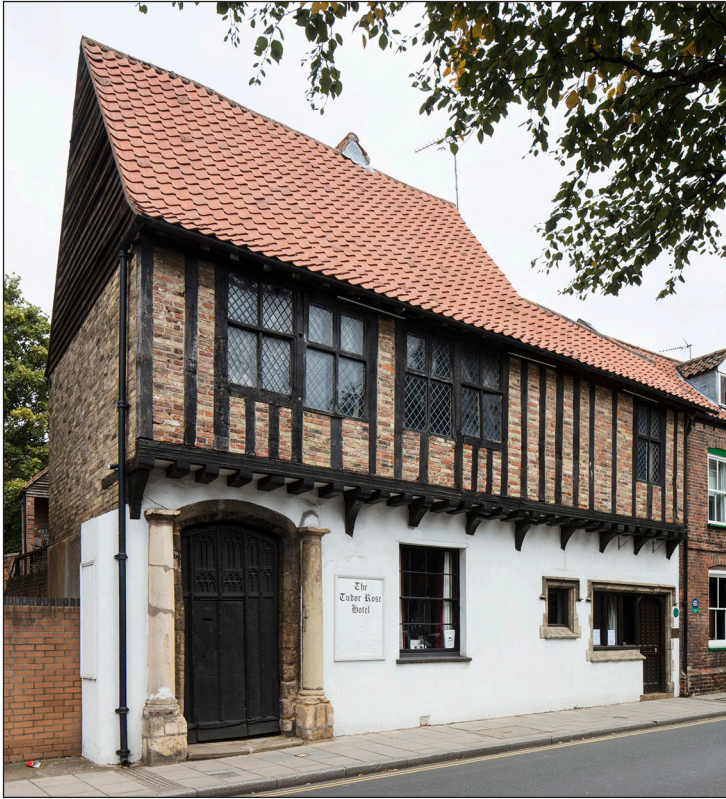
Figure 44: The Grade II Listed Tudor Rose Hotel. [HEA DP217378 Patricia Payne 20-SEP-2017 ©Historic England]*

Beyond the car park itself, a variety of different types of building from a range of different periods contribute to the character of the area. In terms of earlier buildings, the spire of the Grade I Listed St Nicholas Chapel can be seen to the north-east, whilst the car park looks north to the heavily restored façade of the timber-framed Grade II* Listed Tudor Rose Hotel, which incorporates two houses with mid-15th- and 16th-century origins (NHLE 1298153). Most other surviving buildings adjacent to the site are broadly 19th-century in date and brick-built (Fig 44).

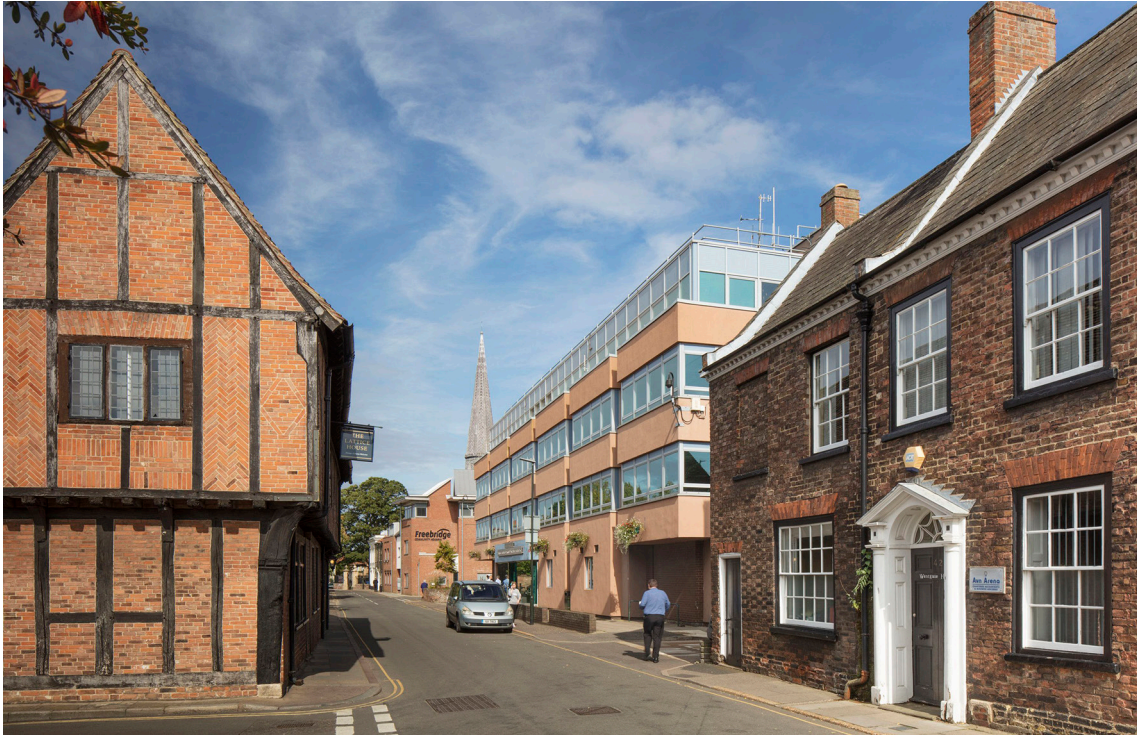
Figure 45: View north along Chapel Street from the corner of Market Lane. Lattice House can be seen in the foreground to the west (left) and Grade-II Listed Westgate House, 42 Chapel Street, can be seen to the east (right) with King's Court beyond. [HEA DP217391 Patricia Payne 20 SEP 2017 ©Historic England]

A number of large modern buildings have also influenced the character of the area including: Lovell House on the north side of St Nicholas Street, a three-storey yellow brick and concrete structure built around 1967; King's Court on the east side of Chapel Street, built between 1976 and 1985 (OS 1:10,000 Epoch 3 Second Revision and Epoch 4 Third Revision); the large extension to the Duke's Head Hotel south of Market Lane; and the flats on the northern corner of Austin Street and Chapel Street (Figs 45 and 46).

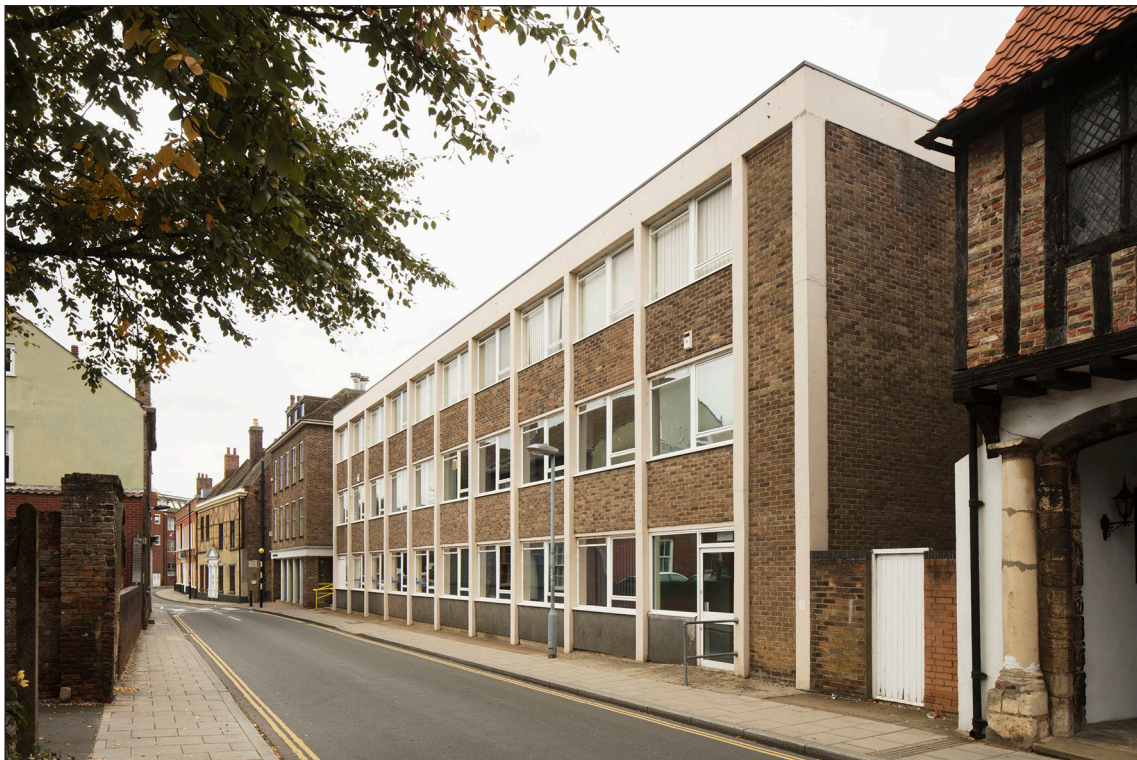
Figure 46: View north-east to Lovell House on the north side of St Nicholas Street. [HEA DP217377 Patricia Payne 20-SEP-2017 ©Historic England]

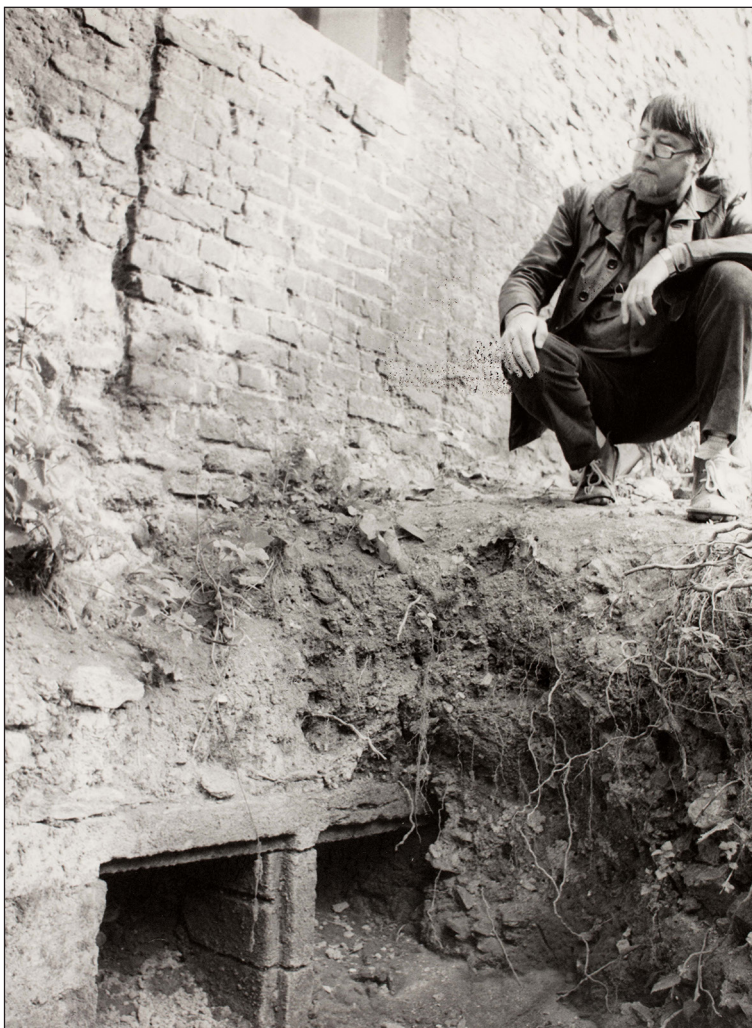
Figure 47: Colin Shewring, Borough Conservation Officer, pictured in 1977 during the excavation of a medieval stone wall with two rectangular openings, or cupboards, immediately beneath the south side of Fells Warehouse. [Source: King's Lynn Norfolk Studies Collection; Image: HEA DP219426].

An excavation undertaken in 1977 at the western end of the southern side of the Fells Warehouse, off Market Lane, around 50m south-west of the Chapel Street Car Park, revealed evidence for a substantial stone building occupied from the 13th to 15th centuries (Rogerson 1979; NHER 1159; NRHE Event 640010). The excavated wall was made of limestone blocks and water-worn boulders and contained two

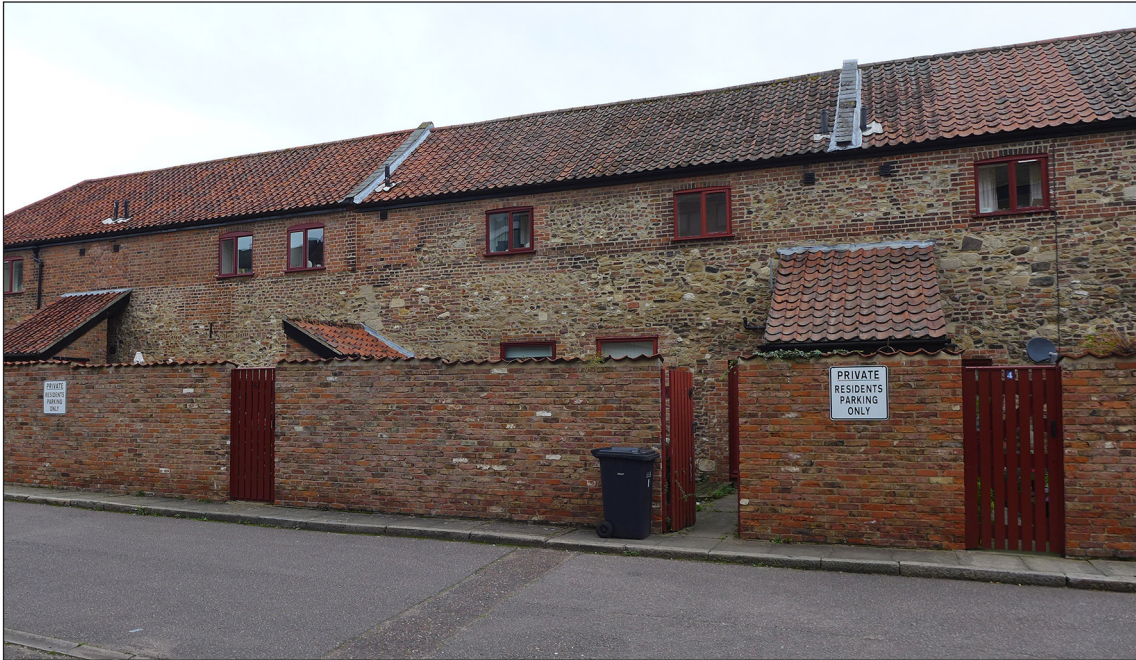
Figure 48: The south elevation of Fells Warehouse. A large quantity of stone rubble and some dressed stone blocks are visible in the rear elevation, which was clearly not intended to be seen. The variation in colour suggests that some stones were internal and some were external to their original building. (Photo: Wayne Cocroft 04-OCT-2017 Historic England)
