Historic England

The Common Staithe, King's Lynn, Norfolk: An architectural and archaeological assessment

Jonathan Kewley

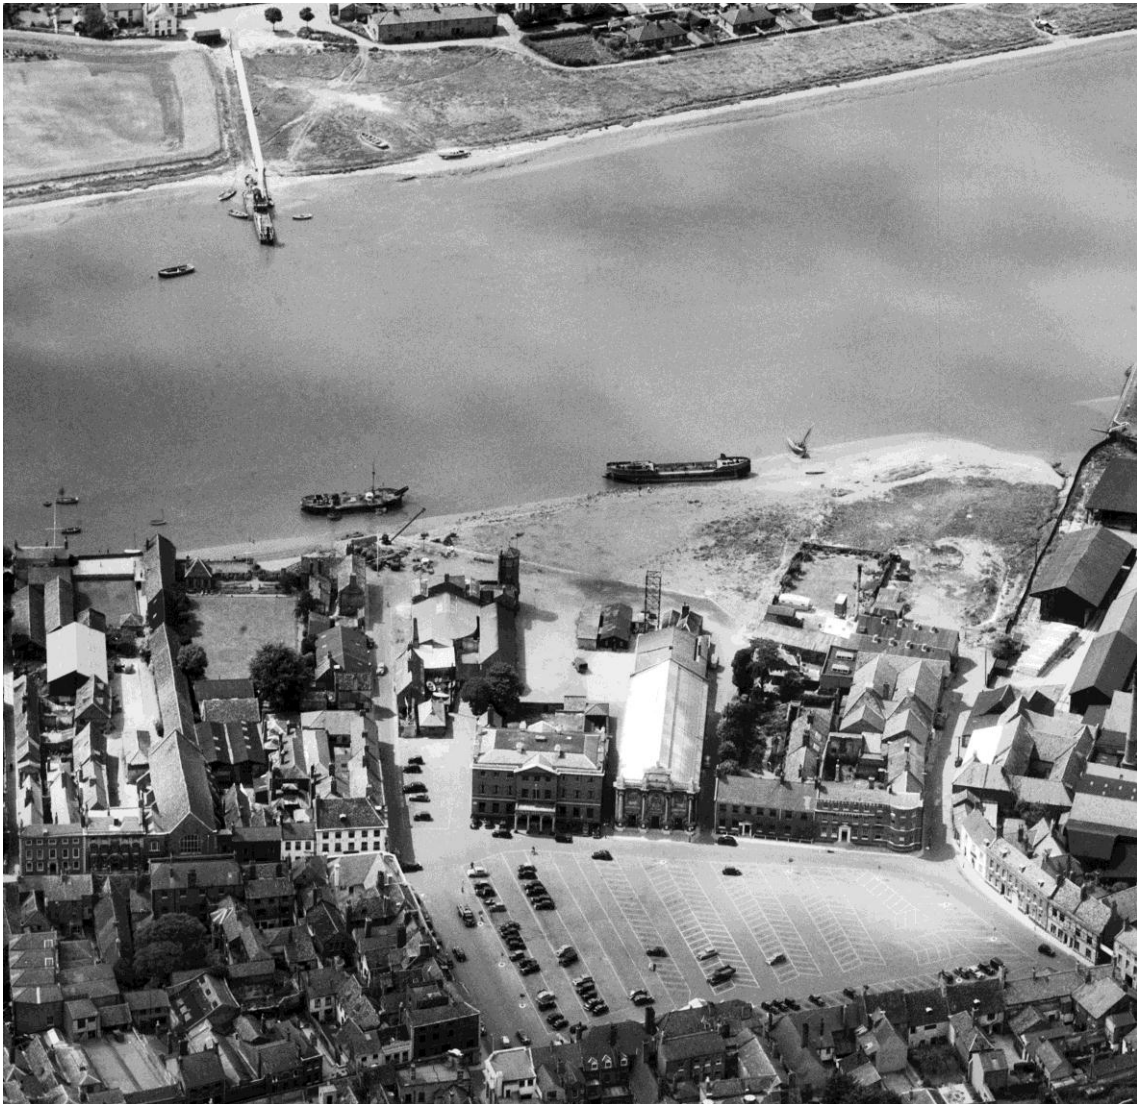
Fig. 7 An aerial view of the Common Staithe and its surroundings from the east in 1952. In the foreground is the Tuesday Market Place and in the background the Great Ouse, with the jetty from which the ferry departed. Note that the foreshore at the Common Staithe, while silted up, has not yet been reclaimed. Detail of HEA (Aerofilms Collection) EAW044459 27-JUN-1952

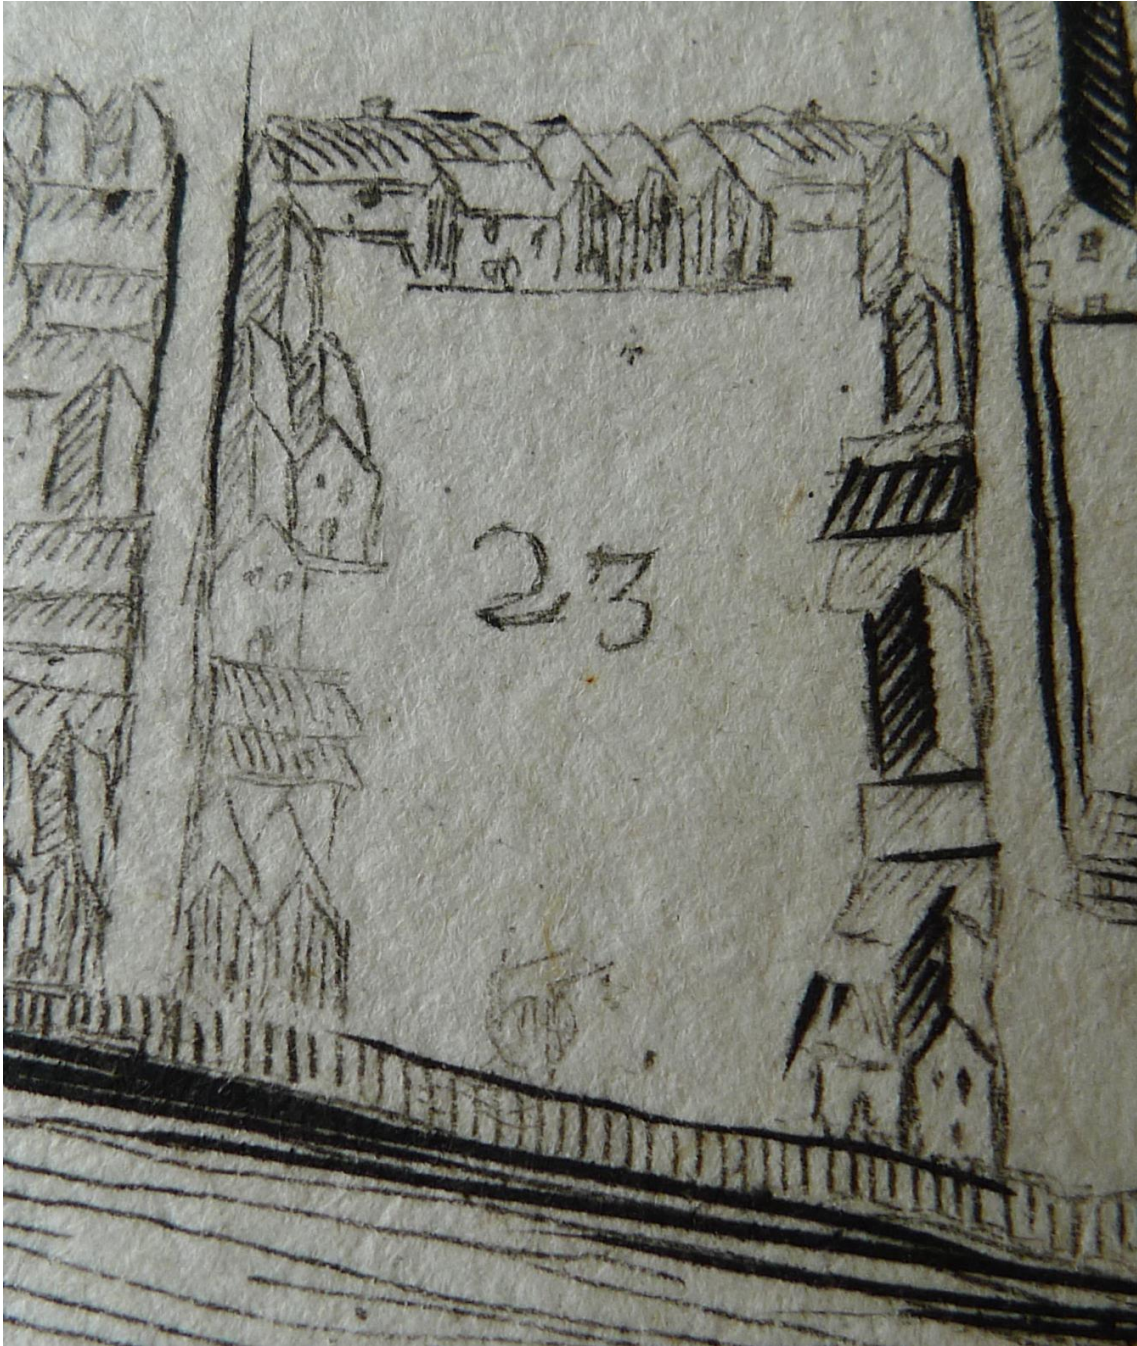
Fig. 13 The Common Staithe Yard c 1670, from Henry Bell's town plan. Note the quay at the bottom, the crane above it in the centre, and the lack of uniformity among the buildings. Norfolk Record Office BL 4/3.

The earliest plan of the site (and indeed of Lynn in any detail) is Wenceslas Hollar's, dated by David Higgins to c. 1660; it includes a prospect from the river showing the Common Staithe Yard (Fig. 11). It was more or less copied by Henry Bell in various versions over the ensuing decades (Figs 12 and 13).³⁰ Bell also produced two prints of the Tuesday Market Place showing the east frontage of the Common Staithe complex, one c. 1675 and the other c. 1687 (Fig. 14).³¹ William Rastrick's plan (dated 1725) shows the Common Staithe Yard in a more schematic form (Fig. 15).

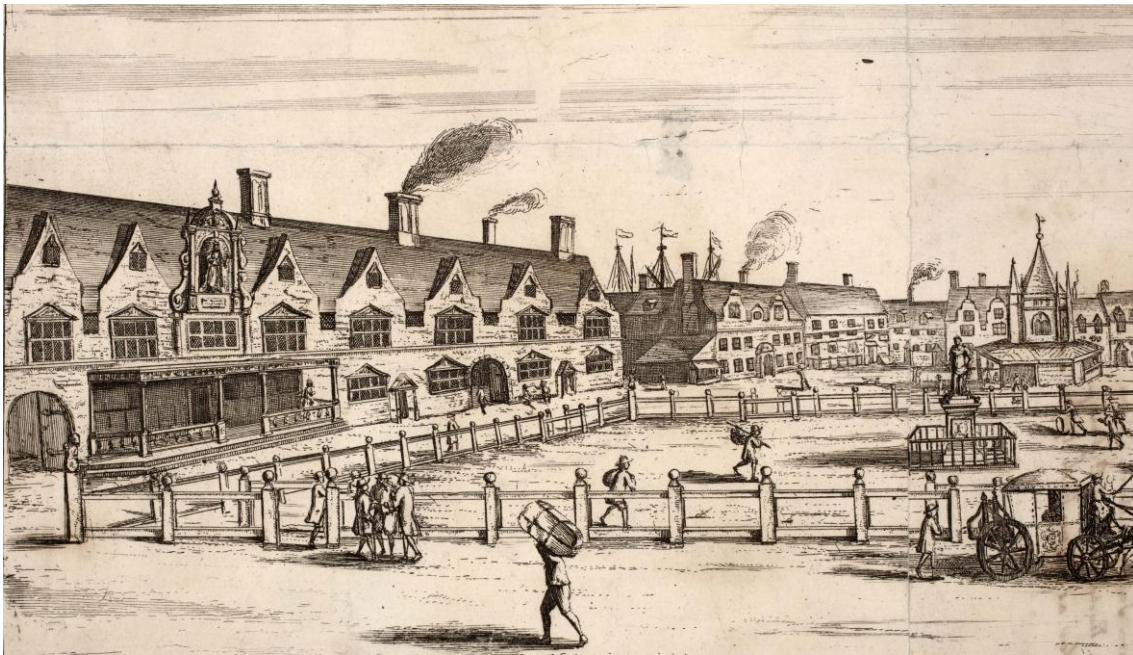
Fig. 14 The Tuesday Market Place c 1687, showing on the left the east front of the buildings on the Common Staithe. The section with the loggia was the Custom House. From a print by Henry Bell. Norfolk Museums Service (Lynn Museum).

the Smetham family and hence will be referred to as Smetham's House) (Fig. 18).⁴¹ Bell's print of 1687 (see Fig. 14) shows an elaborate east front, two and a half storeys high and with eight bays and gables visible as well as two double gates. The first-floor windows are all topped with triangular pediments. The southernmost section of frontage is not shown, but was almost certainly two further bays and gables. The sixth 'gable' from the north is elaborately shaped like a frontispiece and incorporates a large niche, and below it and the gable each side of it is what looks like an open wooden loggia; if the number of bays surmised is correct, this feature was not central.

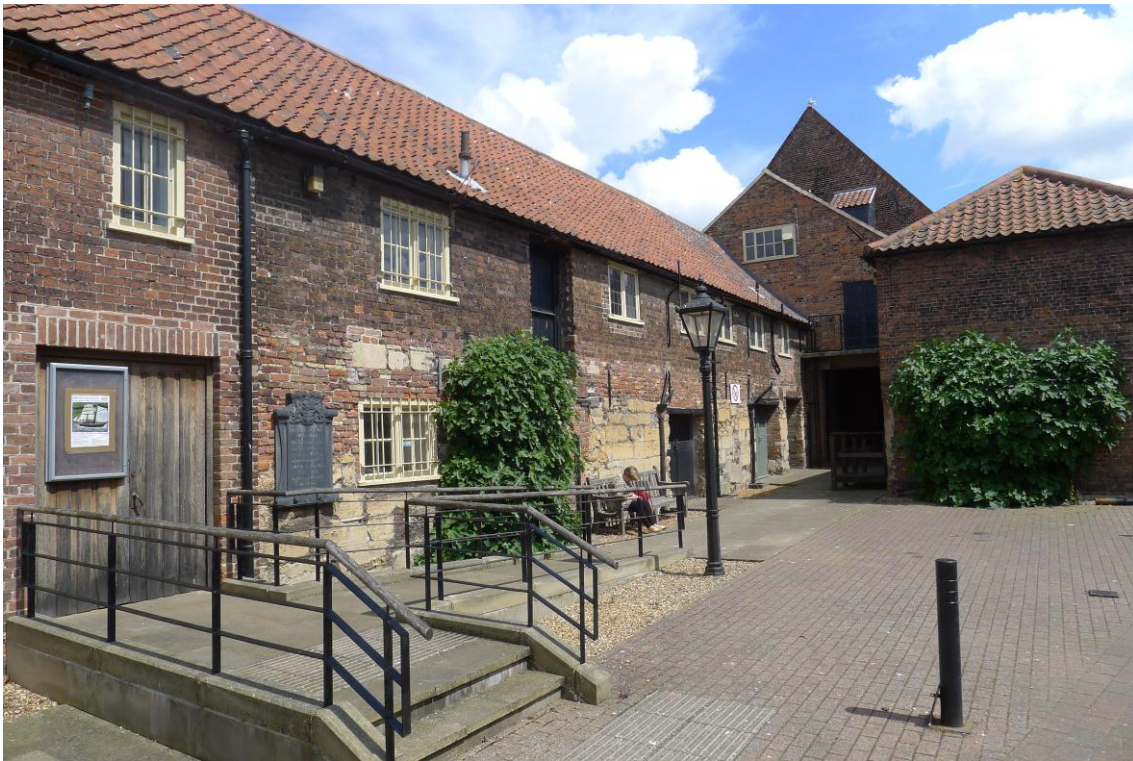
Fig. 16 St George's Guildhall, between King Street and the river; note the use of stone at lower level in the buildings. Photograph: Jonathan Kewley 5-JUL-2017 ©Historic England

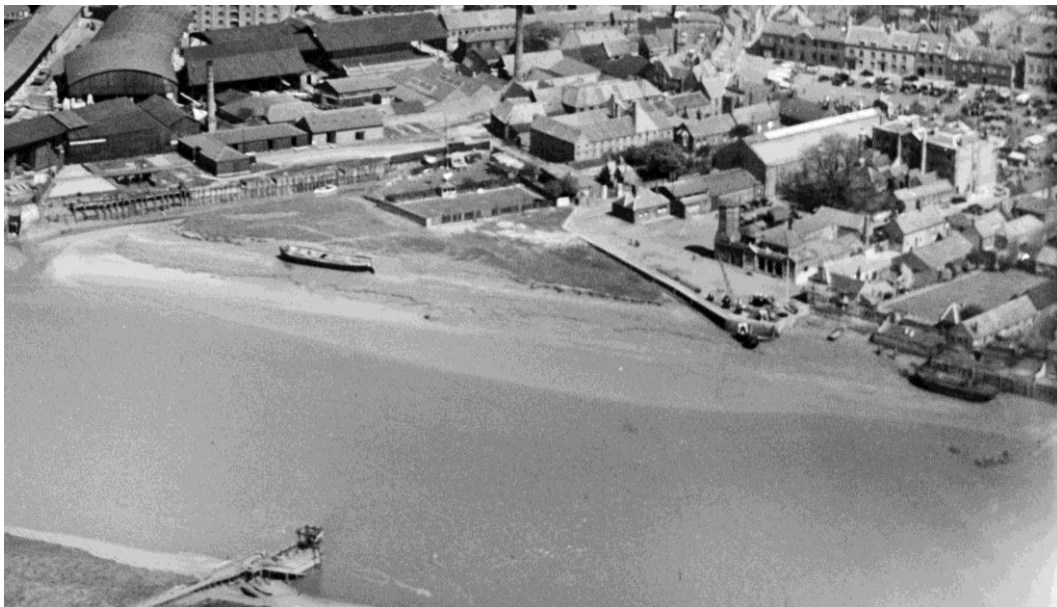
Fig. 20 An aerial view of the Common Staithe from the south-west in 1930, showing how the foreshore had silted up, leaving only the southernmost part of the quay in use. Detail of HEA (Aerofilms Collection) EPW031687 1930.

These early plans and prospects all show a quay forming the western boundary of the Common Staithe. It remained in use as the quay until most of the foreshore was reclaimed, and a new sea wall built further west, in about 1960 (Fig. 20). It still survives, the southern portion fully visible and indeed functioning, the northern three-quarters buried, except for the top kerb, in the car park. It is brick with stone dressings (Fig. 21).

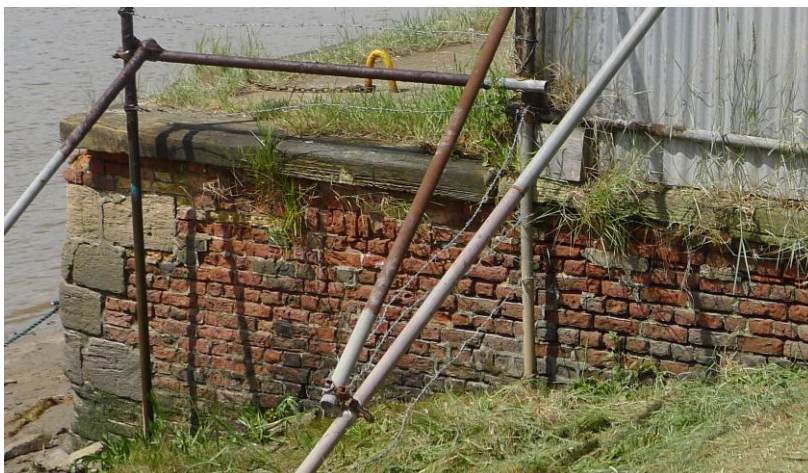
Fig. 21 The south-west corner of the old Common Staithe Quay, brick with stone dressings. Photograph: Jonathan Kewley 3-JUL-2017 ©Historic England

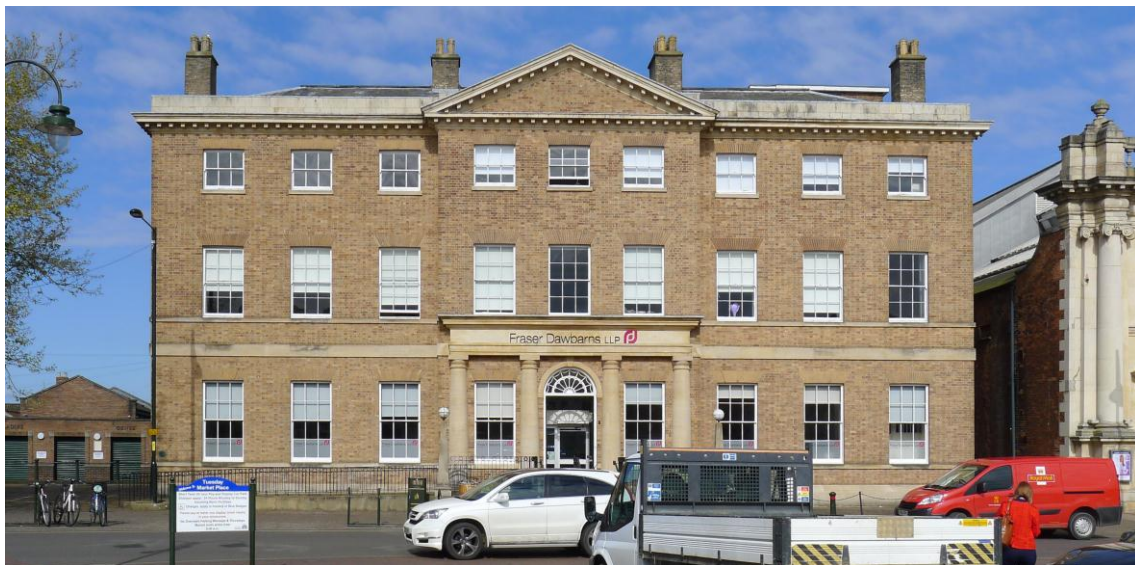
Fig. 25 The house George Hogg built in 1768 on the site of Turner's house; it was re-fronted in the 1950s. Photograph: Jonathan Kewley 3-MAY-2017 ©Historic England

Turner had also acquired what seem to have been the easternmost warehouses on the Common Staithe, creating a plot deeper (east-west) than wide; his land was divided from the Yard by a post-and-rail fence.⁶² The Collyer plan sets this out and shows that while there was a small garden, there was also a washhouse, pantries, stables, coachhouses, warehouses, cooperage and a dung heap. (Fig. 24). This house burned down and was rebuilt for George Hogg, a merchant, in 1768; that is essentially the building which survives at the south-west corner of the Tuesday Market Place today.⁶³ (Fig. 25).

Change took place on the eastern part of the historic Common Staithe (but outside the HAZ boundary) with extensive work to Gurney's. It was refronted, removing a porte-cochère, in the second half of the twentieth century (see Fig. 25). The date is usually given is 1951, but a photograph of 1952 shows the old façade, and a series of record photographs in King's Lynn Library is dated 1955. The refronting had taken place by the time of another photograph in 1963. More significantly, within this same decade, and presumably at the same time, the extensive range of outbuildings was demolished and replaced by largely flat-roofed single storey structures which now cover most of the site. The old outbuildings may possibly have incorporated parts of the old Common Staithe buildings, although this is uncertain. Their most distinctive feature was a triple gable (Fig. 50). It was presumably these outbuildings which were served by the tall, narrow chimneystacks which clasp each side of the rear pediment, to rather bizarre effect.

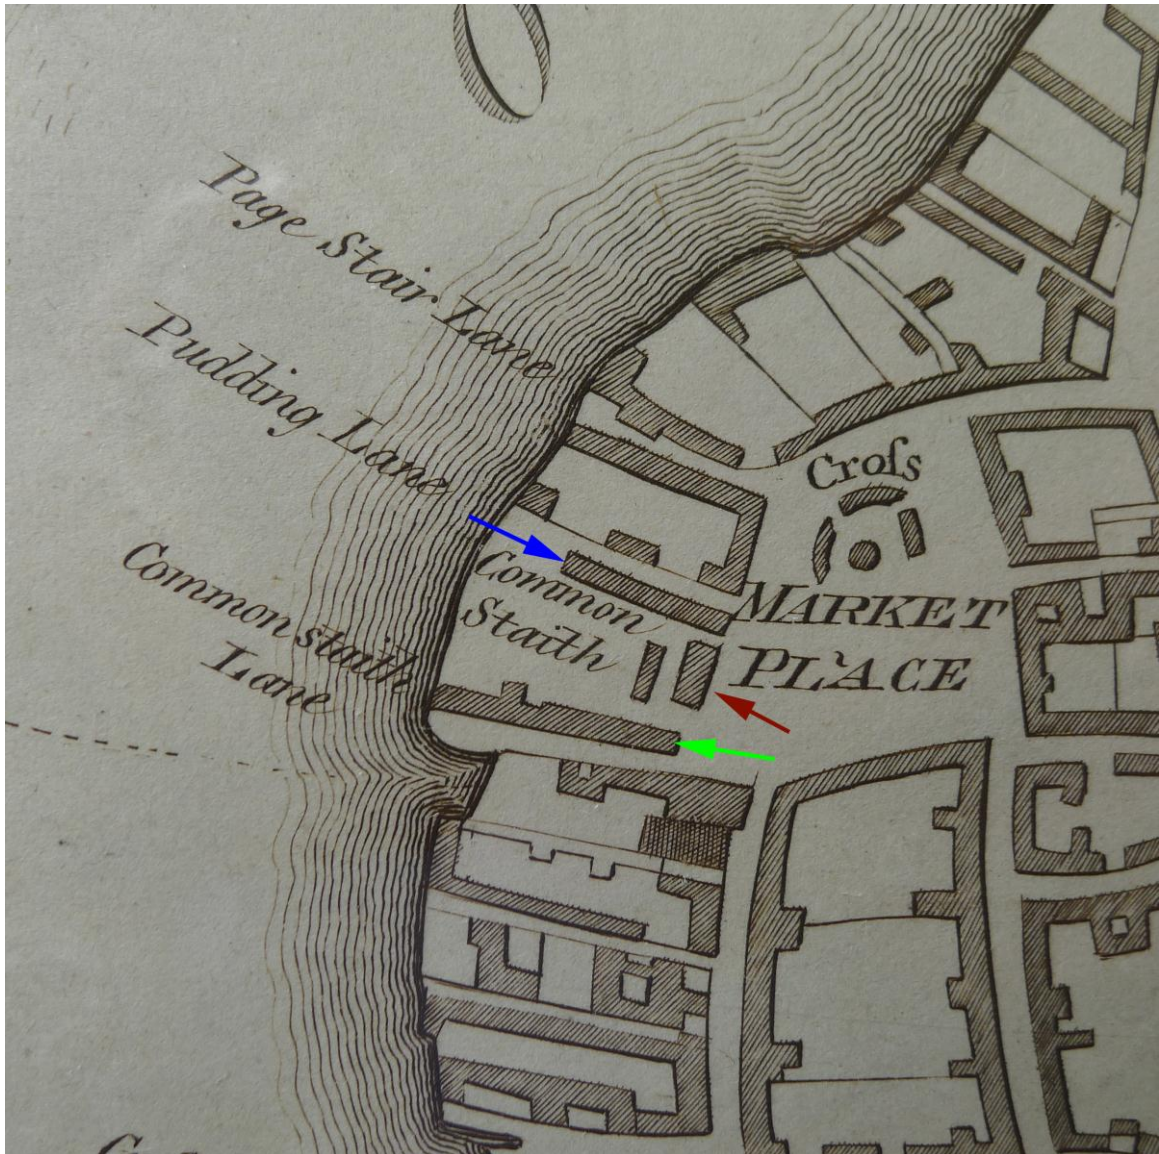
Fig 27 The Common Staithe in the late 18th century, showing the northern range (marked with a blue arrow), the southern range (marked with a green arrow) and Gurney's, marked with a red arrow). Detail of a map, catalogued at Norfolk Record Office as late 18th century and having strong similarities to Faden's map of 1797. Norfolk Record Office BL 4/5

The Common Staithe was still one of the three main wharves of the town in the 18th century, and the remaining, more westerly, warehouses remained in use into the 19th century (they were repaired in 1805).⁶⁵ Despite the loss of the east range, the rear pediment of Gurney's would have maintained a certain architectural cohesiveness to the space, the general form of which can be seen on late eighteenth-century maps (Fig. 27).⁶⁶

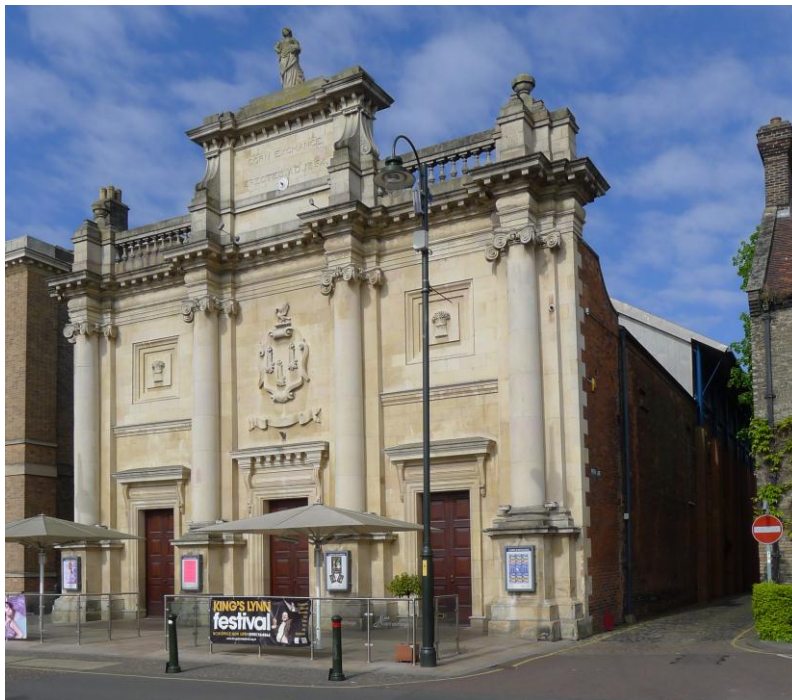
Fig. 31 The Corn Exchange by Cruso and Mabberley from the Tuesday Market Place.
Photograph: Jonathan Kewley 3-MAY-2017 ©Historic England

In 1853-54 the front part of the Market Hall was demolished and replaced with a Corn Exchange, its façade (which survives) a wonderful evocation of an Italian Baroque church, although attached originally to a metal-roofed shed (Fig. 31).⁷¹

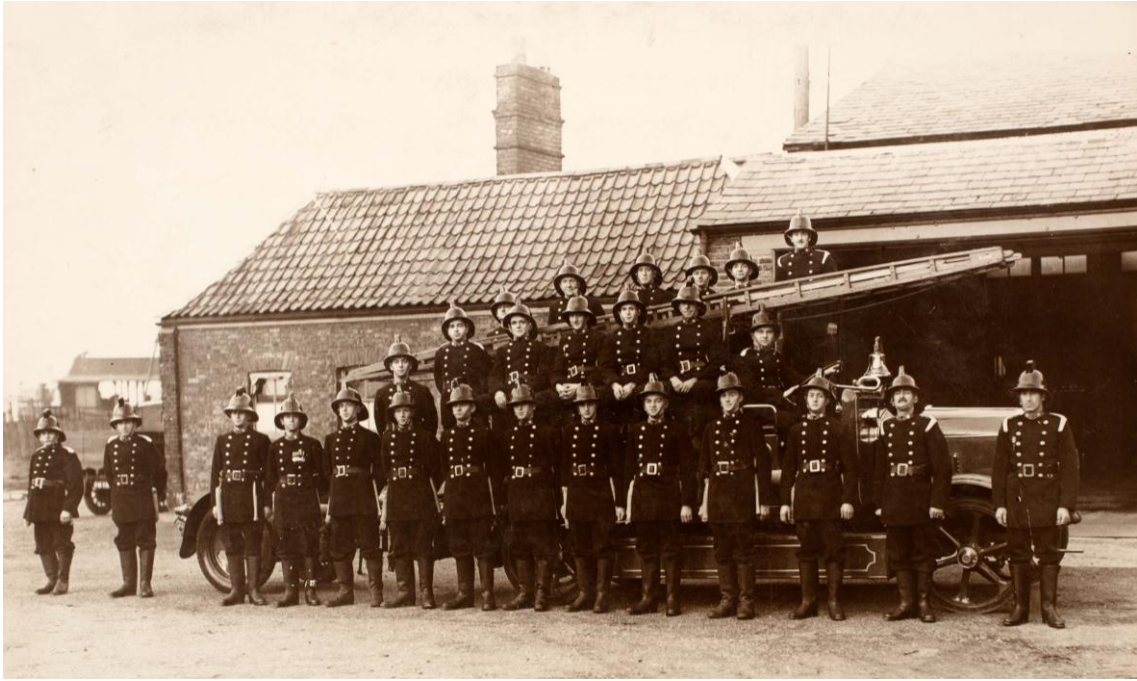
Fig. 32 The Fire Brigade on the Common Staithe in 1939, in front of the surviving back part of the Market Hall. Norfolk Museums Service (Lynn Museum) KILLM 2008 303

The back part of the Market Hall was used as a fire station by 1883 (Fig. 32), and a tower and further building erected to its south (Fig. 33).⁷² The Fire Station and most of the Exchange were in turn demolished in 1994-96 and replaced by a red brick and steel arts centre which now dominates the view from the river.⁷³ Instead of the old gated yard, lanes thereafter led into the Common Staithe on either side of the Corn Exchange – to the north, Water Lane (narrowed when the Exchange was built) and on the south, where the north gates to the Yard had stood between the Angel and the Custom House, what a Victorian source called River Lane.⁷⁴

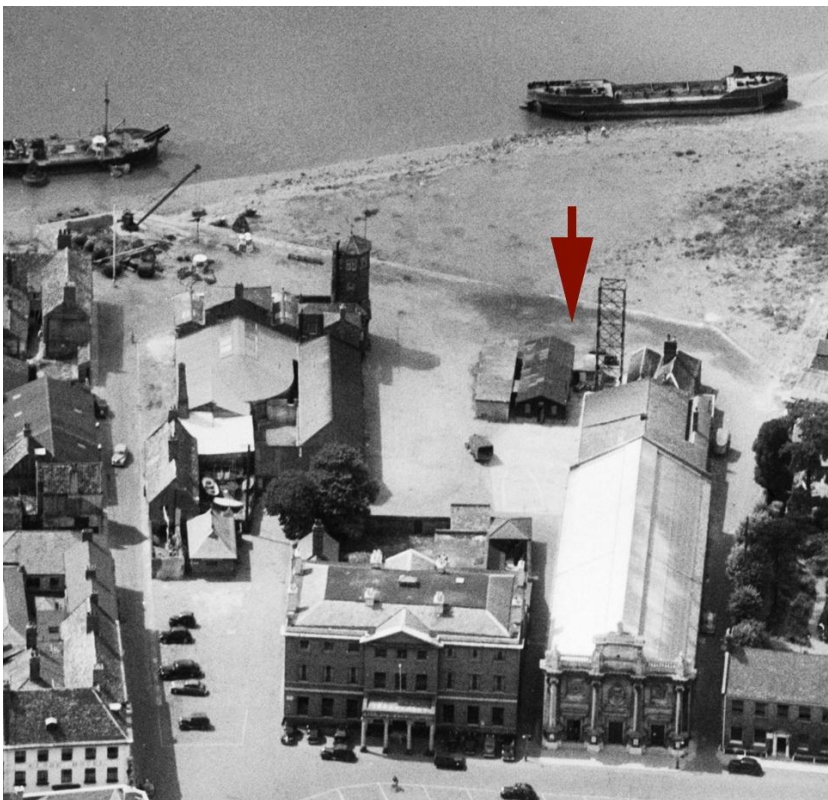
Fig. 33 An aerial view of the Common Staithe in 1952, showing the metal tower and other buildings added to the Market Hall for Fire Brigade use. Detail of HEA (Aerofilms Collection) AFL62343/EAW044459 27-JUN-1952

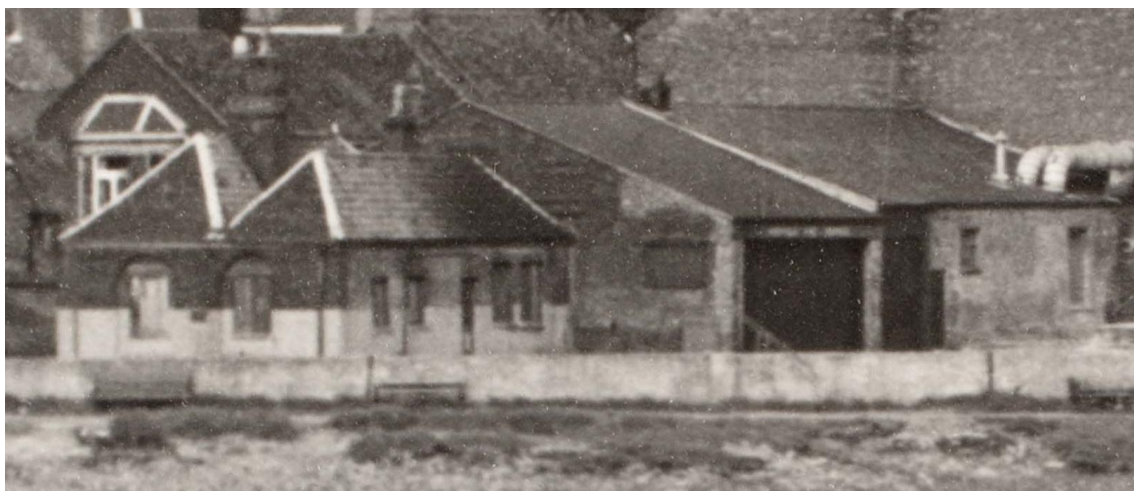
Fig. 34 The Fish Cross, later the Meter's Office, the one part of the old north range of the Common Staithe which survived the demolitions of the late 1820s, finally pulled down in 1967; it is the pantiled building behind the firemen in Fig. 32. Photograph by George King, 1963. Norfolk Library and Information Service (King's Lynn Library Archives)

One part of the range appears to have survived; what was called the Fish Cross was ordered in 1830 to be put into repair by hipping the roofs and enclosing the space between it and the new Market Hall.⁷⁵ This seems to have been the single-storey building, used at some stage as the office of the market official called the meter. It

appears in old photographs with two roofs running east-west, pantiled and hipped at the west end (Fig. 34); it was demolished in 1967.⁷⁶

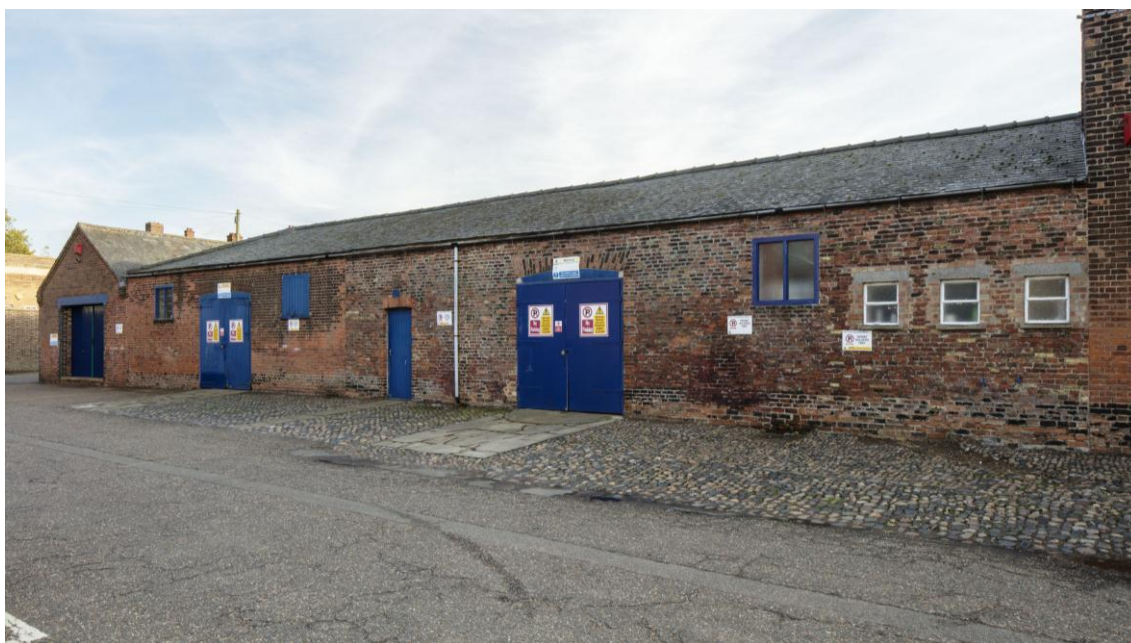
Fig. 35 The warehouses on the Common Staithe, built in 1829 (the right-hand section, up to just left of the foot door) and 1834 (the rest of the range under the same roof; the gabled building beyond is 20th century). Detail of DP 219084 28-SEP-2017 Patricia Payne ©Historic England

The 1829 warehouse (Fig. 35) was built by one William Candler on the basis that he was allowed the materials of Lots 3 and 4 in the auction, and so was probably actually built of them. As explained, no record has survived of what the various lots were, but there is mention that Candler had ‘purchased’ a wall at the west end of the Market Hall site as well as the old warehouses adjoining the Angel; it is not clear whether purchased is careless shorthand for being allowed to use them to build the new warehouse, or whether it distinguishes one lot of materials from the other.⁷⁹ The Corporation seems earlier to have seen all materials from demolished structures (including the market cross) as one resource from which the warehouses could be built and enough be left to raise the sum of £500 they were giving towards the Market Hall.⁸⁰ As will be discussed below, it is likely that this 1829 warehouse was the present Buoy Store, which incorporates some stone at high level in the south wall, something explicable only by the re-use of materials.

The Stores or Warehouses building consists of a single-storey building approximately 26.5m. long, aligned roughly east-west (Fig. 62; see also Fig. 35). Apart from a now-blocked hatch to the Carpenters' Workshop it has no communication with any of the other buildings to which it is attached. It is divided internally into four spaces, the first three comprising the earlier, 1829 building, and the fourth the 1834 addition. They look quite similar in appearance to the rear part of the 1828 Market Hall, demolished in 1997.³

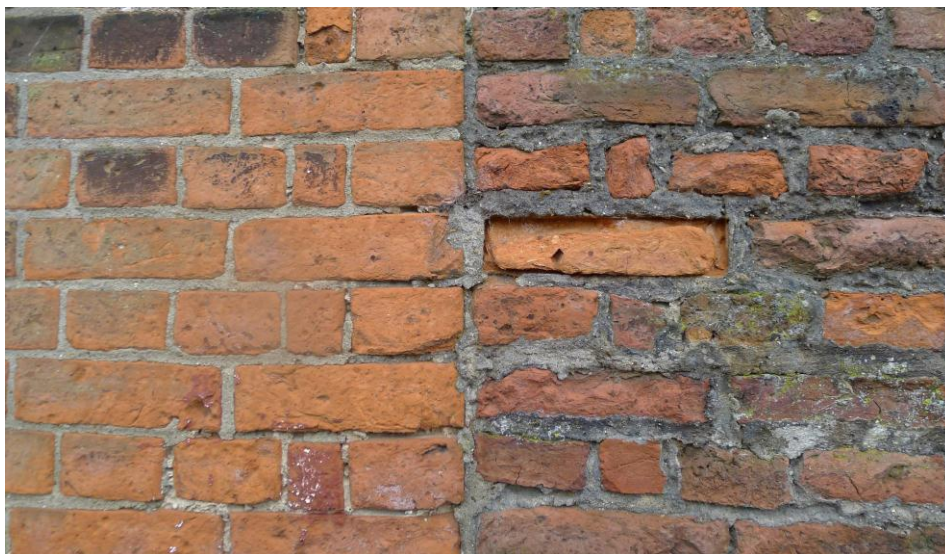
Fig. 36 The break in the brickwork between the 1829 (right) and 1834 (left) warehouses. Photograph: Jonathan Kewley 6-JUN-2017 ©Historic England

In 1834 an addition of thirty-four feet was made at the east end of ‘the warehouse’. This was the present Engineers’ Workshop, east of the Magazine and Buoy Store. There is a clear break in the brickwork between the two sections (Fig. 36), making the Workshop not far off 34ft long, and it does not appear to incorporate old materials in its fabric. The roof looks all one, however. In 1925 it was ordered that the slates should be stripped from it, the ridge repaired, the south side of the roof reslated with the old materials, and the north side covered with corrugated iron; presumably if this was ever carried out, the iron was later replaced with slates.⁸¹ The Engineers’ Workshop is presumably the ‘easternmost warehouse on the Common Staithe Quay’, an application to the Corporation to rent which in 1868 was turned down as it was used by ‘the Beacon’.⁸² To what extent this range was in its early years used by the Corporation and to what extent its component parts were let is unclear.

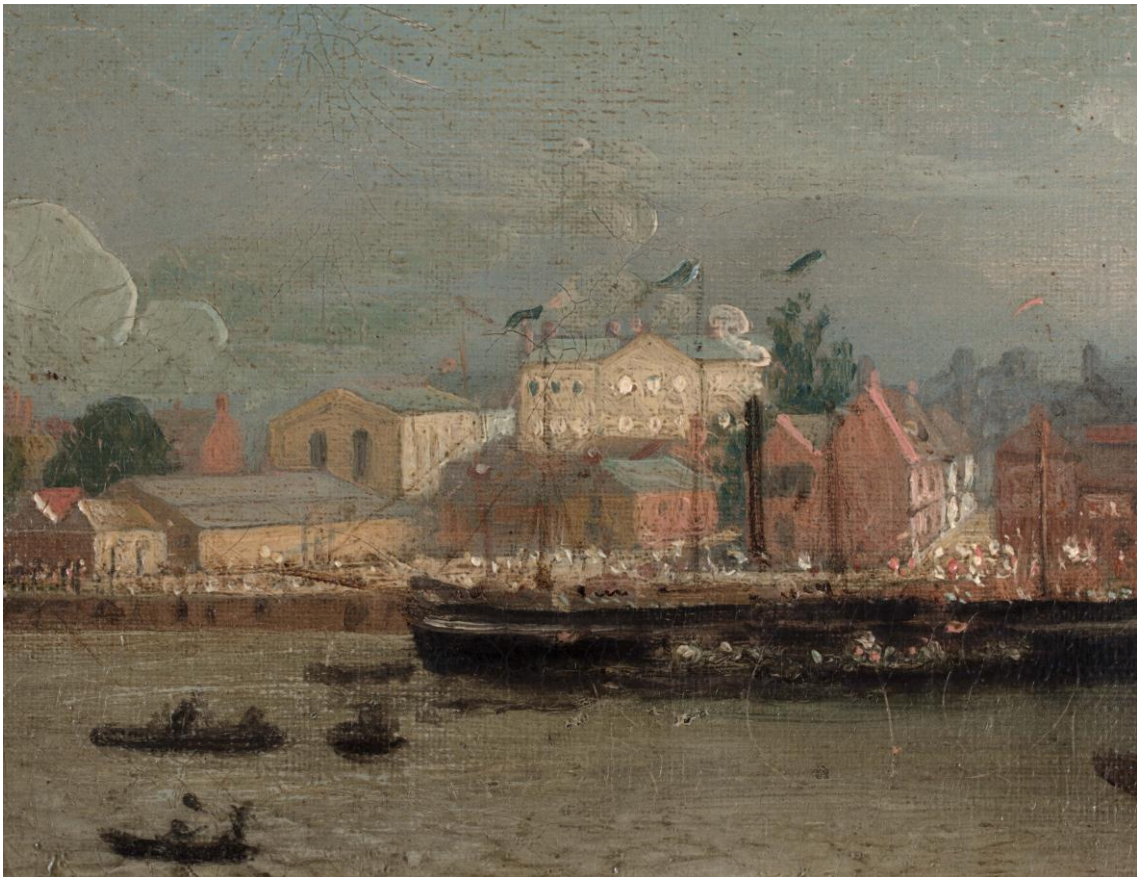
Fig. 37 Detail of an oil in Lynn Museum's collection, date and artist unknown, which shows the Common Staithe from the river. The tallest building is Gurney's, with the old Market House and the taller Corn Exchange to the left. On the right the steep double gables are the southern range of the old Common Staithe, the near end soon to be demolished to make way for the Public Baths. Rather hidden behind the rigging, in front of Gurney's is the 1829 warehouse seen before the Pilot Office was added on to it. Norfolk Museums Service (Lynn Museum)

The old south range seems to have survived untouched; an undated oil in Lynn Museum (Fig. 37) shows the Common Staithe from the west and includes an end-on view of this range with a steeply-pitched M-shaped roof. There is reference in

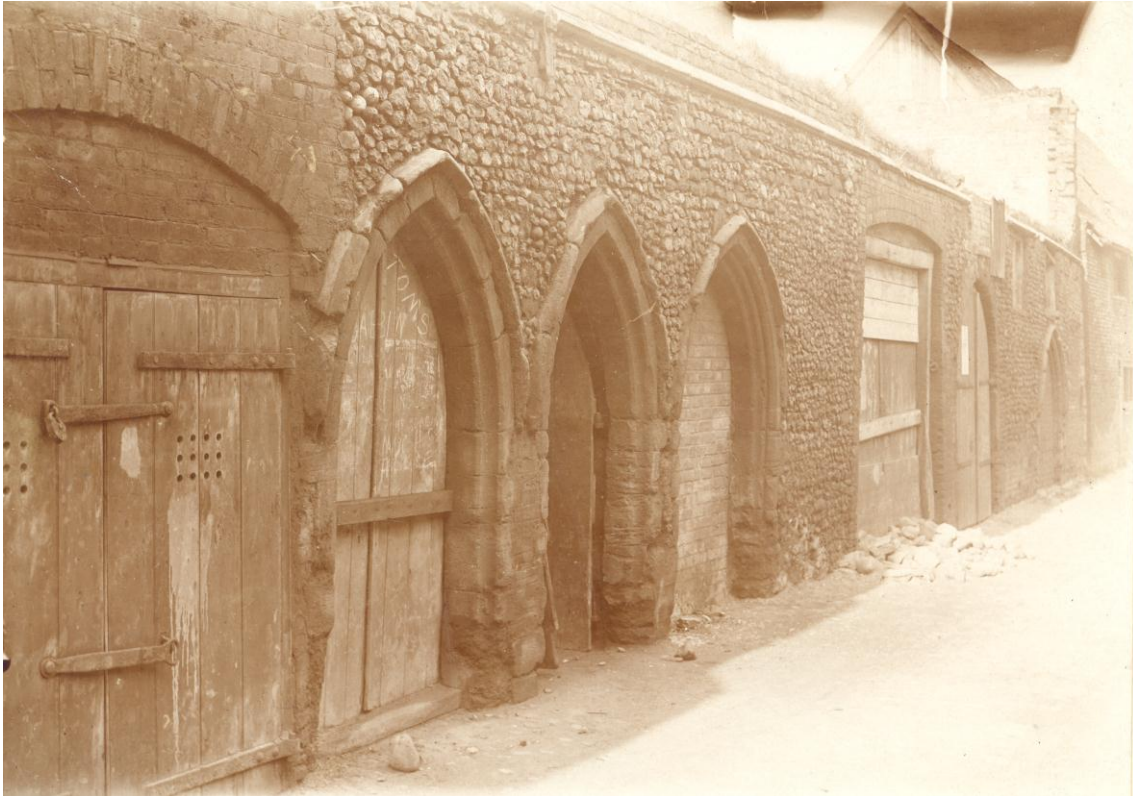
Fig. 39 The north side of the range shown on Fig. 38. Note the building on the very far right with a steep gable and mullioned windows with dripmoulds. True's Yard Fisherfolk Museum TY6136

So far as can be worked out from photographs and a drawing from when the arches were *in situ* (Figs. 112 and 113; see also Fig. 39), the present arrangement of the arches in the Tower Gardens replicates their alignment and relationship to each other, but omitting the brick and the wooden gates which joined them. No interior photographs of the building of which they were part survive, so it is unclear how accurate the south face of the reconstruction is.

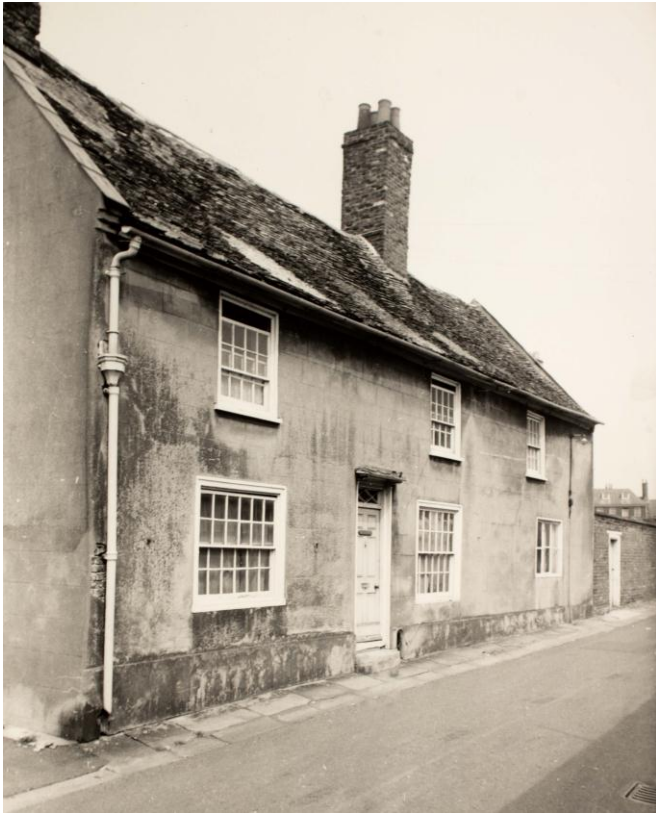
Fig. 41 The last surviving building from the south range of the Common Staithe, prior to its demolition: Birtledene, Ferry Street, from the south-west, early 1960s. Norfolk Museums Service (Lynn Museum)

By 1928 everything in this range east of the Baths had been demolished except for the two south-facing cottages which then or later had been converted into one, called Birtledene (Figs. 41 and 42). They seem to have been occupied in 1891 and 1901 by a fisherman and his family.⁹⁹ They appear to have been of some age judging by the steepness of the roof-pitch. They were demolished by the Corporation in about 1962, except for the north wall which partly survives (see below).¹⁰⁰ A wall leading north from the west end of Birtledene, which also survives, may represent an internal wall in the inner range of warehouses on the southern side of the Common Staithe Yard.

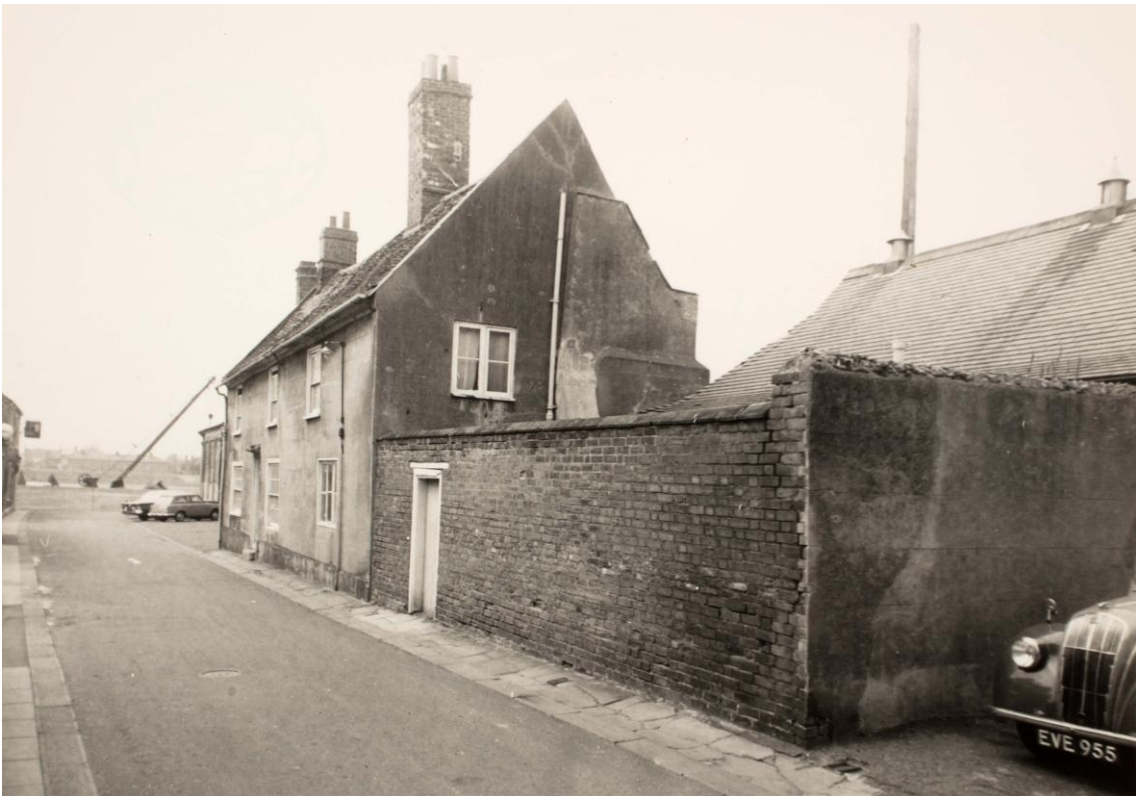
Fig. 42 Birtledene, Ferry Street from the south-east, early 1960s. Norfolk Museums Service (Lynn Museum)

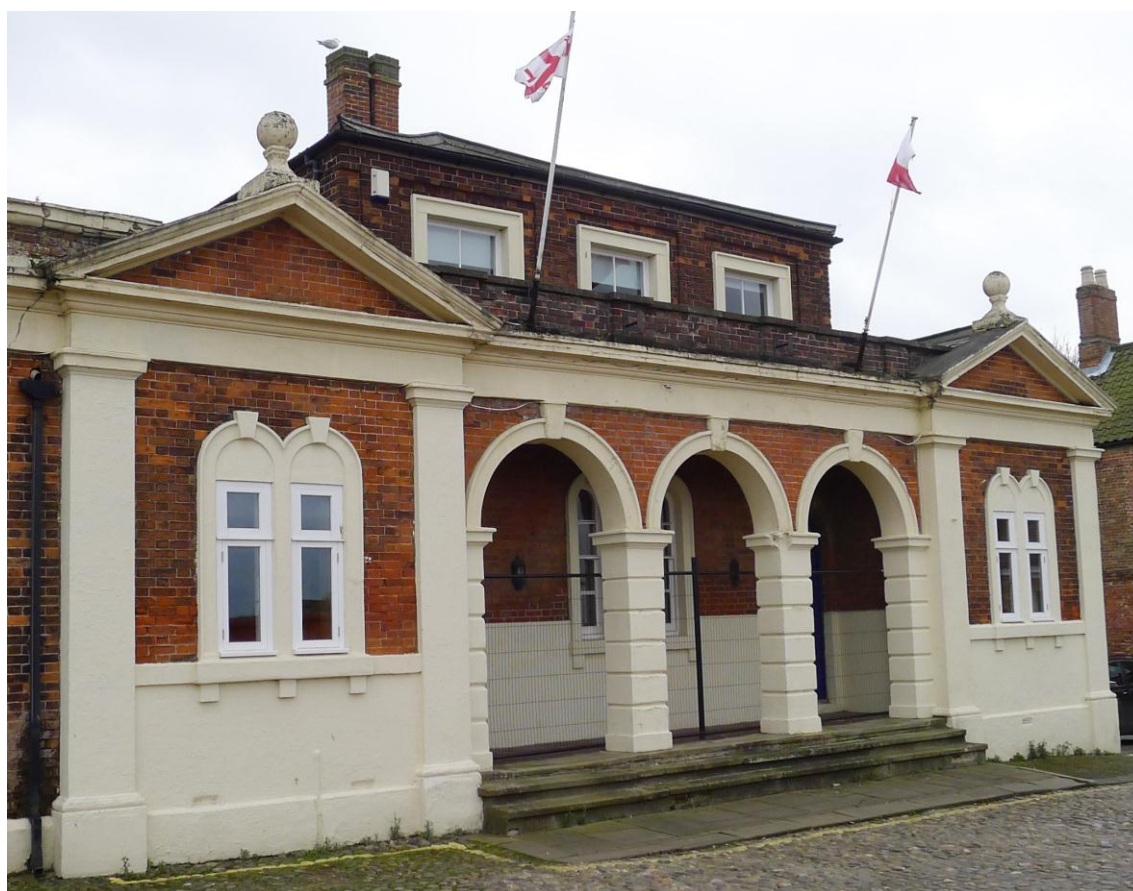
Fig. 43 The principal (west) front of King's Lynn Public Baths. Photograph: Jonathan Kewley 27-FEB-2017 ©Historic England

Contemporary with these were public baths (Fig. 43). Most pre-Victorian public baths (and as Marcus Binney makes clear there were many) were intended for the middle or upper classes, who used not just the swimming pool but also the slipper baths; most middle-class houses still did not have bathrooms in the 1850s, although people bathed in front of the fire in hip-baths filled by housemaids.¹⁰¹ Even at the

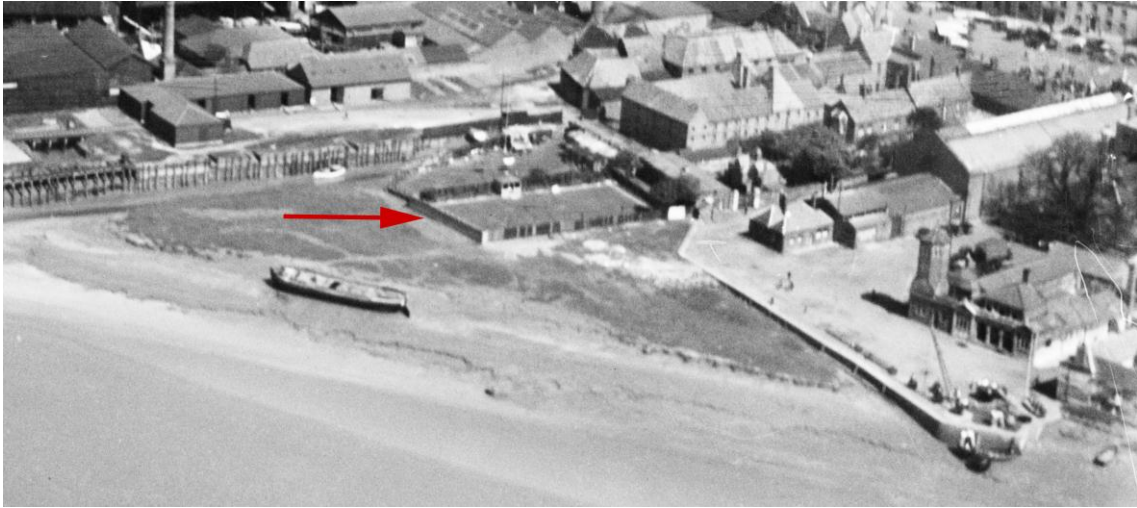
Fig. 45 An aerial view of the Common Staithe in 1930, showing the area (marked with the arrow) taken in from the foreshore as part of the Lynn Laundry. Detail of HEA (Aerofilms Collection) EPW031686 1952

Once the silting-up became permanent, alternative uses for the foreshore emerged, and it was used for 'floatage' by nearby timber merchants.¹⁸⁶ Some foreshore land to the north of the quay was enclosed and became part of the grounds of the King's Lynn Laundry (Fig. 45); it is now part of the site of Trinity Quay. The Common Staithe Quay retained or developed status as the public riverbank; townspeople are recorded promenading on it or watching a regatta.¹⁸⁷ Swimming off it was frowned upon, both because it might be dangerous and as an 'outrage against public decency'.¹⁸⁸ Extensive repairs were carried out in 1874-75, when the southernmost 20 feet were taken down and rebuilt (the coping stones at the angle, which must have projected above quay level, being put back lower), and in 1892 when 103 feet was pulled down and rebuilt.¹⁸⁹

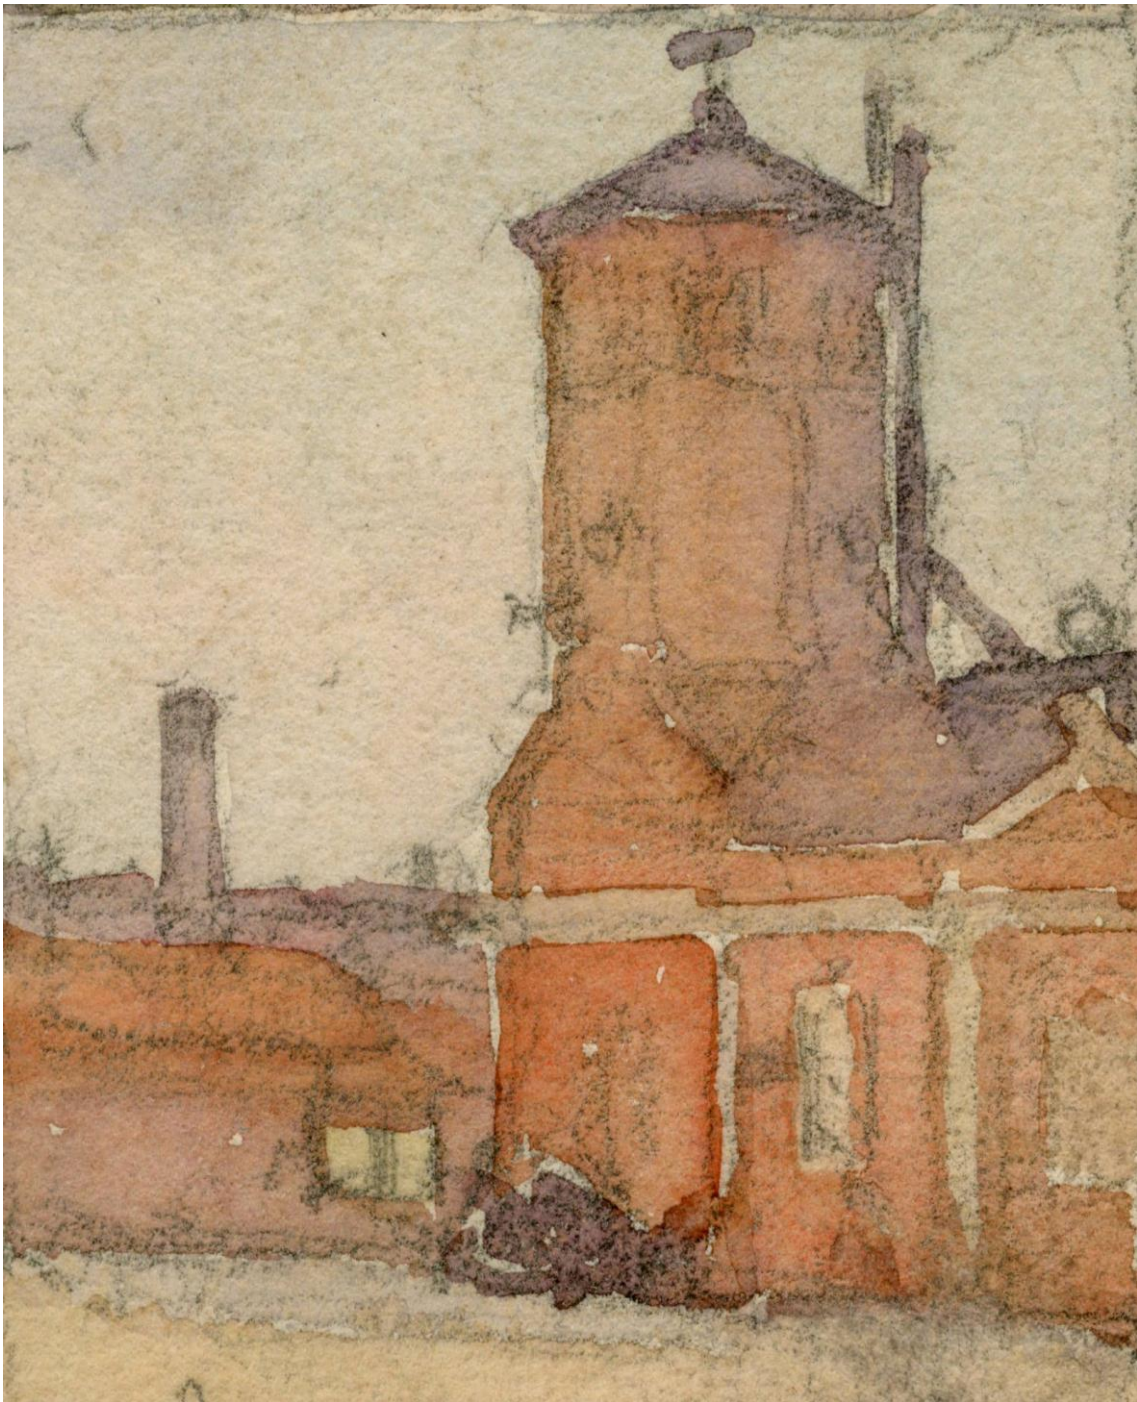
Fig. 46 The Pilot Office from the south-west, a watercolour by the Lynn artist Walter Dexter, 1906. Norfolk Museums Service (Lynn Museum) KILLM 1991 b334

One result of the changing position of the river channel was the building of a new pilot office in 1863 (Fig. 46), something first proposed in 1857.¹⁹⁰ This restored its site to the Common Staithe. This was not the only position in the town with a view downstream, but it had the financial and practical advantage of being in the

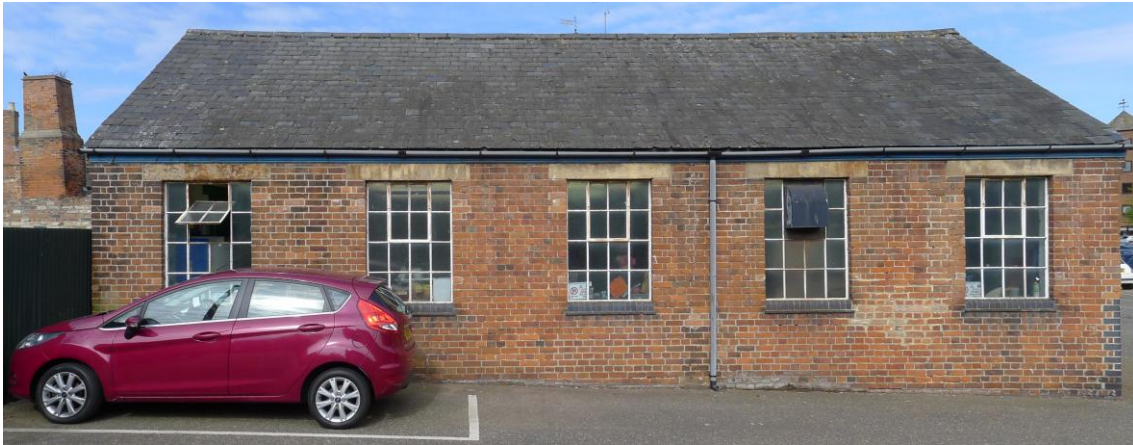
Fig. 47 The Carpenters' Workshop from the east. Photograph: Jonathan Kewley 2-MAY-2017 ©Historic England.

Two buildings were erected within the HAZ site in the 20th century. After the Conservancy Board had to leave the Boal Quay premises, as just mentioned, they were given the use of all the 1829-34 warehouses. These were insufficient, and shortly afterwards, in about 1920, what is now known as the Carpenters' Workshop was built to the east, described originally as 'the new Buoy House' (Fig. 47).²⁰⁴ It abuts the 1829/1834 range on its east but is aligned north-south not east-west, and has no communication with that range except a hatch; the site is shown as open on the 1883 Ordnance Survey map and, like the site of the 1829/1834 range, was part of the historically-open space in the middle of the Common Staithe Yard. Its site may represent the 'piece of land' for use by the Conservancy Board and adjoining their premises, staked out on the Common Staithe in 1899.²⁰⁵
