Historic England

The Common Staithe, King's Lynn, Norfolk: An architectural and archaeological assessment

Jonathan Kewley

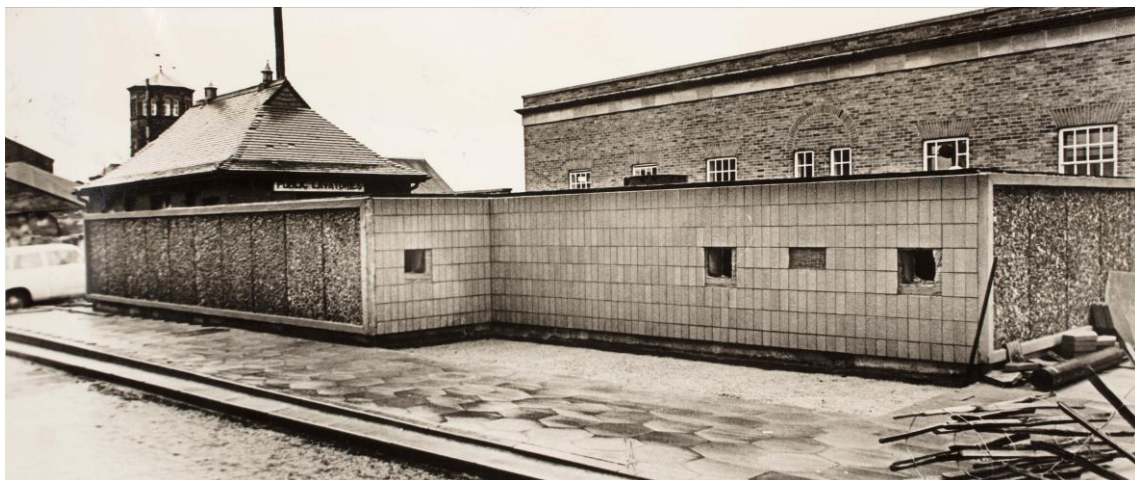
Fig. 49 The public lavatories of 1966, designed by Desmond Waite; their predecessors are visible in the background. Norfolk Library and Information Service (King's Lynn Library Archives)

The second building of 20th-century date was a public lavatory. The Corporation had thought of selling the by-then vacant site of Smetham's House just after the Great War, but had finally voted against it in 1923.²⁰⁶ In 1928 plans were drawn up for public lavatories just south-east of the Carpenters' Workshop (perhaps significantly, leaving space for other future uses of the majority of the Smetham's House site), and they seem to have been built shortly afterwards (Fig. 48).²⁰⁷ A proposal by the Conservancy Board in 1964 to erect their own lavatories 'at the rear of the Buoy Shop' (presumably the Carpenters' Shop) does not seem to have proceeded, and in the end lavatories were built within the Buoy Store by local mariners themselves.²⁰⁸ New public lavatories were built further east in 1966, designed by Desmond Waite, in a flat-roofed Modernist style incorporating flint panels (Fig. 49), upon completion of which the old ones were pulled down; sadly the 1966 building no longer survives.²⁰⁹ They were let into the ground to reduce their external height.²¹⁰

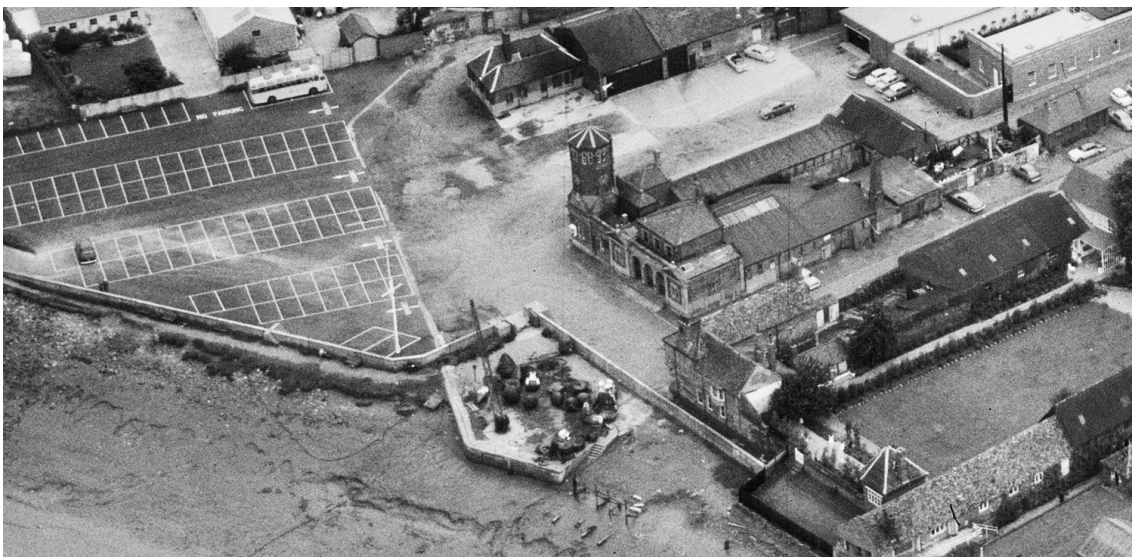
Fig. 52 An aerial view of the Common Staithe in 1963 showing the foreshore outside the Common Staithe Quay metalled and with parking spaces painted on. Detail of HEA (Aerofilms Collection) EAW116074 8-JUL-1963

Sometime between 1952 and 1963 a sea wall was built around most of the grassy area which was raised up to the top of the level of the old quay; an aerial photograph of 1963 shows it metalled and with parking spaces seemingly newly painted (Fig. 52).

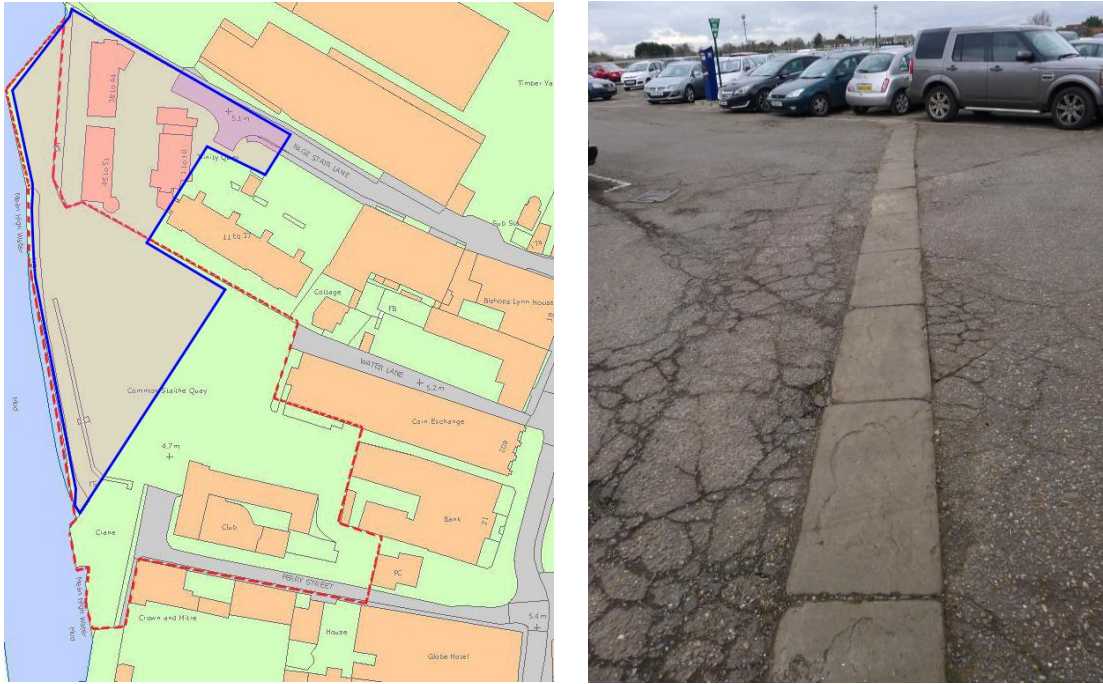
Fig. 54 (above left) The HAZ boundary, showing outlined in blue the portion reclaimed in the second half of the 20th century. Modern Ordnance Survey mapping: © Crown Copyright and database right 2017. All rights reserved. Ordnance Survey Licence number 100024900

Fig. 55 (above right) The top of the old quay, still visible in the paving of the Common Staithe car park. Presumably the 16th or 17th century quay wall survives below it. Photograph: Sarah Newsome 27-FEB-2017 ©Historic England

The area on the river side of this was used recreationally, with park benches from which to enjoy the view (Fig. 53). (Even in the 1850s when the quay was fully operational it had been recorded as being used as a place for promenading).²¹³ In the late 1980s, presumably as a result of the threat of flooding, a sea wall and raised public walkway were built to enclose the tarmacaded area. This reclaimed land, which forms much of the HAZ site (Fig. 54), is currently used as a car park. The line of the old quay is still visible in the paving (Fig. 55).

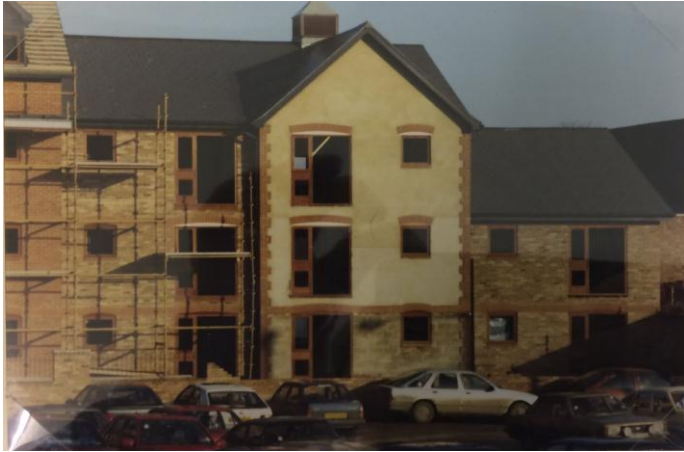
Fig. 57 Trinity Quay under construction in 1990. Norfolk Museums Service (Lynn Museum)

which by 1929 had become the King's Lynn Laundry (Fig. 56). In the 1980s this was demolished and replaced by three- and four-storey flats (Fig. 57). They were named Trinity Quay (presumably a reference to the Trinity Guild which owned the Common Staithe before the Reformation) and have a tower at the south-west corner which echoes that on the Pilot Office (Fig. 58).

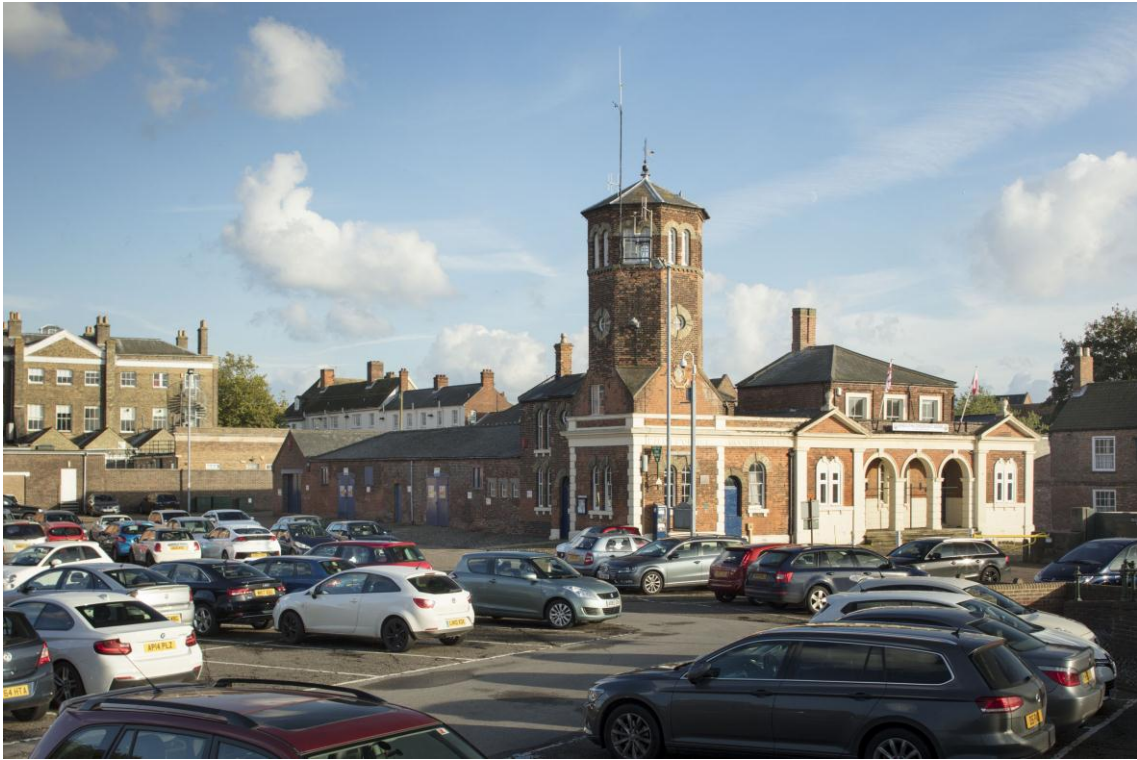
Fig. 61 The buildings on the Common Staithe today; on the left are the warehouses or buoy stores, in the middle the Pilot Office, with a tower, and on the right the Baths. Detail of DP 219084 28-SEP-2017 Patricia Payne © Historic England

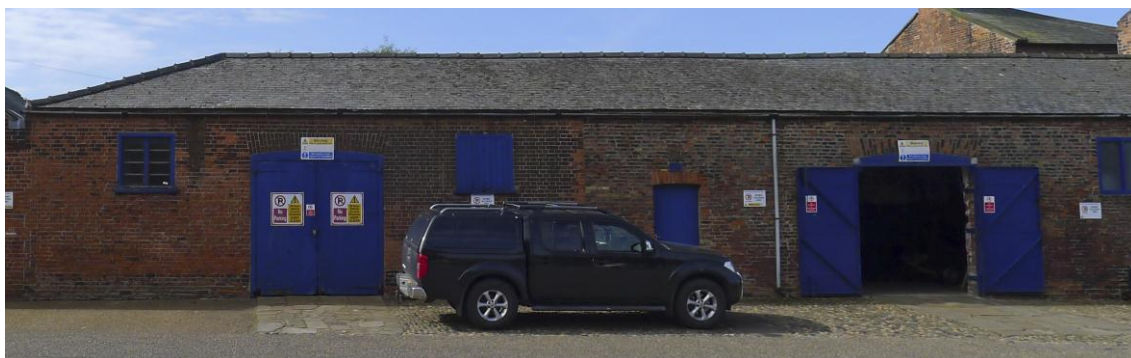
Fig. 62 The warehouses from the north. Photograph: Jonathan Kewley 2-MAY-2017 ©Historic England

The Stores or Warehouses building consists of a single-storey building approximately 26.5m. long, aligned roughly east-west (Fig. 62; see also Fig. 35). Apart from a now-blocked hatch to the Carpenters' Workshop it has no communication with any of the other buildings to which it is attached. It is divided internally into four spaces, the first three comprising the earlier, 1829 building, and the fourth the 1834 addition. They look quite similar in appearance to the rear part of the 1828 Market Hall, demolished in 1997.³

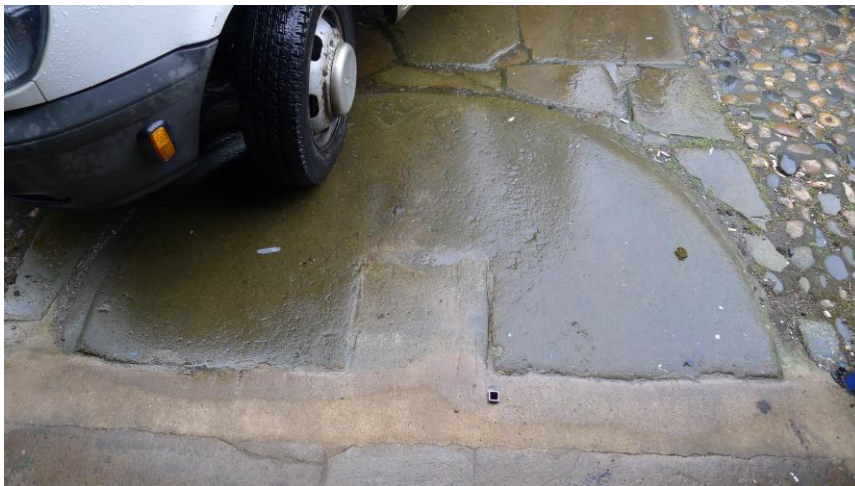
Fig. 64 What appears to be a half millstone (perhaps an edge-runner) at the threshold to the Buoy Store. Photograph: Jonathan Kewley 6-JUN-2017 ©Historic England

At the western end is what is now called the Buoy Store (Fig. 63). It is entered by double doors under a very shallow segmental arch at the east end of the north façade; the threshold is formed by what seems to be half a millstone, perhaps from an edge-runner mill (Fig. 64). There is a high-level, roughly-square window in the

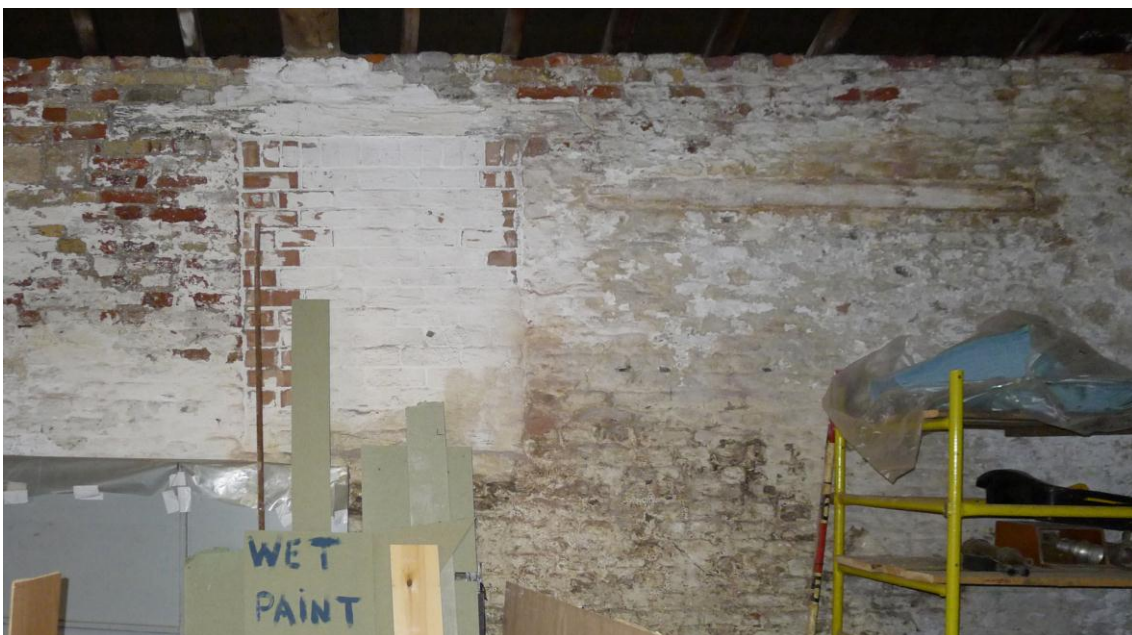
Fig. 65 A blocked-up window in the south wall of the Buoy Store. Photograph: Jonathan Kewley 6-JUN-2017 ©Historic England

centre of the north wall, which at one time in the nineteenth century had a flagpole attached to it (see Fig. 85). Towards the west end of the south wall, quite high up, is a blocked-up window which would have opened onto what is now the open area to the north of the apse of the Swimming Pool Hall (Fig. 65). The north-west corner is now partitioned off as lavatories with three windows punched through what old photographs show to have been a blank wall (see Fig. 85). It has no ceiling and is open to the rafters. Its eastern wall extends only to eaves height, being open above.

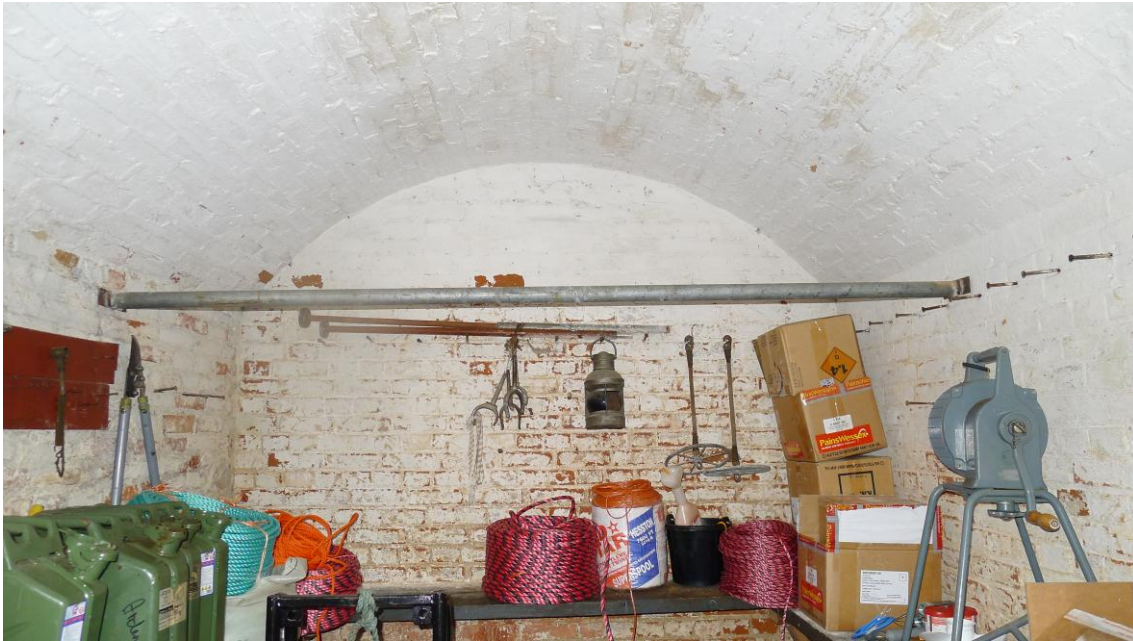
Fig. 66 The interior of the Magazine, looking south. Photograph: Jonathan Kewley 6-JUN-2017 ©Historic England

Immediately to the east of the Buoy Store are two rooms the same width (east-west) as each other. That to the north is the Magazine, with a brick barrel-vaulted ceiling (Fig. 66). Its only opening is a foot door (with a very shallow segmental arch above)

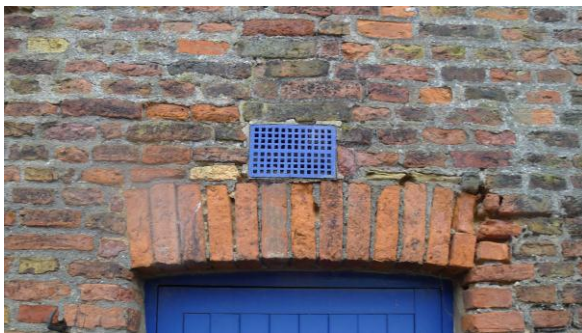
Fig. 67 The ventilator above the door of the Magazine. Photograph: Jonathan Kewley 6-JUN-2017 ©Historic England

in its north wall to the Common Staithe Yard. There is a small iron ventilation grille immediately above the voussoirs on the external wall (Fig. 67), but on the inside, there is a ventilator quite a bit higher, with presumably a pipe between them. The space above the vault is open to the Buoy Store and the Inner Store. The Magazine must have been intended for the storage of explosives for some harbour use, or for the safekeeping of explosives belonging to ships moored in the port.

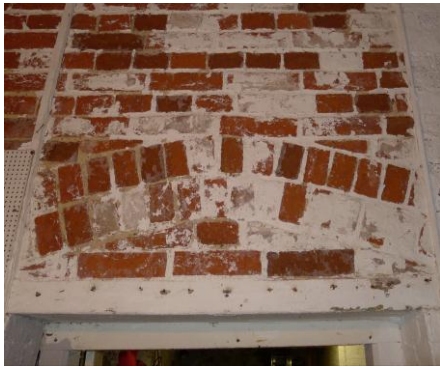
Fig. 68 (*above left*) Two relieving arches above the door from the Buoy Store into the Inner Store. Photograph: Jonathan Kewley 6-JUN-2017 ©Historic England

The Inner Store is accessed by a foot door from the Buoy Store, quite possibly original, with good wavy hinges. There is a very shallow segmental arch above this opening on the west side and two almost serpentine relieving arches, one above the other, on the east face (Fig. 68); this is its only opening. The door has wavy iron hinges (Fig. 69). It has no ceiling and is open to the rafters. Its floor is slightly higher than that of the Buoy Store.

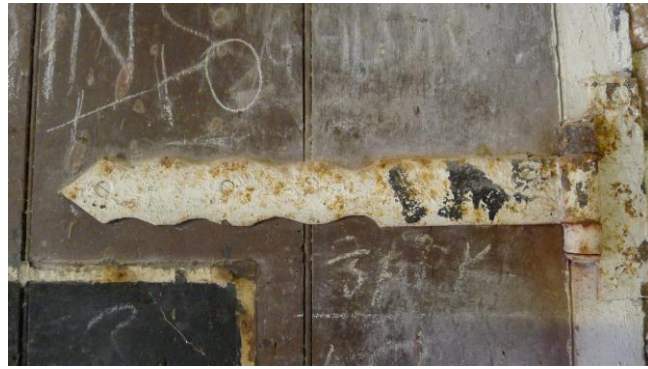
Fig. 69 (*above right*) A hinge on the door from the Buoy Store to the Inner Store. Photograph: Jonathan Kewley 6-JUN-2017 ©Historic England

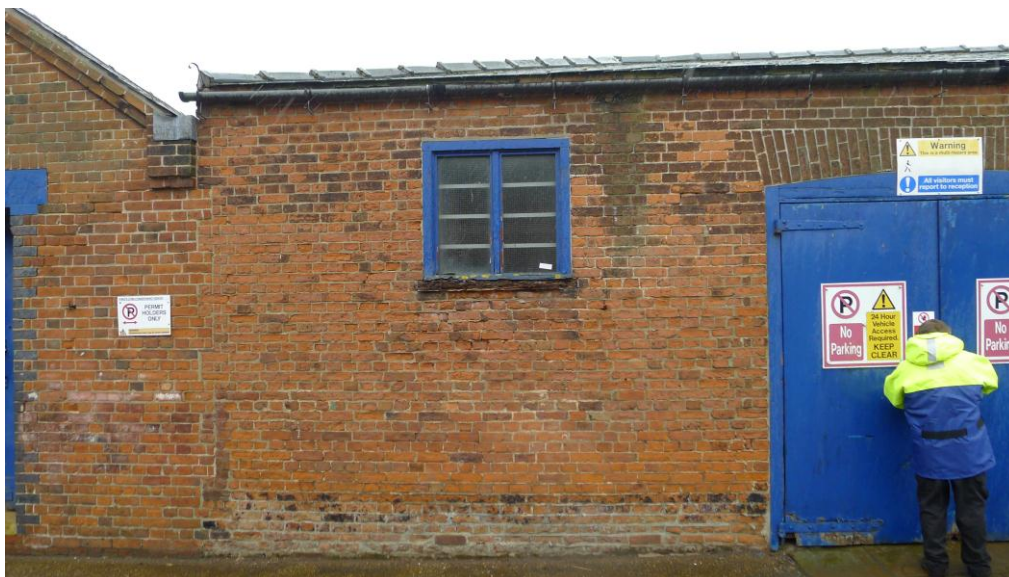
Fig. 70 The Engineers' Store from the north. Photograph: Jonathan Kewley 6-JUN-2017 ©Historic England

The Engineers' Store (Fig. 70) is entered from the Common Staithe Yard by double doors under a very shallow segmental arch (the doorway matching that to the Buoy Store). On each side of the door, roughly midway between it and the ends of the room, are a pair of high, square windows, matching that in the Buoy Store in shape (although the west one has a wooden shutter rather than glass). There is no ceiling, the room being open to the rafters. The Engineers' Store is roughly partitioned by a steel-framed structure which appears to be of 20th-century date running north-south immediately east of the door; the resulting room (Fig. 71) has a low ceiling, leaving the space above open to the main room. In the east wall is a blocked-up hatch leading to the Carpenters' Workshop. Outside the Engineers' Store is a path, the width of the doorway, of broken, perhaps York stone (looking rather like crazy paving) (Fig. 72).

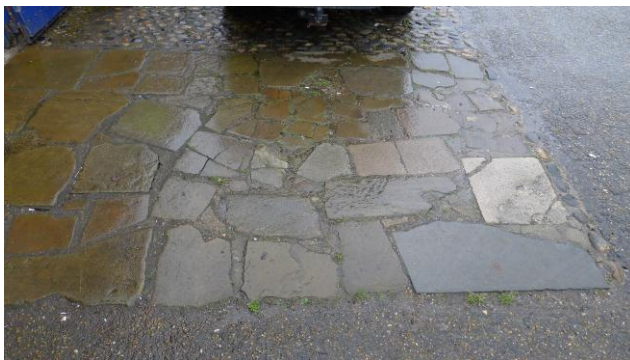
Fig. 72. Paving outside the door to the Engineers' Store. Photograph: Jonathan Kewley 6-JUN-2017 ©Historic England

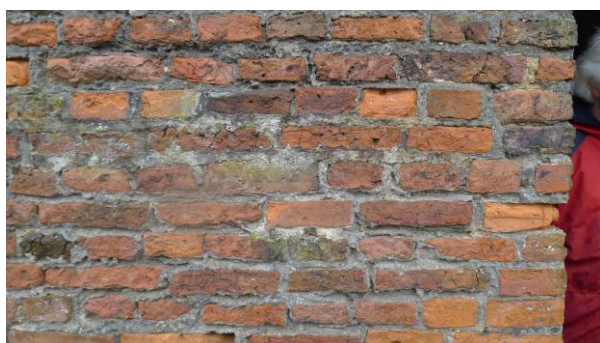
Fig. 74 Brickwork on the north wall of the Magazine (part of the 1829 warehouse), just east of the door. Photograph: Jonathan Kewley 6-JUN-2017 ©Historic England

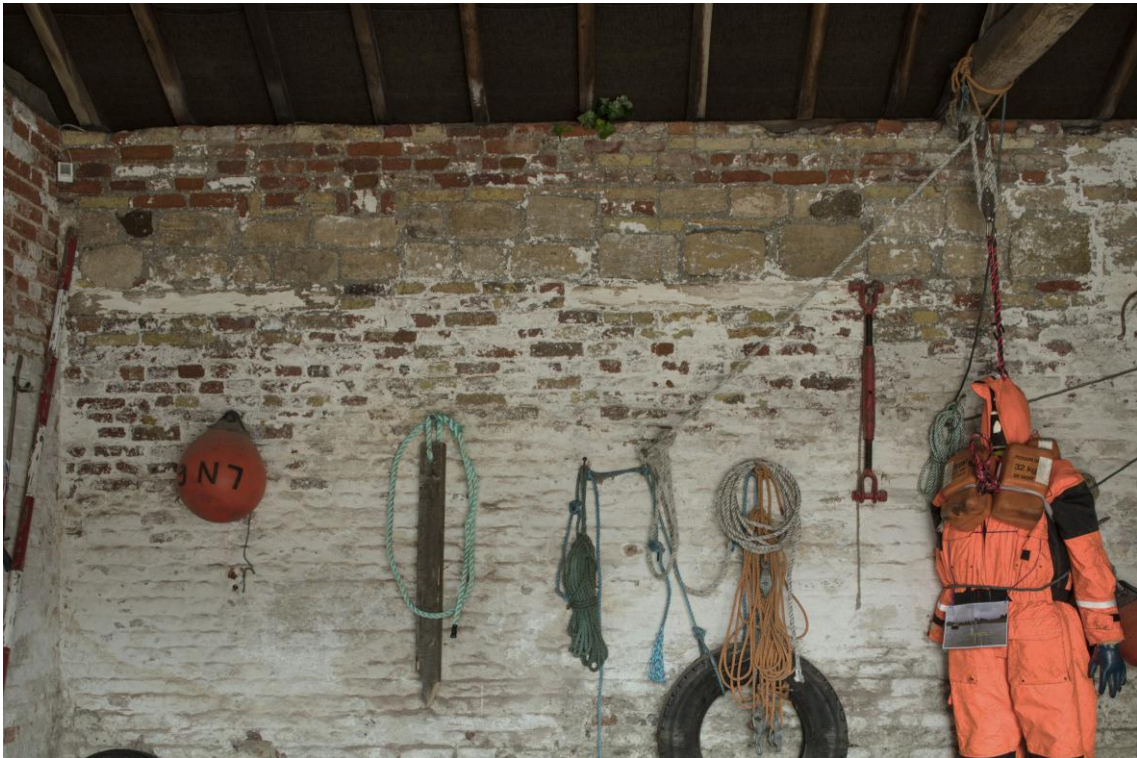
Fig. 75 The south wall of the Buoy Store from inside, showing re-used stone. Detail of HEA Patricia Payne 20-SEP-2017 ©Historic England

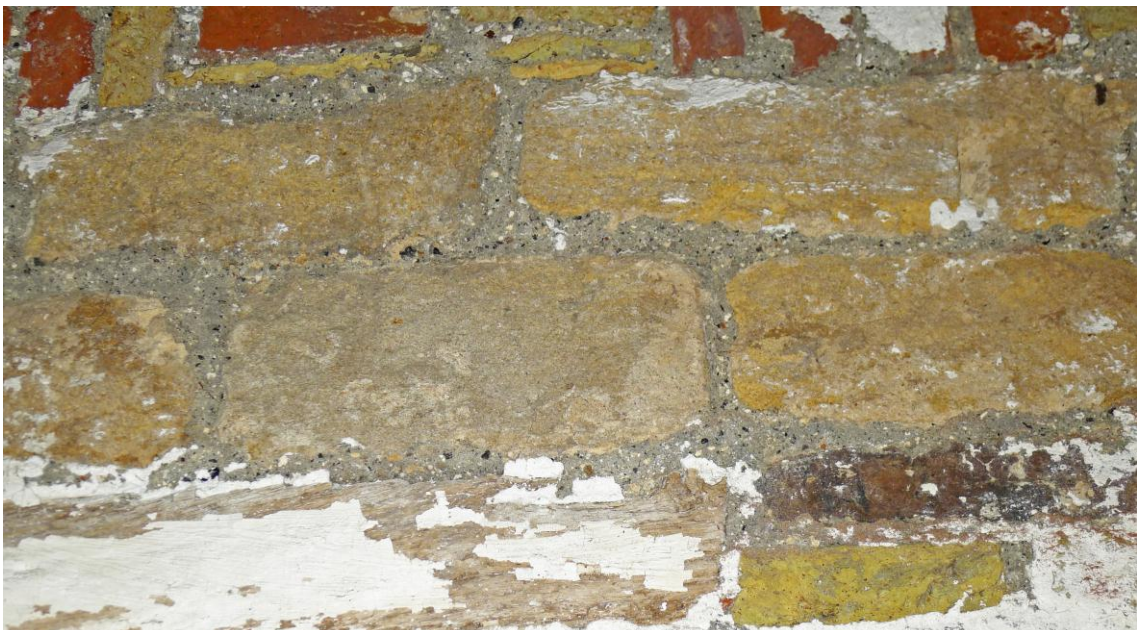
Fig. 76. Close-up of stone at high level on the south interior wall of the Buoy Store. Photograph: Jonathan Kewley 6-JUN-2017 ©Historic England

Towards the top of the south wall of the Buoy Store, seen from inside, there is some stone (Figs. 75 and 76). It is a pale greyish-yellow and mainly roughly dressed into large blocks. It has not been examined by a geologist but is probably clunch, otherwise known as white chalk lump; some was found during the Corn Exchange excavations in 1995 as part of a wall which, if Bates' interpretation is correct, cannot be earlier than the 13th century.⁵ The mortar has some dark inclusions, perhaps not large enough to be galetting (although this was a practice known in the area).⁶ It forms an irregular band from the east end to the blocked-up window. To the west of the latter the wall is whitewashed, and it is more difficult to see what is there; there is a length of wood which might be interpreted as a lintel but as there is no sign of an opening beneath, it is perhaps just timber built into the wall to improve bonding. Some parts of the exterior of the south walls are visible from the Settling Tank (see below).

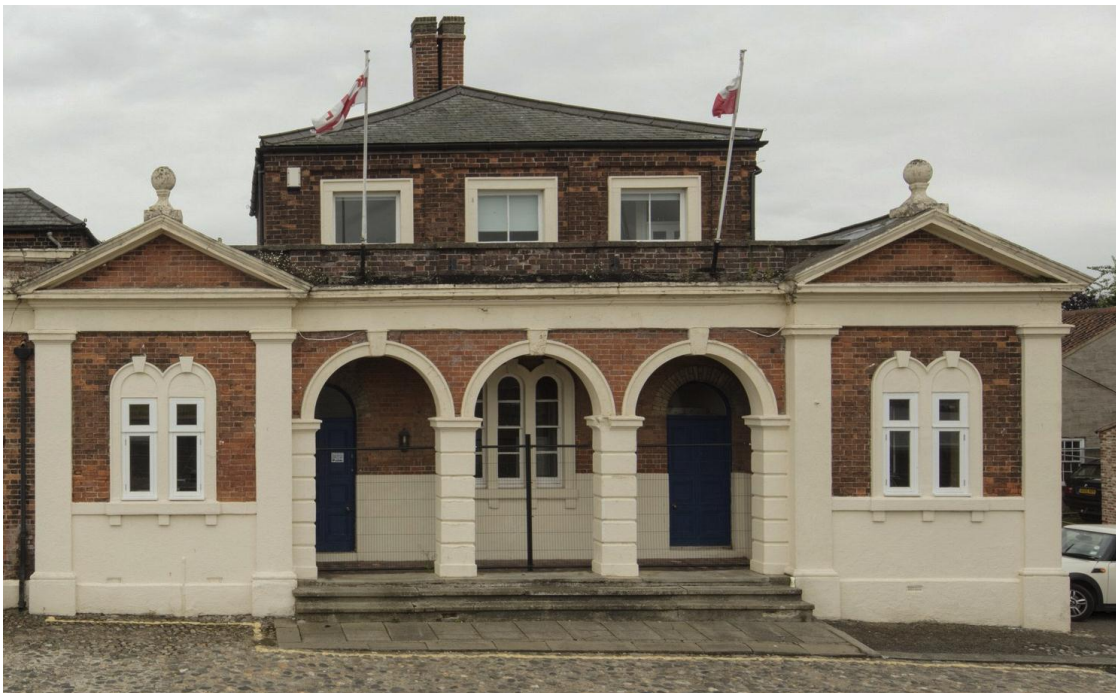
Fig. 77 The west front of the Baths. Photograph Patricia Payne 2-AUG-2017 ©Historic England

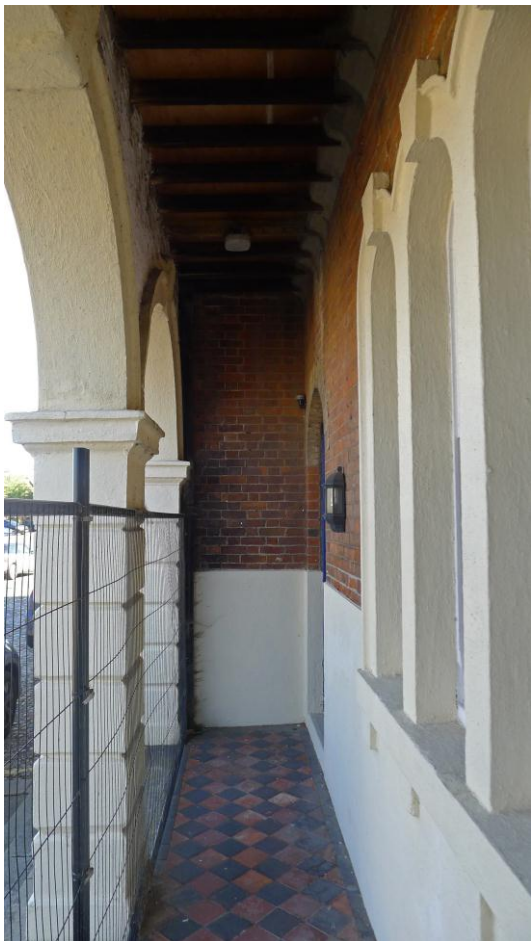
Fig. 78 (*above left*) Looking north along the loggia on the west front of the Baths; note the encaustic tiles on the floor. Photograph: Jonathan Kewley 5-JUL-2017 ©Historic England

The Baths face slightly north of west onto the Common Staithe Quay (Fig. 77). That front is Italianate in style. It is symmetrical and consists of a central three-bay, two-storey block with flanking one-bay, single-storey pavilions. The former is fronted by a loggia (Fig. 78) of three arches with prominent keystones and horizontally-channelled columns, the floor being paved with red and black encaustic tiles; there is a central window of three round-headed lights (each a sliding sash with a central transom) between two entrance doors. The latter are six-panelled (two long above

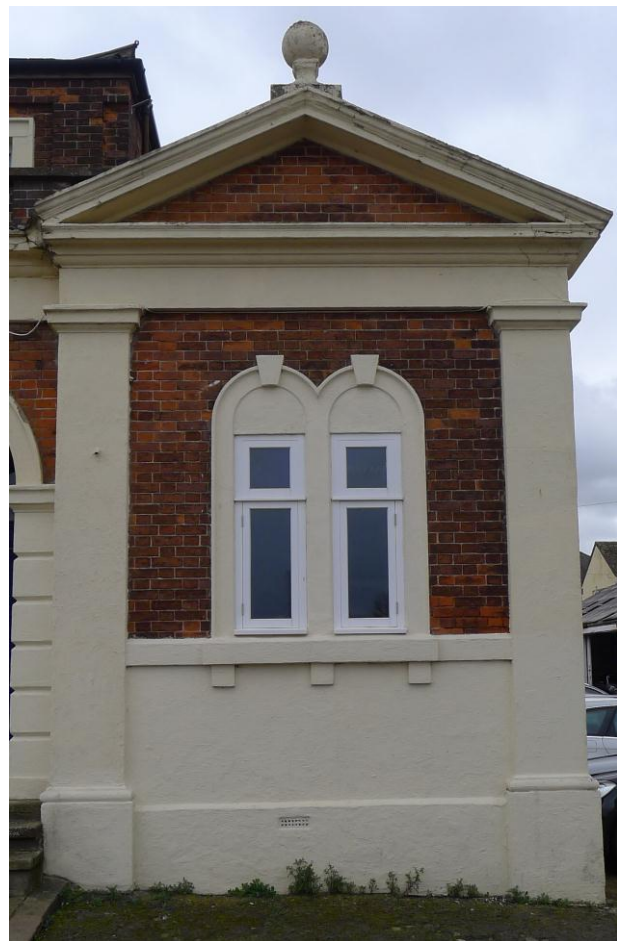
Fig. 79 (*above right*) The south-west pavilion of the Baths building, from the west. Photograph: Jonathan Kewley 27-JFEB-2017 ©Historic England

At first-floor level there are three one-over-one sash windows. The slate roof is gabled at the back (east) but hipped at the front, with a bifurcated chimneystack behind. Each pavilion, which projects slightly further than the loggia, is topped with a triangular pediment supported by a pair of Doric pilasters (Fig. 79) and contains a centrally-placed window, probably originally like the loggia window except of two lights not three; both have had ungainly transom lights inserted in the openings at a relatively early date (they are already there in an undated photograph [Fig. 80] which looks pre-Second World War). Each pediment is topped by a ball on a socle. The front is principally of a brownish-red brick (with recessed sections round the first-floor windows); the mouldings are rendered and currently painted cream.

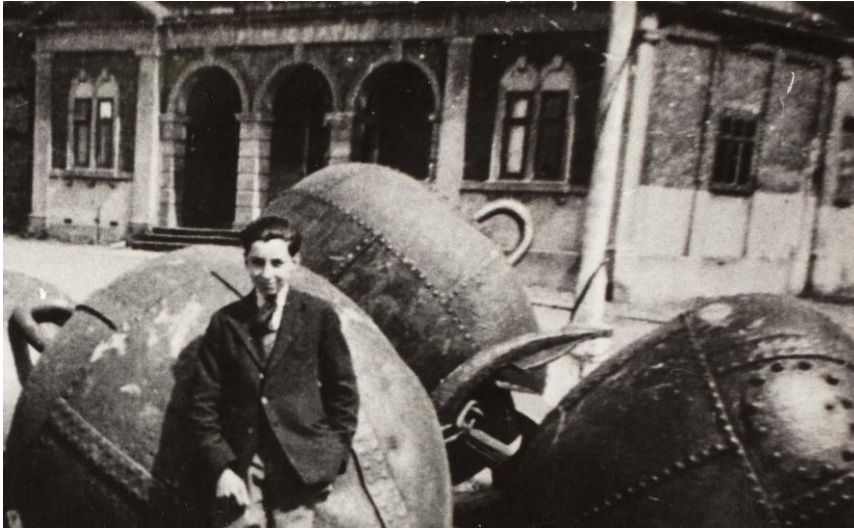
Fig. 80 The west end of the Baths building in an undated, 1920s or 1930s photograph, showing that the windows had already been altered then. Norfolk Library and Information Service (King's Lynn Library Archives)

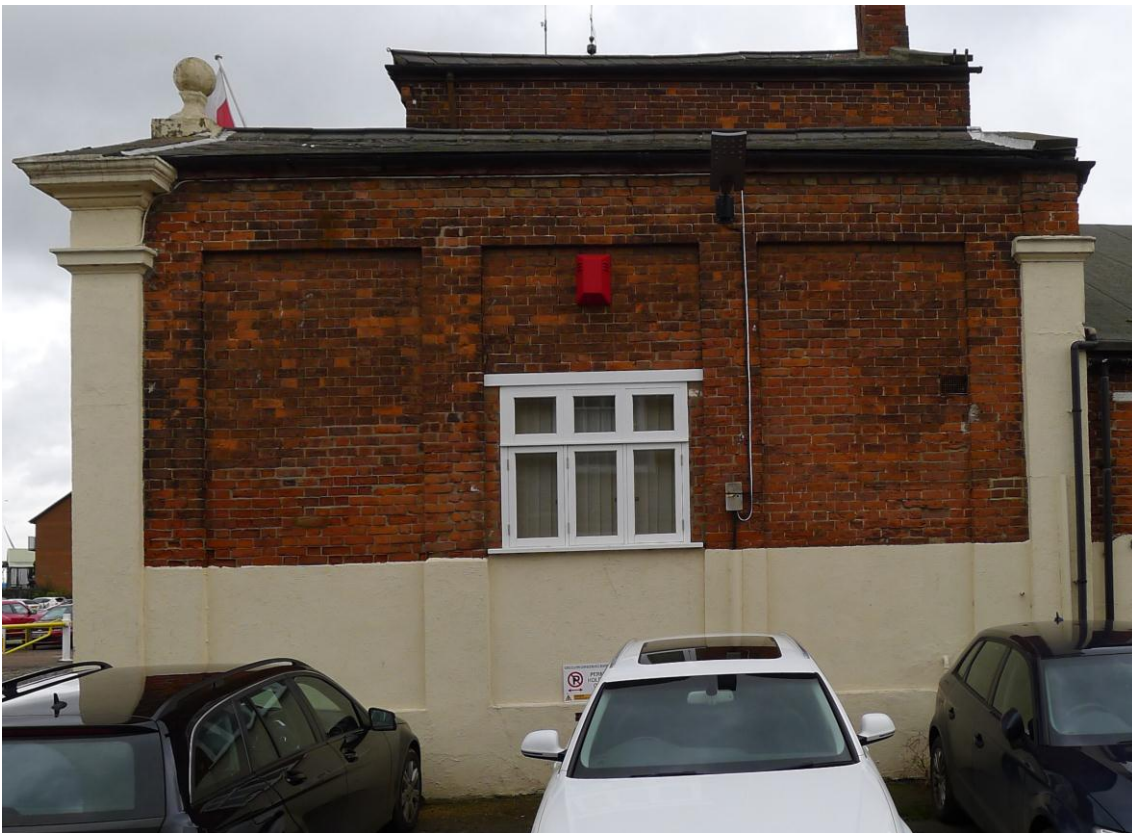
Fig. 81 The south elevation of the front part of the Baths, onto Ferry Street. Photograph: Jonathan Kewley 27-FEB-2017 ©Historic England

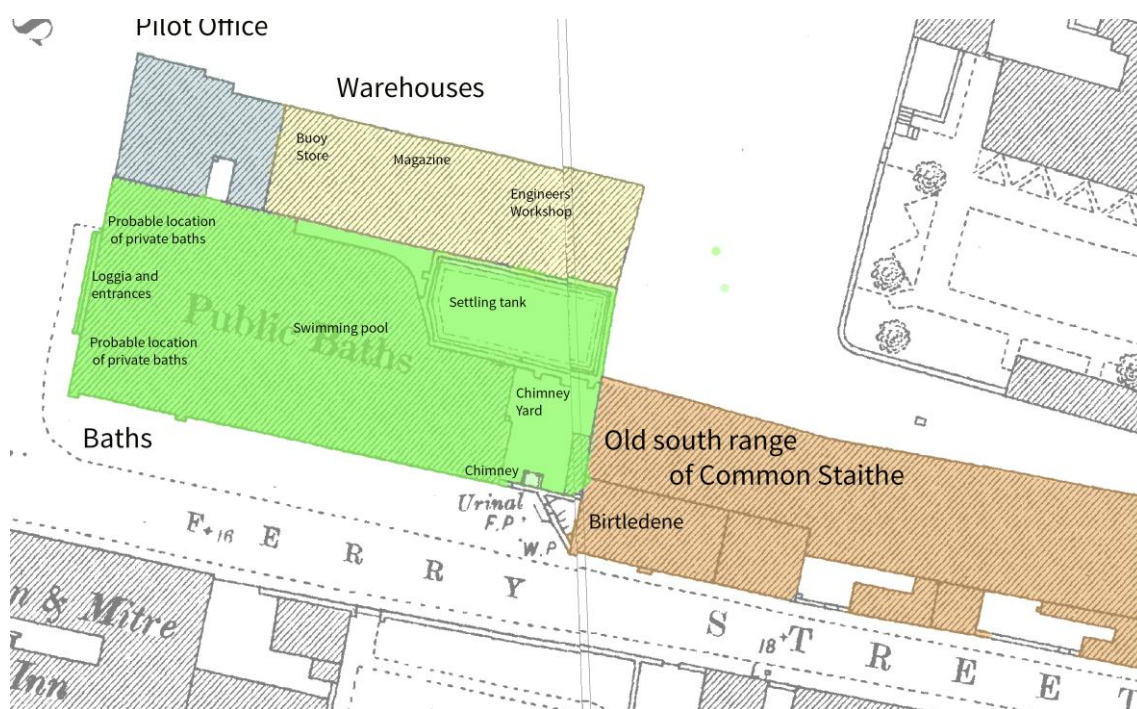
Fig. 83 A reconstruction of the layout of the buildings on the Common Staithe in the late 19th century. 125" to 1 mile OS map, surveyed 1883, taken from the Historic England corporate GIS, NTS (Historic Ordnance Survey mapping © and database right Crown Copyright and Landmark Information Group Ltd (All rights reserved 2018). Licence number 000394 and TP 0024. Graphic: Jonathan Kewley

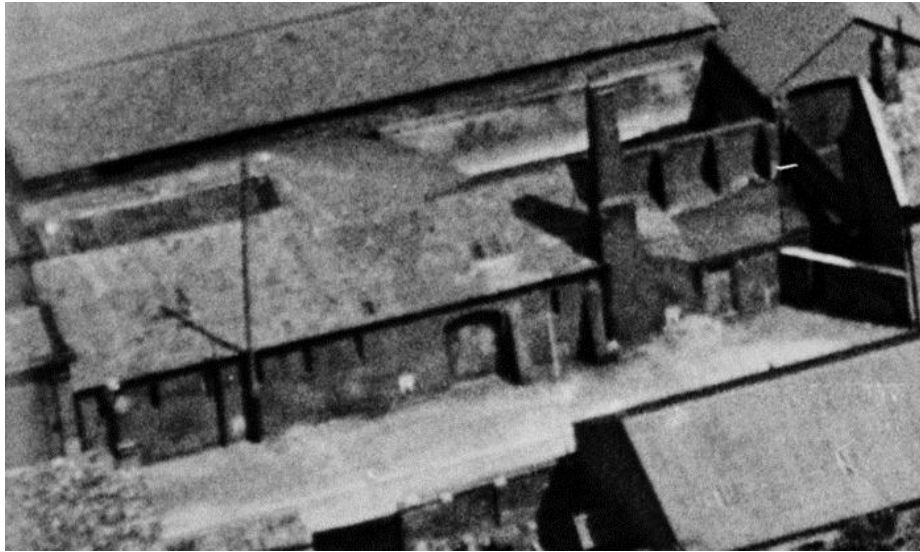
Fig. 85 An aerial view of the eastern part of the Baths complex in 1928. Detail of HEA (Aerofilms Collection) EPW021474 JUN-1928

The more utilitarian-looking part of the Baths building extends back eastwards from the front section (Figs. 85 and 86). It is dominated by the bulk of the Swimming Pool Hall, which presents externally as a large roof, apsidal at the east, rising from a single-storey brick wall facing Ferry Street. The brick in this range is generally more of an orange-red than that of the west front. This wall is punctuated by blank round-headed lancets which echo the front windows. Starting from the west there are three windows with top-hung fanlights and then a door. These are all later insertions which replaced an original three lancets – the windows sometime between 1933 and 1963, the door sometime after 1963.²² The latter was accompanied by a flight of steps (Fig. 87), but they have since been removed; the insertion of the door may relate to what is now the kitchen, which was perhaps a ticket or cash office, possibly when Brown Bros and Taylor used the building in the 1950s.

the chimney for a foot or so. There is then a gap of a couple of inches after which the wall resumes in the same brick and in English bond; this is the east wall of the Boiler Room, and there is a ledged door in it (blocked up inside). At the midpoint of the divided gable of the Boiler Room, a wall runs east, with a straight joint half way along; it is stepped up to the west higher up, suggesting that the western section (which is of the same brick as the gable, and also English bond) may originally have been a buttress. Another wall runs north from the roadside wall east of the chimney to join it and create an enclosure within the Chimney Yard, with the chimney forming its south-west corner. Timbers survive from a monopitch roof over this area, sloping up to the west. It appears on an aerial photograph of 1928 (see Fig. 85). Here this will, for want of any other name, be called the Chimney Store.

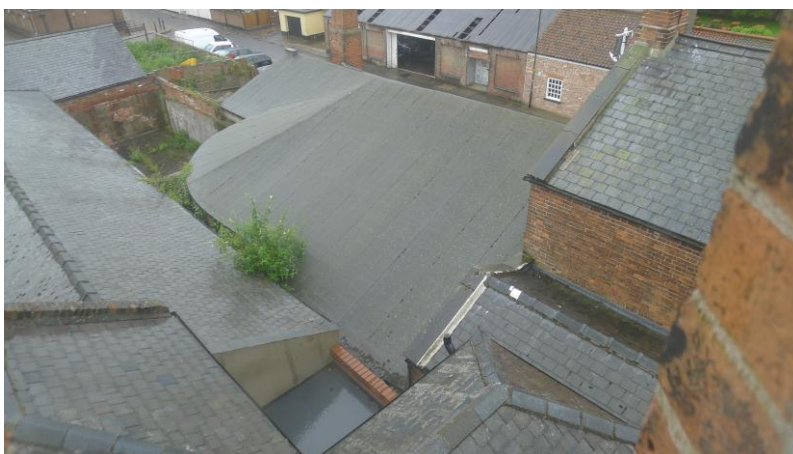
Fig. 86 The roofscape, looking south-east from the Pilot Office tower. The large roof in the centre is the swimming pool hall. Photograph: Jonathan Kewley 6-JUN-2017 ©Historic England

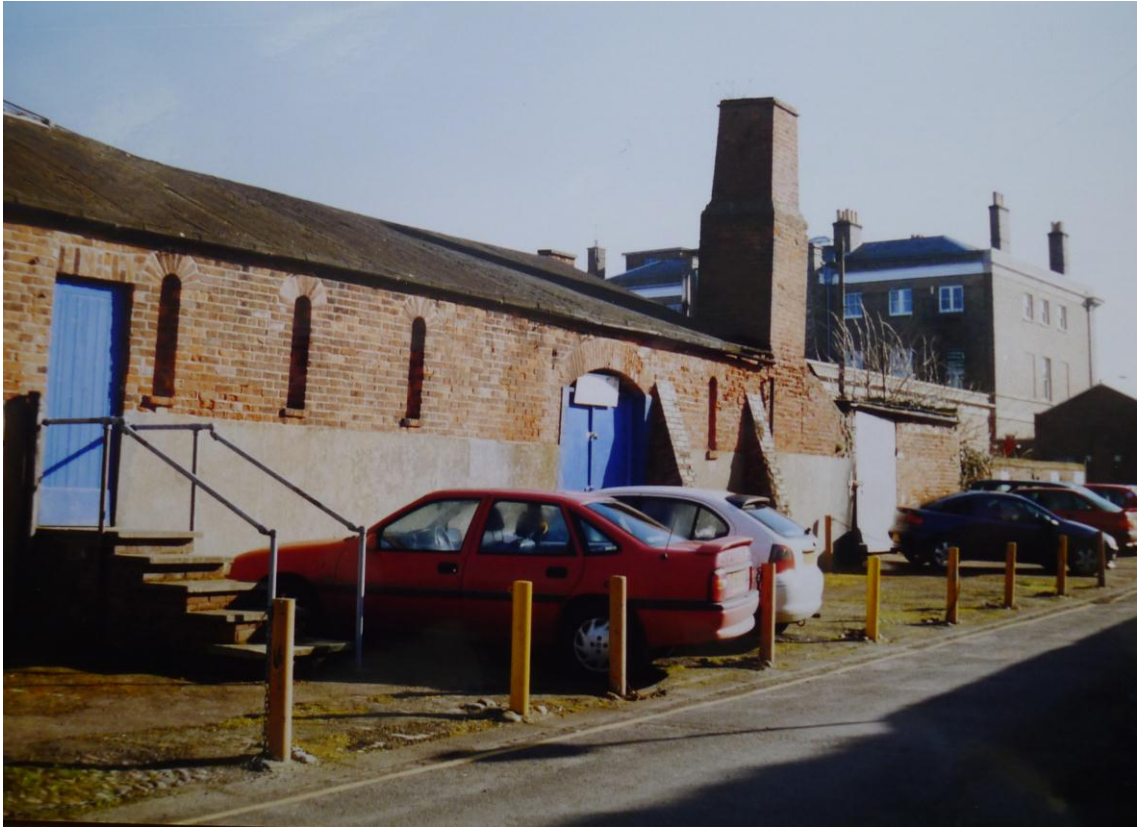
Fig. 87 The south side of the Baths complex c 1980s, showing steps, which are no longer there, to the inserted door on the left. Courtesy of the King's Lynn Conservancy Board

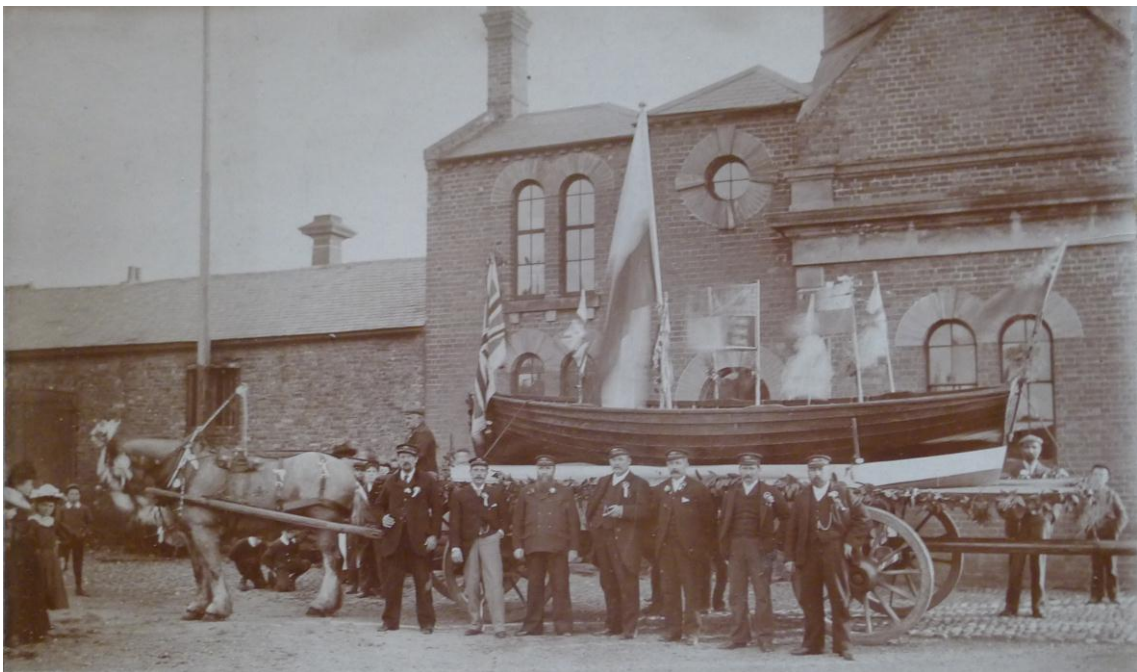
Fig. 88 A view south-east from the Common Staithe Yard in the late 19th or very early 20th century, showing in the distance the Baths chimney, then higher and with a projecting rim. Courtesy of the King's Lynn Conservancy Board

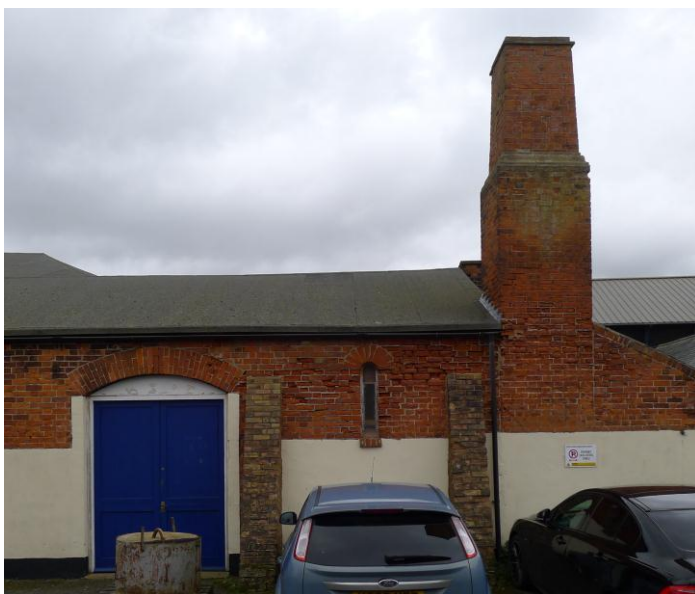
Fig. 89 Buttresses supporting the south wall of the Baths.
Photograph: Jonathan Kewley 27-FEB-2017 ©Historic England

Continuing eastwards along the south front, there are then three of the round-headed lancets. After a gap there are double doors at ground level (not raised like the foot door) with a segmental brick arch above. There is then a single lancet and, at the end of the range, a tall brick chimney; this narrows about three-quarters of the way up its present height, but an old photograph shows that it originally had a projecting rim at the top (Fig. 88). Beyond the chimney is a brick-walled space named here the Chimney Yard, in which has been built a brick leant-to against the east side of the chimney (described in more detail below). The east wall of this yard abuts the wall leading back from the west end of Birtledene. Between the chimney and the easternmost lancet, and between the latter and the double doors, are a pair of brick buttresses, presumably added to support the weight of the chimney (Fig. 89).

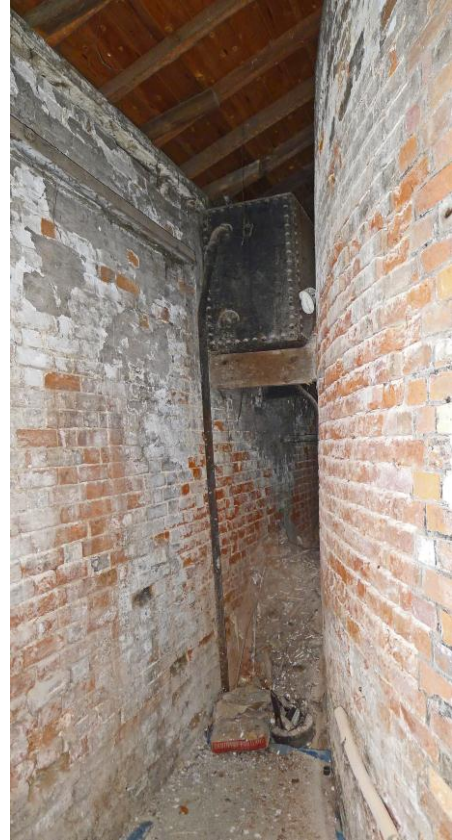
Fig. 90. The space between the south wall of the Baths (on the left) and the cirving south wall of the Swimming Pool Hall (on the right), looking west.
Photograph: Jonathan Kewley 6-JUN-2017 ©Historic England

The space to the south of the Swimming Pool Hall is roofed in and extends east of the swimming pool to the chimney. It includes the southern ‘spandrel’, the narrow part of which west of the double doors contains an iron water-tank of relatively modest size (Fig. 90).

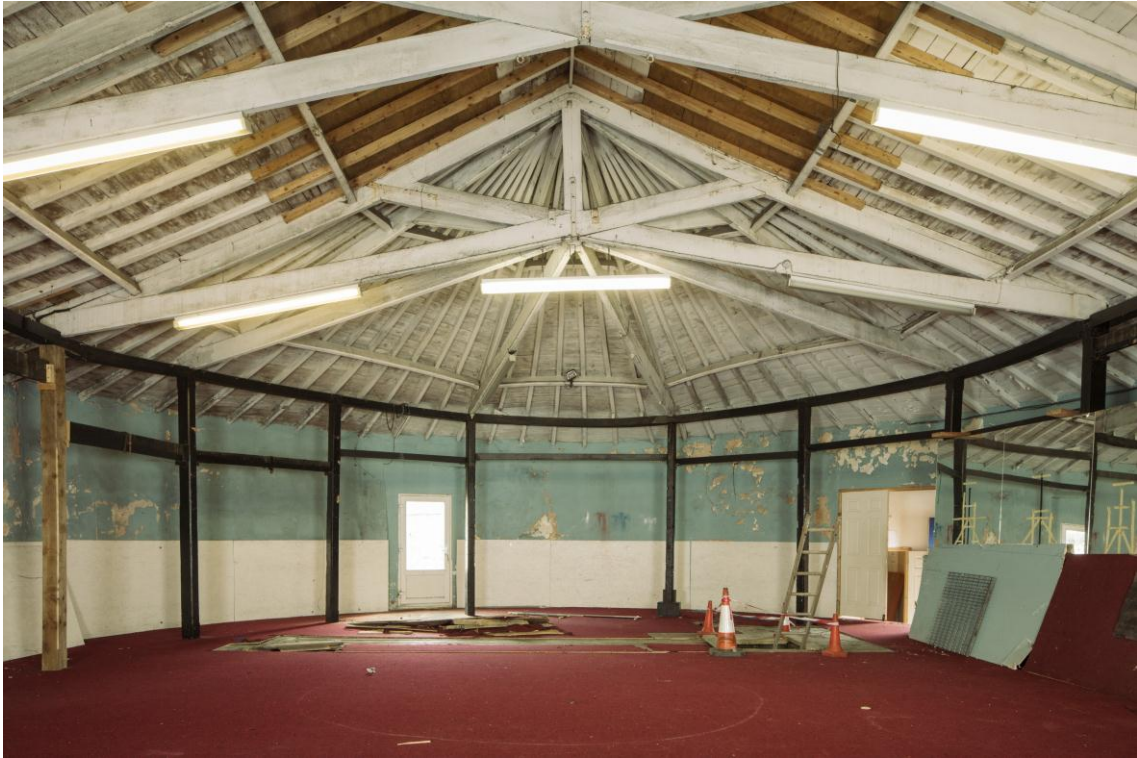
Fig. 91 The Swimming Pool hall looking east. Detail of DP217319 2-AUG-2017 Patricia Payne ©Historic England

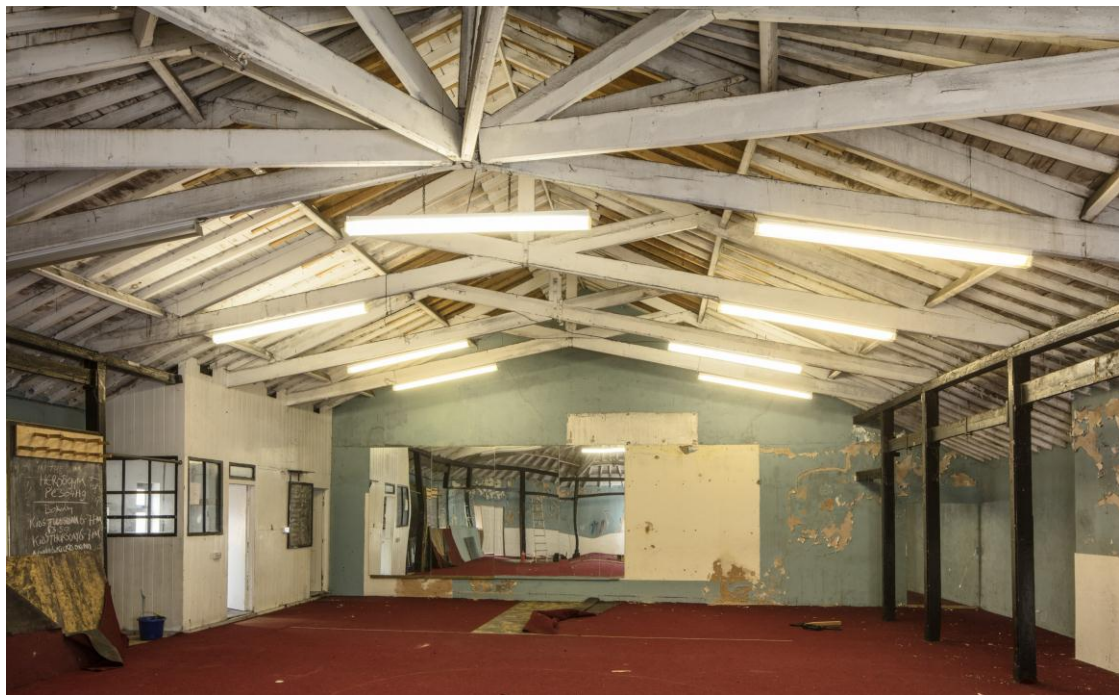
Fig. 92 The Swimming Pool Hall looking west. Detail of DP217329 2-AUG-2017 Patricia Payne ©Historic England

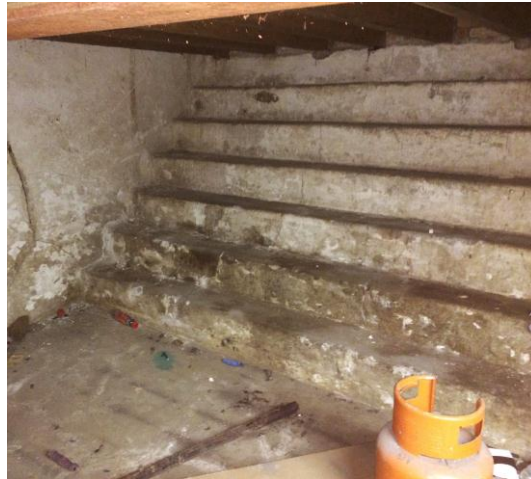
Fig. 94 The steps which run the full width of the west end of the swimming pool.

The west end consists of a full-width flight of seven cement-rendered steps (Fig. 94). At the east end are the mouths of four pipes, the widest higher up toward the south, the next in size also high up but more or less central, and the other two smaller ones progressively deeper and further north.
