Historic England

The Common Staithe, King's Lynn, Norfolk: An architectural and archaeological assessment

Jonathan Kewley

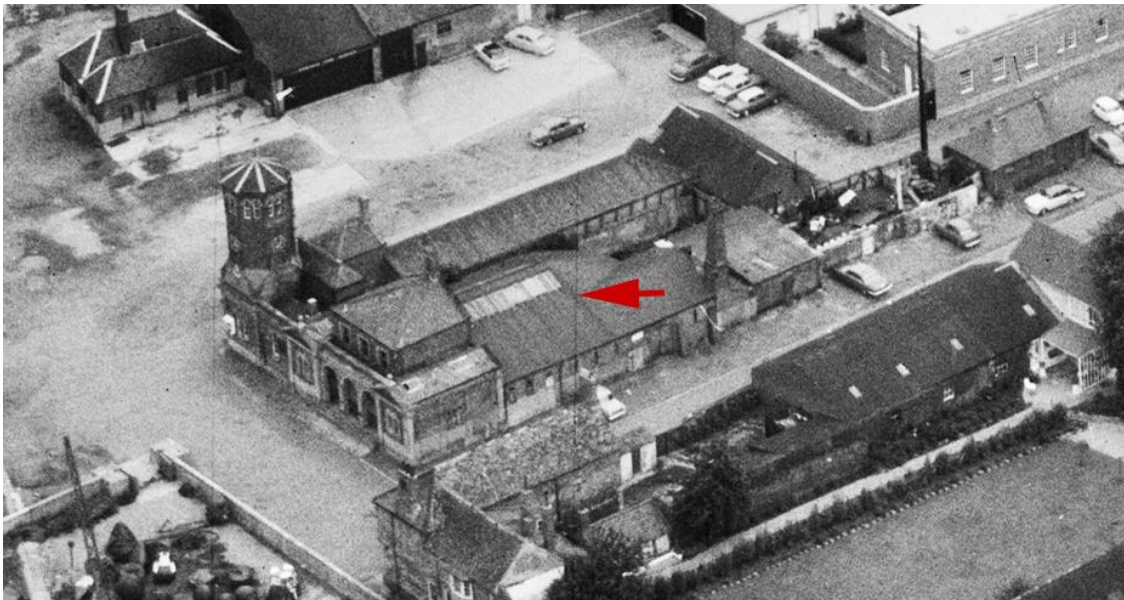
Fig. 95 The Baths from the air in 1963; the arrow shows the then-partly-glazed roof of the Swimming Pool Hall. Detail of HEA (Aerofilms Collection) EAW116074 8-JUL-1963.

The roof is scissor-braced. The rafters presumably rise from a hidden wall-plate, but the braces are supported by a row of stout wooden posts joined by a horizontal member just below the roof. There is a further horizontal row of timbers just below at varying heights, presumably added as strengthening and irregular because the method of fixing is by bolts which run through the upright into the end of the horizontal, thus meaning two gaps cannot be filled at the same height, although in a few cases the horizontal runs through the upright allowing two sections to be done at once. The roof is now felted but originally part was glazed, providing natural light (Fig. 95).

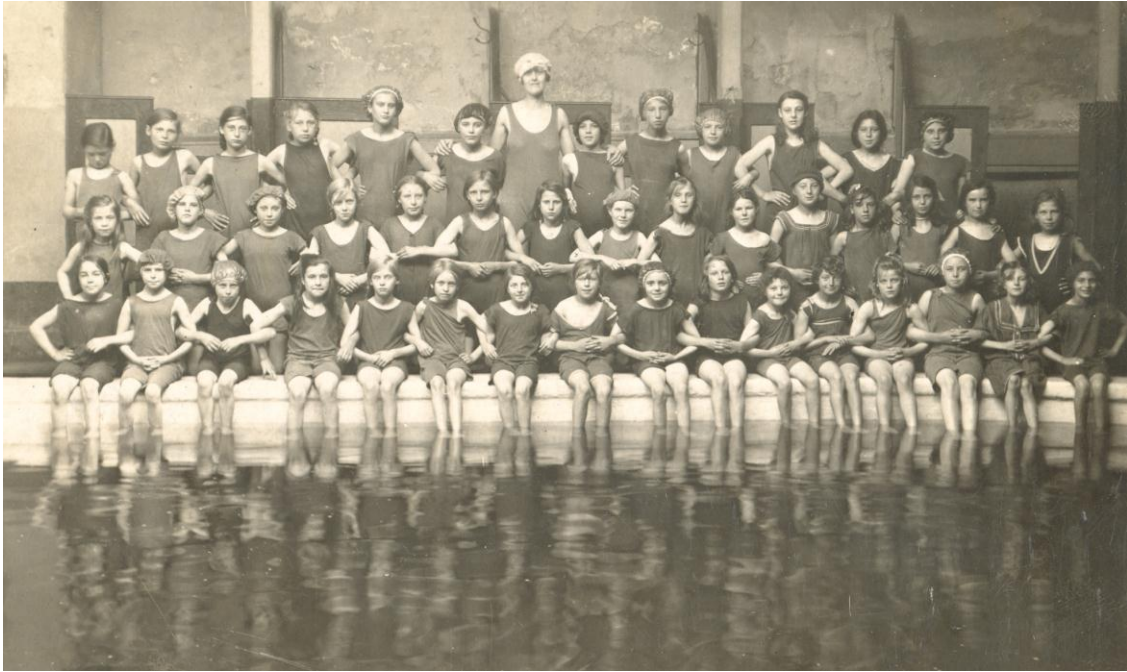
Fig. 96 St Nicholas' Girls School Swimming Gala in the Swimming Pool Hall in 1919; note the changing cubicles in the background. True's Yard Fisherfolk Museum.

A photograph of the north side of the hall in 1919 (Fig. 96) shows changing cubicles around the wall. This seems to be in line with the position elsewhere (as for example at the Lambeth Baths of 1853, and Mayfield Public Baths, Manchester, of 1856-57).²⁷ At some stage, probably in the first half of the 20th century, two and a half bays at the west end of the south side have been enclosed within an L-shaped wooden partition with a door and windows to the rest of the space; it now contains a kitchen and lavatory (Fig. 97). The north-south arm of the L is immediately west of the foot door to the outside, and they are presumably linked, as discussed above.

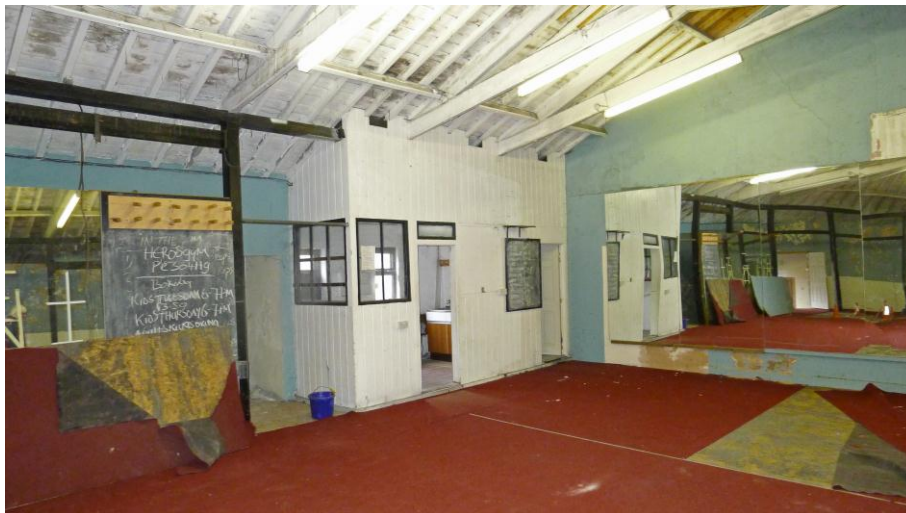
Fig. 97 The enclosed section at the south-west corner of the Swimming Pool Hall. Photograph: Jonathan Kewley 6-JUN-2017 ©Historic England

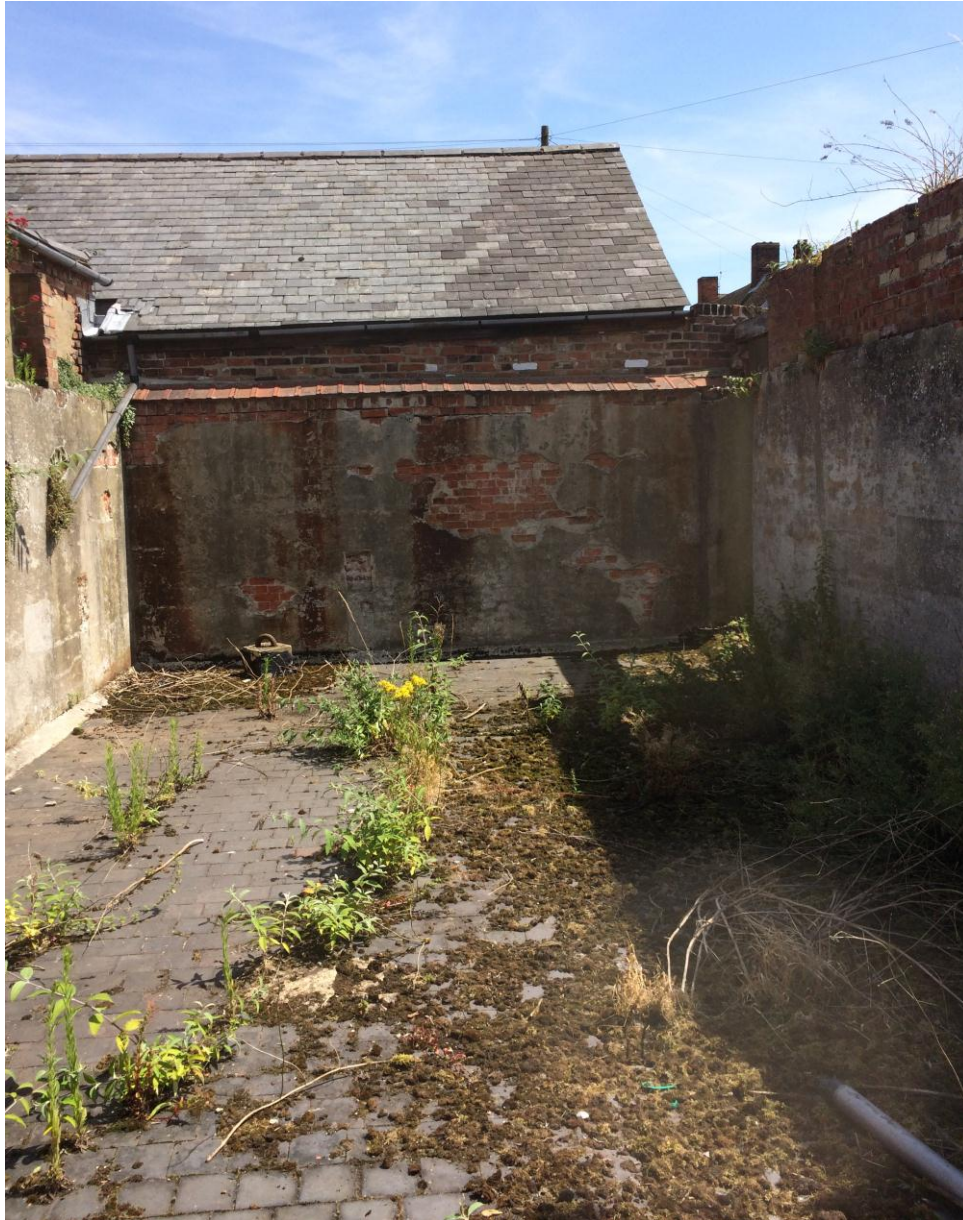
Fig. 98 The Settling Tank looking east. Photograph: Jonathan Kewley 17-JUL-2017 ©Historic England

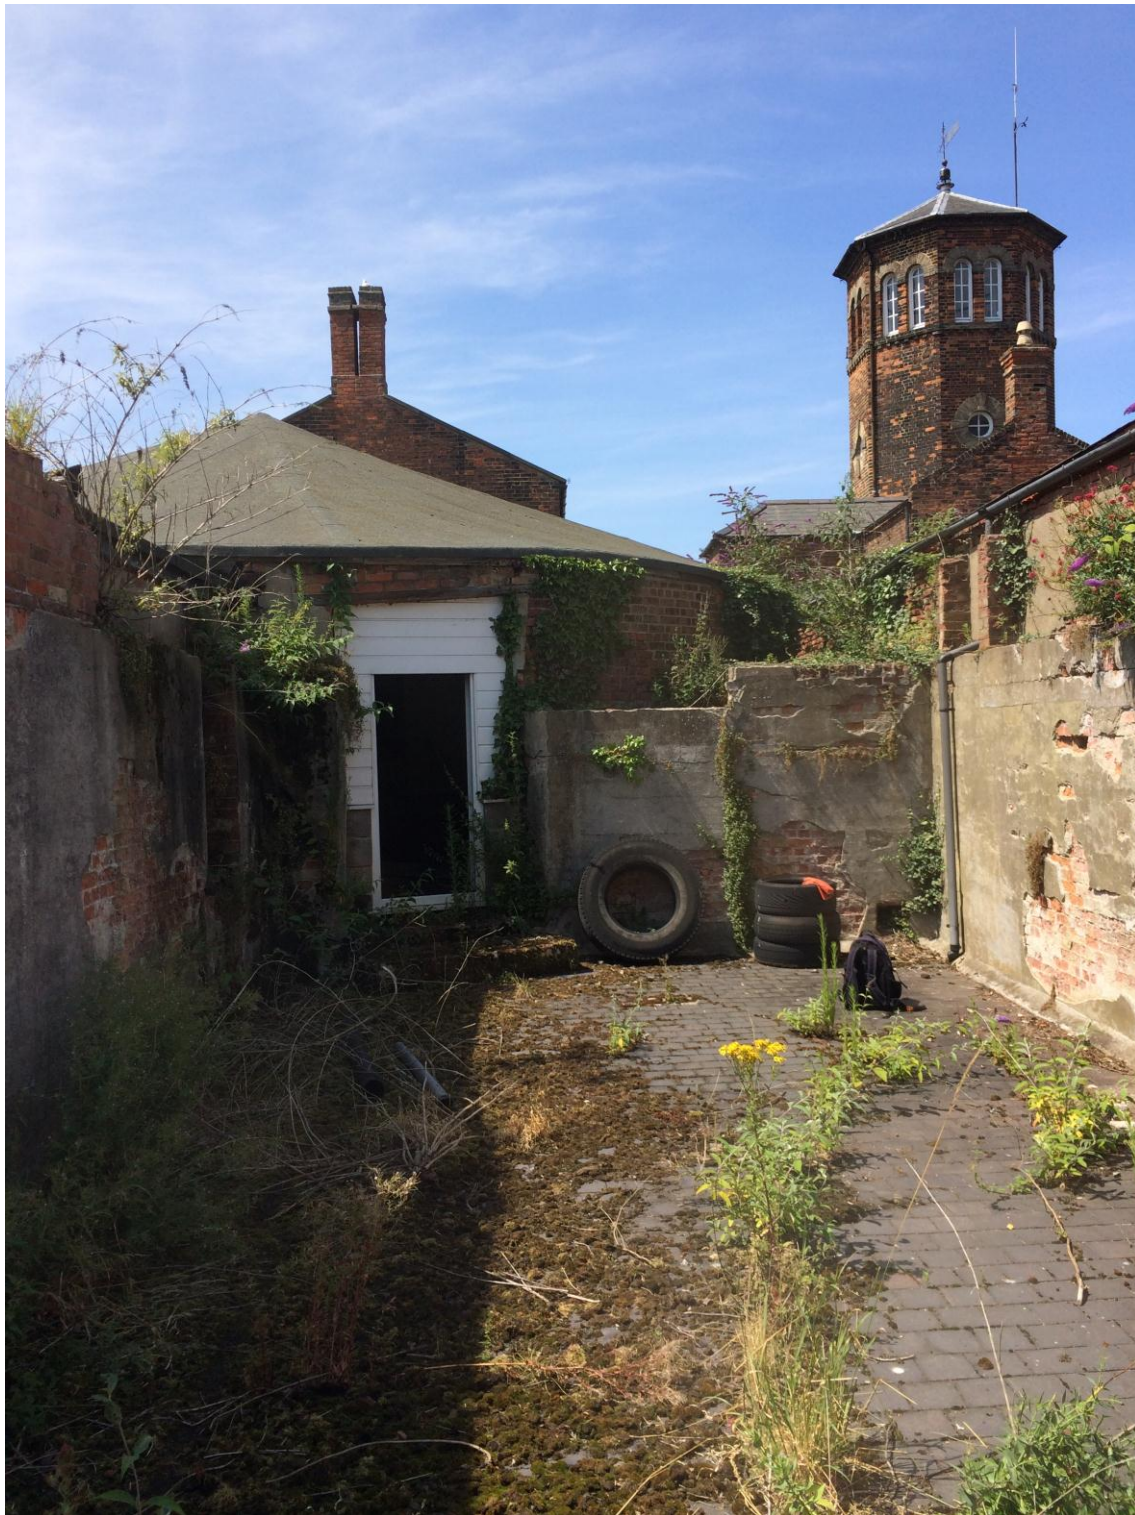
Fig. 99 The Settling Tank looking west. Photograph: Jonathan Kewley 17-JUL-2017 ©Historic England

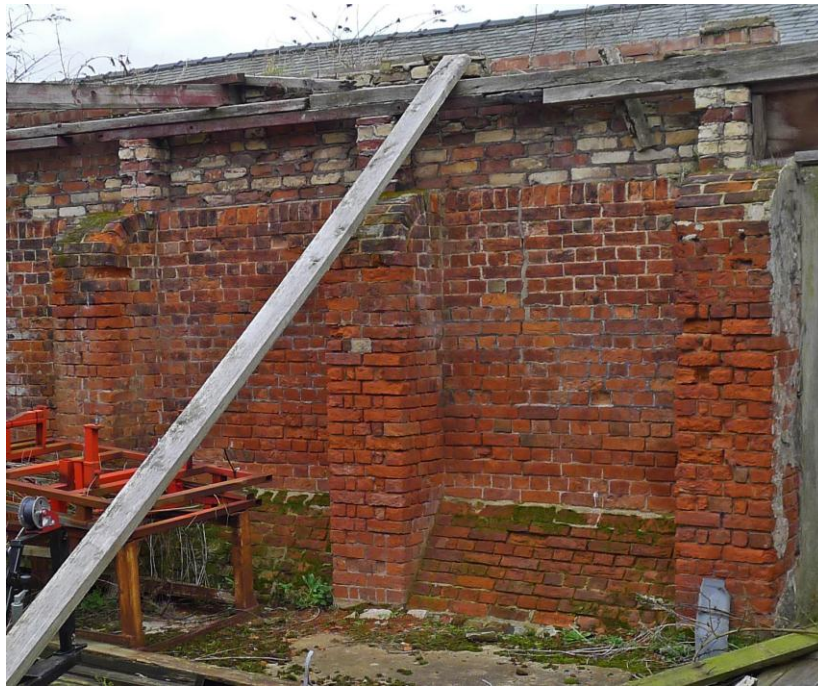
Fig. 100 Buttresses on the outer face of the south wall of the Settling Tank. Photograph: Jonathan Kewley 27-FEB-2017 ©Historic England

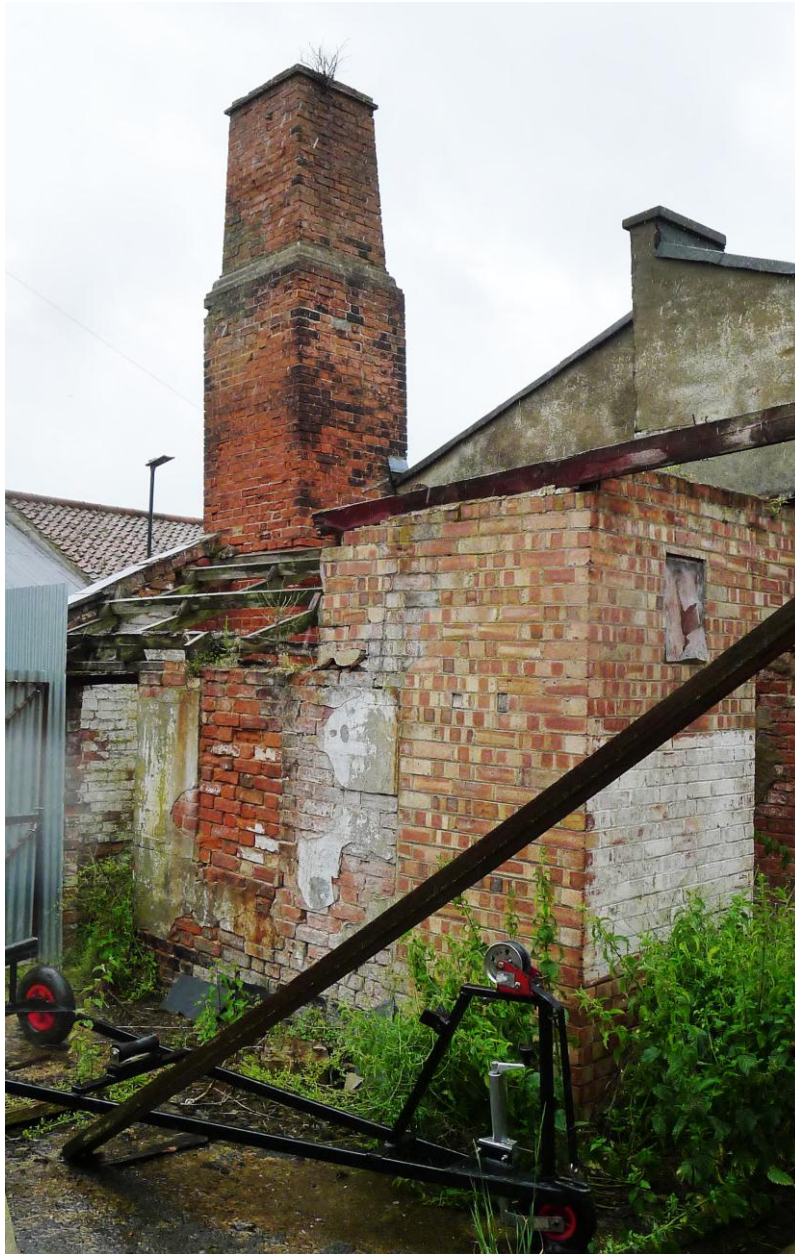
Fig. 101 The Chimney Store, looking south-west. Photograph: Jonathan Kewley 6-JUN-2017
©Historic England

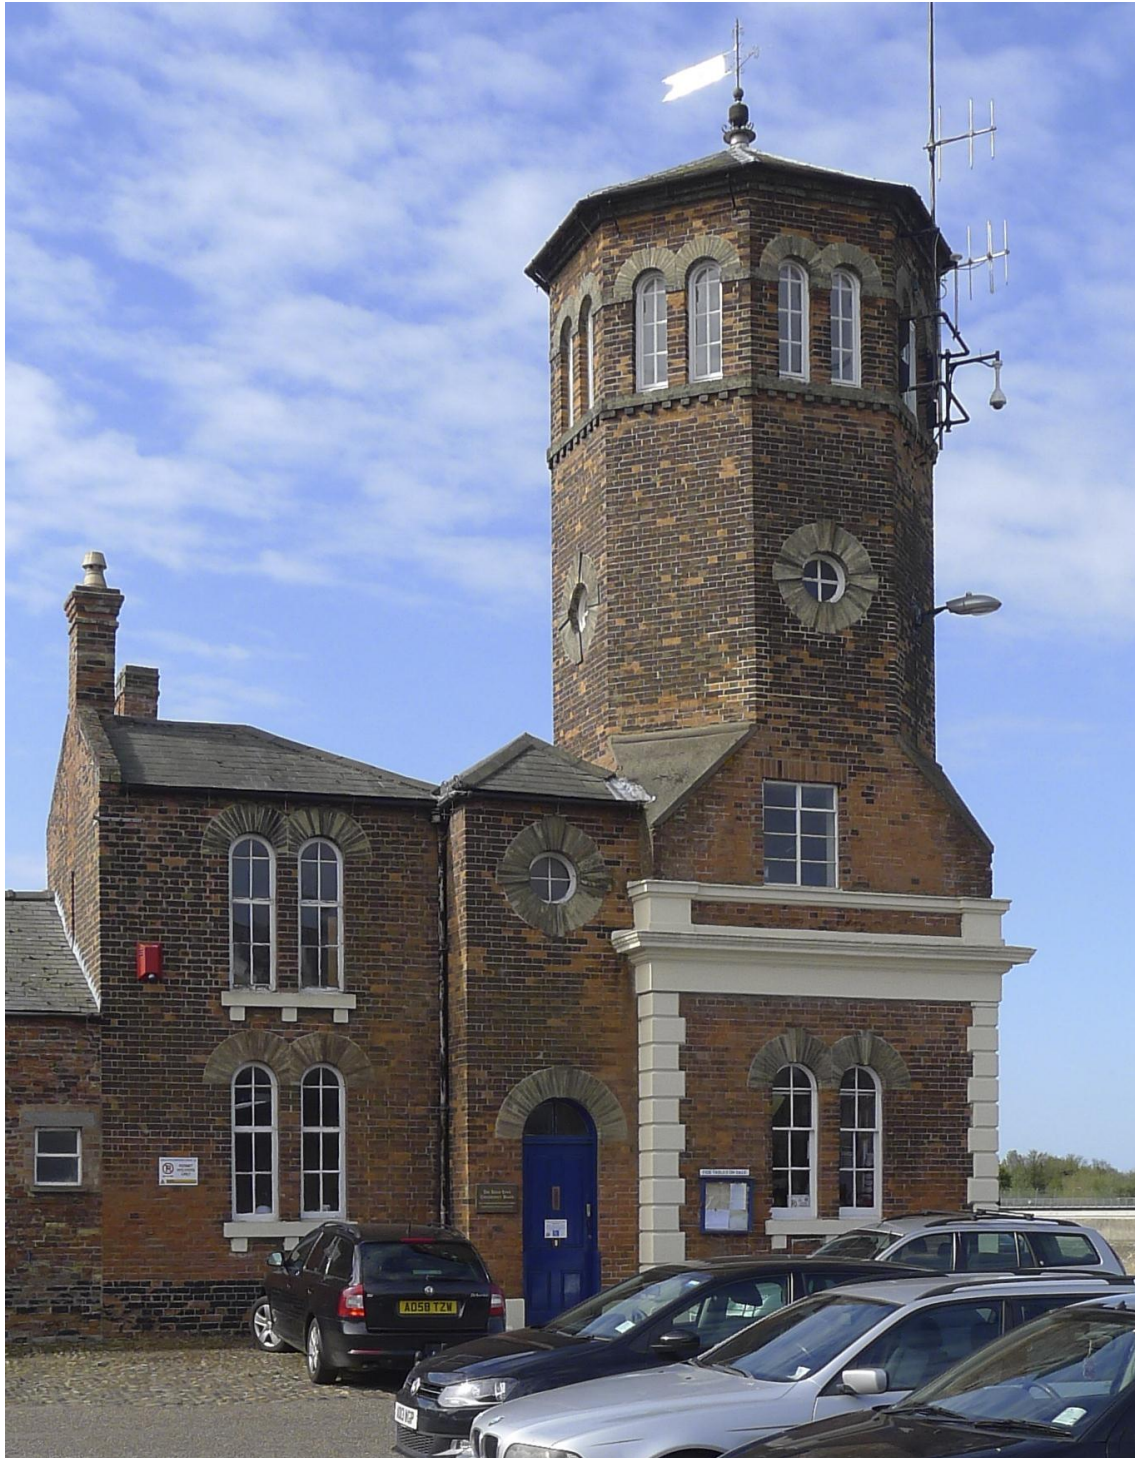
Fig. 102 The north front of the Pilot Office. Photograph Jonathan Kewley 2-MAY-2017 ©Historic England

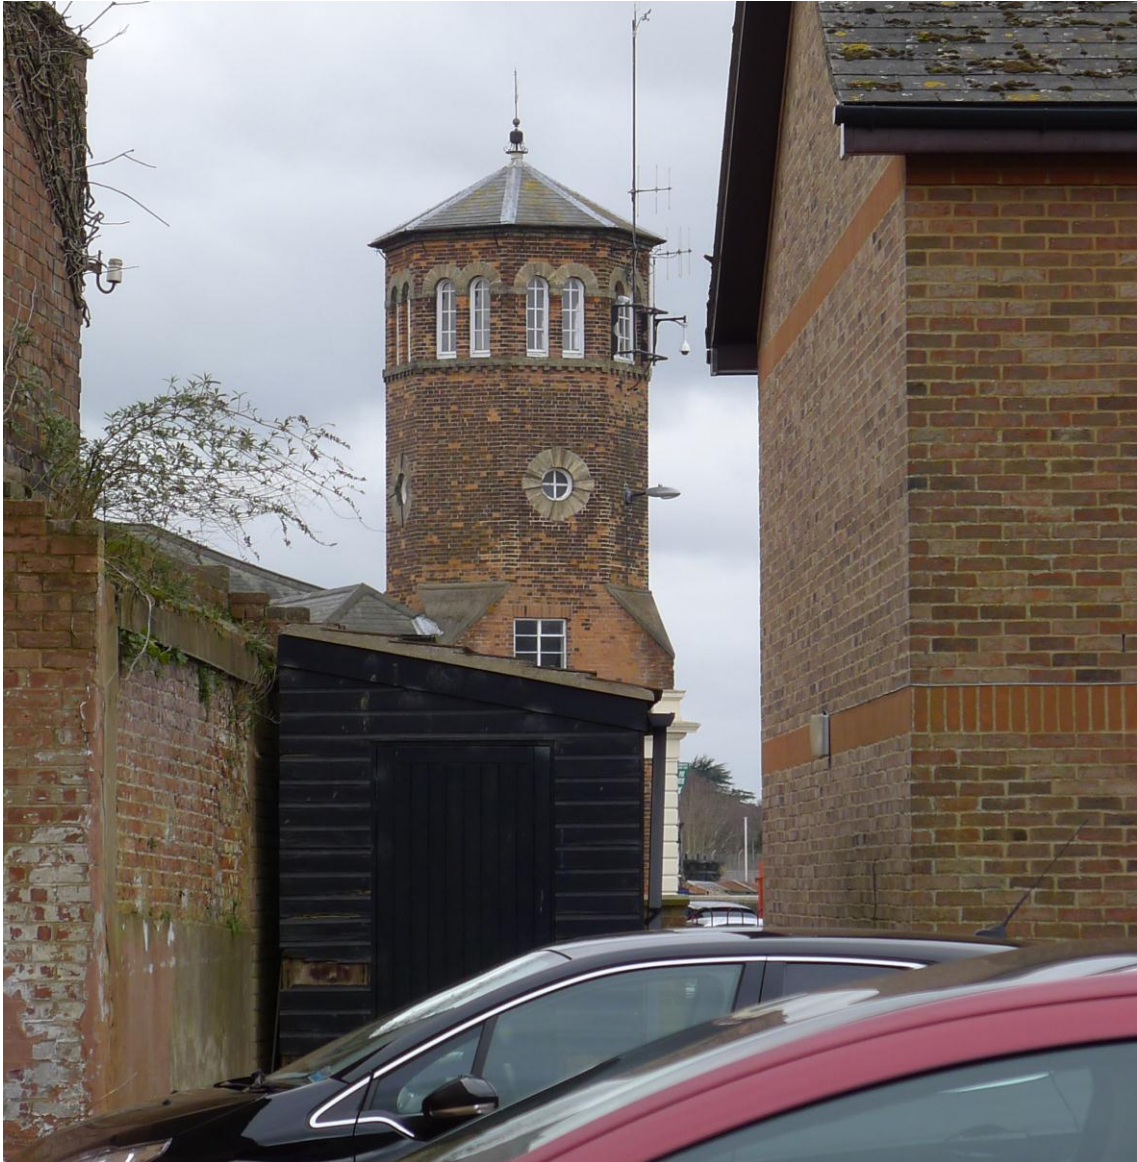
Fig. 103 The tower of the Pilot Office, seen from Trinity Quay to the north. Photograph: Jonathan Kewley 27-FEB-2017 ©Historic England

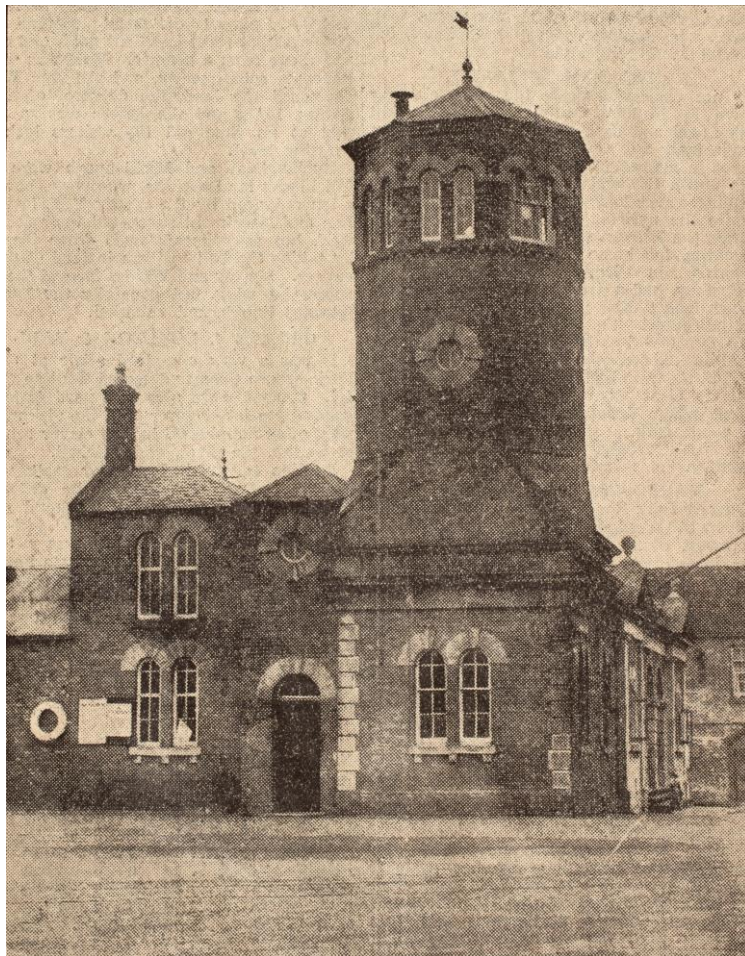
Fig. 104 The Pilot Office from the north-west in 1937. Norfolk Library and Information Service (King's Lynn Library Archives)

At first-floor level the tower originally had no windows, but a Crittall-type metal casement window has been punched through not quite centrally on the north front at some time in the mid-20th century; it is not there in a photograph of 1937 (Fig. 104) but must stylistically have been inserted not that long afterwards. At second-floor level there are small round windows (like the one over the north door) on the north, south, east and west faces. The third-floor is effectively a lantern, with paired round-headed windows like those lower down forming a continuous wall of windows all around the octagon.

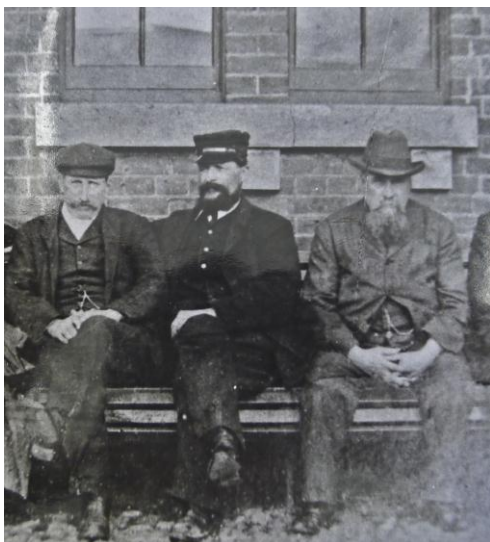
Fig. 105 (above left) A pre-First World War photograph of pilots outside the Pilot Office, showing the window-sill unpainted. Norfolk Library and Information Service (King's Lynn Library Archives)

The whole building is built in English bond of a brownish-red brick, similar to that used for the west part of the Baths. The arches above the windows and doors are of yellow brick; the voussoirs extend right round the portholes with those at the four points of the compass emphasised to give the effect of a cruciform sunburst. The splay-feet of the tower look rendered and coloured to match the brick. The entablature, quoins and windowsills are painted cream but in an early photograph which includes a window-sill it appears unpainted (Fig. 105).

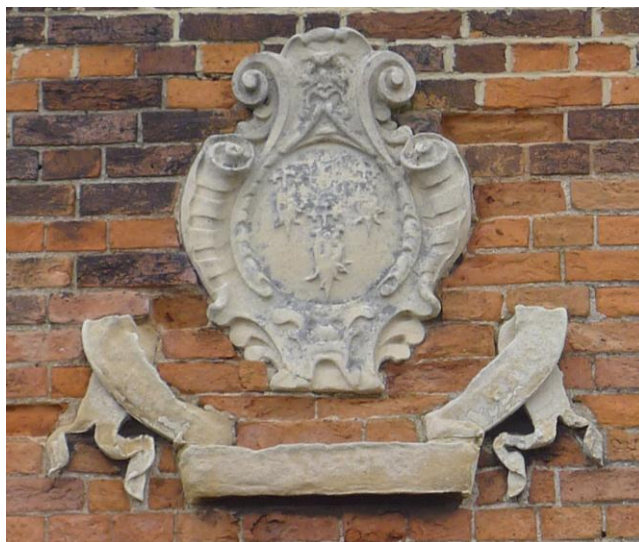
Fig. 106 (above left) The arms of the Borough of King's Lynn on the Pilot Office tower. Photograph: Jonathan Kewley 27-FEB-2017 ©Historic England

There is raised lettering on the west-facing entablatures, to the north 'PILOTS' OFFICE.' and on the south 'MOORING DUES.' The arms of King's Lynn appear in a cartouche on the west-facing gable between the broaches of the tower (Fig. 106); from ground-level they appear to be stone. The cartouche does not look Victorian; perhaps it was brought from the previous Pilot Office.³³ Inside, the north door opens into a long, narrow stone-flagged hall, all except the northernmost part being open to the first-floor ceiling. Stairs lead up northwards in a single flight with plain spindles from near the south end; the newel posts look original (Fig. 107).

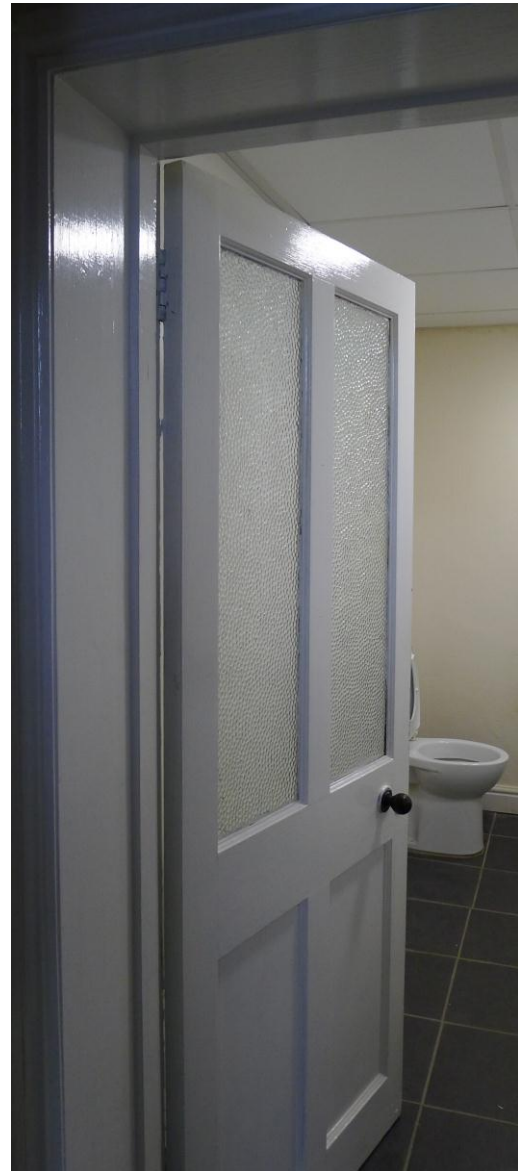
Fig. 108 (*above right*) The doorway from the room now called the Pilot Office to the lavatory behind. Photograph: Jonathan Kewley 6-JUN-2017 ©Historic England

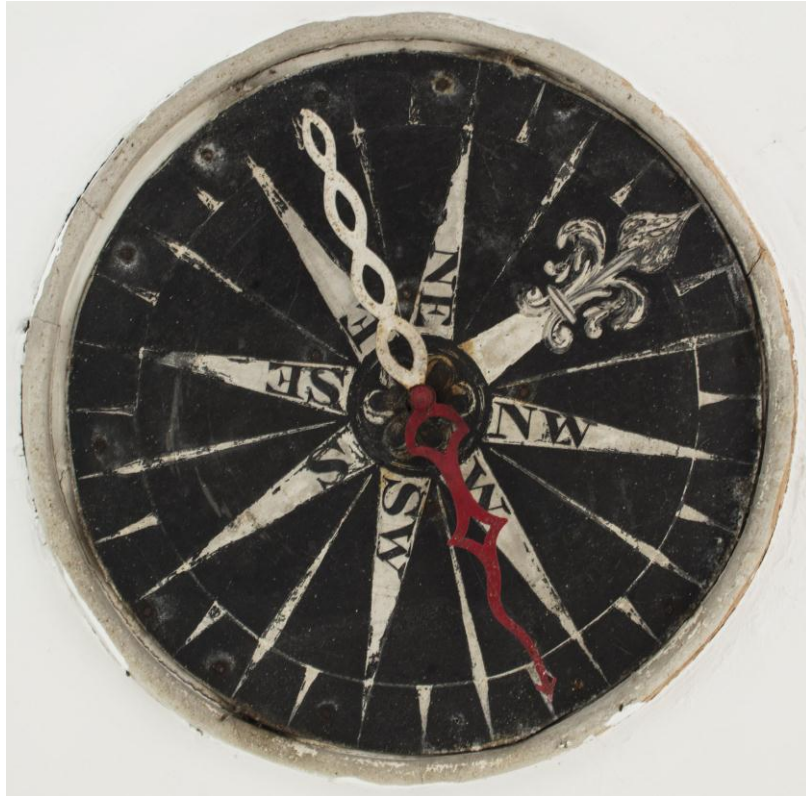
Fig. 109 The dial of the wind-gauge on the ceiling of the Tower Room. Detail of DP217318 20-SEP-2017 Patricia Payne ©Historic England

There is a weather-vane atop the tower with a red, black and white painted wind-gauge dial on the Tower Room ceiling (Fig. 109). The latter appears original although the vane is a modern replacement.³⁷

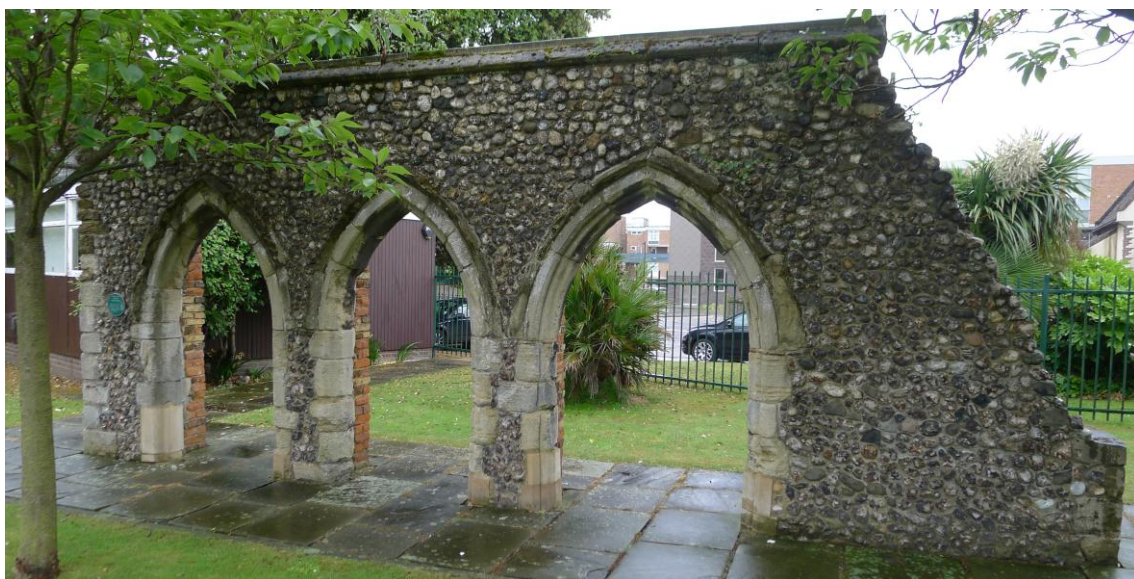
Fig. 110 The main part of the arcade from the Common Staithe, now in the Tower Gardens, looking from the north-north-west. Photograph: Jonathan Kewley 6-JUN-2017 ©Historic England

The medieval arches referred to above, originally behind Smetham's House (see p 20) are now in the Tower Gardens in Lynn (Figs. 110 and 111). The main range consists of a length of flint wall containing an arcade of three complete stone two-centred arches without any capitals. The west end of the wall is faced with dressed stone in the form of alternate courses of quoins and through-stones. At the back (south) there are square openings enclosing the arches and edged with old bricks.

Above, to each side and between these is rubble stone. There is a separate structure consisting of another rather better-preserved arch, attached to some flintwork at the east and one side of another arch at the west. Separate from this is the jamb and beginnings of the springing of another arch, presented in the current layout as the other part of this latter partial arch. There is then a small piece of random stone wall.

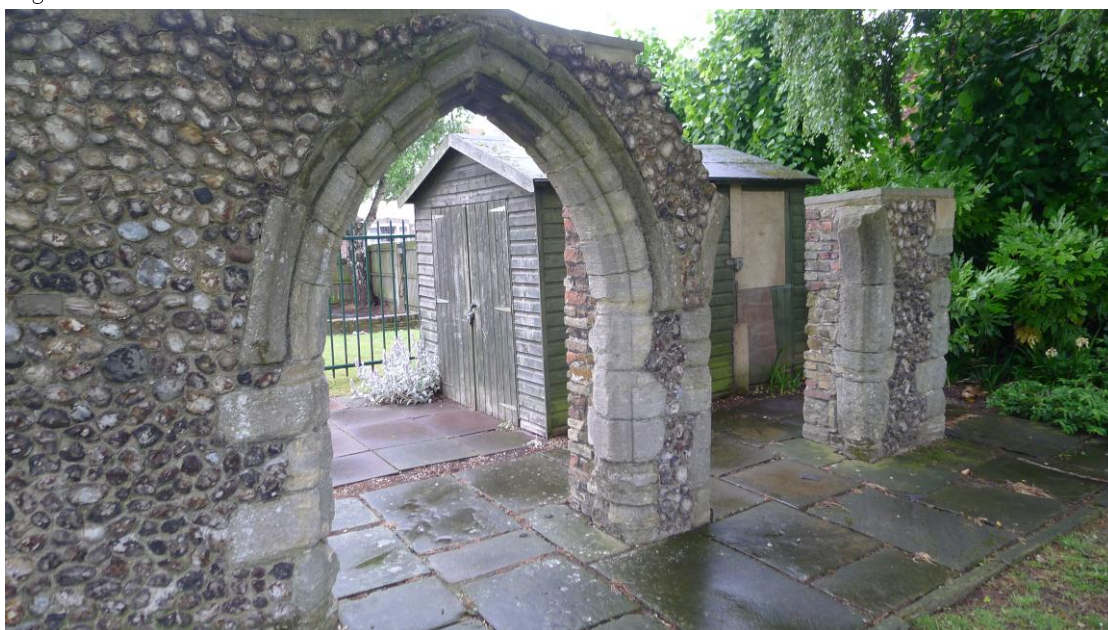
Fig. 111 The other part of the arcade now in Tower Gardens; a view from the north-east. Photograph: Jonathan Kewley 6-JUN-2017 ©Historic England

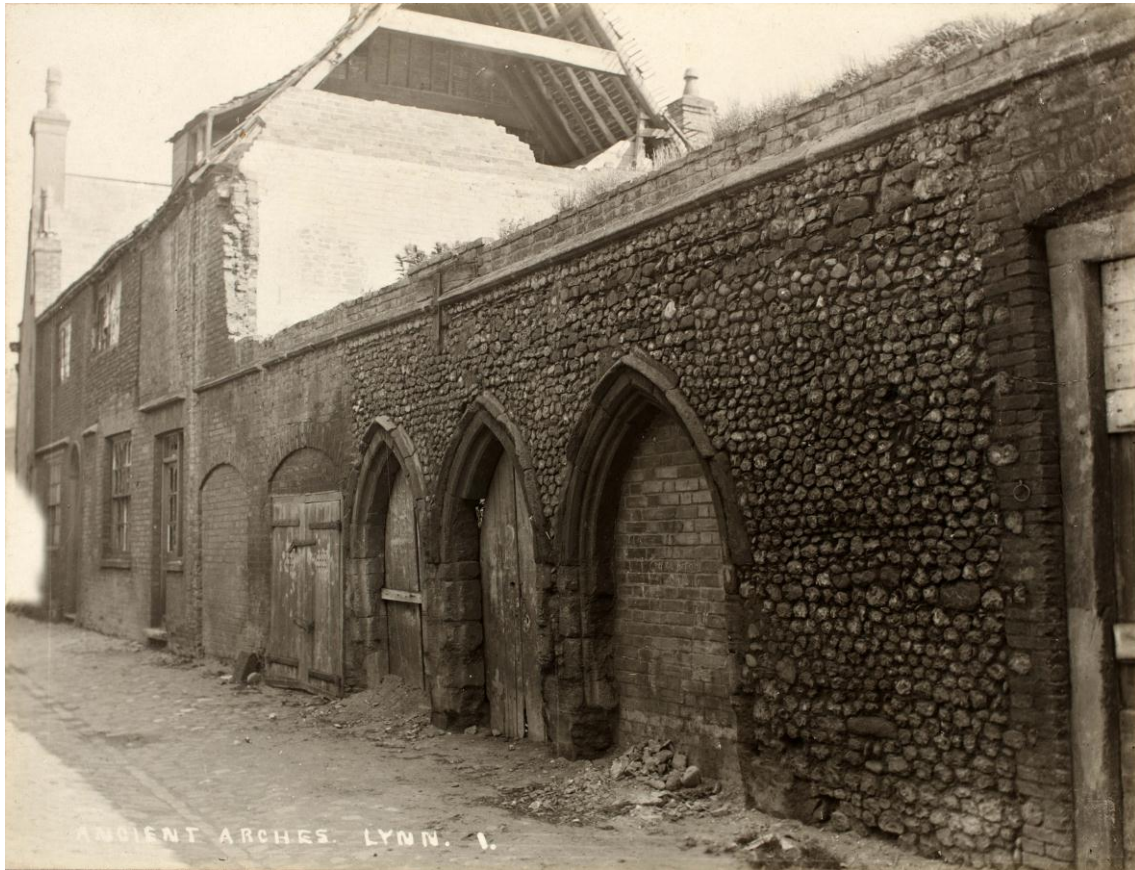
Fig. 112 The arcade in situ in Bank Lane c 1908. This view is taken from the north-west; the two-storey building in the distance, at right angles to the lane, is Smetham's House. Norfolk Museums Service (Lynn Museum)

So far as can be worked out from photographs and a drawing from when the arches were *in situ* (Figs. 112 and 113; see also Fig. 39), the present arrangement of the arches in the Tower Gardens replicates their alignment and relationship to each other, but omitting the brick and the wooden gates which joined them. No interior photographs of the building of which they were part survive, so it is unclear how accurate the south face of the reconstruction is.

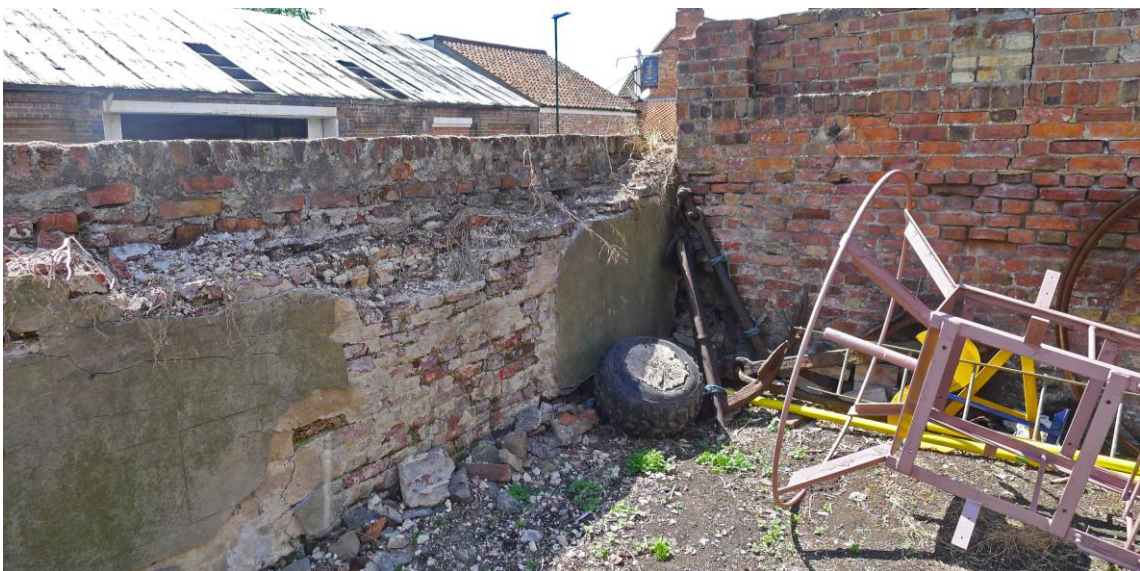
A brick wall approximately 16 metres long runs east-west from the east end of the Chimney Yard (Figs. 115 and 116). It seems to be double-skinned, with the northern skin having partially collapsed; where it has not, it is largely cement-rendered. Part of the collapse includes cobbles. The south skin is finished on top with a course of headers on end; the extreme east end of the wall appears to have been rebuilt recently. It was the back wall of Birtledene before its demolition. There are no openings in it, which is consistent with the back-to-back nature of the buildings. That it is double-skinned suggests that the two ranges were not built simultaneously but at different times, and were structurally separate.

Fig. 115 The double-skinned wall running east-west parallel with Ferry Street, and seen here from the north. The further skin was the back wall of Birtledene and the nearer seems to have been the back wall of one of the warehouses on the Common Staithe.

A detailed study, comparing these walls and the brick and stone re-used in the Buoy Store with other buildings in King's Lynn would be worthwhile and might help our understanding of the evolution of the buildings on the Common Staithe. Such a study is beyond the scope of this report, but Paul Drury argues that brick starts to be used in East Anglia in externally-visible contexts from the early 15th century onwards.⁴⁰

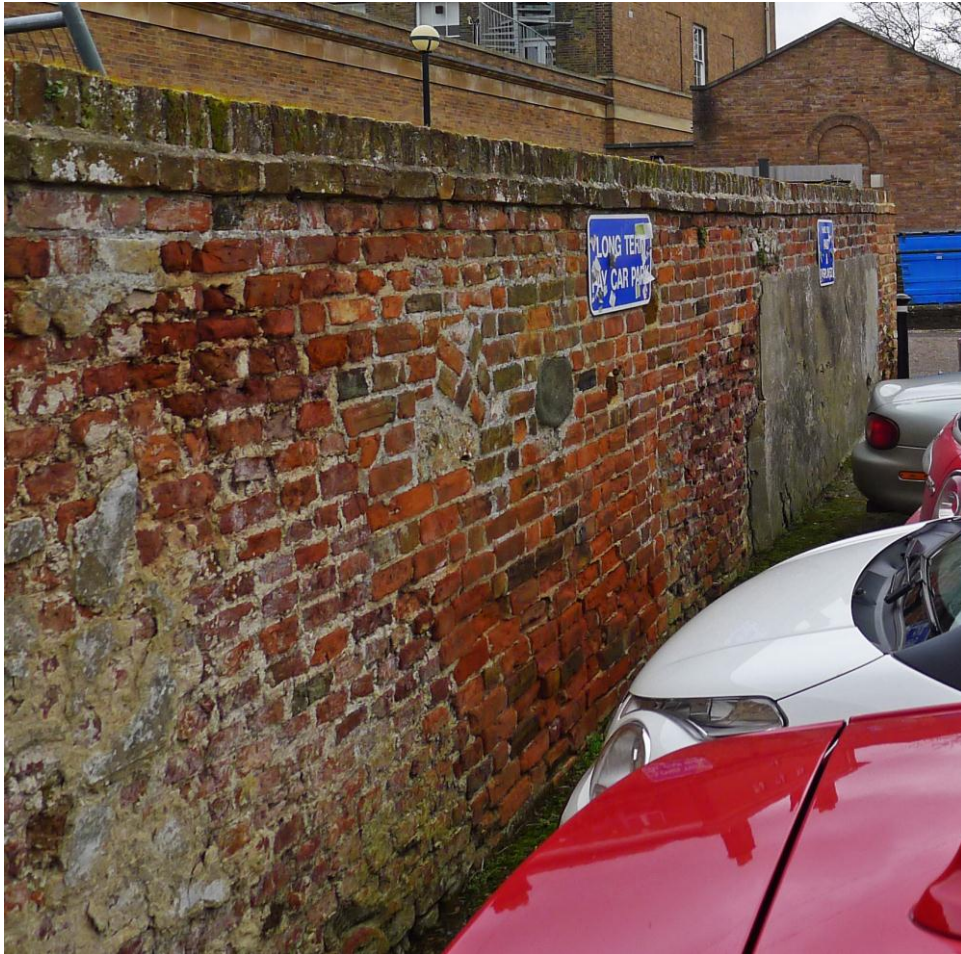
Fig. 116 The back wall of Birtledene, seen from the south (i.e. the inside when the cottage was standing. Photograph: Jonathan Kewley 27-FEB-2017 ©Historic England

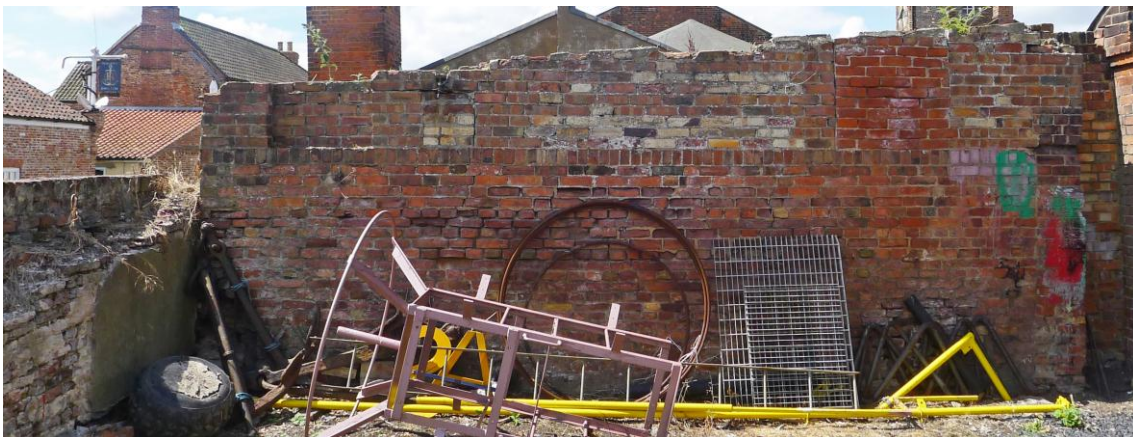
From the west end of this wall another wall runs north approximately 6 m. to the south-west corner of the Carpenters' Shop (Fig. 117). Its lower levels on the west side are hidden by a wall which appears to be part of the Chimney Yard. The brick of this wall looks pre-19th-century (in English bond) up until about shoulder height, when there is a course of headers on end, and the brick above (which is stretcher bond) looks 19th-century or later. This last matches other work in the Chimney Yard and appears to represent a raising of this wall above the level of the header course to take the later roofing-in of the whole Chimney Yard. About three-quarters of the way northwards there is a square of early 19th-century-looking bricks rising above the header line. There are also two blocked openings nearer Ferry Street. At the northernmost end there is what appears to be a buttress like those on the south wall of the Settling Tank, with later-looking brick built above it.

This wall cannot form part of Birtledene (it is north of its north wall) and it is clear from its construction that it is not part of the Baths complex. It must, therefore, be a survival of the buildings on the site before the range between the Baths and the Tuesday Market Place was (except for Birtledene) demolished at the turn of the 20th century.

Fig. 117 Looking west from the yard south of the Carpenters' Shop, showing a wall which seems to be a dividing wall between units of the old south range on the Common Staithe, probably much rebuilt. Photograph: Jonathan Kewley 5-JUL-2017 ©Historic England

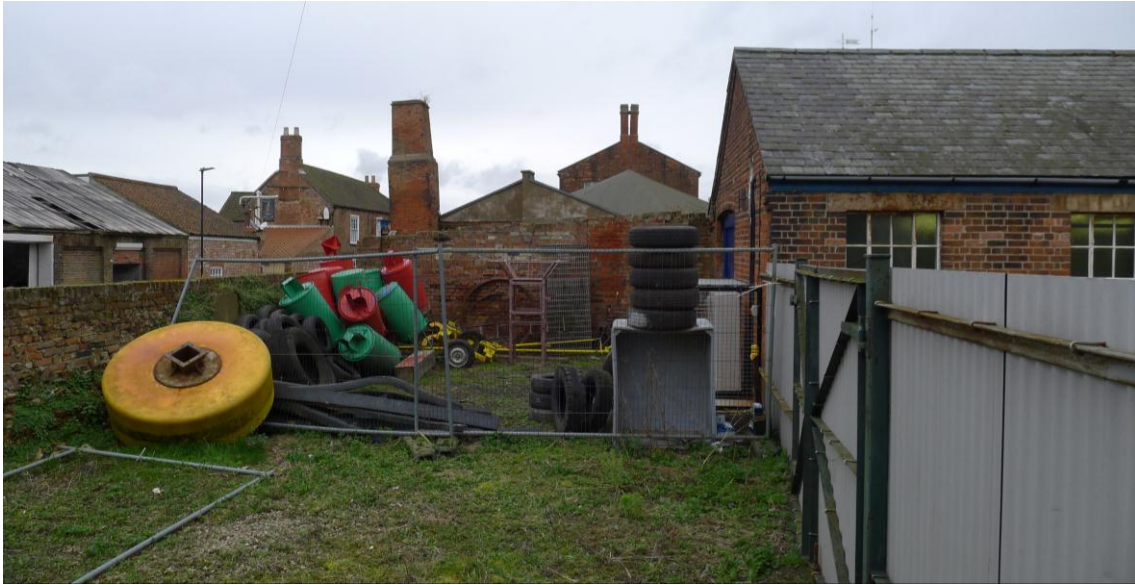
The area north of the long east-west wall currently forms a yard for the Carpenters' Shop (Fig. 118), bounded by the other wall on the west. Its east boundary is not permanently demarcated; at the time of writing it is enclosed by metal hoardings, but the land in the Conservancy Board's ownership stretches a little further east. Further east still are modern public lavatories.

Fig. 118 The yard south of the Carpenters' Shop, looking east. Photograph: Jonathan Kewley 27-FEB-2017 ©Historic England

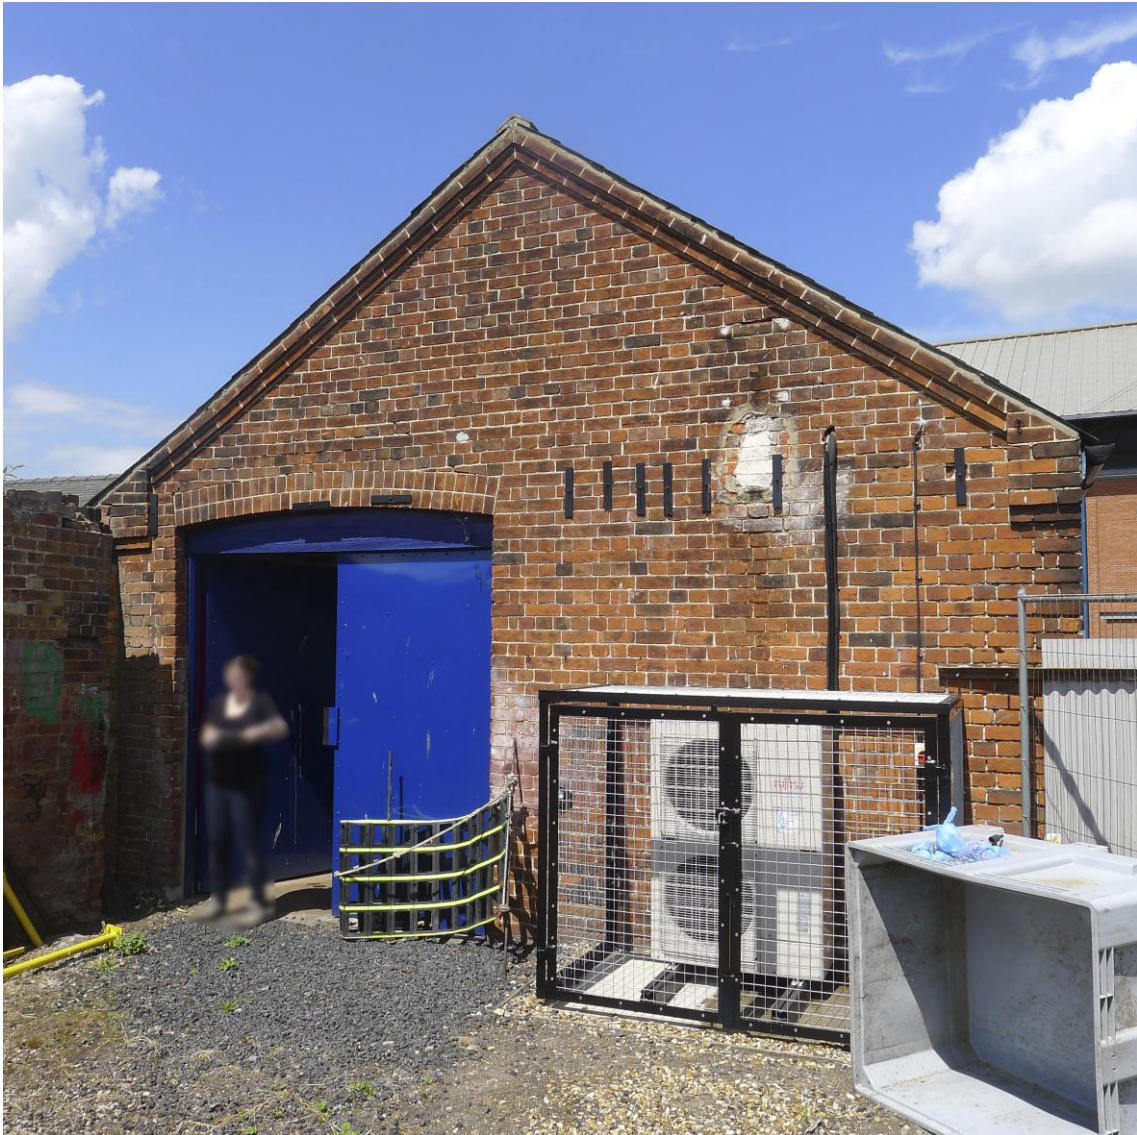
Fig. 119 The Carpenters' Shop from the south. Photograph: Jonathan Kewley 5-JUL-2017 ©Historic England

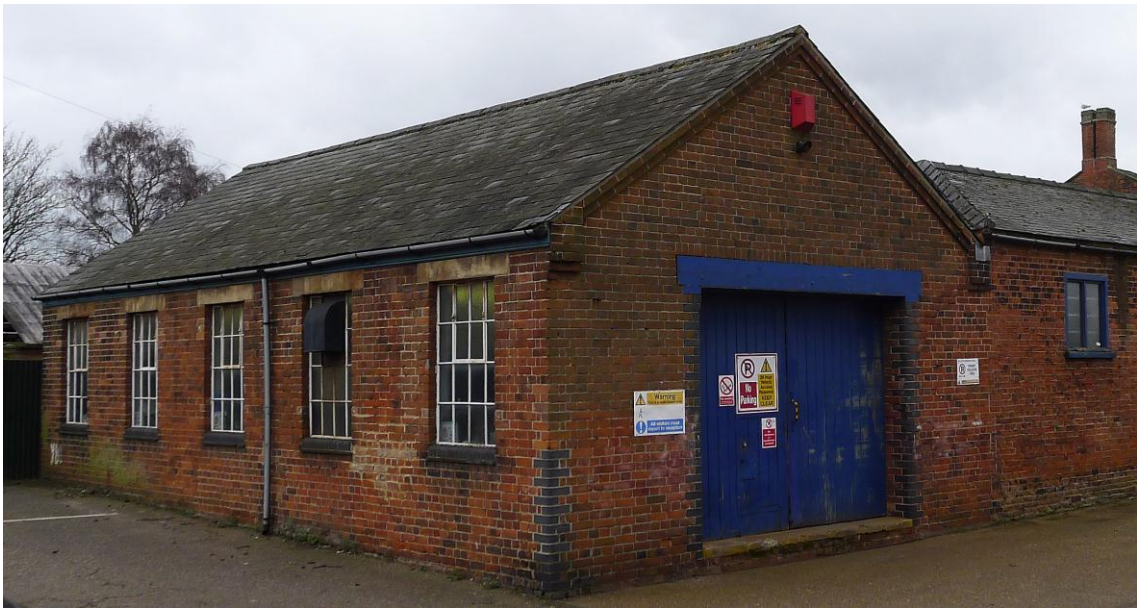
The building known as the Carpenters' Shop lies to the east of all the other buildings in the occupation of the Conservancy Board (Figs. 119 and 120). It abuts the Engineers' Store (the 1834 warehouse) and the Settling Tank on the west but has no internal communication except a blocked-up hatch to the former. At its north-west corner the brickwork is bonded into the earlier north wall of the Engineers' Store in dovetail fashion (Fig. 121). It is single-storey under a double-pitched slate roof running east-west with a gable at each end. It is built of hard red brick in English bond, plain except for two projecting stretcher courses acting as bargeboards on each gable, projecting kneelers on each gable, and the use of dark engineering brick for the lower courses of the north-east corner. In the east wall are five identical metal-framed windows, each of twenty panes, four panes wide and

five tall; the central two on the top two rows form a top-hung opening.⁴¹ There are concrete lintels, and the window-sills are of dark engineering brick of rounded profile. There are wide doors at each end, that on the north wooden and sliding, with a wicket and roughly central, but those on the south hinged double wooden doors faced externally in metal and situated at the west end of that front. The north doors are flat-headed with a course of headers above a lintel and with the jambs of dark engineering brick of rounded profile, but the south doors are under a segmental arch of two courses of headers on end. Their size would suggest that both are vehicular, but rather oddly those on the north are raised three courses of brick above external ground level with no step or ramp.

Fig. 120 The Carpenters' Shop from the north-east. Photograph: Jonathan Kewley 27-FEB-2017 ©Historic England

Internally there is a low ceiling which seems to be supported on brick columns between the windows and at equivalent positions on the west wall; the two southernmost of these may incorporate buttresses to the Settling Tank. It was purpose-built about 1920 to increase the accommodation available to the Conservancy Board; the name of the architect is unknown. It appears largely unaltered.

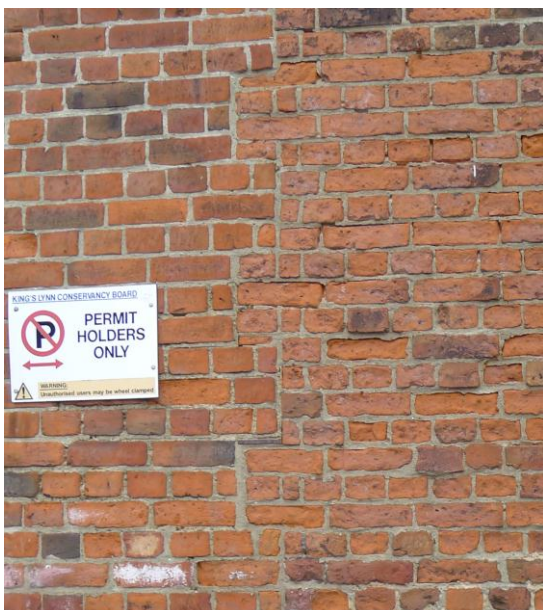
Fig. 121 Dovetail bonding between the Carpenters' Shop (left) and the Engineers' Store (right) Photograph: Jonathan Kewley 6-JUN-2017 ©Historic England
