Historic England

The Common Staithe, King's Lynn, Norfolk: An architectural and archaeological assessment

Jonathan Kewley

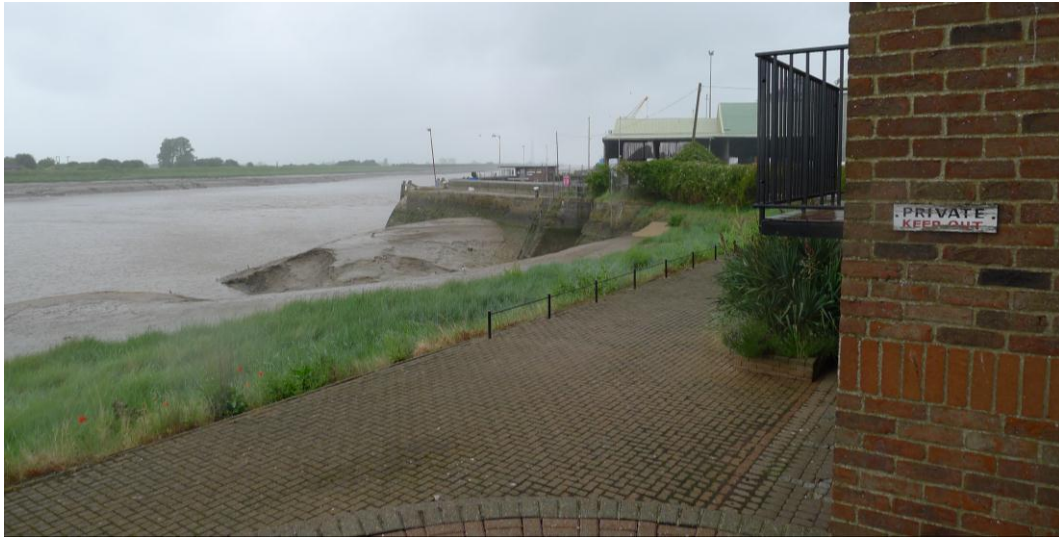
Fig. 122 The river frontage at Trinity Quay, looking north towards the Wash. Photograph: Jonathan Kewley 6-JUN-2017 ©Historic England

The river frontage of the HAZ site consists of three parts. At the far north (Fig. 122), there is no quay, just grass-backed mudflats with, at the east, a path in front of the west front of Trinity Quay. From opposite the south-west corner of Trinity Quay a concrete embankment then runs south-south-west as far as the north-west corner of the Crown and Mitre. At its northern end metal gates can be shut across the path to Trinity Quay if very high water is likely (Fig. 123). Immediately behind it is a paved pedestrian walkway, raised above the level of the Common Staithe Yard and bounded on this inland side by railings atop a brick retaining wall; at intervals on the landward side are embrasures for park benches. It stops level roughly with the north of the Pilot Office, with a short flight of steps down to car park level.

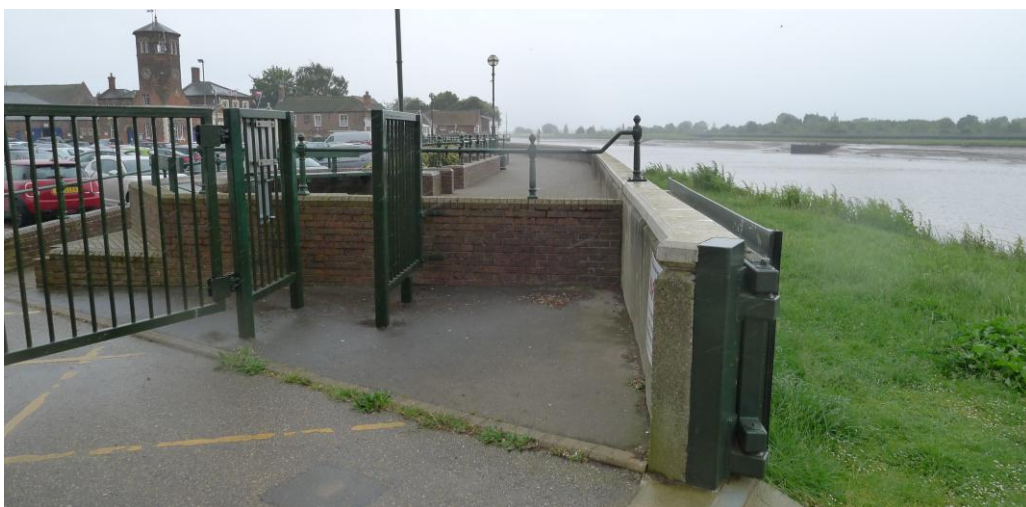
Fig. 123 The raised walkway along the river front of the Common Staithe; note the metal flood gate on the right. Photograph: Jonathan Kewley 6-JUN-2017 ©Historic England

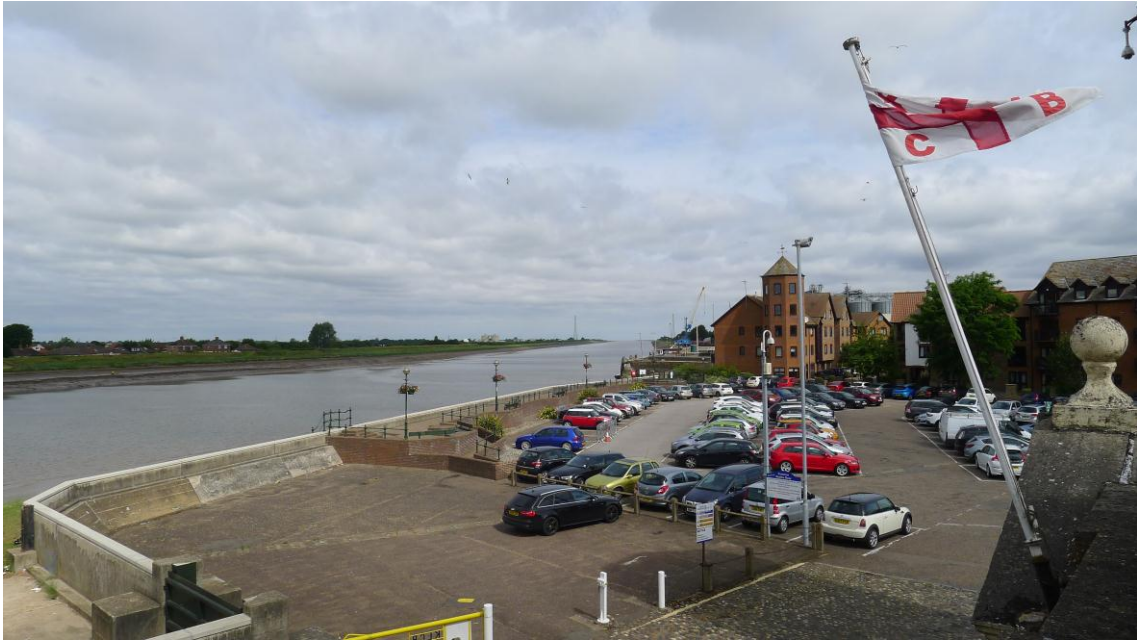
Fig. 124 The quayside at the Common Staithe from the balcony of the Public Baths, showing the flood defences with the clear concreted area belonging to the Conservancy Board in the foreground. Photograph: Jonathan Kewley 4-JUL-2017 ©Historic England

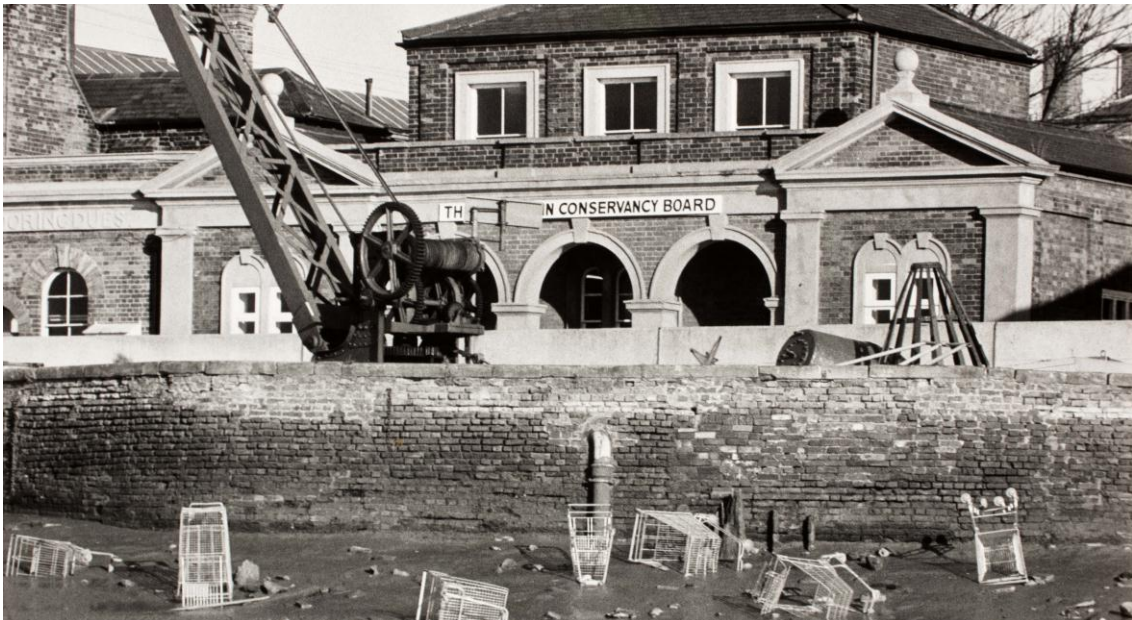
Fig. 125 The southernmost part of the old Common Staithe Quay, its brickwork still visible. Norfolk Library and Information Service (King's Lynn Library Archives)

Opposite the Baths is a concreted area outside this concrete embankment, on which buoys are stored. On its west side is a brick-built, stone-topped quay, quite a bit lower than the concrete embankment, with stone quoins (visible only from the area described in the next paragraph) and a stone top edging. The brickwork, in English bond, looks of some age; it is presumably the water wall referred to in 1853 but repaired on various occasions (see Section 2.7) (Fig. 125).⁴² A large iron drainpipe leads out from it (possibly from the Baths). The line of this quay can be traced in the car park, running north-east almost as far as the east end of Trinity Quay.

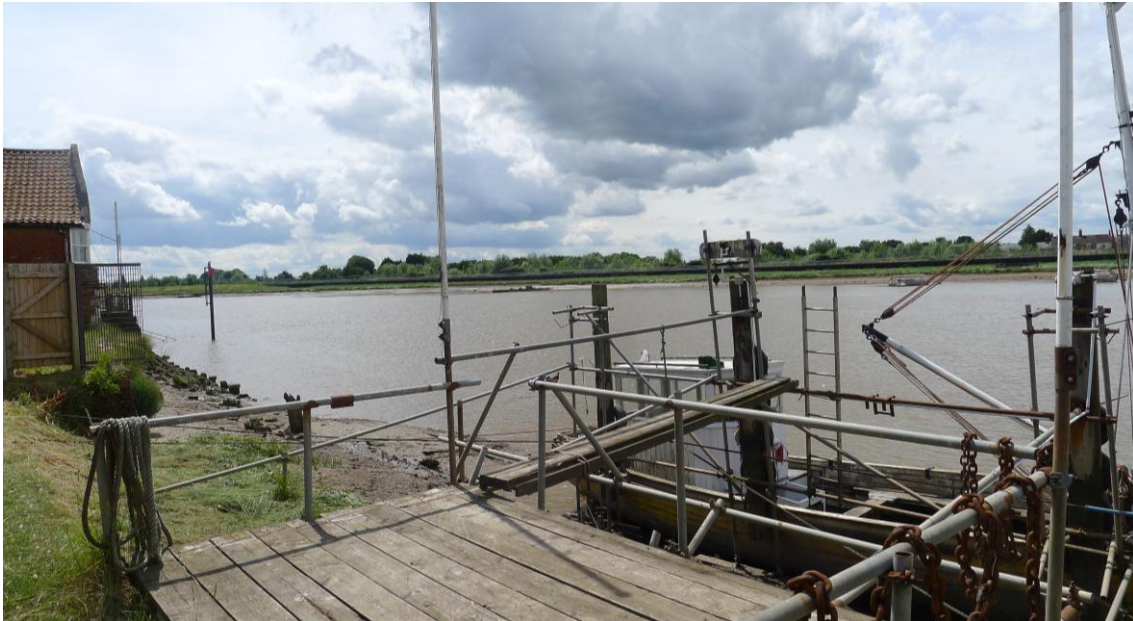
Fig. 126 The scaffolding jetty by the Crown and Mitre. Photograph: Jonathan Kewley 3-JUL-2017
©Historic England

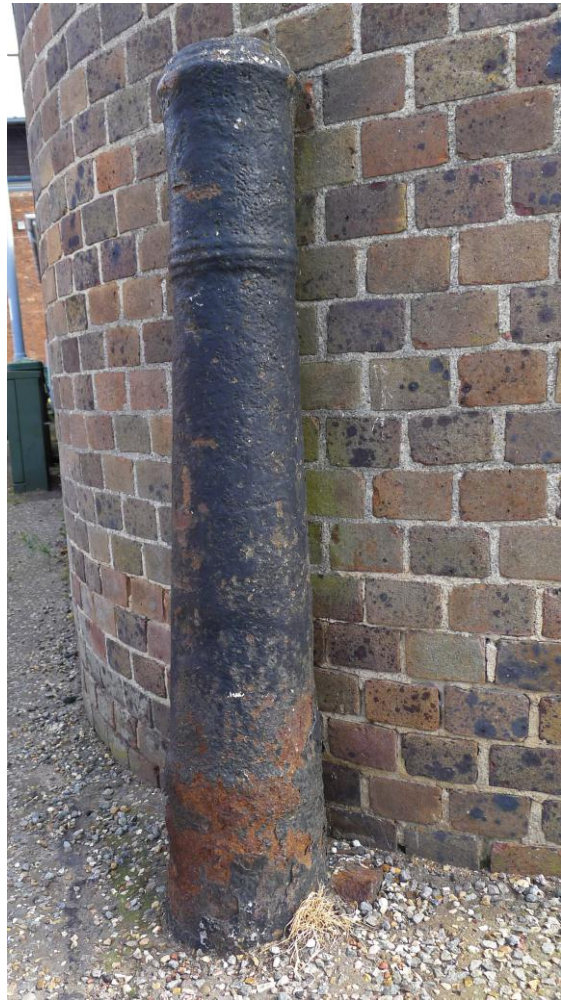
The car park which covers most of the Common Staithe is largely featureless except for the top of the old quay wall, referred to above. At the south-west corner of Gurney's is a cannon acting as a bollard (Fig. 127).

Fig. 127 The cannon acting as a bollard at the south-west corner of the former Gurney's House. It is on the National Heritage List for England. Photograph: Jonathan Kewley 2-MAY-2017 ©Historic England

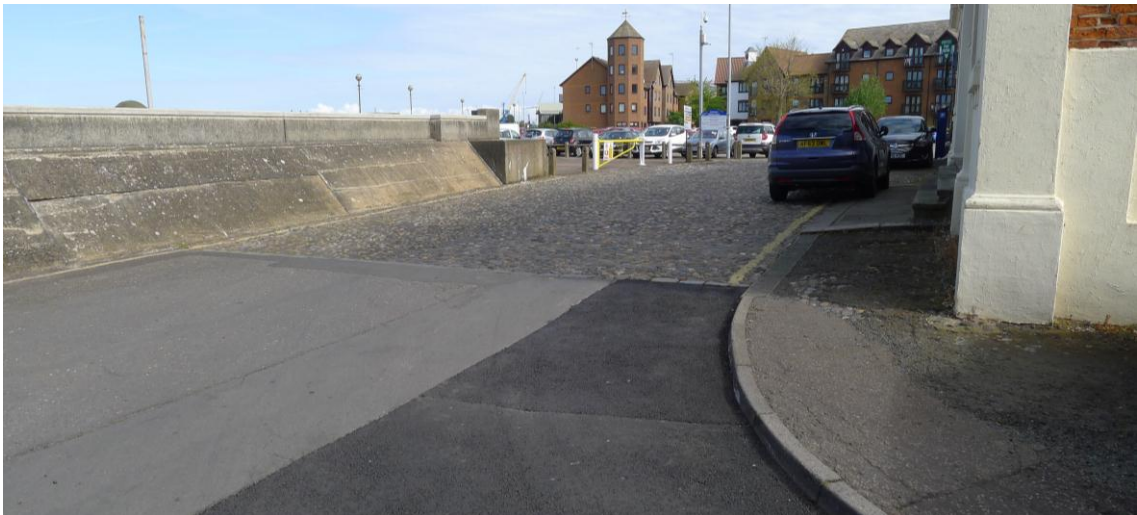
Cobbles survive in the carriageway in front of the west facade of the Pilot Office and Baths (Fig. 128), on the pavement at the corner of Ferry Street and the Common Staithe Quay, where they are partly covered with asphalt, as an unkerbed pavement along the west front north of the loggia, and all along the north front of the Pilot Office and Warehouses as far as the east end of the Engineers' Store (except for where York stone paving leads up to the north door of the Pilot Office and the doors to the Buoy House). There is also York stone paving in front of the Baths loggia.

Fig. 128 The cobbled carriageway on the west side of the Public Baths. Note the cobbles visible under the tarmac on the pavement on the right. Photograph: Jonathan Kewley 2-MAY-2017 ©Historic England
