Historic Places Investigation

Southgates, King's Lynn, Norfolk: Historic Area Assessment

Research Report Series 009-2018

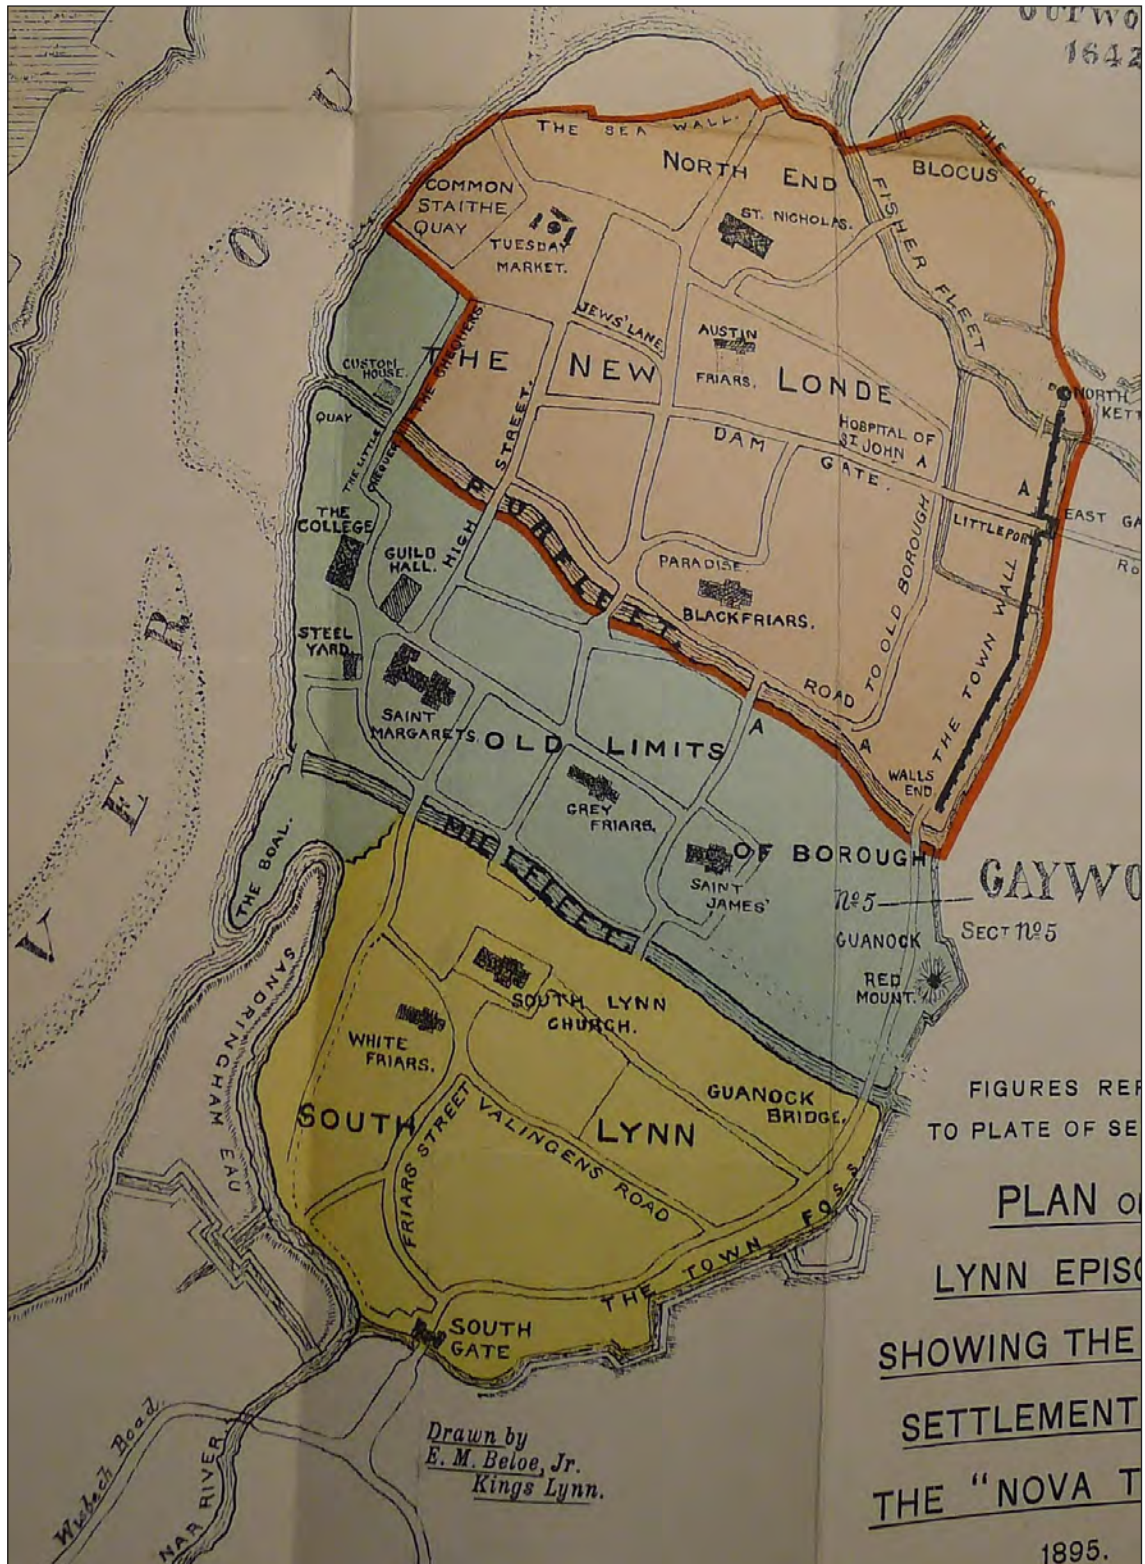
Fig. 1 A plan showing the three areas which developed into modern King's Lynn: first South Lynn, then the original borough and finally the Newland. From E M Beloe 1895 'Freebridge Marshland Hundred and the Making of Lynn' Norfolk Archaeology XII 311-34

The oldest part of the town is what has for centuries been called South Lynn, the parish of All Saints, which seems to have started as an island community in the salt pans (Fig. 1). From 1090 two northward extensions together formed the parish of St Margaret, known first as Lynn Episcopi and then, from the time of Henry VIII, as Lynn Regis or King's Lynn – although to its inhabitants, just Lynn. The parish became a borough, to which South Lynn was joined in the 16th century.

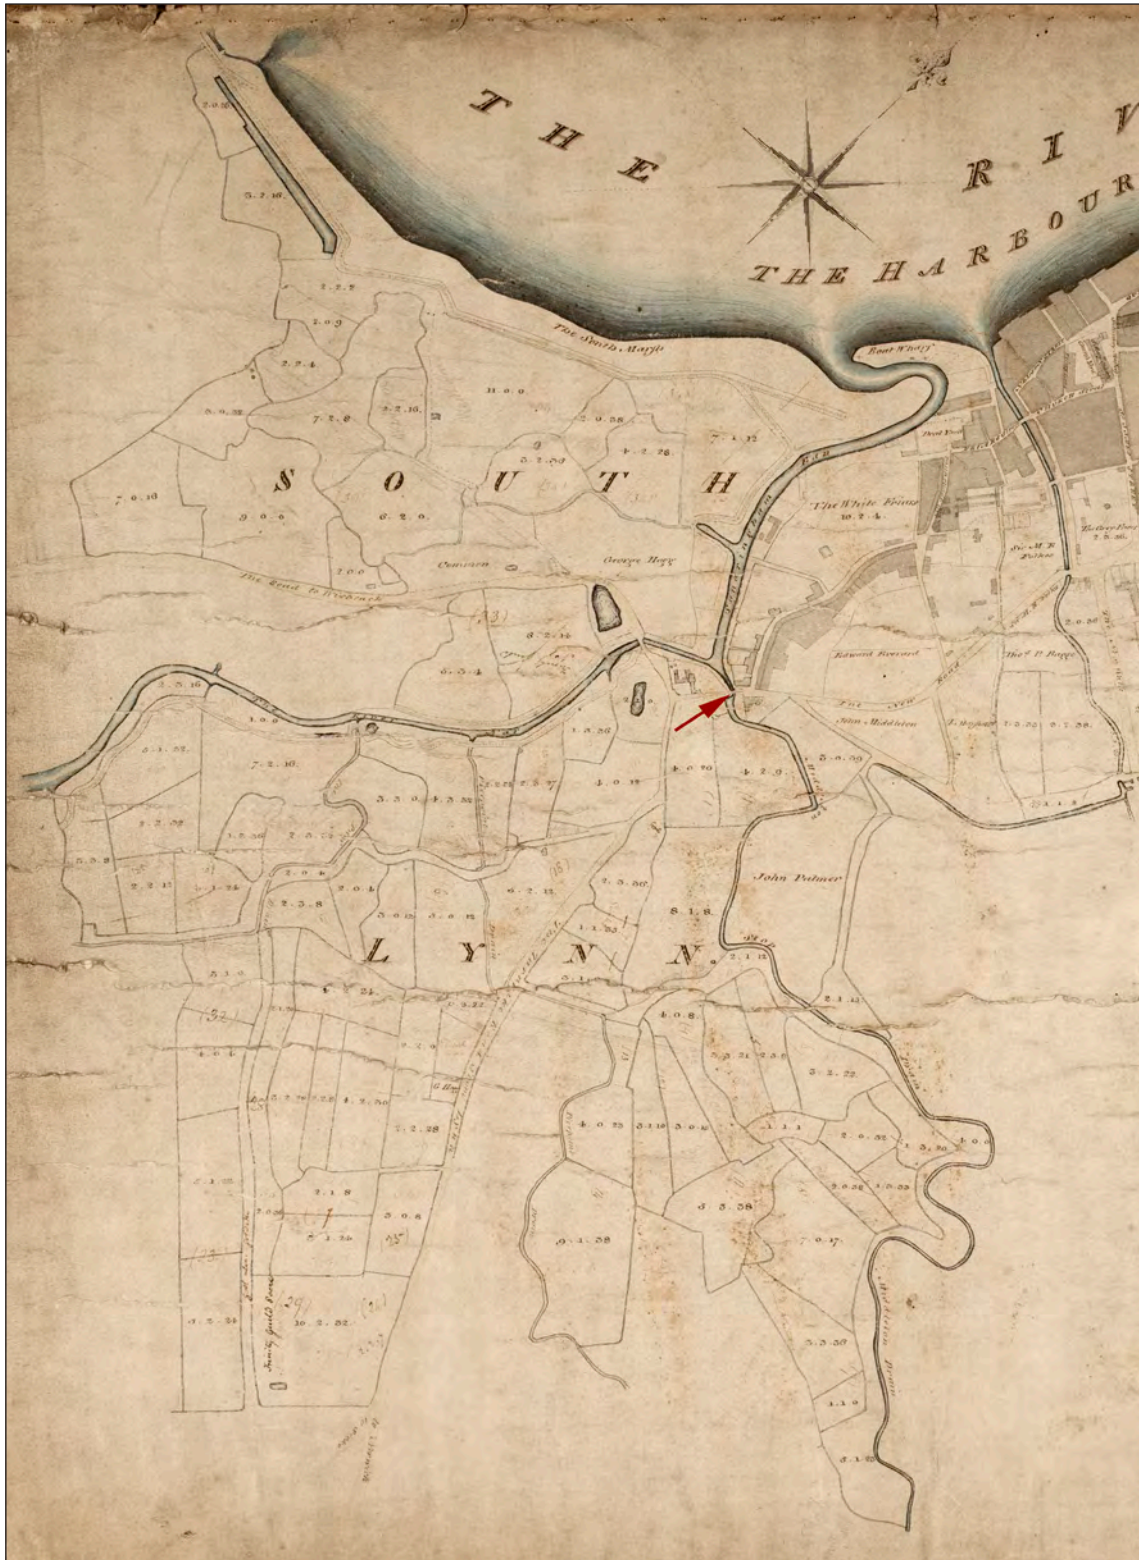
Fig 2. A Map of the Borough of King's Lynn ... with the Estate of the Mayor and Burgesses, by William Newham, the Corporation's chamberlain, 1809 (detail), showing the urban and rural parts of the parish of All Saints, South Lynn. The arrow indicates the position of the South Gate; north is to the right. Norfolk Museums Service (Lynn Museum). Image HEA DP219413

The area within the town's defences was until well into the 19th century much larger than the inhabited area, with much open ground especially to the east and south. All Saints' was a parish with two distinct elements, a northern part which was within the urban defences and part of the town proper, and a rural part taking in the drained and undrained marshland to the south (Fig 2).

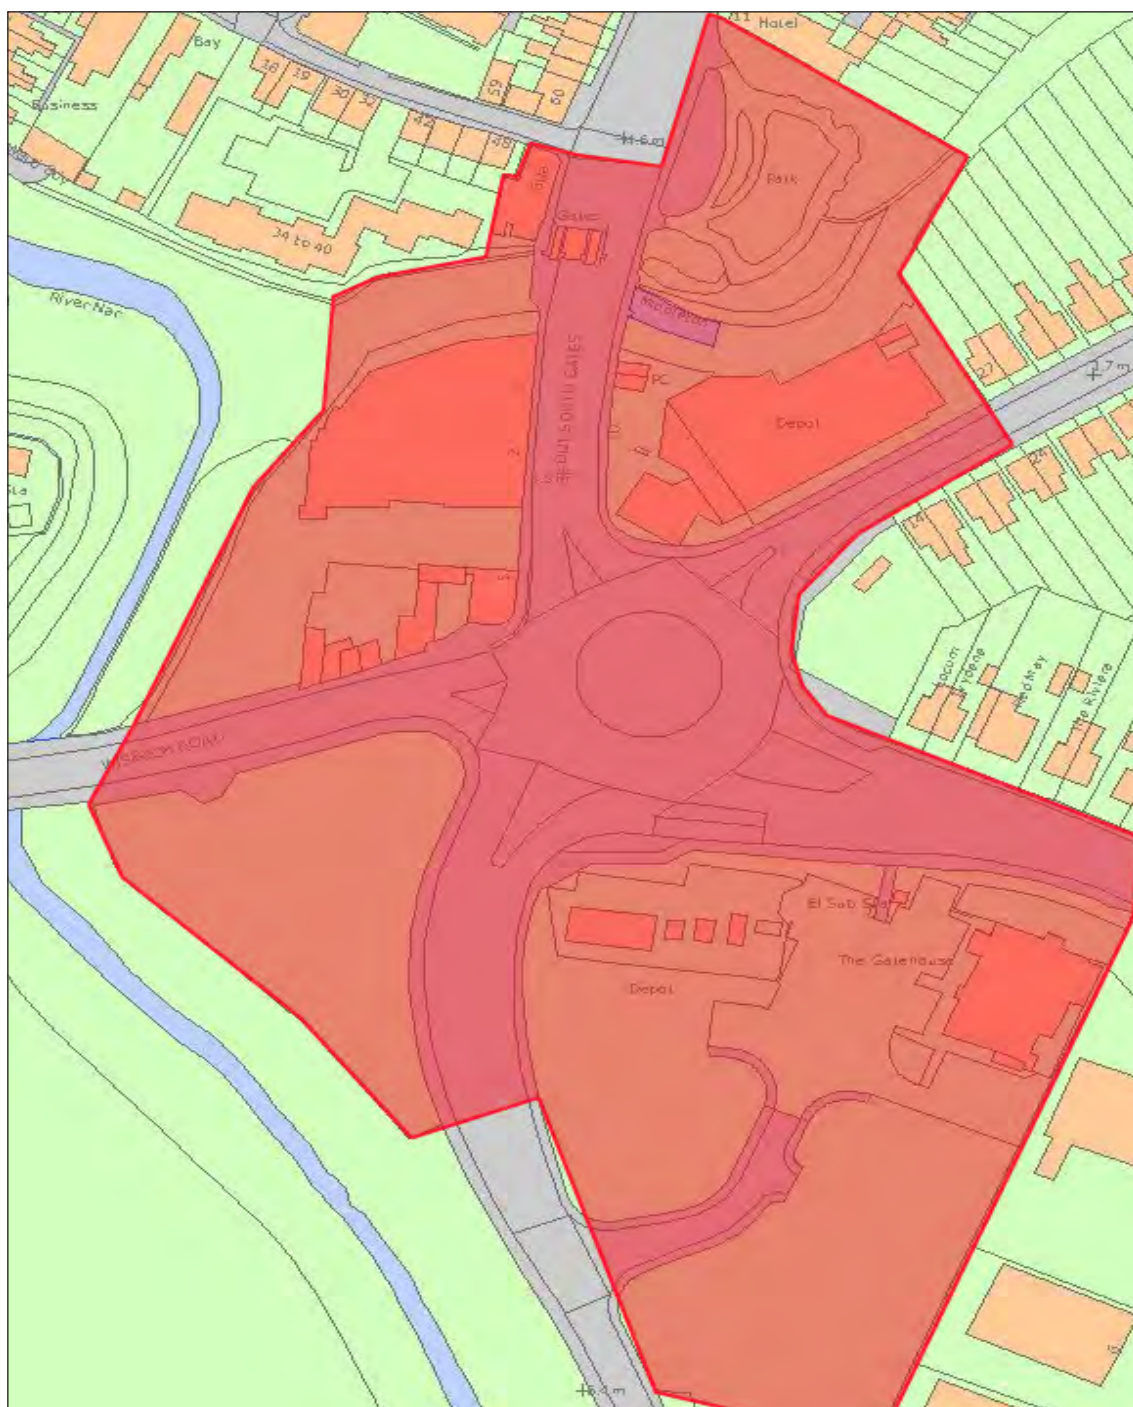
Fig. 3 The Historic Area Assessment area. Modern Ordnance Survey mapping: © Crown Copyright and database right 2017. All rights reserved. Ordnance Survey Licence number 100024900

The area which is the subject of this assessment straddles the boundary between these two parts, that boundary being marked by a medieval gatehouse, the South Gate, which was the focus of Lynn's medieval defences and remains visually the focus of its surroundings today. This area will be referred to in this report as 'the HAA area'. Its boundaries are shown in map form in Fig. 3 and an aerial view in Fig. 4.

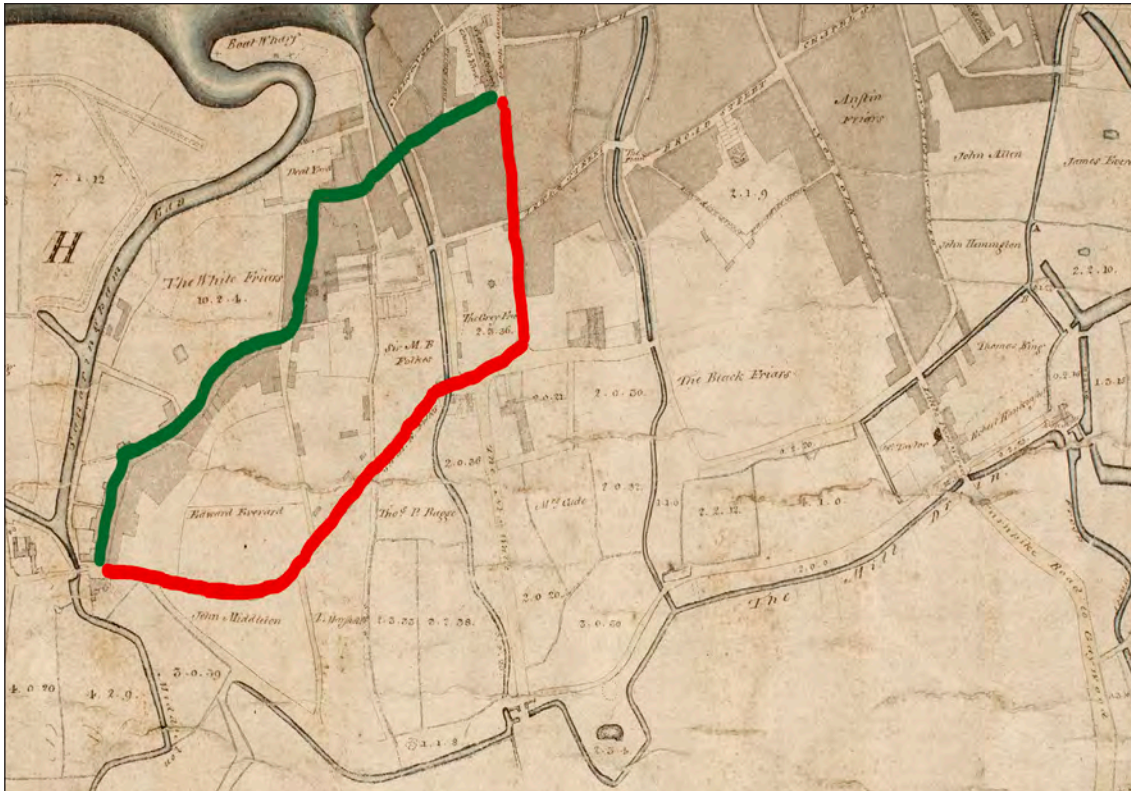
Fig 7 detail of William Newham, *A Map of the Borough of King's Lynn ... with the Estate of the Mayor and Burgesses*, 1809, showing in green the old route from the South Gate to the Saturday Market Place (the centre of King's Lynn) and in red the route via the new London Road. Norfolk Record Office, Bradfer-Lawrence 5/4

The first change to this came in 1804 but affected only the road system within the walls. It consisted of the demolition of buildings immediately inside the gates and the construction of a new road northwards, called London Road, leading straight to the town centre (Fig 7). As the 19th century wore on, new buildings were erected along it, residential, commercial and public, thereby increasing its importance as a route.

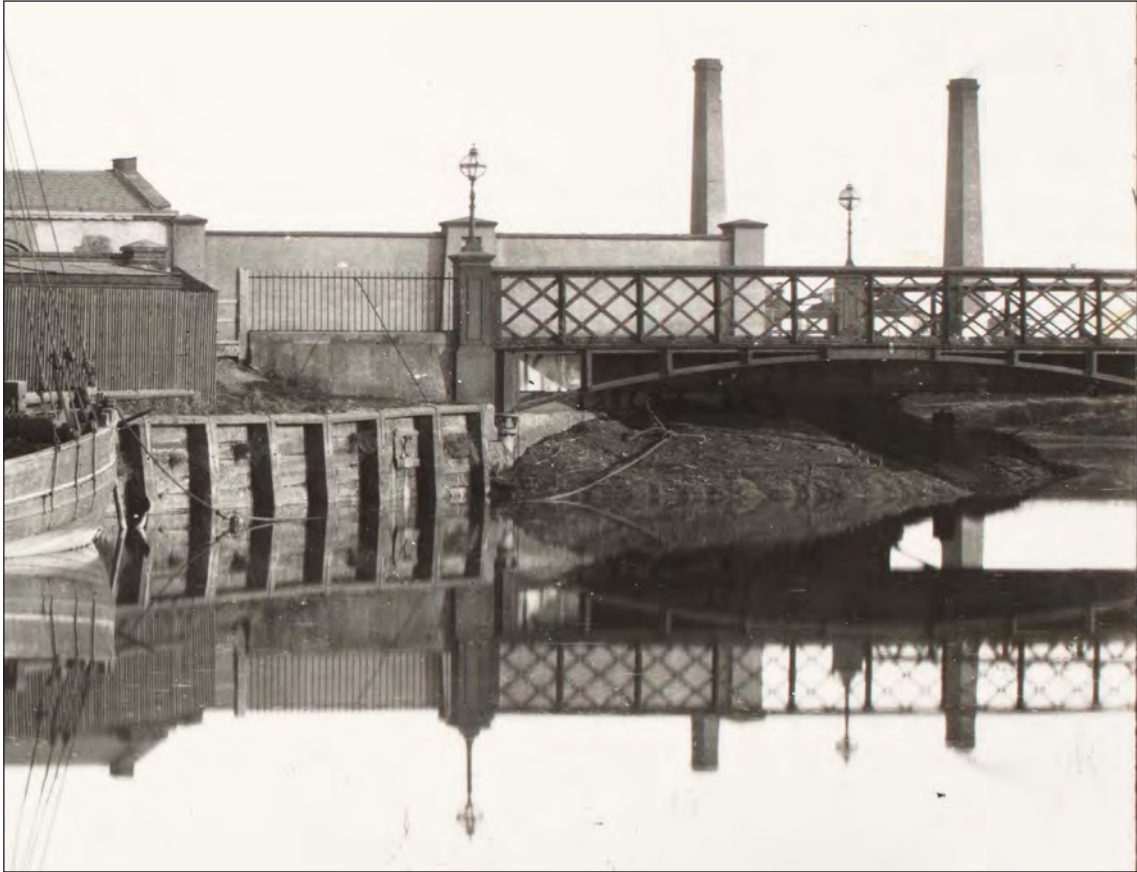
Fig 11. The Long Bridge over the River Nar, from the north. This view probably dates from the late 19th century. Norfolk Library and Information Service (King's Lynn Library Archives). Image: HEA DP219451

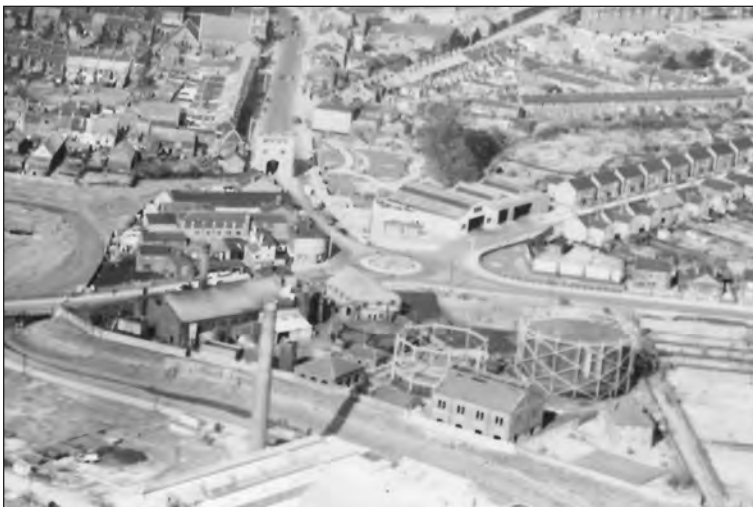
Fig 15. An aerial view of Southgates in 1946 showing the roundabout in the centre of the picture. HEA (Aerofilms Collection) TF6218-0011

Aerial photographs show that a roundabout was present at the junction by 1946 (Fig. 15),⁹ and it was extended to 100ft (c.30m) in diameter in 1959 (Fig. 16).¹⁰ In the 1970s the roundabout was removed in favour of an ordinary junction (Fig 17), but was restored, about the same size, in the 1990s; the alterations in the road layout in 2009, described below, mean that it is now slightly further south than before.

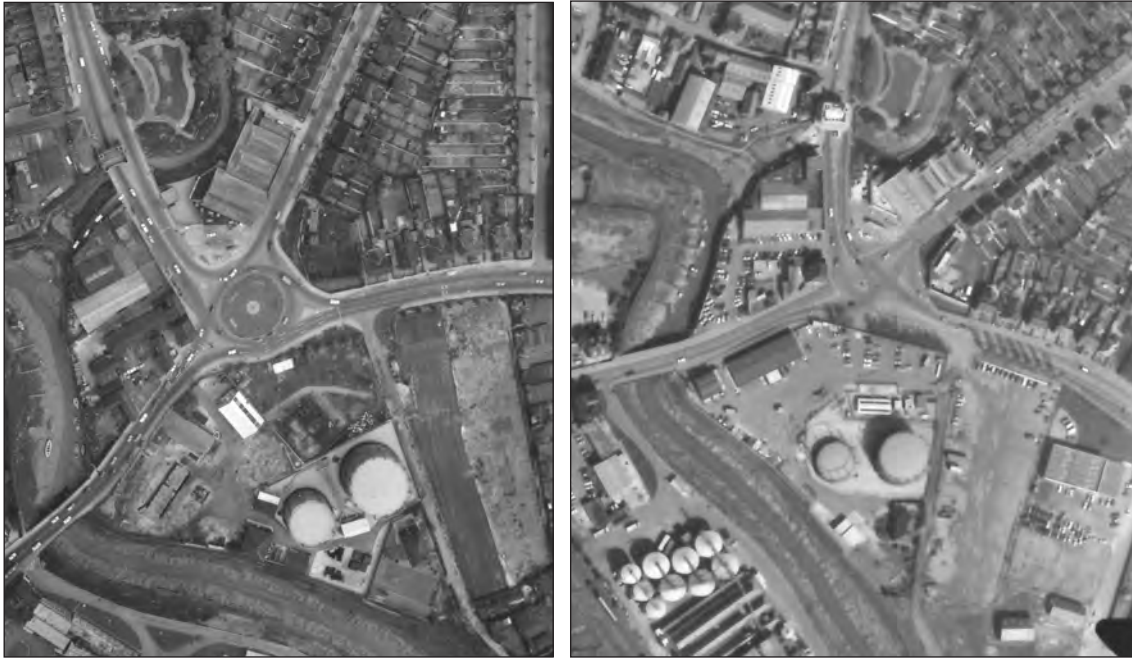
Fig 16 (Left) An aerial view of Southgates in 1965, showing the enlarged roundabout HEA Archive (Aerofilms Collection) MAL-65048-009

Fig 17 (Right) An aerial view of Southgates in 1983 HEA (Aerofilms Collection) OS-83037-19

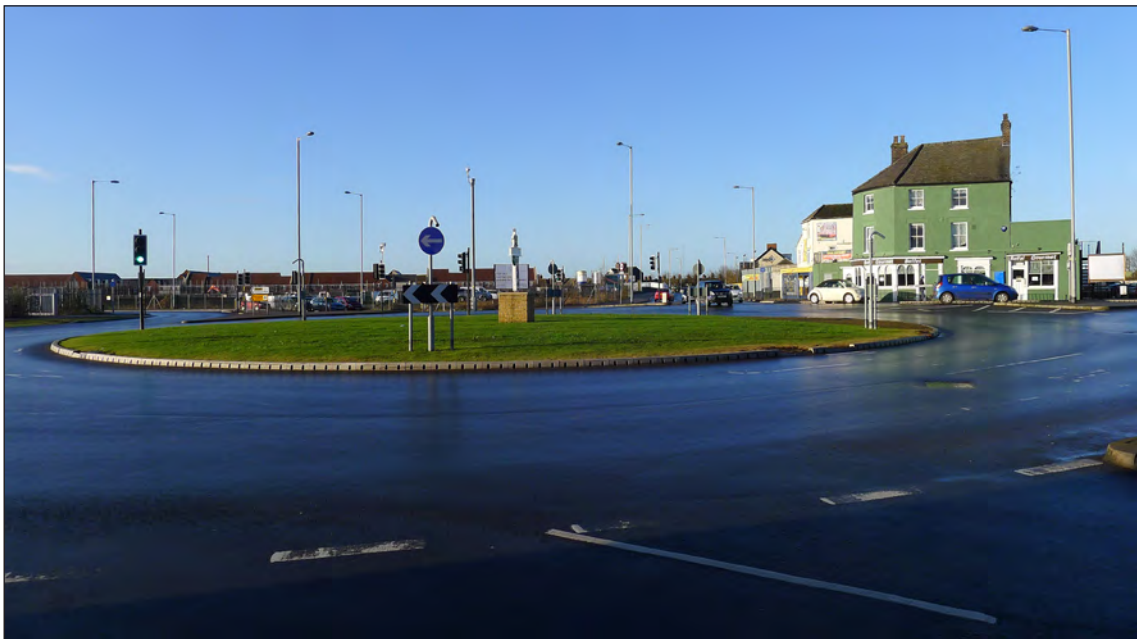
Fig 20 Southgates Roundabout looking west in 2018. Photograph Jonathan Kewley 19-FEB-2018 © Historic England

In March 2009 Norfolk County Council received funding from the Community Infrastructure Fund for various highway works at Lynn, including the improvement of Southgates Roundabout, which was carried out in 2010 (Fig. 20). This involved laying out a new road called Nar Ouse Way, leading more or less due south from the roundabout, dissecting the former Gas Works site (Fig. 21). It leads to a junction on the A17/A47, the modern main west-east route. Nar Ouse Way, Out South Gates and the London Road are now designated the A148. The Hardwick Road, from Southgates roundabout to Hardwick, is the A149. The Wisbech Road is now unclassified and a new bridge carrying the A17/A47 runs alongside the Free Bridge. The effect of all this is that east-west traffic for King's Lynn, on the arterial A17, is led off onto the A148 to the Southgates roundabout. Traffic from the south also comes to the roundabout by the A148 or A149 (Fig 22). This means that Southgates is as much the principal entry point to Lynn as it has ever been.

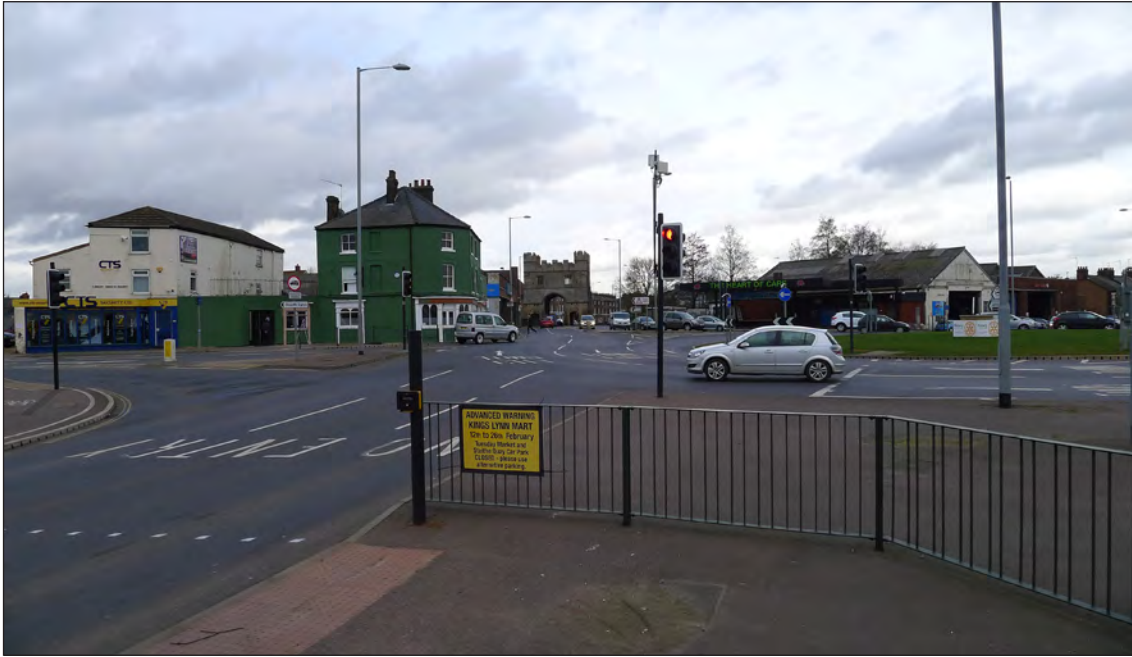
Fig 23 Southgates Roundabout looking north, showing the mass of signage and barriers. Photograph Jonathan Kewley 27-FEB-2017 © Historic England

Signage and street furniture is a major feature of the roundabout and its approaches, with traffic lights, tall lamp posts, metal railings and many metal road signs, together with lines and directions painted on the roads (Fig 23). The road surface is broken up by traffic islands/pedestrian refuges.

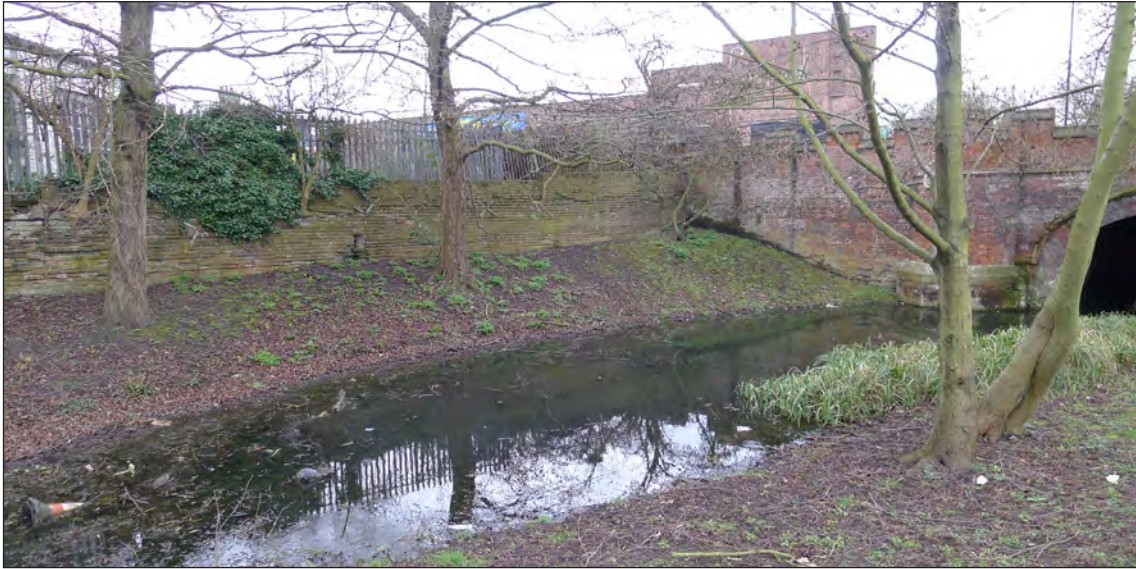
Fig 25 The short section of the Middleton Stop Drain immediately east of Southgates Bridge which still contains water, looking west. Photograph Jonathan Kewley 27-FEB-2017 © Historic England

The Southgates area is bisected by the line of a watercourse which used to flow from east to west through it (Fig. 24). The portion east of the South Gate is now known as the Middleton Stop Drain, formerly the Middleton Fleet, having carried water from the village of Middleton (Fig 25). A few references call it the River Esk (notably Burnet's map of 1846), but these are all late which does not suggest it was an old name.¹⁴ It flowed under the bridge in front of the South Gate and then more or less due west for a stretch which was called the Friars' Fleet, after the Friary which stood a little to the north (Fig 26). It then joined the northward-flowing River Nar, one of the ancient streams of Lynn, which effectively forms the western boundary of the HAA area (Figs 27 and 28).¹⁵ The combined watercourse (by this stage outside the HAA area) flows north and then briefly south to join the Great Ouse at the Boal. It is today generally known as the Nar, but in the 19th century it was the Sandringham Eau (a name found as early as Rastrick's map of 1725 and thus pre-dating the purchase of the eponymous estate by the future Edward VII); that reference gives as an alternative name the Lynn River.

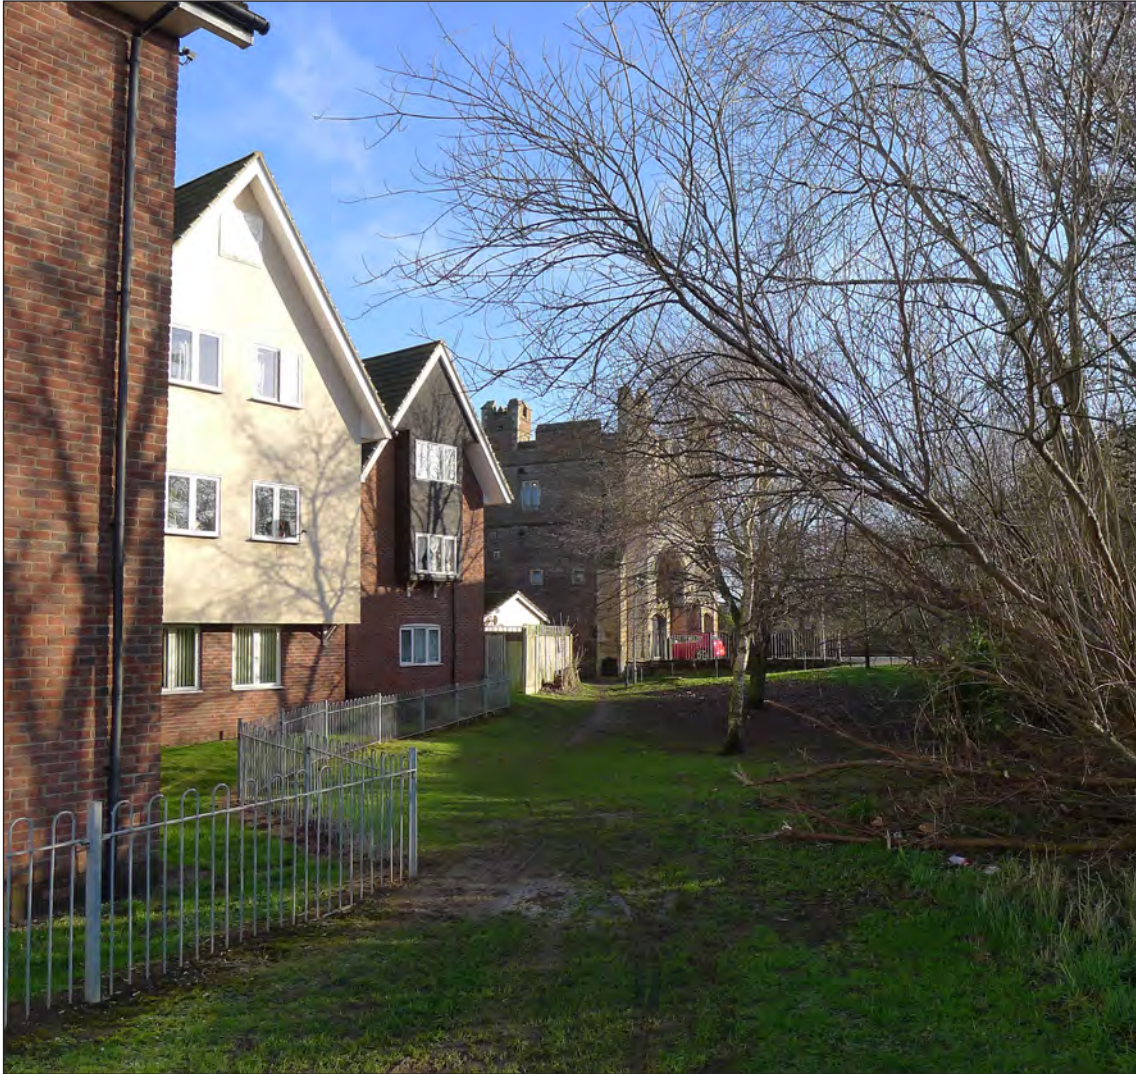
Fig 31 The course of the filled-in Friars' Fleet, looking east to the South Gate. Photograph Jonathan Kewley 19-FEB-2018 © Historic England

There was from at least the 16th century a sluice underneath Southgates Bridge, as discussed below.²¹ During the 20th century most of the water was redirected by the drainage authorities, so that today the Friars' Fleet is entirely dry and only the westernmost part of the Middleton Stop Drain has any water in it (Figs 31 and 32). This has changed the character of the area quite considerably, although the path leading along the north bank of the Friars' Fleet to the South Gate retains something of the feel of a riverbank.

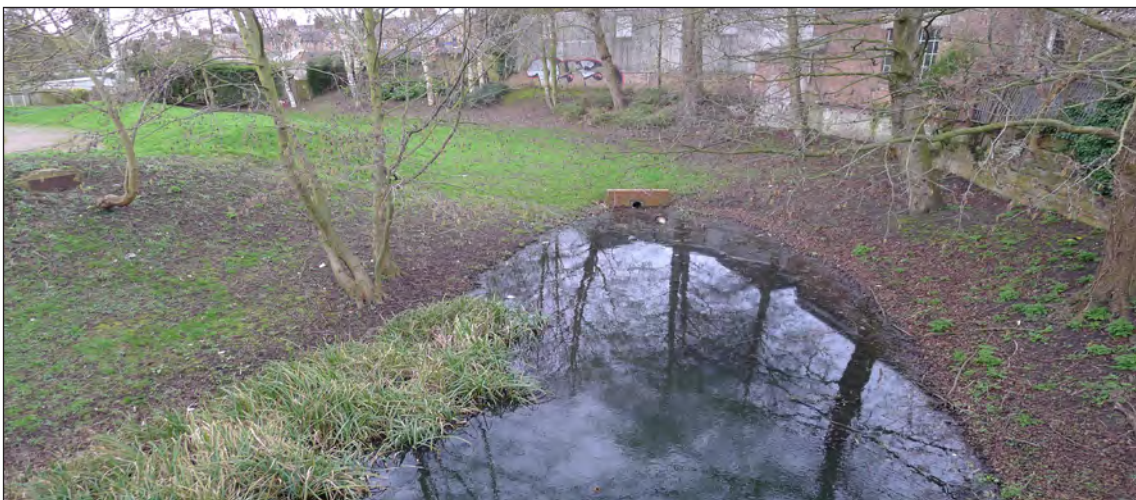
Fig 32 The Middleton Stop Drain looking east from Southgates Bridge, showing the small section still containing water, with the dry bed beyond. Photograph Jonathan Kewley 27-FEB-2017 © Historic England

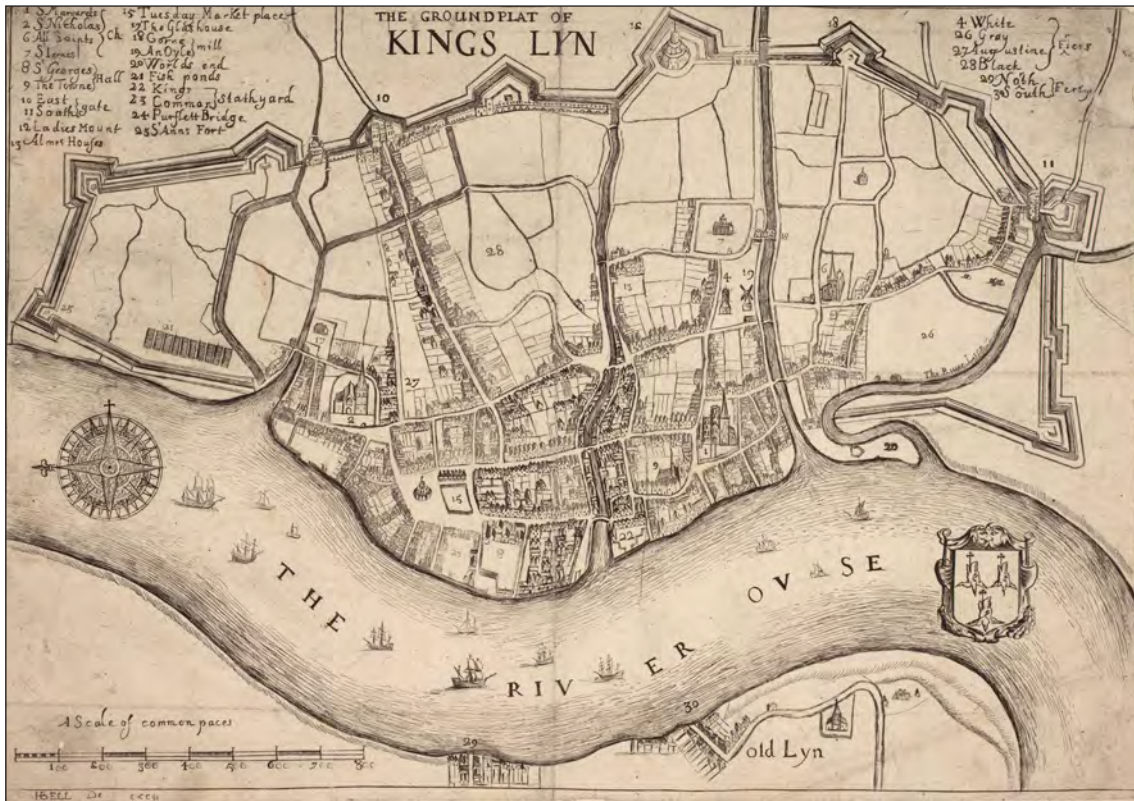
Fig 35 'Groundplat of Kings Lyn' by Henry Bell c 1670, showing the Civil War defences. Norfolk Museums Service (Lynn Museum)

Like most Civil War defences, Lynn's were of earth, hurriedly-built.³¹ They were started by the Roylist borough in early 1643 but had not been finished when it was attacked by Parliament later that year and captured after a month's siege. They were completed by the Roundheads in 1645.³² The line seems to have followed that of the medieval fortifications, and in general existing parapets were revetted with timber, except that to north and south of the town there were much more elaborate outworks, influenced by the Dutch school of engineers (Fig 35). The southern works (Fig 36) were all south of Southgate Bridge and were polygonal, running south-east from the bridge for a short distance, then south-west to about where the roundabout is now, and thence west to the Nar just south of the Long Bridge. On the west bank of the Nar the new works headed to a south-west-facing point and then north up the centre of the peninsula formed by the final bend in the Nar. Neither Bell's nor Rastrick's maps show anything on the east bank of the Nar north of the Long Bridge, despite the fact that the westward run on the west bank does not start until rather further north; Kent's reconstruction adds a fortification on the east bank, without explanation. All these earthworks consisted of a number of features: on the inside was a rampart with a raised outward-facing parapet, from which a scarp ran down to another parapet, beyond which was a ditch, then a covered way, a gently-sloping bank and finally another small ditch.³³

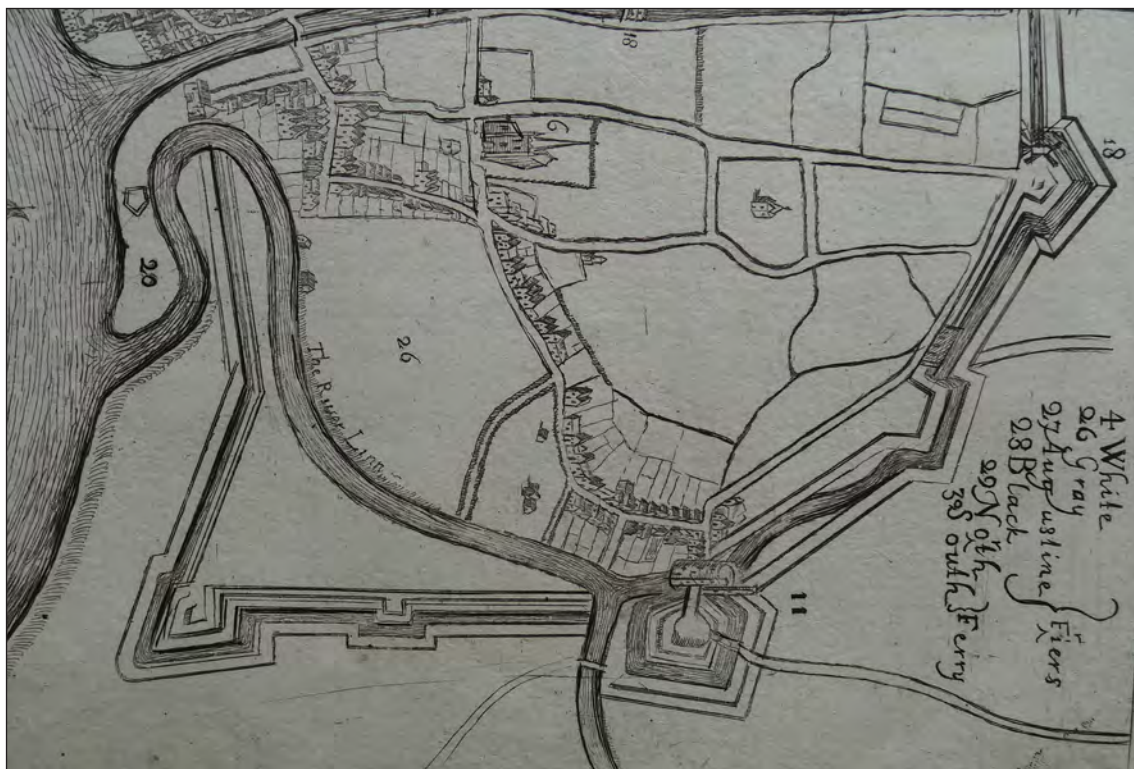
Fig 36 Detail of Henry Bell's 'Groundplat' of c 1670 showing the Civil War defences at the southern end of King's Lynn; the South Gate is just to the left of the figure 11. Norfolk Record Office

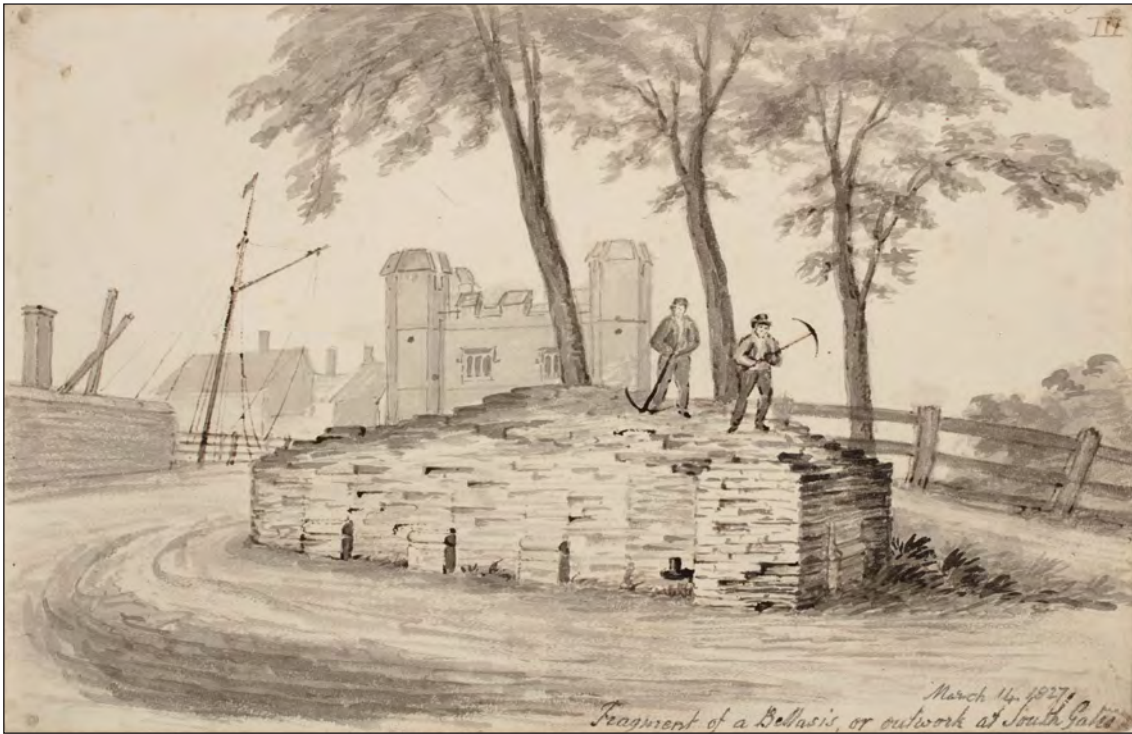
Fig 37 A ruin somewhere near the present-day junction of Vancouver Avenue with the Southgates Roundabout, drawn by the Rev Edward Edwards 1827. Norfolk Library and Information Service (King's Lynn Library Archives). Image: HEA DP219401

Rastrick's map of 1725 (see Fig 6) shows, as well as the line of the Civil War defences just described, something looking like the stump of a road, not readily relatable to the defences, immediately opposite Out South Gates. Georgian views show an overgrown mound somewhere here, or just to the north (so roughly under the present roundabout). This has been interpreted as either the fortified timber tower or bretask, known to have been built somewhere near the South Gate in the 12th century, or as part of the Civil War defences.³⁴ The Rev. Edward Edwards's drawing (Fig. 37) shows a structure apparently built of stone, which he firmly attributes to the Civil War. It appears to be on the north-east corner of the T-junction. He says it survived until at least 1827. It is possible that, rather more overgrown, this is what appears as a mound or clump of trees in the naïve view of a military review south-east of Lynn in 1782 (Fig. 38).³⁵ It may also be the trees (some of which appear as an island in the road) on Newham's map in 1809 (Fig 39).

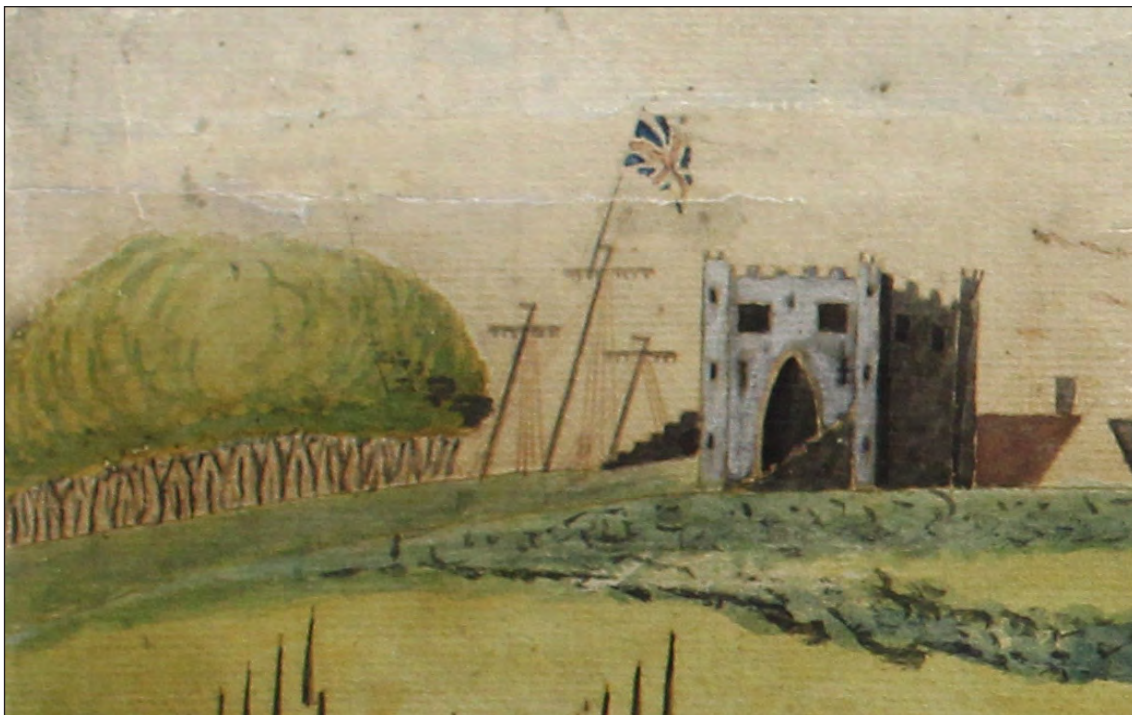
Fig 38 Detail of an anonymous oil 'The Lynn Association as review'd in the year 1782', showing the South Gate with, to the left, a clump of trees which may have contained the ruin illustrated in Fig. 37. Norfolk Museums Service (Lynn Museum) KILLM 1957.6.12

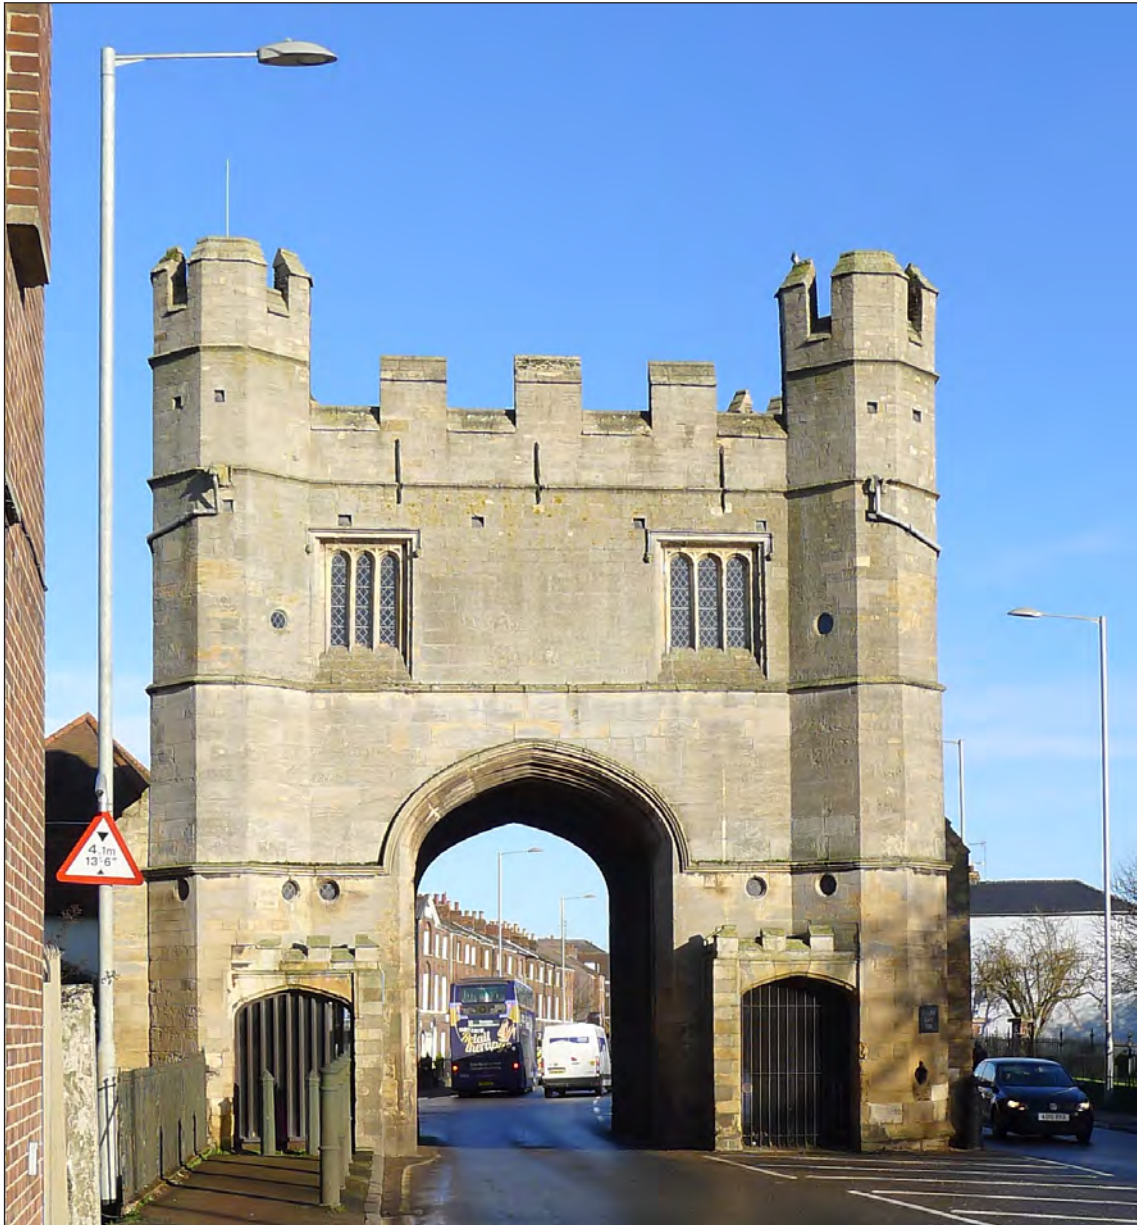
Fig 53 The south front of the South gate. Photograph Jonathan Kewley 16-JAN-2018 © Historic England

The present South Gate of Lynn (Figs 53, 54, 55 and 56) was built in 1437, principally by a London mason called Robert Hertanger, although it was completed by others after he got into financial difficulties. It replaced an earlier, slightly smaller gate, but seems to have used some of its foundations, which may account for the central arch being a little off-centre, towards the west. The structure is of brick, faced with limestone ashlar on the south, outward-facing front and with stone dressings on the other three sides (Fig 57). Smith has noted the great similarity of the bricks (Fig 58) to those used to build St George's Guildhall, also in Lynn. It is interesting that it was faced with stone, at least on the main show front, at a time when exposed brick was becoming fashionable;³⁸ it was not therefore avant-garde.³⁹

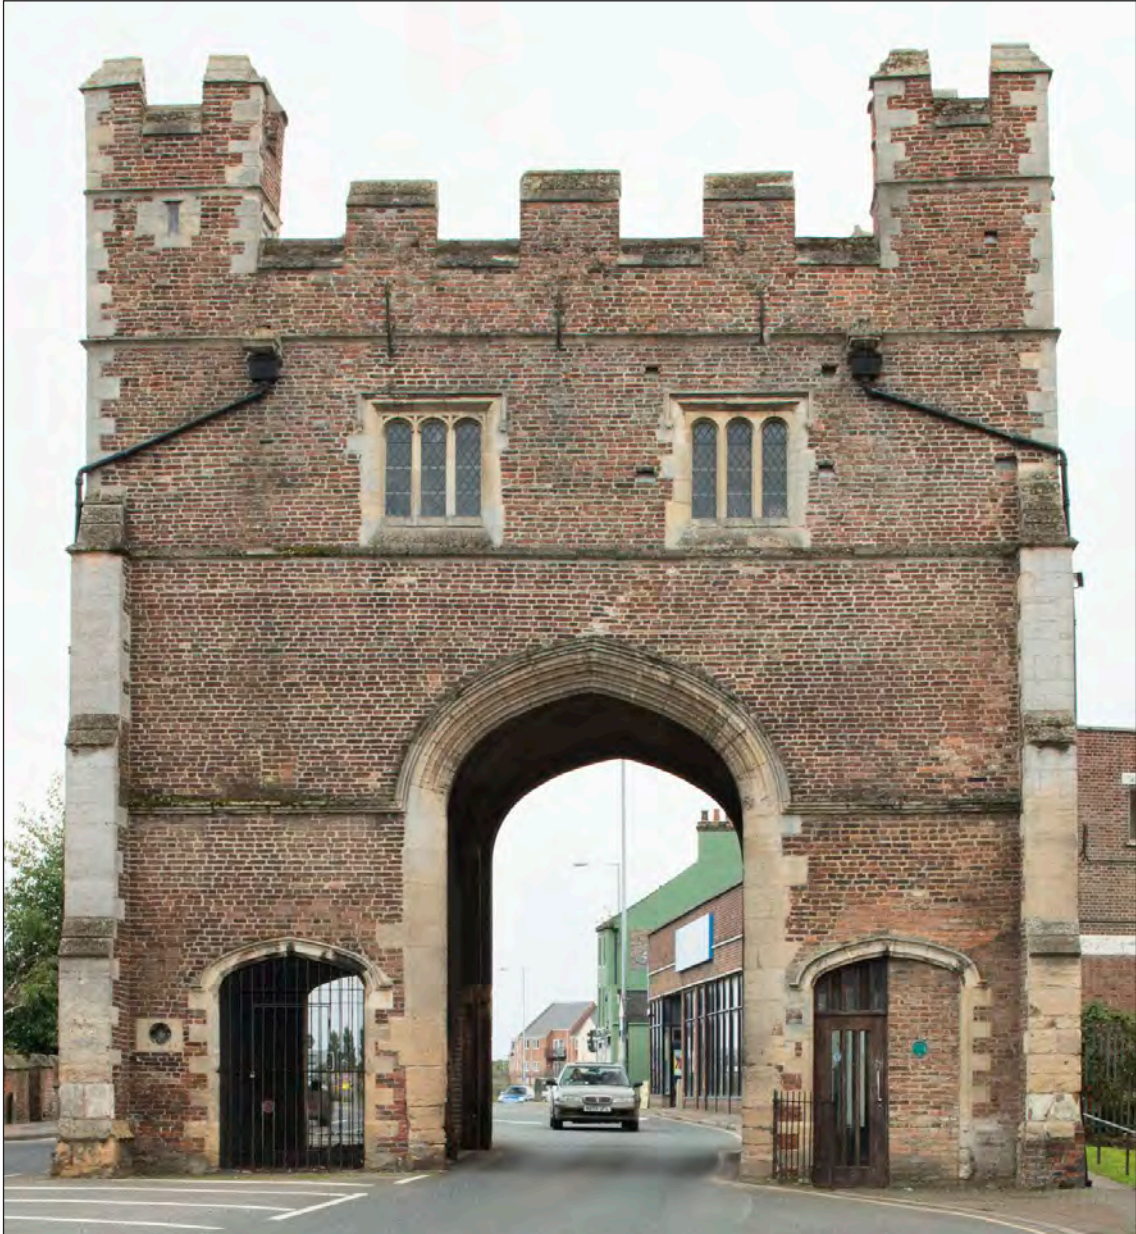
Fig 54 The north front of the South Gate. HEA DP219073 Patricia Payne 20-SEPT-2017 © Historic England
