Historic Places Investigation

Southgates, King's Lynn, Norfolk: Historic Area Assessment

Research Report Series 009-2018

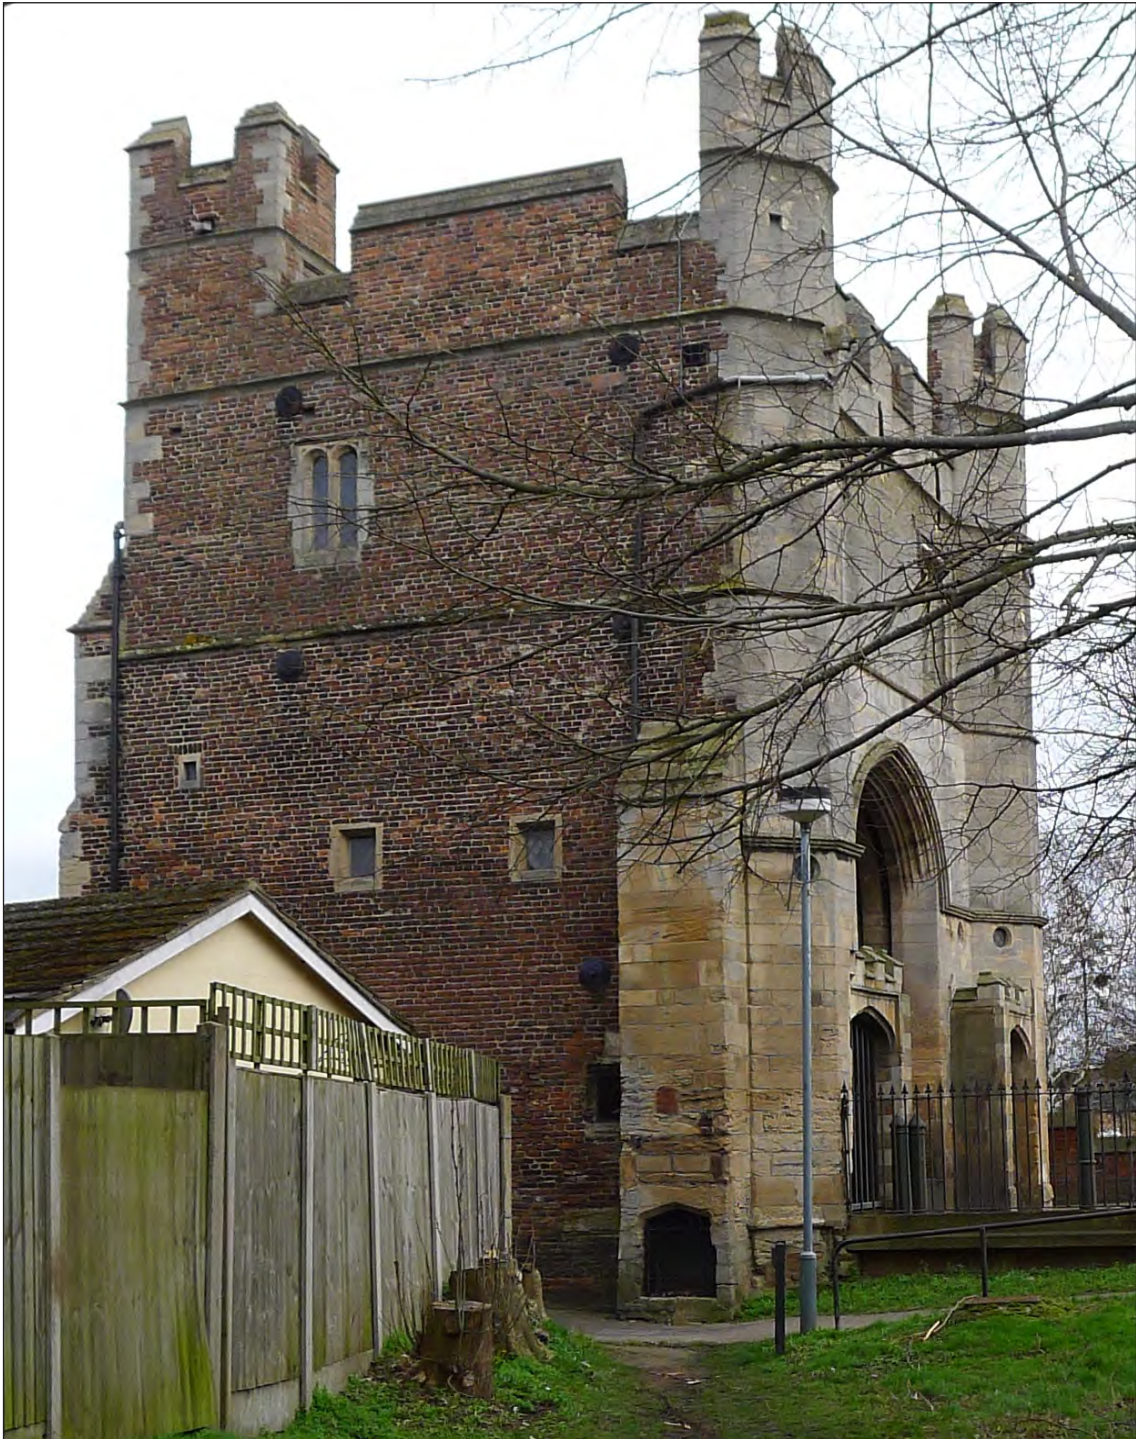
Fig 55 The west elevation of the South Gate. Photograph Jonathan Kewley 27-FEB-2017 © Historic England

The present South Gate of Lynn (Figs 53, 54, 55 and 56) was built in 1437, principally by a London mason called Robert Hertanger, although it was completed by others after he got into financial difficulties. It replaced an earlier, slightly smaller gate, but seems to have used some of its foundations, which may account for the central arch being a little off-centre, towards the west. The structure is of brick, faced with limestone ashlar on the south, outward-facing front and with stone dressings on the other three sides (Fig 57). Smith has noted the great similarity of the bricks (Fig 58) to those used to build St George's Guildhall, also in Lynn. It is interesting that it was faced with stone, at least on the main show front, at a time when exposed brick was becoming fashionable;³⁸ it was not therefore avant-garde.³⁹

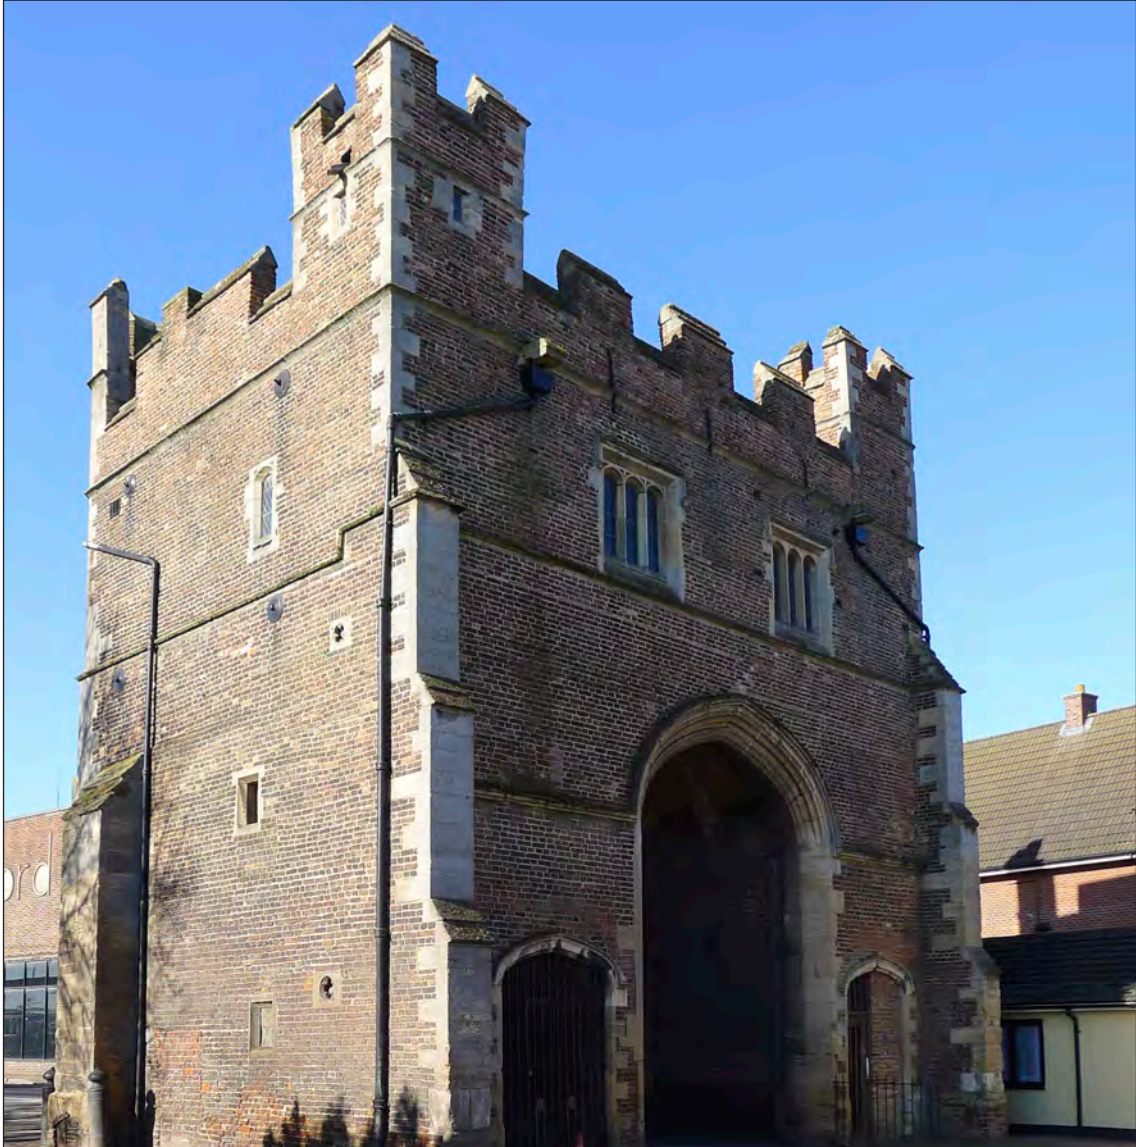
Fig 56 The east elevation of the South Gate. Photograph Jonathan Kewley 5-APR-2018 © Historic England

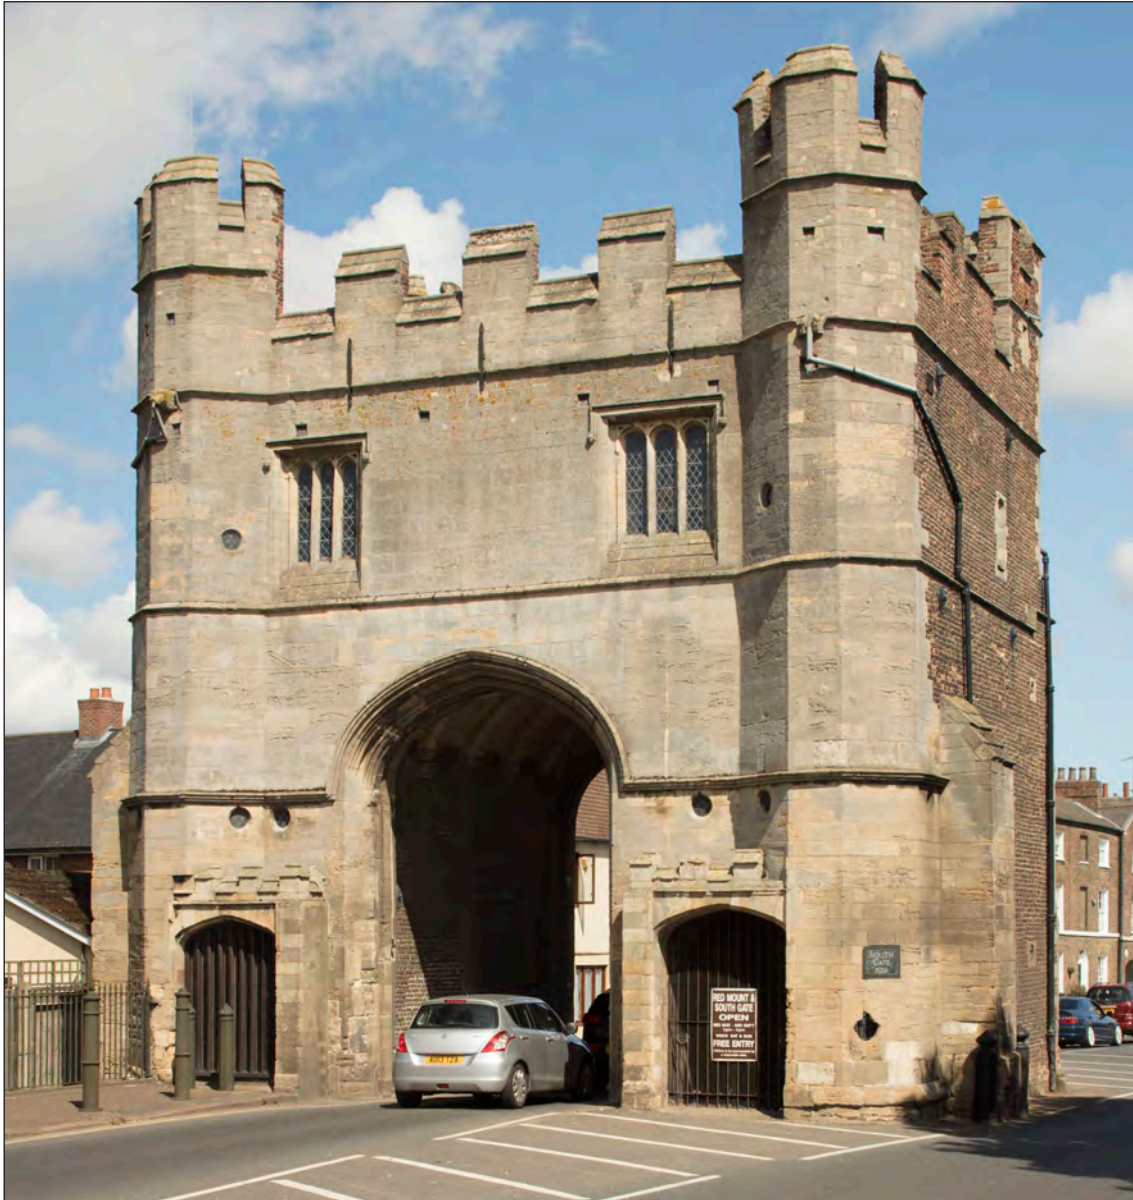
Fig 57 The South Gate from the south-east, showing the stone south and brick east elevations. HEA DP219059 Patricia Payne 15-AUG-2017 © Historic England

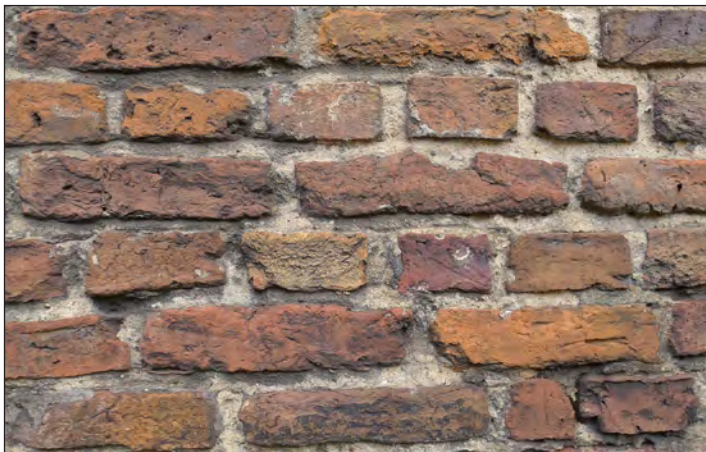
Fig 58 Bricks on the west elevation of the South gate. Photograph Jonathan Kewley 27-FEB-2017 © Historic England

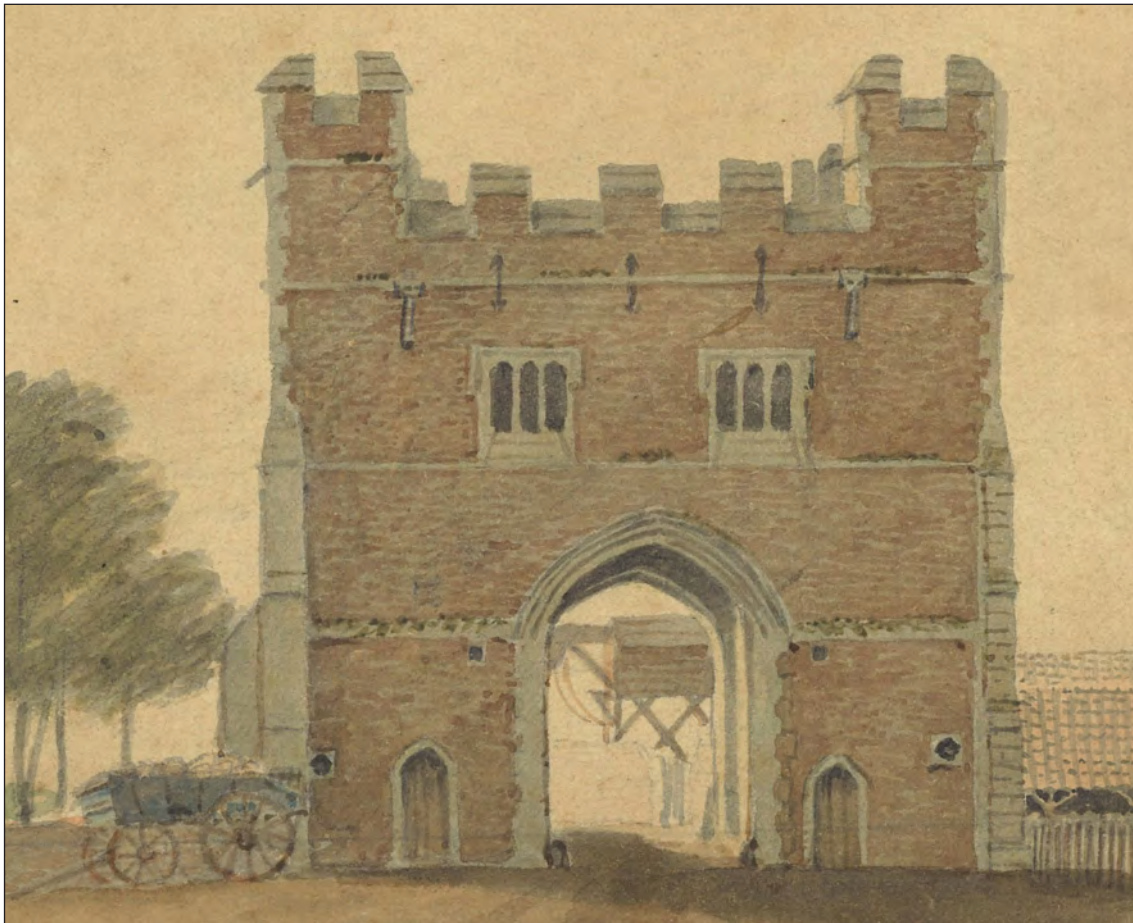
Fig 59 Detail of a drawing by James Sillett of the South Gate from the north c 1810, showing the two foot doors each side of the main arch. Norfolk Museums Service (Lynn Museum) KILLM 1991.741

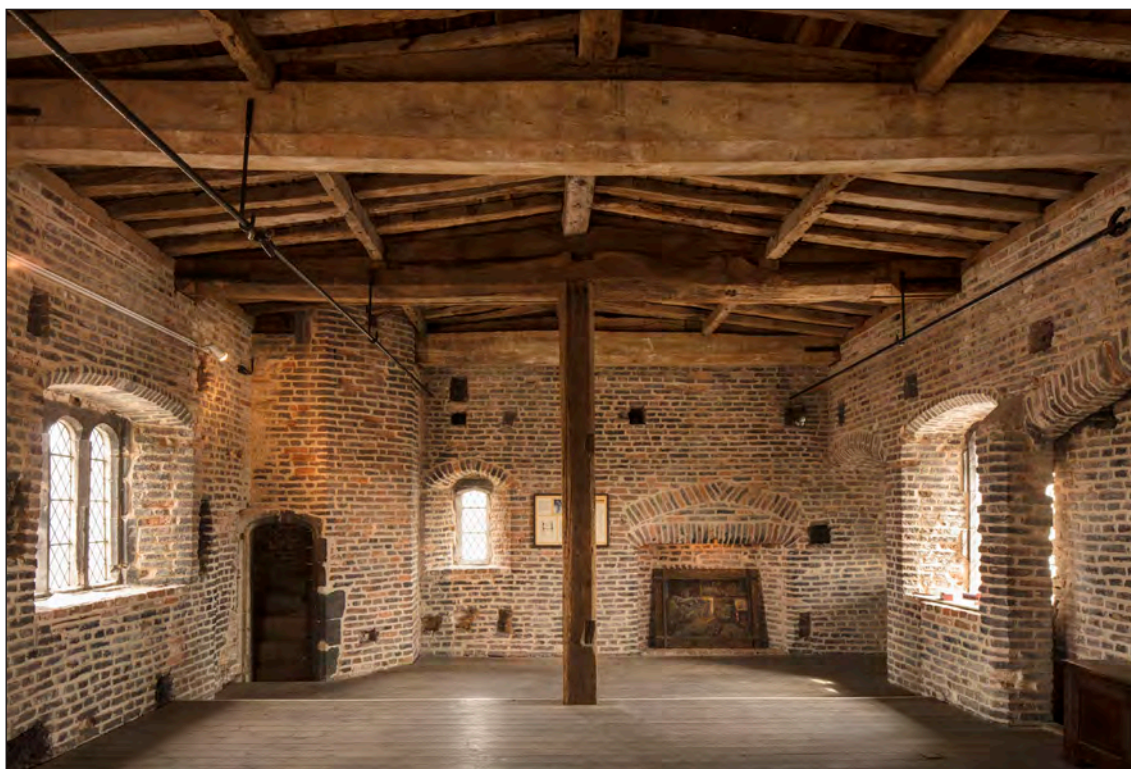
Fig 60 The interior of the second floor of the South Gate, now one room. HEA DP217365 Patricia Payne 13-JUL-2017 © Historic England

There were ground- and first-floor rooms each side of the arch and then on the second floor what is now one room but was probably originally partitioned (Fig 60). Many of the rooms had fireplaces, one with an oven as well, suggesting occupation by a gatekeeper on a daily basis, as well as by soldiery in more troubled times.

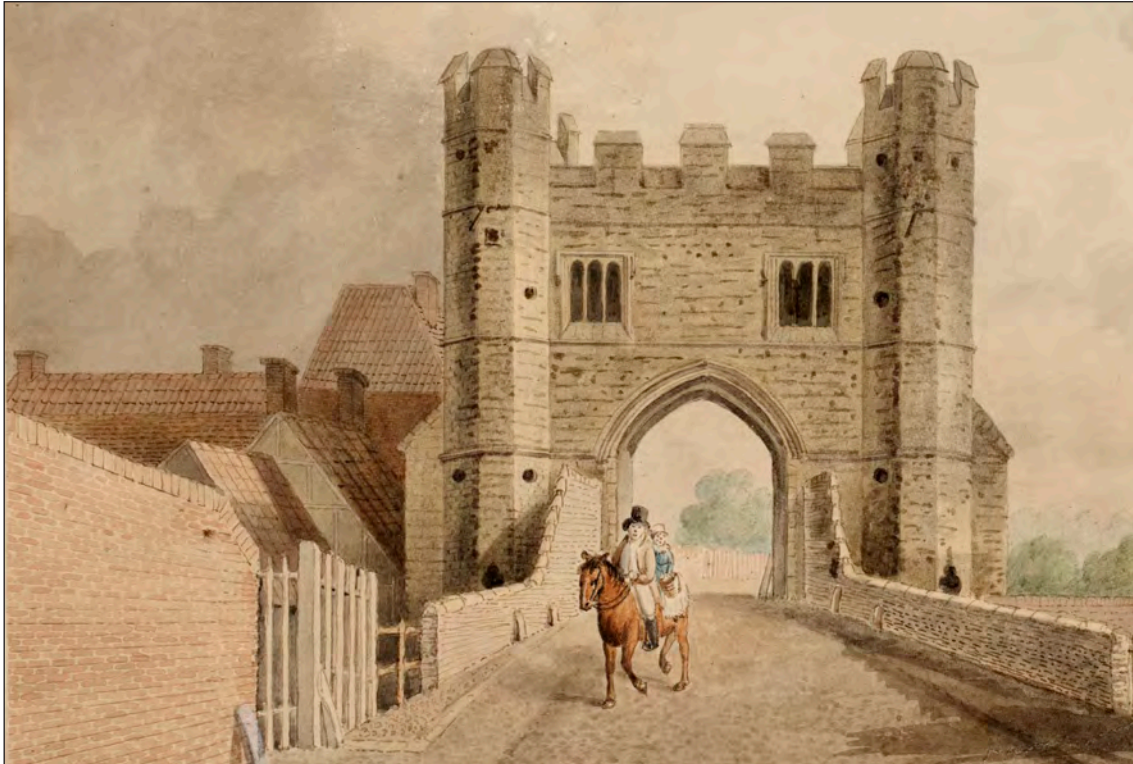
Fig 61 A watercolour by James Sillett c 1809 of the South Gate from the south, showing the shared carriageway. Norfolk Museums Service (Lynn Museum). Image: HEA DP219400

Various alterations and adaptations have, not surprisingly, been made over the years. Two masons were contracted to do something in 1520 (it has been speculated this may have been to finish off the vault).⁴⁰ The gates themselves were taken away in 1795,⁴¹ but vehicles, mounted travellers and pedestrians all had to share the same carriageway through the central arch (Fig 61). In 1817 the General Committee for the Relief of the Poor offered to provide labour to form a way for foot passengers by the side of the main opening if the Corporation provided materials.⁴² There were two possibilities: to punch a footway through the east wing, or to create a footway on the outside of the east wing. The Corporation chose the former, with the proviso that there would be no injury to the building, and a passage was duly built, with at each end a doorway with a four-centred arch, which survive (Fig 62).⁴³

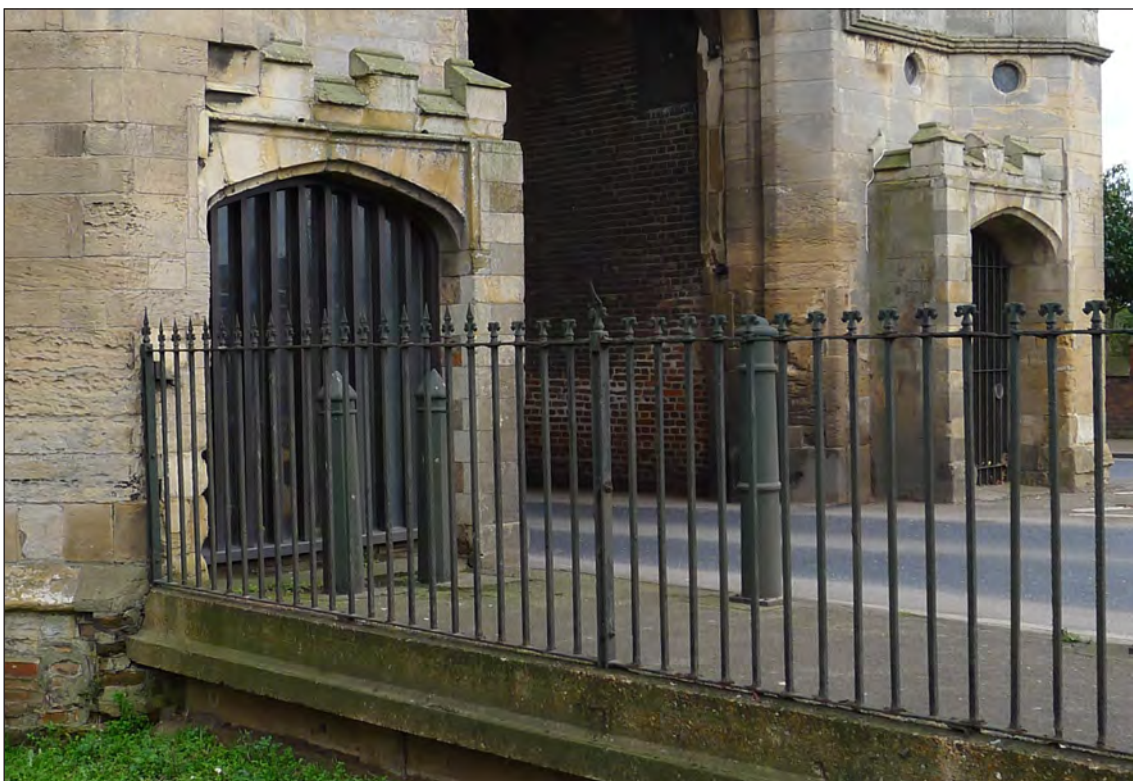
Fig 62 The southern entrances to the former pedestrian passages through the South Gate inserted to the east (right) in 1817 and the west (left) in 1841. The iron railings in the foreground probably date from 1841. Photograph Jonathan Kewley 27-FEB-2017 © Historic England

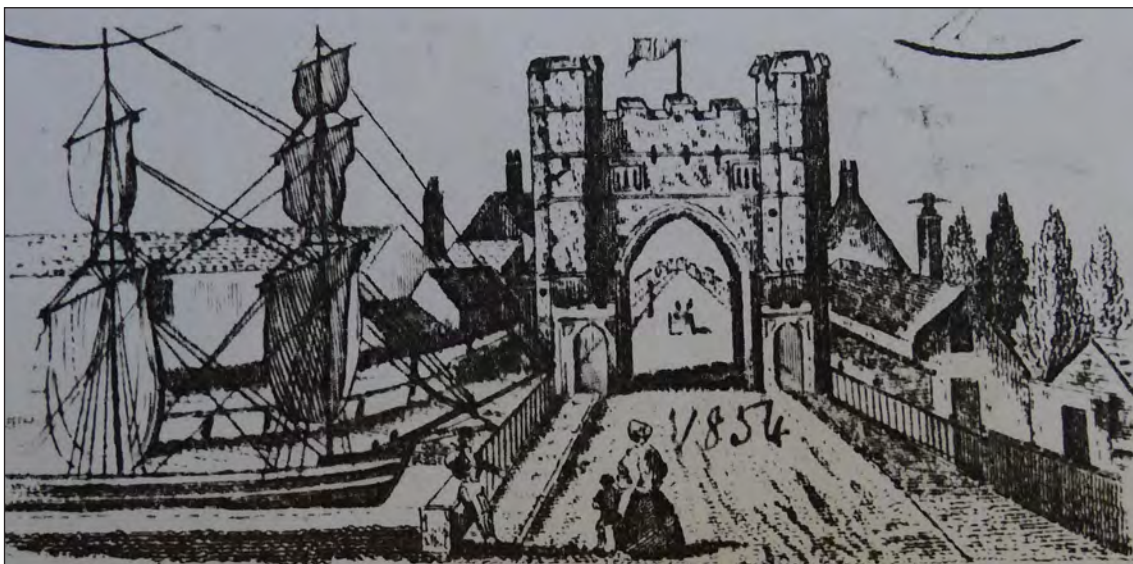
Fig 63 An anonymous drawing of the South Gate from the south, dated 1854, showing its appearance in the period between the insertion of the pedestrian passages and the cutting-through of the new carriageway. Norfolk Library and Information Service (King's Lynn Library Archives)

This did not proceed, but in 1841 the same committee resurrected the proposal to drive a passage through the gate at the west, with a pedestrian platform at the side of the bridge, which was done (Fig. 63), and seemingly also widening the main vehicular opening, of which there is no evidence.⁴⁶ The west passage remained in use until 1982, and the door surrounds again survive.⁴⁷

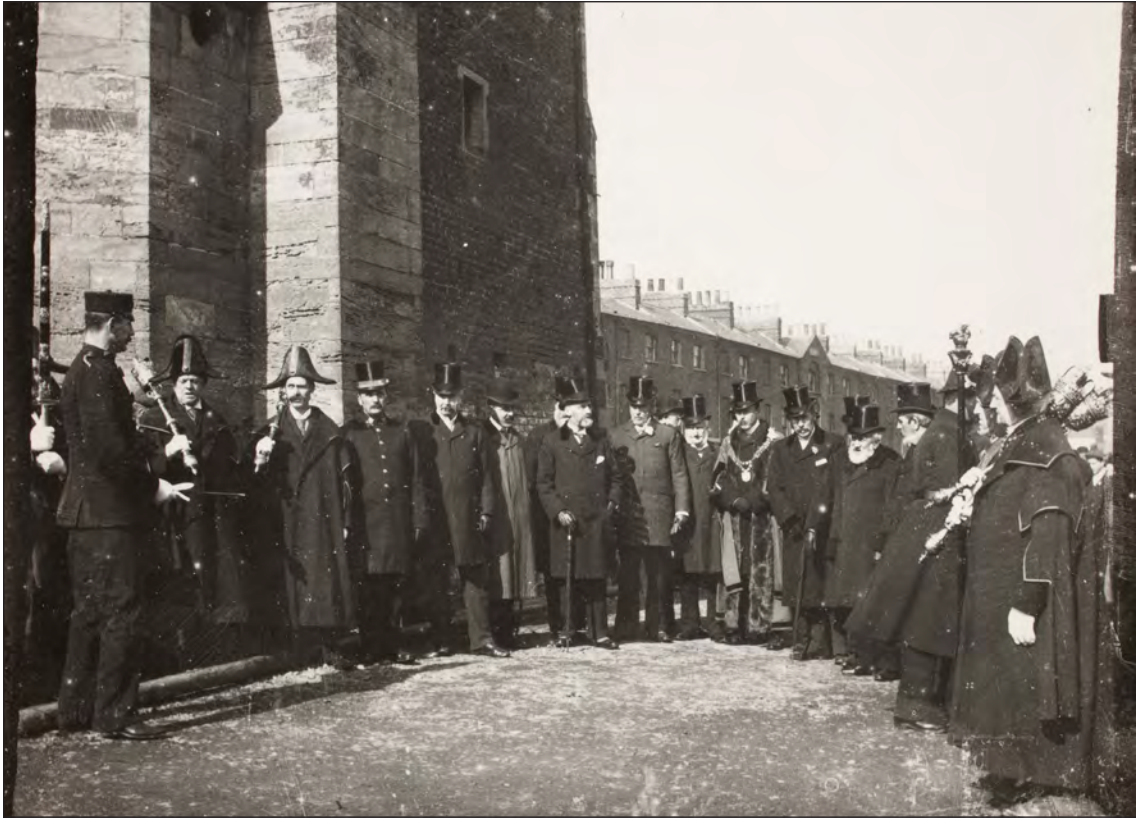
Fig 64 The opening of the new road east of the South Gate in 1900. Norfolk Library and Information Service (King's Lynn Library Archives). Image: HEA DP219453

Plans were duly prepared by one Arthur Saunders, the engineer conducting works at the South Gate – for a road 24 ft. wide (footway 6 ft., carriageway 18 ft.), the cost would have been £398.16.1 (made up of lower works – concrete, brickwork, earthwork £256.14.7, upper works – paving, making road etc £142.1.6). The Paving Commissioners voted against doing it.⁵³ A similar scheme was rejected by the Corporation on grounds of cost in 1865.⁵⁴ However, in 1899-1900 a new road was finally built immediately east of the South Gate which carries southbound traffic, northbound vehicles continuing to pass under the arch (Figs 64 and 65).

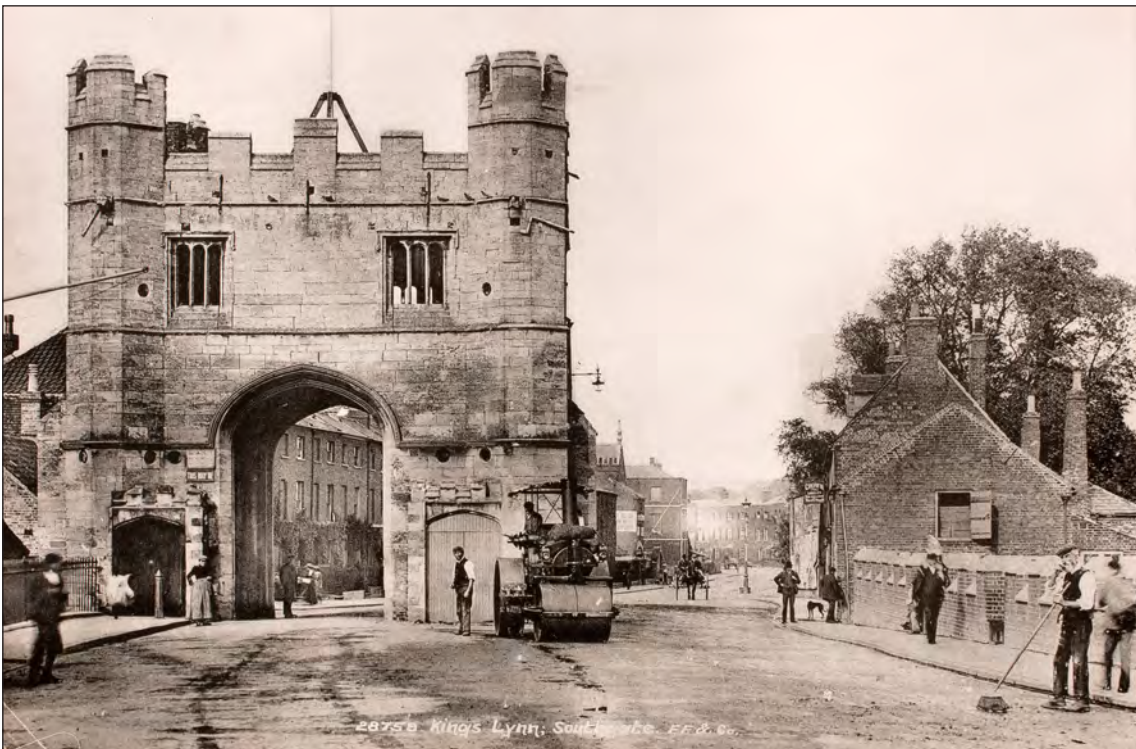
Fig 65 The South Gate from the south after the widening of the road in 1899-1900. Norfolk Museums Service (Lynn Museum) MB01086. Image: HEA DP219364

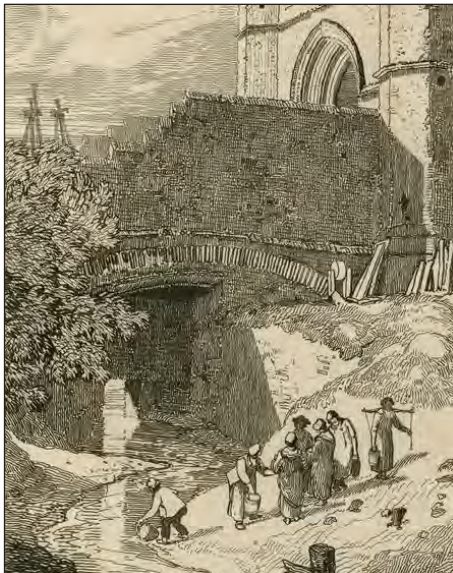
Fig 67 (above left) Detail of 'Ye South Gate, Lynn' by John Sell Cotman, 1815, from the south-east, showing the whole stone arch (with a brick arch above) but with the north half blocked up. Norfolk Museums Service (Lynn Museum) 1951.235.621.B5.

The medieval bridge is no wider than the carriageway through the gates. Its stone arch can be seen, with difficulty, on the east side (Fig 66). John Sell Cotman's drawing from this side in 1815 (Fig 67) seems to show the present stone arch with a brick arch immediately above. The western arch of the old bridge appears to have been brick since at least the beginning of the nineteenth century (see Taylor's etching (Fig 68), which confusingly seems to show the western infill as stone). At a later date the bridge was widened on the east, first to include the width of the pedestrian passageway (Fig 69), and second in 1900 to take the newly-widened road running east of the gate itself. At some time before 1815, the opening was reduced so that it took up only the southern half of the span of the bridge, and a sluice with a door was fitted.⁵⁹ On the west side, the bridge was not extended when the pedestrian passage was knocked through the gate in 1841; instead a passage to it was cantilevered out (Fig 70). It and what seem to be its original railings and bollards survive (Fig 71), although the passage through the gate has been closed since 1982, and indeed has been demolished internally as part of a 1980s 'restoration' of the South Gate. The bridge and sluice ceased to be visible on the west side when the Friars' Fleet was filled in in the 1980s, and it was difficult to see the arch of the bridge even before that, but the old arrangement can be seen in Cotman's drawing engraved in 1818, looking from the west (Fig 72).

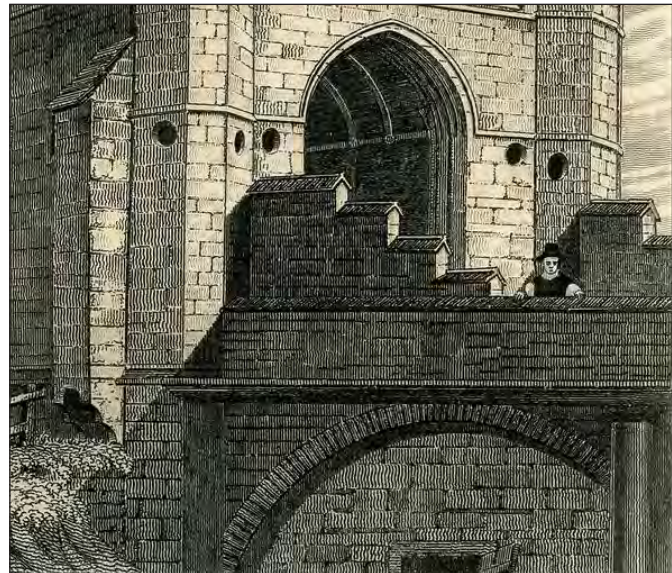
Fig 68 (above right) Detail of 'South Gate, Lynn' by William Taylor, c 1840s, a view from the west showing a brick arch. Norfolk Museums Service (Lynn Museum) 1954.138.Todd18.Freebridge.127.

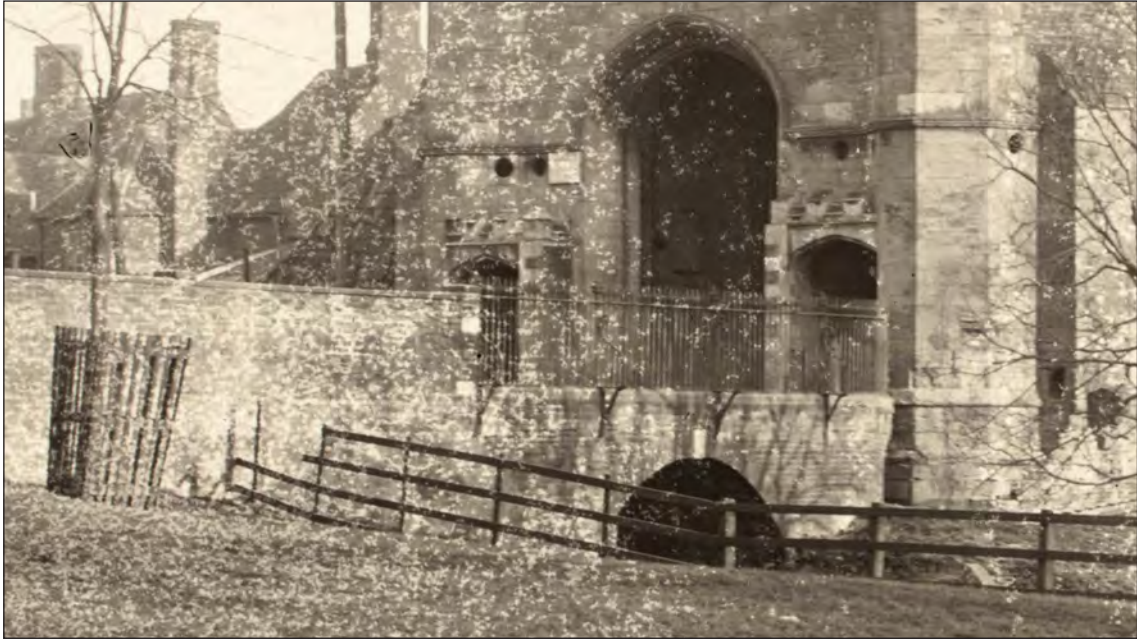
Fig 69 A pre-1899 photograph of the South Gate from the south-east, showing the eastward extension of the bridge constructed in 1817 to carry the new pedestrian footway. Norfolk Museums Service (Lynn Museum) MB05451. Image: HEA DP219374

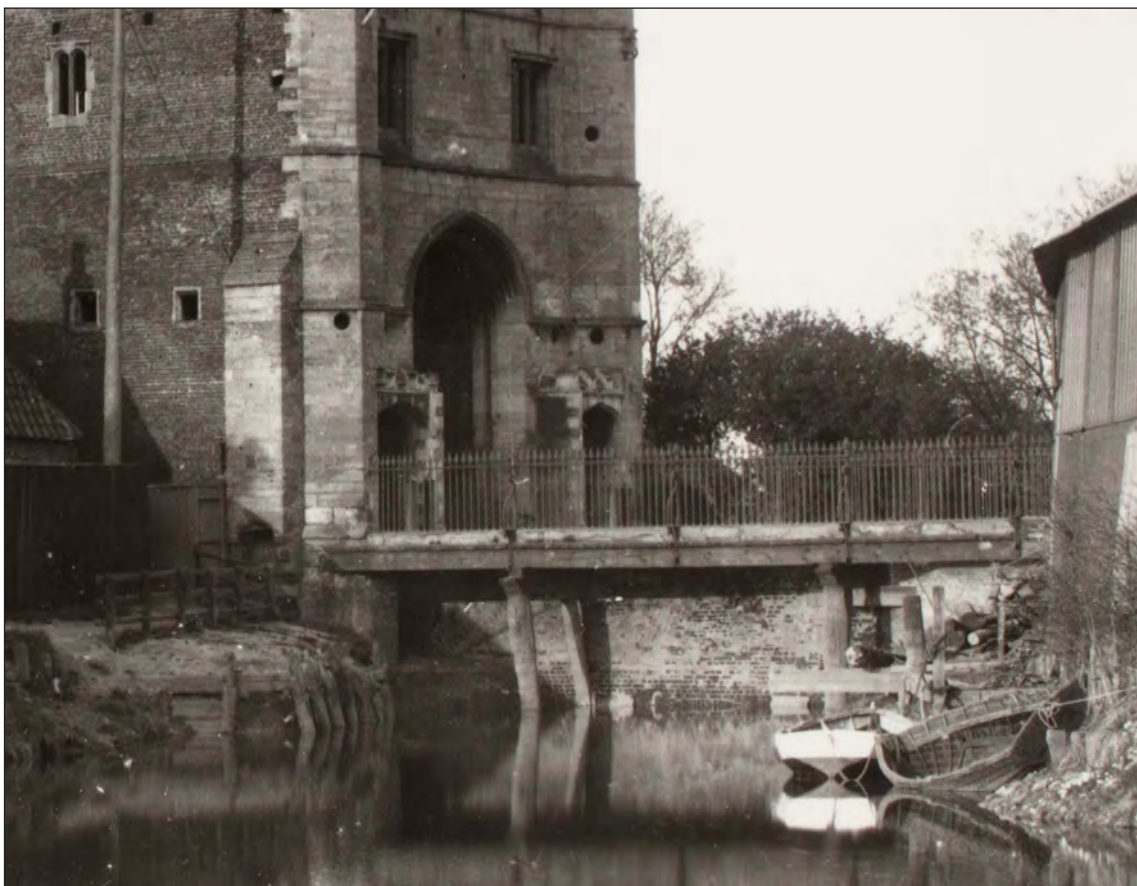
Fig 70 Southgate Bridge from the west, 1891, showing the footway cantilevered out for the 1841 pedestrian passage. Norfolk Library and Information Service (King's Lynn Library Archives). Image: HEA DP219448

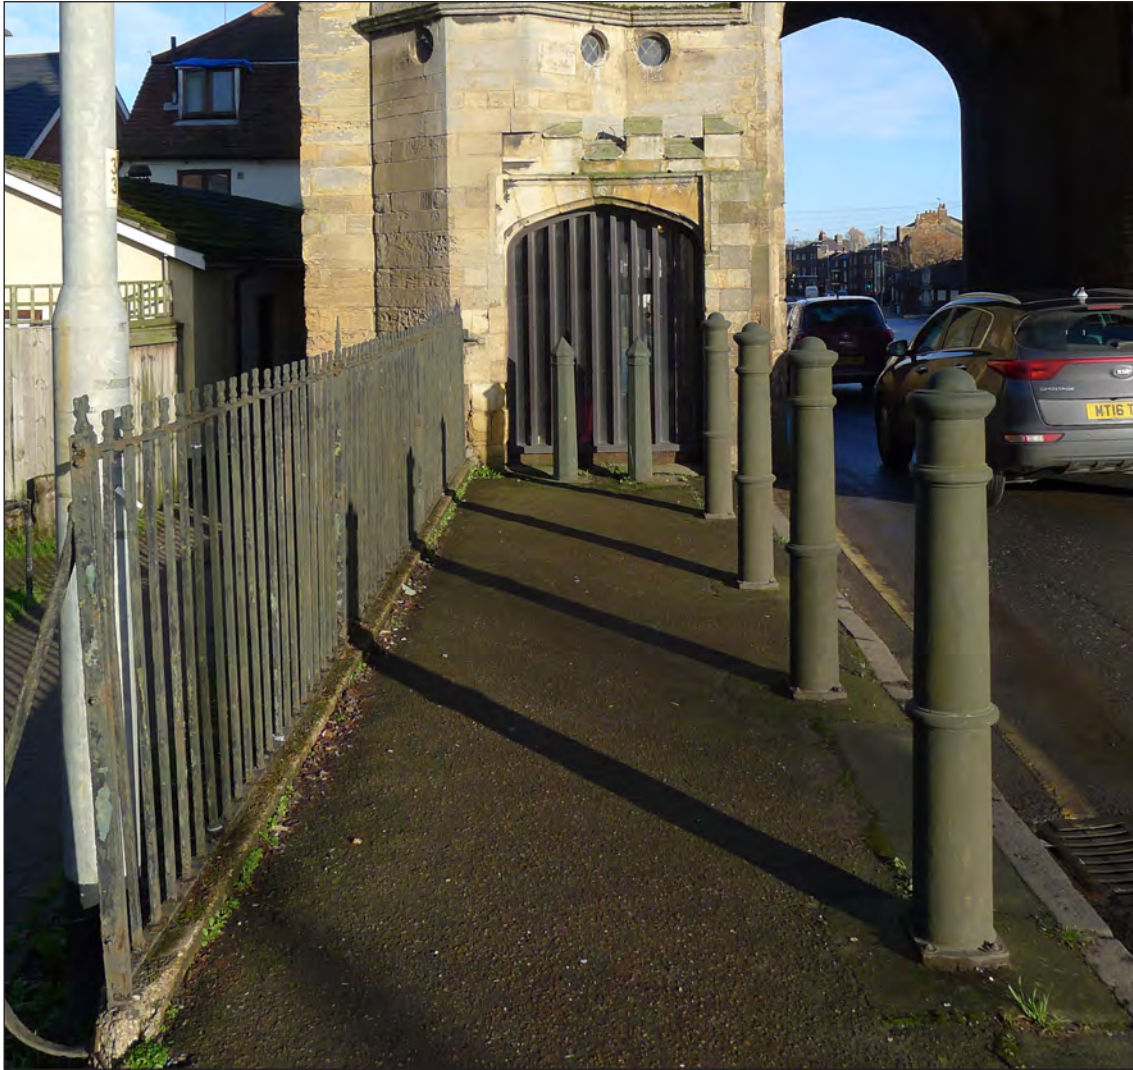
Fig 71 The railings and bollards leading to the former west passage through the South Gate, created in 1841. Photograph Jonathan Kewley 16-JAN-2018 © Historic England

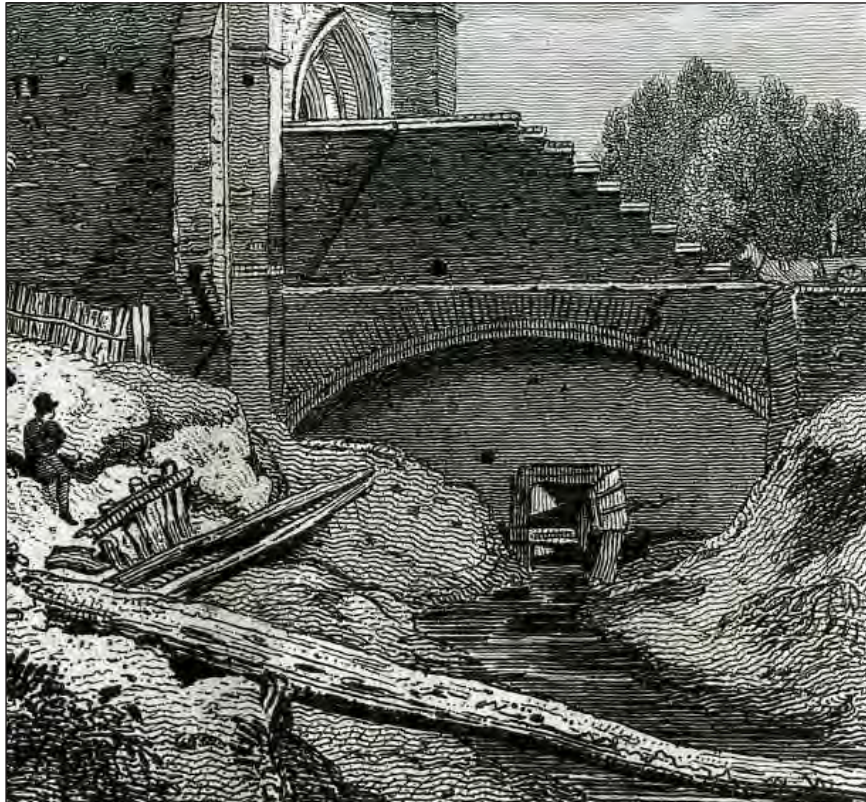
Fig 72 Southgate Bridge from the west by John Sell Cotman, 1818, showing the sluice in the blocked-up arch. Norfolk Museums Service (Lynn Museum NWHCM 1954.138.Todd18.Freebridge.145c.)

The medieval bridge had side walls which tapered down southwards from almost the top of the arch (see Fig 72). These seem to have been pulled down when the side passages were created.

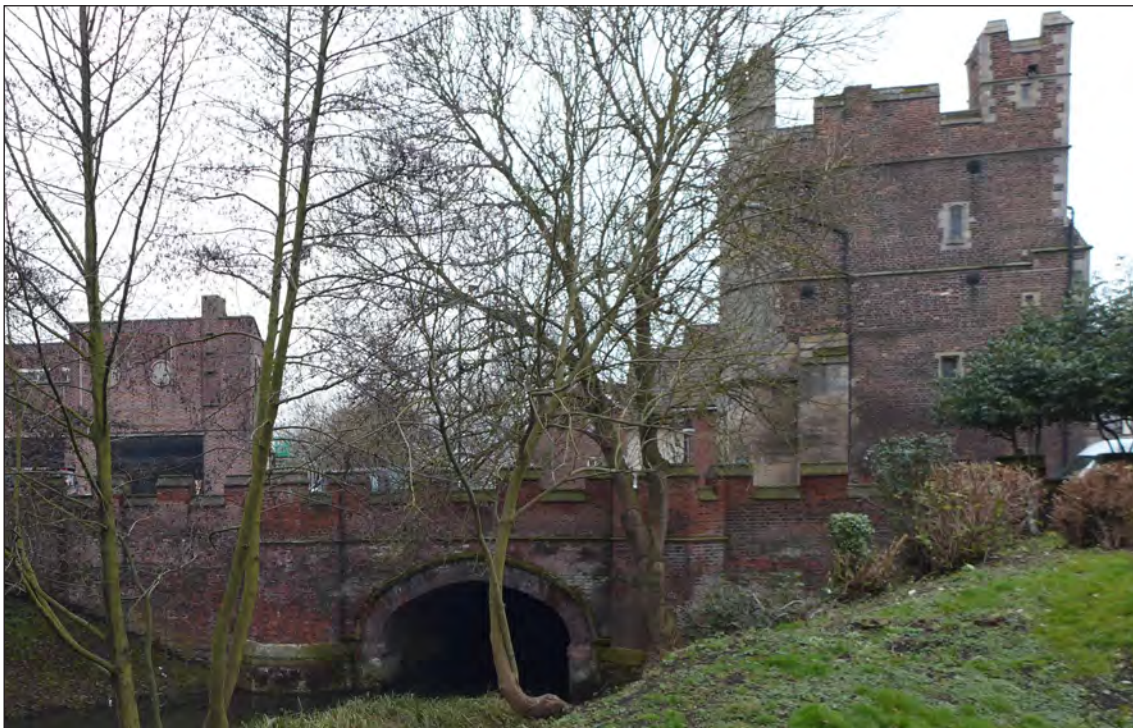
Fig 73 The view west from Southgate Park showing the battlemented wall created in 1899-1900 and combining an eastward extension of Southgate Bridge with a retaining wall to support the road running over it. Photograph Wayne Cocroft 8-FEB-2017 © Historic England

The east walkway was demolished when the road was widened in 1899. As part of the road-widening, the bridge, too, had to be widened, which was done by building a new bridge directly abutting the old, with no visible join at carriageway level. On the east, facing the Middleton Stop Drain (and now Southgates Park), the bridge was faced in brick with stone dressings and two small canted bastions each side of the arch (Fig 73). . The top of the wall was battlemented and carried on southwards for some distance; at the end is a datestone '1899' (Fig 74). The effect of all this is that while it looks quite impressive from the east (in 1899 the main angle of view must have been from the Hardwick Road to the south-east, especially in winter when the trees were bare), those travelling over it are not really conscious that it is a bridge, and it is unfortunate that the medieval bridge, which is still there, is now for practical purposes invisible. It might be hoped that if the road system here is ever altered it might be possible to reveal it again.

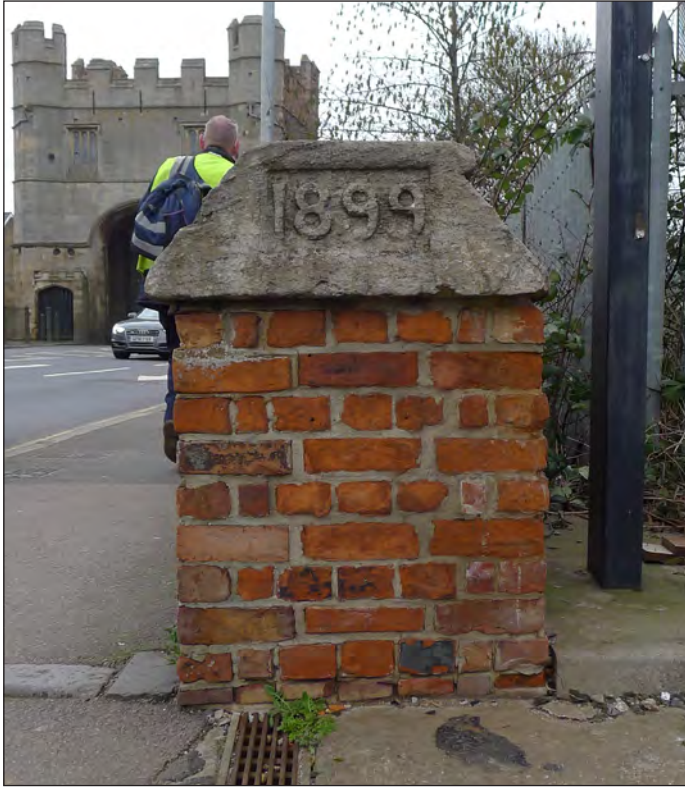
Fig 74 The datestone at the southern end of the battlemented wall on the east side of the carriageway by-passing the South Gate. Photograph Jonathan Kewley 27-FEB-2017 © Historic England

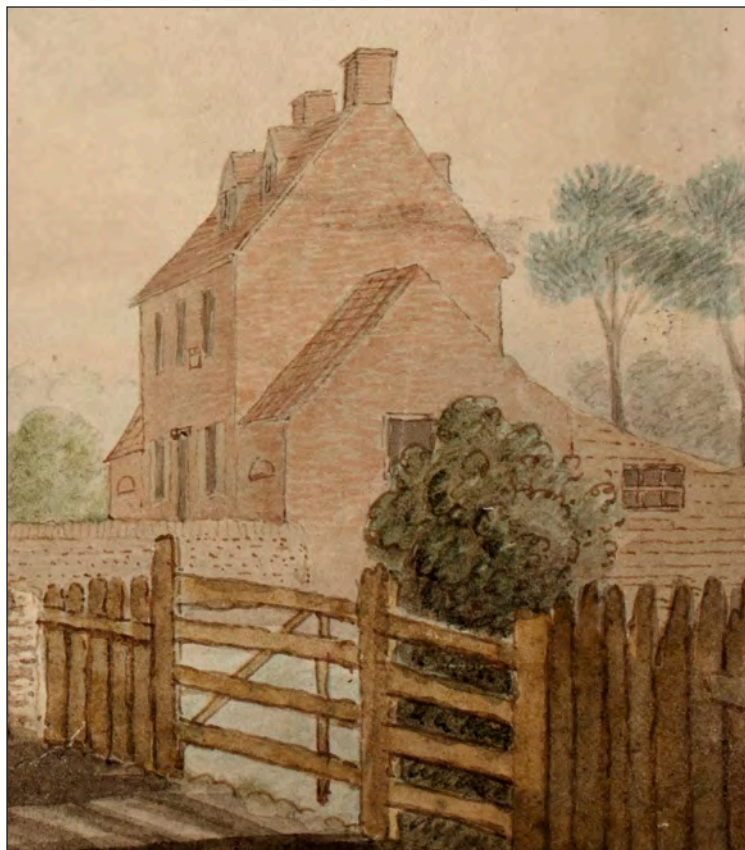
Fig 79 The new Crown Inn from the south-west, detail of a watercolour by James Sillett 1809. It is not apparent from it that there was in fact a watercourse between the fence in the foreground and the inn. Norfolk Museums Service (Lynn Museum.) Image: HEA DP219400

The painter James Sillett in 1809 gives a rather naïve view of the new Crown and exaggerates how far it was set back (Fig 79). A watercolour attributed to him a couple of years later gives a rather clearer impression (Fig 80). It was three bays wide and two and a half storeys tall, with a single-storey building attached on the near (south) side. It can also be glimpsed in a number of photographs of the South Gate (Fig 81).

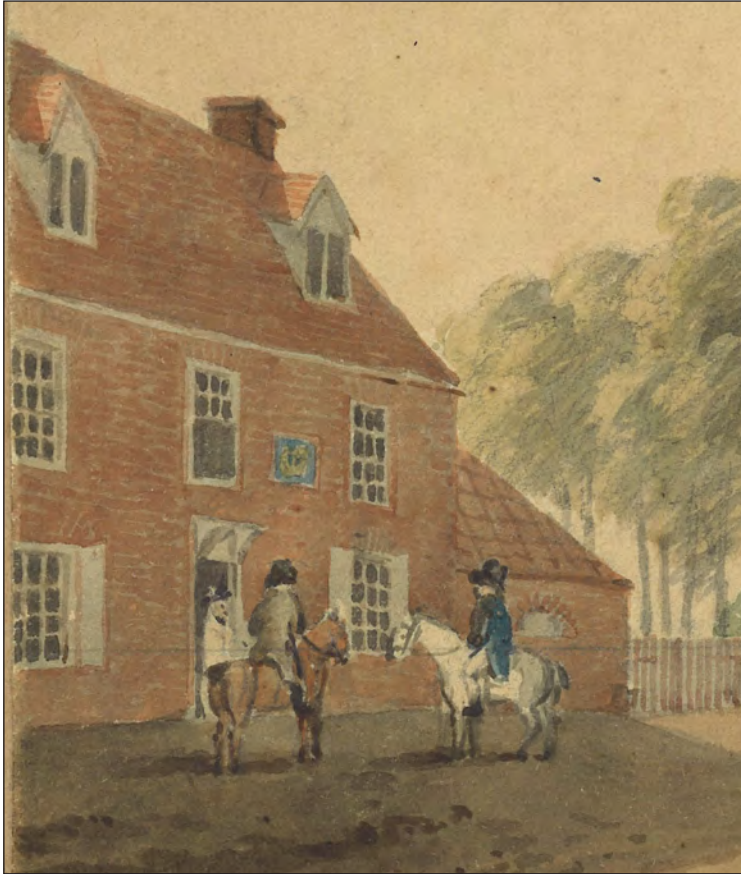
Fig 80 Detail of another watercolour by James Sillett showing the new Crown Inn from the north-west. The clump of trees to the right is somewhere near the south end of Out South Gates. Norfolk Museums Service (Lynn Museum) KILLM 1991.741

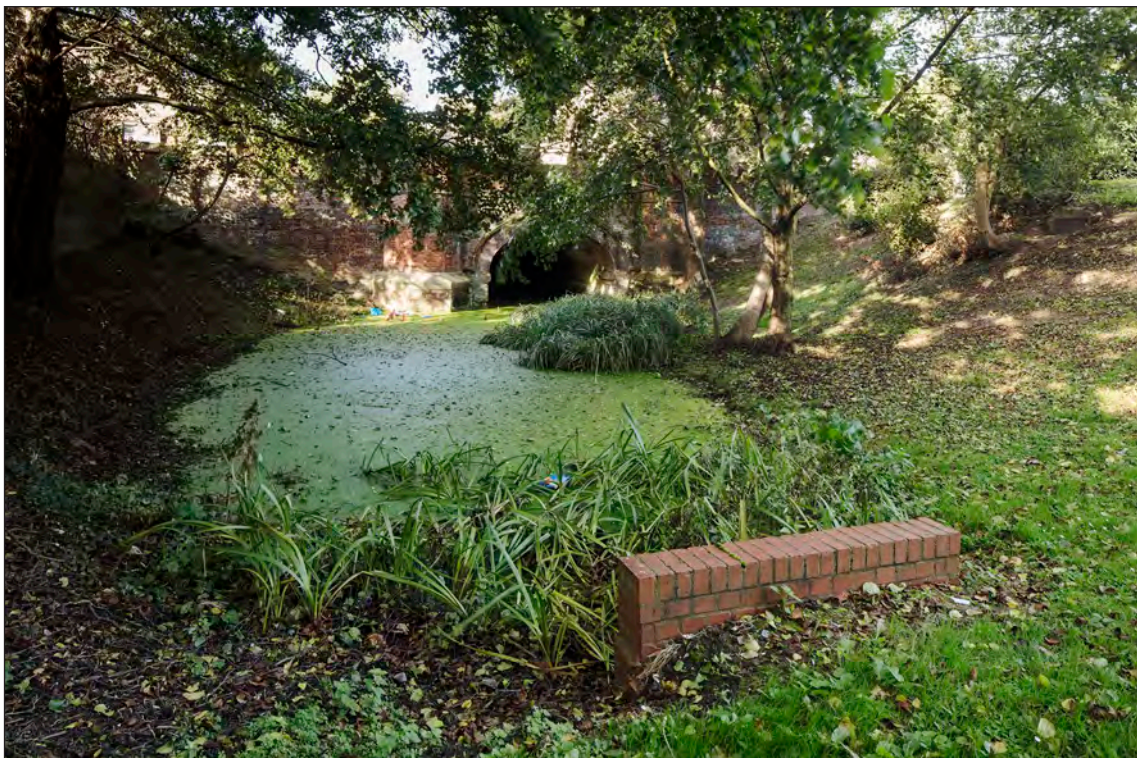
Fig 89 The water-filled western end of the Middleton Stop Drain as it disappears under the bridge. The brick wall in the foreground probably marks some form of sluice at the end of a storm drain (HEA DP219116 Patricia Payne 17-OCT-2017 © Historic England)

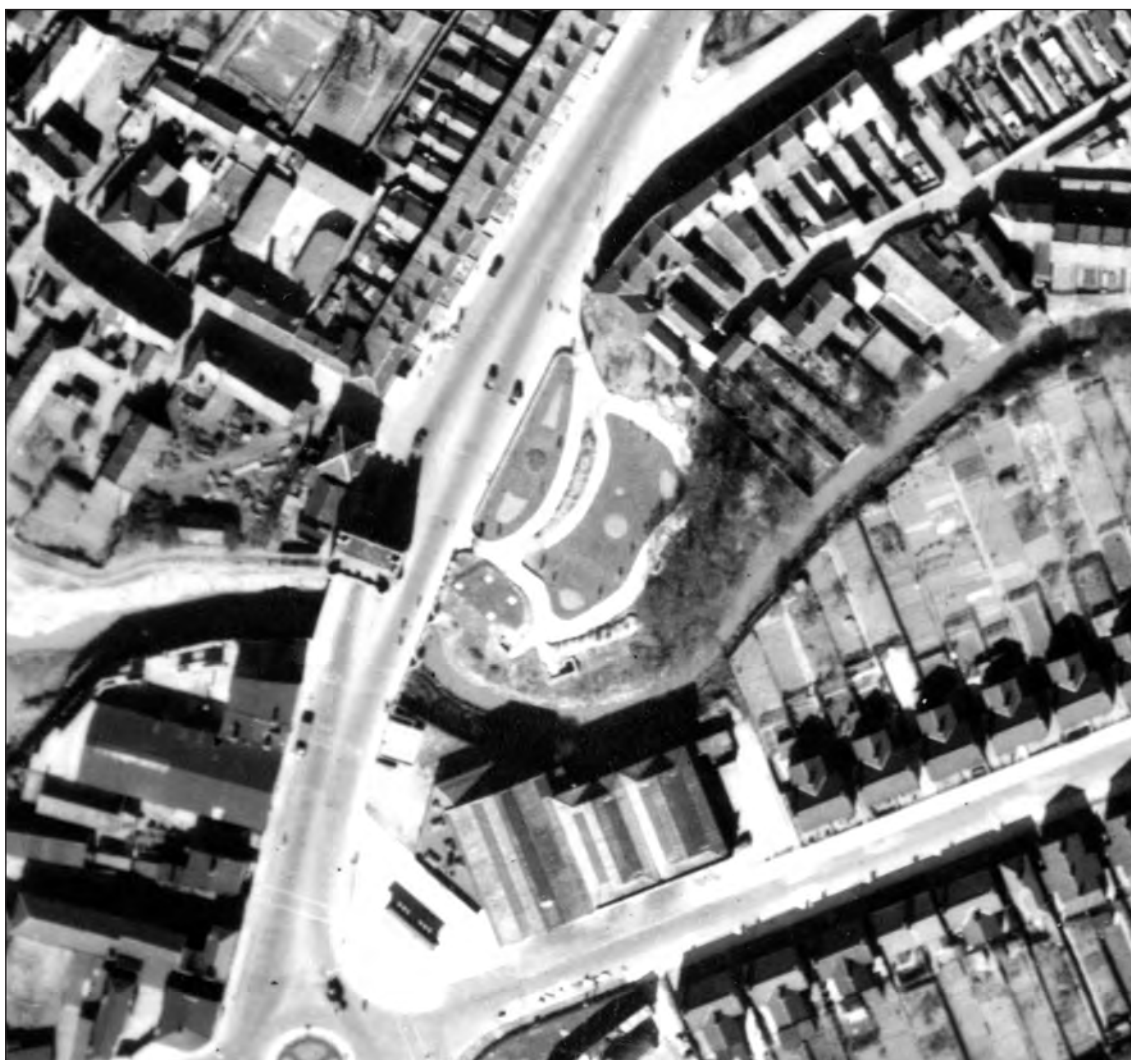
Fig 90 An aerial photograph of the park in 1988 showing the drained watercourse and the newly constructed footpath (Detail from Historic England Archive OS88246/210 17-AUG-1988 © Crown copyright. Ordnance Survey)

Very slight earthworks in the base of the ditch must have been created by the draining process undertaken at some point between 1983 and 1988, also the origin of the two manhole covers (3). The manhole cover to the north is located in the position of a large circular shuttered hole visible on a photograph taken in 1990, and again appears to be related to the infilling of the stop drain. The sloping sides of the ditch are relatively uniform, and the slight undulations recorded probably reflect relatively recent episodes of erosion, vegetation removal or the dumping of loose debris. Two cuts into the northern and eastern sides of the ditch appear to reflect relatively modern access routes into the ditch bottom (Fig 90); the one created by the construction of the concrete-flag path to the north (4a) after the ditch was drained post-1983, and the one to the south (4b) giving access from the western side of the park into the air raid shelter or shelters (see below).
