Historic Places Investigation

Southgates, King's Lynn, Norfolk: Historic Area Assessment

Research Report Series 009-2018

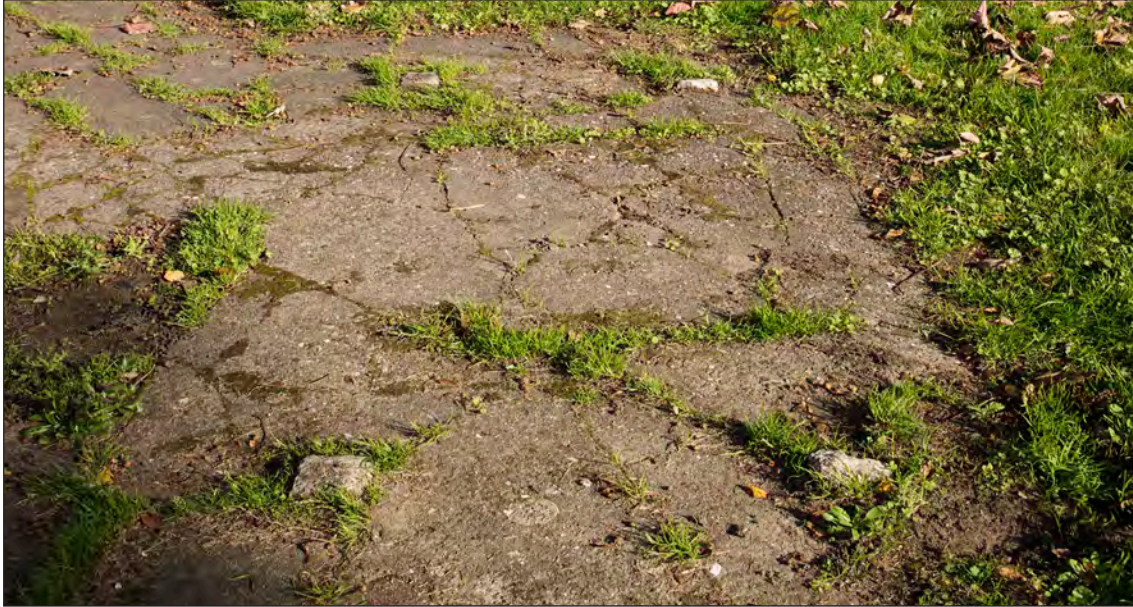
Fig 94: An area of crazy paving in Southgates Park (HEA DP219105 Patricia Payne 17-OCT-2017 © Historic England)

The park consists of three lawned areas – a central lawn which echoes the shape of the Crown Inn's bowling green (5a), an oval-shaped lawn to the west (5b) and the curving lawn to the north, east and south where the ditch is located (5c). The park is planted with one formal oval border to the north (6), an elongated terraced border to the east (6a) and a mixture of mature trees and smaller trees and shrubs spread across the site. The paths are formed of crazy paving, with the exception of one area of tarmac repair (7) and the modern concrete-flagged path running to the north-eastern corner of the park that must have been inserted after the watercourse was drained c.1983-88 (Fig 94).

The crazy-paving is coherent with the original design of the park and fits with its late 1930s date.

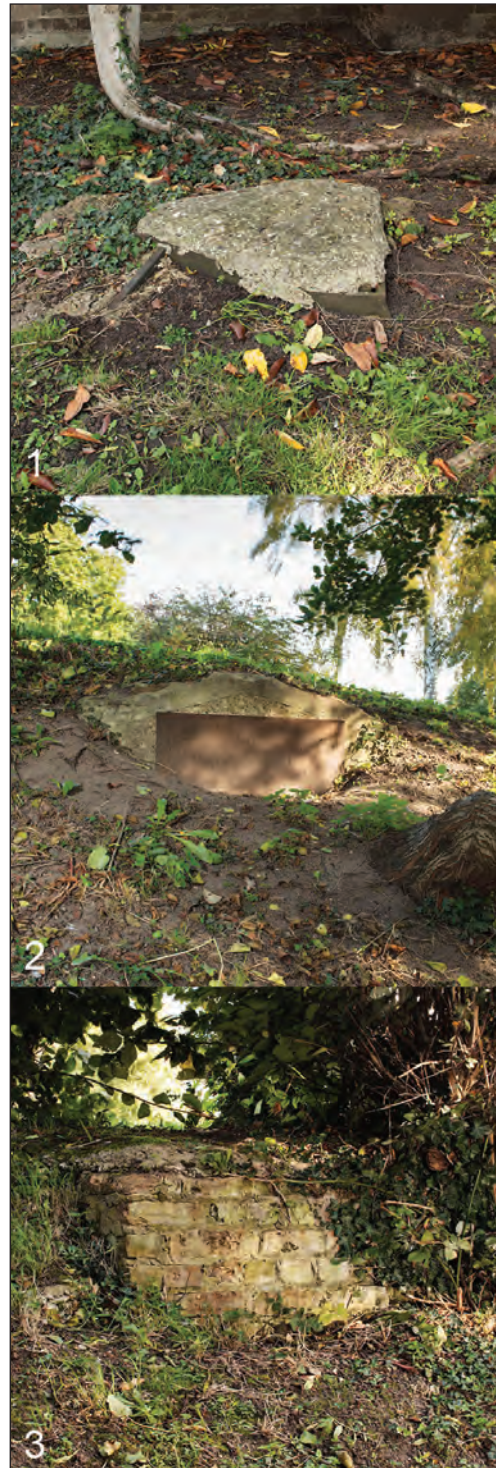
Fig 102: 1) Triangular manhole cover, 2) blocked brick-built entrance and 3) brick structure, all located on the western mound (HEA DP219124, DP219121, DP219120 Patricia Payne 17-OCT-2017 © Historic England)

To the west of this bank, immediately north of the ditch, is another mound. This mound is also about 18m long, and wider than the other mound, with what appears to be a flatter top, though its southern edge merges with the northern face of the ditch and so has been hard to define (12). On top of the mound two of four vents or hatches (12a) (Fig 102) are visible as triangular metal manhole covers (sides 0.7m) set in concrete, whilst on the southern face of the mound the ditch cut between the two mounds gave access to a smaller entrance around 1.5m wide, now visible as a mostly buried concrete structure with a shallow pitched roof constructed of brick, its entrance covered with a steel plate (12b).

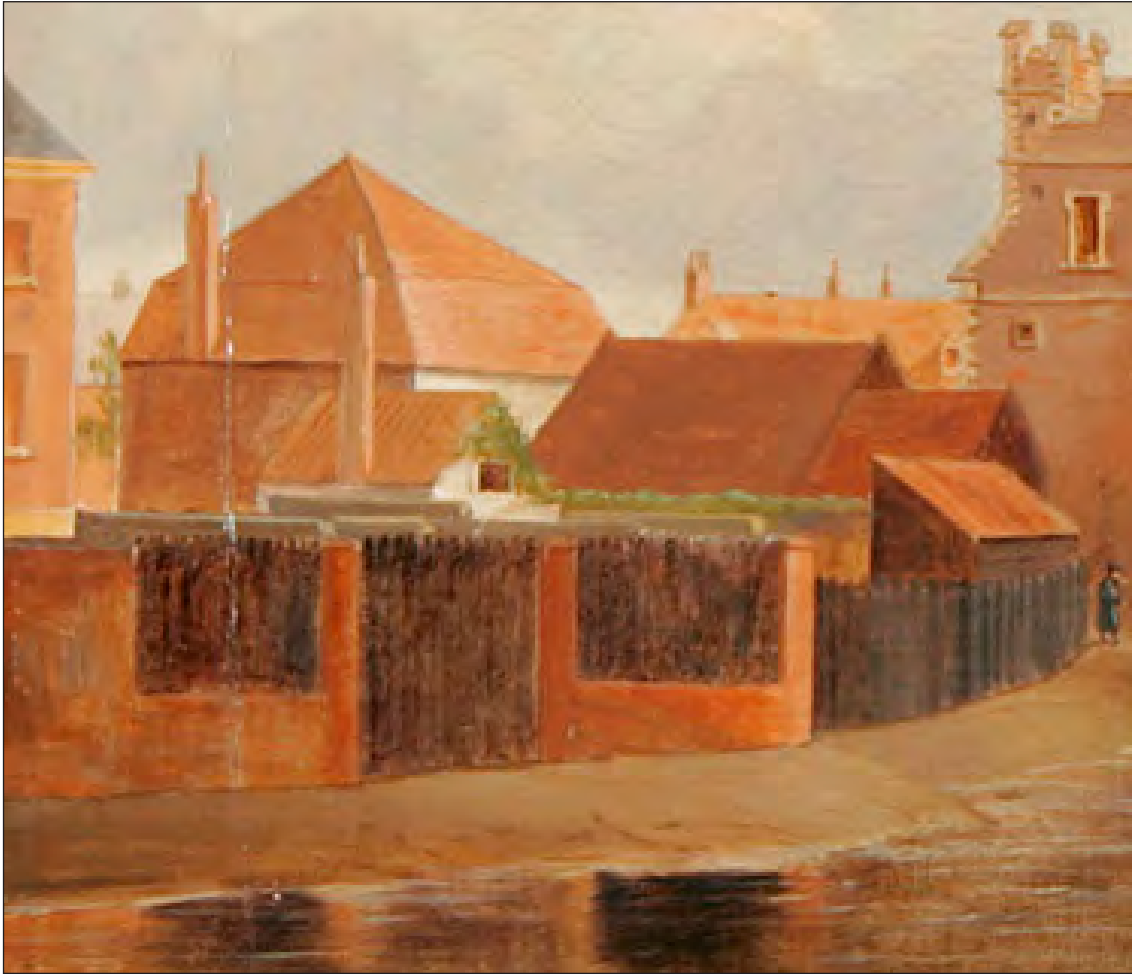
Fig 106 Detail of an oil, possibly by James Sillett, of Friars' Fleet Boatyard, King's Lynn, catalogued as c 1800-1820, showing the Mansard-roofed Honest Lawyer. Norfolk Museums Service (Lynn Museum) KILLM 2004.7

It includes only one building, but that building is of 18th-century date, if not older, and so is, apart from the South Gate itself, the oldest structure in the HAA area, though it is unlisted (Fig. 106). From the mid-19th century until the 1990s it was a public house called the Honest Lawyer (the inn sign was the usual one of a man with his head under his arm – the only honest lawyer being a dead one). In 2000 planning permission was granted to convert it to a house in multiple occupation but in 2009 it became a hostel for the homeless for a year.⁷⁹

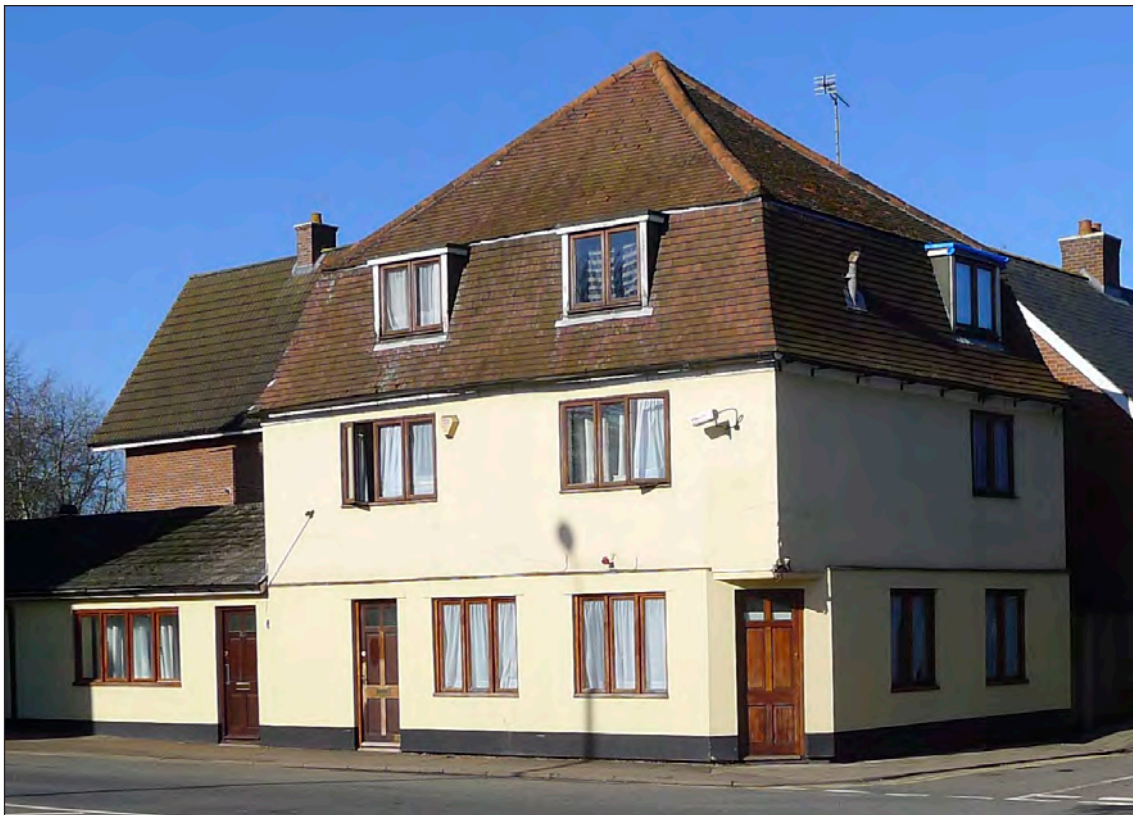
Fig 107 The former Honest Lawyer public house from the north-east. Photograph Jonathan Kewley 5-APR-2018 © Historic England

The main part is roughly square with two windows on the first and second floors on the east front, one on each floor on the north and south, and none on the west. Until relatively recently they were sliding sashes of Victorian appearance (Fig 109) but these were replaced first in the 1950s or 1960s with plate-glass windows of that era and then in the early 21st century with modern wooden three-light casement windows.⁸⁰ A watercolour attributed to James Sillett c. 1810 (Fig 110) shows two windows on the ground floor of the west front, matching those above, but during its years as a pub the northerly one was replaced by what looks more like a shopfront running nearly halfway along the north and east walls from a corner door. Later views show plate glass but a previous version must have had multi-pane windows, as a man was convicted in 1864 of damaging more than twenty panes. No door is visible on the east front in the Sillett watercolour, suggesting that the entrance must have been on the north front, which is obscured. At some stage this shopfront was

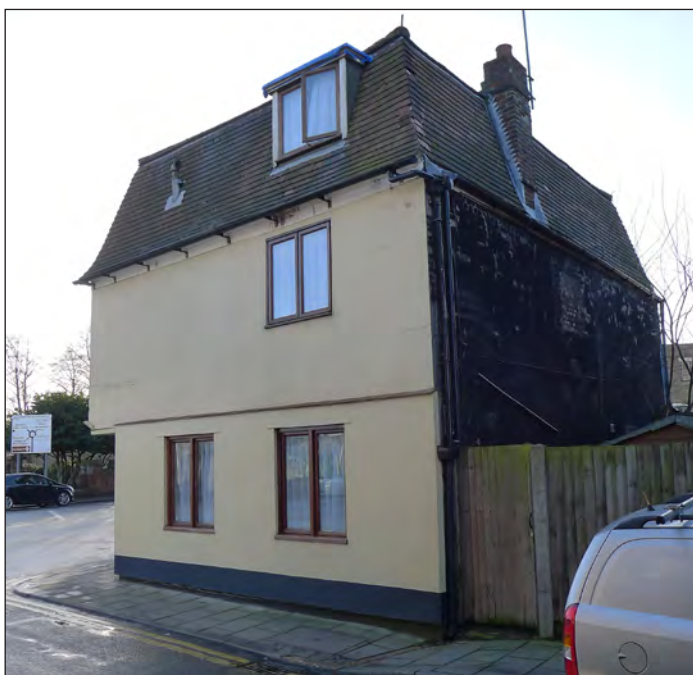
Fig 108 The Honest Lawyer from Southgate Street, looking south-east. Photograph Jonathan Kewley 16-JAN-2018 © Historic England

It consists of a main, three-storey building at the north of the site, with a single-storey roadside range running south as far as midway down the west wall of the South Gate (Figs 107 and 108).

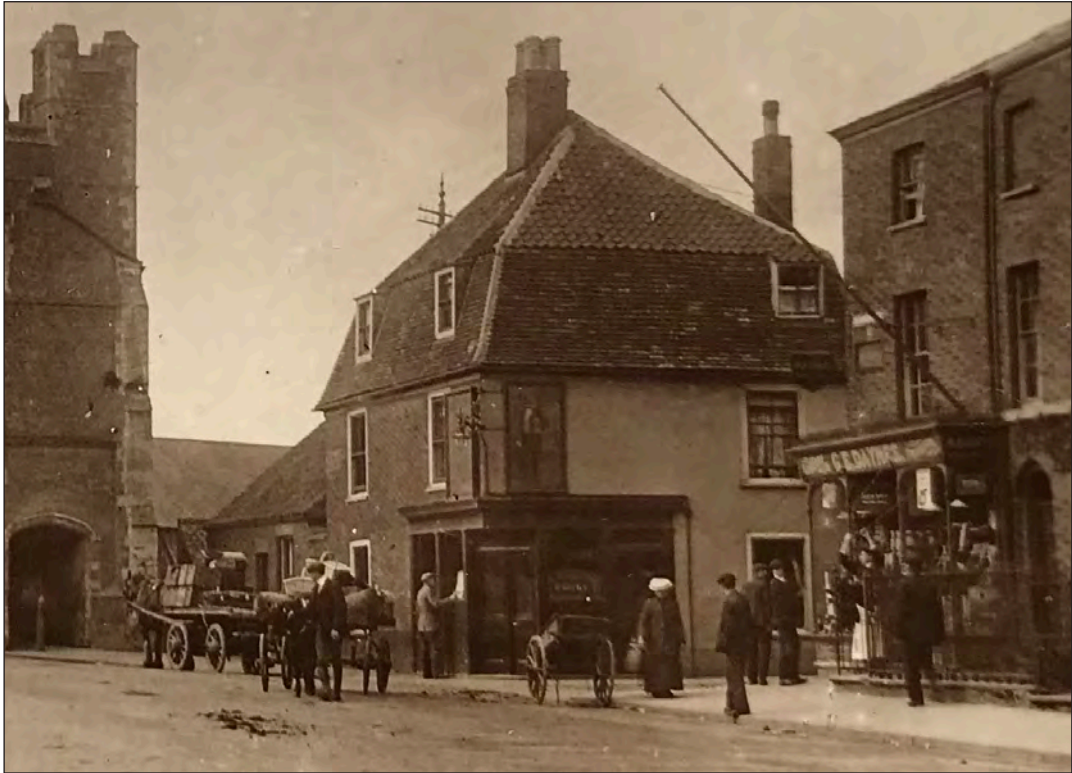
Fig 109 Detail of a photograph probably from the decade before the Great War showing the Honest Lawyer from the north-east. HEA © Historic England

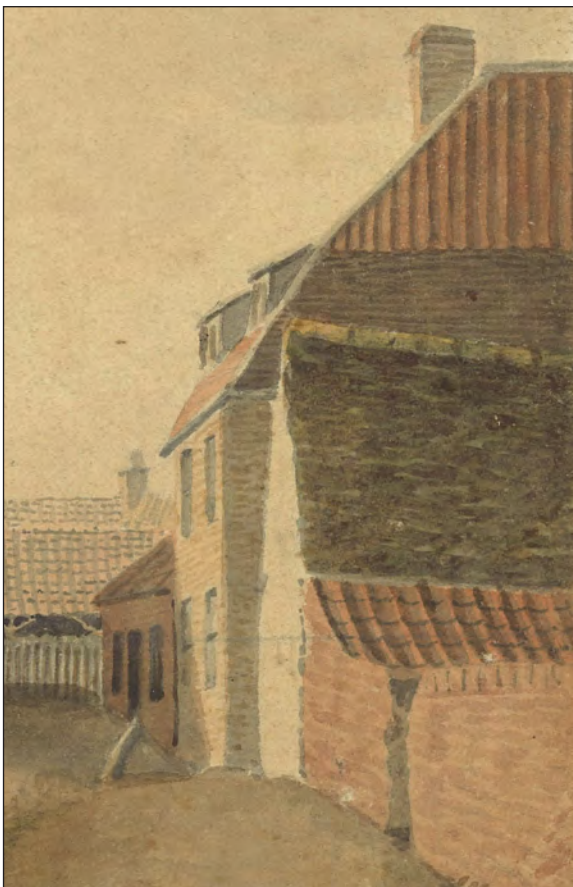
Fig 110 (left) Detail of a watercolour by James Sillett c 1810 showing the Honest Lawyer from the north-north-east; Southgate Street runs between the gabled building in the foreground and the larger building behind (the Honest Lawyer). Norfolk Museums Service (Lynn Museum) KILLM 1991.741.

The earliest images of it seems to be the three paintings attributed to James Sillett in the first two decades of the 19th century (see Figs 110, 111 and 112). The building he shows is recognisably the one there today. The roofs are now all brown tiles but historic images show the lower part of the roof as plain tiles (the traditional Norfolk material) with pantiles (an innovation of the mid-18th century) on the top part of the main roof and the roof of the south range.⁸³ It should be noted that it does not appear in one view of the area attributed to the engraver James Basire (1739-1802), although its accuracy is uncertain.⁸⁴

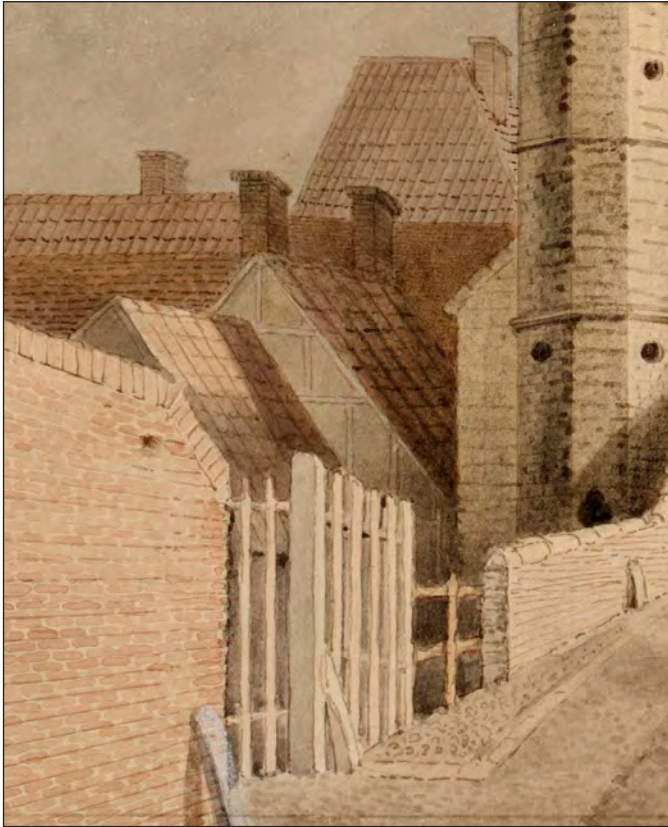
Fig 111 Detail of a watercolour by James Sillett 1809 showing the two gables of the south wing of the Honest Lawyer. Norfolk Museums Service (Lynn Museum). Image: HEA DP219400

The roof of this range is confusing. Two other paintings attributed to Sillett from the first two decades of the 19th century (Figs 111 and 112) show a pantiled roof and a wooden gable level with about half way along the west front of the South Gate, with a higher gable behind; the latter appears to be half-timbered, suggesting an early date. A photograph of c.1870 shows what looks like this lower gable (the site of the higher is out of shot) (Fig 113). However, later 19th-century views show a brick building with a hipped pantiled roof, coming as far south as the midpoint in the west wall of the South Gate (see Fig 26). By the time of the road widening in 1899, the south range had a brick gable roughly level with the north of the South Gate, with to its south a separate outbuilding with a monopitch roof sloping north (to the south side of which was later attached a sign advertising the Honest Lawyer) (Fig 114).⁸² This arrangement survived well into the 20th century. At some stage the south range was reconfigured or rebuilt as a single structure with a gable at the south (coming again to midpoint on the west front of the South Gate), and a roof of ordinary tiles.

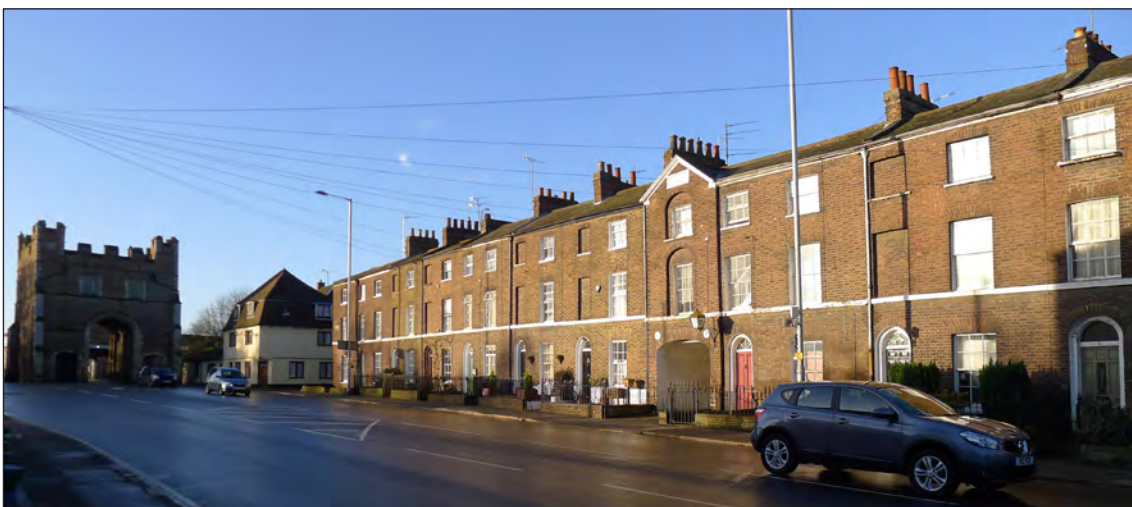
Fig 116 Looking north from the South Gate up the London Road with on the left the Honest Lawyer and Buckingham Terrace beyond, and on the right Southgate Park and Guanock Terrace beyond. HEA 13-JUL-2017 Patricia Payne ©Historic England

pre-19th-century traffic had to pass. Its surroundings, looking out from the HAA site, are mixed (Fig 116). The London Road is wide at this point, and so there is a sense of openness, but created, desired openness rather than the desolate openness south of the gate. Because of the way it nestles beside the South Gate, there is little sense from it that there is openness to the south. Instead the sense is of a wide, quite elegant Georgian space; due north runs the fine, brown-brick pediment-centred Buckingham Terrace of 1825 (Fig 117), and similar terraces can be see further away, up the London Road and along Guanock Place to the north-east. The gap in this Georgian uniformity is the park opposite, where the Crown Inn, which would have provided a Georgian enclosure to the east, was unfortunately demolished in the 1920s or 1930s.

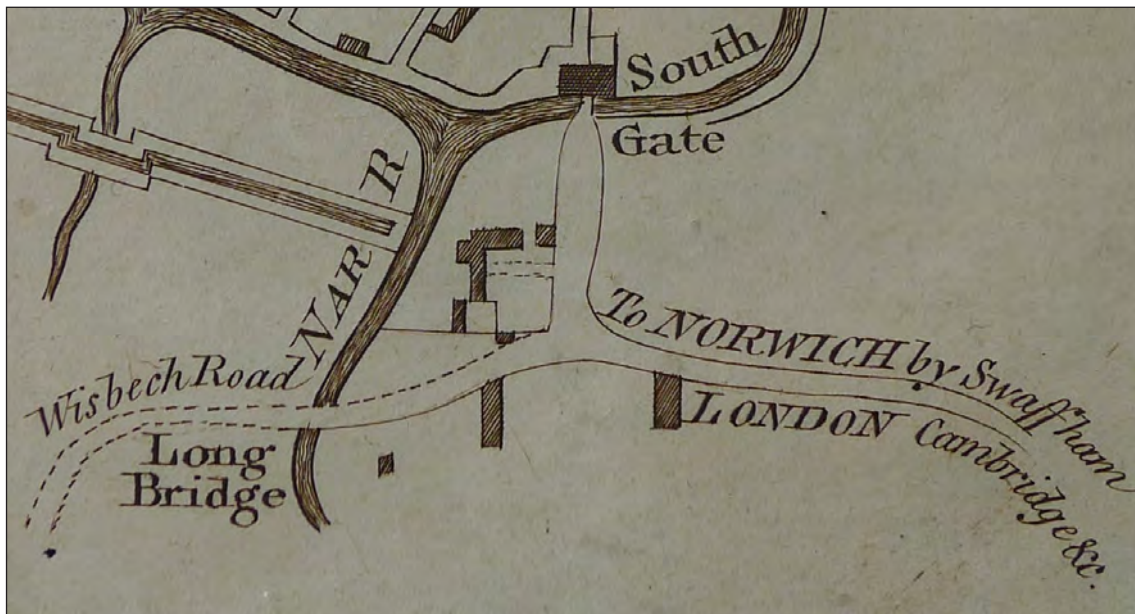
Fig 128 Detail from William Rastrick's *Ichnographia burgi perantiqui Lennae Regis* 1725 showing buildings on site 4. Norfolk Museums Service (Lynn Museum)

It is first shown in any detail in Rastrick's map of 1725 (Fig 128). This shows two buildings attached to each other towards the south-east of the site, seemingly facing – but set back from – Out South Gates. Like all the buildings on Rastrick's map, they are just schematic squares and so little can be taken from it other than that some structures were on the site at the time. A map in the Norfolk Record Office (Fig 129), catalogued as 18th century (and having very strong similarities to Faden's map of 1797) shows a complex of buildings with a main range the shape of an inverted L, with something smaller attached at the south-west and a detached building on Out South Gates, half way down.⁸⁹ There is a west-east wall shown towards the south of the site, with one building on its south side; the area south of the wall is shown not fenced from the Wisbech Road. Newham's map of 1809 (Fig 130) shows something quite similar, although with the building on Out South Gates attached to the rest; the area south of the wall appears completely incorporated into the Wisbech Road.

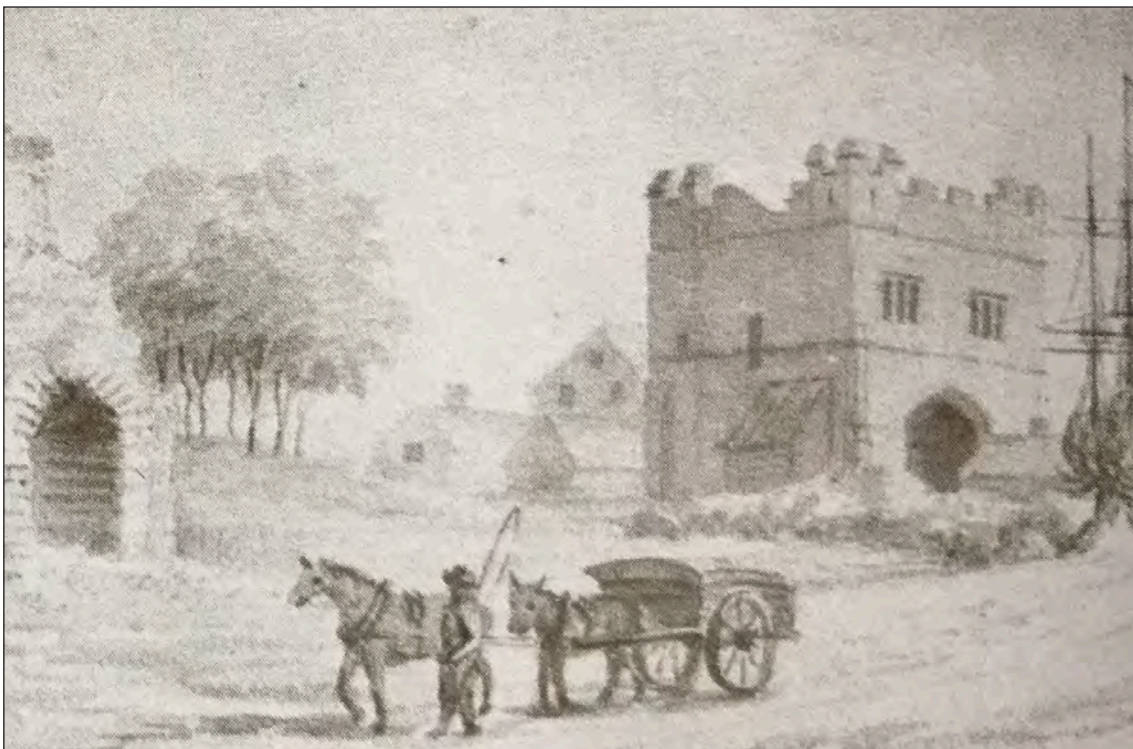
Fig 131 Detail from a watercolour by James Sillett, looking south through the South Gate. Norfolk Museums Service (Lynn Museum) KILLM 1991.741

A watercolour of about 1810 attributed to James Sillett, of the South Gate from the north (Fig 131), shows some buildings behind it which must be south of the Friars' Fleet. Whatever is through the arch is difficult to make out, but appears to be a small wooden structure on timber supports with a hoist in front, perhaps over the road. To the right (west) there appear two pantiled roofs running east-west, the lower open-fronted and single-storey, the higher, behind, having a chimney.

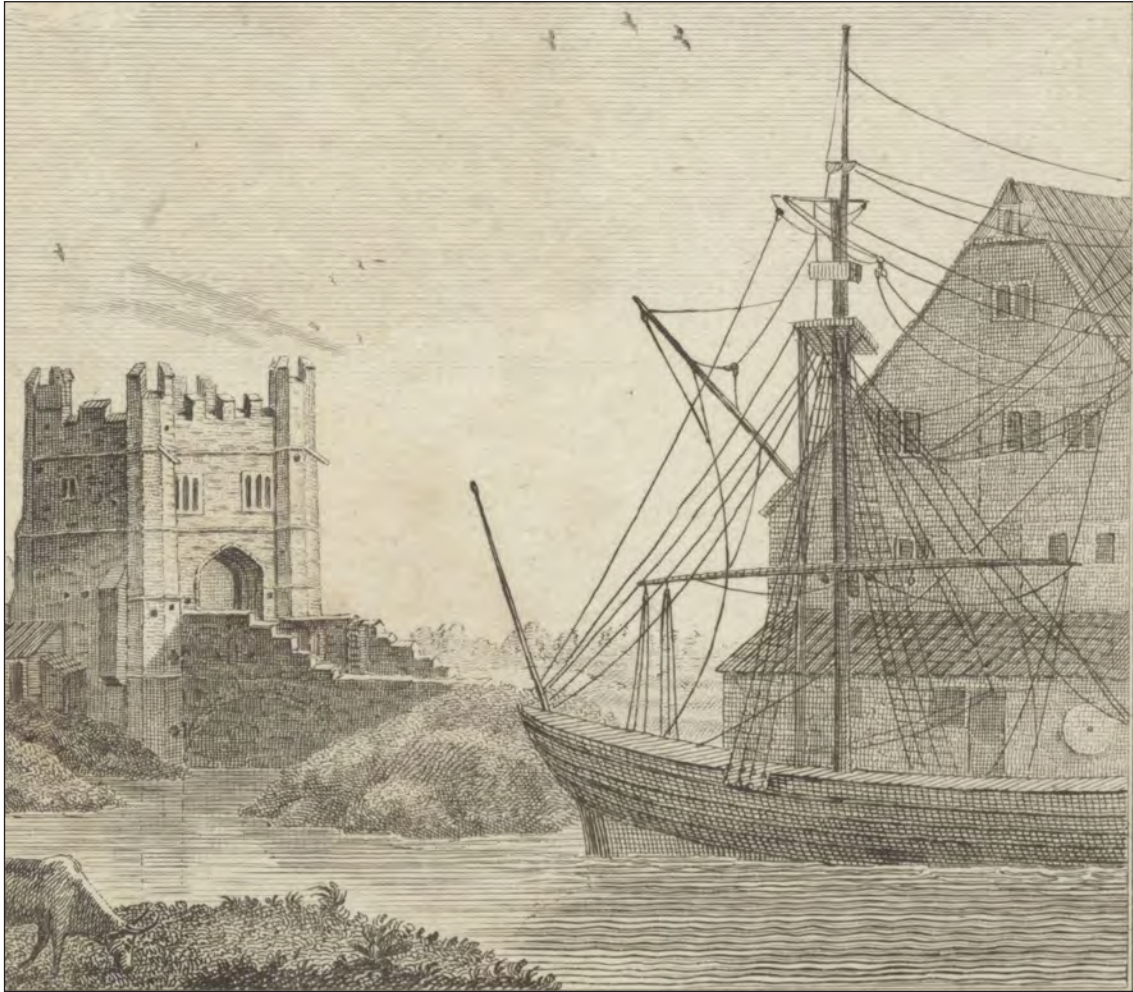
Fig 132 Detail of The Old Gannock Gates and South Gate (LA19) by the Rev Edward Edwards, showing, in the centre, buildings south of the South Gate. Norfolk Museums Service (Lynn Museum)

A better view can be seen in the Rev. Edward Edwards's drawing 'The Old Gannock Gate' (Fig 132), which, according to his notes, shows that ruin in 1800. The gate was behind Guanock Terrace (which leads north-east off the London Road just north of the HAA site boundary), and the artist was looking south-west. On the right can be seen the South Gate, with shipping on the Friars' Fleet further right still. To the left of the gate (approximately where the Bus Garage is today) is a clump of trees on a mound, which seems the same as that seen in Fig. 38, and is what Edwards calls a 'bellasis' on Fig. 37. More important for our current purposes, however, is what is between the clump and the gate. It is a group of buildings which must be somewhere towards the front (east) of this site. There seem to be two single-storey buildings running east-west, the southern having a window in its east gable and probably a chimney behind, and then west of them a three-storey building with an east-facing gable containing one window at second- and two at first-floor levels. This is not necessarily a totally accurate representation (elsewhere on the drawing Edwards seems to miss out the Crown Inn which would have hidden the north arch of the South Gate), but it does seem to tie up with what is shown in plan form by Faden and Newham and visually by Sillett. A print (possibly after James Basire) (Fig 133) shows the area from the west, including a five-storey gabled building. Three of the storeys are within the height of the gable, and the building appears to be brick; it is difficult to interpret the material of the main roof. On the west, close to the Nar, is a single-storey lean-to extension with a pantiled roof. It is certainly possible to see that the buildings depicted by Edwards and Basire are one and the same. What it is is unclear. The building type it seems most closely to resemble is a mill, but that there is no evidence of that here.

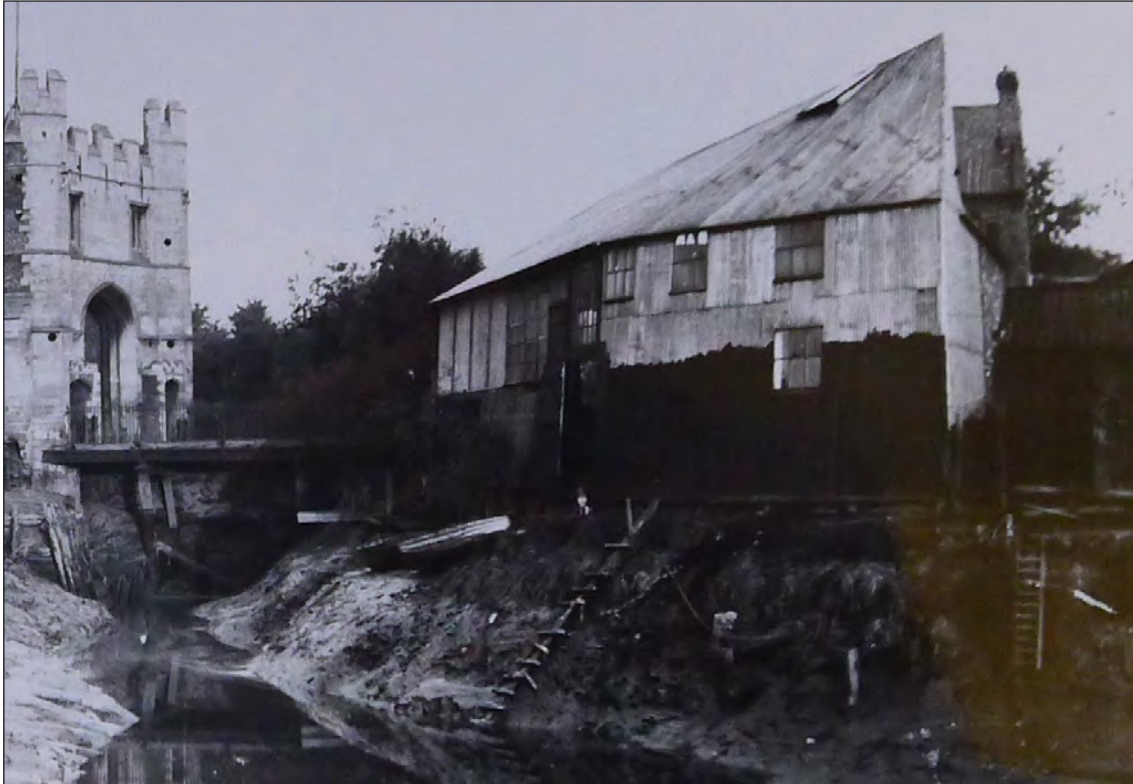
Fig 140 A late 19th century view east along the Friars' Fleet, showing the coal merchants' premises. Norfolk Library and Information Service (King's Lynn Library Archives)

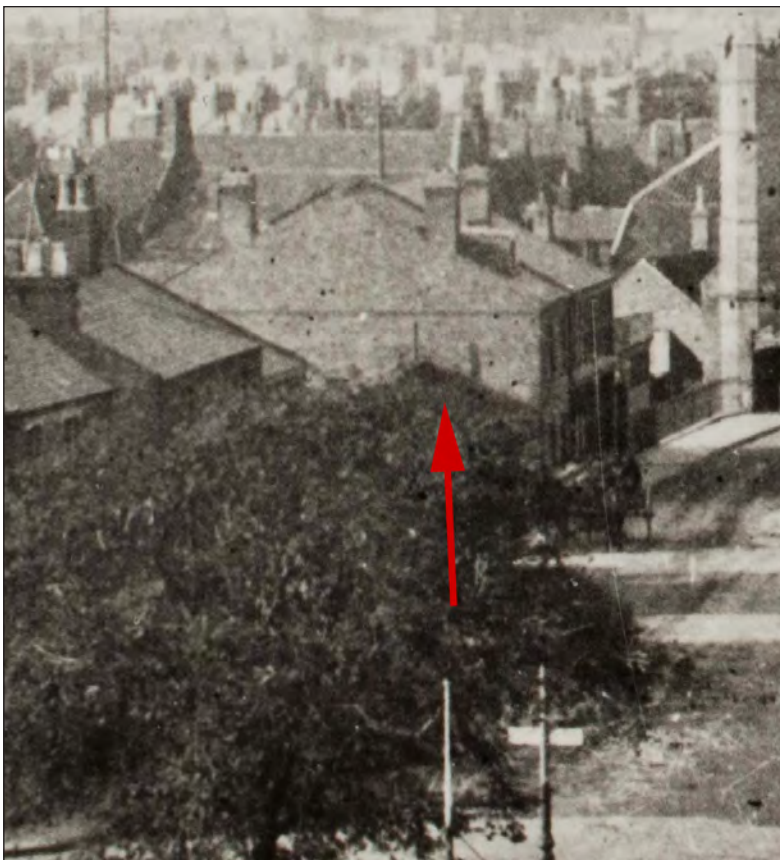
Fig 141 The buildings at the top of Out South Gates on the west, in a detail from a late 19th or early 20th century photograph. Norfolk Library and Information Service (King's Lynn Library Archives)

In one late Victorian or Edwardian view (Fig 141) building B seems to be a pair of two-storey, two-bay buildings, one of which looks domestic but the other (the northern) of which seems to have been refronted and almost entirely glazed. In 1911 the residential part of it had six rooms. The aerial view of 1928 (Fig 142) suggests that the northern section was wider (north-south) than the southern, and that only the latter had chimneys. This is confirmed by an undated postcard (posted in 1906 on kingslynnforums.com), looking from the west, which shows a six-over-six sliding sash at the first-floor area and an open-fronted, corrugated-roofed lean-to behind.

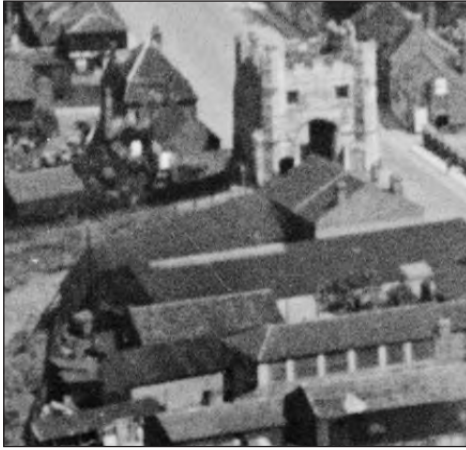
Fig 142 (above) An aerial view from 1928 showing the buildings at the top of Out South Gates, on the west. HEA (Aerofilms Collection) EPW021484

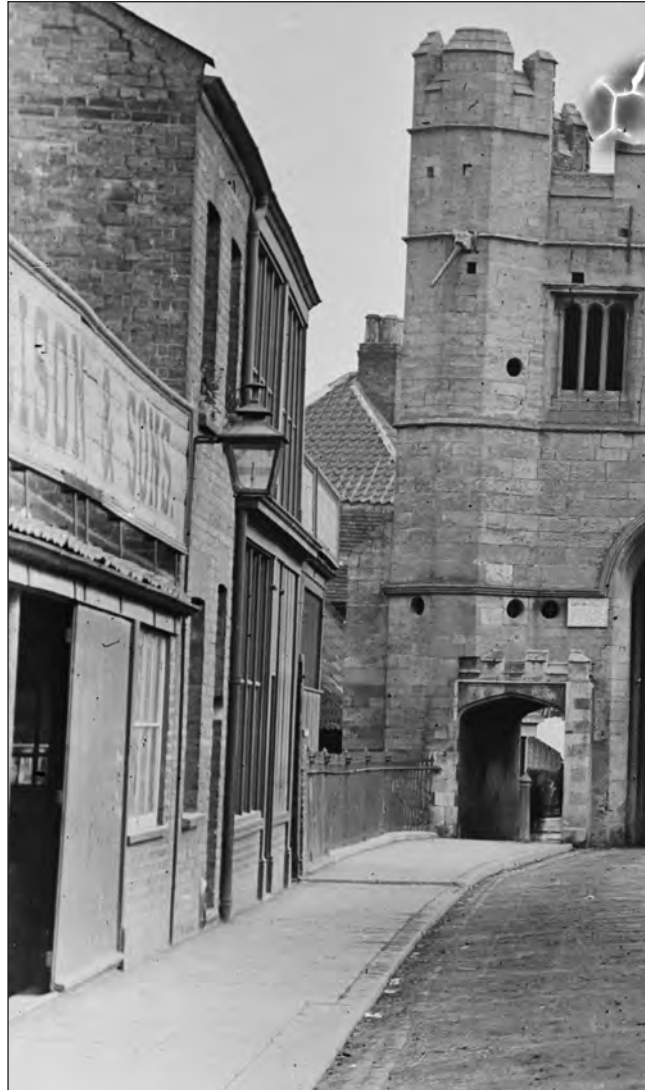
Fig 143 (right) Looking north up Out South Gates before 1899, showing on the left the premises of Collison and Sons, corn merchants. HEA bb37_01003

In one pre-1899 view (Fig 143) only part of the site of building C can be seen, as a single-storey pantiled building (the roof running north-south) with a sliding door and a fascia sign '... ison and Sons'. This must be Henry Collison, corn merchant, who was here certainly between 1891 and 1911.¹¹⁰ A postcard posted in 1906, looking from the west to the back of the site, shows a large wooden shed running east-west with windows in the west gable and a single-storey lean-to shed behind.¹¹¹

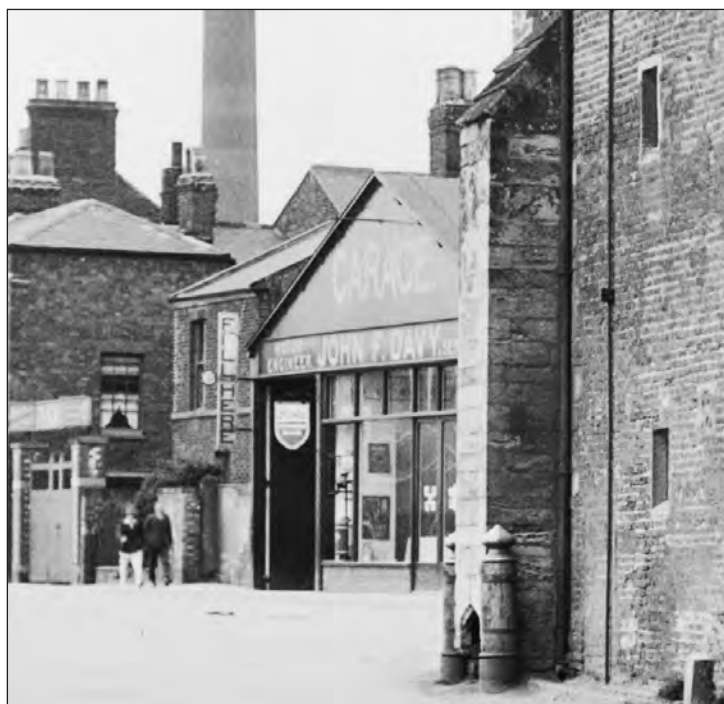
Fig 144 Looking south past the South Gate in 1928, showing John F Davy's garage. Detail of HEA op35020

Collison was the successor to John Palmer, corn dealer, who had been here in 1871.¹¹² By 1928 it had become John F. Davy's Garage, seen in the street-level view of that year (Fig 144), rebuilt as a shed with the gable facing the road; the aerial view (see Fig 141) and the 1927 Ordnance Survey map show that it stretched back almost

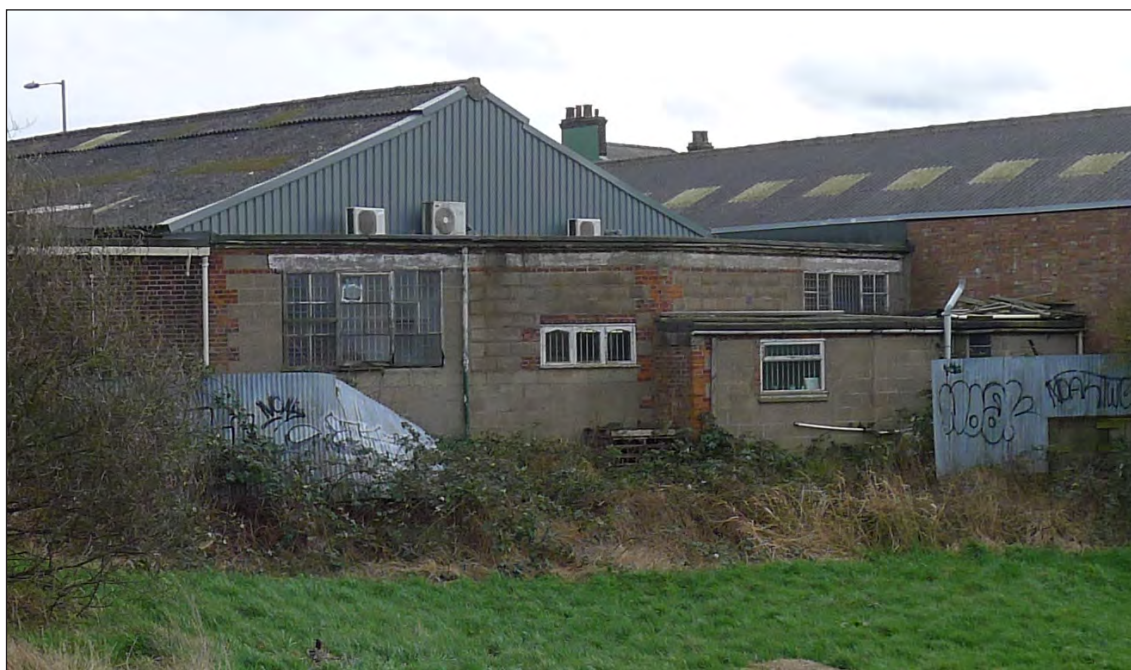
Fig 145 The former Ford garage from the north-west. Photograph Jonathan Kewley 27-FEB-2017
© Historic England

to the river. Davy is listed at 2 Out South Gates in a directory of 1933. While it has lost its east end to the unified roadside range (see below), otherwise this building appears to survive, and thus is the oldest part of the garage complex, with a date somewhere between 1905 and 1928 – stylistically 1920s would seem the most likely. Flat-roofed extensions of block with brick dressings run from it to the west boundary of the site (Fig 145).

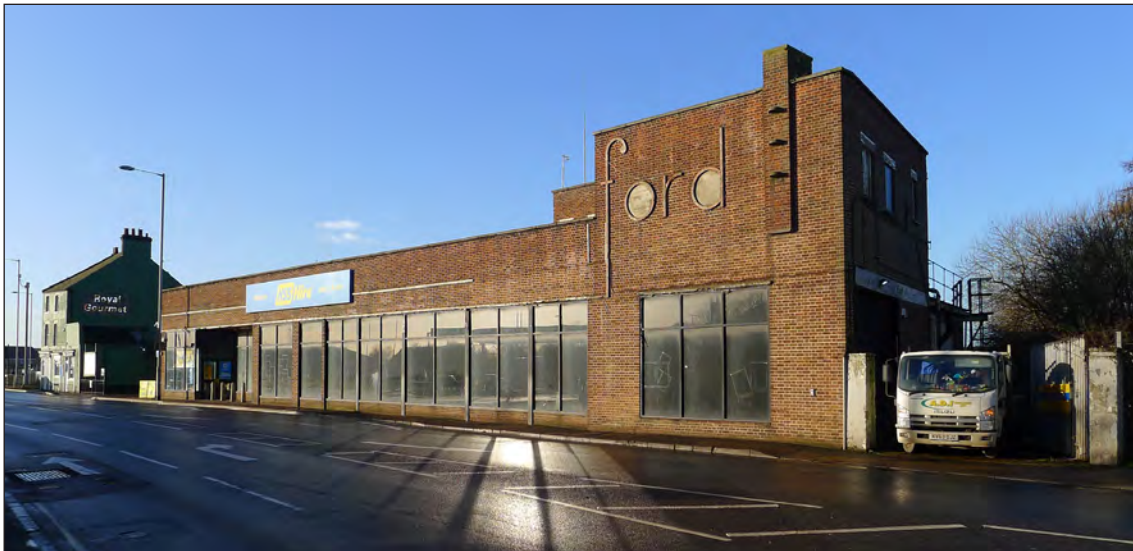
Fig 147 The former Ford garage on Out South Gates from the north-east. Photograph Jonathan Kewley 16-JAN-2018 © Historic England

- The former **Ford Garage** (see Fig 147), which has a unified 1950s frontage concealing a building of various dates from probably the 1920s onwards. It is respectful in height and material to the South Gate, with a turret of its own echoing the military nature of its neighbour (Fig 174). The word 'ford' on this turret is an attractive feature, as are the polished concrete bollards within the recessed shopfront. It is now subdivided between a tool-hire shop, a gym, a hairdresser's and a motor repair business. The historic, pre-20th-century character of its site was open and outward-looking, with timberyards, coal wharves or shipyards looking outwards north or west to the Friars' Fleet or the Nar. The 20th-century character was rather different, with the site built over and turning its back to the rivers.

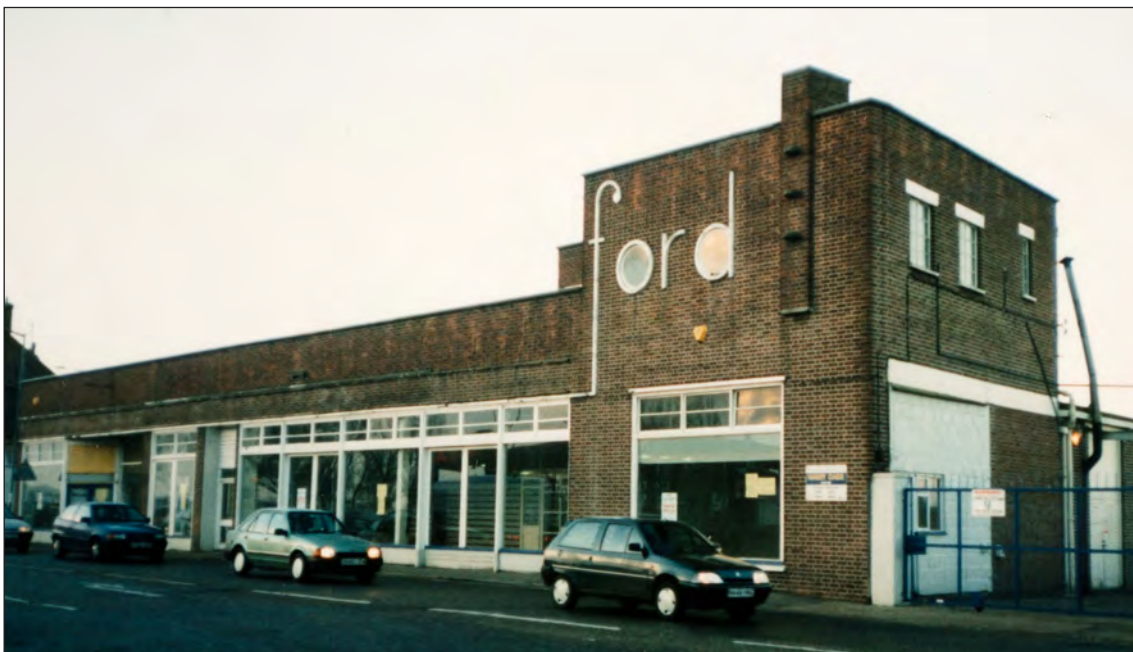
Fig 148 The former Ford garage from the north-east in 1996, showing the original windows. Norfolk Library and Information Service (King's Lynn Library Archives). Image: HEA DP219456

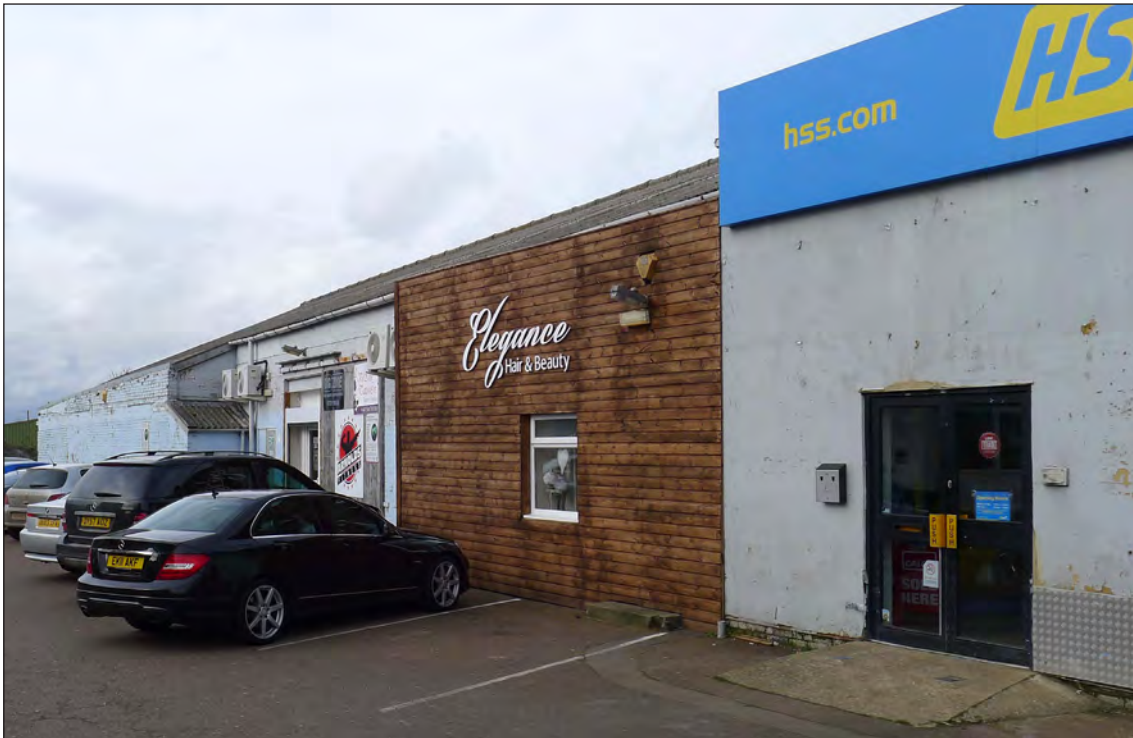
Fig 150 The south elevation of the former Ford garage. Photograph Jonathan Kewley 27-FEB-2017
© Historic England

At some time either before, after or contemporaneous with the new frontage, building D (the southern part of the garage site) was replaced by a building for the garage. It is a long shed, aligned east-west, with a corrugated roof and gables, brick walls, and skylights in the roof. It has a wide, recessed entrance in the middle of the south front, probably added because customers coming by car would want an entrance near where they had parked off-road, not on Out South Gates. This front (Fig 150) has now been subdivided between various tenants. On the west front (Fig 151) is a high, wide opening, suitable for tall vehicles. It is probably the commercial vehicle repair shop illustrated in the *Motor Trader* in 1967.¹¹⁴

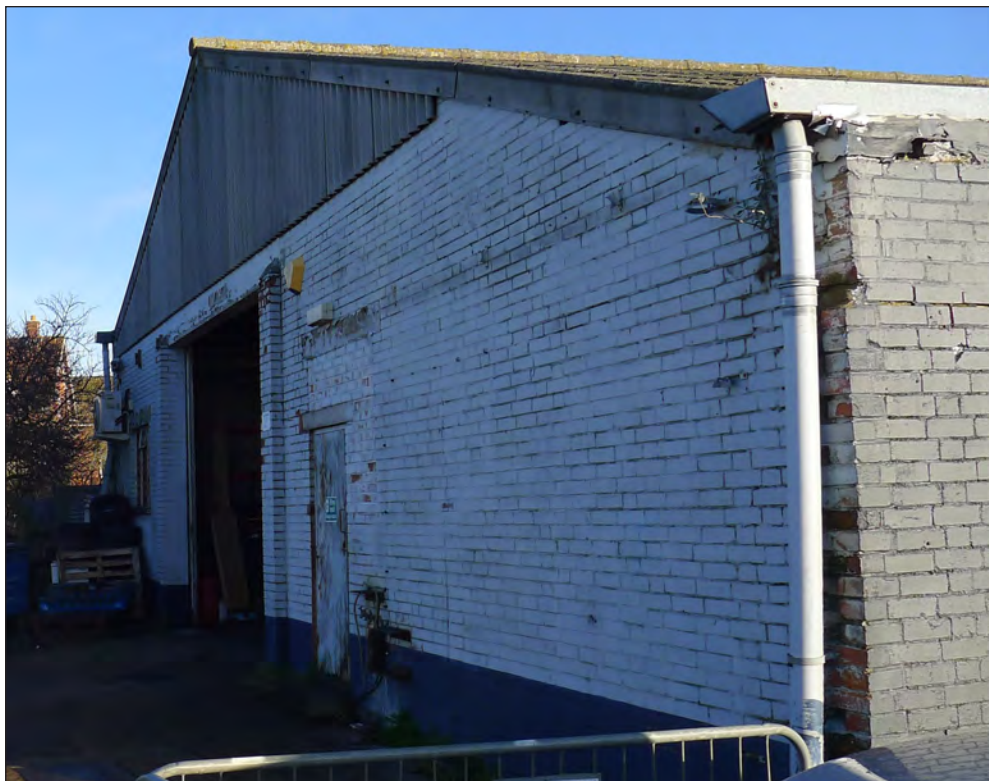
Fig 151 The west elevation of the former Ford garage. Photograph Jonathan Kewley 16-JAN-2018
© Historic England

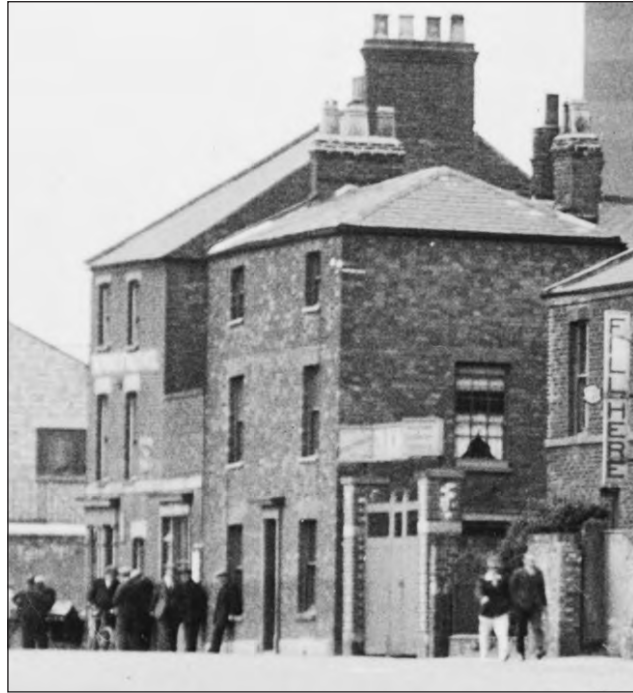
Fig 153 Building E (in the centre) in 1928 with the Prince of Wales public house to the left. HEA detail of op35020

Building E (Fig 153) was an attractive three-storey building of early to mid-19th century appearance, plain brick with a shallow slate roof, hipped to the north. It was of three bays, and with a window on each floor on the outer bays but on the central one just a door at ground level, with a simple doorcase. There was a rather larger six-over-six sliding sash on the first floor of the north wall. In 1911 it had seven rooms.

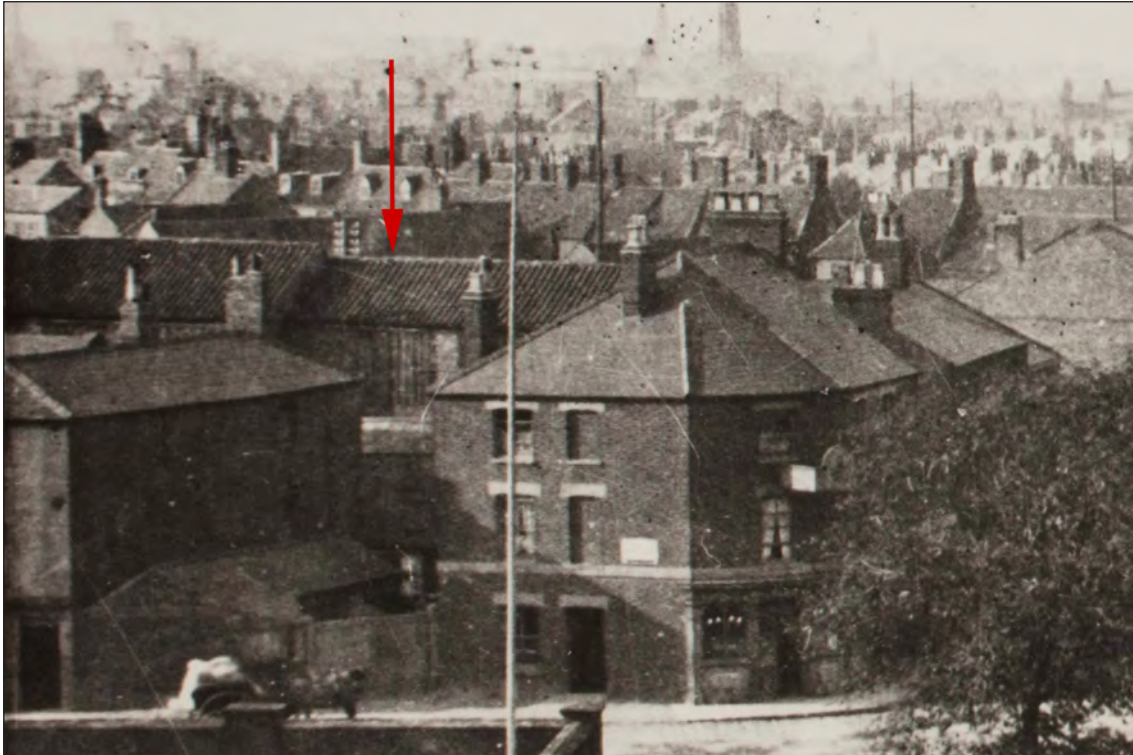
Fig 155 Building F (marked) in a late Victorian or Edwardian view from opposite the bottom of Out South Gates. Norfolk Library and Information Service (King's Lynn Library Archives). Image: HEA DP219452

To the west is a wall a storey high, running first south-west and then more west-south-west, to join the Highland Laddie. The tent view (see Fig 155) shows this as a yard for the Prince of Wales, with the eastern section having double gates into a yard with a single-storey structure along the west side. Today the gates have been replaced by a foot gate on the west and, further east, a replica of the other ground-floor windows. The whole yard seems to be a single-storey flat-roofed extension to the main building.

show a slate roof (see Fig 155). The building is brick, painted, although rendered on the south façade. The bond is variable, suggesting different phases of construction; the lower parts of the west wall of the lean-to and the north wall of the main building are English bond, and the upper floors appear to be Monk bond.
