Historic Places Investigation

Southgates, King's Lynn, Norfolk: Historic Area Assessment

Research Report Series 009-2018

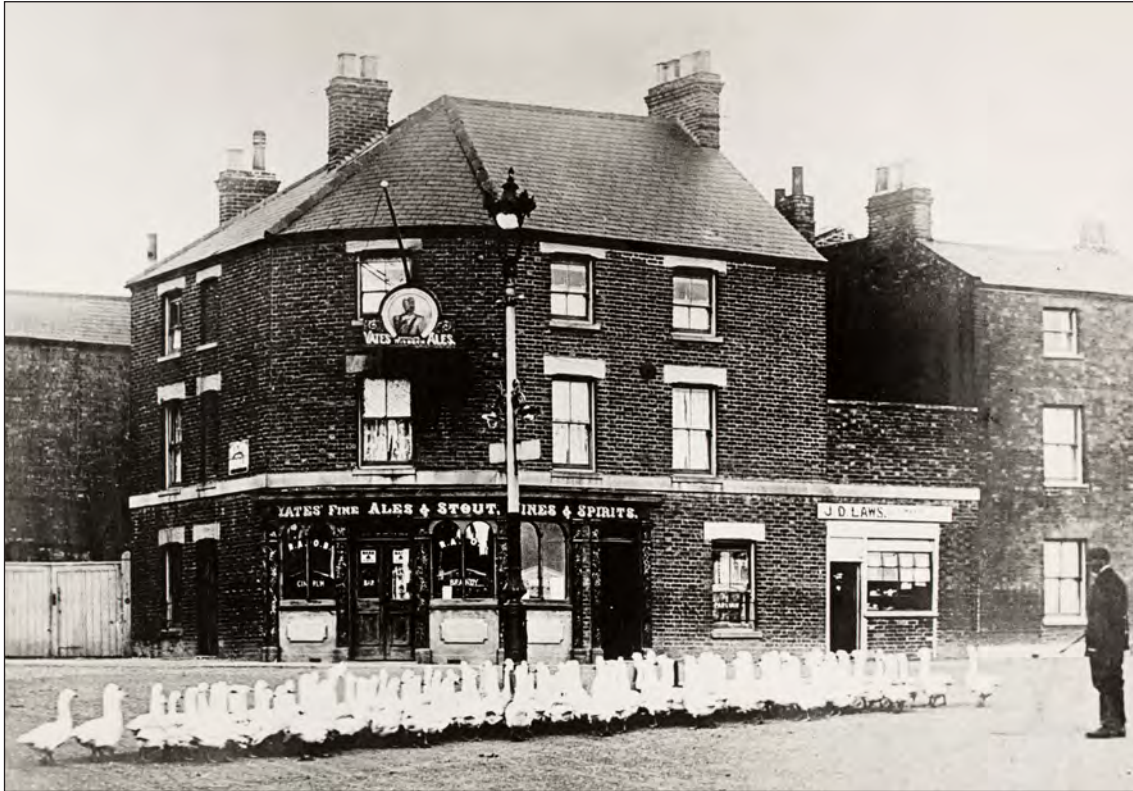
Fig 156 The Prince of Wales public house and Building G (the single-storey building to the right) in a 1909 view. Norfolk Library and Information Service (King's Lynn Library Archives). Image: HEA DP219418

Building G (Fig 156)] is to the north of the former Prince of Wales public house, and from the outside it looks like a single-storey extension to it. It has a very simple shopfront with a door to the left and a window divided into four principal panes on the right; a high parapet conceals a monopitch roof sloping up to the south (Fig 157). In 1933 it was the premises of John David Laws, boot repairer.¹¹⁹ On the 1965-67 Ordnance Survey this is numbered 5 Out South Gates. Behind it (and shown structurally separate in the 1905 Ordnance Survey map) is another small, narrow structure which today looks as though it has been rebuilt or remodelled recently. It has a roof gabled to the south (where it is attached to the former Highland Laddie public house) but hipped to the north. The old maps show it was attached, to the west, to a wider building described below, which occupied what is now the car park for the Highland Laddie.

Building H is the former Prince of Wales public house (Fig 158) –a Victorian corner brick building of canted plan. The Wisbech Road (south) front is of two bays, with windows in the left bay on each floor, and on the right bay a door at ground level and blank windows above. The single-bay south-east-facing front has a window in each of the upper storeys, and on the ground floor a public house arrangement of double doors between plate-glass windows composed of two arch-headed lights, with a prominent raised panel below each; this treatment carries round to the left-hand bay of the east front. The right-hand bay has a window in the top two storeys and probably a door on the ground floor. It is now pebbledashed on the south and east fronts and painted green, but photographs show that it was originally of exposed brick, probably a dark brownish red (see Fig 156). It was painted (although not the present colour) by the 1960s.

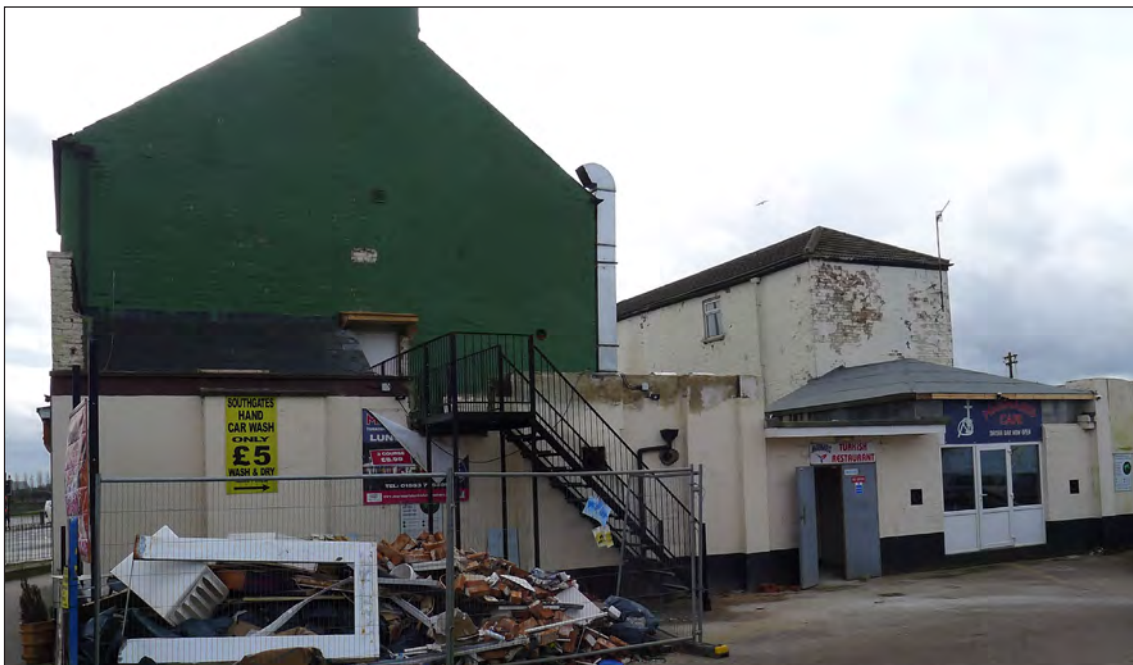
Fig 157 Building G, showing how it runs from the east part, with a monopitch roof, on the left, to the section with the shallow hipped roof to the right. All is now part of the former Prince of Wales. Photograph Jonathan Kewley 27-FEB-2017 © Historic England

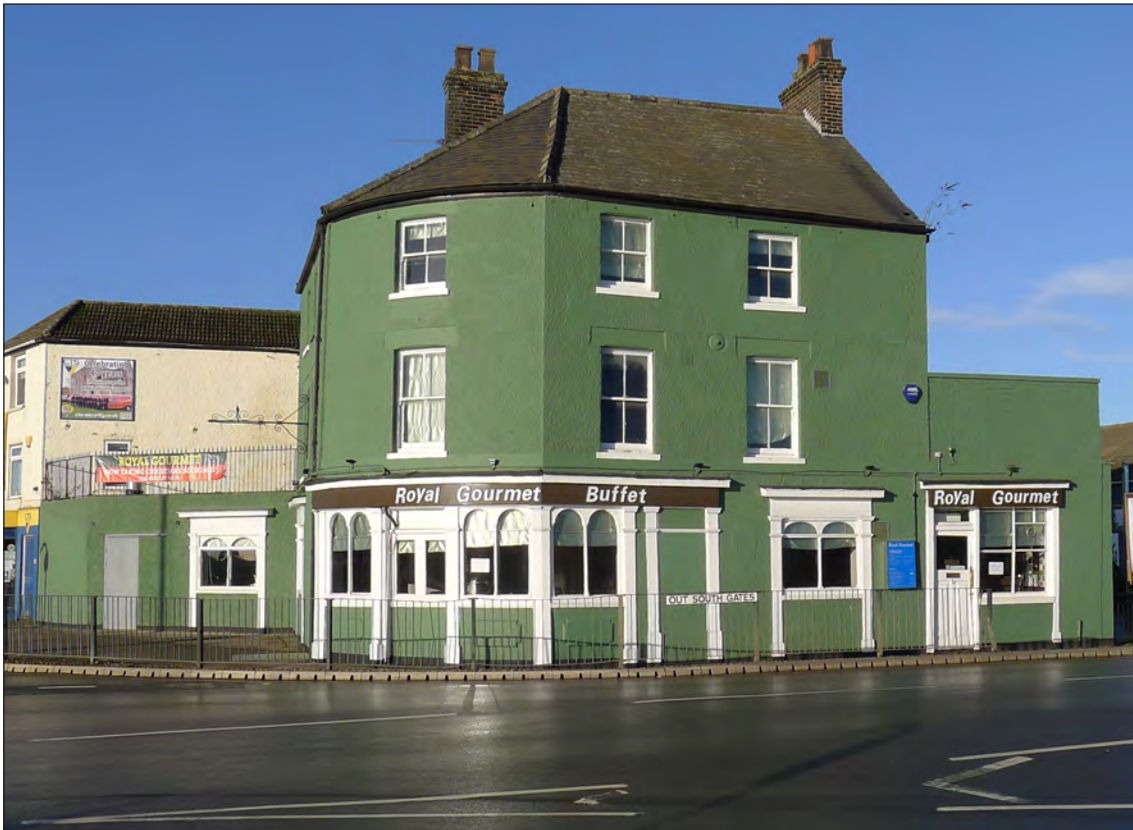
Fig 158 The former Prince of Wales public house on Southgates Roundabout, currently the Royal Gourmet restaurant. Photograph Jonathan Kewley 16-JAN-2018 © Historic England

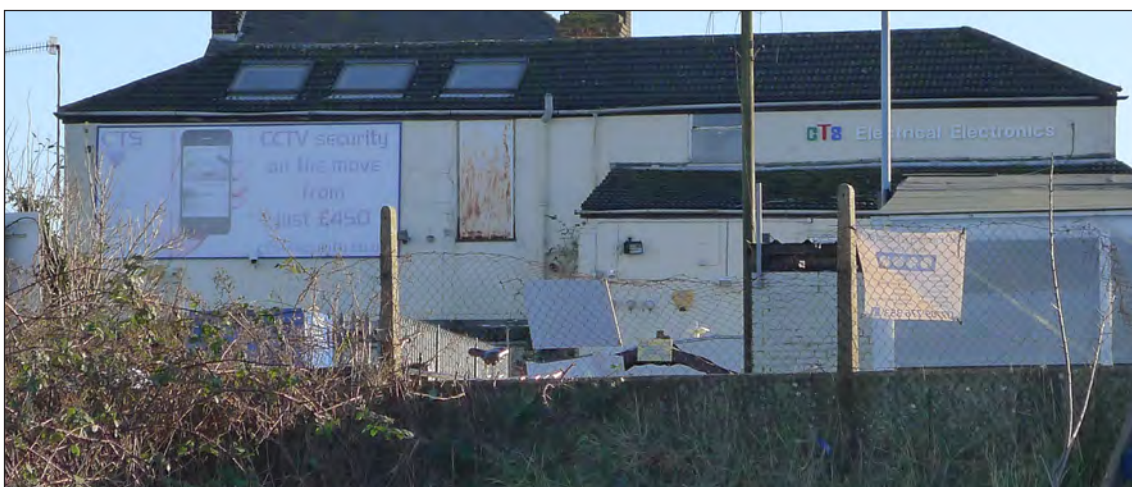
Fig 160 The former Highland Laddie from the west. Photograph Jonathan Kewley 16-JAN-2018 © Historic England

The main range is one bay wide with one window on each of the upper floors, now uPVC but previously sliding sashes. On the west side there is a two-storey, lean-to range, again one bay wide. There is now a window in the upper floor like the other replacements but before 1943 there was a barn door there and a photograph from 1962 shows a wooden casement of cottage appearance, with three lights, each one-over-one.

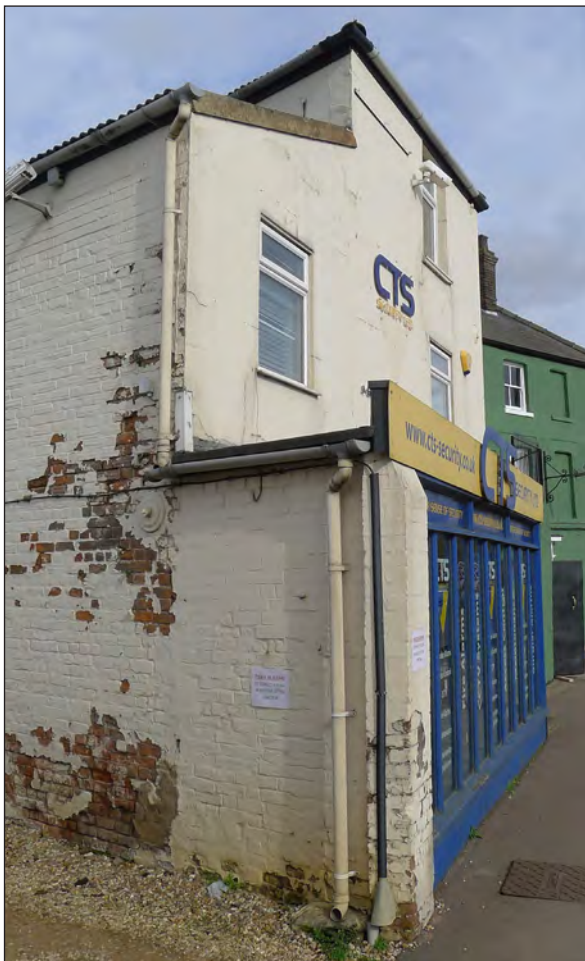
Fig 161 The Highland Laddie from the south-west, showing the projecting shopfront on the Wisbech Road. Photograph Jonathan Kewley 27-FEB-2017 © Historic England

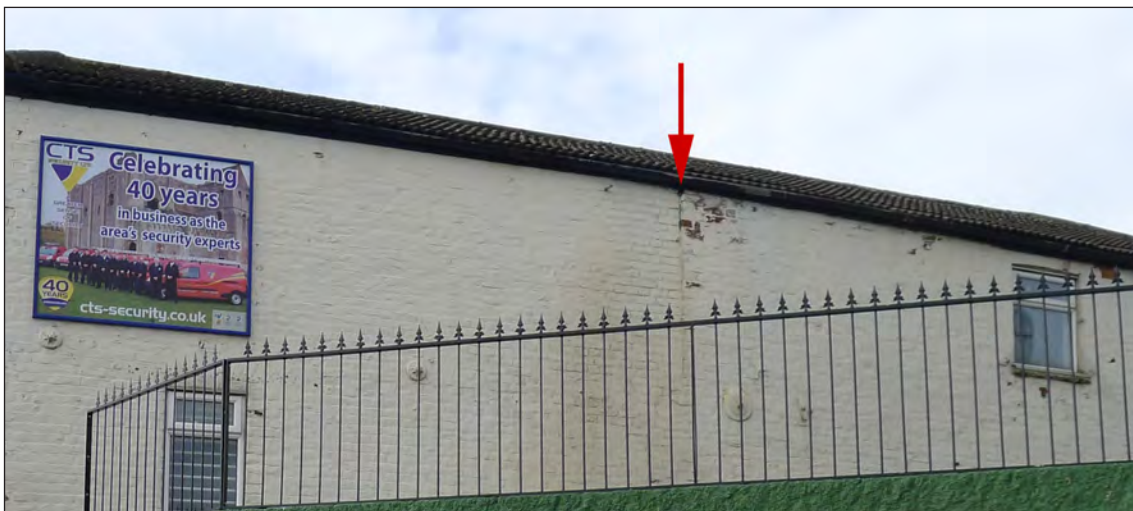
Fig 162 The east wall of the Highland Laddie, showing the break in the brickwork. Photograph Jonathan Kewley 27-FEB-2017 © Historic England

The ground floor of the east front is not visible. At upper levels, there is one window in the southern half, on the first floor, and one in the northern half, on the second floor. There is a vertical break in the brickwork on the second floor about halfway along (Fig 162). The bare part of the wall had an advertising hoarding against it in 1960. Only the top half of the north wall is visible, what appears to be a modern structure (attached to the former Prince of Wales) having been built in front of it. It has no openings in it.

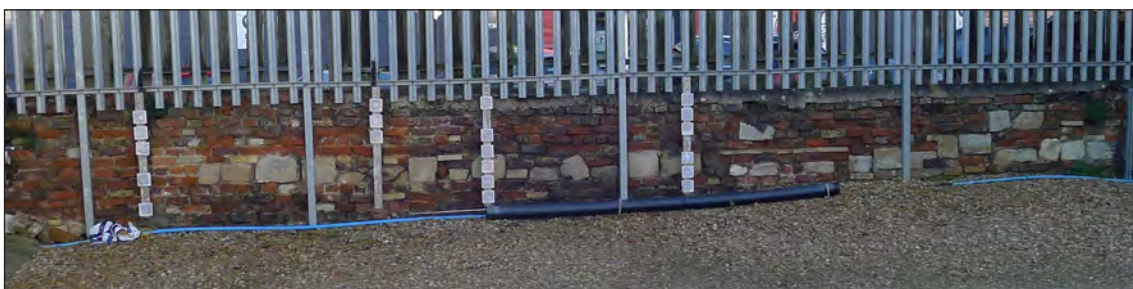
Fig 164 The wall at the back (north) of what is now the yard or car park for the former Highland Laddie, looking from the south. It appears to be the remains of an otherwise-demolished building (see Fig 163). Note the stone amongst the brickwork. Photograph Jonathan Kewley 16-JAN-2016 © Historic England

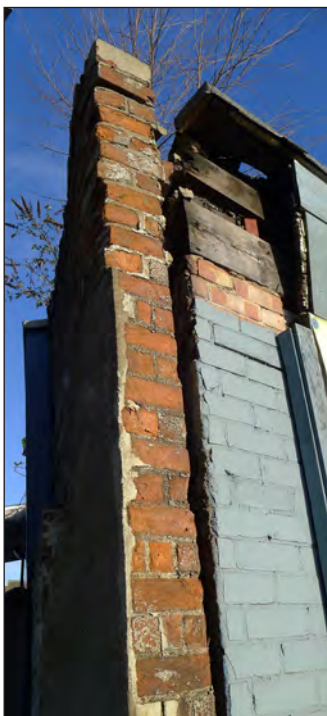
Fig 170 (left) The east (and only surviving) wall of the building west of the shops on the Wisbech Road which was used at one time by the fitters from the Gas Works. Photograph; Jonathan Kewley 16-Jan-2018 © Historic England

Building K was a two-storey structure running north from the Wisbech Road. In 1898 it was used by the fitters at the Gas Works across the road.¹²⁷ It was demolished sometime after 1965. Its east wall still partially survives (Fig 170), used as the support for a makeshift shelter for the car wash which now occupies the site.

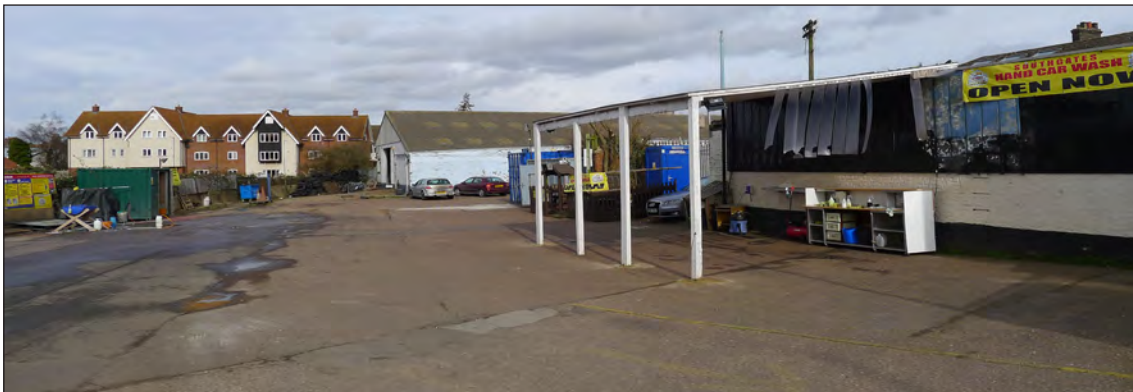
Fig 173 The hand car wash on the site of the demolished buildings west of the parade of shops on the Wisbech Road. Photograph Jonathan Kewley 27-FEB-2017 © Historic England

On the site of buildings E, F, K, L and part of G is now an L-shaped plot running from Out South Gates (between the former Ford Garage and the Prince of Wales) to the Wisbech Road west of the parade of shops. It provides access to and parking for the businesses which occupy the former Ford Garage. Planning permission was obtained in 2014 to use the site as a hand car wash,¹²⁹ and presumably shortly afterwards the present very simple lean-to shelter was built against the surviving fitters' shop wall. (Fig 173).

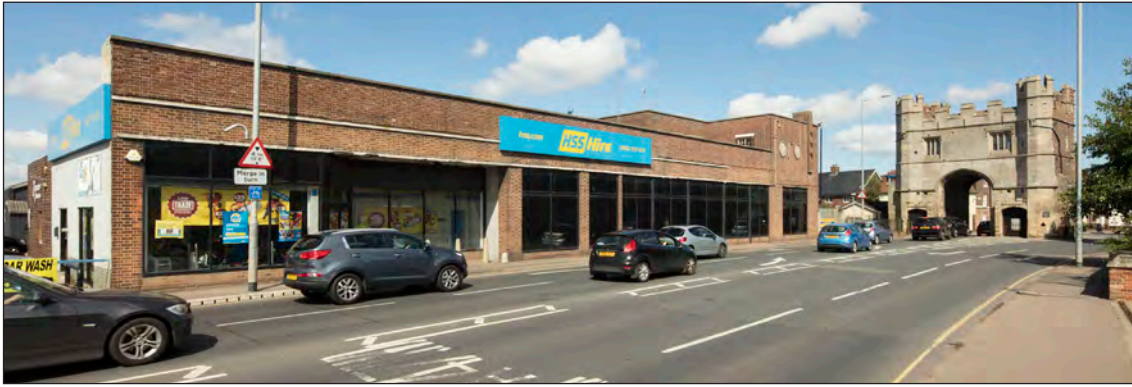
Fig 174 The former Ford garage and the South Gate, the former echoing the form of the latter. HEA DP219058 15-AUG-2017 Patricia Payne © Historic England

- The former **Ford Garage** (see Fig 147), which has a unified 1950s frontage concealing a building of various dates from probably the 1920s onwards. It is respectful in height and material to the South Gate, with a turret of its own echoing the military nature of its neighbour (Fig 174). The word 'ford' on this turret is an attractive feature, as are the polished concrete bollards within the recessed shopfront. It is now subdivided between a tool-hire shop, a gym, a hairdresser's and a motor repair business. The historic, pre-20th-century character of its site was open and outward-looking, with timberyards, coal wharves or shipyards looking outwards north or west to the Friars' Fleet or the Nar. The 20th-century character was rather different, with the site built over and turning its back to the rivers.

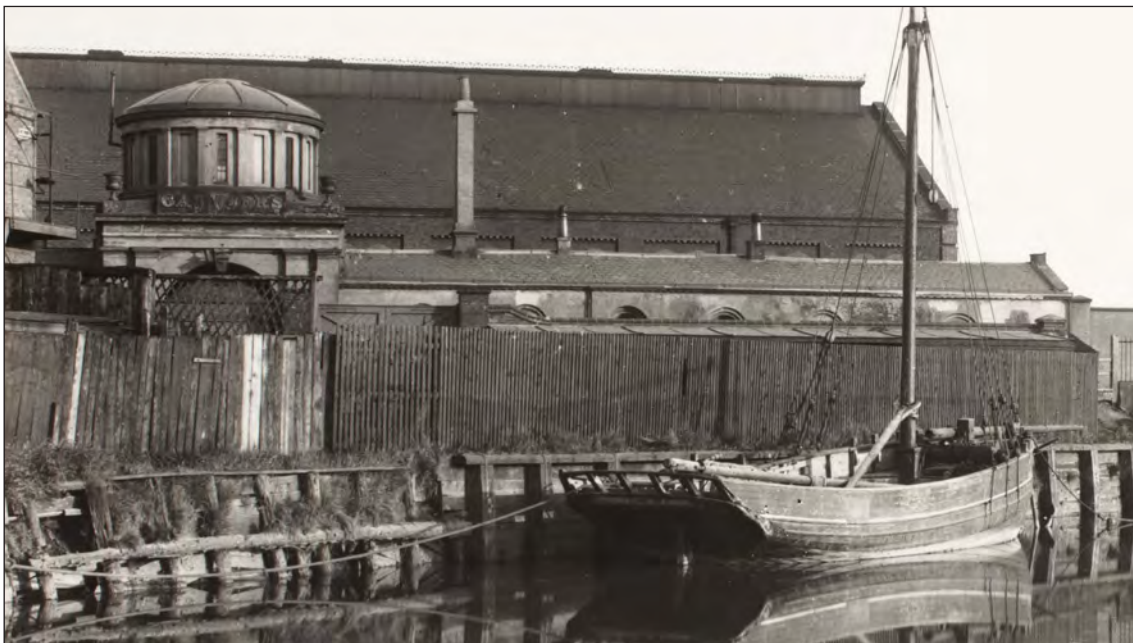
Fig 181 The Gas Works at some time in the late 19th or very early 20th century. The view is from the north, with the Nar in the foreground. Between the wooden fence and the handsome entrance building runs the Wisbech Road. Norfolk Library and Information Service (King's Lynn Library); image: detail of HEA DP219451

dome'. This appears in a few photographs (Figs 181 and 182); was indeed handsome, with a broad, arched gateway flanked by two Doric pilasters each side supporting an entablature above which was an attic with a urn at each end and a tablet with the word 'GAS WORKS' in raised letters; above it was a drum with tall, narrow windows (which look iron-framed) between Doric pilasters, and a shallow dome on top. It was, however, badly positioned as it would not have been visible from the distance necessary to show it off properly. No architect is recorded, and it was probably designed by Malam himself; one of his employees said that it was his practice to draw out the plans himself 'for the masonry and other parts' of any building he was constructing.¹³⁷ It seems to owe much to James Gandon's Four Courts of 1786-96 in Dublin (Fig 183).

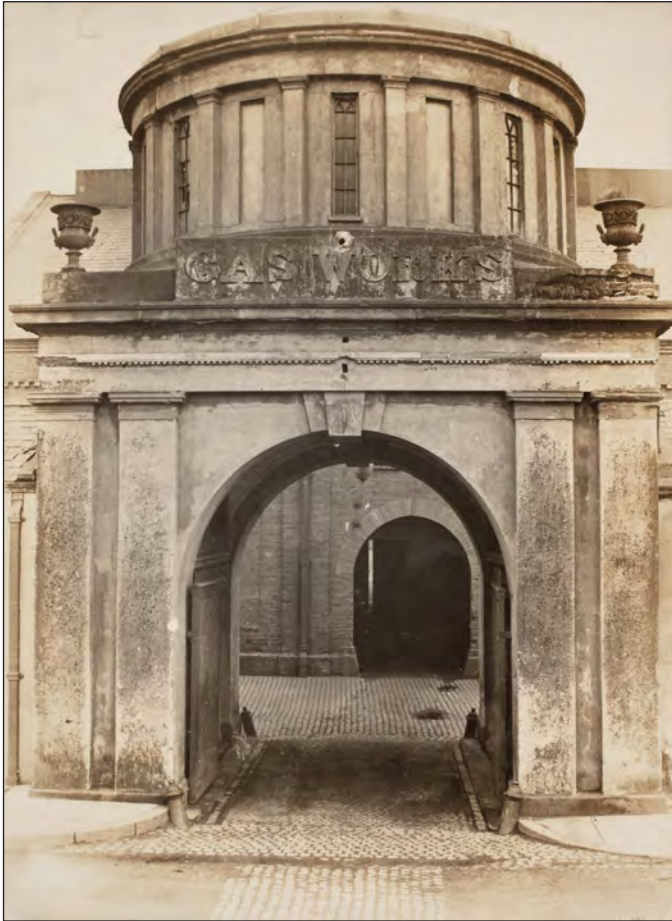
Fig 182 (left) The entrance to the Gas Works, probably in the second half of the 19th century. Norfolk Library and Information Service (King's Lynn Library); image: detail of HEA DP219417

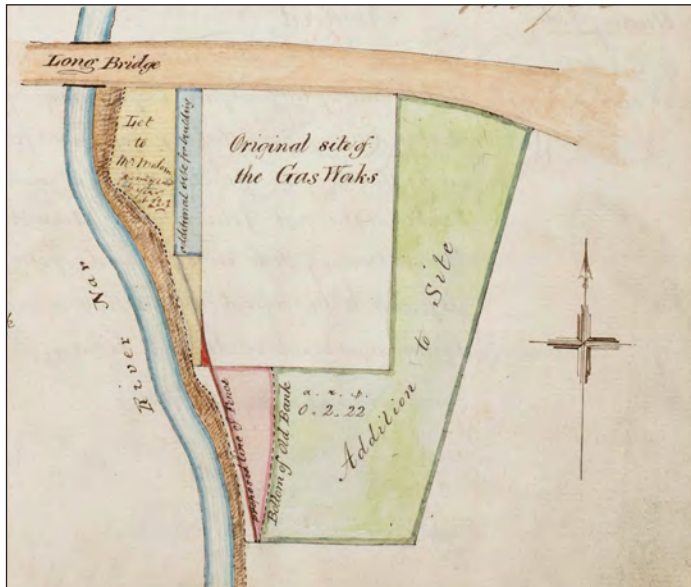
Fig 184 A plan of the Gas Works in 1856. In the centre, in white, is the original plot let by the Corporation to the Paving Commissioners and sublet by them to the Malams. To the left, in yellow, is an extra plot let by the Corporation directly to the Malams but not built on. In 1856 the main lease was varied to include the area in green but remove the tiny area in red. Note the reference to 'bottom of old bank', showing the embankment keeping the Nar from flooding. King's Lynn Borough Archives KL TC2 1-3 3. Image HEA DP219411

The same 1845 description added, 'In the buildings behind are eighteen retorts and two gasometers, each capable of holding 16,000 cubic feet of gas...'138 By 1854 there were 25 retorts.139 In the mid-1850s areas to the east, west and south were added to the lease, and the western wing (the coke shed) extended westwards, with a new purifying house to their south (Figs 184 and 185).140

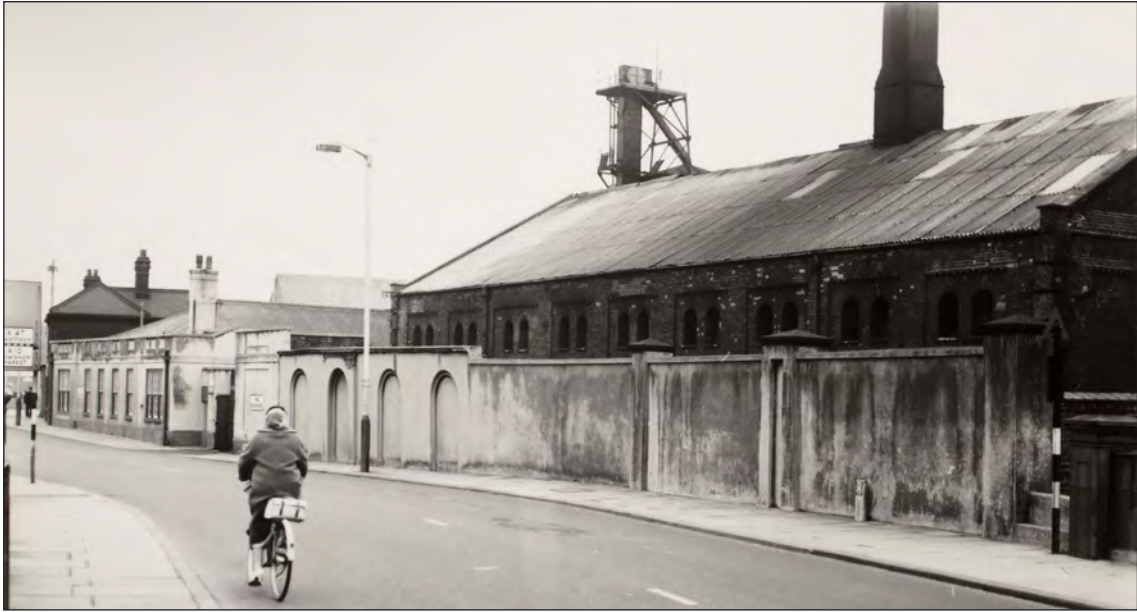
Fig 187 The Gas Works looking west along the Wisbech Road c 1960, showing the retort house on the right. Note that the domed entrance has been demolished. Norfolk Library and Information Service (King's Lynn Library); image detail of HEA DP219462

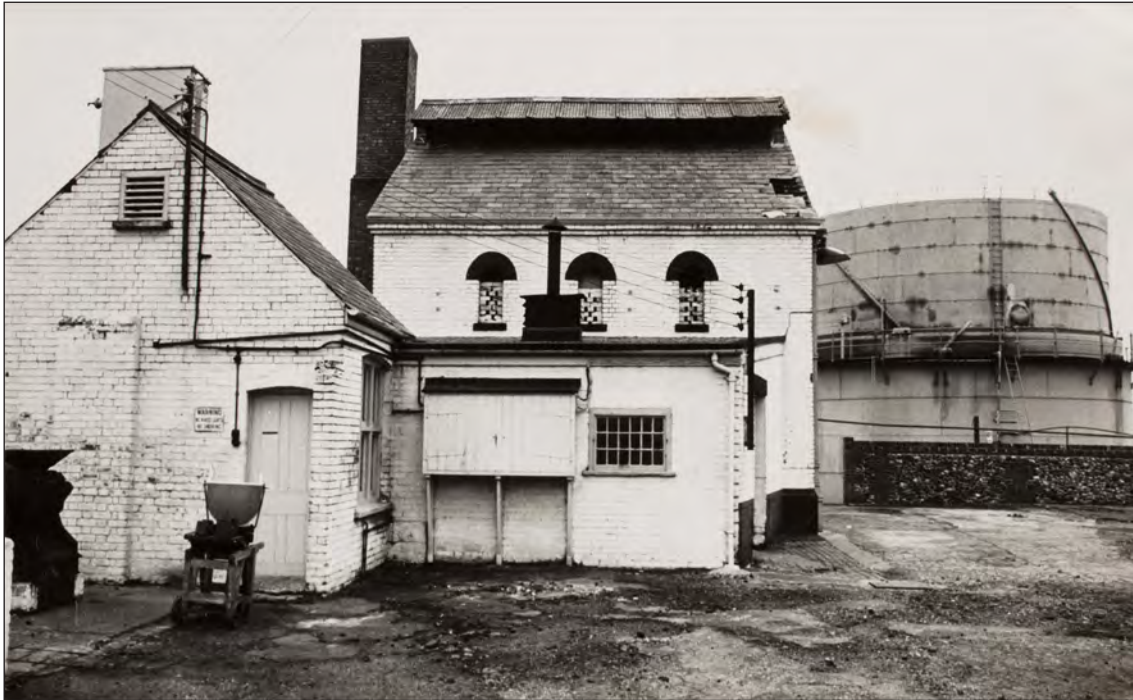
Fig 189 The new purifying house near the riverbank, and gasometer behind, both built in or shortly after 1897. Norfolk Library and Information Service (King's Lynn Library); image: HEA DP219439

The works proposed (and presumably built) in 1897 were a new purifying house on the riverbank and a new, third, gasometer, 90ft across (Fig 189). By 1928 a large building of 20th-century appearance with a shallow-pitched roof can be seen in the north-east corner of the site (Fig 190); this provided a fitter's shop, a smithy and engineers' stores, replacing the old.

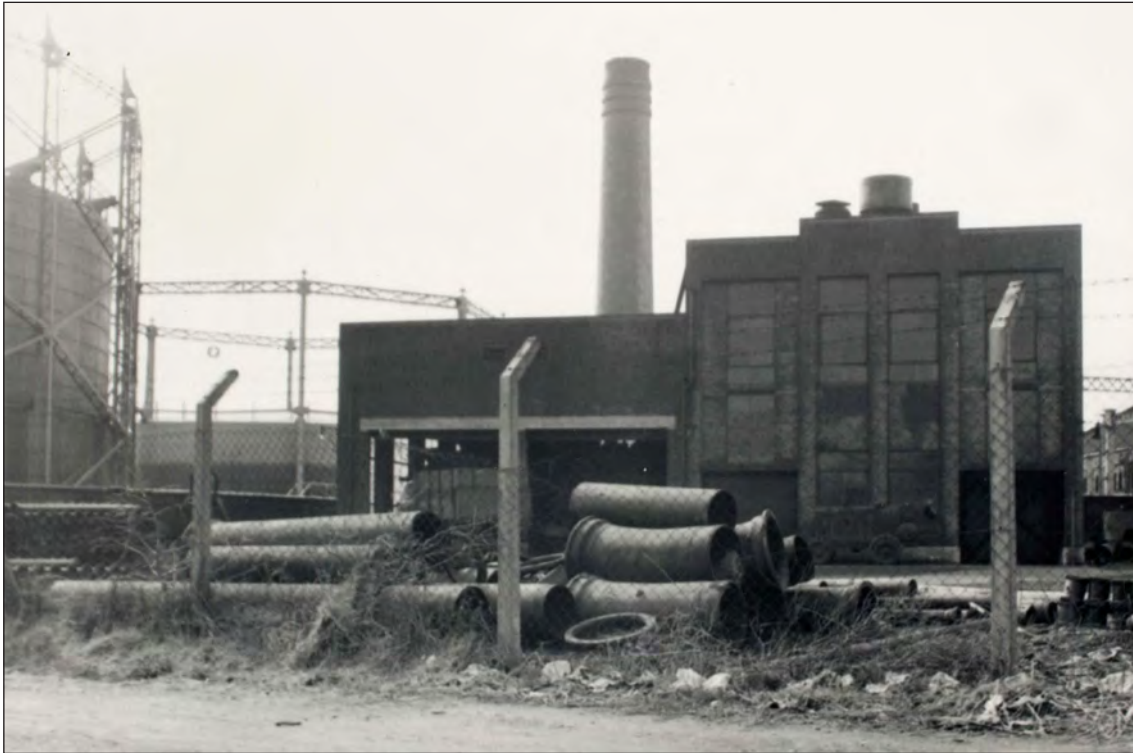
Fig 191. The Gas Works in 1964 showing on the right the carburetted water gas plant. Norfolk Museums Service (Lynn Museum) 1992.217.49; image HEA DP219380

The Victorian Gas Works occupied only the south-west quadrant of the area centred on the present roundabout. Not until 1939 did the company buy from the Corporation a further small plot (three roods) to the east, directly facing the South Gate. Perhaps because of this important sightline, the Corporation retained a small roadside strip which they were to lay out as a small public garden, backed by a new wall, which was carried on to the Gas Works gate.¹⁴³ A carburetted water gas plant was subsequently built on the site (Fig 191, and see also Fig 190).¹⁴⁴

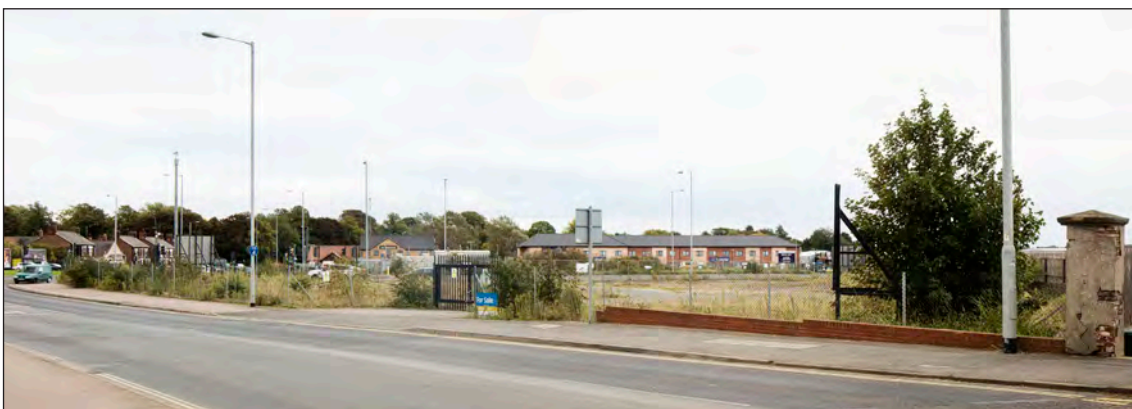
Fig 196 The Gas Works site from the Wisbech Road, 2017, looking south-east. On the right is the pier which is the one surviving part of the main Gas Works site. HEA DP219071, 20-SEP-2017 Patricia Payne
© Historic England

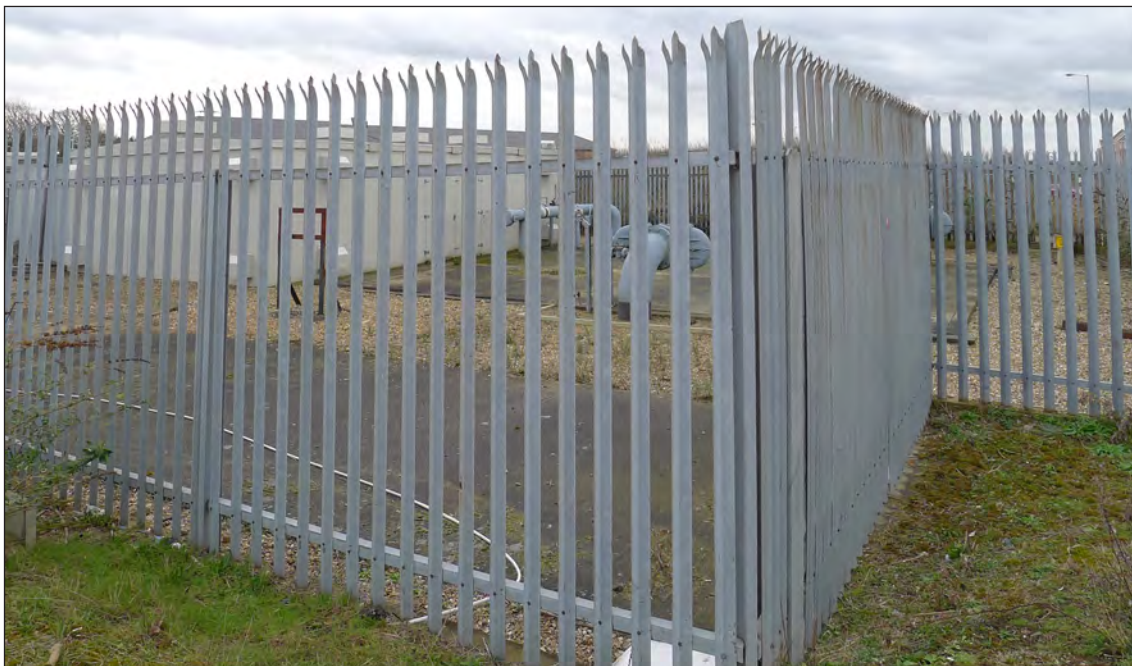
Fig 207 The National Grid Gas Pressure Reduction Station and Depot which lies between the Hardwick Road and Kellard Place; this view is from the north. Photograph Jonathan Kewley 27-FEB-2017 © Historic England

The National Grid Gas Pressure Reduction Station and Depot (Fig 207) remained (and remains) in place at the north end of this area, immediately south of the roundabout; its site is the southern half of the plot bought by the Gas Company from the Corporation in 1939, the northern part being now part of the roundabout. The only buildings on it are three flat-roofed, windowless, tank-like metal structures, painted a pale grey, with some externally-visible pipework, and a small, flat-roofed brick structure. (Fig 208) The perimeter of the site is marked by modern metal railings, which dominate the external appearance. In the absence of landscaping it makes a very utilitarian visual statement in such a prominent position. There is an electricity substation east of it.

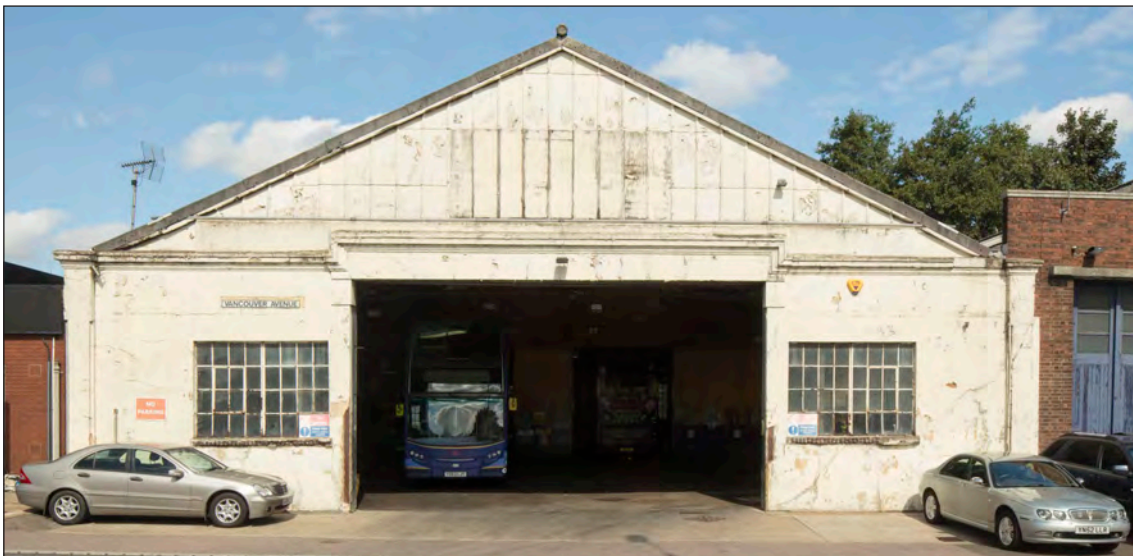
Fig 226 The principal, south front of the earlier half of the Bus Garage. Detail of HEA DP219056 15-AUG-2017 Patricia Payne © Historic England

The King's Lynn garage currently consists of two parts. The western, earlier section (Fig 226) is said to have been built in 1932,¹⁵⁸ but in fact appears in an aerial photograph of 1928 (see Fig 224) and a map surveyed in 1927 (see Fig. 225). It is approximately 21m wide and 26m long. It is constructed of red brick, which on the front (south) elevation is rendered and painted cream. The building is in effect a shed with a strictly symmetrical stripped classical facing. There are pilasters at each side with a cornice running between them, raised in the centre over a wide vehicular entrance, which has been widened and heightened since the 1928 photograph (presumably to accommodate taller buses). The front elevation of the shed, above the cornice, is treated as a pediment, with a metal-framed window, now blocked up. At each side of the doors are multi-paned metal windows. The west elevation is no longer visible as the filling station has been built against it, but the 1928 photograph (see Fig 224) shows it to have had regularly-spaced pilasters and a large central doorway, probably the main entrance. The rear elevation (Fig 227), to Southgates Park, drops the classical dress. The gable or pediment is of corrugated metal. Below it is an irregularly-shaped flat-roofed extension which goes up to the park boundary and then wraps round the north-west corner, behind the petrol station; the western wall is rendered, the northern bare brick and the south-western faced with brick to match the modern filling station. It has a central chimney.

The Bus Garage, still in use at the time of researching this assessment, is an attractive building with some presence when seen from the south (Fig 240). It is an interesting commentary on changing perceptions of style in the inter-war years – the earlier, 1920s part classical, and quite an imposing structure, the 1930s extension aiming at flat-roofed Modern (even if not hiding its gables very well). It is a public building (at the time of the Munich crisis the Corporation designated it as an auxiliary fire station) but it is important to remember it is and seems always to have been a bus garage or depot not a bus station – in other words buses were kept and maintained here, but passengers were not picked up or dropped off. It was therefore a building to be seen but not visited.

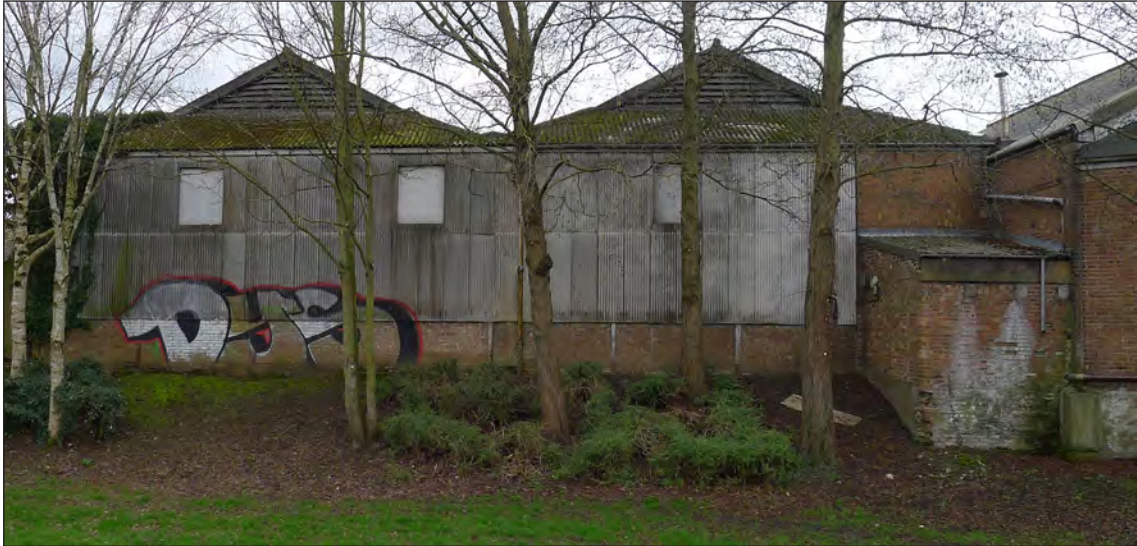
Fig 229 The rear (north) elevation of the 1933 extension to the Bus Garage, from Southgate Park; in the foreground is the now-dry course of the Middleton Stop Drain. Photograph Jonathan Kewley 27-FEB-2017 © Historic England

To the east lies an extension of 1933 (Fig 228) in what Calladine and Morrison call a standard Tilling design, after the bus company of that name.¹⁵⁹ Approximately 26m wide by 22m long, it consists of a double roof with front-facing gables partially hidden behind a low continuous brick parapet, thus in the new style of that decade. There is a single vehicle entrance on the west, with a wider vehicle entrance in the centre (making three vehicular openings in all, including the original building, and allowing, as was the ideal, a separate entrance and exit). The east and north walls (Fig 229) are of corrugated metal, and the roof is also corrugated. The façade is red brick, laid in English bond. A brick lean-to extension on the east (Fig 230), with a corrugated roof, is probably that for which planning permission was granted in 1950.

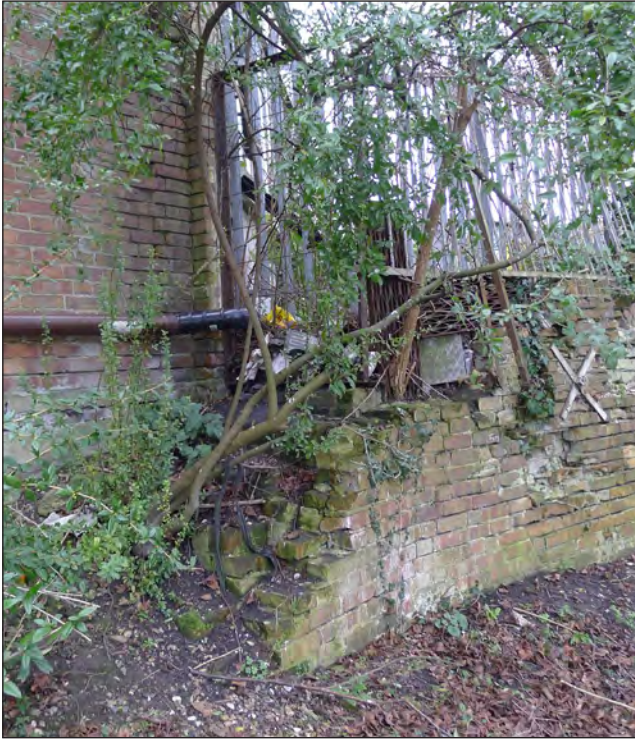
Fig 231 The north-west corner of the Bus Garage, showing its relationship to the older retaining wall on the right. Photograph Jonathan Kewley 27-FEB-2017 © Historic England

At the back (north) the ground slopes sharply to the Middleton Stop Drain, and the lower stages of the Garage are a brick retaining wall. Towards the west (Fig 231) this joins a more sharply north-west/south-east retaining wall of older brick, which probably relates to embanking works for the Middleton Stop Drain (see Fig 25); it does not match the brickwork of the 1899 battlemented bridge and is probably earlier, perhaps from when the east passageway was cut through the South Gate.

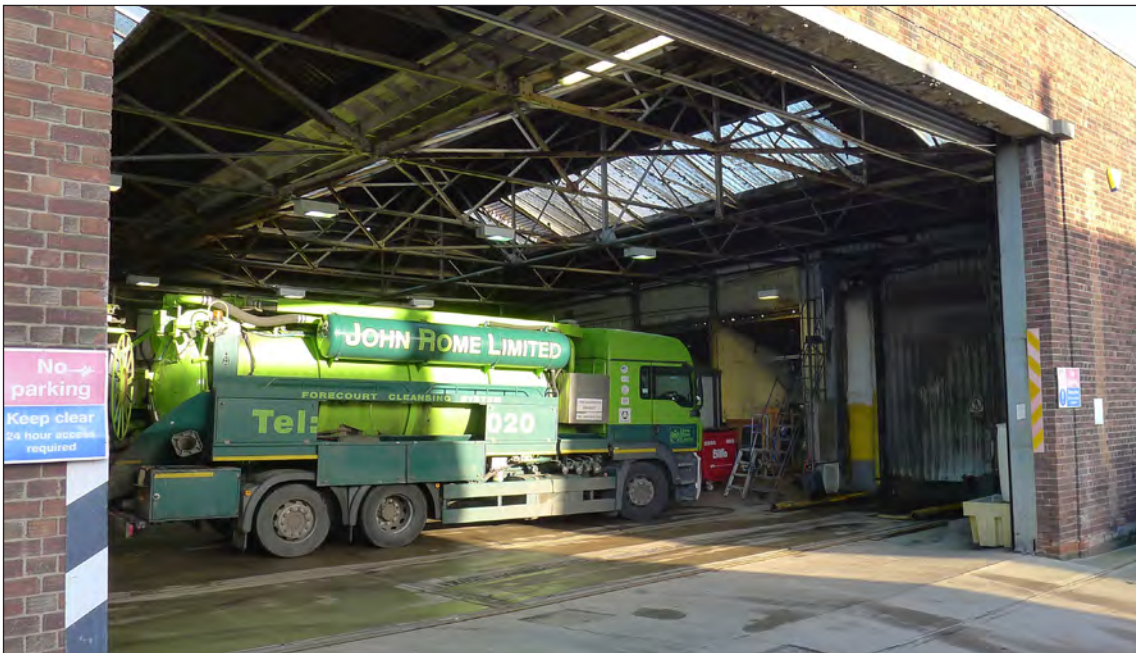
Fig 232 The interior of the eastern section of the Bus Garage, looking from Vancouver Avenue. Photograph Jonathan Kewley 16-JAN-2018 © Historic England

The interior of the 1920s and 1933 sections is all one space, although the rear extension to the west part is divided off. Light steel trusses are visible internally (Fig 232), and the interior is lit by long continuous roof lights in the eastern part. It appears that in the original 1920s building there may, contrary to the usual position as outlined by Calladine and Morrison, have been no offices, which were added only in the later extensions to the north-west.

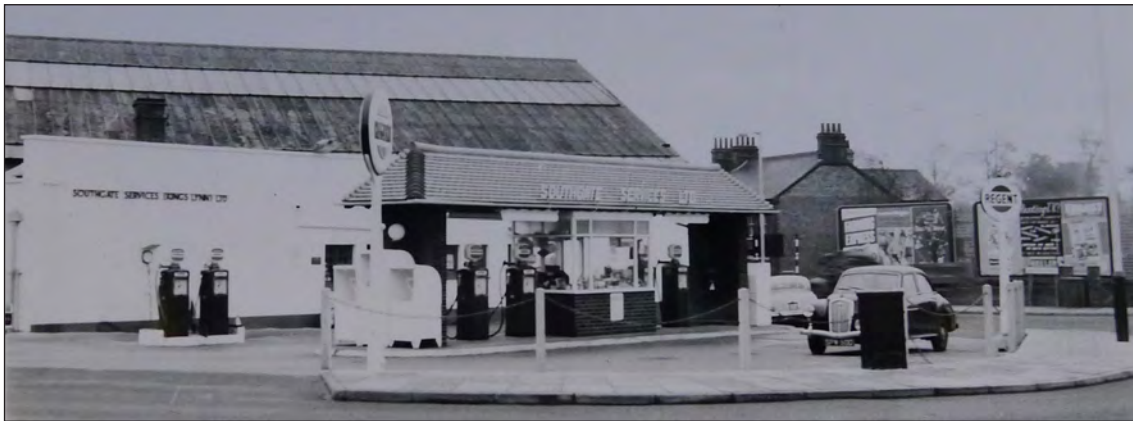
Fig 233 The filling station from the west c 1959-60, with the roof of the Bus Garage behind. Norfolk Library and Information Service (King's Lynn Library)

In 1928 (see Fig 224) there were external petrol pumps (two sets of three) right at the south-west corner of the Bus Garage site, at the junction. There was no canopy over them. In 1938 planning approval was granted for a petrol pump enclosure. This was to the Eastern Counties Omnibus Company, so the site must then have been in one ownership with the Bus Garage and was perhaps used principally for fuelling buses, although in 1933 its proprietor is listed as one Leo C. Taylor, presumably a tenant. Images from 1959 and 1960 (Fig 233) show an attractive petrol station, then selling Regent petrol and called Southgate Services (King's Lynn) Ltd; some pumps were underneath a low hipped-roofed canopy with a kiosk in between. A screen wall backs the premises and hides the south-west side of the Bus Garage and what are possibly stores against it. The whole site is demarcated from the road and pavement by a post and chain fence. In contrast to what came afterwards, this filling station was attractively-designed, was of modest scale, and did not hide either the Bus Garage or the South Gate (Fig 234).

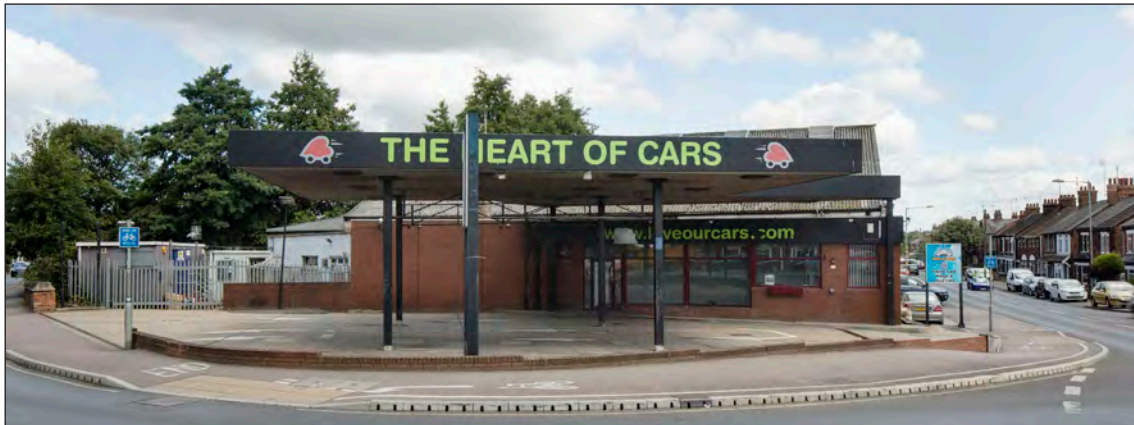
Fig 235 The filling station from the south-west in 2017. Detail of HEA DP219062] 15-AUG-2017 Patricia Payne © Historic England

In 1967 Regent was renamed Texaco.¹⁶⁰ In 1986 planning permission was granted for the rebuilding of the filling station, and the resulting building is what exists now (Fig 235).¹⁶¹ The canopy is irregularly shaped, consisting of a main square supported by four stanchions, and a smaller section connecting it to a single-storey brown-

brick, rectangular sales building which abuts the southern half of the south-west front of the Bus Garage. The canopy runs right up to the road and looks squashed on its site. At the time of research it was painted black which, with the darkish brick behind, made it also look dark. In 2008 a planning application to convert the premises into a hand car wash was refused.¹⁶² To its north (Fig 236) is a Portakabin-type building surrounded by modern metal railings, accessed from the forecourt. It is set back behind the dwarf wall which starts at this point and runs northwards as the eastern boundary of the eastern carriageway past the South Gate (Fig 237).

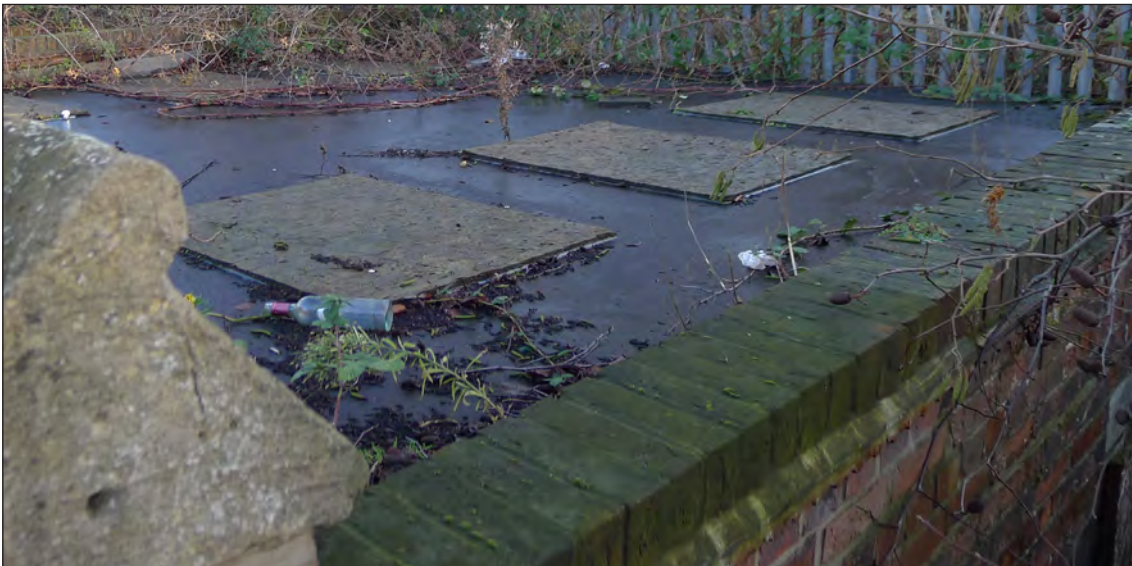
Fig 238 The underground former public lavatories on the east side of Out South Gates. Photograph Jonathan Kewley 16-JAN-2018 © Historic England

In the north-west corner of the site (Fig 238) a small plot was bought by the Corporation in 1938 for the construction of underground public lavatories, accessed by steps (separate flights for men and women) from Out South Gates immediately south of the bridge, breaking through the battlemented retaining wall (see Fig 73). There was a direction to erect an illuminated sign but this has not survived, and the lavatories appear to have been disused for a number of years.¹⁶³ Underground lavatories were a feature of public sanitary provision in the first half of the 20th century, but as here, most have now closed.

- The underground public lavatories east of Out South Gates (area 7) which must have disturbed deposits at the southern end of Southgates Bridge.
- The Bus Garage (area 7) which may have damaged evidence of an earlier course of the Nar, although given its shed construction this may have been less complete than might at first sight.

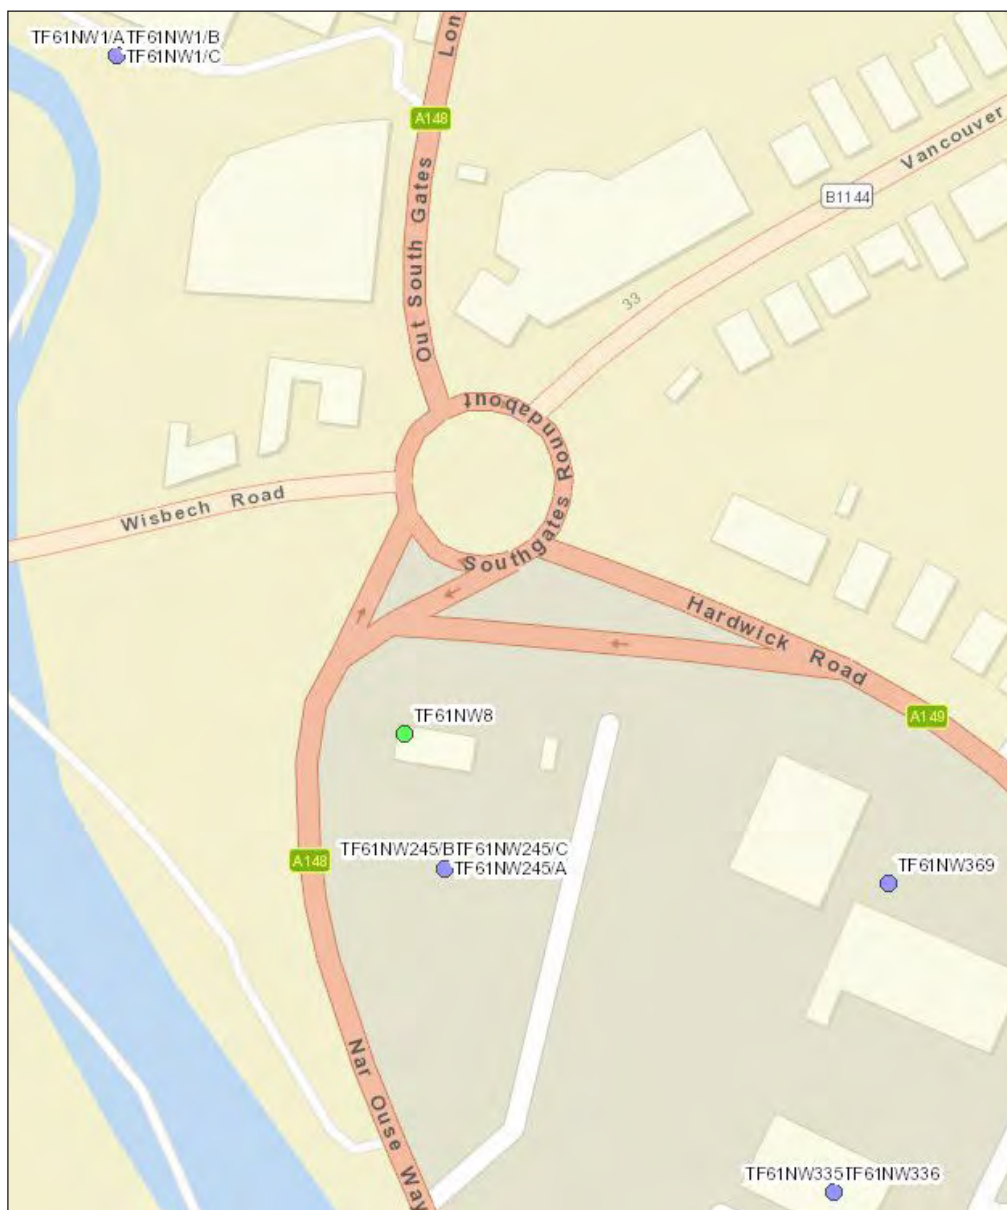
Fig 241 Boreholes in and around the HAA site. Modern Ordnance Survey mapping: © Crown Copyright and database right 2017. All rights reserved. Ordnance Survey Licence number 100024900

It is very difficult to comment of the vertical extent of any potential archaeological remains without excavations across the HAA area, and generalisation is difficult due the variations in topography between the higher ground and the fleets. Deposits in Southgates Park were excavated to a depth of roughly 5.5m OD (1.7m below the ground surface).¹⁷³ Borehole data for the area available from the British Geological Survey (BGS) was analysed for the project by Matt Canti (Historic England). Of the six cores in the vicinity (Fig 241), only two were located in the HAA area and it should be noted that none was taken for archaeological purposes. The ones within the HAA area were at the west end of the National Grid Gas Pressure Reduction Station and Depot (TF61NW8) and a few yards south of it (TF61NW245A, B & C). They revealed some differences: the former has 4.27m of clay immediately below the surface, followed by 0.61m of peat and the same amount of sandy silt, below which the clay resumed, while the latter has 0.36m of subsoil above 1.47m of loam and silt, below which is clay with some peat. The difference is presumably that the northern site has been scalped during the 21st-century works whereas the southern retains

a more natural topography; the latter site (currently vacant and awaiting building) may therefore have greater archaeological potential. Both cores contained peat which has the potential to preserve information about past environment. Two core sites on Horsley Fields (TF61NW369 and TF61NW335/TF61NW336), just east of the HAA area boundary, are fairly similar to each other, with nearest the surface up to 0.6m of 'made ground', then a sandwich of grey to brown silty clay down to at least 6m with a filling of dark brown peat.¹⁷⁴ The basal Kimmeridge clay was encountered below 7 to 8m. There are unfortunately no cores for any of the areas either side of Out South Gates. A programme of coring in the historic town of Great Yarmouth (<http://www.heritage.norfolk.gov.uk/gyam> accessed 29 Nov 2017) revealed that the BGS cores (taken for non-archaeological purposes) significantly underestimated the depth of archaeological deposits.¹⁷⁵
