Historic Places Investigation

Southgates, King's Lynn, Norfolk: Historic Area Assessment

Research Report Series 009-2018

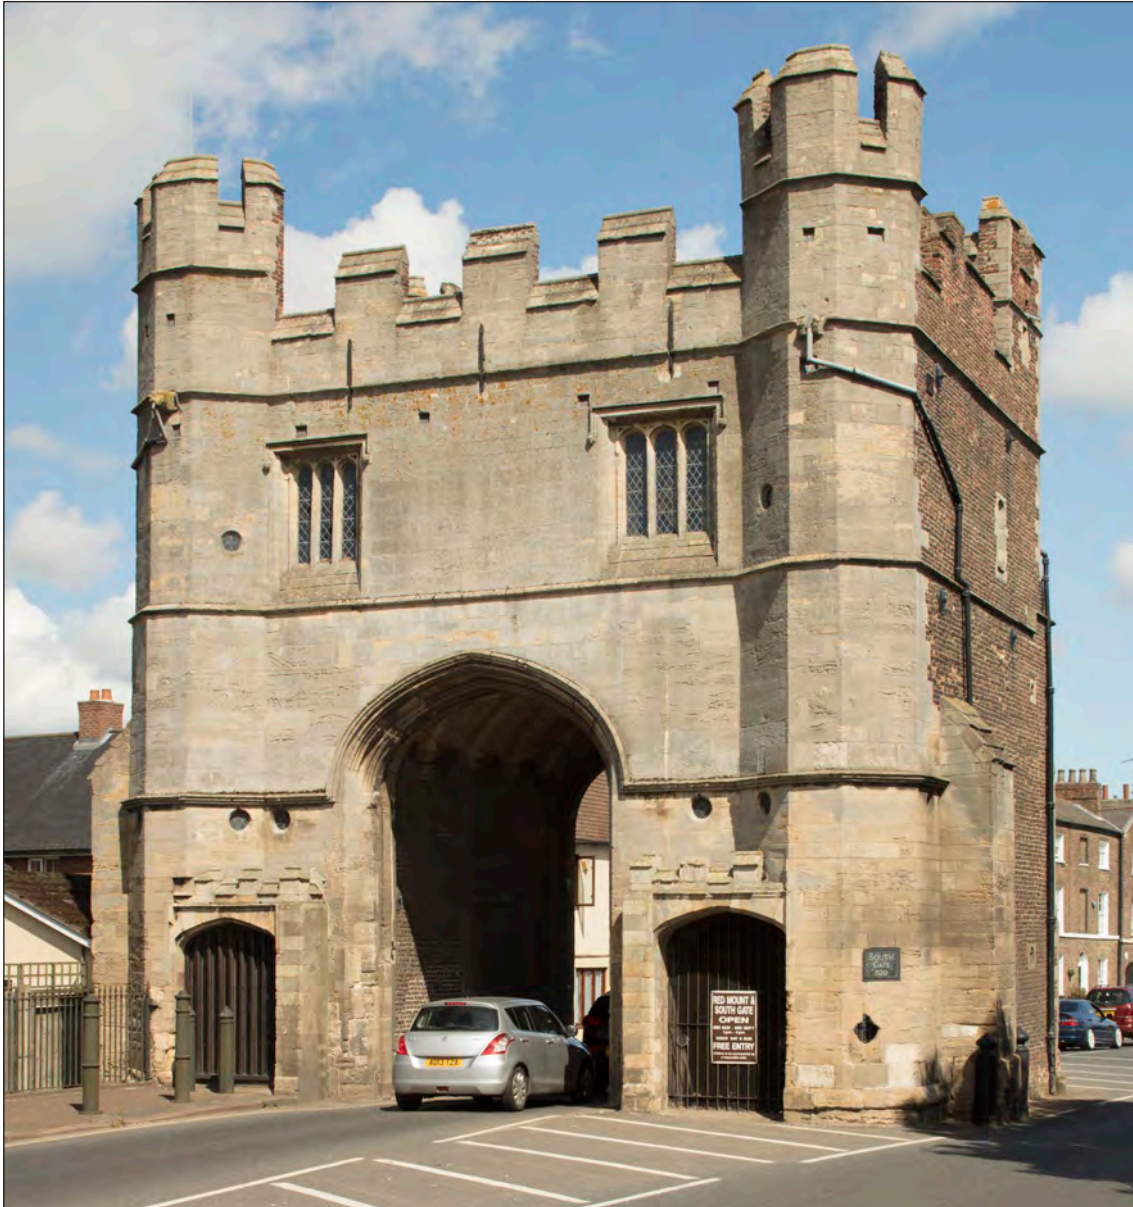
The South Gate from the south-east, showing the stone south and brick east elevations. HEA DP219059 Patricia Payne 15-AUG-2017 © Historic England

The present South Gate of Lynn was built in 1437, principally by a London mason called Robert Hertanger, although it was completed by others after he got into financial difficulties. It replaced an earlier, slightly smaller gate, but seems to have used some of its foundations, which may account for the central arch being a little off-centre, towards the west. Lynn was first granted a murage licence in 1266, which may be the likely earliest date of any defensive works on the South Gate site; it may have taken the form of a wooden tower (a bretask) although that may have been further south.

The south wall contains a large blind arch between the windows, designed to house a portcullis. Only one of the shallow-pitched roof trusses is original and the roof itself, accessed from the north-eastern stairway, was replaced and re-leaded in the 1980s.

Condition: Heritage at Risk (HAR) Risk Assessment Level (08/01/2007): Vulnerable

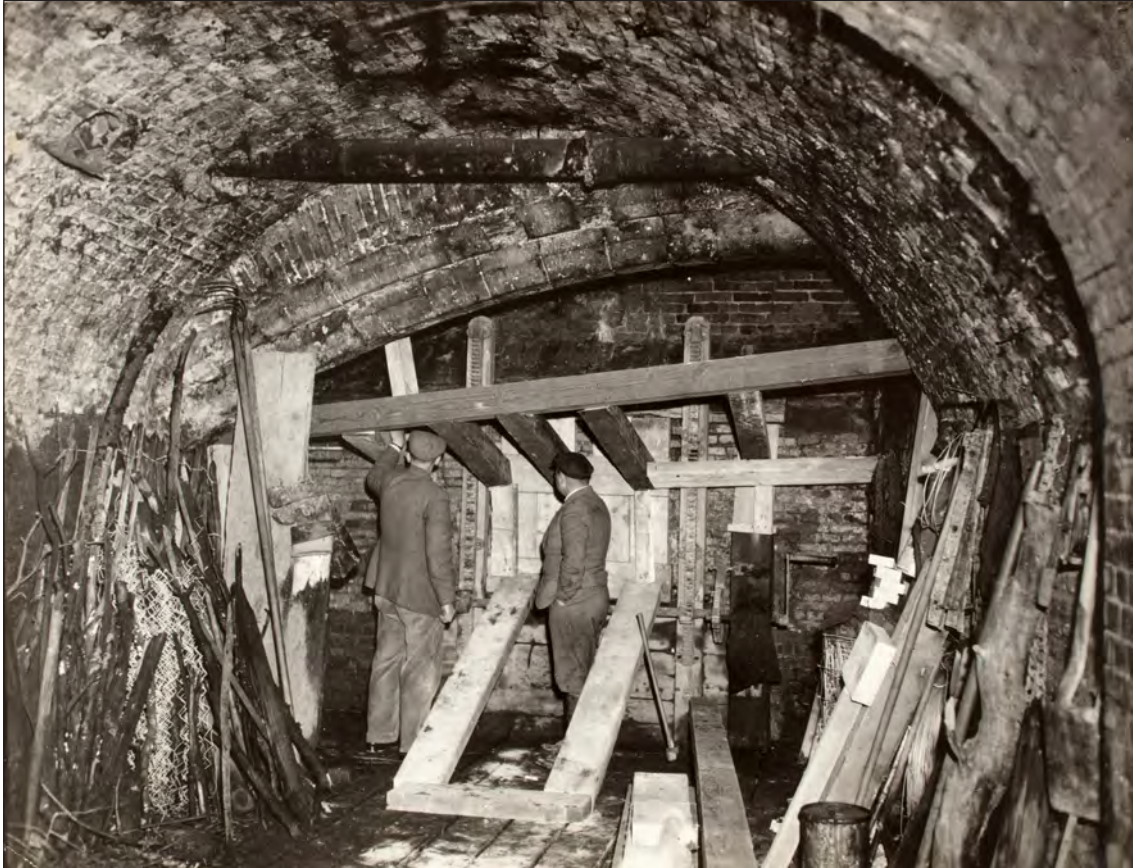
Underneath Southgates Bridge when the Middleton Stop Drain had temporarily been drained, probably in the 1950s. Note the stone arch immediately above the wooden beam. Norfolk Museums Service (Lynn Museum) MB03282. Image: HEA DP219363

There must always have been some sort of bridge immediately south of the South Gate, given that it was the main entrance to the town. Part of the brief given to the mason Robert Hertanger in 1437 was to build not just the present South Gate but also a bridge. The Chamberlain's Survey of 1557 includes Southgate Bridge under stone bridges repairable by the Corporation, and the innermost arch, seen in old drawings and still visible on the east side, does indeed have an arch of stone although otherwise it seems to be brick. There is mention of a drawbridge being fitted in 1642 during the Civil War, but if it was, the stone one must have been built again after the siege. At some time before 1815, the opening under the arch was reduced so that it took up only the southern half of the span of the bridge.

Condition: Impossible to say. Access on the east is impeded by uncertainty as to what debris is in the water.

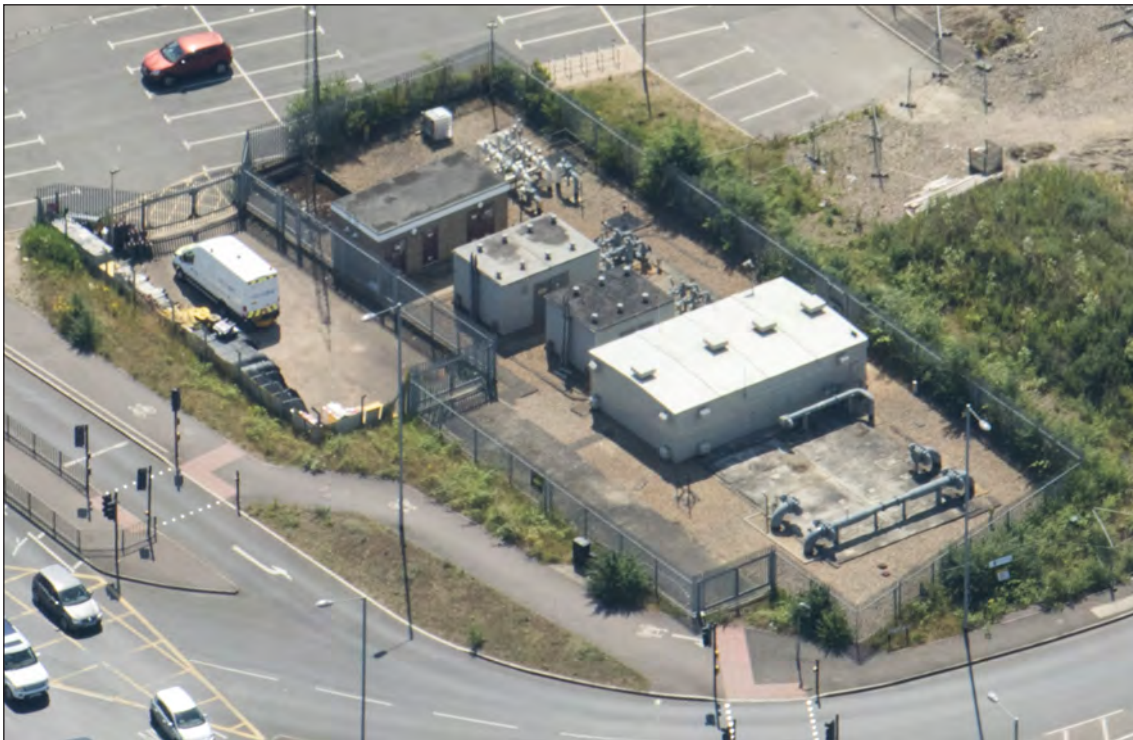
The National Grid Gas Pressure Reduction Station and Depot from the air. Detail of HEA 33197/025
Damian Grady 19-JUN-2017 © Historic England

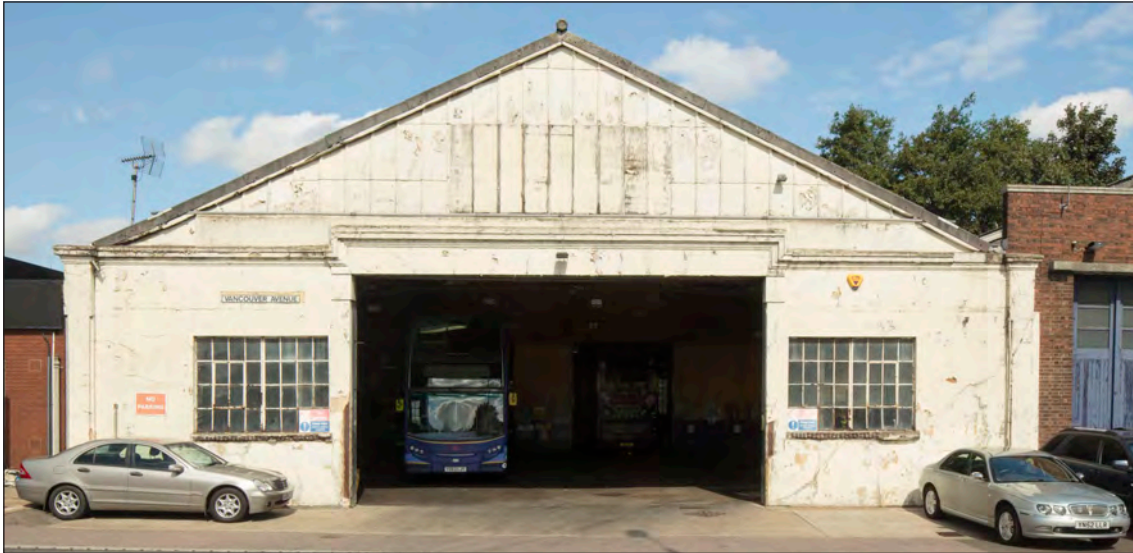
The principal, south front of the earlier half of the Bus Garage. Detail of HEA DP219056 15-AUG-2017
Patricia Payne © Historic England
