# Devon Cobbled Churchyard Paths

Evaluating their Significance,  
Survival and Adaptation

A project undertaken by  
Keystone Historic Buildings Consultants  
for Historic England and SPAB

March 2016

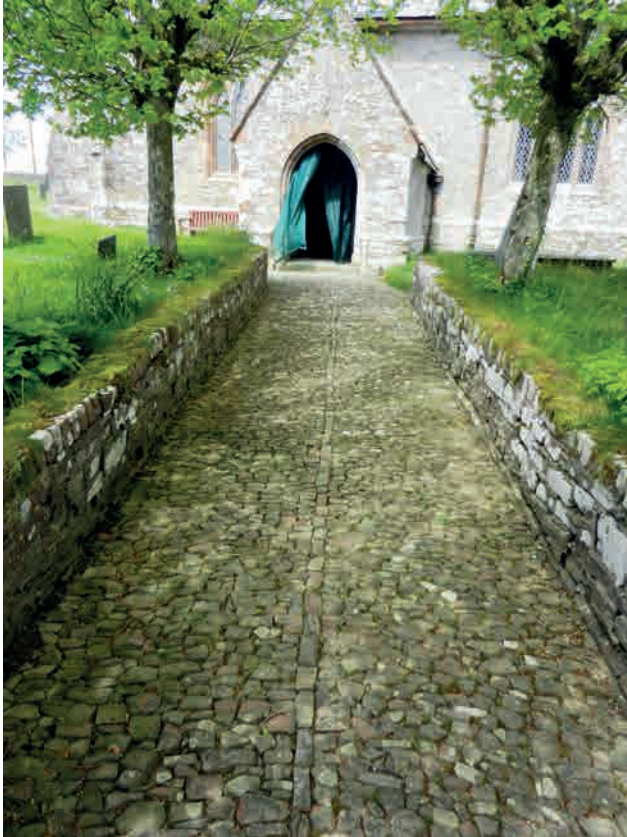
*Fig.2 . Peters Marland, St Peter. Church (except tower) rebuilt in 1868.*

Cobblestones are a form of surfacing surviving from pre-history with ancient and contemporary examples found in many places all over the world. At their most simple cobbles were, and are, a method of keeping people, livestock, vehicles or things out of the mud and of easing mobility by providing a hard surface composed of small stones in the raw, not dressed to shape, and rammed down [Fig.2].

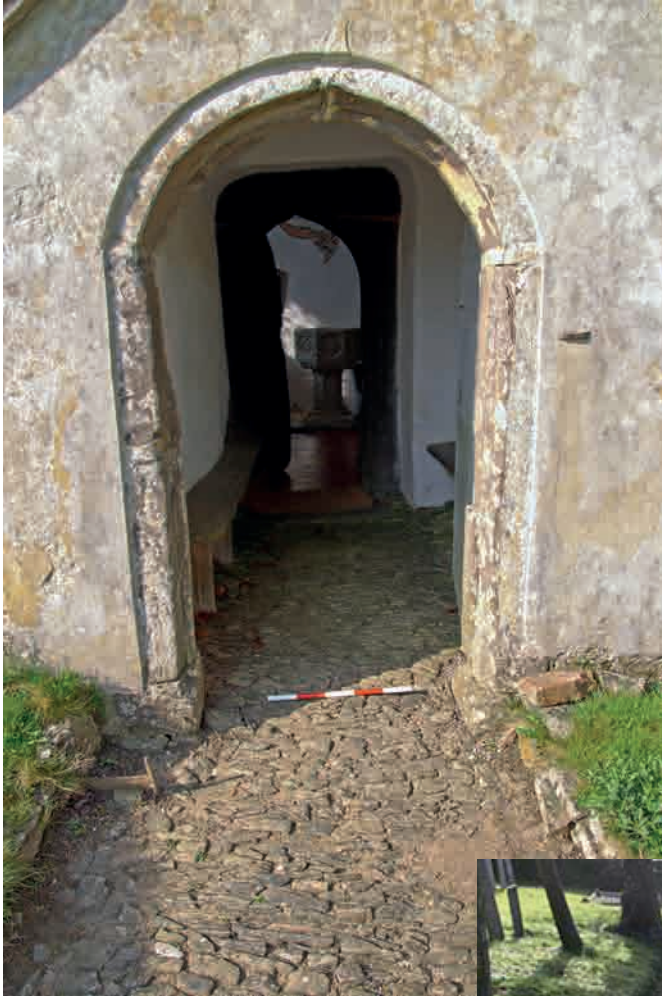
*Fig.3. The path to the Church of St Peter, Satterleigh uses large, rustic cobbles similar to those found in farmyards. The cobbled surface is continued into the south porch.*

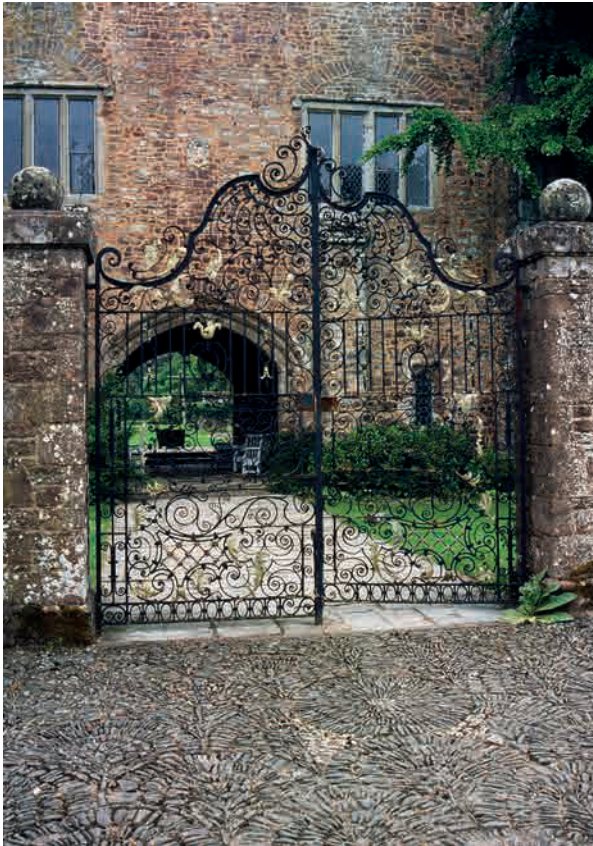
*Fig.5. Cobbles laid in fans in front of the 18th century Italian gates at the entrance to Bickleigh Castle: the castle (really a fortified house) was restored by successive owners after 1925. Nothing as elaborate as these fan patterns, a continental European tradition, is found in churchyard paths. Dr Stuart Blaylock.*

buildings conceived or perceived as Picturesque architecture [Fig.5]. At the utilitarian end of their range examples flooring animal houses and farmyards can be very uneven for the human foot but were serviceable for livestock and the rough treatment of mucking out [Fig.6].

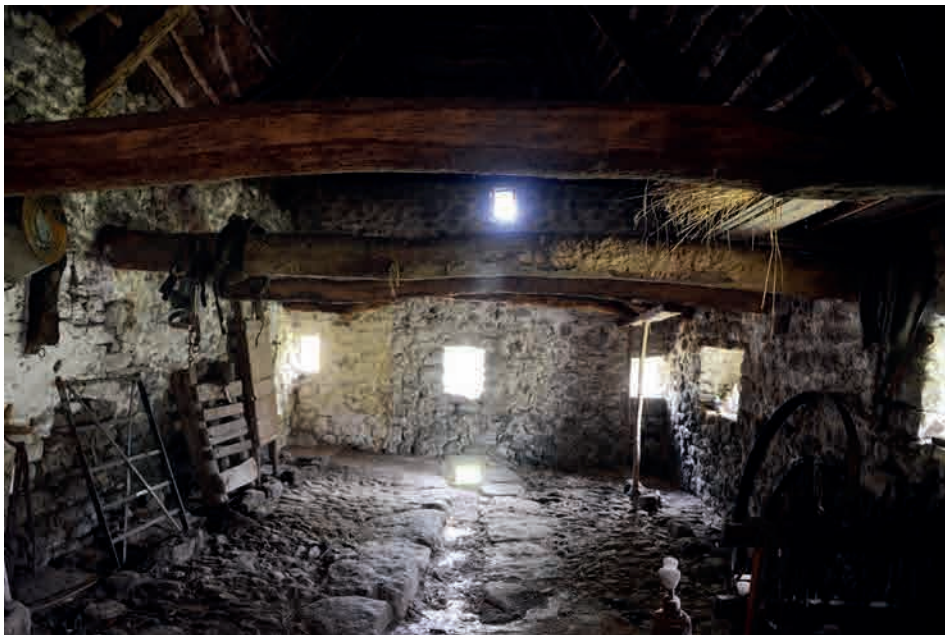
*Fig.6. Random-laid granite cobbles of probable late medieval date provide functional rough-surfaced platforms for cattle on either side of a central drain in the shippon end of a Dartmoor longhouse, Higher Uppacott, Poundsgate. The flooring may be as early as the 14th century, the date of the primary phase of the longhouse. J R L Thorp.*

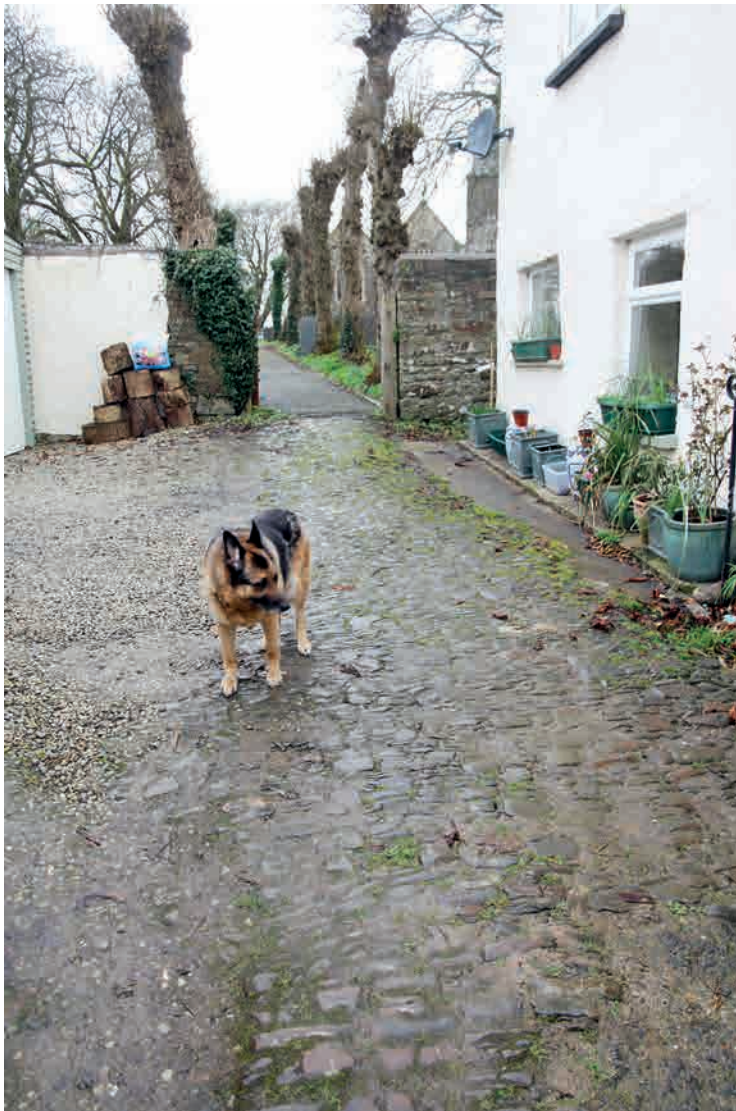
*Fig.7. Judging from cobbles surviving outside the churchyard boundary, the church path to Beaford, All Saints and St George, was originally cobbled.*

There are many cobbled paths and sometimes cobbled courts that lie outside the walls or boundary buildings that, at first sight, define the 2015 churchyard. Cobbled paths leading to the churchyard boundary make it highly likely that the path to the church inside was once cobbled, even if it has been resurfaced since [Fig.7]. Cobbled areas at Huish [Fig.8] and Hatherleigh [Fig.9] parish churches are obviously part of the 'churchyard' although outside the churchyard boundary.

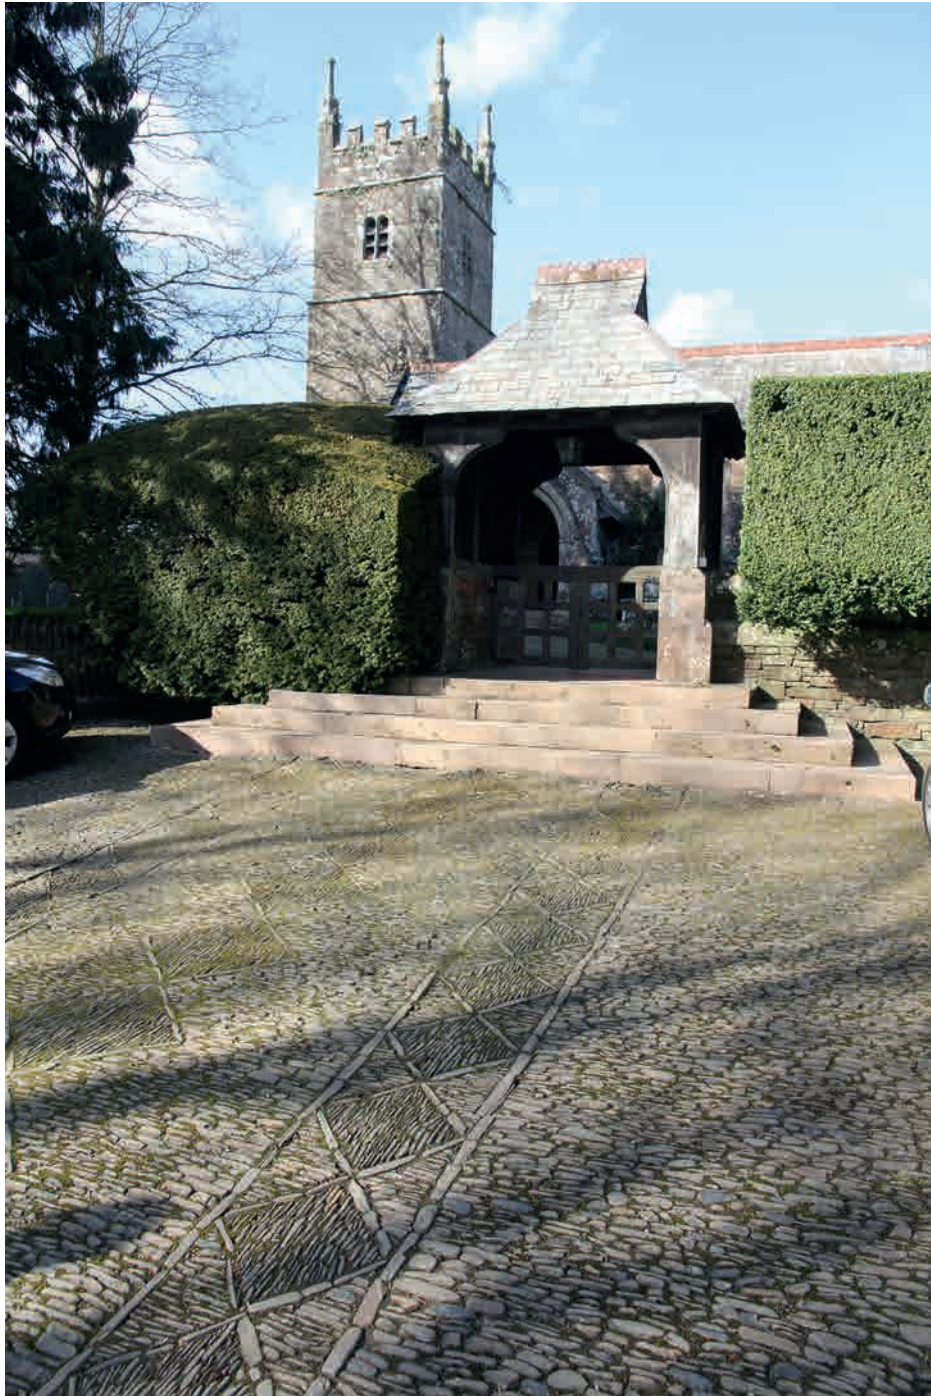
*Fig.8. The court that lies outside the boundary walls of the church of St James the Less, Huish, rebuilt (apart from the tower) by G E Street, is part of a sophisticated Victorian and perhaps Edwardian church landscape. This provided, inside the churchyard, several patterned cobbled paths leading to the church porch, vestry and rectory, but also provided a patterned cobbled court between the lychgate and road beyond which is a World War 1 memorial. The court may have had a ceremonial function as well as providing an area for parking vehicles.*

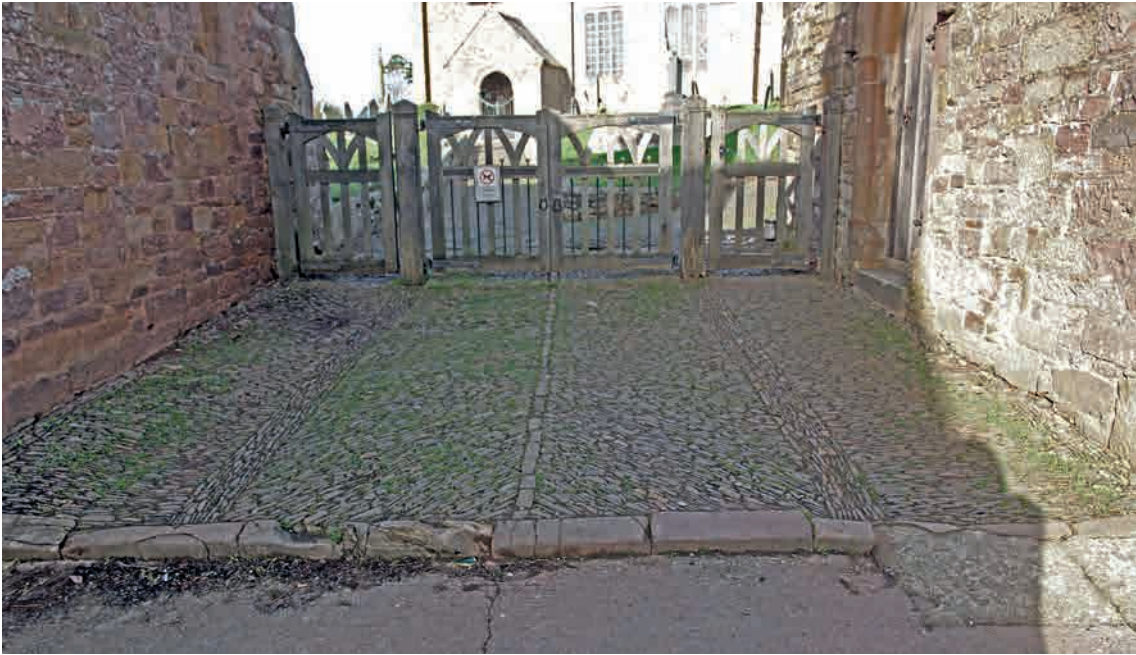
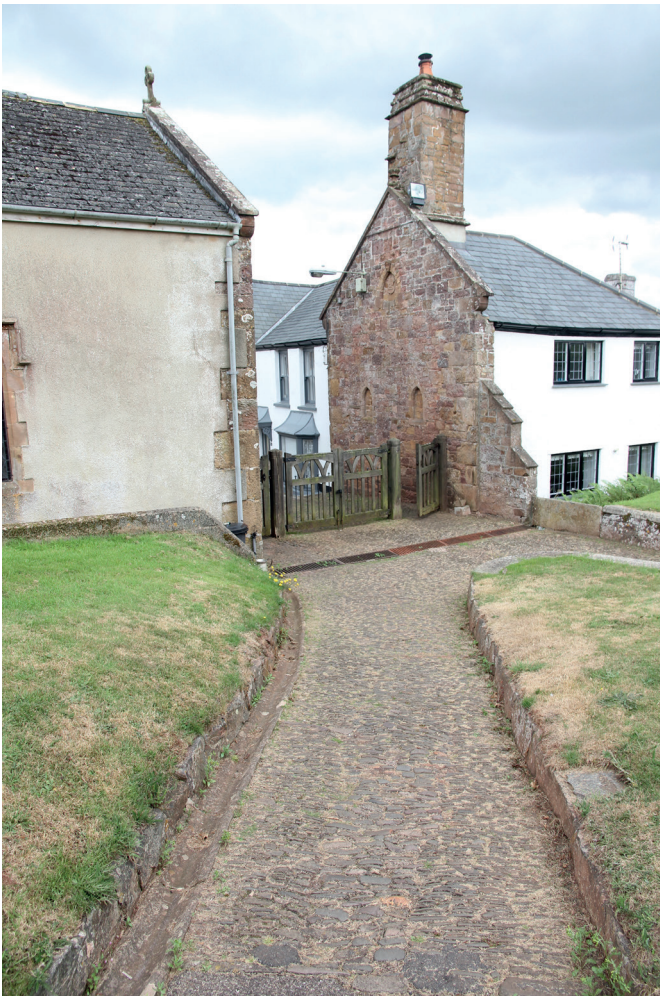
*Fig.9. At Hatherleigh, St John the Baptist, (top and left), a town church, a cobbled area outside the main gateway to the churchyard from the S continues to be used as part of funeral rituals. The coffin is rested on trestles in its own distinct cobbled enclave, between the town and the churchyard gates, flanked by the gable end walls of Gothic buildings before being carried into the churchyard through the gate and up the cobbled path to the church.*

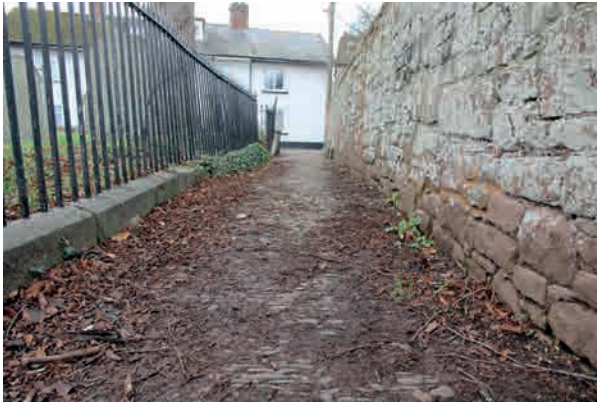
*Fig.10. The Church of the Holy Cross, Crediton, has a cobbled path outside the churchyard railings from what is now the church car park to the churchyard, as well as cobbled paths inside the churchyard boundary.*

However, the ownership, historic and current, of other cobbles outside the churchyard boundary is not so clear [Figs.10, 11]. Cobbled areas lying between the existing churchyard and adjacent houses may once have belonged to the church but over time have become the responsibility of the County Highways Authority or may be 'orphans' of uncertain ownership and responsibility for maintenance [Fig.12].

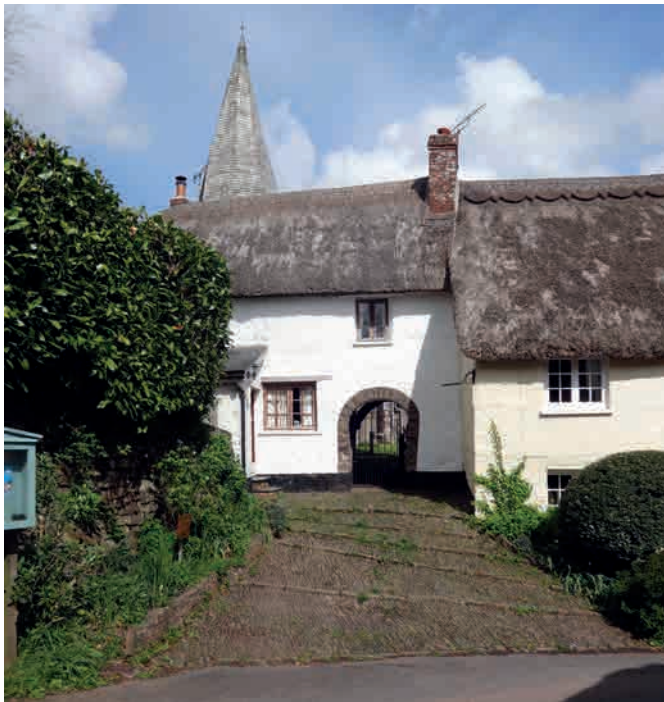
*Fig.11. At West Worlington, St Mary, picturesque shallow cobbled steps rise between the road and the passageway, spanned by a building, that leads into the churchyard. The steps are not inside what most people would consider to be the churchyard boundary. It was only by chance that it was discovered that ownership is claimed by the church.*

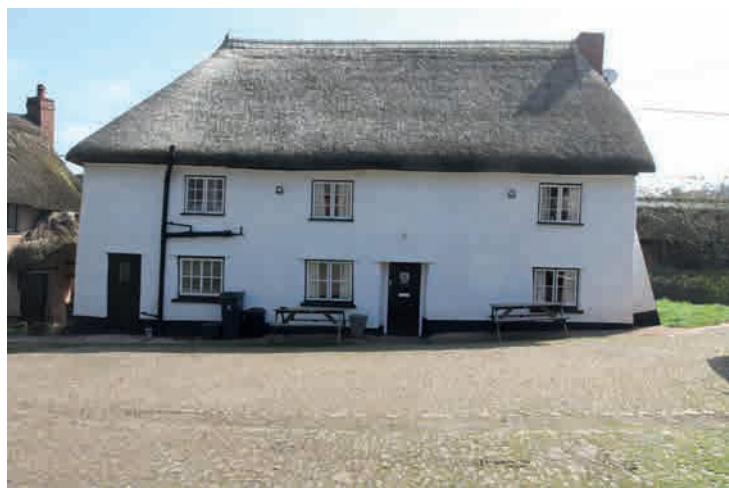
*Fig.12. A cobbled area, 'the Causeway' immediately outside the lychgate at Upton Pyne, Our Lady, was probably once church property.*

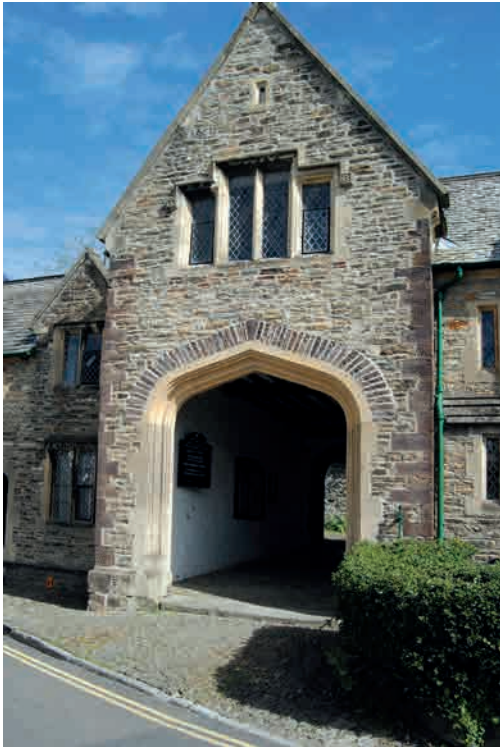
*Fig.13. A cobbled footway outside the entrance to Pilton, St Mary, connects with cobbles under the 1849 entrance to the churchyard between almshouses and continues as a path through the churchyard to the porch.*

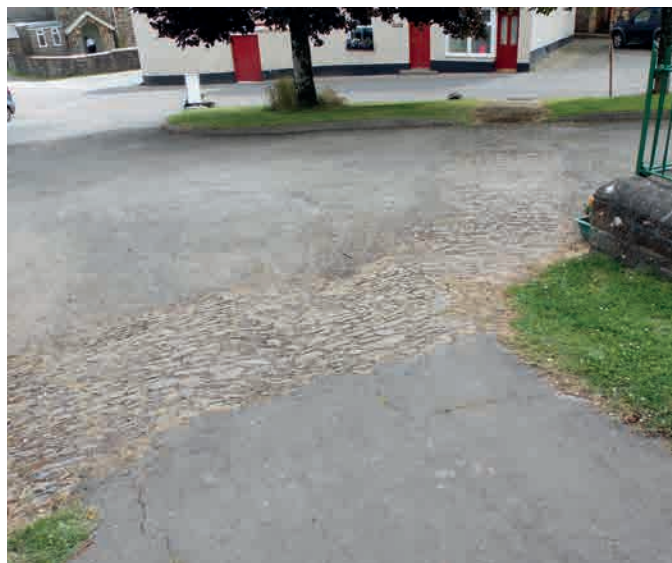
*Fig.14. At Buckland Brewer, St Mary and St Benedict, a cobbled pathway can be traced from the south porch of the church of St Mary and St Benedict through the churchyard, out through the lychgate, across the village square, as a snicket between buildings, then a footway in front of cottages as far as the former vicarage. Whether this was a particular improvement to keep the incumbent's feet dry en route to the church (pers.comm. members of the history group and an owner weeding the pavement outside his house), or is a surviving remnant of what was once a thoroughly cobbled village, has not been established for this report.*

The gazetteer has not been consistent in photographing all cobbles outside the modern boundaries of the churchyard, and when they have been photographed it proved difficult to know where to stop. There are many examples of surviving village and town cobbles in Devon in the public realm or visible from it, sometimes remnants only, sometimes very extensive. These may join up physically with churchyard cobbles and represent a considerable contribution to the character and history of a village or small town, e.g. Pilton [Fig.13]. At Buckland Brewer a long, winding cobbled path through the village links the south porch of the church with the former rectory [Fig.14].

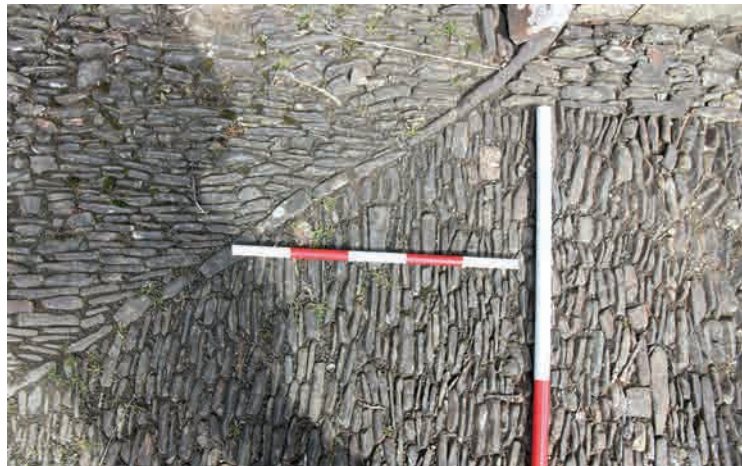
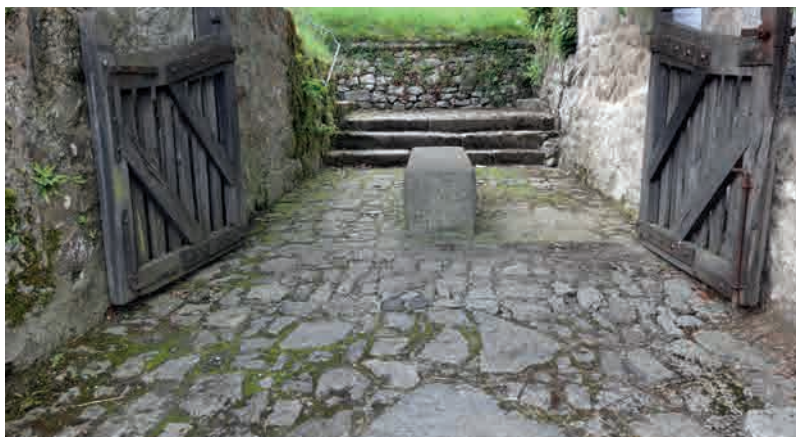
*Fig.15. The range of cobblestone sizes illustrated in the contrast between the tiny cobbles at Petrockstow, St Petrock, above, and the large cobbles? or should they be called random stones? at Throwleigh, St Mary, below.*

The modern geological definition identifies cobbles according to size as a clast (that is a broken piece of an older rock) with a particle size of 6.4 centimetres (2½ ins.) to 25.6 centimetres (10¼ ins.) The size of cobbles used for Devon church paths is very varied, both within individual church paths and from path to path [Fig.15]. The largest cobbles at Coldridge, for example, are about 25cms x 30cms on the surface. At Petrockstow some of the smallest cobbles are no larger than a digestive biscuit laid on edge and only about 2cms x 5cms on the surface. At the limit of definition by size for this project are paths surfaced with large random-laid stones. Some of these stones are very large, 50cms x 50cms or more and the paths might be better-defined as random rubble paving rather than cobbles. However, they have been included as they present some of the same conservation issues as paths constructed of smaller stones.

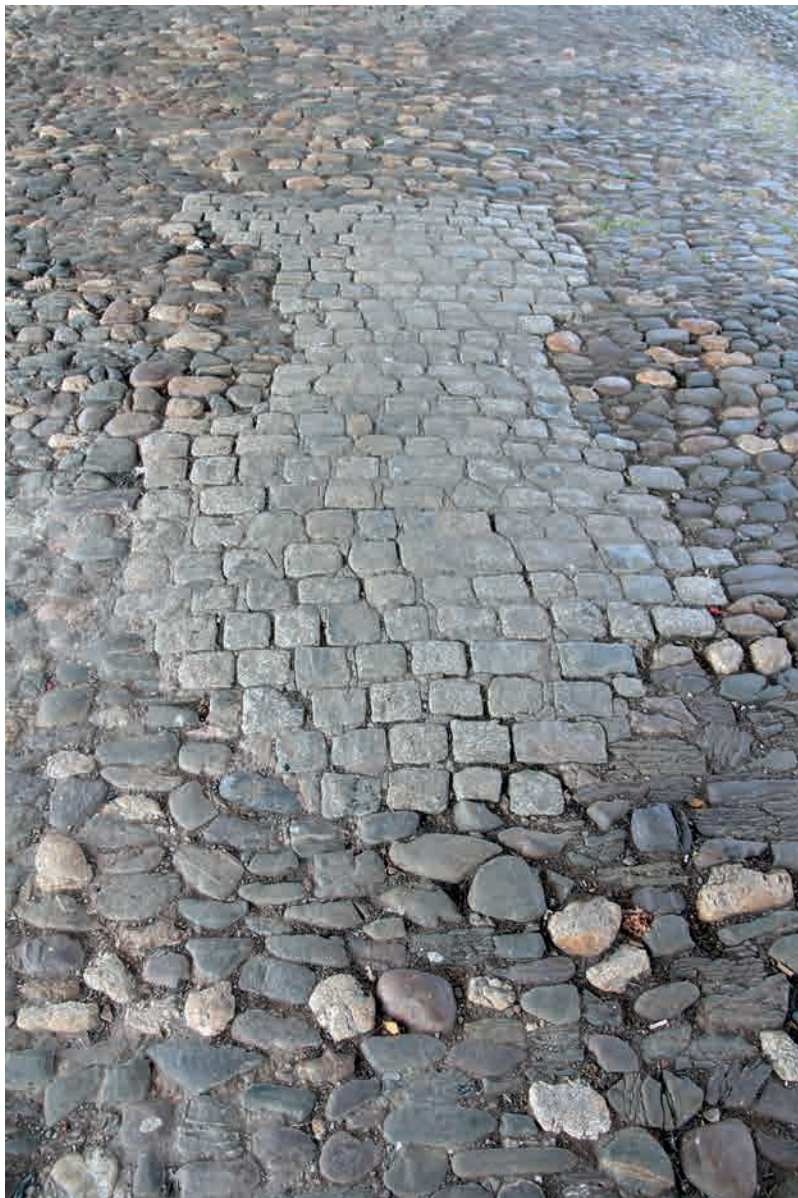
*Fig.16. Exeter transit shed, the Quay. Cobbles patched with small granite setts.*

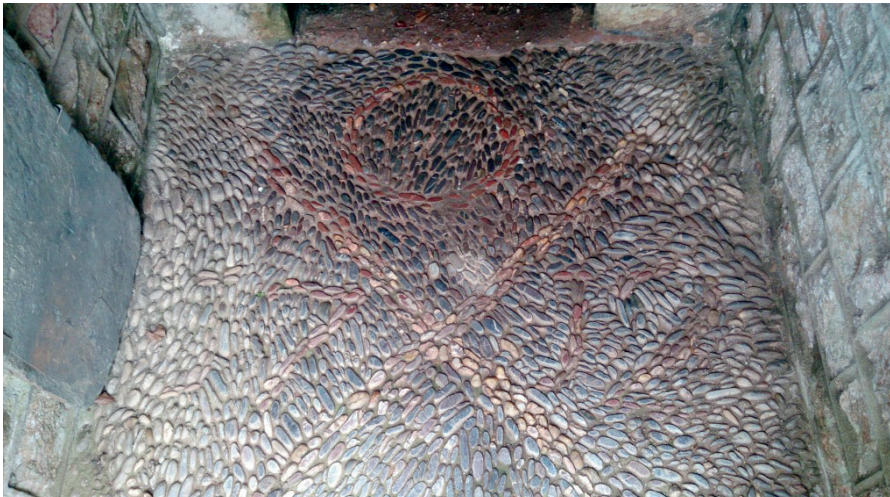
*Fig.17. (Above) Kingskerwell, St Mary, dated 1712. Located close to the 'Devon marble' limestone area of South Devon, this is interpreted here as masons' offcuts used for the patterned area in grey and pink.*

There are exceptions to the use of uncut stones: masons' offcuts and quarry waste. The earliest dated cobbles inside a churchyard boundary are interior cobbles flooring a disused porch at Kingskerswell, St Mary. This cobbling is a one-off. It incorporates a very early date of 1712 and a pattern of lozenges and a wreath-like circle, picked out in pink on grey cobbles [Fig.17]. Most of the cobbles have rough sides but very flat, shiny tops, although in the corners the stones are more conventional pebble cobbles laid horizontally. The flat-topped cobbles may be what was left over when South Hams limestone (which can be polished and is sometimes called Devon 'marble') was sawn or split, either at the quarry or in a masons' yard when it was being dressed, the polished appearance coming from footfall (*pers.comm.* Peter Dare, retired Exeter Cathedral mason). South Hams limestone was used locally for footway flags. In Ipplepen, the parish adjacent to Kingskerswell and the site of a limestone quarry, flags of the local pinkish limestone can be found surfacing the footways. It would be thrifty to make use of quarry and masons' waste if they provided stone fragments that could be individually laid, although the careful selection for colour and the patterns at Kingkerswell suggests that no expense of labour was spared in the porch. Some paths may employ quarry waste [Fig.18].

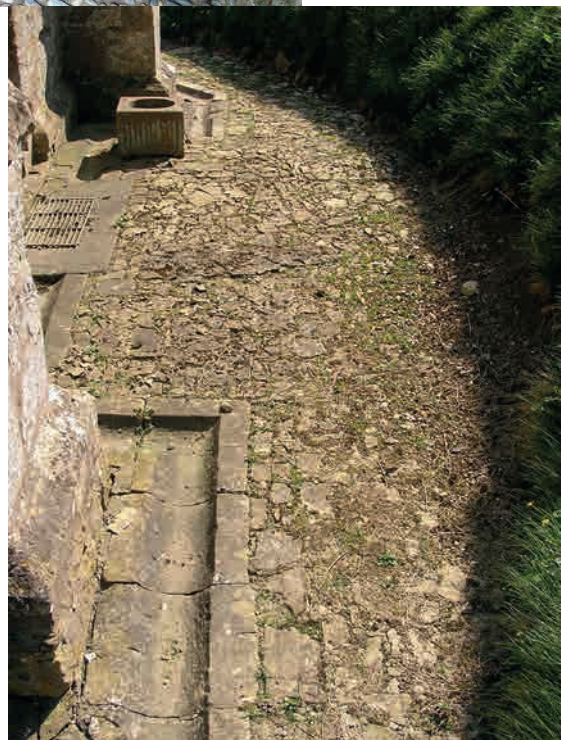
*Fig.18. (Right) Membury, St John. This cobbling may use quarry waste from the nearby Tolcis quarry that produced white lias.*

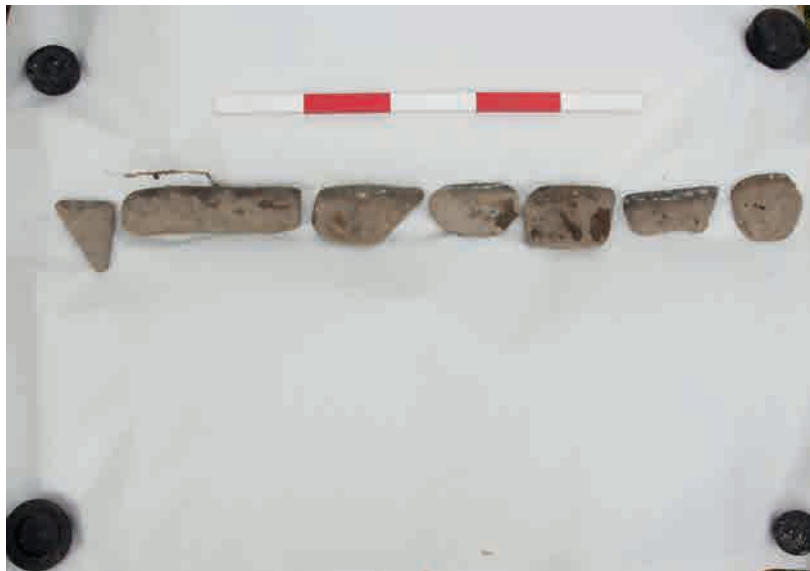
*Fig.19. Cobbles excavated from Merton, All Saints, photographed as they were laid and proving that they were not 'pitched' if this is defined as thrust in vertically.*

We have found the phrase 'pitched stone' unhelpful. 'Pitch' derives from the Middle English *piche*, to fix, erect, place etc. Sometimes 'pitching' seems to be used to refer to cobbles in contrast with 'paving', meaning flags. However, some modern authors take it always to mean setts. Bristol's Commission of 'Pitchers and Paviours' (John Macadam was a commissioner in 1806) probably indicates a mixture of cobbles and setts/flags in the city. 'Pitched', in the sense of 'upright' or 'thrust in', is sometimes used to describe stones where the length of the stone in the bedding is greater than the length that appears on the surface. This makes good sense to ensure that the structure of a path is secure and the stones unlikely to be accidentally kicked out. Judging from what you can see on the surface, most surviving churchyard cobbles in Devon could be 'pitched' on this definition. However, the trials at Merton church established that many of the cobblestones from both phases of a two-phase path were laid horizontally, their length on the surface greater than their depth [Fig.19]. This may be an exception and there are domestic and farmyard examples where this is not the case. At St Peter's church Tiverton, on the N side of the church, degradation of the path surfaces reveals 20th century egg-shaped pebbles laid horizontally [Fig.20], but in most cases we have not been able to see whether church path cobbles are laid vertically or horizontally.

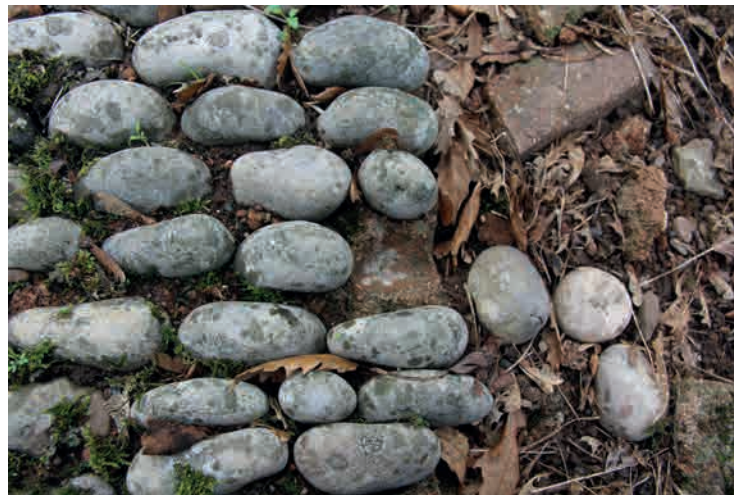
*Fig.20. Egg-shaped cobbles used at the church of St Peter, Tiverton, laid in cement in the 20th century. These are laid horizontally.*

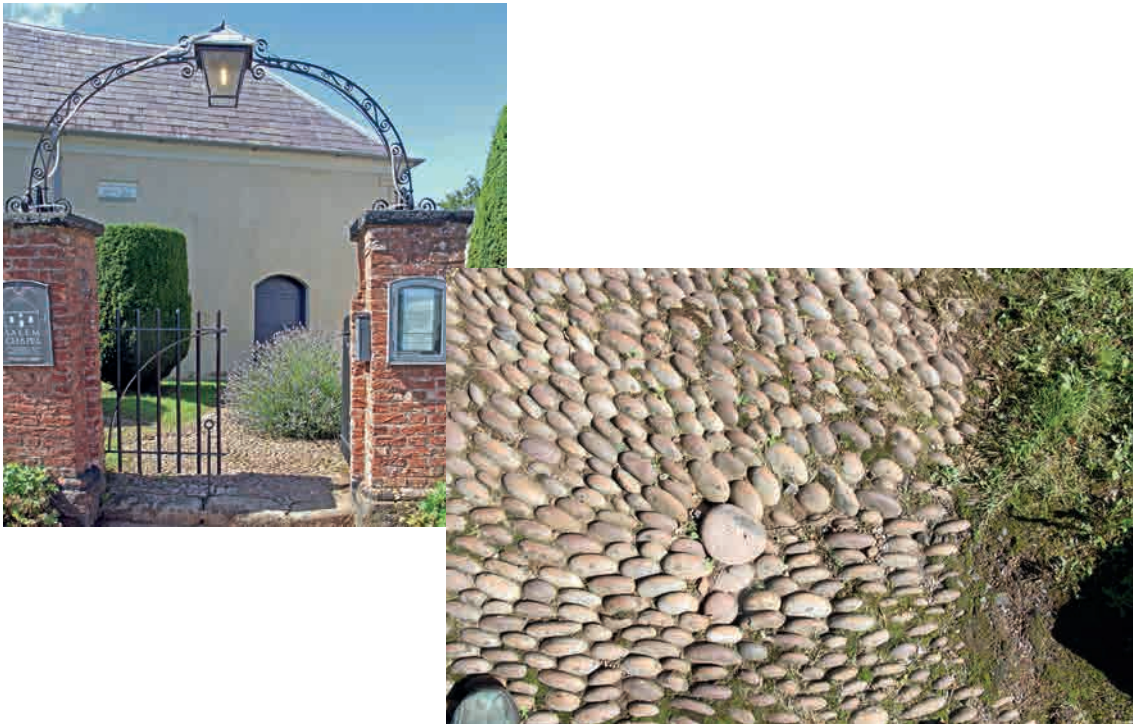
*Fig.22. Quartzite pebble cobbles from the E Devon pebblebeds used for a court outside Salem Chapel, E Budleigh. The domed shape of the stones, rising above the bedding, make these uncomfortable to walk on and they do not provide a secure purchase for a walking stick.*

A small number of Devon churchyard paths are constructed from pebbles from the E Devon pebblebeds. These are Triassic deposits of mostly quartzite pebbles. The quartzite pebbles are water-worn, not by the sea but in an ancient river running N into E Devon from Brittany before England was separated from continental Europe. These pebbles are rounded, sometimes more or less spherical, sometimes egg- or doughnut-shaped. Their shape means that the surface of a pebble path presents a series of domes or domes with flattened sides above the bedding [Fig.22]. A handful of East Devon churchyards have paths or areas of pebble cobbles. The quartzite pebbles were also used for paths to houses, for roadway gutters and even for facing walls. There is a high concentration of their use in the area south and west of Ottery St Mary, but pebble cobbles sometimes turn up in churchyard paths where they seem likely to have been brought from some distance, e.g. at Poltimore and the 20th century paths on the N side of St Peters, Tiverton.

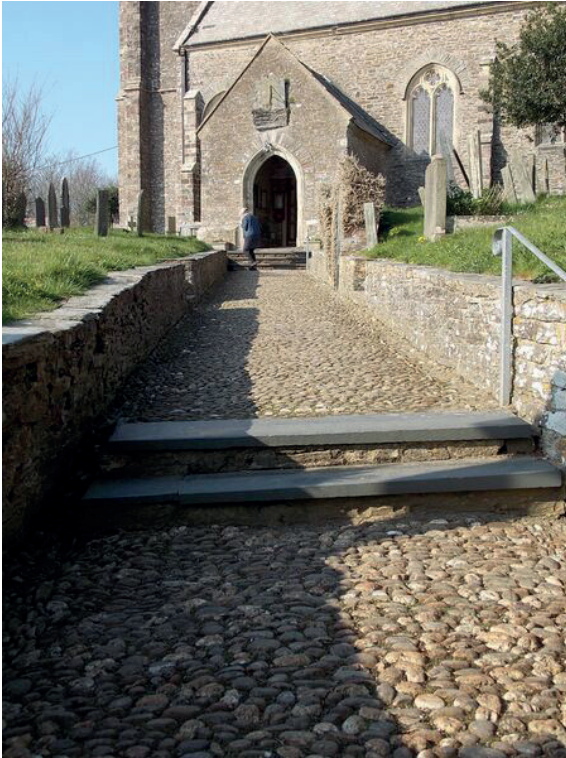
*Fig.24. Berrynarbor, St Peter. Sandstone/siltstone cobbles with rounded pebble-like tops, possibly from alluvial gravels but more likely from the beaches of N Devon (pers.comm. Dr Richard Scrivener, provisional assessment of geology based only on photos, not on a visit).*

The cobblestones from the Culm Measures are water-worn Carboniferous sandstone from the Bude and Crackington formations. They have been water-worn in ancient rivers knocking off sharp edges and angles and reducing a stone to its hard core. Some are slightly domed [Fig.24].

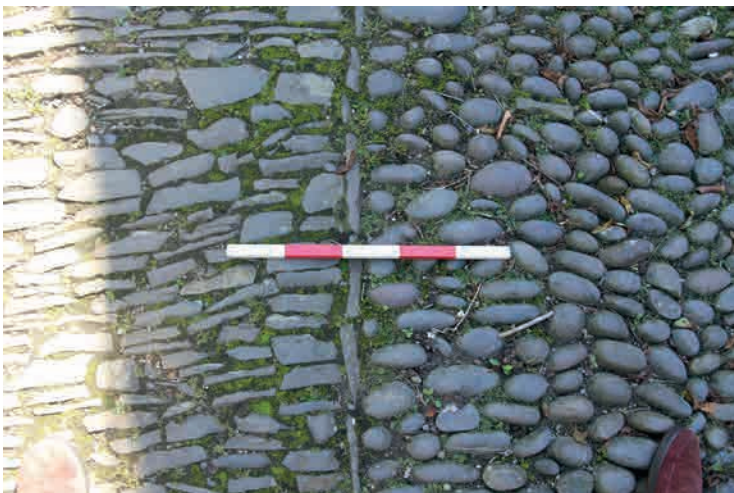
*Fig.25. Pilton, St Mary. A unique example of flat-topped and slightly domed Carboniferous sandstone cobbles used side-by-side, presumably two different phases.*

However, they can be a very different shape from the East Devon quartzite pebbles. Some river channel cobbles are approximately tile-shaped, usually quite thin with flattish surfaces and some rounded corners and these were preferred for church paths. The Culm Measures also produce larger and coarser sandstone cobbles with sharp angles. The latter have been subject to slower erosion by water resulting in a more angular product and are sometimes known as 'head cobbles'. These may have been gathered from field-picking. There is a huge variety of size, flatness and angularity and a wide range of colours, through greys and brown with some pinkish stones [Figs.25, 26].

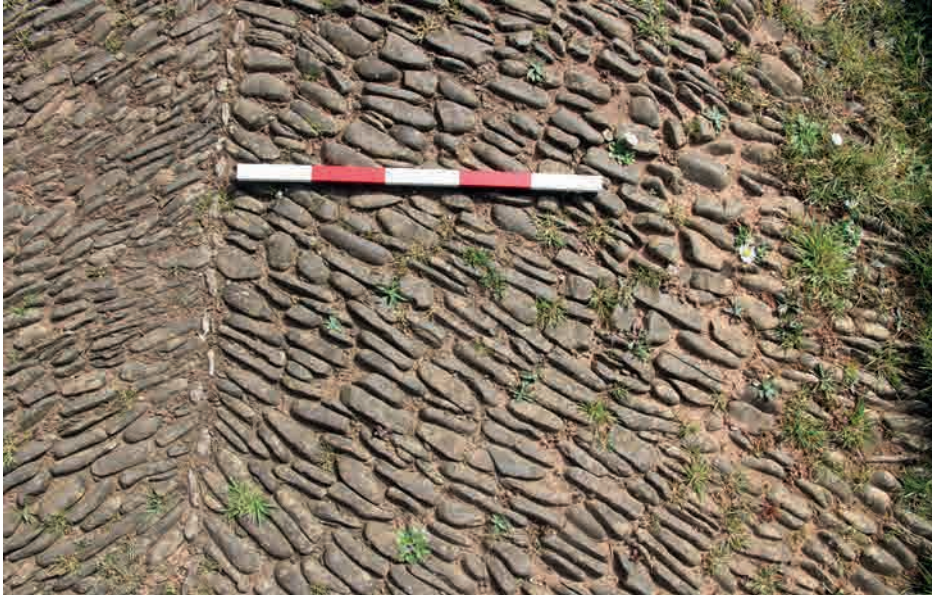
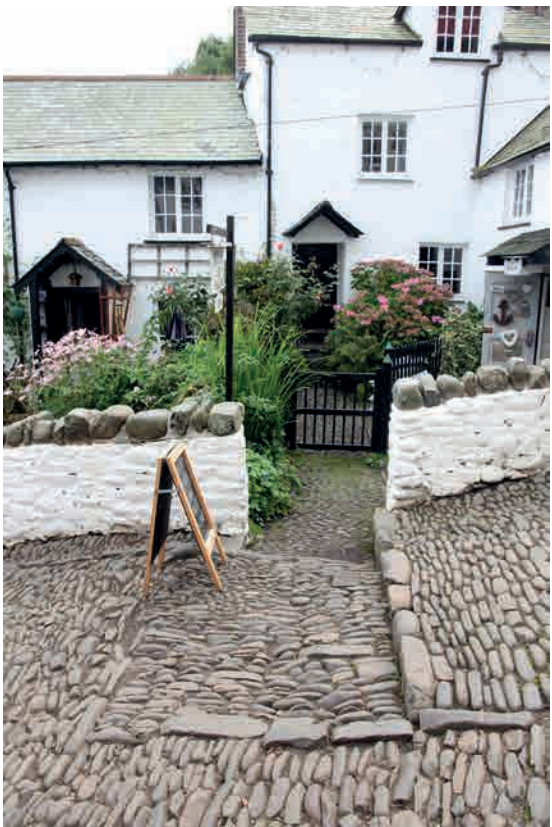
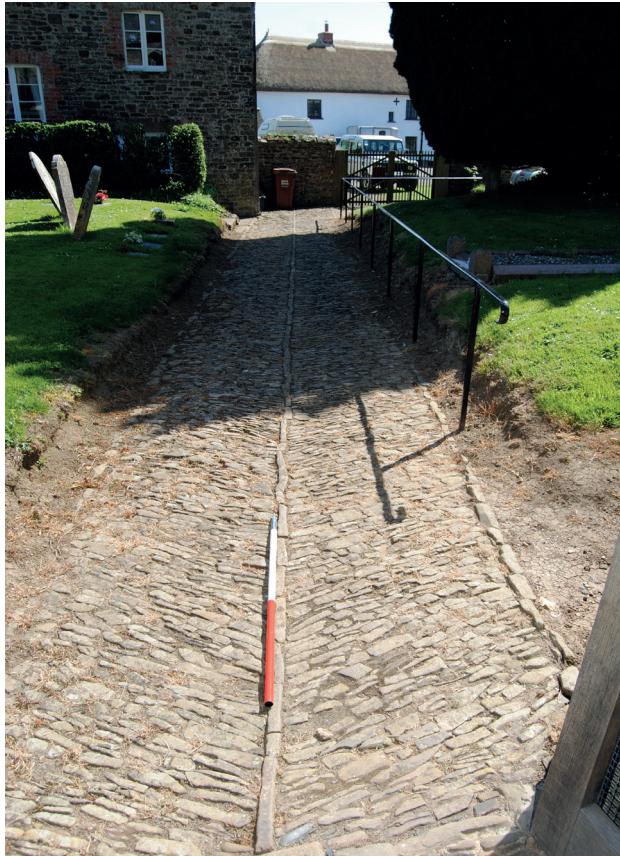
*Fig.26. Carboniferous sandstone cobbles illustrating something of their variety of shape, colour and size. Clockwise from top.*

*a) Small, flat-topped cobbles were preferred for many church paths, e.g. at Upton Pyne, Our Lady.*

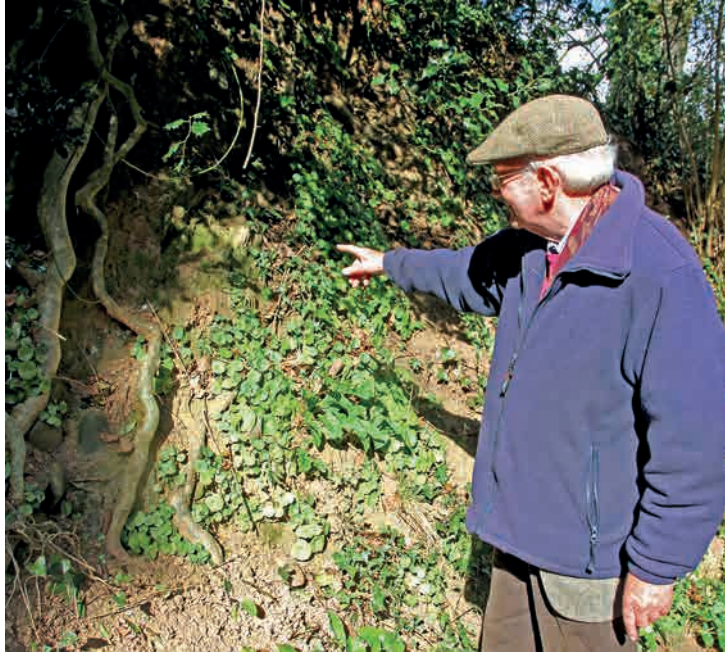
*Fig.27. An ancient river terrace above the current course of the River Exe at Brampford Speke. Dr Richard Scrivener pointing out that the face of the terrace is full of Carboniferous sandstone cobbles. A pit dropped on the top of the terrace would produce abundant cobbles.*

Culm Measures cobbles could be sourced from rivers, but can also be found in abundance in ancient river terraces, where they could be picked out of the terrace face or gathered from a pit on top [Fig.27].

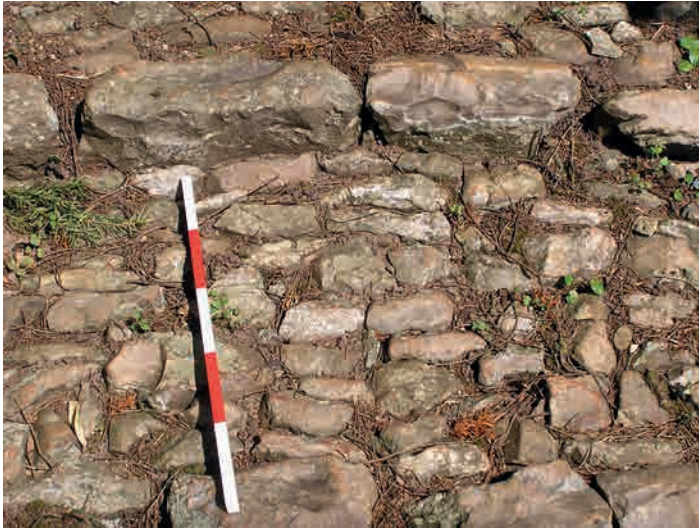
*Fig.28. (Above) Chert cobbles at Offwell, St Mary on the S path to the lychgate. The 19th century porch (right) is surfaced with quartzite pebbles.*

There is evidence of the use of other sources of stone: the Kingskerswell limestone cobbles are noted above. Offwell church in E Devon has some chert cobbles. Chert is a hard siliceous rock deposited in deep water and found in both north and south Devon. The chert cobbles at Offwell are knobby and uneven and found in conjunction with areas of quartzite pebble paths [Fig.28]. In short, the makers of cobbled church paths employed suitable material to hand and there was a wide range of what was considered suitable. It is noticeable that although granite cobbles are found in domestic settings and survive used in drainage channels to later surfaced roads, they are uncommon in churchyards even where granite is locally abundant and used for the church building, retaining walls and as flags for the apron round the church, as at South Tawton [Fig.29]. In those areas of Devon which are a blank for cobbled churchyard paths, the south and the south west of the county, we might assume that the most practical stones for cobbling were simply not available.

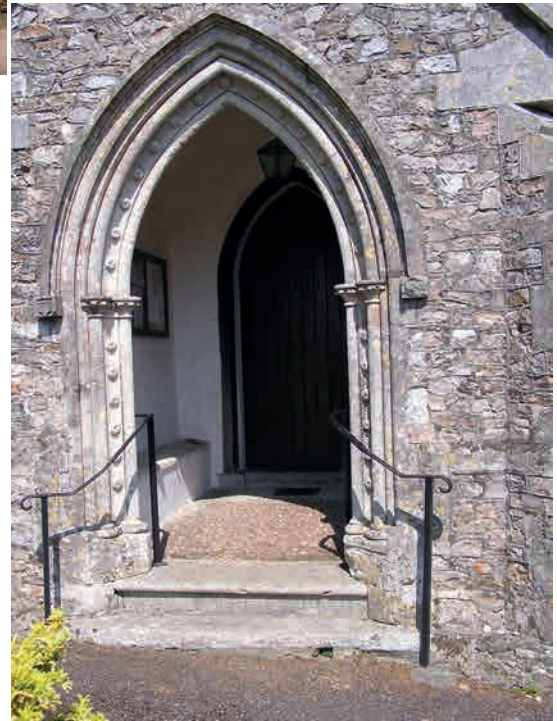
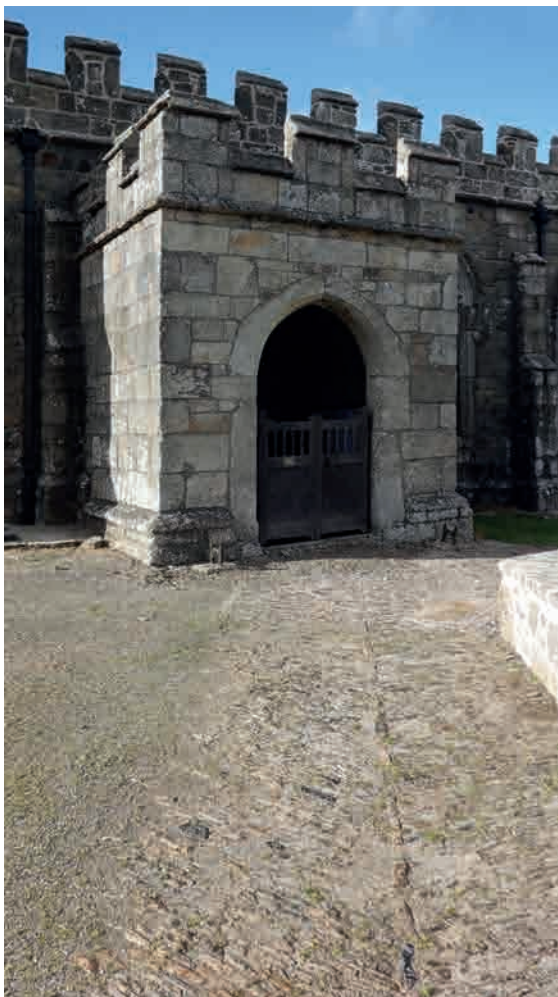
*Fig.29. (Left) South Tawton, St Andrew. Abundant use of granite for the building, for revetment walls to the path and for an apron round the church, but sandstone cobbles used for the path.*

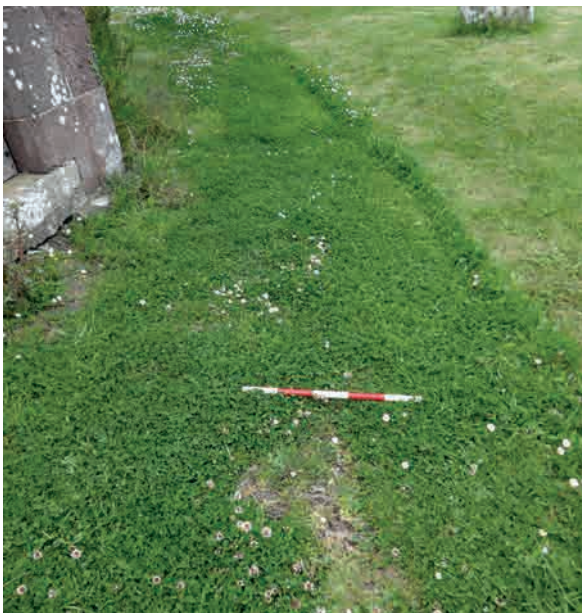
*Fig.32. A sub-path lost to grass at Cheriton Bishop, St Mary.*

As all maps do, the distribution map distorts the evidence. It allows each path or path fragment to colour a whole parish. In reality, an orange-coloured parish may indicate just one path or, in exceptional circumstances as many as six. The map tells nothing of the relationship between a church path and surviving cobbles in a village, a combination that can create an absolutely distinctive sense of place. The gazetteer may have missed some chapels of ease. It is more likely to have missed cobbled sub-paths lost under grass and weeds [Fig.32] or under tarmac or cement. Unless a few patches of cobbles are visible it is difficult to confirm that these once existed.

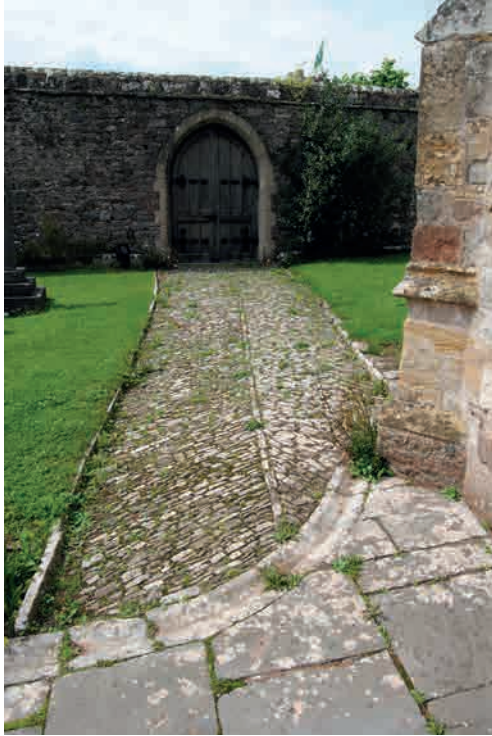
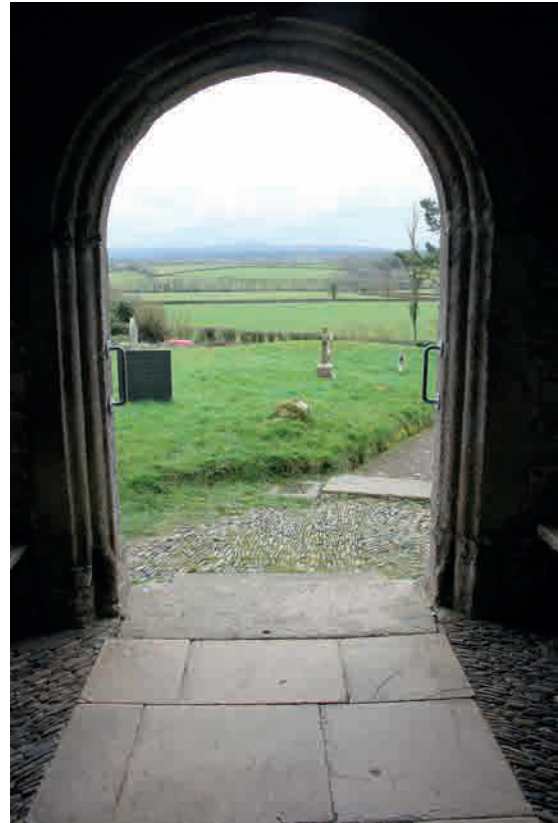
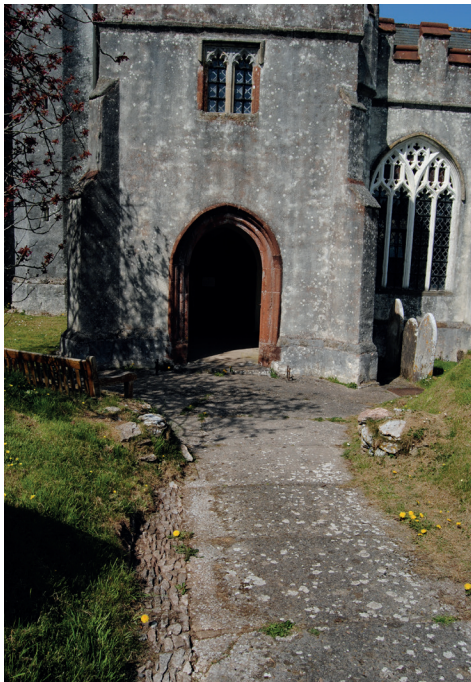
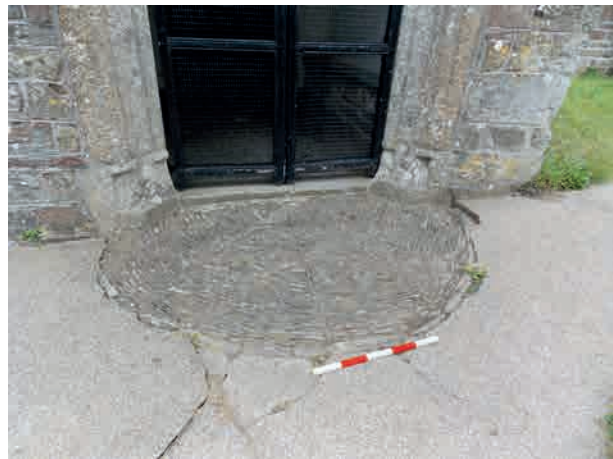
*Fig.33. Examples of churchyard cobbles marked beige on the distribution map. These include whole sub-paths, e.g. Holcombe Rogus, All Saints (topleft), a sub-path leading off the flagged path to the S porch to a doorway in the property boundary wall with Holcombe Court. They also include fragments of cobbled schemes, e.g. Iddesleigh, St James (top right) has a concrete principal path but has retained a small patch of cobbles outside the S doorway and the cobbles on either side of a flags in the porch; Torbryan, Holy Trinity (bottom left) where cobbled drains survive, now on either side of a concrete path and Monkleigh, St George. In common with many other churches, this retains only a decorative cobbled 'doormat' to the porch entrance.*

Cobbles other than principal paths noted on the distribution map range from entire sub-paths, usually from a secondary entrance into the churchyard, to small remnants of cobblestones, whether drainage channels now serving tarmac or concrete paths, complete drainage aprons round the church building or sometimes just a very small patch of surviving cobbles. A number of churches have retained a cobbled 'doormat' immediately outside the south porch even when the rest of a path has been replaced [Fig.33].
