# Devon Cobbled Churchyard Paths

Evaluating their Significance,  
Survival and Adaptation

A project undertaken by  
Keystone Historic Buildings Consultants  
for Historic England and SPAB

March 2016

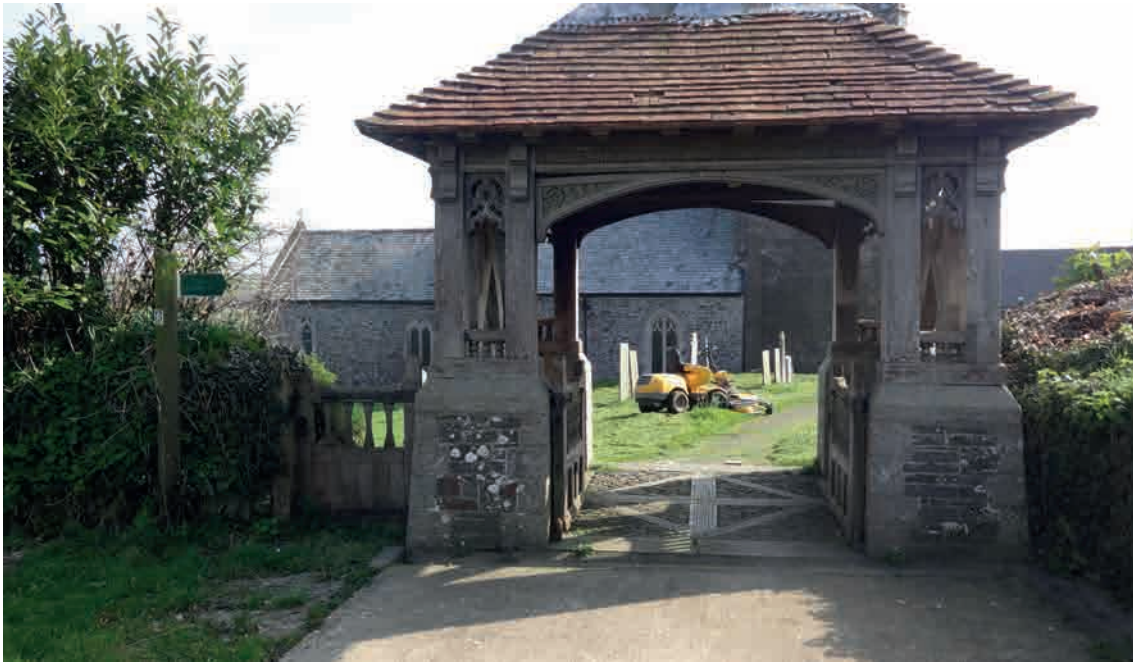
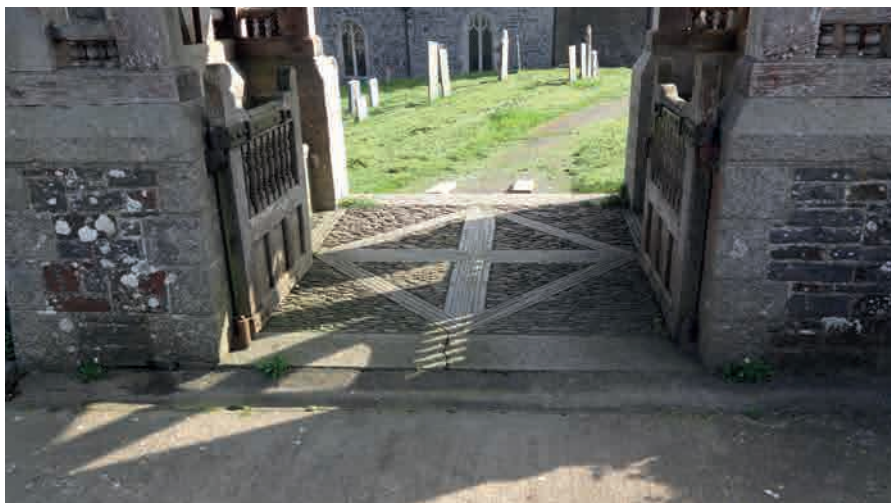
*Fig.34. The 1908 patterned cobbles of the lychgate at Warkleigh, St John the Evangelist. Cobbled lychgates appear usually to have been built independently of work on church paths.*

Test-driving the gazetteer forms quickly established that cobbled lychgates were in a category of their own [Fig.34]. Judging from dates and inscriptions where these are visible, they were often erected independently of any work on the churchyard paths. In origin, the lychgate ('lych' meaning corpse) was part of the funeral service providing a symbolic and actual sheltered place at the entrance to the churchyard for part of the funeral service: not all funeral

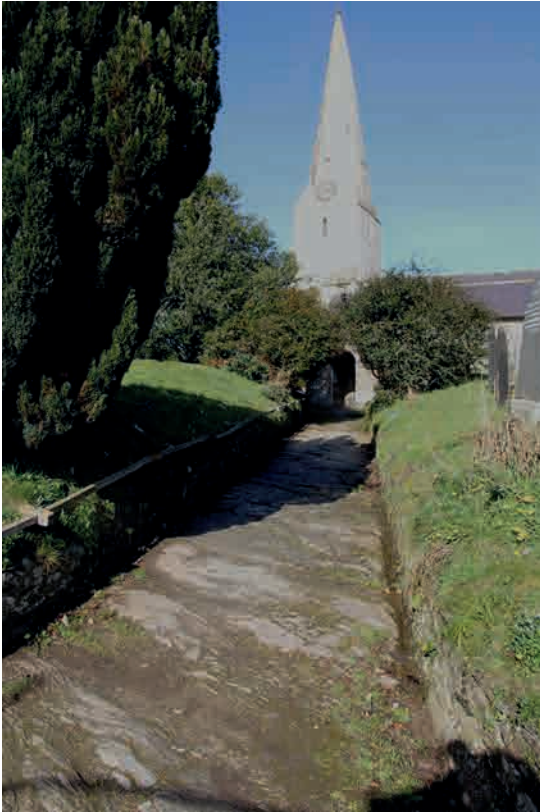
*Fig.35. Diptford, St Mary, has a lop-sided bedrock path. There have been attempts to level parts of it up with cement.*

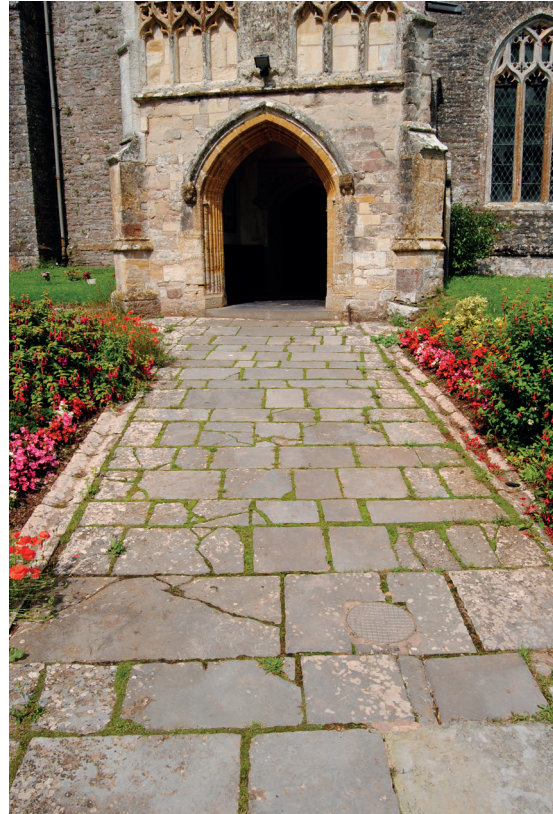
*Fig.36. A rare example of a flag path, Holcombe Rogus, All Saints. The church also has a cobbled sub-path to the garden boundary of the adjacent great house, Holcombe Court. See Fig.33.*

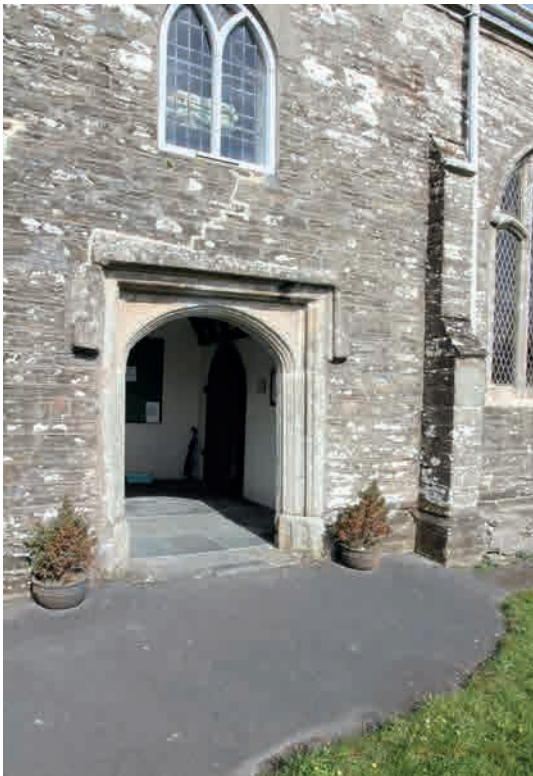
*Fig.37. Loddiswell, St Michael, in the largely cobble-free zone of the South Hams, has both a slate-floored porch and the body of the church is flagged with slates. Is the tarmac path a replacement of slate flags?*

The South Hams slate industry is best known for providing roofing slates and slates for slate-hanging, but also produced flooring slate, window sills and, in the 19th century, a wide range of slate objects. Large slate flags survive flooring some of the south Devon church porches and some church interiors [Fig.37]. If slate flags were used, were they lost before the cobbled paths because they were slippery? Did the slate used break down? This is what happened to the largely lost blue lias paving (also now considered very slippery for external use) of 18th century Bath which was replaced with Pennant stone when it became economically available. Alternatively, were the Devon churchyard paths in cobble-free areas constructed of and replenished with waste from the abundant local stone quarries? A small number of churchwardens' accounts were searched for the areas where no cobbles were found and Modbury, for example, has references to 'chippings' from 1820/21 and by 1822 it is plain that these are for the church path. However, the 1820s entries make a distinction between 'chippings' and 'stones' (drawn, with 'chippings' in 1820-21, but not necessarily for work on a path) and in 1826/7 there is a payment for a cartload of 'pebbels'.<sup>3</sup> These may have been for a path or used for some other purpose. More research is needed to understand the lost churchyard paths of south Devon and why they were so comprehensively replaced with tarmac and cement when cobbled paths further north have survived.

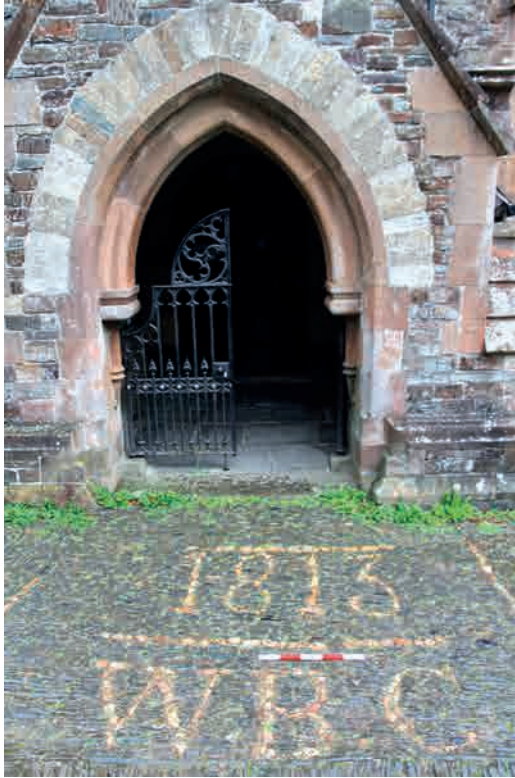
*Fig.38. Initials of a local architect/mason at Great Torrington, St Michael with a date of 1813. Walter Browne Cock rebuilt the church tower with spire in 1828 and the market house in 1842. One of the other two examples of initials records, not a contractor, but churchwardens. Note that the dated cobbles about a late 19th century porch, indicating some relaying when the porch was built. These are the only churchyard cobbles mentioned in Pevsner's Devon.*

Judging from documentation historic cobblestoning was masons' work. At St Michael and All Angels, Great Torrington, the initials 'WBC' picked out in white/brownish cobbles with the date 1813 are plausibly those of Walter Browne Cock, the local architect/mason who rebuilt the church spire and, with a partner, William Dunk, built the town's market hall [Fig.38]. The initials may be intended to record his work on the church building as well as, or rather than, the cobblestone path. Laying cobbles may have been one of those rural skills that many parishioners could turn their hand to, like thatching. Thatching was learnt on ricks and farmbuildings, utilitarian cobblestone-laying may have been learnt in farmyards or private courtyards. Masons may have been employed only for the best cobble work. It is unlikely that a mason would have been employed for some of the cobbled garden paths of smaller vernacular houses.

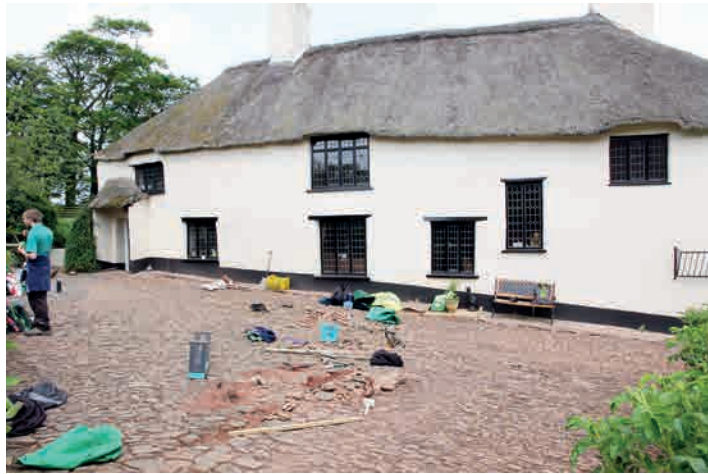
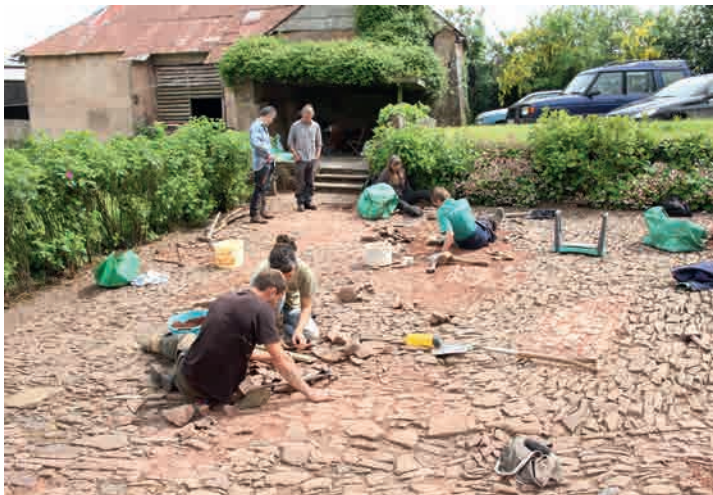
*Fig.39. Above and left. Repairing farmyard cobbles in Mid Devon on a one-day cobblestone-laying course tutored by Jennie Goodwin for the Devon Rural Skills Trust. The cobbles were larger than most used for church paths and expectations were for a rougher surface than churchyard cobbles.*

A Devon Rural Skills Trust course on cobblestone laying was run in May 2015 [Fig.39], repairing a cobbled farmyard in Mid Devon. The farmyard cobbles used were much larger and more angular (head cobbles, rather than river channel cobbles) than is common for Devon churchyard paths with a more uneven surface. The cobbles were bedded and jointed in red Mid Devon subsoil with no evidence of any aggregate or lime added. The bedding included many earthworms and evidence of their progress through it.

This one-day course provided useful insights into some of the principles of cobblestone-laying explained by an experienced practitioner as understood by Jo Cox, a complete novice, and working on patch repairs rather than laying from scratch. The principles listed below relate to the particulars of the farmyard cobbles on the site in question. They are not a British Standard specification for laying cobblestones. The principles below have been supplemented on the basis of the investigation of the construction of the church path at Merton and in the light of what has been understood of cobblestone construction from research and observation by Ray Harrison and some of the key elements are dealt with in more detail in Section 7.

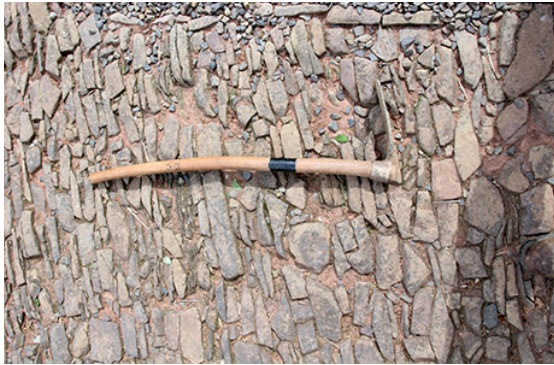
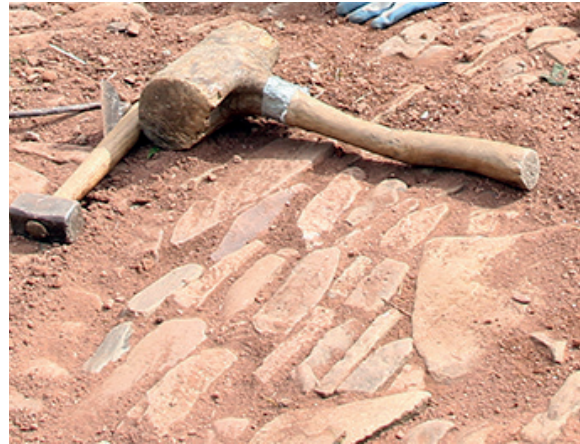
*Fig.40. Tools. Clockwise from top left. Tools used by experienced cobblestone layers on a Devon Rural Skills Trust training day in 2015: a 'digger', a short-handled tool useful for easing out large cobbles and a wooden mallet for knocking cobbles in. This was made of a single piece of holly. A 'rammer' illustrated in *The Construction of Carriageways and Footways* by H Percy Boulnois' 1895, p.48, weight given as 40lbs. Rammers being used by workmen re-paving *The Strand* with setts in 1859 (with a conductor in the foreground), *Illustrated London News*. The parent tool is known from a late medieval manuscript illumination of sett-laying, which also shows setts laid by men working off low stools. The medieval rammer had handles on both sides, rather than one side and one end, and needed two men to use it.*

The tools used on site on the Devon Rural Skills Trust training day included anything suitable for easing out cobbles, on this site a plasterer's trowel was sufficient. However a 'digger', a short-handled, single-headed mallet-like tool, thought to be peculiar to Devon and evidently a general-purpose tool, was recommended and the professionals on site also had large multi-purpose wooden mallets. A tool called a 'rammer' in the late 19th century was used both for laying setts and cobbles. In a technical publication of 1895 this was described as hardwood, bound with iron and weighing about 40 lbs. An earlier version, requiring two people, can be seen in use in a late medieval manuscript illumination. The same image shows people working from low stools, rather than kneeling, though this would transfer the strain on the knees to the back. Ray Harrison reports seeing setts laid in fan patterns in Thanet, Kent by craftsmen sitting on one legged stools. The size of the fans was determined by how far a layer could stretch forward and to the sides off the tilted leg of the stool. The workers observed were from continental Europe.

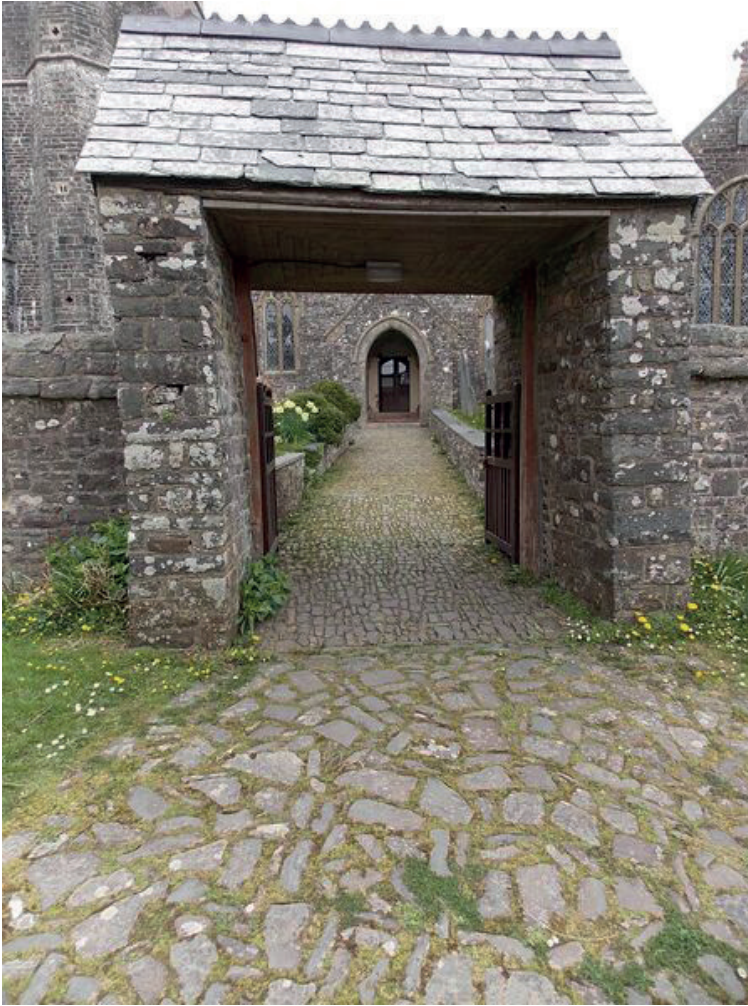
*Fig.41. West Woolfardisworthy, Holy Trinity. Smaller cobbles used inside the churchyard boundary compared with large, random-laid cobbles outside reinforce the special character of the churchyard as an enclosed space and the setting of the church building.*

It is hard to say just how much sorting before use went on. Most of the cobbled church paths in the Culm Measures area use noticeably smaller cobbles than those used for village footways or farmyards: thus (with some exceptions) the paths are daintier in appearance than those outside churchyards [Fig.41]. To date we have been unable to determine whether the use of smaller cobblestones fits into a specific date range of church paths, e.g. perhaps these are later than the larger cobbles?

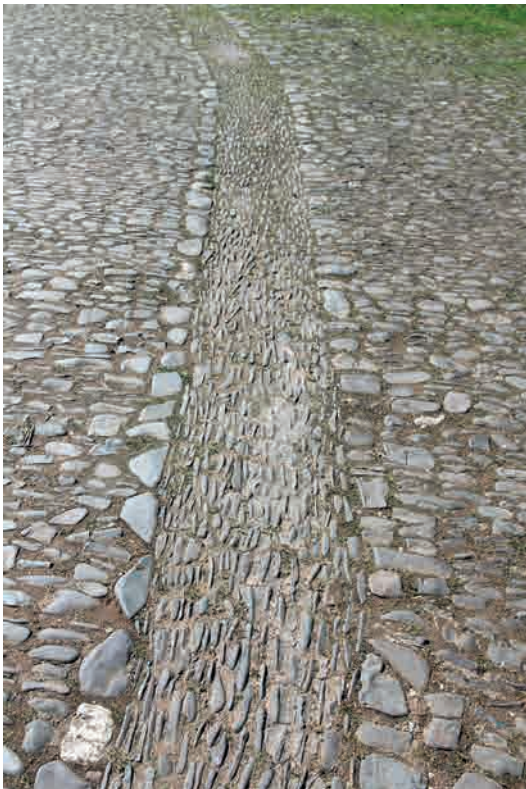
*Fig.42. Small cobbles selected for a surface drainage channel in 'the Causeway' outside the lychgate of Upton Pyne, St Mary.*

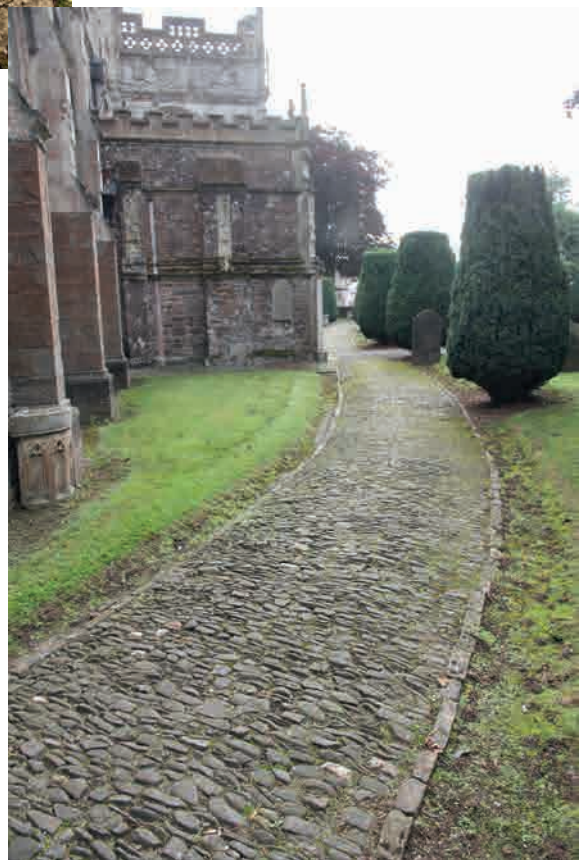
*Fig.44. Cobbles laid across the short axis of one of the churchyard paths at Tiverton, St Peter.*

- Random-laid cobbles (rare) [Fig.43].
- Cobbling at right angles across the short axis, sometimes (but rarely) with a spine [Fig.44].
- Cobbling along the long axis. Few cobbled paths have their cobbles laid longitudinally, unless for drainage channels, although small areas of paths may be laid this way [Fig.45].

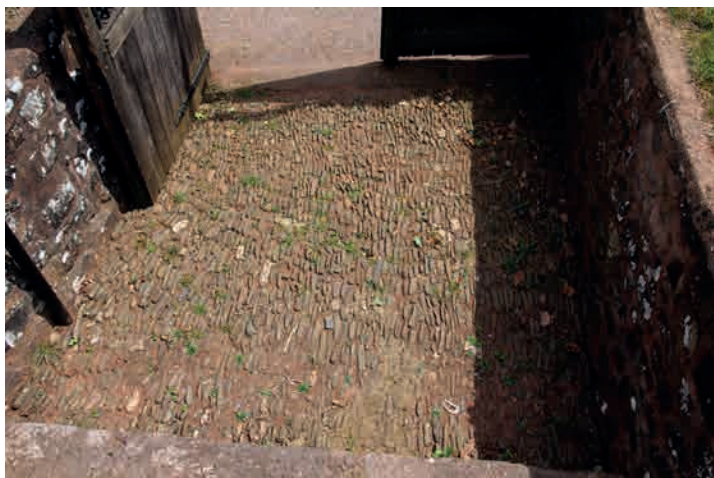
*Fig.45. A rare example of cobbles along the long axis of a surviving section of a cobbled footway at Chevithorne, Tiverton. The cobbles can be no earlier than 1843, when the church was built to the designs of Benjamin Ferrey.*

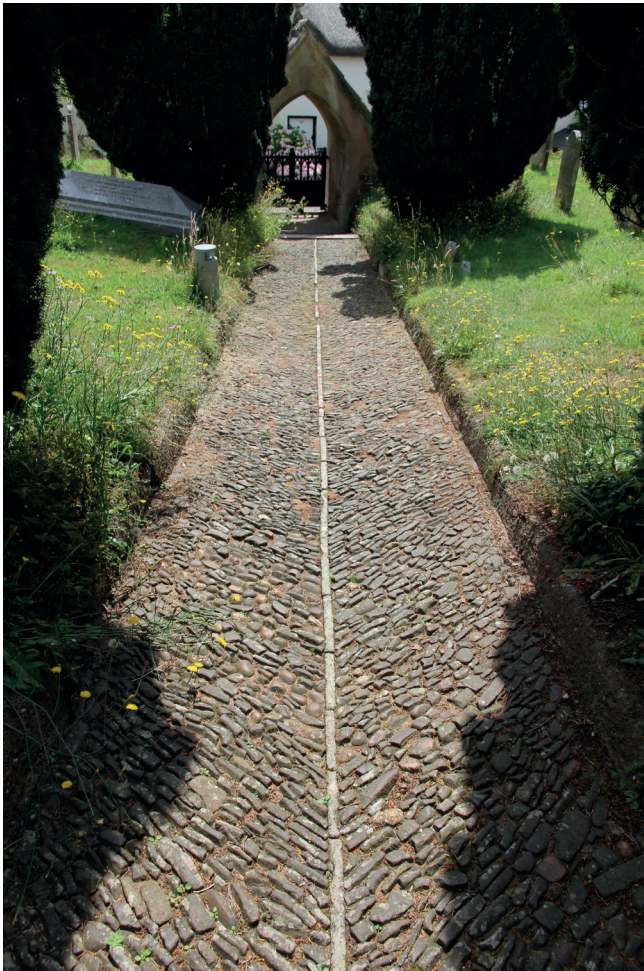
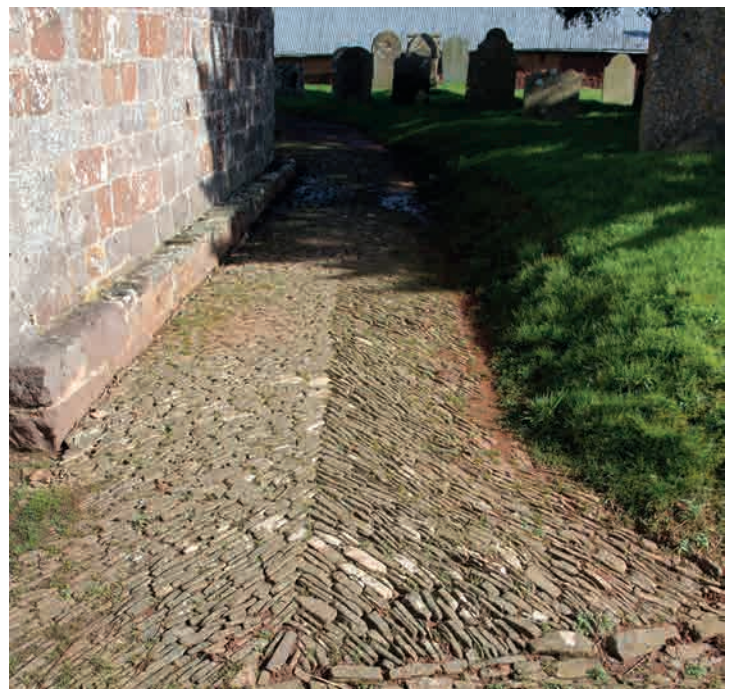
*Fig.46. Examples of the herringbone design. Sowton, St Michael (top) has a dressed stone spine; Colebrooke, St Andrew, right, has a notional spine. Herringbone paths are usually laid 'pointing' in the direction of the church.*

- Cobbling herringbone fashion, the cobbles laid to a centre point, which may be notional or material [Fig.46]. If material it is a spine of cobbles, single or (rarely) double. Sometimes the spine is constructed of dressed stones. Sometimes the spine uses cobbles of a different, usually white, colour. The 'arrows' of the herringbone are usually arranged to point in the direction of the church building.

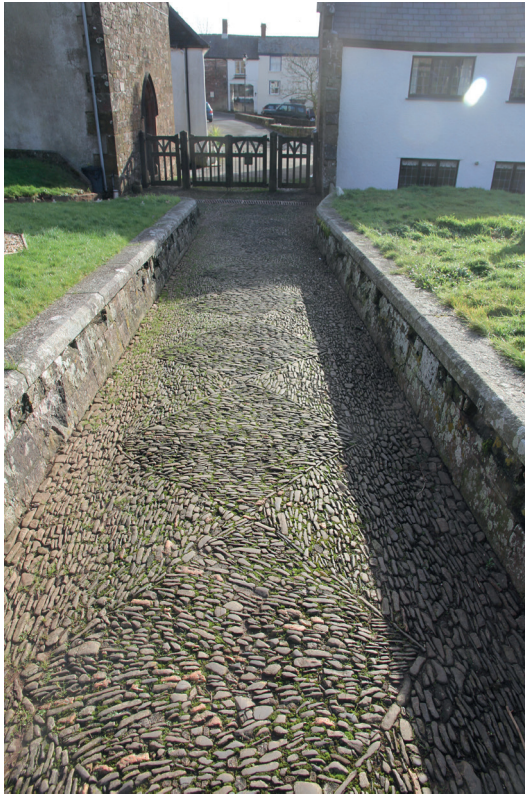
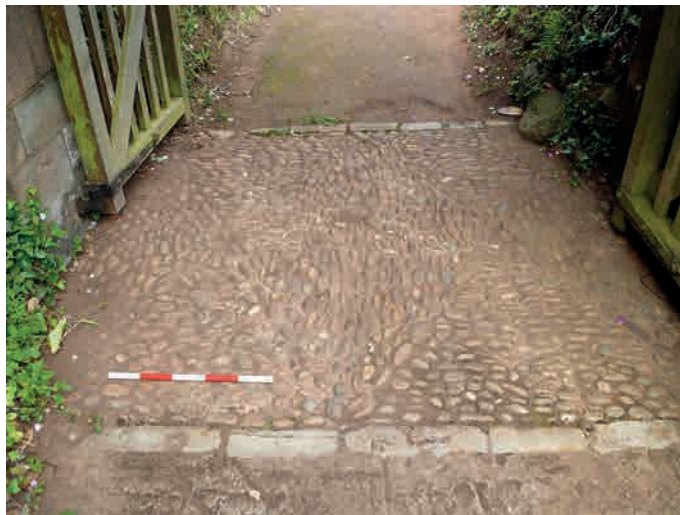
*Fig.47. Variations on the lozenge pattern. Clockwise from top left. Hatherleigh, St John the Baptist, has very large lozenges; at Inwardleigh, St Petrock, the lozenges are contained by tramlines of internal kerbs. The lychgate at Clyst Hydon, St Andrew has a lozenge pattern contrived in pebbles. These are always less striking than those designed using flattish-topped cobbles.*

- Patterned cobbles. The common pattern found is the lozenge [Fig.47]. In the sandstone river channel type of cobbles, lozenges are restrained by their own edge stones (internal kerbs) which form a border. The cobbles inside the lozenges are laid at right angles to the rest of the path. The lozenges may add structural stability to the path (*pers.comm.* Richard Burrows) and were probably laid first, the side cobbling then laid from outer path kerbs or a revetment wall up to the lozenges. In all cases but one the cobbles inside the lozenge are laid longitudinally. At Hatherleigh, where the lozenges are unusually large, the cobbles are laid across the path inside the lozenges and along the length of the path outside the lozenges. There are a couple of examples

where the lozenges are laid between tramlines of internal kerbs. Lozenges can also be found decorating the pebble-type of cobblestone but are less visually striking when contrived in pebbles that have a less obvious grain. Larger or longer stones are used to make up the lozenge edges but the patterns lack the linear contrast and counterpoint of the tile-shaped cobbles.

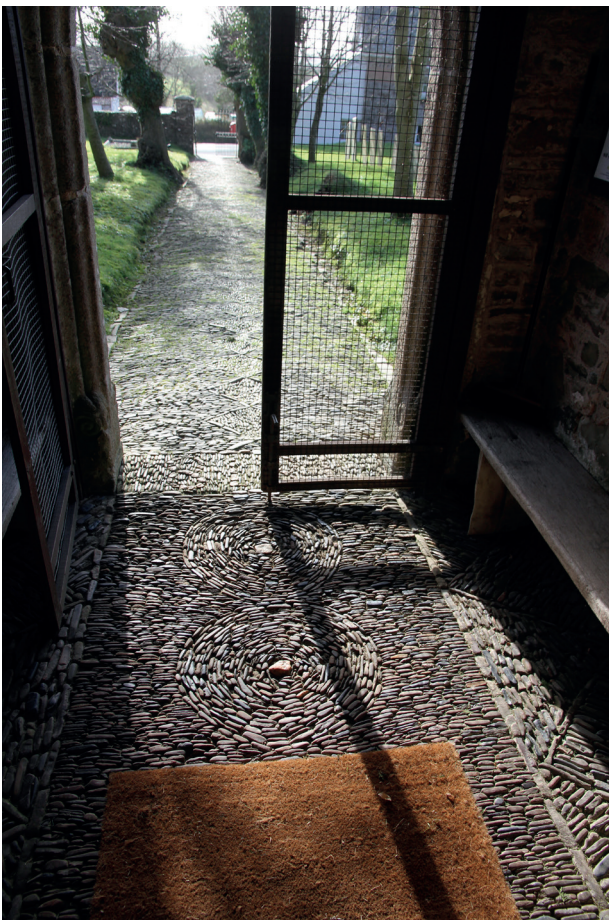
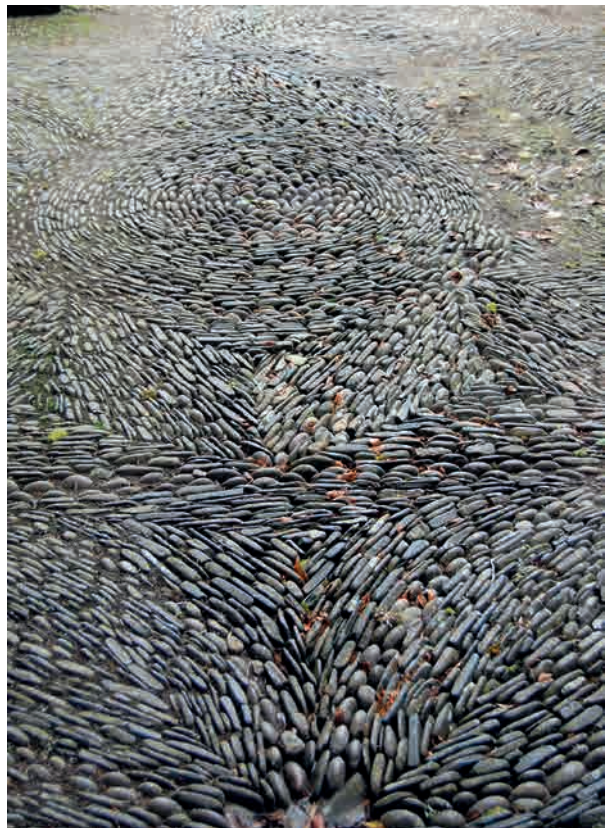
*Fig.48. Meeth, St Michael (top). A unique example of whorls, used here in the porch (cobbles dated 1818). A more elaborate version of whorls was used in a secular context at the Picturesque Swiss Cottage at Endsleigh, designed 1810 by Sir Jeffry Wyattville for the Duke of Bedford, with grounds laid out by Repton. Endsleigh cobbles photograph by Peter Marlow.*

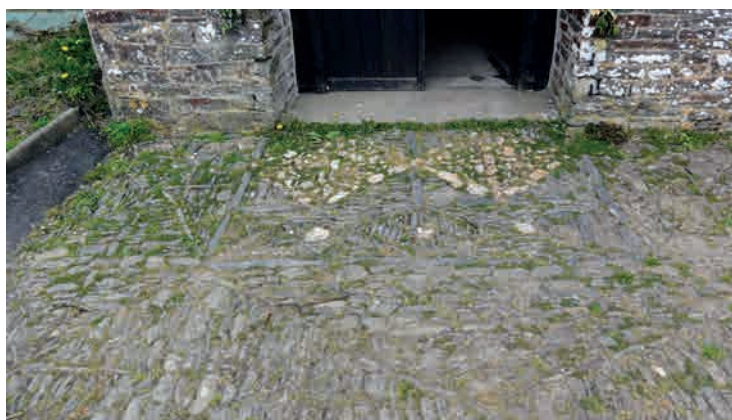
*Fig.49, High Bickington, St Mary. A rectangular cobbled 'doormat' incorporating lozenges and white quartzite cobbles. This mat is unusually elaborate. Semi-circular patterns are also often found.*

The entrance to the church porch is often emphasised with a pattern, e.g. lozenges or a cobbled 'mat', picked out with a semi-circle or rectangle: these may be subdivided by kerbs into patterns. The cobbled 'doormat' can also be found outside the front doors of domestic buildings. It is notable that the sense of the importance of the church entrance means that the cobbled 'mat' or perhaps just a small section of a cobbled path serving the same purpose, may be retained outside the south porch even when the principal path has been replaced with tarmac or cement [Fig.49].

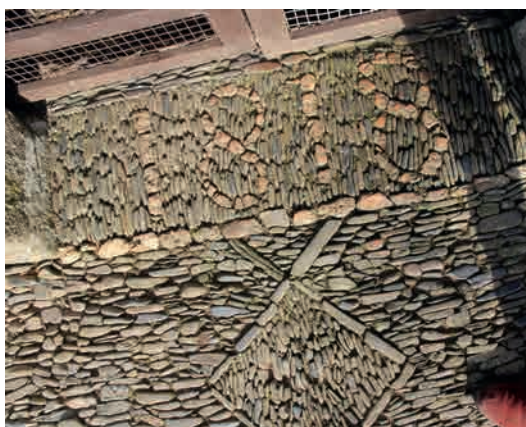
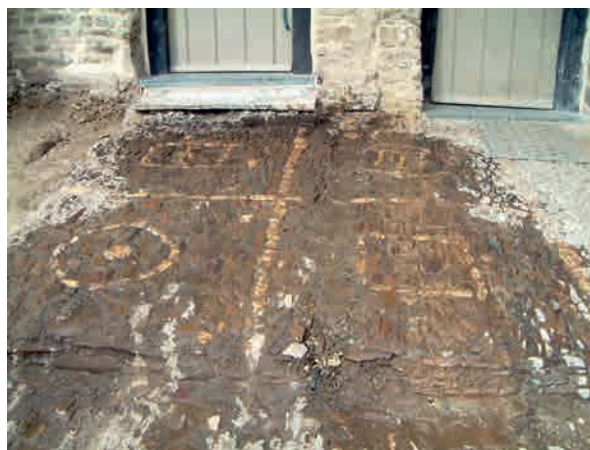
*Fig.50. White cobblestones for dates and patterns: Meeth, St Michael (above), 1818 date. White cobblestones used for decoration can also be seen in a Devon farmhouse setting (right). Jonathan Rhind.*

Cobbles of contrasting colour, usually, but not invariably white quartzite, may be used for modest decorative effects and , rarely, for initials and dates [Fig.50].

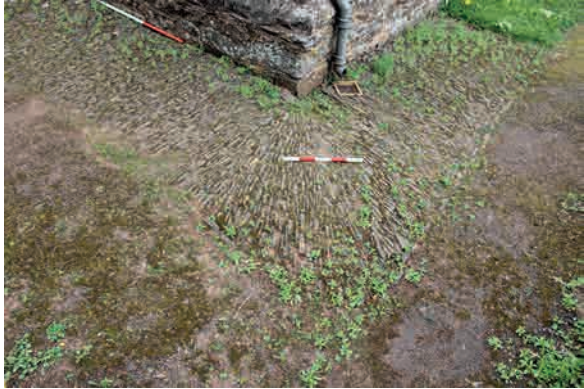
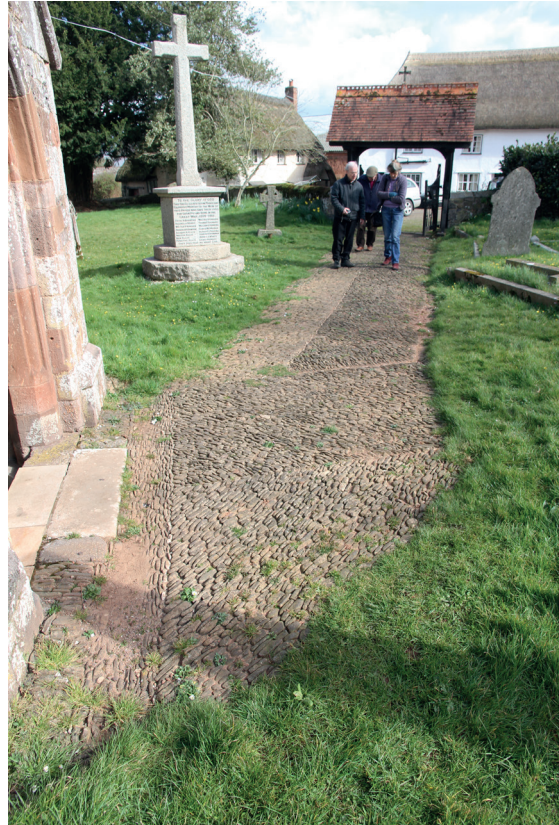
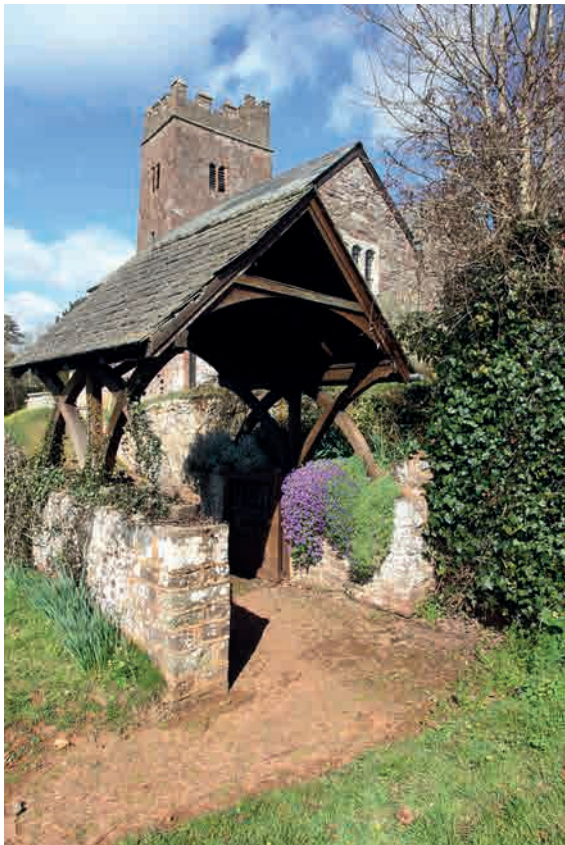
*Fig.51. Changing direction. At Newton St Cyres, St Cyriac and St Julitta (top left), the cobbled apron round a vestry of c.1920s date turns a corner of 90 degrees in the form of a fan. At Upton Pyne, Our Lady (right), internal cobblestone kerbs create a junction where a path turns a corner and the cobbles on either side are laid in different directions. At Upton Hellions, St Mary (bottom left), a path turns one right angle before arriving at the lychgate and another as it turns to the church porch. The cobblestones are laid the same way along the whole length of the path, so they lie at right angles across the main section of the path, but on the long axis on the short sections of path before the lychgate and the porch.*

The small size of cobblestones and the use of internal kerbs allows a path to change direction in several ways and far more easily and economically than a flagged path [Fig.51].

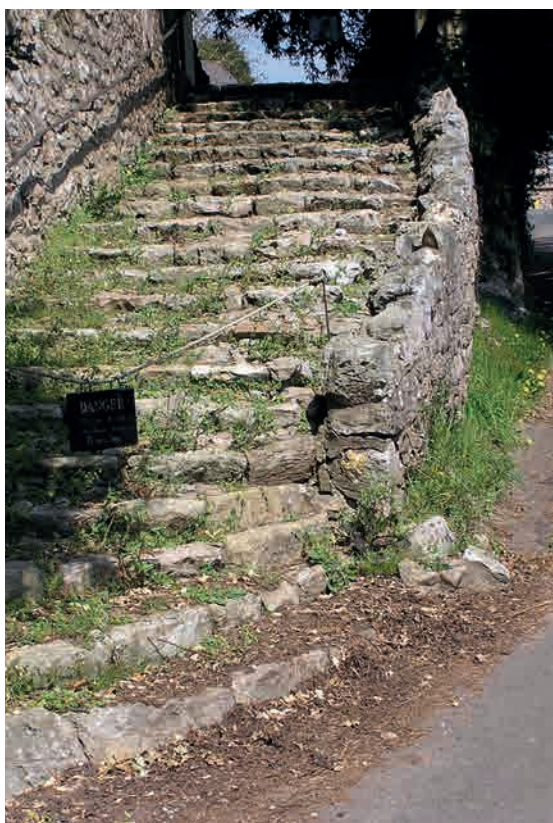
*Fig.52. Various flights of cobbled steps. This page. Offwell, St Mary (left), closed for safety reasons; Dunchideock, St Michael and All Angels (right). Nest page (top), Sandford, St Swithun, showing a cobbled village pavement and the steep rise of cobbled steps to the S porch and (below) South Tawton, St Andrew, cobbled steps as part of a very fine Arts and Crafts lychgate of 1903. These examples of cobbled steps show how cobbles can morph from the vernacular into the polite, satisfying the principles of Picturesque as well as Arts and Crafts architecture.*

Devon's topography means that some church paths rise steeply to the church porch. This can exacerbate access problems. Some cobbled church paths are quite steep. The steepest gradients are managed with cobbled steps. Examples of steps range from the rustic with large undressed stones used as the risers, to more refined examples with dressed granite or freestone risers [Fig.52]. Gradients may be managed by laying the tread of one step low to a kerb projecting from its surface, and the next step up slightly higher to it. This provides a series of vertically projecting kerbs as risers, helpful in visually identifying the steps but also presenting a series of trip hazards.

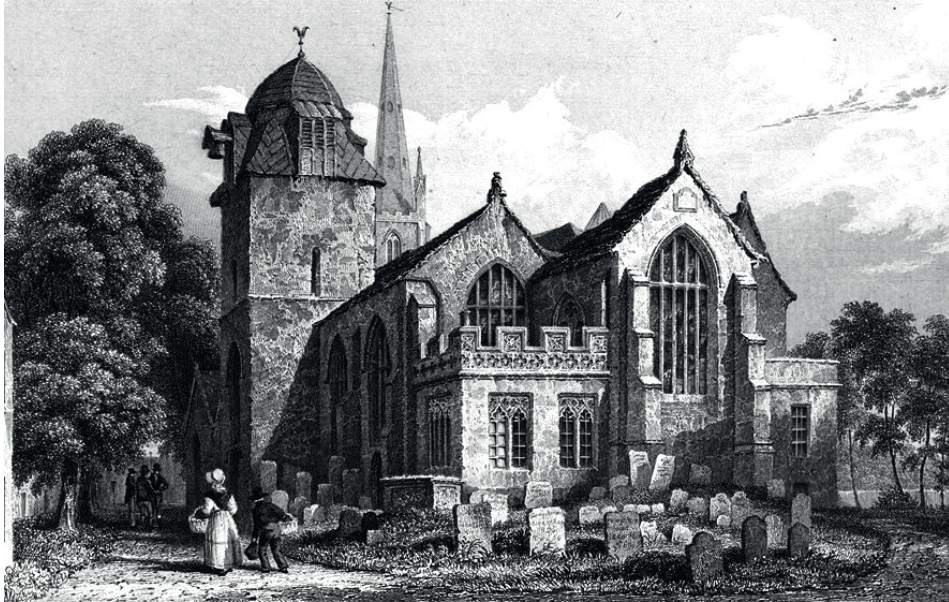
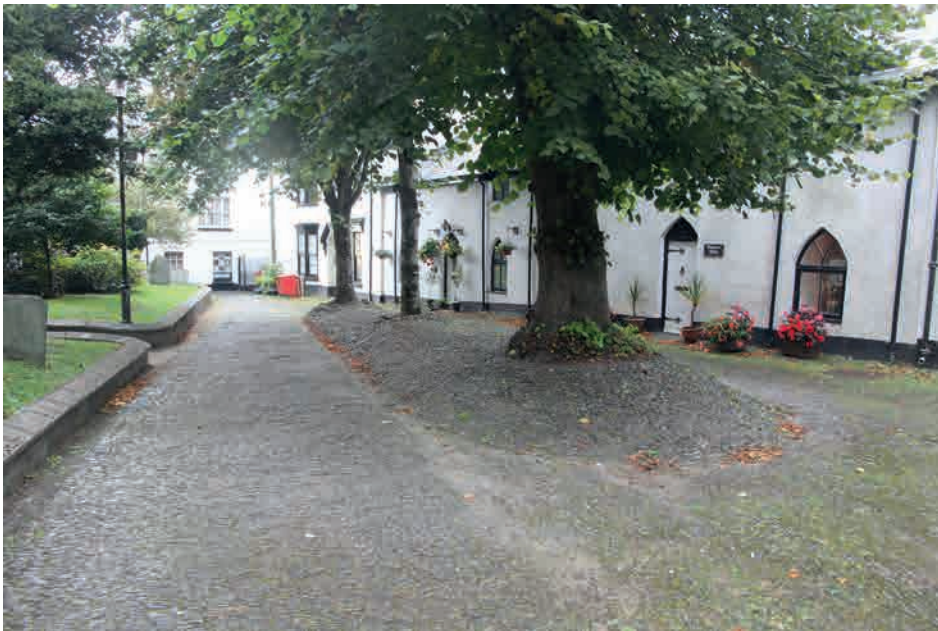
*Fig.53. Great Torrington, St Michael. The trees on the left of the 1831 engraving (top, looking W) are on the same site as the trees in the photograph below (taken looking E). The revetment wall to the churchyard turf is not shown in 1831 and, like the tree mound and paths in the photograph is probably 1870s on documentary grounds.*

At Great Torrington the roots of a row of trees that separate two cobbled paths in the churchyard are mounded up with cobbles. This mound is reputed to be the site of a Civil War mass burial. An 1831 engraving suggests that the 'trays' for the two cobbled paths on either side of the trees may have been dug out after 1831, the cobbled mound helping to retain the trees, planted at a higher level, by preventing soil round the roots from washing away, the permeable bedding allowing oxygen to reach the roots [Fig.53].

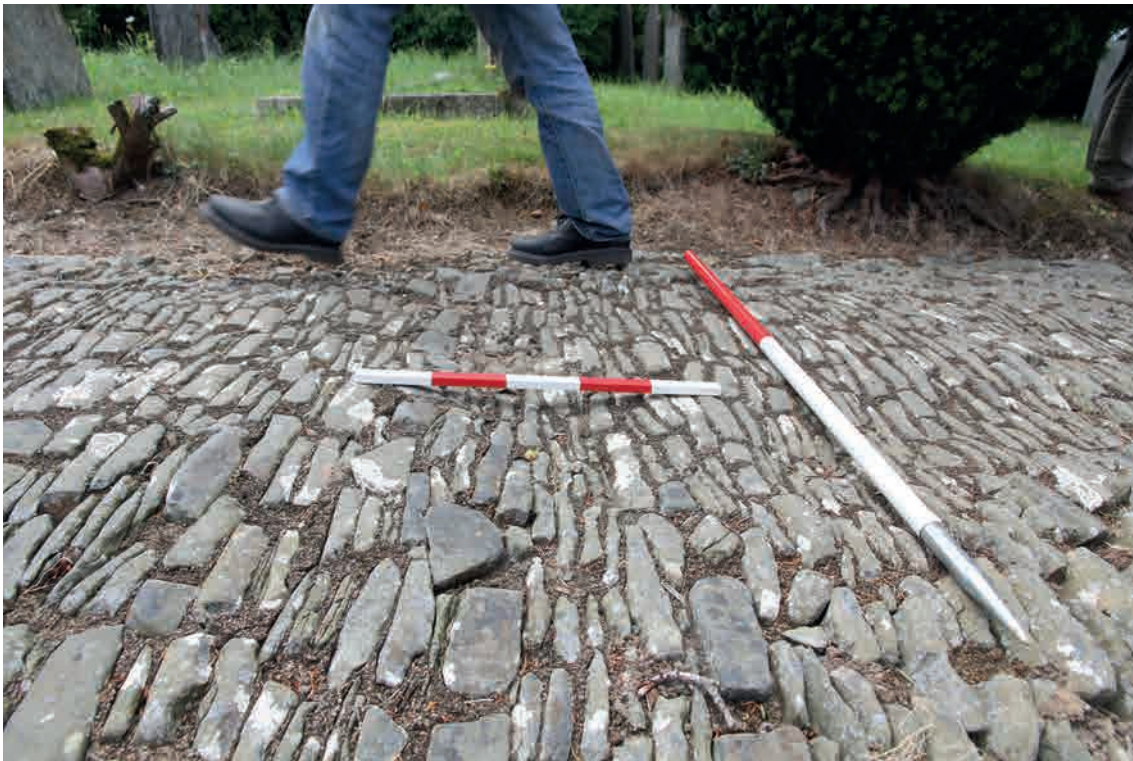
Fig.56. Slumps in the path at Merton have occurred without fracturing the pavement.

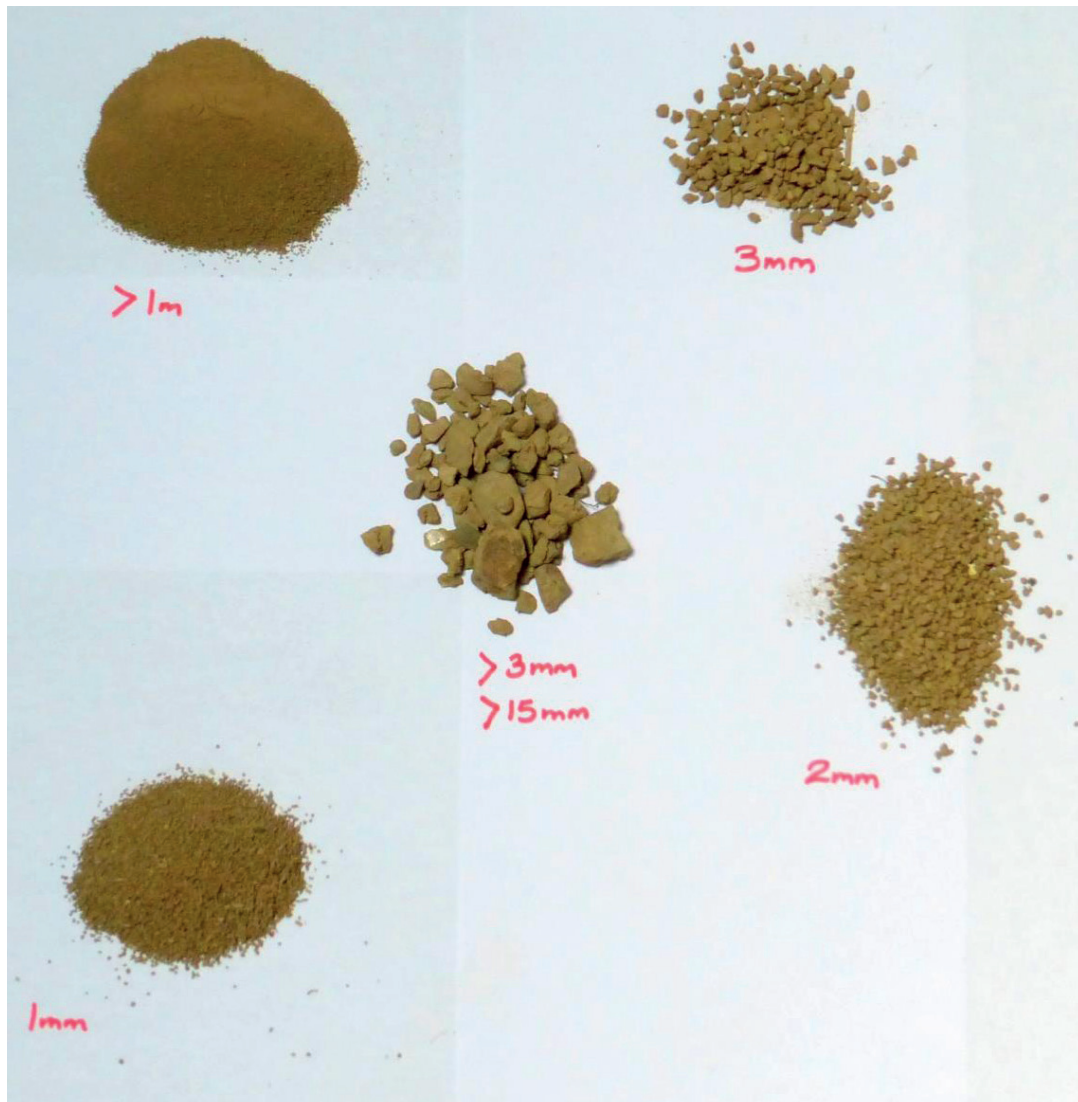
*Fig.58. Analysis by John Alexander of the components of the earthen matrix at Merton. More detailed analysis from this and other sites is needed to better understand the composition of the earthen matrix for bedding and jointing above formation level and how this contributes to performance. John Alexander.*

To date much more is understood of how to lay cobbles than about the earthen material used to bed and joint them, other than it should be sub-soil and certainly come close from the site. Only after some simple sedimentation tests at various sites have been done, to establish comparative levels of sand/silt and clay present in path bedding and joints, will it be possible to safely move towards specification of works. Some tests to examine the amount of water held day-to-day in bedding and joints and to examine scour out could also be worthwhile [Fig.58]. The latter might indicate if the swelling of the clay mineral element in the jointing material actually helps to stop more water passing through it and protects the path bedding and formation levels from becoming saturated.

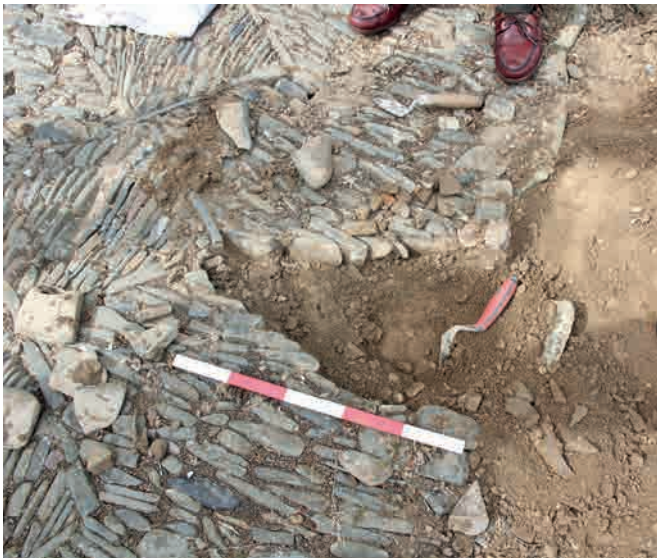
*Fig.59. Left, excavation of the 2-phase Merton path revealed a sub-base incorporating small stones above formation level for the cambered, patterned section only. Below, sketch of the Merton camber by John Alexander. The section of plain path had gritty sand only in the bedding.*

At Merton where a sunken area in the cambered, patterned path was lifted and examined, foundation material incorporating aggregate was found within the tray. This consisted of an ochre-brown sandy/clay composition containing small blocks of the local hard sandstone, few of which were larger than 3-4cms in both directions [Fig.59]. A number were square or oblong but most were irregular and smaller. It was impossible to be certain, but it may be that in the centre of the cambered path the sub-base was deeper than at the sides. The sub-base was topped by another course comprising the bedding matrix material for the cobbles as well as the cobbles themselves. It is not known how varied the gauge of aggregate in the sub-base may be from path to path. Excavation of domestic cobbles at Moistown, Broadwoodkelly, revealed a substantial layer of large irregular stones below the (external) cobbles [Fig.60]. An agreement of 1804 with builders for Eglad House, Awliscombe, east Devon has identical specifications for both the floor of the back kitchen and the 'whole of the court and offices' 'to be pitched with flint stones [chert, presumably] well bedded in gravel and well rammed', clearly requiring gravel aggregate.<sup>8</sup> Unfortunately, none of the cobbles are now visible (*pers.comm.* John Thorp) so the size of the gravel cannot be determined. Bedding in ashes is also recorded and a layer of ashes was found at formation level in an excavated cobbled path at Tiverton, St Peter. Practitioners report examples of no aggregate in bedding or it may be gritty sand only. Merton has a two-phase path and the phase adjacent to the lych gate was characterised by cobbles set directly on about 6 inches of subsoil to which only some gritty sand had been added. The question of how much and what size of aggregate is most effective in the sub-base and/or bedding and jointing material remains to be answered.

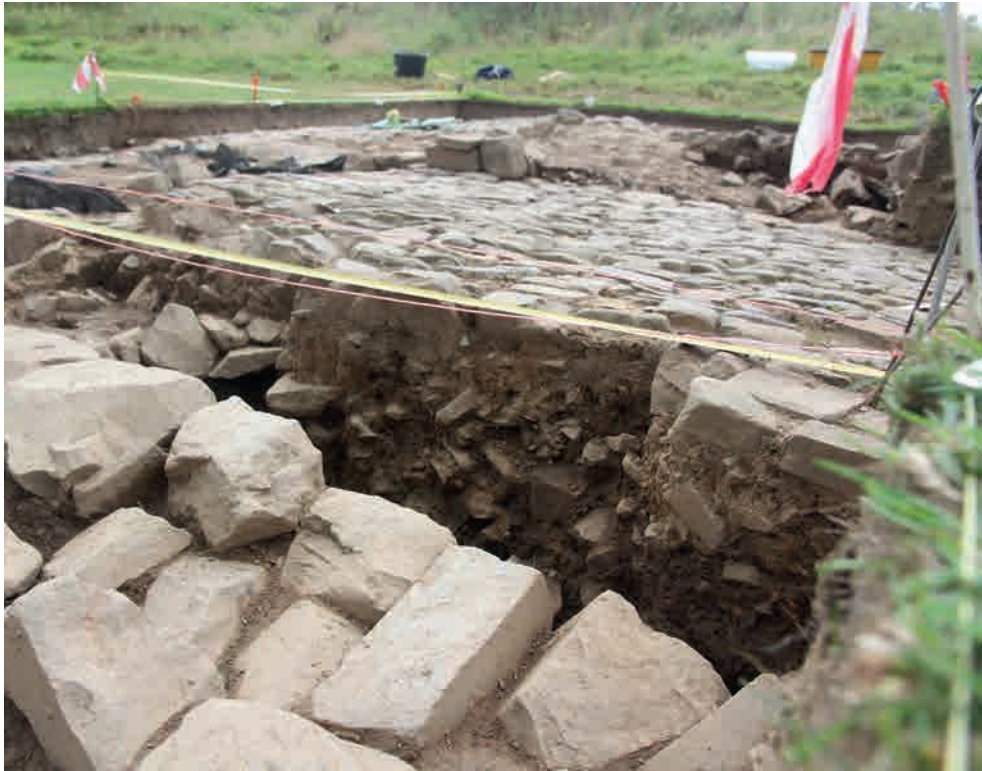
*Fig.60. Recent excavation by ACE Archaeology Club of a wing of a house abandoned by the early 20th century at Moistown, Broadwoodkelly. This revealed a sub-base incorporating large stones beneath large, coarse interior cobbles. Interior and exterior cobbled paving on this site has not yet been phased.*

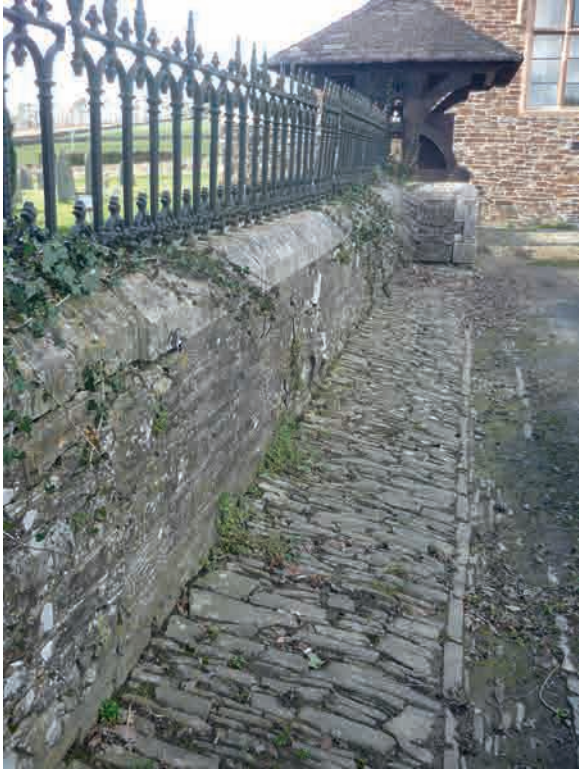
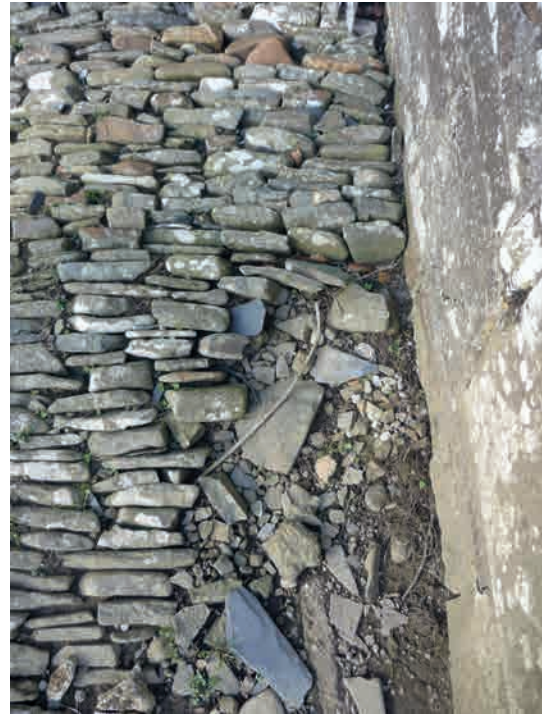
*Fig.61. Examples of jointing scour out. This may be localised, e.g. (top) the sloping cobbled apron to the Victorian churchyard wall at Merton has retained most of its earthen jointing except (top right) where water from the lychgate roof has washed it out, some of the cobblestones eventually falling out of the matrix. (Below) a more general washout of jointing with a deposition of silt and clay which has collected in a shallow gutter between two sections of path.*

In certain circumstances rainwater running over paths was noted to have eventually begun to scour out joints leaving stones standing side by side looking like so many bared teeth [Fig.62]. Cobbles are usually laid across the path at right angles to its direction but occasionally they are laid parallel to it. Scouring-out between joints was often noticeable where path-water was flowing with, rather than against, the grain of the cobbled surface. It was also observed occasionally where cobbles were laid in the favoured herringbone pattern. In addition it seems that in some cases water running the length of a path had picked up sufficient momentum and volume to start scouring-out between cobbles as it approached the path-foot. Localised chronic bedding washout can be found where water drips from the eaves of a church building or lychgate onto a path [Fig.61]
