# Devon Cobbled Churchyard Paths

Evaluating their Significance,  
Survival and Adaptation

A project undertaken by  
Keystone Historic Buildings Consultants  
for Historic England and SPAB

March 2016

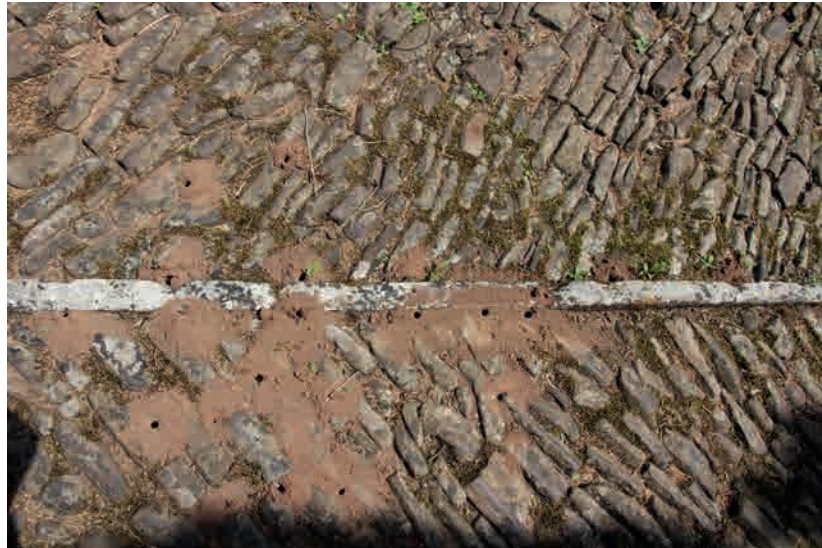
*Fig.62. Insects at work at Sowton. Bees or wasps are nesting in the jointing material, throwing up casts onto the cobbled surface. As with earthworm activity this will affect the density and composition of jointing material and may make the cobblestones shift.*

Weed growth followed by weeding (see below) is likely to contribute to bedding loss. Earthworm and insect activity in the sub-base or jointing may loosen it by creating air pockets. At Sowton, small bees or wasps were observed flying in and out of the bedding and throwing up sandy casts on the cobbles [Fig.62]. As with extensive worm activity, losses or changes of composition in the earth matrix may eventually encourage cobblestones to shift position and cause slumps.

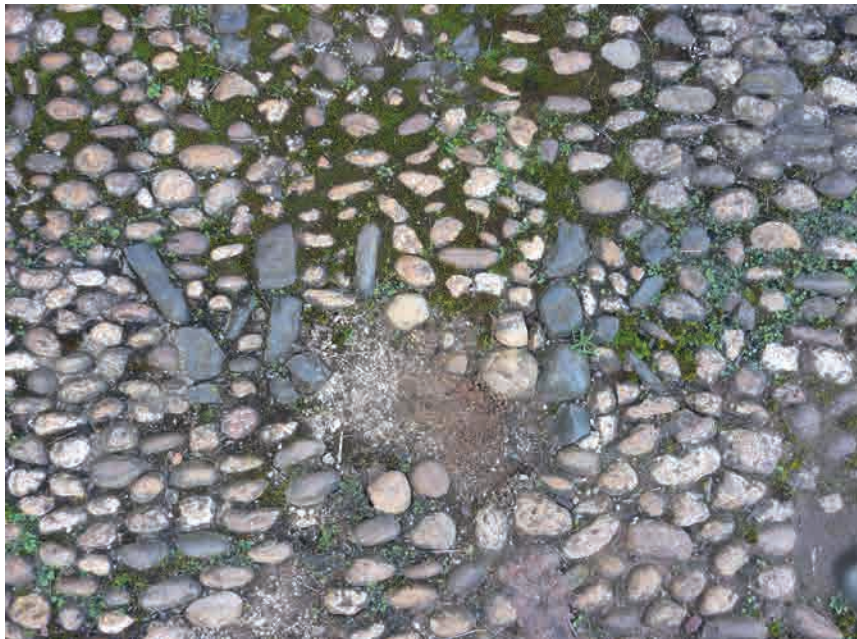
*Fig.63. Some types of cobblestone may be able to withstand jointing loss better than others. Very small pebble-shaped cobbles at Poltimore are easily dislodged if only a small loss of jointing occurs.*

Given that replenishing jointing by brushing in more material seems not to be practised as an element of maintenance, it is surprising that some paths with considerable losses of jointing have remained intact. Presumably this is due to the practice of laying cobbles touching one another and therefore locking them together when rammed. The shape of pebble cobbles means that they are less likely to be locked together and less able to withstand jointing loss [Fig.63].

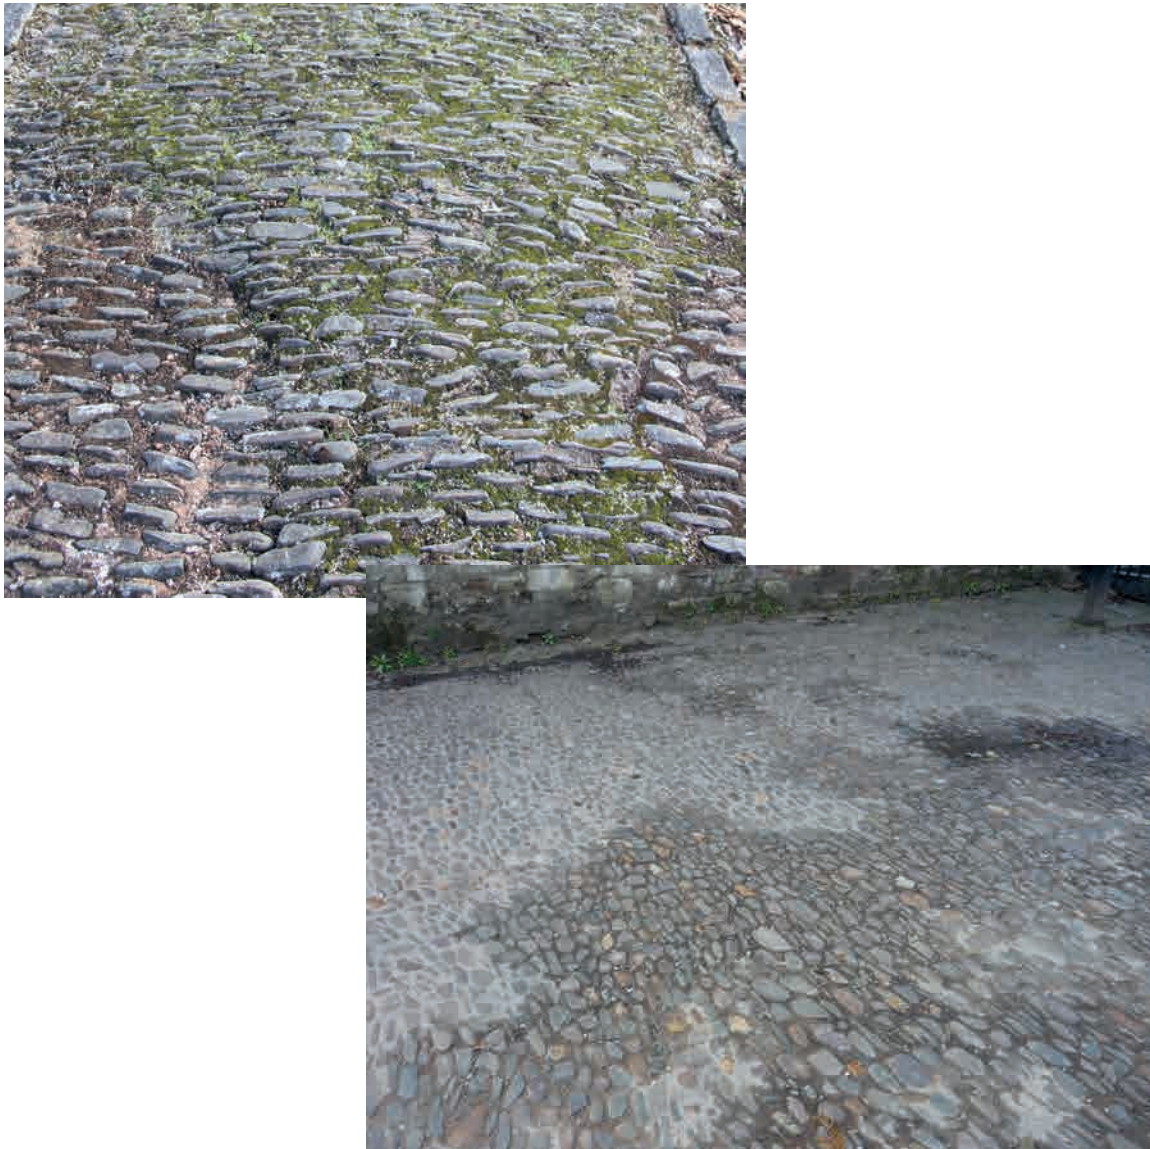
*Fig.64. Well-meaning repairs in cement create rigid patches in a flexible pavement, speeding up jointing scour at the junction with the earthen jointing. This is illustrated at Tiverton St Peter (top) and more comprehensively in a semi-secular context at Cathedral Close, Exeter where the extent of cementitious jointing may eventually damage the path down to and beyond the formation level: note the top right slump.*

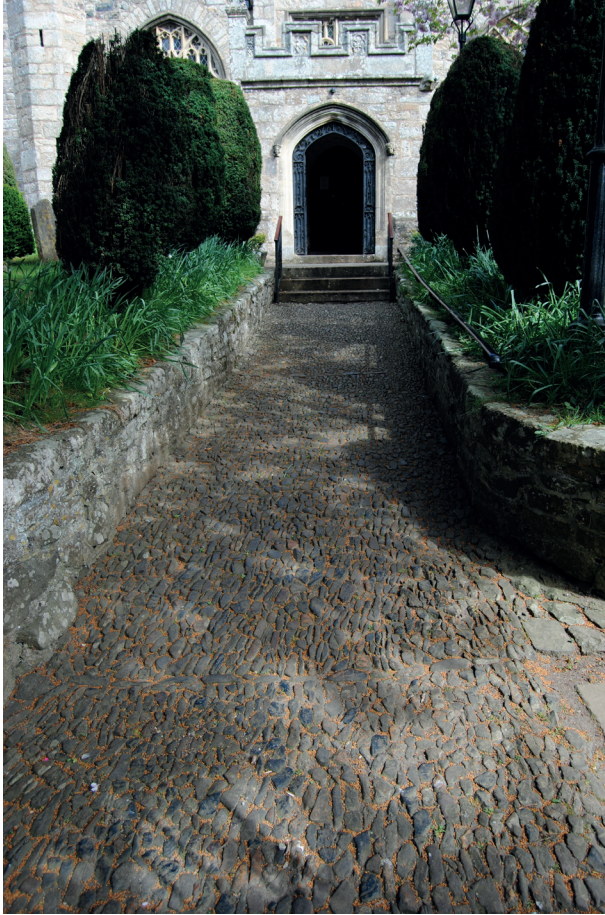
*Fig.66. Path drainage here follows the direction of travel of the cobbles making use of a gradient from porch to churchyard boundary.*

The great majority of churchyards investigated were on sloping terrain so the completely flat path, free from gradients, is rare. The herringbone pattern, pointing uphill, may help to direct water to the sides of paths. There are quite a few places where there is only a modest rise in the ground between churchyard boundary and church porch. The construction of the pavement of these paths could be of the simplest. They do not always have a crossfall to throw water off to one side and away from the pedestrians' feet and pavement surface. Water flows down the length of the path, perhaps to be diverted away at the low point or to simply run out under a lych gate, over a step, or steps, down to a highway [Fig.66]. This is the arrangement also with some of the steeper, and also some subsidiary, churchyard paths.

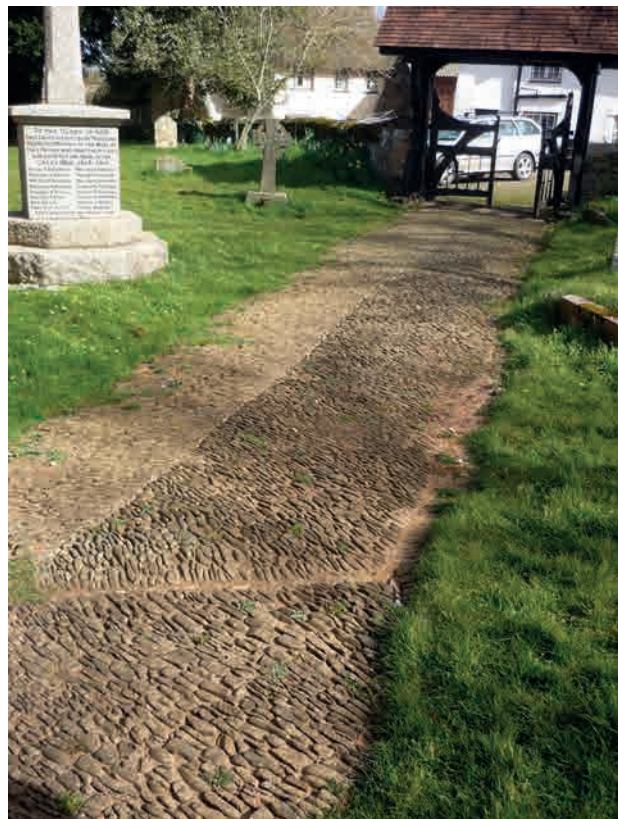
*Fig.67. This path (Upton Pyne) has crossfalls from the centre line to each side. Water falling on it is channelled to a diagonal junction in the paving in the foreground. Here and at the junction with the grass, jointing material scoured out from between the cobbles is deposited. We did not investigate the path edge detail, if any.*

In the slightly more complicated 'straight crossfalls from the centre to both sides' arrangement, a pretty common regional detail is a spine of cobbles set up along the centre line of the path. This is the high point and from it the cobbling slopes straight down to the kerb lines on each side of the path [Fig.67]. Sometimes the spine is omitted, the cobbles of the opposing slopes meeting and butting against each other along the centre line.

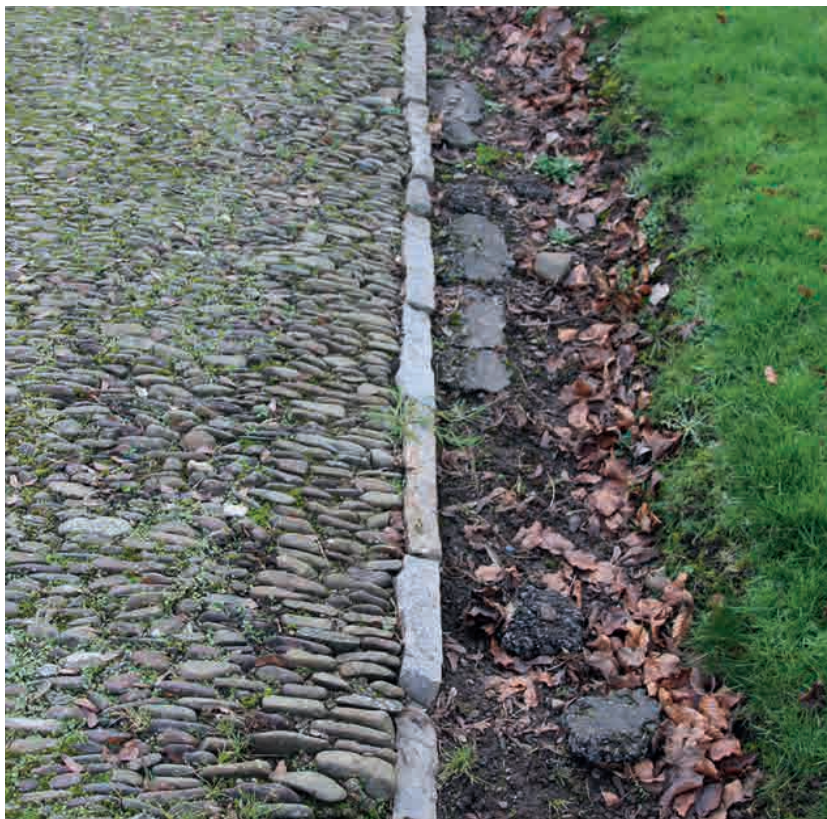
*Fig.68. Open gutters either side of one of the paths at Tiverton, St Peter with evidence of disintegrating asphalt lining. The edge restraint of dressed stone kerbs looks substantial but these are overturning into the gutter, probably for a second time as the cobbles adjacent to the kerbs appear to have relaid after an earlier failure.*

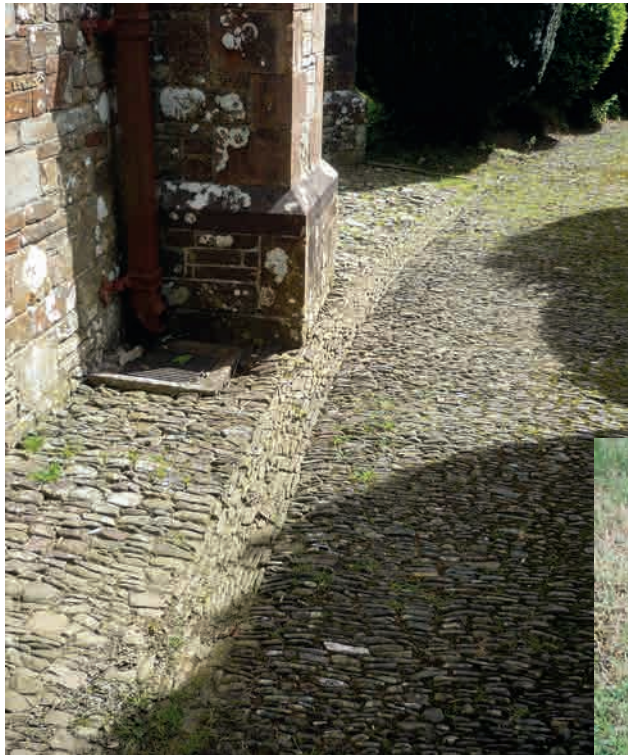
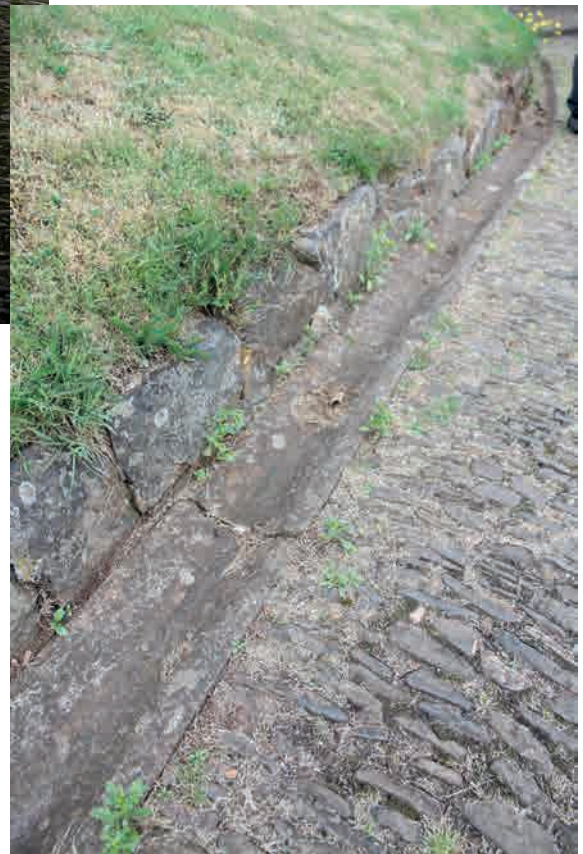
*Fig.69. Examples of open gutters which also function as edge restraint. Clockwise from top left: a cobbled gutter at Petrockstow; a stone gutter at Hatherleigh and a ceramic gutter at North Molton.*

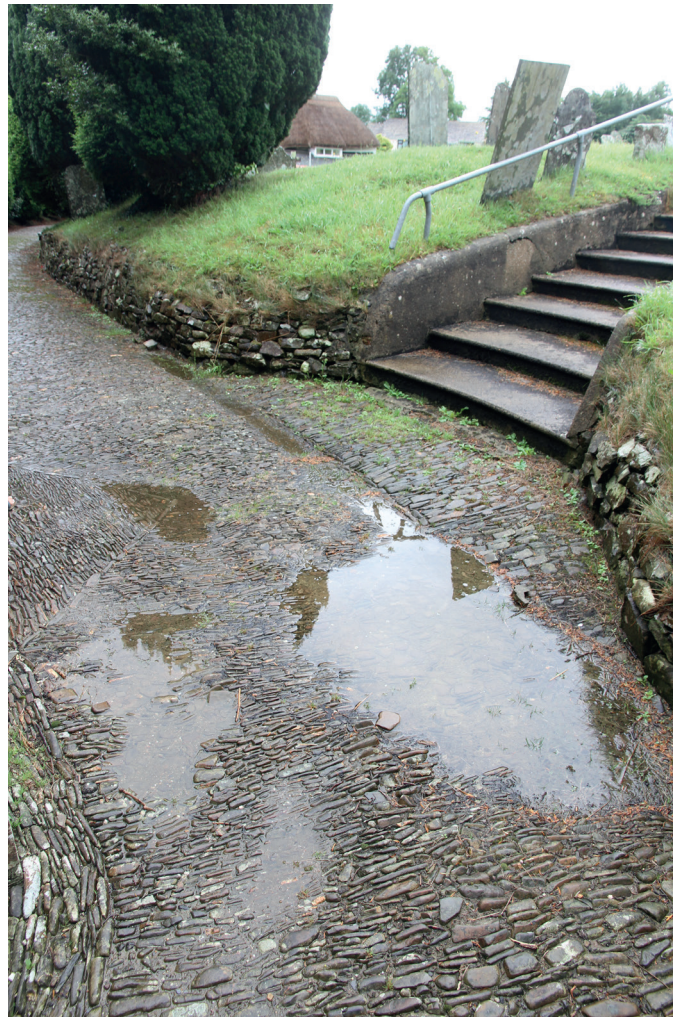
*Fig.70. An uncommon example of a group of water-filled sinkings after rainfall at Petrockstow.*

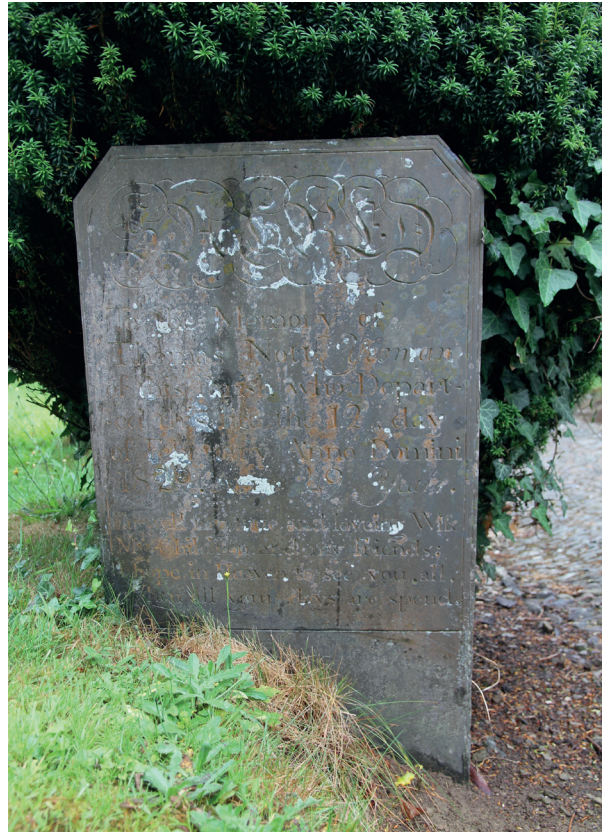
*Fig.71. The scribing line on this 1870s headstone adjacent to the path at Merton indicates that the expected depth of the installed headstone below turf level has been altered, the turf angled back, altering the form of the earthen gutter alongside the path. An old photo (c.1900) shows that the turf was originally revetted with what appear to be large, thin stones. How much impact these changes have made to the cobbled path is not clear. It is possible that the gutter has lost some form of lining.*

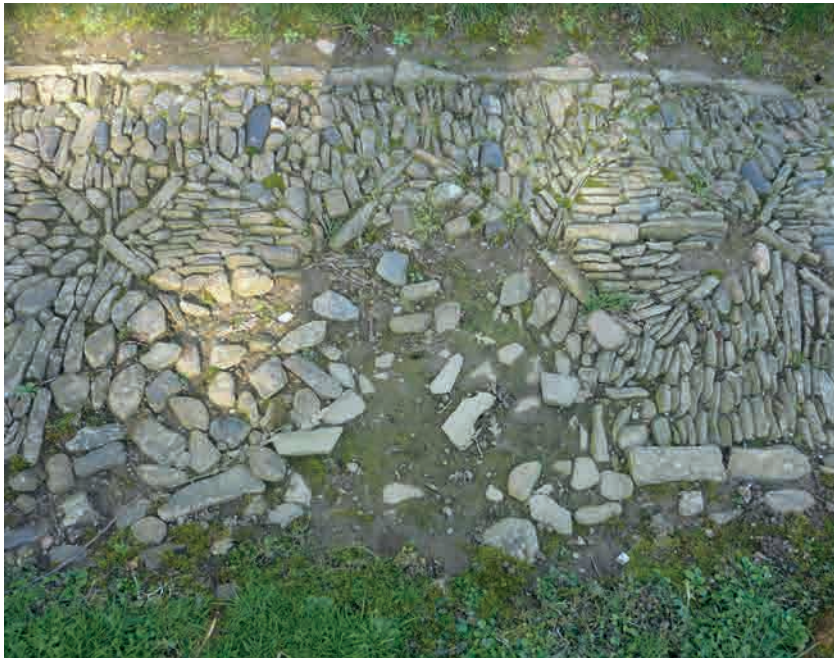
*Fig.72. The curious 'floating apart' of one of the paths at Huish may relate to poor churchyard drainage. When visited all the Huish paths had fleshy weeds growing out of the jointing.*

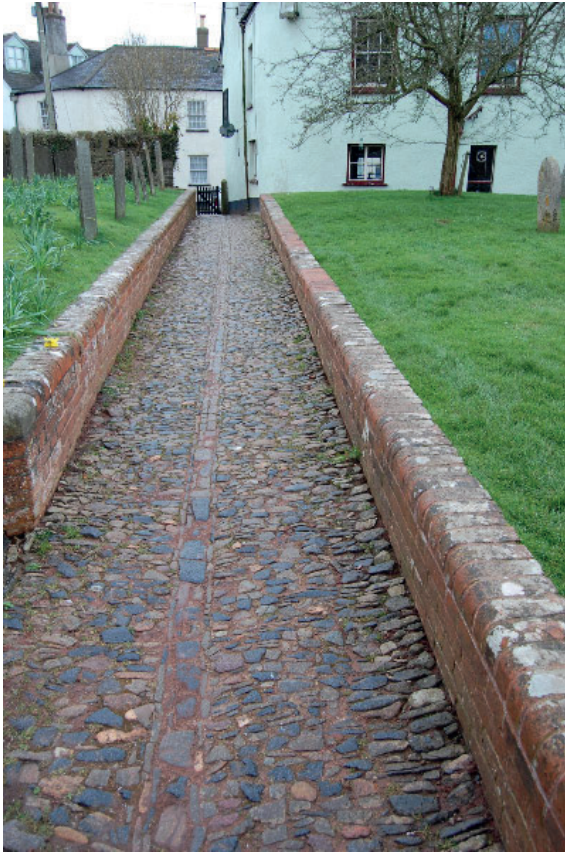
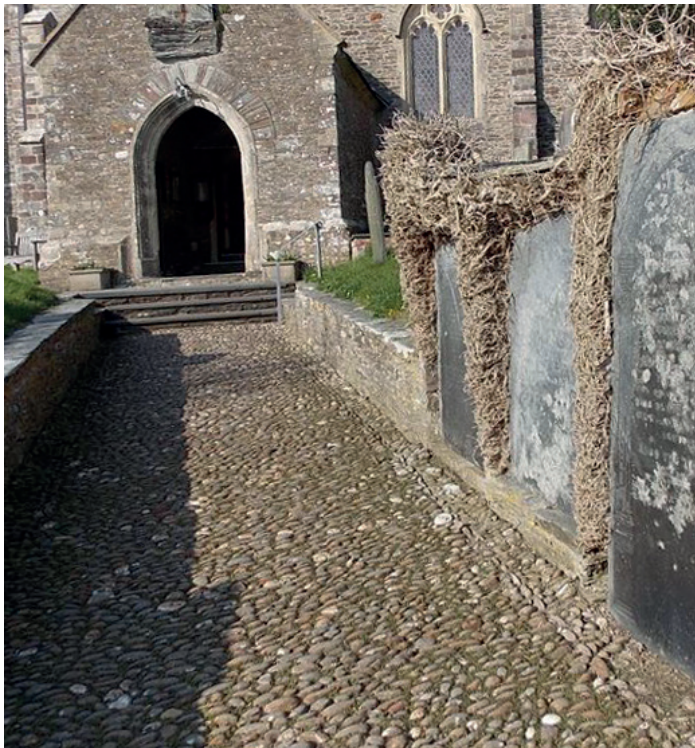
*Fig.73. Paths between revetment walls that provide stable edge restraint are generally in better condition than paths with various types of small dressed or undressed stone kerbs.*

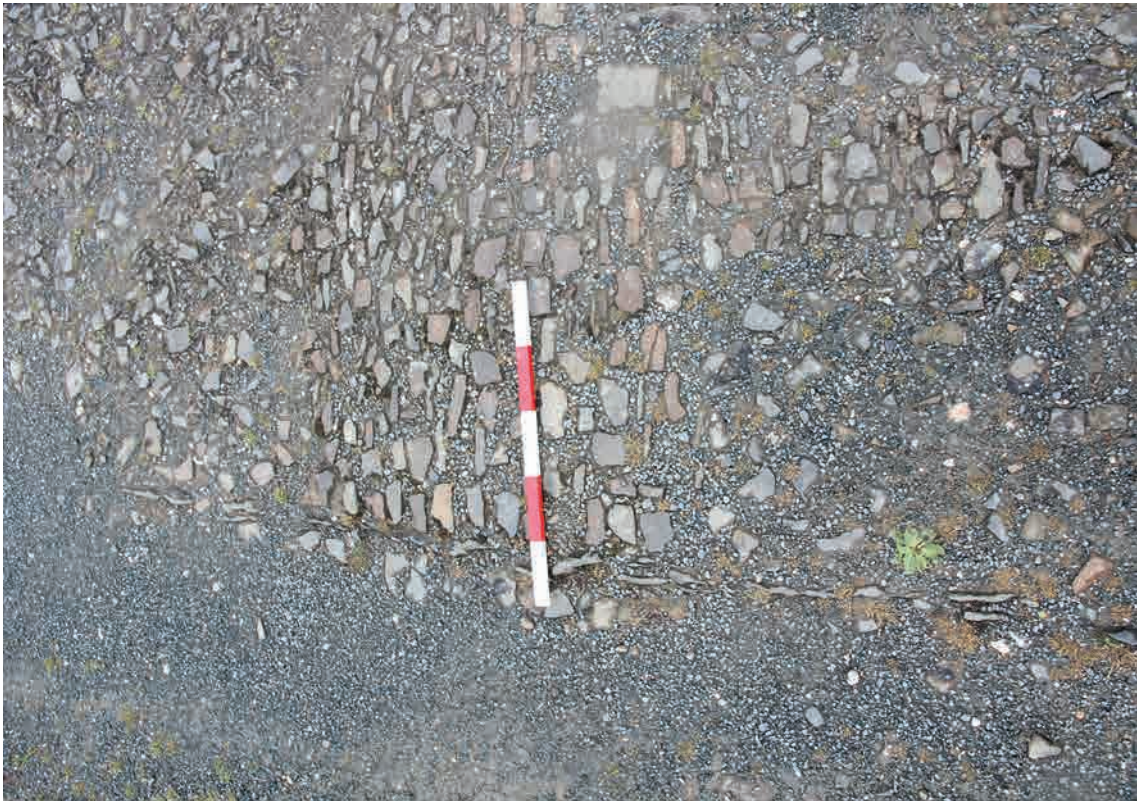
*Fig.75. The remains of a cobbled path to the church at Merton through what was once a school playground but is now a car park. This has maintained upright kerbs buttressed by the car park material.*

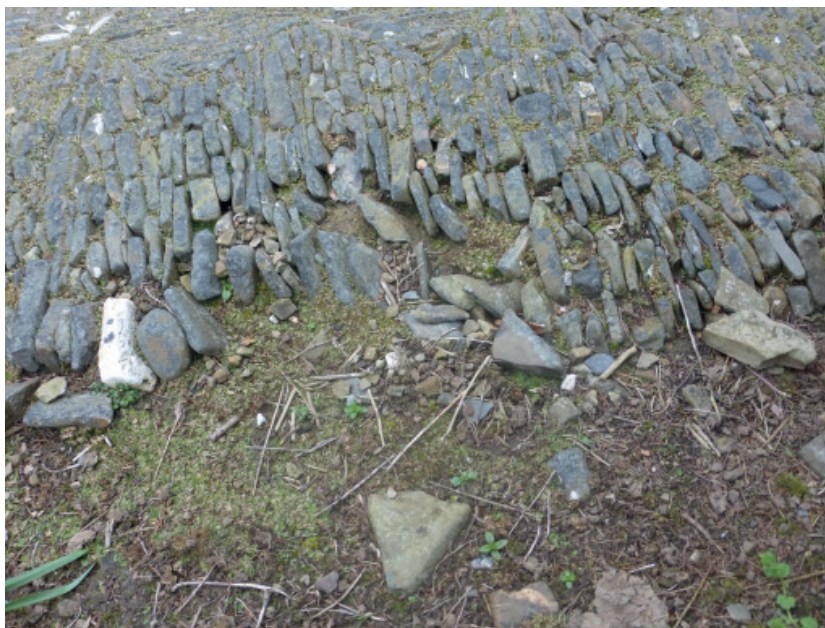
*Fig.76. Path kerbs to the churchyard path at Merton have overturned, a common failure and, in this case, dispersed, along with part of the cobbled path surface.*

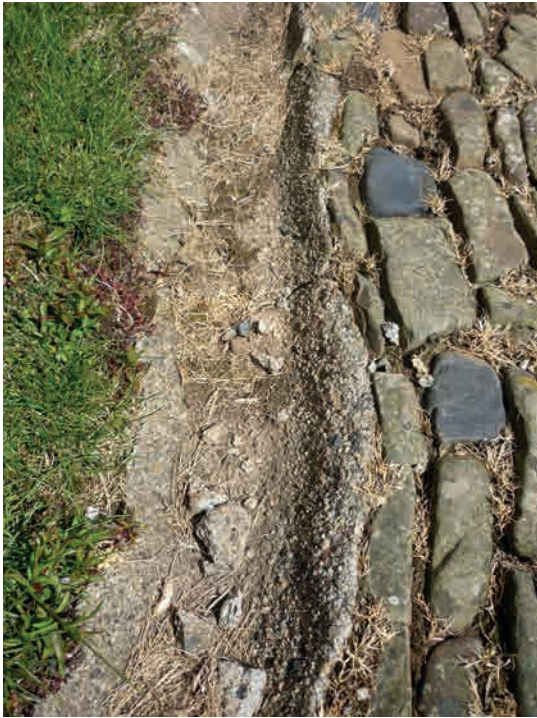
*Fig.77. Several of the Tiverton gutters formed in the ground surface adjacent to the path were once lined with asphalt. It is not known whether this lining was primary or an amendment.*

The failure of kerbs is very common. At Merton, inside the churchyard, the lack of a deep, buttressed, kerb foundation, the extra outward pressure developed within the cambered pavement and the scouring away of soil from alongside the outer faces of the kerbs by rain water coming off the cambered path and flowing downhill on and next to it, had over time combined to cause the kerbs to 'overturn' outwards [Fig.76]. The same problem can be seen in a number of church paths. The outward overturning of much more substantial worked stone kerbs at Tiverton, for the same reasons, has already been noted. Here there had been a definite intention to arrange path-side gutters alongside, and set down from, the path kerbs. But these kerbs appeared to have been laid in 'earth', probably topsoil. Some sections were in the process of rolling down into the earth-formed gutters next to them, loosening adjoining path surfaces in the process. There were signs that at least one length of gutter had once been lined with asphalt [Fig.77].

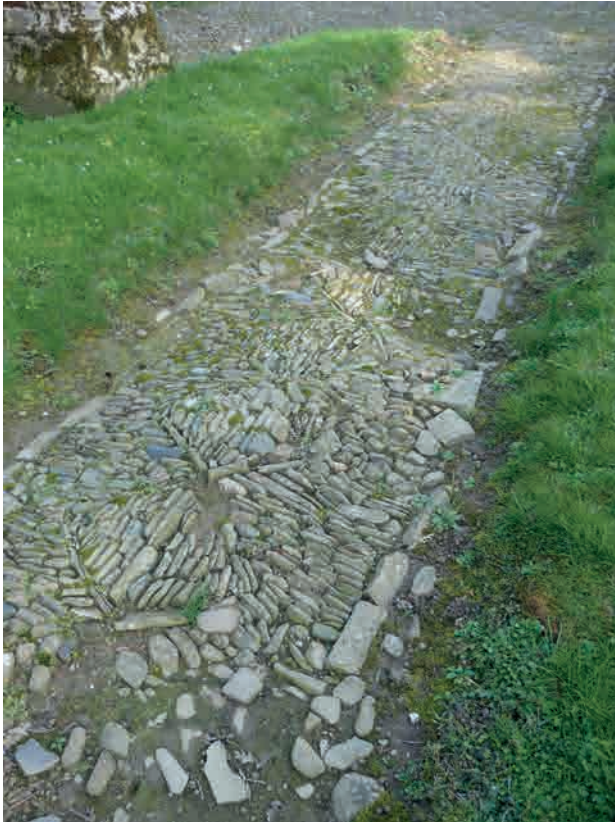
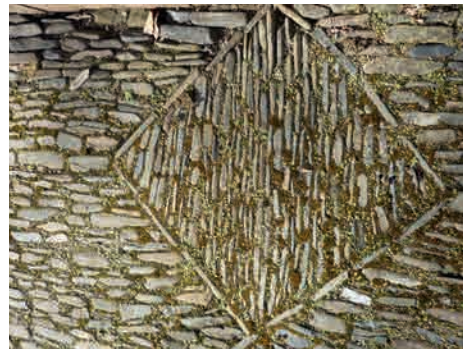
*Fig.78. Path destabilisation at Huish inside the churchyard (left). Curiously, the large cobbled court outside the churchyard boundary, used for car parking, appeared to be in very good order (above), perhaps benefiting from the weight of vehicles.*

Kerb failure by rolling, or otherwise moving outward, invariably destabilised the surrounding path surface. Often the effect of rain had caused exposed areas of matrix material left behind by the kerb to slump out too, this in turn dragging out more of the matrix and then the cobbles themselves. At Huish once very attractive and relatively flat paths in various states of failure were observed. Some examples showed the start of the process while others showed its virtual end, this being the dispersal over the ground of all or most of the path components [Fig.78].

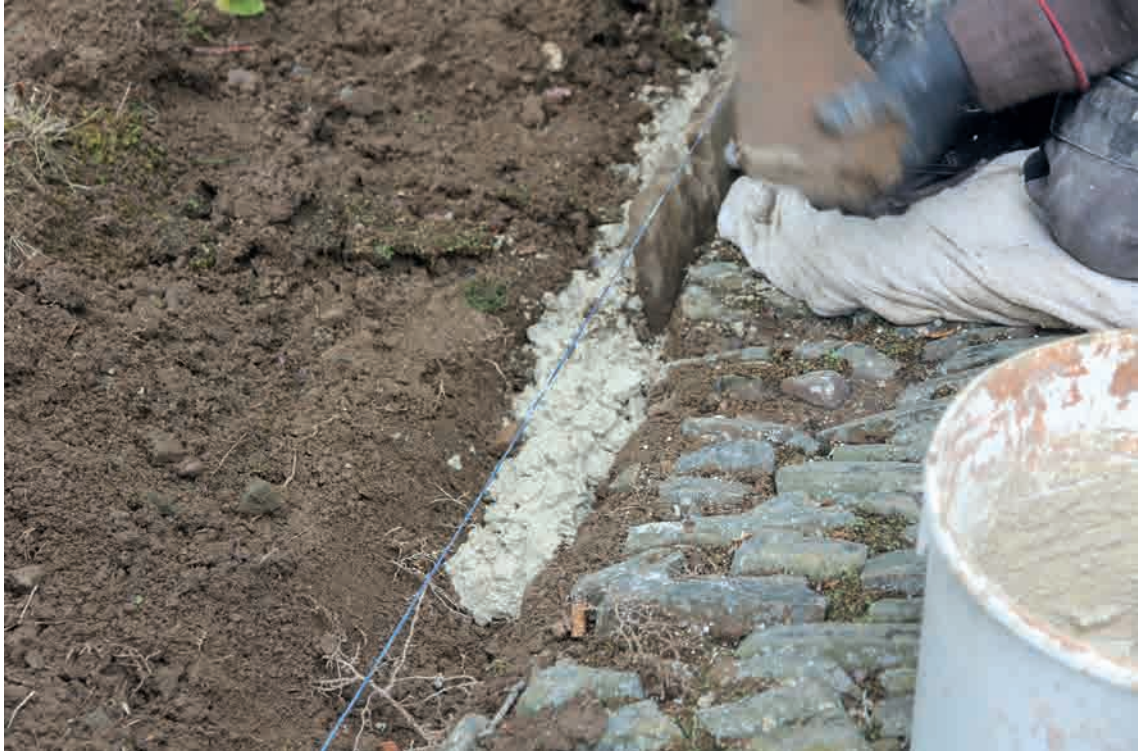
*Fig.79. Trial re-laying of kerbs at Merton by Williams and Burrows, trials funded by the SPAB and undertaken under the supervision of John Alexander. On the S side of the path the kerbs were reinstated with haunching using lime. The N side kerbs were relaid using subsoil and some buttressing with small stones.*

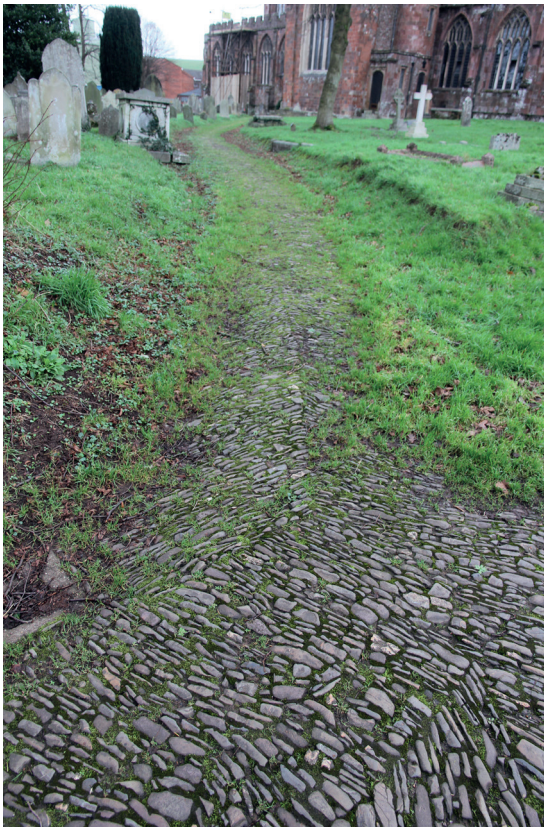
*Fig.80. A sub-path at Crediton disappearing as grass invades from the sides. Next page (top), a highly-Romantic route to Buckland Brewer church beneath coppiced trees. The cambered path is carpeted with moss and most church-goers prefer to use an alternative route. Below. A fleshy weed growing out of the jointing of one of the Huish paths.*

Many paths observed were surprisingly free from weeds. Other paths, particularly little-used sub-paths or paths at remote churches with few users and visitors, were disappearing under grass. Over time weed growth (along with any rotting organic matter that stays on a path) will turn sub-soil jointing into humus-rich topsoil, encouraging more plant life. Footfall helps to keep plants from gaining a hold. In the past salt was commonly used to keep pavings clear. Today weedkiller can do the job, although substantial dead weeds and grass may need to be brushed or pulled out afterwards and this can deplete jointing material. Laborious hand-weeding is also employed on some paths (*pers.comm.* Churchwarden from Meeth).

levels of the earthen cobble jointing against wash out by rain. Usually grass invades from the sides. As noted earlier this tendency may be another reason for the presence of the earthen ground gutters found alongside paths, perhaps produced by the repeated chopping back of grass at the path edges, although some may be primary features of paths. If left completely unattended-to, paths can disappear beneath grass which will cover the cobbles as well as the bedding. One or two of these were noted in the gazetteer and it is suspected that many more survive but were not identified. Providing deep rooted weeds do not gain a foothold as well, and perhaps if the grass is cut occasionally, this may not necessarily be damaging to cobbled surfaces and provide a reasonably firm surface for footfall in dry weather, but a potentially slippery grass surface in wet weather.

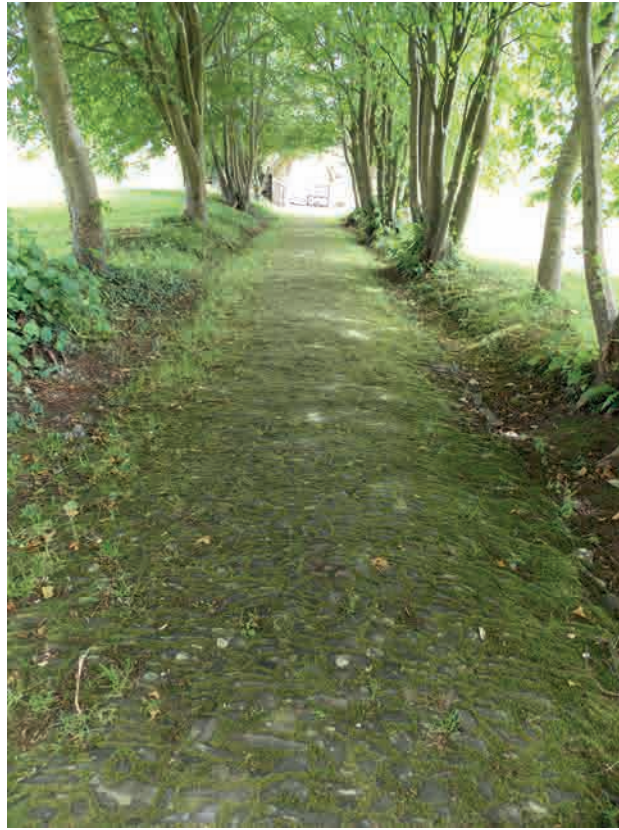
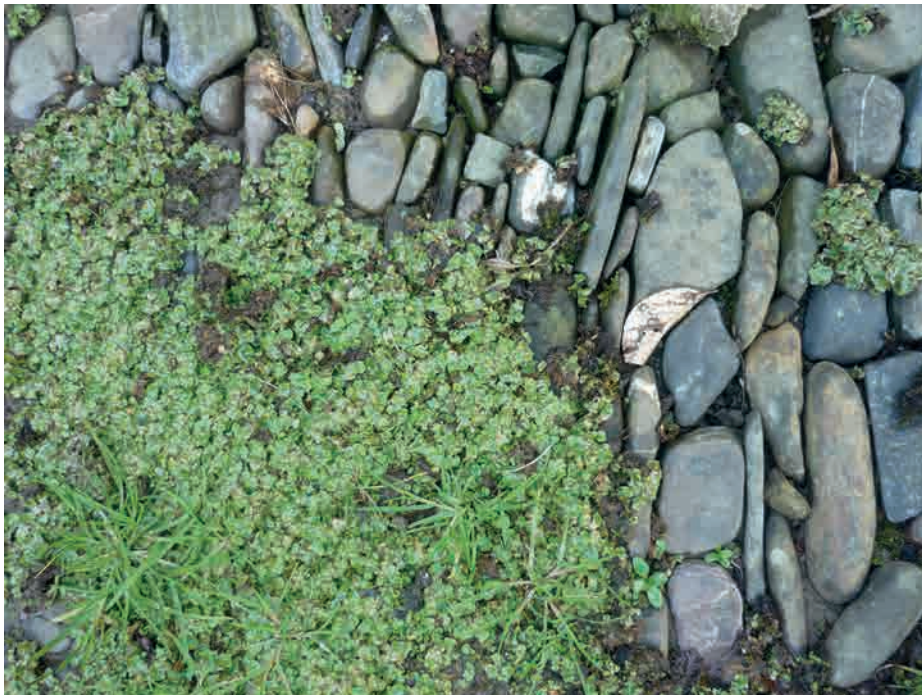
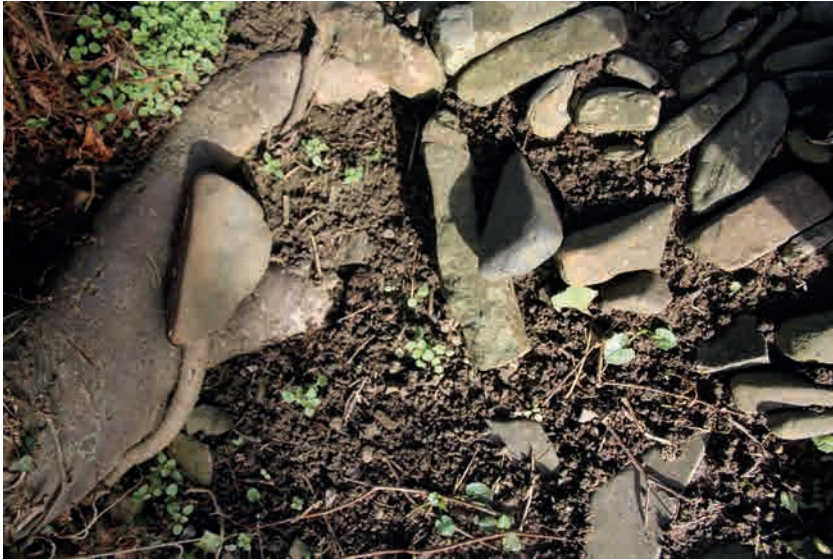
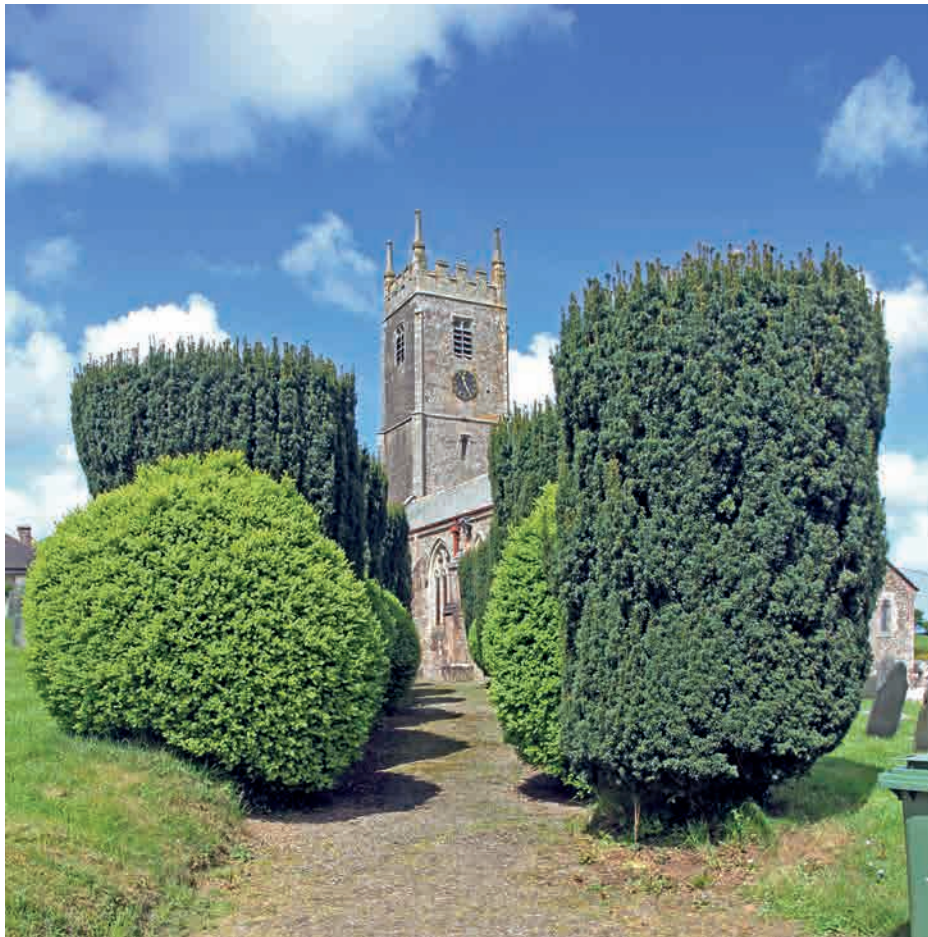
*Fig.81. Top. Tree roots disturbing cobbles at Meeth. Below, the narrowing of the Petrockstow path from the spread of yews interplanted with box.*

The 19th century fashion for tree-planting alongside paths can be very attractive but has several undesirable impacts on cobbled paths. Shade and obstacles to ventilation encourage moss and other plant growth in the joints between the cobbles. Leaf litter or needle litter from yews, if not cleared away, will create humus in the jointing material. Tree roots can disrupt cobbles. Trees and shrubs planted close to a path and not kept cut back can eventually narrow a path to the extent that it may be unusable for any processional purposes and tricky for an individual to negotiate.

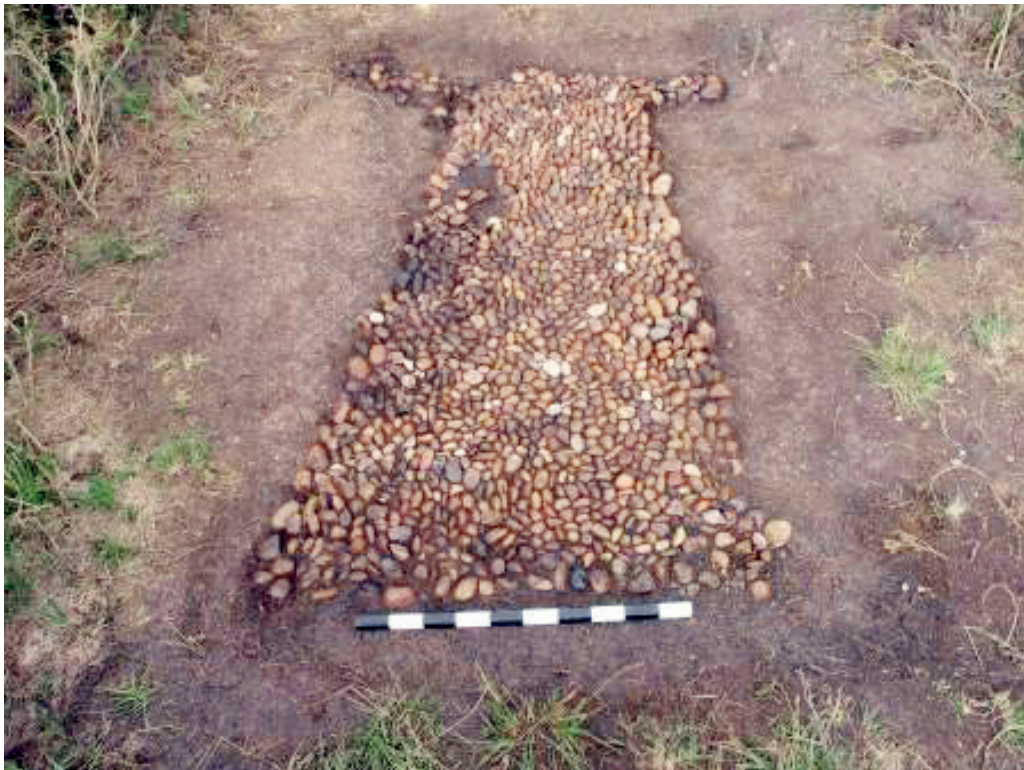
*Fig.82. The middle bronze age cobbled platform is 2.8m long and wide enough to accommodate a body, narrowing at one end where there are two curious pebble 'horns'. Radiocarbon dates from birch charcoal 1460-1310 BC and 1390-1120 BC have established a middle Bronze Age date. The pebble platforms may be part of a ceremonial complex related to earlier prehistoric constructions and it has been suggested that they might have been used for excarnation (removing the flesh and organs of the dead). Reproduced with the permission of the Devon Pebblebeds Project.*

The earliest evidence of cobblestone surfaces in the county is known from archaeology and comes from middle Bronze Age pebble platforms under earth mounds. These were first identified by George Carter in Aylesbeare parish in 1937 and in 2010 the East Devon Pebblebeds Project examined and recorded a platform revealed by swaling [Fig.82]. Apart from being the earliest example of cobblestone paving known in Devon, the method of construction is of interest. Large pebbles form restraining kerbs to the platform: these are laid horizontally. The pebbles inside the kerbs are laid long side down in a sub-base of clay mixed with reddish sand laid on the grey natural subsoil. The pebbles are laid with only their tops showing. Archaeology has identified cobbled Roman street surfaces in Exeter. A fragment of one of

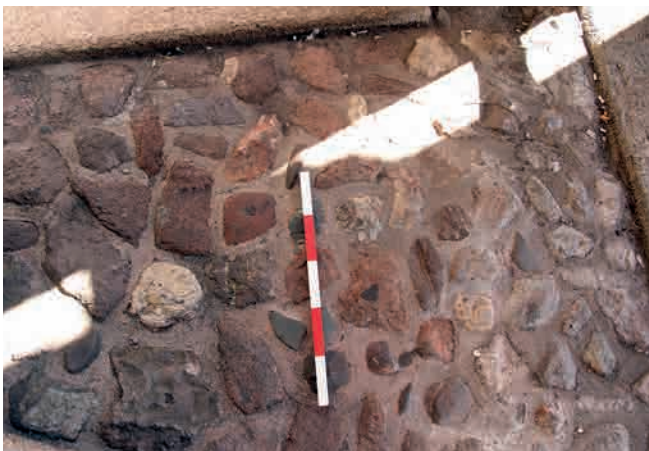
*Fig.83. The relaid cobblestones from a Roman Road surface in Exeter are large, some more than 20cms on the surface and include irregularly-shaped pieces of the distinctive red conglomerate found at Heavitree on the eastern outskirts of Exeter, some purplish volcanic stone, found on the south west side of the city (Poccombe stone) and one or two water-worn stones probably pulled out of the River Exe. Poccombe stone was used in the Roman City walls.*

these, found during redevelopment, was relaid in cement in 1981 in an obscure corner of what is now a shopping precinct [Fig.83]. The ritual Bronze Age pebble pavements of East Devon and the Roman street surface cannot be taken as evidence for any continuity of cobbled surfaces from prehistory up to the surviving cobbled church paths. To date we have found no medieval documentation for cobbles in Devon, whether church paths or other footways or roads. Little enough survives in the way of medieval written records for the construction of major buildings, so it is unsurprising that road and path surfacing would fall below the documentary radar. Exeter cathedral is the great exception in Devon with detailed medieval fabric accounts. These cover not only the cathedral building but also expenditure on utilitarian items including thatched workshops and water supply but has nothing that we have been able to identify as cobblestone surfaces.

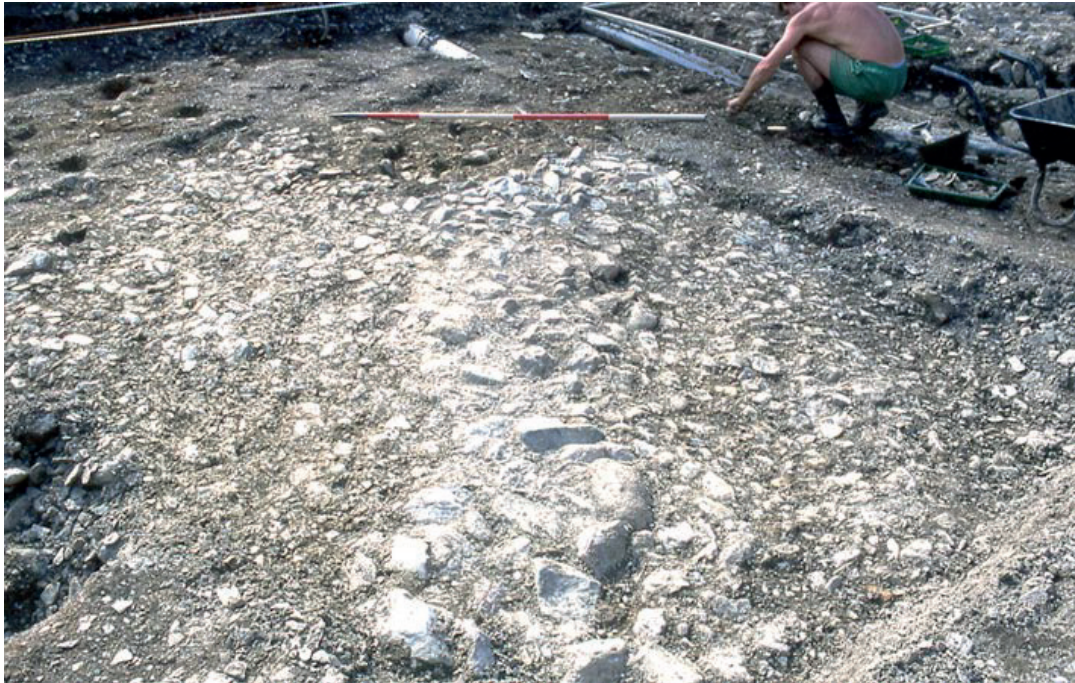
*Fig.85. The Buckfast Abbey trackway. This could be defined as a surface of spread stone or partially spread stone, rather than individually-laid cobbles. Stewart Brown.*

The organisation of great houses, monasteries and abbeys may have presented a different picture, or perhaps these are sites where archaeological excavation is more likely to have discovered early cobbles. Excavation by Stewart Brown at Buckfast Abbey has found examples of medieval cobbles surfacing a trackway and in two animal houses. The 14th century trackway is made up of river cobbles of a wide range of sizes in a clay matrix, with a very rough, rubbly and uneven surface [Fig.85].

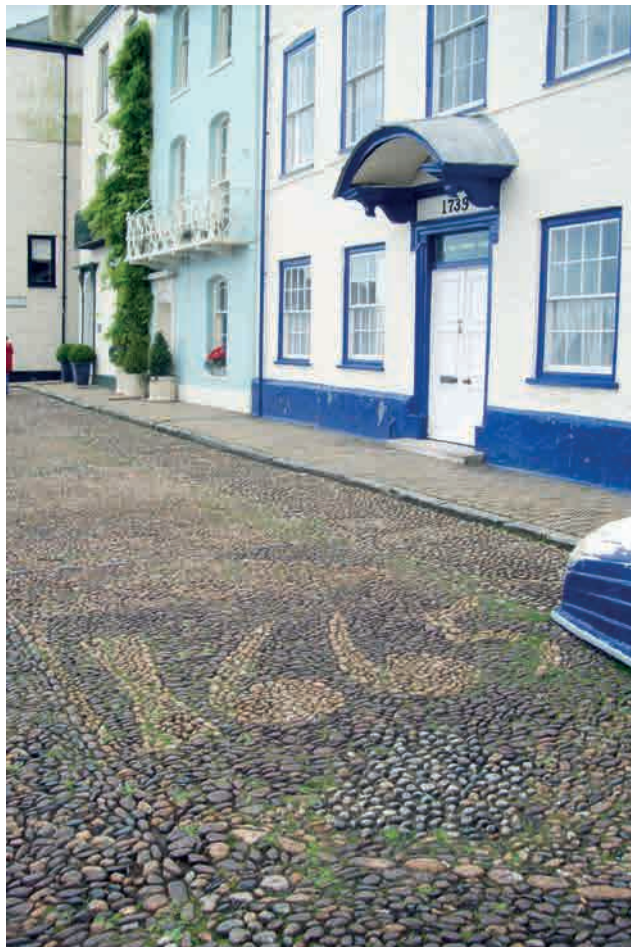
*Fig.86. Dated cobbles at Bayard's Cove, Dartmouth. The form of the numbers making up the date is convincing, even if there has clearly been much re-laying over time. These are the earliest internally-dated cobbles in Devon known to the authors of this report. Dr Stuart Blaylock.*

Cobbles at Bayard's Cove, Dartmouth, have an internal date of 1667. This may have been preserved through phases of re-laying what is now a very patched surface, but the form of the numbers is convincing and makes this the earliest example of internally dated cobbles known in the county [Fig.86].

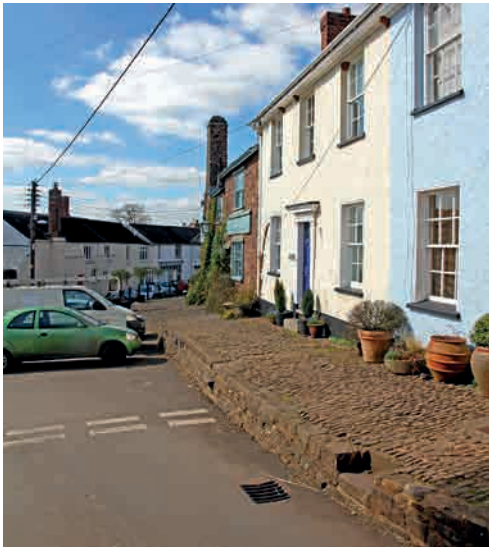
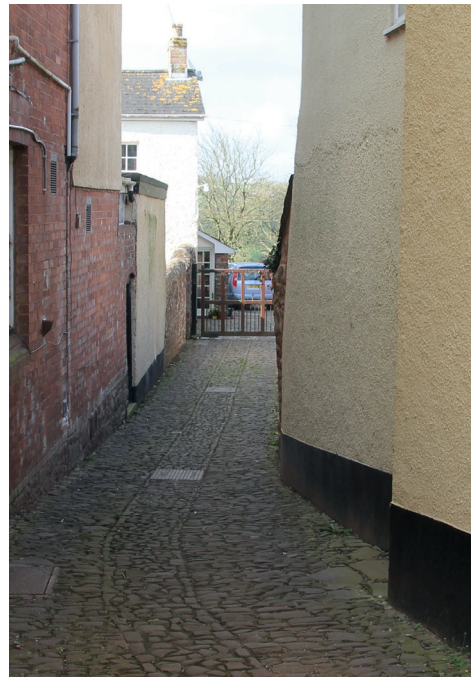
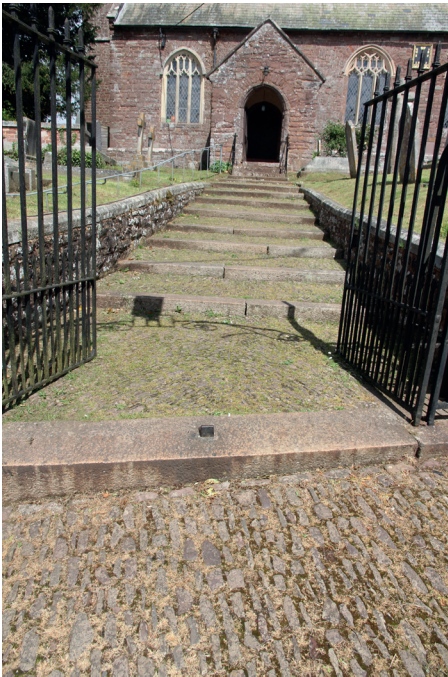
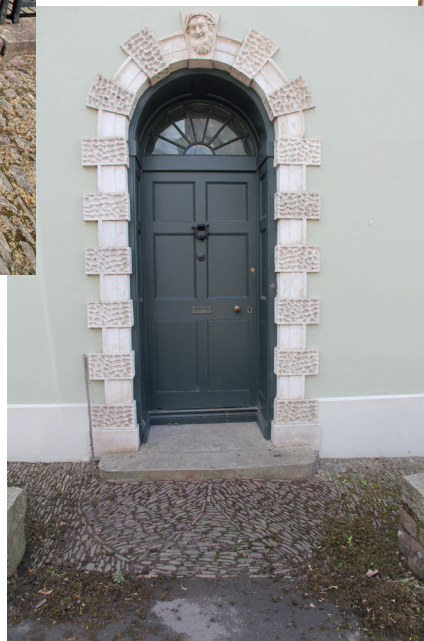
*Fig.88. Sandford village has many surviving cobbled footways, providing a distinctive character to the village.*

In Sandford, which, like Clovelly, preserves abundant footway cobbles including several cobbled paths and cobbled steps in the churchyard, surveyors were letting out the maintenance of all 27 miles of the parish roads in 1852 and 1862 for three year periods [Fig.87]. The Sandford documentation does not, unfortunately, establish the date of the wealth of surviving cobbled footways in the village, one raised high above the roadway in causeway fashion, others not. There are cobbled snickets and private garden paths and yards, as well as a surviving network of paths in the churchyard [Fig.88].

Cobbled paths across gardens and cobbled private yards are presumed to have been the work of the householders. It seems unlikely that all this Sandford cobbled paving is the same date and likely that the parish had particularly good access to sources of cobbles that were exploited, for both public and private use, throughout the 19th century and perhaps earlier. Some of the existing cobbled pavements of Thorverton village must have been laid, or relaid, in the late 19th century as they neatly abut late 19th century brick houses and include arrangements for draining the house roofs across the pavement and into an open drainage channel [Fig.89].

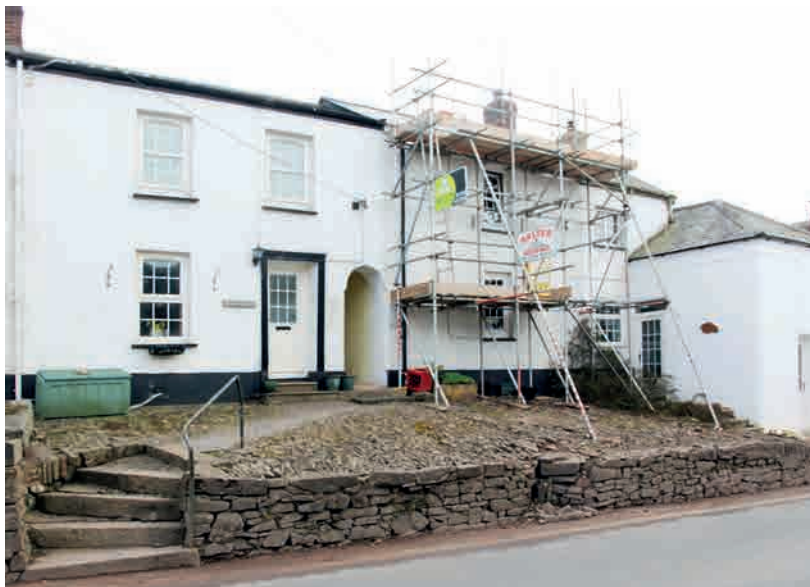
*Fig.89. Thorverton village (top) also has a wide range of cobbles. Some of these are evidently late 19th century. The raised cobbled pavements in Bow village (below) are probably earlier.*
