# Devon Cobbled Churchyard Paths

Evaluating their Significance,  
Survival and Adaptation

A project undertaken by  
Keystone Historic Buildings Consultants  
for Historic England and SPAB

March 2016

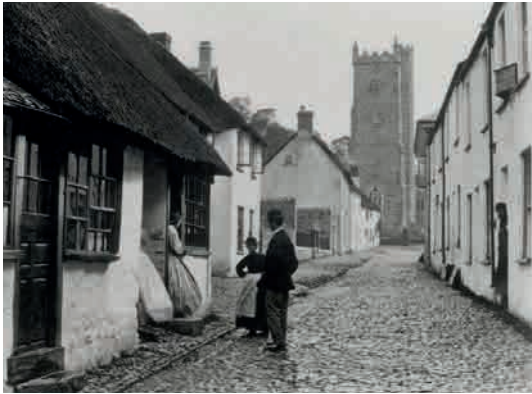
*Fig.90. Moretonhampstead in a photograph of the 1870s showing a cobbled street, roadway and footway, in a Dartmoor town. The footway is on one side of the street only. Where buildings have been extended by front outshuts, presumably for shops, this is only a narrow strip. Moretonhampstead History Society, reproduced with permission.*

Conscientious searching of 18th century Devon prints has turned up scarcely anything of value in illustrating road and footway paving. Village and other cobbles were sometimes recorded in the era of photography [Fig.90]. The best evidence for proving that many Devon towns and some villages had cobbled footways by the late 19th century comes from the newspaper reports covering proposals to replace them: the period of greatest activity being c.1890-1940, including the early period of the widespread use of the bicycle and the use of the motor car. In 1894 the Local Government Act had passed all the powers, duties and liabilities of existing highway boards or surveyors to the newly created rural district councils. However, as the newspaper reports reveal, the decision to modernise and improve by lifting cobbles could also be made by town councils, sometimes acting as the Sanitary Authority, or by charitable trusts who owned tracts of urban property.

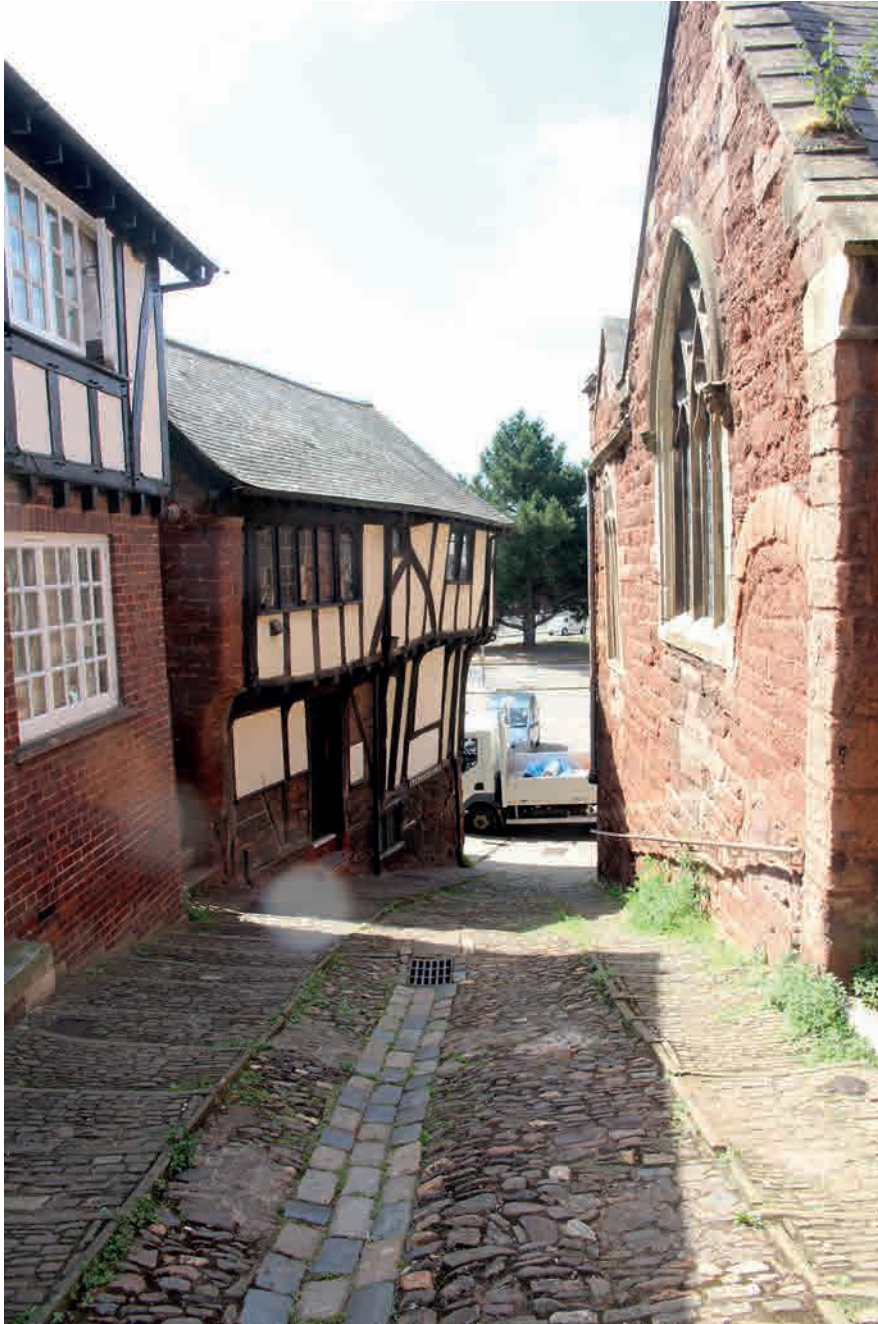
*Fig.91. Stepcote Hill. A survival, somewhat altered, of a commonplace type of urban street surface with large roadway cobbles either side of an open drain and smaller footway cobbles. It is probably 19th century. The drain has been partly underground and the risers of the steps of the cobbled footways, now stone, were timber at one time.*

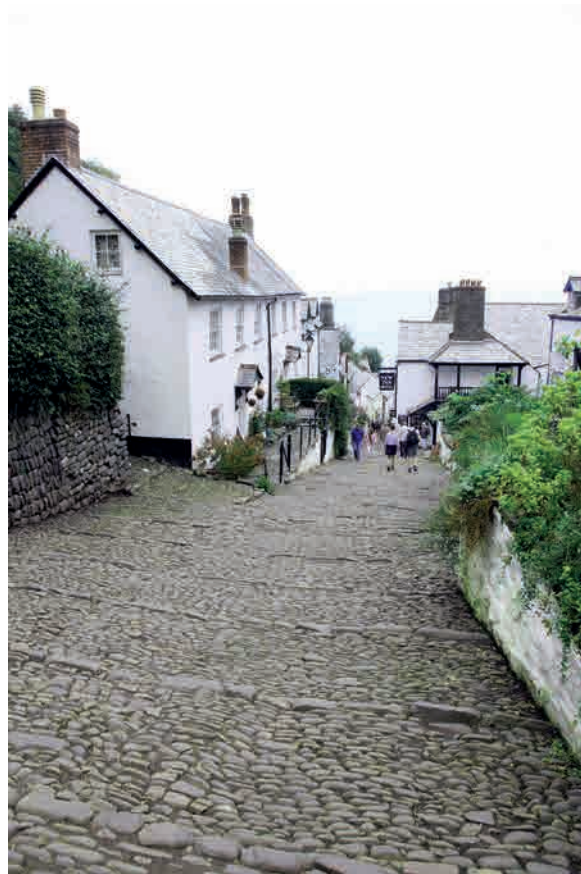
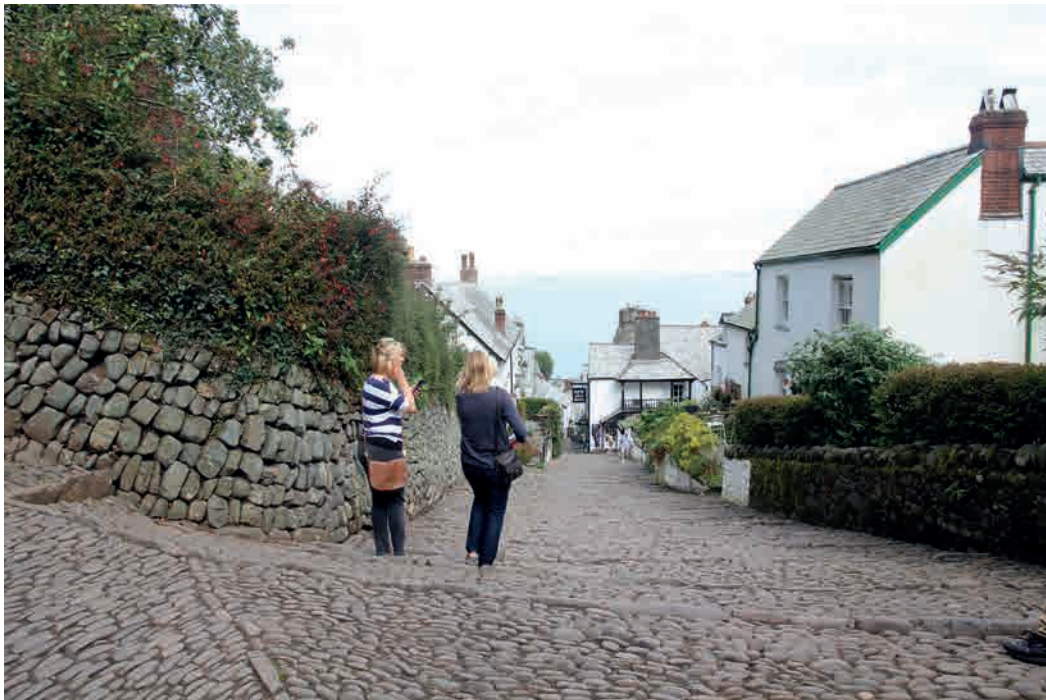
*Fig.92. Clovelly is an outstanding cobbled village/small town in Devon, its cobbled streets a key attraction for tourists. The cobbles are maintained by the estate that owns the village. Built on a steep slope down to a harbour on the N coast, most of the houses are mid/late 17th century in origin, perhaps providing a date for the origins of the cobbled streets. Residents in 2015 use wheeled trolleys to pull shopping to their houses and wear rubber-soled shoes.*

to get up and down the hill to the harbour across very uneven paths cobbled with sandstone cobbles was (and still is) reckoned a key part of its charm, along with the chance to hire a donkey, or now a landrover to do the hard footwork [Fig.92]. There is now an admission charge of £6.95 for visitors entering the estate-owned village. The charge put to village repairs and conservation including the cobbles. These were much relaid in 2010 after major flood damage when a river above the village burst its banks and dislodged many of the cobblestones, but these are still very uneven, as explained on the Clovelly website. Residents favour shoes with thick rubber soles (*pers.comm*).

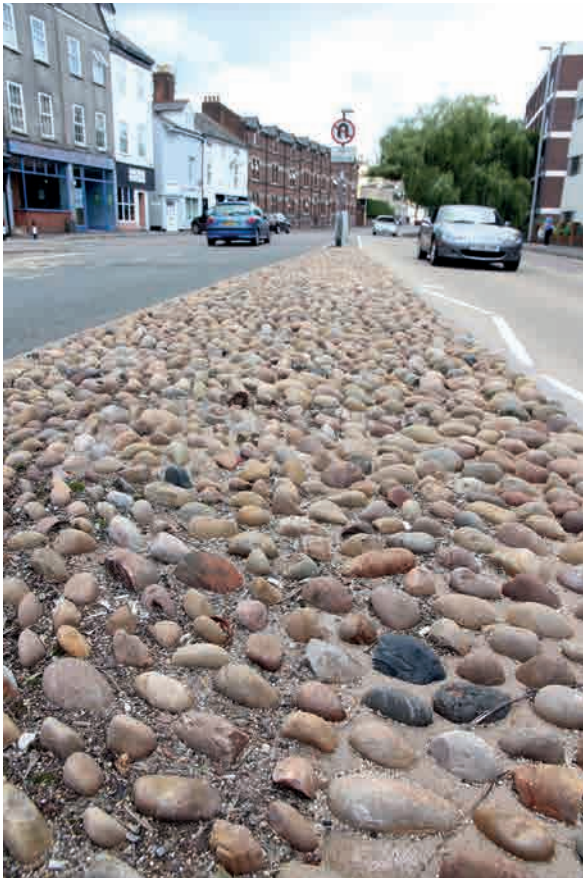
*Fig.93. 'Keep off' 20th century pebble cobbles on a traffic island in Blackboy Road, Exeter, part of a hard landscaping scheme to control pedestrian movement. Large pebbles/small boulders are laid in cement, their irregular domed tops presenting a surface that no-one would choose to walk on.*

at all, were principally of the 'keep off' variety, laid so that each stone emerges high above the concrete bedding to provide maximum discomfort to the feet in the cause of safety and controlling pedestrian flow [Fig.93]. This familiar use of urban cobbles has surely contributed to the perception that they are all an obstacle for pedestrians. The artificial materials with which they were associated in urban landscaping in the 1960s and 1970s were considered, relative to natural materials, 'simpler to specify, less expensive to maintain and seen as safer for vehicles and pedestrians'.<sup>30</sup>

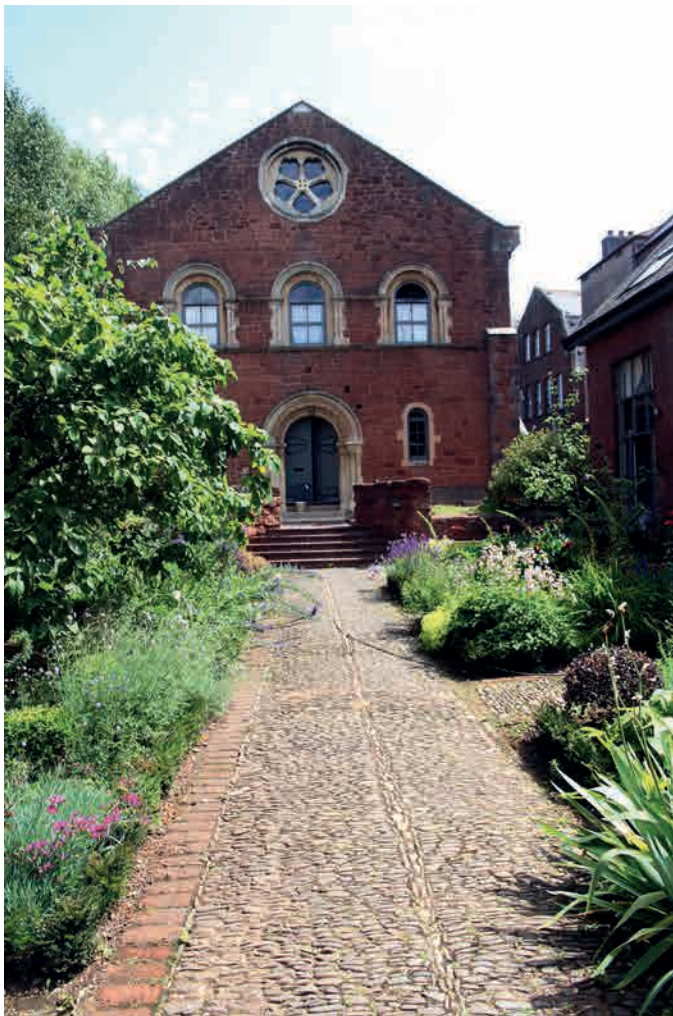
*Fig.94. Cobbled path at the Mint, Mint Lane, Exeter. Rediscovered by excavation during 1990s redevelopment, this was restored and extended to provide a garden/courtyard setting for three historic buildings including the former Roman Catholic church shown here.*

In the 21st century cobbles have survived in the public realm, sometimes re-laid, sometimes as new areas of cobbles established for their contribution to the character of historic places (e.g. Totnes; Chulmleigh). The path to the former Roman Catholic church off Mint Lane, Exeter, was revealed during redevelopment to convert the building into apartments and has been retained and extended to create a courtyard garden [Fig.94].

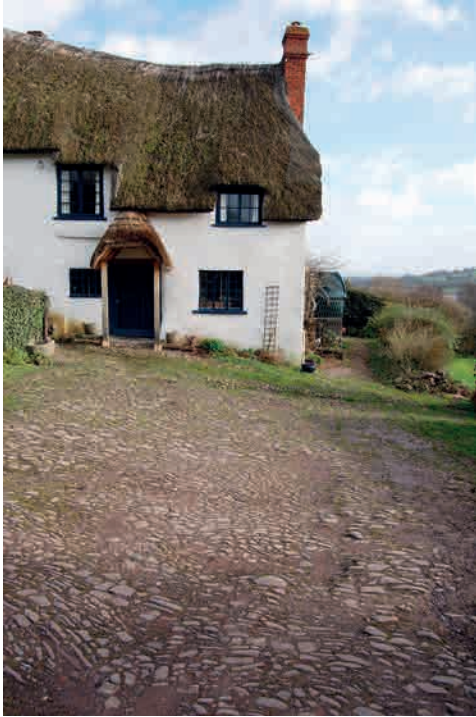
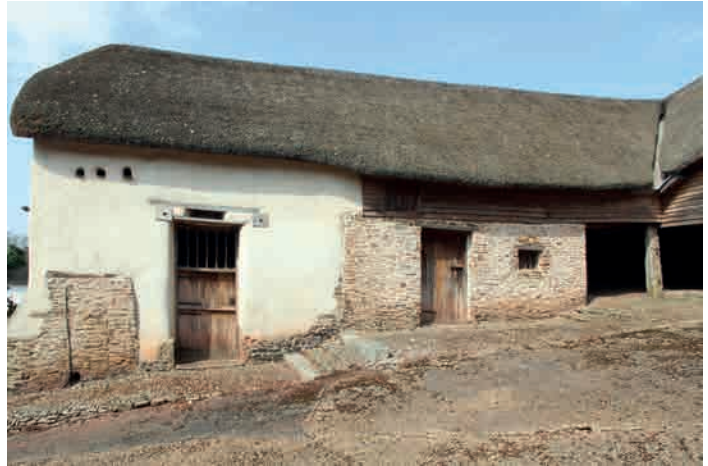
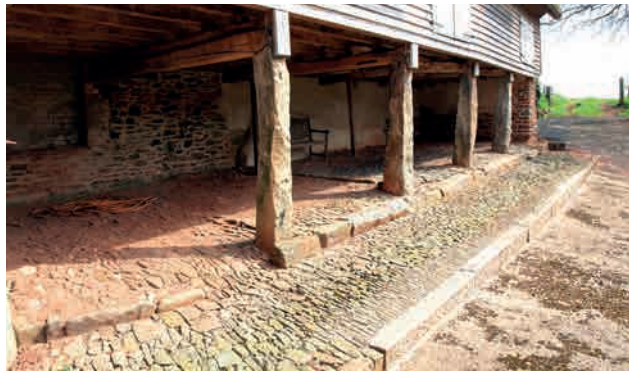
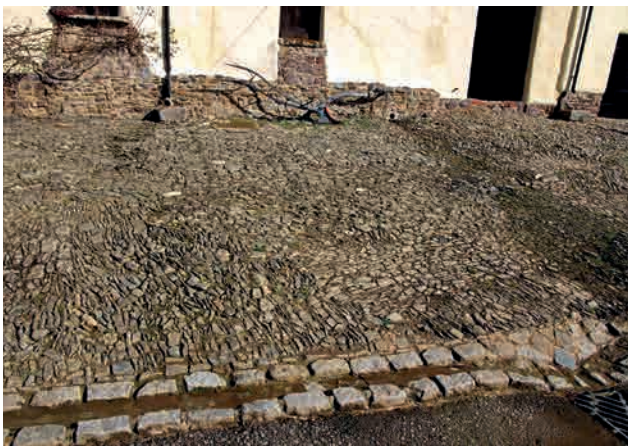
*Fig.95. Cobbled farmyards: Gotham, Tiverton (top left) on a steeply sloping site; a mid Devon farmstead with cobbled footways and cobbled interiors to the buildings (two right-hand photos); cobbles in the farmyard at Great Heale, Colebrooke (below). Great Heale by JRL Thorp.*

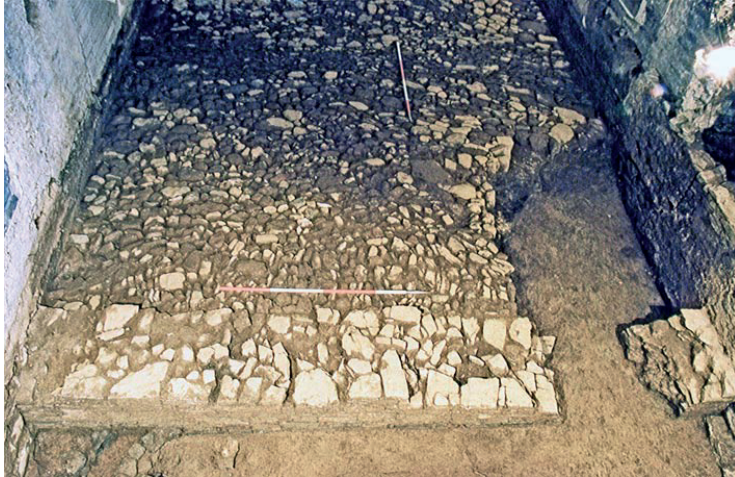
*Fig.96. Buckfast Abbey. 14th century stable floor. Stewart Brown.*

Buckfast Abbey provided very extensive and superior 14th century accommodation for guests. A stable associated with the Abbey's Southgate is, like the Buckfast trackway, dated to the 14th century [Fig.96]. Stewart Brown comments that its cobbled stable floor was so uneven that it was difficult to walk on, even in diggers' boots and must have been covered with straw litter most of the time (*pers.comm.*). Presumably the cobbles made it easier to muck out than an earth floor and may have prevented horses from slipping. A late medieval animal house in an agricultural complex in the outer court of the abbey also had a multi-phase floor with cobbles [Fig.97].

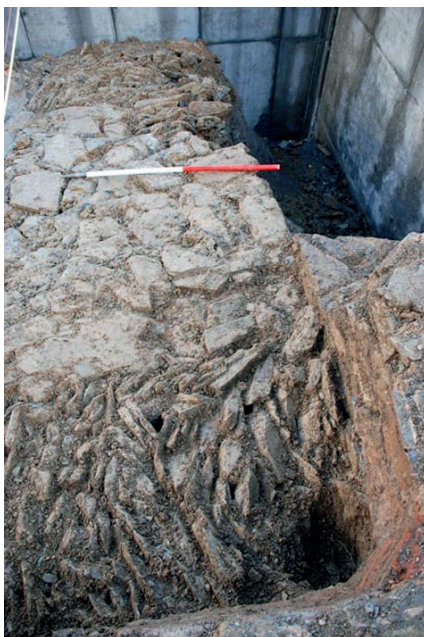
*Fig.97. Cobbled flooring of a late medieval livestock building at Buckfast Abbey. The soft clay ground was first consolidated with a sub-base of tightly packed pitched stones (local slate stone) then another similar layer was set on top, and finally a stone rubble floor. There were two post-medieval floors on top, the last probably 19th century. Stewart Brown.*

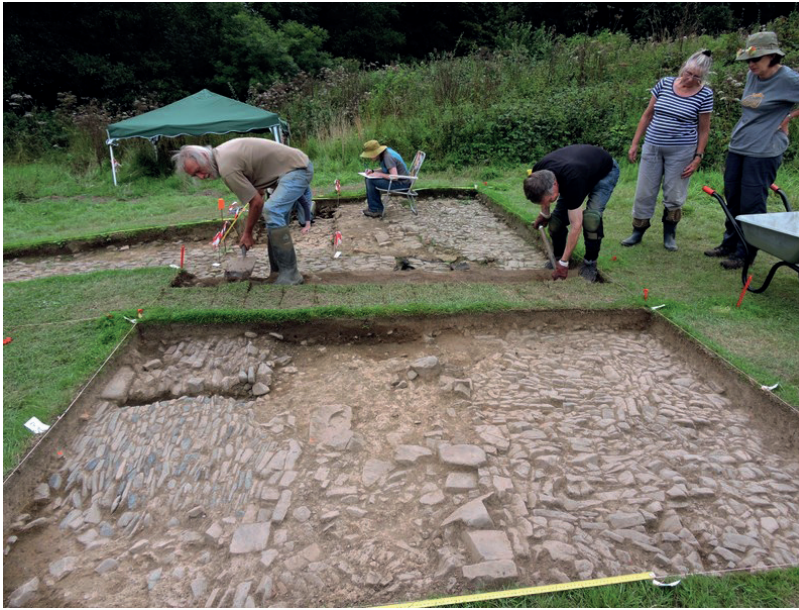
*Fig.99. Moistown, Broadwoodkelly. Excavation by the ACE Archaeology Club of the wing of an abandoned house has revealed extensive interior and exterior cobbles.*

levels tend to stay the same. Therefore each floor repair takes out some, or all, of the previous floor. Thus the few examples of excavated late medieval farmhouses from Devon (e.g. Brown and Laithwaite 1993, and Thorp and Alcock, forthcoming) produce no datable medieval floor levels. Current archaeological excavation at Moistown, Broadwoodkelly is noted above. The interior cobbles were smaller and more neatly-laid than those outside [Fig.99].

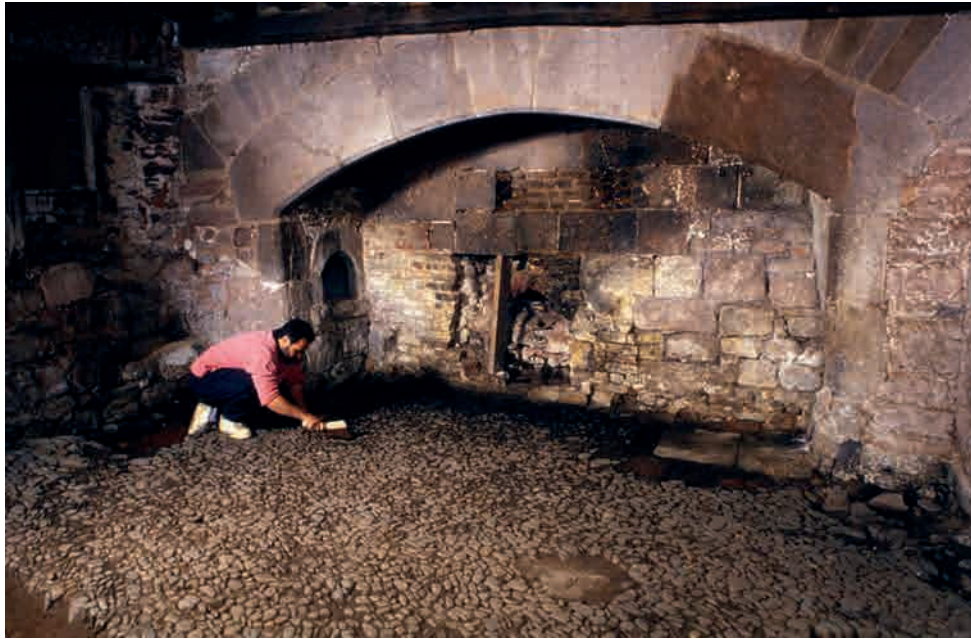
*Fig.102. Bowhill, Exeter, kitchen cobbles, probably early 18th century. David Garner for Historic England.*

At superior social levels cobbles are sometimes found flooring the service rooms. Take, for instance, Bowhill, Roger Holand's grand c.1500 gentry mansion, now enclosed within the western outskirts of Exeter. Evidence of primary cobbles or 'pitched stone' were revealed by archaeological excavation in the western service room and were suspected in the kitchen although excavation stopped at a secondary 'fine cobbled pavement' [Fig.102].<sup>39</sup> Service rooms floors continued to be newly-cobbled in the 19th century. In 1806 Thomasine Anne Elliot built a small Georgian mansion at Awliscombe near Honiton in east Devon. The original building contract survives in the Devon Archives and Local Studies Service. It specifies boarded floors to the domestic ground floor rooms, paved flags ('broadstone') for the kitchen, lime and sand for the footman's pantry and larder and the floor of the Footman's Pantry and Larder to

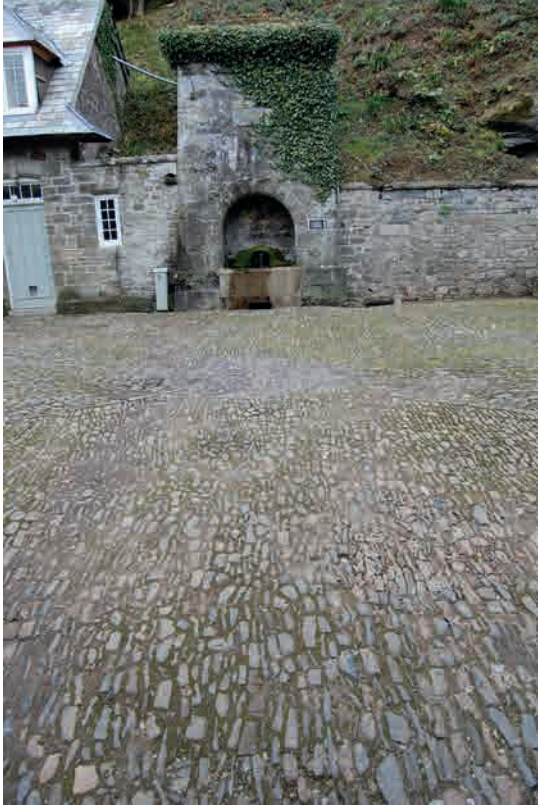
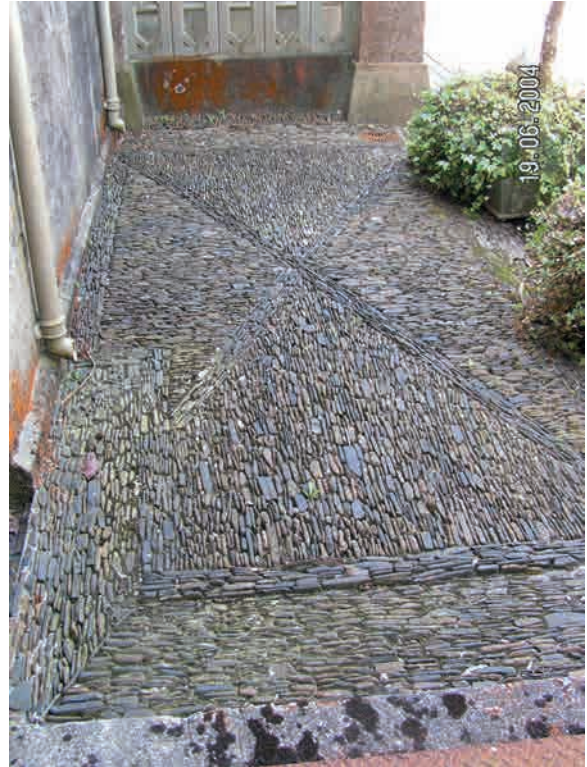
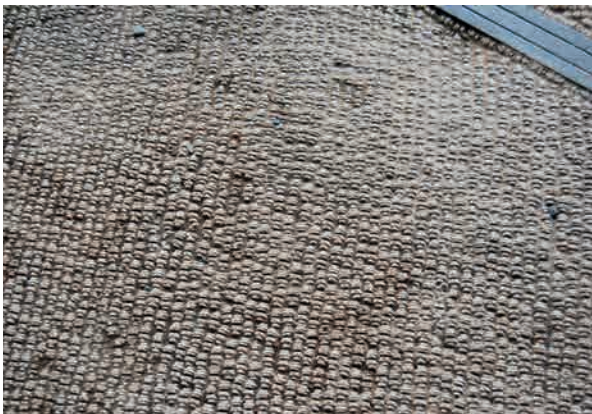
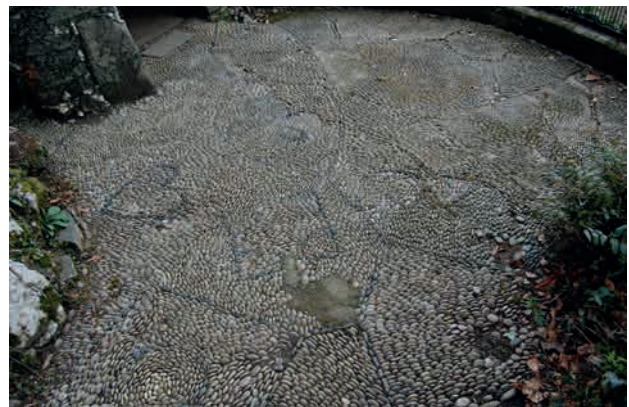
*Fig. 103. A range of cobbled surfaces at Endsleigh, Milton Abbott, designed 1810. These employ flat-topped cobbles, including patterns (top); pebble cobbles with coloured patterns for the shell house (bottom right) as well as sheep's knuckles in a highly self-conscious Picturesque context (bottom left) Photographs by Oliver Bosence and Peter Marlow.*

In general these use smaller cobbles than those found on public footways, though there is a wide range from the plain to the fancy. Endsleigh Cottage (in fact a substantial house for an aristocratic patron) is a key example in Devon of a range of cobbled surfaces in a context described by Pevsner as 'one of the most revealing testimonies to the strength of the Picturesque movement'. The surface designs are tellingly adjusted according to the architectural status and likely wear and tear of different locations [Fig.103].

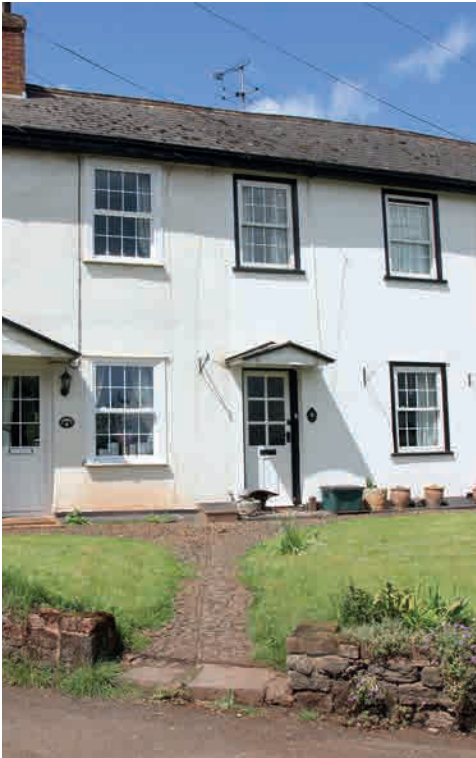
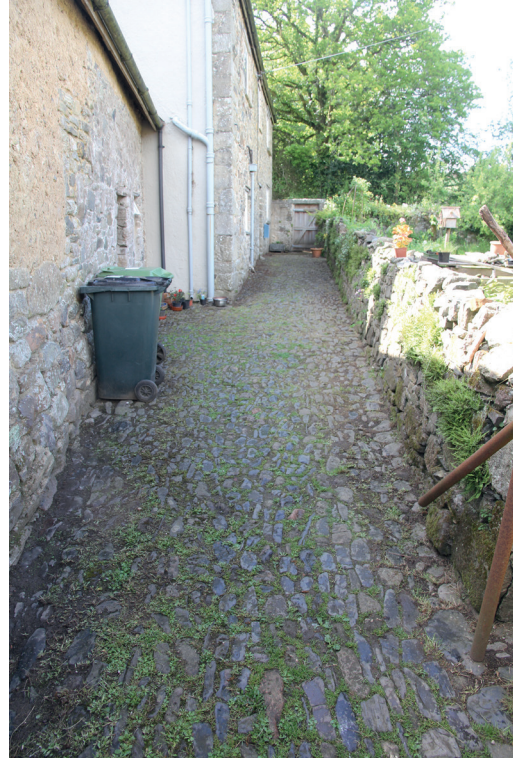
*Fig.104. Left, a herringbone garden path to 19th century estate cottages at Upton Pyne and, right, a path to a farmhouse, Sweet Sigford where the cobbles are, unusually, laid along the long axis of the path.*

At the vernacular level, garden paths are often very similar to church paths, employing much the same range of surface designs [Fig.104]. The influence of Arts and Crafts garden design on the later churchyard paths has not been investigated in any depth for this report, although the pebble cobbles at the chapel of St Lawrence, Crediton, restrained by blue rope-finished tile kerbs would look equally comfortable in a secular garden setting [Fig.105]. Gertrude Jekyll's designs tended to favour flags, either squared or random, or fine gravel.<sup>42</sup>

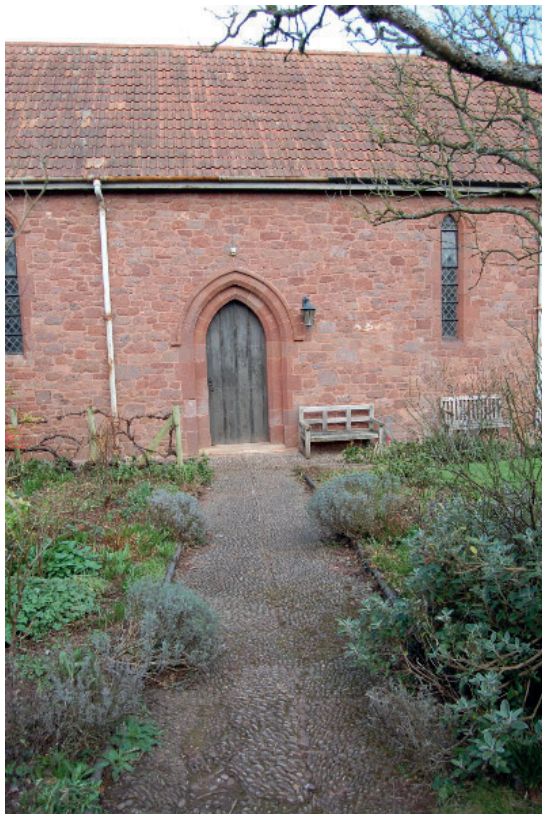
*Fig.105. The pebble path to the chapel of St Lawrence, Crediton, radically restored in the 1920s, is indistinguishable from a garden path.*

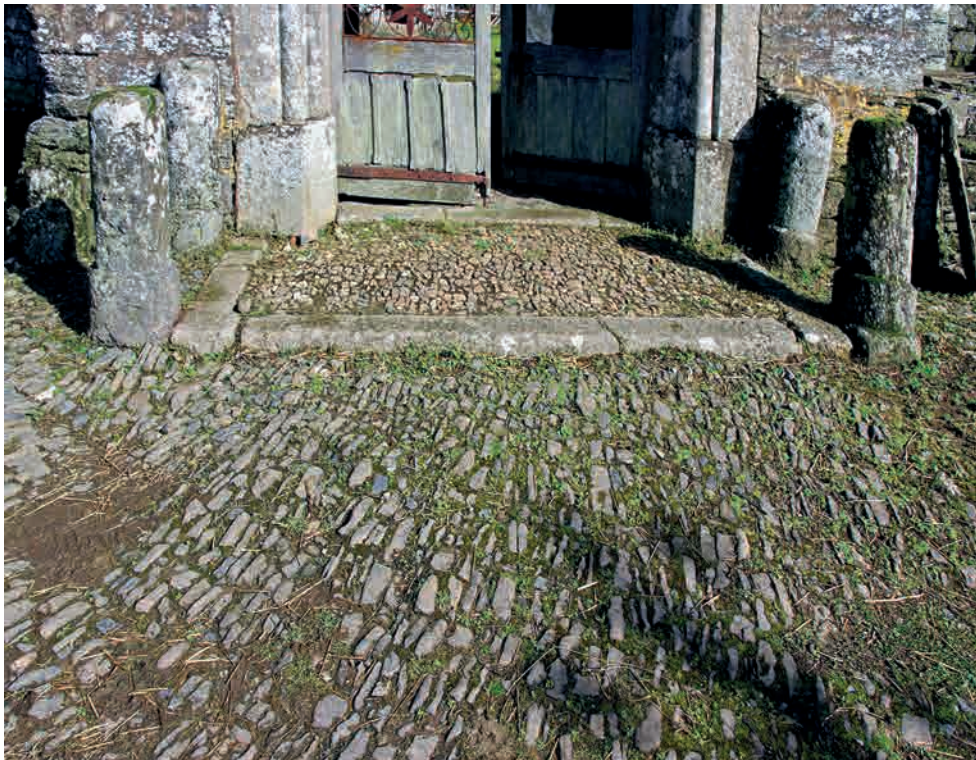
*Fig.106. Bradstone Manor. Judging from context the sandstone cobbles in the foreground may be 17th century. The more dainty quartzite cobbles of the step are thought to be 19th. JRL Thorp.*

During the course of the Devon Cobbles Project Keystone were also undertaking an archaeological watching brief during repairs to the mid 17th century Gatehouse (listed Grade 1) at Bradstone Barton on the Cornish border. Conversion to a holiday let involved the insertion of a service trench. Although this was designed to approach the gatehouse from outside the main steading it involved disturbing a cobbled surface across the southwest front and extending north eastwards along the outside of a probably late medieval faux-defensive crenellated wall to an earlier block (now a stable). It is made up of medium to chunky blocks of slightly water-rolled stones (grey in colour but otherwise not unlike the sandstone cobbles

used in the Sandford village pavements). The individual cobbles were between 10-13 cms deep (over half were closer to 12cm). To lay the cobbles the topsoil had been removed down to a shilletty subsoil 12-13 cms below the present surface. The cobbles are laid in a clayey loam containing some small chippings on top of the formation level. Dating is impossible, but a mid 17th century date might be proposed from the context. At the gatehouse entry there are mid 17th century wheel-protecting bollards set into the cobbles and a mounting block [Fig.106]. The main entry to the house through the gatehouse was superseded by a new wagon-size gateway a short distance to the south east in the early 18th century. The service trench also cut through a smaller section of much smarter cobbles which occupied an outer set up to the gatehouse wagonway. These comprise very small tightly-set white quartz stones. The cobbles measured between 5-11cms deep although the great majority were between 7-8 cms. They were laid over a clayey sub-base containing a high proportion of small stone slivers (looking like the discarded chipping produced from dressing the local Bradstone): cobbles and bed were 11cms deep. There is clear evidence for an early-mid 19th century refurbishment of the gatehouse which involved converting the upper floors into a kind of romantic Gothic-style chapel. It is assumed that it was at this time the former forecourt was converted to a garden containing the pretty white cobbled path [Fig.107].

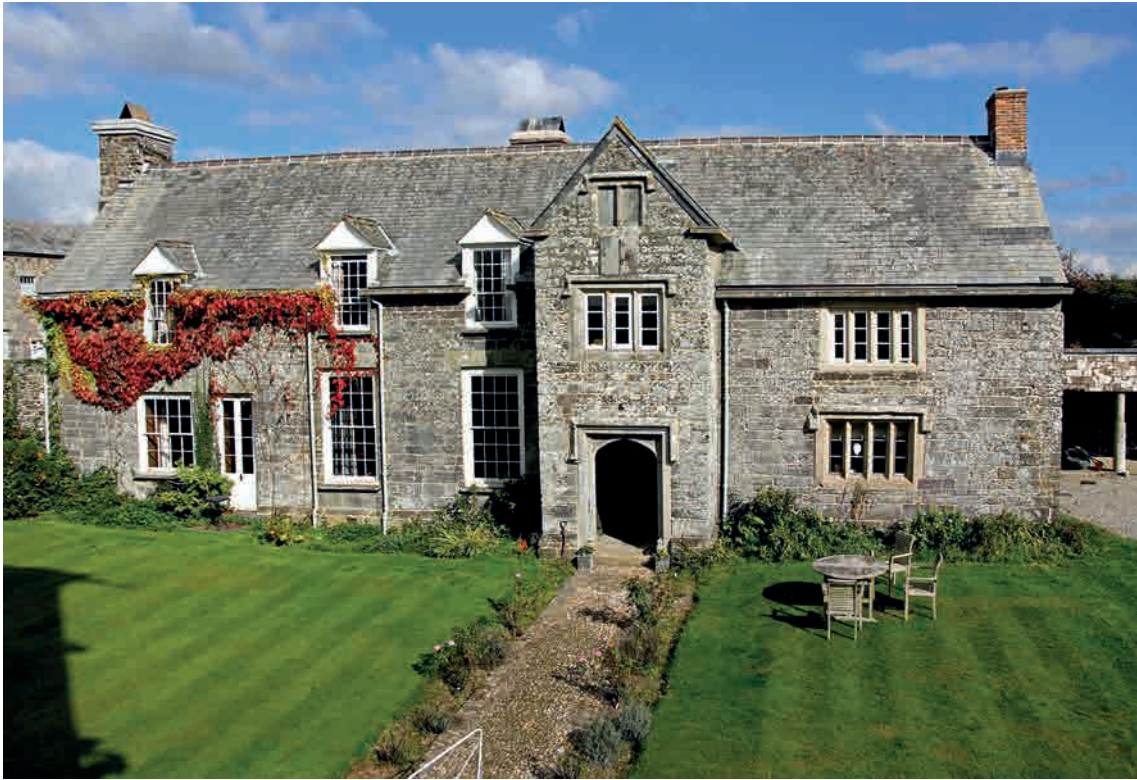
*Fig.107. The quartzite cobbled path through the former forecourt of Bradstone Manor, transformed into a garden, is assumed to be 19th century. JRL Thorp.*

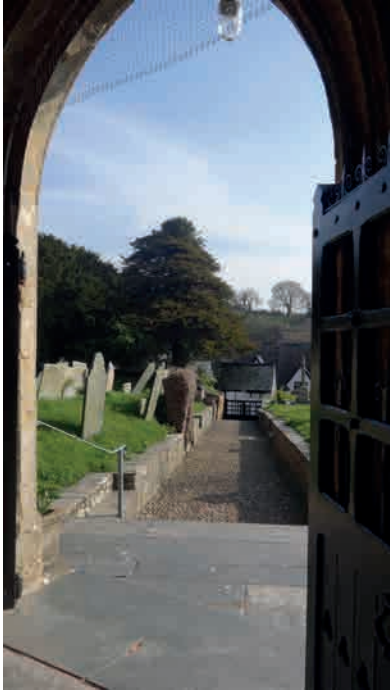
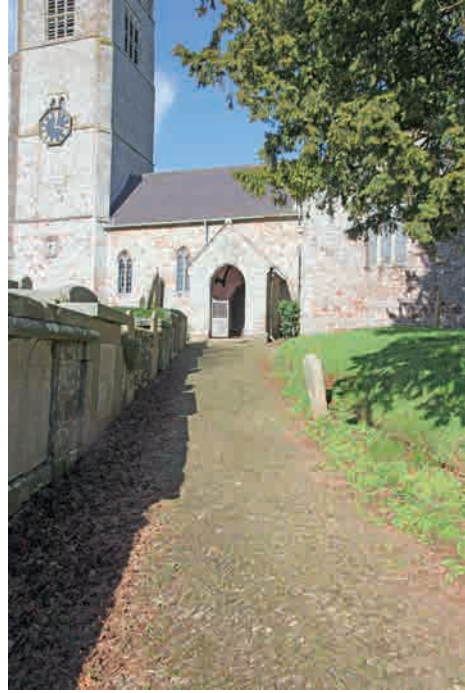
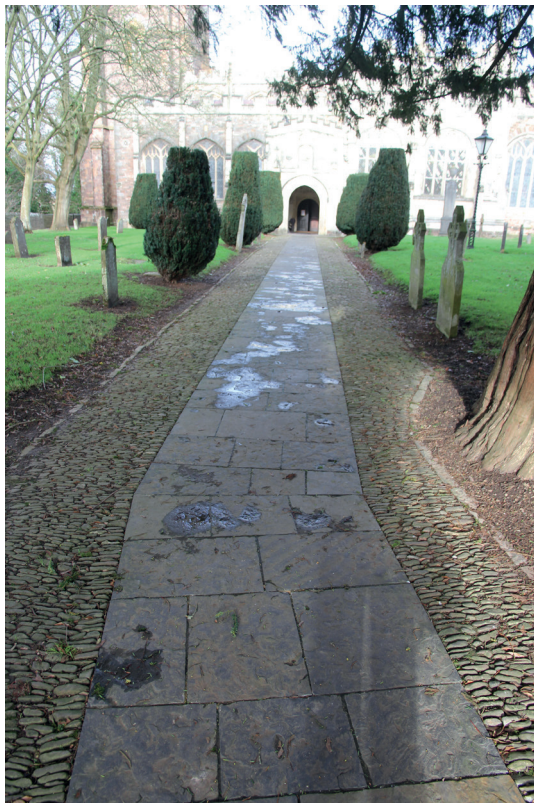
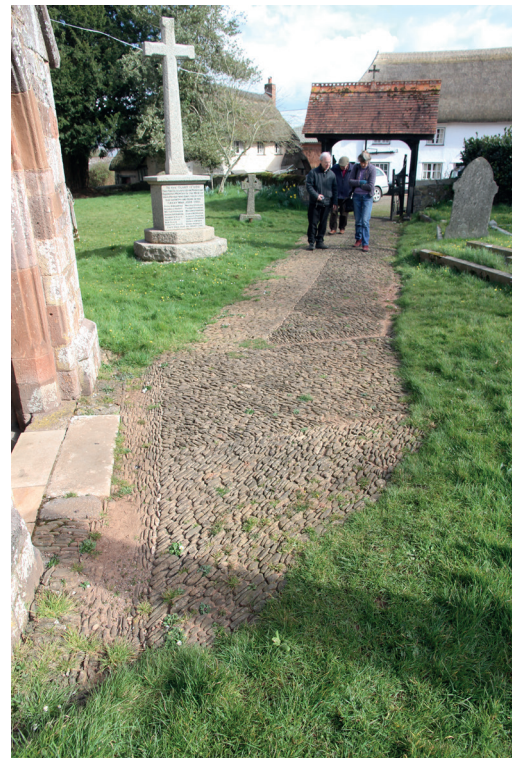
*Fig.108-111. The relationship of paths to the churchyard greensward. Clockwise from top left: Berrynarbor, sunk in a 'tray'; Colebrooke, monuments revet one side of the path; Upton Pyne, path and churchyard turf nearly level; Tiverton St Peter, path only slightly sunk and level with the porch floor.*

The relationship of the surviving paths to earlier paths, to the historic levels of the soft landscaping of the churchyard and to the floor level of churches has not assisted with dating. Rather it has raised some interesting questions about the frequency with which churchyards were re-landscaped in the 18th and 19th centuries. If a cobbled path has been laid on the same route as its predecessors, as one would expect for many principal paths, it might be assumed that it would be a sunken path, the level of the churchyard having risen with burials over the centuries, assuming the path was not regularly raised or built over earlier paths. Some cobbled paths are indeed sunk in a deep 'tray', well below the existing level of the churchyard greensward, which may be revetted alongside the path with single stones laid on edge or masonry or brick walls [Fig.108]. The path at Copplestone makes use of monuments to revet one side of the principal path [Fig.109]. However, other paths are constructed scarcely below the level of the churchyard turf [Fig.110] raising the question of whether these churchyards have been levelled/re-landscaped and when? The relationship of the ground level outside the porch to the porch and nave floor level has also proved a conundrum. There may be steps down into the porch (a potential problem for access, e.g. Church of the Holy Cross, Crediton) as would be expected in a churchyard raised over time with burials, but where medieval outer porch doorways survive, the mouldings and their stops generally relate well to outside ground levels. Some churches have a flat surface from a cobbled path straight into the church porch (e.g. Satterleigh).

Tiverton, a thriving town in the medieval period as well as in the 16th and 17th centuries and with a population that nearly doubled between 1801 and 1851, indicating much pressure on burial space, has paths with, in some areas of the churchyard, only a drop in level of about 10cms from the churchyard turf and there is no step down into the early 16th century south porch (rebuilt in 1825). However, the surface of other paths in the churchyard are nearly as close as this to the level of the turf on one side, but dropped considerably below on the other. The published churchwardens' accounts include a 1646 reference to a considerable payment, £5 4s 10d for 'covering the churchyard'. This was associated with labour and the cost of two wheelbarrows and must have been re-landscaping, even if this was only a dump of earth. This was the year after the town was affected both by a royalist skirmish, requiring the making of 205 graves at 4d each, and by a plague.<sup>43</sup> The extent to which Tiverton and other churchyards were re-landscaped in the 18th and 19th century seems likely to be discoverable only from archaeology. At Tiverton the minor collapse of a path in the 21st century revealed that it was constructed over a burial vault (*pers.comm.* Dr Stuart Blaylock). Throughout the 1870s Great Torrington was busy about their churchyard, which was a 'disgraceful' and needed transforming from 'a reproach to the town' into an 'ornament to the town'. There was a churchyard wall committee and a churchyard improvement committee. Amongst the improvements planned was 'levelling, smoothing and planting the ground'.<sup>44</sup> At Merton, the turf flanking the existing path was growing out of earth full of small stones, very different from the composition of the subsoil dug from just outside the churchyard for bedding the repaired cobbles during trials. This may be evidence of re-landscaping, perhaps only adjacent to the path.

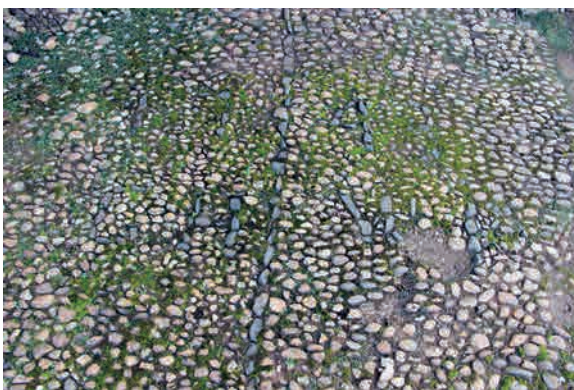
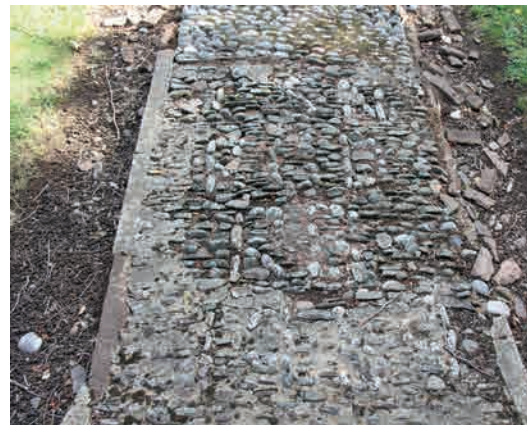
*Fig.112 The earliest and latest dates in dated paths. Left, Poltimore, 1743 and right, a sub-path of pebbles in cement at Tiverton St Peter, dated 1969. Both paths are atypical.*

Internal dates in cobbled churchyard paths are 18th (one) or 19th century, with one dated 1969. We must bear in mind that early dates may have been transferred from an earlier path into a relaid one. The cobbled porch at Kingskerswell has a date of 1712, as noted above. The path to the south porch at Poltimore is the earliest dated path, 1743, with initials [Fig.112]; the latest date in any path seen is 1969 (N side of St Peter's church, Tiverton).

Both the Poltimore and Tiverton paths are exceptional. Poltimore makes use of very small pebbles that appear to be carefully selected for colour and size and were probably brought from a distance (*pers.comm.* Dr Richard Scrivener): the 1969 Tiverton example is one of several 20th century paths on the N side of the churchyard. These follow the same routes as paths mapped on the 1890 OS map (minus one that has disappeared), but are evidently re-laid, being constructed of pebbles laid in cement in contrast to the network of c.1868-1874 cobbled paths which employ river channel sandstone cobbles.<sup>45</sup>

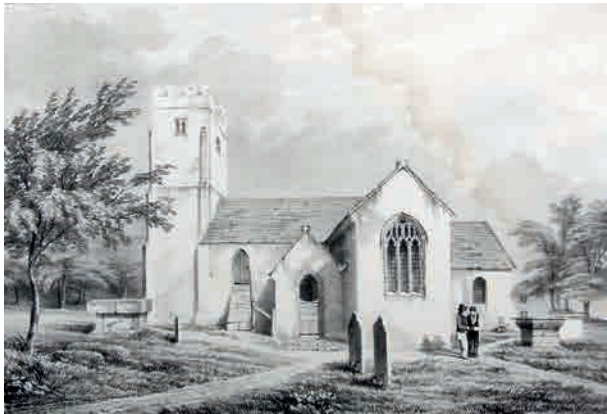
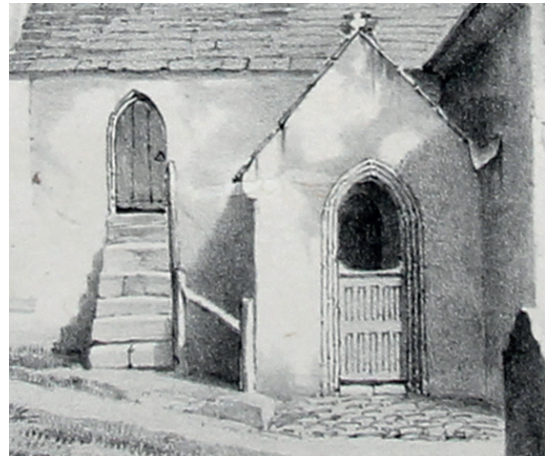
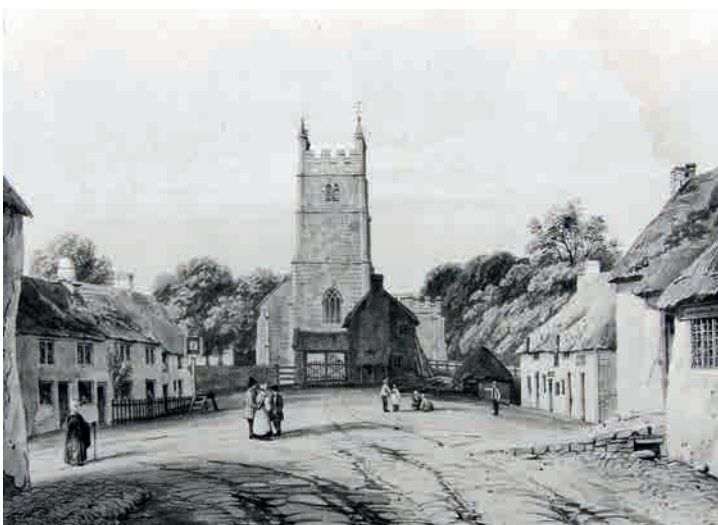
*Fig.113. Examples of Spreat's 1842 engravings of selected Devon churches. The only churchyard where cobbles are definitely shown is Whitestone, just outside Exeter (top), with detail. These have disappeared. His engraving of Chudleigh (left) shows cobbled footways and an uneven road surface. The churchyard has a stile and a thatched building, perhaps a church house, built partly inside the boundary, which is part masonry wall and part wooden fencing.*

Early 19th century engravings of churches have proved disappointing. Cobbles are laborious to draw and views of churches frequently omit the paths, or give no indication of how they were surfaced. A selection of churches drawn by William Spreat was published as engravings in 1842 as *Picturesque Sketches of Devon Churches*. This is generally a very good source for illustrations of churches before the great wave of Victorian restorations in Devon, where churches were restored early and then often. Spreat is careful to show architectural finishes, whether pegged slates, or render falling off towers, and even thatch in poor condition, showing its fixings, on adjacent buildings. However, he seems to have fallen back on a convention for drawing churchyard paths (and roadways) with what appear to be slightly rutted surfaces with a few loose stones, sometimes in rows, shown on top. Spreat does occasionally draw a few cobbles (usually unconvincingly large) in the village settings of the churches and clearly shows a

patch of cobbles in one churchyard, Whitestone, also drawn very large [Fig.113]. A thorough search of 19th century plans can be helpful where these exist, but there has not been time to investigate these in any depth. Crediton, for example, has plans showing extensions to the east and north side of the churchyard, the latter establishing that the north end of one of the cobbled church paths cannot be earlier than 1872 [Fig.114], although this may be a seamless extension of an earlier path. An early (pre-1913) photograph of Merton church is unusual in helpfully showing the cobbled path before the removal of a revetment to the churchyard turf [Fig.115].

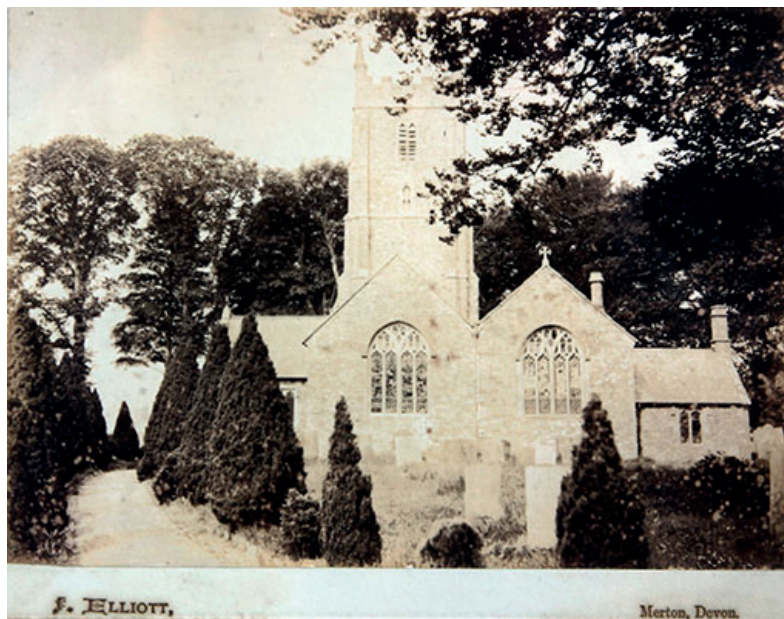
*Fig.115. An old photograph (c.1900?) hanging in Merton church is difficult to make out but shows that there was a revetment to the churchyard turf which has disappeared since.*

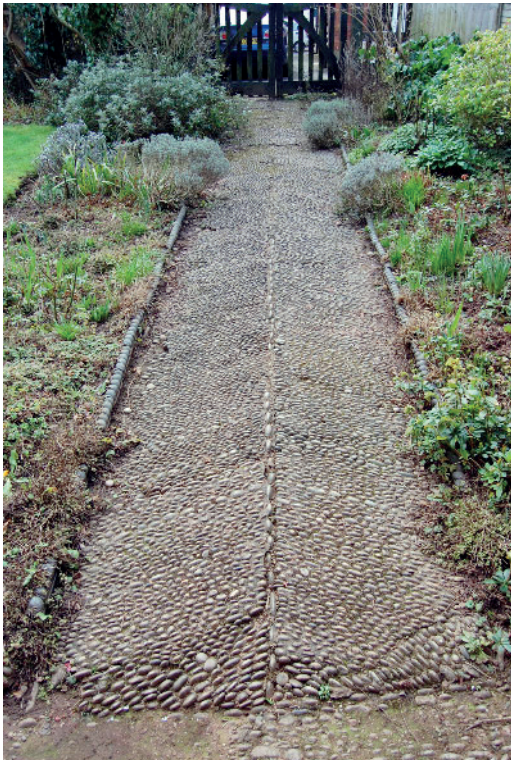
*Fig.116. This path leading to the chapel of St Lawrence and in the setting of a chapel restored from a cottage in 1920-21 is unlikely to be any earlier.*

The Chapel of St Lawrence, Crediton, was completely restored from a previous incarnation as a cottage in 1920-21 by Sir Charles Nicholson and here it would be surprising if the pretty pebble cobbled paths, associated with rope-finish edging tiles, were any earlier [Fig.116].

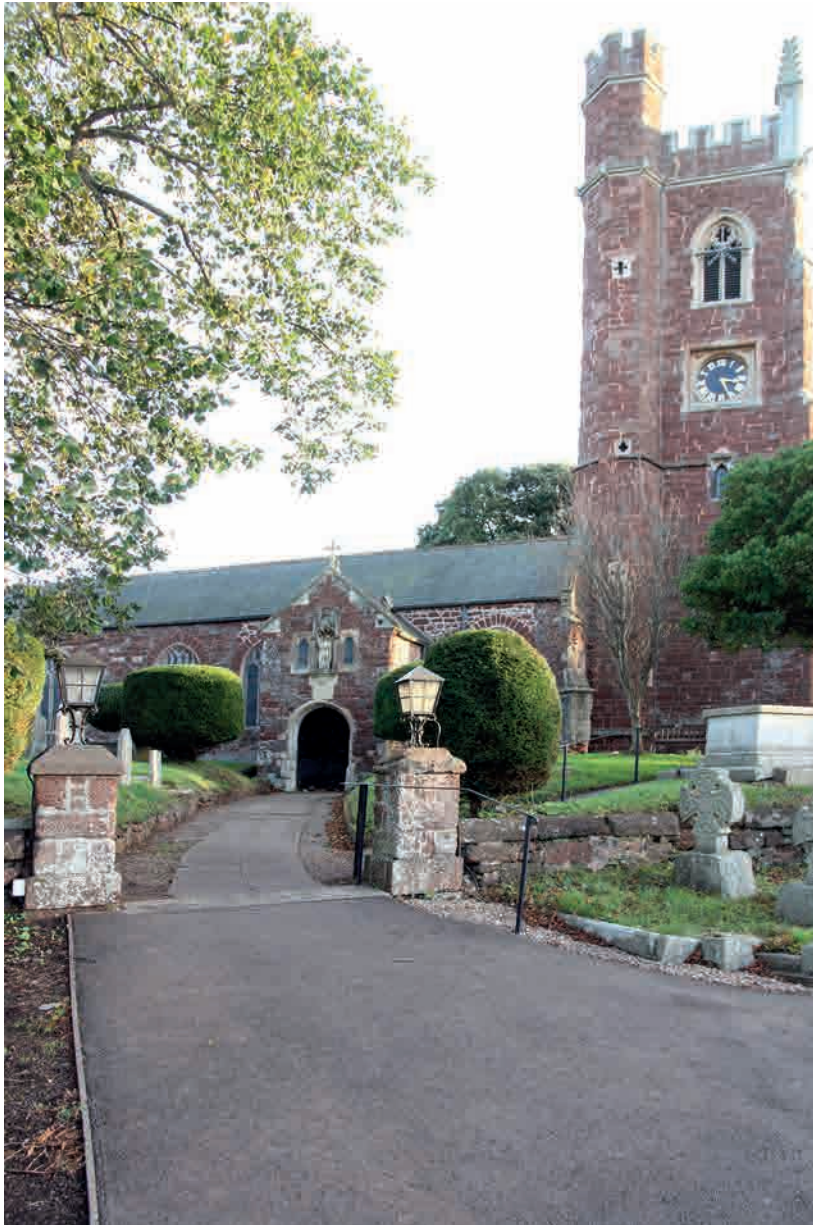
*Fig.123. A churchyard extension at Alphington, now a suburb of Exeter, is unusually legible for retaining the walls and piers of an earlier boundary. There are cobbles to both phases. The path through the earlier phase has been amended with concrete slabs driven through. Cobled steps (not shown in the photograph) are part of the extended churchyard.*

sanitary reasons the old system of digging up or disturbing existing burials to make room for more ceased, as a better understanding of hygiene and disease developed. In the second half of the 19th century, many churchyards, or parts of churchyards were closed and new cemeteries on the outskirts of towns were established and, where possible, old churchyards were extended [Fig.123].

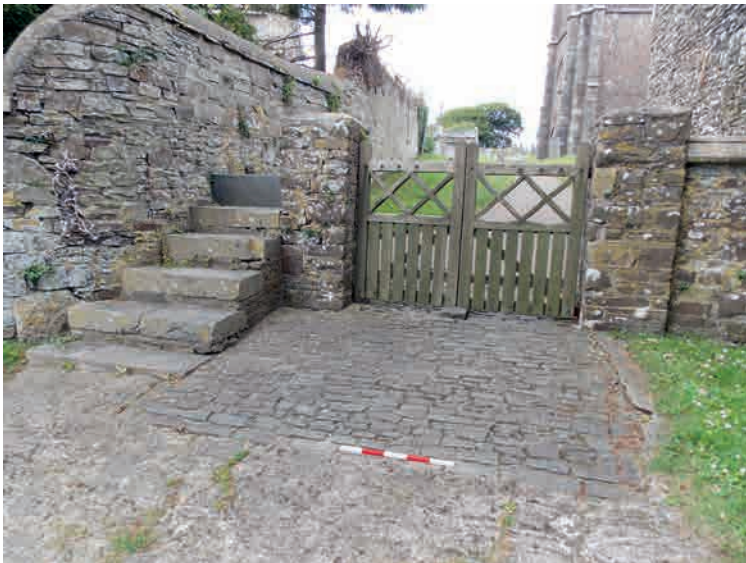
*Fig.124. Church of St George, Monkleigh. One of several surviving stiles in Devon churchyard boundaries. Some churchyards have more than one. These indicate livestock pastured in the churchyard, though whether these were sheep used primarily as mowing machines or solely exploitation for agriculture is not known.*

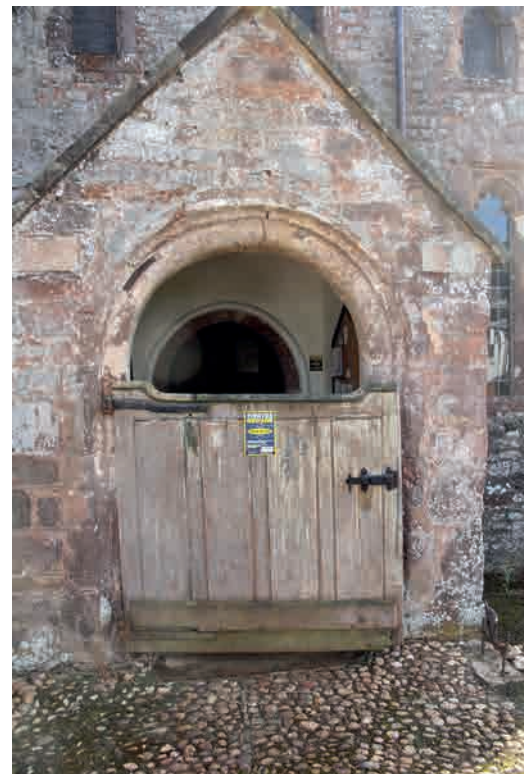
*Fig.125. The jambs of outer porch doorway of many churches preserve fittings for gates or doors. Few survive: the example at Poltimore St Mary is probably early 19th century. Documentary references sometimes distinguish between the 'churchyard' gate and the 'church' (presumably porch) gate. These gates may have designed to keep livestock out of the porch.*
