# Devon Cobbled Churchyard Paths

Evaluating their Significance,  
Survival and Adaptation

A project undertaken by  
Keystone Historic Buildings Consultants  
for Historic England and SPAB

March 2016

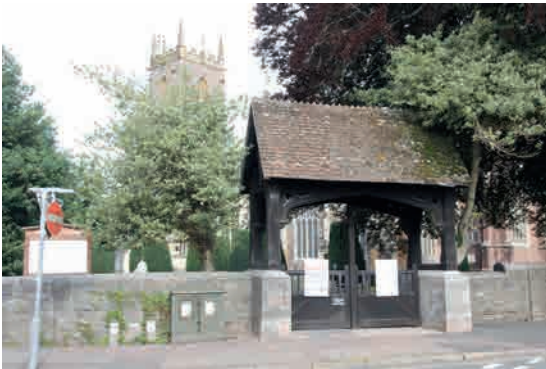
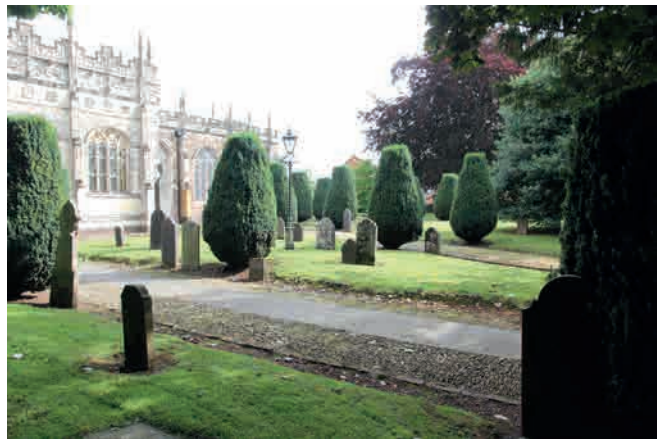
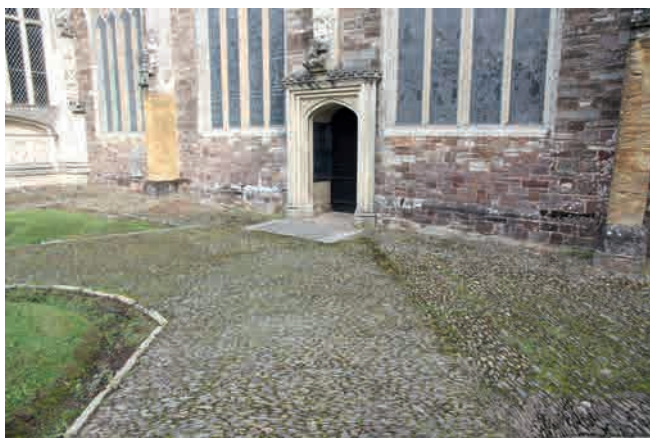
*Fig.128-130. Tiverton, St Peter. Clockwise from top left. The lychgate; a view across the S side of the churchyard, looking NE; one of the cobbled paths (forked) in the early 20th century; the large cobbled apron where paths meet outside the SE doorway.*

The history of the large town churchyard of St Peter's Church, Tiverton illustrates the influence of 19th century cemetery design on the Victorian transformation of the setting of the fine late medieval and 1850s church. Tiverton has a masonry churchyard boundary with three entrances: two with gates and one with an unusually tall lychgate [Fig.128]. Inside there is a network of cobbled paths, those on the south side using sandstone river channel cobbles, some flanked by yew trees providing multiple vistas, and stands of specimen trees [Fig.129]. Late 19th and early 20th century photographs show that, before the yews matured, the vistas were simply punctuated by verticals: now they are more tunnel-like. The pattern of path routes allows for arrival from any of the three entrances both to the very splendid early 16th century south porch (rebuilt in the 1820s) but also to a south east doorway, which has a sizeable cobbled apron in front at the meeting of several paths [Fig.130]. It seems likely that this relates to the seating set aside for the town corporation on the N side of the eastern arm of the church, a reflection of Tiverton's sense of 19th century civic pride. The path that extends from the north-east corner of the churchyard may be connected with access for residents of the castle, who had a right of way through the churchyard before it was re-designed. The path routes tell something of the story of the church's connection to the town and the castle.

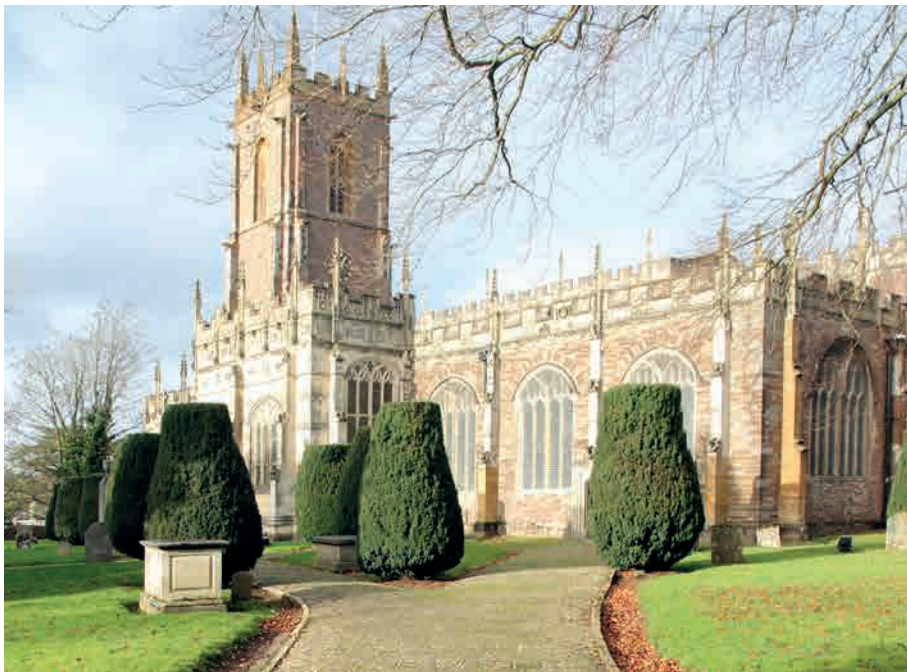
*Fig.134. The existing path from the SE (dated 1874). Even allowing for some artistic licence in the Spreat engraving it seems clear that that existing path does not follow the same route as its predecessor.*

the lychgate. This is shown in a photograph of 1890 not only with the existing timber gates, but a (now missing) wrought iron outer gate, suggesting a more proprietorial approach to the churchyard by the churchwardens, as had been feared in 1851. A comparison of Spreat's 1842 engraving [Fig.133] with a photograph of the churchyard in 2015 from more or less the same angle strongly suggests that the existing cobbled paths are not late 19th century re-layings of paths in place in 1842 but paths on new routes [Fig.134].

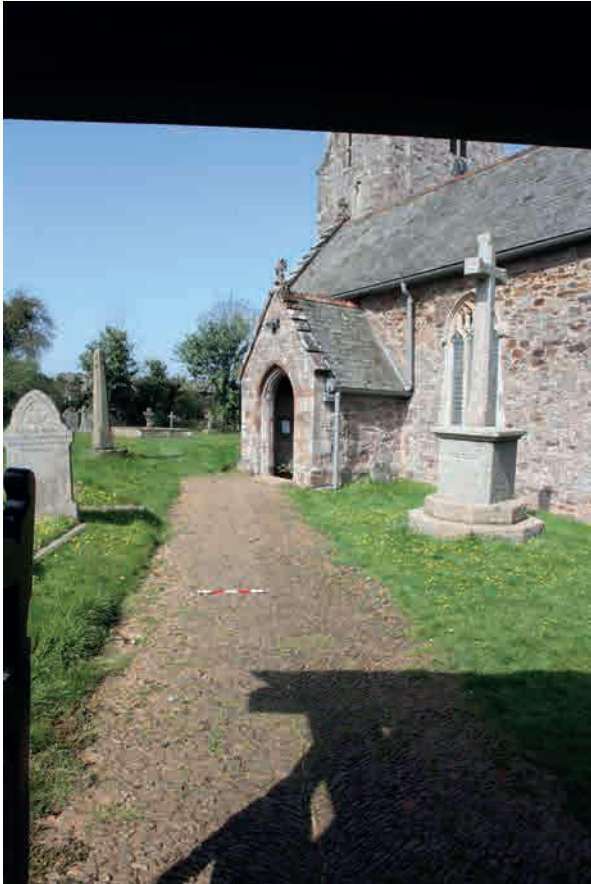
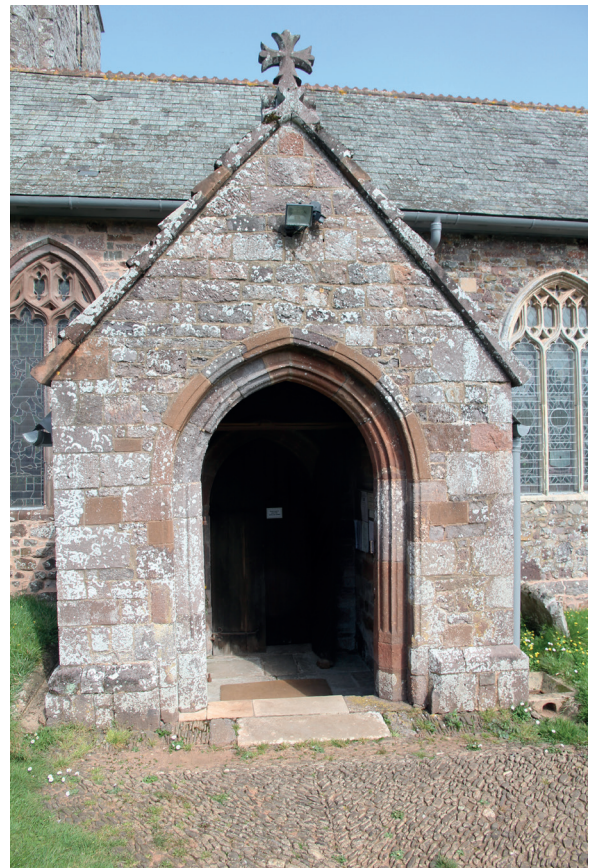
*Fig.135. Upton Pyne, Our Lady. This has a visible surviving cobbled path from the S porch to the lychgate and probably more lost under grass. The porch was rebuilt to the designs of William White in the 1870s.*

During the Upton Pyne restoration of the 1870s by William White, the south porch was rebuilt and the (presumed) early 19th century cobbles adjacent must, at the very least, have been re-laid to fit it. A lychgate was added during the restoration to provide a more dignified entrance to the churchyard from the SE and this involved re-laying a path. In 1887 a churchyard repair fund was established by Countess Iddesleigh, who transferred an investment of \$1,000 held in the St Paul Minneapolis and Manitoba Railway Co into a bond for keeping the churchyard and monuments in good order. Following this paths were cut from the Northcote vault and from the W door and churchyard round the west, north and east sides of the churchyard, repairing the old path near the S door and near the lychgate at the same time. The path from the south porch to the lychgate is visible.

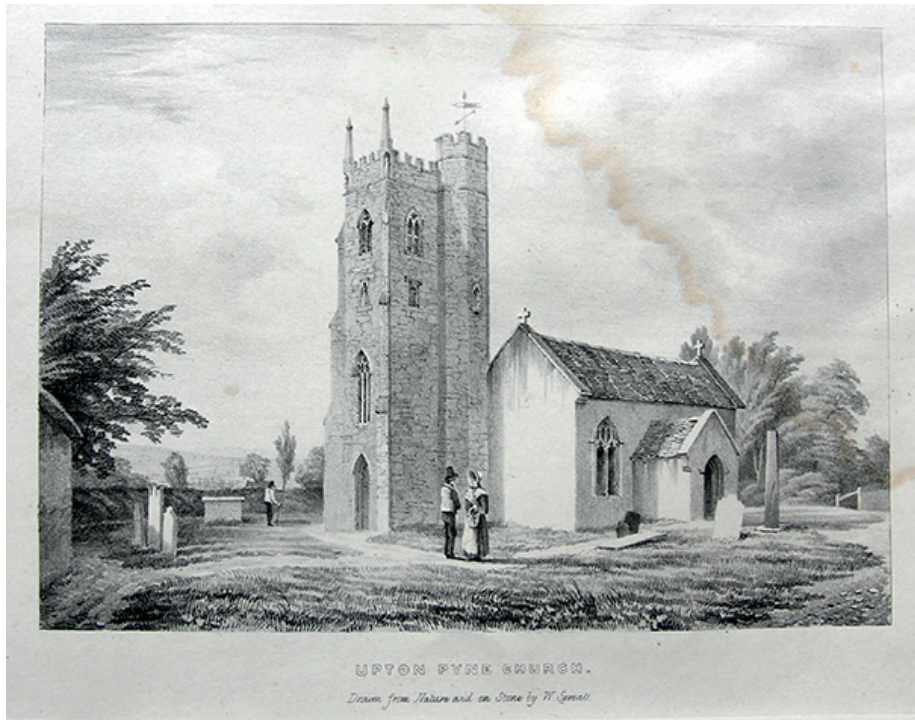
Fig.136. Spreat's 1842 engraving of Upton Pyne, Our Lady.

In the 18th century a vestry or perhaps priest's house was attached to the W tower - this had been removed before the 1842 tithe map, which appears to show the main entrance into the churchyard in the north-east corner. Spreat's 1842 engraving shows paths in existence in a view from the south west [Fig.136]. In 1861 a small piece of land at the east end 'where a path used to be' was taken into the graveyard with a wall carried round the E end. In 1873 a piece of ground on the west side was added for the Northcote family vaults. In earlier days the Northcotes would have been buried inside the church, but the nuisance - both the disruption to an interior and 19th century anxieties about disease emanating from the corpses in reopened family vaults - pushed new burials outside, however superior the family. The treatment of internal vaults by Victorian church restorers re-flooring medieval churches reflects the contemporary concerns with public health, e.g. the vaults at Salisbury, St Thomas were emptied by Gilbert Scott and back-filled with sand (*pers.comm.* Francis Kelly).

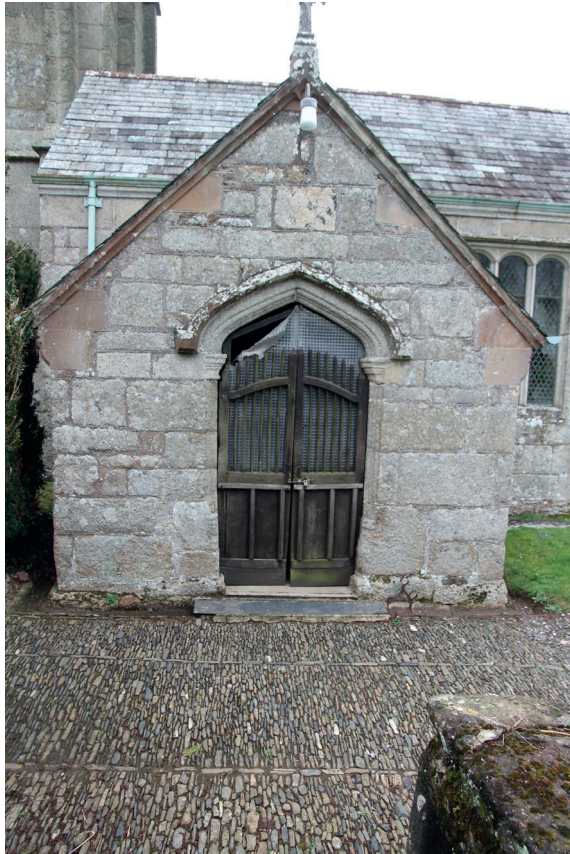
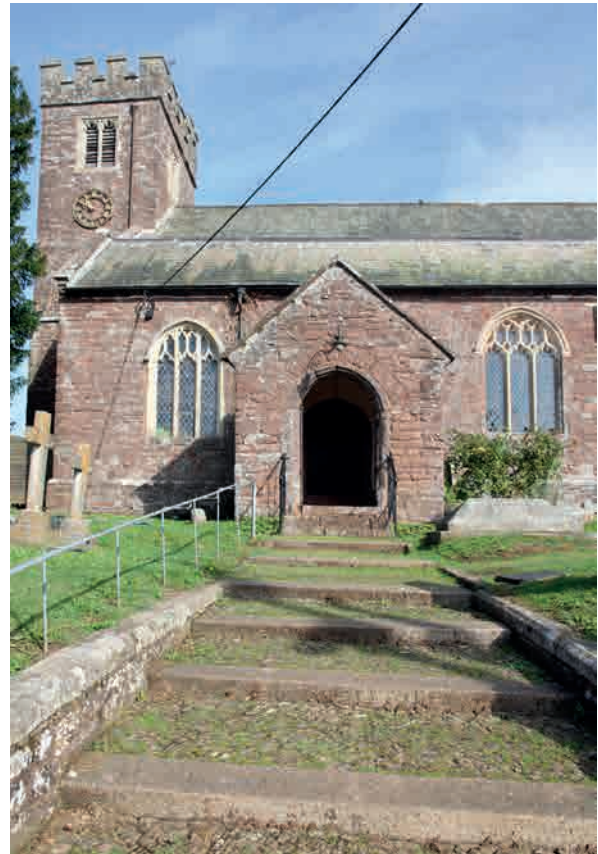
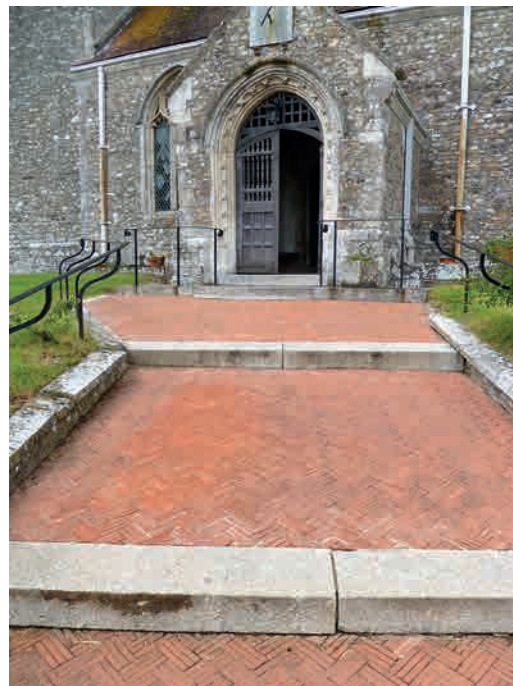
*Fig.140. The neatly-laid sandstone river channel cobbles at the Church of St Mary Exbourne (top left) provide a harmonious and subtle colour contrast with the granite church and also suit the reddish and purple colours of the church of St Swithun, Sandford. These compare favourably with the shrill colour contrast between the brick path and the Church of St Mary, Payhembury.*

The colour of cobbles is usually harmoniously within or close to the tonal range of colour as the exposed masonry of the church building, Devon's churches having a wide range of stone colour [Fig.140]. Cobbles fit comfortably with modest and high status church buildings [Fig.141]. The fall of light on the multiple surfaces of cobblestones is attractive [Fig.142]. There are churchyards where the colour, local geological distinctiveness and 'hand-made' qualities of cobbled paths relate directly to the products of the local slate headstone industry [Fig.143]. The aesthetic qualities of cobbles can be lost if they are unsympathetically relaid [Fig.144].

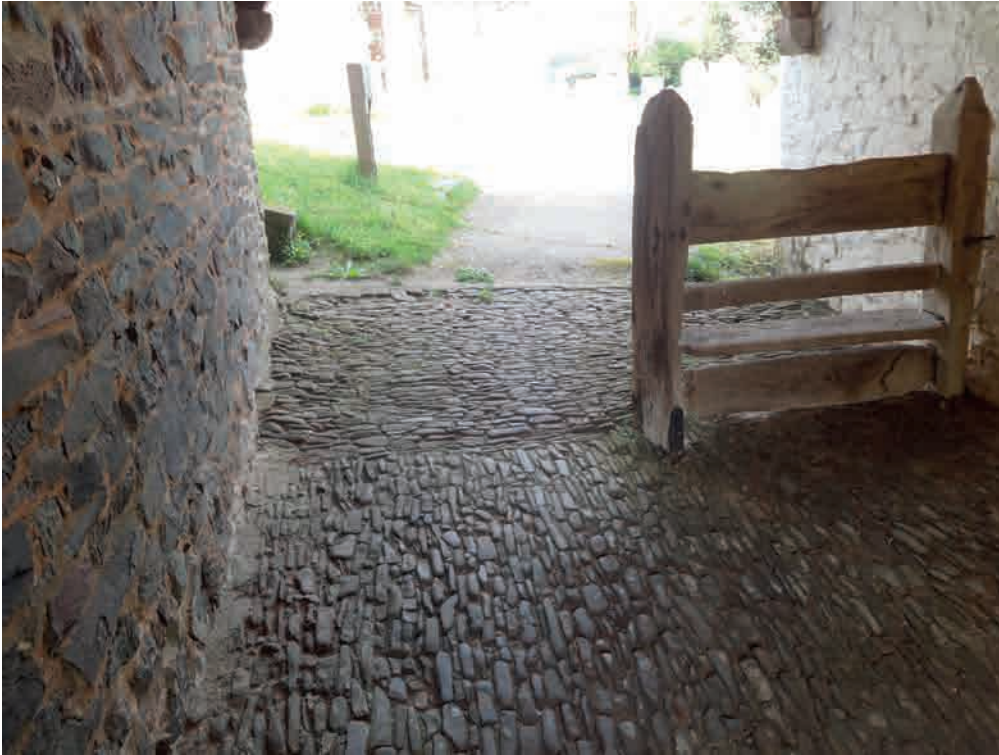
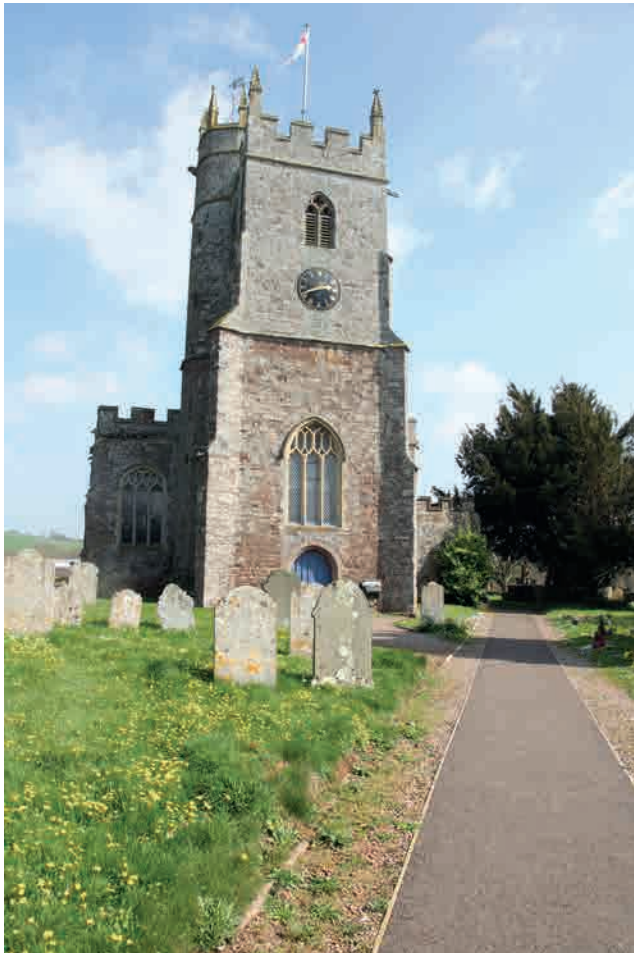
*Fig.142. Light falling under the lychgate of West Worlington reinforces the simple pattern of individually-laid stones. The tarmac path at Silverton looks industrial by comparison.*

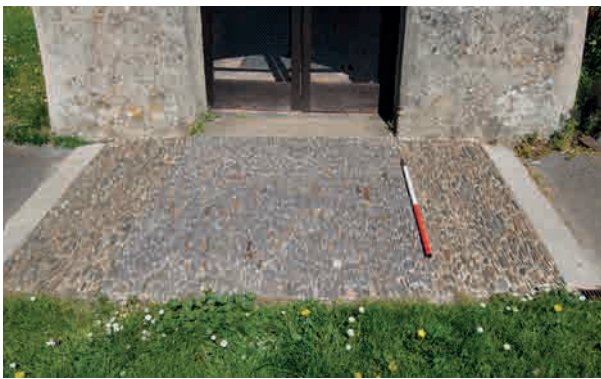
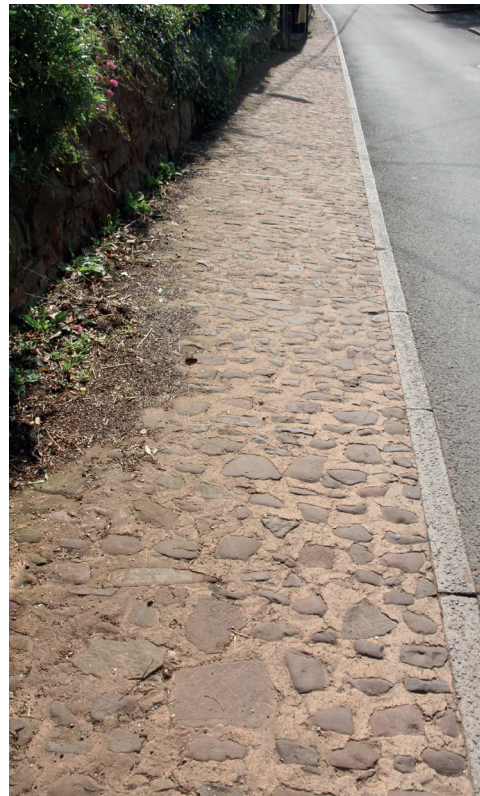
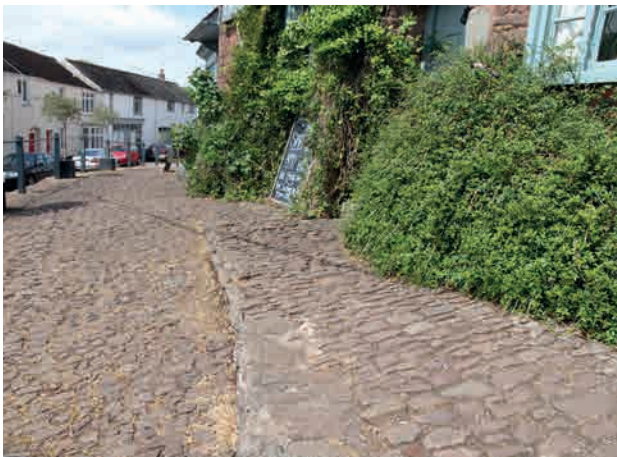
*Fig.144. A cobbled 'doormat' outside the porch of Trusham St Michael (top left) has been relaid in cement losing the visual liveliness of traditionally-laid cobbles. This can be seen in more extreme form in a cobbled secular footway relaid in cement with cement kerbs at Sandford (right) which can be compared with other surviving Sandford footways (left), which have had some cement repair but are largely traditional.*

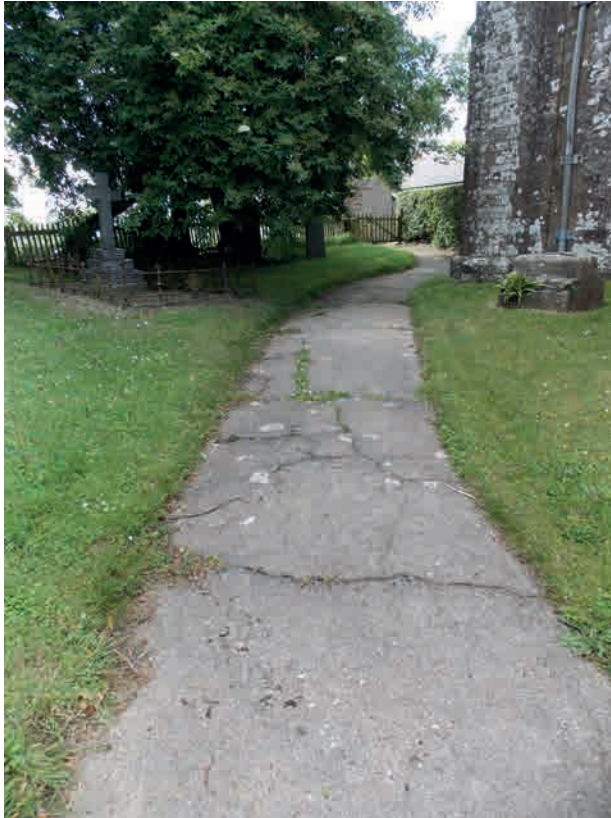
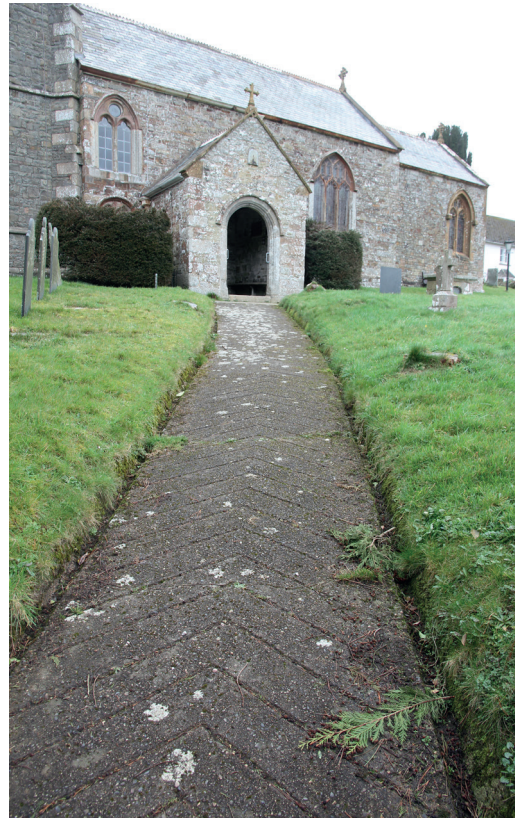
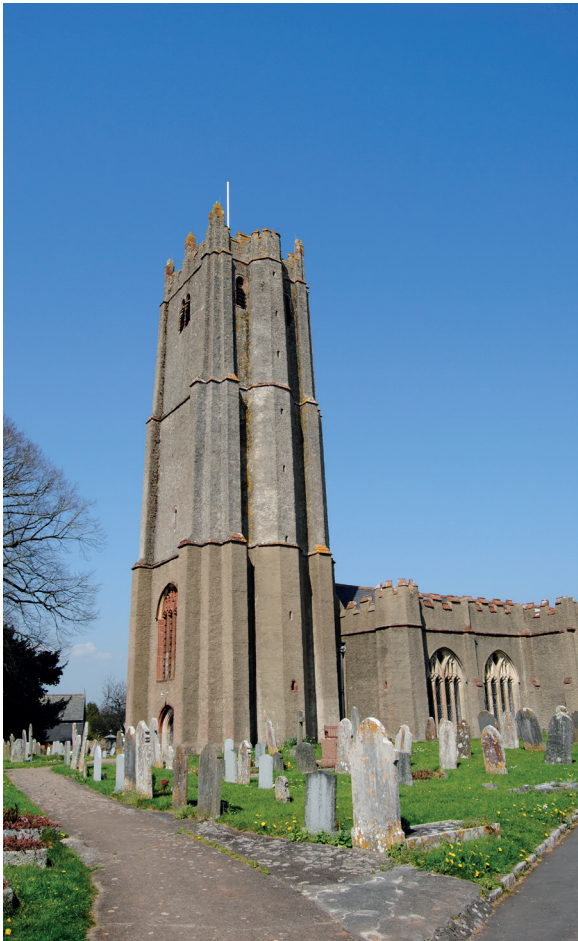
*Fig.145. Examples of cement and tarmac path surfacing leave a church 'high and dry' in its setting and, unlike cobbles, do not provide a pleasing link with the churchyard landscape. Clockwise from top left: Alwington; Iddesleigh; Ipplepen.*

Historically cobbles satisfied a sequence of evolving aesthetic preferences. Like thatch, they satisfied the Picturesque requirement of being rustic and irregular in form and colour. Their sense of antiquity and ruggedness suited the Gothic Revivalists. They chimed with Arts and Crafts thinking, as derived from Ruskin, providing simplicity, truth to materials and materials from the locality and the visible marriage of design and craftsmanship. Some of the visual appeal of cobbles in the 20th and 21st century has been magnified by the low aesthetic quality and dreary utilitarian look of tarmac and concrete, which are the standard existing alternatives [Fig.145].

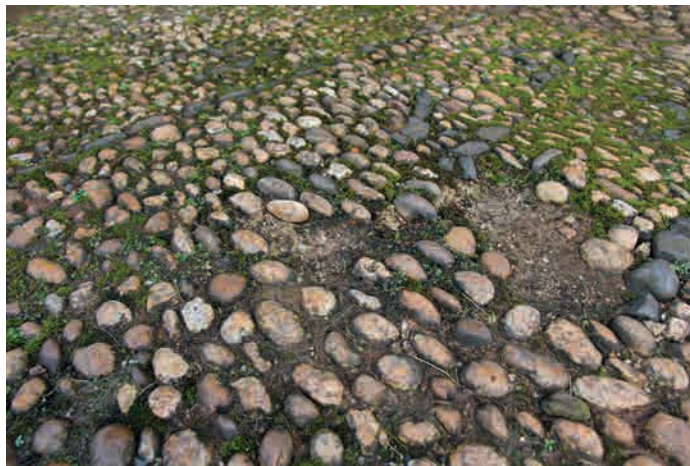
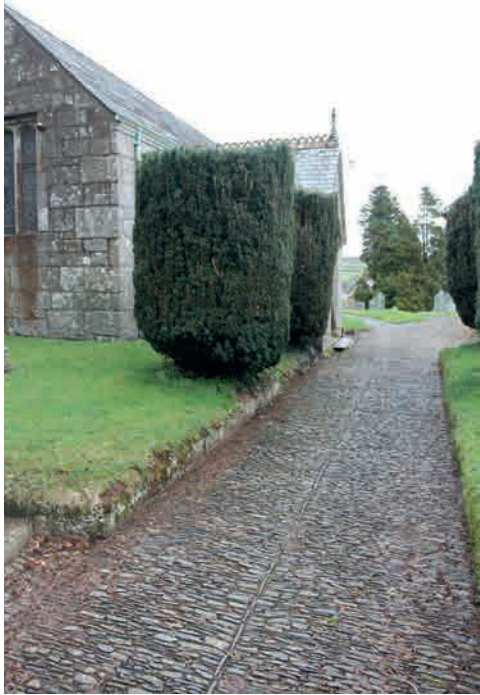
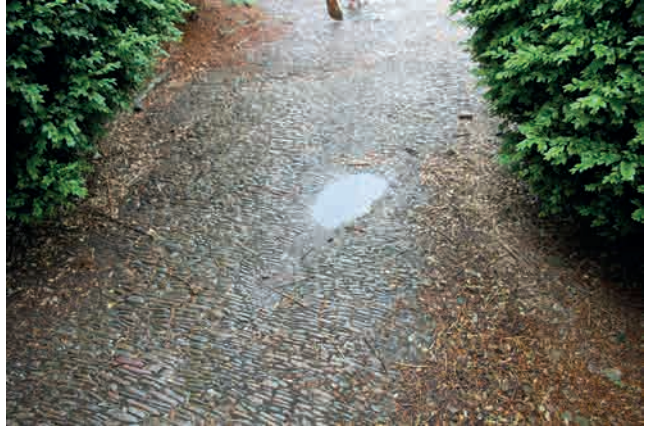
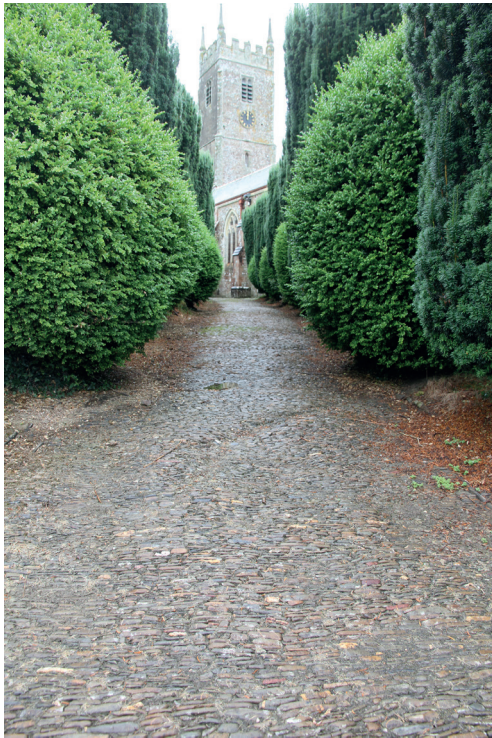
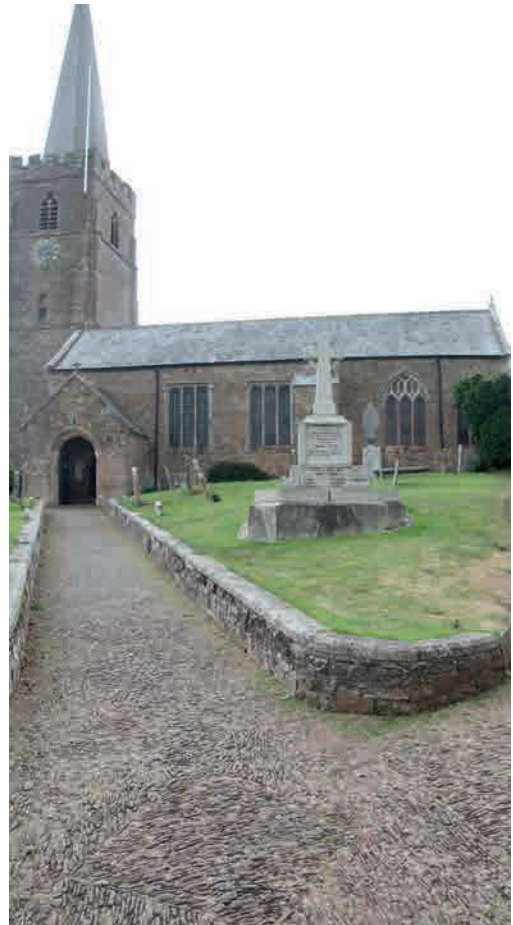
*Fig.146. Variations in cobbled surfaces: this page and opposite. Above, lost and loose pebble cobbles at Poltimore. Opposite, clockwise from top right. A relatively level, even and flat path at Exbourne; a water-filled sinking at Petrockstow after rain; a well-preserved path at Hatherleigh between revetment walls. The overshadowed path at Petrockstow illustrates the impact of environmental factors. It does not allow sun to shine on the path or air movement to keep it dry. The narrowing of the width by the foliage is also a barrier to access for people with visual impairment or two people walking side by side (such as a disabled person holding on to a companion or a bride to her husband) or those carrying a coffin.*

- Types of cobbles.  
Assuming good condition, cobbled surfaces using pebbles are intrinsically more uncomfortable to walk on or wheel across and potentially more hazardous than cobblestones with flat or flattish tops. The form of the pebbles means that a rounded or dome-like portion of each cobble will project above the bedding. Each cobble will be felt through a thin-soled shoe and a horizontal surface for a walking stick will not be found. On the other hand, cobblestones with flattish tops, kept in good repair are at the advantageous end of practical design: that is a wide, flat path well-contained by kerbs or masonry walls and with a natural predictable uneven-ness underfoot.

- Condition  
In poor condition, with unrepaired slumps, or 'islands' of cement repair, or spreading with loose cobbles because kerbs have failed, all types of cobbled surface can present access barriers.

- Environmental Factors  
These include good/bad drainage and availability of sunlight and air movement to keep paths dry.

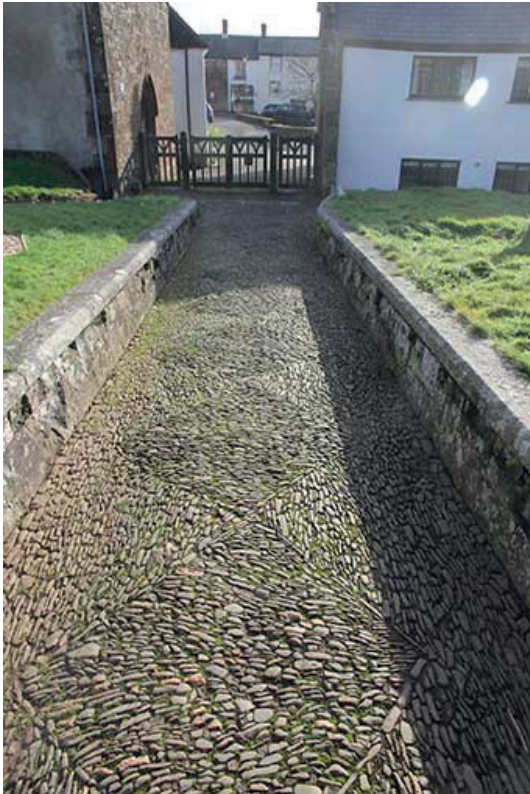
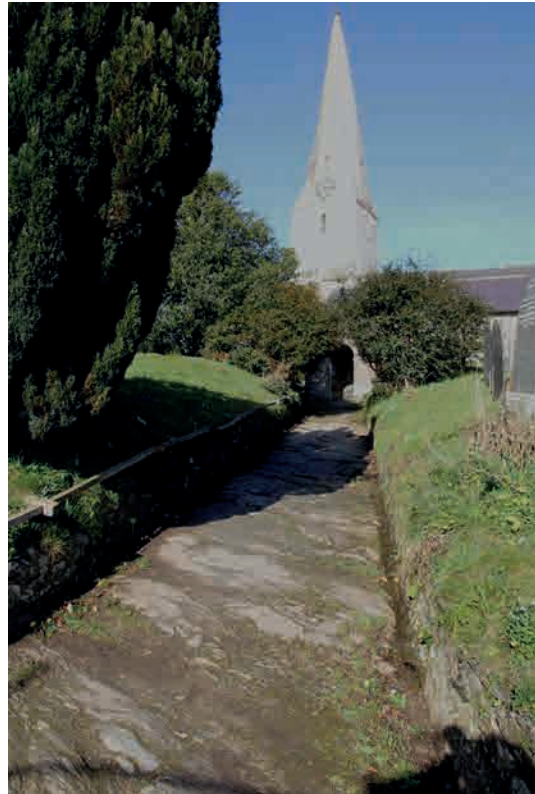
*Fig.147. A long, fairly steep path at Hatherleigh (left). The low flanking walls provide resting places for churchgoers. The steep uneven bedrock path at Diptford (right) has a lop-sided camber. The handrail is useful here.*

Many rural villages in Devon are located on hilly terrain with the church at the highest point functioning as a landmark. This often means that the path leading to a church, as well as some of the paths around the village, may be very steep. Many disabled people find a steep slope difficult to walk or wheel up or down, particularly if there are no resting places or anything to hold onto. A steep camber on the path can also cause access difficulties. Steep gradients are difficult to address in churchyards as there are often conservation and financial constraints on creating a longer and less steep path. A handrail and provision of resting places can be very useful in these situations.

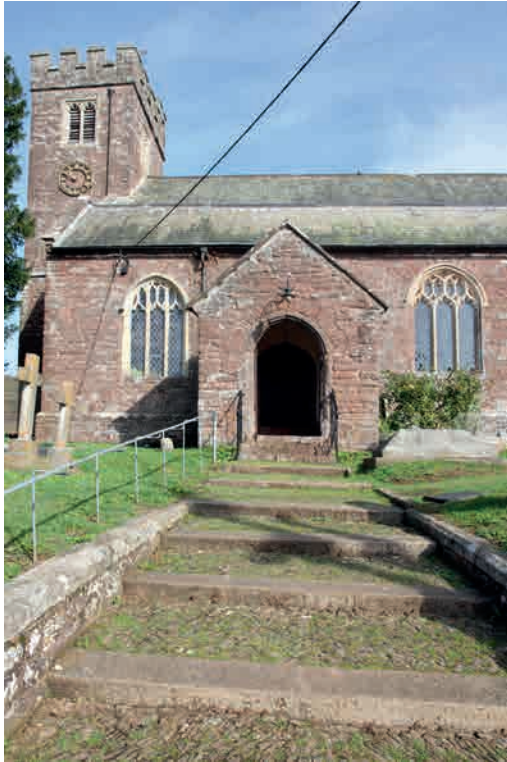
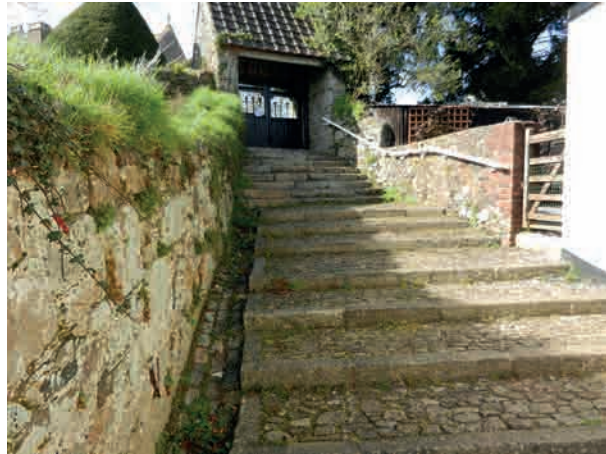
*Fig.148. Examples of handrails to steps: (left) Sandford, cantilevered, on the left side, (right) Ilington on the right (avoiding the drainage channel). Handrails on both sides of a path, if possible, are helpful to both right-handed and left-handed people, travelling up or down a flight of steps.*

These present similar problems to paths in relation to their surface. Ideally steps should have continuous handrails to both sides. Where the width of the path allows, a central handrail may be useful as people with only one usable hand can make use of it both ways.

Some disabled people find steps easier to use than slopes and vice versa. Handrails to cobbled steps would assist people both with the steps and with the cobbled surface.

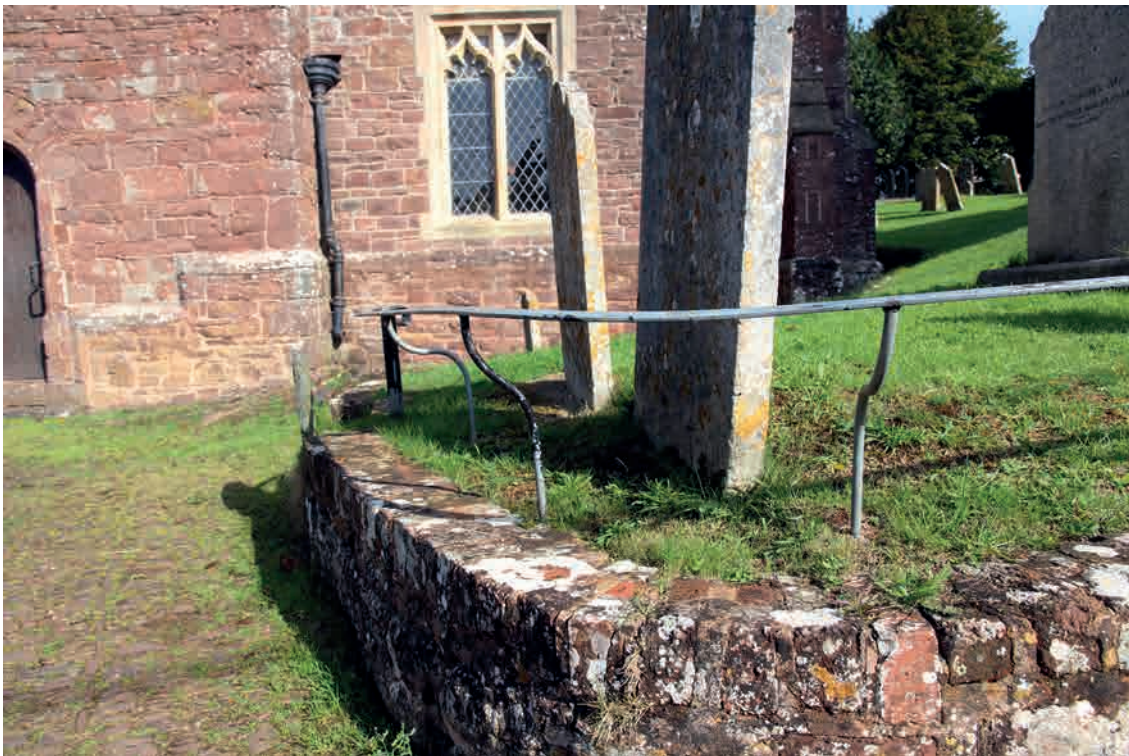
*Fig.151. A welcome and serviceable handrail at Sandford on a path that avoids some, but not all, of the steps up to the church. It is need of re-decoration to make it more appealing to use, or abandoning the painted surface altogether.*

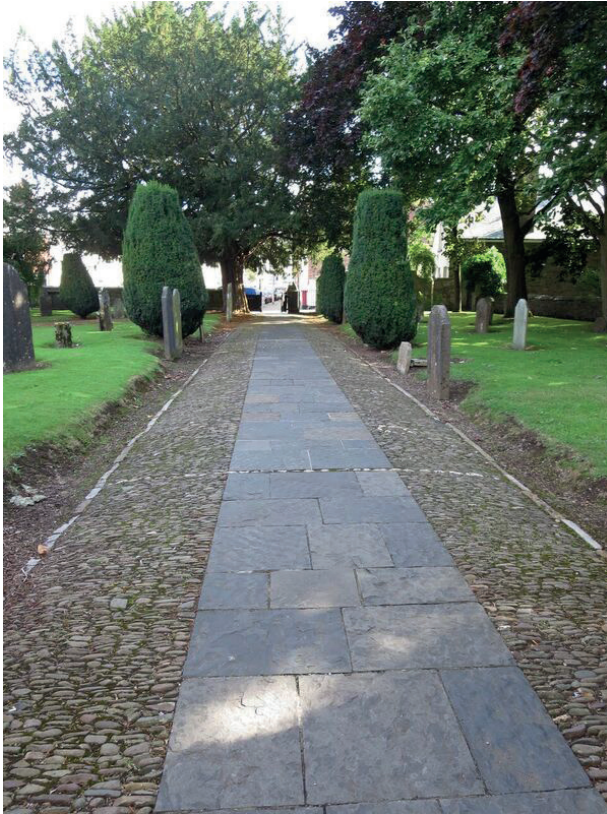
*Fig.152. Examples of new paths through cobbles. Paved path of riven Pennant stone at Tiverton (top left). This has undulations greater than those recommended in Part M but considered to provide a more natural-looking finish. A path of paviours at Poltimore (top right). These provide a good surface for access but do not extend to the principal entrance, which is the one most-used. Concrete paviours inserted into a cobbled path at Crediton. These are visually assertive in the setting and it is disappointing that they lead to a very steep ramp into the church in the south porch.*

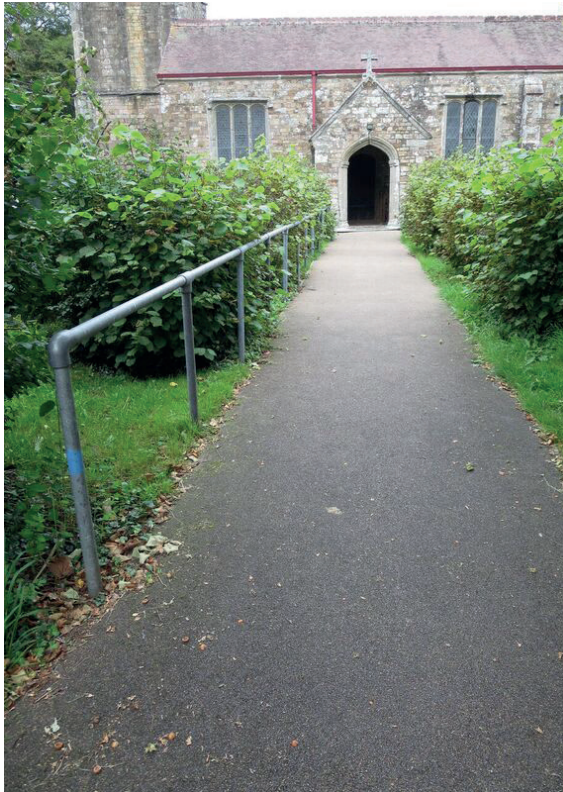
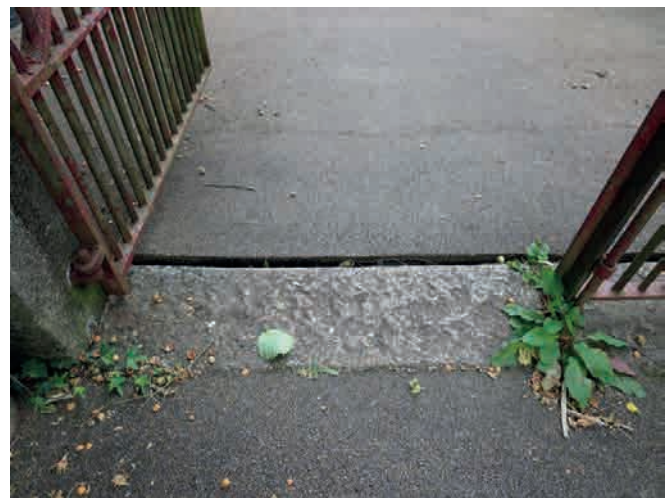
*Fig.153. The playtop overlay at Black Torrington: the cobbled path survives below. The handrails are not sympathetic to the setting and do not extend alongside the full length of the path. A gap has opened up between the path surface and a former granite step. The ramp into the porch has no handrails, the slip-resistant strips are coming off – possibly creating a trip hazard – and there is an upstand to the front edge and a gap where it meets the porch.*

This may be a solution in some cases. However, care has to be taken with the way in which the surface is laid. The path below is a playground surface material called 'Playtop' [Fig.153]. The surface itself is firm and even. This would be cheaper than laying a new path but not as durable. It tends to have a warranty for approximately 5 years and will eventually need replacing. This particular path has developed gaps at each end – which is something that often happens over time with these types of surfaces.

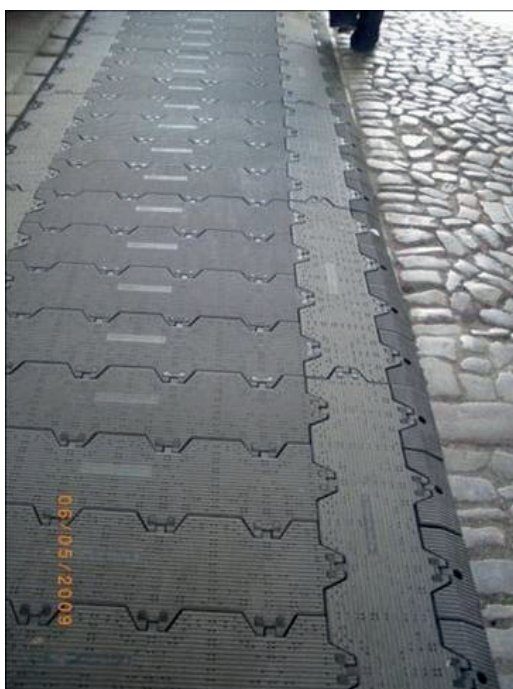
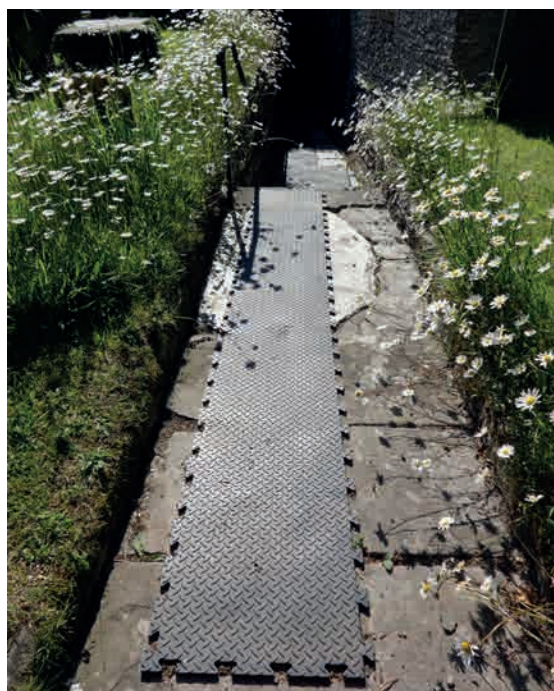
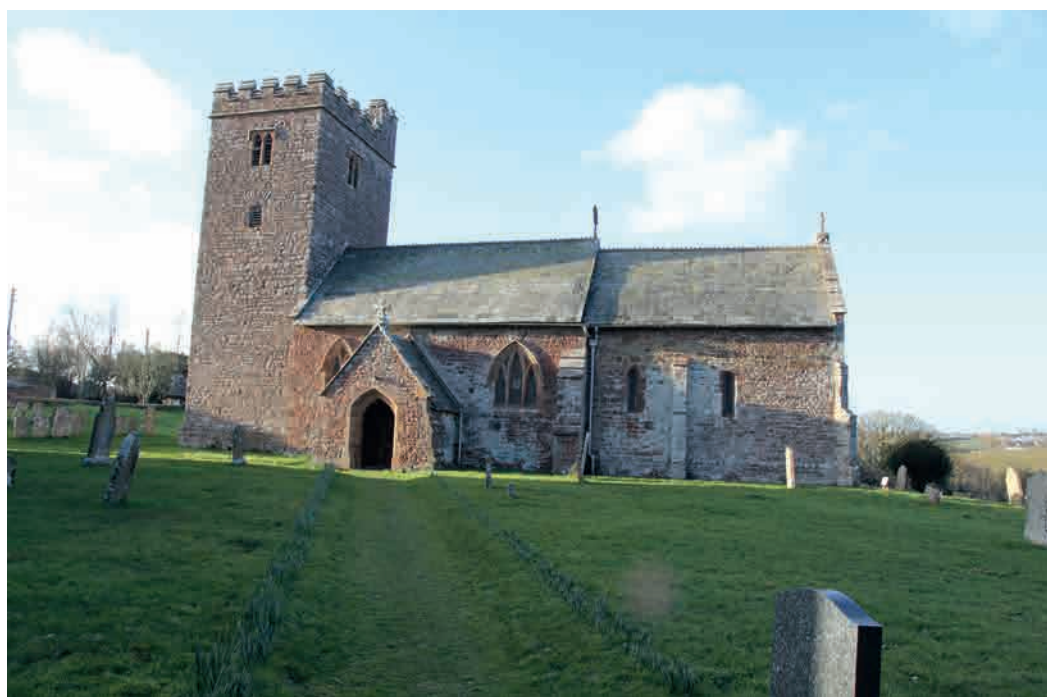
*Fig.154. Top left. Temporary cover over secular cobbles (photograph provided by Kim Auston). This is quite unsightly but may be appropriate in some settings, e.g. market places. The only similar example seen at a church was at Marwood, top right, used not for cobbles, but uneven flags. A path at Stockleigh Pomeroy church may be an example of grassed-over cobbles. Grassing over may work in some rural settings. A handrail would be helpful.*

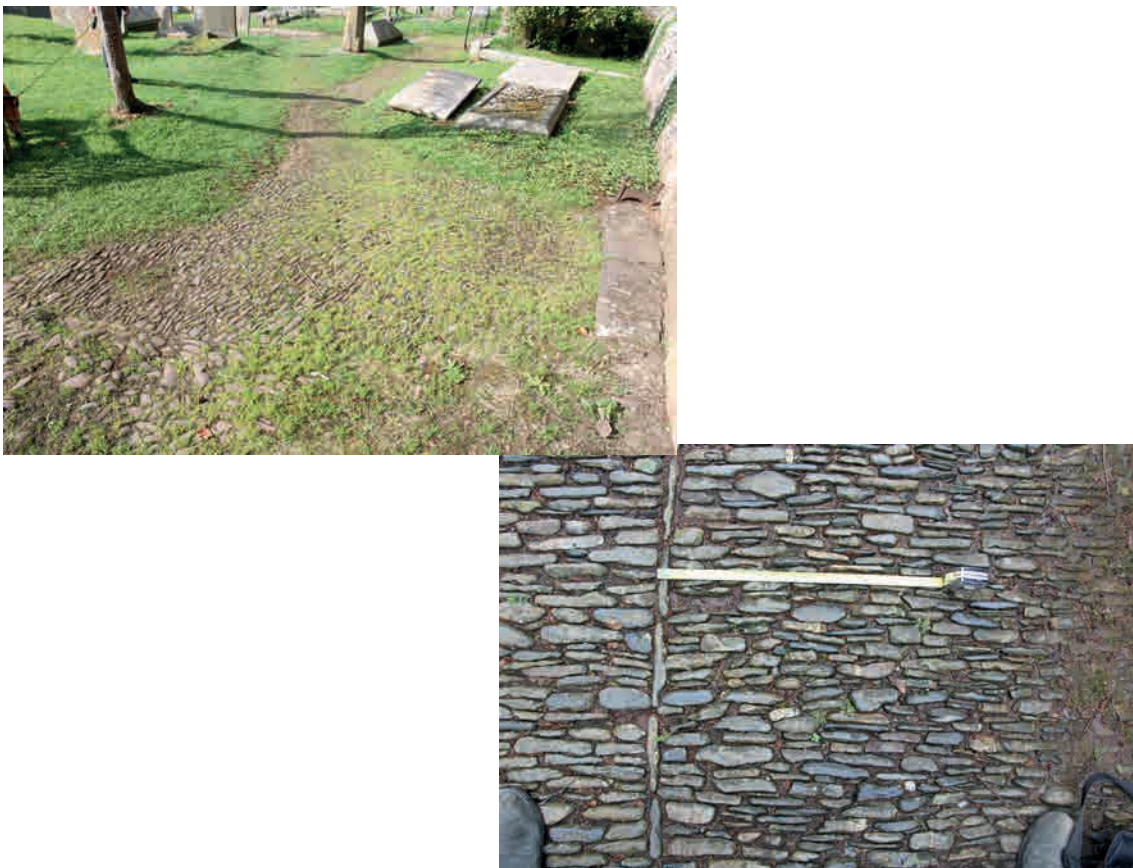
*Fig.155. Weed/grass growth. Top, Sandford St Swithun. Below, Exbourne, one of the best-maintained paths seen. Weeds here are killed with a chemical weedkiller whenever they are noticed by a parishioner who regularly walks through the churchyard (pers.comm.) Revetment walls to the path keep it isolated from the churchyard turf: this avoids weedkiller spread.*

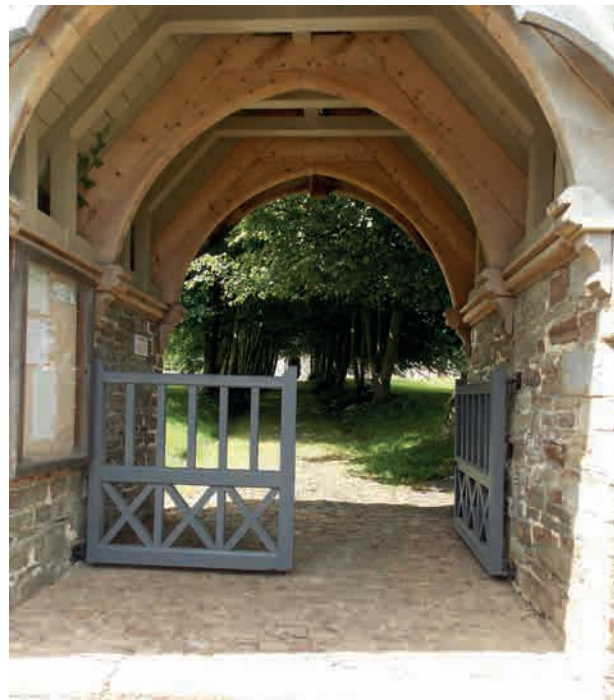
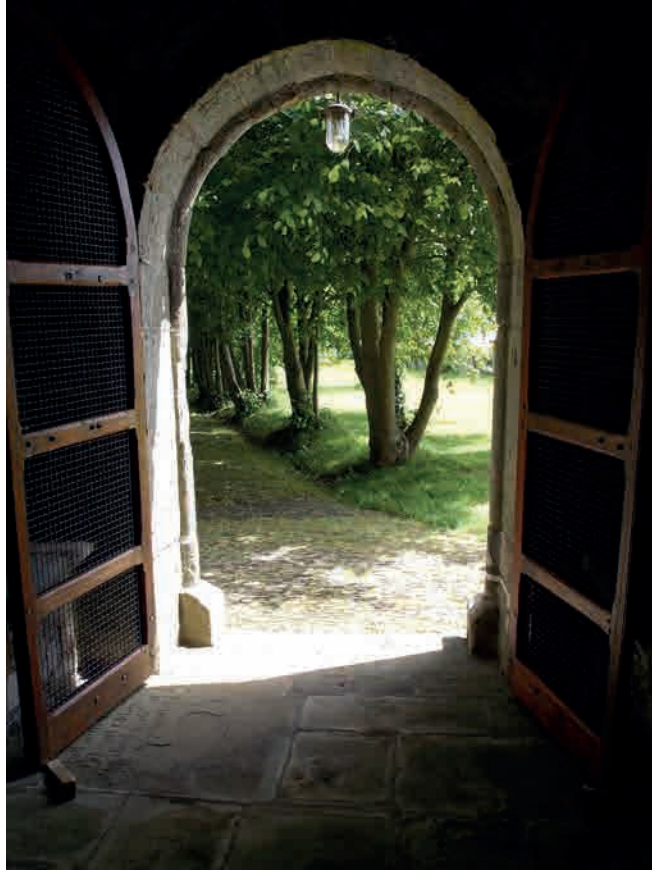
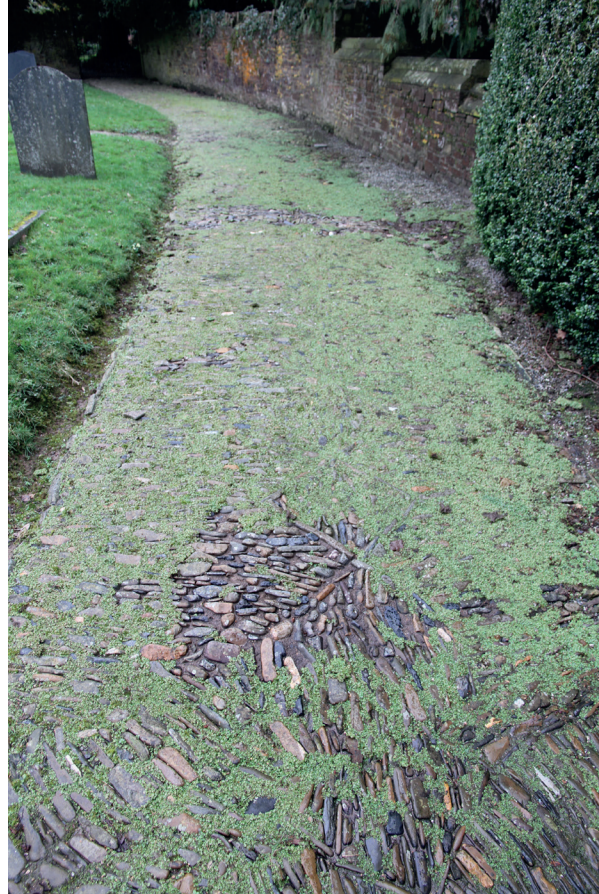
*Fig.156. At Buckland Brewer a path is overshadowed by coppiced trees that meet over it (above and next page, top). This has encouraged a thick carpet of moss and a dark tunnel that makes a memorable contribution to the entrance to the church from the lychgate. However, many locals avoid the path, considering it hazardous. At Huish, facing page, right, specimen trees (part of an important landscaping scheme associated with the church) overhang a sub-path to the old rectory and encourage a cover of fleshy weeds. These examples represent real conflicts of interest between different sorts of churchyard heritage, natural and architectural.*

Avenues of trees overshadowing a path can be an immensely attractive and distinctive Romantic element of a churchyard landscape and key contributors to the setting of a church building [Fig.156]. Trees reduce sunlight and ventilation and encouraging moss growth and weeds which can be slippery. Weeds and grass will gradually convert subsoil jointing material into humus and encourage more weeds. Leaf drop from deciduous trees, if not cleared away, will have the same effect. Tree spread, over time, can narrow a path rendering it un-negotiable for processional occasions and difficult for people with disabilities. In one case, Meeth, tree root damage was noted, disrupting kerbs.

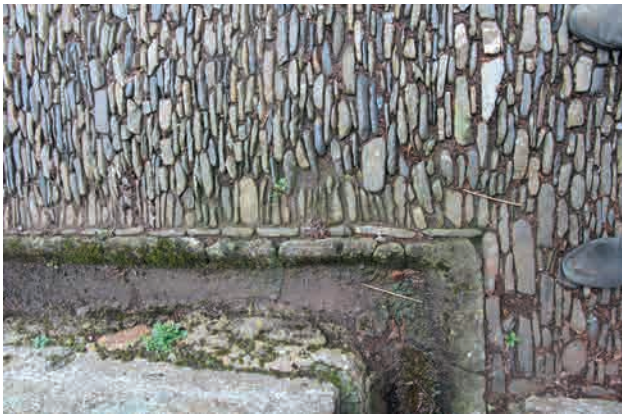
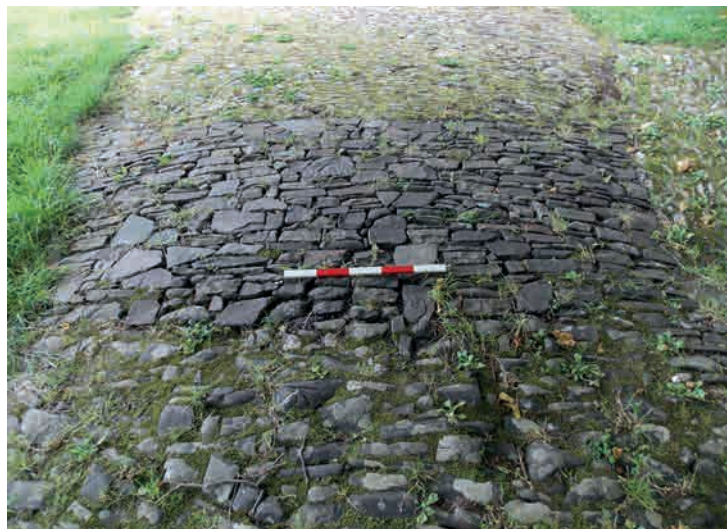
*Fig.157. Top. Small repairs to the Exbourne cobbles are visible adjacent to a drain along the front of the porch. Below. A large section of repair to the path at Buckland Brewer. Repairs to this path include replacing tarmac with cobbles. The church has the advantage of a skilled cobblestone-layer living just outside the lychgate who has also repaired a long cobbled footway in the village.*

Small-scale and some larger areas of repair were noted, as well as one large cobbled area that had been completely relaid [Fig.157]. Some repairs, including reversing cement-work, are so successful that they were only recognised by chance by talking to local people (e.g. at Meeth). Many paths have examples of small repairs in cement, presumably prompted by loose cobbles. Cement repairs to jointing are ineffective and speed up deterioration, as analysed above in Section 7. A complete relaying of a sub-path at Tiverton St Peter (on the route of an earlier path, on map evidence) in cement using pebbles laid horizontally and cast concrete kerbs has comprehensively failed. The work was probably done in the 1960s [Fig.158]. However a small section of re-laying in a weak cement mix was pointed out to Jo Cox and Ray Harrison at Upton Pyne and seems to have been effective. The 'Causeway' at Upton Pyne, a large cobbled court immediately outside the lychgate was relaid (exact date not established, probably 1980s) by Devon Direct Services using probationers. This is an area which is used for parking. Rather surprisingly, use for vehicles (the same is true of the courtyard at Huish, St James) seems not to have damaged the surface of the cobbles [Fig.159]. The cobbles have remained very even, but are reckoned slippery and hazardous in wet weather and the relationship of the level of the relaid surface to adjacent buildings was misjudged, causing drainage problems to the buildings (*pers.comm.* Paul Bowd).
