# Devon Cobbled Churchyard Paths

Evaluating their Significance,  
Survival and Adaptation

A project undertaken by  
Keystone Historic Buildings Consultants  
for Historic England and SPAB

March 2016

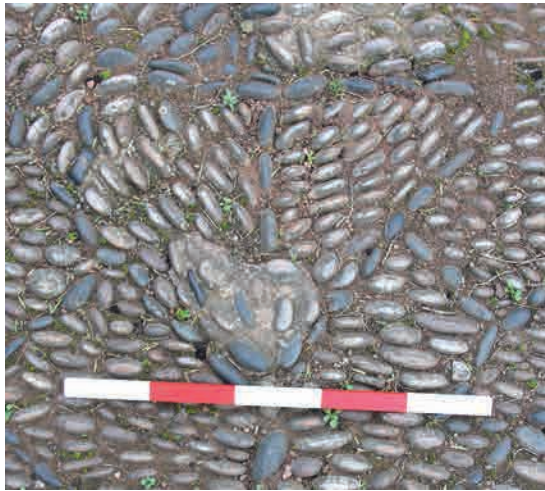
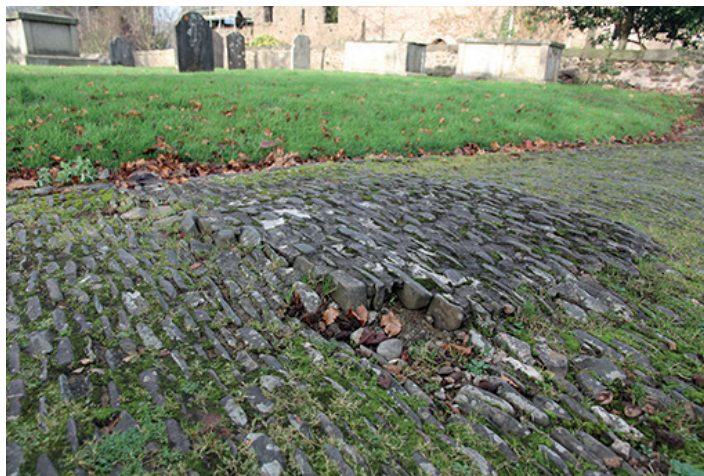
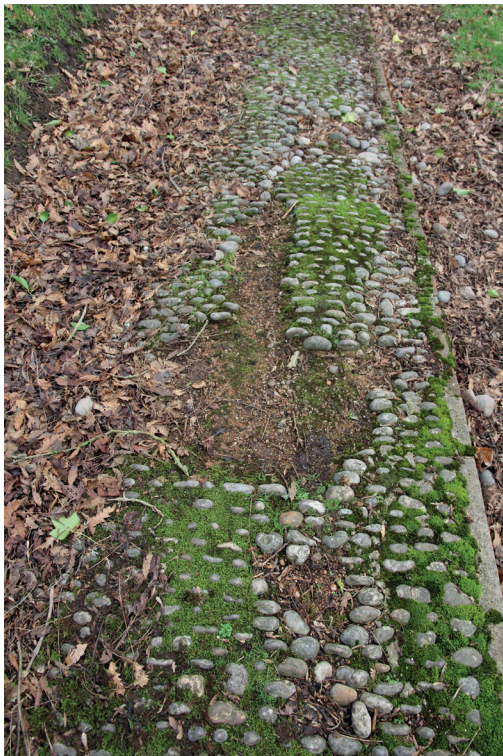
*Fig.158. Top, a tiny patch in cement to a patterned section of a path at Alphington is typical of well-meaning work but eventually ineffective work to reinstate dislodged cobbles and keep a path even. Middle, a much larger cement patch to a sub-path at Tiverton St Peter is causing damage to the adjacent earth-jointed cobbles. Bottom, a sub-path at Tiverton, relaid in the 20th century using pebbles laid horizontally, bedded in cement with concrete kerbs has failed. In the opinion of the authors of this report this little-used and, in terms of construction, untraditional path is a lost cause and would be better removed than retained.*

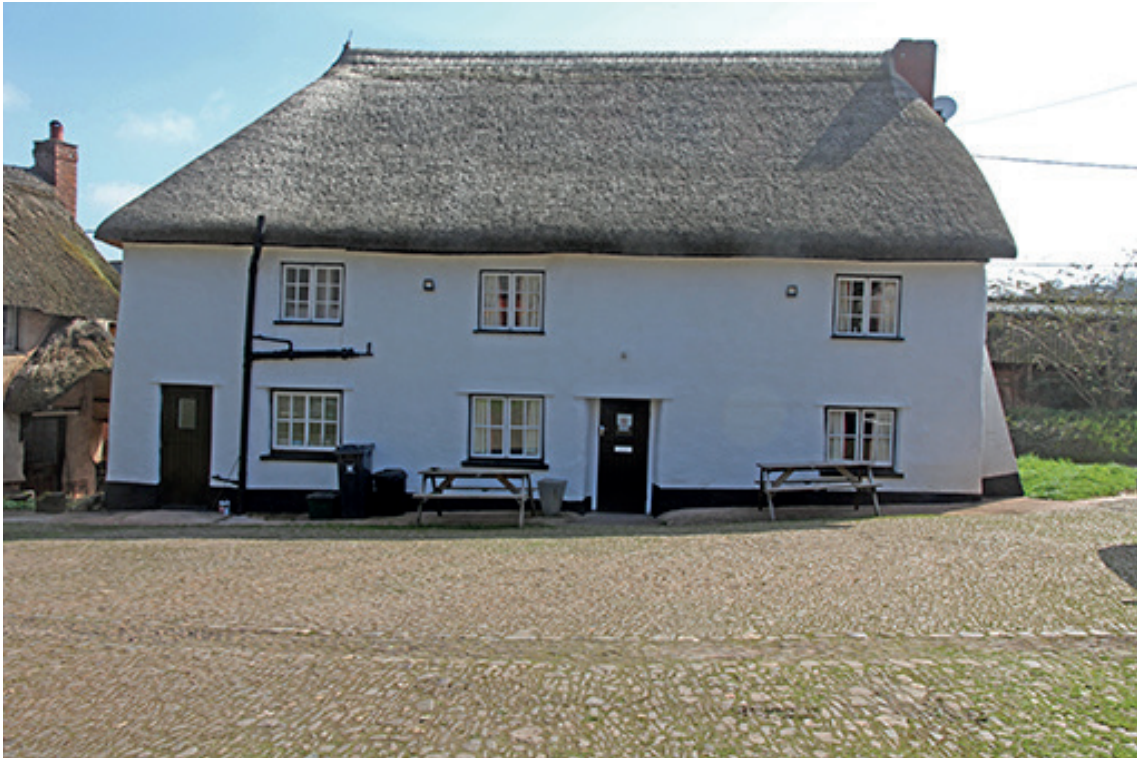
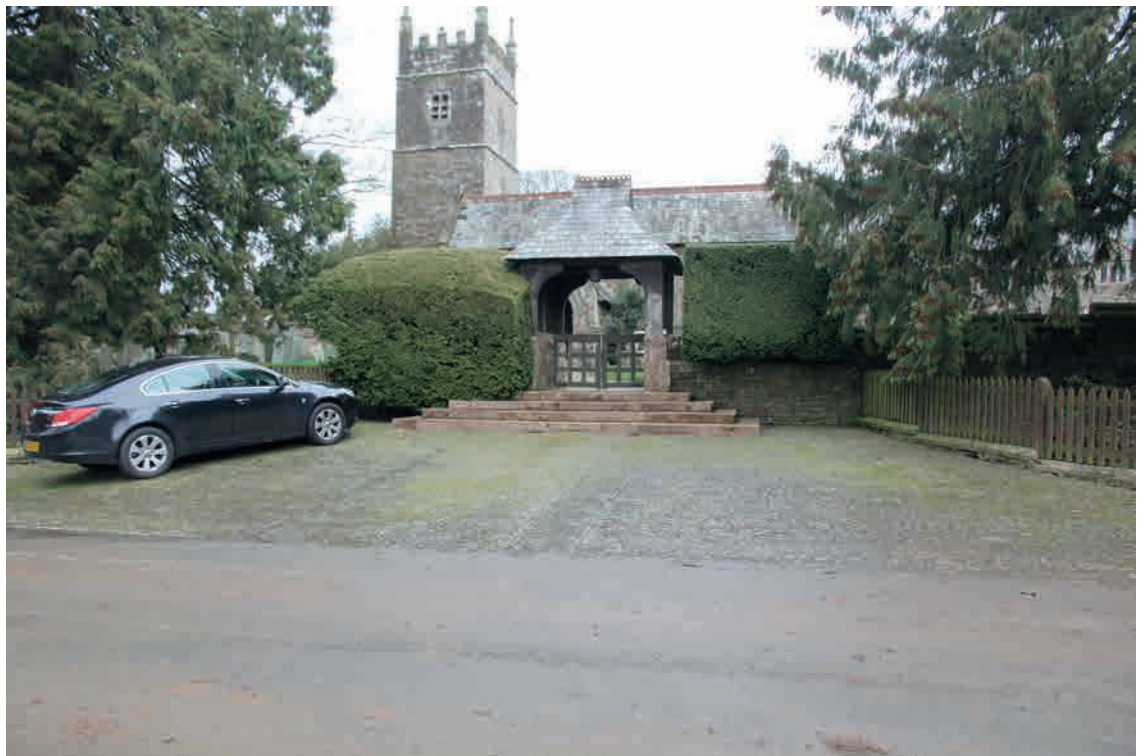
*Fig.159. A large area of cobbles just outside the lychgate of Upton Pyne church has been completely relaid (probably in the 1980s). This is used for vehicles, which do not seem to have damaged the surface. The court at Huish is also used for parking. The cobbled surface appears to be in very good condition, although the paths inside the churchyard boundary are not.*

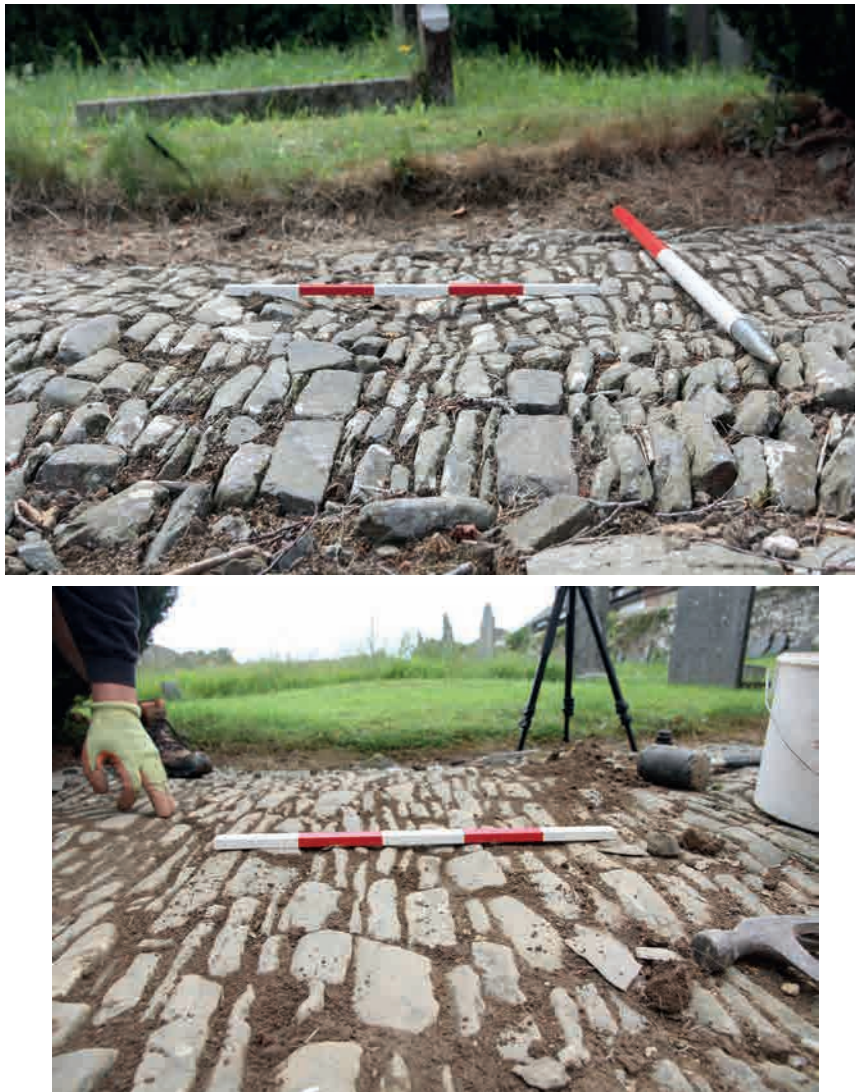
*Fig.160, Slumps repaired by relaying (including relaying lost and overturned kerbs) during the trial at Merton, work by Williams and Burrows, supervised John Alexander, funded by the SPAB, associated with discussions with Francis Kelly of Historic England, Simon Cartlidge of the DAC, Jo Cox and John Thorp of Keystone and Ray Harrison.*

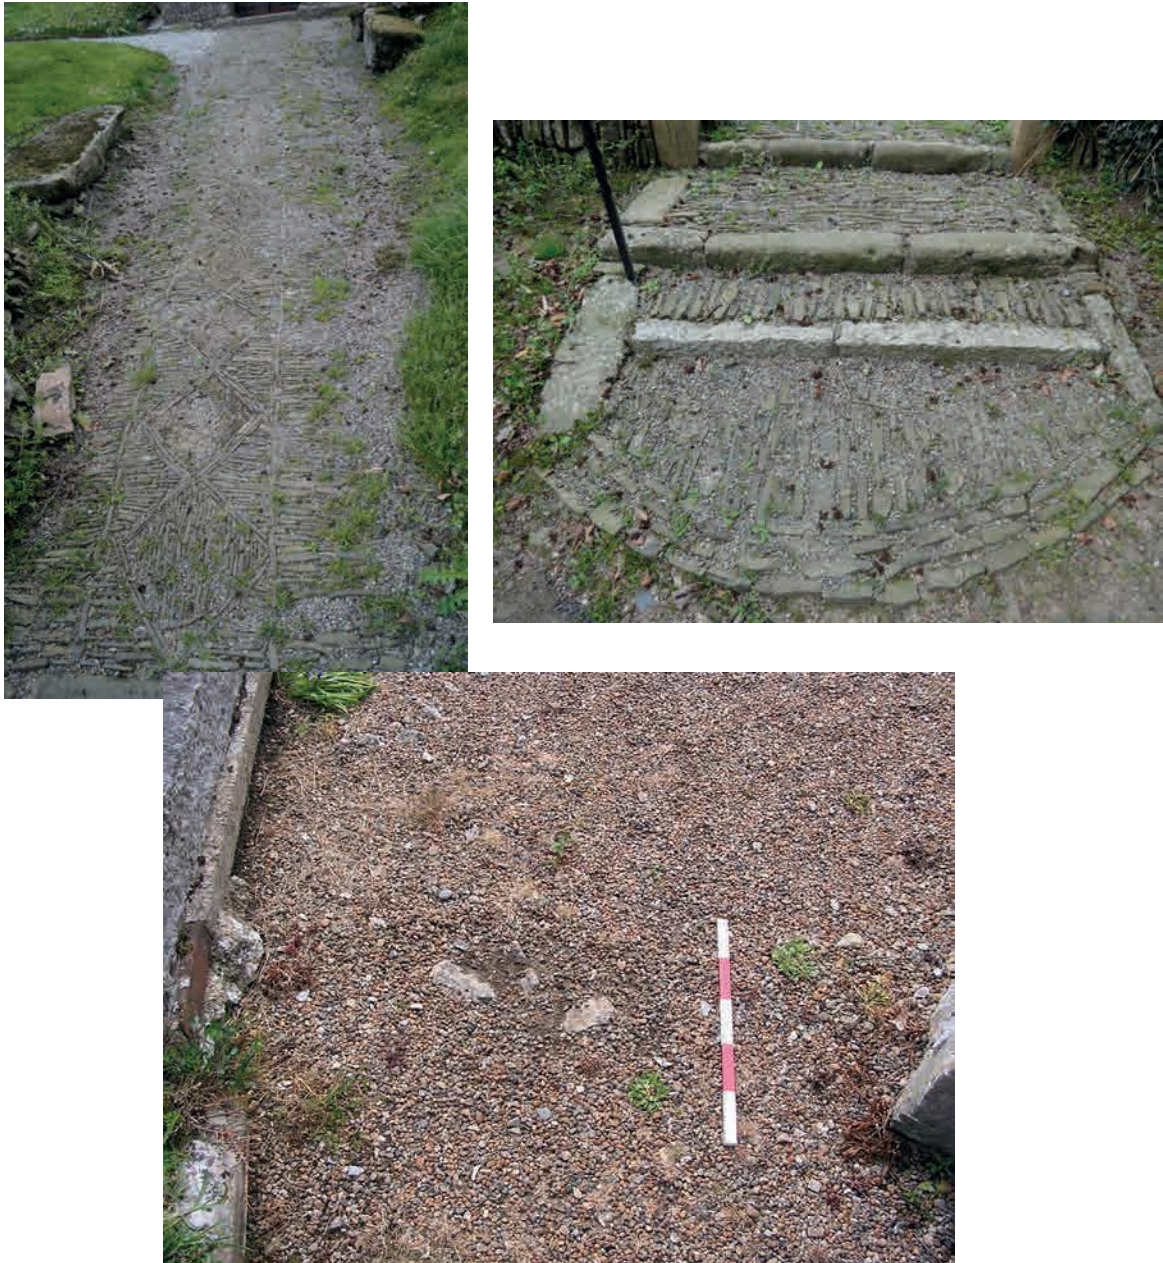
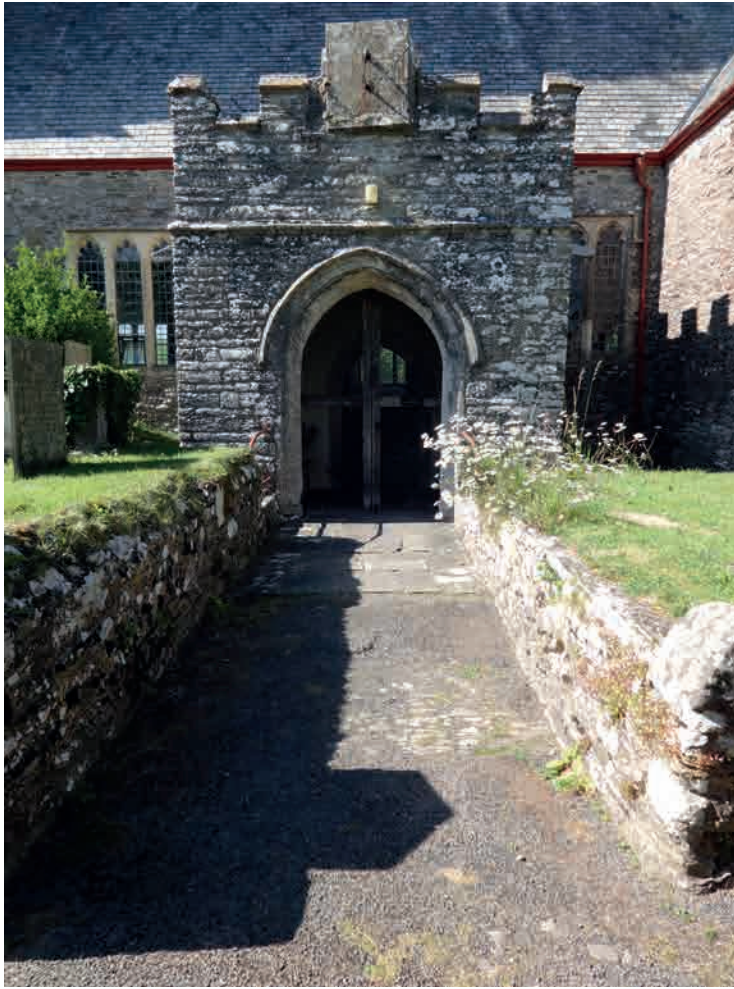
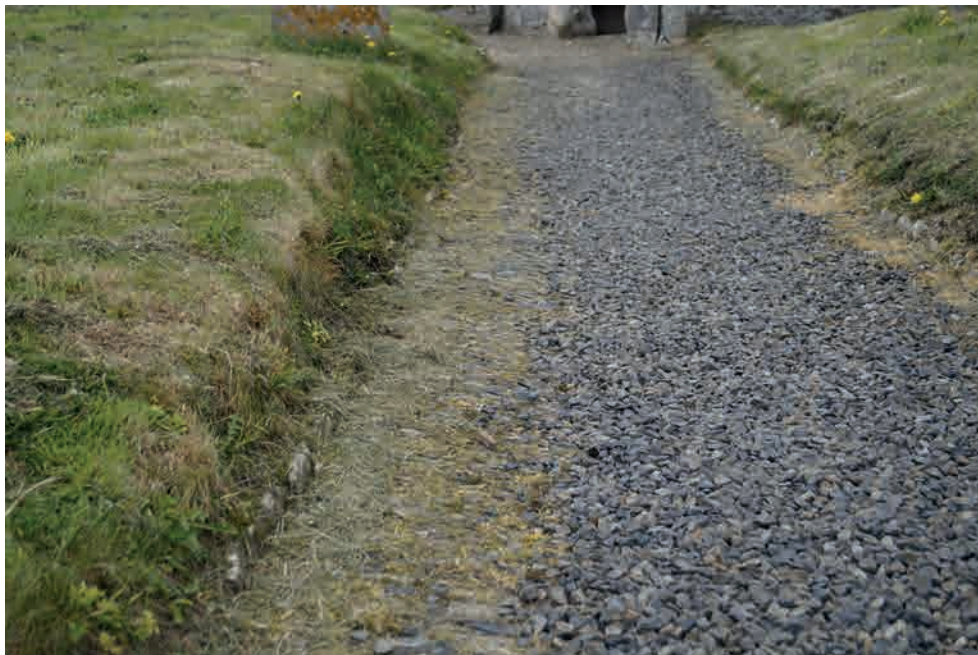
*Fig.161. Examples of gravel scatters, using different gauges and depths of gravel. Top, Inwardleigh, on a patterned path and steps; (below) a fairly deep layer of pea gravel at Uplyme; next page, Marwood (top) and roadstone at Bondleigh (below).*

Many paths have received a gravel scatter: this is the most common 'amendment' to paths seen during the project [Fig.161]. In most cases the objective is to counteract slipperiness. The gravel used ranged in size from fine crushed stone, through pea gravel to roadstone. Depending on depth, gravel scatters obscure the cobbled surface, though patches of cobbles are usually visible. There may be a reluctance to take gravel right up to a porch in case footfall brings it into the church and scratches encaustic tiles. At Bondleigh a substantial scatter of roadstone on a steep path, introduced following a fall by a parishioner, also disguised slumps in the path but the roadstone would make the path very difficult to negotiate for a wheelchair.

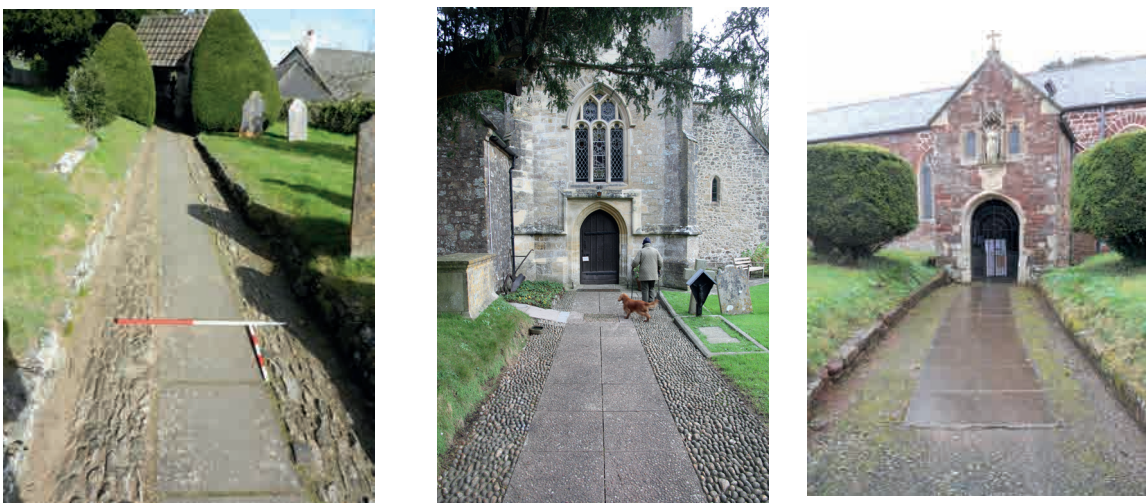
*Fig.162. Concrete slabs driven through cobbled paths at Ilington (c.1970s); Salcombe Regis, driven through a pebble path and Alphington, the slabs discontinuous, presumably to retain a patterned area in the cobbles.*

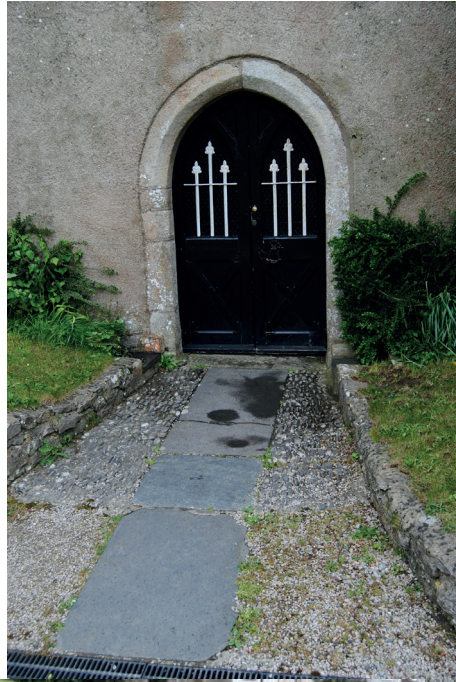
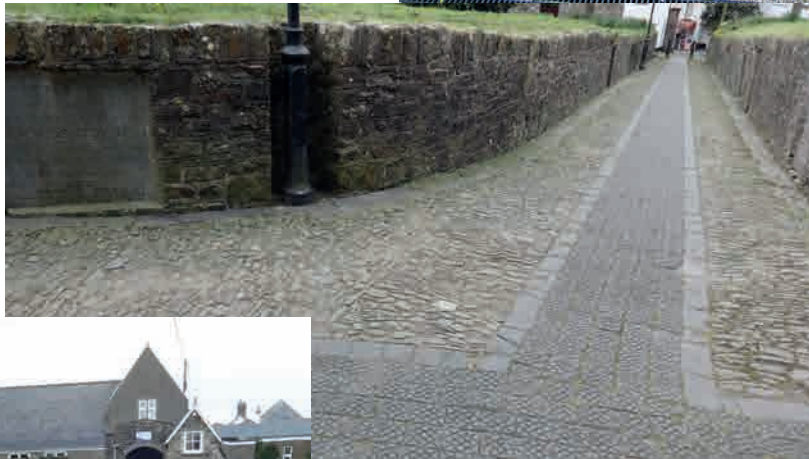
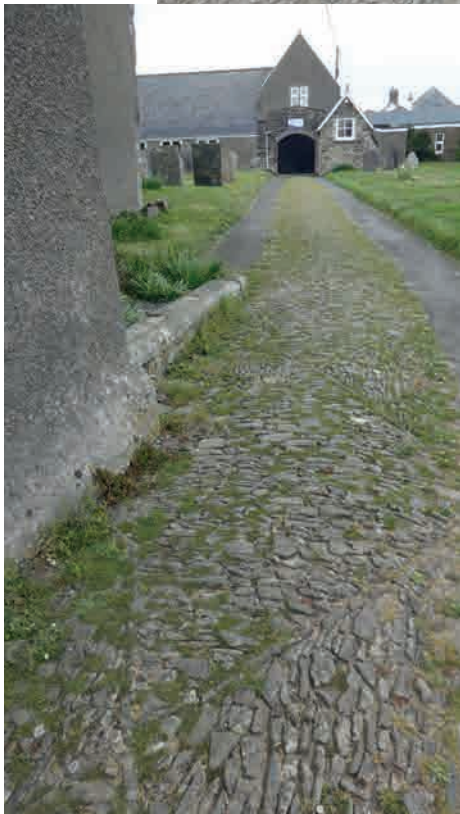
*Fig.163. Slate flags at Highweek; blue paviments at South Molton (these may both be early 20th century amendments). Tarmac at High Bickington, rather surprisingly laid retaining a central strip of cobbles and leaving narrow tarmac walkways on either side.*

Smooth paths through cobbles at Tiverton St Peter (Faculty of 2012) and Crediton, Holy Cross (Faculty of 2009), two of Devon's 'Big Three' parish churches, have created much interest. Both projects were completed only after years of discussion and were expensive, Tiverton costing over £16,000. The cost of the Crediton work is difficult to assess as the work was dogged by many problems including re-doing the work. There are, however, many earlier examples of this type of amendment. Provided the path is wide enough, this leaves borders of cobbles on either side. Most of the smooth paths are concrete slabs [Fig.162], although some are slate, which can be very slippery and some of the paths at South Molton have been amended with diamond pattern blue paviments of the type sometimes found in stable flooring and High Bickington uses tarmac [Fig.163].

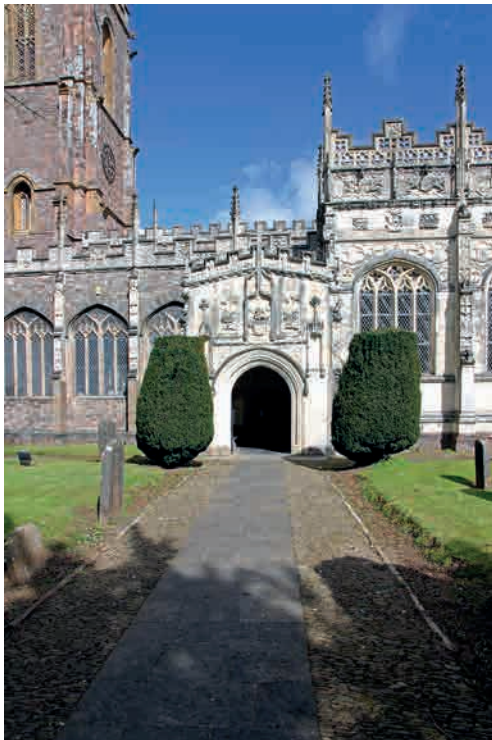
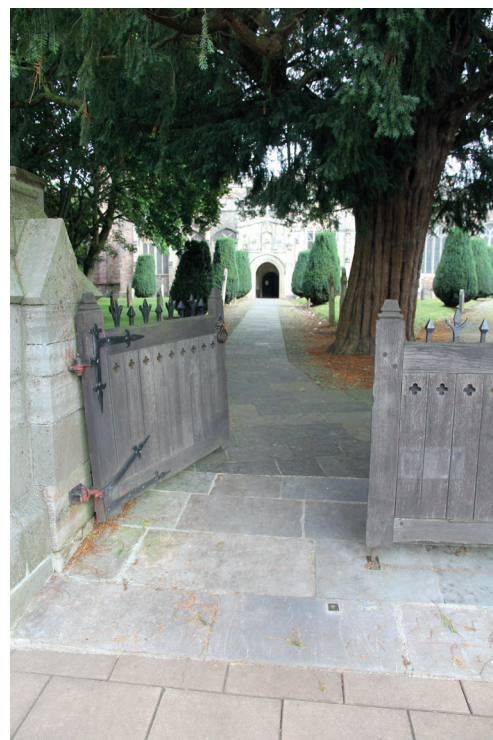
*Fig.164. A path of riven Pennant stone driven through cobbles at Tiverton St Peter. It was possible to preserve white quartzite initials in one of the cobbled borders. Level access from the footway outside the church and into the S porch made this a less complicated amendment for improved access than might be the case on another site.*

Tiverton, St Peter is a very busy town church with many evening events. A flagged stone path was built by Williams and Burrows through the wide cobbled path (one of several in the churchyard) from the south boundary to the south porch. This is generally agreed to have eased access and to fit well aesthetically with the church and churchyard [Fig.164]. Selecting natural stone or artificial flags of the right colour for the church and churchyard and for a high quality finish proved difficult. It was understood that the riven finish of the Pennant stone chosen would be likely to produce puddles (as it does), bringing a risk of ice in frosty weather after rain [Fig.165], but this was a compromise felt to be more in keeping with the character of the church than a smooth finish Pennant. The path amendment at Tiverton, which unlike the amendment at Crediton, is visually unassertive and is mistaken by many for an original path design, has been very influential. However, Tiverton had several natural advantages for a path amendment that can be forgotten by other churches wishing to follow suit. The original cobbled path in question was wide enough to leave good width borders of cobbles (incorporating initials in white quartzite) on either side resulting in visually satisfying proportions relative to the smooth path. There was (rare) a level surface straight into the 16th century porch (unlike Crediton with several steps down, or Sandford, with steps up), simplifying the access issue. The colour palette of the church building made it possible (after much investigation) to find natural stone in a colour and tone that suits both the existing cobbles and the church. Devon's extraordinary geology has given the county's church buildings a startling range of colour, including the light purple of volcanic stone or the near scarlet-colour of Crediton (intensified by coloured cement repairs to the church masonry). Finding a suitably-coloured natural stone (likely to conclude in introducing a non-local stone) or artificial slab for a smooth path is a tough call. It can also be forgotten that cobbles retained on either side of a smooth path amendment will continue to require maintenance (weeding) and repair (e.g. overturned kerbs).

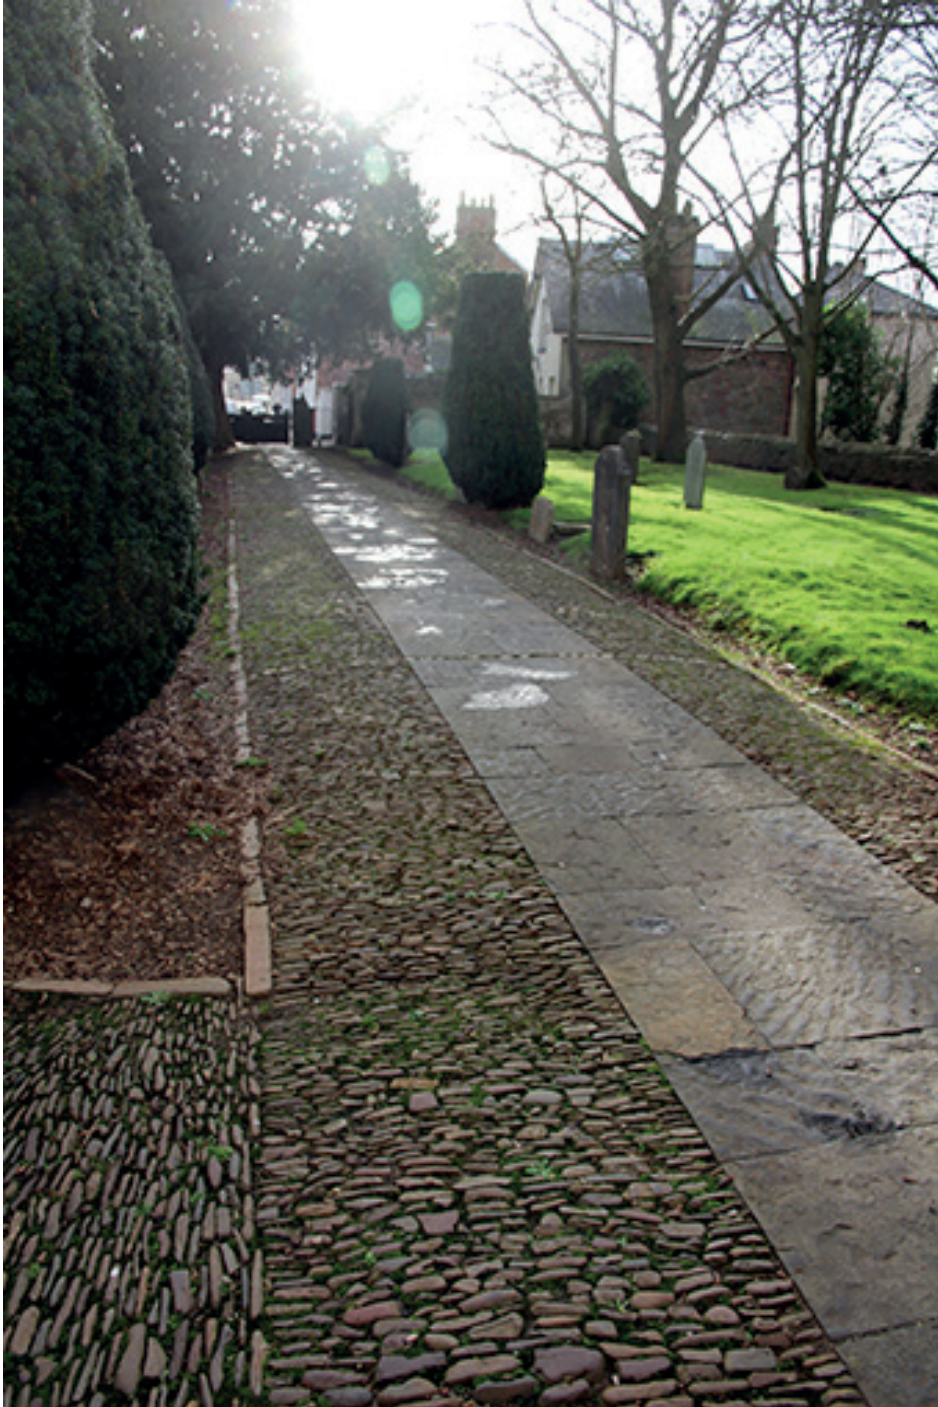
*Fig.165. The riven surface of the new path at Tiverton St Peter collects water in wet weather, which is not ideal for access if it freezes, but was chosen as a better fit with context than Pennant with a smooth finish.*

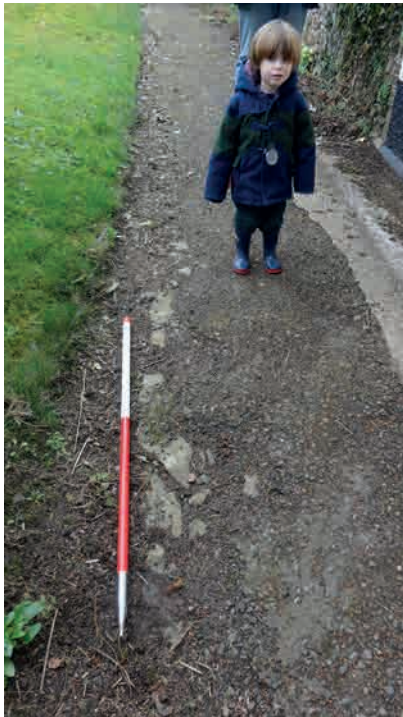
*Fig.166. Cobbles visible through tarmac at Kennerleigh church.*

Examples of tarmac covering cobbles were usually identified only because thin or worn tarmac had exposed something of the cobbled path surface [Fig.166]. Covering over with tarmac (or concrete) would now be unlikely to receive a faculty (*pers.comm.* DAC staff) reflecting changed perceptions about the importance of retaining high visual quality in a churchyard.

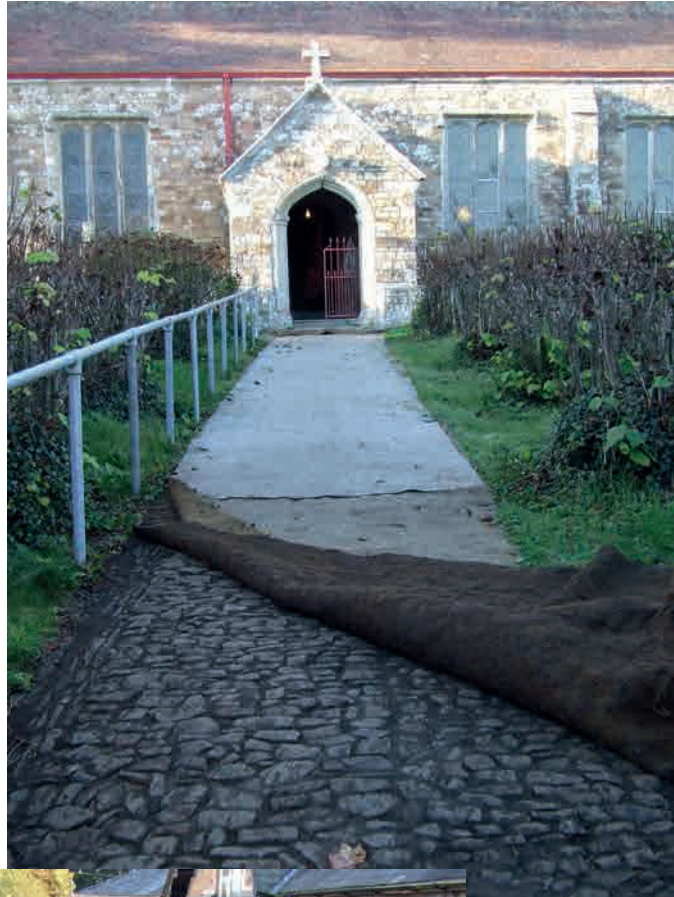
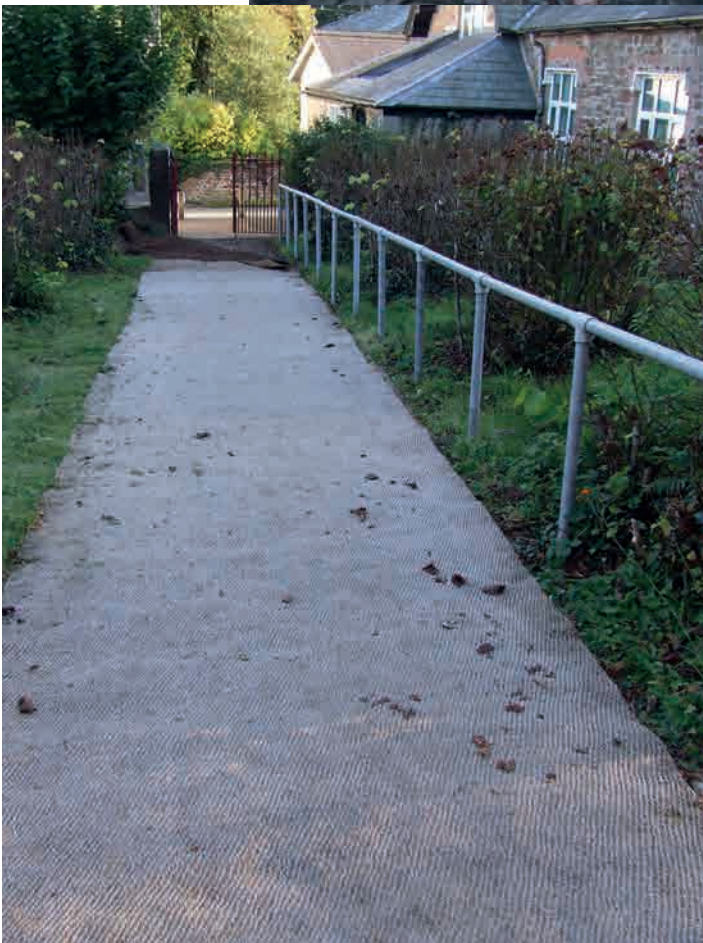
*Fig.167. Coir matting (since replaced) used to cover cobbles on a steep path to a busy church at Black Torrington. Photographs supplied by the DAC.*

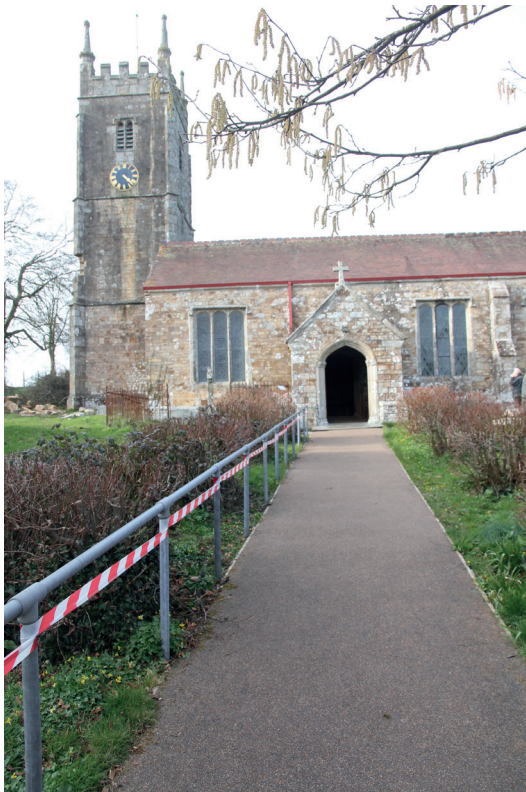
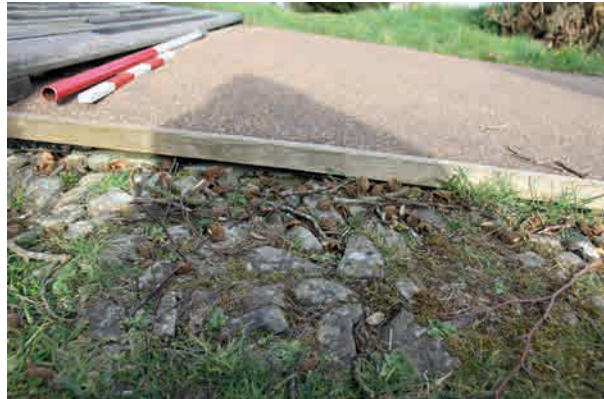
*Fig.168. 'Playtop' laid over the Black Torrington cobbles, which are protected by a membrane. The detailing is utilitarian.*

The most recent example of covering over cobbles at Black Torrington, on a steep path, followed temporary use of coir 'cricket matting' over the cobbles [Fig.167]. This was used for several years and proved serviceable but froze after wet weather in winter and the PCC considered that it was inhibiting access to a busy church that provides many facilities for young and old in the small town and has a heavy footfall. In 2010 a faculty was granted for the use of a product 'playtop', an impact-absorbing playground surface laid over a membrane over the cobbles, which survive below. This was a controversial proposal with 20 objections. Only one objection was from a worshipper, but the numbers of objections within the faculty system, which is not understood as well as the secular system for objecting, revealed a widespread concern in the drawbacks of losing sight of the cobbles. This pinpoints a very difficult issue for churchwardens which is eliciting and valuing the opinions of those who are not regular church worshippers, but who have a sense of ownership of the church building and churchyard. Some urban churchyards, in particular, are used as local shortcuts and paths may be used daily by residents who rarely, or never, enter a church. Discussions preceding the faculty for the work at Black Torrington included assertions that the path was not really 'cobbled' at all. Perhaps because it was built of flat-topped rather than pebble-shaped cobbles. It is hoped that the definitions provided in this report will clarify future debates. Replacing the tubular handrails that had accompanied the coir matting with handrails of a better design at Black Torrington was a condition of the faculty. According to technical literature, Playtop should be lifted and inspected every five years. The churchwardens are pleased with the results which, in the opinion of the authors of this report, have had a considerable impact on the aesthetics of the entrance to the church, which now has a bland and somewhat industrial appearance [Fig.168].

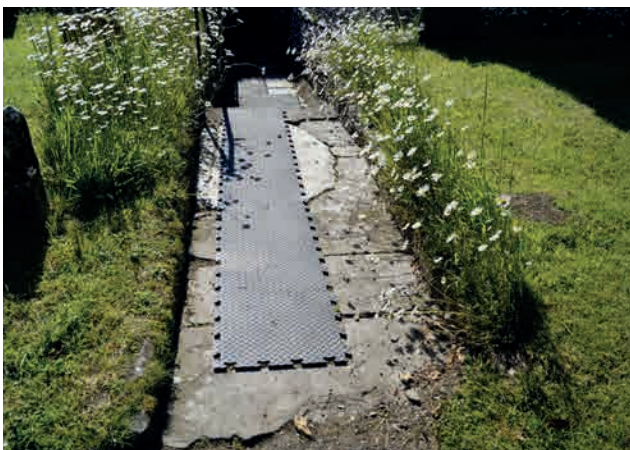
*Fig.169. Temporary rubber matting over uneven slabs at Marwood.*

Temporary covering over of cobbles was not seen over cobbled paths [Fig.169]. The suggestion that churches might make use of a mat that could be rolled out for, say, weddings and funerals, for which there may be a tradition of using a west entrance, has been discussed during the stage of informal advice from the DAC (e.g. at Crediton, Holy Cross). This could be rolled up and stored when the W entrance is not in use. This has not been tried out. For long paths, e.g. at Petrockstow, it would be burdensome to put down and require considerable storage space and it would be difficult to manage on curved paths. Keystone investigated what might have been a more permanent (and no doubt expensive) covering option, an 'eye-mat'. This is a type of matting is printed with a series of 1-1 photograph of the flooring below. Eye-mats are currently used in a number of heritage contexts, e.g. covering over brasses and medieval tiling in church buildings to spare them from footfall damage. Presumably potential ventilation problems have been solved, given that they have been used in National Trust houses, as well as cathedrals. To date the company producing these mats does not produce a product suitable for exterior use.

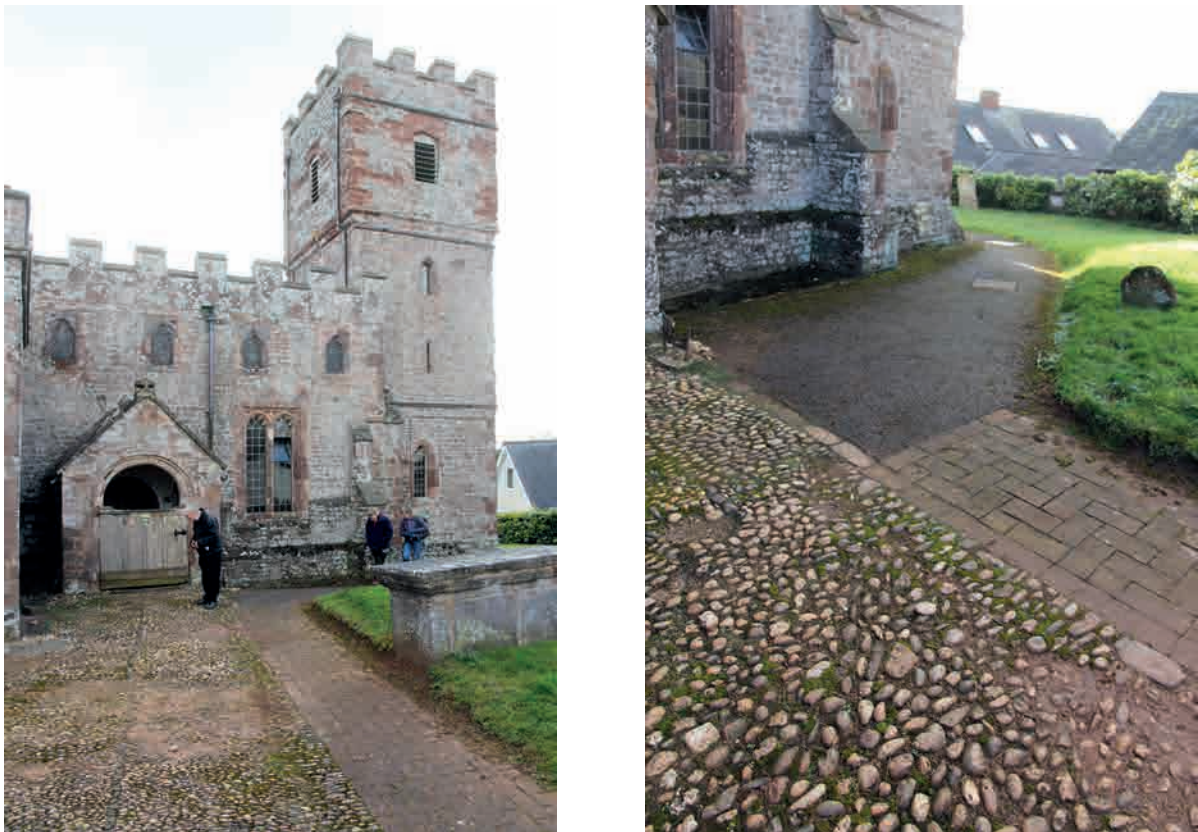
*Fig.170. The bye-path at Poltimore. The cobbles in front of the S porch continue to be used out of preference for the traditional S porch rather than the W entrance.*

At the small church of Poltimore St Mary a bye-path was created by lifting some cobbles in a path notable both for having the earliest date in a churchyard path, 1743, and for being constructed of very small pebbles, probably brought from some distance. The pebbles are inherently problematical, their small size making them very easy to dislodge. A path of concrete flags, a good surface for many disabilities, was created from the lychgate, past the cobbles leading to the south porch and, then in tarmac, round to a level entrance in through the west door in the tower [Fig.170]. In practice (*pers.comm.* the church key-keeper) only the flagged section of the path bye-path is actually used, church-goers preferring then to cross over the small pebbles to enter, as they always have done, via the south porch.

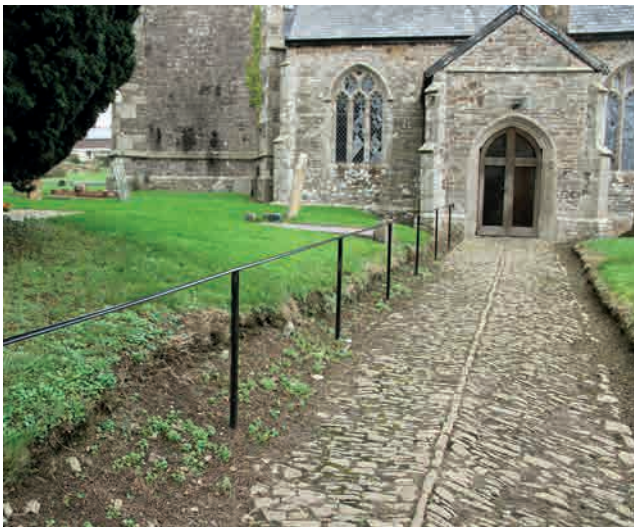
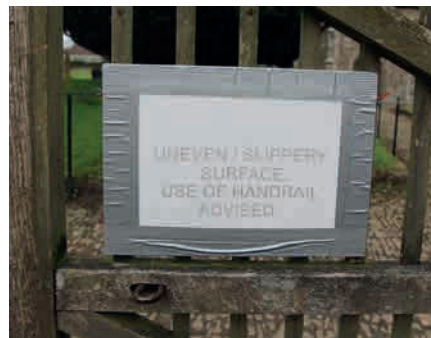
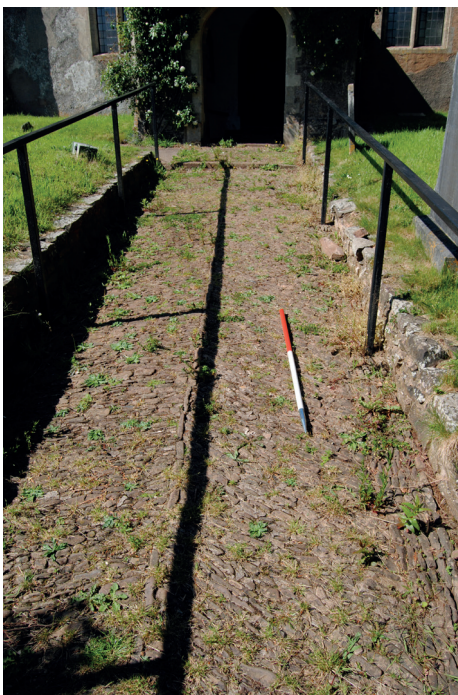
*Fig.171. Handrails installed at Coldridge following a 2011 faculty. These are accompanied by a sensible notice on the churchyard entrance. The uprights of the Cadeleigh handrails are fixed into the cobbles. There may have been reasons why a cantilevered arrangement off the churchyard turf was not possible.*

The provision of handrails is a common amendment to ease access, although one curate was mistakenly certain that permission would not be granted for handrails via the faculty system. Some handrails are more elegant and less assertive than others: the tubular 'scaffolding' type is unattractive and can include joints uncomfortable to the hand. Not all handrails satisfy a range of disabilities: access to the burial ground may leave gaps in the rail, awkward for people with poor or little sight. The Coldridge handrails, installed in 2011, are accompanied by a sensible notice recommending that they are used [Fig.171]. The guidebook to this historically very interesting church has found room for a brief account of the cobbles, noting that they may not be ideal for 'Sunday best' shoes but are a source of pride for the church. Handrails can be planted alongside a path. Cantilevered handrails at a convenient height, as Jan Loveless notes above in section 13, can be provided when the path is deeply-sunk, but these can also prevent churchgoers from stopping and resting on the walls. Handrails are not appropriate if the path is steeply-cambered as they encourage people to walk along sloping edges.
