BRONSIL CASTLE

Eastnor, Herefordshire

**A survey of the remains of a 15th century mansion,
it's surrounding moat, and ponds.**

Archaeological Investigation Series Report AI/14/2001

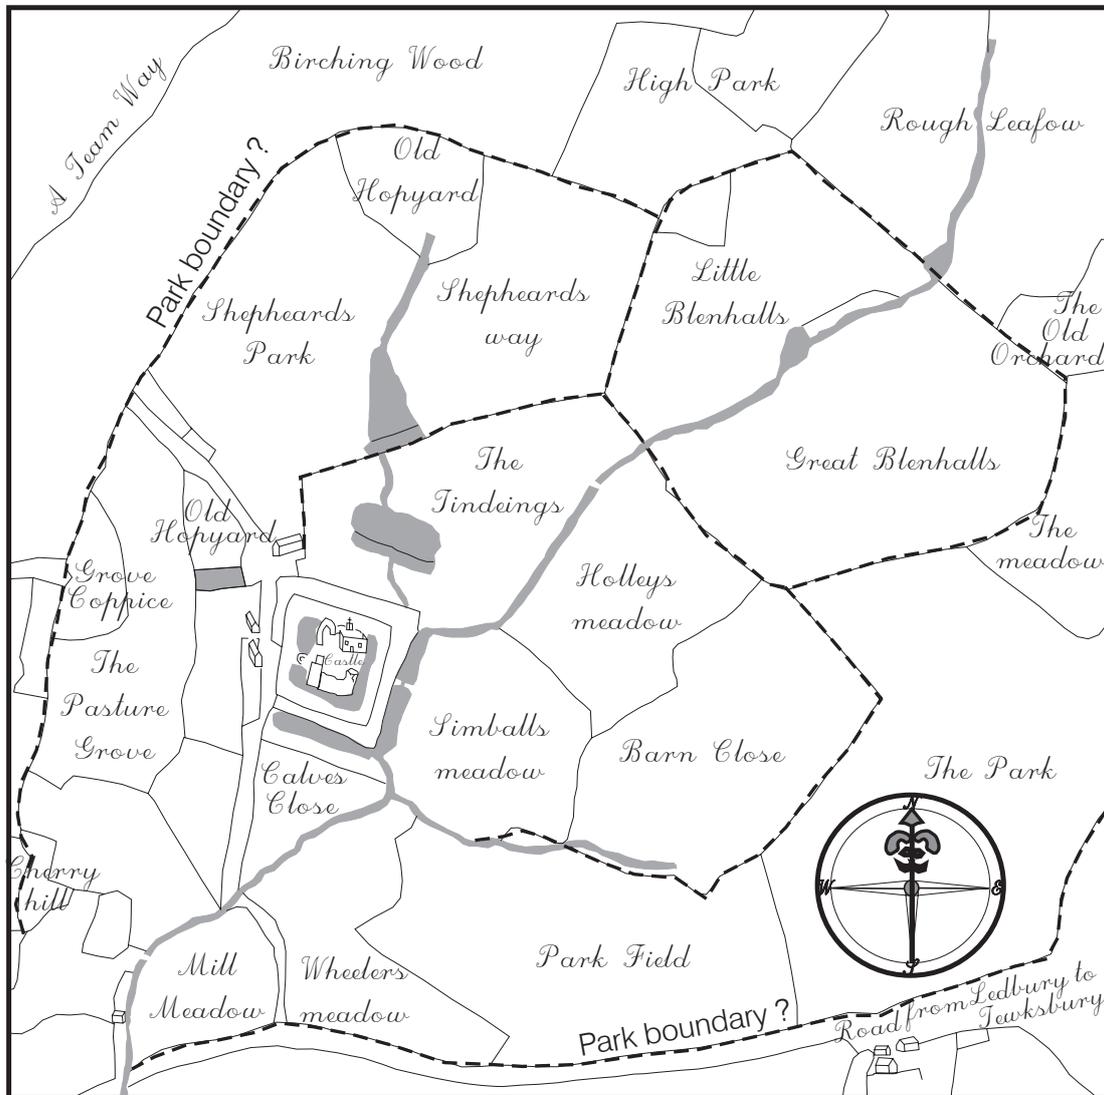
Fig 1: Drawing based on a map of Bronsil by Edward Moore, 1726.

The first depictions of Bronsil Castle appear in the 18th century, by which time it was already ruinous. An estate map of 1726 (Moore) (Fig 1) shows two buildings, one on the northern edge of the island and the other on the southern edge. The northern building has a cross on it and so may have been a chapel. The moat appears to be little different in plan from today. A pecked line running around it may represent a walkway and what may be the vestiges of an outer moat appear as ponds to the south and east of the site. There is no indication of an outer moat on its western side, where a drove-way leads from the ledbury to Tewkesbury road up onto the Malvern Hills. Access to Bronsil was by this route, which follows the course of the present drive north from 'Mill Meadow', but has a more easterly course to the south. The field name 'Mill Meadow' and a small building, almost certainly the mill, are shown downstream from Bronsil Castle. North of the moat, are two large ponds - one where a pond remains today at SO 749374 and one above it at SO 749375. Both appear to have been created by damming a stream, as is seen by banks shown across their downhill ends.

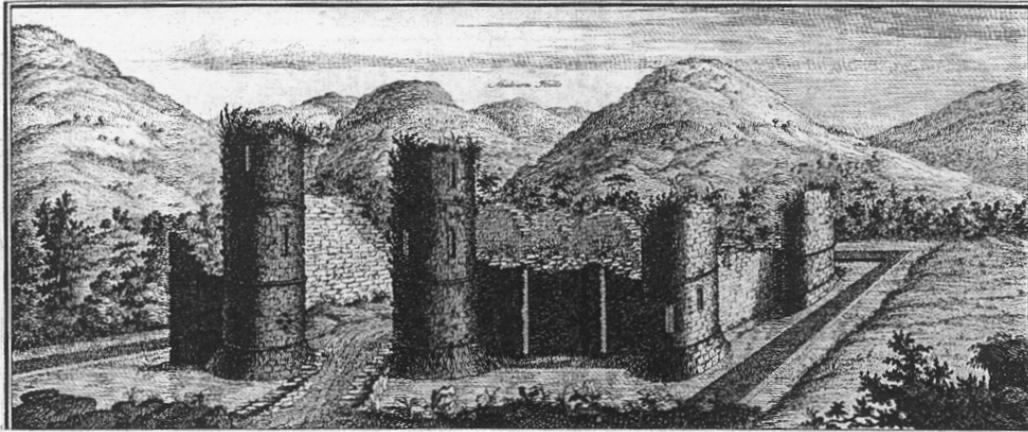
Fig 2: Samuel and Nathaniel Buck's engraving of Bronsil Castle, 1731.

The next depiction of the site is an engraving of 1731 by Samuel and Nathaniel Buck (Fig 2). Most of the castle's exterior wall is shown standing, but there is no indication of any of the buildings shown on the earlier map. The castle appears with round angle towers on the south-west and south-east and has a gatehouse with large round towers in the centre of its western side. One curious feature is a group of four circular holes set in diamond pattern near the base of the northern gate tower. This has been interpreted as a form of gun port (Shoemith 1996, 100). An underground chamber on the island is also mentioned in the caption to the engraving. It apparently lay towards the southern side of the island (Shoemith 1996, 101). Clearly some artistic licence has been used in this portrayal of the castle. The masonry appears far more regular than surviving portions show. The lowest stages of the towers have splayed bases while there are no signs of this now, although it could be concealed by the raised water level in the moat. The ruins of the eastern range of buildings are shown as three very uniform 'humps' in the background. One notable and problematic feature is a double moat shown on the southern side of the castle, which appears to continue around the northern

and eastern sides, with the western side lost in the foreground. It is very narrow and bears little resemblance to the earthwork remains visible at the site today. The Buck brothers are known to have devoted their summer months to making drawings and their winters engraving plates for printing (Ambrose 1981, 1). It may be that the castle's surroundings, and the moat in particular, were not sketched at the time of their visit, but added to the engraving from notes.

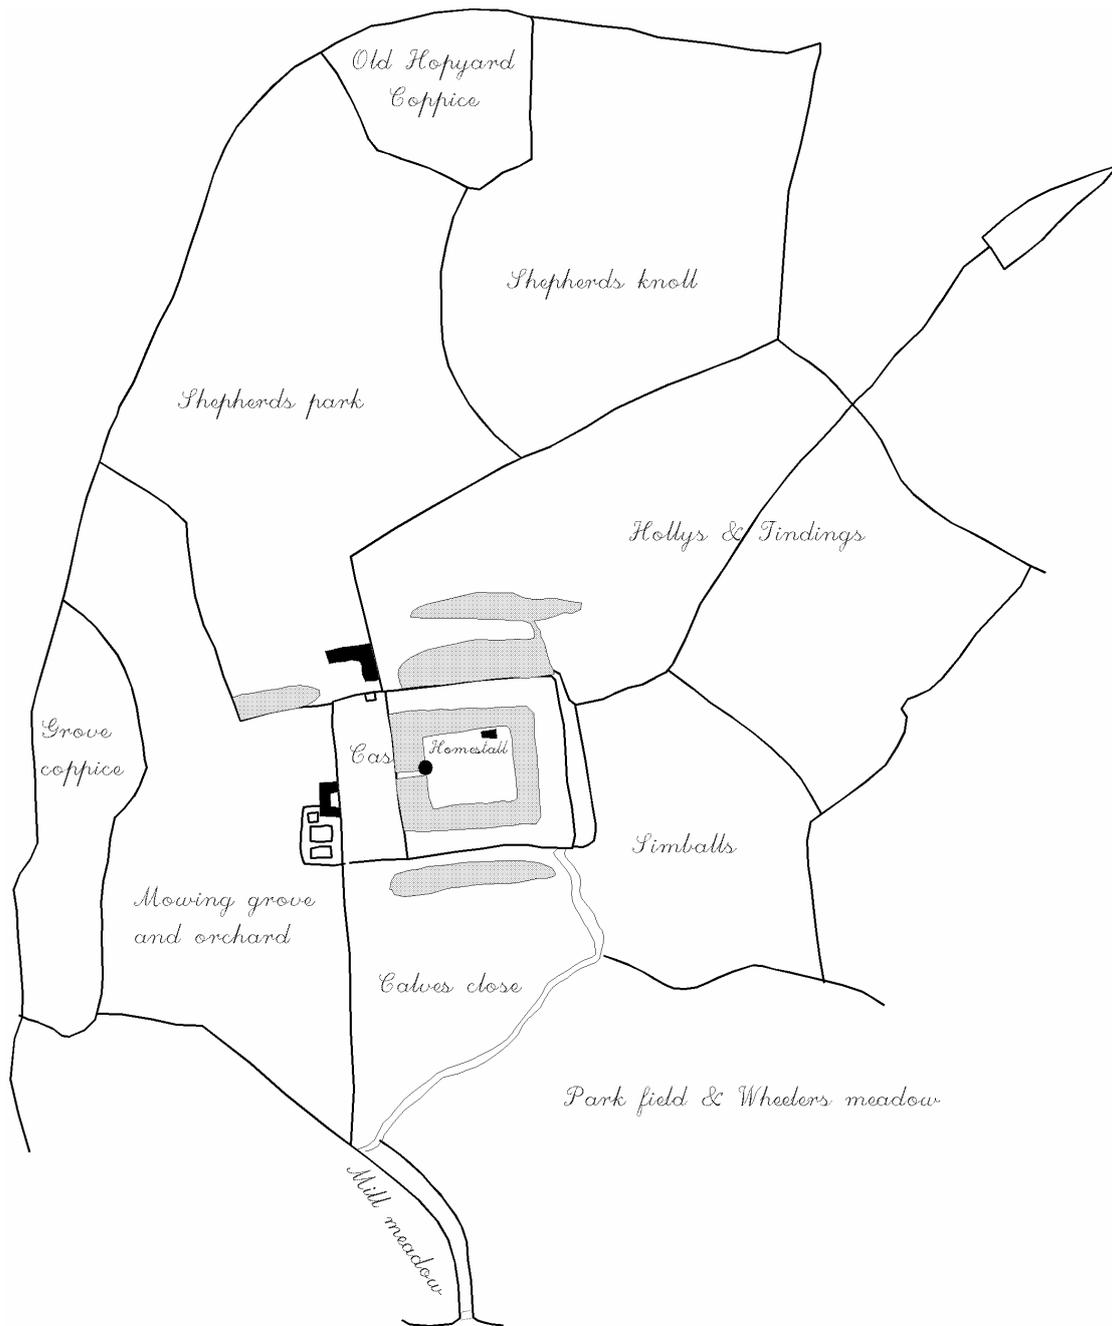
Fig 3: Drawing based on Davis's plan, 1808.

By 1808, when a further estate map was produced (Fig 3), the eastern ponds were dry and water had collected north of the moat's retaining bank, possibly within the relict northern arm of the outer moat. The water supply to the moat continued to be from channels in its north-eastern corner, and the outflow continued to be from its south-western corner. A building shown outside the north-western corner of the moat by Moore was still standing in 1808, but

by this time the island had very few buildings remaining. The only structures were a small building on the northern edge of the island, named 'homestall', and a circular feature on the western side named 'castle'. This stood in the position of the castle's northern gate tower. It is perfectly situated within full view of a house, which has appeared for the first time to the west of the moat, indicating that it may have been rebuilt as a romantic ruin. The new house must have either replaced the two buildings shown here by Moore, or have partly incorporated one or both of them as part of its fabric. It comprises a main range fronting the moat with side wings projecting forward from each end. The rustic stone bridge, visible in its present position and it may also date from this period.

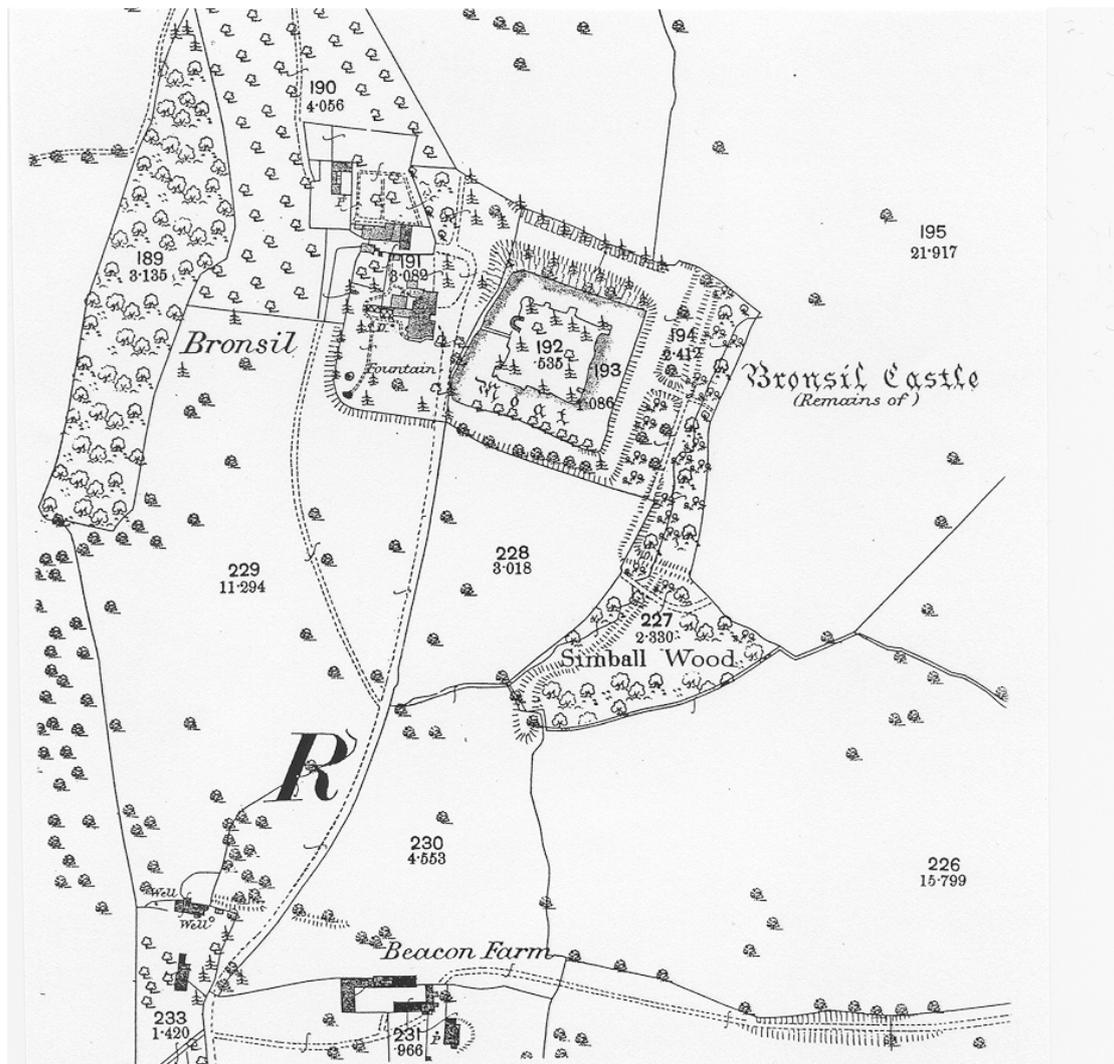
Fig 4: OS 25" map, 1889 (surveyed 1886).

On the Ordnance Survey 1st edition 25" map of 1889 (Fig 4), a few changes to the site are visible. The south-western corner of the moat seems to have been enlarged, but this difference in depiction may be purely because this OS survey was more accurate than the previous surveys. The house beside the moat has been enlarged and a complex of outbuildings and yards has been constructed to its north. The area east of the moat has become wooded. Two

major channels carry water through the former ponds to the east of the moat, and a new driveway to the house cuts through the former millpond and its dam to the south of the site.

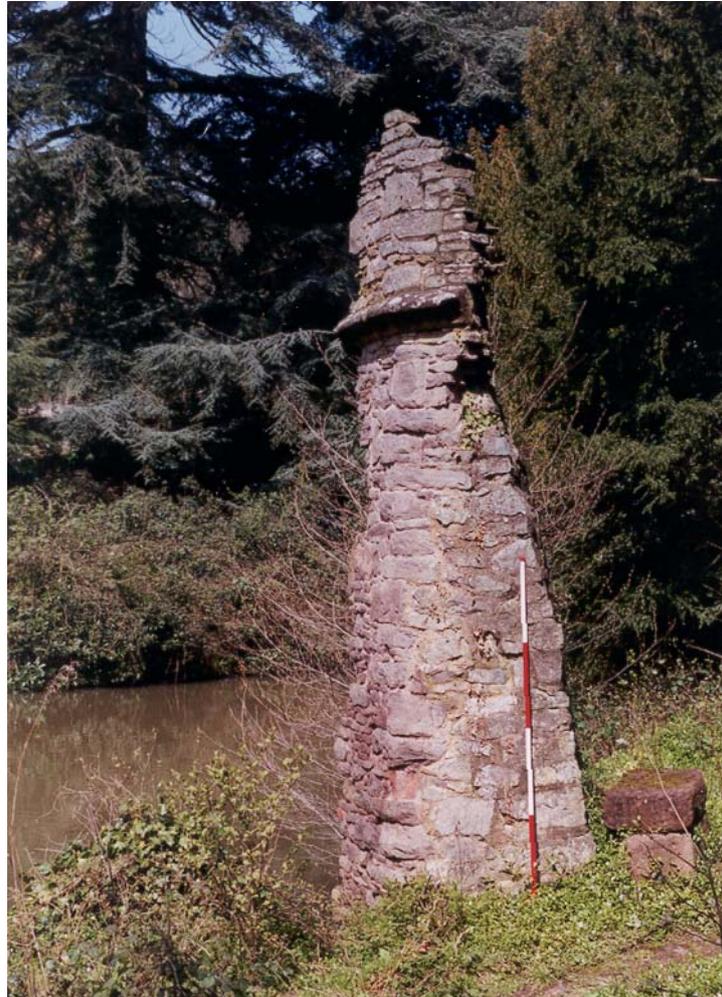
Fig 6: Remains of the northern gate tower, 2000.

The island is low-lying, its edge only an average of about 1.2m above the present water surface, and parts of its interior being barely above the water level. In some parts the curtain wall of the castle survives (i), while elsewhere (j) its tumbled remains skirt the island. Although stone robbing has reduced the castle to little more than an earthwork, a few fragments of masonry survive. The largest is part of the gatehouse's northern tower (k) (Fig 6) which, as described above (p7) could well have been altered by later rebuilding. The circular drain hole noted near its base in earlier accounts is no longer in situ, but its ashlar blocks lie on the ground. The tower is clearly of two builds, with the outer being later. Until

major collapses in 1979 or 1980 and 1990 (Morris 1990) much more of it survived. A photograph, taken in 1990 (Shoemith 1996, 97), shows it standing more than two string courses high.

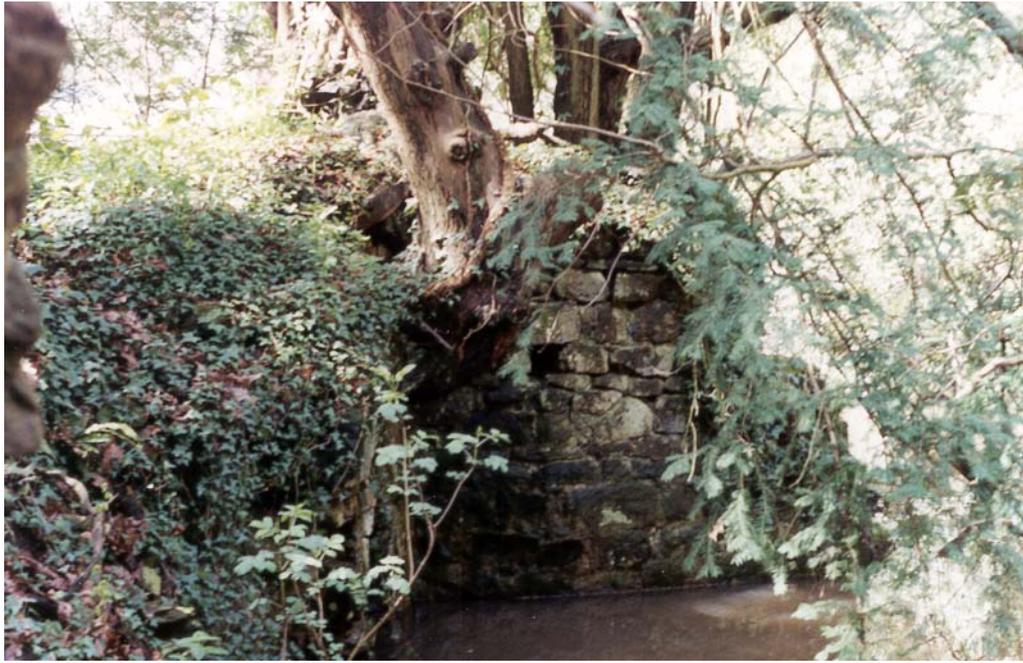
Fig 7: Footings of the curtain wall of the north-eastern tower

The other masonry remains of Bronsil Castle are less substantial. At (l) faced masonry standing $c1.3\text{m}$ high represents the remains of a wall running parallel with the moat's edge. At the north-eastern corner of the island the wall of the corner tower is still intact and visible rising for approximately 1.2m above the present water level (Fig 7). Along the northern side of the island small sections of faced masonry (m) protrude from a largely rubble bank. These mark the line of a wall running parallel with the edge of the island. At the north-eastern corner are the remains of a newel staircase (n) (Fig 8), while in the centre of the island are two further walls (o). These masonry remains are all of Devonian Red Sandstone, which are the predominant surface rocks of Herefordshire and provide the stone for many of its castles.

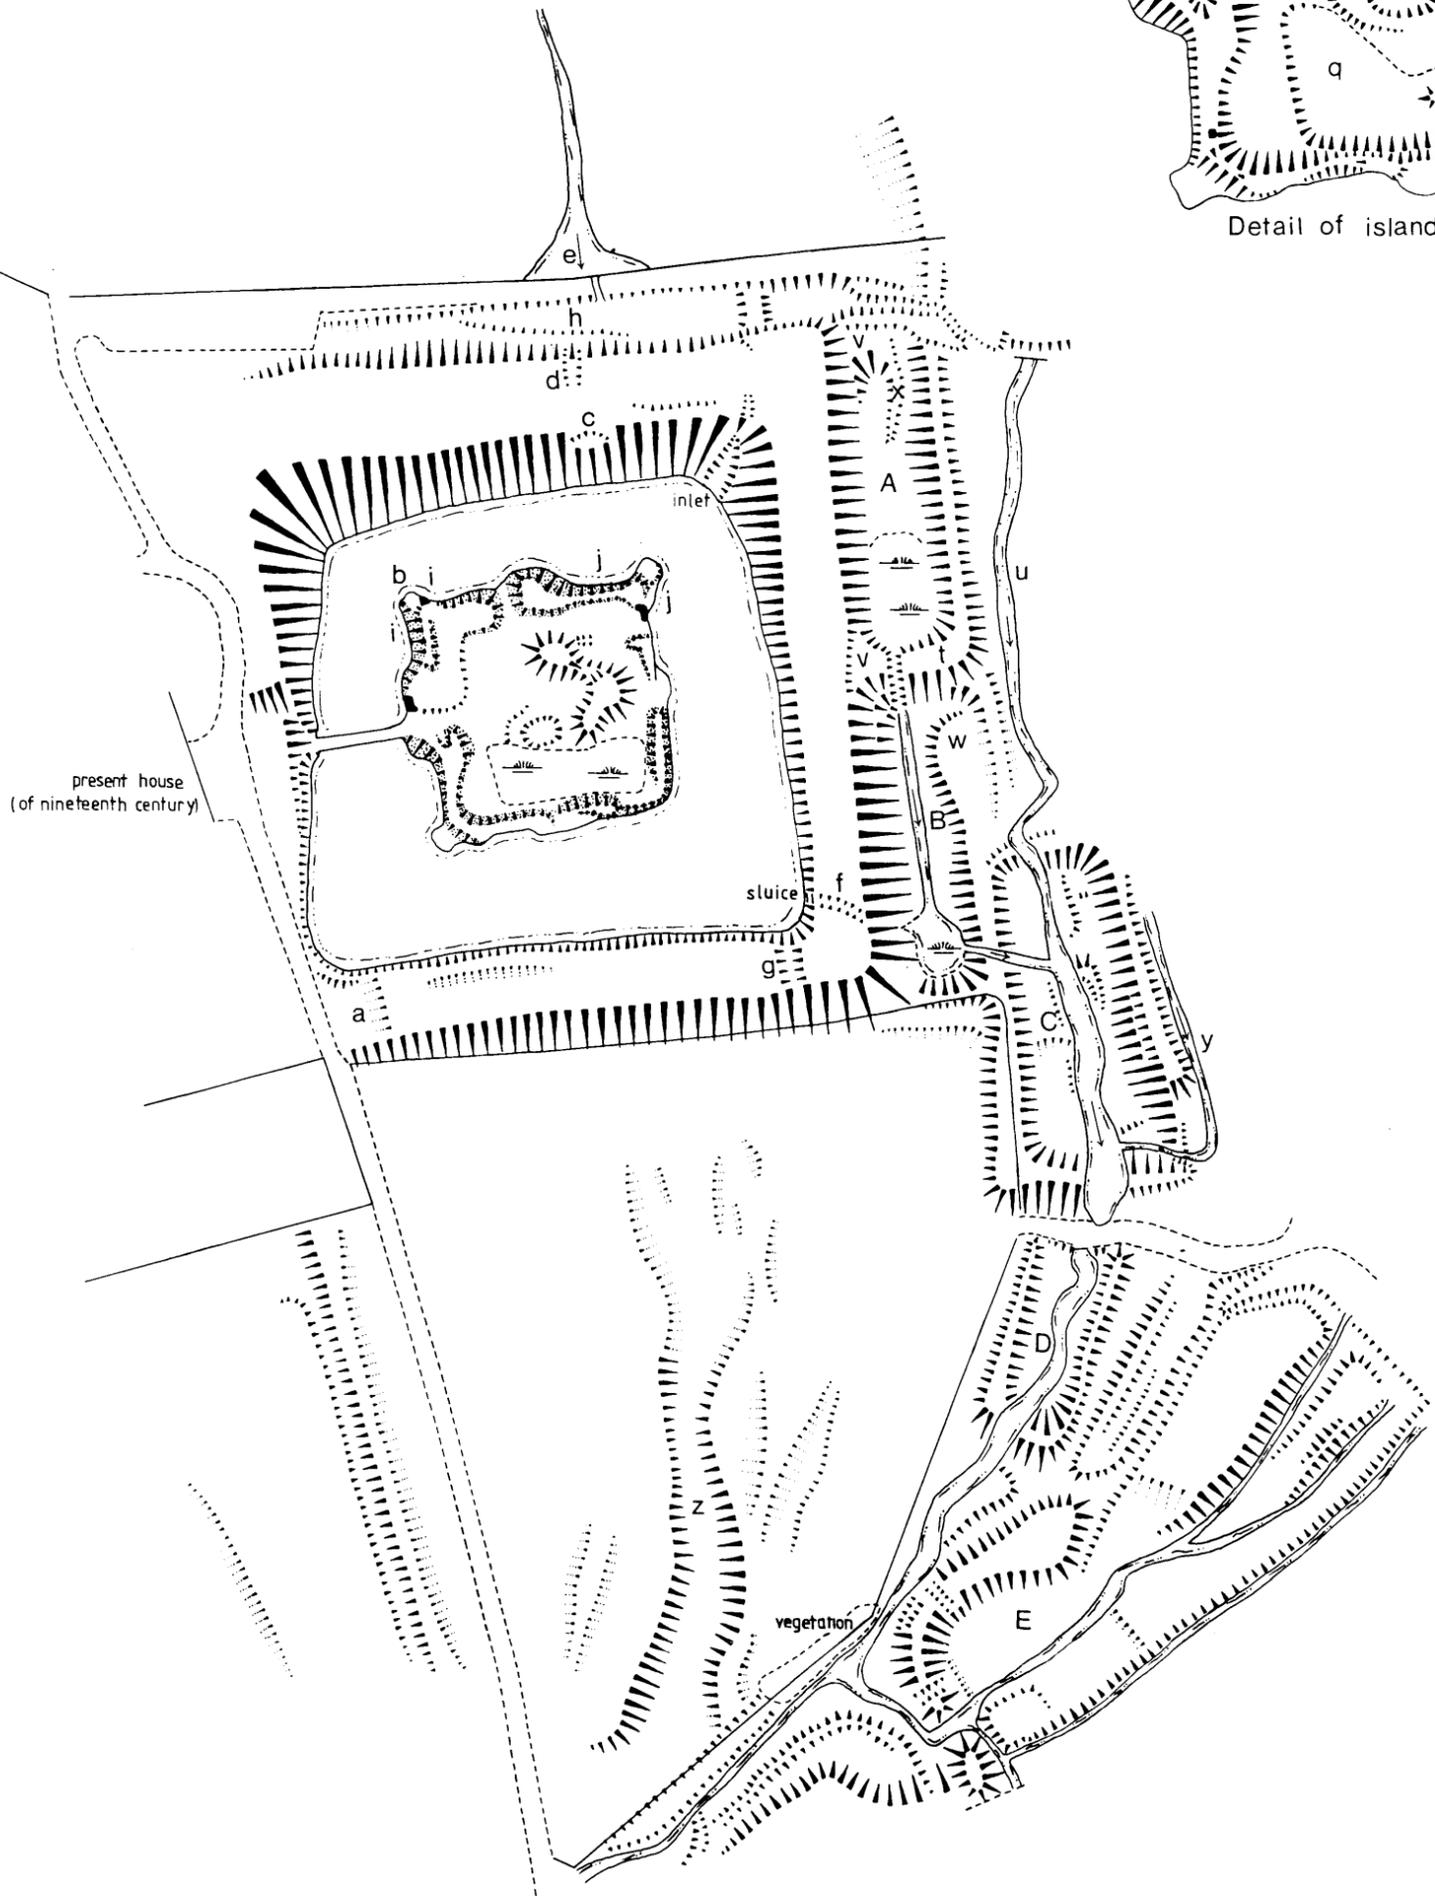
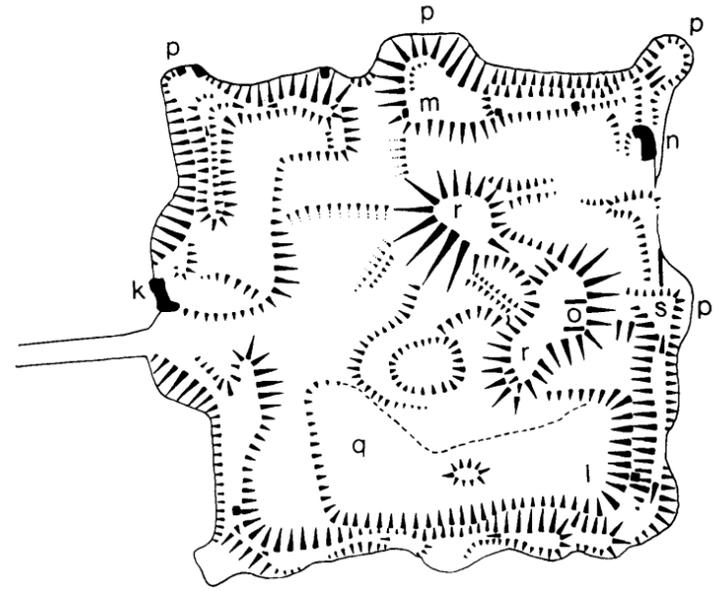
Fig 5: Bronsil Castle, English Heritage survey 2000.

Reference letters in the text all refer to the plan, Fig 5.

The moat is a substantial earthwork, wider than the average medieval moat. It was not possible to examine its profile since it is still water-filled, but it appears to be of a considerable depth and its profile is almost certainly of the U-shape generally found in medieval moats. It is roughly square in plan and of no great extent, enclosing only 0.51 acres, an average area for a medieval homestead. The moat has been constructed by damming water across a valley, and hence the southern, down-slope, arm is greater than the others and its retaining bank stands *c*2.5m high.

The moat is retained on two other sides, the north and east, by broad flat-topped banks. The eastern bank is a substantial feature, rising up to 3m from the bottom of adjacent ponds. The northern bank is slighter, but still stands up to 1.6m above the external ground level. On all three sides this retaining bank or dam stands above the level of the island. On the remaining side, the west, there is no indication of an outer retaining bank, the moat here being simply defined by its ditch. It is possible, however, that this side of the moat was once also retained by a bank, and that it has been obliterated by later activity. The earthwork evidence also suggests that the retaining bank once continued westwards. At (a) and (b) on the survey plan, its southern and northern sections are truncated by the driveway to the house and a car parking area, while the south-western corner of the moat in particular seems to have suffered much disturbance, having a clean-cut, yet shallow, profile of recent appearance. Indeed, a good deal of landscaping probably took place for the succession of buildings and gardens to the west of the moat.

Slight depressions in the retaining bank, visible in several places, may mark the positions of former sluices. At (c), a 1.5m deep depression in the outer side of the moat is in line with a shallow depression (d) in the bank, which in turn is aligned with a water course (e). This may represent a former inlet for water supplying the moat. At the south-eastern corner of the moat are two shallow depressions across the bank, one of which (f) follows the line of the current outflow pipe and sluice, and the other (g) may represent a former outlet or overflow channel. The present system of filling the moat is from a culvert feeding into its north-eastern corner. This is linked to a system of channels connected with field drains and natural springs.

To the north of the moat, and parallel with it, is an outer, lesser feature (h), possibly the remains of the outer moat indicated by documentary sources. This is now partially overlain by a dirt track way for vehicle access, but is still water-filled in places. Its eastern end connects with the pond complex and it clearly once continued further to the west also, but it is overlain by the gravelled car parking area. The two dry ponds to the east of the moat may represent its eastern arm. No earthwork remains of an outer moat could be traced on the southern side.

In addition to masonry fragments, the island contains earthwork features. The positions of the castle's angle towers and intermediate towers survive as earthwork platforms (p). These are present on all but the south-eastern corner of the island, where there may never have been a projecting tower (Butcher 1985, 10). Banks varying in height from 1.4m externally to 0.7m high internally also surround much of its perimeter. Some of the masonry described above protrudes from these banks which clearly represent the footings of buildings around the edge of the island. Further banks in the interior define at least two sub-rectangular depressions (q) almost certainly marking the positions of former buildings. These are now very waterlogged, but the present level of water in the moat may be higher than it was intended to be. This was said to be the case in 1985 (*ibid*, 10). The centre of the island is dominated by two amorphous mounds (r) standing up to 2.5m high. These appear to be heaps of rubble from demolished or collapsed buildings.

Adjoining the moat to its east is a line of five ponds. These descend along the valley side. They appear as a series of stews feeding each other so that the water of each upper pond was let into the lower in turn. A ditch cut along their side (u) probably allowed some of them to be emptied without disturbing the rest. All the ponds are dry now and the watercourses which once fed them are carried by channels through the pond beds and dams.

The northern pond (A) is sub-rectangular and elongated in plan. It is clearly defined on all sides. Its western side is now formed by the moat's retaining bank, which rises 3m above the bottom of the pond. Its southern side is defined by a substantial dam standing 3.5m high above the bottom of pond (B), and 1.8m deep internally. This dam overlies the northern end of pond (B), while a break of slope (v) indicates that the retaining bank of the moat has been heightened, so covering the original western sides of ponds (A) and (B). No indications of any former inlet sluice to pond (A) were seen, but it must have been in the northern side. The obvious place for any outflow from this pond is where a channel now cuts the dam, and this was probably the position of the original sluice.

Pond (B) is also sub-rectangular in plan. Like pond (A), its western side is now defined by the retaining bank of the moat, which rises to c3.8m above the bottom of the pond at its greatest depth. It is denuded on its eastern side, with only a slight bank remaining, overlain by the dam of pond (A) above and by the northern bank of pond (C) below. The southern end of the pond survives as a bank standing 1m high internally. This is again overlain by the south-eastern corner of the moat's retaining bank. Water is carried through pond (B) by channels, but its southern end remains waterlogged. An inner scarp (w) within this pond, on the same alignment as a spur within pond (A) at (x), may represent the north-western corner of a pond pre-dating pond (B). Alternatively, the scarp can be projected northwards where it aligns with bank (x) and channel (h) to form a narrow channel, thus providing good evidence to support the idea of an outer moat, as indicated by documentary sources.

Pond (C) has been dug into the hillside and so has steep scarps on its eastern side, a bank on its northern side and dams on its southern and western sides. It is of a less regular plan than ponds (A) and (B), having a slightly trapezoidal shape, wider at its southern, lower, end. It is well-defined on all sides, on the northern bank measures 1.5m high internally. The southern dam is 2.1m high, which continues on its western side. It is out of line with ponds (A) and (B), suggesting that it was an afterthought, and the fact that its north-western corner overlies the south-eastern corner of pond (B) confirms this. Water is currently fed through the pond by three channels which converge there - one from the moat, via pond (B), one (u) which by-passes the ponds above and a contour-following channel (y), which runs above the pond and parallel to it. A breach has been made through the head of this pond to carry away the water from these three channels. A further slight earthwork in pond (C), a break of slope on its eastern side, possibly marks an old water level.

A small sub-rectangular pond, pond (D), lies below pond (C). Its eastern side is defined by a bank 1m high and its western side by a bank 1.1m high externally. Its northern side is overlain by a track-way and the outflow channel from pond (C) also cuts it here. At its head, or southern side, is a dam 2.1m high breached by the out-flow channel.

Pond (E), which appears to have been larger than those discussed above, was only surveyed in part and does not survive in its entirety. It is on a slightly different alignment to the others described, is different in nature and appears to have been fed from a different watercourse. Its north-western side is defined by a spread bank, while the head of the pond is a dam 2m high, which would have held a considerable amount of water. The remainder of the pond has been obliterated by a track-way forming the boundary of the survey, but vague scarps beyond may mark its former continuation. It is possible that this pond may have powered a mill and waterwheel, probably located on or just below the dam. A break in the western side of this pond and a channel running parallel to its western side may represent by-pass routes for water when the mill was not in use. A mill at Bronsil is mentioned in a deed of 1569 (Shoemith 1996, 101)
