## Odiham Castle, Hampshire

Archaeological Investigation Report Series AI/17/2004

**County:** Hampshire  
**District:** Hart  
**Parish:** Odiham  
**NGR:** SU 7255 5187  
**NMR No:** SU 75 SW 11, 73  
**SAM/RSM No:** 24326  
**Date of survey:** January - March 2004  
**Surveyed by:** Graham Brown and John Lord  
**Report author:** Graham Brown  
**Illustrations by:** Deborah Cunliffe  
**Photography by:** Graham Brown

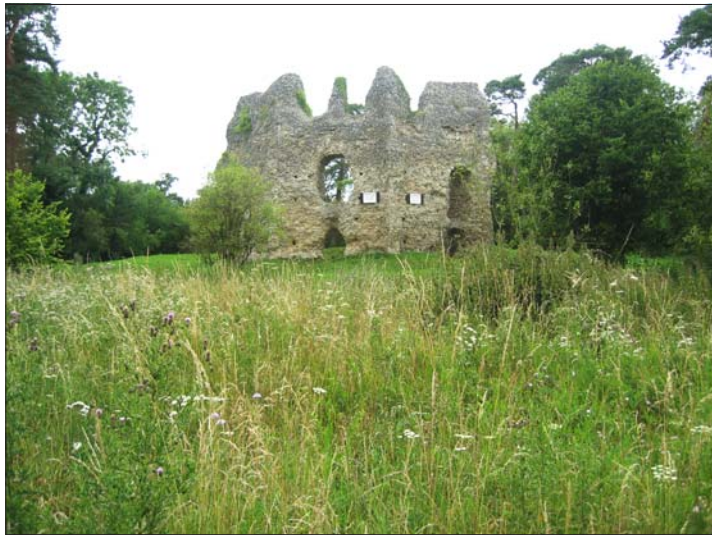
**Figure 4.**  
*View of tower from the southern platform*

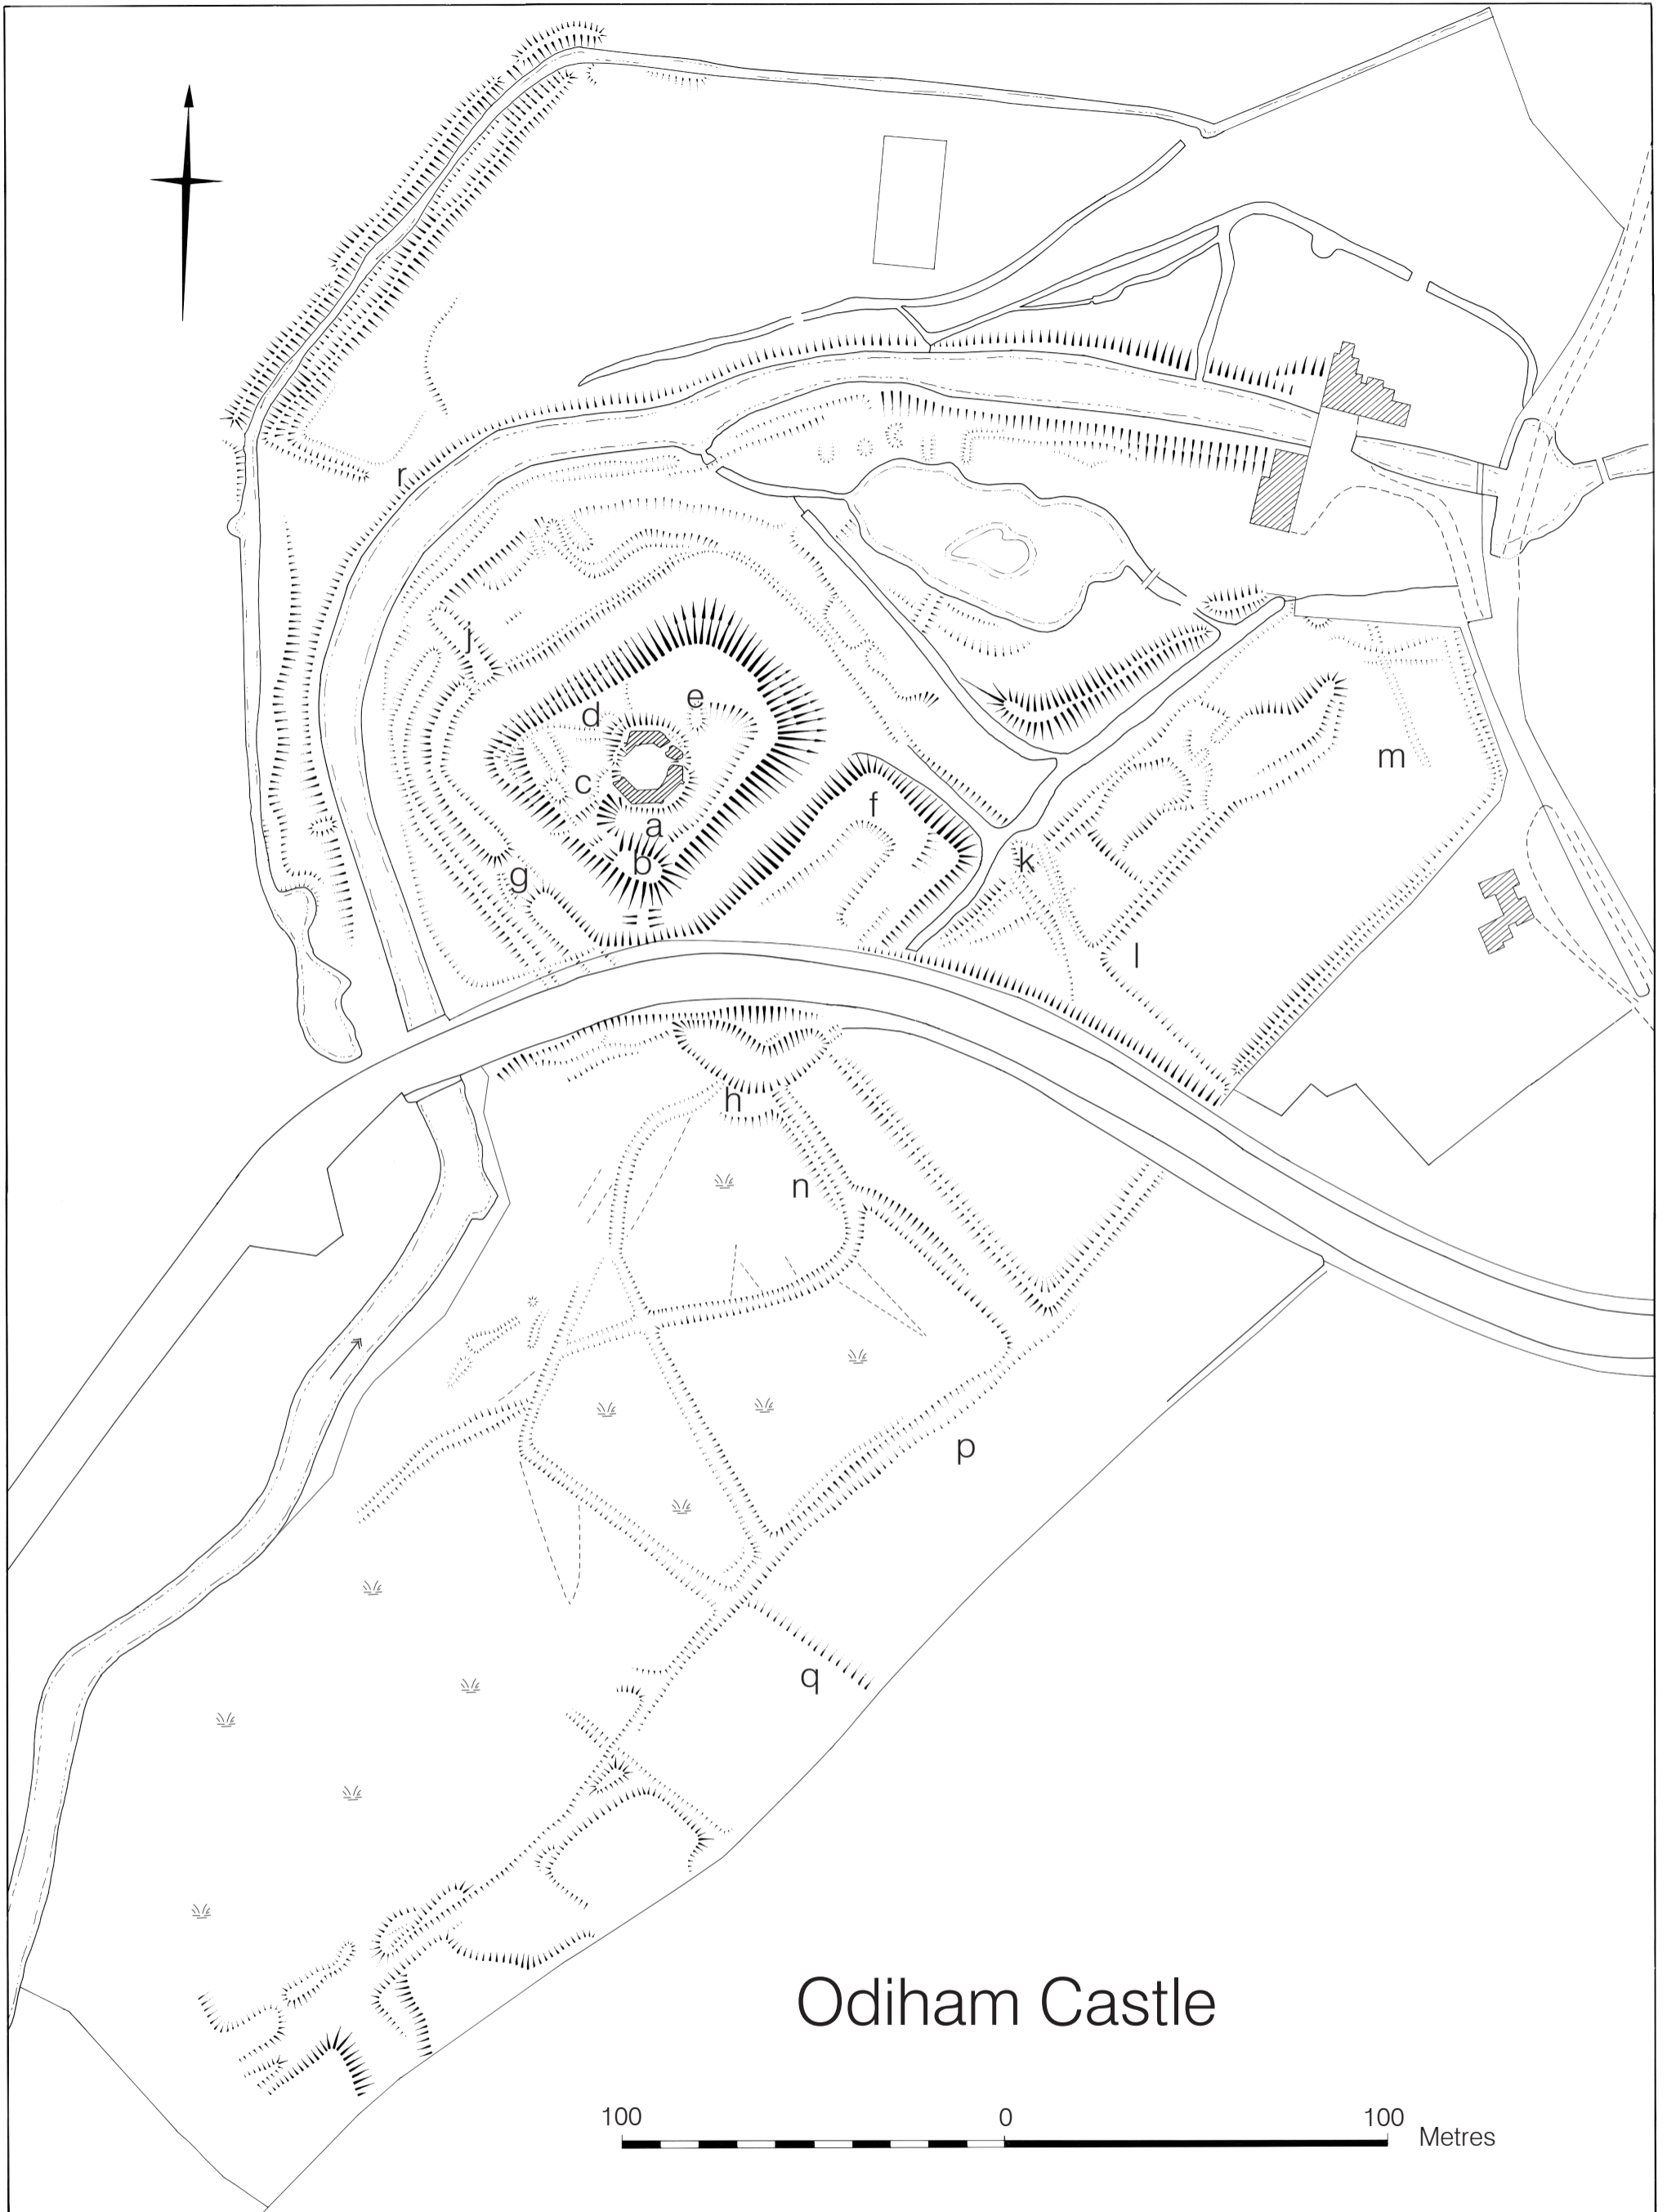
# Odiham Castle

The two platforms occupy low-lying ground within a relatively wide loop on the southern side of the river Whitewater (fig 5). The platforms are on the same alignment. The northern platform, the slightly larger of the two, measures 60m x 45m and stands c1.5m above its surrounding moat. Set 5m south-west of the centre of the platform are the remains of the octagonal tower (fig 4). Surrounding the tower is a berm, which measures up to 2m wide, with a partial ditch (a) beyond. This ditch measures up to 5m wide and 0.3m deep on the southern side of the tower. The ditch gradually diminishes thus leaving a slight, spread bank, on the south-east and north-east sides and is probably the remains of the moat that surrounded the tower which was back-filled in the 15<sup>th</sup> century (*above*).

An elongated mound (b), occupies the southern corner of the northern platform. This mound, which measures 14m x 7m, extends north-west along the edge of the platform and may be the remains of a perimeter wall. Further north-west along the edge of the platform (and within the excavated area) is a low, spread mound (c); the intervening depression between the two mounds is aligned on a cut in the side of the platform, which also lies directly opposite a gap in the outer bank of the moat. The southern end of the depression marks the terminal of the outer ditch bordering a palisade that was excavated during the 1980s (*above*).

At (d) there is a shallow bank, which is possibly a wall fragment that leads from the berm surrounding the tower towards the western corner of the platform. This bank can be traced further south-east as a slight scarp that cuts into the side of the platform.

The north-eastern side of the platform is largely devoid of earthworks apart from a small mound (e), which is probably recent stone clearance rubble.

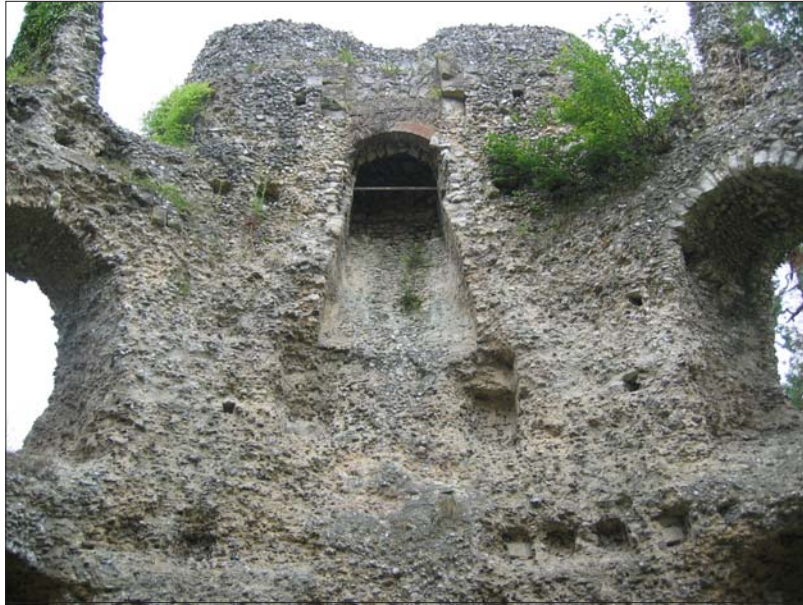
The octagonal tower is a three storey structure that sits on a small earthen mound. The internal base of the tower is c1.7m lower than the surrounding platform. It measures c12m diameter internally, with walls c3.5m thick. Internally, ashlar is evident on the lower courses of the wall standing to a height of c1.2m.

**Figure 6.**  
*Internal detail of the tower showing chimney*
