# **BOMBING DECOY AT THE OUTSTRAY HUMBERSIDE**

## **ARCHAEOLOGICAL SURVEY REPORT**

**TA 22 SW 11**

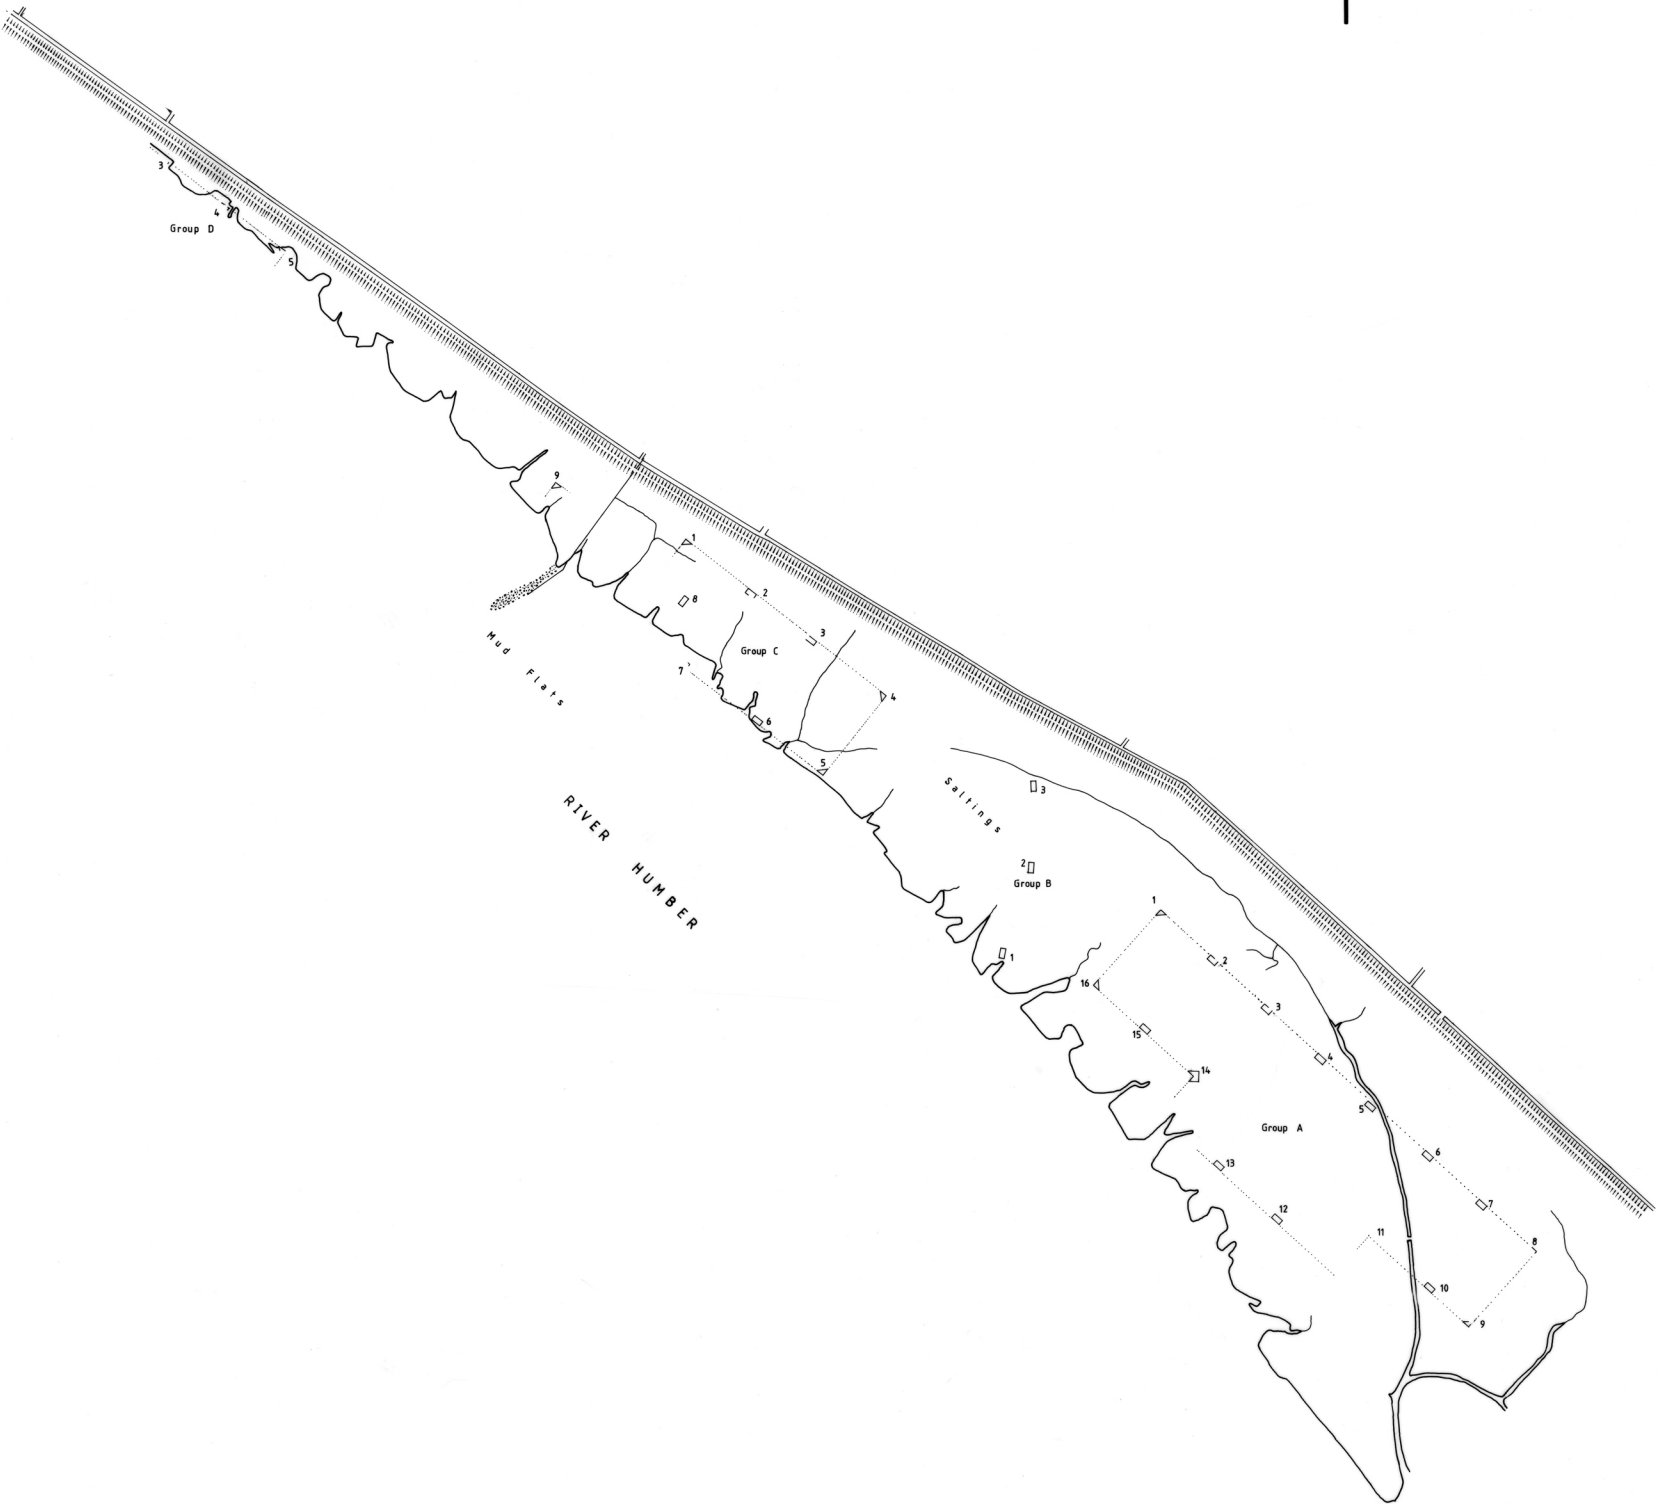
Enlargements at 1 : 100 scale

A2: rectangular, water-filled; wooden post survives to full height (see RCHME enlargement at 1:100).

A14: waterlogged and pentagonal; detail of post-foundation hidden beneath the turf (see RCHME 1:100 enlargement).

C5: triangular and water-filled; post 0.2m high.

Tank C5

Tank A14

Tank A2
