# SPAB Building Performance Survey

Interim Report I  
October 2015

Research conducted on behalf of the SPAB by ArchiMetrics Ltd  
Supported by Historic England

## The SPAB Building Performance Survey Interim Report 2015

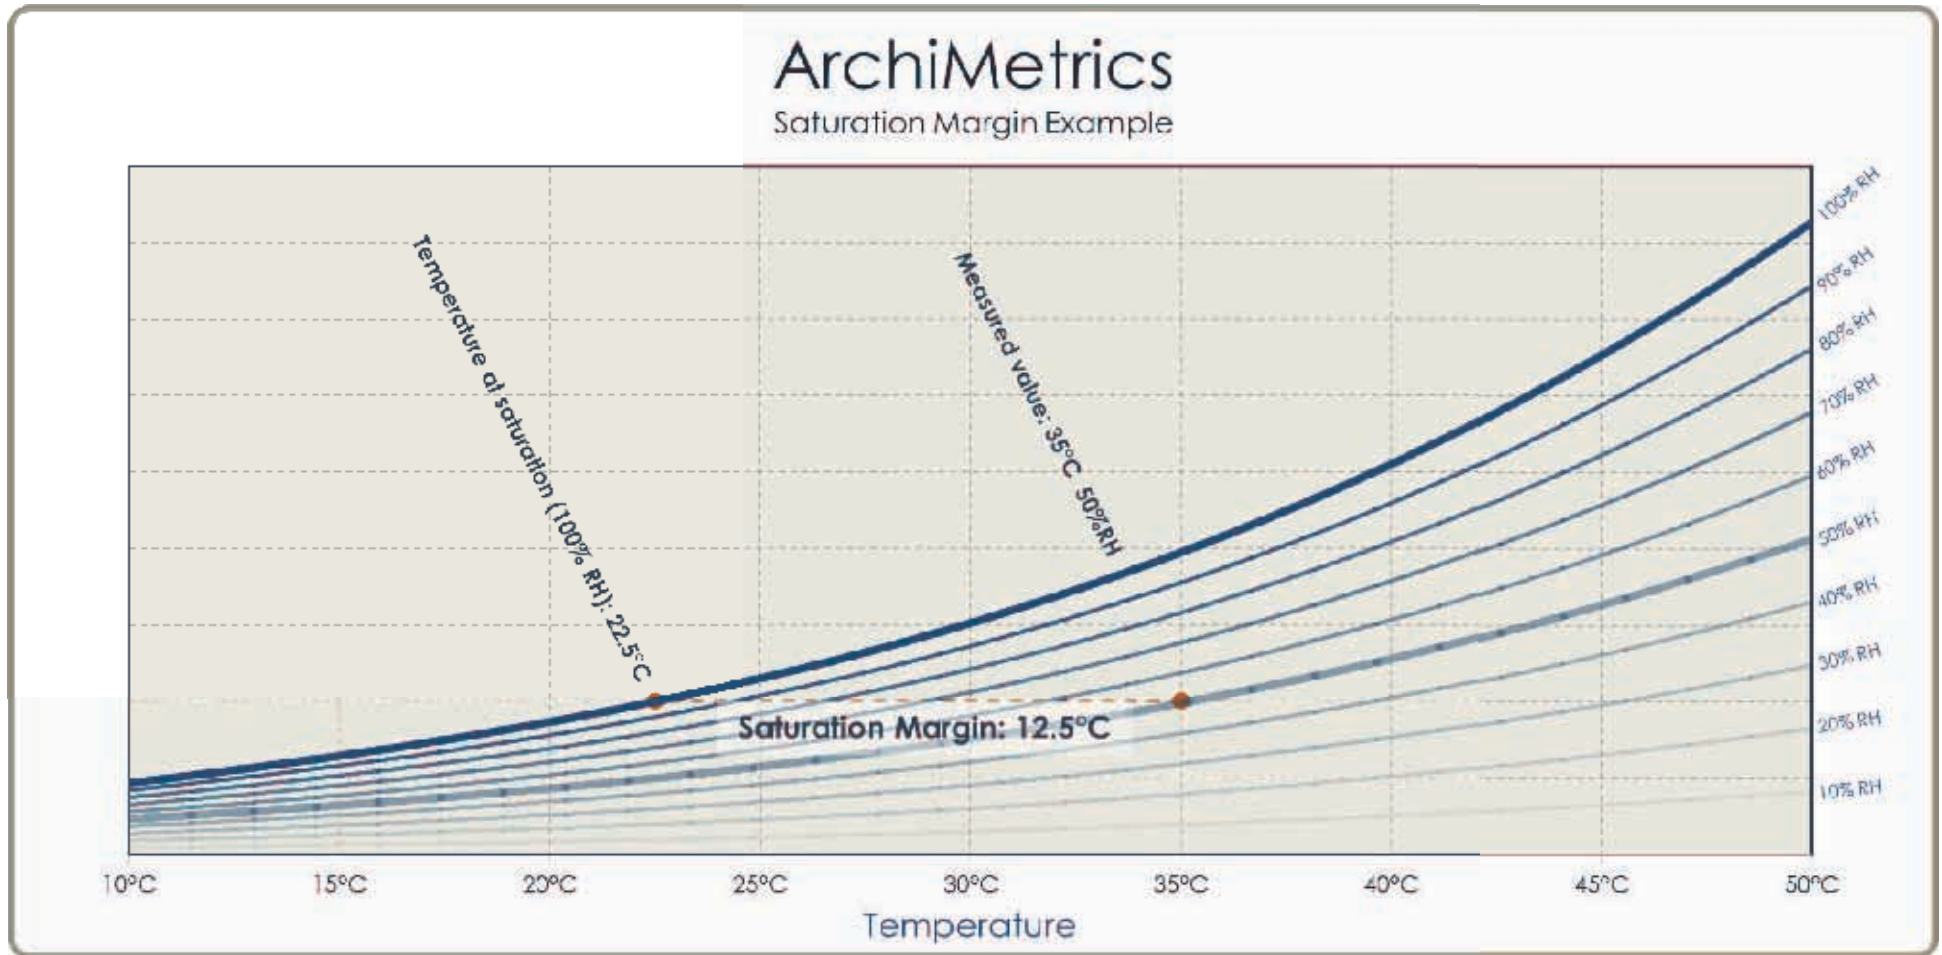
Figure 1. Illustration of Saturation Margin principle

Dewpoint is the temperature at which air reaches vapour saturation. The difference between the measured temperature and dewpoint temperature we term the 'saturation margin' and represents the temperature drop required for condensation to begin at the measured locations within the wall, Figure 1. In previous reports we have used the term 'dewpoint margin' as a means by which to quantify the risk of interstitial condensation. The term 'saturation margin' shifts the emphasis of this concept to point to the condition of wall material as well as the possibility of condensation. A narrow saturation margin is an indication that the air within the wall material is close to saturation, 100% RH. We may measure high RH values due to wetting from wind-driven rain, vaporisation from wet materials as a result of built-in construction moisture, the failure of rainwater goods and/or vapour control layers or just the inability, over time, for a wall to evaporate its moisture load. The term 'saturation margin' moves us away from the dewpoint/condensation risk paradigm which sees only internal water vapour moved by diffusion and condensed by cold temperatures as the sole moisture risk to buildings. 'Saturation' in this context refers to the state of air, but it also hints at the condition of surrounding fabric which may well be wet as a result of influences other than those of internally-driven vapour diffusion and condensation. Nevertheless, due to cycles of condensation and evaporation, this wet material can

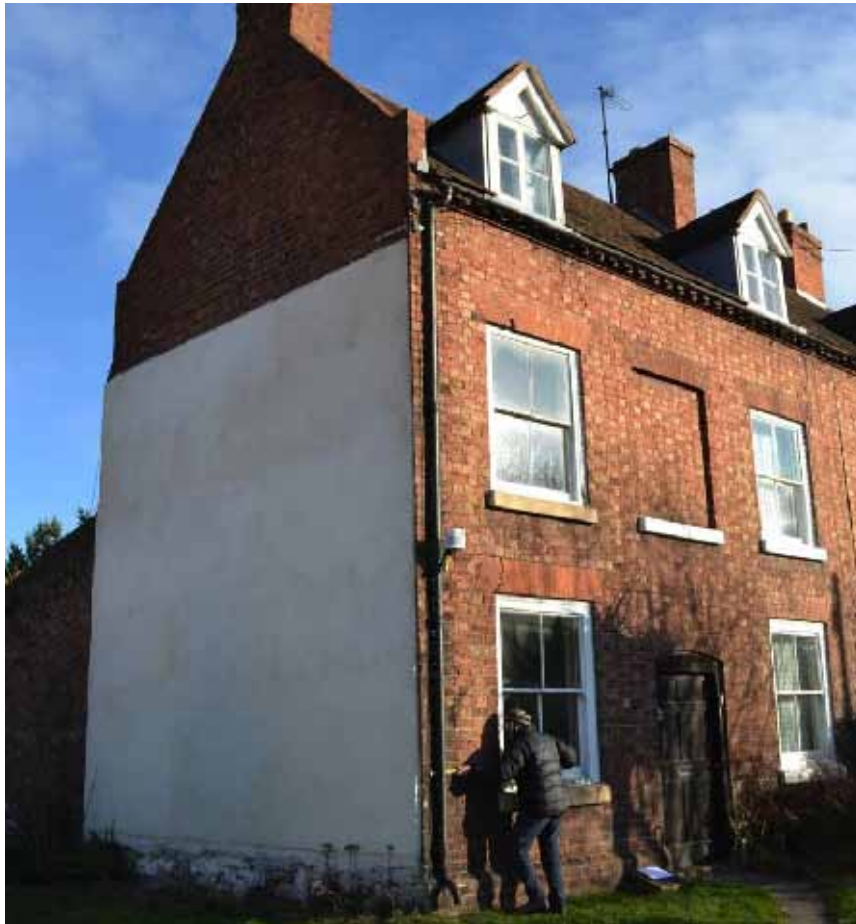
## 2.1. 116 Abbeyforegate, Shrewsbury - 2014 - 15.

Description: End-of-terrace (originally mid-terrace) house, 2 storeys with attic dormer. Dating from 1820 but with earlier core. Brick with plain-tiled roof, with elements of timber-framing and a modern single-storey extension at rear accommodating a kitchen and bathroom.

Refurbishment: Between February 2011 - December 2012 the following refurbishment work was undertaken at Abbeyforegate: internal insulation of all external walls on the ground and first floors with 40 mm woodfibre board finished with lime plaster (excluding the rear single-storey extension) and fitting of secondary double-glazing to ground and first floor sash windows on the front elevation. In 2013 a wood-burning stove was fitted in the ground floor sitting room and the flue lined and backfilled with vermiculite.

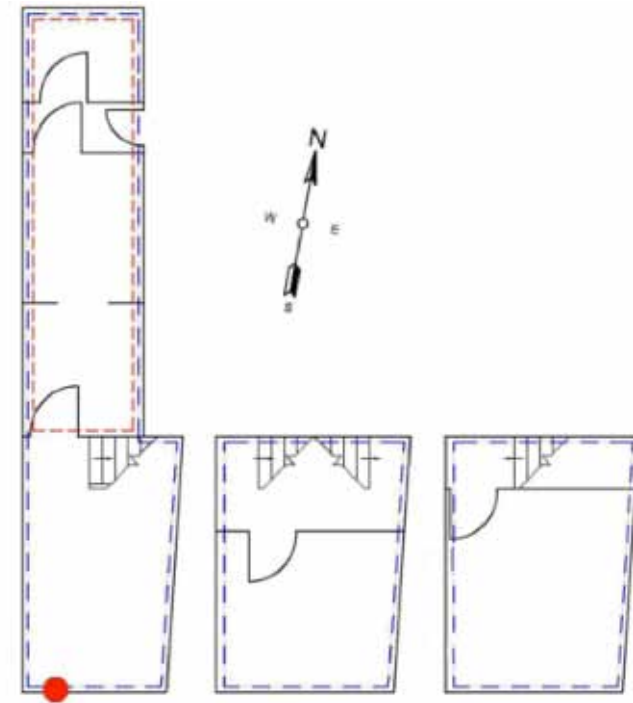
Figure 2. Plan of 116 Abbeyforegate, Shrewsbury, with ground floor on left hand side. The red dot indicates the location of the IHGM monitoring equipment.

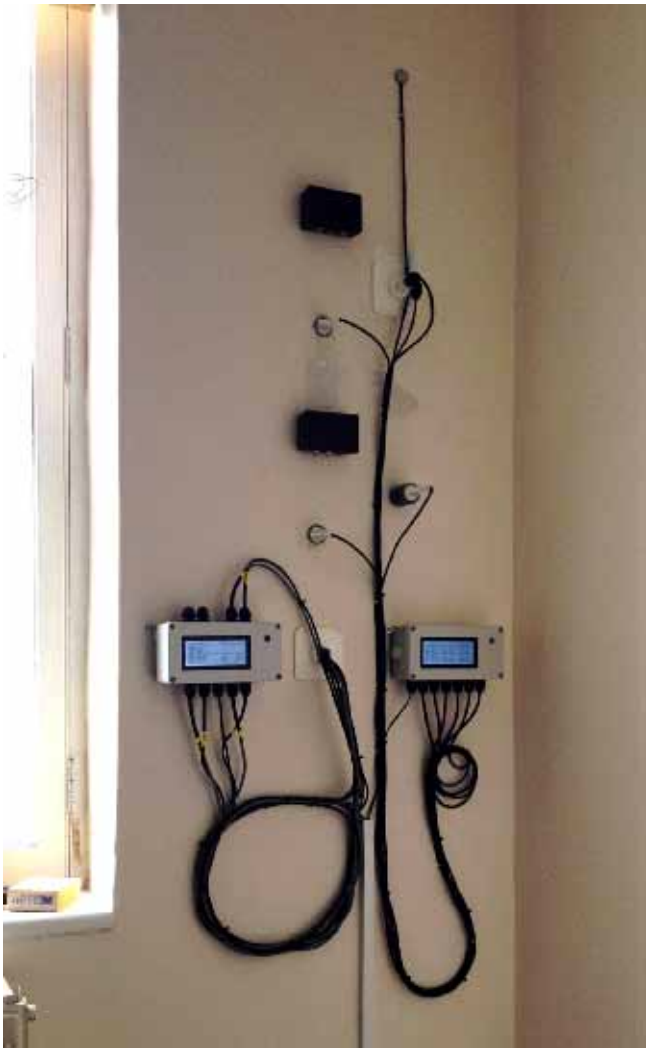
Figure 3. Interstitial Hygrothermal Gradient and Material Moisture Monitoring, Shrewsbury.

Measurements of temperature and relative humidity (%RH) are being made through a section of south-facing brick wall of the living room at Abbeyforegate (Figures 3 and 4). Combined temperature and relative humidity sensors are located at four points within the wall at the heights and depths given in Table 1. This table also gives details of the wall build up before and after insulation (in green).

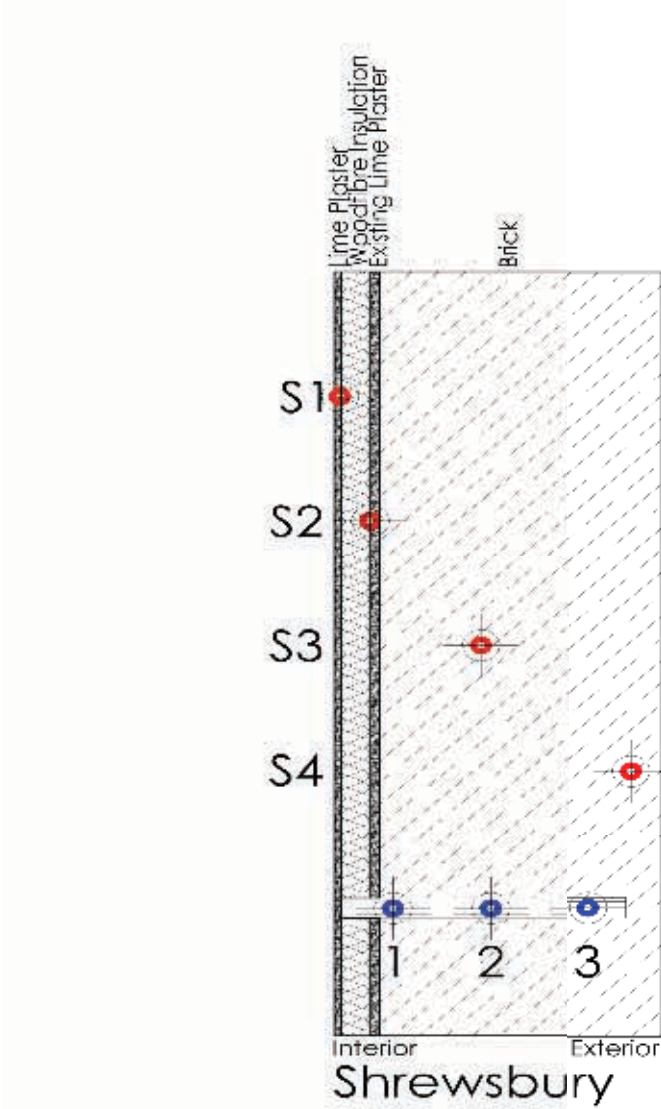
Figure 4. Position of wall sensors through section, Shrewsbury □ red IHGM, blue Material Moisture

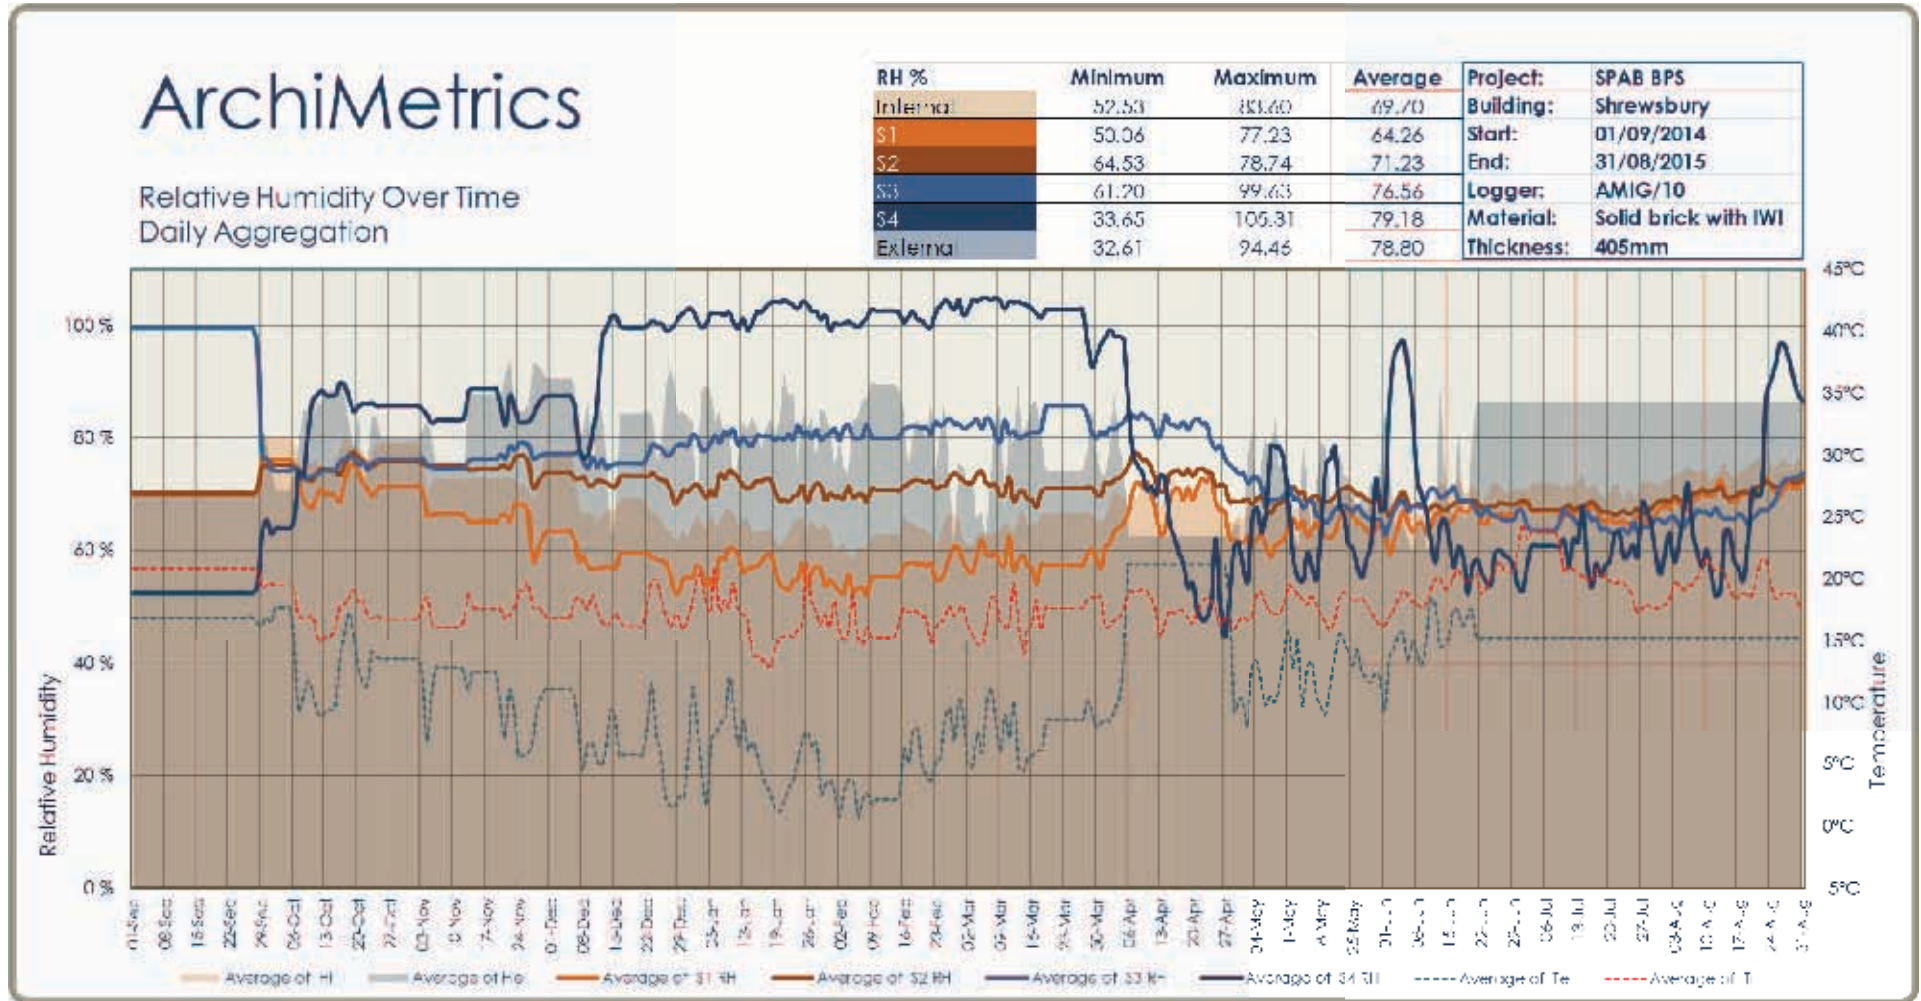
Figure 5: Relative Humidity over time, Abbeyforegate, Shrewsbury 2014 - 2015.

Figure 5 shows the RH responses measured in and around the test wall at Shrewsbury over the past year. These show moisture vapour behaviour to be broadly consistent with those measured over previous years, post-refurbishment. The %RH responses are quite dynamic and we have ascribed this to the condition of the wall. The wall is quite thin and made of porous brick, it is south-facing so receives direct sunlight as well as the effects of the prevailing weather, with pointing in a poor state of repair. These elements combine to create a changeable picture with regards to heat and air exchange for the wall with a concomitant effect on temperature and moisture behaviour. Of continued note are the extremes of response at sensor 4 located in close proximity to external conditions, 50 mm back from the external wall surface. As with previous years there is a period of time over the winter months where %RH at this location is at, or exceeds, 100%. However, with the move into spring and warmer external temperatures, %RH at sensor 4 falls rapidly and is often the lowest recorded response over the summer months. This pattern, which repeats that of all previous years since measurements began in 2012, shows high %RH in the south-facing wall as a result of cold temperatures, rain and wind-driven rain over the winter months and lower %RH due to heat and direct sun in the spring and summer months.

Exceptions to this general pattern occur occasionally between April and September 2015 when the wall is subject to heavy rainfall causing %RH to peak at sensor 4 before drying out once again, most notably in the weeks beginning 1st June and 24<sup>th</sup> August. Rain, in combination with winds and decreasing temperatures are also most likely to be the cause of the start of the 100%+ RH peak measured over winter, see Figures 6 and 7. In October and November 2014 %RH fluctuates between 80 – 90%, the rise seen from 8<sup>th</sup> December onwards

coincides with an increase in wind speeds from a south-westerly direction driving rain into the wall fabric which, coupled with falling temperatures, raises %RH measurements to dewpoint and beyond, a condition that persists towards the external side of the wall until spring 2015.

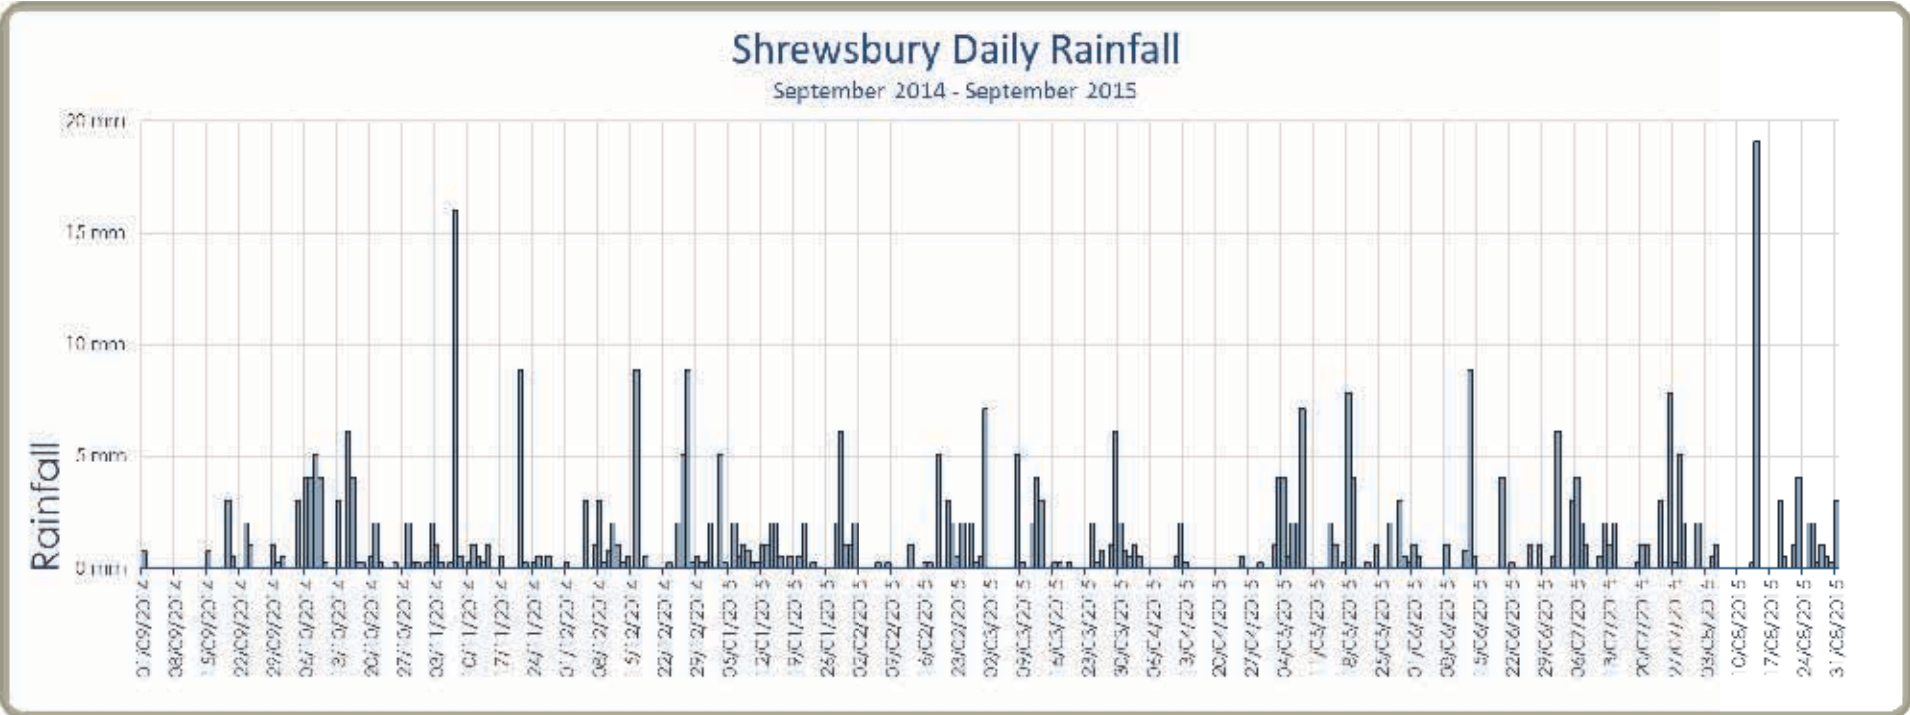
Figure 6: Daily Rainfall mm, Shrewsbury 2014 - 2015.

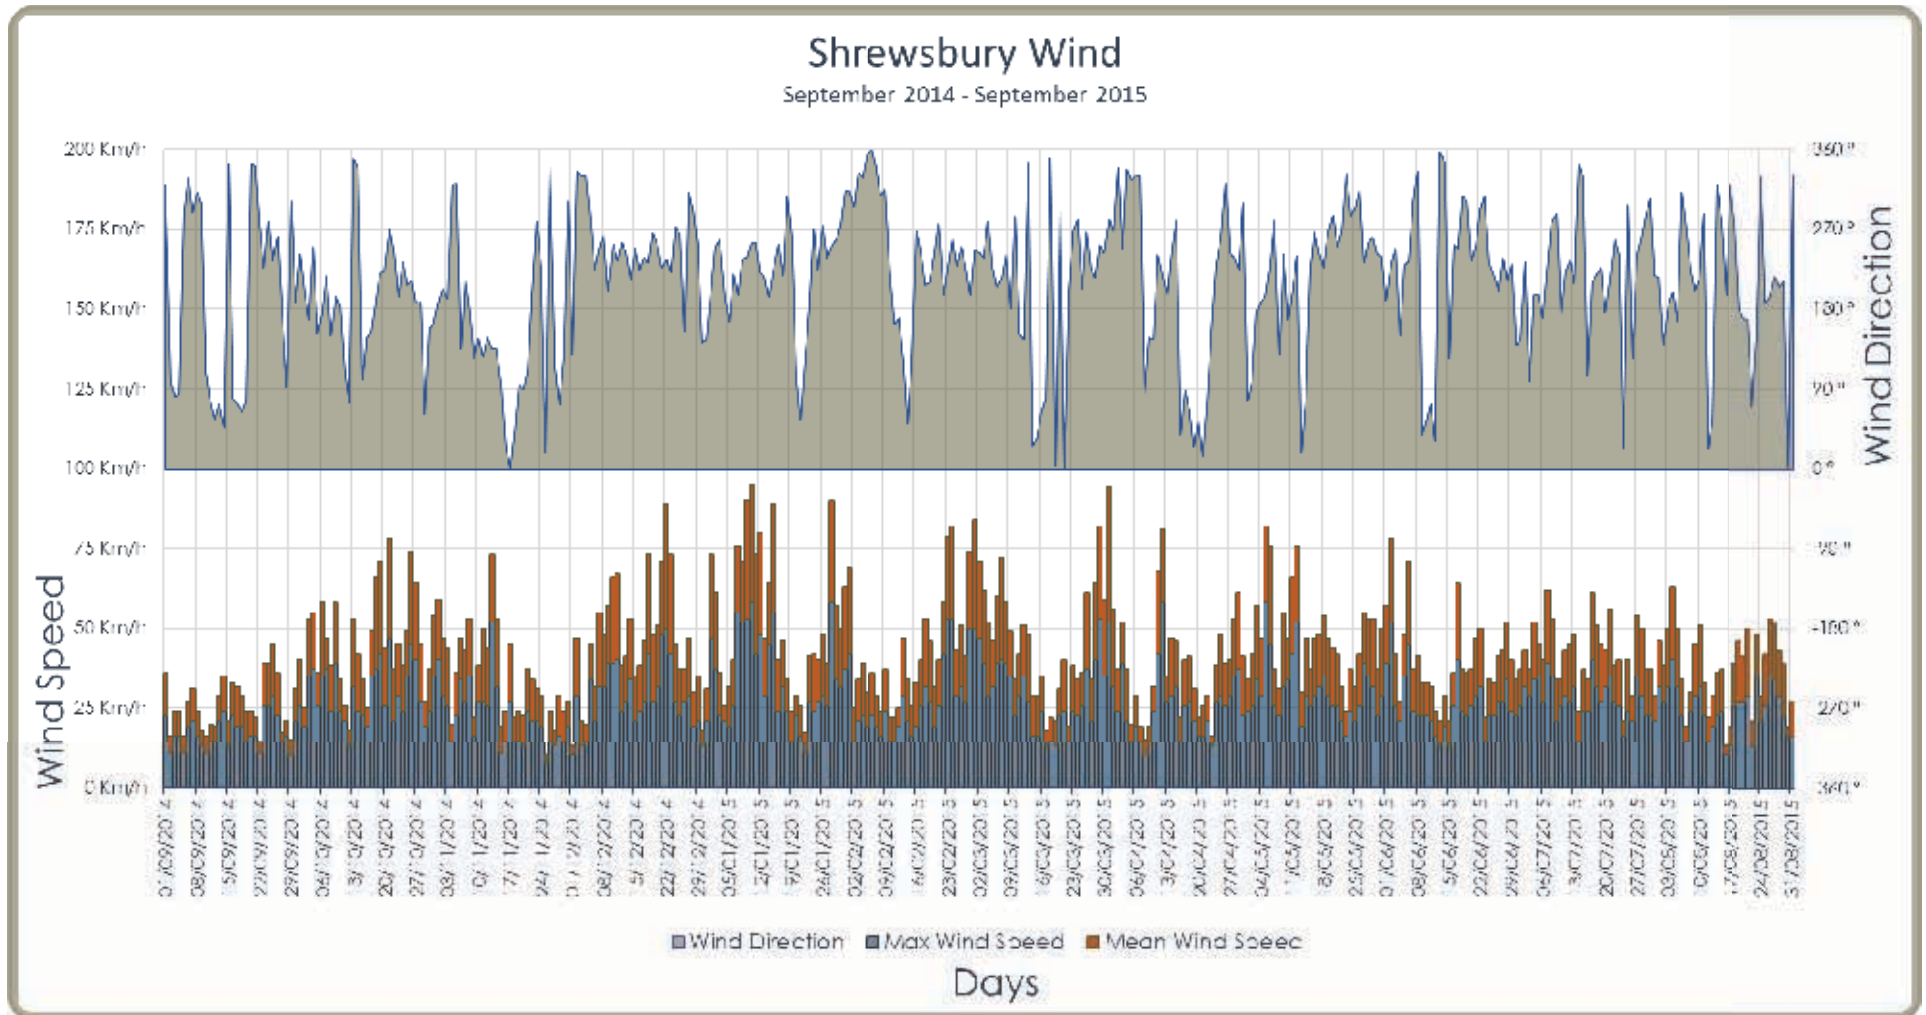
Figure 7: Annual Wind Speed (km/h) and Direction, Shrewsbury 2014 - 2015.

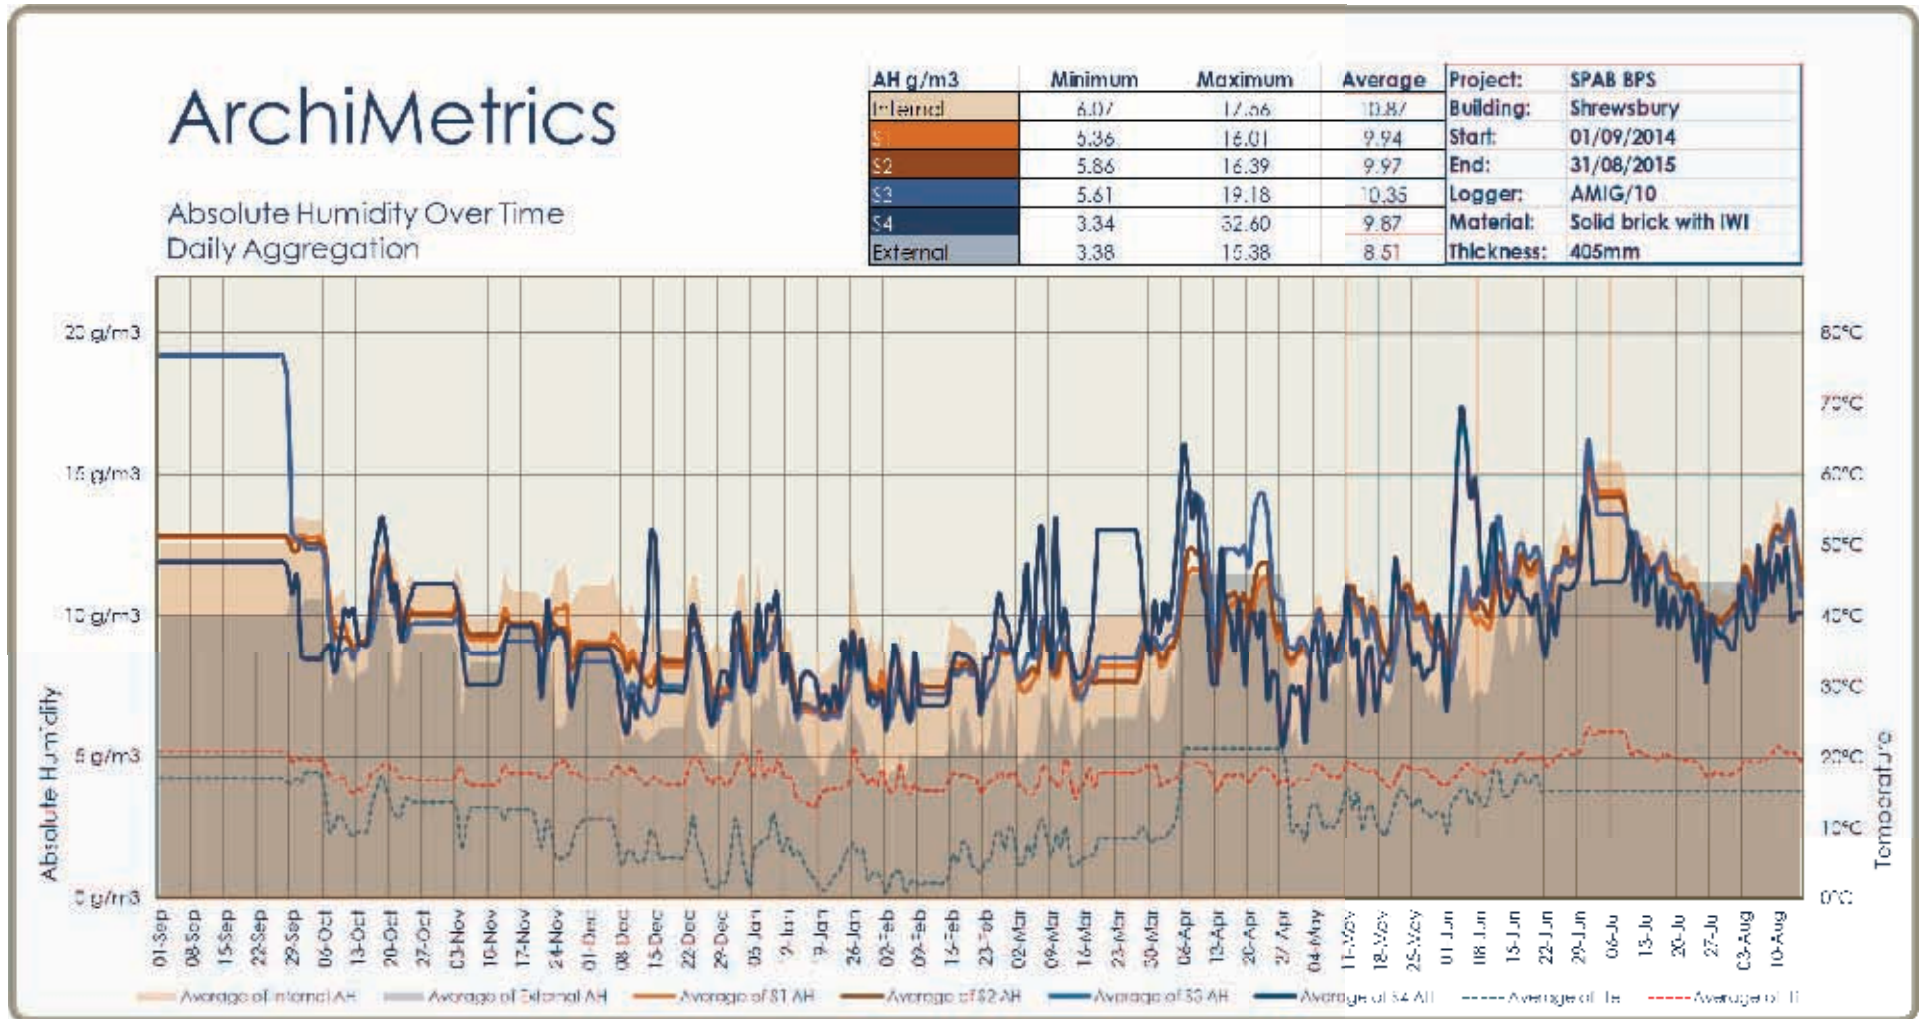
Figure 8: Absolute Humidity over time, Abbeyforegate, Shrewsbury 2014 - 2015.

Figure 8 shows an analysis of absolute humidity through the insulated wall section at Shrewsbury between 1st September 2014 □ 31st August 2015. This shows the same seasonal variation as observed in previous years; the weight of vapour within the wall increases with that of atmospheric humidity over the summer months. There is a similarity between this AH analysis and that of %RH where responses found at

sensor 4 can be more extreme and are detached from those of the other sensors. Once again, this is due to the location of this sensor and the qualities of the wall fabric which mean it is measuring conditions closely influenced by changeable atmospheric conditions. Some peaks in the weights of vapour measured at sensor 4 can be seen, like those of %RH, to coincide with periods of wet and windy weather, in December 2014, June and August 2015. There is an interesting exception to this seen at the end of June 2015 where a peak in AH is not accompanied by a similar rise in RH. This takes

place over a period of alternately hot and rainy days, where, on 30<sup>th</sup> June temperatures reach a peak for the year, 38°C. (Unfortunately, external temperature data is missing for this part of the year from the analysis in Figure 8 but the influence of high external temperatures, which also reach an annual peak, can be seen in records of internal air temperature influenced by solar gain through glazing.) Rain on the days surrounding this temperature peak on 30th June accounts for the raised vapour within the wall structure at this location. However, the generally warm air temperatures and heating of the south-facing external fabric by the sun means that %RH remains low over this same period.

The drying that takes place within the brick section of the wall starting around the beginning of April is also visible in Figure 8. In the previous section this was seen as a rapid drop in %RH at sensor 4 due to the sharp increase in external temperatures beginning on 1<sup>st</sup> March. The effect on measurements of AH is exactly the opposite as weights of vapour within the wall at sensor 4 increase due to the heat encouraging evaporation from wet fabric, Figure 9. After this initial drying, from 6th April onwards, weights of AH decrease as material at this location loses its residual moisture (also reflected in the decrease of %RH over this time). At this time a similar if less pronounced trend, of AH increase followed by decrease, is seen further into the wall at sensor 3, albeit delayed by about half a day. At sensor 3 there is also a second bout of drying a week or so later, around 20th April, which is not preceded by similar activity at sensor 4. All four sensors within the wall stop their trend of decreasing AH on 12<sup>th</sup> April and begin to measure increasing weights of vapour again in response to an isolated rain event (apart from the start and end of the month this is the only rainfall seen in April). Following this rain, AH at sensor 4 falls rapidly once more to reach its lowest annual weight, 3.34 g/m<sup>3</sup>. But this response is not followed at sensor 3 as was seen previously but instead there is a further increase in AH prior to a drop in the weight of

vapour at this location. This suggests that prior to 12<sup>th</sup> April the wall had not evaporated all the residual moisture accumulated in the fabric deeper within the wall at sensor 3 and the increase in weights following the rain event, above and beyond those measured at sensor 4, is due to the evaporation of this additional water facilitated by warmer temperatures.

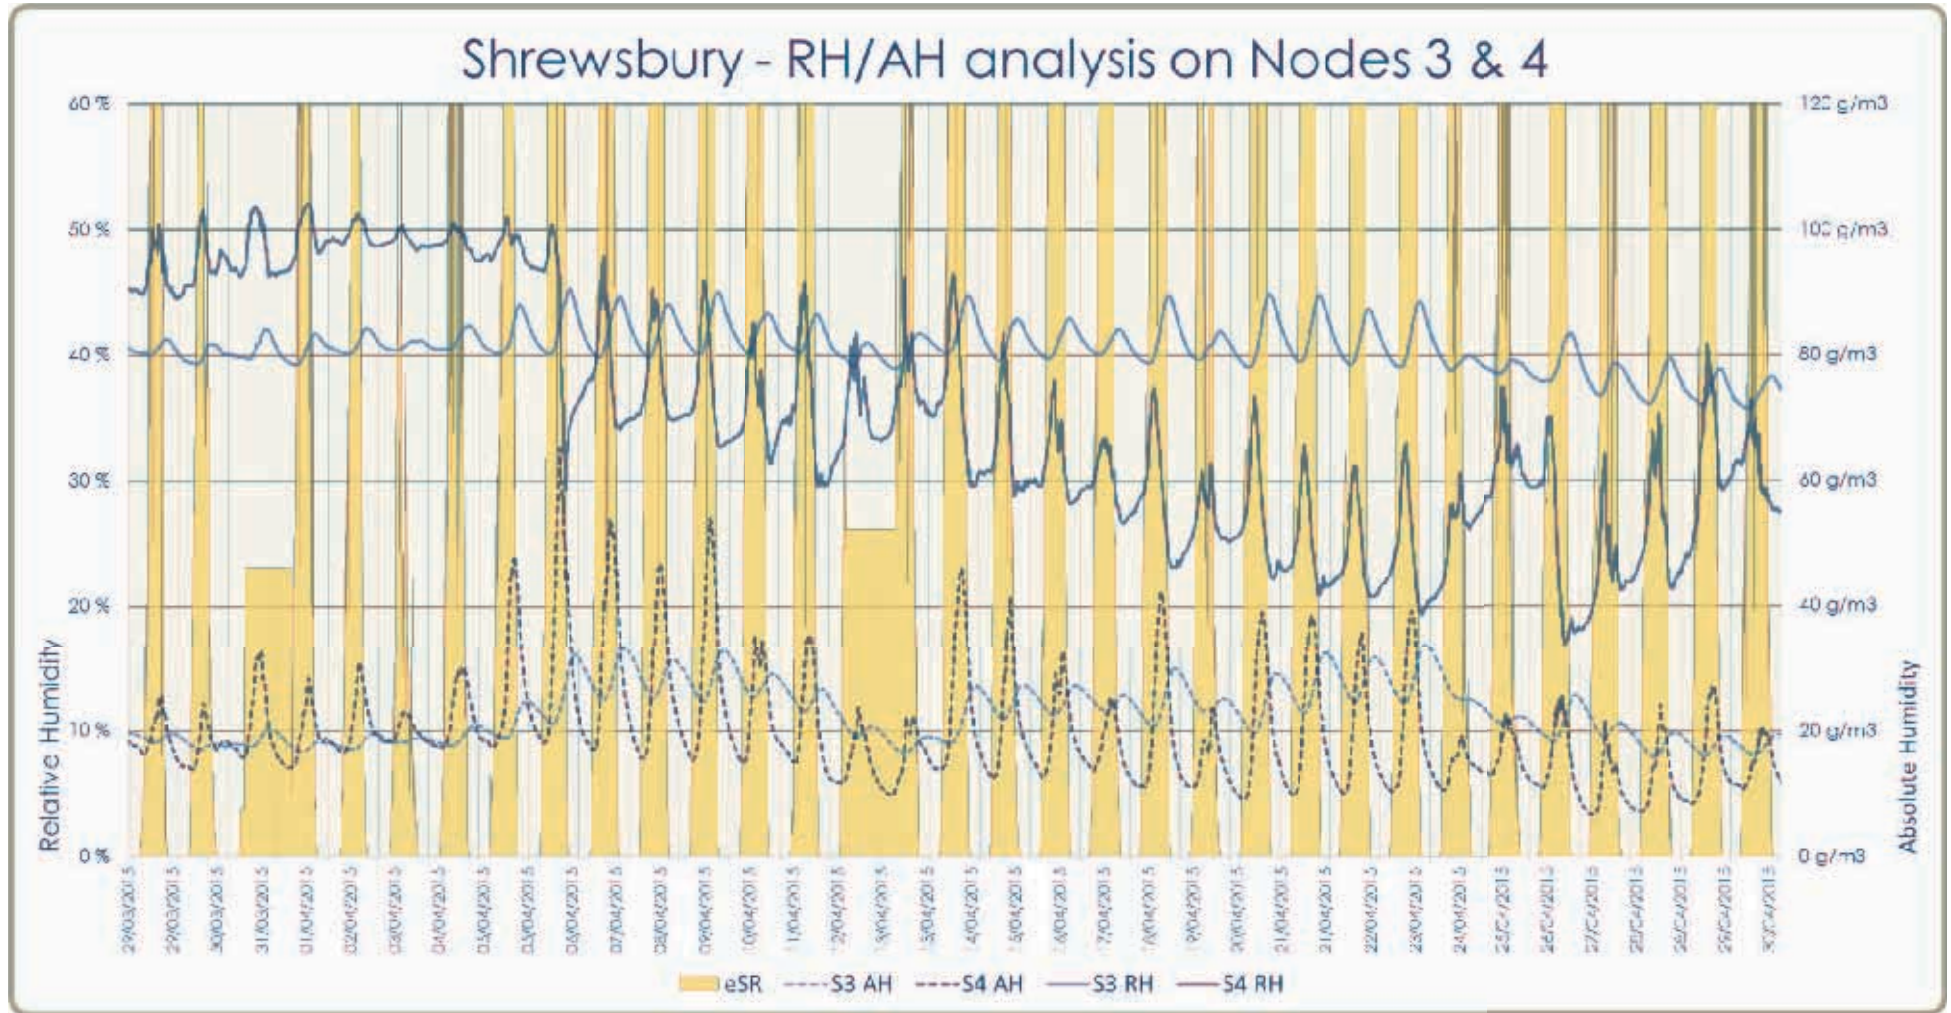
Figure 9: AH and RH Solar Analysis sensors 3 & 4 over time, Abbeyforegate, Shrewsbury 2014 - 2015.<sup>2</sup>

<sup>2</sup> In this and other Solar Analysis figures eSR refers to external surface radiation – the two thicker lines 31/03 - 01/04 and 12/04 - 13/04 are occasions where data has been lost and so the last recorded value persists until new data is received hence it appears that the sun is shining throughout the night!

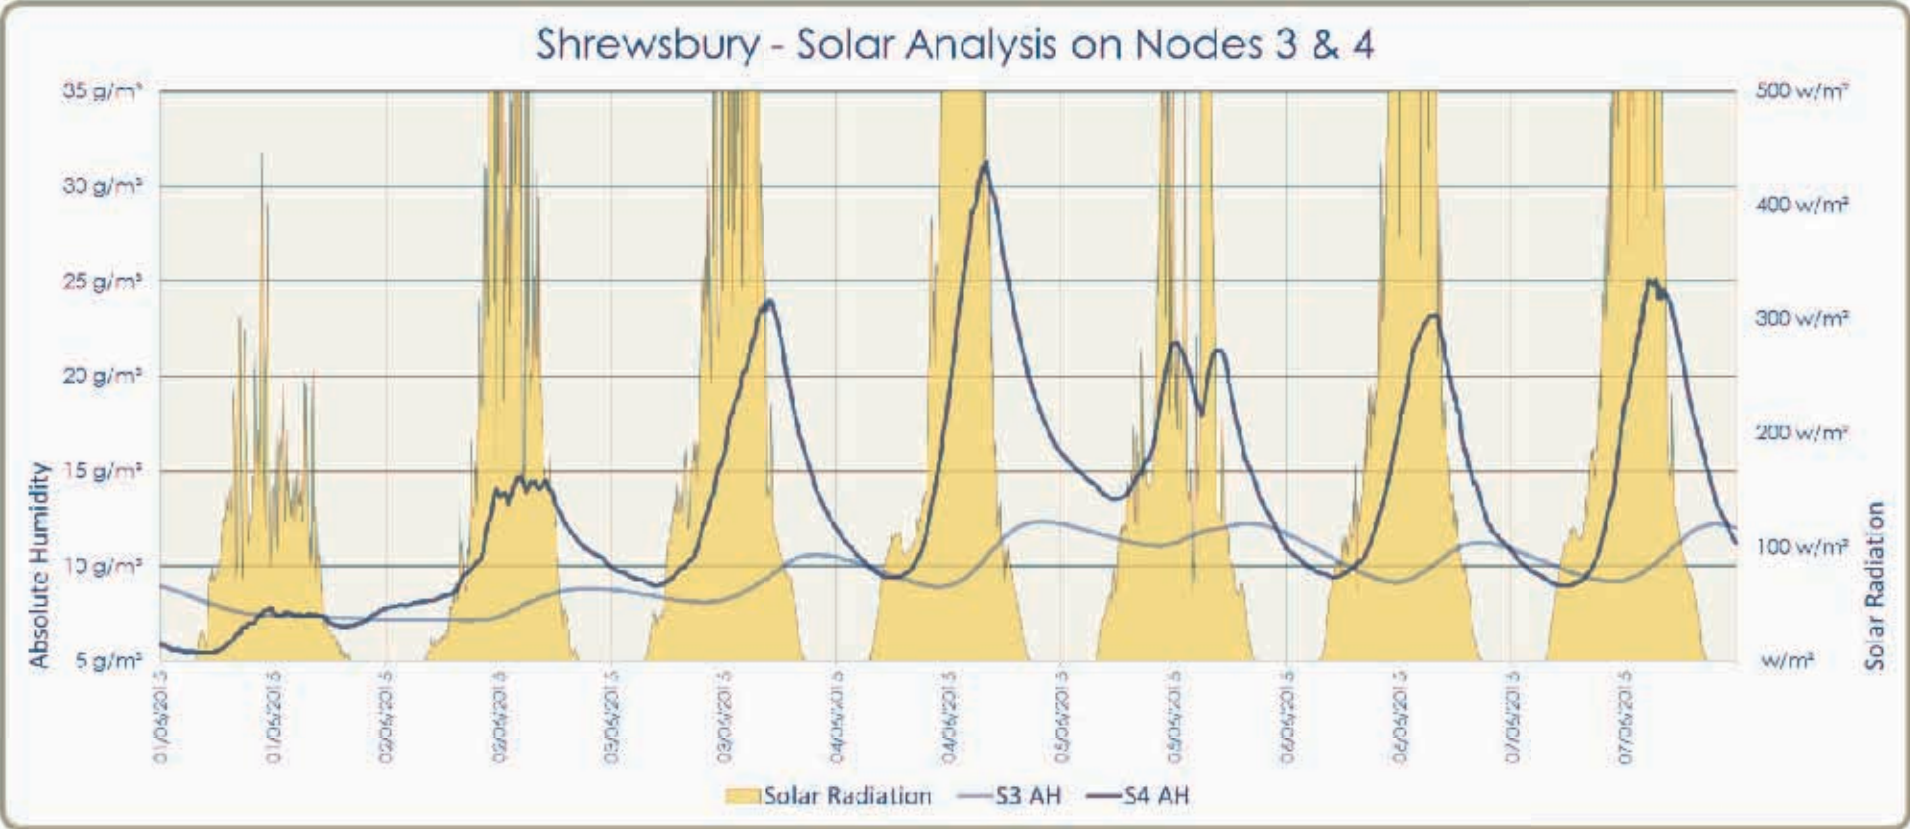
Figure 10: Solar Analysis on nodes 3 and 4 wk. bg. 1<sup>st</sup> June 2015, Abbeyforegate, Shrewsbury 2014 - 2015.

The processes of solar-driven evaporation can also be observed in detail during the first week of June, Figure 10. There is little rainfall recorded for Shrewsbury this week and it is a week that shows a significant spike in the aggregated AH data at sensor 4, Figure 8. This spike can also be seen in the solar analysis of AH at sensors 3 and 4, Figure 10. The spike at sensor 4 coincides with a day of intense solar radiation measured from the south-facing wall. Interestingly the AH peak lags behind that of the solar radiation. This offset shows the time taken for the heat to pass through from the surface to warm the brick further back and cause the vaporisation measured at sensor 4. A similar offset and more muted response is then seen further back at sensor 3 where the effects of the heat are diminished. An examination of the peaks and the troughs of the sensor 3 and 4 gradients provides us with a sense of the AH trend over this week. In the first four days peaks and troughs rise up the scale in response to the increasing intensity of solar radiation on the wall. This 'stair-stepping' was first observed in the wall in Riddlecombe in 2013 and suggests over this time rates of vapour diffusion are unable to keep pace with that of the vaporisation of moisture from the wall material. In Figure 10, following on from the climatic radiation event 4<sup>th</sup> June we see these peaks and troughs begin to descend the scale. This suggests that surrounding fabric has lost much of its residual moisture and that the vaporisation response is subsequently diminished to the extent that diffusion is now able to move sufficient quantities of vapour to cause measurements of AH to begin to decrease as part of the drying process.

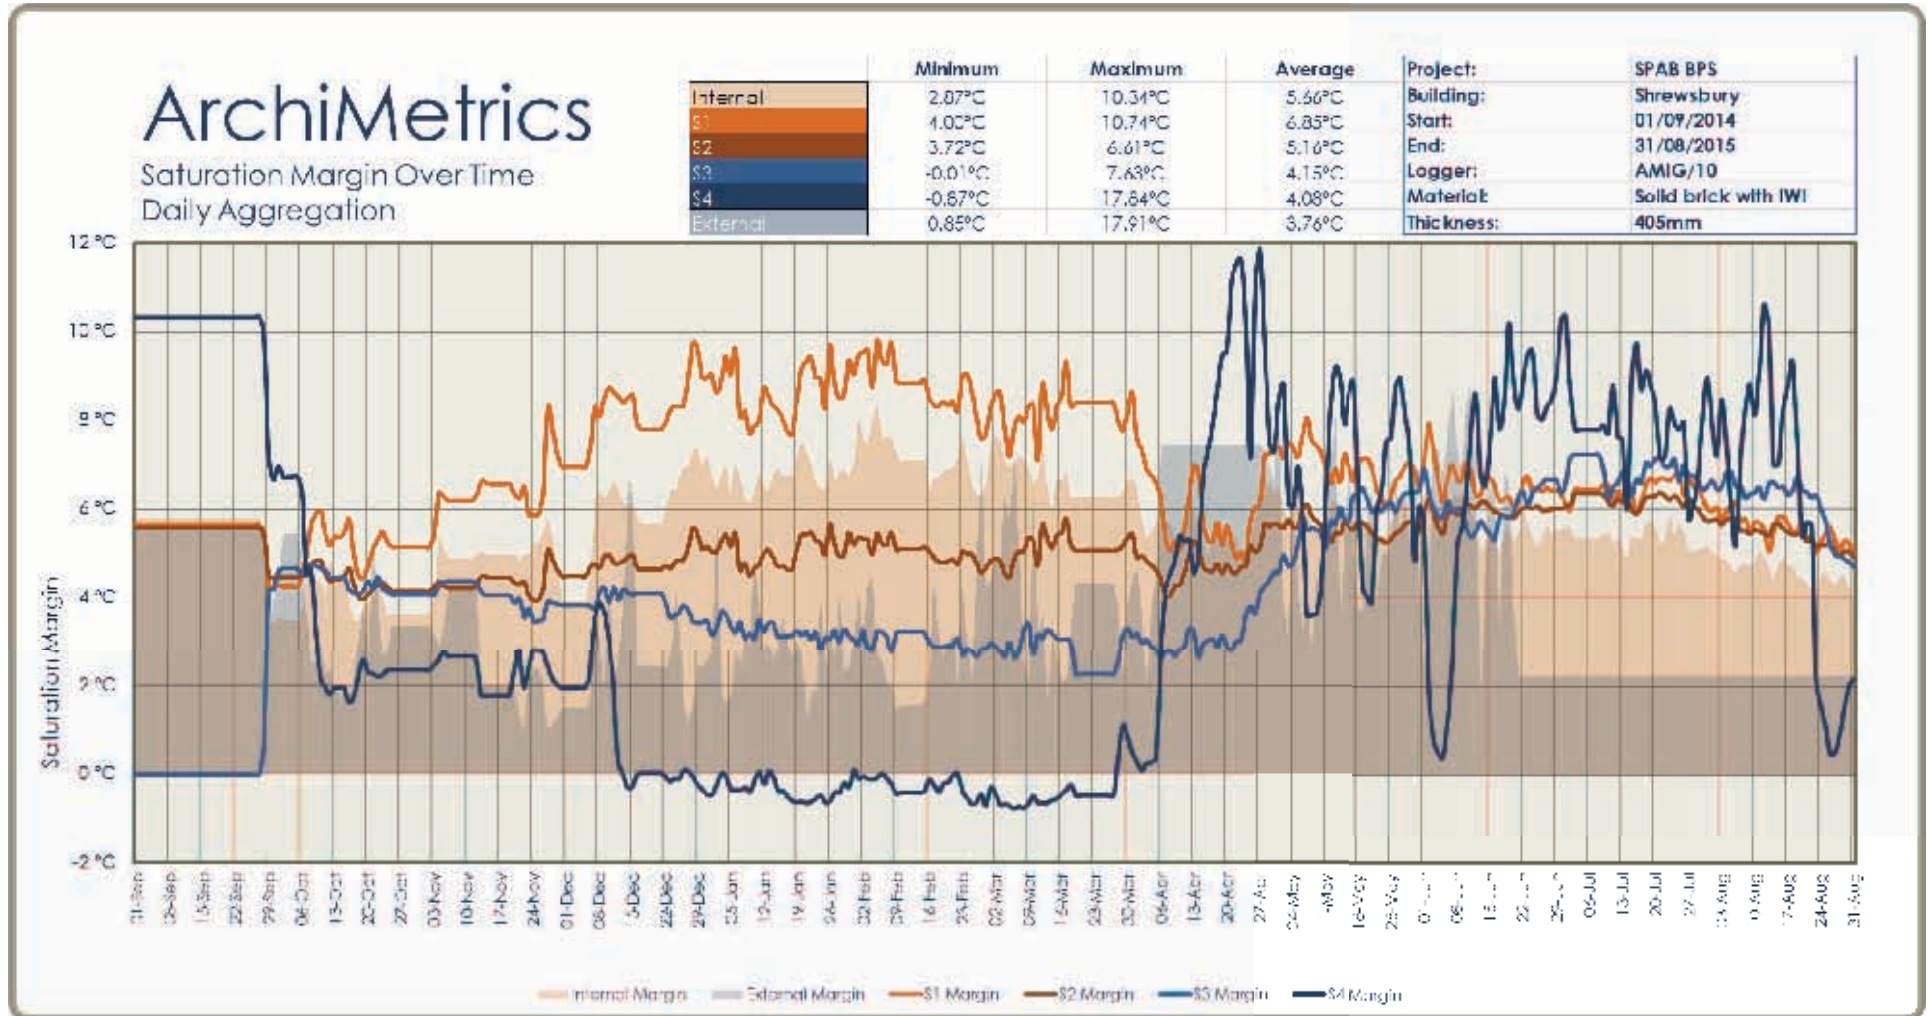
Figure 11. Saturation Margin over time, Abbeyforegate, Shrewsbury 2014 - 2015.

The range of saturation margins across all sensors for the three years, post-insulation, is quite consistent and shows neither an increasing or decreasing trend. The difference between pre- and post-insulated margins, one indication of the degree of change that has taken place, is also smaller and where margins have increased since refurbishment is shown as a negative number. In general, the margins found at Shrewsbury, in comparison with the other insulated walls in this study, suggest a lesser risk to the wall from moisture.
