# SPAB Building Performance Survey

Interim Report I  
October 2015

Research conducted on behalf of the SPAB by ArchiMetrics Ltd  
Supported by Historic England

## The SPAB Building Performance Survey Interim Report 2015

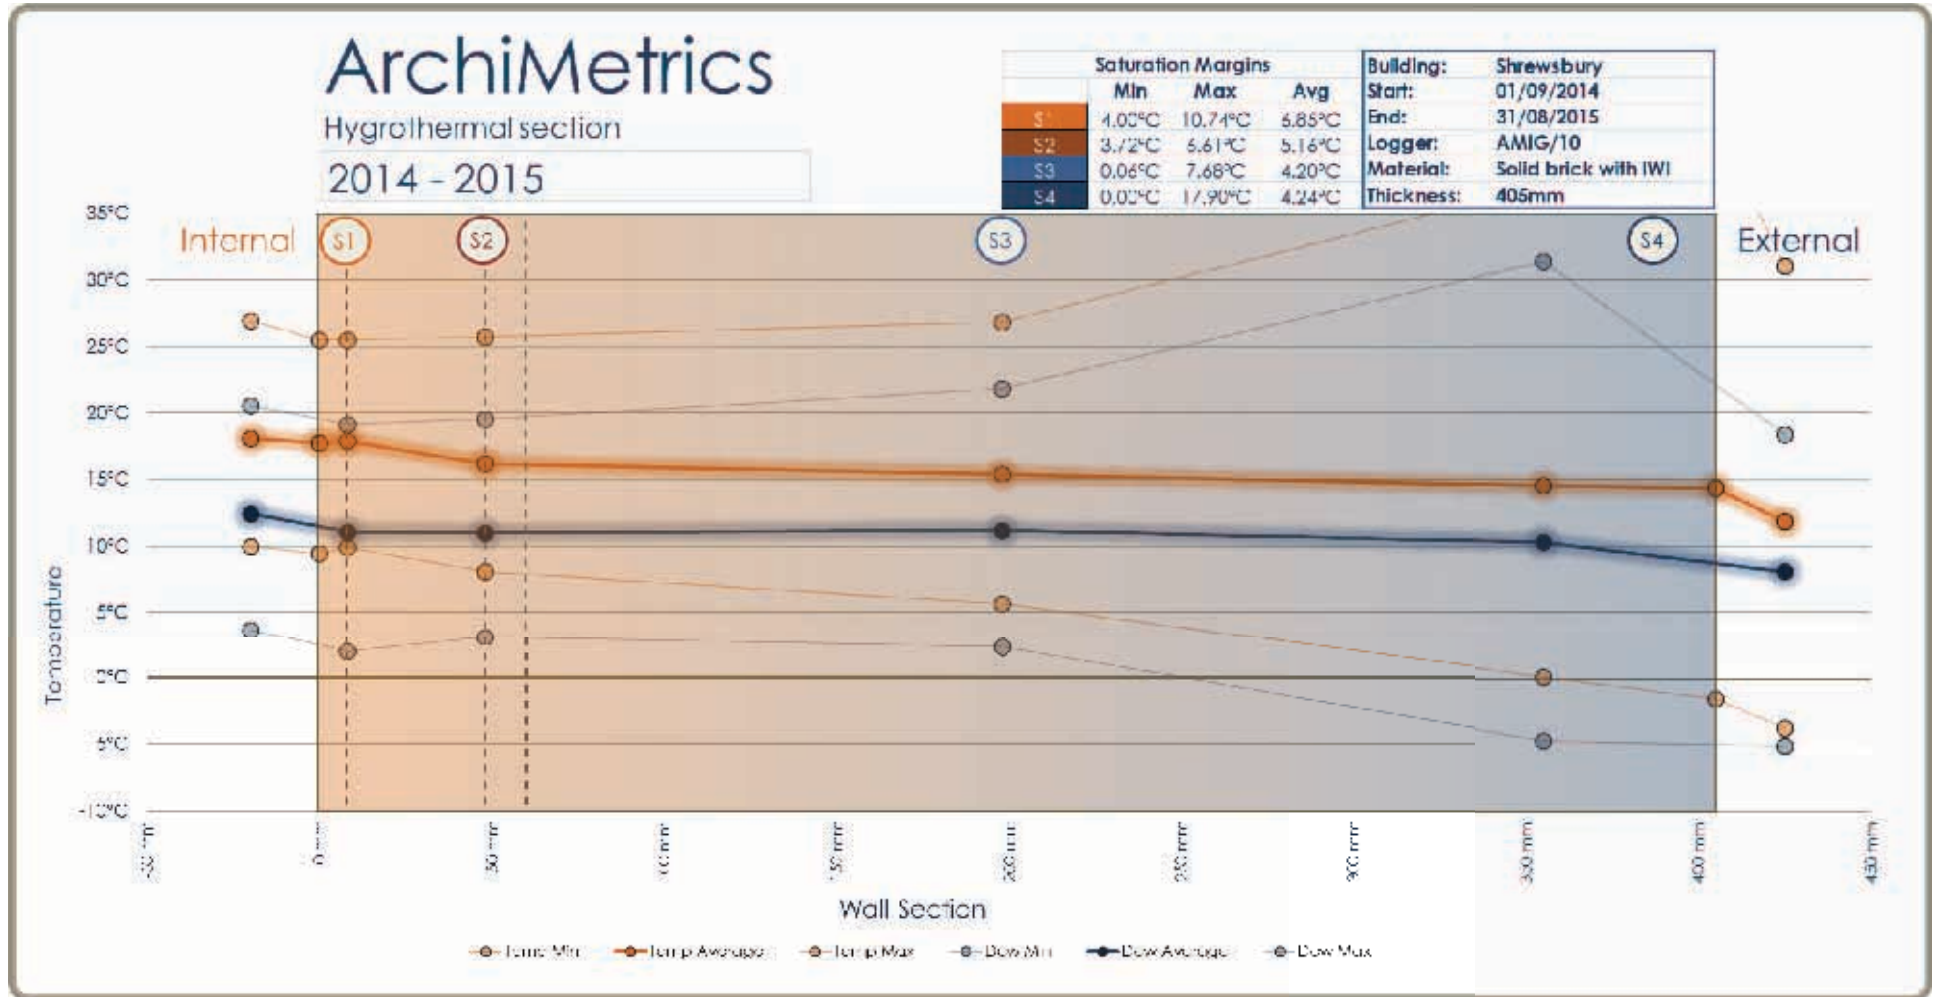
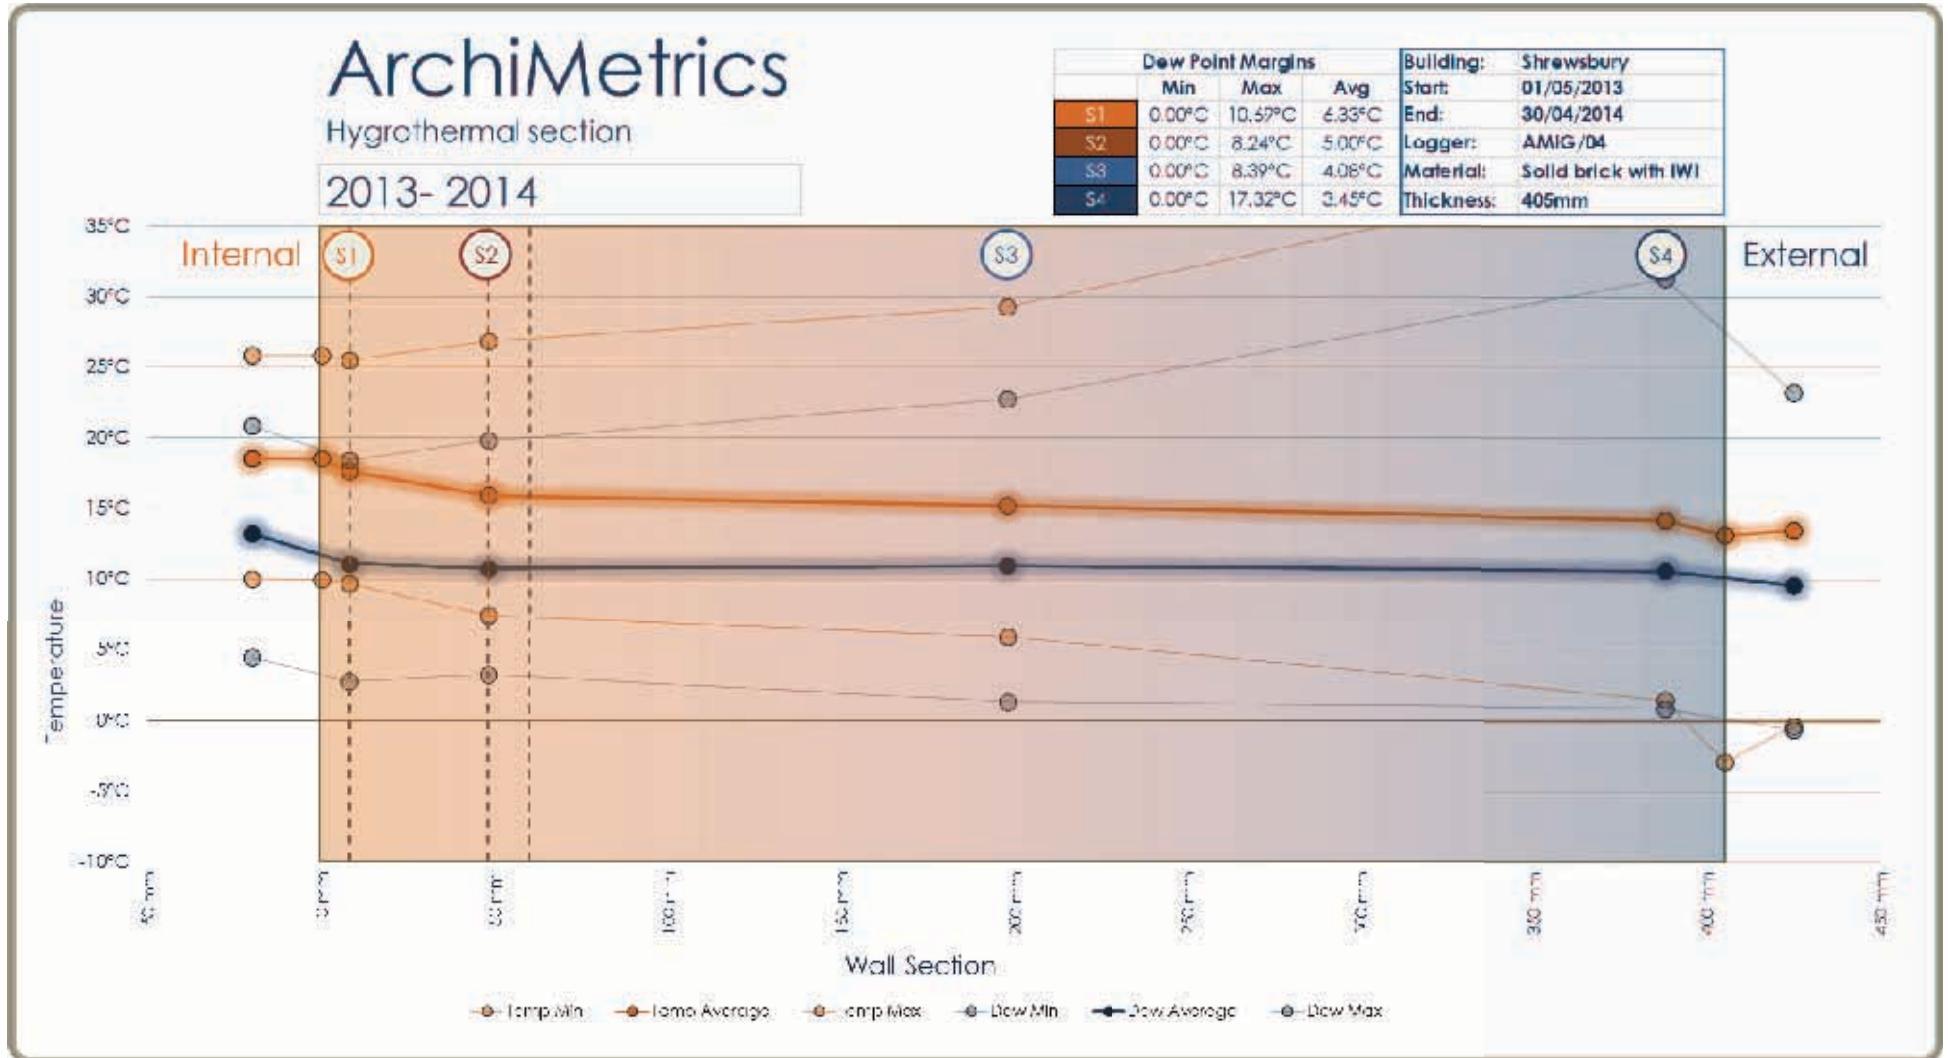
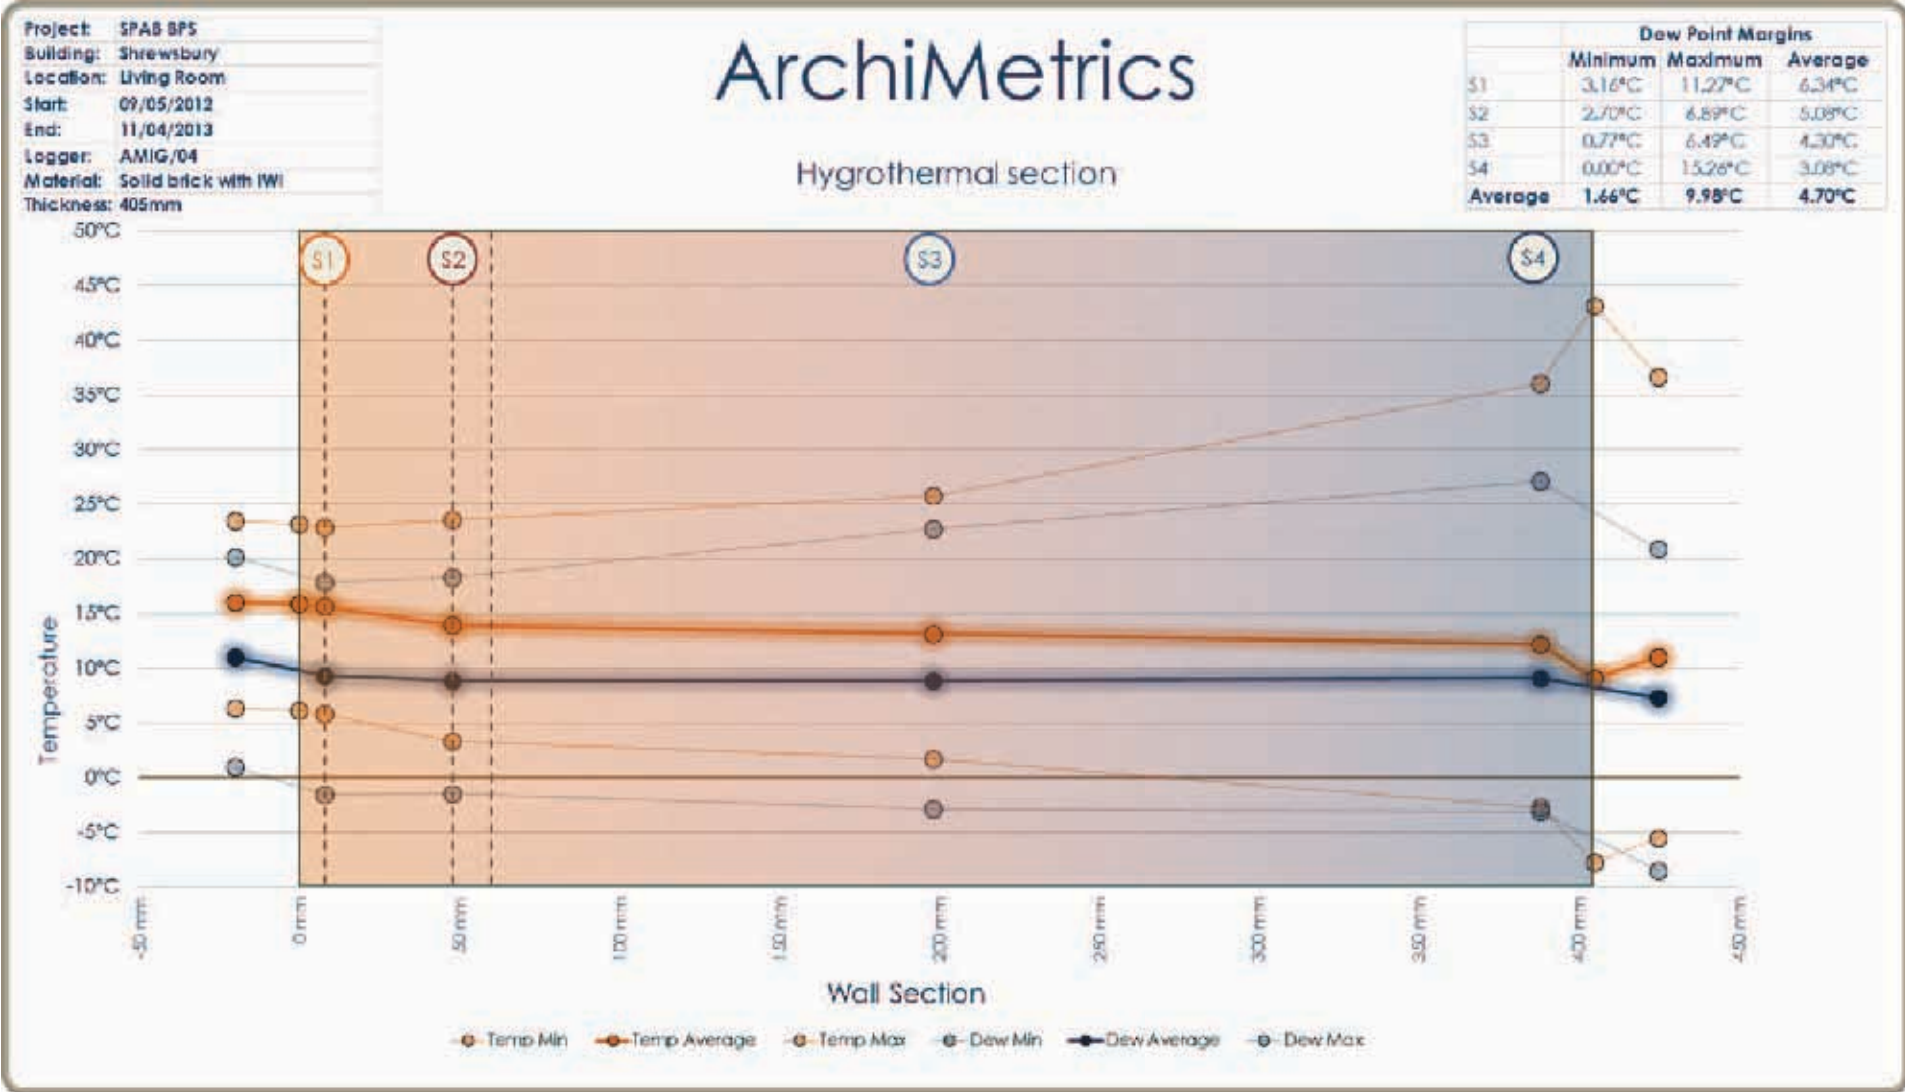
Figure 12. Hygrothermal Section, Abbeyforegate, Shrewsbury 2014 □ 2015 (capped).

Figure 13. Hygrothermal Section, Abbeyforegate, Shrewsbury, 2013 - 2014.

Figure 14. Hygrothermal Section, Abbeyforegate, Shrewsbury, 2012 - 2013.

Measurements of temperature and RH are also used to plot annual averages of measured temperature and dewpoint temperature gradients through the wall section (Figures 12,13 and 14). These analyses show the similarity between the past three years and indeed the slight increase in temperature separation between the two margins found in 2013 – 14 and this year. Through the four measurement points, on average, we find no convergence of the two gradients, which in other walls coalesce towards the external wall face. Once again this suggests that over an annual cycle the wall is performing within safe margins with regard to risks from moisture

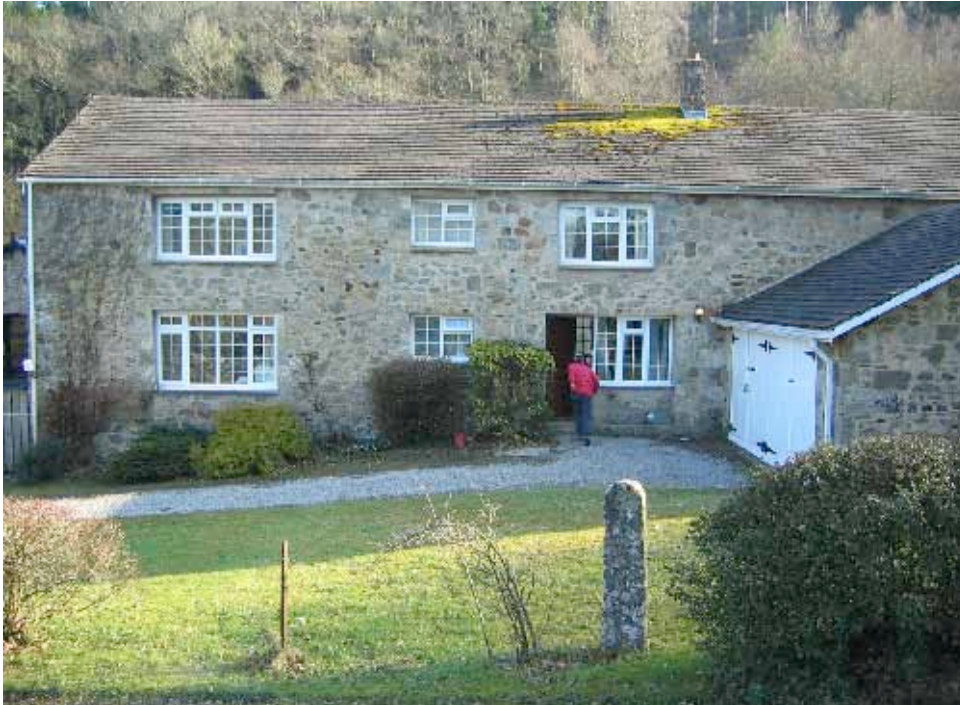
## 2.2. Mill House, Drewsteignton, Devon - 2014 - 15.

Description: A barn built in granite dating from the nineteenth century or possibly earlier converted to a dwelling in 1970s incorporating a circa 1950's agricultural building at rear.

Refurbishment: The 1950's extension to the rear of the building has been extensively rebuilt as a timber-frame construction, insulated with woodfibre insulation and has new double-glazed timber windows (the windows in the earlier 'barn' section of the house are in uPVC). In 2012, for experimental purposes, a short section of wall in a room in the older barn part of the dwelling, pictured above, was internally

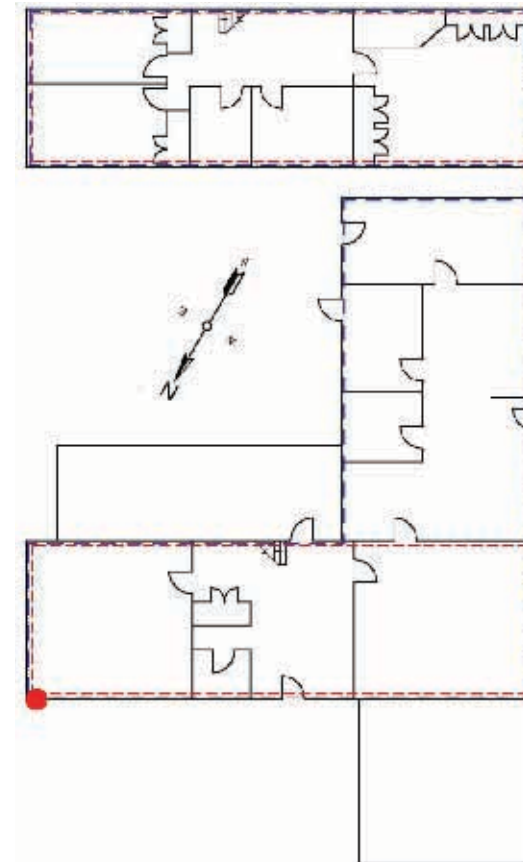
Figure 15. Plan of Mill House, Drewsteignton, the red dot indicates the location of the ground floor monitoring equipment.

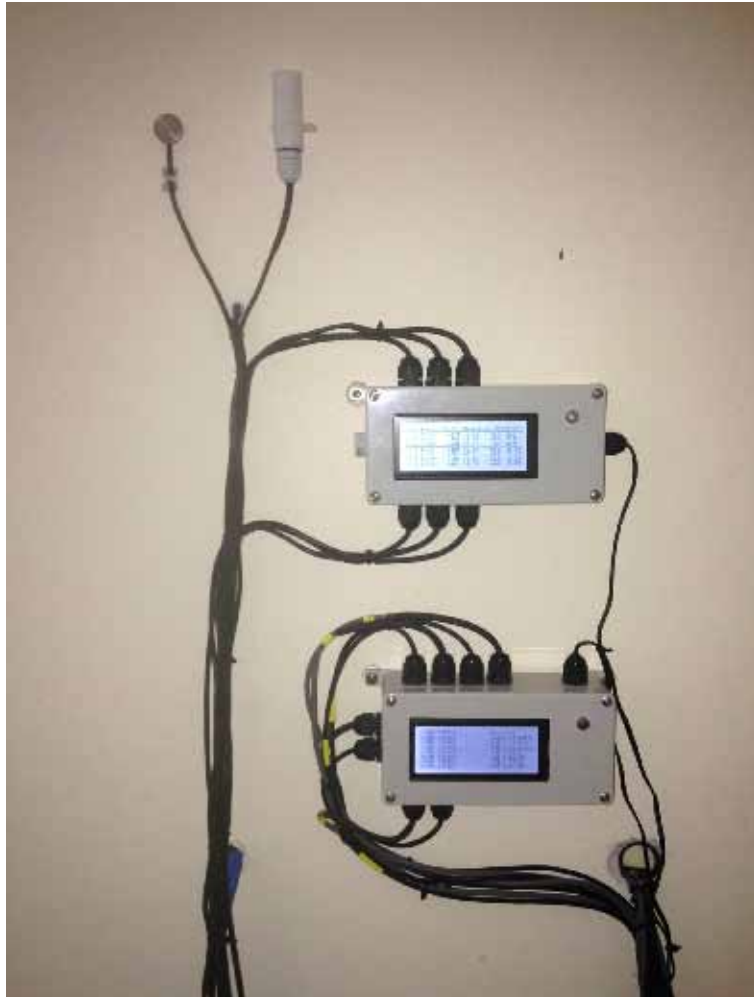
Figure 16. Interstitial Hygrothermal Gradient and Material Moisture Monitoring, Drewsteignton.

Measurements of temperature and relative humidity (%RH) are being made through the test section of the north-west-facing wall of the study room at Mill House (Figures 16 and 17). Combined temperature and relative humidity sensors are located at four points within the wall at the heights and depths given in Table 7. This table also gives details of the wall build-up before and after insulation (in green).

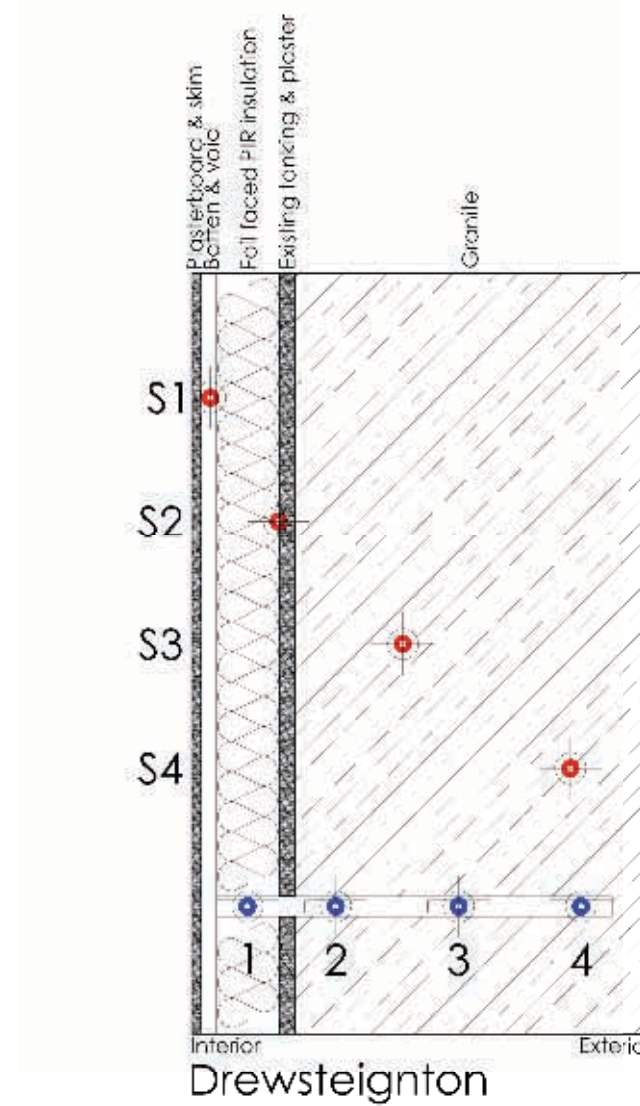
Figure 17. Position of wall sensors through section, Drewsteignton □ red IHGM, blue Material Moisture

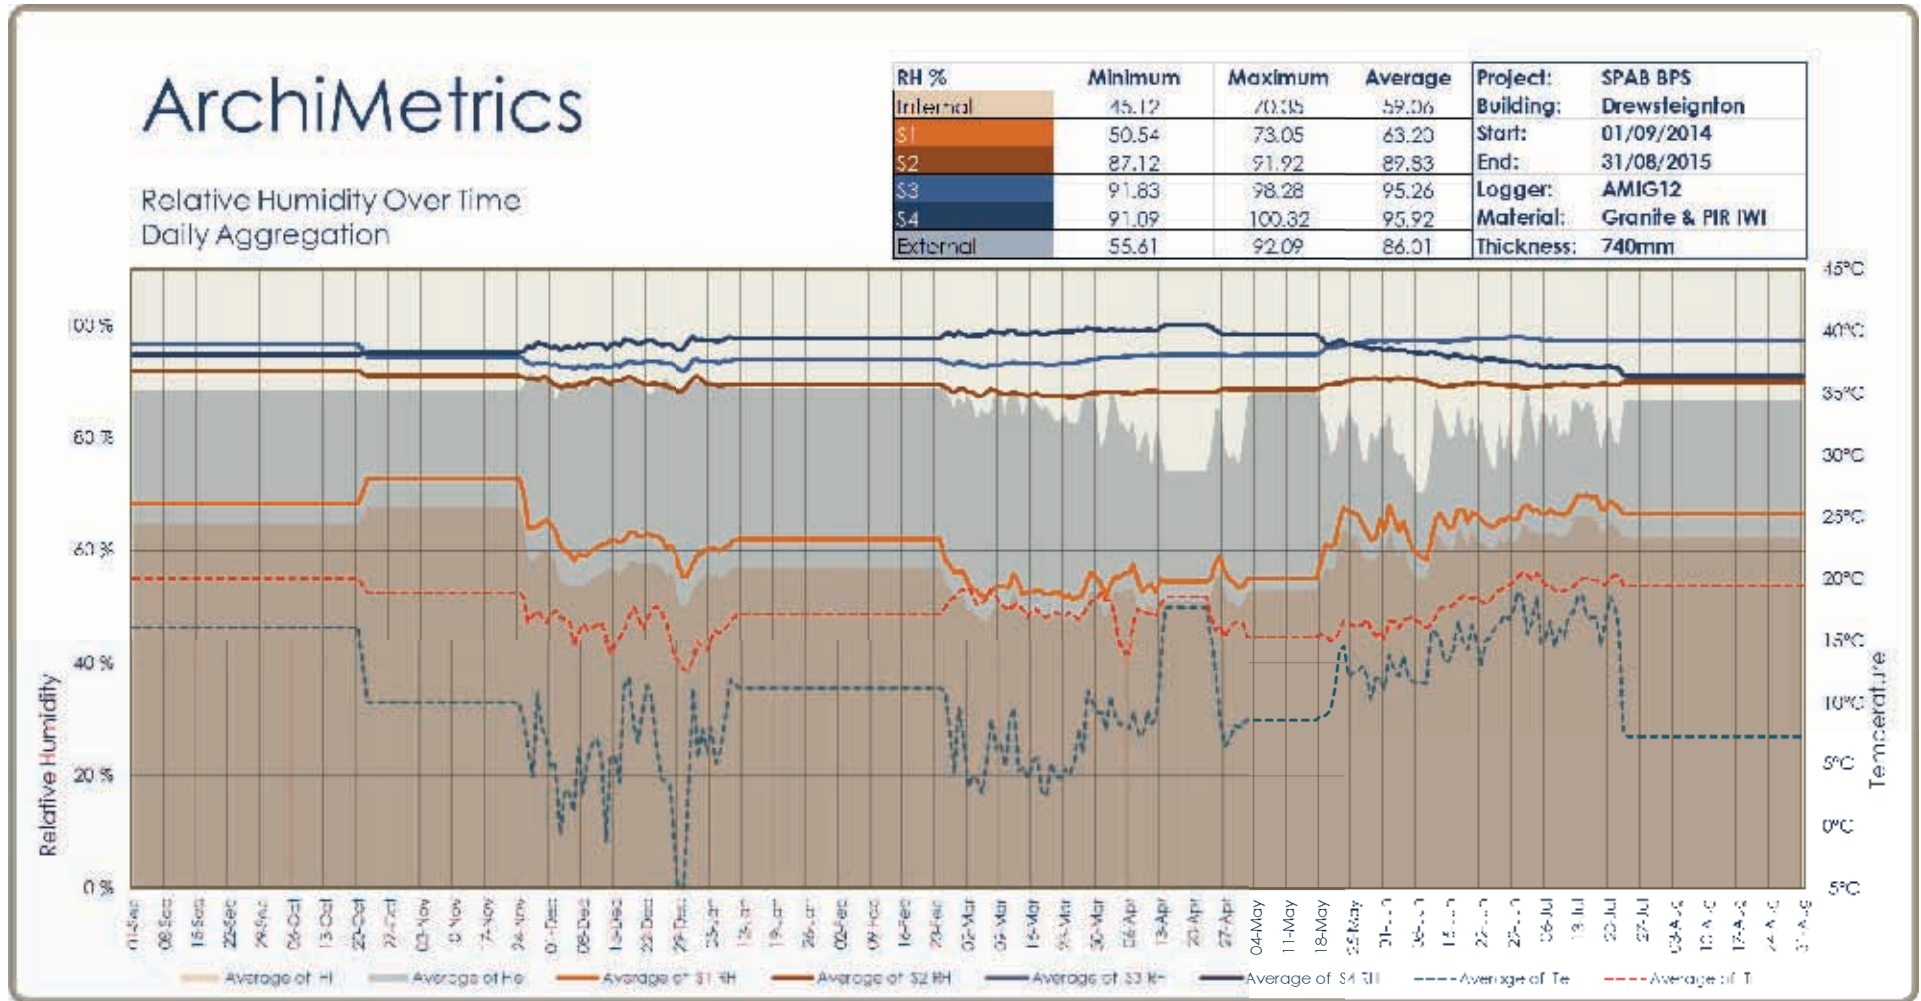
Figure 18: Relative Humidity over time, Mill House, Drewsteignton, 2014-2015.

An examination of Figure 18 suggests that warmer summer temperatures may have some impact deep within the wall fabric as during these months, while %RH decreases at sensor 4, it increases at sensors 2 and 3. (Sensor 3 is positioned approximately half-way through the granite wall and sensor 2 is at the granite/foil-faced PIR insulation interface.) We have seen this behaviour elsewhere during the summer and have ascribed it to evaporation from damp materials increasing the vapour load of the air. It would seem that whilst a certain quantity of moisture may evaporate from materials this moisture, located further away from the external wall surface and unable to move towards the interior due to the presence of the foil vapour barrier, may not be able to leave the body of the wall during the warmer summer months. The vapour may then become stuck in cycles of evaporation and condensation and as the wall continues to receive moisture from the external environment its moisture load increases over time. This would account for the trend of rising %RH seen for this wall since it was insulated.

With regard to mould fungus, the wall at Drewsteignton is also at risk when examined against the 80% RH mould risk threshold. Only sensor 1, positioned in the air layer between the plasterboard dry-lining and insulation, records conditions below this threshold and levels here generally follow those of the interior. The three other sensors, however, now show averages of 90% or above and only sensor 2 records a minimum value over the year of below this (87%). Whilst %RH >80% may not represent a risk to masonry materials, high %RH may be an indication of material moisture content above 18% and in these circumstances organic materials embedded in the wall structure, such as timber lintels, joists etc. would be at risk of mould growth.

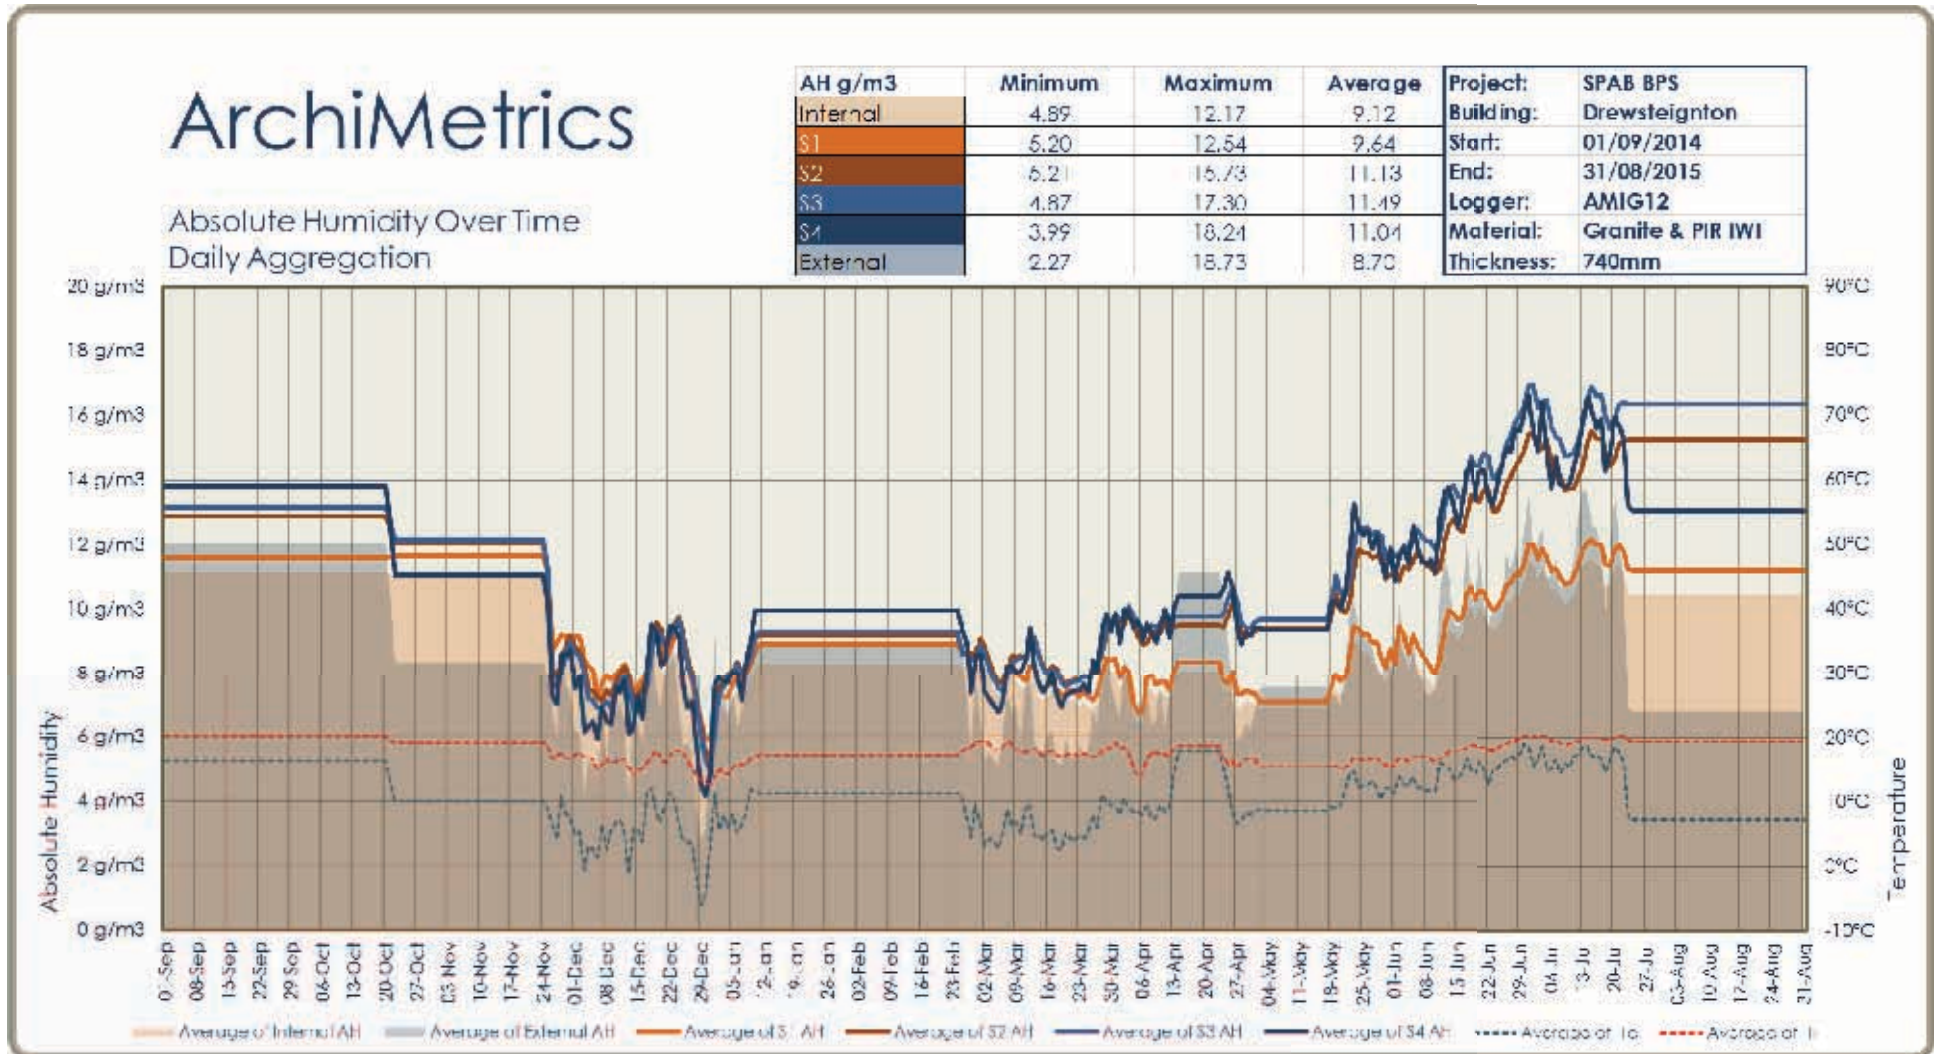
Figure 19: Absolute Humidity over time, Mill House, Drewsteignton 2014 - 2015.

Figure 19 shows an analysis of absolute humidity through the insulated wall section at Drewsteignton between 1<sup>st</sup> September 2014 □ 31<sup>st</sup> August 2015. The same seasonal variation that was noted in previous reports is in evidence; generally quantities of vapour within the wall increase with that of atmospheric humidity during the spring and summer months when air is more humid. Also, as with previous

years, the plot of AH from sensor 1 installed in the air layer behind the plasterboard is somewhat detached showing lower weights of vapour than those of the other sensors during this period. Here, as with the analysis of RH, sensor 1 reflects internal room conditions and the differentiation between this gradient and those from the sensors embedded in the masonry side of the wall (sensors 2 - 4) reveals the physical separation that has taken place via the construction of an air layer and installation of a vapour impermeable material (the foil-faced PIR board). Also of note over the spring and summer months are the

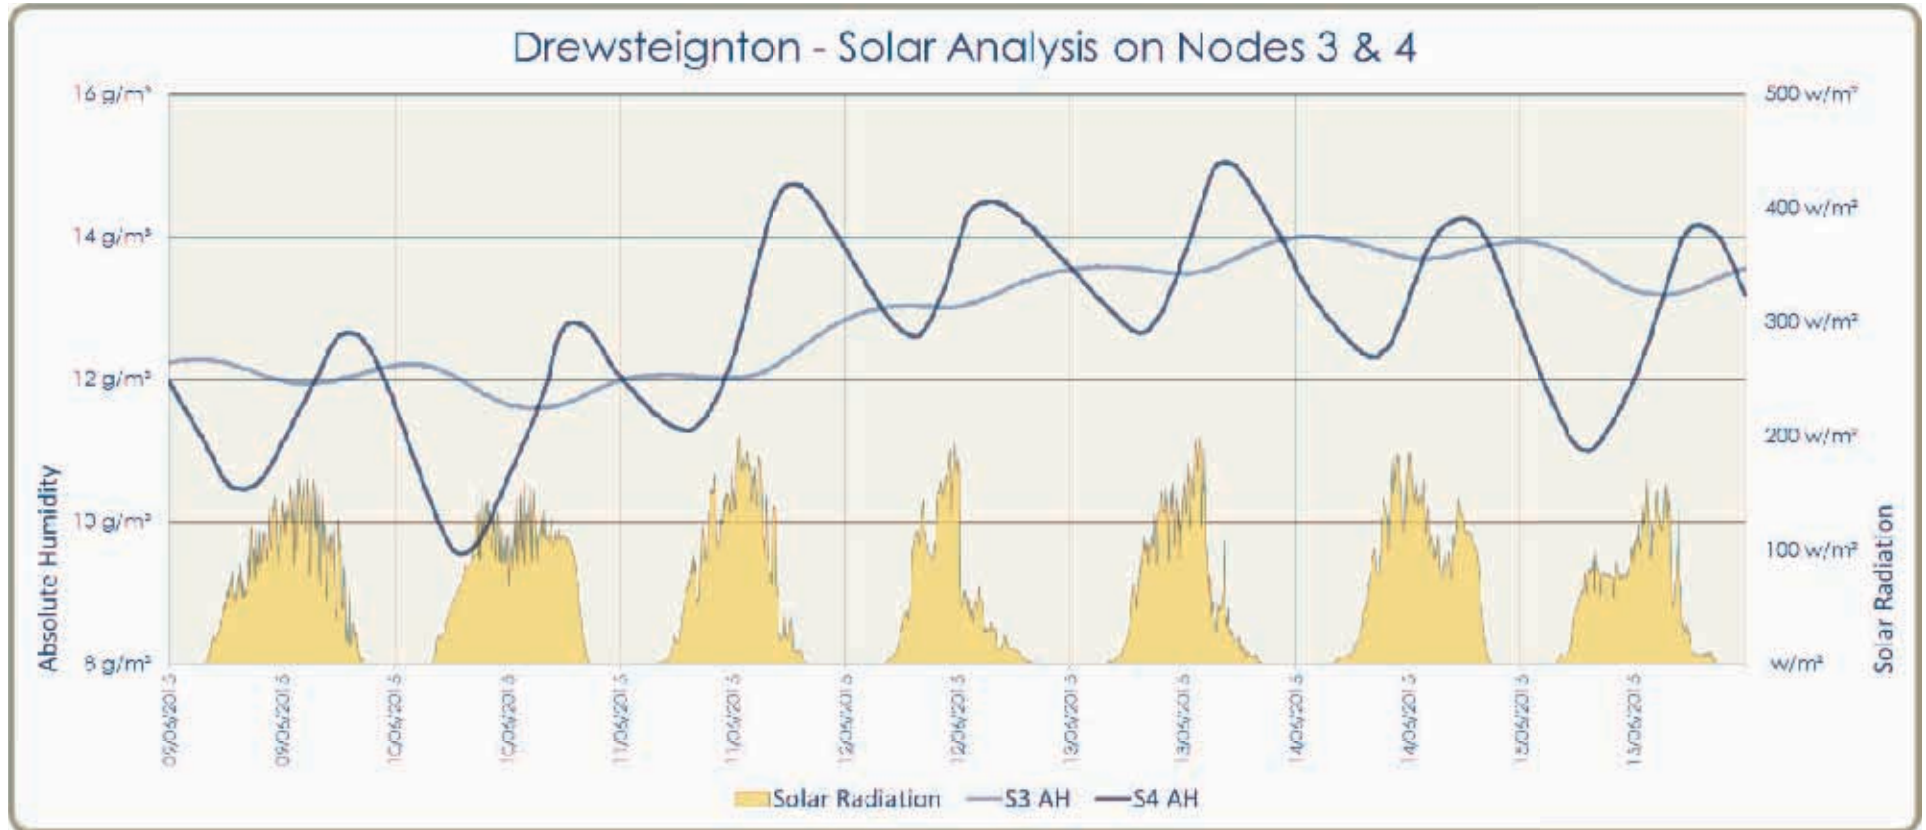
Figure 20: Solar Analysis sensors 3 and 4, Drewsteignton, June 2015.

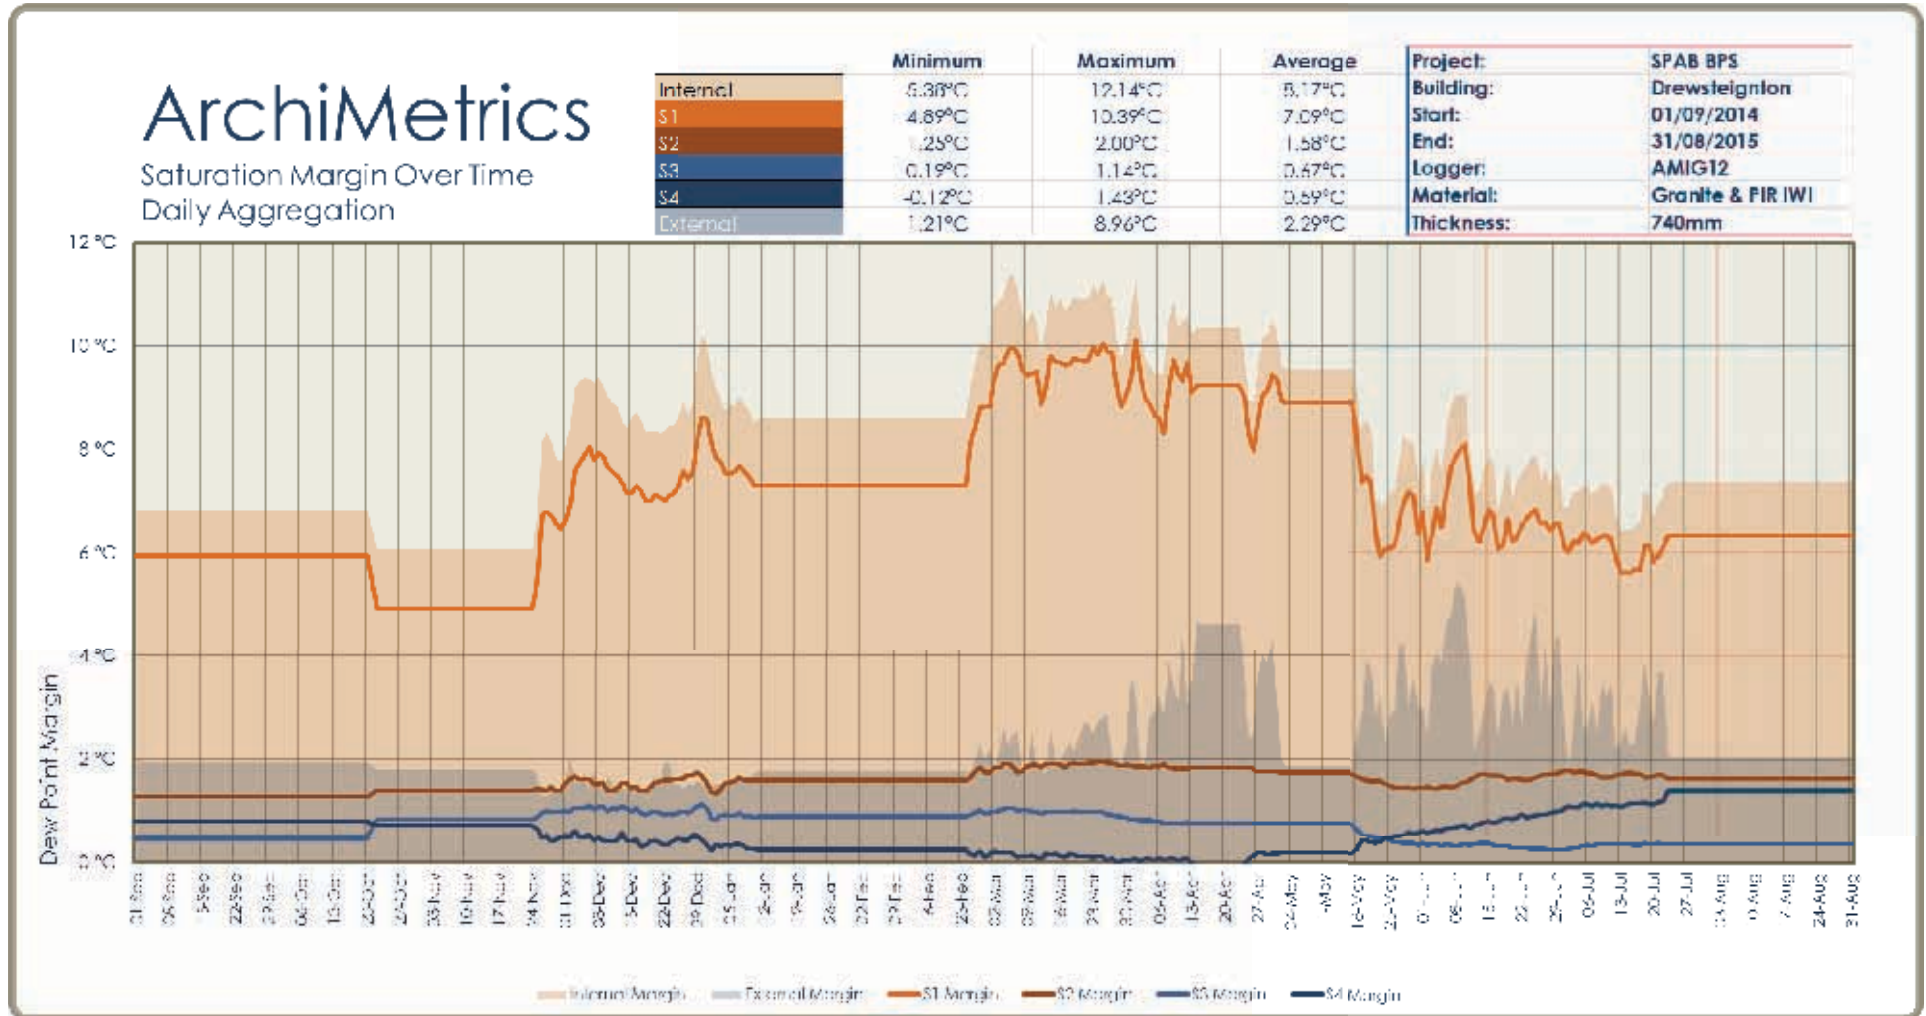
Figure 21. Saturation Margin Over Time, Mill House, Drewsteignton, 2014 - 2015.
