# SPAB Building Performance Survey

Interim Report I  
October 2015

Research conducted on behalf of the SPAB by ArchiMetrics Ltd  
Supported by Historic England

## The SPAB Building Performance Survey Interim Report 2015

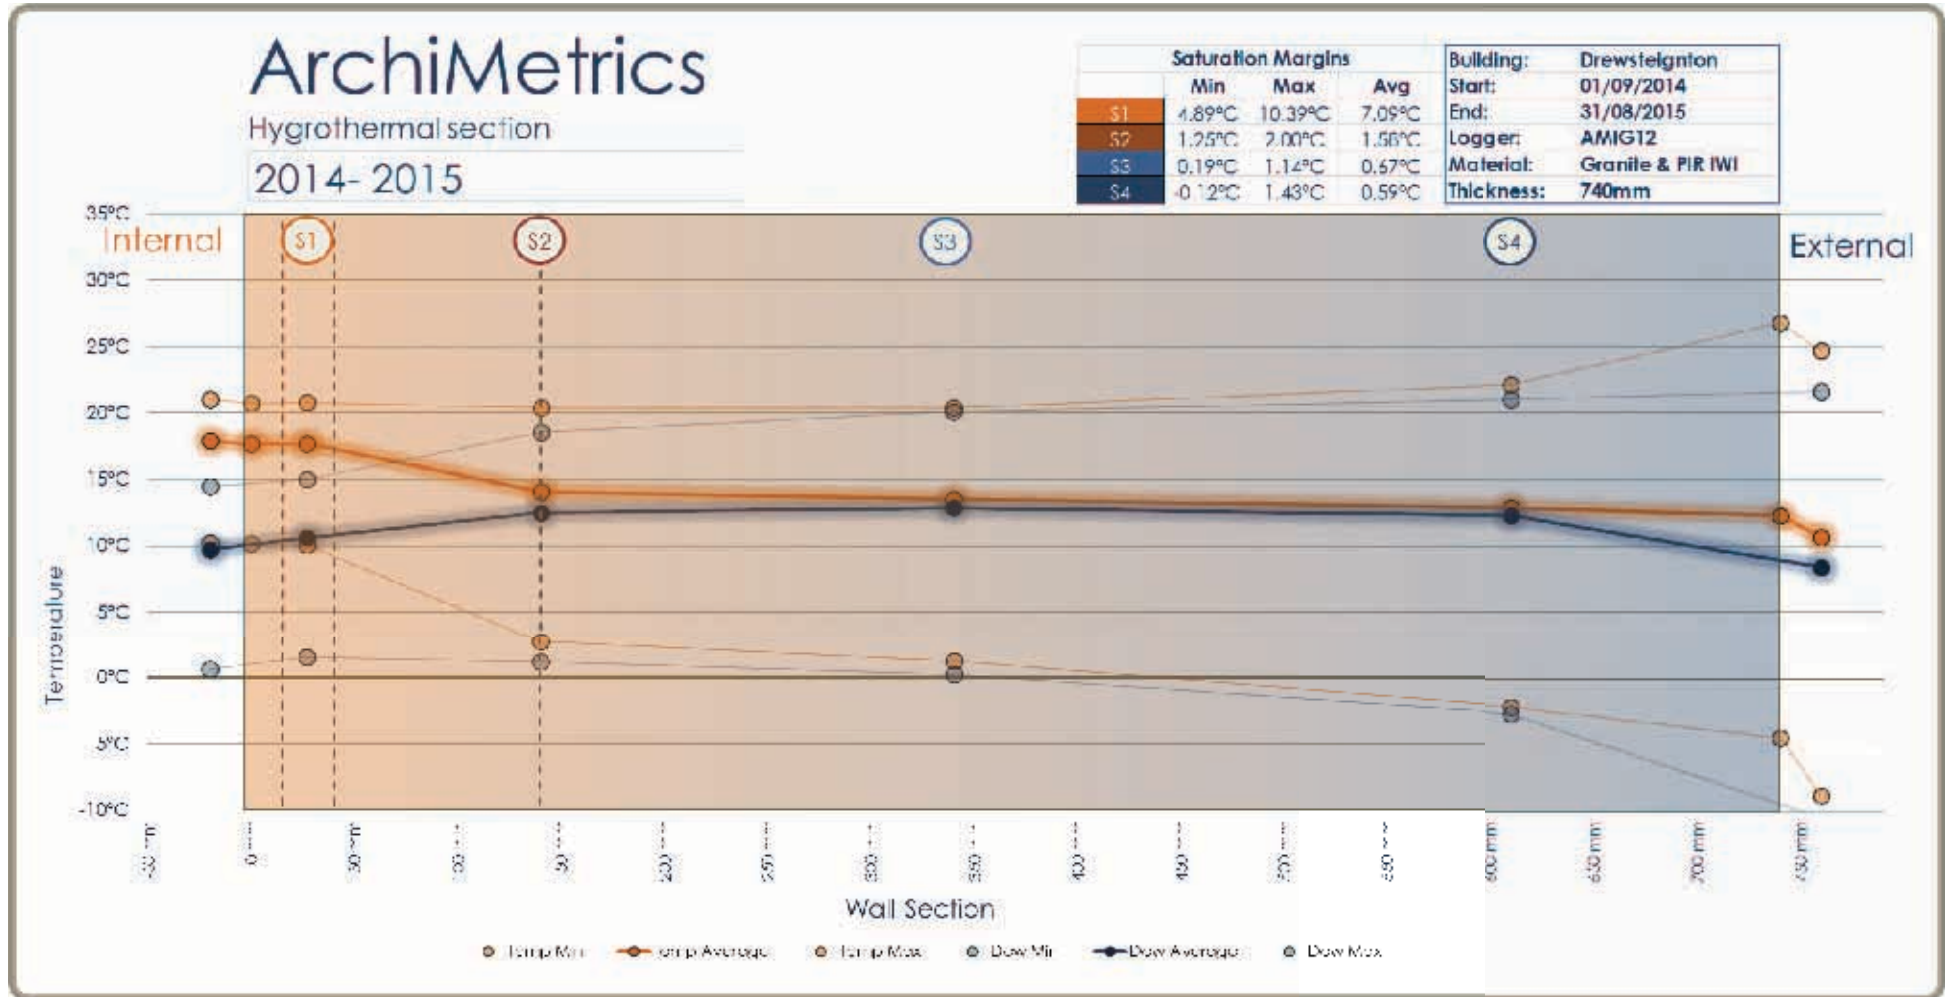
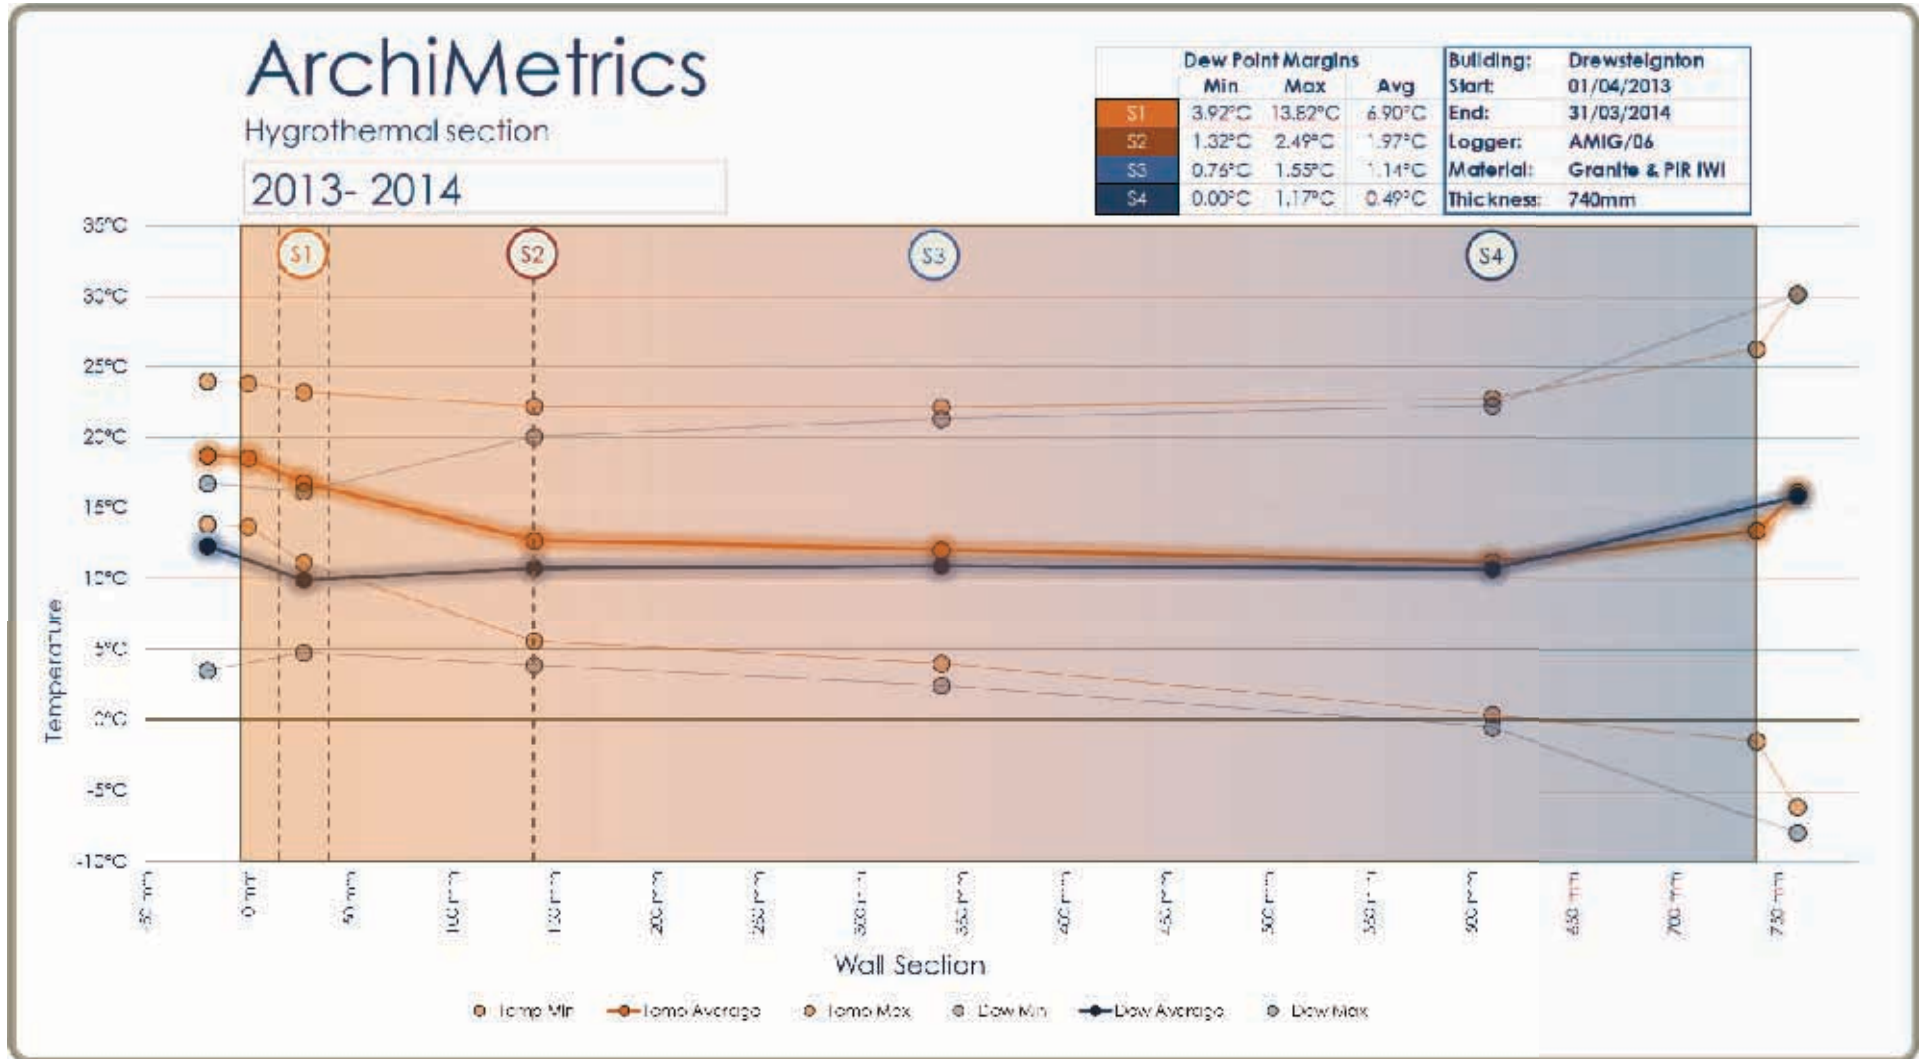
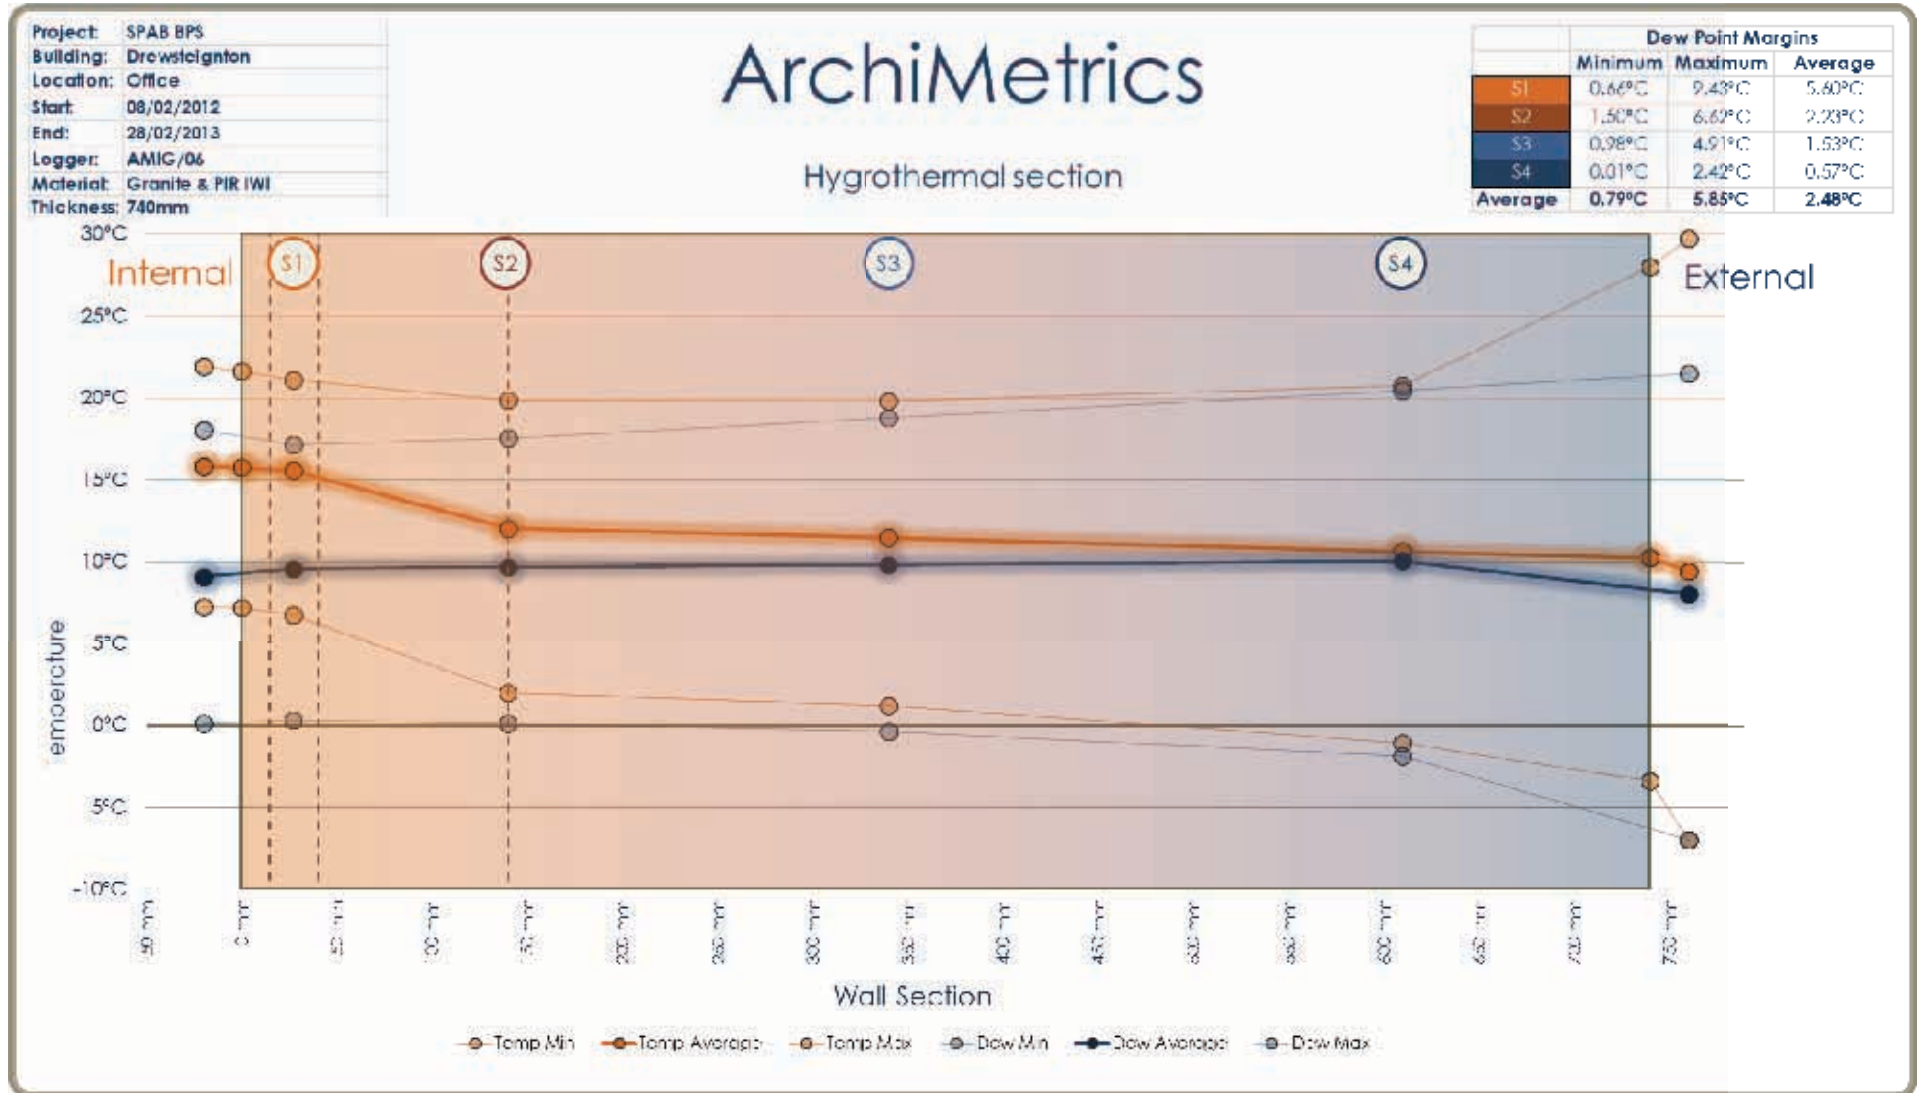
Figure 22. Hygrothermal Section, Mill House, Drewsteignton, 2014 □ 2015 (capped).

Figure 23. Hygrothermal Section, Mill House, Drewsteignton, 2013 - 2014.

Figure 24. Hygrothermal Section, Mill House, Drewsteignton, 2012 - 2013.

Measurements of temperature and %RH are also used to plot annual averages of measured temperature and dewpoint temperature through the wall section (Figures 22, 23 and 24). In these Figures the convergence of the measured temperature and dewpoint temperature gradients, shows, on average, just how close the air may be to saturation through the masonry part of the section. Comparison with previous years’ analyses (Figures 23 and 24) shows how actual temperature and dewpoint temperature have continued to become more aligned over the past year, particularly in the centre of the wall around sensor 3. As with evidence from the saturation margins, %RH and AH analysis this shows how, with regard to indications of moisture performance, we find a worsening picture for the wall at Drewsteignton.

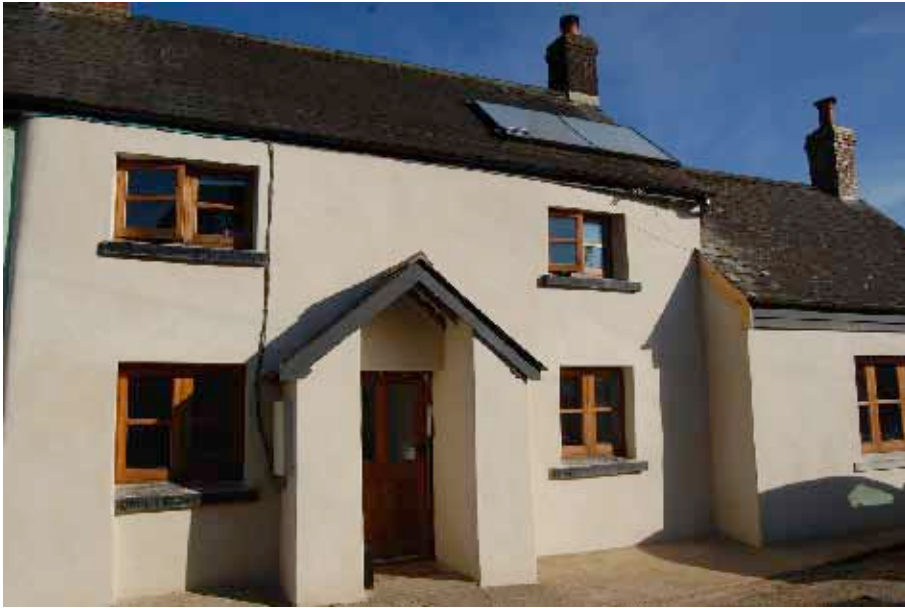
### 2.3. The Firs, Riddlecombe, Devon - 2014 - 15.

Description: Two-storey, semi-detached, nineteenth-century cob cottage with early twentieth-century single storey addition in cob to east side and more recent extensions to rear. Mainly new timber double-glazed units.

Refurbishment: Work at The Firs, Riddlecombe included the removal of external cement render, walls were repaired and re-rendered with a perlite-based insulating lime render. Internally gypsum plasters have largely been replaced with lime and limewash finishes. Floors in the older part of the house have been insulated. Particular attention has been paid to air tightness detailing through the house.

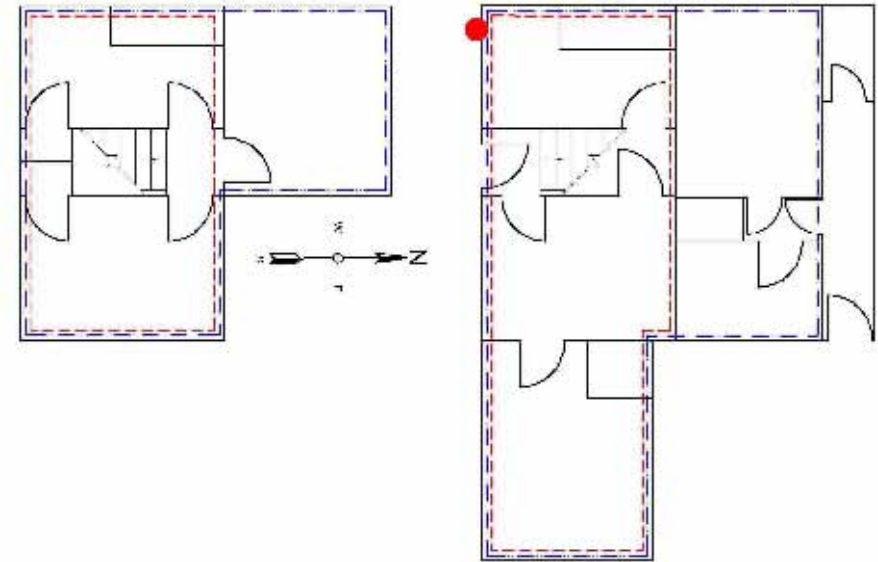
Figure 25. Plan of The Firs, Riddlecombe (ground floor on right hand side). Location of IHGM monitoring equipment shown by red dot.

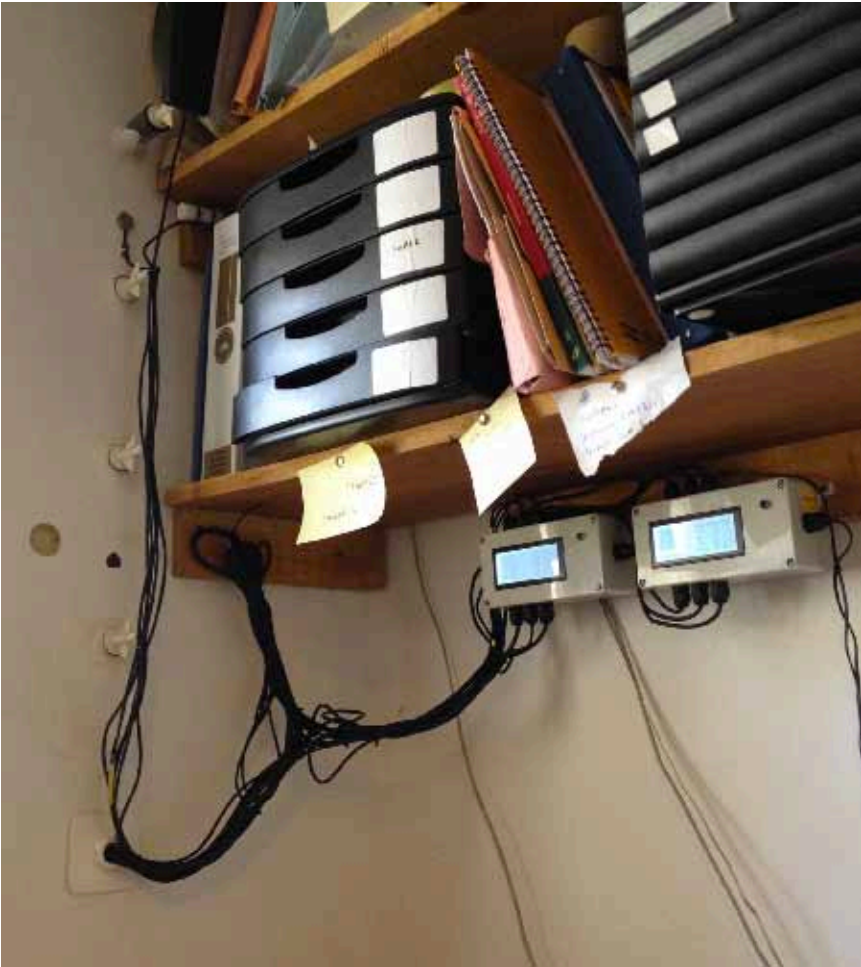
Figure 26. Interstitial Hygrothermal Gradient and Material Moisture Monitoring, Riddlecombe.

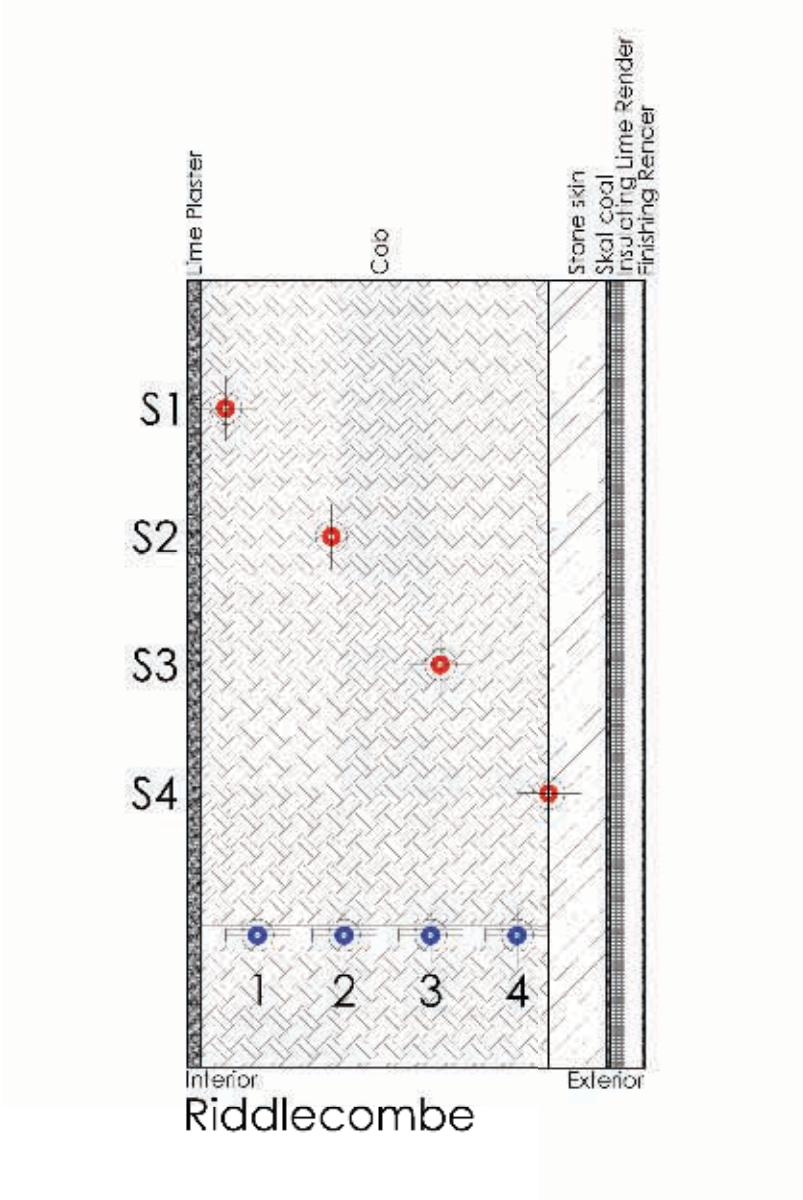
Figure 27. Position of sensors through wall section, Riddlecombe.

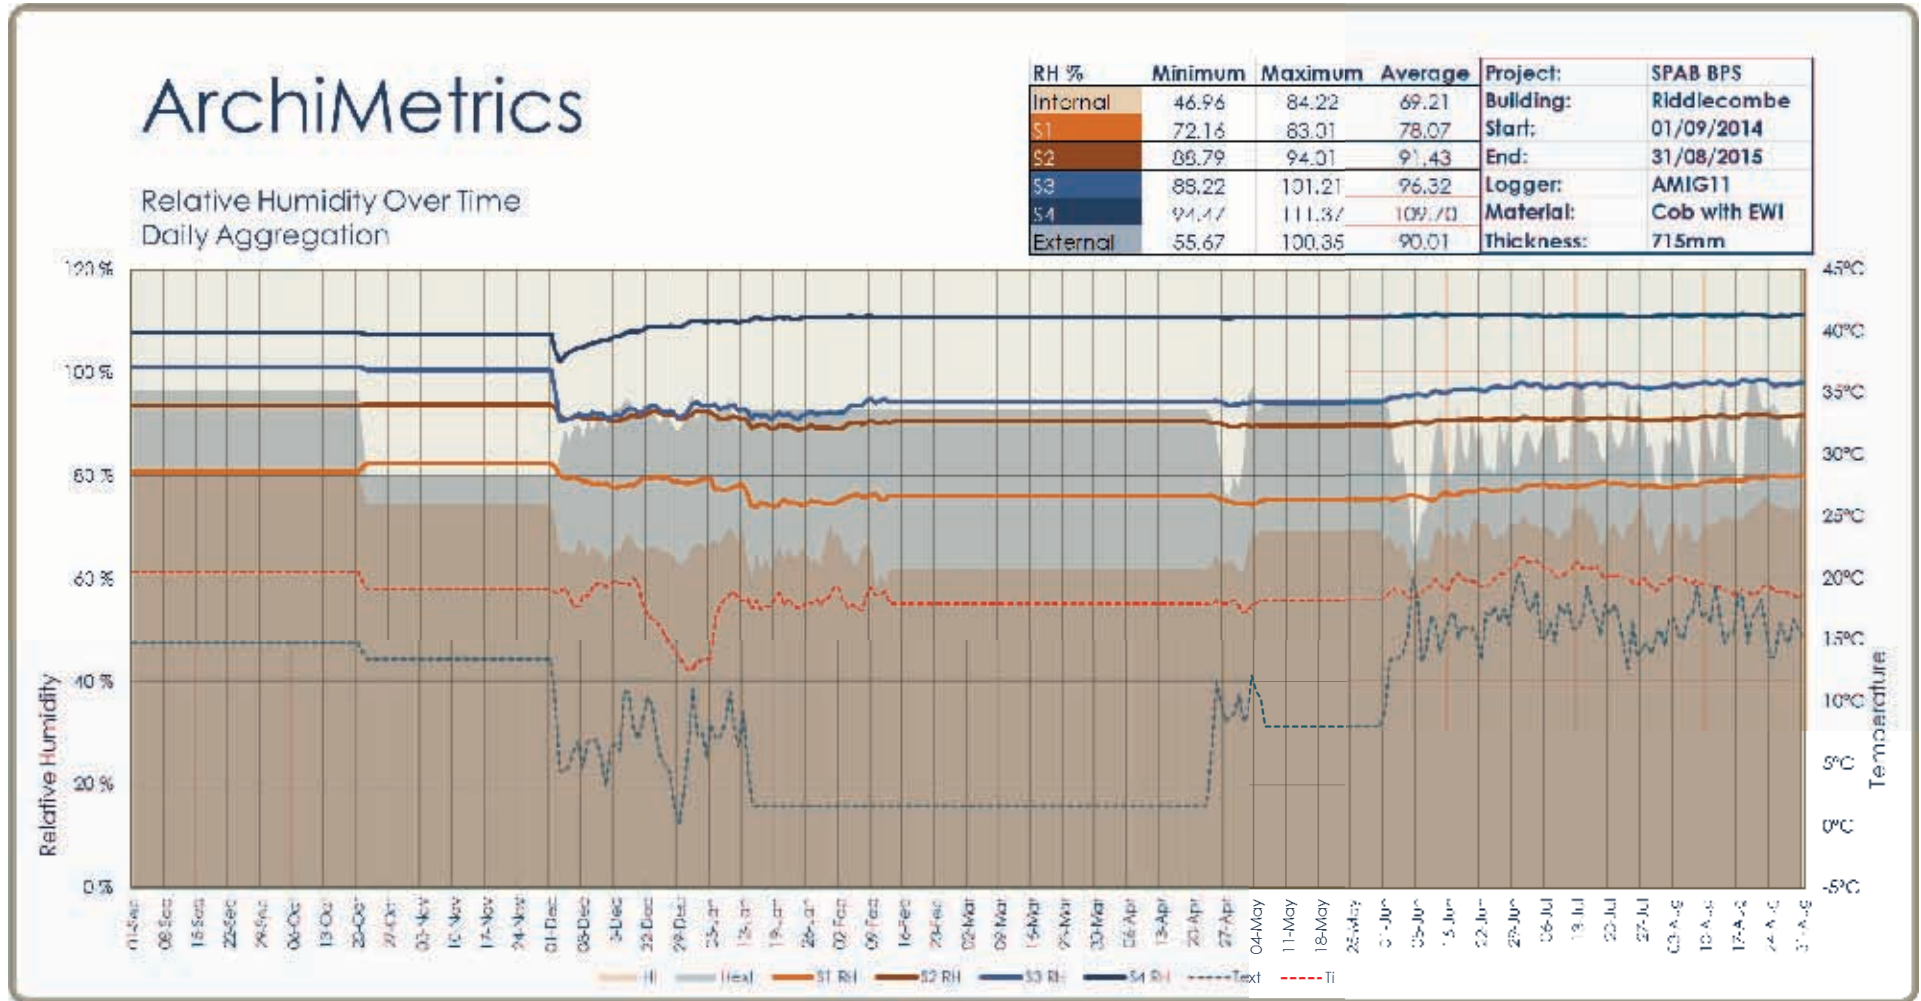
Figure 28: Relative Humidity over time, The Firs, Riddlecombe 2014 - 2015.

below 80% RH. The 3 others are all, like those of Drewsteignton, above 90%. However, unlike a granite stone, wall earth-based materials may be less tolerant of high humidity. They are also more likely to contain organic materials susceptible to rot and be less stable at high moisture content.

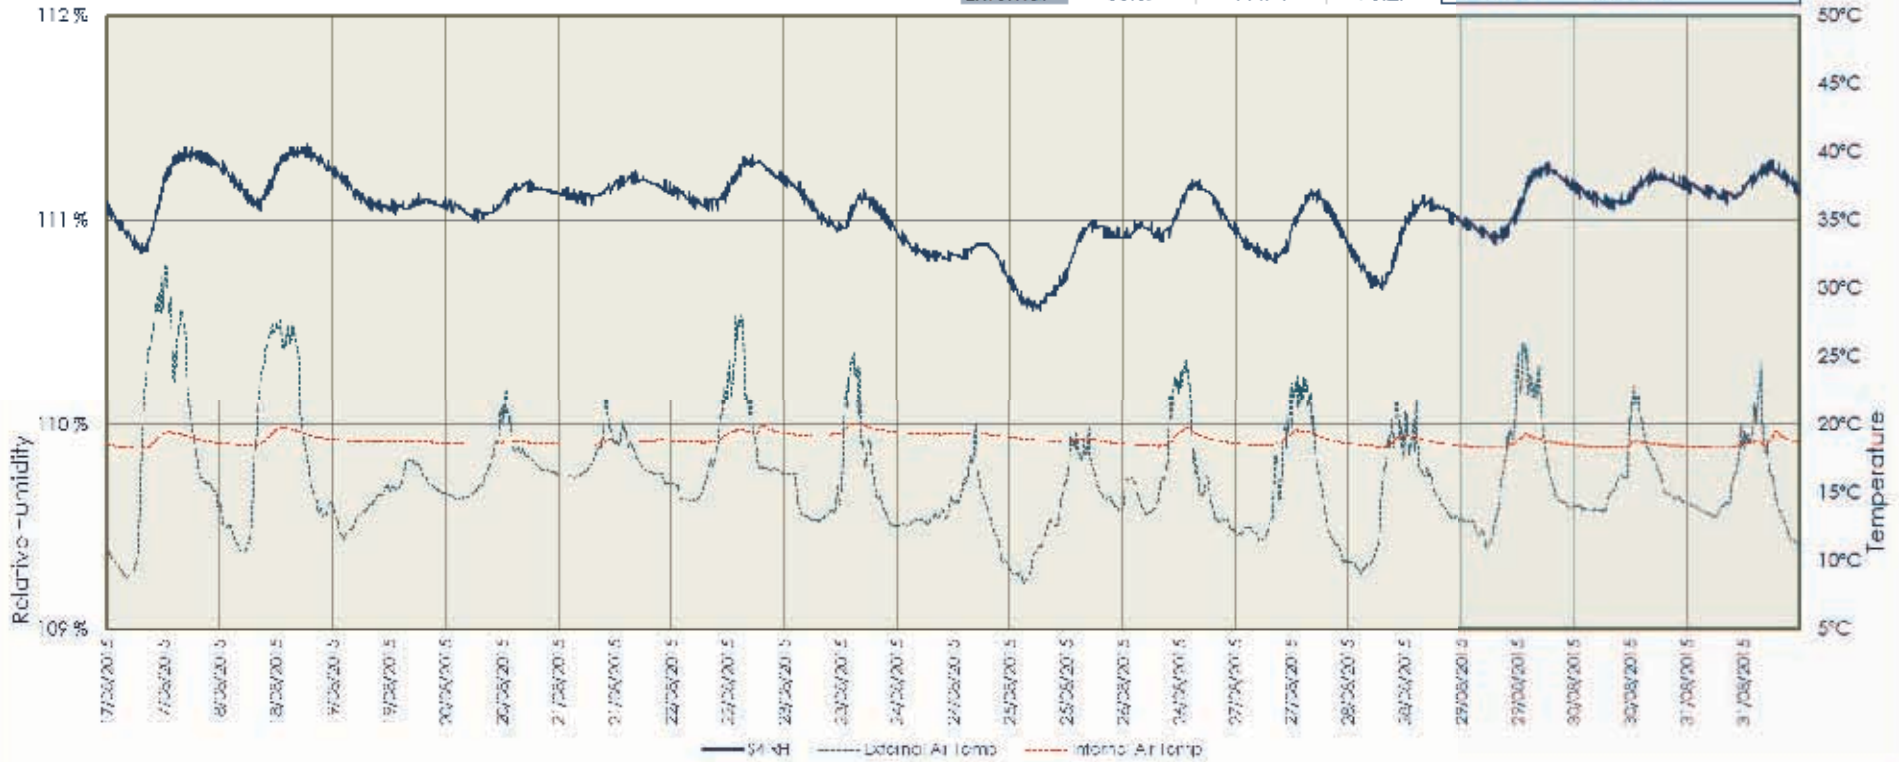
Figure 29: Relative Humidity over time, detail, The Firs, Riddlecombe August 2015.

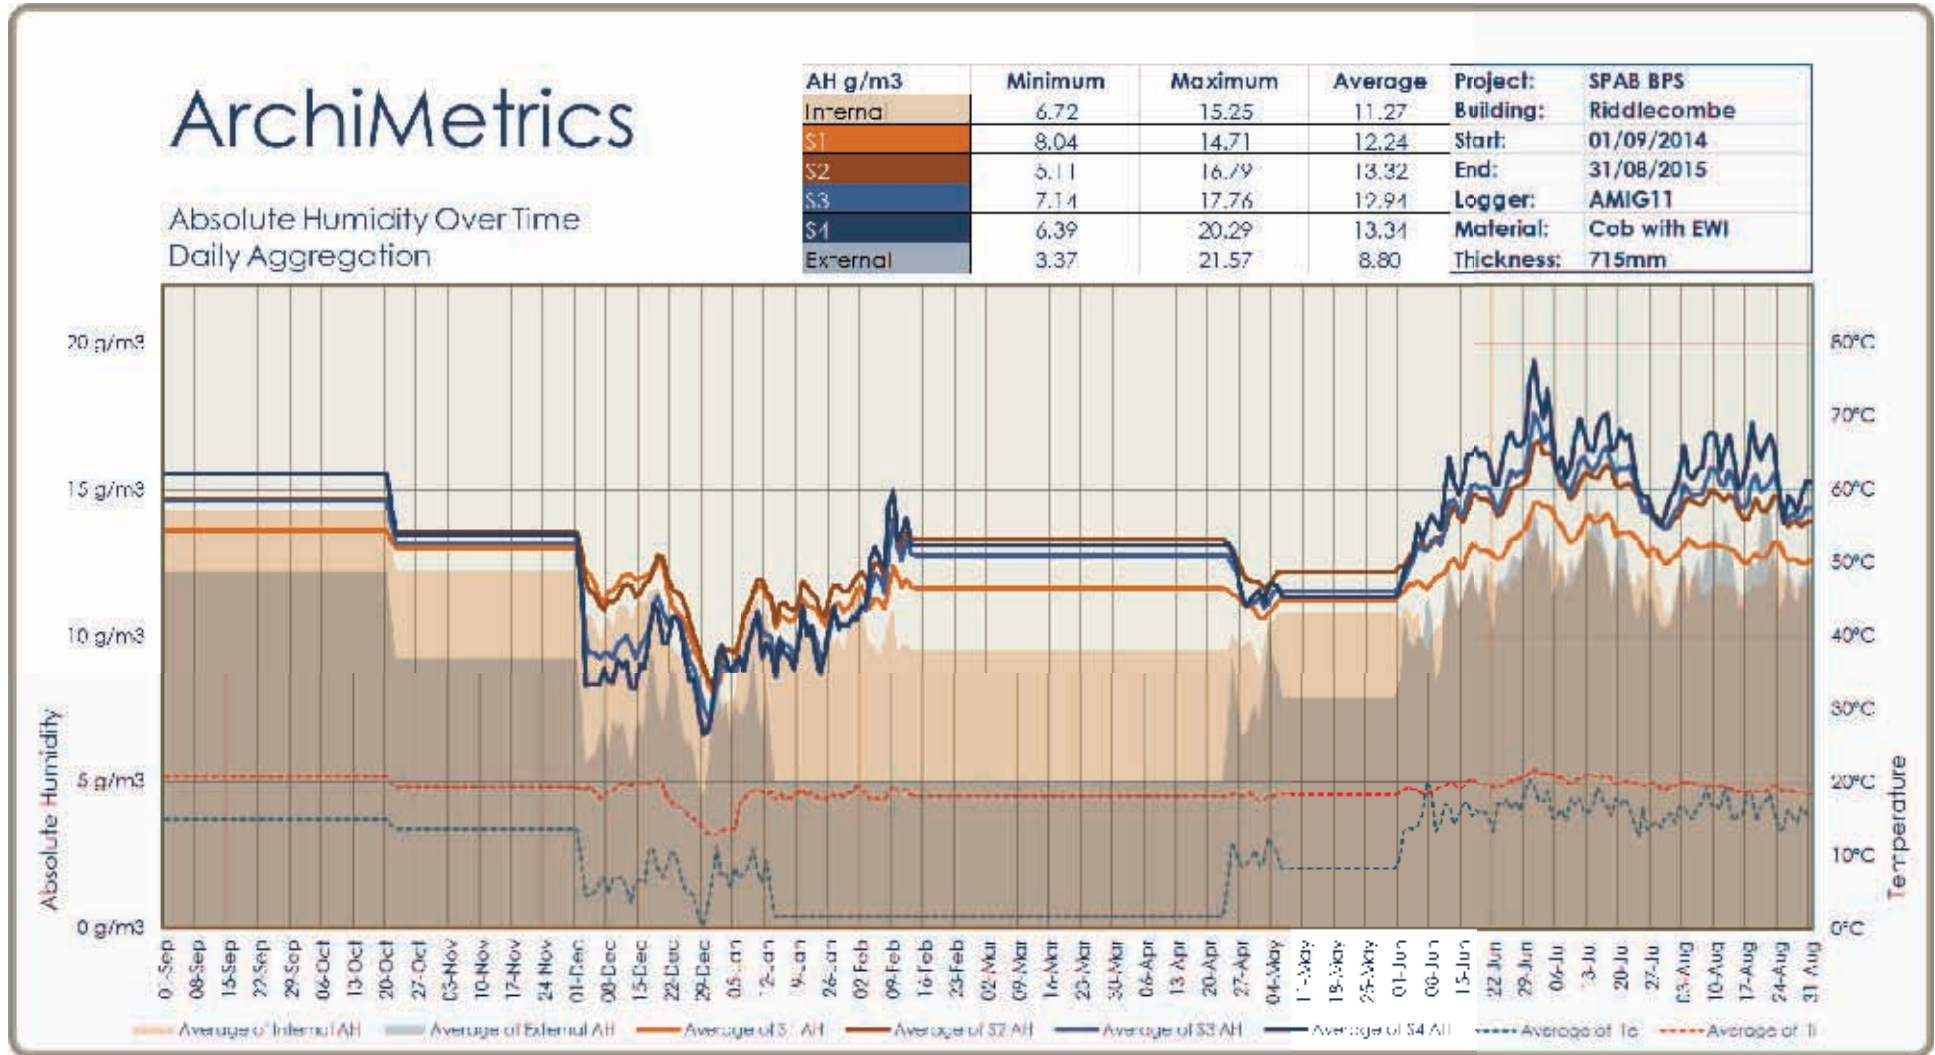
Figure 30: Absolute Humidity over time, The Firs, Riddlecombe, 2014 - 2015.

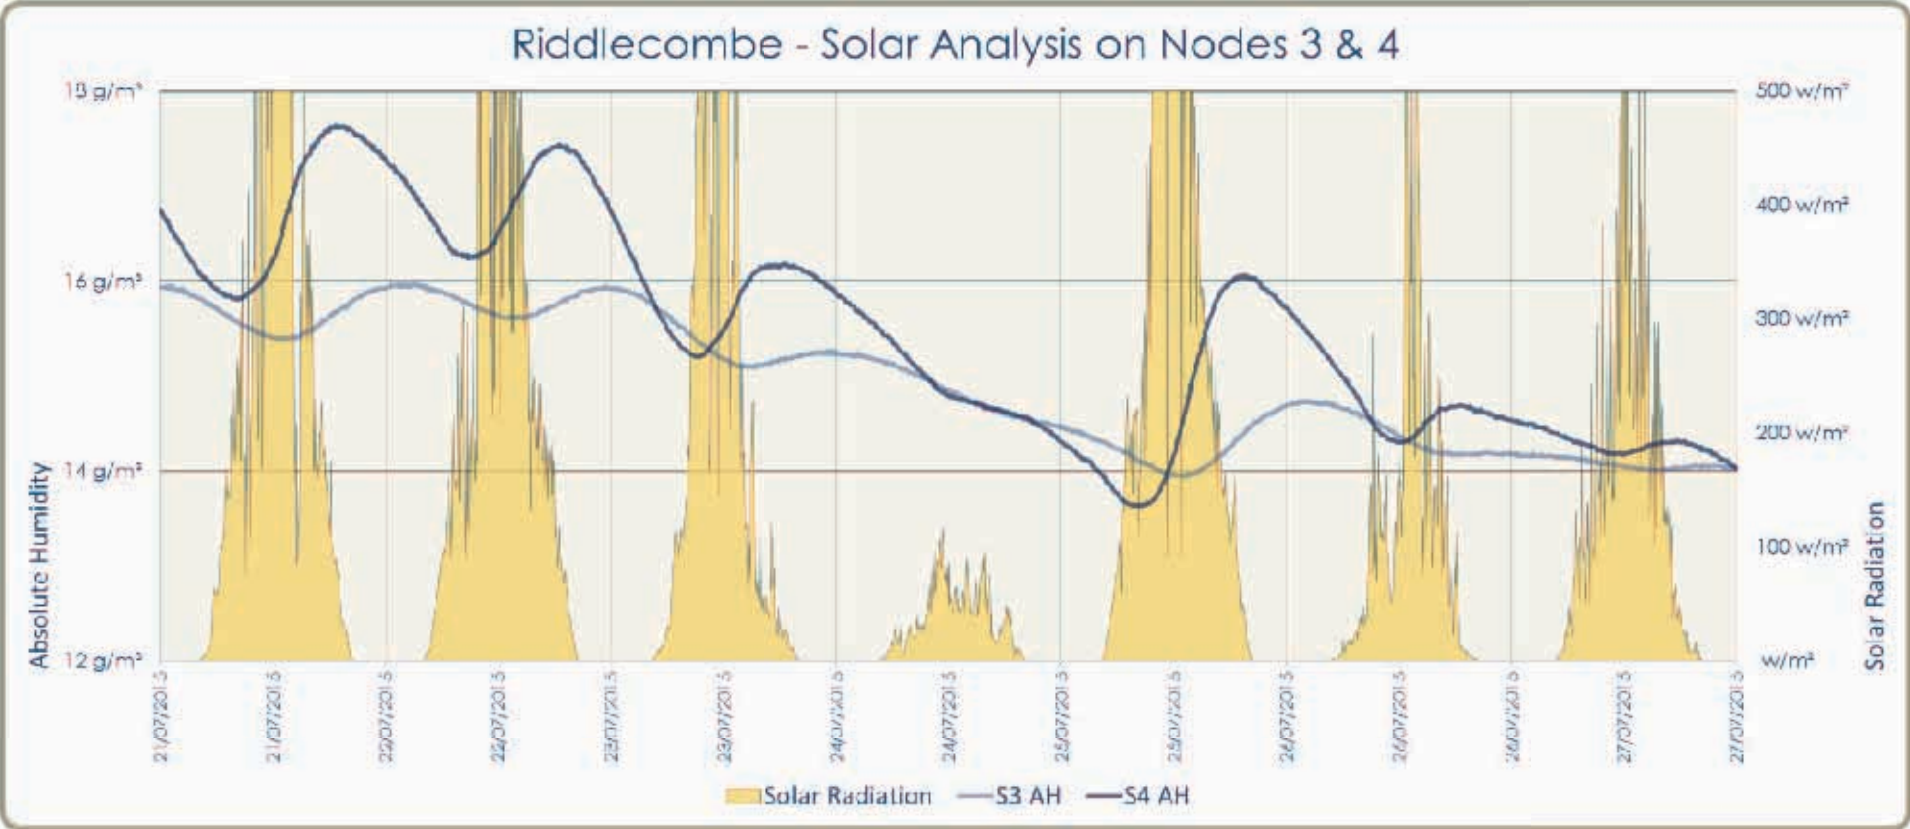
Figure 31: Solar Analysis - Absolute Humidity sensors 3 and 4 over time, Riddlecombe, July 2015.

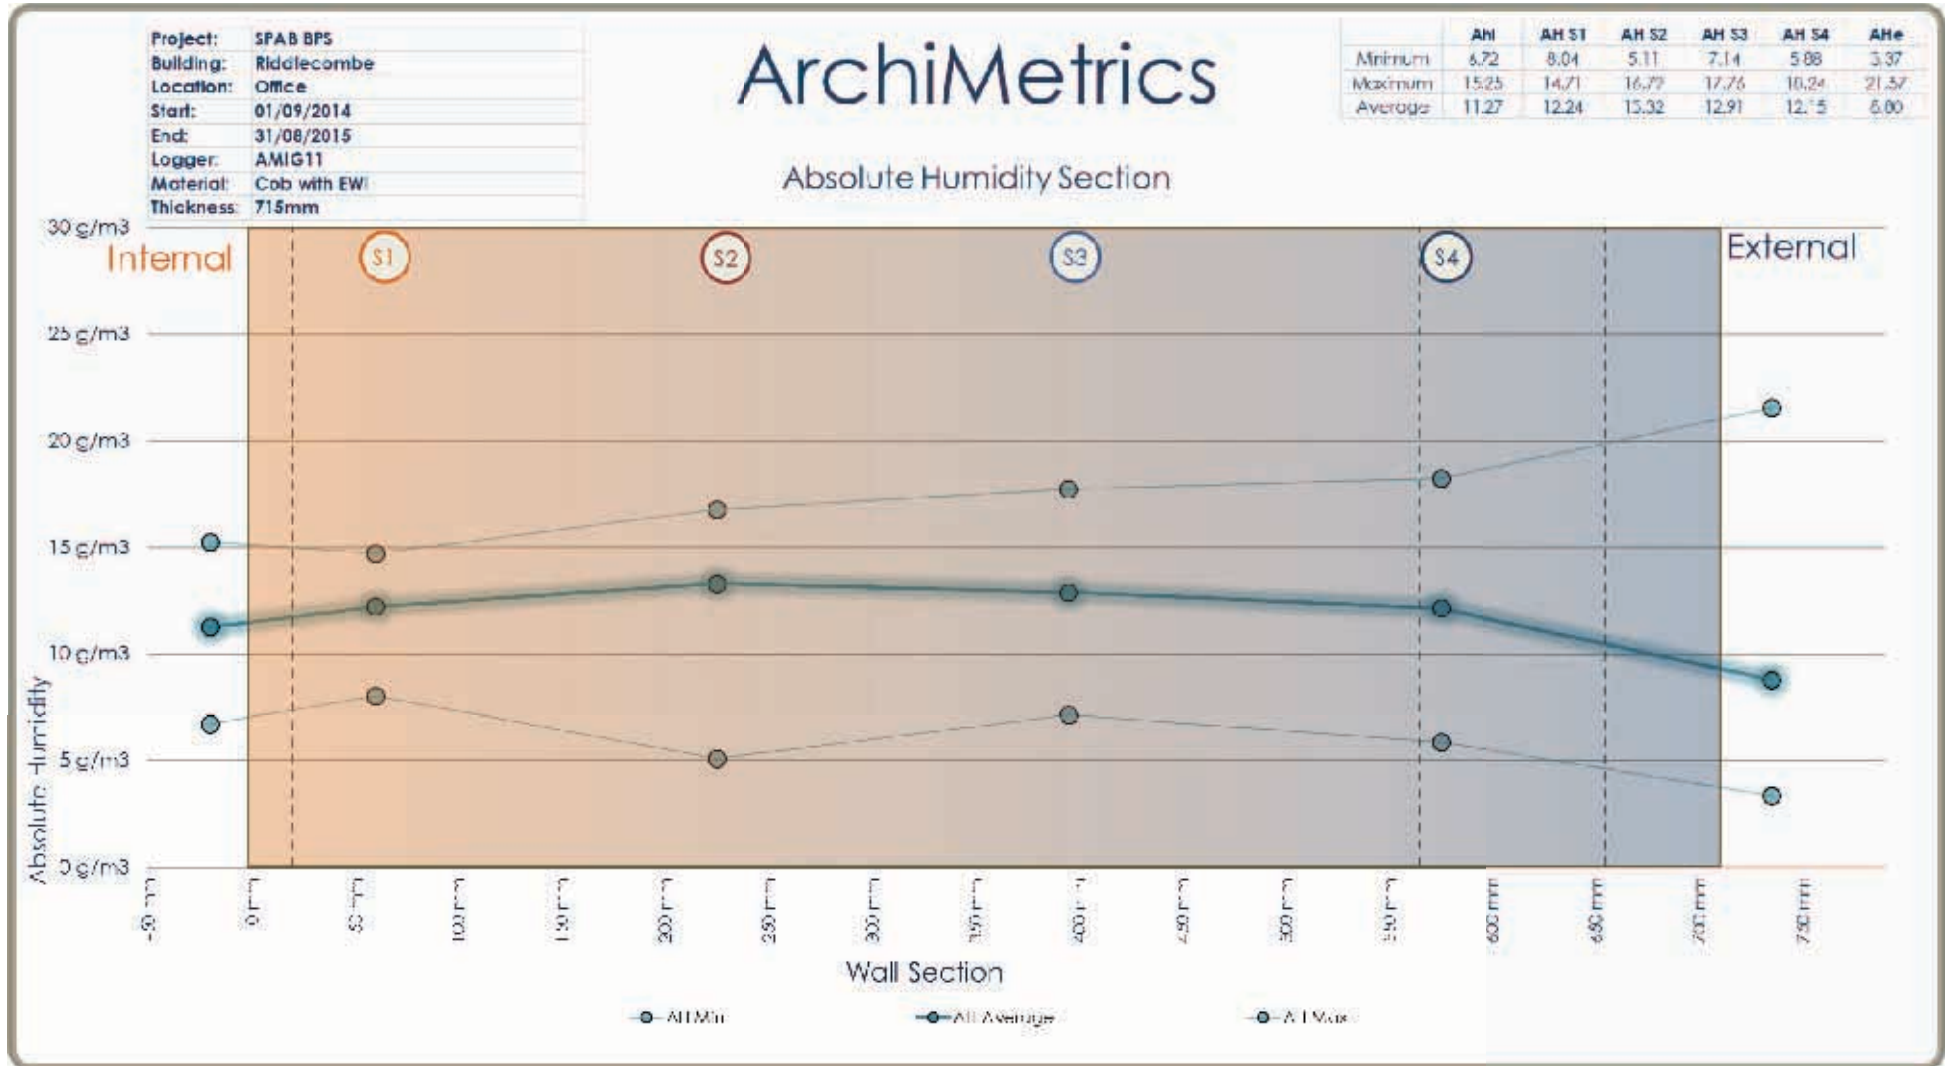
Figure 32: Absolute Humidity average section (capped). Riddlecombe, 2014 □ 2015.

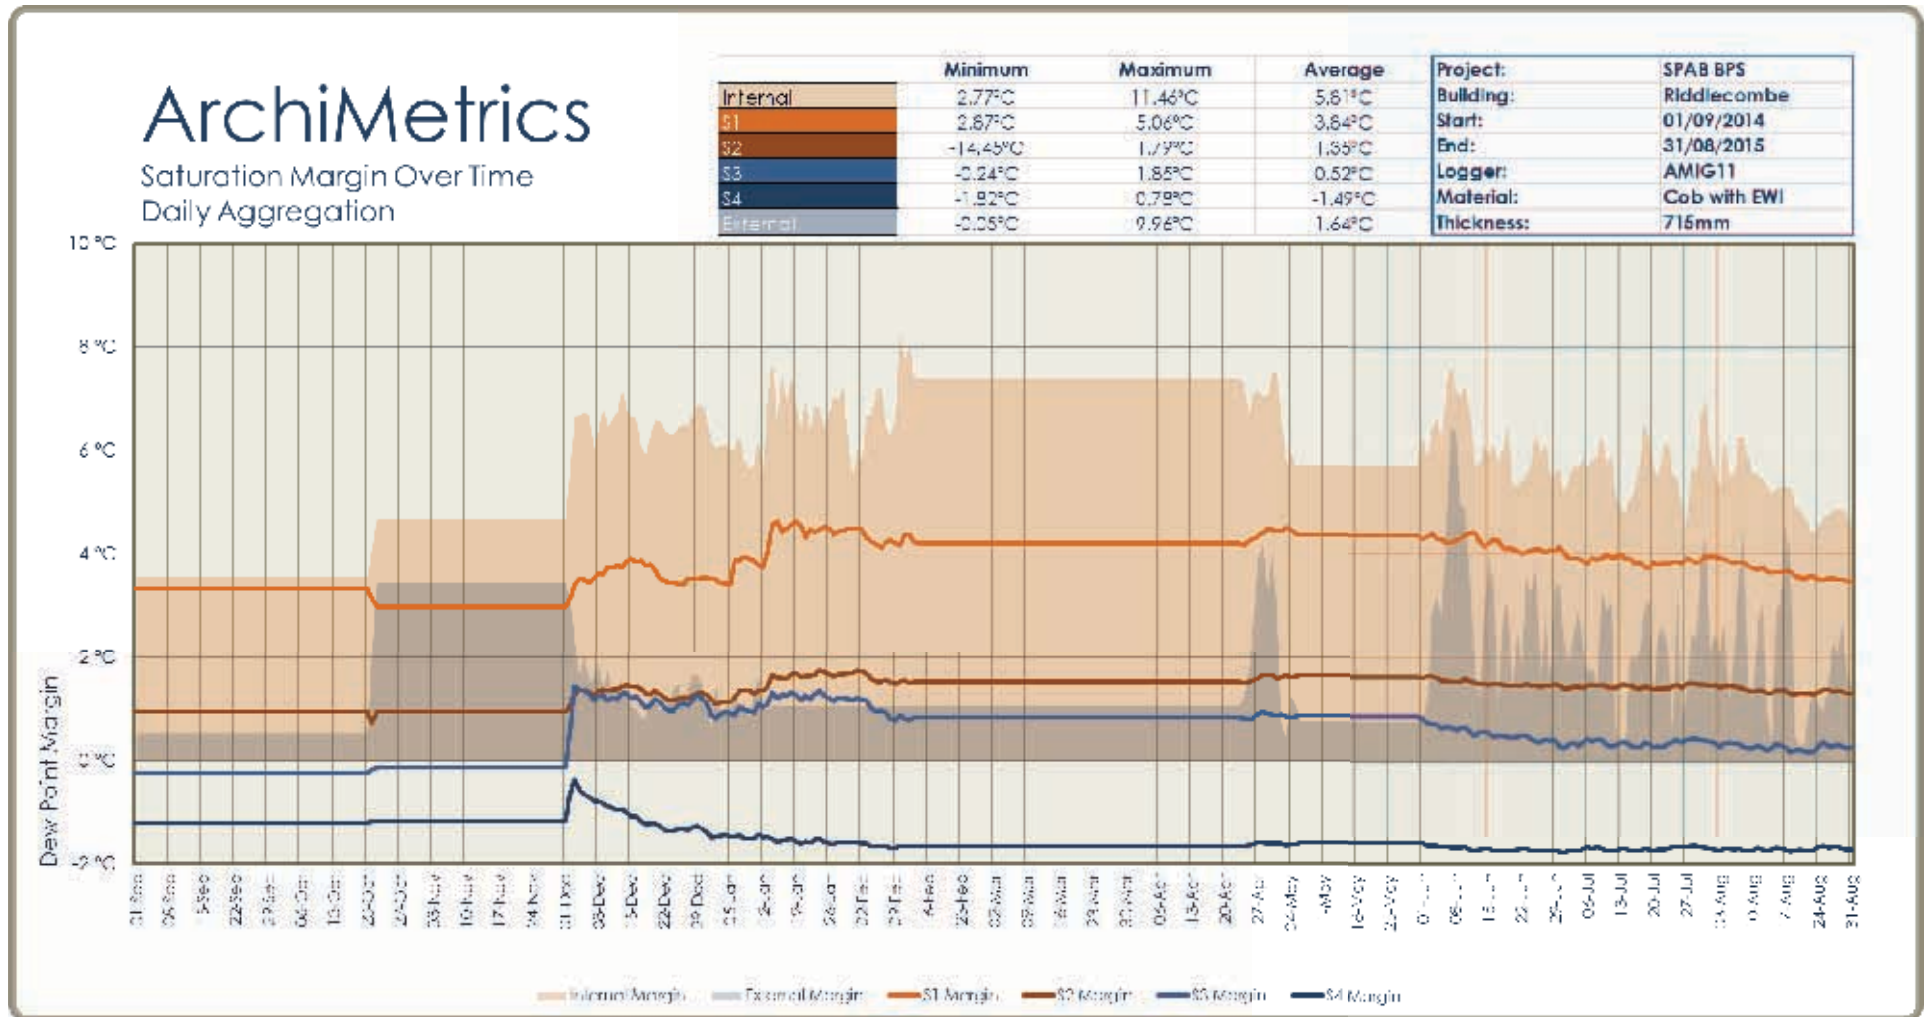
Figure 33. Saturation Margin over time, The Firs, Riddlecombe, 2014 - 2015.
