# SPAB Building Performance Survey

Interim Report I  
October 2015

Research conducted on behalf of the SPAB by ArchiMetrics Ltd  
Supported by Historic England

## The SPAB Building Performance Survey Interim Report 2015

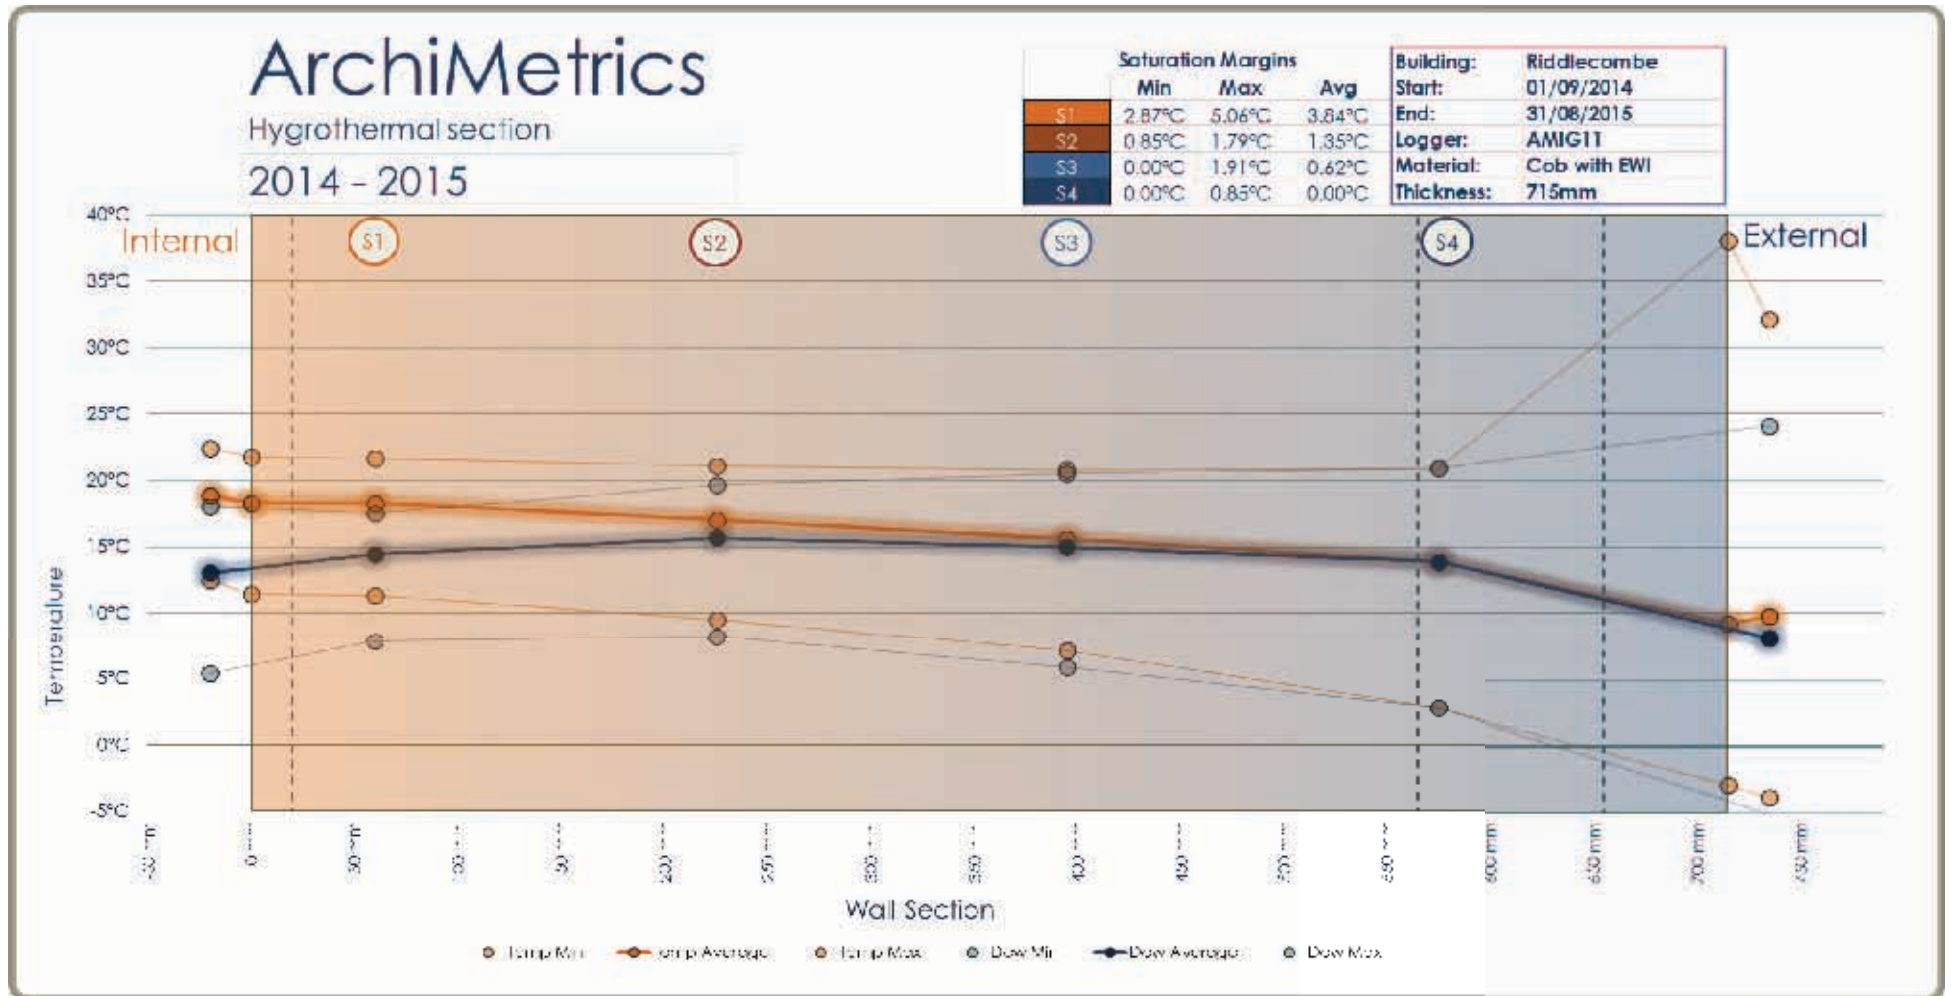
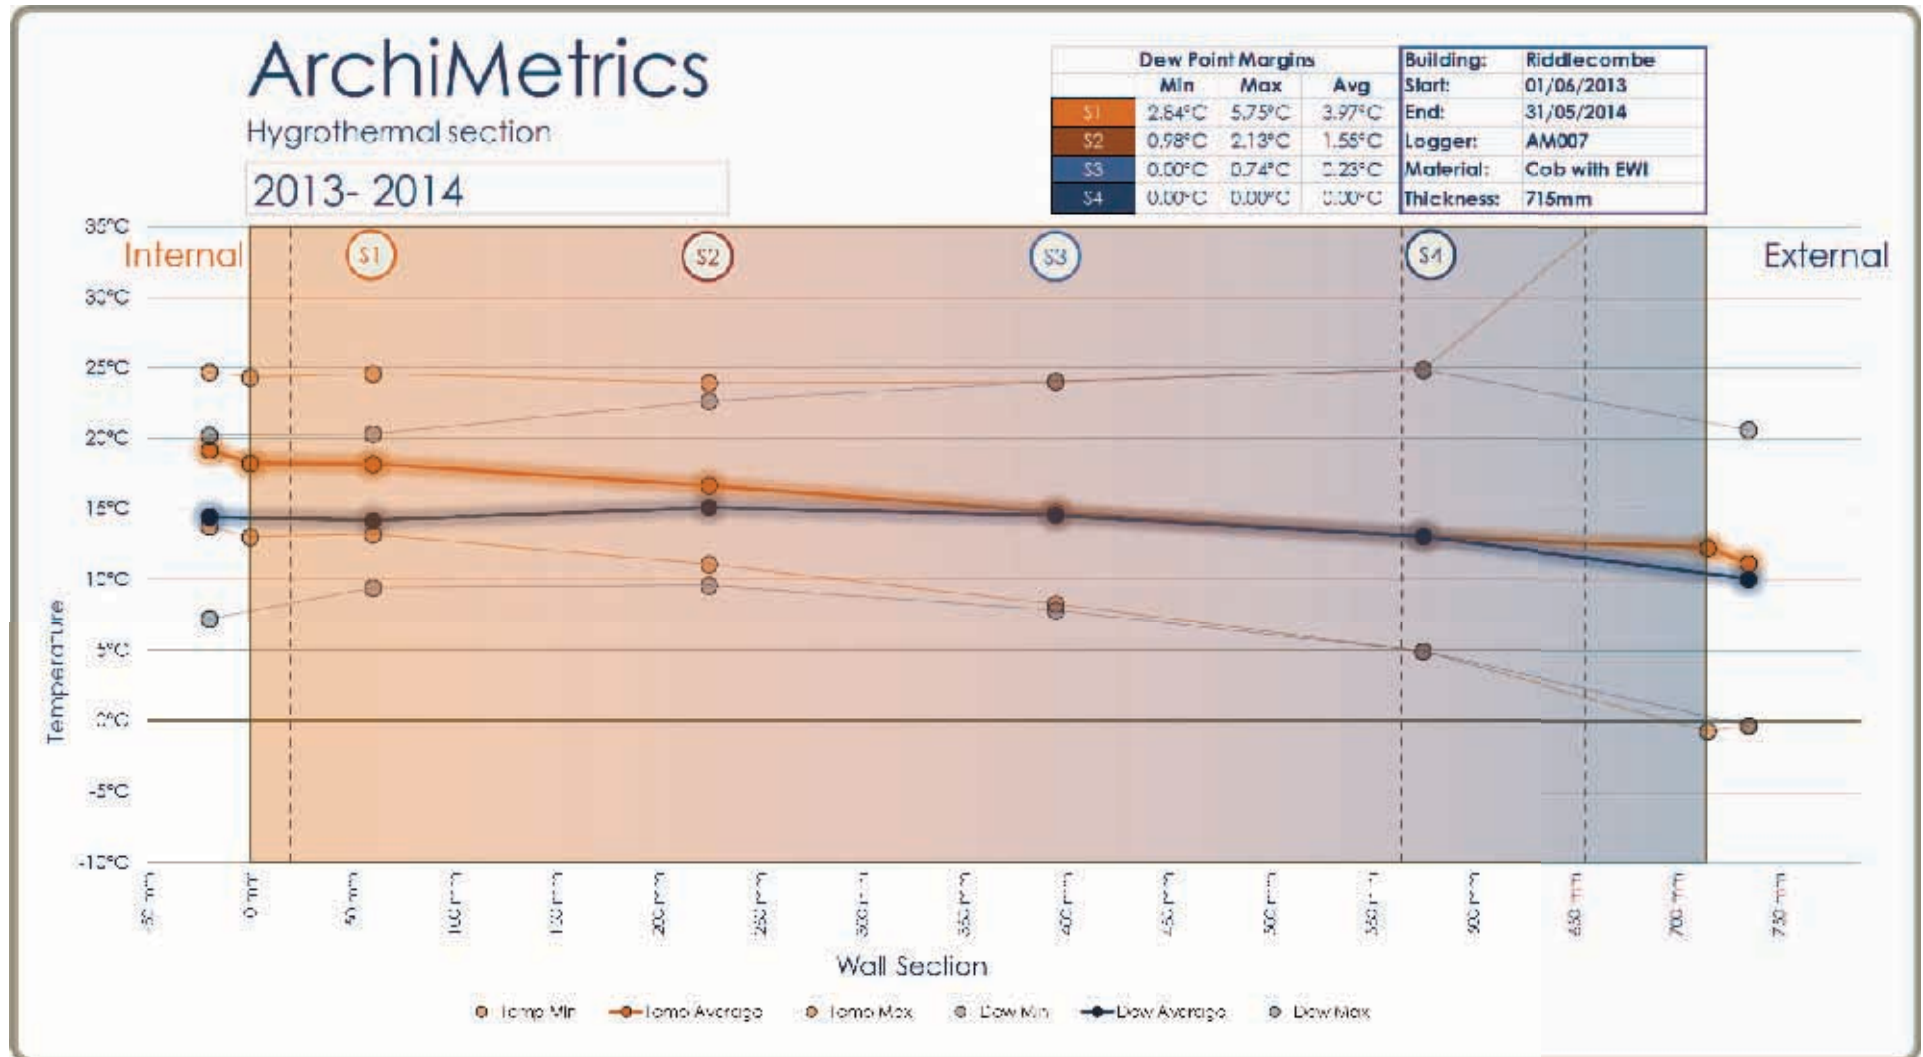
Figure 34. Hygrothermal Section, The Firs, Riddlecombe, 2014 - 2015.

Figure 35. Hygrothermal Section, The Firs, Riddlecombe, 2013 - 2014.

Measurements of temperature and RH are also used to plot annual temperature and dewpoint temperature gradients through the wall section (Figures 34 and 35). A comparison of the two monitored years shows the slight increase in the margin that occurs between the measured temperature and dewpoint in 2014 -15 at sensor 3. It also shows the increased convergence of the two gradients measured at sensor 1 and 2. This naturally corresponds with observations elsewhere of a slight reduction in %RH at sensor 3 and an increase in weights of vapour (AH) at sensor 2. That these changes have taken place over a year may indicate a very slight improvement in the vapour profile for the cob wall at Riddlecombe. However this will only be borne out by continued long-term measurements.

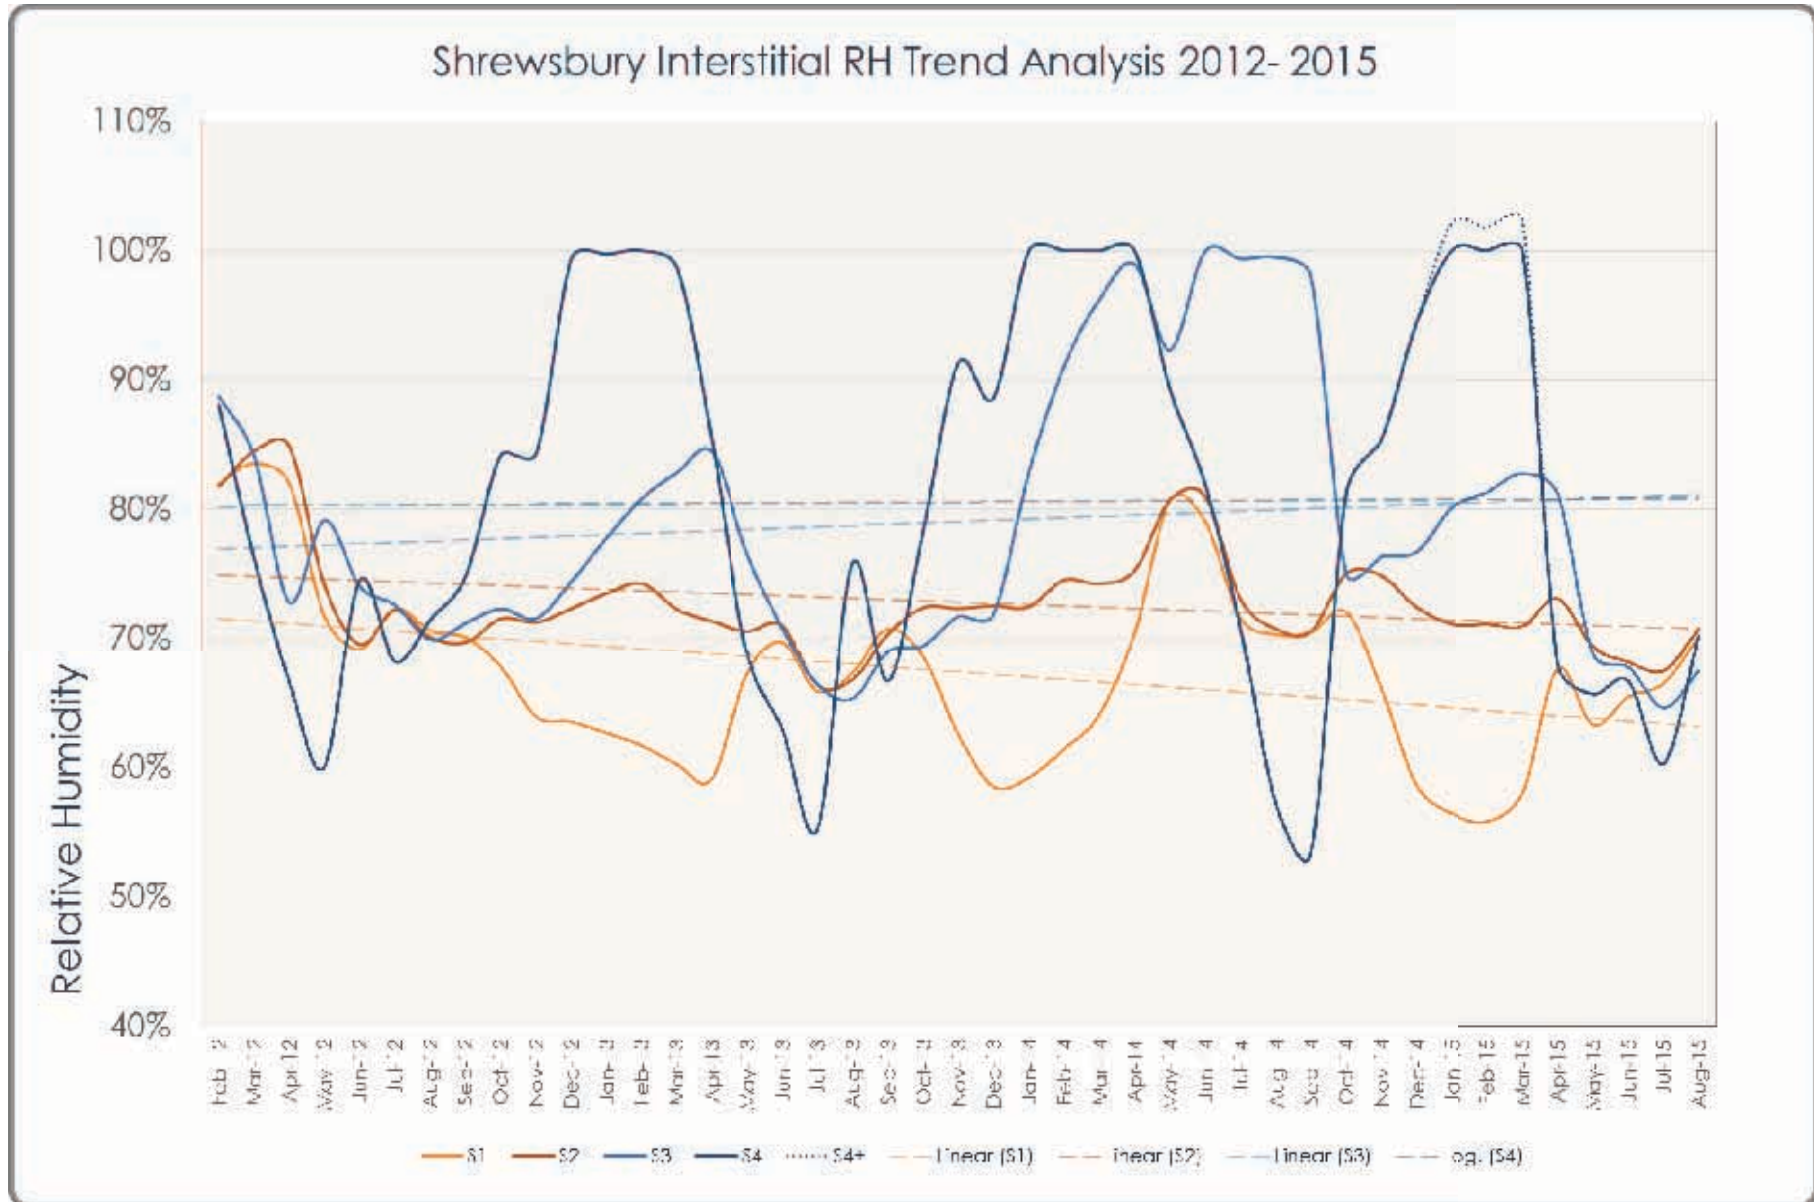
Figure 36: Relative Humidity Trends over time, Shrewsbury 2012 - 2015.

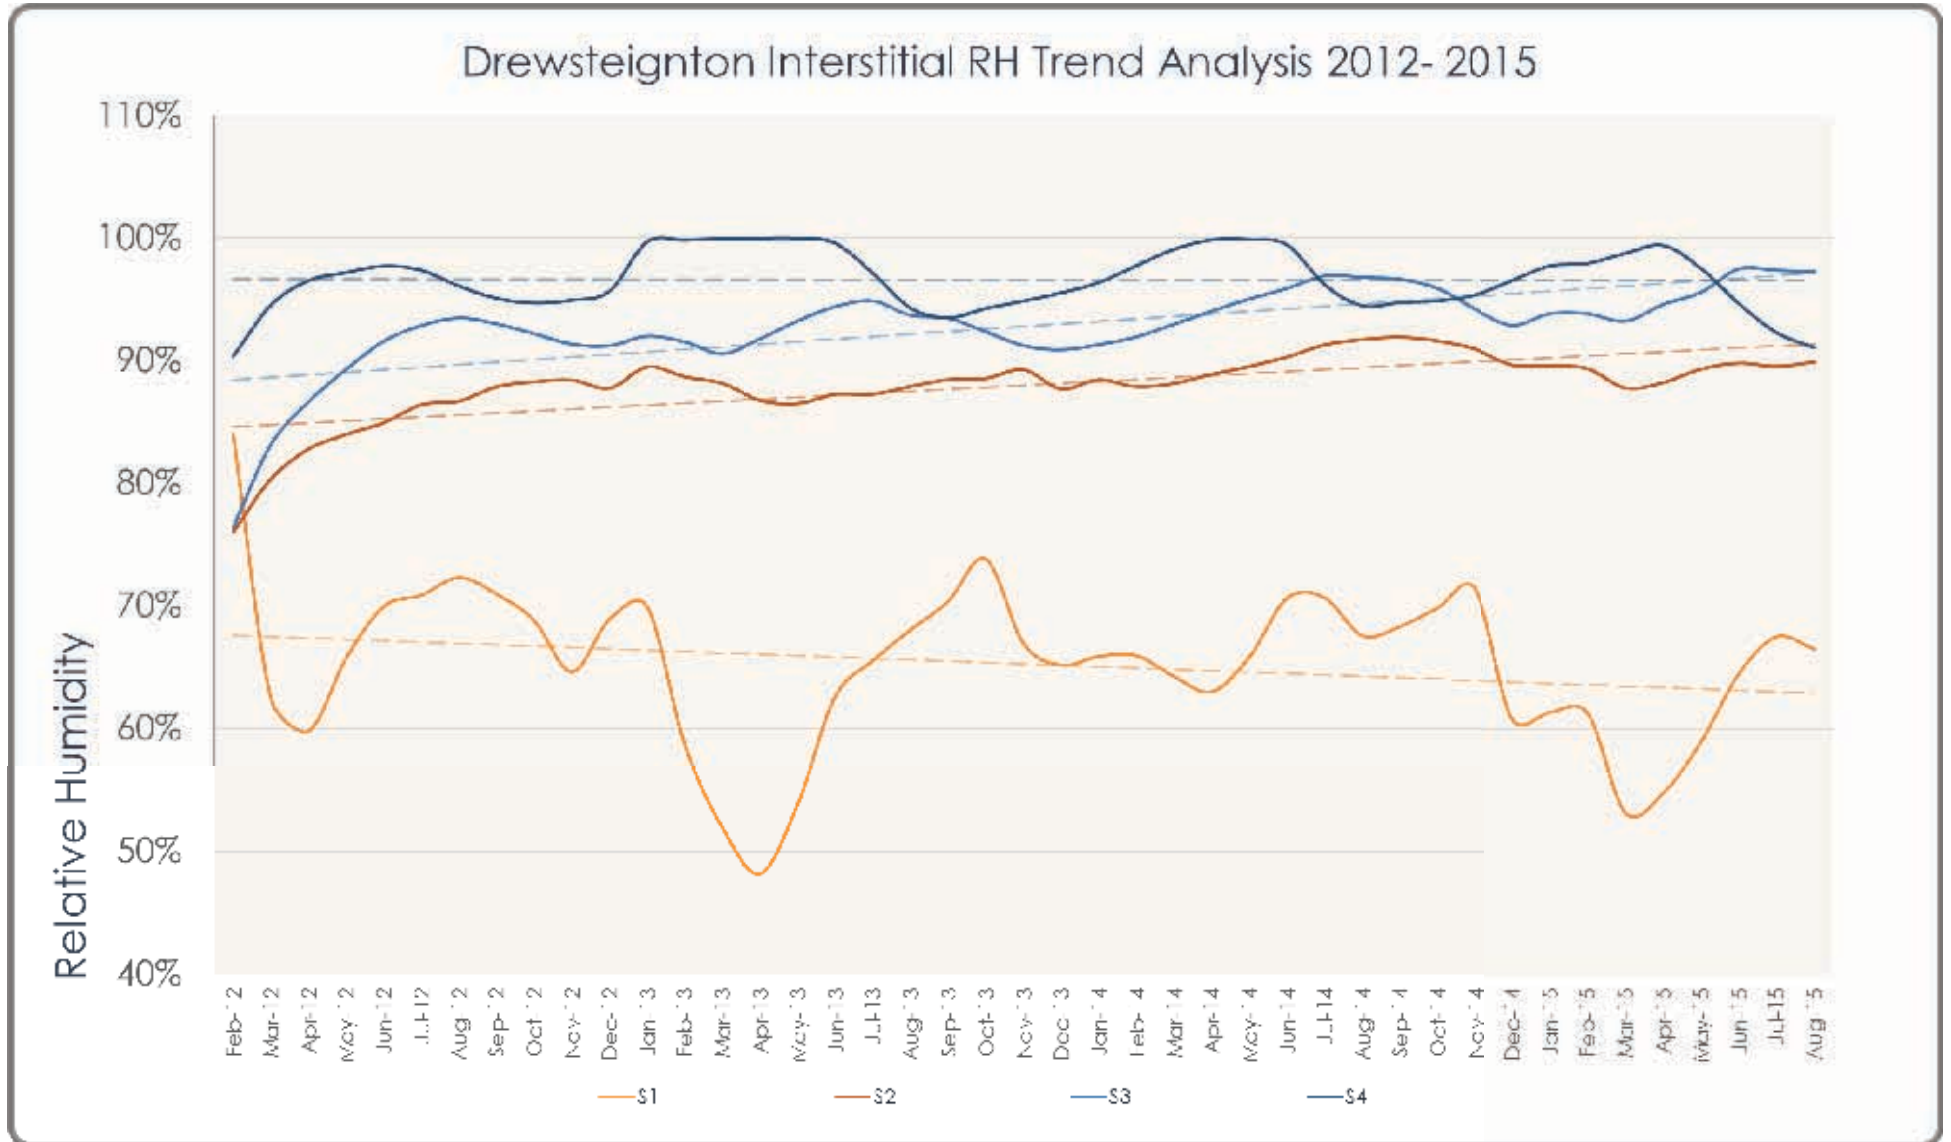
Figure 37: Relative Humidity Trends over time, Drewsteignton 2012 □ 2015.

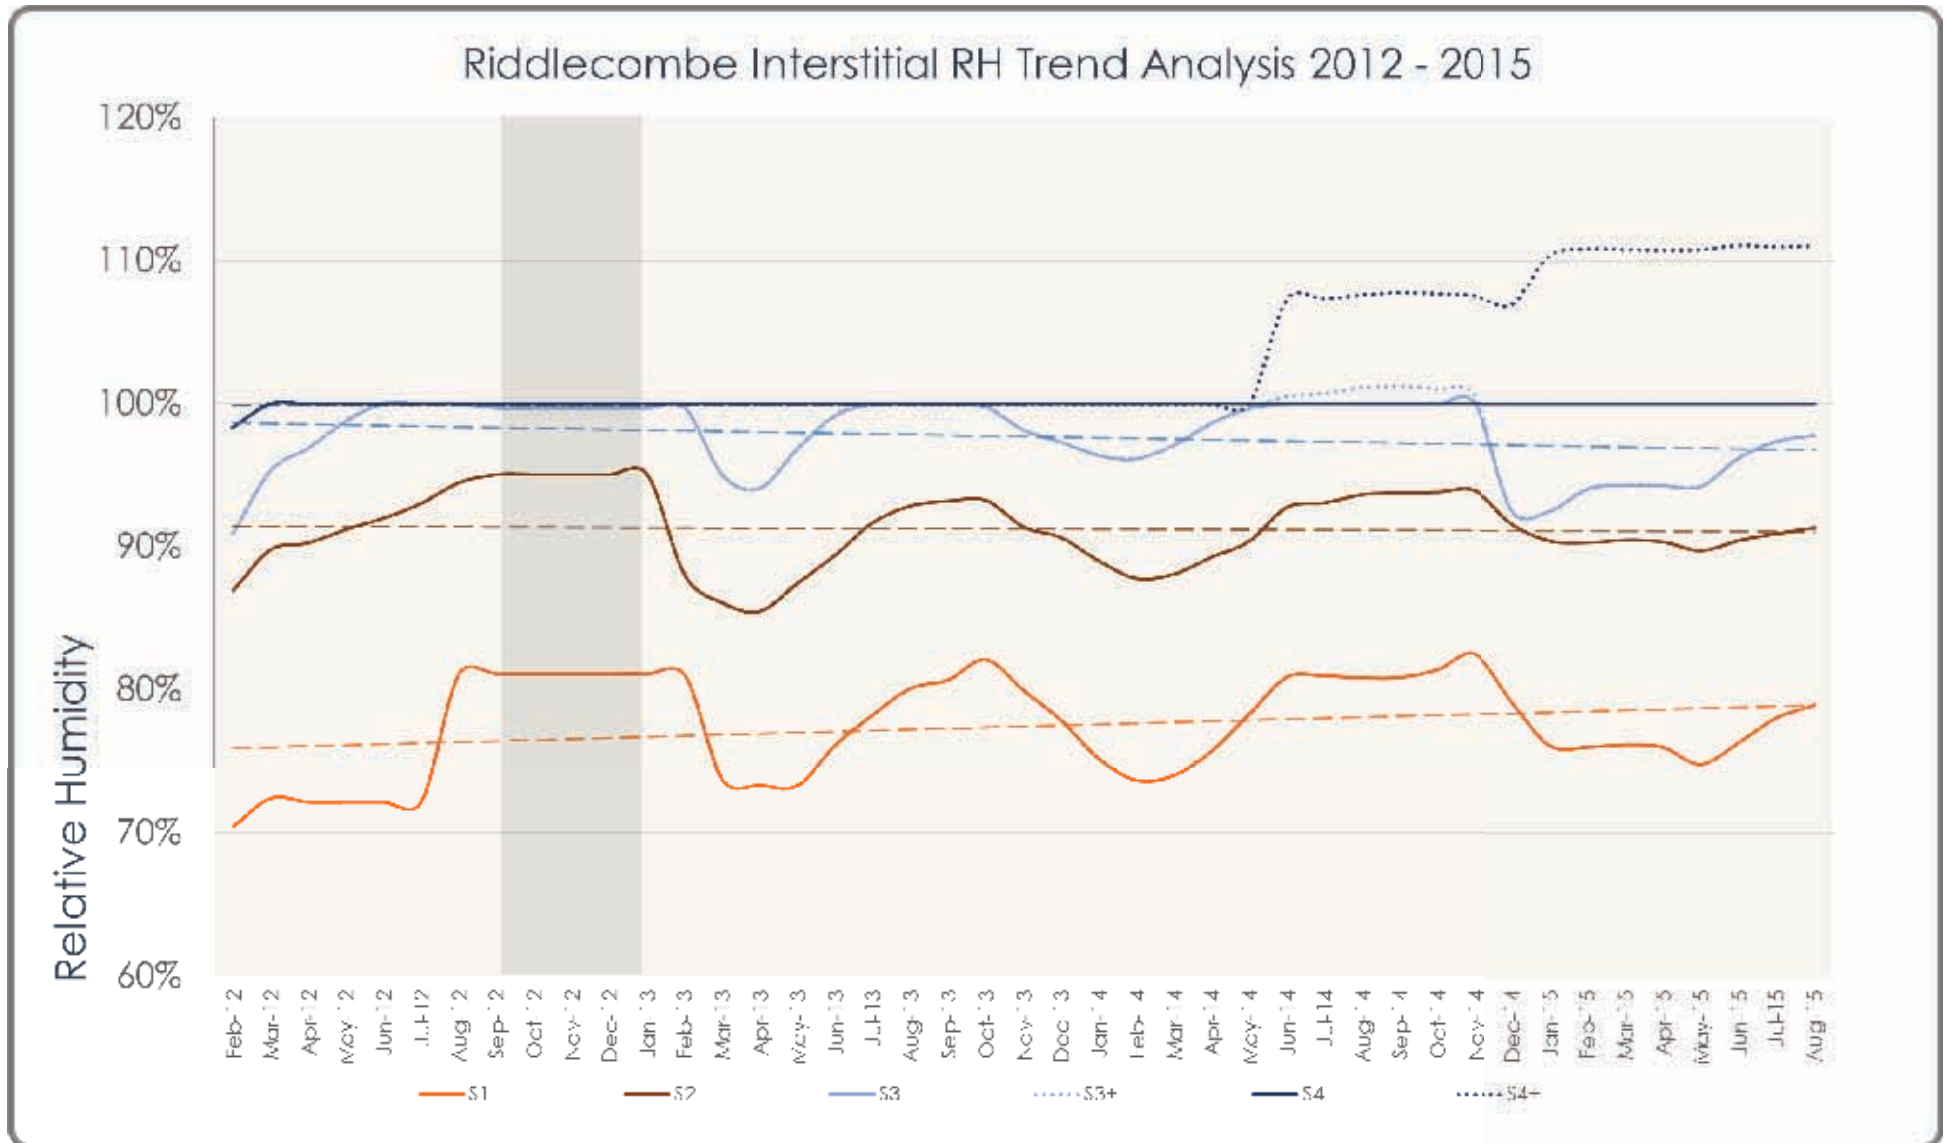
Figure 38. Relative Humidity Trends over time, Riddlecombe, 2012 - 2015.

Like Drewsteignton, the trends of %RH at Riddlecombe are high, well above the 80% threshold for mould growth, Figure 38. However, unlike Drewsteignton, the trend within the centre of the wall at Riddlecombe, at sensors 2 and 3, is one of falling RH. The trend for sensor 4, towards the external side of the wall, static at 100%, indicates perpetual saturation of the air and this persistence implies a wet substrate at this location. The high measurements of %RH at sensors 2 and 3 also suggest damp material but the decrease found over time here may imply that this material is drying out through solar driven vaporisation, albeit slowly. The upward trend at sensor 1 may also be a response to the drying taking place deeper within the wall as vapour travels back toward the internal wall surface, the area of lower vapour concentration.

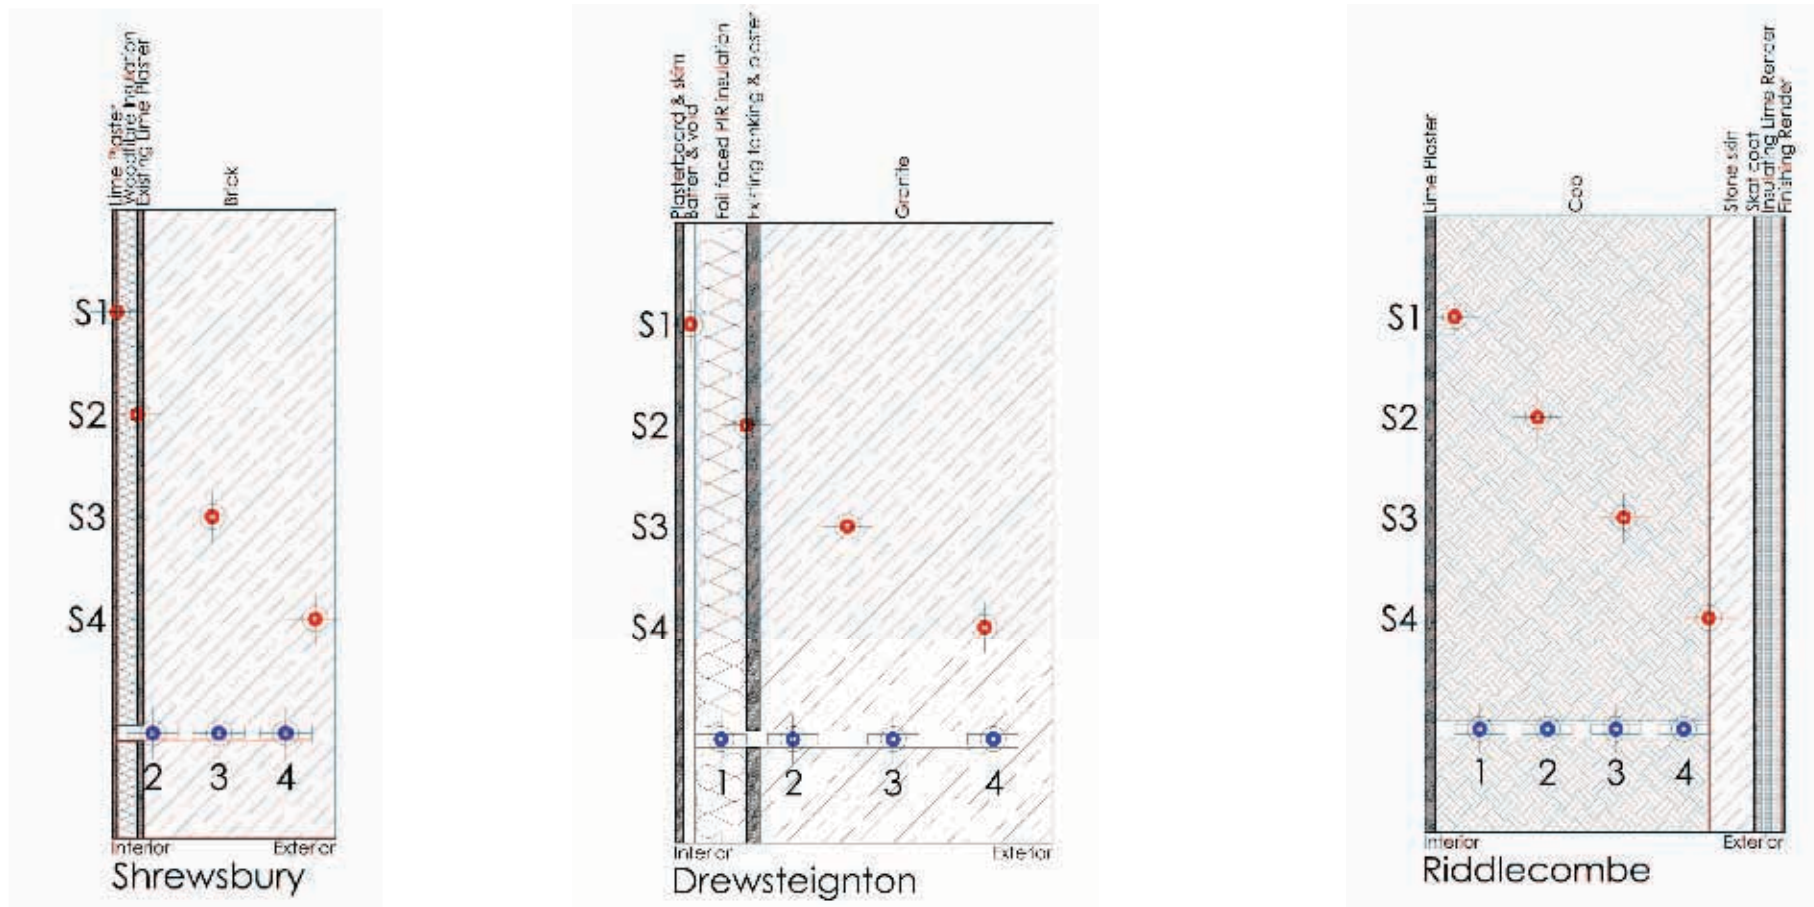
Figure 39. Wall build-ups and sensor positions; IHGM (red) and material moisture (blue).

Between May and June 2014 three ArchiMetrics material moisture sensing units were installed within the walls already under study in the SPAB Building Performance Survey. Further details concerning these units and the installation methodology are given in the introductory section of the report. Figure 39 provides details of the wall build-ups and sensor positions for each wall, blue indicating moisture sensors.

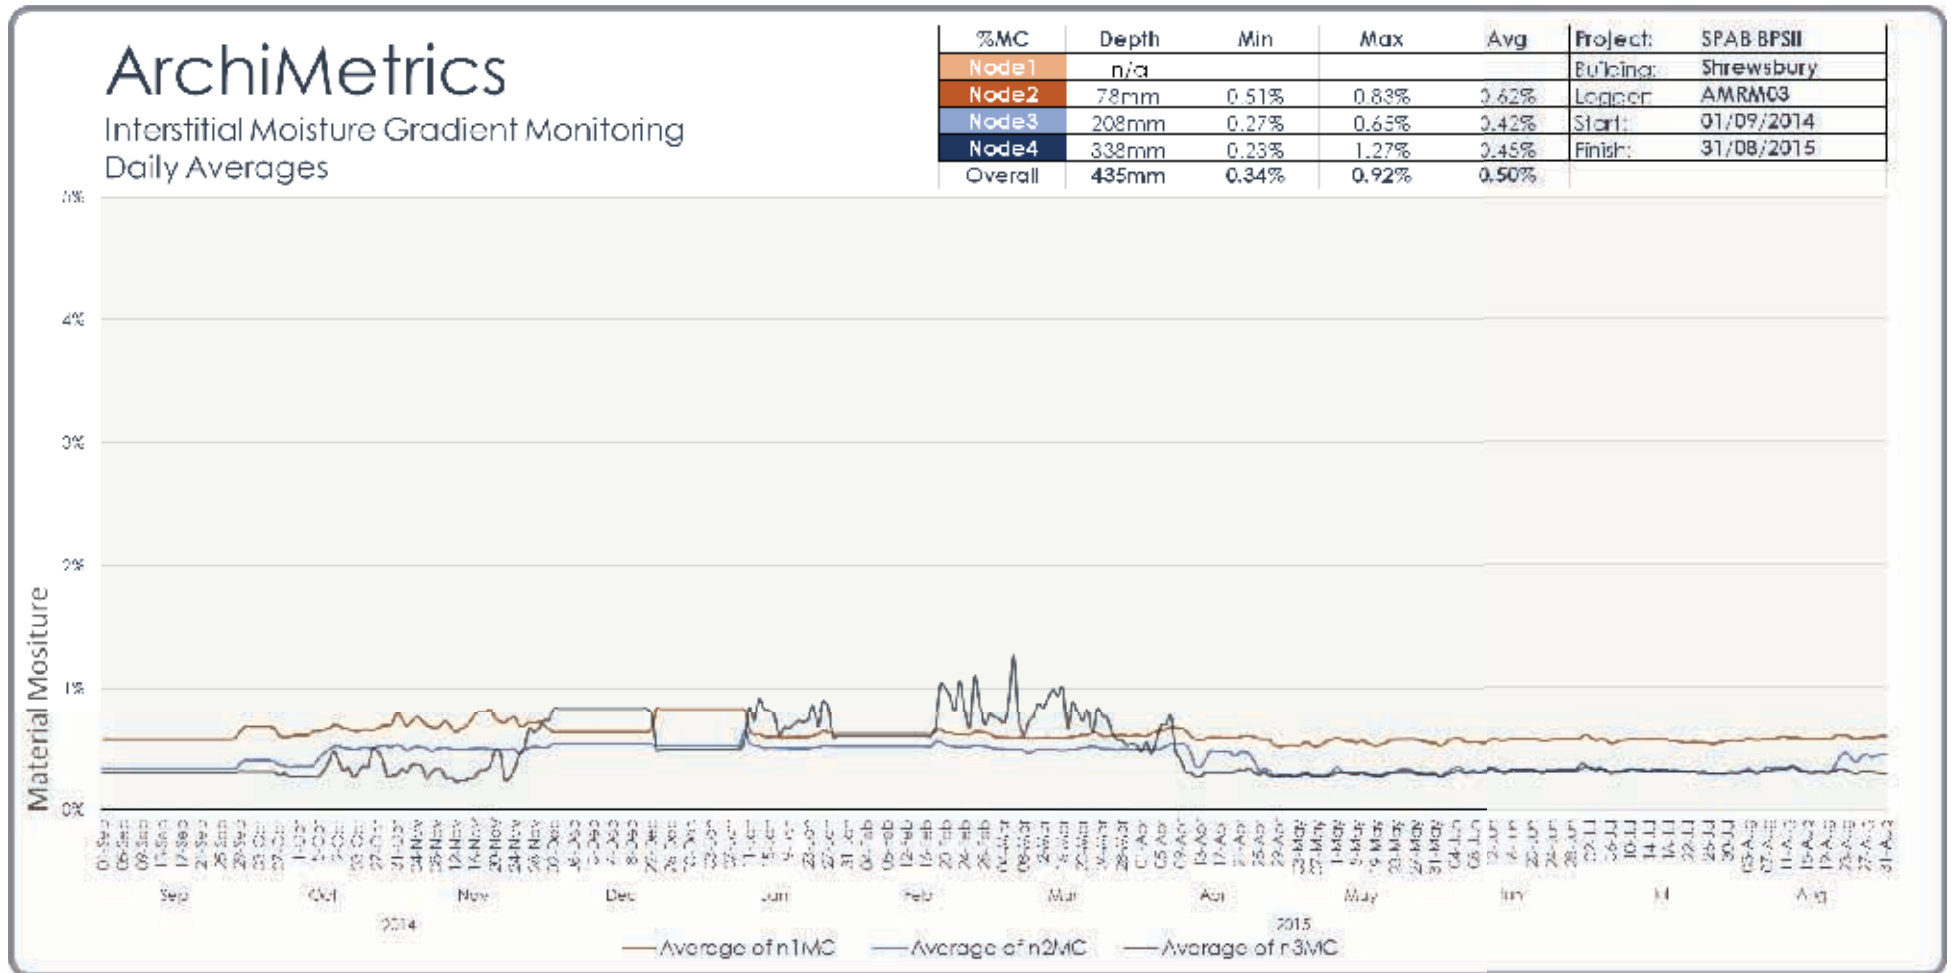
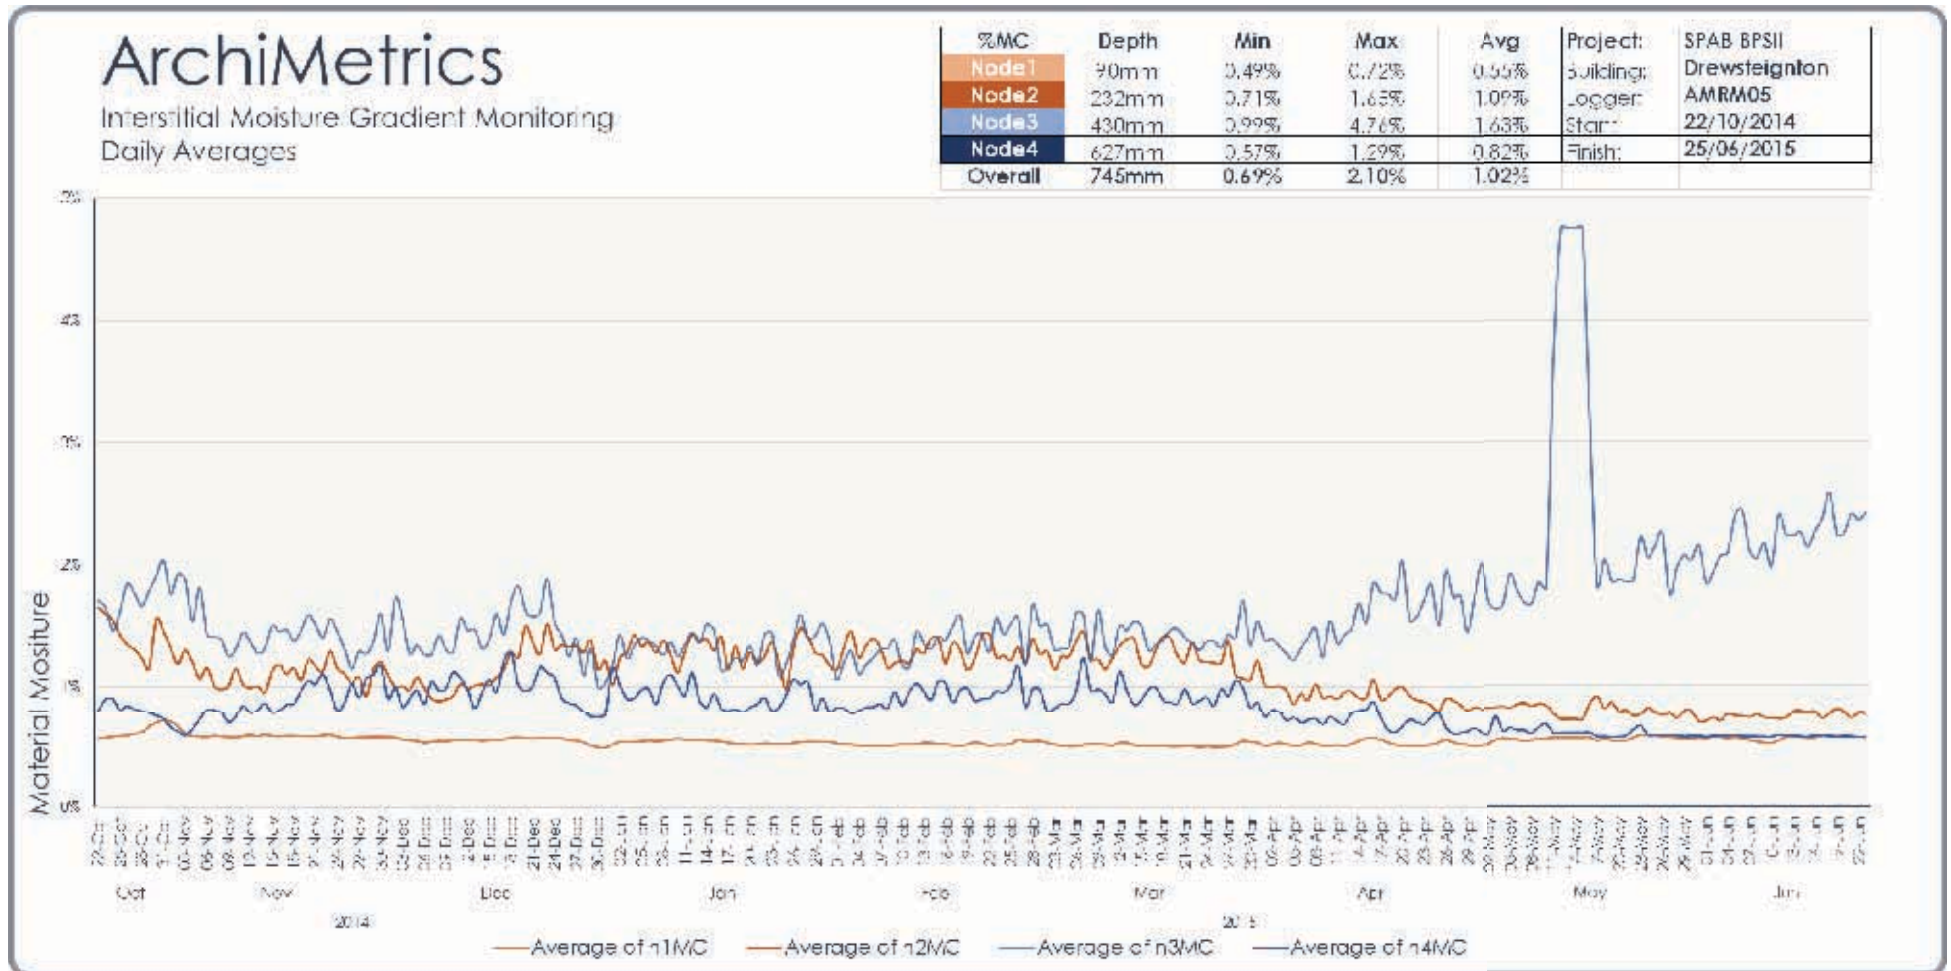
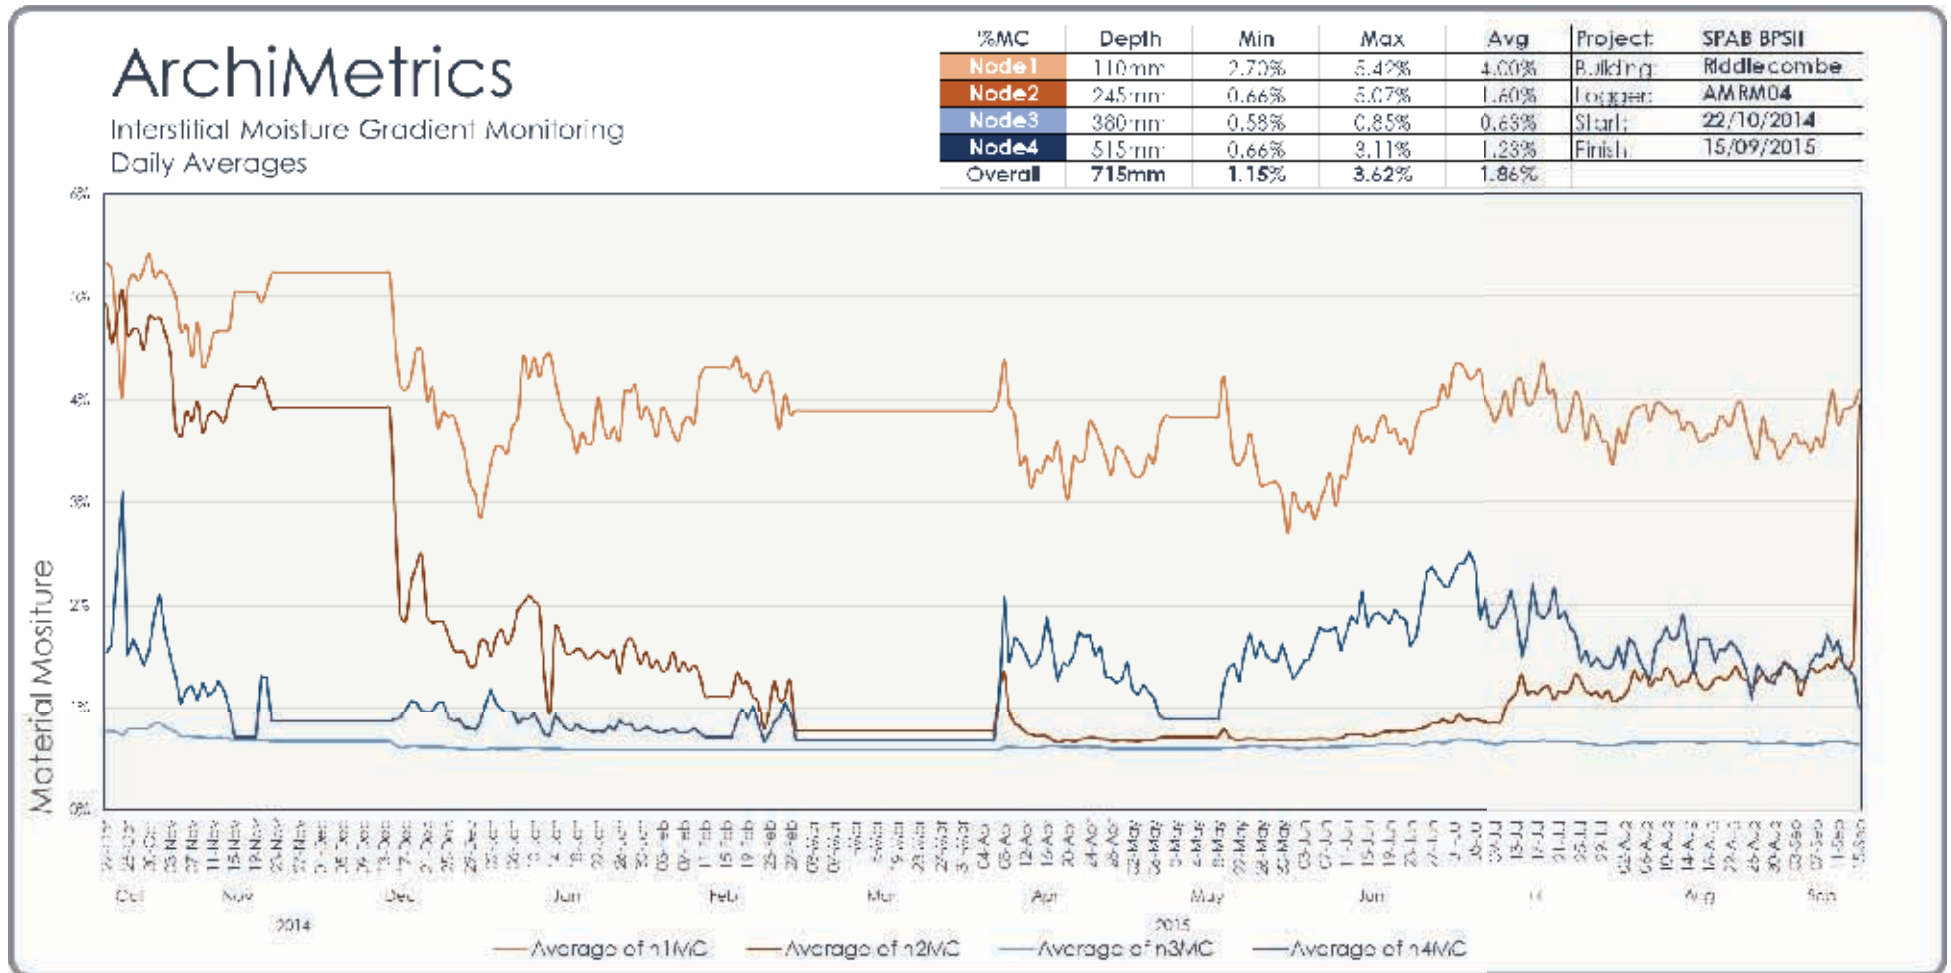
Figure 40: Material moisture content over time, Abbeyforegate, Shrewsbury 2014 - 2015.

Figure 41: Material moisture content over time, Mill House, Drewsteignton, 2014 - 2015.

Figure 42: Material moisture content over time, The Firs, Riddlecombe, 2014 - 2015.

Figures 40 – 42 show plots of moisture content measured by the individual interstitial wall sensors for each of the three walls for the year 2014 -15. The date range of each analysis graph is given in a table at the top right corner along with sensor depth information and minimum, maximum and average quantities for the reported period. The moisture content scale of the graphical analysis (vertical Y axis) is 0 – 5% for the walls at Shrewsbury and Drewsteignton and 0 – 6% for Riddlecombe. Flat lines indicate periods of time where no data is available.
