# SPAB Building Performance Survey

Interim Report I  
October 2015

Research conducted on behalf of the SPAB by ArchiMetrics Ltd  
Supported by Historic England

## The SPAB Building Performance Survey Interim Report 2015

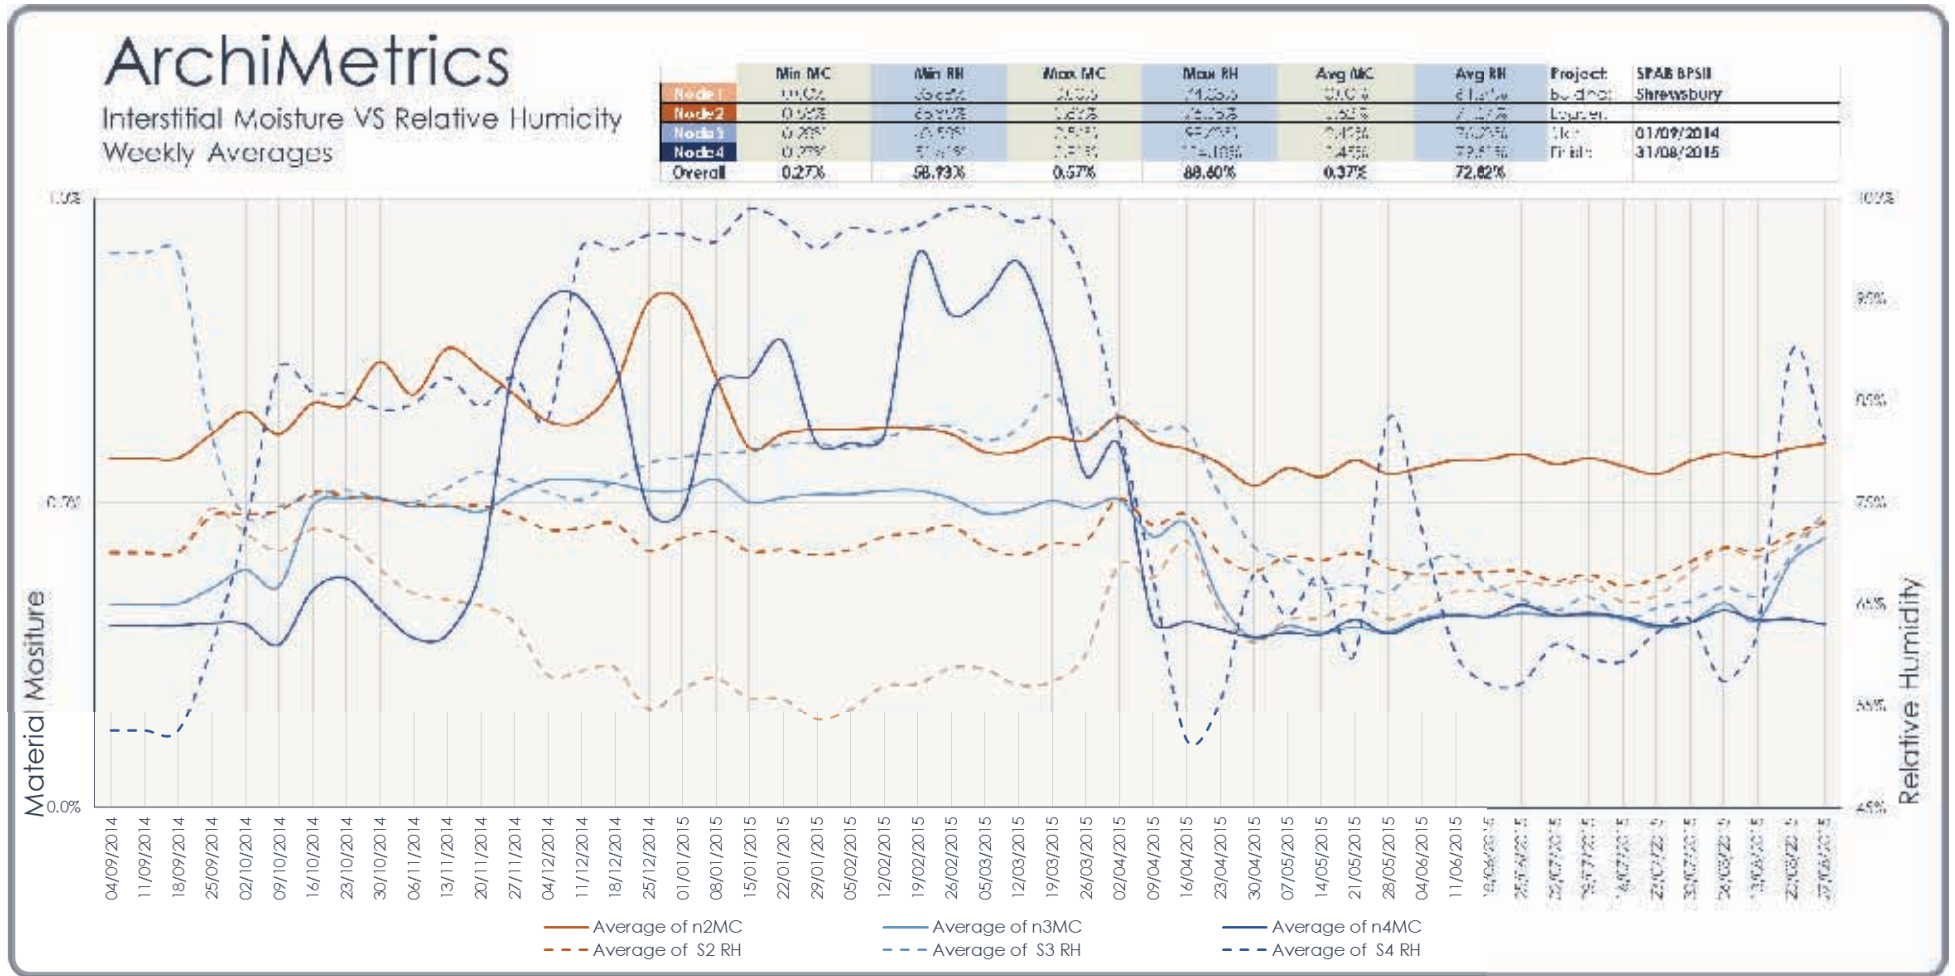
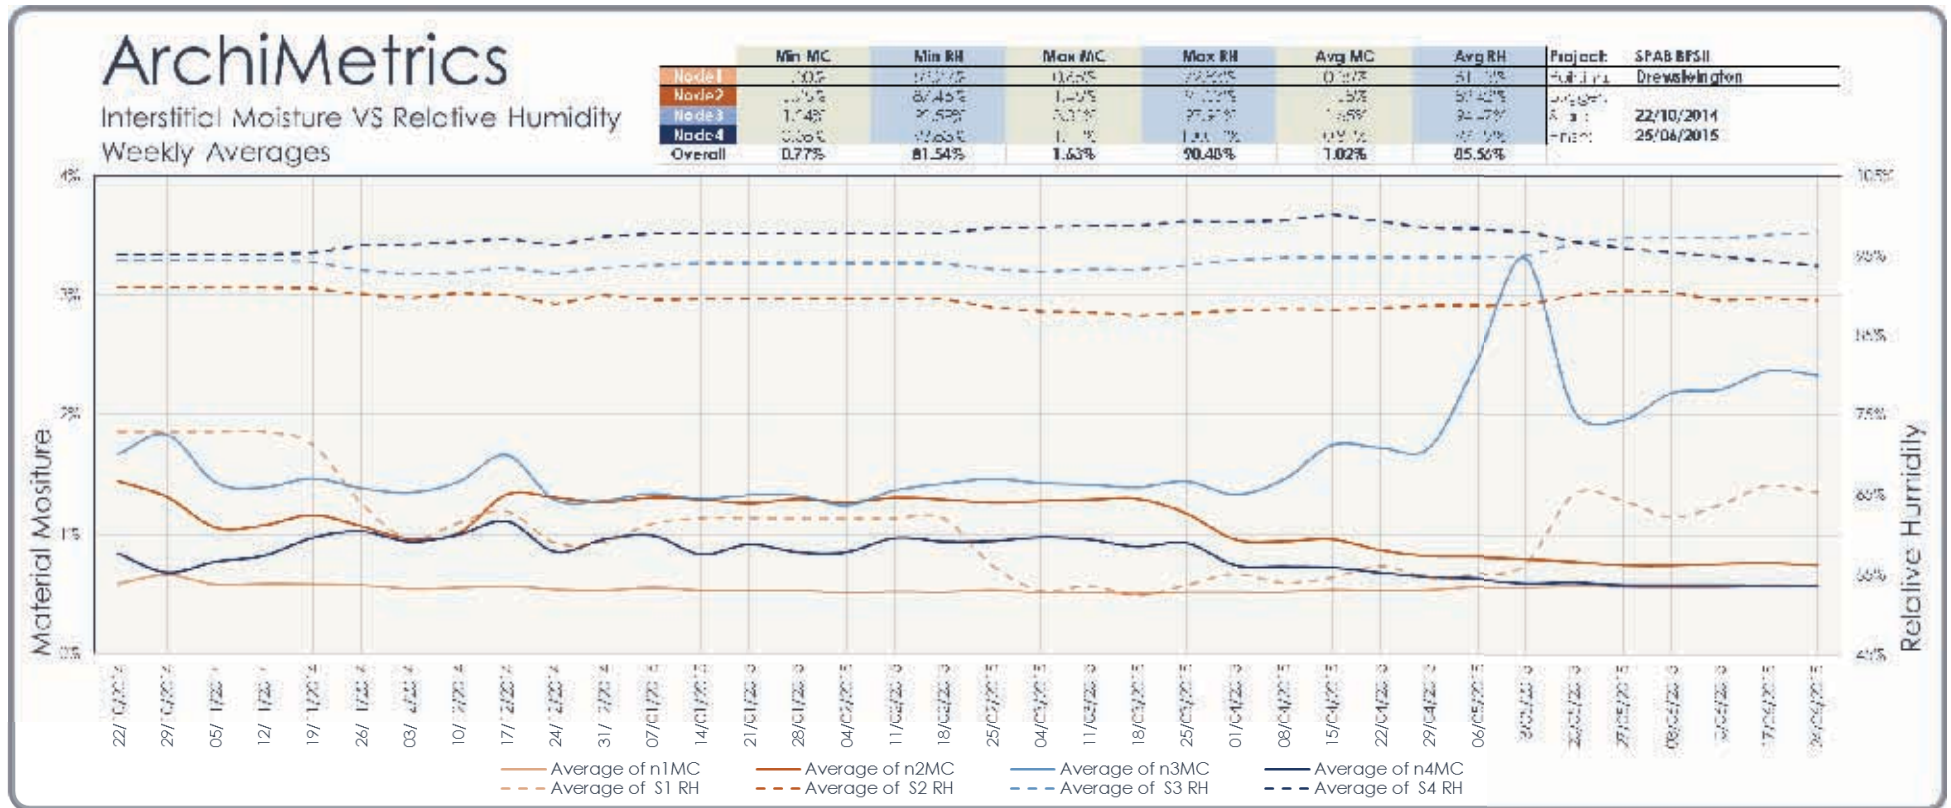
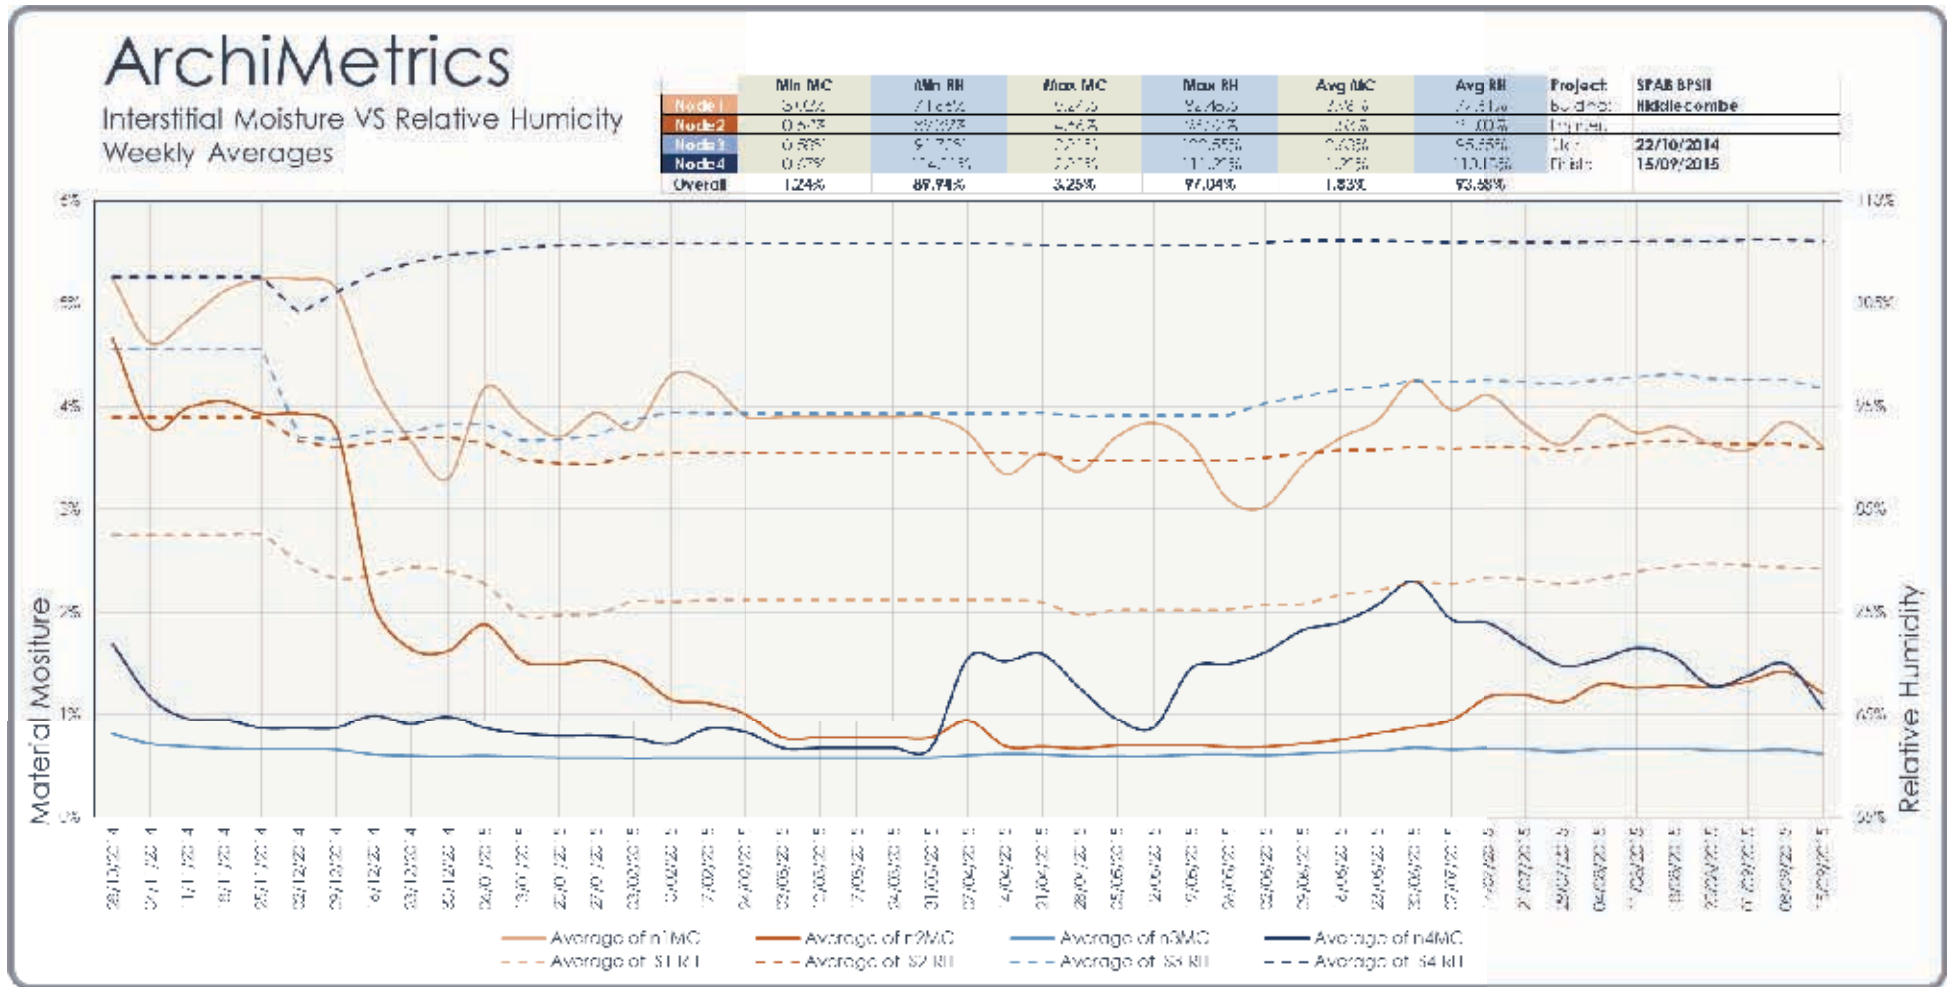
Figure 43: %MC and %RH comparison, Abbeyforegate, Shrewsbury 2014 - 2015.

Figure 44. %MC and %RH comparison, Mill House, Drewsteigton, 2014 -15.

Figure 45: %MC and %RH comparison, The Firs, Riddlecombe, 2014 - 2015.

Figures 43 – 45 show a comparison between the moisture content plots for the individual sensors for each of the three walls alongside measurements of %RH. %MC is mark as a solid line whereas %RH is a dashed line. The date range of each analysis graph is given in a table at the top right corner along with minimum, maximum and average %MC and %RH quantities for the reported period. The material moisture scale (%MC) is given on the left-hand side of the graph, %RH on the right-hand side.
