# The Frith, Mortimer West End, Hampshire: Analytical Earthwork Survey

Olaf Bayer and Mark Bowden

NGR: SU 626 630

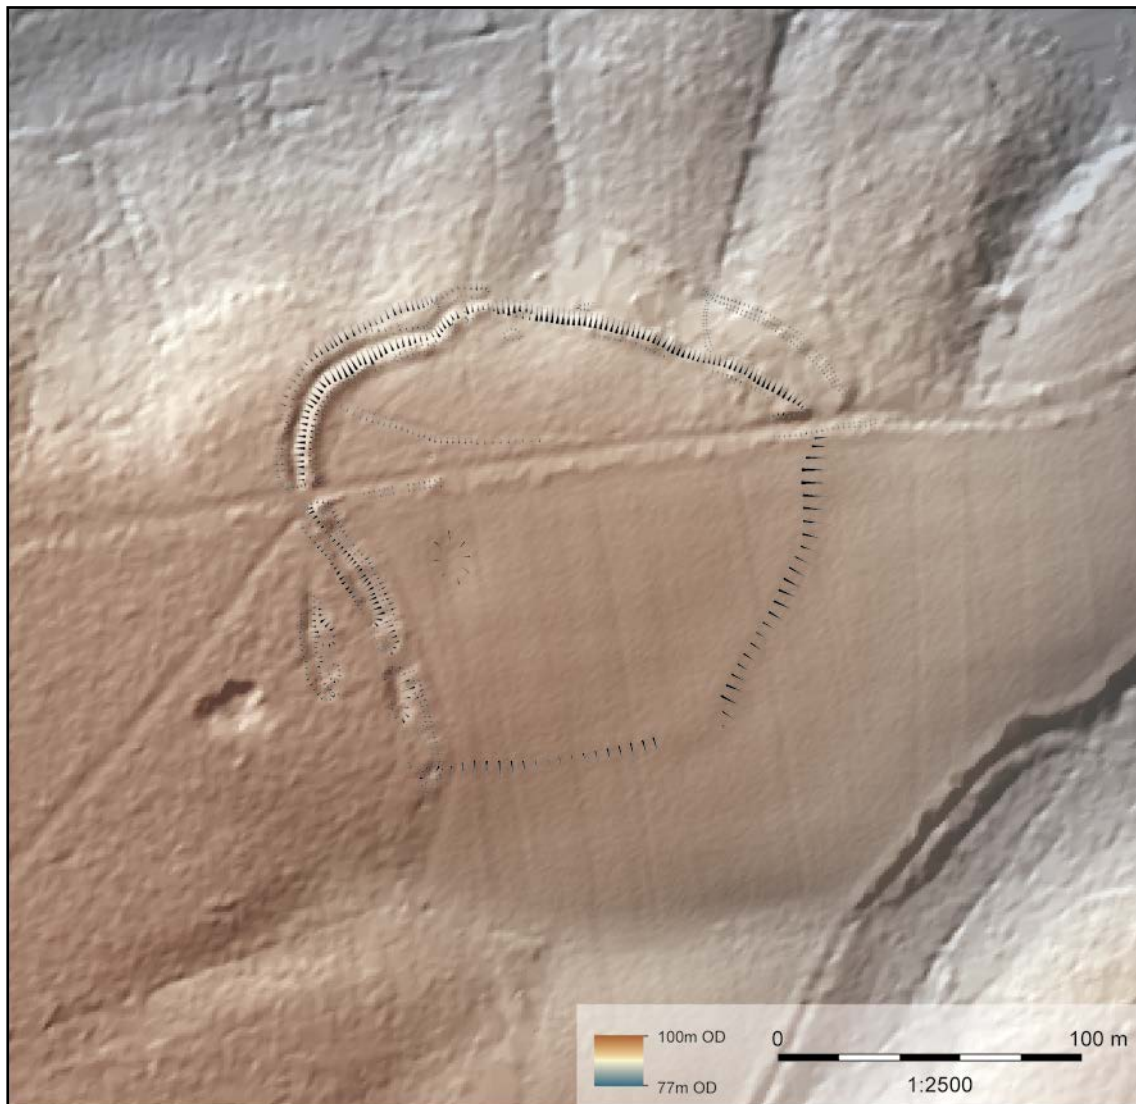
Figure 2: The Frith topography. Derived from 1m lidar digital terrain model © Environment Agency copyright and/or database right 2017. All rights reserved.

Centred on SU 626 630 the enclosure lies at between 90 and 95m OD at the eastern end of a spur approximately 1.5 km to the north-west of Calleva and 1km north of Silchester. Solid geology comprises sand of the London Clay Formation, overlain by sands and gravels of the Silchester Gravel Member (BGS 2017), capped with freely draining very acid sandy and loamy soils of the Southampton Association (Cranfield University 2016). The enclosure occupies the eastern end of a low ridge defined by the confluence of two minor tributaries of the West End Brook, itself a minor tributary of the Foudry Brook (Fig 1). Ground to the west of the site is level but it falls away sharply to the north and south, and more gradually to the east (Fig 2). The site lies on the edge of an extensive area of mixed woodland owned and managed by The Englefield estate. Today it is divided into three areas by a north/south running post-and-wire fence cutting off the western enclosure circuit, and an east/west running trackway that cuts across the centre of the monument (Fig 3). Each of these areas is

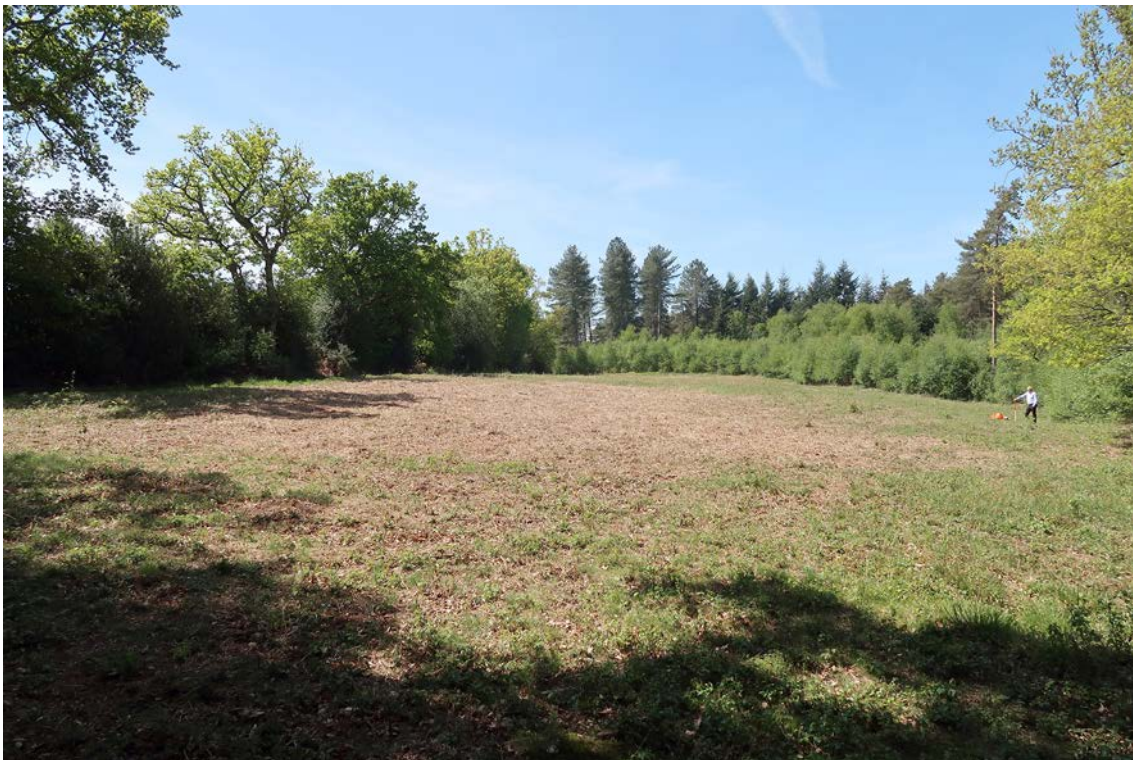
Figure 4: Looking west across the hillfort interior in area 1. The interior bank is just visible in front of the low tree line in the centre of the photograph. (© Historic England, photograph Olaf Bayer).

- Area 1 (Fig 4) lies to the north of the trackway and includes the northern and north-eastern rampart and over 20% of the enclosure's interior. The interior of the enclosure in this area was cleared of coniferous plantation in 2004/5 and vegetation appears to be heavily cut back on an annual basis. The defensive circuit lies just inside an area of mature and regenerating mixed woodland. Earthwork preservation in this area is generally good but with some damage caused by roots and tree throws.

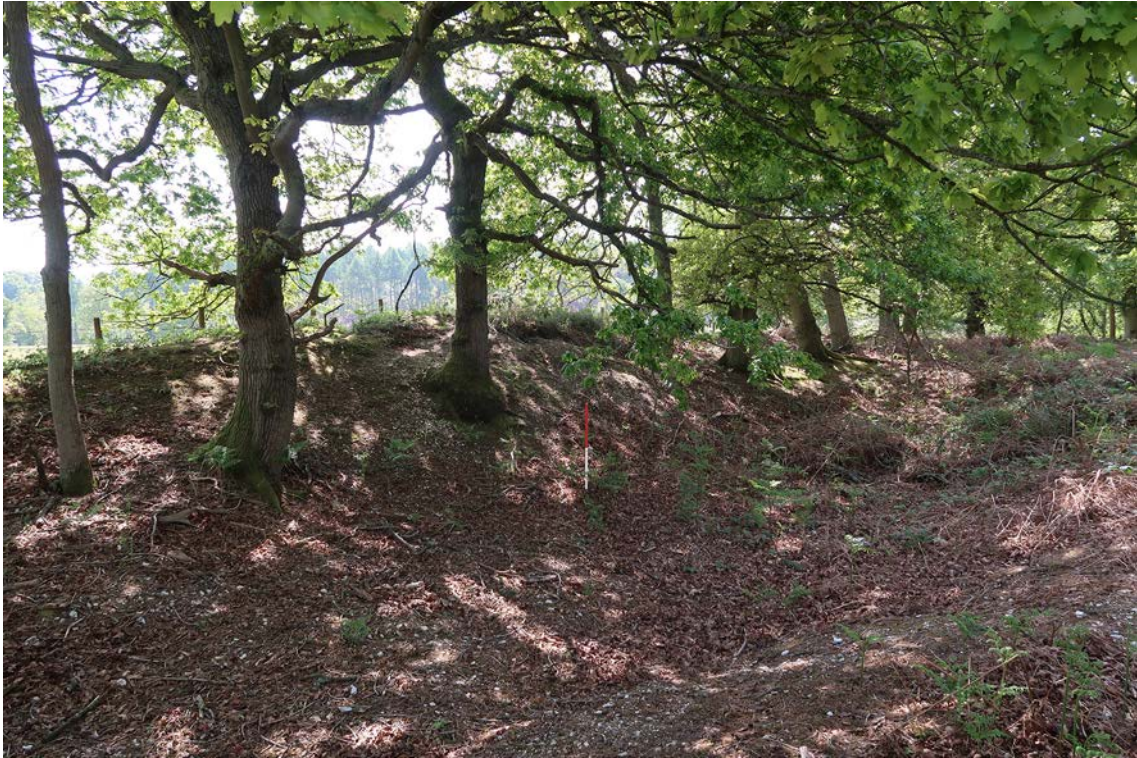
Figure 5: Hillfort ditch and rampart overlain by woodland bank (2.1) south of the western entrance in area 2. Scale 1m. (© Historic England, photograph Olaf Bayer).

- Area 2 (Fig 5) lies to the south of the trackway and to the west of the fence line. This area is under mature deciduous woodland on its eastern edge, with conifer plantation on its western edge. This area includes the western rampart and an outlying length of associated earthwork. Earthwork preservation is generally good in this area although some areas of badger disturbance to the enclosure bank were observed at its northern end. Lidar shows an area of quarrying (see Fig 2) immediately to the west of area 2. Other negative features in this area may be the result of small scale quarrying.

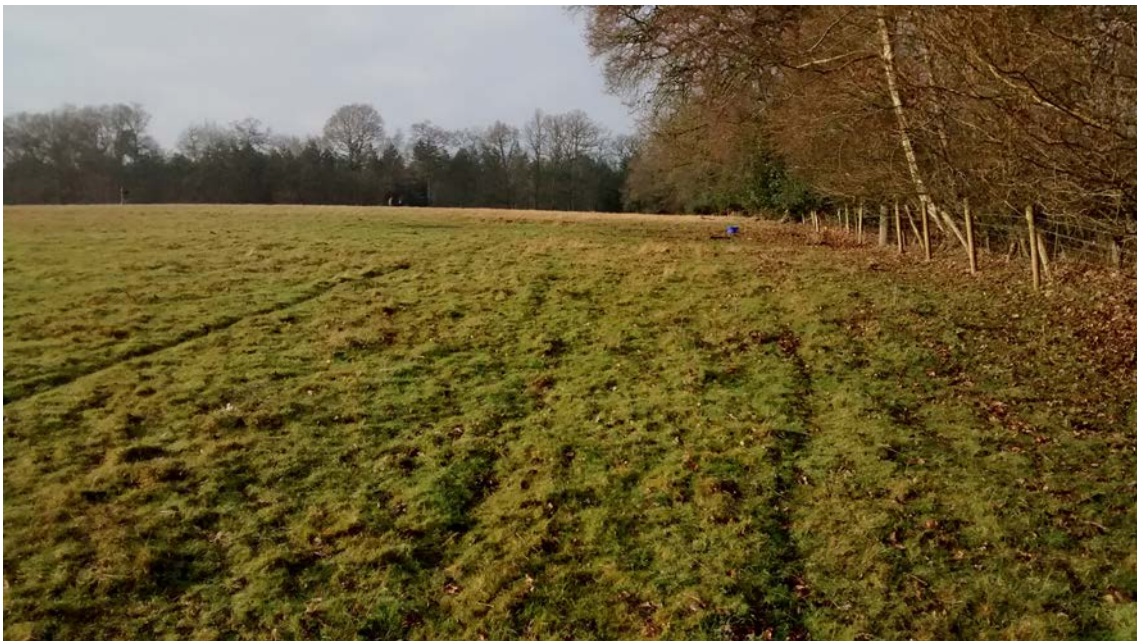
Figure 6: Looking west across the levelled hillfort rampart in area 3. (© Historic England, photograph Mark Bowden).

- Area 3 (Fig 6) lies to the south of the trackway and to the east of the fence line. This area is under closely grazed pasture and includes approximately 70% of the enclosure interior as well as the southern and eastern rampart. Earthworks in this area have been substantially levelled by ploughing.

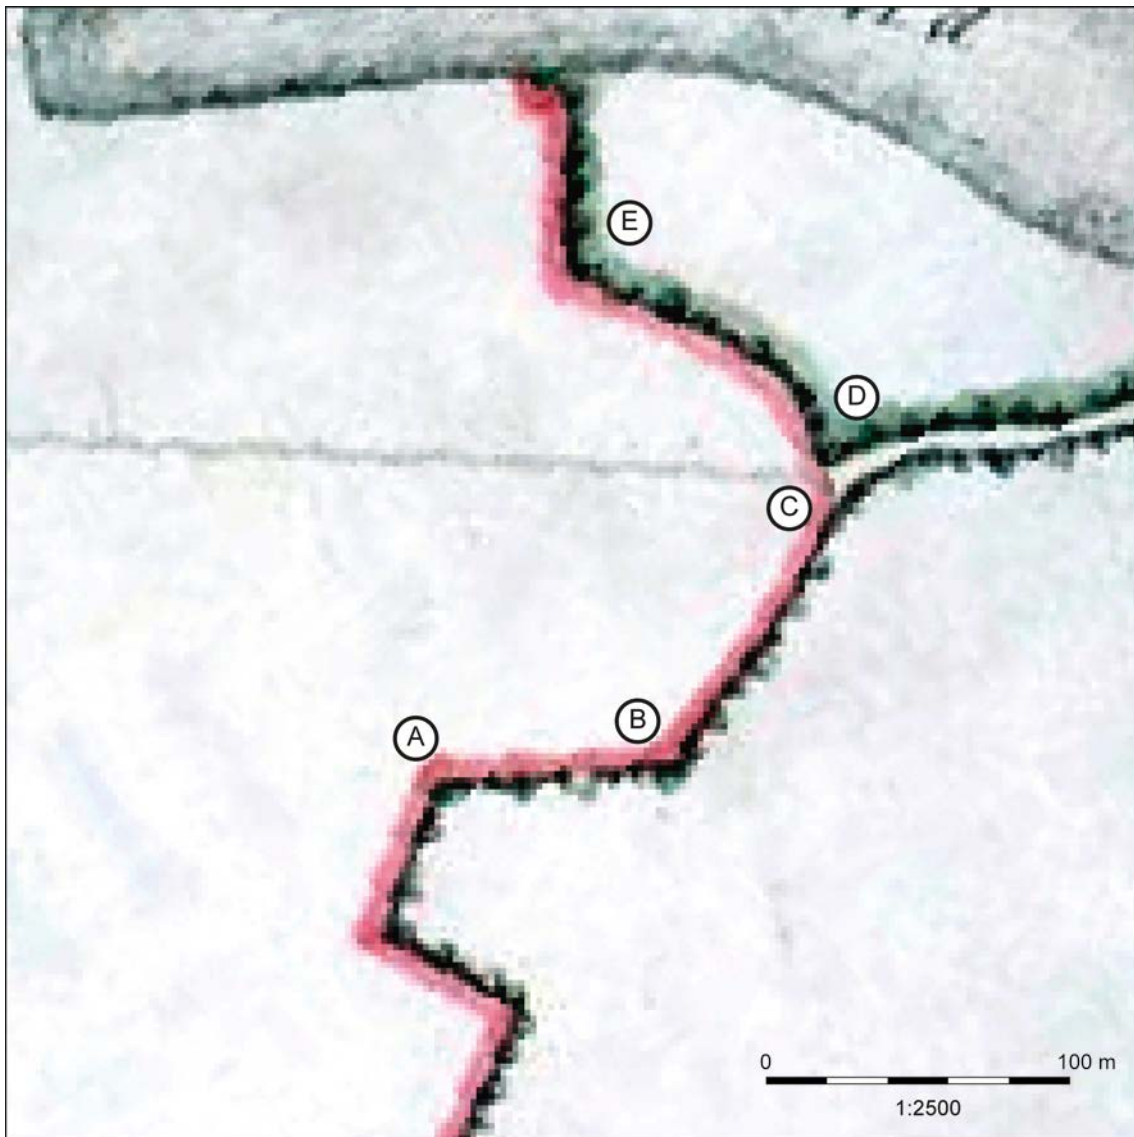
Figure 7: Extract of 1802 Stratfield Mortimer Enclosure map. Reproduced by permission of the Berkshire Record Office. (D/ER/P3).

The earliest cartographic depiction of the hillfort is on the 1802 enclosure map for Stratfield Mortimer parish (Fig 7). The map shows the now much removed southern and eastern sides of the hillfort forming part of the eastern edge of enclosure No. 38, owned by Richard Benyon (points A to C). At this point the eastern edge of enclosure 38 forms the boundary between land enclosed in 1802 to the west, and pre-existing older enclosures to the east (Woodward 1999, 12-16). The fact that boundaries drawn in 1802 appear to echo the morphology of the hillfort suggests that this element of its bank and ditch may have survived as an extant earthwork feature at this date. The curving boundary of the enclosure to the north of the track way (points D-E) follows the line of a woodland bank (see Fig 19 feature 2.2) outside,

and to the north of, the enclosure's defences. This bank forms the south-western extent of a series of plots associated with the pond, quarries and brick kilns at Pond Farm and excluded from enclosure (Woodward 1999, 12). The northern and western elements of the hillfort are not depicted. Although these are likely to have been the best preserved elements of the hillfort, they are omitted from the enclosure map, presumably as they do not coincide with the external boundary of new enclosures. To the south of the hillfort the continuation of the eastern edge of enclosure No. 38 shows elements of field boundaries depicted on subsequent historic mapping.

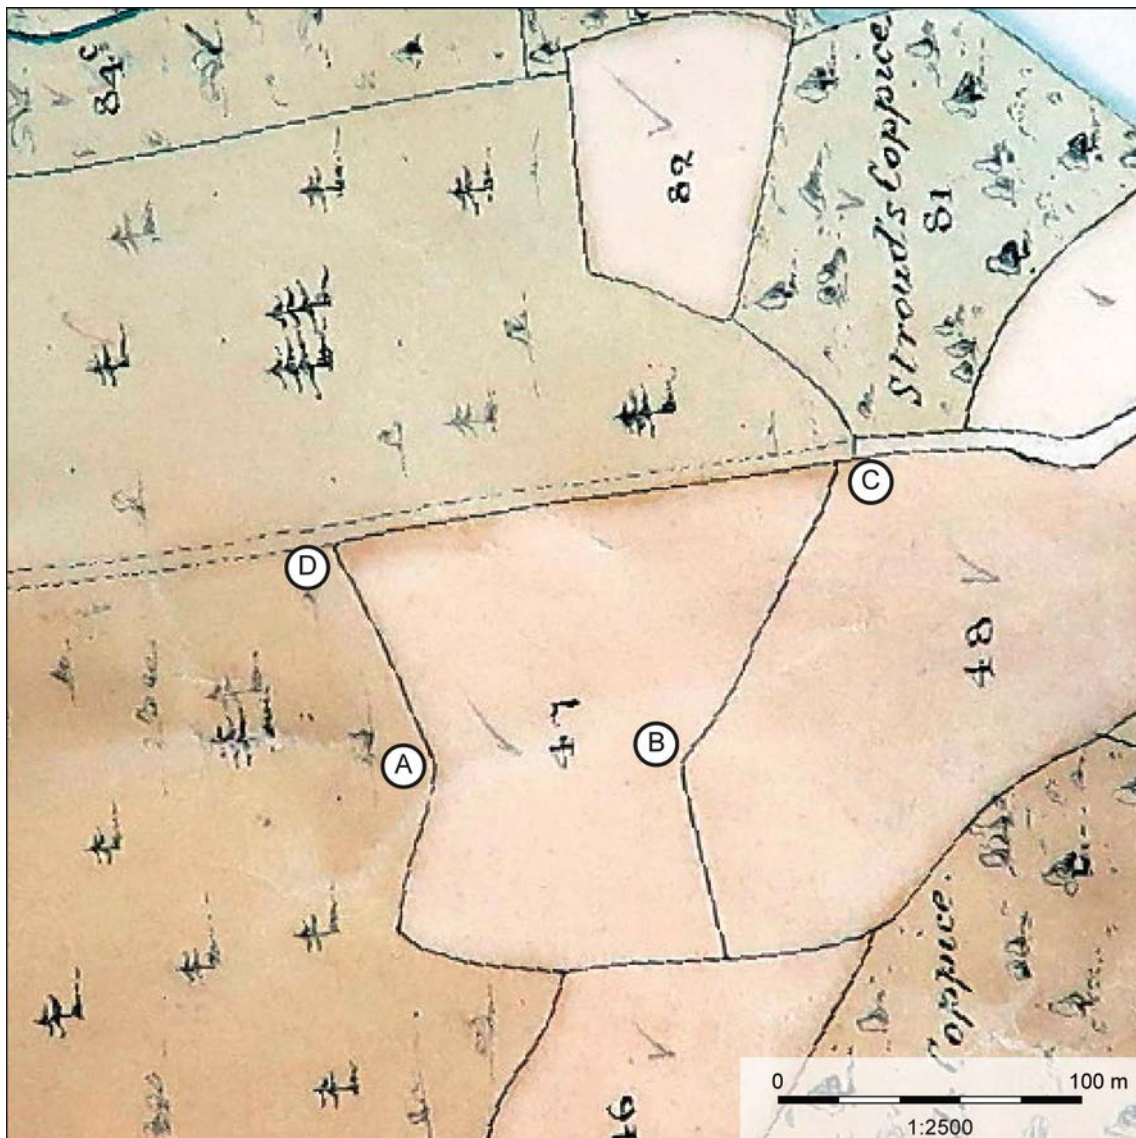
Figure 8: Extract of 1840 Stratfield Mortimer Tithe map. Reproduced by permission of the Berkshire Record Office. (D/D1/120/1).

The 1840 Stratfield Mortimer tithe map gives a much fuller depiction of the study area (Fig 8). The most significant change since 1802 is the apparent removal of the southern edge of the hillfort (between points A and B). The eastern hillfort defences

(between points B and C) remain unchanged, as does the woodland bank to the north of the trackway. The woodland bank overlying the western hillfort defences (points A to D, is a new addition to this map, as are several field boundaries to the south of the hillfort. It is likely that these boundaries were omitted from the 1802 enclosure map, as they did not mark external limits of new enclosures. Land use in 1840 is broadly that seen today; areas 1 and 2 were in woodland (plot 33, Fir Plantation), whilst area 3 was in open fields (plot 47, The Common Piece, and plot 48, The Five Acres).

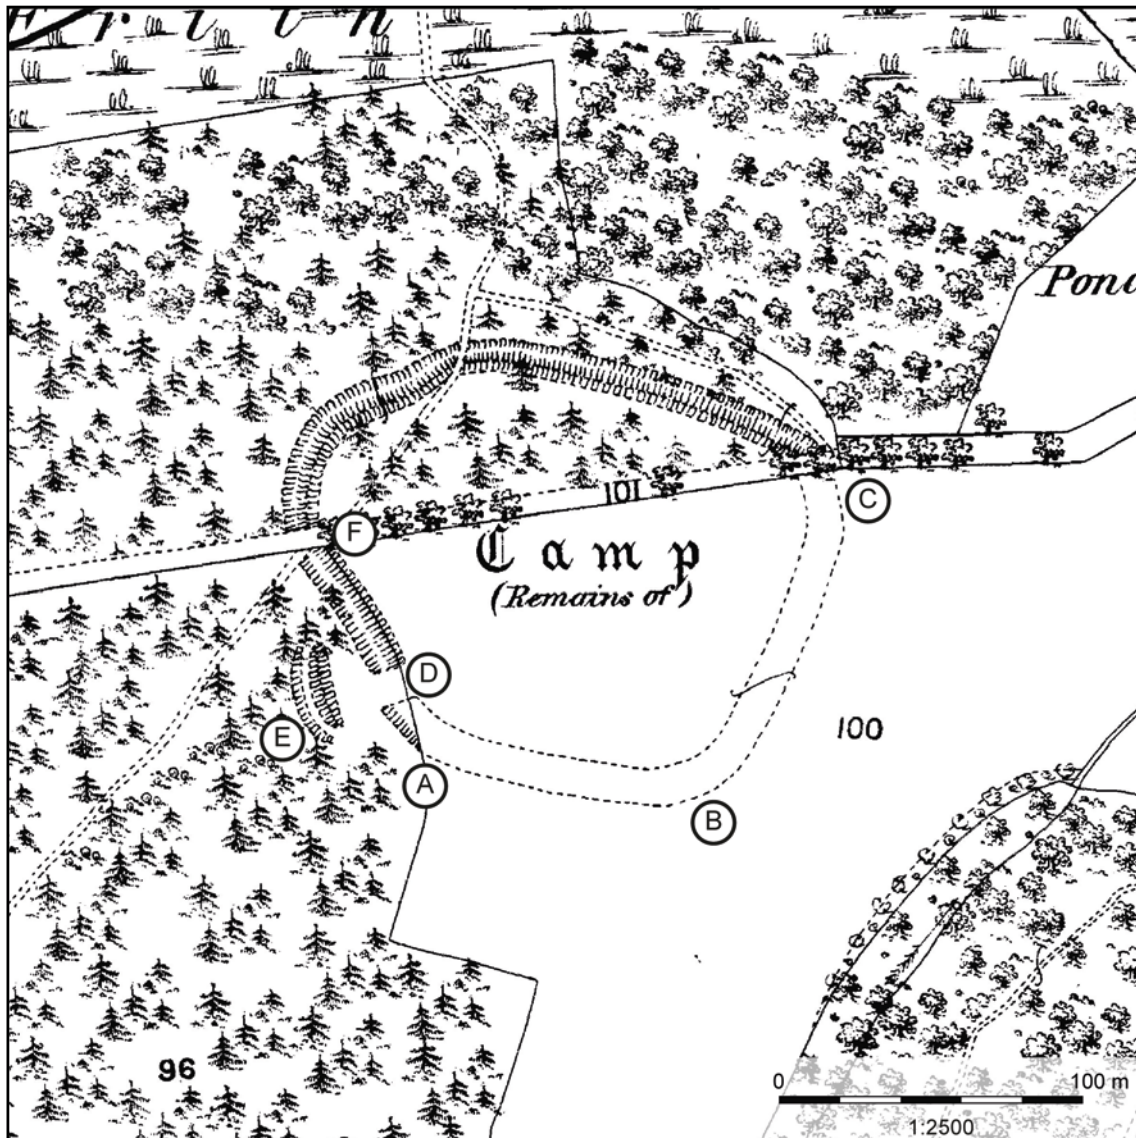
Figure 9: Extract of Ordnance Survey 1:2500 mapping, 1879. Base map © Crown copyright/database right and Landmark Information Group Limited (all rights reserved 2017).

The first detailed and metrically accurate depiction of the hillfort is the 1872 Ordnance Survey six-inch mapping of the area (Fig 9). In areas 1 and 2 the hillfort's defences are shown as an internal bank and external ditch. The western entrance

(point D) is shown as a nearly 10m wide gap in the defences, which is fronted approximately 12m to its west by a curving length (approximately 35m), of bank and ditch (point E). In area 3 the hillfort's defences are shown as a dashed line (points A to C). Presumably the ditch and rampart had been substantially removed by this point but survived as a slight earthwork. Woodland bank (2.1) (see Fig 13) running along the full length of the western rampart in area 2 is shown for the first time (between points A and F).

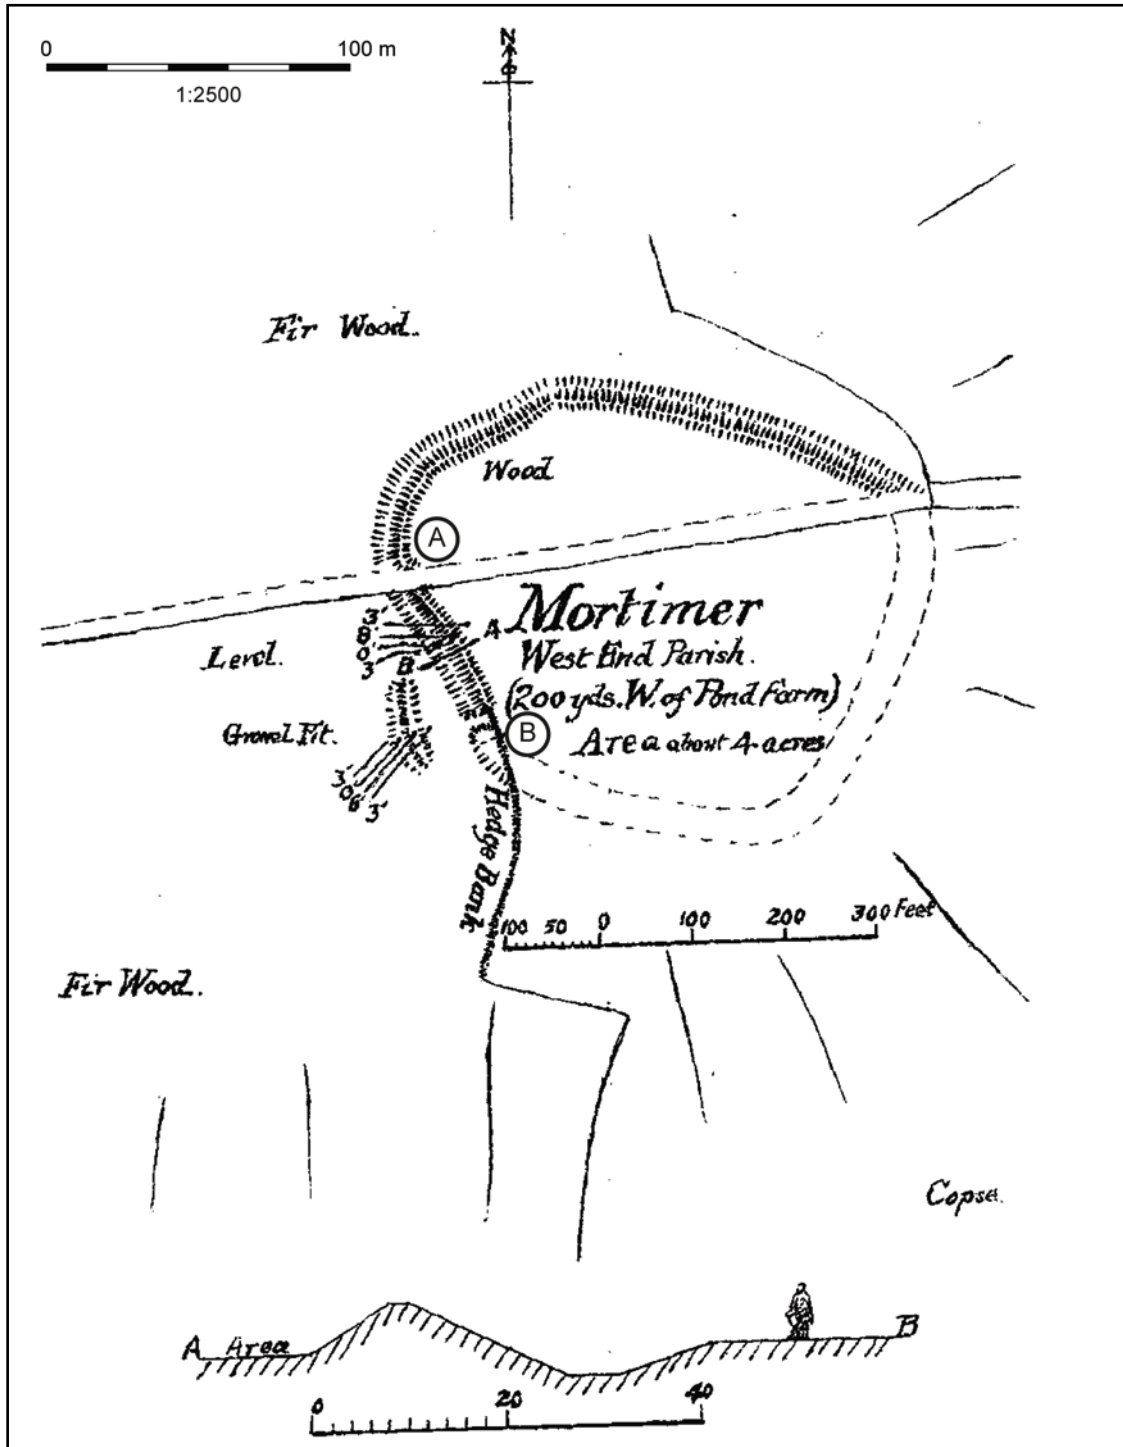
Figure 10: Williams-Freeman's 1915 survey of 'The Frith'.

The hillfort is included in Williams-Freeman's survey of the Field Archaeology of Hampshire (Fig 10; 1915, 387). Williams-Freeman's surveys consisted of annotation and additions to the Ordnance Survey six-inch mapping (1915, vii). The plan remains substantially unchanged from the 1872 mapping. Two slight amendments are made; at point A where Williams-Freeman notes "The bank appears to be slightly turned inwards where the modern road passes through the western side, but this may probably be of modern construction to form the bank of the road" (1915, 387); and at point B where additional detail is added to the bank termini on either side of the western entrance. In addition to his plan Williams-Freeman (1915, 387) includes a profile across the western hillfort defences, and a series of height measurements for the western outwork.

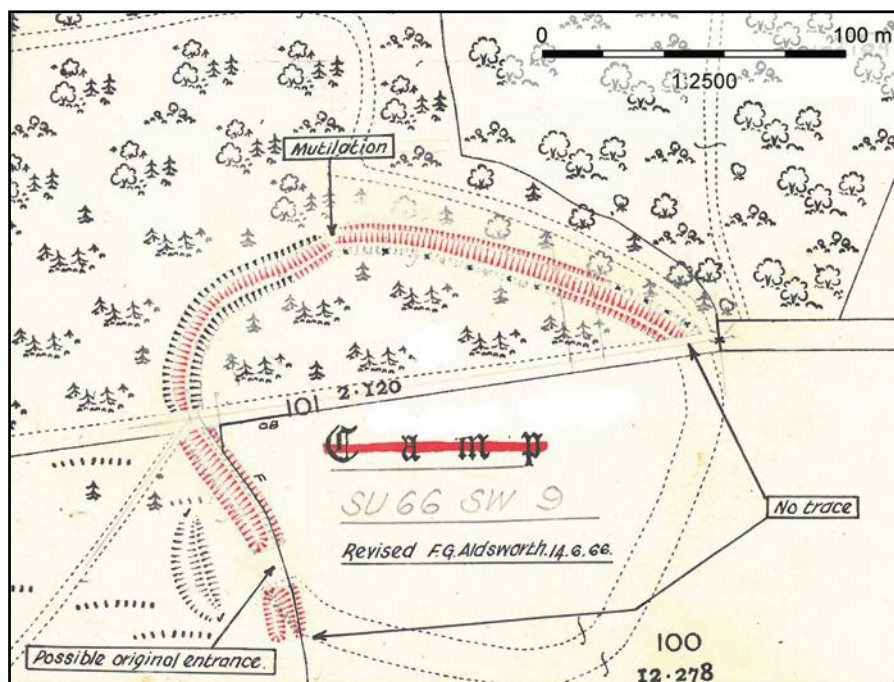
Figure 11: Ordnance Survey Antiquity Model for The Frith (Aldsworth 1966).

The hillfort was resurveyed for the Ordnance Survey by F.G. Aldsworth in 1966 (OS Antiquity model) and published as part of the 1969 1:2500 mapping of the area (Fig 11, see Fig 12). Minor changes (shown in red) are made from previous mapping. Further detail is shown, including a substantial depression immediately to the south of the western entrance. In area 1 the north-eastern arc of the hillfort's defences is changed to depict the slight traces of both the inner face of the internal bank and the outer face of the external ditch.

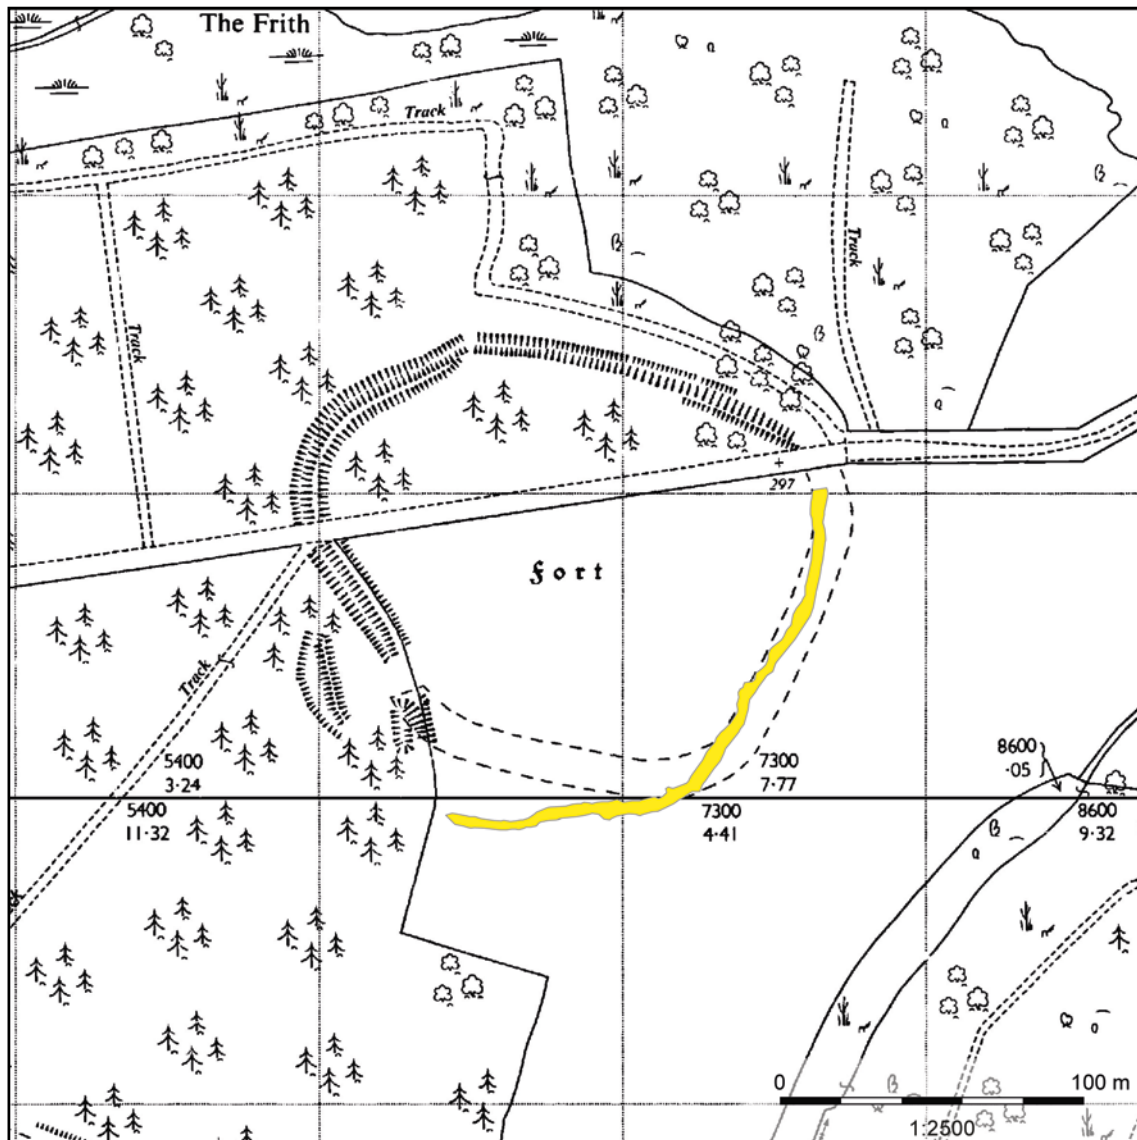
Figure 12: Extract of Ordnance Survey 1:2500 mapping, 1969 with extent of ditch from gradiometer survey shown in yellow (after Creighton and Fry 2016b). Base map © Crown copyright/database right and Landmark Information Group Limited (all rights reserved 2017).

Gradiometer and ground penetrating radar (GPR) surveys of the majority of areas 1 and 3 were carried out in 2015 (Fig 12; Barnett and Thornley 2015; Creighton and Fry 2016a, 168 and 171). The surveys give an accurate location for the now ploughed-out southern and eastern sections of the hillfort ditch. The eastern section of the ditch corresponds closely with that shown on mapping from 1872 onwards. However, the southern section lies up to 27m to the south of the position shown on mapping from 1872 onwards (see Figs 9 to 11).

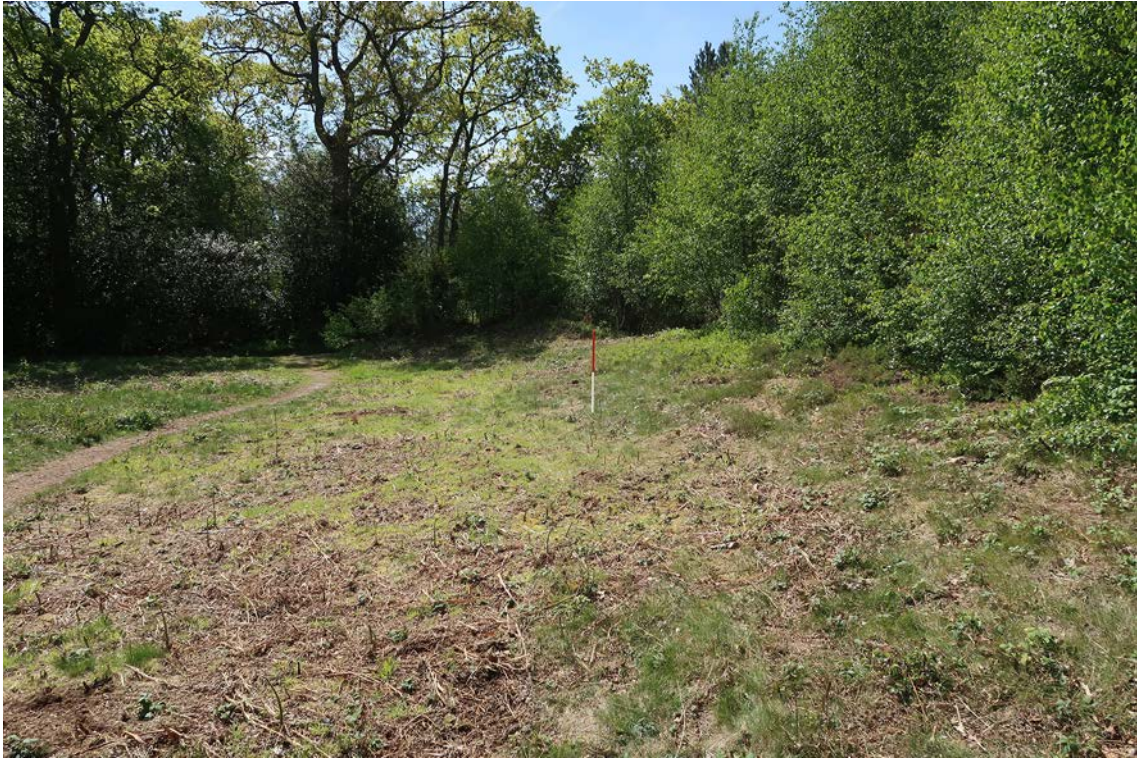
Figure 13: Looking west towards the interior edge of the rampart in area 1. Scale 1m. (© Historic England, photograph Olaf Bayer).

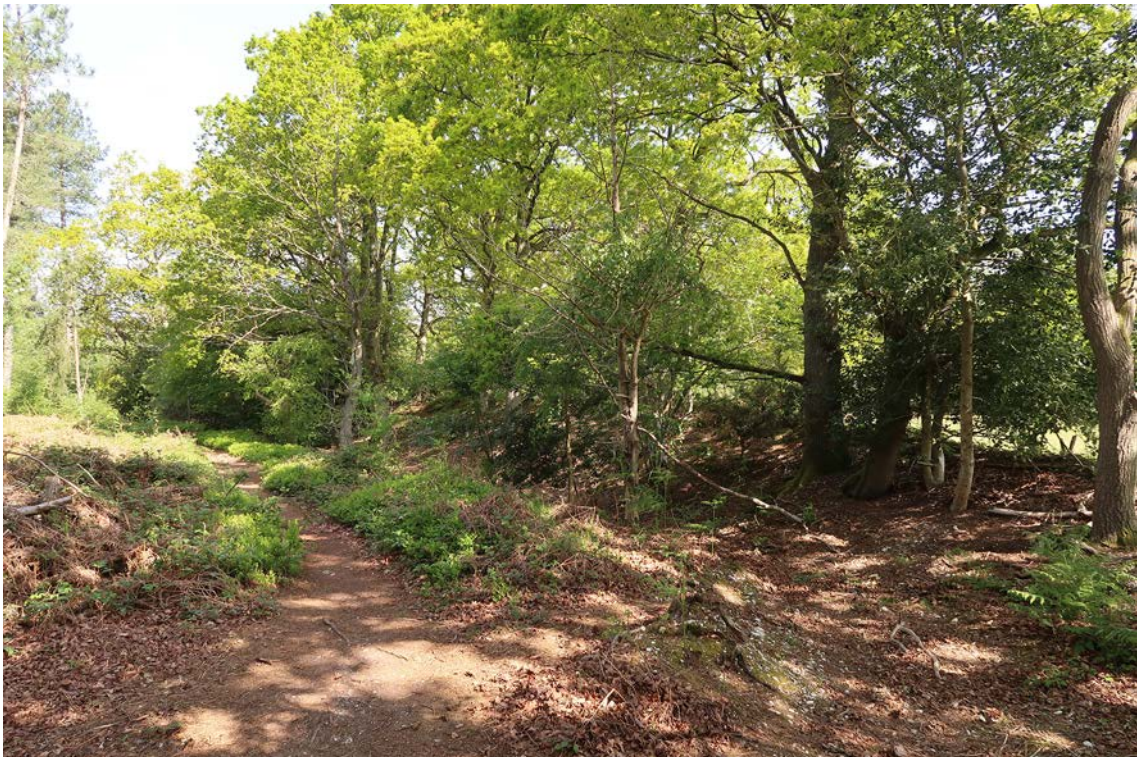
Figure 14: Looking north-east towards the hillfort ditch and rampart to the north of the western entrance. (© Historic England, photograph Olaf Bayer).

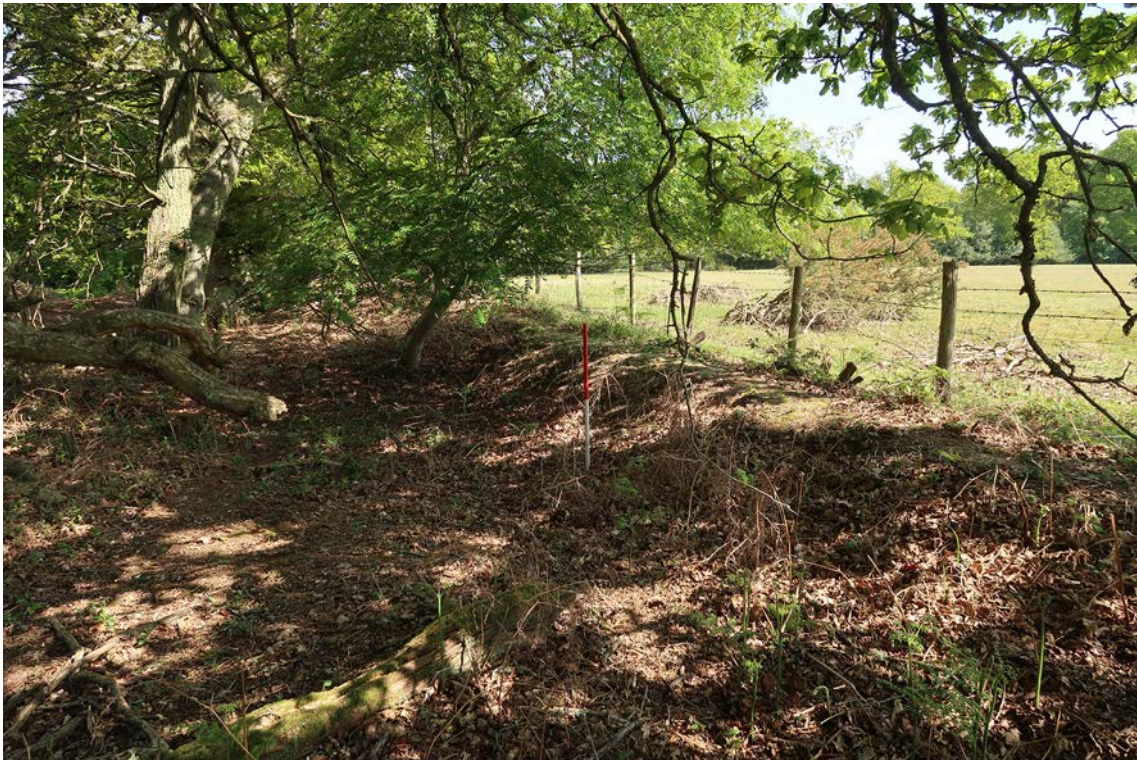
Figure 15: Looking north-east towards woodland bank 2.1 south of western entrance. Scale 1m. (© Historic England, photograph Olaf Bayer).

Two lengths of woodland bank were recorded within the survey area (Fig 19). Feature 2.1 runs along the spine of the hillfort's western rampart in area 2 (Fig 15). It blocks the western entrance (see Williams-Freeman 1915, 387) and continues beyond the southern limit of the survey area. It measures approximately 3m wide at its base, by 0.5m high. It is likely to be this feature that marks the boundary between plots 33 and 47 on the 1840 tithe map (see Fig 8).

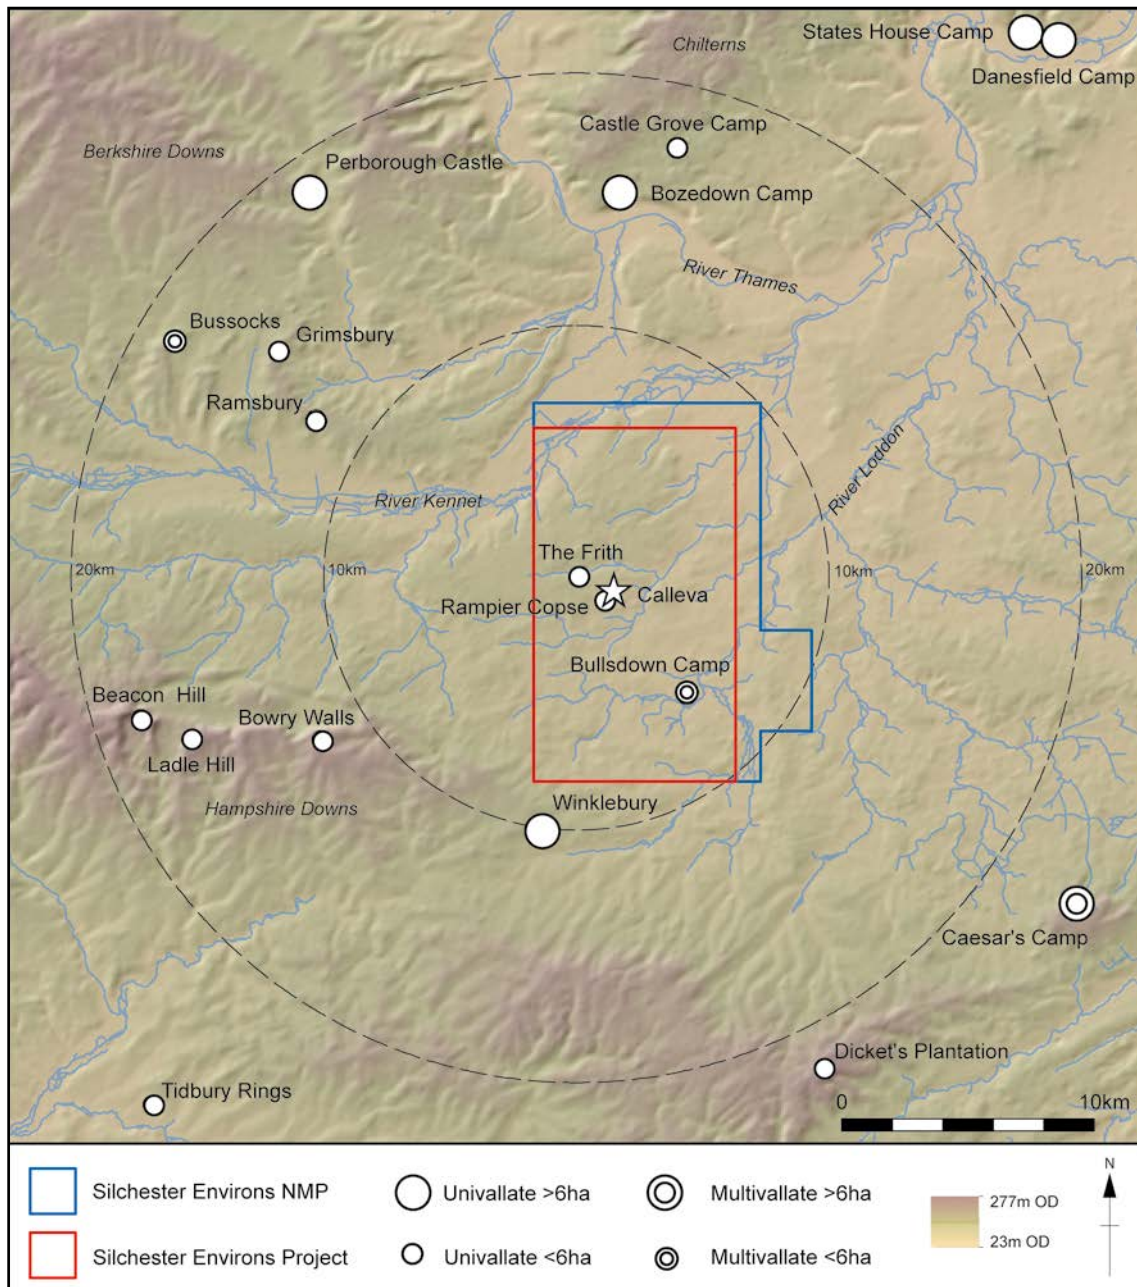
Figure 16: Hillforts in the wider Silchester Environs. Contains digital surface model data derived from 90m SRTM topography data courtesy of CGIAR; rivers data derived from OS data © Crown copyright and database right (2017), hillfort locations after Lock and Ralston 2017.

The Frith is a small, sub-oval univallate hillfort with one, or possibly two entrances. It is irregular in plan with a combination of nearly flat and gently curving sides, linked by both gradual and abrupt corners. Figure 16 shows the distribution of hillforts within a 20-25km radius of The Frith. The Silchester Environs is an area with comparatively few hillforts (Lock and Ralston 2017). The area is distinct from the line of hillforts along the northern edge of the Hampshire Downs between 10 and 20km to the south and south-west; and loose groupings of sites on the Berkshire Downs between 10 and 20km to the north-west, and on the southern edge of the Chilterns between 15 and 20km to the north.

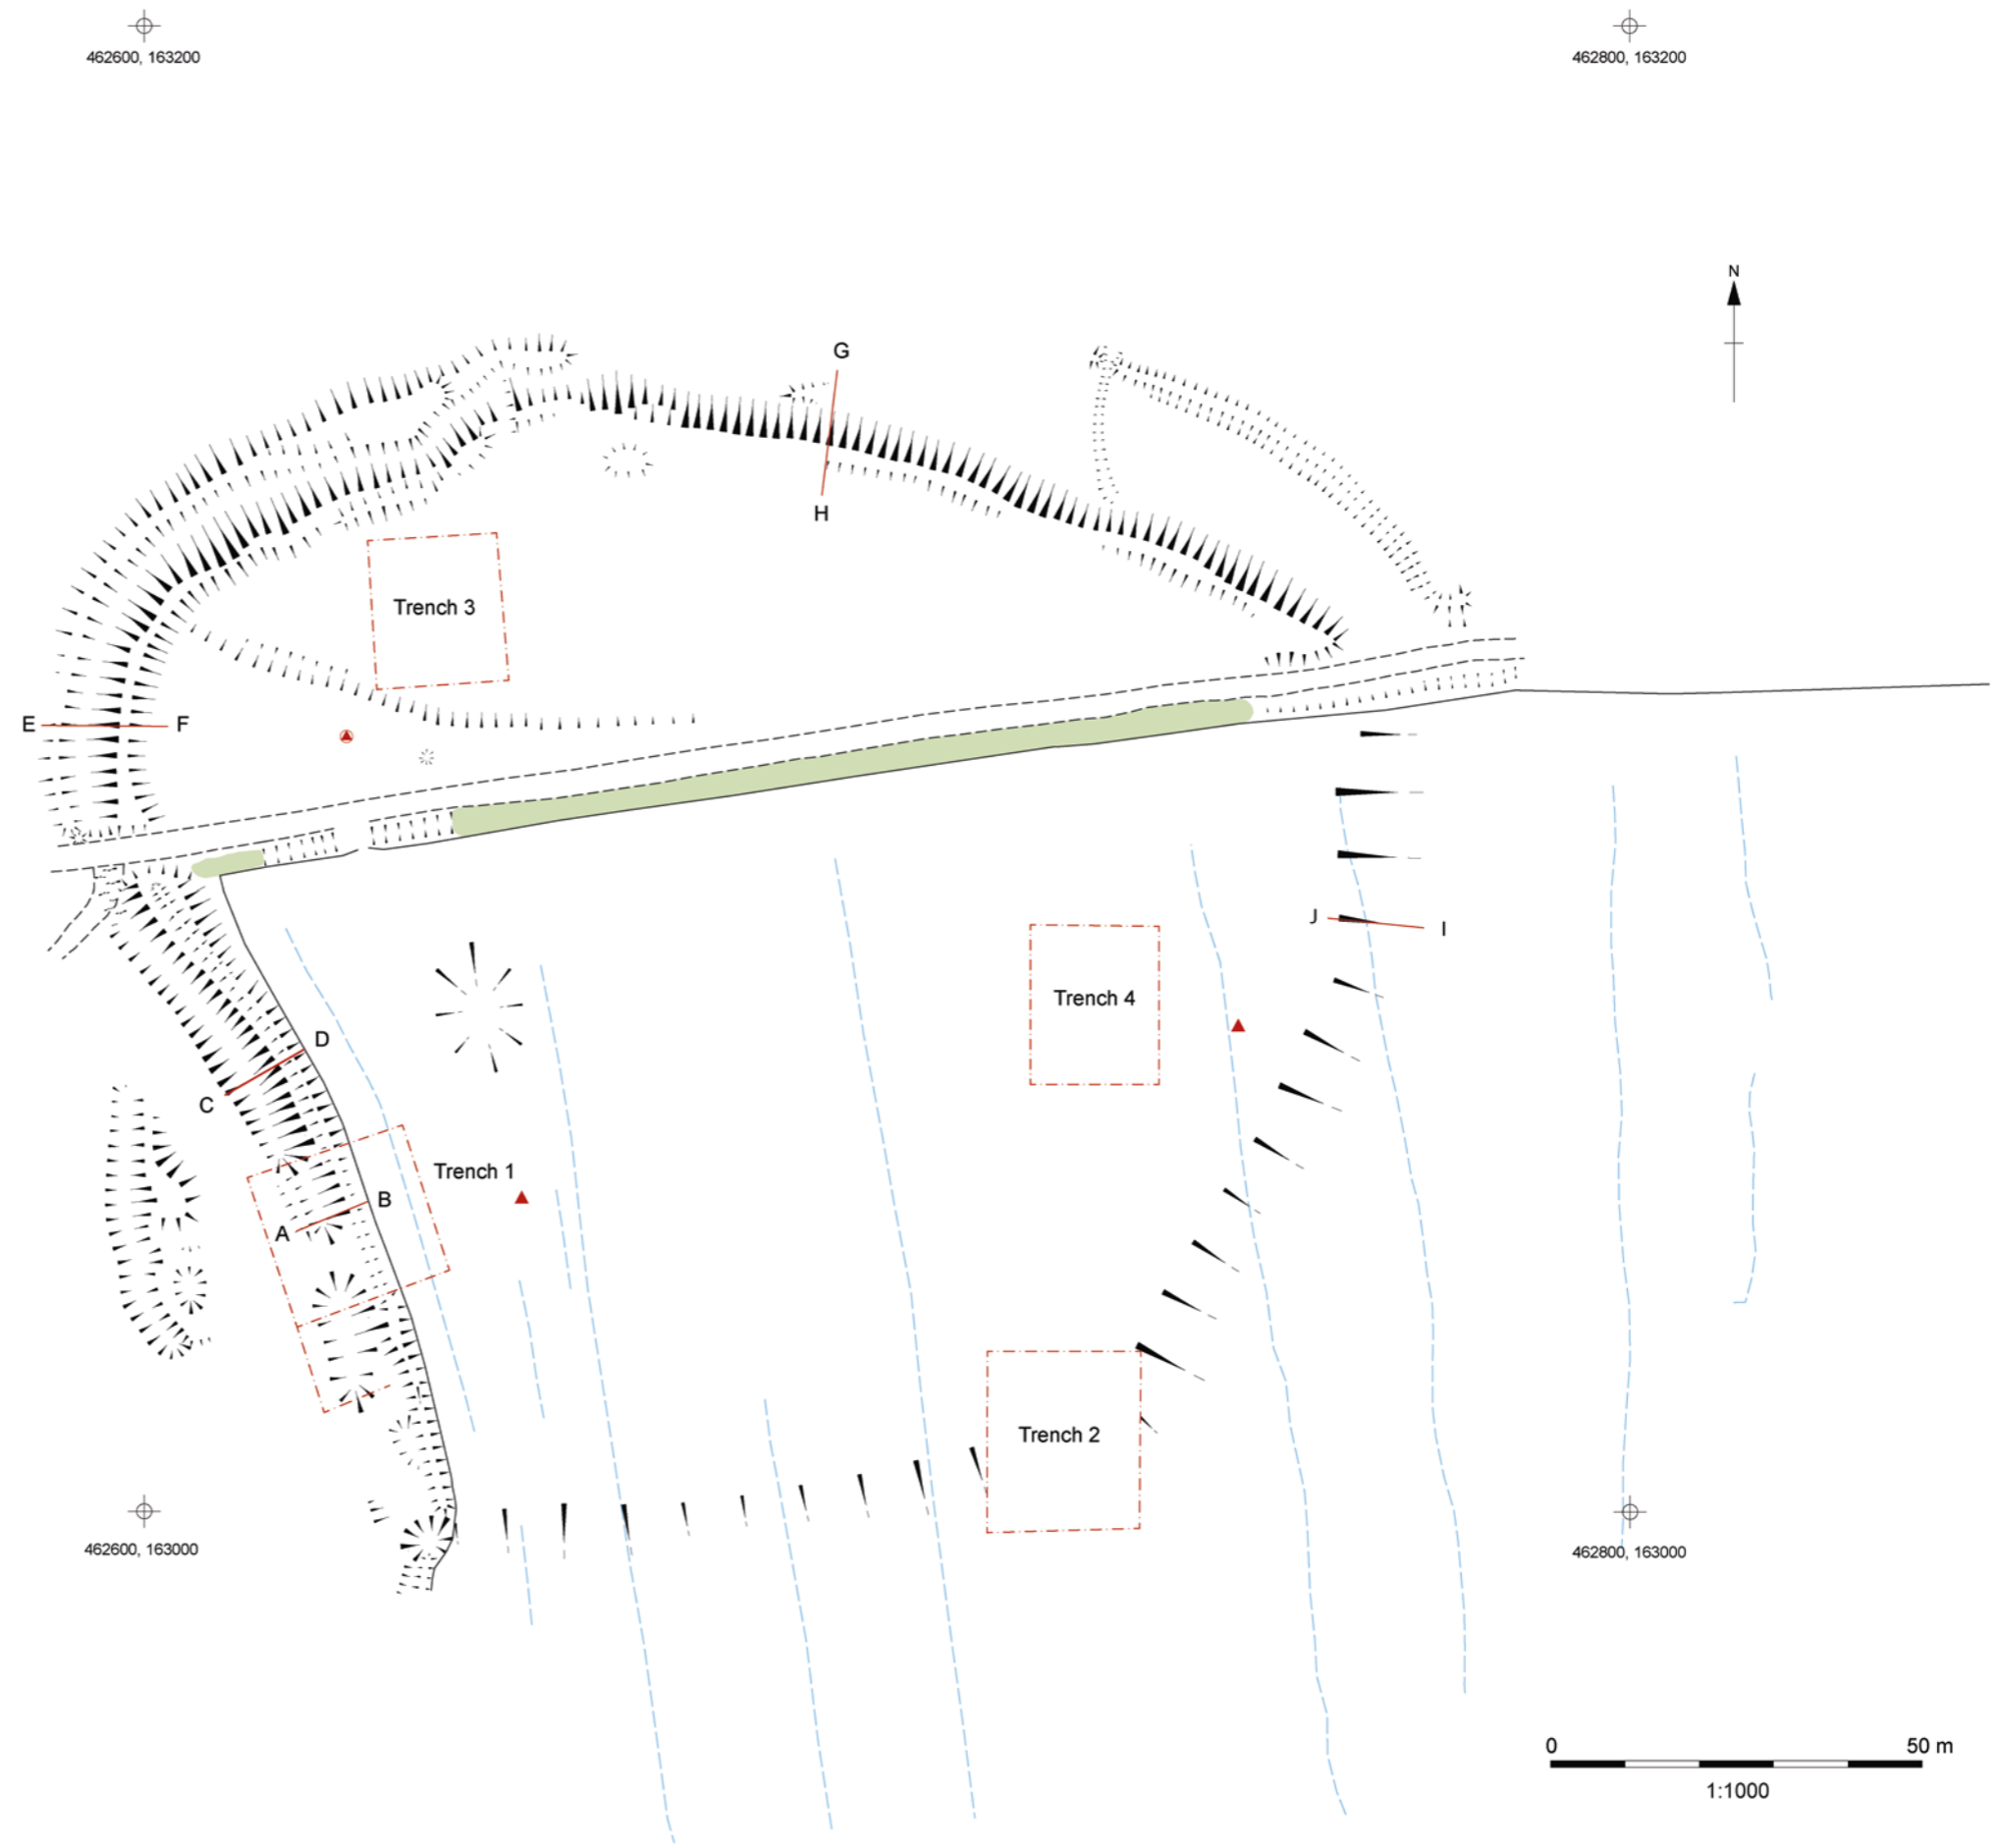
The survey results are presented as three principal drawings at the end of this report. Fig 17 gives a detailed view of the survey area at a scale of 1:1000. Earthwork features are depicted with hachures and a series of additional lines and polygons showing fence lines, tracks, land drains and areas of dense vegetation.

Figure 17. The Frith, final survey drawing at 1:1000 (© Historic England).

An internal bank survives around much of the defensive circuit. It is most pronounced on its western and north-western sides (areas 1 and 2) where it stands to a height of up to 1.2m above the surrounding ground level. Along the northern and north-eastern sides (area 2) the bank survives as a relatively slight and discontinuous feature with a maximum height of 0.3m. In this area the bank defines the top of a substantial outward facing scarp dropping up to 1.5m below the enclosure's interior. The southern and eastern sides of the bank (area 3) survive under pasture only as a much-denuded and spread, outward-facing scarp, up to 0.6m high (Fig 17 profile I-J).

Profiles A-B, C-D, E-F and G-H (Fig 17) were recorded in the field with a pocket level and level staff. Profile I-J is derived from an Environment Agency 1m Lidar DTM using ArcGIS 10.3.1.
