# The Frith, Mortimer West End, Hampshire: Analytical Earthwork Survey

Olaf Bayer and Mark Bowden

NGR: SU 626 630

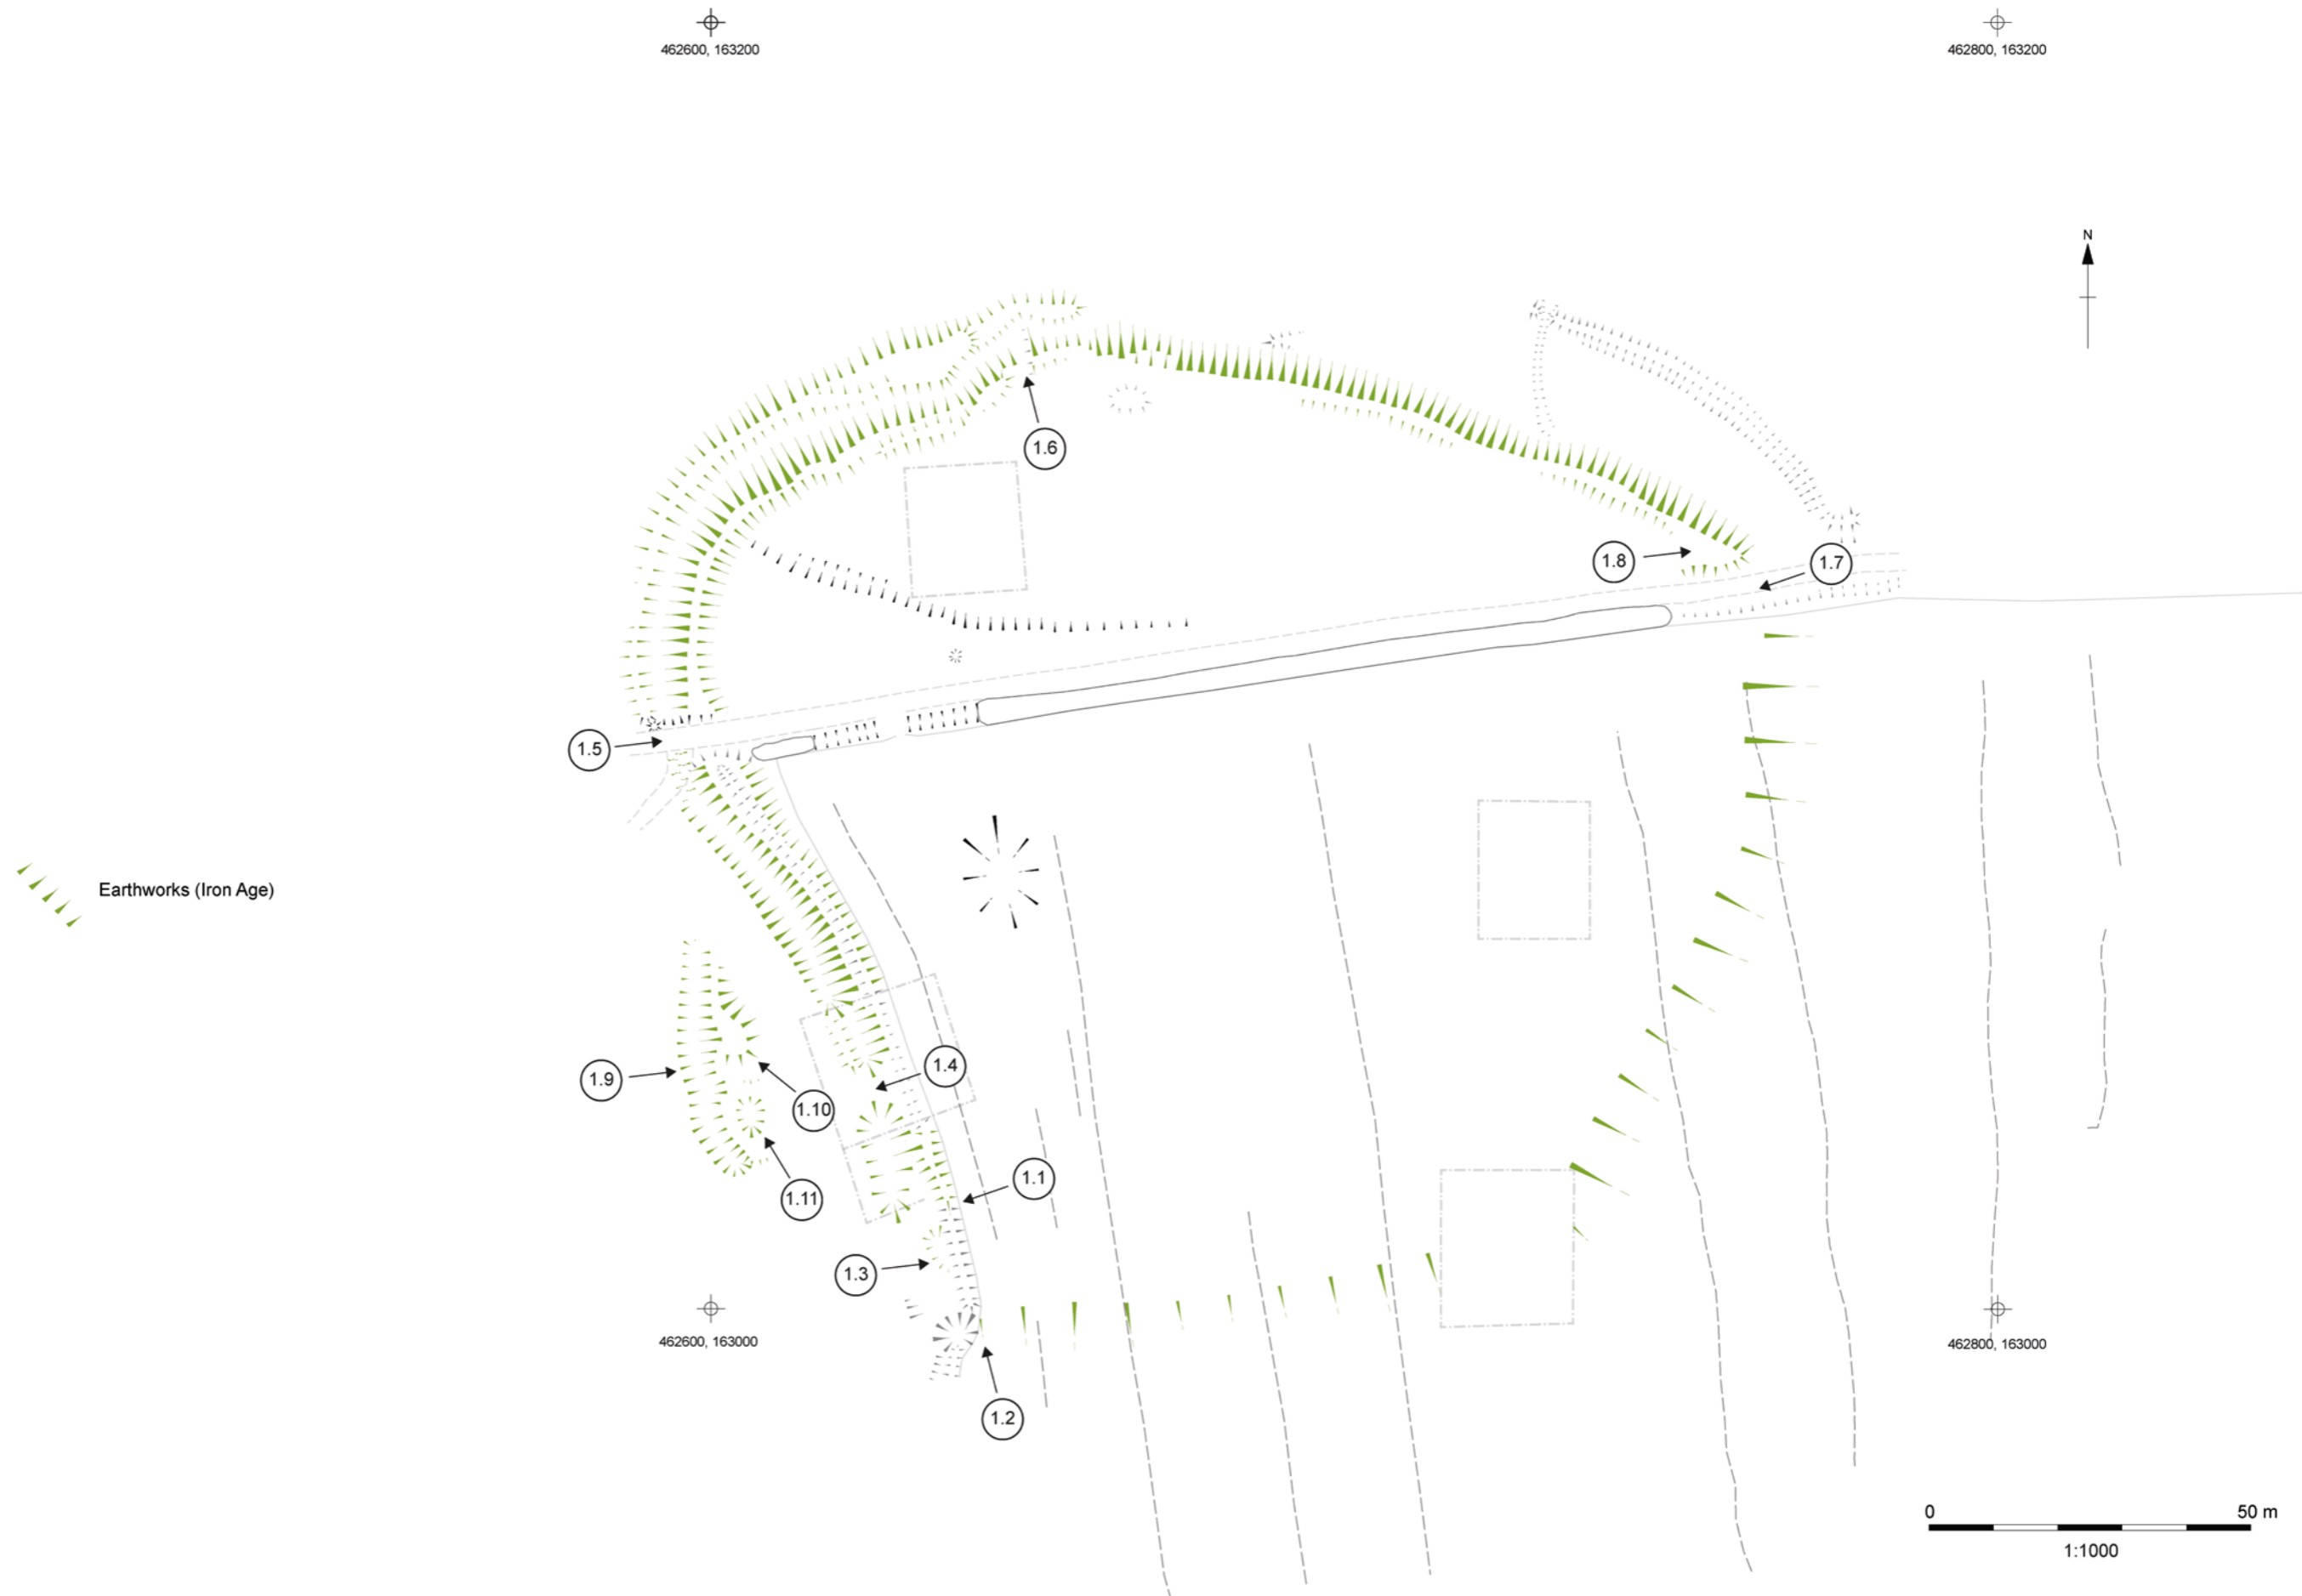
The hillfort is the earliest phase of activity recorded by the survey (Figs 17 and 18). It is defined by an enclosing earthwork bank and external ditch. Internally the enclosure measures approximately 155m west/east by 135m north/south, and encloses an area of slightly under 1.6ha. It is irregular in plan with a combination of curving and flat sides, and both gradual and abrupt corners (Fig 18).

Figure 18. The Frith, Iron Age features at 1:1000 (© Historic England).

For ease of reference earthwork features are grouped together into two phased and annotated plans (see Figs 18 and 19), and are presented below as text descriptions. All bracketed numbers refer to annotated features on Figs 18 and 19. All feature numbers with a '1' prefix refer to Fig 18, and all feature numbers with a '2' prefix refer to Fig 19.

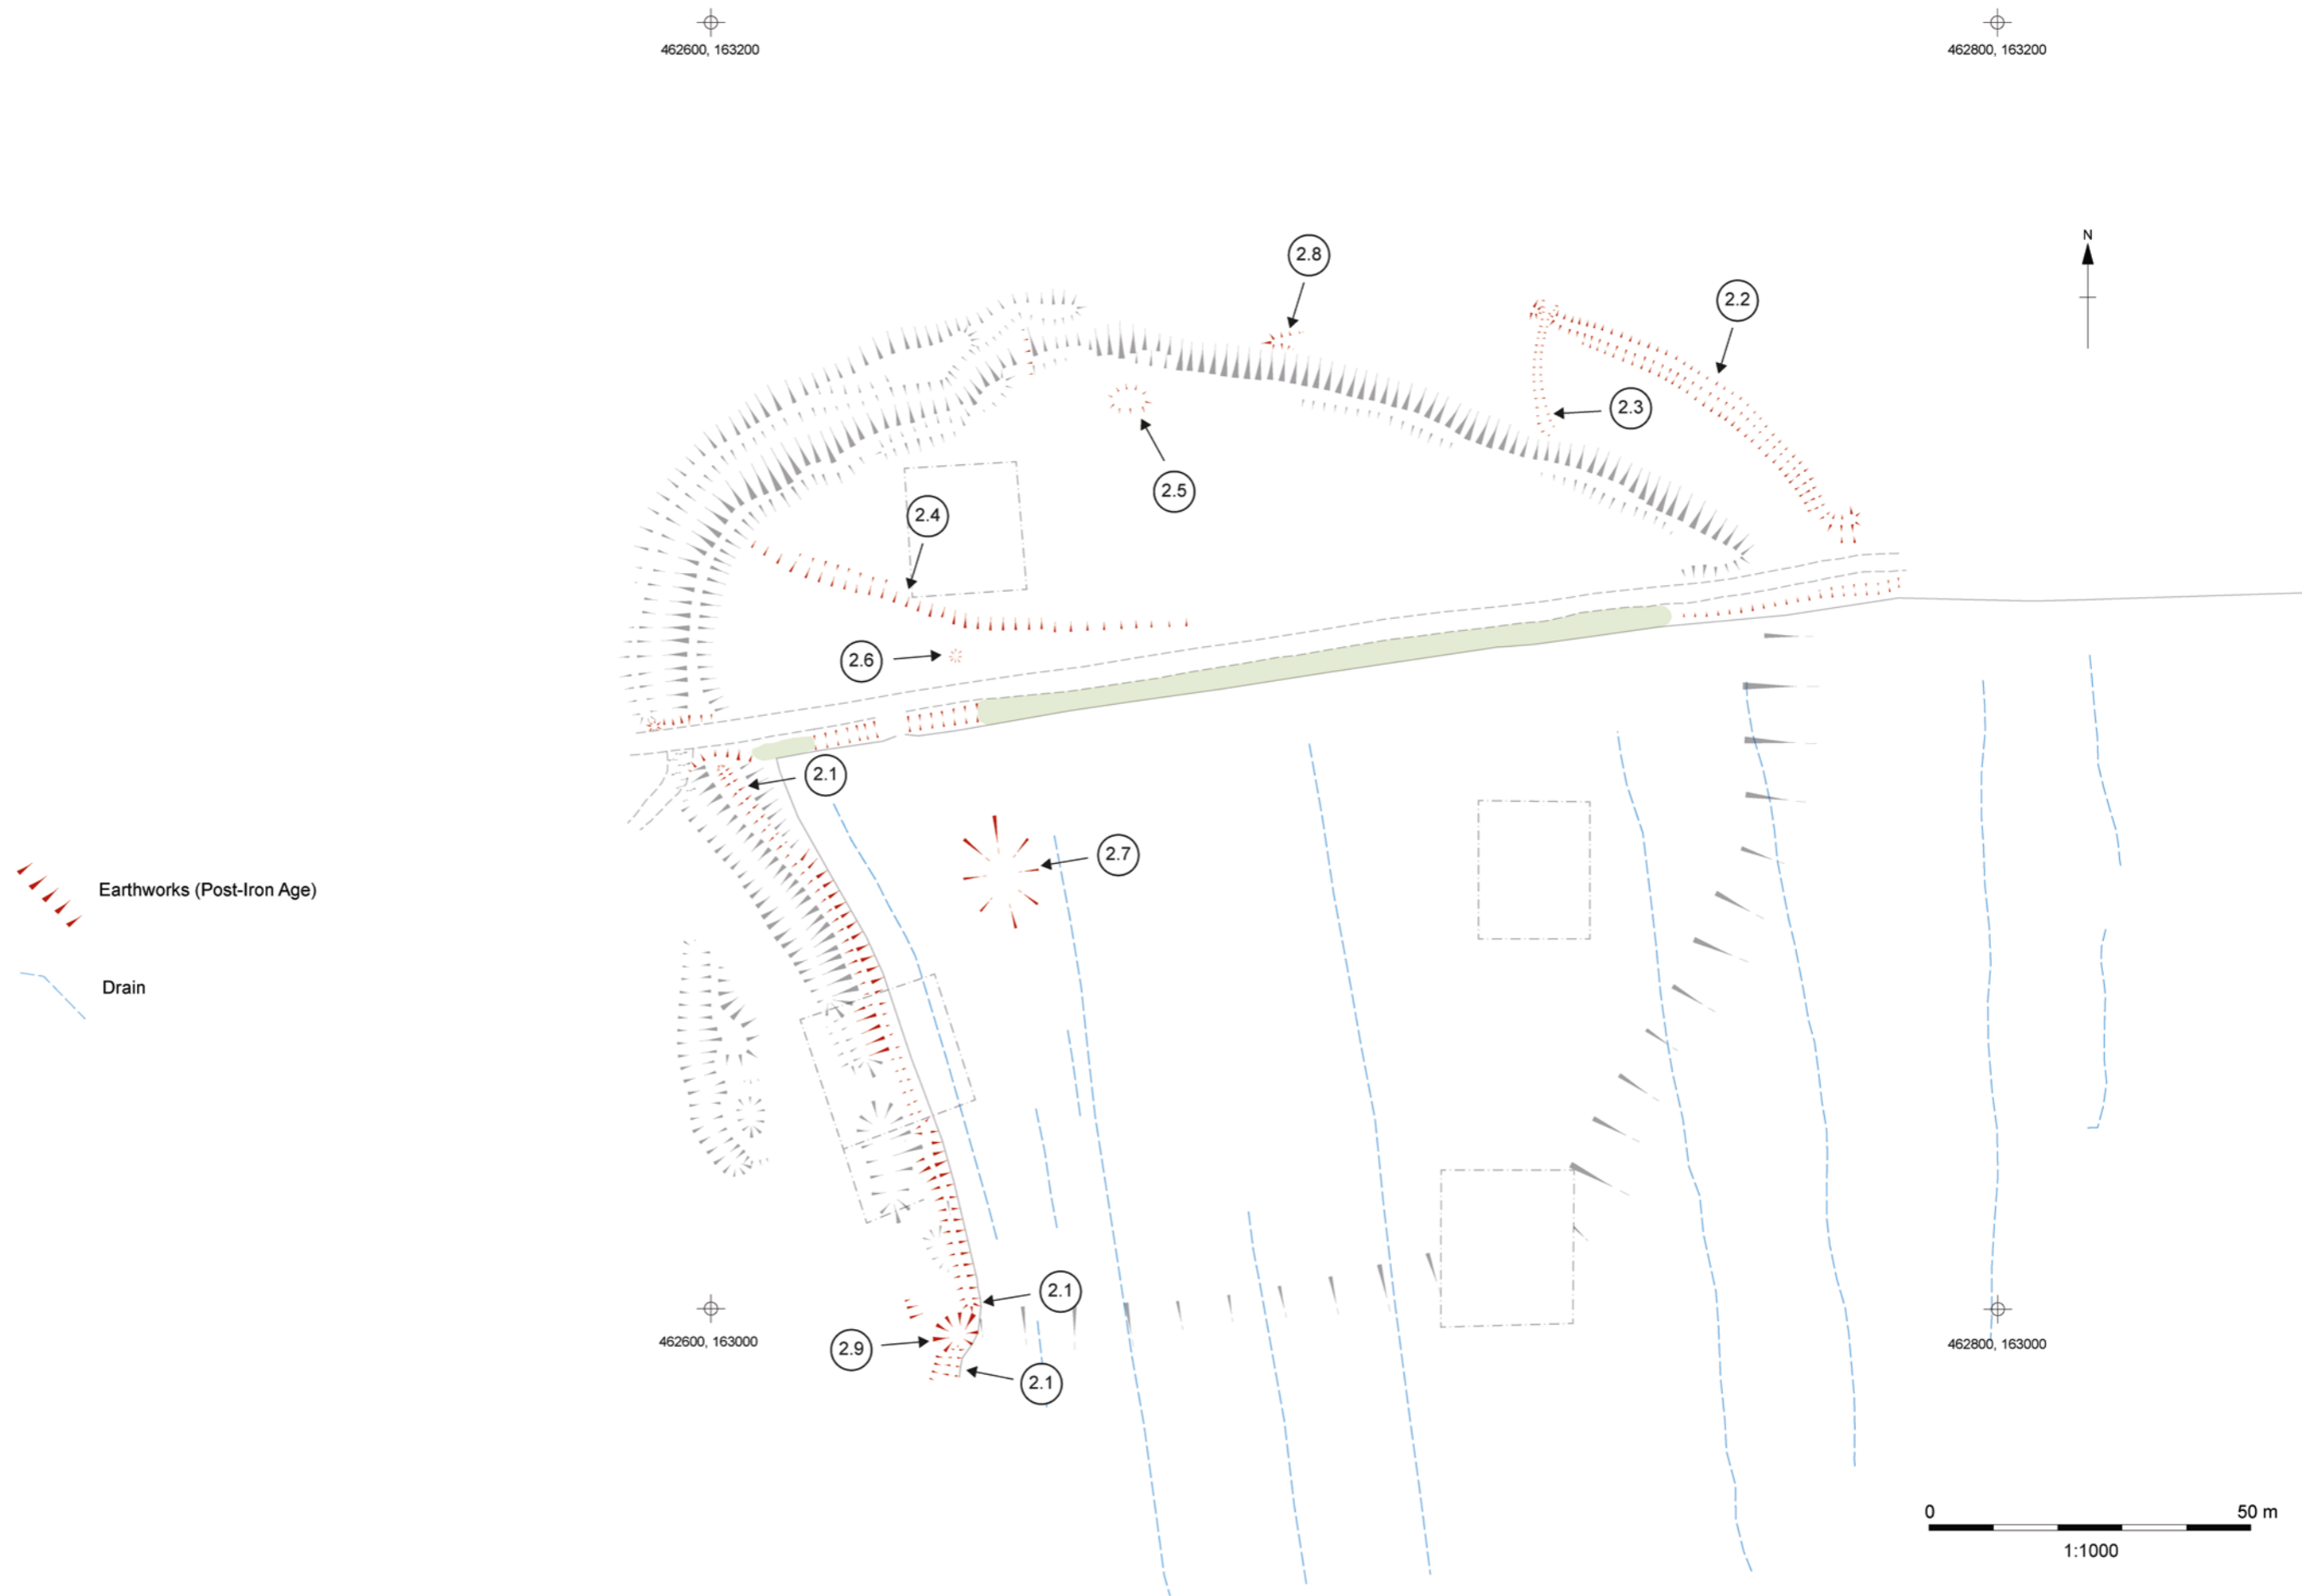
Two lengths of woodland bank were recorded within the survey area (Fig 19). Feature 2.1 runs along the spine of the hillfort's western rampart in area 2 (Fig 15). It blocks the western entrance (see Williams-Freeman 1915, 387) and continues beyond the southern limit of the survey area. It measures approximately 3m wide at its base, by 0.5m high. It is likely to be this feature that marks the boundary between plots 33 and 47 on the 1840 tithe map (see Fig 8).

Figure 19. The Frith, post Iron Age features at 1:1000 (© Historic England).

A series of north to south running land drains (shown in blue in Figs 17 and 19) were recorded within and to the south of the hillfort in area 3. These features show as shallow (approximately 0.1m to 0.2m deep) linear depressions.
