Rapid Coastal Zone Assessment Survey

Yorkshire and Lincolnshire:

Donna Nook to
Gibraltar Point
Phase 2

Humber Archaeology Report No. 325

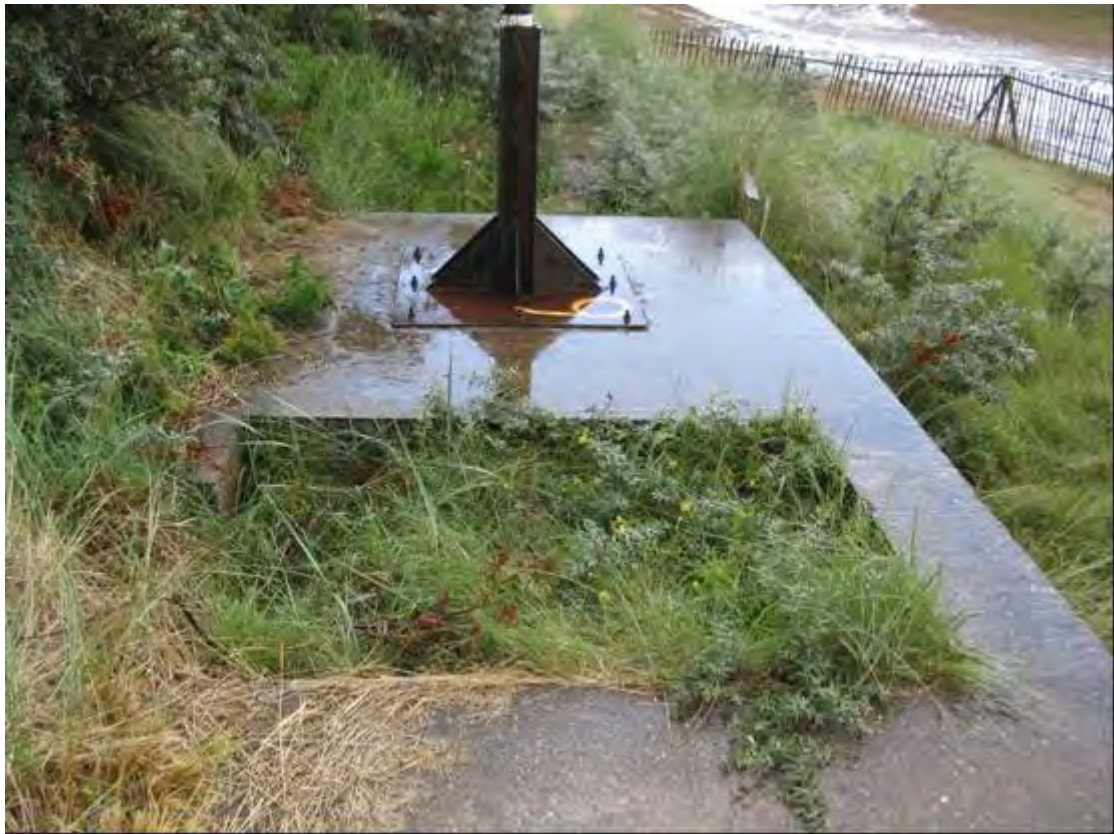
Plate 3 Infilled AA gun pit in roof of WW2 pillbox NS12, North Somercotes

The few surviving WW2 structures north of Donna Nook include pillboxes NS12, NS17 (Plate 4), and NS24 (Plate 11). Of these, NS12 (Plate 3) and NS24, 3-bay AA pillboxes, appear to be in good condition, but brick blockhouse NS17 has been damaged. Observation post NS15 has been demolished to ground level (Plate 8), but the underground entrance and side chamber are in good condition (Plates 5–7).

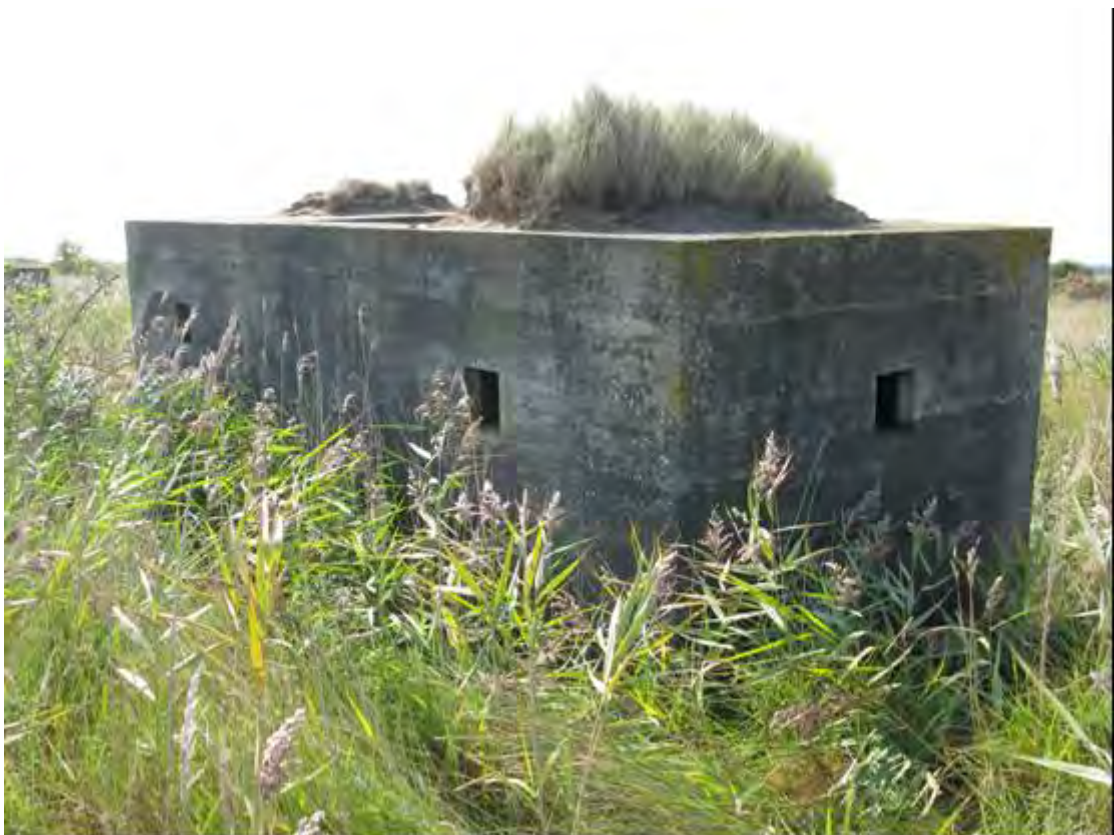
Plate 24 AA pillbox NS72, North Somercotes

Five hundred metres south of NS53 was a previously unrecorded group of structures including 3-bay pillbox NS66, in apparent good condition in an area of gorse (Plate 29), with a second example further south (NS72: Plates 24–26). Nearby were the abutments of a probable wartime bridge (NS67: Plate 30), presumably allowing access over the sea defences to the pillboxes and a cluster of other WW2 or later structures, including a brick observation post (NS73: Plates 26, 28), concrete ramp (NS68: Plate 21), brick building (NS69: Plates 21–23, 26), concrete platform (NS70: Plate 22), and a demolished building (NS71). The observation post had later additions and was marked 'OP4' (Plate 27), suggesting that it had been recommissioned as part of the bombing range. To the south, a set of anti-tank cubes (NS56: Plate 31) protecting the lane giving access to the foreshore from Jarvis's Farm were still partly in situ, although some had been moved after the war to allow the road to be brought back into use; nearby were fragments of what appeared to be a pillbox or observation post (NS74) with a rusticated finish. At the south end of the parish, a 3-bay pillbox (NS59) remains in good condition, but is apparently sinking into the underlying former silts (Plate 32).

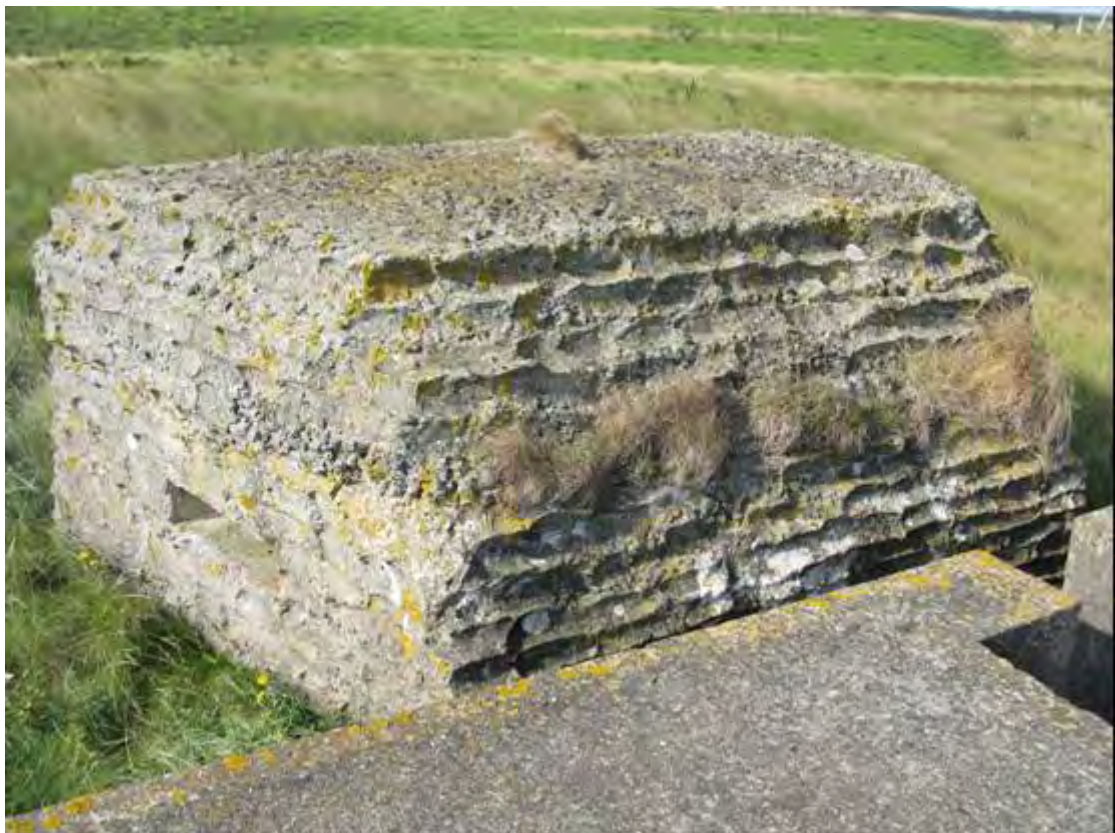
Plate 34 Rusticated square pillbox, SH1 pair, Skidbrooke with Saltfleet Haven

WW2 structures dominated the catalogue of 20th-century monuments in this parish. Two pillboxes recorded as SH1 at the northern boundary with North Somercotes survive in apparent good condition (Plates 33, 34); interestingly, one of these is a standard Lincolnshire-type AA pillbox (Plate 36), twinned with a rusticated blockhouse (Plate 35), and ten anti-tank blocks (SH2: Plate 37) remain close to their original positions blocking a beach exit immediately to the west. Further south, gun emplacement SH4 is in poor condition, the last remnant of a 3- or 4-inch coastal battery (Plates 38, 39), although a single anti-tank cube (SH6: Plate 40) remains more-or-less in situ further west on Howden's Pullover Lane, presumably protecting the western approaches to the battery.

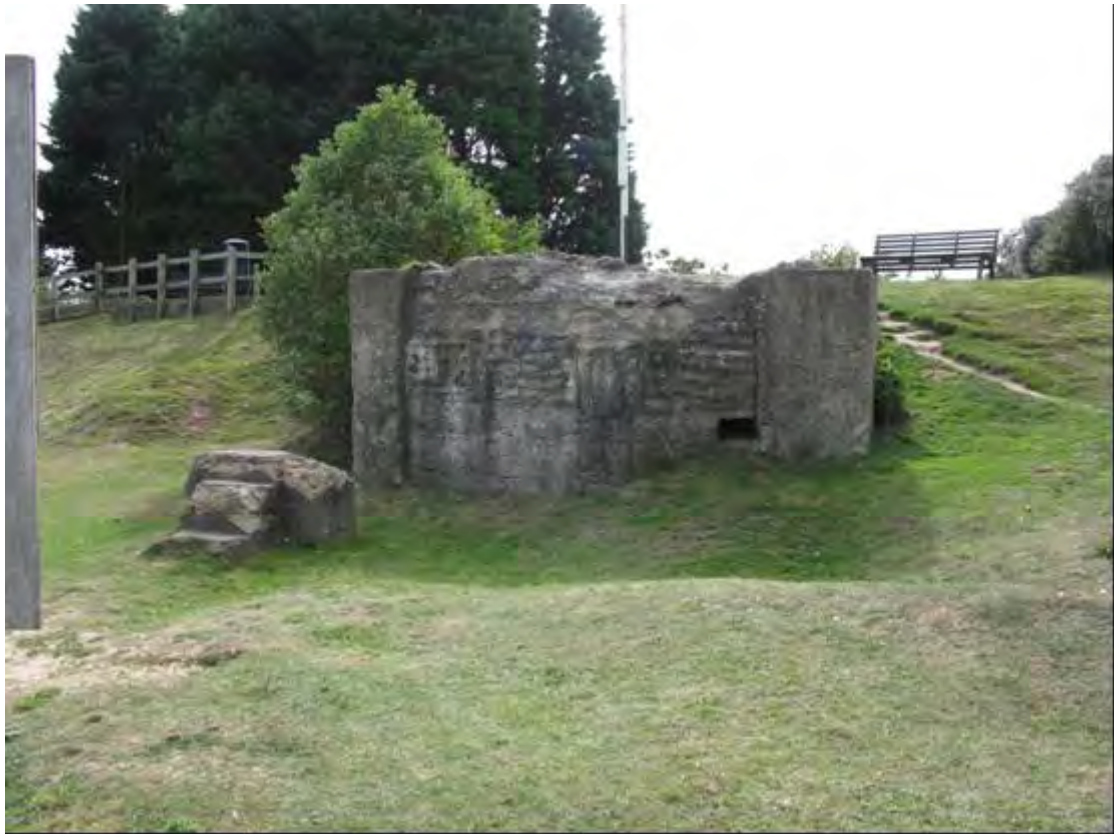
Plate 41 Pillbox SH8, looking south-west, Skidbrooke with Saltfleet Haven

On the northern outskirts of Saltfleet, pillbox SH8 (Plate 41), with a commanding view over the saltmarsh (Plate 42) is in good condition, although the rusticated finish, which seems to be favoured on this short stretch of coast, had been damaged. A firing range to the south (SH11) had been dismantled, and a possibly related oval earthwork at the west end (SH13) had also disappeared; a similar but smaller earthwork structure at the south end of the parish (SH27: Plate 58) was also not visible.

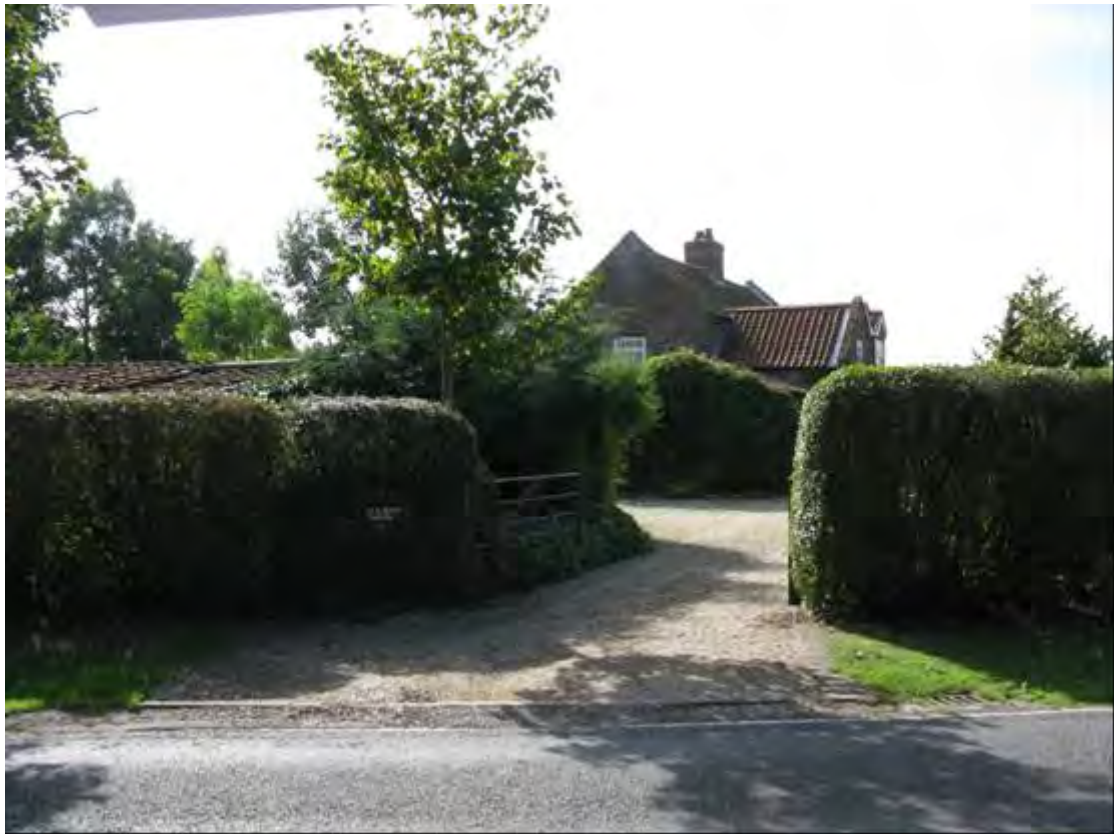
Plate 43 Seabank House (SH10), Skidbrooke with Saltfleet Haven

On the northern outskirts of Saltfleet, Seabank House, a late 17th-century building with later additions (SH10: Plate 43) remained in good condition, as does the contemporary Manor House (SH18: Plate 48) further south.

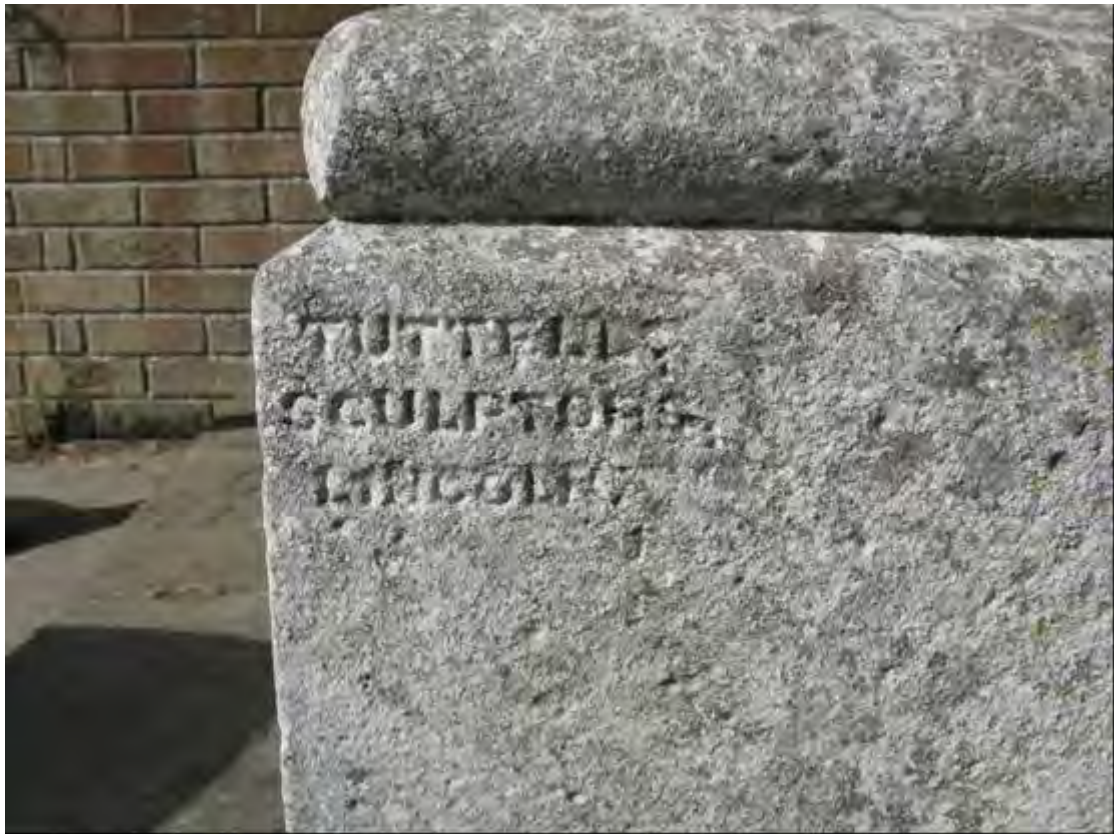
Plate 45 Mason's details, Saltfleet pump (SH14), Skidbrooke with Saltfleet Haven

Several monuments recorded in the village during the Phase 1 survey were still extant and in good condition, including the later 19th-century communal pump (SH14: Plates 44, 45), Methodist Chapel (SH16: Plate 46) and New Inn (SH17: Plate 47). The village windmill (SH20: Plate 49), originally built in the late 18th century, but largely rebuilt in the 19th century, has been restored as a dwelling after a period of dereliction.

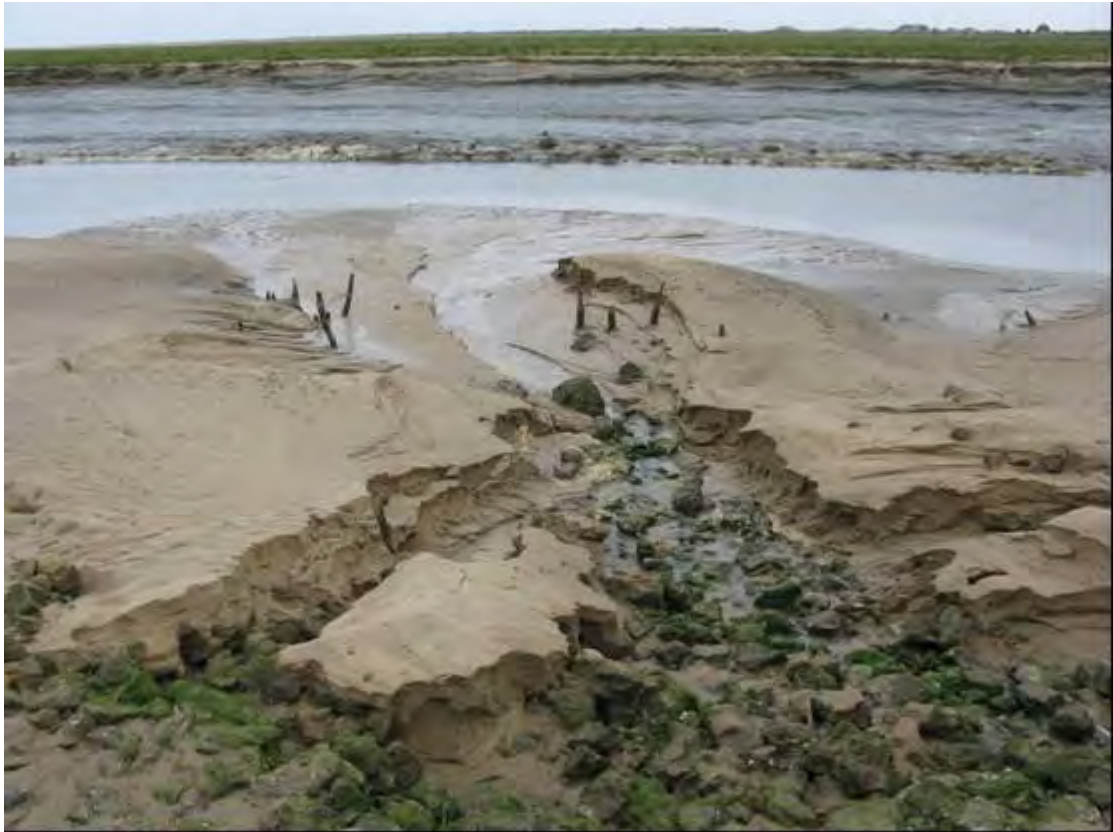
Plate 51 Exposed causeway SH22, Saltfleet Haven

At the south end of the parish is the formerly important channel of Saltfleet Haven (SH21: Plates 50, 51), which at the seaward end contains a stone causeway (SH22: Plates 51, 52), in good condition, flanked on the north side by several groups of timber piles (SH23: Plate 53, SH28: Plate 54, SH29: Plates 55, 56) in fair condition; these may be the remains of previous attempts to reinforce the edge of the channel. There were still some extant remains of the wreck of a steam vessel previously recorded next to the Haven channel at the seaward end of the piles (SH24: Plate 57), although it was in very poor condition.

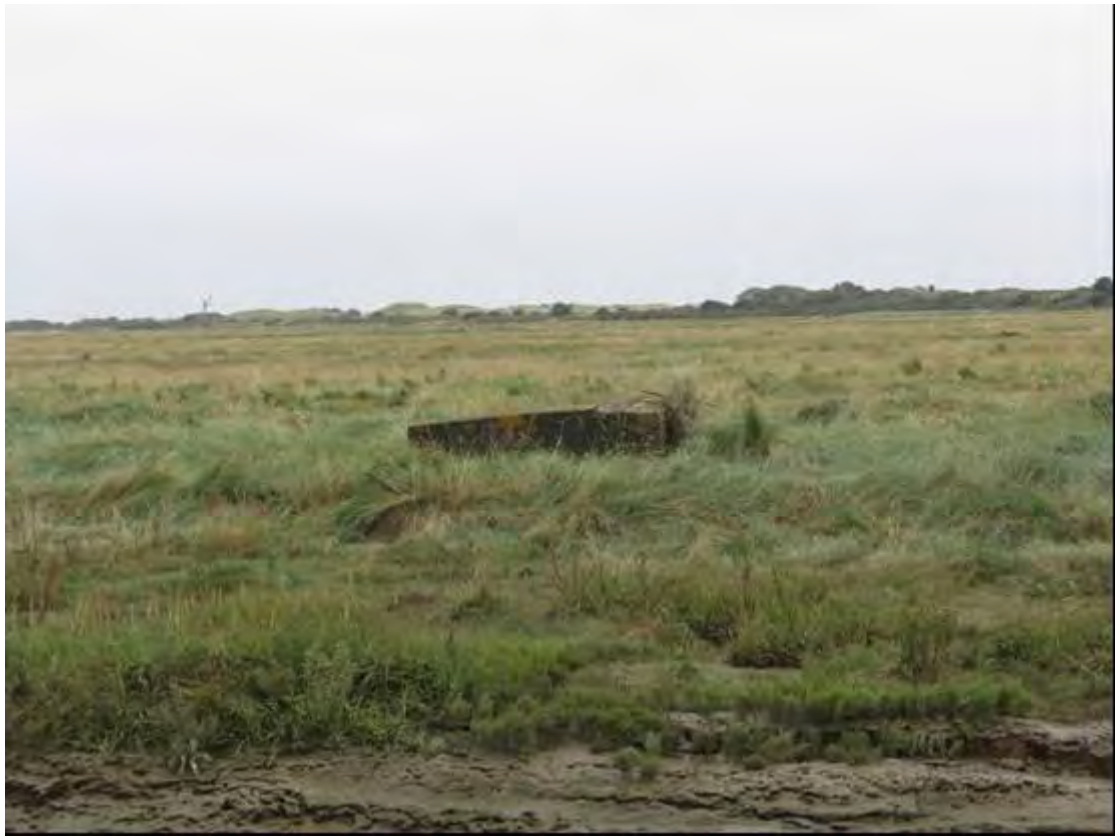
Plate 59 WW2 concrete structure SA1, Saltfleetby

On the south side of Saltfleet Haven, two concrete blocks (SA1: Plate 59) may be the remains of WW2 anti-landing obstructions, perhaps blocking the channel. An enclosure located inland to the south-west (SA9) had been ploughed out. East of the Great Eau, pillbox SA6 was in good condition (Plate 60). Further south, searchlight

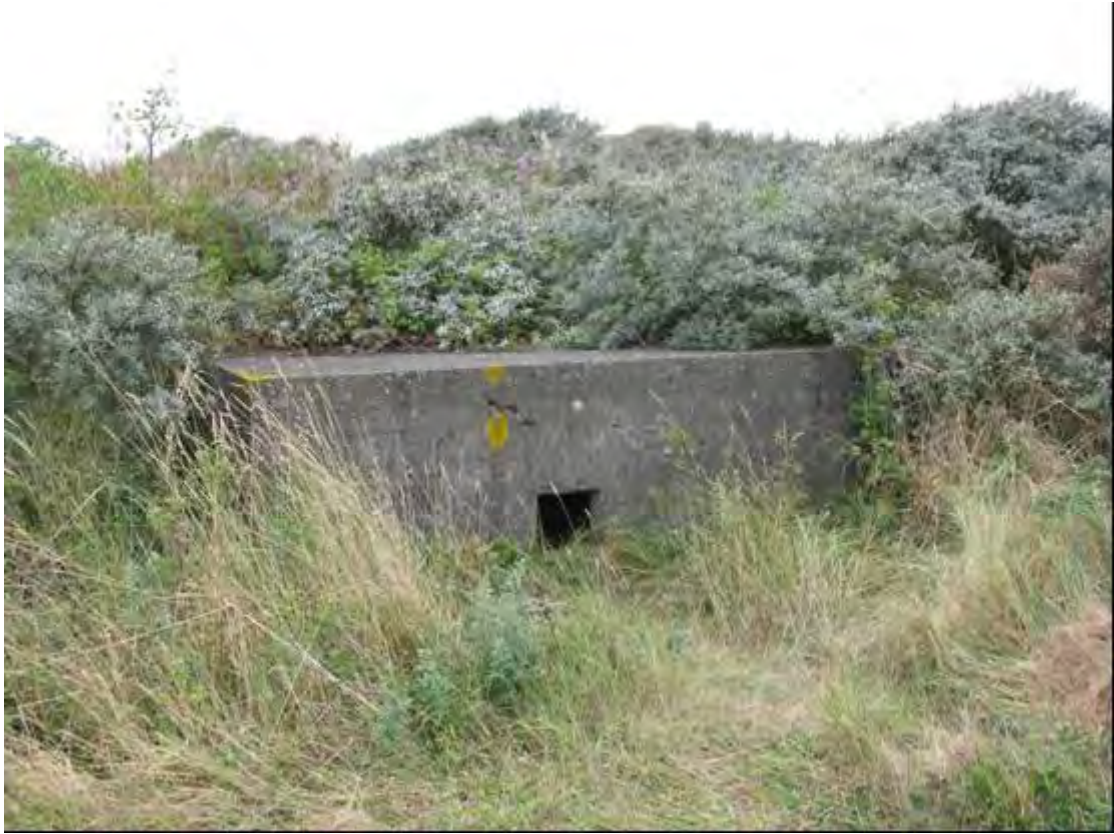
Plate 67 Pillbox SA30, Saltfleetby

The Phase 1 report noted a second cluster of WW2 features south-east of Sea View (the Rimac Defended Locality), but most of these have been destroyed, including pillboxes SA21, 25, 31, army camp SA22 (Plate 66), gun emplacement SA23, trench SA24 and enclosure SA29. To the east, pillbox SA30 has survived facing east from the seabank (Plate 67), the last of three which included SA21 and SA25.

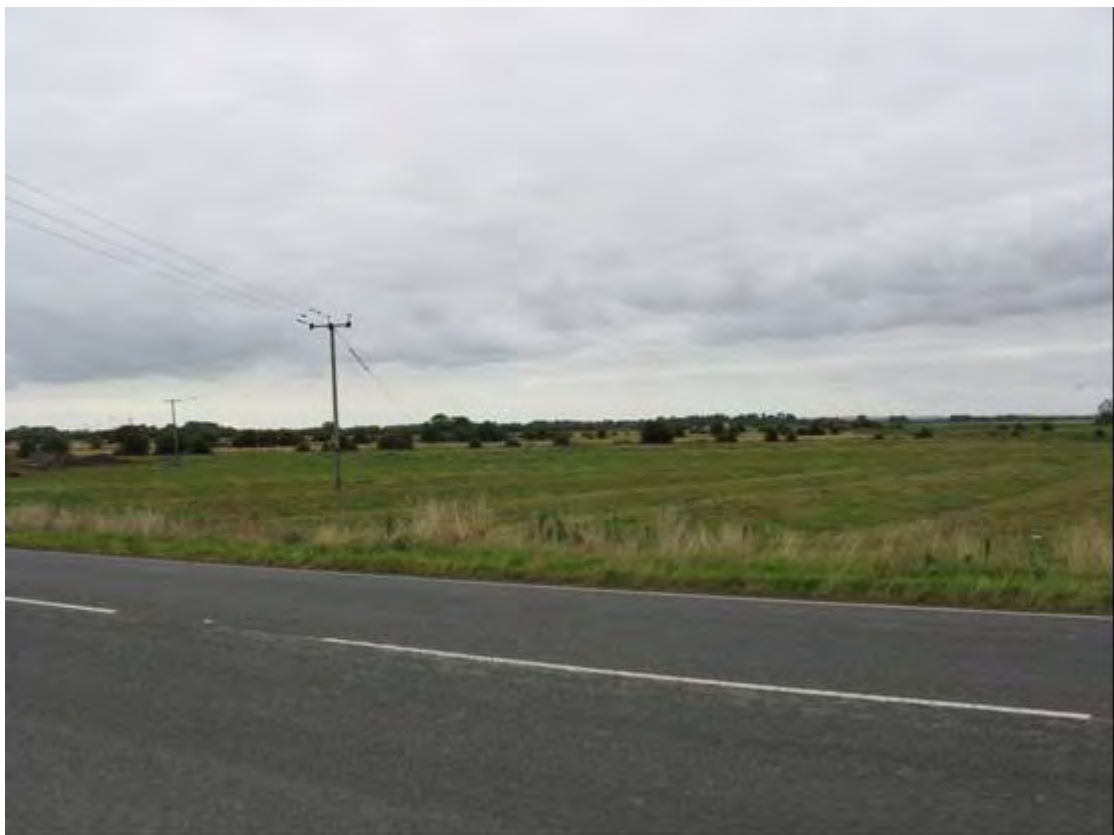
Plate 82 Surviving ridge-and-furrow near DMV TS12, Theddlethorpe All Saints

Extensive traces of medieval ridge-and-furrow and enclosures (TS8: Plate 80, TS12: Plates 81, 82), mainly west of the A1031, were still extant, although ploughed out in some areas, including a possible DMV site at TS12. These were apparently part of the same complex noted in Saltfleetby (SA34), with a concentrated nucleus of enclosures or house platforms at TF 4711 8987 (TS16: Plate 84). These appear to mark the location of one or more small settlements or farmsteads. There was no sign of a further enclosure located to the east near the former coastline (TS14).

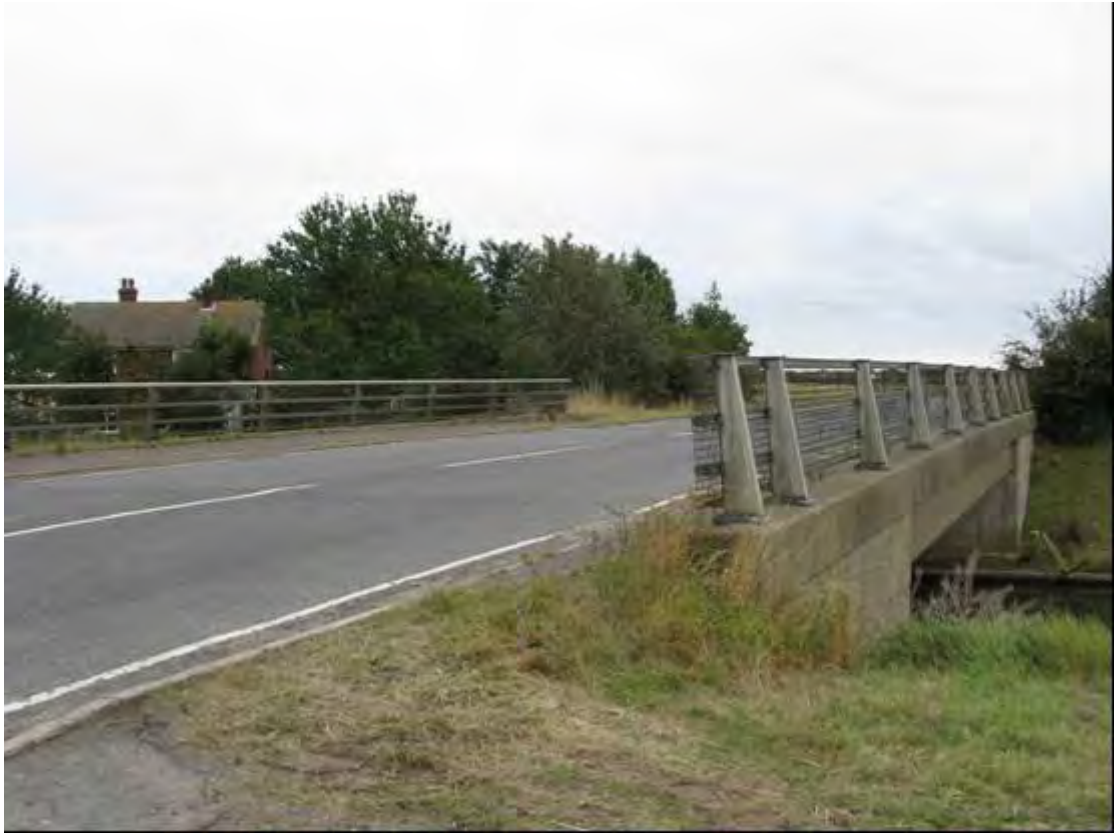
Plate 83 Site of WW2 mined bridge TS11, Theddlethorpe All Saints

A mined bridge to the south (TS10) is apparently still extant as a farm bridge linking two fields across a ditch near the old seafront, although no access was available in 2009. Further to the south-east behind the seafront was another pillbox (which the corrected grid reference place just inside the Theddlethorpe St Helen boundary; this record (formerly TS15), has therefore been transferred (now TH18). Inland, a second mined bridge (TS11) carrying the A1031 across the Great Eau has been replaced by a more modern structure (Plate 83), while a pillbox at Sea Bank Farm (TS17) has apparently been demolished.

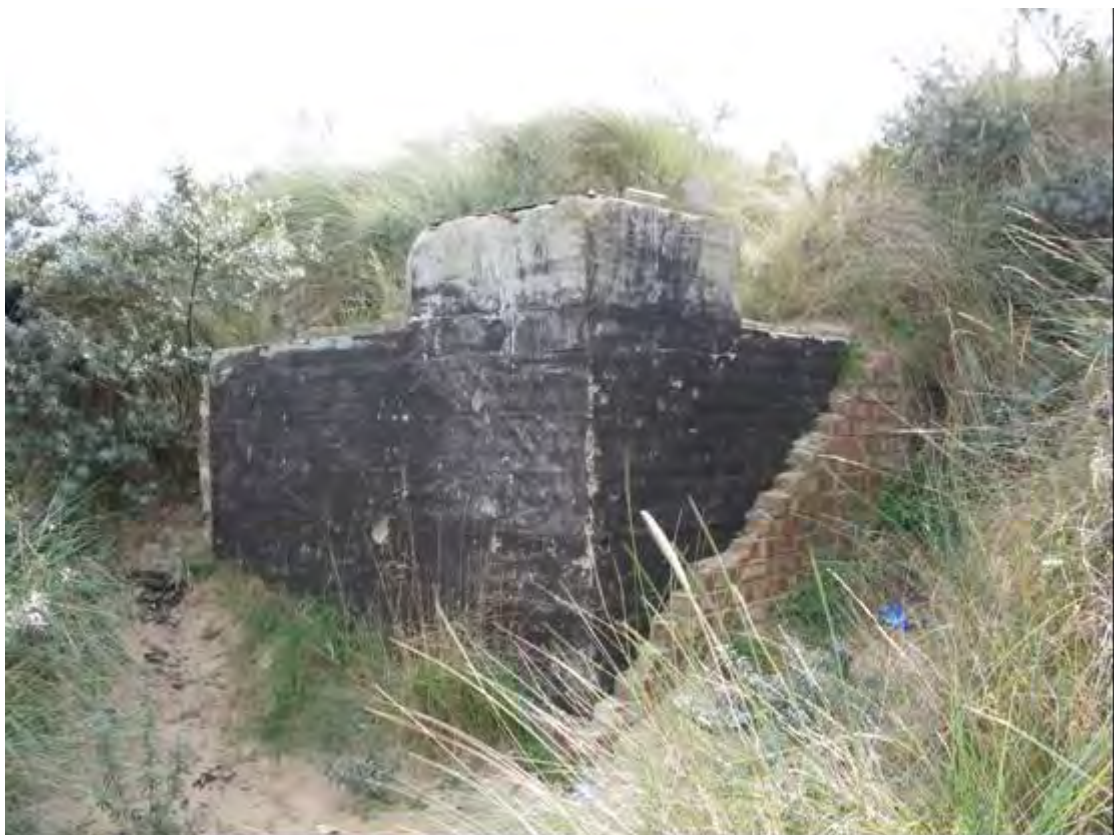
Plate 98 Remains of ROC post MS4, Mablethorpe

At the north end of Mablethorpe town, ROC post MS4 is now in poor external condition, with the brick skin collapsing to reveal the inner concrete structure (Plate 98).
