# CURTIS'S AND HARVEY LTD EXPLOSIVES FACTORY, CLIFFE AND CLIFFE WOODS, MEDWAY ARCHAEOLOGICAL SURVEY AND ANALYSIS OF THE FACTORY REMAINS

Volume 1 of 2

Rebecca Pullen, Sarah Newsome, Andrew Williams and Wayne D Cocroft

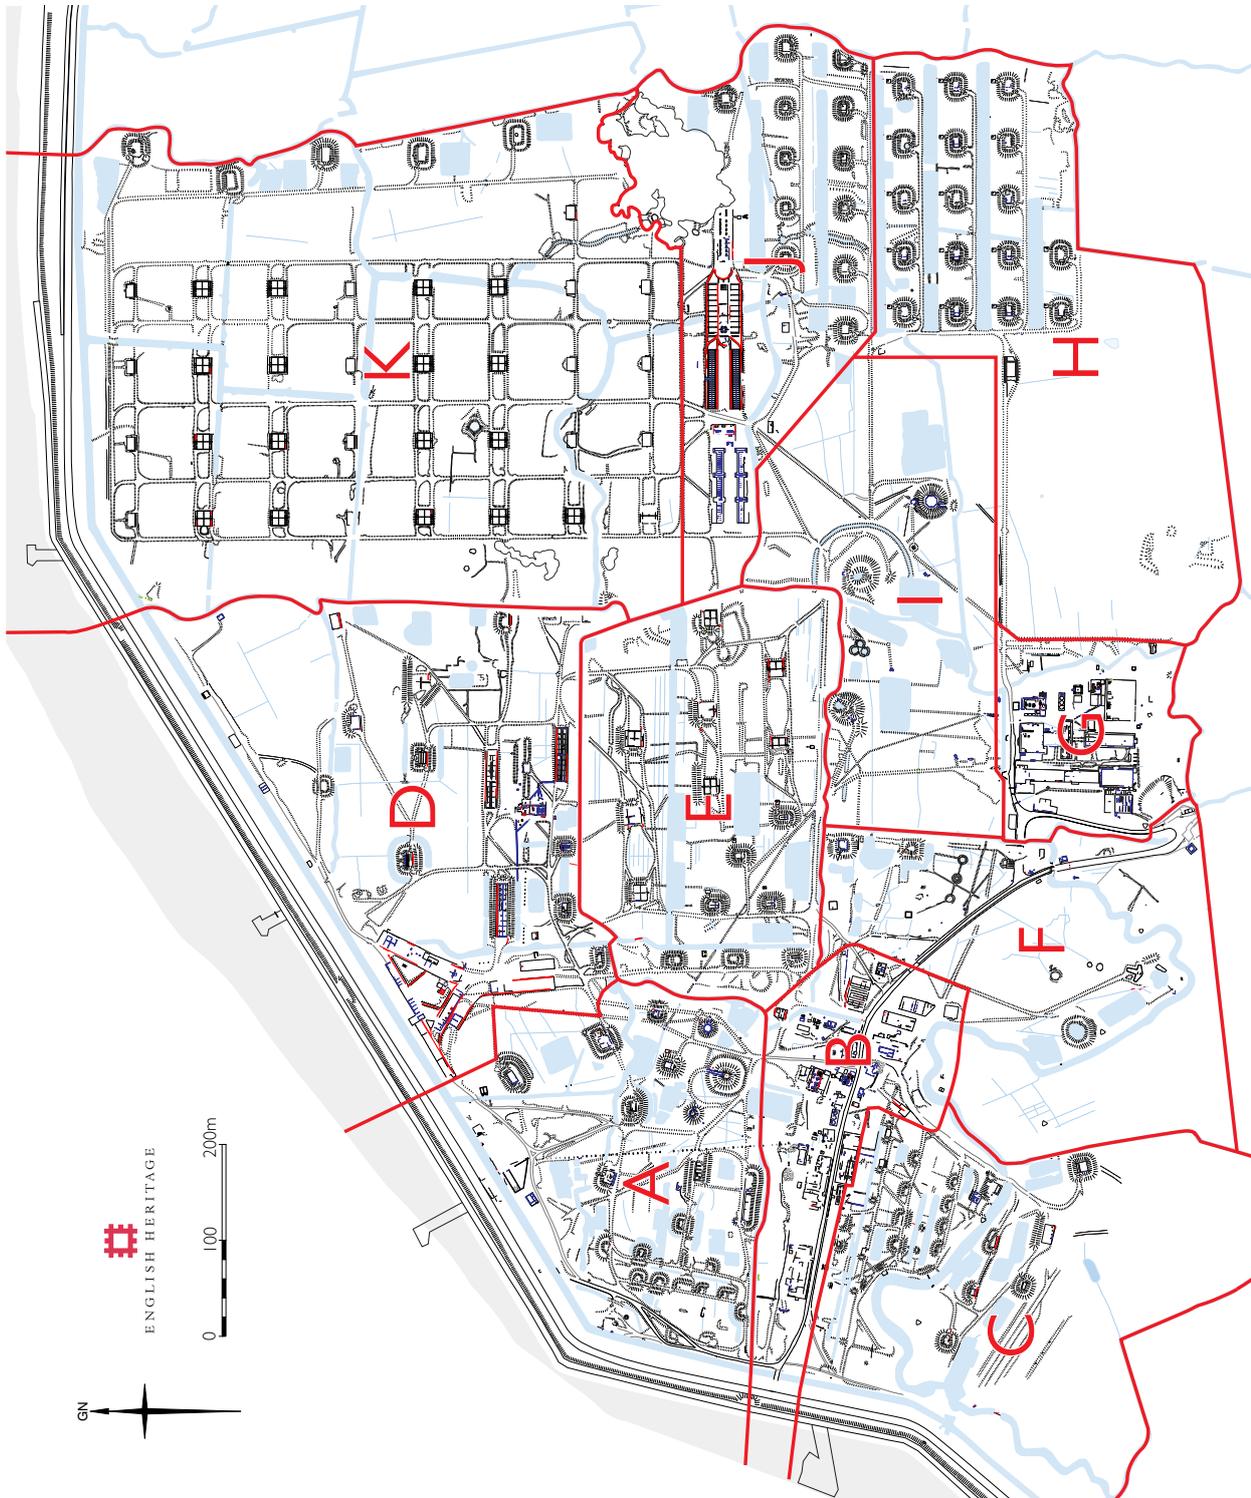
Figure 2: Reduced version of full survey, showing Areas A to K as used to organise descriptions of the factory remains throughout this report. Drawn by Philip Sinton © English Heritage.

Although primary documentary sources reveal that Curtis's & Harvey had established a numbering system for buildings at their Cliffe factory, these sources only enable us to assign original numbers to a handful of structures on the site. With this in mind, a new numbering system was established to accompany the survey drawing to provide a way of orientating the reader, and of anchoring individual descriptions, essential for a site of such great size and complexity. The new number sequence runs consecutively from **1** to **284** and includes all identifiable discrete 'structures' (see explanations of terminology above) believed to belong to the factory complex. Numbers have not been assigned to generic features found factory-wide, such as tramway embankments, culverts and manholes, or to features identified as having origins either pre- or post-dating the operational period of the explosives works. Linear features and features grouped in a linear arrangement were also noted in several instances across the factory site, in the form of post arrangements, extensive culverts and alignments of distinctive triangular foundations. The five clearest linear features have each been assigned a number to aid description and identification: linears **L1** to **L5**. The four wooden jetties connecting the factory to the Thames shipping route have also been labelled for ease of identification: jetties **J1** to **J4** ordered by construction date from earliest (**J1**) to latest (**J4**). Finally, to further aid orientation around the site and to provide a simplified grouping system for geographically and functionally related structures, the area of investigation has been divided into eleven zones, **Areas A** to **K**, predominantly using the drainage dykes as boundaries (Figure 2). These zones have been used to order the descriptions of factory structures in section 6.

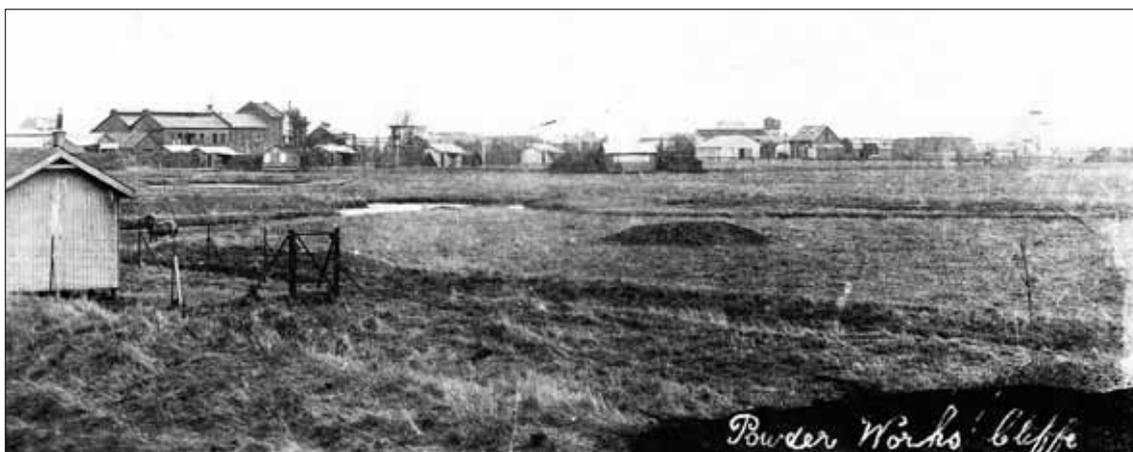
Figure 5: Curtis's & Harvey Ltd Explosives Factory taken around 1908, showing the acid and guncotton processing buildings in **Area B**, with the taller structures of the nitroglycerine factory in **Area A** just visible in the background © Cliffe and Cliffe Woods Parish Council, reproduced by kind permission of Pat Leviston.

Amongst the local community there is interest in the social history of the site, but its industrial archaeology has not been addressed in any detail. Passing mention of the factory is made in several publications relating to the history of the local area, typically with an emphasis on factory employees and often focussing on the unfortunate accidents they encountered (eg Munday 1994; Thomas 2008). In his pictorial books about Cliffe, Allan Cherry includes a pair of formal photographs of the staff lined up in their Curtis's & Harvey uniforms with anecdotes from personal accounts (Cherry 1998, 54-5). He also published what currently appears to be the only known photograph of the factory prior to the dismantling of the buildings, which is thought to have been taken around 1908 and probably shows the early acid-handling and guncotton preparation area towards the west side of the site (Cherry 1991, 29) (Figure 5).

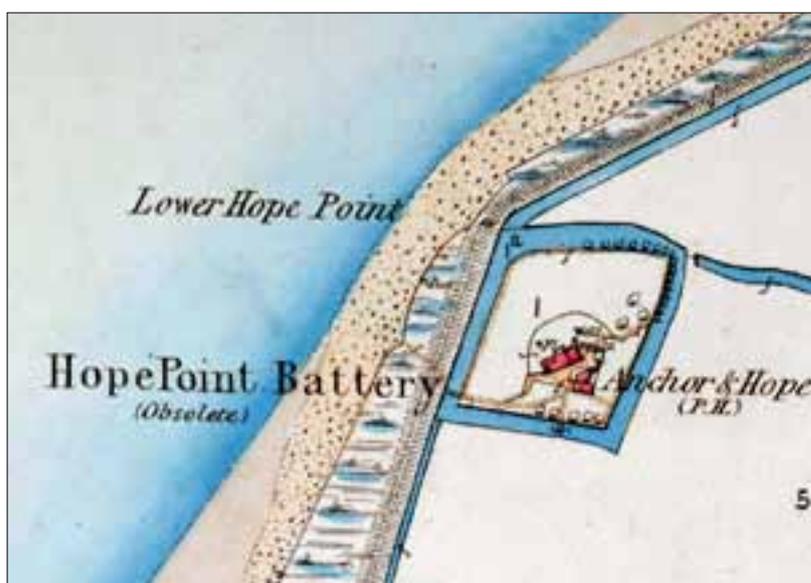
*Figure 9: Extract from the 1860 1st edition 25-inch Ordnance Survey map, Kent sheets IV.9, showing the disused Hope Point Battery and the Anchor and Hope Public House. MALSC U0565\_E689, Medway Archives and Local Studies Centre, Strood; reproduced by kind permission.*

For a short period in the mid-late 19th century, while the 18th-century battery at Lower Hope Point was out of use but still standing, the 'Anchor and Hope' public house was opened in a building at the south-east edge of the battery complex (see Figure 9). It is mostly likely that establishment of the alehouse marked a reuse of an existing part of the battery complex, rather than construction of a new purpose-built building. A licensed publican, Mr Joseph Henry Germain, is recorded at the Anchor and Hope in 1847 (Bagshaw 1847, 310), and subsequent trade directories log the inn as active in the 1850s and 1860s (Kelly & Co 1855a, 308; 1855b, 1312; 1862, 789; Melville & Co 1858, 313). By 1874 the establishment no longer appears in the records having presumably closed (Kelly & Co 1874, 1209). No remains of the pub survive; like the battery, it has been erased by later use and remodelling.

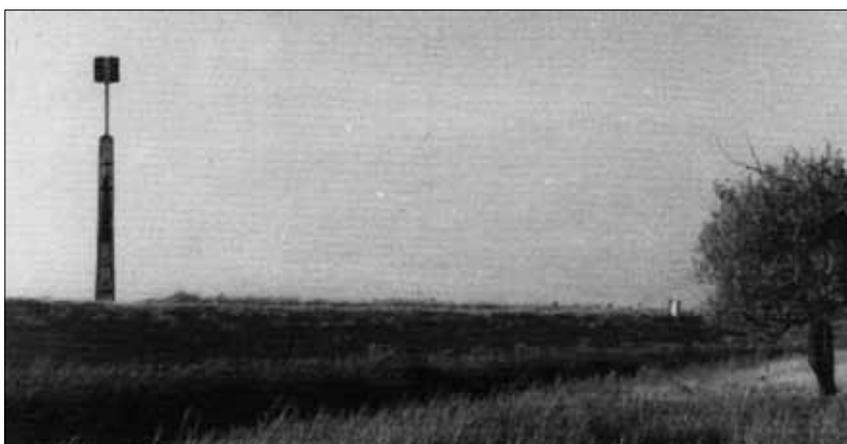
*Figure 10: The Point Beacon on the edge of the River Thames, undated (after Cherry 1998, 52) © Allan Cherry, reproduced by kind permission..*

The 18th-century battery at Lower Hope Point was flanked by two open iron-framed navigational beacons, one on the foreshore ('The Point Beacon') and the other to the rear of the battery (Figure 10). Although it is unclear when the beacons were first erected or whether the beacons or the battery came first, they pre-date the area's association with explosives manufacture and are likely to have remained in use during, and perhaps even following, the factory's period of operation. The tumbled remains of the Point Beacon now lie on the foreshore and the circular base of its inland partner was recorded during the EH survey of the factory grounds (see section 5.5).

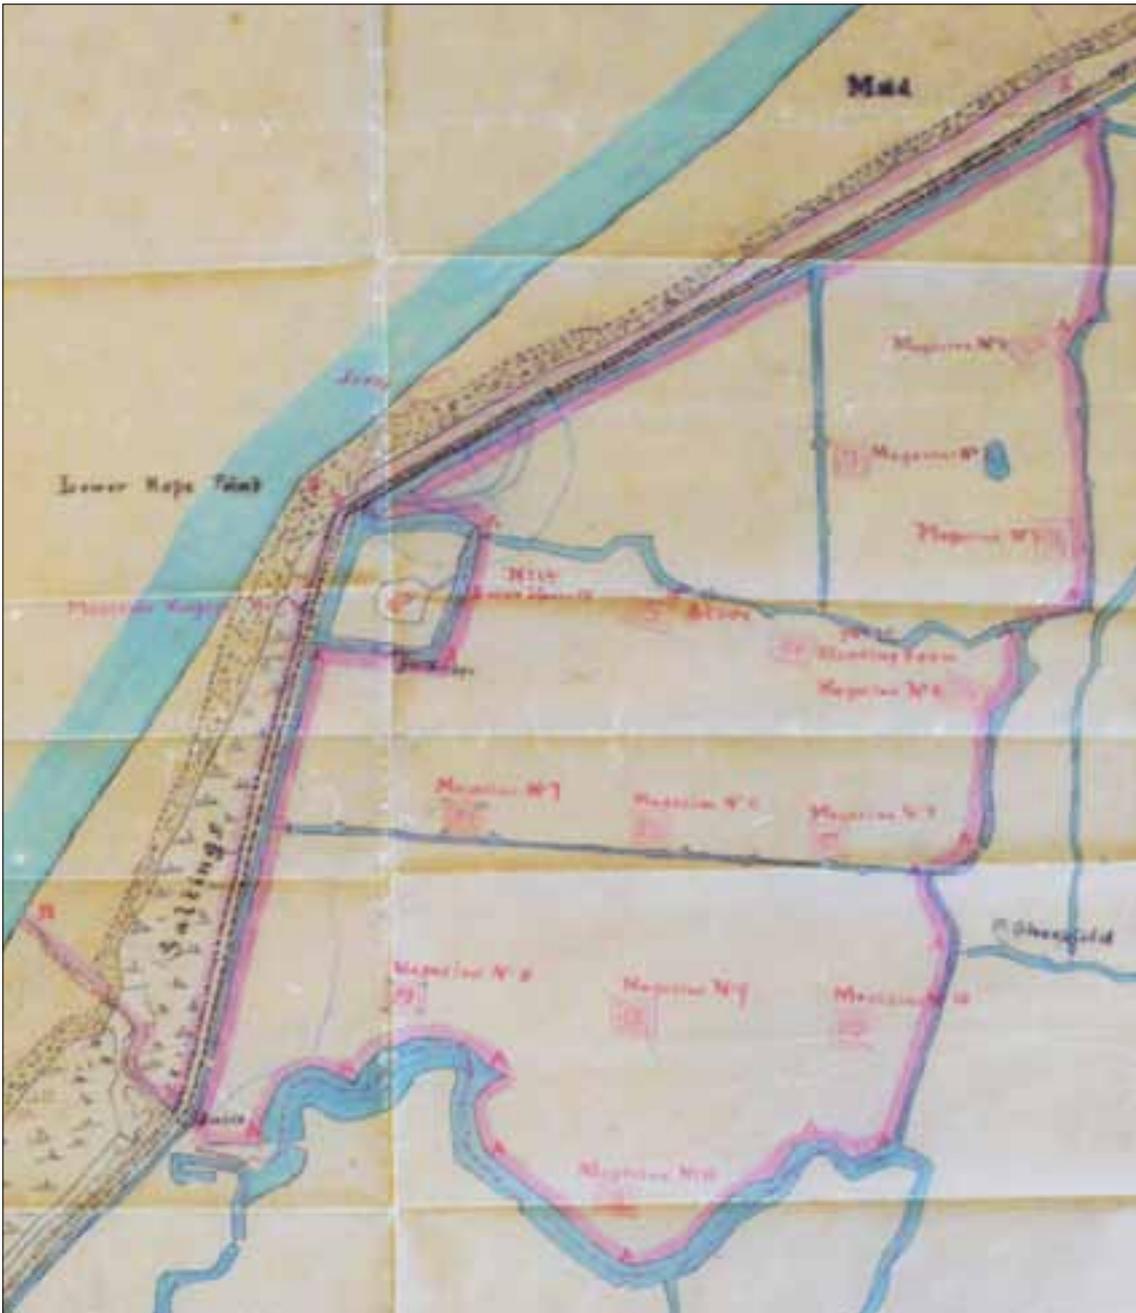
Figure 12: Hay, Merricks & Co's proposed gunpowder factory layout for Lower Hope Point, 1890. KHLCKS-SINK/AIC/1119 © Kent History & Library Centre, Maidstone; reproduced by kind permission.

The draft licence documents are accompanied by a plan showing the proposed layout of the site, depicting 14 new buildings: 11 magazines, a blending house, a boiler house and a stove, along with a magazine keeper's house reusing buildings on the former battery site and a jetty 40 yards (36.58m) in length (ibid) (Figure 12). Term 10 of the draft licence allowed for the addition of a tramway, and specified that tram rails within 3 yards (2.74m) of any part of a 'danger building' must be made 'of wood, brass or other suitable material'. Further to this, the First Schedule of the draft licence details the constructional specification for buildings:

plan, like that produced in 1890 (see Figure 12), shows fourteen proposed structures. However, both the arrangement of the buildings and the numbering system differs slightly from that proposed in 1890, and a pencil label to the left of the site says 'Cordite Magazines'. This could represent another proposed layout, this time by Curtis's & Harvey

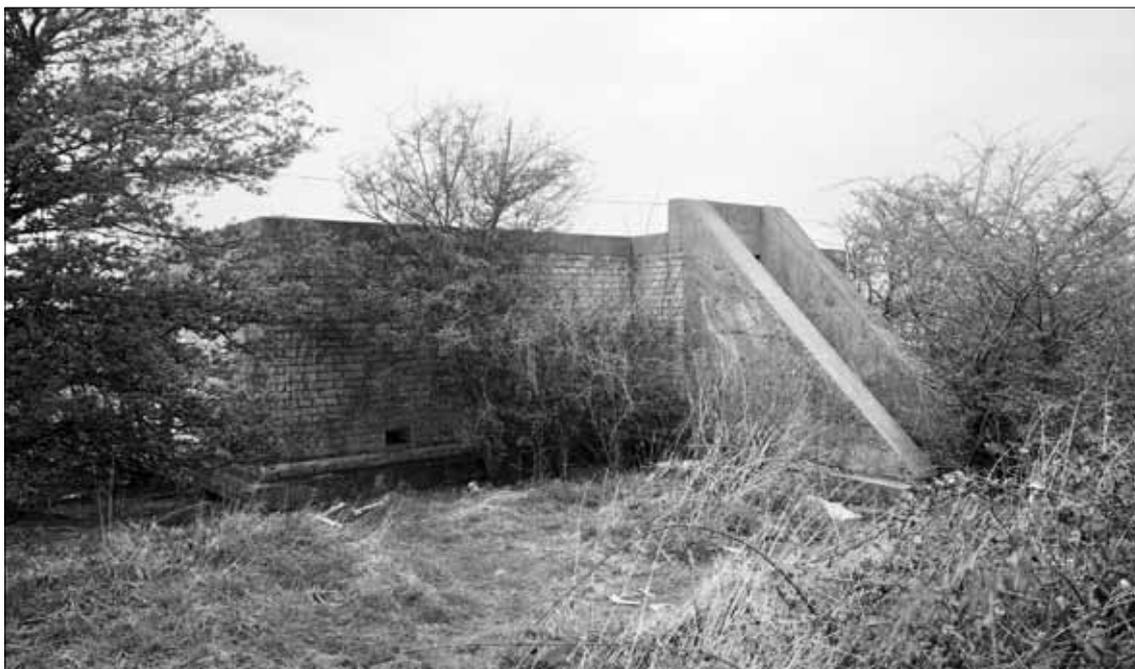
*Figure 18: Decoy control bunker for the Type Q airfield bombing decoy on Cliffe Marshes. NMR BB94\_08743 31-Mar-1995, Dank Silva © English Heritage.*

In addition to wartime activities relating directly to the area of investigation, the area immediately surrounding the former factory site was heavily involved in military defence schemes at this time. A Type Q airfield bombing decoy (NMR TQ 77 NW 122) - an arrangement of lights designed to simulate ground activity on an airfield - was established on the marshes in an attempt to draw German bombers away from RAF Gravesend (Dobinson 2000, 250). An associated control bunker survives roughly 1km to the south of the explosive works (NMR TQ 77 NW 146) (Figure 18). No further ground evidence has been identified. It remains uncertain whether the site was abandoned before or after it became operational.

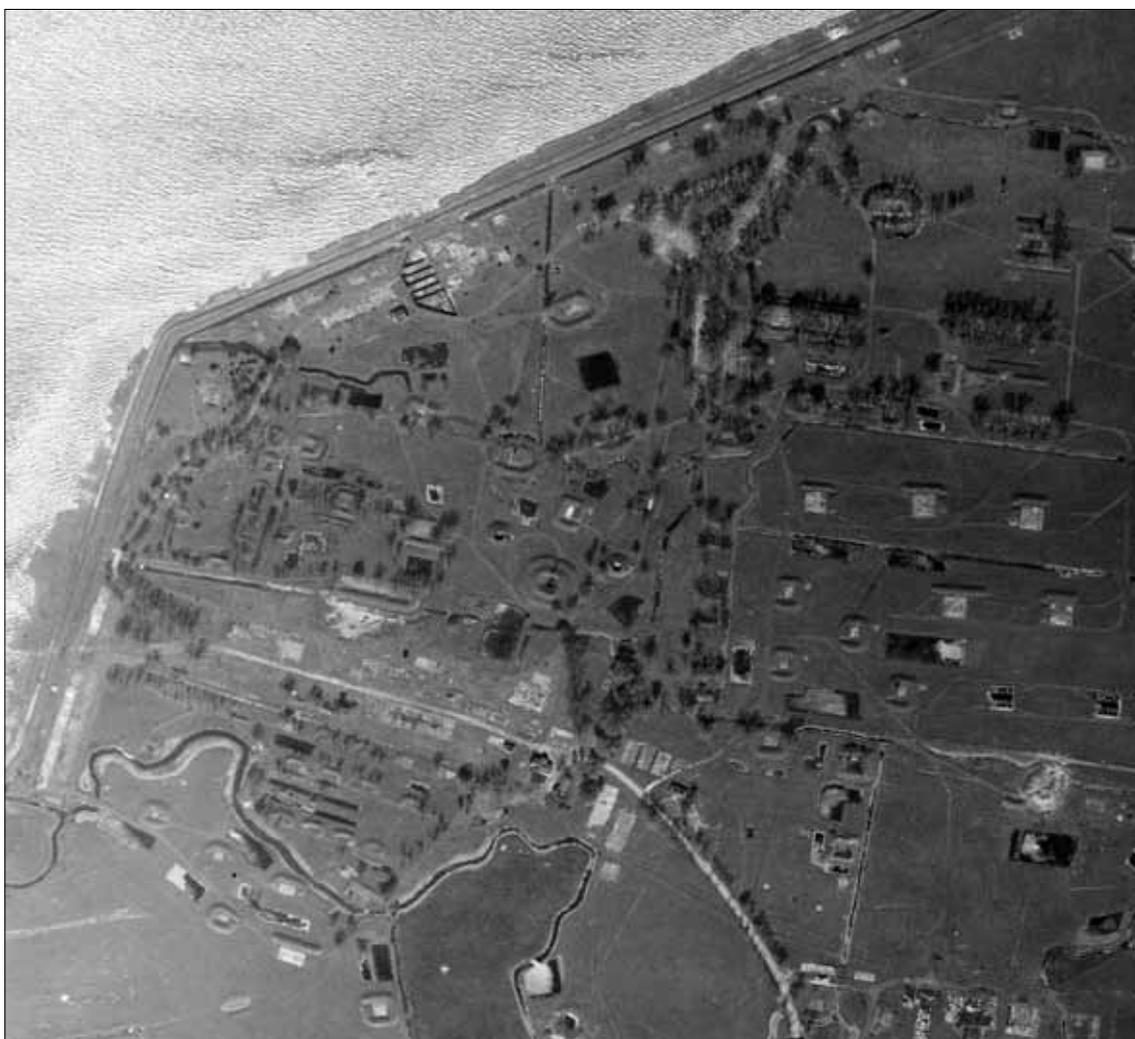
Figure 19: Extract from 1946 RAF aerial photograph of the site, showing relatively dense tree coverage and riverside factory remains lost since the sea wall was rebuilt in the 1980s. NMR RAF 106G/UK/1447 1073 01-May-1946 © English Heritage.

Vertical aerial photographs taken by the RAF in 1945, 1946 and 1947 show that in the mid-1940s the site was in a remarkably similar state to how it is found today, with only small changes having occurred since. The most notable difference between then and now is that the photographs show fairly dense tree coverage around many of the building remains across the western side of the complex which has now been largely removed. Trees were planted between factory buildings to provide additional protection from accidental explosions by acting as barriers capable of absorbing blast debris. The line of the old sea wall, and consequently the marginal areas of the factory lost

during the subsequent rebuild in the 1980s, were also still in place at that time (Figure 19). Subsequent RAF aerial photography of the site from 1955 shows that the mature vegetation across western parts of the site had gone by this time (Figure 20); this could have been the result of dramatic tidal flooding in 1953, rather than an act of intentional clearance.

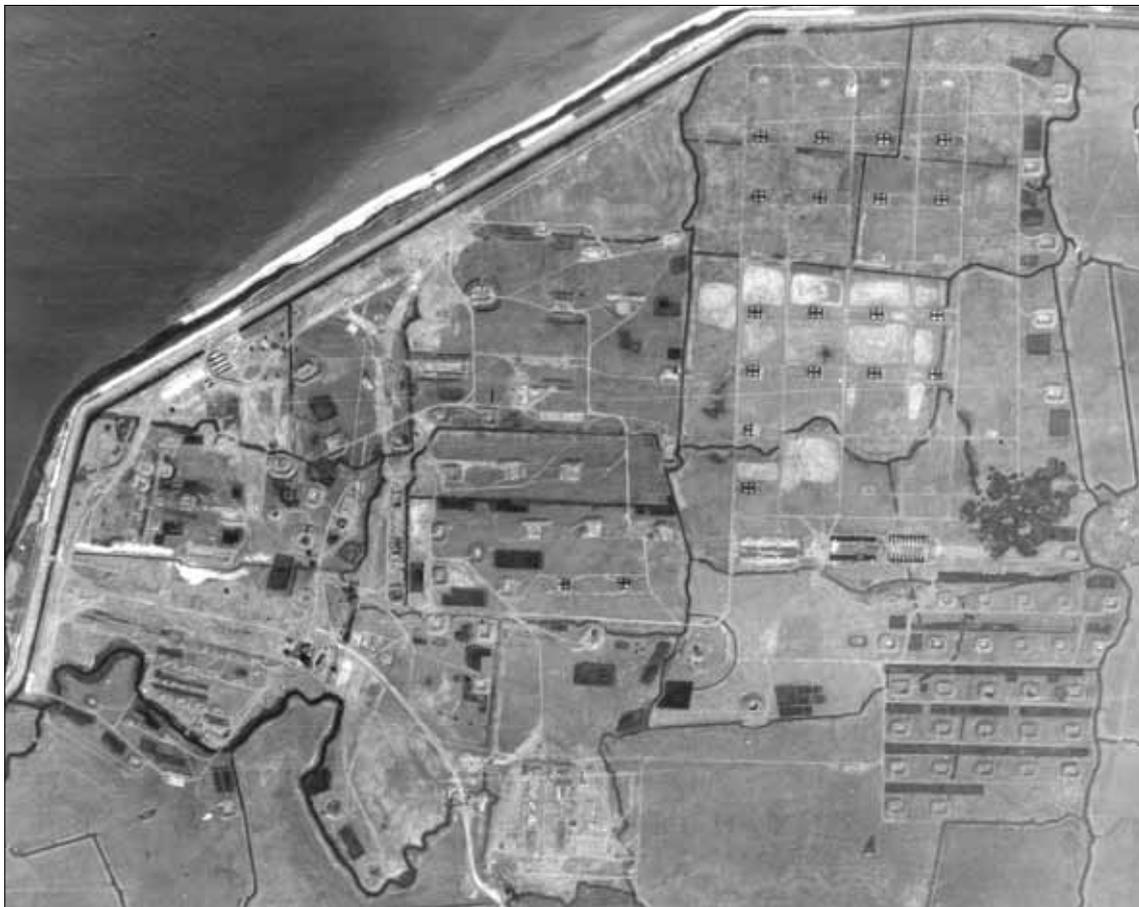
Figure 20: Extract from an RAF vertical aerial photograph of the site taken in 1955, showing that most of the tree cover had been removed by this time. NMR 540 RAF.1699 0113 12-Aug-1955 © English Heritage.

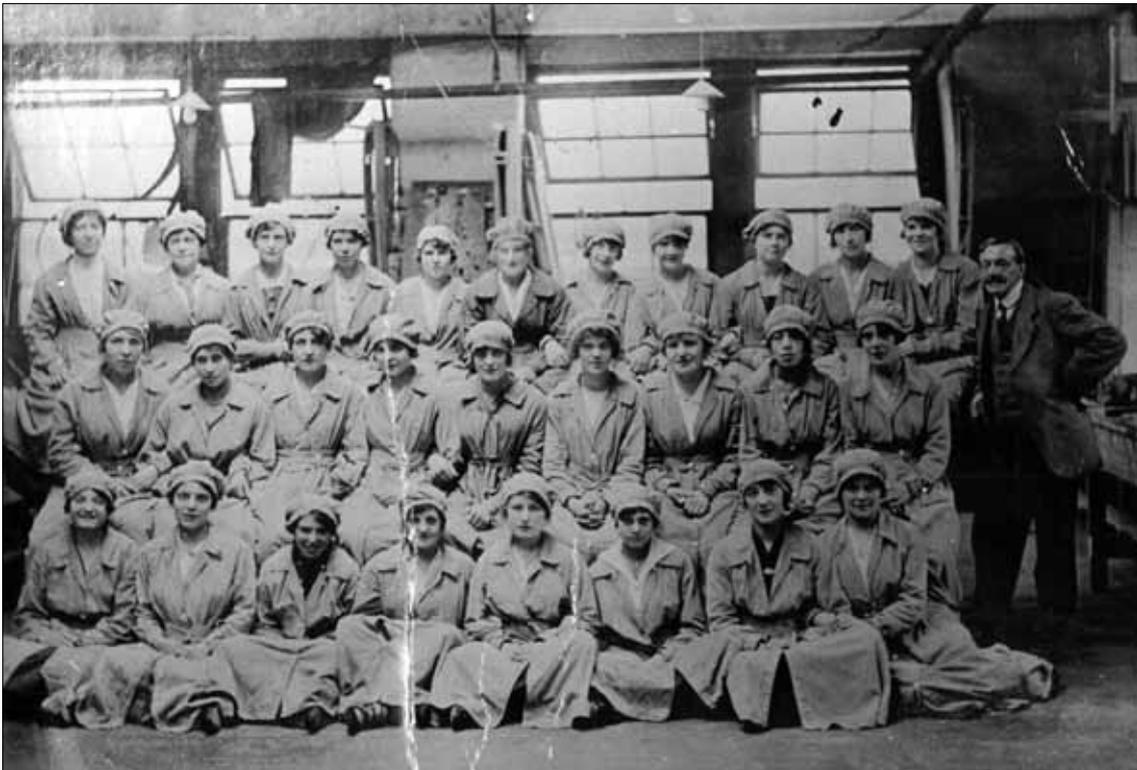
*Figure 21: Staff at Curtis's & Harvey's Cliffe factory, taken during the First World War WWI, showing the interior of what might be structure **251** © Cliffe and Cliffe Woods Parish Council, reproduced by kind permission of Joy Dan.*

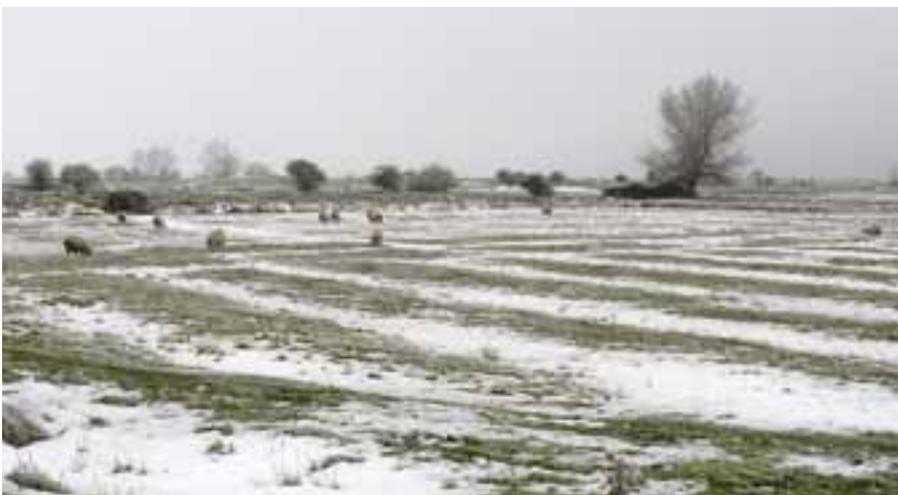
Figure 23: Drainage ridges in the area north of structure 27, showing up clearly in the snow. Photograph: Wayne Cocroft, 2010 © English Heritage.

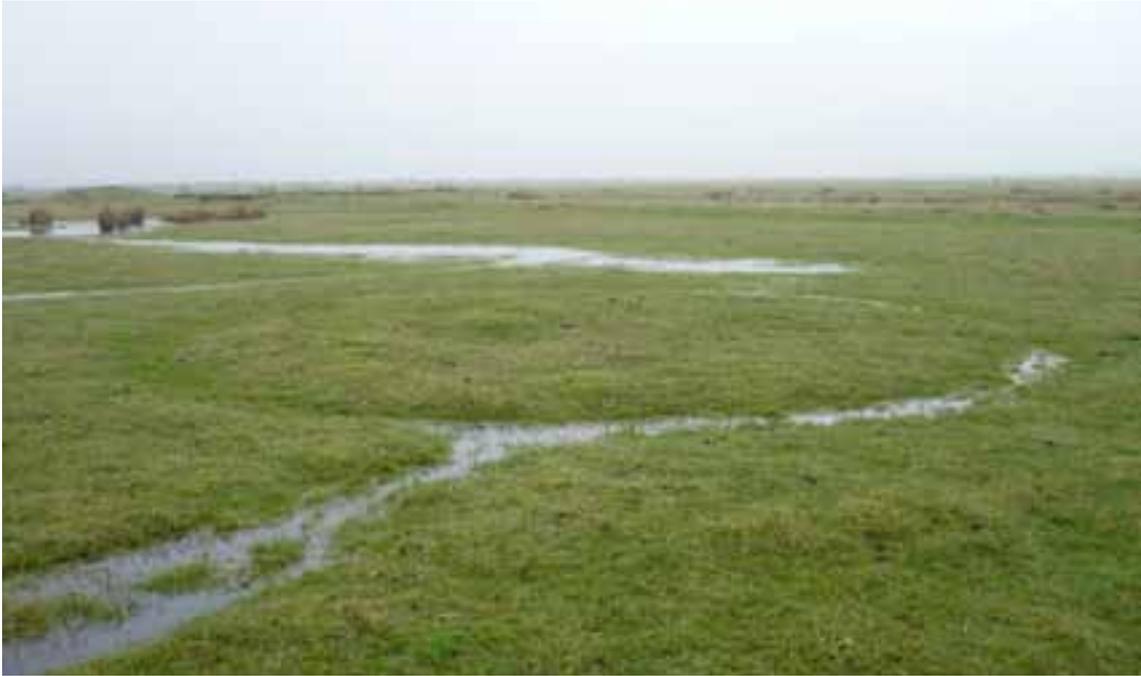
Figure 25: Low circular mound with encircling gully, located in **Area F**. Photograph: Rebecca Pullen, 2011 © English Heritage.

Within a wide meander in the main drainage dyke that marks the southern edge of the area of investigation in **Area F**, there is a very low, neat circular mound surrounded by a narrow ditch, with traces of flanking scarps to the north-west and south-east of the encircling gully (NGR:TQ 71905 78338). The central mound has a diameter of about 8m, stands no more than 0.25m high and is encircled by a shallow gully 0.9m wide with a possible narrow causeway or entrance on the west side. Approximately 1.5m outside the gully, and flanking the north-west and south-east quarters of the feature, are traces of a low spread back scarp. The function and date of this feature remain uncertain; the possibility that the ditched mound had some connection either with use of the site as an explosives works, or with management of the site for agricultural purposes, has not been dismissed (Figure 25).

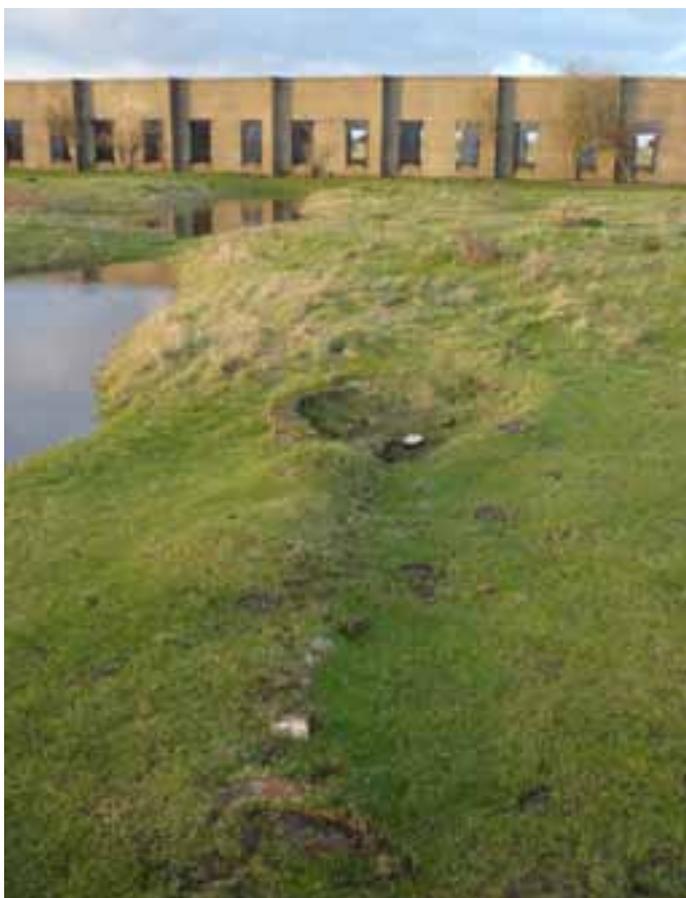
Figure 26: (left) Remains of brick sheep wash (NMR TQ 77 NW 307) in **Area J**, with circular chamber and exit ramp in the foreground, and structure **247** in the background. Photograph: Rebecca Pullen, 2011 © English Heritage.

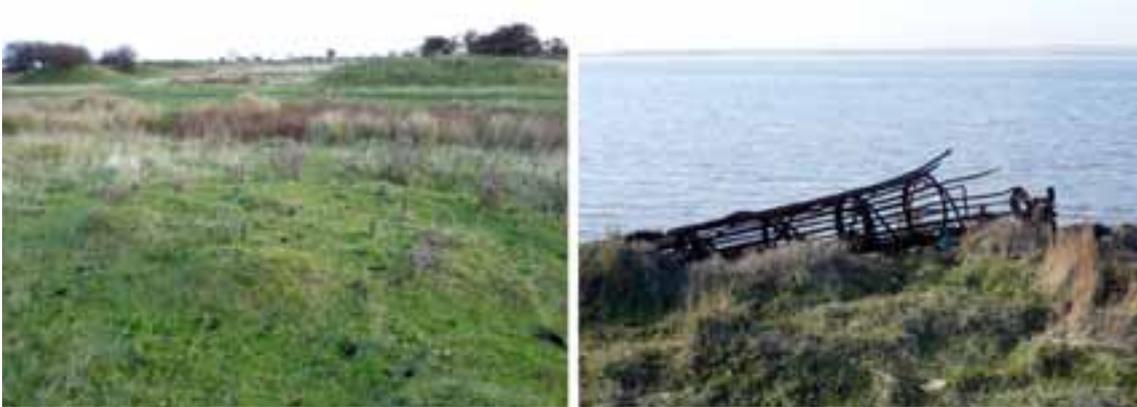
Figure 28: Remains of the beacon base in **Area A** (left), and the collapsed superstructure of the Point Beacon on the foreshore (right). Photographs: Rebecca Pullen, 2011 © English Heritage.

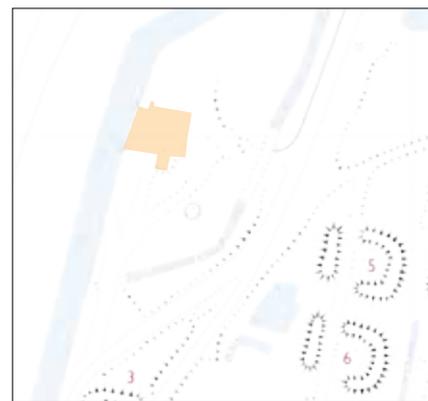
Traces of a firm foundation platform were recorded under a thin covering of grass where Hope House once stood. The foundation extends at least 12m x 12m, and probably spreads a little further to the north and west (Figure 29). At the south end of the platform, the footings of a concrete or cement wall were recorded flush with the ground and seem to denote an entrance porch or similar; from this point traces, of a track preserved only as a vegetation mark run south to join what became the main factory road. Along the edge of the drainage ditch west of the platform are the remains of a brick drain cover and traces of concrete rubble, indicating that parts of the building's infrastructure were truncated during excavation of the new ditch line in the 1980s.

Figure 29: Extract from the survey showing the footprint left by Hope House (orange), with the circular beacon base to its south-east (not to scale) © English Heritage.

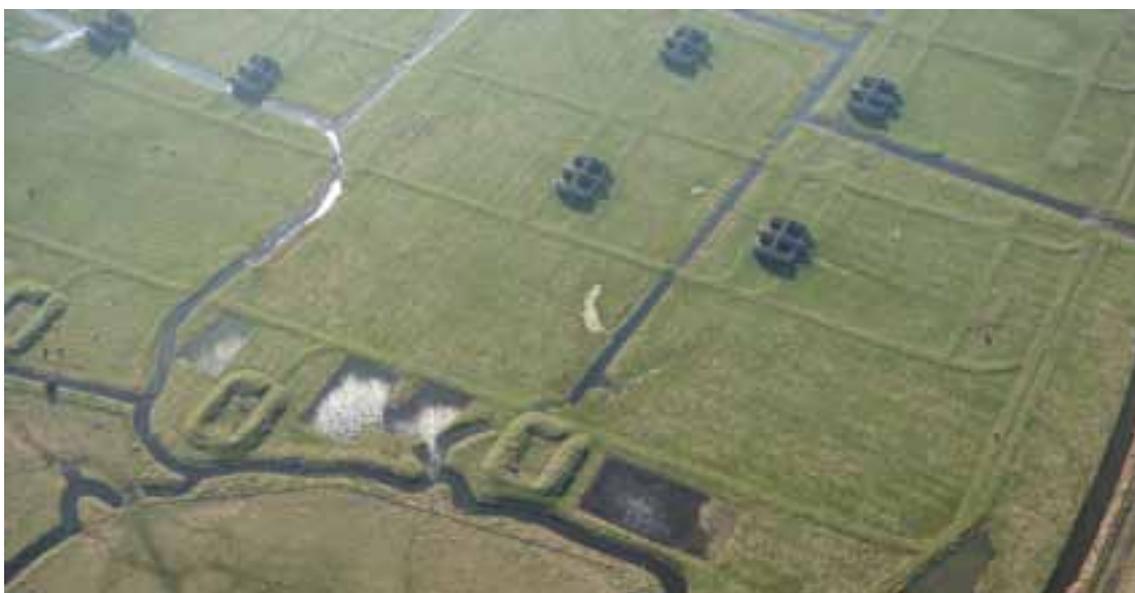
*Figure 31: Embanked tramway earthworks clearly visible running between buildings in the north-east corner of **Area K**, looking south-west. Also note the blocks of marsh drainage ridges underlying the factory features, and the unusual instance of paired parallel tramways (right hand side). Extract from NMR 26892/030 08-Mar-2011, Damian Grady © English Heritage.*

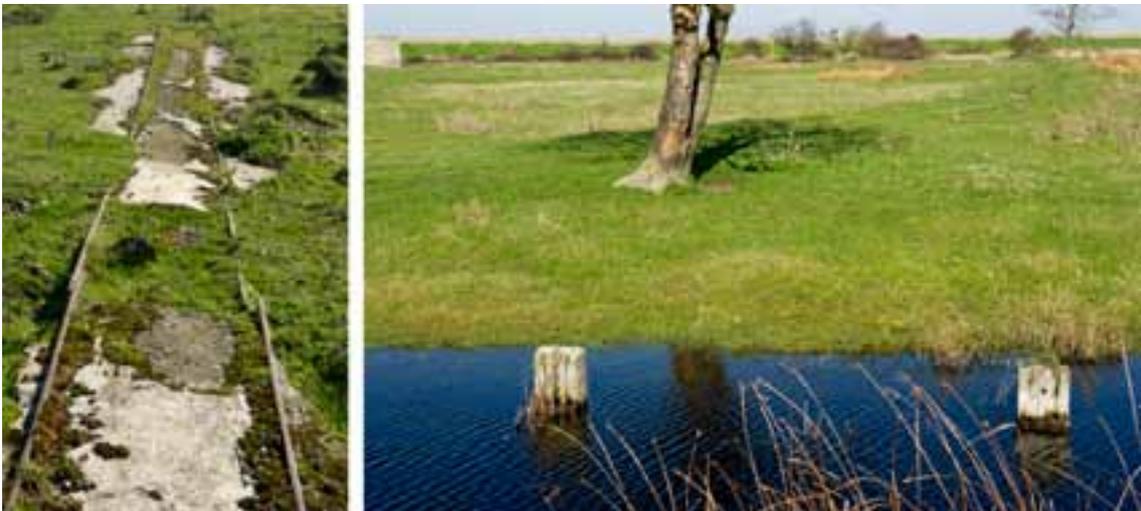
Figure 32: (above left): Iron tram rails and cambered concrete tram-bed near structure **107**. NMR DPI41545 07-Mar-2011, Steve Cole © English Heritage.

Figure 33: (above right): Wooden posts that formerly supported a tramway where it crossed a drainage dyke, looking north from structure **2**. NMR DPI41533 07-Mar-2011, Steve Cole © English Heritage.

To facilitate movement of materials around the site, the tramways would have had to cross the drainage dykes in several places. There are now no tramway bridges standing, but square-section wooden posts were noted protruding from the water just north of structure **2** where the tramway would once have crossed (Figure 33). The low height of the posts (flush with the banks either side of the drainage dyke) and their sturdy nature, suggest that these carried the weight of the tramline rather than a pipeline.

In the case of structure 2, the later erection of additional buildings on the surrounding ground resulted in a slight remodelling of the bank in the south-west corner in order to create a third point of entry related to a re-routing of nearby tramlines (see Figure 46 composite survey extracts). Redundant wooden bridge supports for the earlier tramline protrude from under the water in the drainage dyke to the north (see Figure 33).

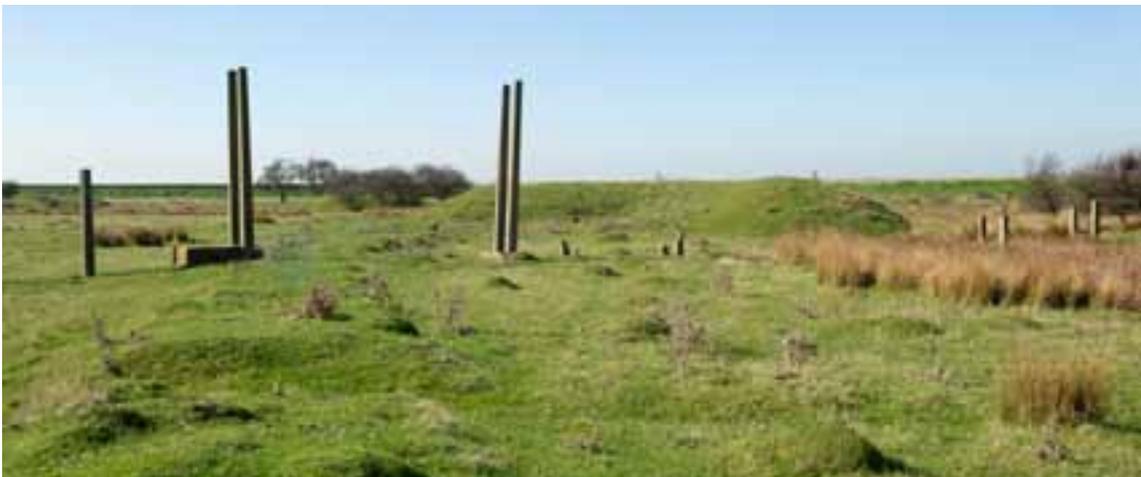
Figure 37: Part of **L1**, showing the northern group of taller concrete posts straddling the perpendicular path of a tramway embankment, looking west. Extract from NMR DPI41568 07-Mar-2011, Steve Cole © English Heritage.

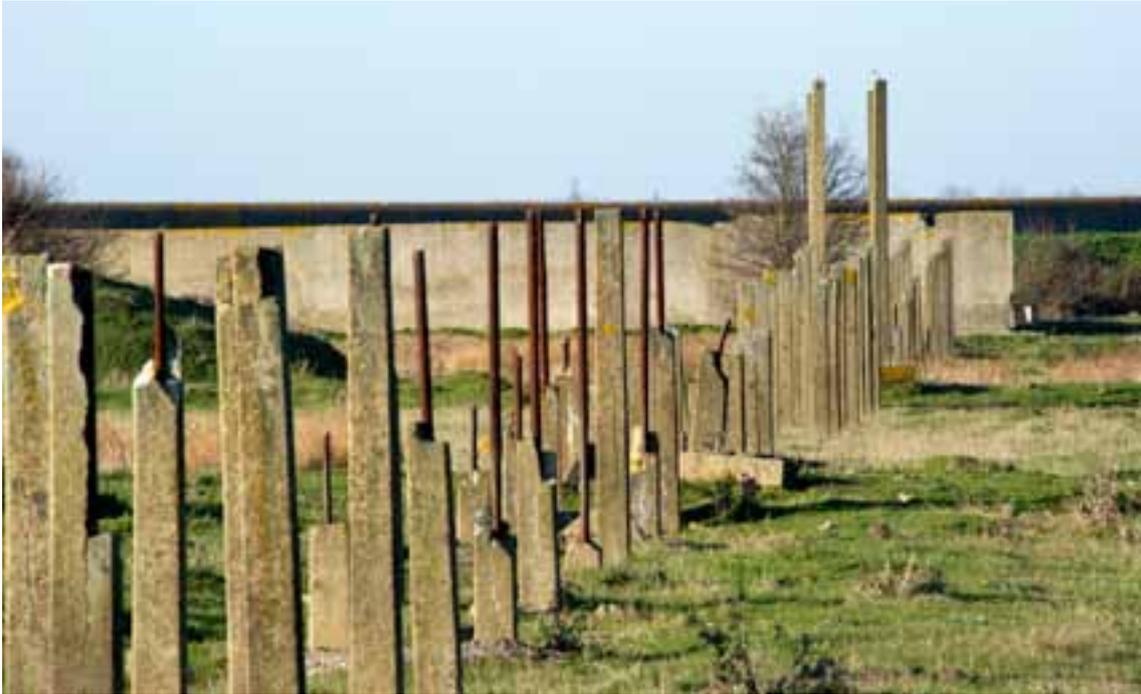
Figure 38: Part of **LI**, showing the posts at the north end aligned on a notch in the top of structure **24**, looking north. Also note the fall in post heights from north to south between structure **24** and the taller group of four posts, and again in the group of posts immediately to their south. Extract from NMR DPI41606 07-Mar-2011, Steve Cole © English Heritage.

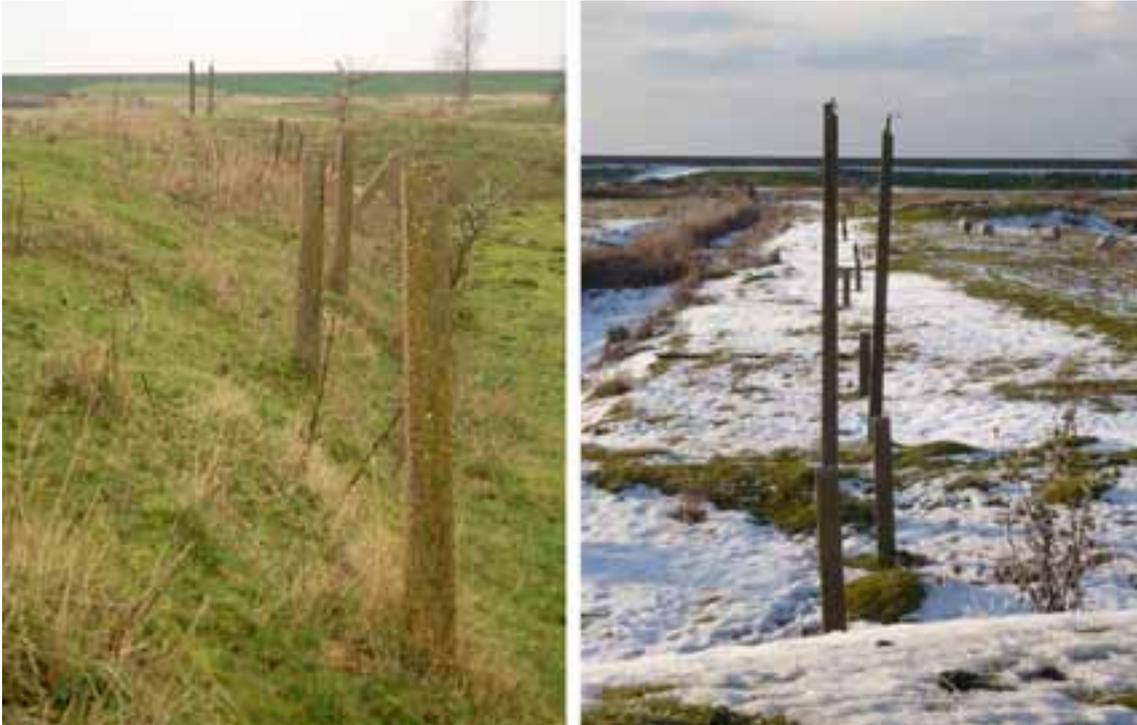
Figure 39: (left) East end of **L2** where posts are set into the earthen traverse of structure **I9**, looking west. Photograph: Rebecca Pullen, 2010 © English Heritage.

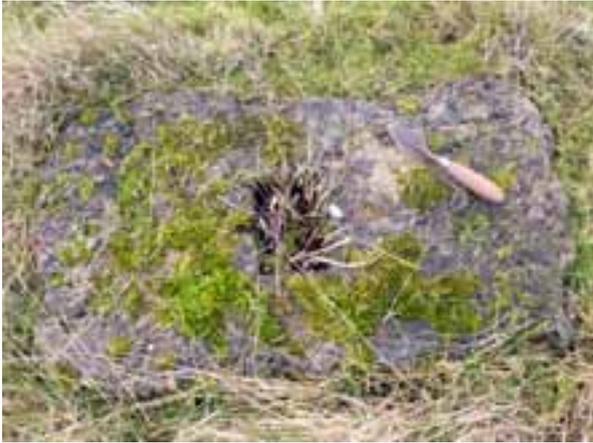
A neat alignment of eighteen small concrete blocks was recorded running for a distance of just over 100m on an east-west line roughly between structures **I14** and **I32** (**L3**) (see Figure 30). Almost all of the blocks are constructed of coarse concrete and set flush with the ground surface. Where they are seen in full they measure 0.85m x 0.48m in plan. In the centre of each block is a small sharply defined rectangular hole, 160mm x 110mm, aligned across the width of the block and often surrounded by a residue of bitumen (Figure 41). The concrete blocks almost certainly represent the bases for a line of upright rectangular-section posts, probably of wood rather than the reinforced concrete seen in **L1** and **L2**. Perhaps the posts supported steam pipes to heat nearby buildings; there would have been a great many runs of wooden posts carrying steam pipes when the factory was operational.

Figure 41: (left) One of the concrete post bases that make up **L3**. Photograph: Rebecca Pullen, 2011 © English Heritage.

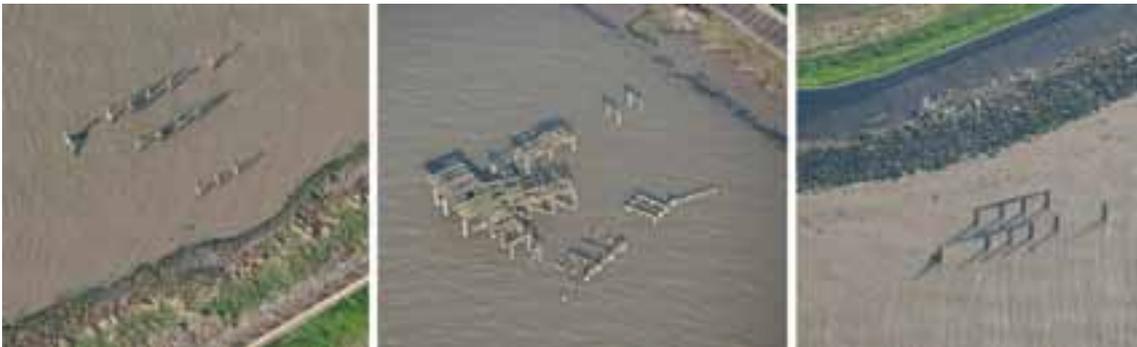
During the factory's operating years, at least four wooden jetties were built into the River Thames (see Figure 30), all of which have some physical remains still standing: jetties **J1** to **J4** (Figure 43).

Examination of RAF aerial photographs from the 1940s revealed that the surviving structures were severed at their landward end during the Second World War as a precaution against potential enemy invasion (F Small, pers comm). This disconnection from the mainland was furthered during the 1980s when the sea wall was moved inland and rebuilt as a more substantial concrete structure. Today the remains of the abandoned jetties are in varying states of disrepair. For reasons of practicality and safety, the extant wooden structures of the jetties could not be included in the survey of the factory; although these features were all assessed in 2005 as part of the North Kent RCZAS (Wessex 2006). The remains of **J1**, **J2** and **J3** were accurately transcribed using vertical aerial photographs as part of the HPHLP aerial photographic survey, but **J4** was not easily identifiable in the available photographs (see Figure 6).

Figure 43: (left to right) Remains of wooden jetty structures **J2**, **J3** and **J4**; note how they are all now cut off from the shoreline. Extracts from (left to right) NMR 26892/028, 26891/044, and 2682/032 08-Mar-2011, Damian Grady © English Heritage.

The North Kent RCZAS recorded the remains as monument 'WX17747': a steel pile and grid structure on the foreshore, consisting of three rows of square-section wooden piles, with a 30m wide at the river frontage (see Figure 43). Individual piles measure 0.3m x 0.3m in section and 5m tall; additionally, two horizontal timbers and one diagonal brace remain (Wessex 2006, 61).

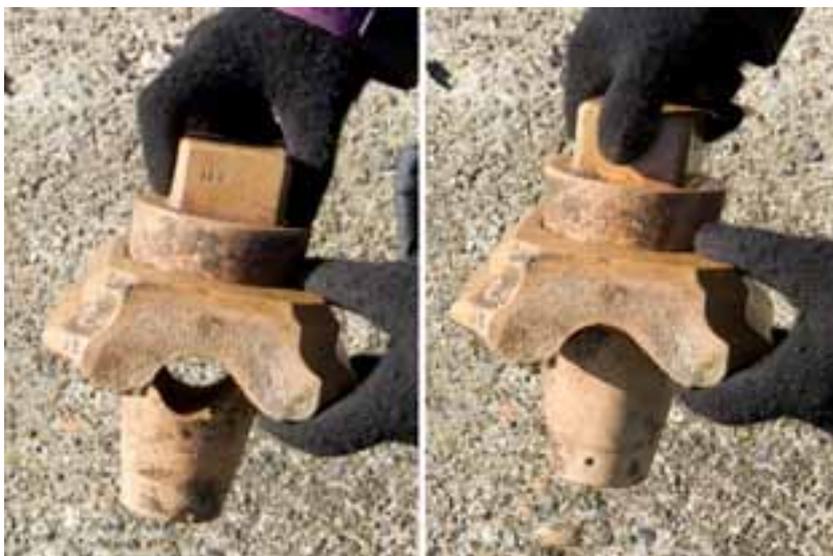
*Figure 45: Part of an earthenware acid valve found near acetone recovery house **132**, shown open (left) and then twisted 90 degrees to closed (right). NMR DPI41559 and DPI41560 07-Mar-2011, Steve Cole © English Heritage.*

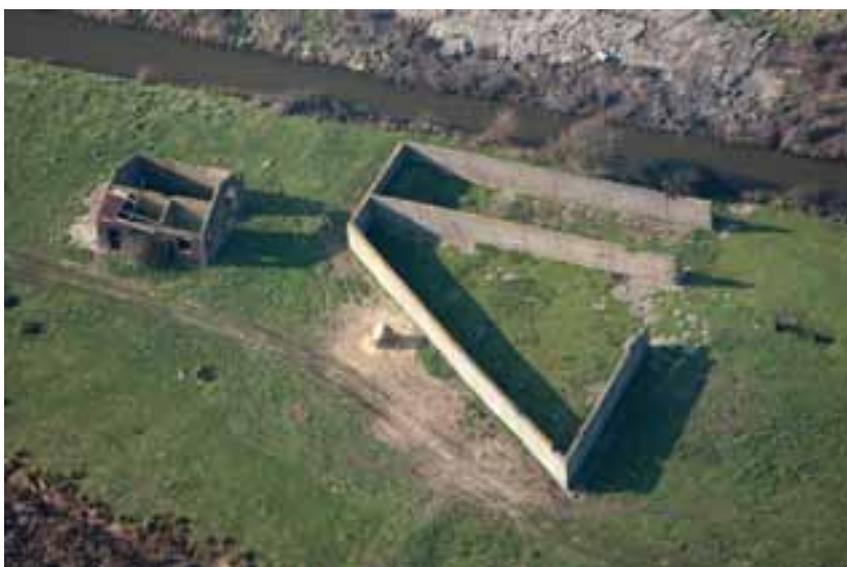
On the opposite bank of the drainage ditch to structures **21** and **22**, stand brick building **23** and concrete structure **24** (Figure 48). Structures **23** and **24** may have functioned as a pair, possibly relating to the storage, weighing and administration of materials entering and exiting the factory via the adjacent jetty, **J1**.

Figure 48:  
Structures **23** (left)  
and **24** (right),  
seen from the air.  
Extract from NMR  
26892/021 08-Mar-  
2011, Damian Grady  
© English Heritage.

Next to brick building **23** is structure **24**: a large and distinctive concrete edifice unlike anything else recorded on the factory site. Featureless narrow reinforced concrete walls, 0.4m thick x 2.2m high, mark out the trapezoidal footprint of a roofless building with no indication of ever having been covered. The concrete walls show evidence of cracking and patched repairs, and a series of notches were noted in the top of the walls, seemingly aligned with the paired posts of the elevated pipeline **L1** (see Figure 38). The internal space is divided into two large exposed bays by a single partition wall of equivalent dimensions to the external wall; the larger space is roughly triangular, with a smaller rectangular bay to its north-west. Both internal spaces have a featureless concrete floor, now largely under grass, and a large 6-7m-wide opening for access at the north-east end (see Figure 48). Traces of a concrete yard were recorded beneath the grass in front of these entrances.

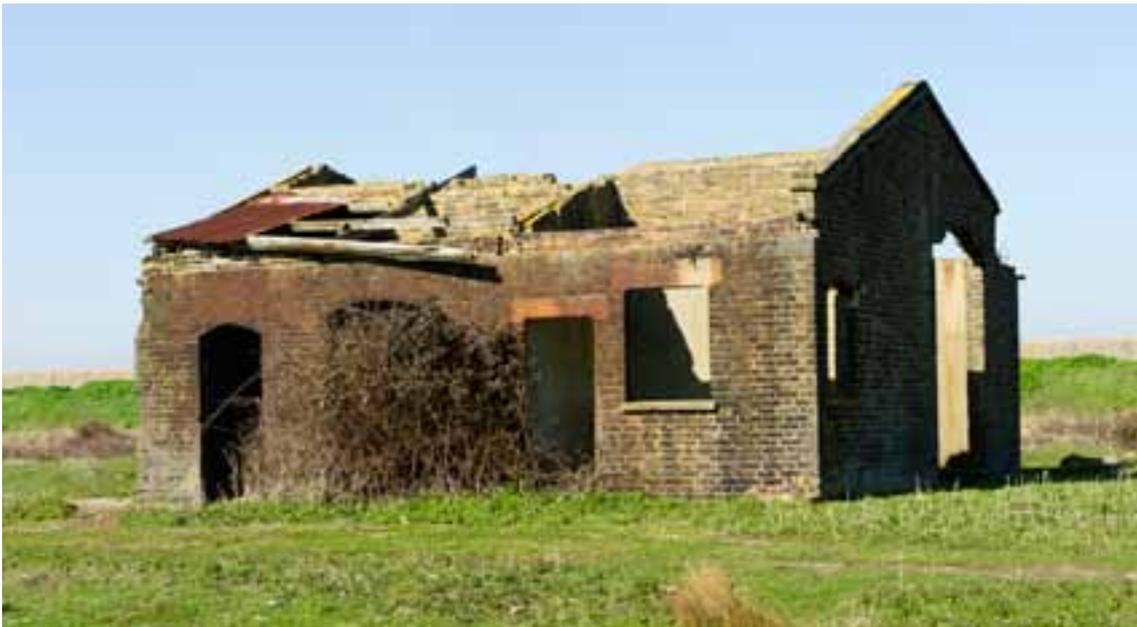
Figure 50: The south-east and north-east elevations of structure **23**, showing the two distinct forms of door and window openings, and the remains of the lightweight roof. NMR DPI41536 07-Mar-2011, Steve Cole © English Heritage.
