# CURTIS'S AND HARVEY LTD EXPLOSIVES FACTORY, CLIFFE AND CLIFFE WOODS, MEDWAY ARCHAEOLOGICAL SURVEY AND ANALYSIS OF THE FACTORY REMAINS

Volume 1 of 2

Rebecca Pullen, Sarah Newsome, Andrew Williams and Wayne D Cocroft

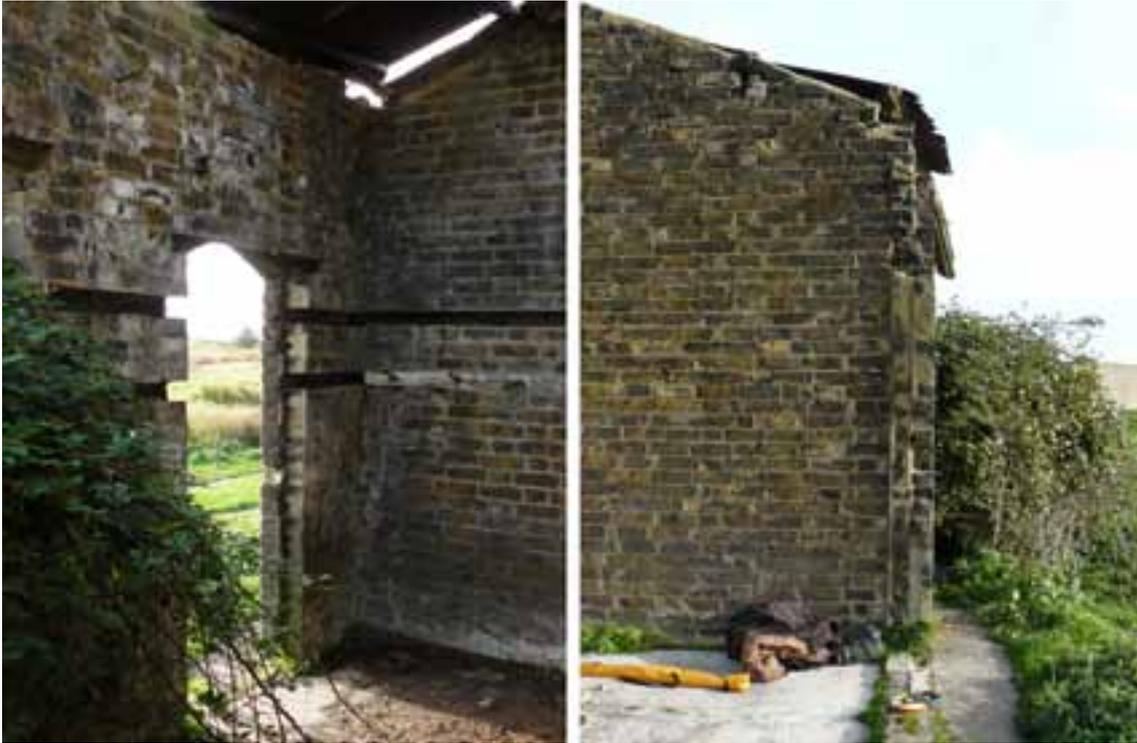
Figure 51: (left) Recessed grooves within the west room of structure **23**, with part of a wooden baton in situ. Photograph: Wayne Cocroft, 2010 © English Heritage.

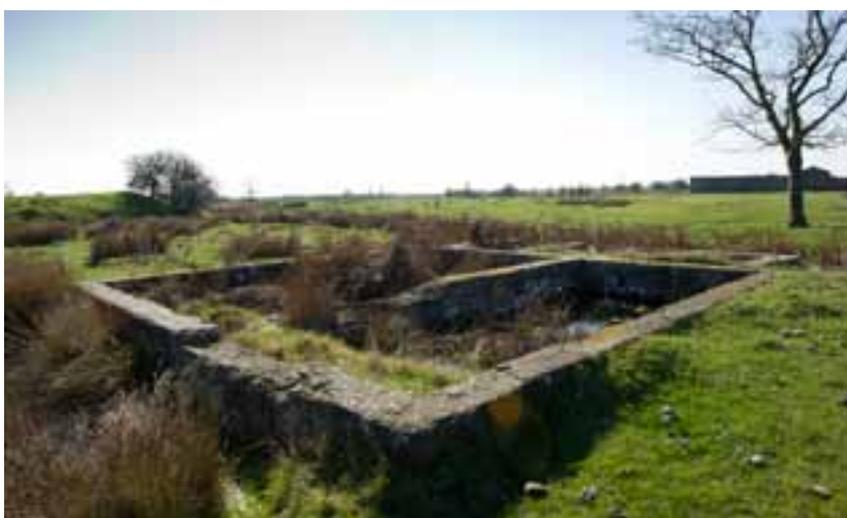
Structure **26** appears to be the remains of a large conjoined pair of deep concrete tanks, located against the east bank of a drainage dyke, east of structure **25**. On three sides the tanks stand to a height of 0.23m, but along the northern edge, earth has been mounded up so that the ground rises to meet the top of the concrete. Internally, they have been faced with a cement render; and each measures approximately 6.2m x 2.8m, and is at least 1.2m deep. At the west end, the main tanks are adjoined by two smaller concrete boxes linked by a scrap of surviving concrete surface flush with the top of all four (Figure 54). No suggestion for a former superstructure is evident. The concrete construction may have related to water management; and absence from the 1908 25-inch OS map confirms that structure **26** was built during or after 1907.

Figure 54:  
Structures **26**,  
looking south-west.  
NMR DPI41566  
07-Mar-2011, Steve  
Cole © English  
Heritage.

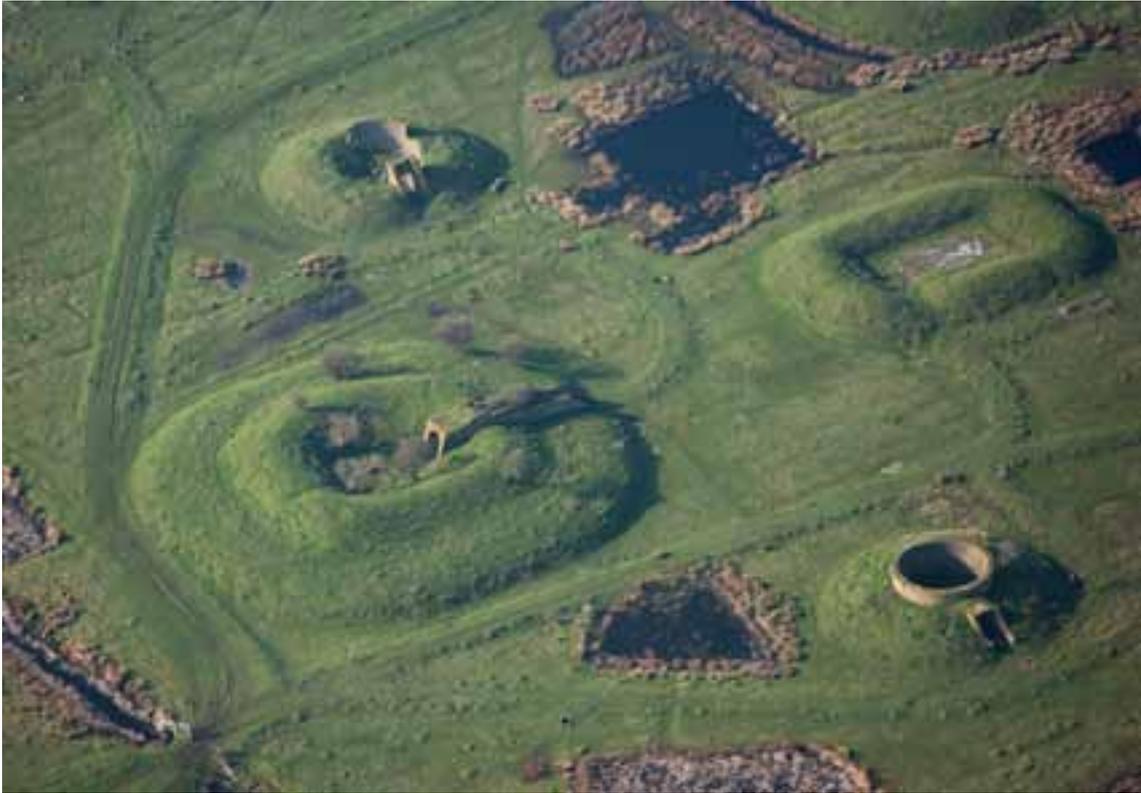
In the south-east corner of **Area A** is structure **31**, a large sub-circular earthen mound standing to twice the height of most other traverses nearby, and with a distinctive stepped profile which is unique amongst the factory remains at Cliffe (Figure 55). The interior of the mound formerly housed a nitroglycerine nitrating house, in this case one equipped with a nitrator-separator, since we know that the separate nitrating and separating tanks in structure **31** were replaced by a nitrator-separator in 1904 (Explosives Inspectorate 1905, 59). Flanking the nitroglycerine hill are the smaller circular mounds of two further buildings relating to the nitration process: structures **30** and **32**. These are thought to be wash houses where the newly prepared nitroglycerine was washed to remove any unwanted residues and then filtered to remove any remnant water (see section 4.2). The well-formed earthworks of the wash houses sit at 45 degrees to the entrance of nitroglycerine hill **31** (**30** to the north-west and **32** to the north-east), each spaced as little as 20m away from the larger mound between them. This group is located in the same position as the earliest nitroglycerine factory at Cliffe built around 1901, but it has been remodelled and rebuilt on more than one occasion since then, due to damage caused by accidents in 1904 (Cooper-Key 1904; HMSO 1905, 59) and 1911 (Cooper-Key 1911), and perhaps also as a result of tightening safety regulations.

Figure 55: Structures **30**, **29**, **32** and **31** (clockwise from top) from the air, looking north-west. Extract from NMR 26890/030 08-Mar-2011, Damian Grady © English Heritage.

Nitroglycerine hill **31** is surrounded on all sides by the embanked courses of tramways and paths (see Figure 55). Leading directly to or from the north entrance of **31**, the broad sweep of a tramway connects this building to the nearby circular nitroglycerine wash house **30**. Also apparently serving the entrance of **31**, a short straight embankment, thought to be a pathway, leads across to another tramline to the east. A series of narrow drains or gullies were noted criss-crossing this area along with a handful of small brick manholes.

Flanking the nitroglycerine hill are the remains of two circular wash houses **30** and **32** (see Figure 55). The two structures share several traits: both measure about 22m in overall diameter and their well-formed steep-sided mounds both stand to a height of 2.2m. Encased within each mound is a roofless circular brick revetment with a short narrow brick-lined approach and an arched entry tunnel accessed from the east (Figure 59). Internally, the brick walling stands to a full height of 3.5m, which protrudes approximately 1.4m above the top of the earthwork. At present, the remains of structure **30** are in a poor state of repair when compared with those of structure **32**; apart from the brick entranceway and about a quarter-arc of the circular brick structure, the walls of **30** have largely collapsed into the centre and without the revetting brick walls, parts of the inner face of the earthwork have also slumped. The circular revetments of **30** and **32** are very similar in construction, each has brick walls in English bond topped by a projecting course of headers under a flush header row. In the case of structure **30** only, this is then capped

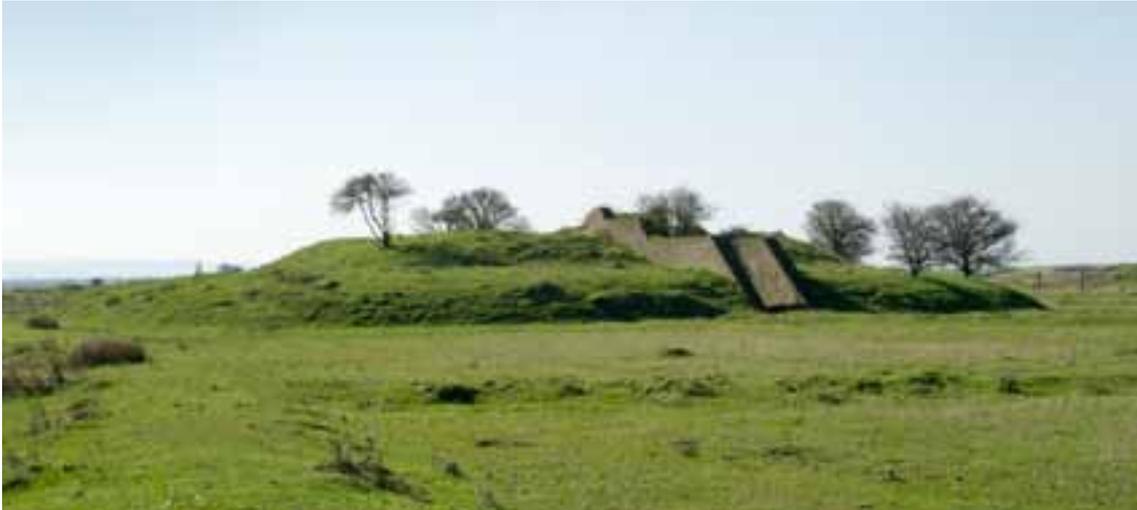
The entrance on the north side consists of an elongated roofless passage, 11m long, flanked by high brick revetting walls that increase in height in a series of steps roughly matching the profile of the mound (Figure 56), ending in a vaulted tunnel which opens into the interior. The flanking walls have an angled face on their external north end, and ascend in three distinct steps from the outside of the mound to a maximum height about 1m above the top of the traverse, before stepping down once on the south side to the top of the vaulted tunnel. Encased within a rectangular elevation, the vaulted brickwork

Figure 56: Structure **31**, looking south-west. NMR DPI41523 07-Mar-2011, Steve Cole © English Heritage.

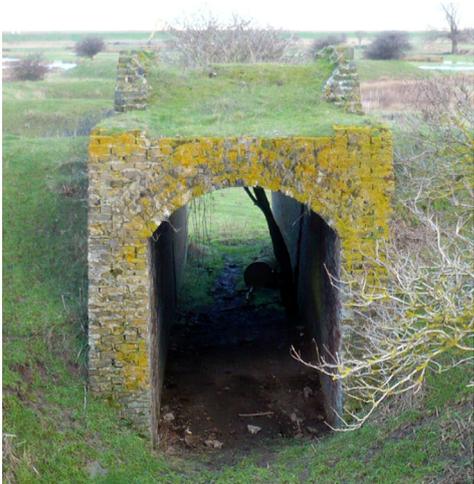
comprises an arch of four concentric header rows - a sturdy construction which could have supported additional weight if necessary. There is also some suggestion in the brickwork above the tunnel that there may have been a structure over the entrance at one time (Figure 57). One possible explanation for this robust vault is contained within the official accident report for an explosion involving the early nitroglycerine mound in 1904. This informs us that the glycerine tank was supplied by means of a bogie cart and windlass (Cooper-Key 1904, 4), that being a lift operated by a winding mechanism, instead of using a pipeline and compressed air. Historic photographs of contemporary sites show that cart lifts were sometimes located in front of the main entrance through the traverse; in these cases, carts were raised from the tramway and then moved inside on rails fixed above the entrance.

Figure 57: (far left) Entrance to the access tunnel inside nitroglycerine hill **31**, with possible evidence for a structure on top of the brick arch. Photograph: Rebecca Pullen, 2011 © English Heritage.

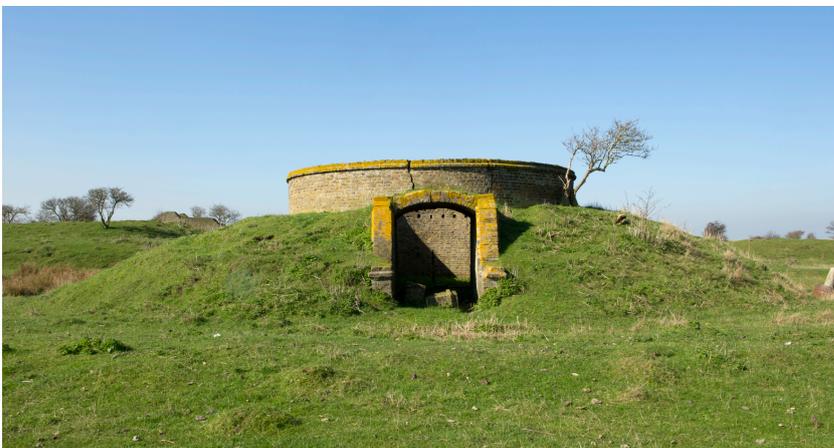
Figure 59: Structure **32**, looking west. NMR DPI41519 07-Mar-2011, Steve Cole © English Heritage.

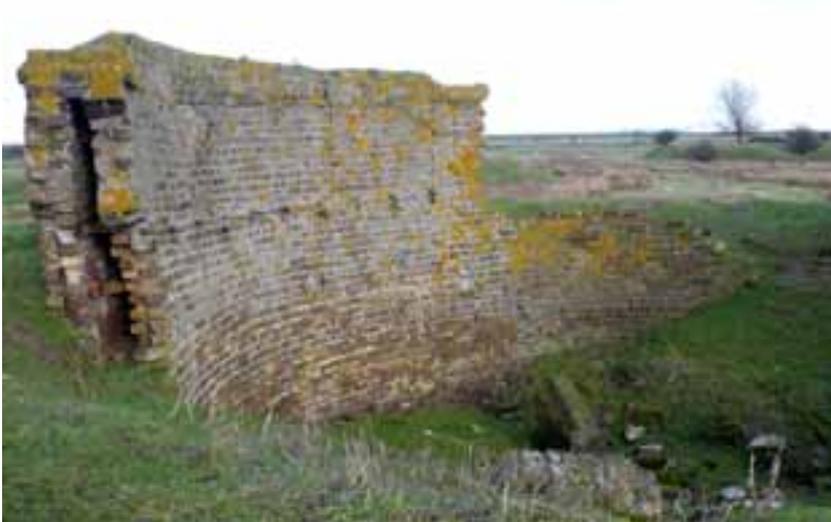
Figure 60: The interior face of the revetment wall belonging to structure **30**, showing the wall cavity and the mid-height line of joist sockets. Photograph: Rebecca Pullen, 2011 © English Heritage.

by a render-covered chamfered top concealing two further courses. The walls are 0.8m thick, constructed of two brick faces separated by a central void, seen in section where walling for structure **30** has partially collapsed (Figure 60). Internally, at a height roughly equivalent with the top of the earthwork, a row of joist pockets for the suspension of a wooden floor for a second storey are clearly visible in the brickwork of both **30** and **32**. It is likely that a free-standing timber 'roundhouse' would have stood within the circular brick walls, with a narrow gap left between the two for access and to allow light into the building, much like those recorded at RGPF Waltham Abbey (see Foreman 2001).

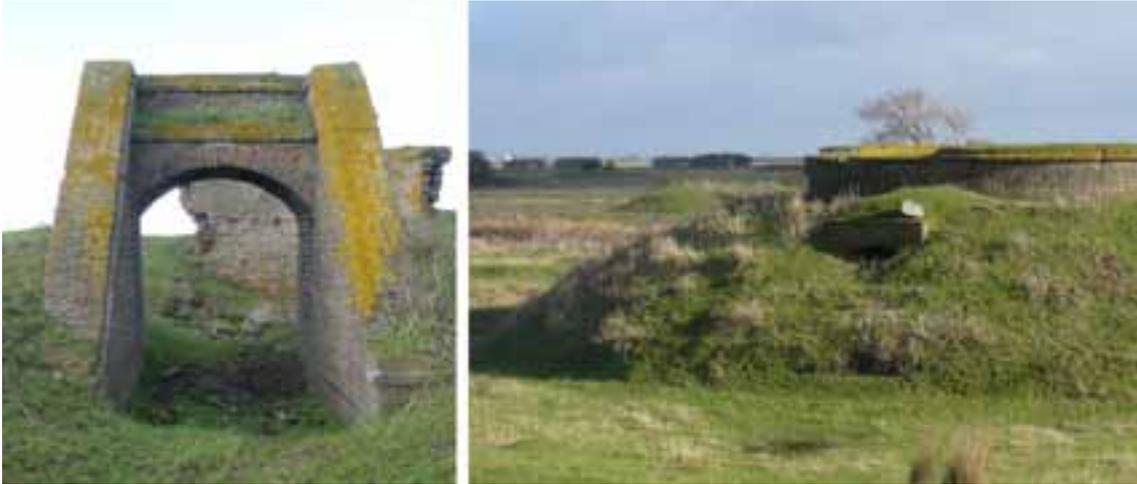
Where **30** and **32** visibly differ is in their entrance features. The brick entrance to structure **30** is a tall and robust construction comprising a wide arched opening 1.75m across and 2m tall. The circular walling continues above the arch to match the rest of the structure, but with an intermediate pair of stepped back rows above the arch on the external face (Figure 61, and see Figure 59). Either side of the arch, the approach is protected by angled brick flanking walls that extend for around 3m and reduce in height from the top of the circular brick wall towards the foot of the traverse, forming a revetment for the break in the earthwork. On the interior face of the entrance, the mark of a shallow double-pitched roofline abutting the brick is visible as a render line, suggesting that an internal porch or covered passage would once have led into the timber roundhouse. In contrast, the entrance to structure **32** appears less robust. The doorway is of similar dimensions, but in this case the angled flanking walls stop at the same height as the doorway arch and the upper courses of the circular tower continue unaffected above the arch. In addition to these variations, structure **32** shows clear traces of a previous entrance on its west side, now blocked by earth, suggesting that either the current eastern entrance is a later alteration or that a pair of entrances once co-existed. Just visible above the earth now mounded across the former entrance are the upper courses of a narrow vaulted brick tunnel, 3.3m tall, with a rectangular exterior profile (Figure 62); the arch and neat blocking brickwork are also visible in the interior face of the tower. Evidence for an equivalent blocked doorway round the west side of structure **30** is less conclusive, and any really ephemeral traces in the traverse slopes may have been masked during the survey as this area was then under a light covering of snow. There are possible hints of the top of an angled flanking wall under the grassy top

Figure 61: (left) The external face of the entrance to structure **30** on the east side of the earthwork. Photograph: Rebecca Pullen, 2011 © English Heritage.

Figure 62: (right) Structure **32** showing the blocked entrance within the west side of the earthwork. Photograph: Rebecca Pullen, 2011 © English Heritage.

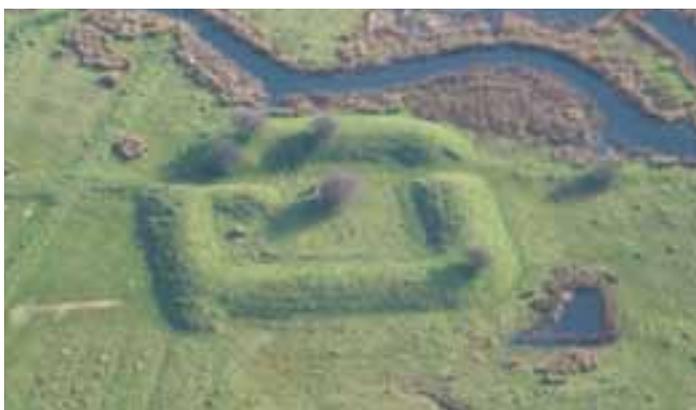
Directly north-west across the drainage dyke from **28** is structure **27**, the largest of the single-storey, rectangular mounded structures on site, and with a traverse arrangement not directly repeated elsewhere amongst the factory remains. The traverse comprises two earthworks: a straight section along the south-east side and a roughly C-shaped mound with a short projection inwards at the east corner (Figure 63). The earthwork lessens in height and projects slightly at the north corner; the purpose of this is unclear and could be due to general slippage. Inside are two building foundations and a smooth concrete tramway that runs beside the south-east edge of the buildings foundations, and which enters and exits the space through narrow gaps between the two protective mounds. The internal space is divided between the grass-covered floors of adjacent buildings: a larger rectangular concrete foundation with remnants of internal and external brick walls revealing narrow internal doorways and wider external ones, and to its north-east, the trace of a small square platform with a central 0.65m high brick plinth. The 1908 25-inch OS map shows only a small isolated building with no bund and no tramline connections in the position of the smaller foundation slab (see Figure 16). The unusual form of the earthworks and a slightly raised area of ground between the two foundations, could hint at a former arrangement where a less substantial traverse snugly enclosed the smaller building prior to construction of its larger partner. Overall, structure **27** is located in a well-connected position, with easy tramways routes from here to a large number of different factory processing areas, and as such, may have performed a function necessary for several different aspects of explosives production. One possible interpretation is that this was a mixing house, where nitroglycerine could have been combined with guncotton, kieselguhr or a blend of saltpetre and woodmeal to make various blasting explosives. Although a building would only ever be used for mixing with one of these material types, separate mixing houses would be provided for production of each explosive compound.

*Figure 63: Structure 27 seen from the air, looking south. NMR 26890/041 08-Mar-2011, Damian Grady © English Heritage.*

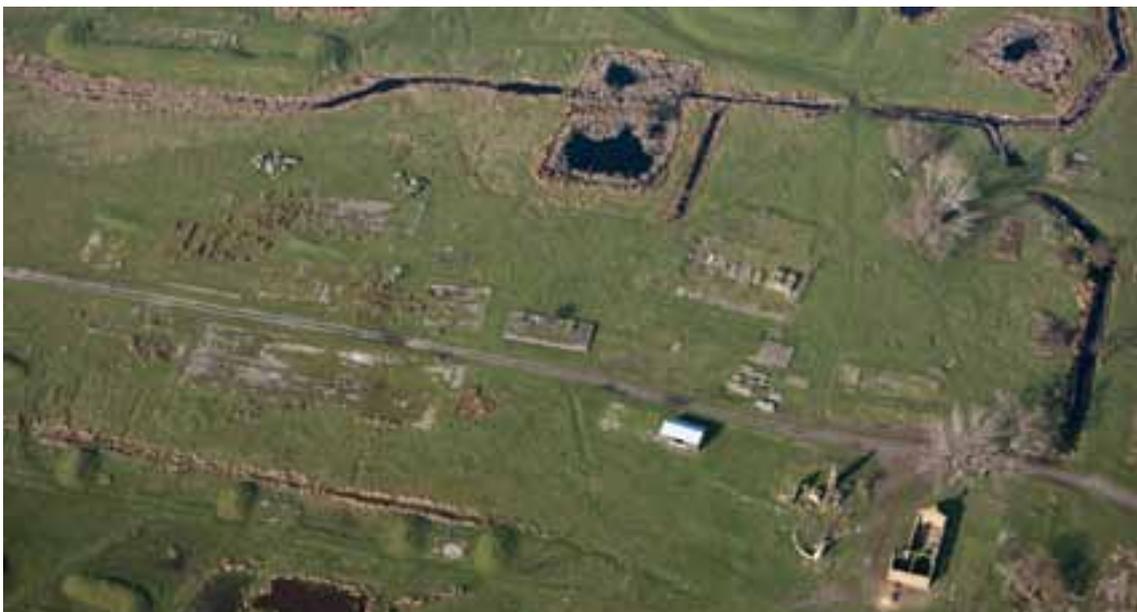
Figure 66: Part of **Area B** looking north, showing structures **37** to **53** north of the road, and **62** to **68** south of the road. NMR 26890/038 08-Mar-2011, Damian Grady © English Heritage.

Further east along the roadside is the large concrete foundation of structure **39**. It is possible to trace an area of 57m x 23m of concrete surface extending right up to kerb of the road (Figure 66); however, some of this hard-standing could represent a tram-bed for the tramline which formerly ran along the north edge of the road. Most detail on the floor of the building is now masked by grass and the remains of several rotten heaps of straw or manure. Vegetation marks suggest that the building was divided by several internal walls, and the presence of short lengths of open drains formed of purposely shaped blue floor bricks and a patch of acid-resistant blue brick flooring with a hatched surface, suggest a function relating to the use of acids. Due to its size, location, lack of protective traverse and the presence of blue brick flooring, it is likely that the function of structure **39** related to processes associated with manufacturing guncotton. If, as already suggested, cotton picking processes took place in structures **35** and **36**, it is likely that structure **39**, and **63** to its south, were engaged in the next stages of manufacturing guncotton; possibly nitration or 'dipping' of the cotton, or with washing and pressing the saturated cotton charges (see section 4.2). A pair of tram rail segments were recorded at the west end of the slab aligned perpendicular to the road, presumably these once connected to the tramline formerly paired with the road. A number of large buildings are marked in this area by the 1908 25-inch OS map, but due to the lack of clarity of the shape and size of structure **39**, it is not possible to positively identify whether the mapped buildings included **39** or whether it represents a later rebuild (see Figure 16).

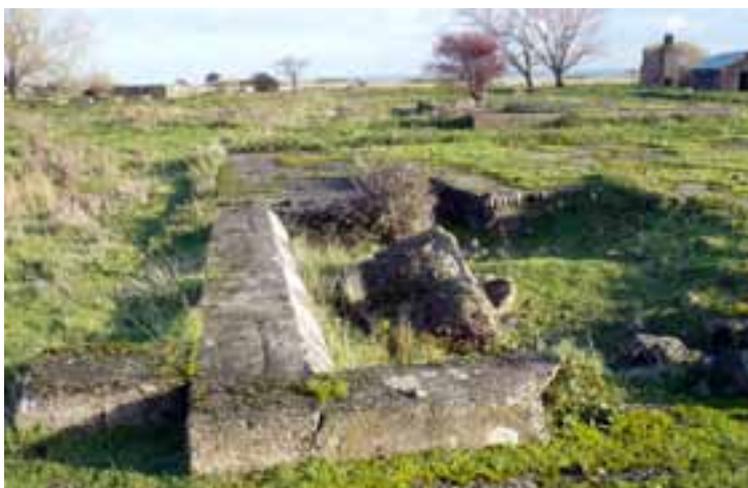
*Figure 67: The tank at the north-west corner of structure 40. Photograph: Rebecca Pullen, 2011 © English Heritage.*

Just beyond the east of **39** is structure **40**, a smaller concrete foundation set at a slight angle to the road, with a distinctive large hollow in its north-west corner, probably used for, or as, a tank. The main body of the hollow measures roughly 5m x 4m, with a narrow extension at the east end (Figure 67). The north and west edges of the hole are chamfered, whereas other sections of the edge are lined with smooth blue engineering bricks or show the distinctive irregular edge of concrete poured against corrugated iron shuttering. Much of the interior of the hollow is now filled with spoil and concrete rubble, which has also masked its southern edge. A building is depicted in the same position and alignment as structure **40** on the 1908 25-inch OS map. A number

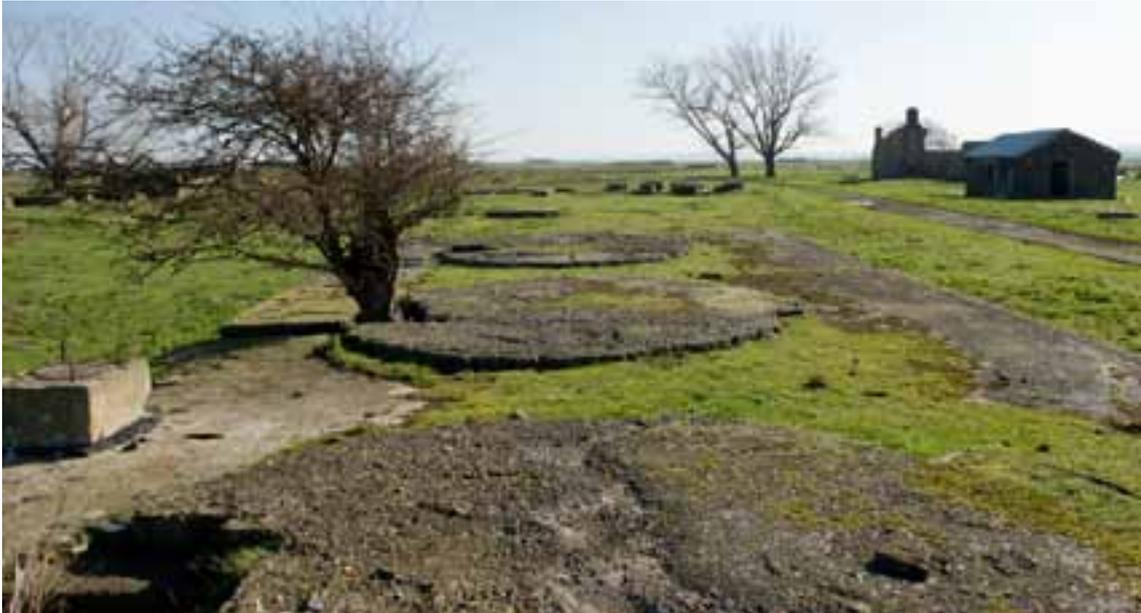
Structure **41** sits to the east of **40**, continuing the line of concrete slabs along the north edge of the road. The rectangular concrete base measures 16.7m x 7.3m in plan and, at 0.45m tall, it stands considerably higher than other nearby foundations. Projecting from the north side of the slab are five iron hooks for supporting a pipe or cable. The surface of the slab is dominated by a line of three evenly spaced, slightly raised, large circular concrete pads; the north side of each circle is interrupted by a rectangular hole cut to ground level through both the circular pad and the edge of the build foundation itself (Figure 68). The circular features are edged with smooth blue bricks that create a shallow step, beneath which the slab is floored with surviving patches of hatched blue acid-resistant bricks set into a fairly thick cement mortar. A line of uniform small circular depressions is visible across the centre of the eastern circular base; elsewhere the coarse

Figure 68: Structure **41**, looking east. NMR DPI41512 07-Mar-2011, Steve Cole © English Heritage.

concrete of the bases is fairly featureless and uneven. In addition to the three large circular bases, there is a small rectangular plinth topped with four narrow iron studs and the impression of a small machine or fitting. This building probably held three large tanks, perhaps for washing or spinning, as part of the production processes for guncotton. The gaps along the north edge would allow the tanks to be easily emptied, and presence of blue brick flooring suggests an association with acid-handling. Absence of this structure from the 1908 25-inch OS map illustrates that **41** was erected after its revision in 1907.

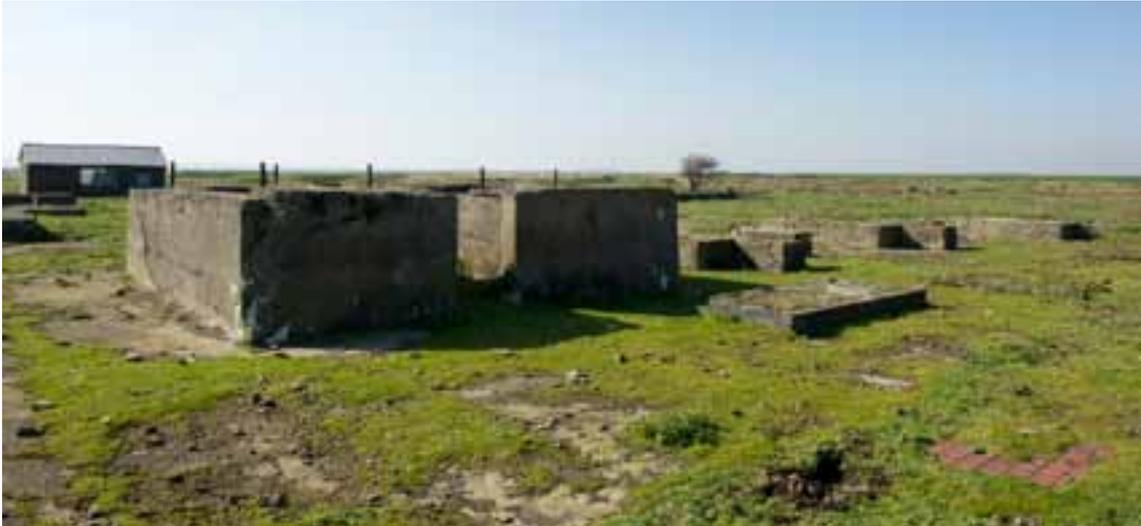
Structure **43** is the larger and more northerly of the two. Its foundation appears to comprise three main rooms or conjoined buildings visible as two concrete slabs connected by a smaller central one. The north-east foundation is characterised by the basal course of a dismantled brick plinth, a neat rectangular hole in the floor, a single wide iron pipe and traces of a possible internal division. At its south-east corner is a small room or building with traces of a red quarry tile floor and several iron fittings and pipes at floor level. This leads into the largest area of structure **43** where the foundation is divided in two on an east-west alignment. The south-west half is a fairly

Figure 69: Structure **43**, looking south-west. NMR DPI41515 07-Mar-2011, Steve Cole © English Heritage.

blank area or yard marked by the imprints of a blue brick floor, while the north-east area is characterised by at least ten machine-bed plinths of varying shapes and sizes, some brick-built and others concrete (Figure 69). Towards the east edge is the largest plinth: a concrete edifice 1.15m tall and laid-out as a symmetrical pair of conjoined machine-beds, each with a large central hole marking the rough removal of former machine attachments, and with a narrow opening between the two on the north-east side. Also distinctive, are three matching elongated brick plinths, rectangular at one end and semi-circular at the other, with traces of a narrow, shallow wheel pit along the west side of each, marking the probable position of flywheels. Each plinth also appears to relate to an open irregular void in the floor adjacent to the semi-circular end and crossed by a pair of parallel narrow flat iron strips (see Figure 64). Also, though obscured by vegetation, a narrow, gently scooped rectangular hollow lined with red quarry tiles is present next to the west side of each of these plinths. The make-up of the superstructure for this building remains ambiguous, but the lack of any clear brick wall scars points to a light construction of timber or corrugated iron. Spoil heaps and extensive evidence of burrowing, (possibly by badgers) is notable along the west and north periphery of structure **43**.

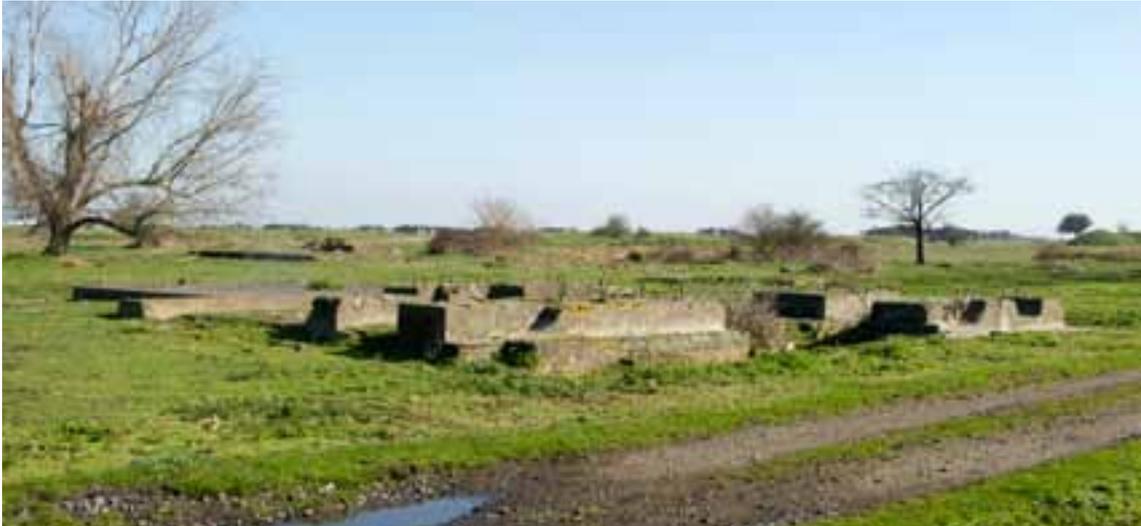
Immediately south-east of **43** is structure **44**, an L-shaped building with ancillary structures adjoining to the north and east. The main concrete foundation hosts a tight cluster of concrete plinths of mixed size and shape, all topped by patterns of protruding iron studs marking the positions of former machine attachments (see Figure 64). Unlike machine-beds elsewhere across the site, several of those associated with **44** have split-level surfaces with chamfered or curved sections falling away from the top of the plinths (Figure 70). At the north-east end of this slab is another, slightly smaller, square concrete foundation, featureless apart from a couple of L-shaped iron fittings and a pair of small holes in the floor. Nestled between this and the foundation with all the plinths is a narrow rectangular hollow or tank, at least 0.4m deep, and bound by a low narrow concrete wall and to its south by a low chamfered brick wall with bitumen residue on its surface. Likewise, the south-west corner of the main foundation is fringed by a low

Figure 70: Structure **44**, looking north-east. NMR DPI41509 07-Mar-2011, Steve Cole © English Heritage.

L-shaped hollow, edged by a thin dwarf brick wall with an internally chamfered top suggestive of a tank or sunken yard. At the far north end of **44**, obliquely abutting the square concrete slab to its south-east, is another tank-like feature over 0.4m deep, with stepped-concrete edges raised slightly above ground level. Additionally, based on its close proximity, a small stand-alone concrete building foundation measuring 4.6m x 3.1m has been included in this structure complex.

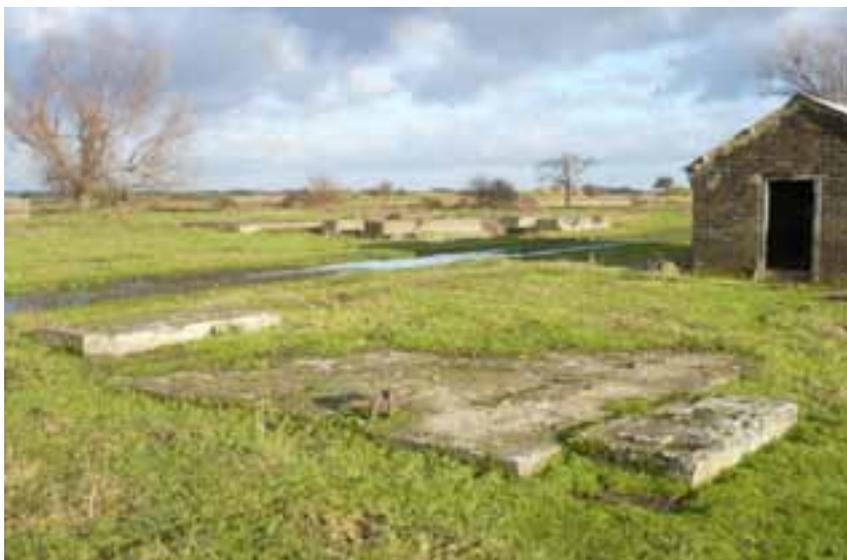
Figure 71: Structure **64** (with **44** and **65** behind).  
Photograph:  
Rebecca Pullen,  
2011 © English  
Heritage.

Moving east, structure **64** is a small rectangular concrete foundation parallel to the tarmac track. It measures 6.6m x 4.1m and has remnants of a cement surface. Near the north end of the slab is a concrete plinth or machine bed, 0.2m high, with a single cut-off corner to the south-west and two narrow strips of iron running lengthways across the top and secured at each end by a thin iron stud. Halfway along the west edge of

the foundation a large iron pipe, probably for conveying steam, emerges vertically from the concrete floor before turning through 90 degrees into a shoulder joint (Figure 71). Adjoining the south edge of the base is a further small plinth flush with the main slab and punctuated by a number of cut-off iron studs. Structure **64** is absent from the 1908 25-inch OS map.

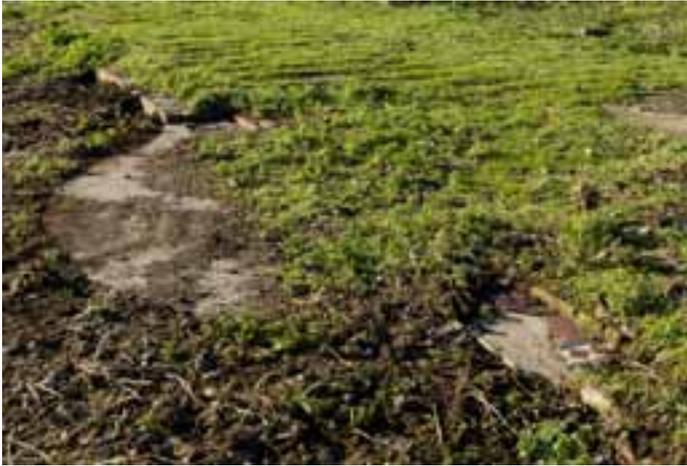
Structure **46** comprises two rectangular concrete bases. The main foundation is aligned east-west along the road; it measures 20m x 4.5m in plan and is constructed of closely laid concrete beams spanning the width of the floor. Adjoining this at the west end is a

Figure 72: Structure **46**, showing the remnants of the semi-circular threshold and decorative floor tiles. Extract from NMR DPI41600 07-Mar-2011, Steve Cole © English Heritage.

smaller featureless foundation slab with a footprint 7.7m x 4.8m. The most diagnostic feature of structure **46** is an elaborate entranceway located at the centre of its south edge. Where visible through the encroaching grass, this entranceway comprises a semi-circular concrete threshold at ground level, leading up to a low step surfaced with decorative tiles in a pattern of red, white and blue, then stepping up into a semi-octagonal space with remnant red quarry tiles, before a final step brings it up to meet the main floor (Figure 72). On the opposite side to this threshold is a slight projection in the concrete slab which could suggest a rear entrance, or a perhaps a bay window.

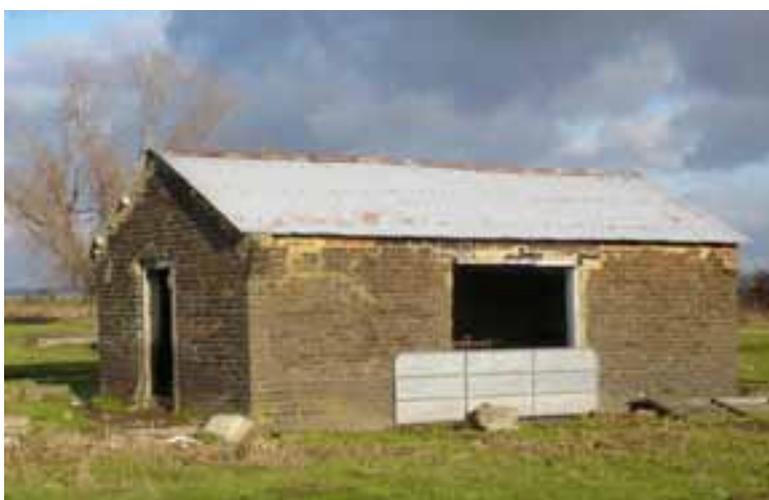
A further group of buildings thought to have had administrative, domestic or supporting functions were recorded on the south side of the tarmac road. At the western edge of this group, structure **65** is a small, single-storey brick building, measuring 7.5m x 4.2m in plan, re-roofed and currently used to store hay. The store is of red brick stretcher bond construction, with a low wide door opening in the centre of the south wall, with evidence of a blocked window to its west, which leads into the main room of the building (Figure 74). A second narrow doorway in the west end leads into a much smaller square room in the north-west corner of the store; the two rooms are not connected internally (see Figure 64). A pair of windows in the north wall provides light for the two interior rooms. Both doorways have timber frames, and the window openings have crudely inserted timber lintels. The internal walls of both rooms are plastered, and the larger room has the remains of an asphalt floor and a set of coat pegs set into the south wall at the west side of the door. A recess in the partition wall of the smaller room appears to mark the position of a stove or similar, and witness marks for shelves or other fixtures

*Figure 74: Structure 65, looking north-east. Photograph: Rebecca Pullen, 2011 © English Heritage.*

were also noted during the survey. The pitched corrugated iron roof is supported by a lightweight steel truss and timber purlin frame on stepped brick kneelers; this roof is a later alteration. The building sits on a concrete foundation with an apron of exposed concrete running along the east and south exterior. Adjoining the west end of the building is the concrete surface of a yard or small light-weight building. This area is blank on the 1908 25-inch OS map, proving that structure **65** was built later than the revision date in 1907.

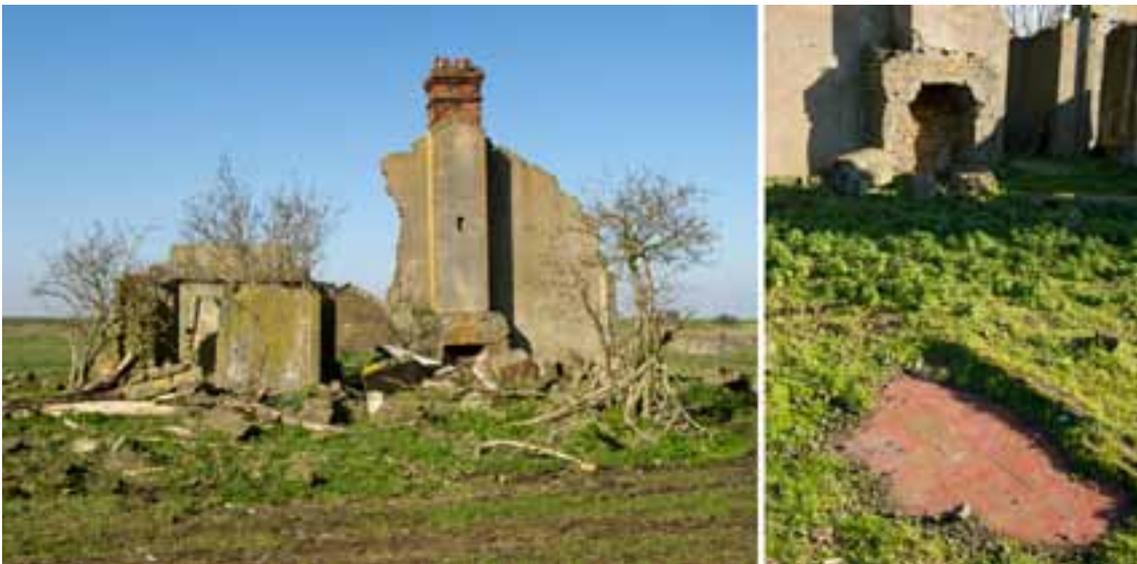
An embanked earthwork runs a short distance from the south-east corner of **65** before becoming a more formal concrete path apparently serving the roofless and now largely ruinous remains of brick building **66** (see Figure 64). All of the external walls are in a collapsed state and much of the resultant debris is present as a large rubble heap. Several sections of the internal walls are standing, including an off-centre stack with matching chimneys either side, and a pair of neighbouring door frames leading into two adjacent small rooms; all of which are rendered with a thin layer of cement (Figure 75). Parts of the wall adjoining the chimney stack survive to the height of the roofline, with visible notches to hold purlins. At the point where the north wall would have met the base of the roof pitch, a paired line of small peg holes are thought to relate to the position of a lightweight ceiling. The floor plan is only partially identifiable amongst the rubble and encroaching grass, but where visible it suggests two or more main rooms on the north side of the building, served by the pair of chimneys, and a series of smaller rooms along the south side of the building, giving a maximum footprint of around 14.5m x 14m. There are remnants of a decorative tiled doorstep in the north-west corner where the main entrance would have faced out towards the road (Figure 76).

Figure 75: (above left) Remains of 'The Poplars' (**66**), looking west. NMR DPI41517 07-Mar-2011, Steve Cole © English Heritage.

Figure 76: (above right) The decorative tiled doorstep of 'The Poplars' (**66**), looking south-east. NMR DPI41599 07-Mar-2011, Steve Cole © English Heritage.

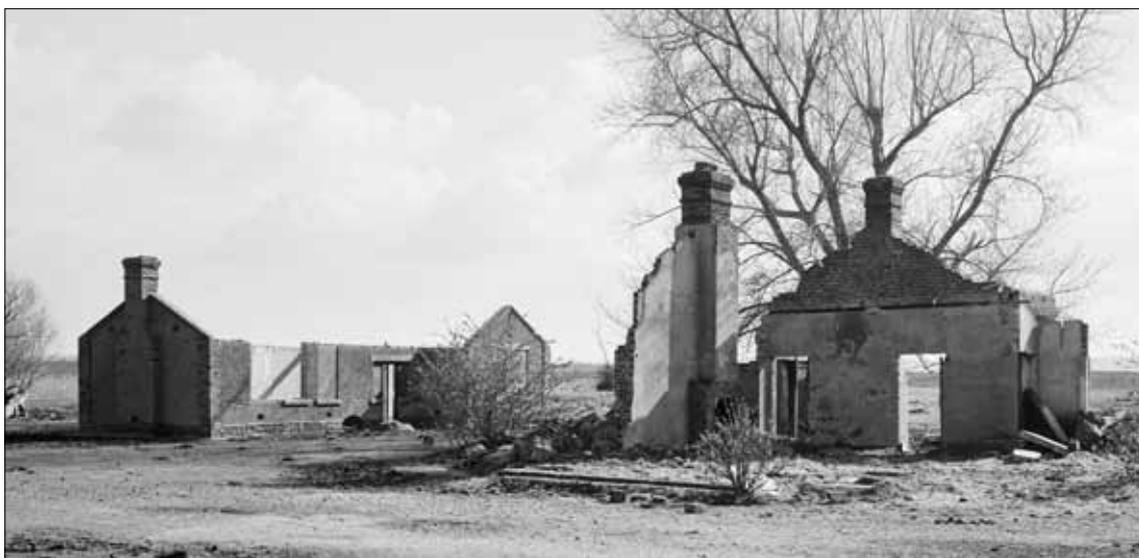
Photographs of building **66** taken by RCHME in March 1995, show more sections of wall than are currently standing, illustrating the structure's continuing deterioration (Figure 78).

Figure 78: (below) Structures **67** and **66**, showing the north-facing interior gable wall (right edge of image) that is no longer standing. NMR BB94\_08718 31-Mar-1995, Danke Silva © English Heritage.

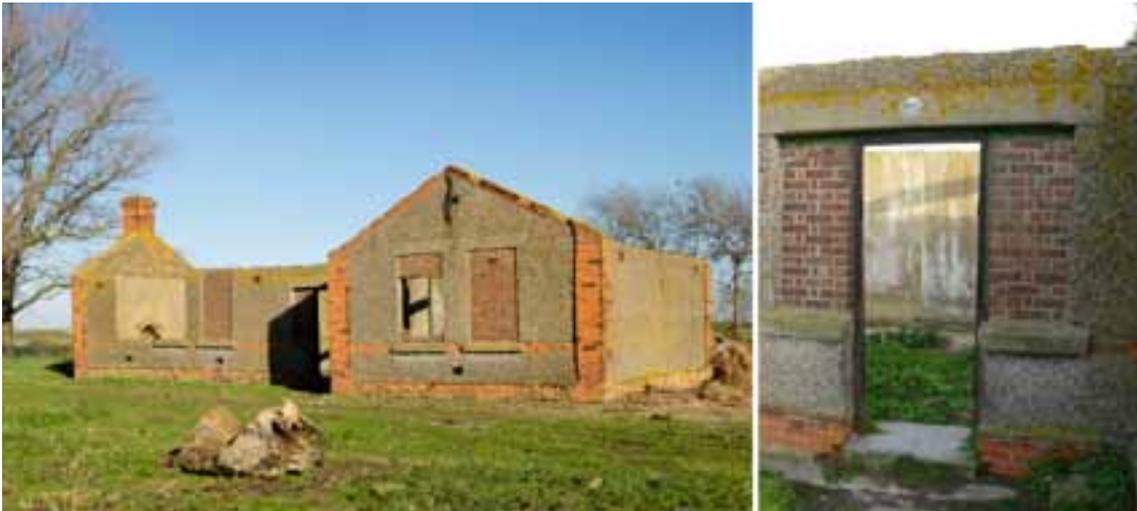
Standing a short distance to the south-east of the ruins of 'The Poplars', is a simpler and more complete single-storey, roofless, brick building (**67**). Built on a concrete foundation, the external walls of **67** are of orangey-red brick pier (stretcher bond) and panel construction with a pebble-dash render facing on the main panels (Figure 79). The building is L-shaped in plan, with a 15.5m long footprint; the main body of the building is 5.5m wide, widening to 7.6m in a short projection to the west at the south end. A single doorway in the corner of the long west wall leads into the largest of three rooms: a single room encompassing the complete north end of the building, which in-turn opens into two small ancillary rooms arranged side-by-side at its southern end (see Figures 64, 66 and 79).

Figure 79: (above left) Structure **67**, looking north-east. NMR DPI41597 07-Mar-2011, Steve Cole © English Heritage.

Figure 80: (above right) Structure **67**, showing the circular paint mark above the door, looking north-east. Photograph: Wayne Cocroft, 2010 © English Heritage.

Each of the east and west walls is punctuated by fairly low rectangular windows with concrete sills and flat concrete chamfered lintels (equivalent to those thought to represent a second phase of remodelling in structure **23**, the brick building in **Area A** interpreted as a weighing and checking house associated with jetty **J1**). The windows all appear to have been neatly blocked with English bond brickwork (using Flettons), and subsequently several have been fully or partially reopened. The only door into the building is situated at the southern end of the main west-facing long wall, tucked in the sheltered corner of the L-shaped layout. Although the door itself is missing, the iron frame of an outward-opening door, hinged on the south side is still present, as is the loop for a catch or padlock on the north side. The door is flanked by a pair of blocked windows with green-painted wooden frames; a single concrete lintel supports the wall above all three, and a degraded circular stamp of green and white paint suggests there was once a label or plaque above the door which may have displayed the building's identification number (Figure 80).

Building codes or numbers would have been clearly displayed on the outside of each building (see Figure 80). There may even have been signposts placed at various locations across the site, such as at junctions in the tram network, especially important for a site frequently enveloped in thick and disorientating sea mist.

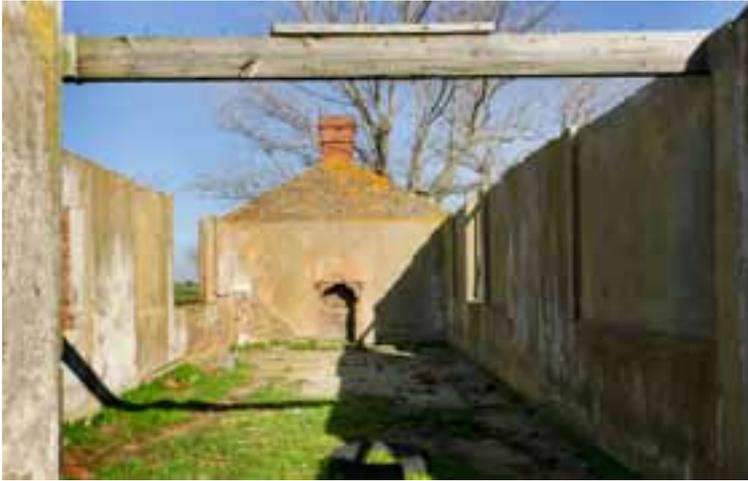
Figure 81: (above left) Inside structure **67**, looking north, showing the small fireplace and the rendered recesses of the blocked windows. NMR DPI41518 07-Mar-2011, Steve Cole © English Heritage.

The building is entered by a concrete step; the height of the threshold, along with witness marks in the render at skirting board level on the interior walls, are suggestive of a former suspended floor. The interior wall render is missing in places and stops purposely at ceiling height on the gable ends, marking the position of a suspended ceiling. Here, light brown bricks in stretcher bond are exposed; a contrast to the bright orangey-red bricks chosen for the exterior brickwork (Figure 81). Where the window blocking is still in place, the brickwork in the shallow recesses left in the internal walls has been rendered over, except for in the western gable end and the small windows either side of the door. The centre of the north wall is marked by a small fireplace with witness marks in the render where the fire surround has been removed (see Figure 81). A clustered group of narrow, vertical pipes or telephone cable conduits are set into the top of the south wall, and appear to be responsible for a large crack emanating from this point. The presence of inserted timberwork could suggest the abandoned building has been reused at some point, possibly as a sheepfold; this may also account for the reopening of several blocked windows.

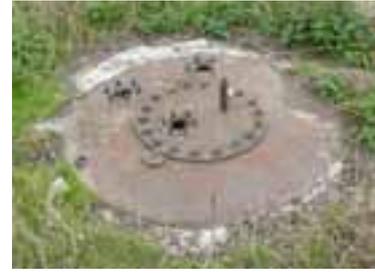
Figure 82: (above right) Buried oil tank near Structure **67**. Photograph: Wayne Cocroft, 2010 © English Heritage.

A single tall square-section concrete post - similar to those recorded in **L1** and **L2** - was noted standing about 3.5m south of the south-east corner of **67**; this was possibly a lamp post or a telegraph post associated with the probable telephone cable conduit in the south wall, and has since fallen down. Additionally, the circular iron top of a tank (probably for oil) is visible set in concrete and sunk into the ground 8m from the south end of the building (Figure 82).

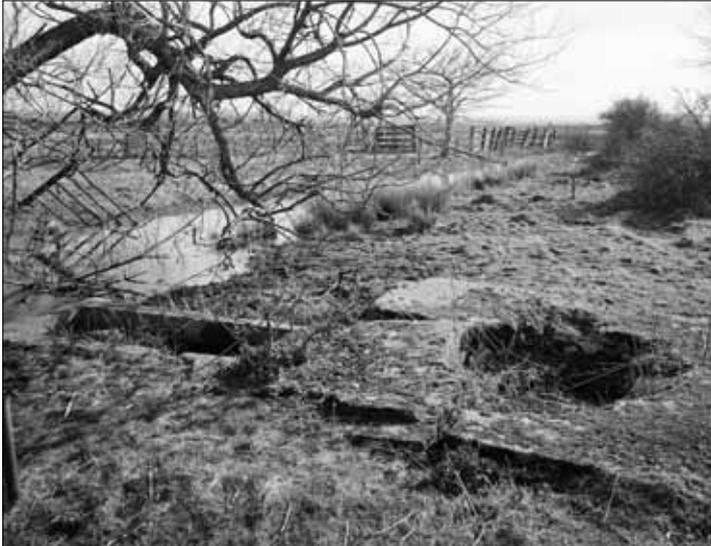
Figure 83: Structure **50**, looking south-east. NMR BB94\_08723 31-Mar-1995, Danke Silva © English Heritage.

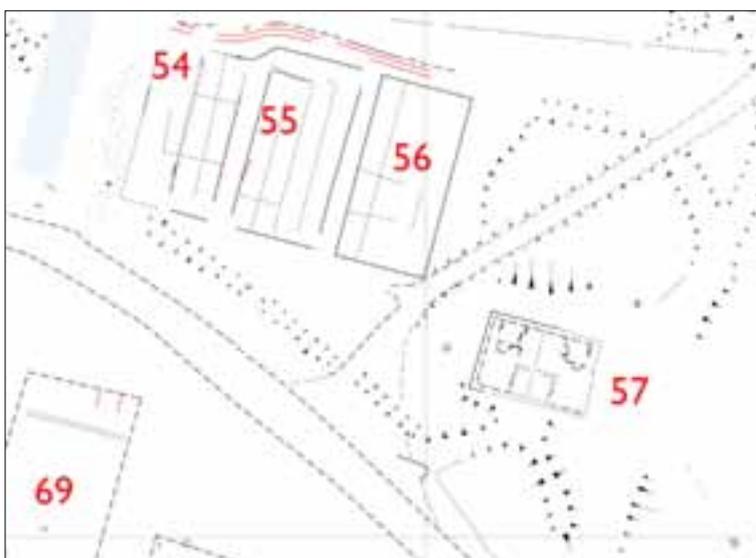
Figure 84: Extract from the survey showing trio of structures **54**, **55** and **56**, and the probable semi-detached guards' cottages of structure **57** (not to scale)  
© English Heritage.

A short distance south-east across the probable farm track, is structure **57**; a rectangular building foundation measuring 12.7m x 8.9m, with a neat arrangement of floor features revealing the symmetrical layout of a pair of domestic spaces. This appears to be the remains of a semi-detached pair of small cottages, presumably a simple, single-storey building that was perhaps the sometime-homes of factory watchmen. The slab is divided centrally along a roughly north-south line, either side of which the features recorded are

mirrored (see Figure 84). Central to the southern edge of the foundation there appear to be two small entrance halls, seen as brick wall scars around a smooth concrete floor; from these visitors would turn 90 degrees and enter the main room with their back to the party wall. The floor of each cottage is covered by a skin of bitumen carrying the imprints of a decorative herringbone brick floor; wall lines are clearly visible through the bitumen. The internal space of each cottage seems to have been divided into three main areas: a large area at the front of the building with a fireplace on its back wall (roughly central to the cottage) and two further rooms behind the fireplace. The first of these is an elongated space behind the entrance foyer and against the party wall, the second is in the corner diagonally opposite the entrance and seems to comprise a small ante-room leading into a roughly square room directly backing onto the fireplace.

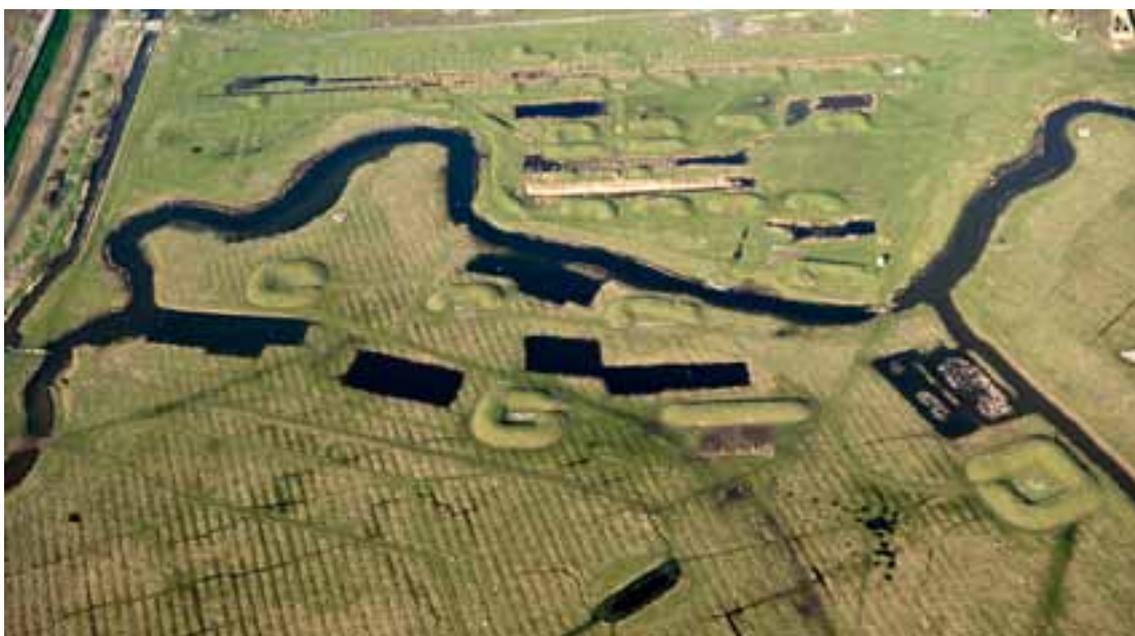
Figure 85: **Area C** from the air looking north, showing the contrast in scale and layout of structures either side of the sinuous 'delph ditch' drainage dyke. NMR 26892/001 08-Mar-2011, Damian Grady © English Heritage.

the structures are small and laid out in ordered rows, to its south the structures are larger and more spread out (Figure 85). North of the dyke, the area is covered by evenly spaced parallel rows of small concrete bases each, with a protective earthwork bank (see section 6.8 for the area south of the dyke).
