# CURTIS'S AND HARVEY LTD EXPLOSIVES FACTORY, CLIFFE AND CLIFFE WOODS, MEDWAY ARCHAEOLOGICAL SURVEY AND ANALYSIS OF THE FACTORY REMAINS

Volume 1 of 2

Rebecca Pullen, Sarah Newsome, Andrew Williams and Wayne D Cocroft

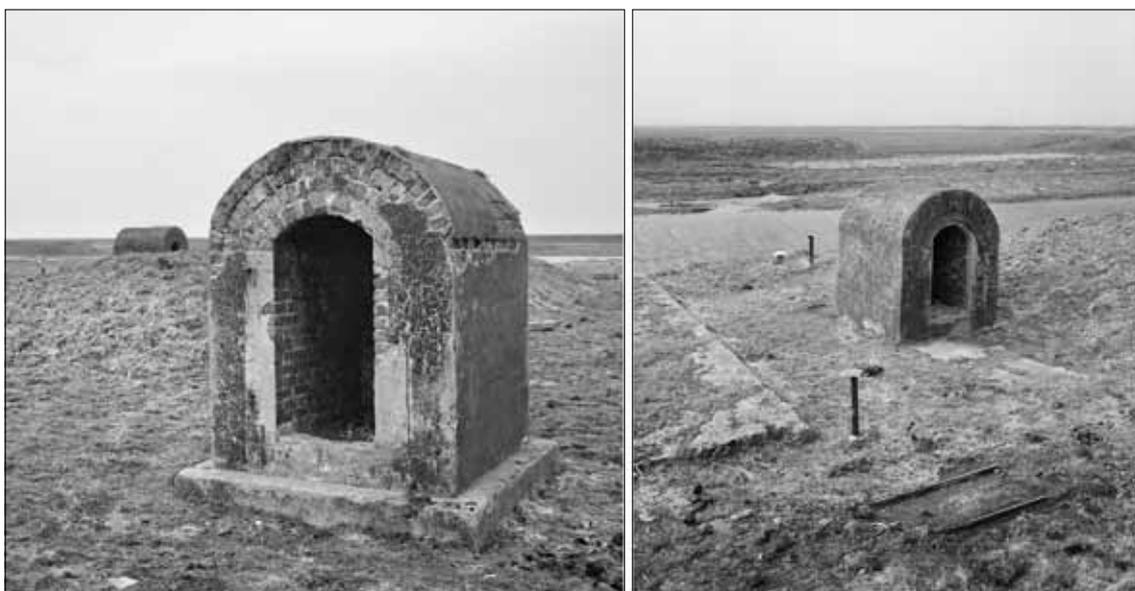
Located north-east of **96**, structure **95** is a distinctive small brick-built barrel-vaulted structure standing 2m tall on a concrete foundation slab 2.3m x 2m in plan (Figure 87). The brick superstructure has a footprint of 1.9m x 1.7m, and is orientated NW-SE. An opening in the south-east elevation indicates that the building faced out towards the line of a passing tramway, the embankment for which has now been largely eroded by modern vehicle tracks. The opening measures about 1.3m high x 0.75m wide. Internally, the opening projects back for about 1.3m to create a small interior chamber the same size and profile as the doorway and there are remnants of a thick concrete floor. A pair of large iron hinges located alongside the south-west side of the doorway and a horizontal iron loop intended to receive a central bolt or lock on the opposite side, signify the former presence of a heavy-duty outward-opening door. The whole exterior of the building is covered with remnants of a cement render with a blackened surface; where this has eroded it exposes common modular red bricks in English bond, topped by a barrel vault built of a segmental arch comprising four concentric bands of headers. Interestingly, photographs of the site taken by RCHME in 1995, show structure **95** close to an identical brick building that was located at the west side of structure **96**, and orientated with the opening facing south-west towards the drainage ditch (see Figure 87). Comparing the photographed location of the second brick structure to the 1907 25-inch OS map revision, it is clear that both **95** and its matching partner had been built by 1907. Demolition or removal of the second structure at sometime between 1995 and 2010 may account for some of the spoil and rubble accumulated across the surface of structure **96**.

Figure 87: (left) Structure **95**, with the top of its former partner just visible in the background, looking west; (right) the concrete foundation of structure **96** and the second barrel-vaulted brick structure that has since been demolished, looking south-west. NMR BB94\_08740 and BB94\_08741 31-Mar-1995, Danke Silva © English Heritage.

At present, the most satisfactory interpretation for the function of structure **95** and its missing partner, is that they were expense magazines, used for holding particularly sensitive small explosive components.

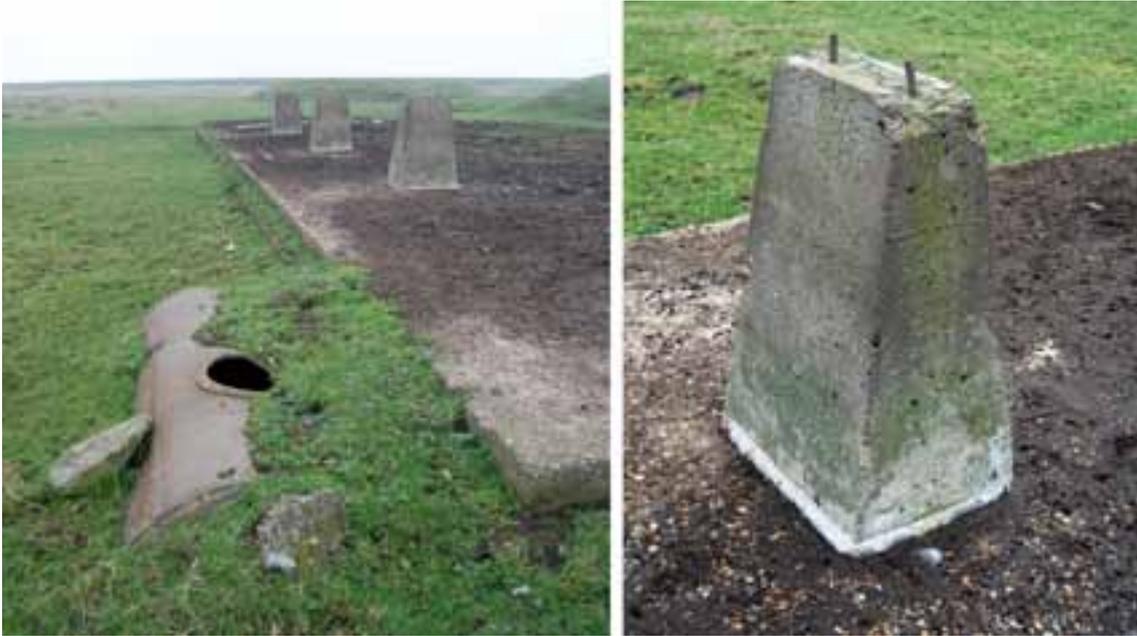
Figure 88: (left) South edge of structure **101** showing the iron tank and trapezoidal concrete plinths, looking west; (right) detail of one of the trapezoidal concrete plinths. Photographs: Rebecca Pullen 2011 © English Heritage.

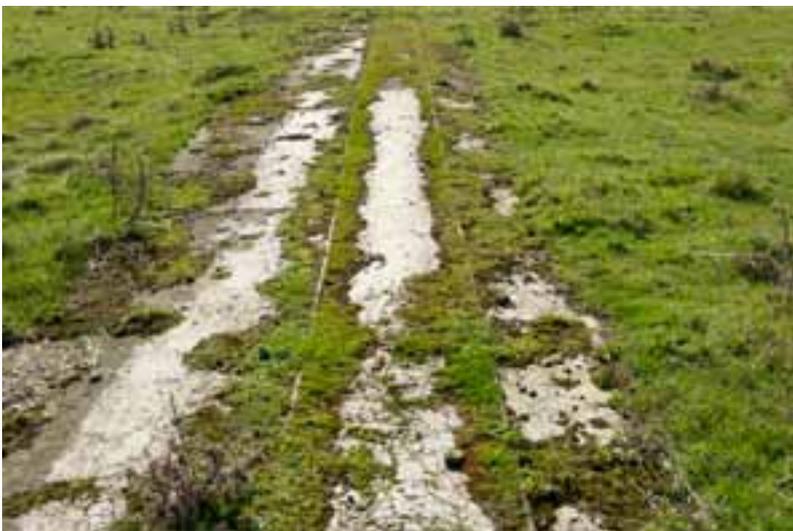
*Figure 90: Iron tram rails and cambered cement tram-bed between structures **107** and **108**, looking south-west. NMR DPI41543 07-Mar-2011, Steve Cole © English Heritage.*

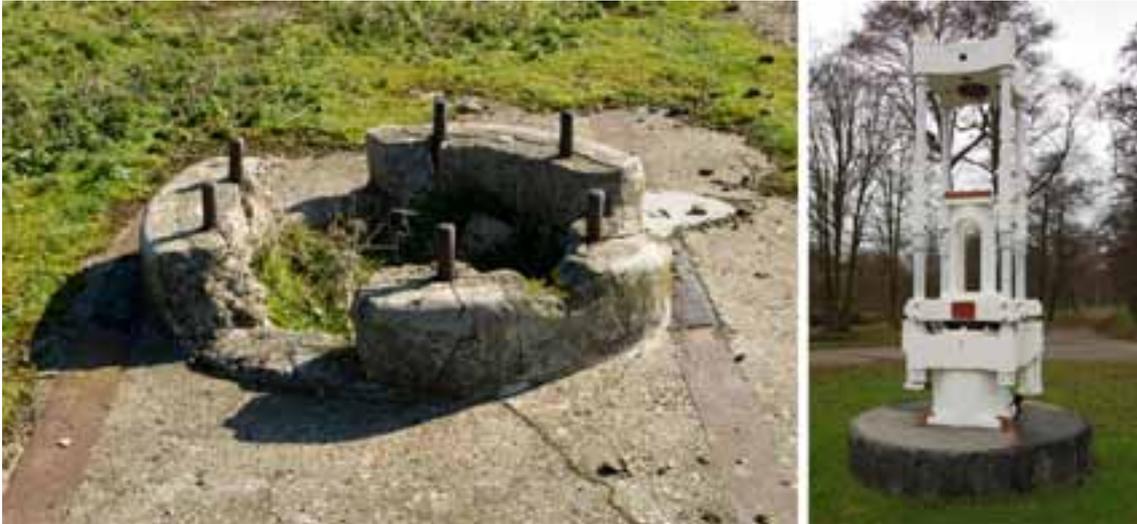
Figure 91: (above left) Detail of a hydraulic press base in structure **108**. NMR DPI41541 07-Mar-2011, Steve Cole © English Heritage.

Figure 92: (above right) A preserved hydraulic cordite press displayed at the Royal Gunpowder Mills visitor site, Waltham Abbey, Essex. Photograph: Rebecca Pullen 2011 © English Heritage.

Also facing into this central triangular space is structure **108**, another elongated coarse concrete building foundation with similar proportions to **107**. It measures at least 46m x 9m and is set on a NW-SE alignment with tramlines that branch off from nearby structure **106** and run beside both long edges of **108**. The tramline along the north-east side of **108** appears to truncate an earlier tramline approaching at an oblique angle from structure **107** to the north-east, presumably indicating a change in function or layout of the buildings in this area. A brick wall scar was recorded along the length of the slab forming a back wall to the south-west; additionally, short segments of brick wall footings surviving at the north-west end suggest that there was a brick superstructure comprising up to eight individual cells with frontages opening into the central triangular space. Based on these witness marks, the cells measured about 6.7m x 5.3m internally, each with a low circular machine base located towards the back wall of the cell. From the north-west end, the first five cells have surviving examples of these circular concrete bases. The machine bases comprise three low curved segments of concrete, 0.22m high x 0.3m wide, arranged in a ring with gaps of 0.35m between each segment (Figure 91). The concrete segments are covered with a thin surface of smooth cement render with visible pouring marks; and protruding from the top of each segment is a pair of thick threaded iron studs. Narrow parallel iron plates flank either side of the bases and align with the length of the building. The eighth cell, at the far south-east end of the slab, contains a small pair of rectangular plinths, one brick and one concrete with protruding iron studs. Based on the distinctive form of the circular concrete bases, **108** has been interpreted as a cordite press house. It probably once contained large hydraulic presses similar to those known to have been in use at RGPF Waltham Abbey (Figure 92), and may have been powered by structure **110**, thought to be the base for a hydraulic accumulator tower.

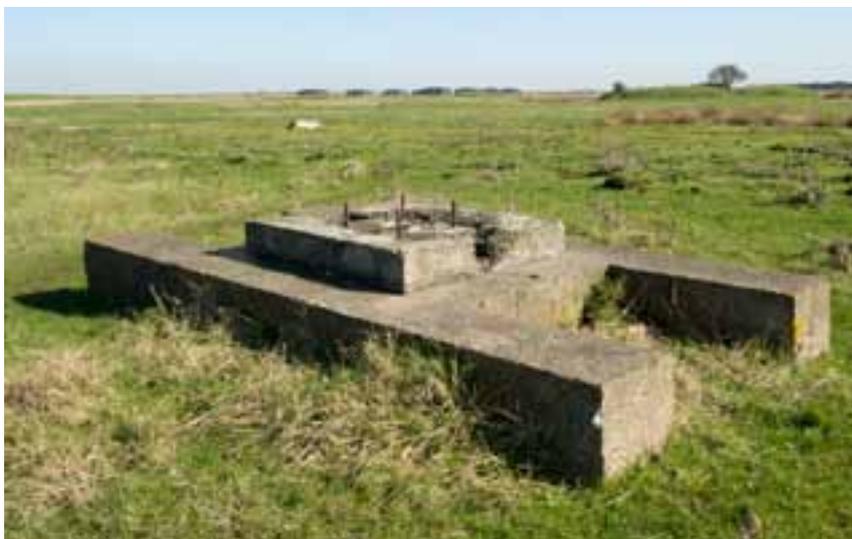
Structure **111** is a lone concrete plinth with an H-shaped footprint, sitting between the large building slabs of **107** and **112**. It measures 4m x 2m in plan and stands to a height of 0.4m above ground level. Located centrally on the structure is a further concrete plinth measuring approximately 1.2m square by 0.2m high, with an arrangement of five tall iron studs in its top, presumably the bedding plinth for a machine (Figure 93).

*Figure 93: Structure 111, looking east.  
NMR DPI41546 07-Mar-2011, Steve Cole  
© English Heritage.*

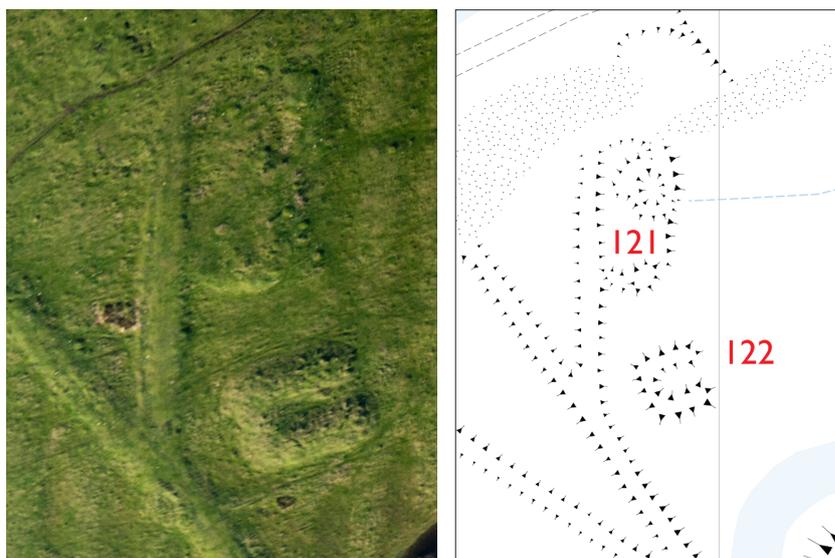
Structures **121** and **122** are a pair of small low earthworks that appear different in form from the rest of the factory features (Figure 94). Located a short distance north-east of **112**, structure **121** is a low sub-rectangular platform with a smaller sub-square platform on its north-east corner. At the centre of the smaller platform is an oval hollow with a pattern of twelve threaded iron bolts with hexagonal nuts arranged in two clusters of

Figure 94: (far left) Structures **121**, and **122** from the air, extract from NMR 26892/016 08-Mar-2011, Damian Grady © English Heritage; (left) detail from the main survey drawing © English Heritage.

four and two lines of three. The feature appears to abut or underlie the tramway to its west; conversely, a low earthen mound at the south end of the main platform gives the impression of partially overlying the tramway embankment. One possible interpretation is that **121** represents the base for a wireless mast.

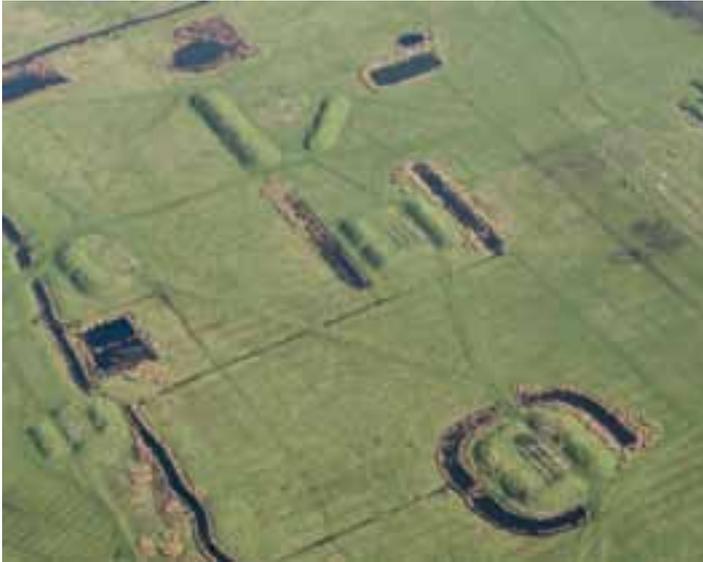
Figure 95: Structures (clockwise from top) **127, 126, 123, 120** and **124**, from the air looking south-east. Extract from NMR 26890/043 08-Mar-2011, Damian Grady © English Heritage.

Structure **127** is south-west of **125**, along a narrow and poorly formed embanked tramway or path. It comprises a fairly square building foundation, 16.5m x 13.5m in plan, with remnants of an asphalt floor and traces of four equally-sized internal divisions laid out as a quadrant. The slab is enclosed by a triangular arrangement of straight earthen mounds along the north and south-west edges, and a tramway along the south-east (Figure 95). A second tramway serves the north side of the foundation and connects it to **126** to the west and to **123** beyond. The foundation is one of a series of distinctive four-room buildings recorded across much of the north-east quarter of the whole site. In plan form it is directly equivalent to the better preserved examples of **143-146** to the

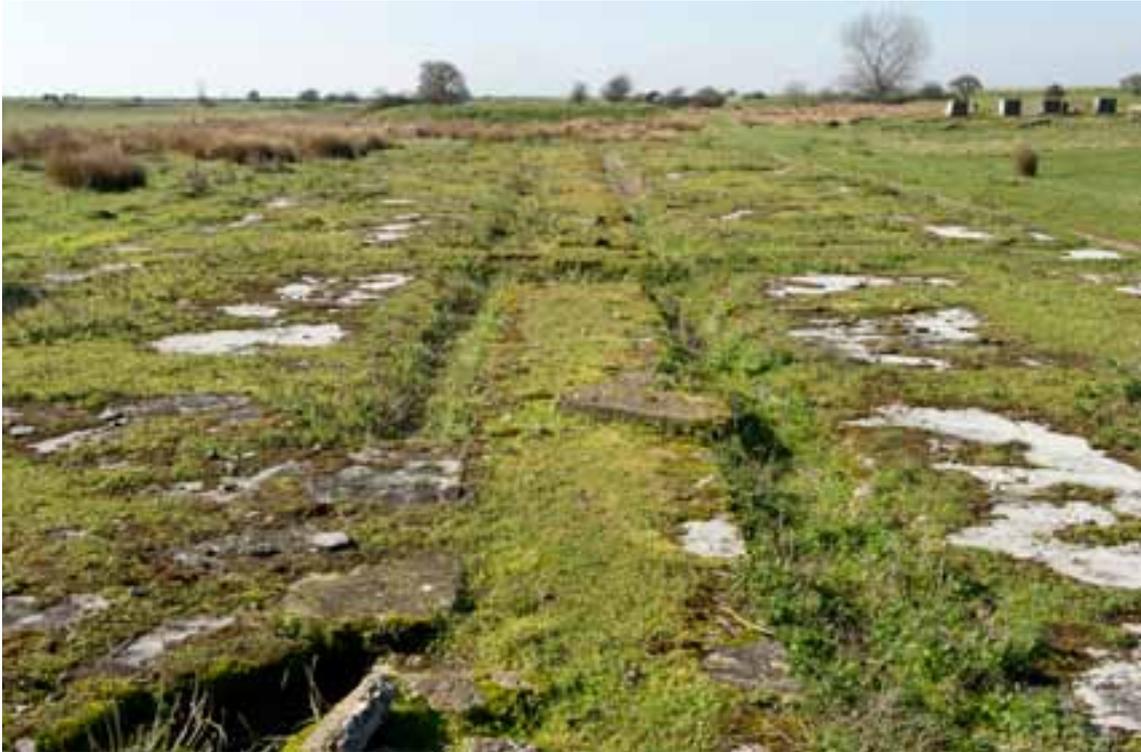
Figure 97: Structure **131** showing the channels in the concrete slab and the remnants of asphalt flooring, looking west. NMR DPI41563 07-Mar-2011, Steve Cole © English Heritage.

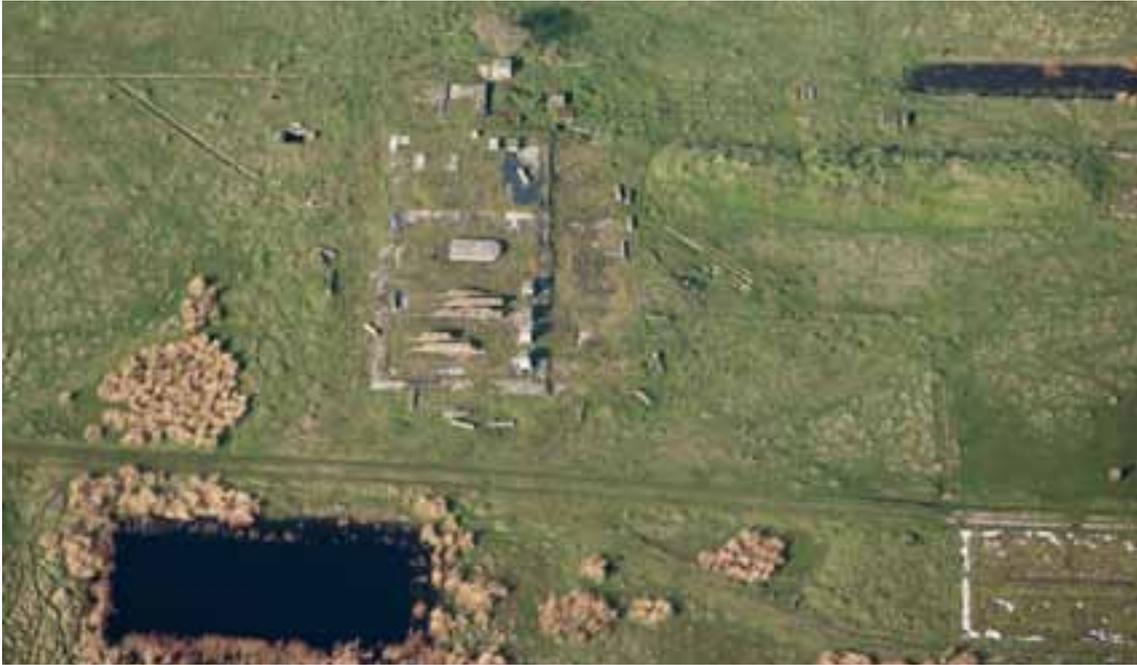
Figure 98: Structure **132** from the air showing the complex layout of plinths and hints of the network of brick-lined channels connecting it to the acetone recovery stoves either side, looking north. Extract from NMR 26890/048 08-Mar-2011, Damian Grady © English Heritage.

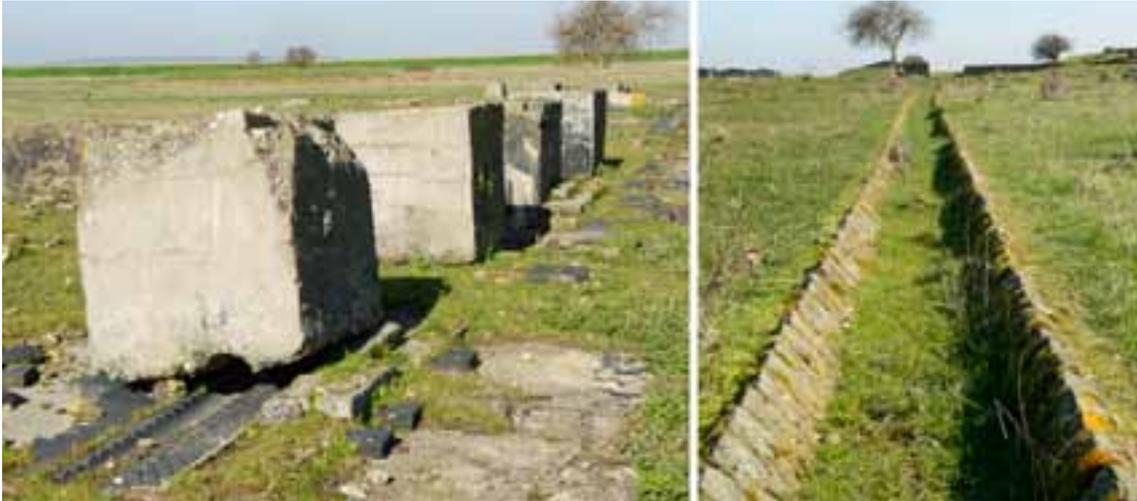
Figure 99: (above left) The blue brick drain beneath concrete plinths in structure **132**, looking north-west. NMR DPI41555 07-Mar-2011, Steve Cole © English Heritage.

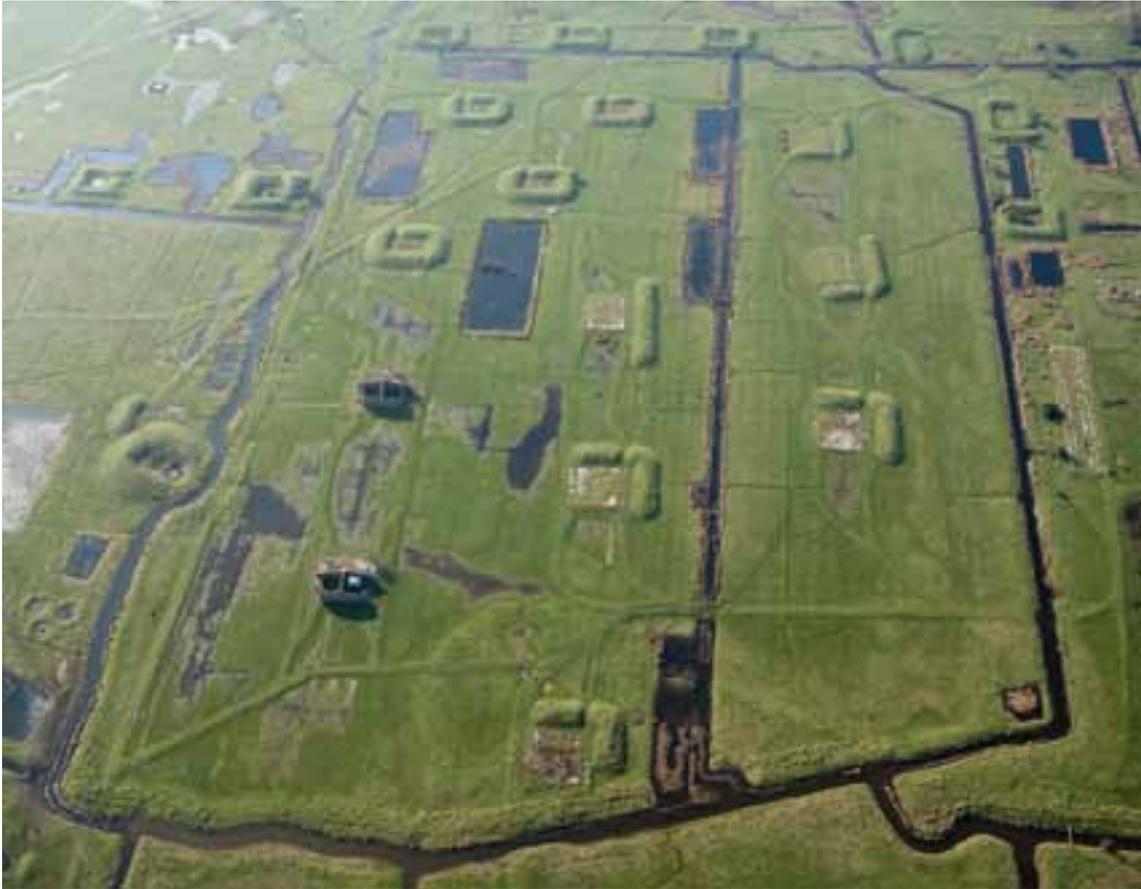
**Area E** is a roughly trapezoidal area of land created by the pattern of drainage dykes at the centre of the factory, and filled by two distinctive structure groups interconnected by a complex network of tramway embankments (Figure 101). The south-west side of the area contains seven evenly spaced concrete building foundations, each tightly encircled by a protective earthen traverse (**I39-I41** and **I49-I52**). Most of these have been interpreted as guncotton drying stoves, based on the presence of small exterior hut bases comparable with the known fan sheds associated with the guncotton stoves in **Area H** belonging to HM Cordite Factory (**267a-283a**). In contrast, the north-east side of **Area E** contains the remains of eight square concrete building foundations, each with evidence for four-rooms in a square arrangement (**I43-I48** and **I53-I54**). Using comparable examples in **Area K** of the HM Cordite Factory site (**206-212** and **222-231**),

Figure 101: **Area E** viewed from the air, looking west, with cordite drying stoves in the foreground and guncotton drying stoves at the top of the image. NMR 26890/013 08-Mar-2011, Damian Grady © English Heritage.

brick, rather than concrete as seen in equivalent standing structures **I53** and **I54**. All six slabs are accompanied by a protective earthen bank along their north side and, for all but structure **I46**, along either the eastern or western side as well (see Figure 101). Iron bolts or wooden posts survive next to several of the traverse openings through which tramways entered the drying stoves. These are presumed to be tie-pins and support posts for wooden or corrugated iron shuttering used to prevent subsidence of bank material onto the track.

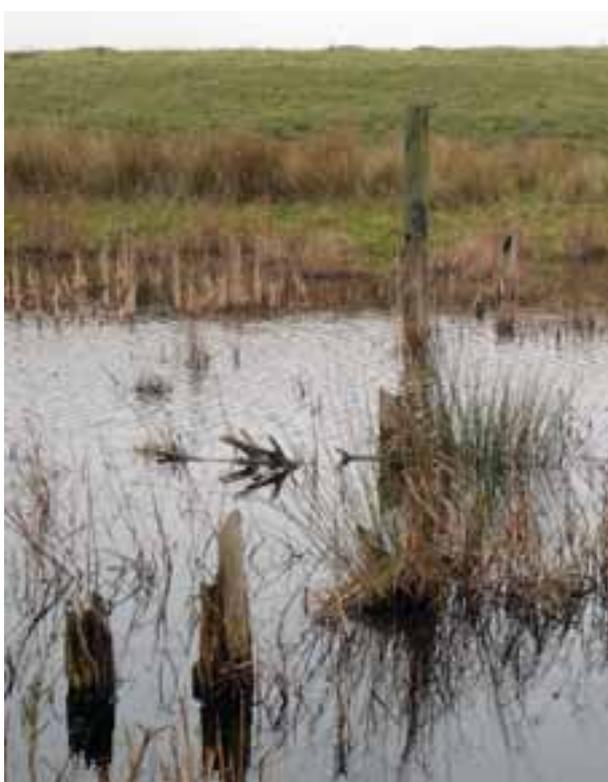
*Figure 102: Wooden posts in the water-logged borrow-pit north of guncotton drying stove **I52**, looking north. Photograph: Rebecca Pullen 2011 © English Heritage.*

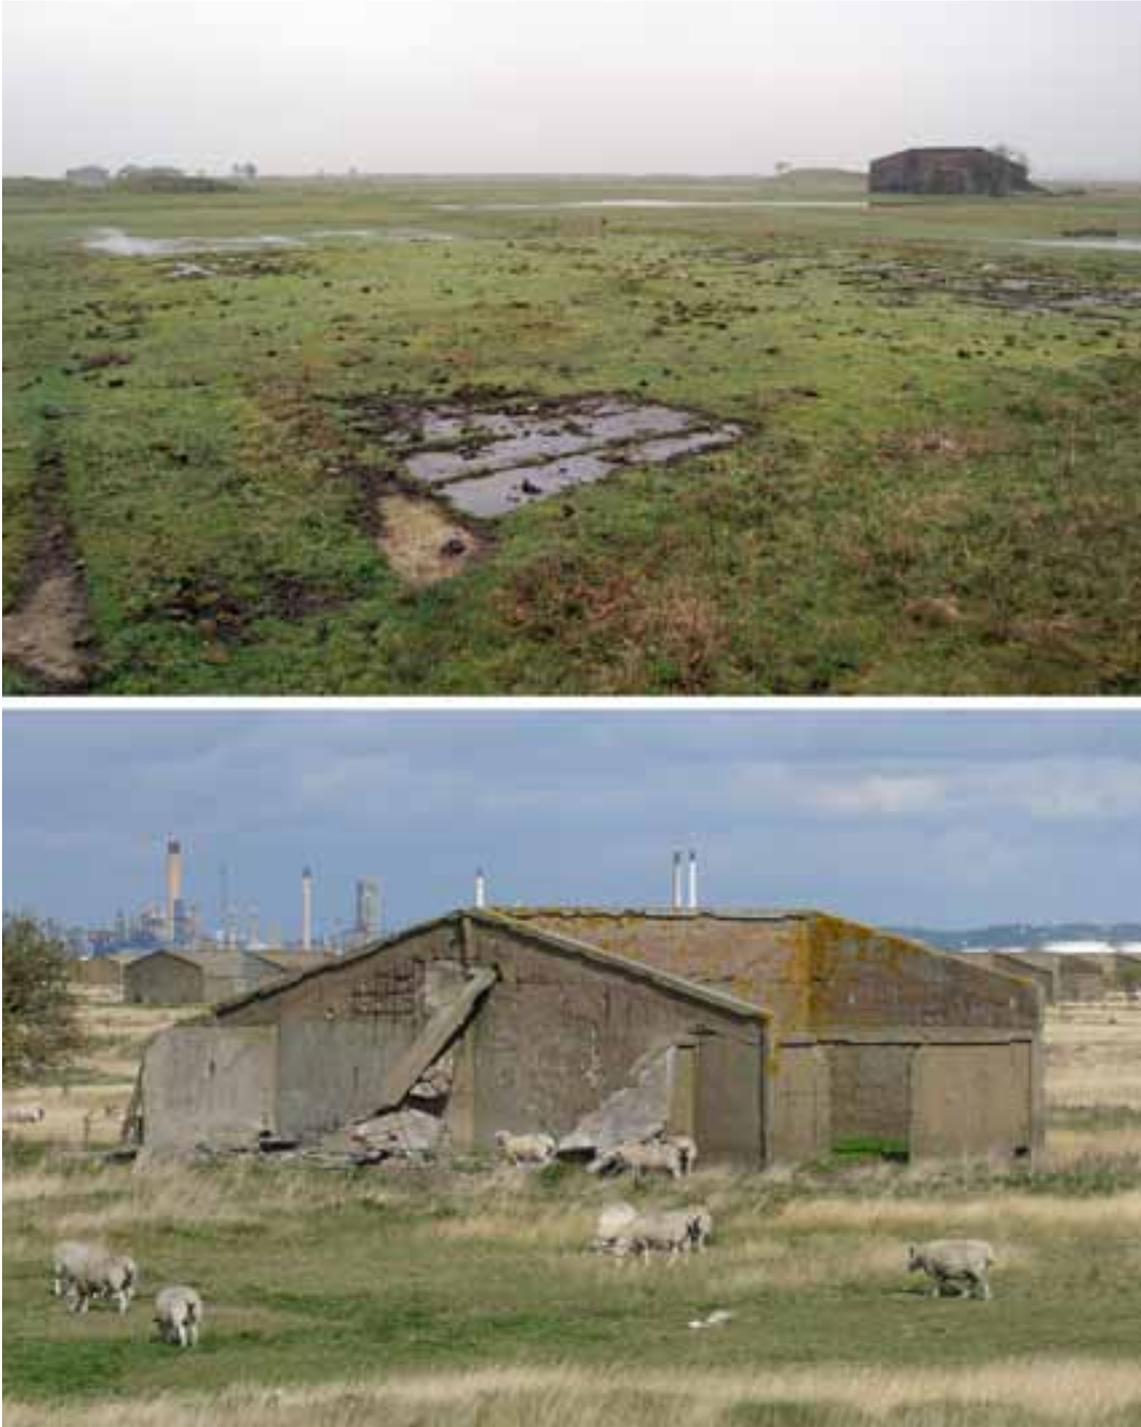
Figure 103: The two forms of cordite drying stove remains present in **Area E**, showing (top) the floor plan remains of former brick structure **147**, looking south-east, and (bottom) the standing reinforced concrete remains of structure **153**, looking north-east. Photographs: Rebecca Pullen 2011 (top) and Wayne Cocroft 2010 (bottom) © English Heritage.

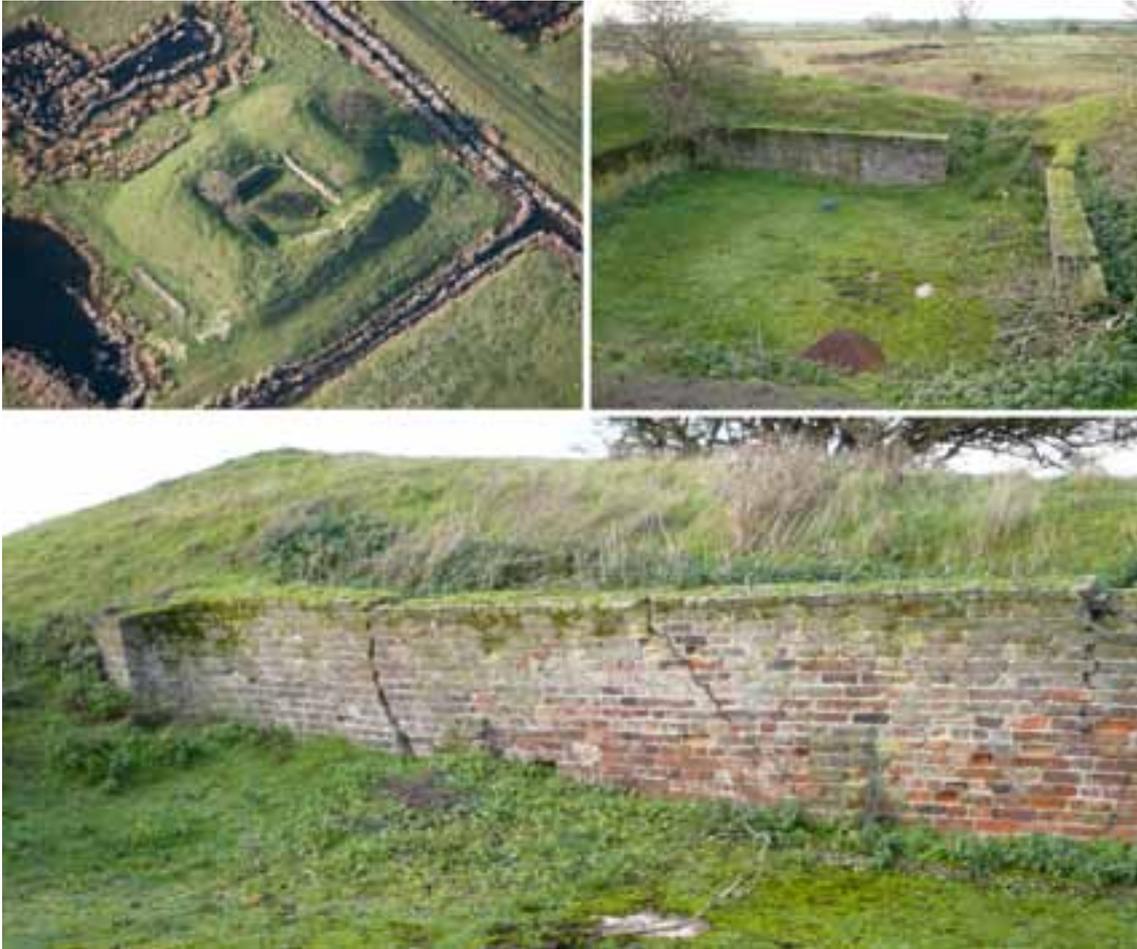
Figure 105: Structure **156** (clockwise from top left): oblique aerial view looking north-west; interior looking west; detail of the north stretch of the internal revetment wall suffering with subsidence. Photographs: Extract from NMR 26890/039 08-Mar-2011, Damian Grady (top left), and two ground shots, Rebecca Pullen 2011 © English Heritage.

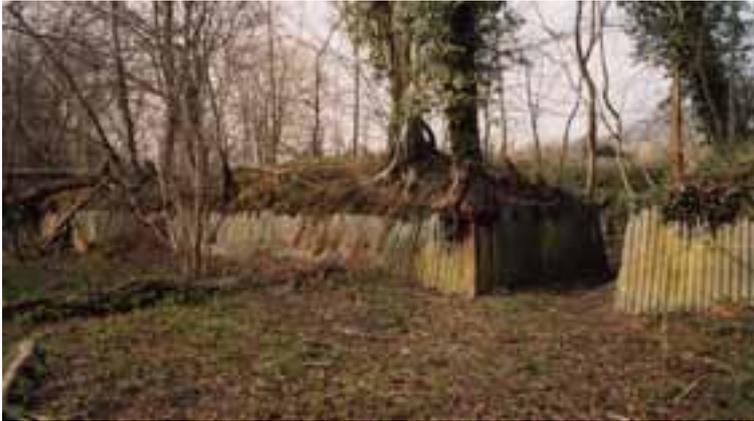
*Figure 106: A corrugated iron earth-filled traverse known as a 'Chilworth Mound' shielding the front of an explosives magazine at the Chilworth Factory, Surrey. NMR AA044446, Wayne Cocroft © English Heritage.*

It is worth noting that where structures **156**, **157** and what might be structure **155**, are depicted on the 1908 25-inch OS map, they are the only factory buildings for which the earthwork traverses are portrayed as grey shaded structures with sharp square corners (see Figure 104); all other earthworks are depicted with hachures and more rounded corners (see Figure 16). Presumably, these traverses were constructed in a different manner, for example the earth may have been covered with corrugated metal sheeting to create 'Chilworth Mounds' (Figure 106).

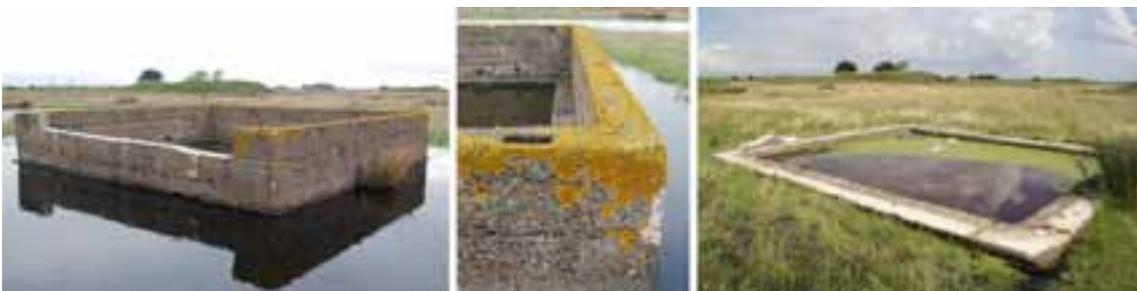
*Figure 107: Structure **158** (left and centre) as recorded during the survey at the start of 2011, detail of hole cut into the corner to hold a superstructure or cover, and (right) with the sides reduced to ground level, as seen in Summer 2012. Photographs: Sarah Newsome 2011 and 2012 © English Heritage.*

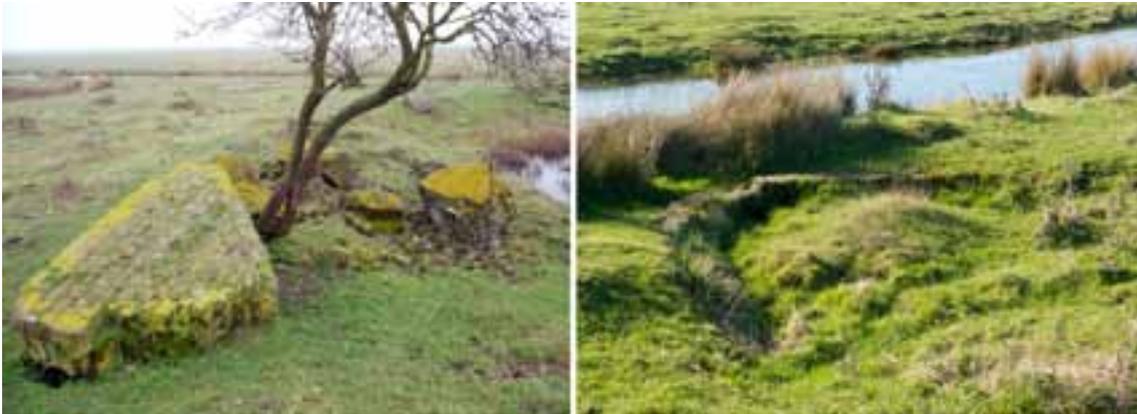
Figure 108: (above left) Distinctive structural brickwork fragments on the bank associated with structure **103**. Photograph: Rebecca Pullen 2011 © English Heritage.

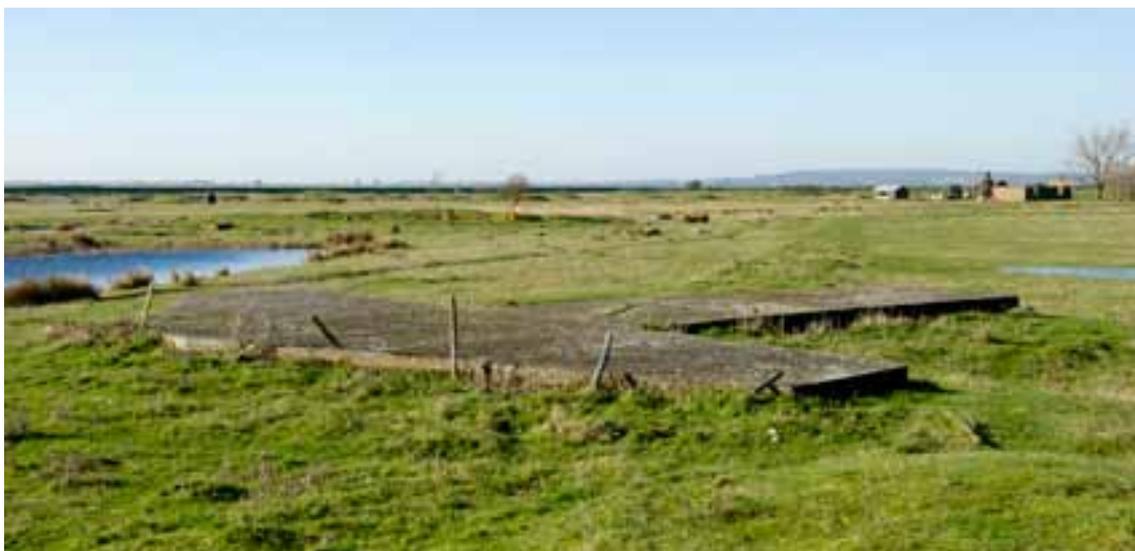
Immediately north of **104**, and forming the termination point of the tramway approaching from the north-west is structure **105**: a curious concrete slab with an arrow- or T-shaped plan and a pattern of iron bolts in the top, measuring 16m x 18m across its longest axes (Figure 110). Its function remains unclear, however its position could link it to the alignment of triangular concrete bases of **L4**, thought to be part of an aerial ropeway or major elevated pipeline leading west from the south central area of the factory out towards **J3**, the largest of the factory's jetties on the River Thames (see section 6.2). One of these triangular bases is located to the south of **104**, and another is east across the drainage dyke from **105** (see Figure 42).

Figure 110: Structure **105**, looking north-west. NMR DPI41590 07-Mar-2011, Steve Cole © English Heritage.

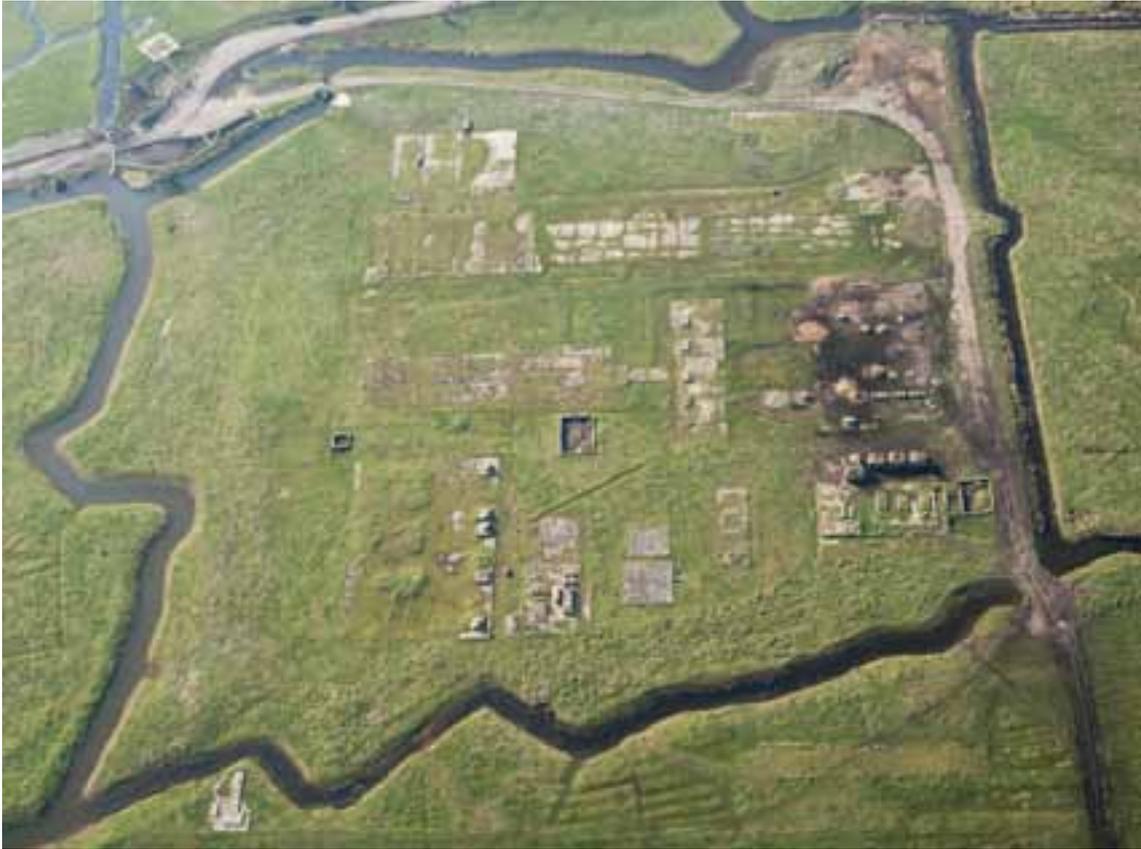
Figure 112: **Area G** from the air, looking west. NMR 26890/018 08-Mar-2011, Damian Grady © English Heritage.

Located at the southern edge of the factory site, **Area G** houses a coherent complex of interlinked concrete building foundations (Figures 112 and 113); these mark the entrance to the guncotton manufacturing plant belonging to HM Cordite Factory (ibid). Alongside buildings for processing cotton and acid, are a number of buildings relating to support roles and administration. **Area G** is surrounded on all sides by drainage dykes. It is worth noting that the east-west dyke that marks the north edge of **Area G** is a later addition, not seen on the 1908 25-inch OS map. This dyke is also absent from the map accompanying the 1923 sales particulars (see Figure 111); however, as the track to its south on the map marks the northern edge of the HM Cordite Factory land in this area,

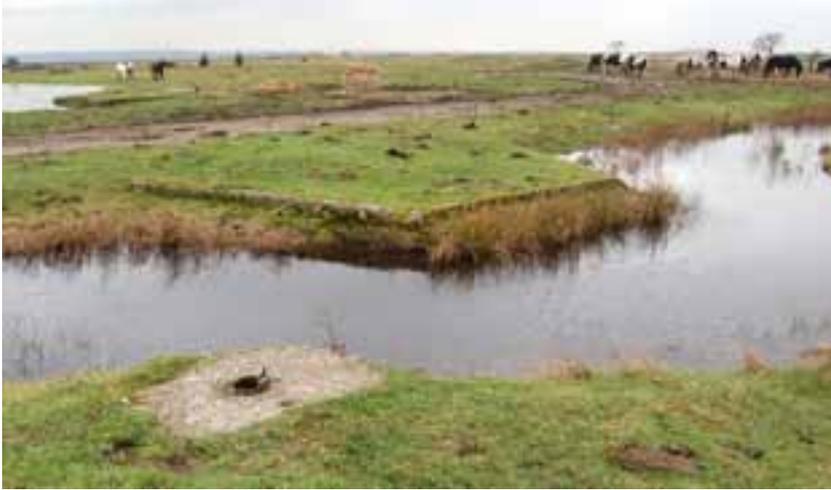
Returning to the north edge of **Area G**, structures **173a** and **173b** are two trapezoidal concrete bases with concrete kerb edging, almost identical in form. They each sit right against the south edge of a drainage dyke, and seem to represent former crossing points enabling branches off the main road in **Area G** to access the large earthen platform and associated drains on the north side of the dyke in **Area I** (see Figure 113). However, the dyke itself appears to loop out and around the larger base of **173a**, suggesting that **173a** was in place before the dyke was cut. A pair of concrete pads with central iron fittings were recorded opposite this structure (Figure 114). The 1923 sales particulars plan does not include a dyke in this position (see Figure 111); it may not have been drawn because these features and the dyke are just outside of the area covered by the auction event.

Figure 114: Structure **173a** looking south-west. Photograph: Sarah Newsome 2011 © English Heritage.

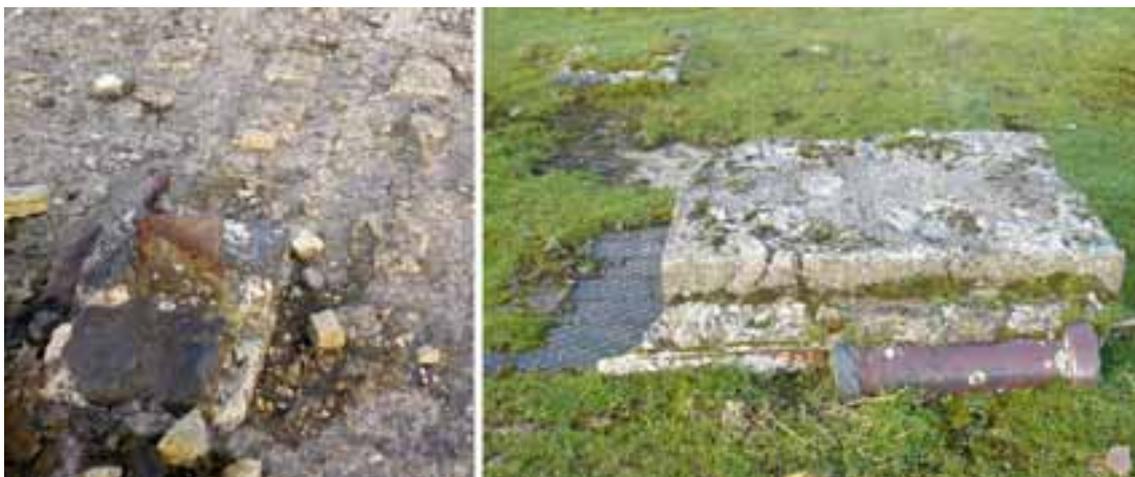
Figure 115: (above left) An upright L-section iron fitting in structure **178** surrounded by mortar imprints of an acid-resistant brick floor. Photograph: Rebecca Pullen 2010 © English Heritage.

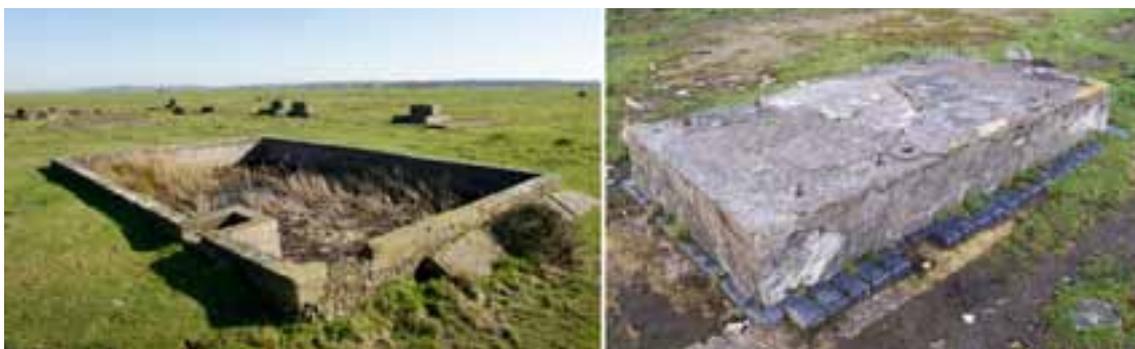
Structure **183** is a large concrete tank measuring 9.7m x 7m in plan, located next to the projection or porch base at the north-east corner of boiling house **182**. On the inside of its north edge is a rendered brick manhole which appears to be a later addition, and probably housed a pump or pipe maintenance point (Figure 117). The tank is likely to relate to the large quantities of water being handled in the adjacent boiling house.

Figure 117: (above left) Structure **183**, looking south-east. NMR DPI41570 07-Mar-2011, Steve Cole © English Heritage.

Figure 118: (above right) One of the large plinths within structure **181**, with remnants of an acid-resistant blue brick floor. Photograph: Sarah Newsome 2011 © English Heritage.

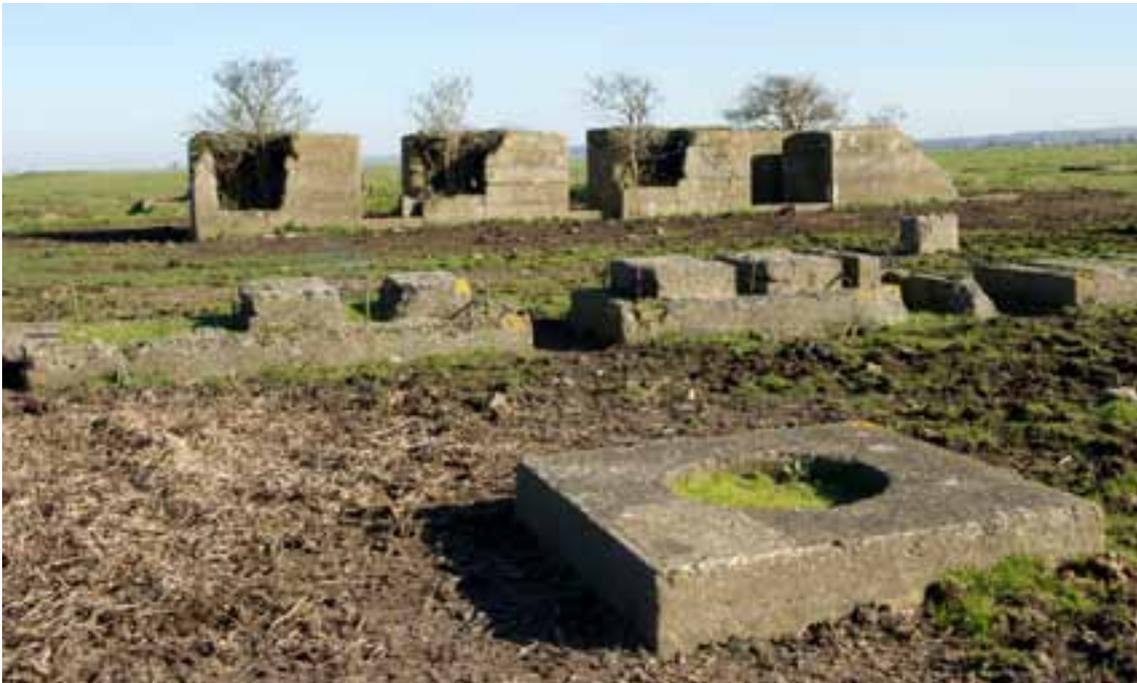
Moving north, structure **180** is another large concrete foundation, measuring 40m x 24m, that appears to have been divided internally into two main areas (see Figure 113). At the east end, is a larger room containing several small concrete plinths, primarily located around the internal edges of the space, each with protruding iron bolts. Towards the north-east corner sits a line of three low rectangular concrete plinths, all 3.2m x 1.4m in plan with three rectangular segments set within the top: some of these segments are depressions, some are flush with the outer plinth and others are additional blocks sitting 0.23m proud of the main plinth. This variation appears random, rather than a repeating pattern across the features; it is unclear whether the differentiation denotes different machine forms, remodelling for reuse, or partial demolition. West of these, is a pair of low concrete plinths each measuring 1.5m square with a circular hole, 0.8m in diameter and 0.1m deep, at the centre (Figure 119). A smaller area at the west end of the slab contains only a single brick plinth, 3.7m x 1.5m in plan, in the north-east corner and surrounded by a thin brick wall.

Figure 119: Mixed plinths within the remains of structure **180** and, in the background, the cuboid forms of structures **185a-185d**, looking east. NMR DPI41583 07-Mar-2011, Steve Cole © English Heritage.

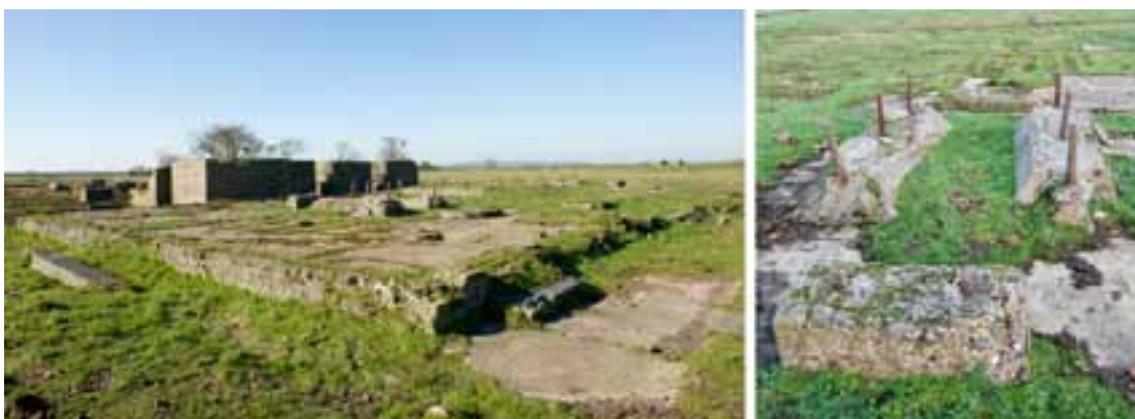
Figure 120: (left) Structure **186**, looking north-west with the cuboid forms of structures **185a-185d** in the background; (right) detail of plinth with curved recess designed to hold a cylindrical tank or motor within **186**. Photographs: NMR DPI41580 07-Mar-2011, Steve Cole (left), and Sarah Newsome 2011 © English Heritage.

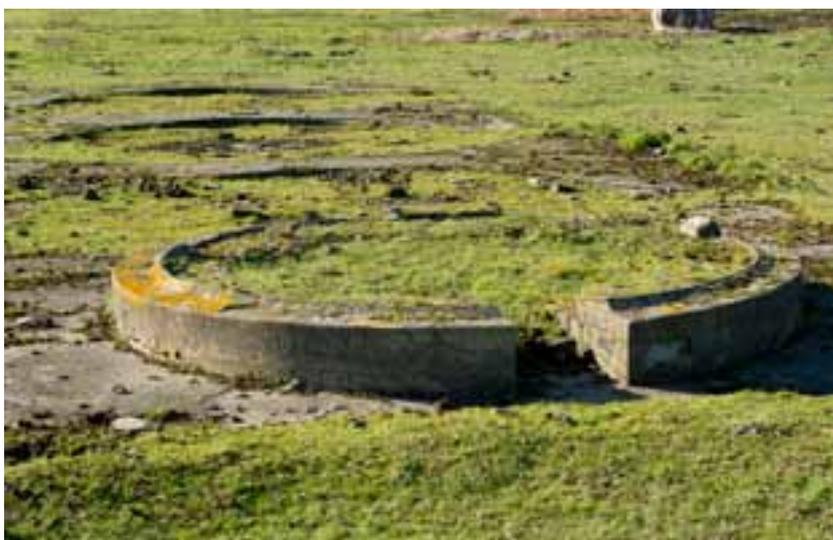
Figure 123: Structure **188** looking north-west. NMR DPI41579 07-Mar-2011, Steve Cole © English Heritage.

Structure **188** is a lone concrete slab, 18m x 6m in plan, located to the south of **186**. Most of its surface is taken up by four prominent circular features. The western three circular features each measure roughly 3.8m in diameter, and look like voids or scars left by the removal of a set of circular tanks. At the east end of the slab there is a smaller penannular cement-rendered brick plinth, 0.22m high, with an open notch at its east side (Figure 123); this fourth circular feature is particularly reminiscent of the three probable tank bases previously described with structure **41** in **Area B**.

Structure **188** is not depicted or described in the 1923 documents (MALSC 06a\_DE\_Series\_1001\_1200/DE1087\_3). It stands slightly apart from the other buildings and seems to be grouped in the area of service buildings for the guncotton production, rather than forming a direct part of the manufacturing flow line. Its proximity to washing house **181** could suggest that **188** was a store for the soda that was added at this point in the process. Alternatively, the bases could signify centrifugal spinning machines used to wring out the cotton pulp at various points in the process to remove excess liquid (see section 4.2).

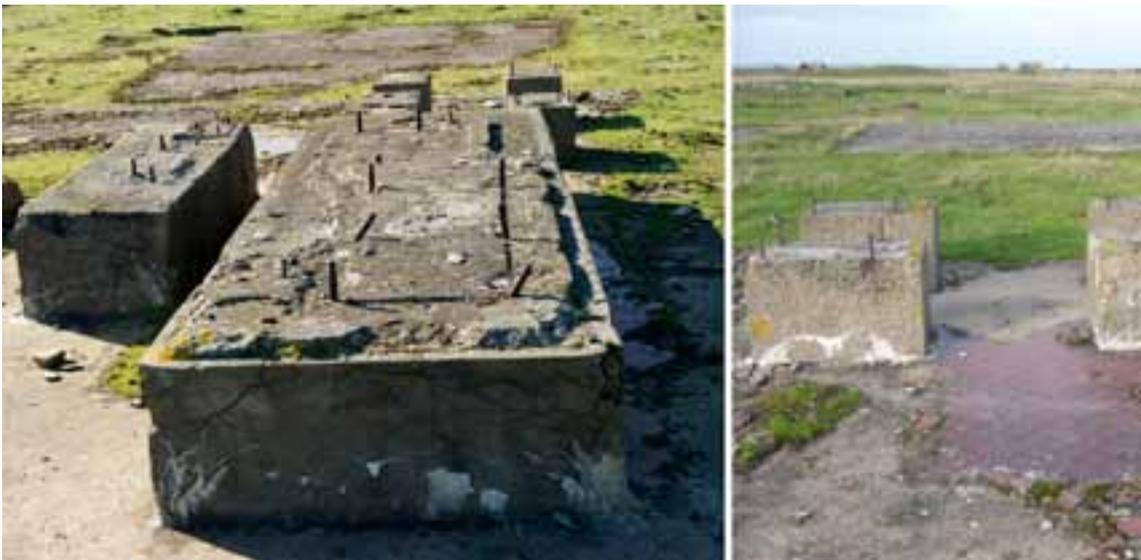
Figure 124: Structure **192** (left): large plinth showing the clear imprint of a machine preserved in its top, (right) smaller concrete plinths surrounded by remnants of a red quarry tile floor, looking north with structure **190** in the background. Photographs: NMR DPI41572 07-Mar-2011, Steve Cole (left), and Rebecca Pullen 2010 © English Heritage.

South of **189** and **190** is a further pair of concrete slabs, structures **191** and **192**. Structure **192** is the largest of the pair: it measures 15.5m x 10.5m and has a small ancillary room projecting south from the south-east corner. The main floor area supports three fairly large concrete machine beds, a group of four smaller concrete plinths (0.5m tall), a brick plinth and remnants of a red quarry tile floor laid in a diamond pattern set obliquely to the walls (Figure 124). The two concrete plinths in the north-east corner are 0.7m tall and each have the well-defined imprint of a machine on their surface, punctuated by tall iron studs. As seen elsewhere, the pair might have supported a single steam engine with the drive wheel fitted vertically into the space between them (something like a 'Warwick Engine'). In the centre of the southern side of the slab, a single flanged iron steam pipe emerges vertically from the ground and turns 45 degrees to enter the building between two of three 0.2m-high plinths aligned along the south edge of the slab (see Figure 124).

The 1923 sales particulars for this area show that this building was formerly the refrigerator house, '119', known to have contained a gear-driven horizontal single stage double-acting air compressor made by Bracket & Co, paired with a Siemens electric motor (Siemens was another local firm with a large factory at Woolwich), which explain the presence of the large machine beds (ibid) (see Figure 111). The function of the refrigerator house was to cool water and other liquids that were then pumped through in coils in various aspects of processing to maintain safe working temperatures. The
