# CURTIS'S AND HARVEY LTD EXPLOSIVES FACTORY, CLIFFE AND CLIFFE WOODS, MEDWAY ARCHAEOLOGICAL SURVEY AND ANALYSIS OF THE FACTORY REMAINS

Volume 1 of 2

Rebecca Pullen, Sarah Newsome, Andrew Williams and Wayne D Cocroft

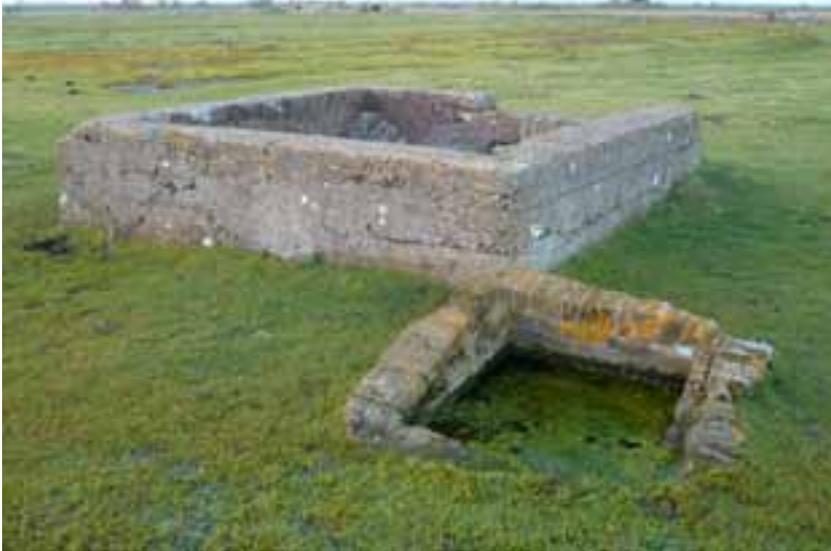
*Figure 125: Paired concrete tank and brick manhole south of structure 193, looking north-west. Photograph: Rebecca Pullen 2010 © English Heritage.*

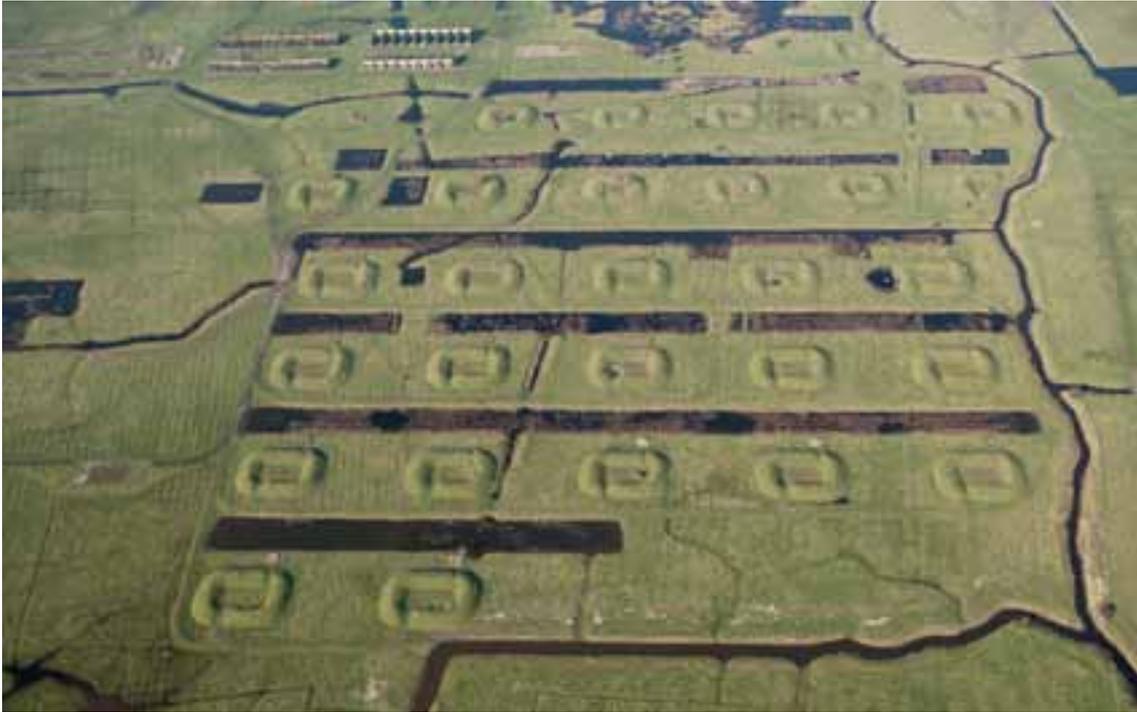
Figure 126: **Areas H** (foreground) and **J** from the air, looking north. NMR 26891/019 08-Mar-2011, Damian Grady © English Heritage.

Structure **284** is located at the west edge of **Area H**, where the tramway from **Area G** widens to the south to create a small building platform with tramlines either side, allowing carts to pass north and south before reconverging to the east. A 27m-long stretch of the concrete tram-bed, at the typical width of 2.5m, with clear impressions from the 2 foot-gauge tram rails seen as vegetation lines spaced 0.65m apart, survives to the north side of the platform. The platform comprises a concrete building foundation 15.3m x 9.1m in plan, constructed of narrow parallel concrete rafts aligned east-west. The 1923 sales particulars describe the building in this position as store '103', which comprised a timber floor, timber and corrugated iron walls with sliding doors and a corrugated iron roof (ibid). The tramway leads directly east from this storage point into a gridded arrangement of seventeen former guncotton stoves, suggesting that **284** was a temporary holding area for wet guncotton before it was moved to the drying stoves.

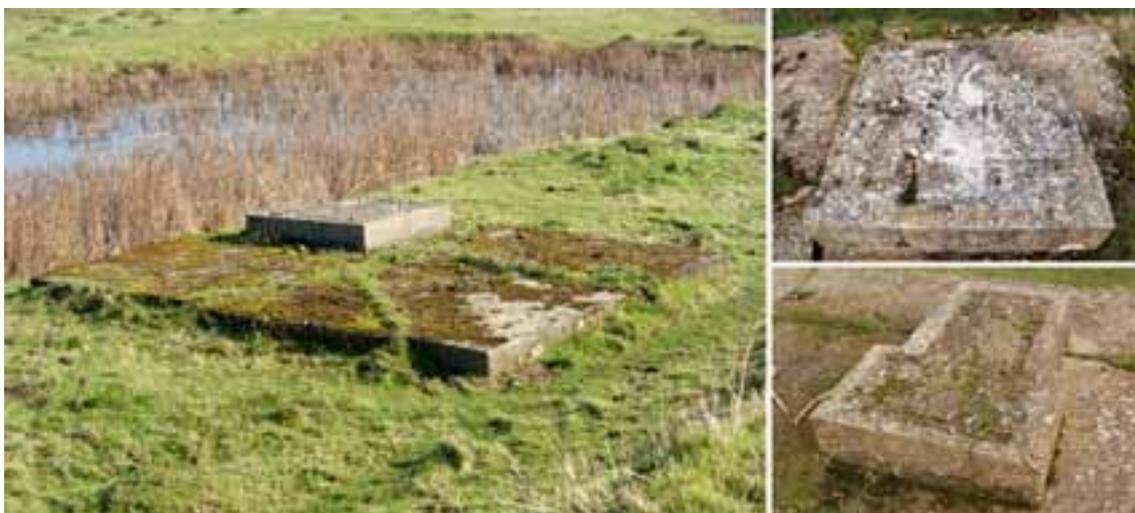
Figure 127: Fan shed bases in **Area H** (clockwise from left): structure **272a**; detail of the typical plinth top belonging to **282a**; detail of the atypical plinth top belonging to **283a**. Photographs: NMR DPI41647 08-Mar-2011, Steve Cole (left), and Rebecca Pullen 2010 © English Heritage.

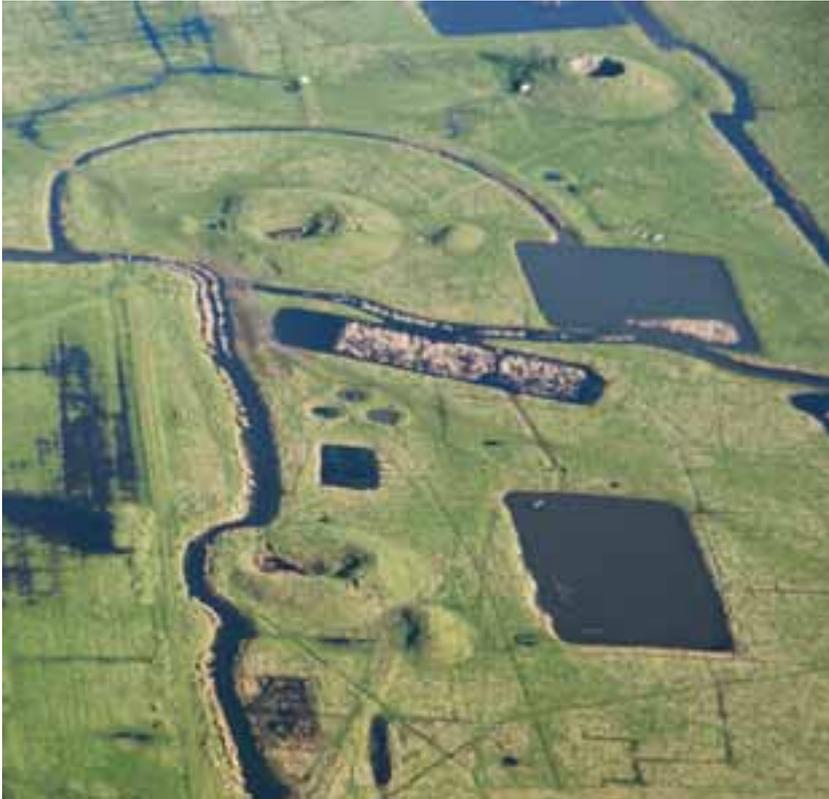
Figure 128: **Area I** from the air, showing the large earthwork traverses of (top to bottom) structures **168**, **167** and **166**, looking east. Extract from NMR 26890/013 08-Mar-2011, Damian Grady © English Heritage.

At the south-east end of **Area I** is structure **168**. Arguably this would have been, and perhaps still is, the most imposing structure on the site. Thought to have been constructed around 1914-15, it is the second of two nitroglycerine hills confidently identified amongst the factory remains (the other being structure **31**). Apart from a handful of associated features to its north-west (**167**, **170** and **171**), structure **168** is located in relative isolation compared to most other factory structures. It sits in an area of open marshland, equidistant between the acid and the guncotton processing plant (**Area G**) and guncotton drying stoves (**Area H**) belonging to HM Cordite Factory. To its east is a large water-filled borrow-pit created during construction of the mound, and the drainage dyke running along its southern edge has been re-routed to bow around an ancillary bund covering the main entrance to the mound (see Figure 128).

enclosed ground 20-30m out from the foot of the mound (see Figures 128 and 136). Combined with borrow-pits and drainage dykes to the west of **167**, the semi-circular ditch creates a seemingly purposeful enclosure, making **167** look like it has received special treatment, perhaps by being defined as a dangerous space. If the ditch was excavated to function contemporaneously with the nearby factory structures, then it could have been installed as physical boundary, possibly to act as a firebreak.

Roughly equidistant between the mounds of **166** and **167** is structure **169**: a tight cluster of three circular features in a clover leaf formation (see Figures 128 and 136). Each circular feature is 10-12m in overall diameter. Much like nearby **170**, they are each formed of a narrow low circular bank with a concave scooped-out centre, now filled with ground water. The three pits or ponds are all interconnected by narrow breaks in their banks. The whole group appears to be served by a tramway or path approaching from the north-west and by a pipe channel or drain traceable for a considerable distance, leading from the south-east edge of the group to the space between mounded structures **156** and **157** in **Area F** (thought to be mixing houses for Cheddites or gelatine-type explosives, see section 6.11). Possible explanations for **169** include settling ponds associated with the washing processes for nitroglycerine, or the hollows for acid eggs, both of which would have been present in the nitroglycerine factory.

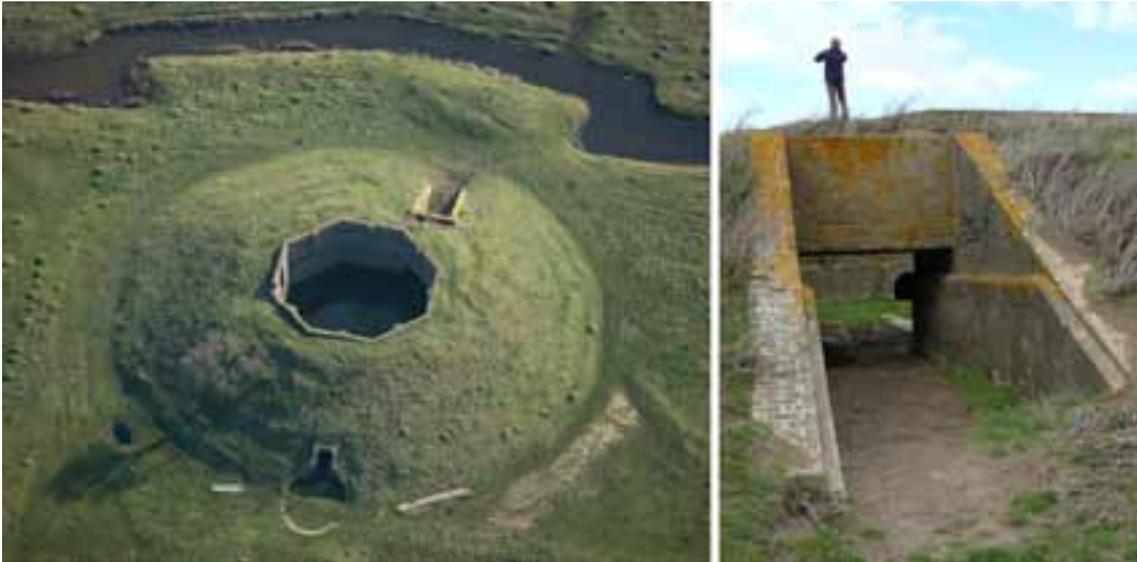
Figure 129: (above left) Structure **168** from the air, looking south. Extract from NMR 26891/026 08-Mar-2011, Damian Grady © English Heritage.

Figure 130: (above right) Looking into structure **168** through the large southern entrance, with the low vaulted tunnel entrance visible within. Photograph: Wayne Cocroft 2010 © English Heritage.

large hexagonal space floored with concrete and surrounded by tall brick revetting walls (Figure 129). The main access to the nitroglycerine house was through a broad rectangular brick entrance in the southern side of the mound. Externally, the opening measures 2.5m wide by 1.3m high and is topped by a substantial 0.36m-wide lintel of coarse poured concrete, supporting a 16-course brick elevation reaching a height of 3.5m above ground level (Figure 130). Flanking either side of the entrance is a pair of brick revetting walls, projecting 6.5m out from the opening. They are steeply angled to match the slope of the earthwork, and step out at the base by a single brick width roughly coped with concrete render. Internally, the concrete lintel slab carries the main hexagonal retaining wall over the entrance.

Opposite this opening is an oval earth bund standing 0.7m tall. It is positioned 3m from the base of the main traverse, allowing the tail end of an embanked tramway to access **168** from the east (see Figure 129). Its purpose appears to have been to absorb any blast force projected through the entrance in the event of an explosion; however, it looks to be of insufficient height for this purpose, and there are no structures south of **168** to warrant such protection.

The revetting wall is a complete hexagonal circuit of brick, built right against the inside of the earth mound, creating a space within the mound 11m in diameter (see Figure 129). The walling is 4.45m tall and built in rough English Bond, reinforced internally by full-height brick piers set centrally to each elevation. Despite this several, settlement

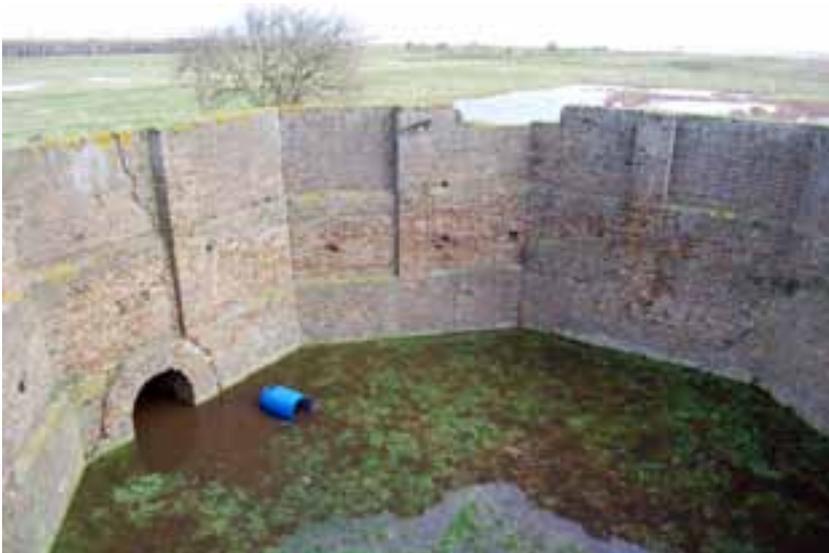
*Figure 131: The waterlogged interior of 168, showing the construction of the revetting wall, with the low tunnel entrance on the north side, and notch in the brick parapet at the north-east side. Photograph: Sarah Newsome 2011 © English Heritage.*

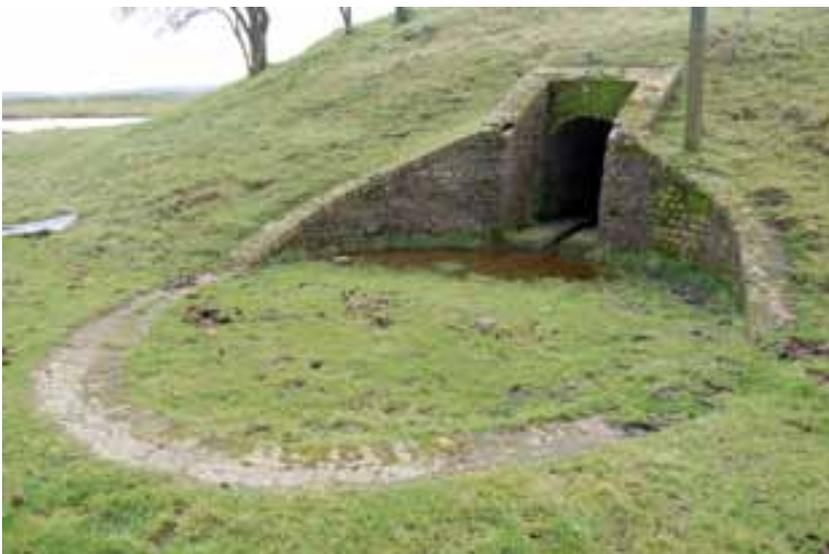
*Figure 132: The low vaulted tunnel exiting from the north exterior of 168 into an ovoid tank or yard. Photograph: Sarah Newsome 2011 © English Heritage.*

There is a second opening into the mound in the form of a low narrow vaulted tunnel that reduces in height gradually as it enters the interior from the north side. The vaulting comprises four concentric courses of headers. On the inside of the structure, this is seen as an arch flush with the wall and starting from floor level (Figure 131). On the outside of the mound, the tunnel's archway initially opens into a rectangular recess created by parallel retaining walls, which splay-out in a curve to clasp the south half of an ovoid tank marked by a ring of bricks set flush with the ground (Figure 132). The floor of the tunnel

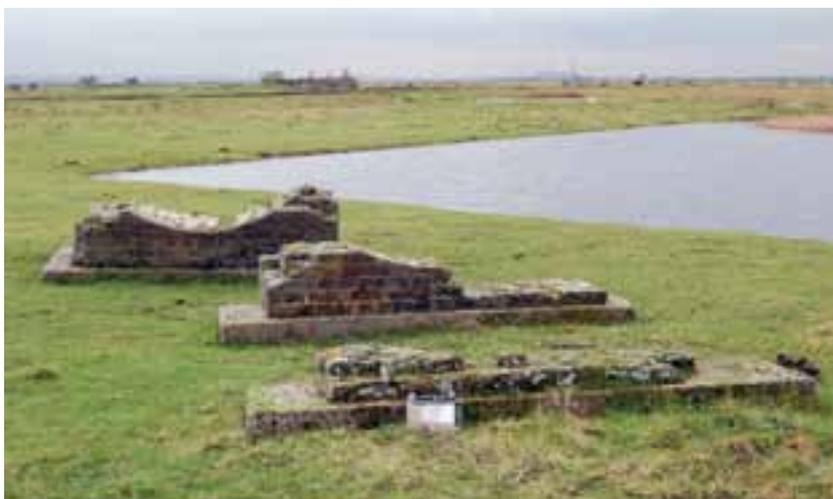
*Figure 134: The moulded brick plinths of structure 171, looking south-west. Photograph: Sarah Newsome 2011 © English Heritage.*

Structure **171** refers to a group of three roughly parallel rectangular concrete bases, all measuring 2.7m x 0.65m in plan and each topped with a brick plinth, south-west of **170**. The top of the brick plinths have a U-shaped profile with a thin mortar surface, possibly designed to hold a horizontal cylindrical tank about 1.5m in diameter (Figure 134).

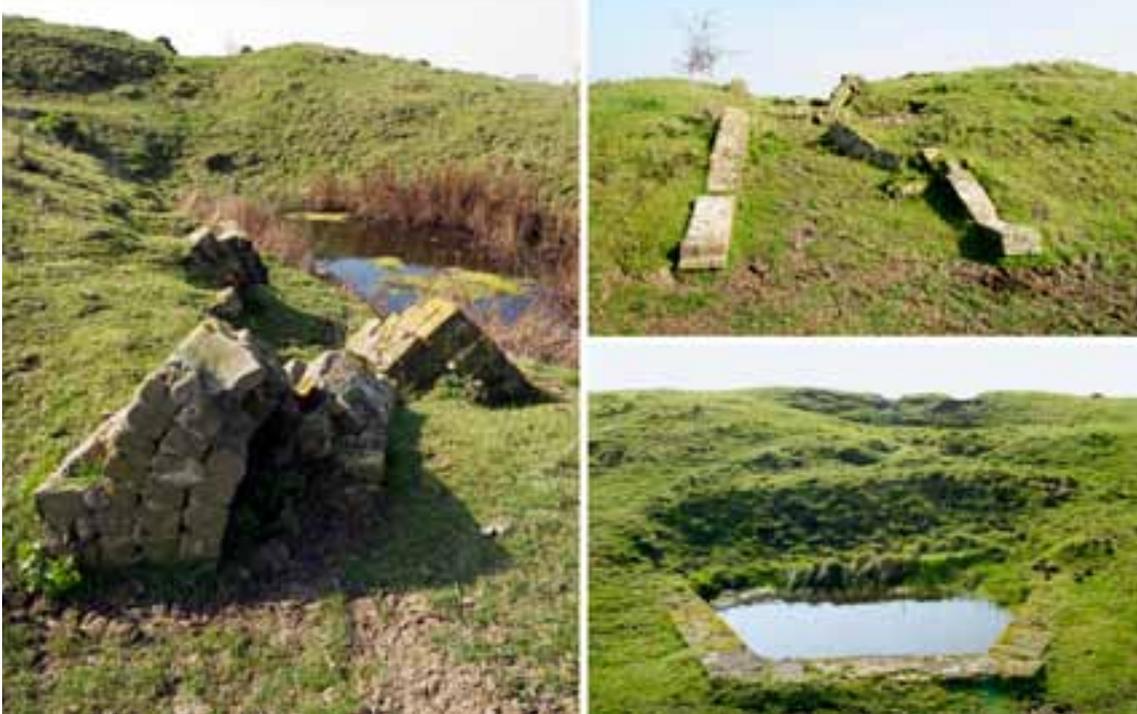
Figure 135: (clockwise from left) Collapsed vaulted brick tunnel on the north-east side of **166**; in-filled wide entrance on the south-west side of **166**; and trapezoidal tank or forecourt on the north side of **167**. Extracts from NMR DPI41682, DPI41683 and DPI41679 08-Mar-2011, Steve Cole © English Heritage.

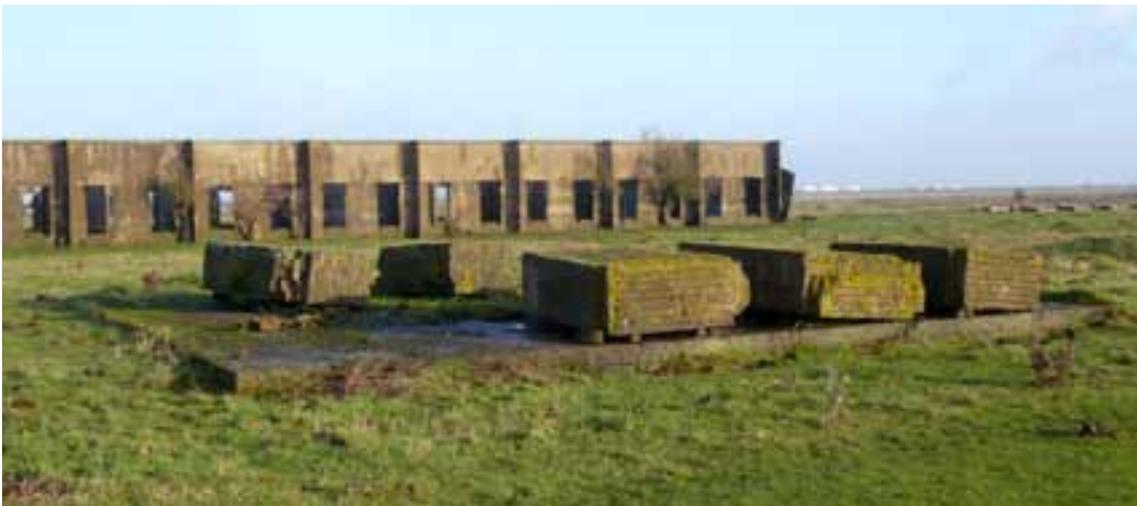
Figure 139: Structure **255**, looking north-east with **247** in the background. Photograph: Rebecca Pullen 2011 © English Heritage.

South-east along the tramway from **254** is structure **255**: a rectangular concrete foundation measuring 10m x 7m. Six brick plinths sit on top of the slab; only one in the north-east corner is in its original position, the other five are much larger and have at some point in the past been toppled onto their sides (Figure 139). A purposefully curved surface on what would have been the top sides of the fallen plinths looks as though it may have held a tank at one time, and a thick concrete render on the end of the plinths suggests that a coating was added in situ using corrugated shuttering. The 1923 sales particulars explains that these are the remains of building number '104', weigh house and adjoining stores. It had walls of timber and corrugated iron, a corrugated iron roof and a concrete floor, and is described as having had brick bases on the floor of the store (ibid).

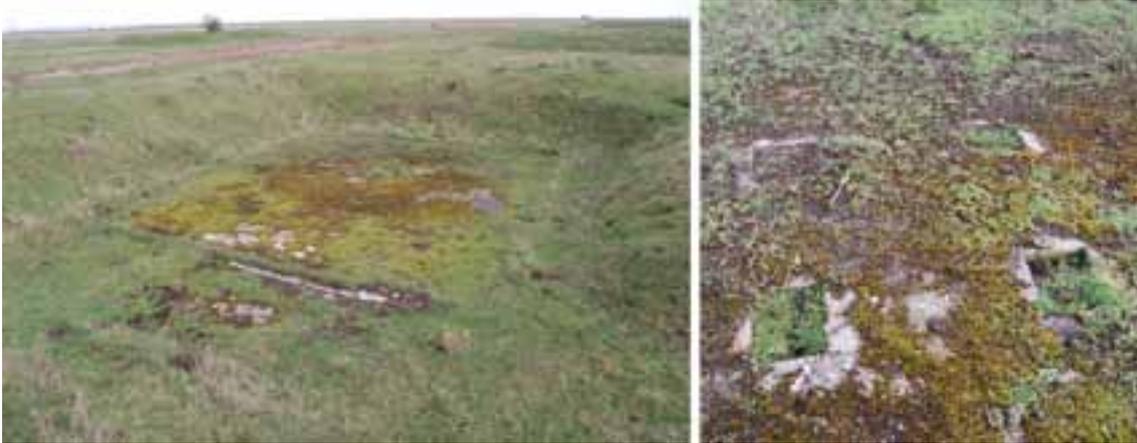
Figure 140: Structure **258**, showing (left) the interior space divided into a main building floor and a slightly lower narrow porch or 'dirty' area; (right) the small square floor holes that mark where a lead mixing vessel once stood. Photographs: Rebecca Pullen 2011 © English Heritage.

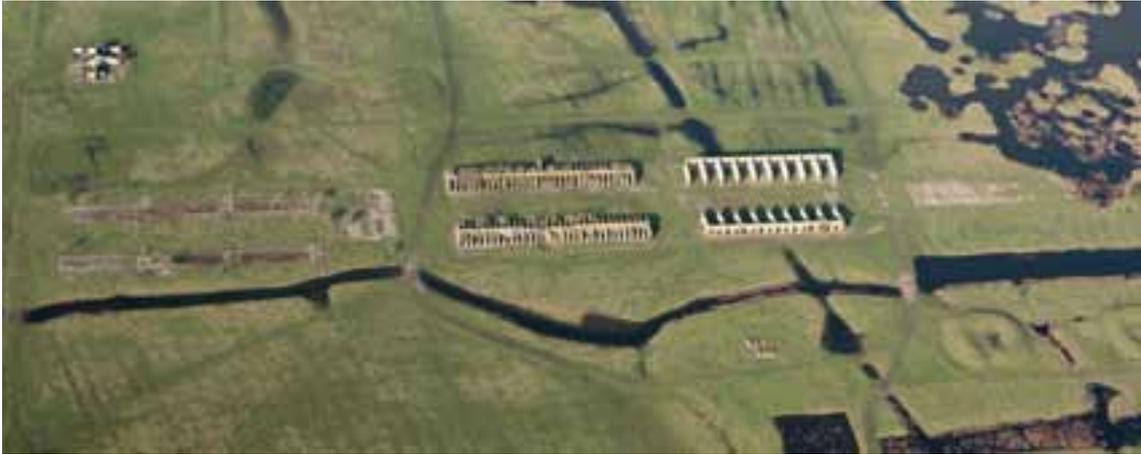
Figure 141: The long east-west alignment of large cordite processing buildings in **Area J**, looking north. NMR 26891/007 08-Mar-2011, Damian Grady © English Heritage.

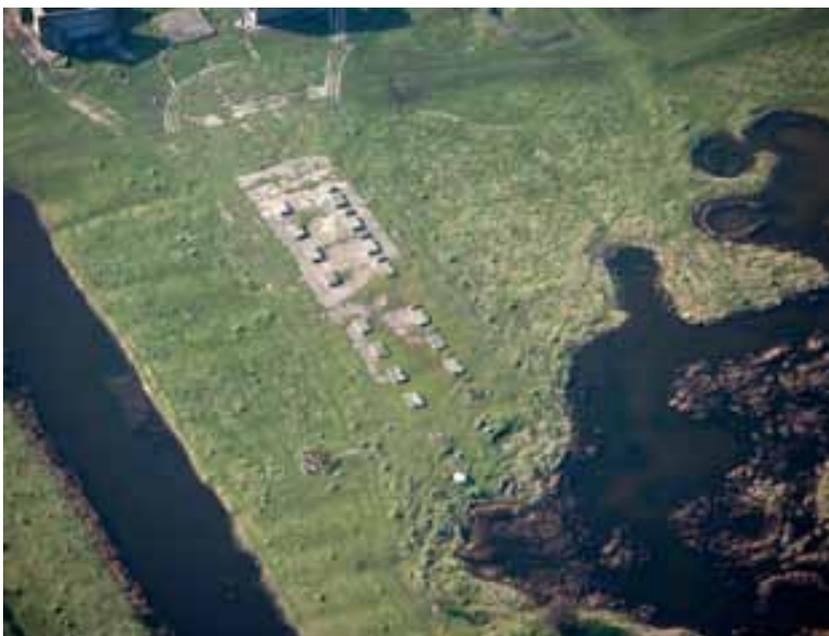
Figure 142: Structure **251** from the air, looking north-west. NMR 26891/013 08-Mar-2011, Damian Grady © English Heritage.

The concrete foundation measures 12m wide and survives to 57m in length, with the trace of tram rails alongside the north and south sides of the building. Along the internal length of the slab are two rows of rectangular concrete plinths aligned so the two rows are slightly staggered in relation to one another (Figure 142, and see Figure 138). The plinths almost certainly represent the machine beds that once supported the incorporating machines. They are principally orientated east-west, measuring 2.1m x 1.3m in plan and 0.3m high, each with up to five iron studs in the top. Around half of the plinths, mainly along the north side of the slab, are paired with a smaller lower rectangular plinth orientated north-south, measuring 1.12m x 0.56m in plan, with a rectangular groove lengthways in the centre of the top. The sides of the plinths are all covered with a thin layer of smooth off-white cement render.

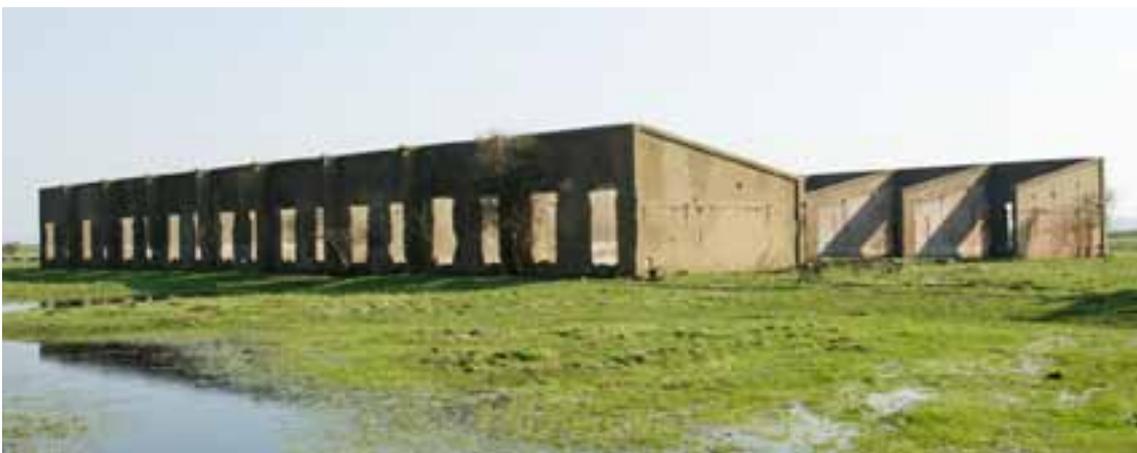
Figure 143: Paired concrete structures of **247** (foreground) and **246**, looking south-east. NMR DPI41708 08-Mar-2011, Steve Cole © English Heritage.

The tram rail scars that run alongside the incorporating house (**251**) converge to its west, forming a central semi-circular rail arrangement, where they also split to run along the external long edges of **246** and **247** (see Figure 138). Structures **246** and **247** are a mirrored pair of elongated standing concrete buildings, a short distance west of **251**, that are divided into individual cells. Both buildings are roofless, with reinforced concrete walls arranged to form a row of nine bays opening onto the central space between the two structures (Figure 143). As mentioned above (structures **153** and **154** cordite drying stoves, see section 6.10), the use of reinforced concrete as a construction material is known to have had limited uptake in the British explosives industry and, as such, the examples on the Cliffe site represent a rare survival (see sections 4.3, 8.3 and 8.5).

The 1923 sales particulars list structures **246** and **247** as cordite press houses 'J4' and 'J5 (1-9)', each with a set of nine press rooms and a lean-to boot house. The press houses are described as having concrete and asphalt floors, with reinforced concrete walls and a corrugated iron roof. The lean-to structures were floored with timber and had walls of match-lined corrugated iron with corrugated iron roofs (MALSC 06a\_DE\_Series\_1001\_1200/DEI087\_3). Cordite paste was moved from the incorporating house to the press houses where it was passed through a hydraulic press under great pressure and extruded into long cords of varying diameter, according to need (see section 4.1).

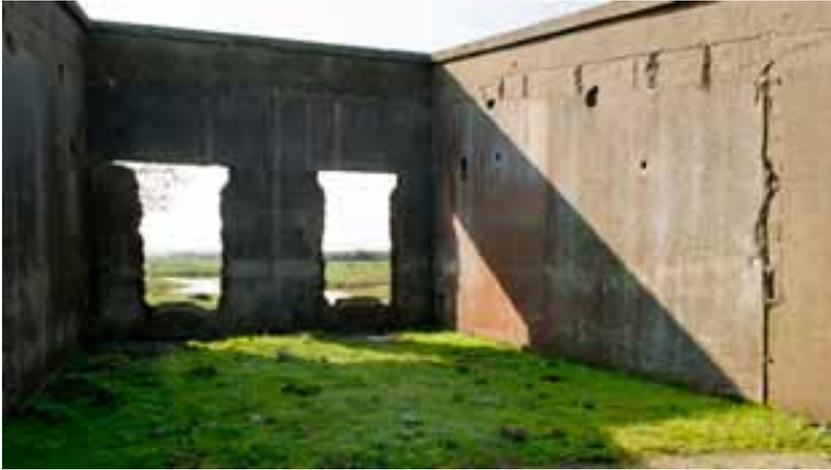
Figure 145: Inside a cell in press house range **247**, showing roof and walls scars, and various openings and conduit holes in the walls. Photograph: DPI41655 08-Mar-2011, Steve Cole © English Heritage.

Structures **246** and **247** are identical in construction: both are aligned east-west and comprise nine individual bays on a concrete foundation, and each is served by tramlines running along both long sides of the structures (see Figures 138 and 144). The only discernible difference is that the easternmost bay in the southern range (**247**), has almost entirely collapsed or been demolished. A 50m long spine wall forms the outward-facing 'rear' side of each building. From this, partition walls project out 8.3m to create nine separate bays at intervals of 5.5m, all facing into the central area between **246** and **247**. Corresponding to each partition wall is a short length of wall projecting 0.75m from the rear of the spine wall which acts as a support or buttress. The walls are all constructed of reinforced concrete, with integral piers and coping. As the partition walls stretch away from the long spinal wall they slope gradually downwards in height so that the two buildings are trapezoidal in section (see Figure 144). Although there are no front walls to the bays, witness marks for set back entrance walls enclosing each were noted inside the bays, and were these probably not made of concrete (Figure 145).

The interior of each bay is rendered in fine grained cement which stops short of the full wall height, denoting the position of a lightweight roof structure carried on square-section rafters running parallel to the front entrance wall through square holes in the partition walls. The roof scar visibly pitches down towards the front of the buildings, parallel with the sloping top line of the partition walls (see Figures 144 and 145). Thin iron pins, and the holes where pins have been removed, project through the rear spine wall at a level just below the height of the iron roof. These probably held a wall plate to support the roof. The partition walls stand taller than the roofline, creating a series of parapets: these increased the structural stability of the building and reduced the possibility of a fire spreading from one bay to the next in the event of an accident. Each partition wall has a collection of holes for elements such as pipes, conduits and bearings boxes, and evidence for former features or fixtures was also noted in the floor of the bays (see Figures 144 and 145). Set between the openings in the middle the bay floor are five or six iron studs; in the south press house range (**247**), these studs are substantial and appear to delimit a backfilled pit or recess within the floor, suggestive of a heavy machine fixture with a circular footprint, almost certainly the scar left by a cordite press. Many of the floor surfaces are largely obscured by debris and vegetation, but in **246**, a smaller group of studs were noted set within a smaller recess, with witness marks for a small motor or machine on the east side of the marks. These differences might indicate that the two press house ranges were engaged in preparation of cordite of different sizes or uses. The pattern of fixtures in the floor of **246** may indicate that cordite produced in here was of a thinner diameter than that made in **247**, the adjacent extra witness marks could relate to reeling machines used to reel the narrower cords.

The rear wall of every bay is pierced by a pair of equally spaced large rectangular openings raised above ground level (see Figure 145). Corresponding to the exterior side of each of these, is a set of square sockets in the concrete floor (see Figure 144). The holes could suggest the presence of a platform for loading between the press houses and the tramway through the openings, however, the location of a huge hydraulic press in the centre of each bay would not leave much room for moving material around the sides, and so they were most likely large windows.

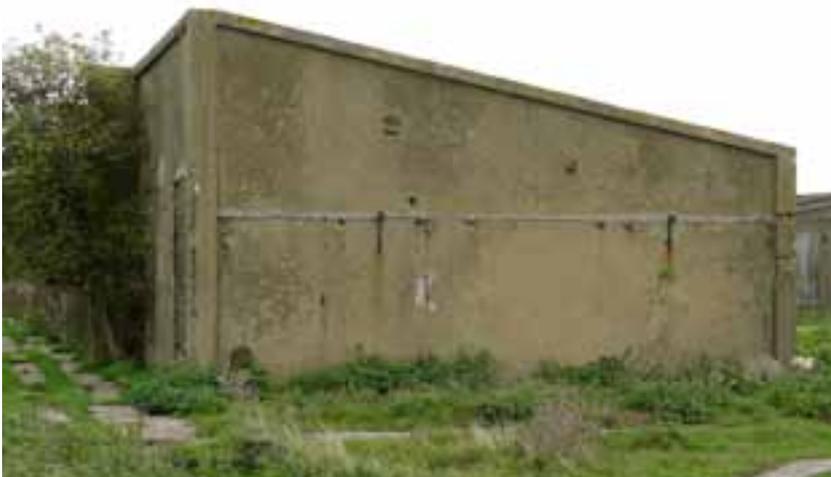
Figure 146: Cordite Press House **246**, showing iron brackets and witness marks for a lean-to structure at the west end. Photograph: Wayne Cocroft, 2010 © English Heritage.

At the external west end of both press house ranges, are witness marks for the corrugated iron lean-to structures mentioned in the 1923 sales particulars (ibid). Also along this roof scar is a line of fairly substantial iron brackets to suspend a pipe; the witness marks for the lean-to appear to respect the brackets as though the corrugated iron sheeting went round the hooks (Figure 146).

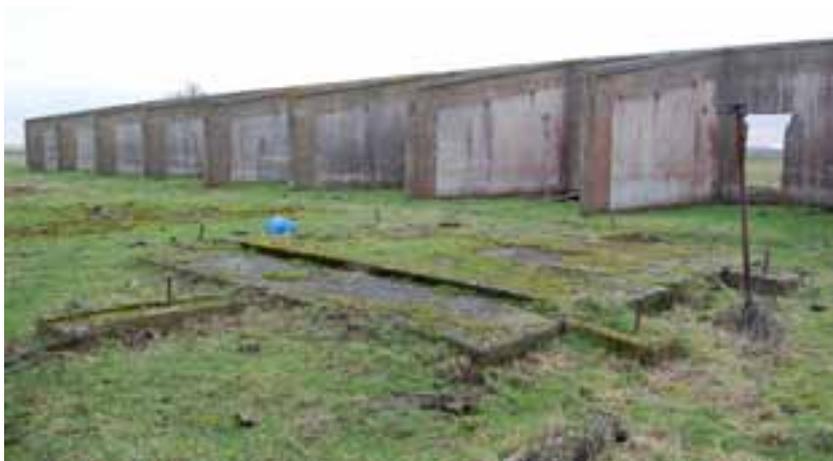
Structures **248** and **249** are two roughly square concrete building foundations positioned side-by-side at the west end of the linear space between press houses **246** and **247**. The western slab, **248**, is a robust and fairly detailed foundation, it sits slightly proud of the ground surface, measures 5.5m square and has a series of rectangular concrete piers projecting from its edges (Figure 147). Single elongated piers, 1.8m x 0.55m, project from the north and south edges, and a pair of shorter piers project from the east and west edges. In all cases, the concrete piers or plinths have a central shallow flat-based groove, 0.22m wide, along their length and a large iron bolt protruding from the surface. East-west across the centre of the slab is a slightly raised area of concrete 3m wide and inset within this is a brick-edged depression measuring 2.3m square internally. The robust nature of **248** suggests it supported a facility that involved notable weight or movement.

*Figure 147:  
Probable hydraulic  
accumulator base  
248, with remains  
of cordite press  
house 247 behind,  
looking south-east.  
Photograph: Rebecca  
Pullen 2011 ©  
English Heritage.*

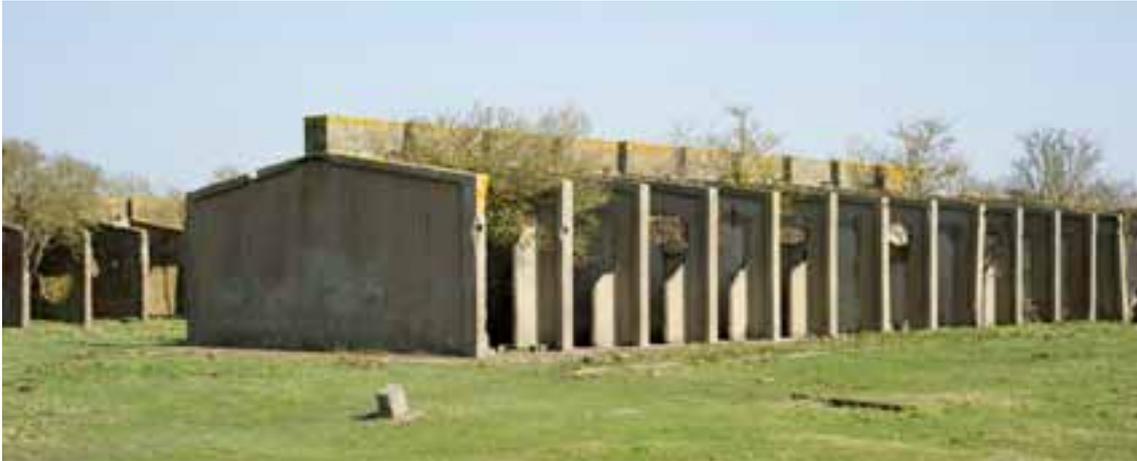
Figure 149: Structure **245** showing the cement rendered outward-facing cells, looking north-east with **244** behind. NMR DP141685 08-Mar-2011, Steve Cole © English Heritage.

Continuing west from press houses **246** and **247**, next in the linear arrangement of cordite processing buildings are the parallel structures of **244** and **245** (see Figures 137, 138 and 141). Each range comprises a roofless standing structure composed of a long central spine wall of brick, with reinforced concrete partition walls projecting from it to create 30 individual narrow compartments in two back-to-back rows of 15 (Figures 149 and 150). Again, the use of reinforced concrete as a construction material is known to have had limited uptake in the British explosives industry and, as such, the examples on the Cliffe site represent a rare survival (see sections 4.3, 8.3 and 8.5). The

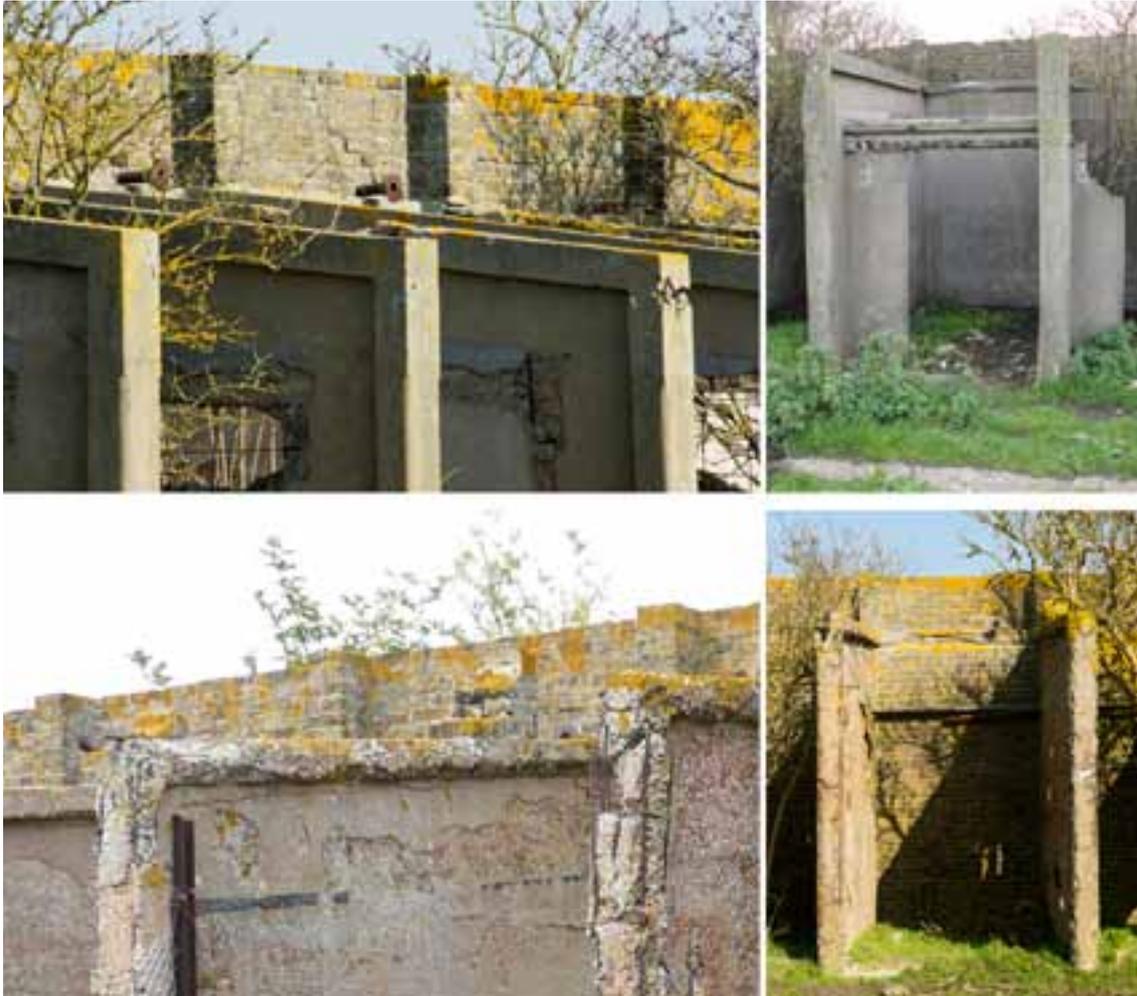
The compartments themselves are not all identical, there are two distinct types; the north-facing row of cells in **244** and the south-facing row in **245** (that is, all of the outward-facing cells) are of one form, and the inward-facing row of cells for **244** and **245** are all of a second form. The main distinction is that the back walls (spine wall) in the outward-facing compartments are surfaced with a fine cement render up to the height of the adjacent cell walls. The render continues seamlessly around all the compartment walls, creating a homogenous and easy to clean internal surface with no crevices in which residues could build up (see Figure 151). The back wall of the inward-facing compartments is bare brick, and the render on the side walls has largely flaked off and may have been of poorer quality than that in the fully rendered cells. Another difference is in the evidence for a front wall and entrance to each stove. The outward-facing cells have a narrow brick wall covered in a thick layer of concrete render next to a doorway, topped by a lintel composed of a slot for a narrow timber beam sandwiched between two single courses of concrete rendered brick (see Figure 151). Conversely, the inward-facing bays have no surviving solid front wall remnants and no clear scar for a wall line in this position, and may have had a more lightweight arrangement of corrugated iron or timber. One feature attributed only to the inward-facing rows of compartments is a line of small stepped brick piers with quarter circle shaping on their outer edge, positioned on the top of each cell wall approximately a third of the way along the length from the spine wall (see Figure 151). These mounts would have supported a pipe, possibly a steam pipe, along the length of the range; well above the height of the lightweight roof.

Figure 151: (upper pair) Acetone recovery stoves **245** (left) and **244** showing the outward-facing rendered cells; (lower pair) structure **244** showing the inward-facing cells without render. Photographs: (top left) NMR DPI41686 08-Mar-2011, Steve Cole; (top right and bottom left) Wayne Cocroft 2010; (bottom right) NMR DPI41659 08-Mar-2011, Steve Cole © English Heritage.

fire in 1918 (ibid). Overall, each building range has a footprint of 60m x 8m, which is divided into 30 compartments each with internal dimensions of 3.25m x 1.9m. The long brick spine wall is built in stretcher bond and stands to a height of 4.15m - eight courses taller than the perpendicular stove walls - and forms the back wall to each of the stove compartments. At the point where each cell wall abuts the main spine wall a short brick pier or buttress stands between the top of the cell wall and the top of the spine wall (Figure 151).

The concrete walls of the inward-facing bays are in a particularly poor state of repair and are heavily degraded with many large holes in the walls and the fabric is distinctly reddened; this suggests that the 1918 fire was more ferocious in the inner areas of **244** and **245**.

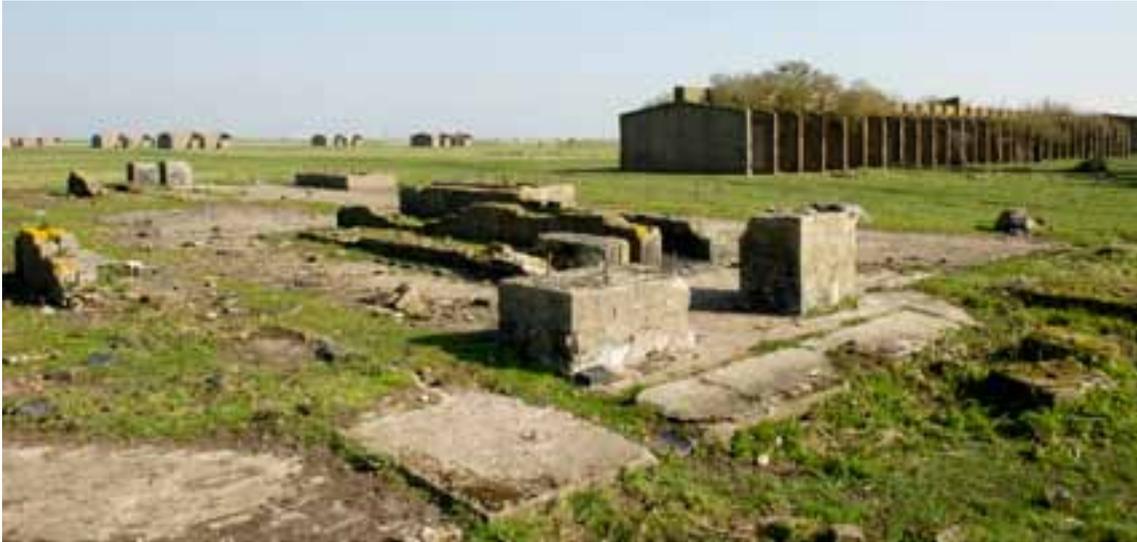
The ground floor surface of the acetone recovery house is more complex and contains a number of brick and concrete plinths (Figure 152). At both the north and south ends of the building, there are sets of three parallel brick plinths all measuring 5.5m long and two

Figure 152: Remains of acetone recovery house **243**, with structure **244** in the background, looking north-east. NMR DPI41667 08-Mar-2011, Steve Cole © English Heritage.

brick widths wide, only the south-east plinth still stands to its full height of 0.48m above the floor level. A covering of cement render on the sides of the plinths shows signs of a black bitumen coating in places. At the outer end of each group is a pair of small roughly square cement-rendered and bitumen coated brick plinths, each about 0.66m high with four iron studs protruding from the top. Along the eastern wall is a pair of larger lower concrete plinths, each 0.33m tall with matching arrangements of 12 to 13 iron studs protruding from the surface. North of these plinths is a purposeful rectangular area of smooth-surfaced blue brick flooring. A further pair of small concrete machine bases survives in a heavily degraded state in the south-east corner of the building. Open floor drains, formed of moulded blue engineering bricks integral to the brick floor, run just inside the east and west wall scars of the building, confirming a function associated with the presence of liquid chemicals, in this case acetone recovered from vapour.

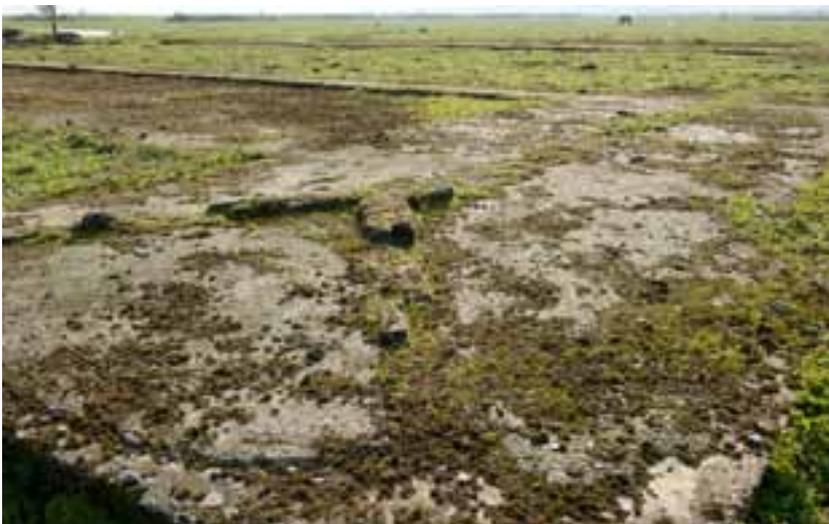
*Figure 153: Acetone recovery stove foundation **240**, showing traces of the angled brick wall scars. Photograph: NMR DPI41670 08-Mar-2011, Steve Cole © English Heritage.*

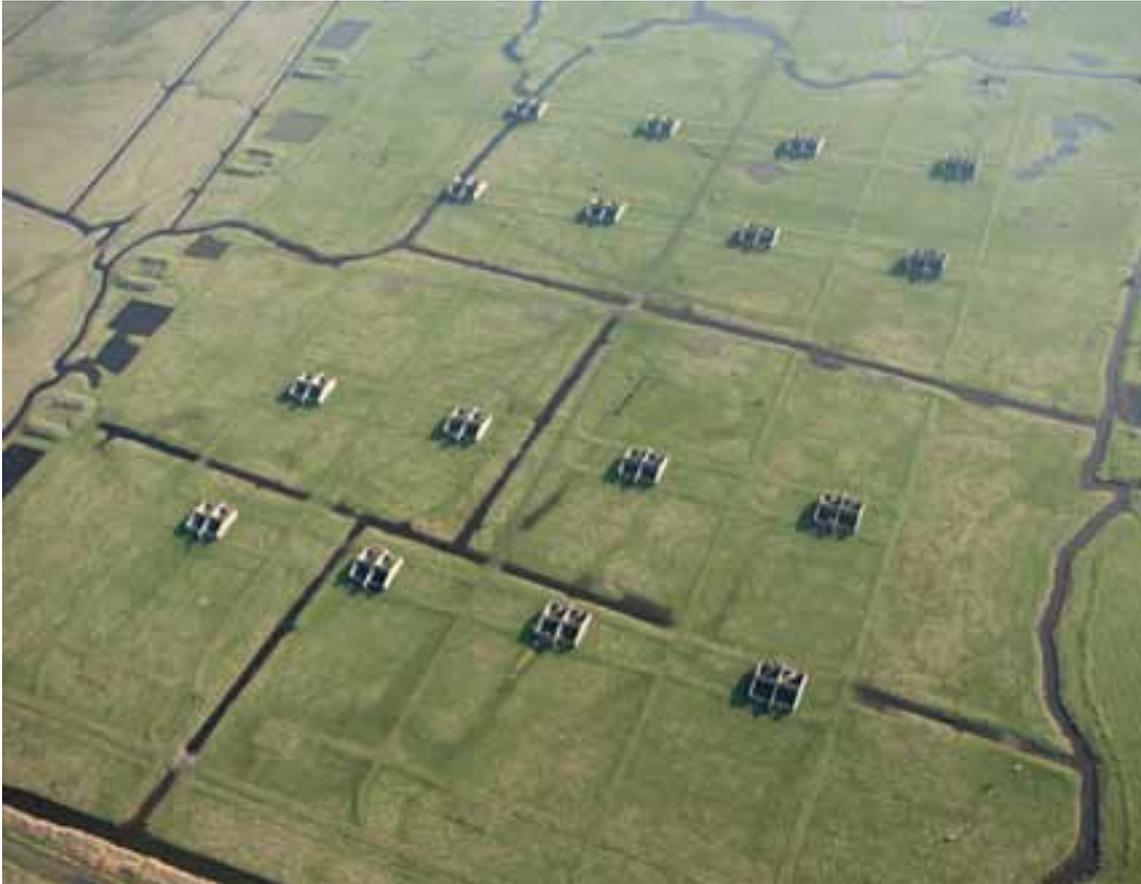
Moving north from the acetone recovery stoves, the site opens out into a very large and ordered area of buildings arranged in regimented lines and serviced by a grid of interconnected tramways (Figure 154). The grid is formed of five parallel tramways aligned north-south and connected by junctions to a series of east-west tramways which serve buildings located midway between each north-south tramway. Each junction has a corresponding small platform for the tumbler points controls. The structures in the gridded zone are of two distinct forms: roofless square buildings each partitioned

Figure 154: The north end of **Area K** showing the regular gridded layout, looking south-east. NMR 26891/001 007 08-Mar-2011, Damian Grady © English Heritage.

As previously stated, the blending houses form only part of the regular layout that dominates the north-east portion of the site. They are interspersed by two blocks of larger standing reinforced concrete structures, each partitioned into four equal internal compartments (**205-212** and **222-231**) and located on the same gridded plan as the blending houses (see Figure 154).

Structures **203**, **204**, and **219** to **221** are a widely spaced row of five large earthwork traverses surrounding concrete building foundations, located in the far north-east corner of the site, beside the dyke that marks the eastern extent of the factory (see Figure 154).

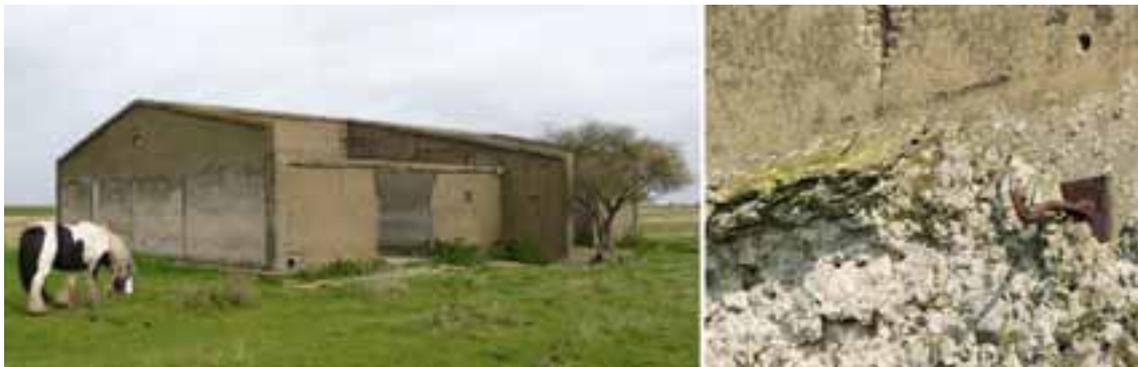
*Figure 156: Cordite drying stove **205**, showing the rough-surfaced coating on the west gable end (left); and a detail of the pitched top, iron hooks, bitumen stain and small holes. Photographs: Rebecca Pullen 2011 © English Heritage.*

The exterior elevations of the gable end walls show evidence of a thick coating of rough surfaced pinkish-white asbestos-like material, covering the wall to a height equivalent to that of the front walls. This was probably a form of fire-proofing. In most cases, this covering has been entirely removed, leaving only trace remnants and the occasional marks where the material has been cleaned off. In a couple of cases, a proportion of this material remains in situ, the best example being on the west-facing gable exterior of structure **205** where the coating is almost complete (see Figure 156). A slight pitch or chamfer was noted along the top edge of the material on **205**; now much degraded, it appeared that this once continued across the full width of the wall, perhaps to direct water away from the surface. The coating is divided into four sections by three vertical channels that mark the former location of wooden or metal batons. Additionally, at the top of each of the four sections, is a large iron hook set slightly off-centre. The asbestos-like coating covers the hook's back plate but leaves the line of hooks protruding. Just above the upper edge of the wall coating is a narrow horizontal bitumen stain, and immediately above this is a line of widely spaced small holes through the concrete, possibly from rods supporting a lightweight structure inside the stove (see Figure 156).

The footprint of each standing structure is 15.7m x 13.3m, divided into four interior spaces measuring 7.6m x 6.5m apiece, and each is built on a slightly raised coarse concrete foundation, 0.25m wider on all sides than the building footprint (Figure 155). The west- and east-facing exterior elevations of each structure are gable ends, 4.6m tall at the centre. At this height, a partition wall runs between the gable walls forming a barrier between the back-to-back stoves. At 2.4m, the north and south elevations are much lower, each consisting of the front wall and entranceway to a pair of adjacent cordite drying stoves. A wing wall runs north-south between the side-by-side stoves, mirroring the pitched line of the gable ends and projecting 2.2m beyond the front elevation to form a barrier between tramways terminating on either side (Figure 156).

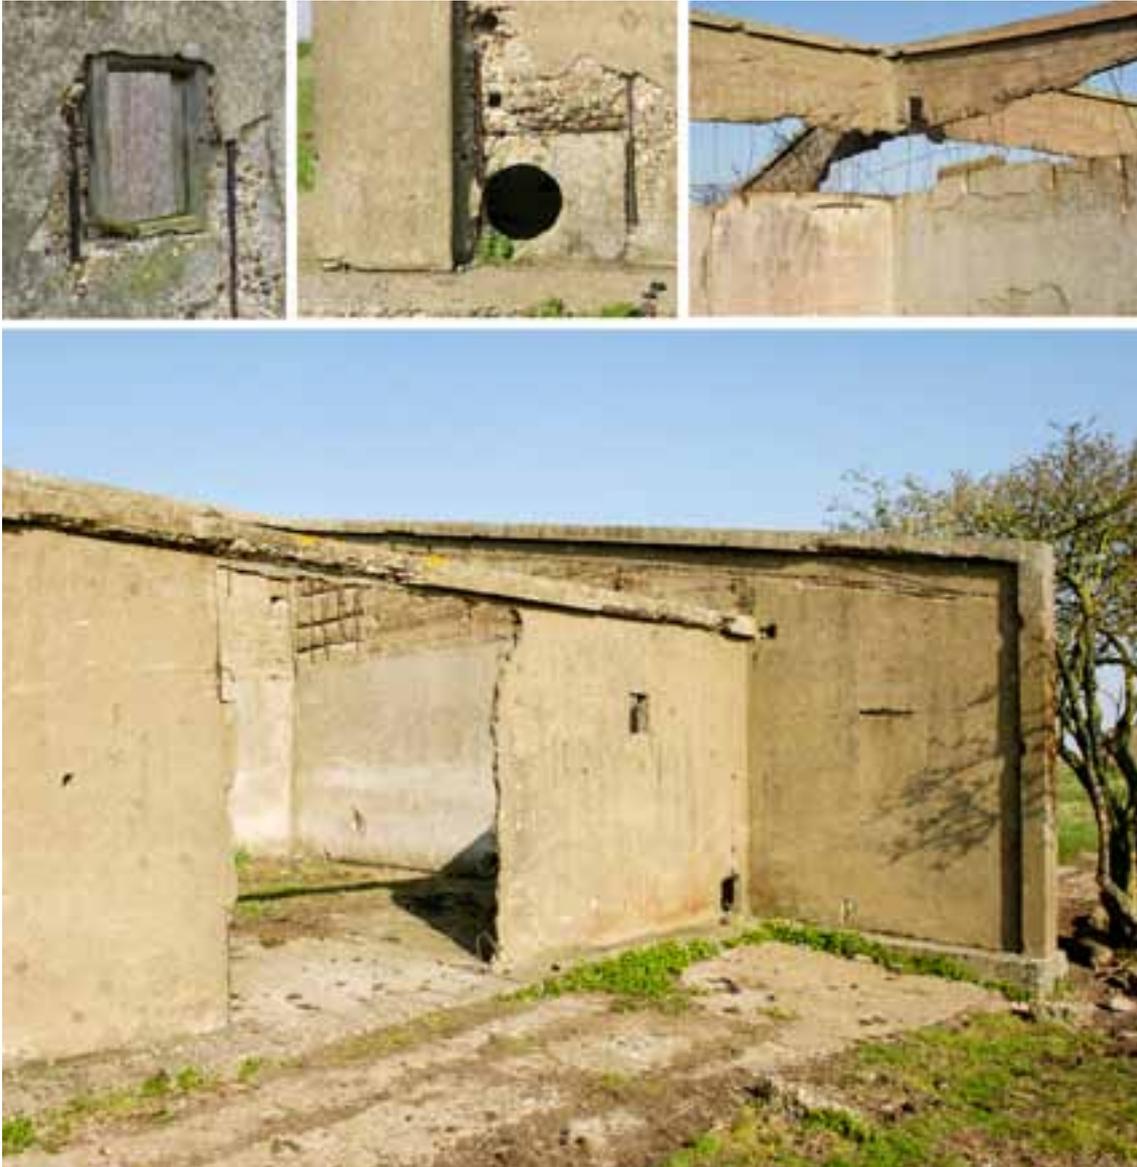
Figure 157: Cordite drying stove **205** (clockwise from top left): squint window detail; circular opening for a pipe at the base of the front wall; damage and degradation of the walls; and south- and west-facing elevations of the south-west stove compartment showing the roof scar and smooth square floor for the lean-to porch. Photographs (clockwise from top left): Wayne Cocroft 2010; NMR DPI41706; DPI41707; DPI41705 08-Mar-2011, Steve Cole © English Heritage.
