# CURTIS'S AND HARVEY LTD EXPLOSIVES FACTORY, CLIFFE AND CLIFFE WOODS, MEDWAY ARCHAEOLOGICAL SURVEY AND ANALYSIS OF THE FACTORY REMAINS

Volume 1 of 2

Rebecca Pullen, Sarah Newsome, Andrew Williams and Wayne D Cocroft

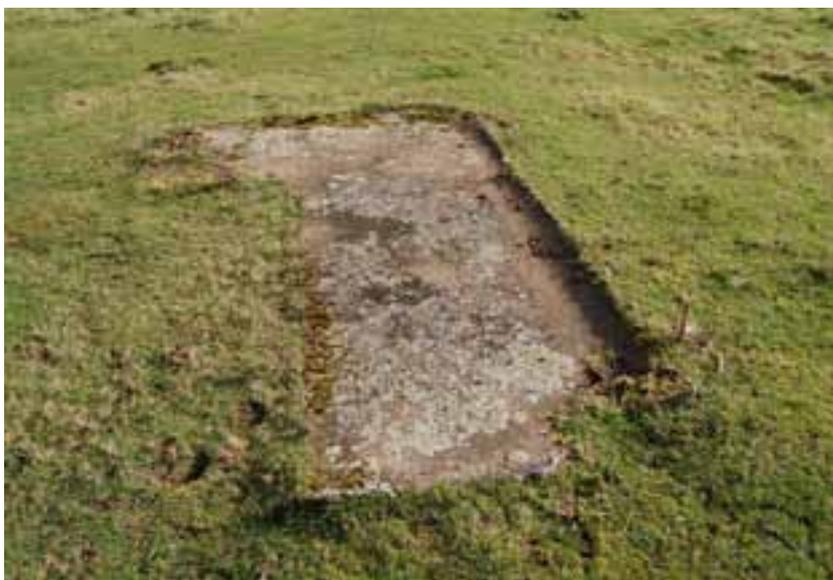
Structures **201**, **202**, **213** and **214** are the remains of four small platforms reached by narrow embanked pathways leading off from the main tramways between the rows of blending houses and cordite drying stoves. With the exception of structure **201**, a remnant of concrete floor is visible on the surface of each platform, suggestive of small buildings with footprints approximately 3m square. In two cases (**202** and **213**), the concrete survives in a coherent L-shaped form with a linear concave depression along the southern edge suggestive of a drainage or water run-off function (Figure 158). Through a process of elimination using the building lot descriptions in the 1923 sales particulars, these features have been interpreted as single-compartment earth closets, which would have been topped by a simple corrugated iron superstructure (ibid). The sales particulars do not assign building numbers or locations to the earth closets, but they do list a total of 20 in the HM Cordite Factory:

*Figure 158:  
Structure **202**  
looking east, showing  
the low platform  
with L-shaped  
concrete floor with  
moulded floor drain.  
Photograph: Rebecca  
Pullen 2011 ©  
English Heritage.*

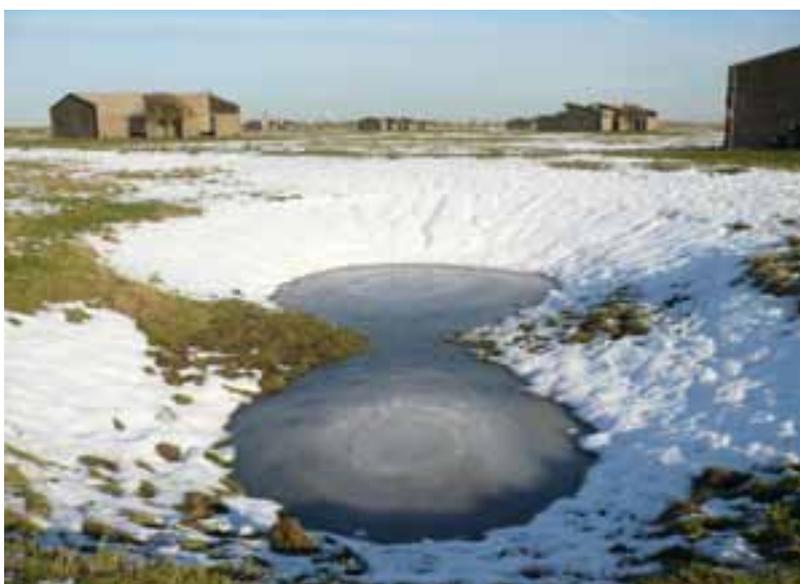
Two types of crater were noted during the survey. Firstly, there are several craters that appear to result from aerial assault or aerial target practice, the most obvious example being the vast irregular shaped cluster of conjoined bomb craters spanning up to 150m across, located at the far eastern edge of the site in **Area J** (see Figures 141 and 142). The extensive cratering has partially truncated incorporating house **251** and entirely destroyed a laboratory building described in the 1923 site auction documents (MALSC 06a\_DE\_Series\_1001\_1200/DEI087\_3). Local resident Clifford Dowsett recalls childhood memories of a large chalk circle marked on the ground in this area that was used for aerial target practice around the time of D-day, 1944 (C Dowsett, pers comm to R Pullen, June 2011). Smaller examples of this type of crater, often clustered in conjoined groups, were recorded west of **226** and **230**, and north of **105** (Figure 159).

*Figure 159: Pair of conjoined bomb craters, west of structure **226**, looking north-east. Photograph: Rebecca Pullen 2011 © English Heritage.*

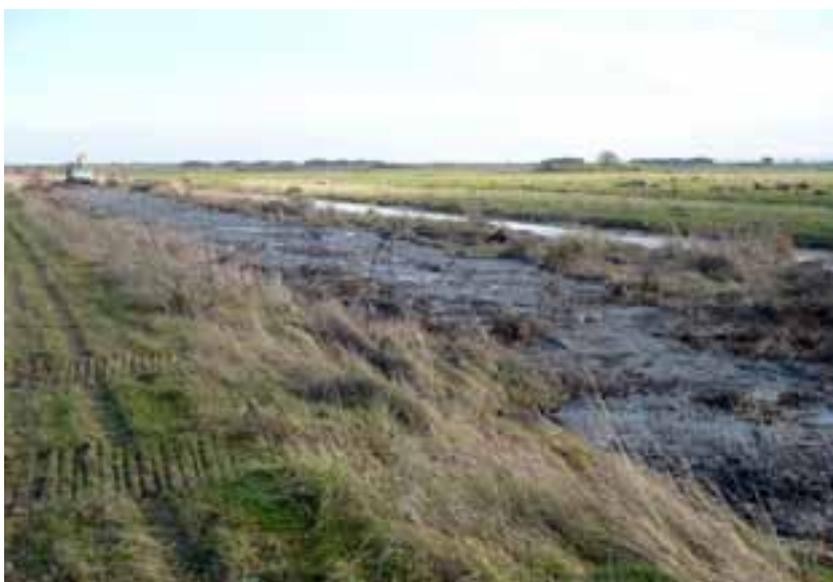
Low amorphous spreads of earth were recorded along the sides of several of the drainage dykes, often overlying and masking factory features including tramway embankments and foundation slabs. In most cases, these were fairly firm and covered with grass and, thereby were interpreted as upcast from ditch clearance carried out several years ago. During fieldwork in January 2011, dredging work was undertaken on behalf of Natural England along the boundary dyke running parallel to the landward face of the sea wall; sediments were removed by mechanical excavator and deposited in a broad band along the outside of the ditch, closest to the sea wall (Figure 160). As stated in section 6.3 (see **21** and **22**), it was unfortunately not possible for all sections along the outside of this drainage dyke to be checked for remnants of factory structures before dredging material had masked much of the area.

*Figure 160: Active dredging of the drainage dyke alongside the sea wall, and associated sediment spreads, looking east.  
Photograph: Rebecca Pullen 2011 © English Heritage.*

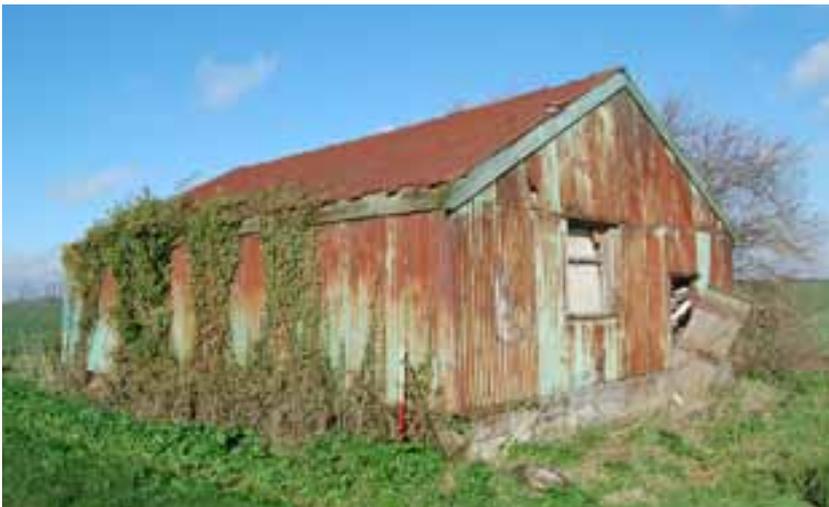
Some elements of the factory could be said to have an afterlife elsewhere in the local area. As well as being broken up and sold for scrap or reuse, some building materials salvaged from the factory following its closure appear to have been reused in a number of sheds and outbuildings that can be seen around the village today. In particular, the design of the lightweight iron and timber buildings, essentially in pre-formed pieces, was such that they could be easily assembled and disassembled, making it possible to move and re-erect them wholesale if desired. A lone corrugated metal shed currently located on the north side of Cooling Road, leading east out of Cliffe is a case in point (Figure 166). The building has a rectangular footprint measuring 9.2m x 7.5m, with a large pair of outward-opening double doors creating an entrance 3.5m wide centrally in its west-facing gable end, and a regular outward-opening door and single small window in its east-facing gable. Comparing the footprint of this shed with the size of the concrete building foundation slabs surveyed on the factory site (excluding those with clear evidence for a brick or concrete superstructure), suggests a possible correlation with the size of structure **2**, **102**, **116**, **120**, **128** or **160**. The wide double doors at one end suggest a building type that required a loading facility. The structure also has the vestiges of a paint scheme adhering to the exterior - red on the roof and green on the walls - which local hearsay suggests was a scheme used at the explosives factory.

*Figure 166:  
Corrugated metal  
shed located on  
Cooling Road in Cliffe,  
thought to have been  
salvaged from the  
explosives factory.  
Photograph: Rebecca  
Pullen 2011 © English  
Heritage.*

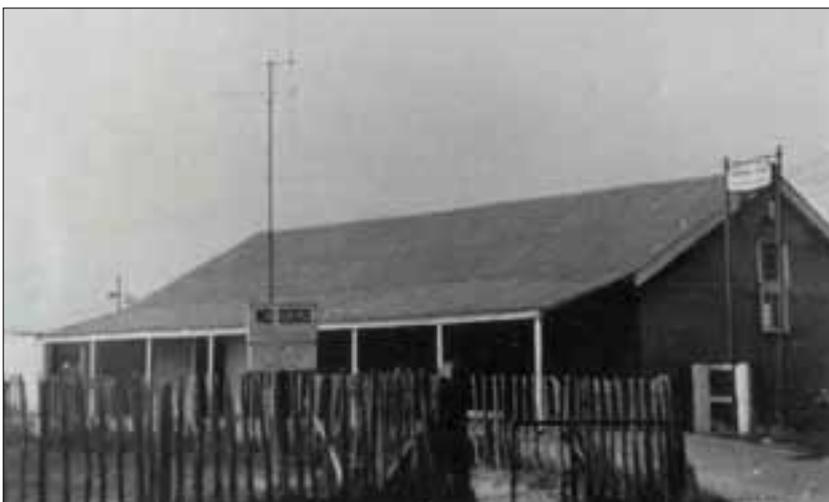
*Figure 167: The  
former 'Terminal  
Club' in Church  
Street, Cliffe, another  
corrugated metal  
building salvaged from  
the explosives factory,  
undated (after Cherry  
1998, 30) © Allan  
Cherry, reproduced by  
kind permission.*

In his *Pictorial History of Cooling and Cliffe*, Cherry (1998, 30), shows a photograph of the 'Terminal Club', in Church Street before it was demolished in advance of new development. Cherry states that the building was originally owned and used by Curtis's & Harvey on their explosives works land, and later re-erected in the village as the British Legion Club after the factory had closed. Judging from the photograph (Figure 167), it appears to have been a fairly large rectangular building with a covered ground floor veranda along at least one of its long sides. No clear correlation to a known factory building has yet been made.

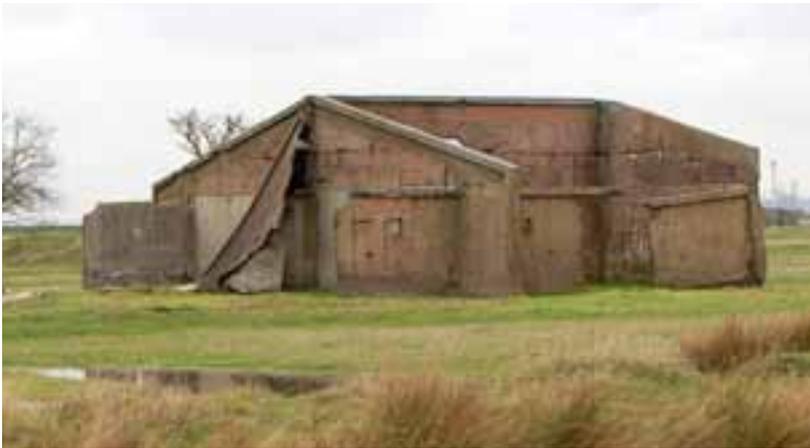
While the plan form and extent is well preserved, the condition of individual features is poor, suffering largely from the comprehensive stripping of all reusable materials following the closure of the works. Furthermore, it is likely that thermal remediation (removing trace residues of chemicals by fire) was used to ‘clean’ the site of all chemical residues by setting fire to the structures. Any remaining standing buildings, such as the reinforced concrete stoves, may have been structurally weakened in the process. Reddening from fire was noted on the interior walls of many of the reinforced concrete structures (Figure 168).

*Figure 168: The remains of cordite drying stove 154 showing the characteristic reddening of the concrete caused by thermal remediation. Photograph: Rebecca Pullen 2011 © English Heritage.*
