Weston-super-Mare, North Somerset: Great Weston Heritage Action Zone, Aerial Investigation and Mapping Project

Research Report Series no. 50-2018

Great Weston Heritage Action Zone
Aerial Investigation and Mapping Project

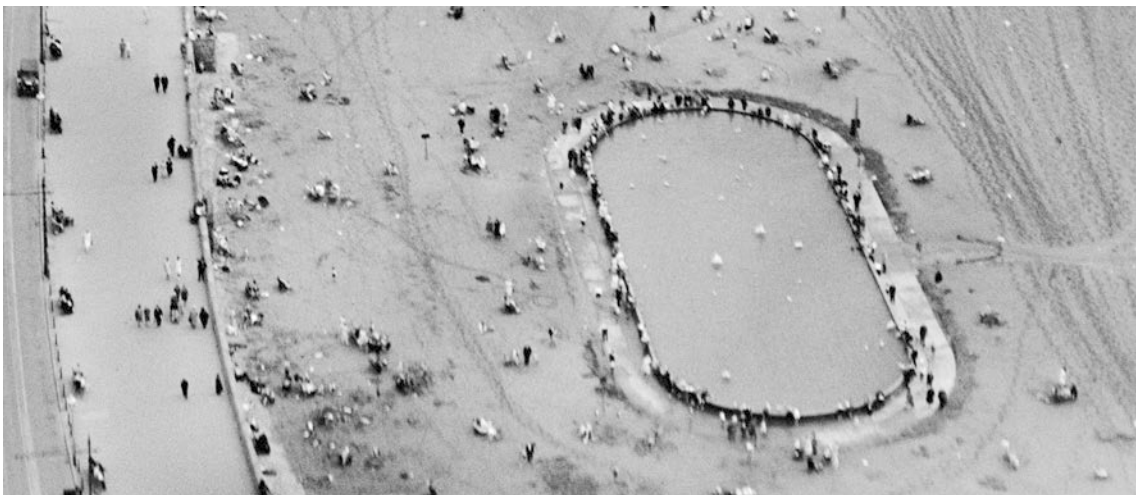
Figure 8 One of two model boat lakes that existed on Weston's beach. This was to the north of the pier and can no longer be seen. The outline of the other pond can still be made-out in the sand to the south of the 1930s open air pool. Detail of AFL 60516/EPW023969 Sep-1928 © Historic England (Aerofilms Collection)

Some of the aerial photographs show relatively short-lived features such as the painted sign advertising the public baths on Knightstone Island (Fig 5), the temporary arrangement of huts on the beach (Fig 6 & 7) and the model yacht ponds (Fig 8). While these aerial photographs document change, they also highlight the more constant aspects of this seaside town. In particular, the vast crowds of holidaymakers and the unchanging nature of the exterior of some of the guesthouses (Fig 9).

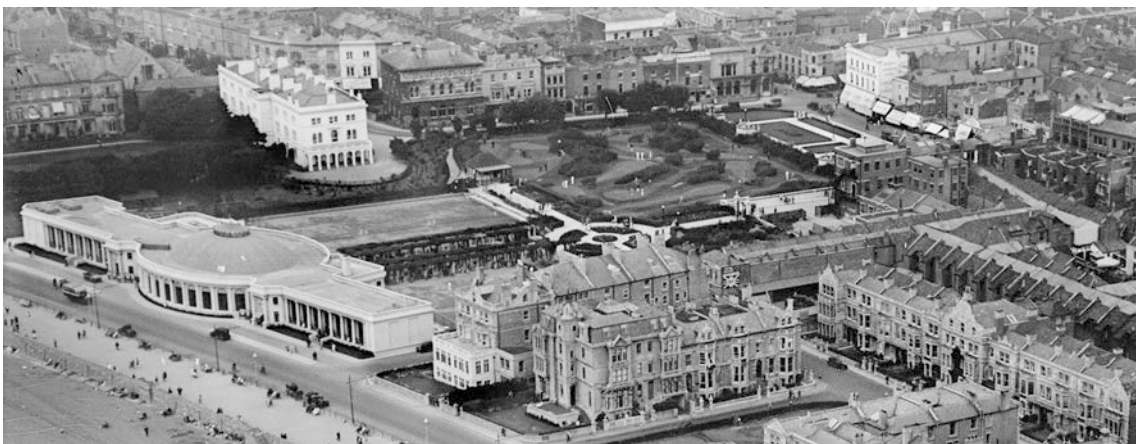
Figure 10 Winter Gardens 1928. Lances department store is the white building towards the top right. Detail of AFL 60516/EPW023960 Sep-1928 © Historic England (Aerofilms Collection)

An aerial photograph taken in 1928 (Fig 10) shows the landscaping of the Winter Gardens and its pavilion on the seafront the year after it had opened. Although the pavilion survives today, the area behind which included tennis courts and a putting green, were redeveloped and is now largely occupied by the Town Square and part of the Sovereign Centre. A number of buildings shown in this photograph have since been demolished including Lance's department store and the Royal Arcade.

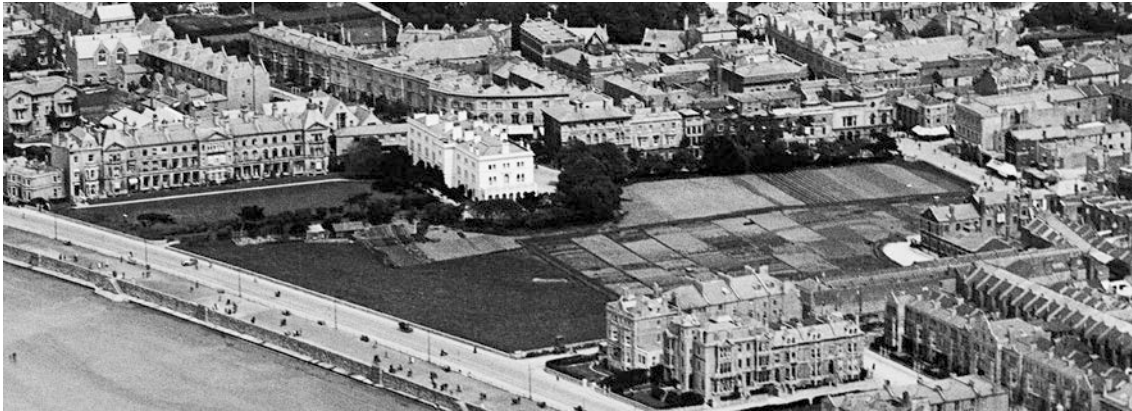
Figure 11 Site of Winter Gardens in May 1920. Detail of AFL 60014/EPW001039 May-1920 © Historic England (Aerofilms Collection)

Figure 11 is of the same area in 1920, before the Winter Gardens and pavilion had been created. Most of this open area is not laid out as lawn but is instead under cultivation in the form of allotments. The most likely explanation for allotments in this town centre location in 1920, is that they originated during the First World War. Allotments were dug in response to food shortages and these are likely to have been created from 1916 onwards after local authorities were given powers to take over land for use as allotments (Way 2008, 17).

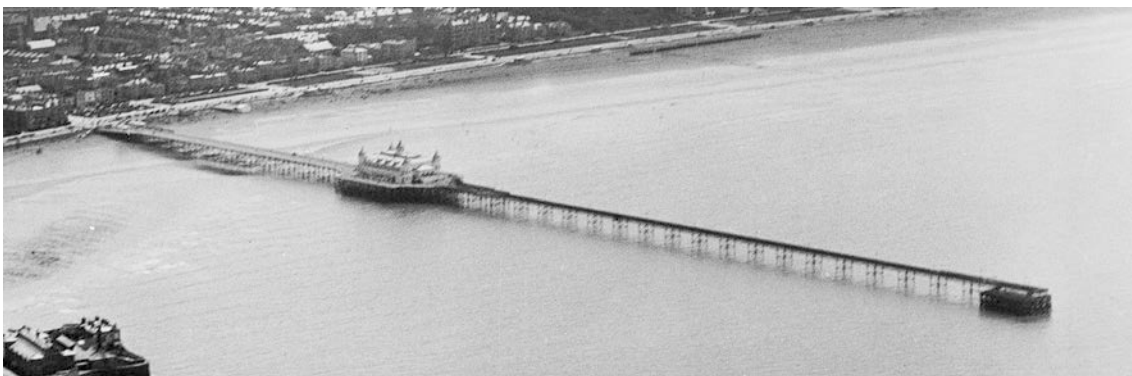
Figure 12 The Grand Pier in 1920 showing the landing stage extension. Detail of AFL 60014/EPW001032 May-1920 © Historic England (Aerofilms Collection)

A number of aerial photographs taken illustrate the popularity of Weston as a holiday destination and the facilities created for visitors to the town. Weston's Grand Pier is a popular attraction and the historic aerial photographs document some of the changes made to this structure since it was opened in 1904. In 1906 a landing stage was added (Fig 12), but the currents and muddy bay made it difficult for shipping to use and it was eventually demolished (Wills & Phillips 2014, 254). Seen on Aerofilms photographs taken in 1920, the landing stage had gone by 1928.

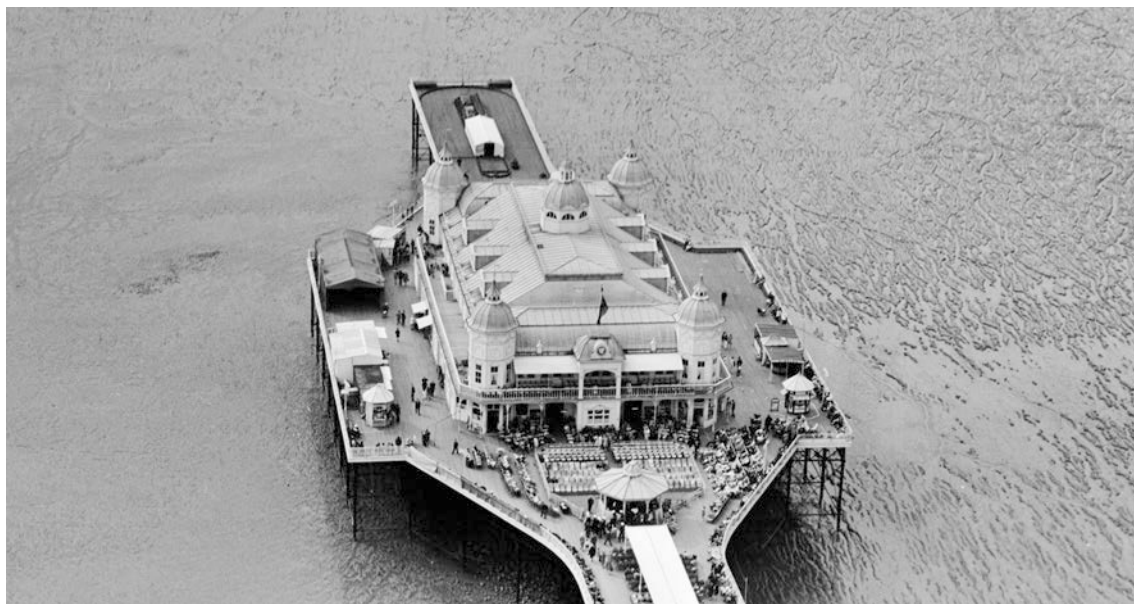
Figure 13 The Grand Pier pavilion with bandstand in front seen in 1928. Detail of AFL 60516/EPW024071 Sep-1928 © Historic England (Aerofilms Collection)

The truncated pier was photographed in September 1928. These images provide a variety of different viewpoints of the pier. Figure 13 shows an audience gathered at the bandstand to listen to the Royal Marine Band, whose presence is advertised at

The original pavilion seen in Fig 13 was destroyed by fire in January 1930 and an aerial photograph taken in July of that year shows the damaged remains (Fig 15). A new pavilion opened in 1933 (Fig 16) but this too burnt down in 2008.

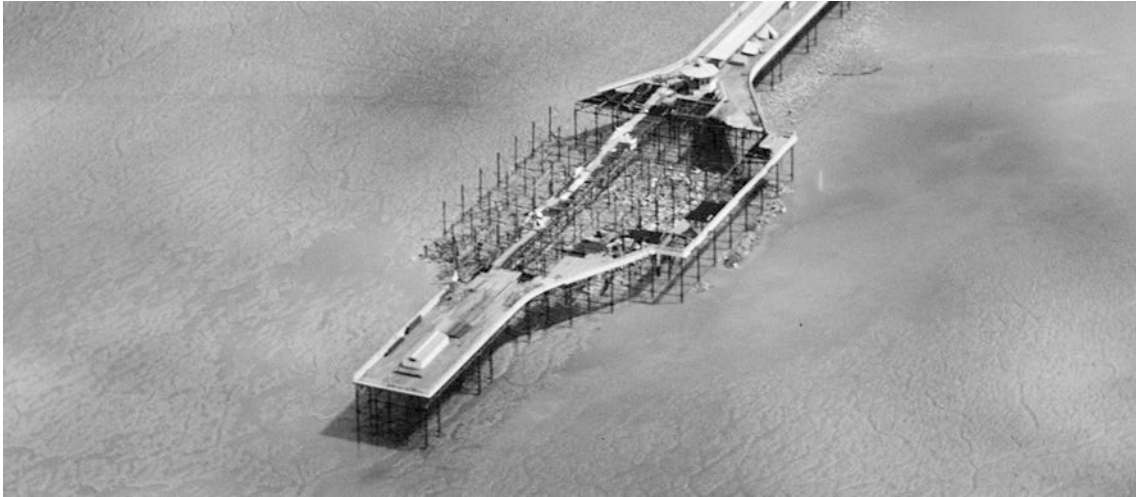
Figure 15 The fire damaged pier in 1930.

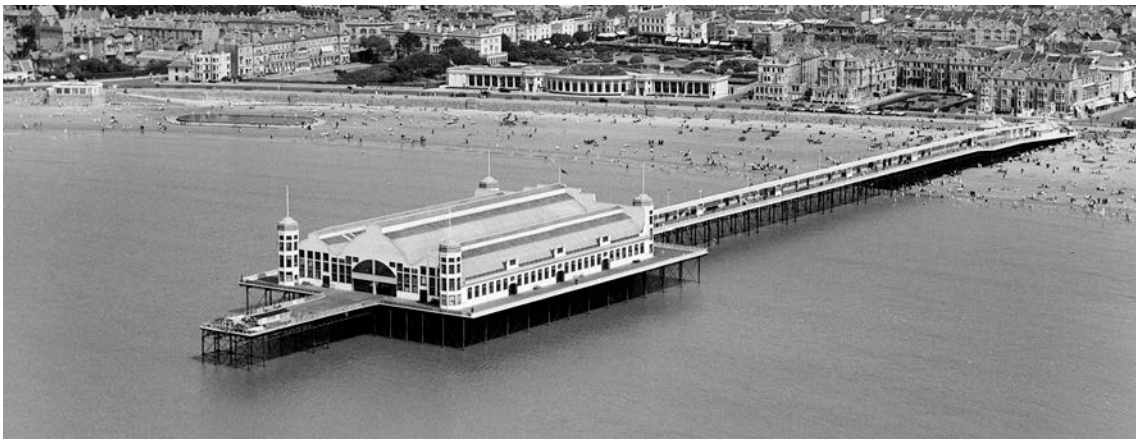
*Figure 16 The new pavilion seen in 1935. The Winter Gardens are in the background. On the beach to the left is one of two oval model yacht ponds in the town (see Fig 8).
AFL 60874/EPW048451 Jul-1935 © Historic England (Aerofilms Collection)*

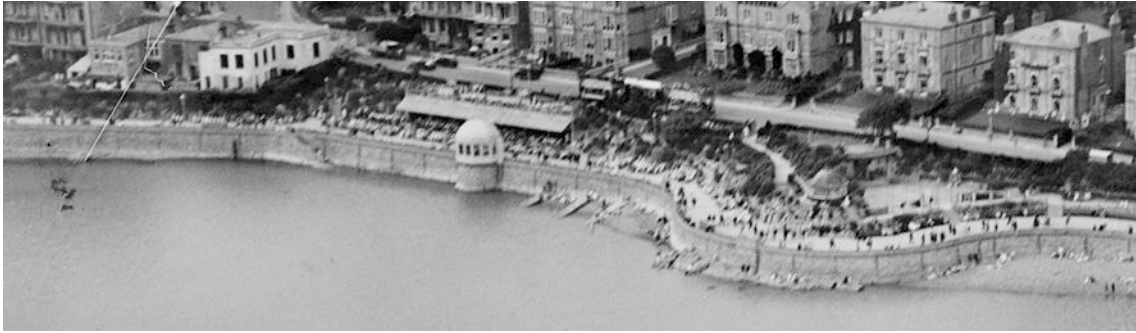
Figure 17 The original stone-fronted Marine parade in 1928. The bandstand is the white domed structure near the centre of the photograph. Detail of AFL 60516/EPW023963 Sep-1928 © Historic England (Aerofilms Collection)

The Aerofilms collection illustrates a number of facilities constructed in the 1920s and 1930s that catered for holidaymakers to the town. This included the creation and development of Marine Lake in Glentworth Bay that ensured easy access to the sea, even when the tide was out. The earliest aerial photographs of the town, taken in 1920, show Glentworth Bay prior to the construction of the causeway that created Marine Lake. The causeway was built across the bay in 1927-9 (Beisly 2001, 96) between the seafront and Knightstone Island. A promenade had previously been built along the shoreline of Glentworth Bay in 1883-7 and is first seen on the 1:2,500 1888 Ordnance Survey map. This was incorporated into the new development and by 1920 a bandstand was built on one of the promenade's semi-circular bastions that projected into the sea (Fig 17).

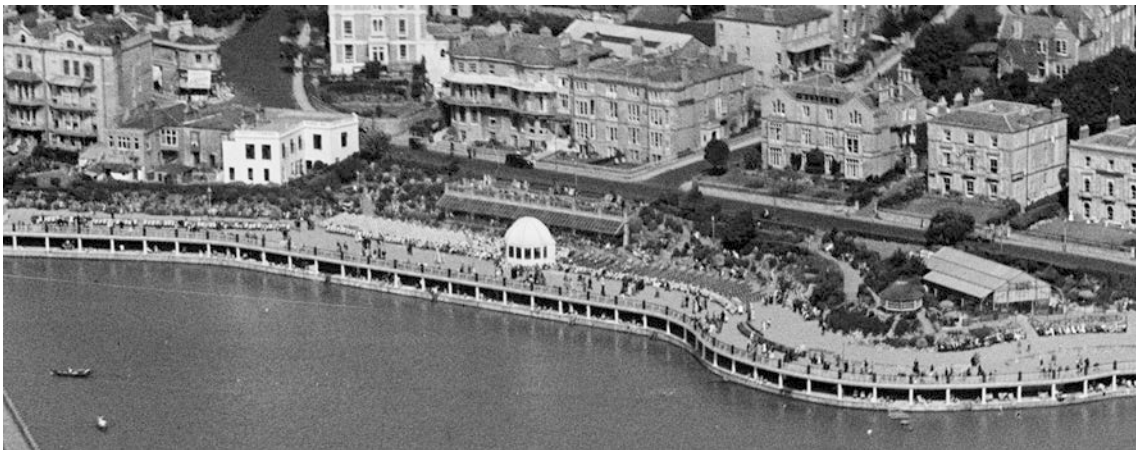
Figure 18 Seen in 1932, the same bandstand as in Fig 17 no longer at the water's edge after the widening of Grand Parade - which based on 1931 OS map evidence had been renamed Madeira Cove. The newly built area was called Marine Drive. Detail of AFL 60818/EPW039937 Aug-1932 © Historic England (Aerofilms Collection)

The popularity of this part of town appears to have been greater than the original scheme had planned for and by 1932 the parade had been extended over the lake and supported on a series of posts forming a colonnade (Fig 18). The broad band of deck chairs seen here are arranged well beyond either side of the bandstand. This indicates the large numbers visiting, but also suggests a less than satisfactory audience experience for those sitting at the extreme ends of this seating arrangement.

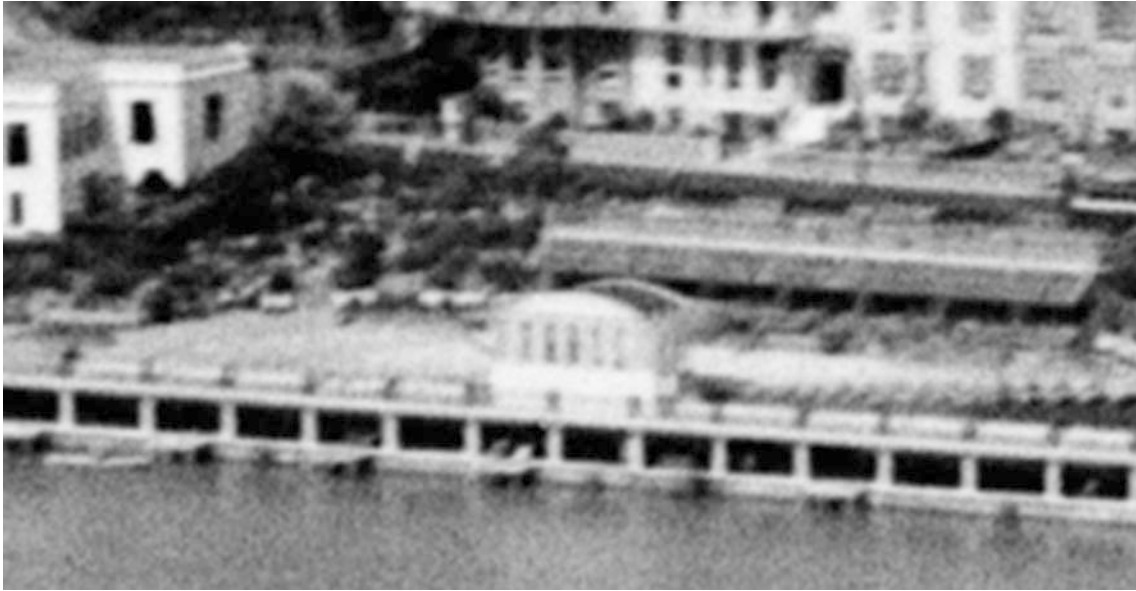
Figure 19 New bandstand at Marine Lake in 1935. A similar design of bandstand was later built on Beach Lawn (see Fig 23). Detail of AFL 60874/EPW048450 Jul-1935 © Historic England (Aerofilms Collection)

By 1935 the original bandstand had been demolished and a new bandstand located on the water's edge on the newly widened parade (Fig 19). This mid-1930s bandstand had a short life and had been demolished by 1939. This was replaced with a much larger development that necessitated a further extension of the parade over the water. This larger area allowed the construction of the Rozel bandstand and auditorium that included some covered seating in 1937 (Fig 20), (Brodie, Roethe and Hudson-McAulay 2019).

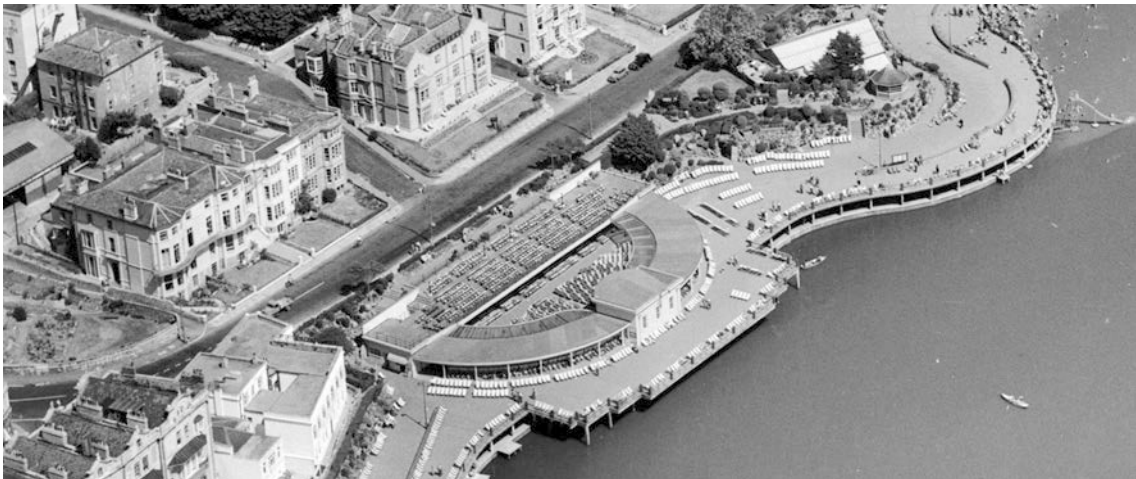
Figure 20 A widened Marine Parade accommodates the large Rozel bandstand and open-air auditorium. Note the water slide at the top right of the photograph. Detail of AFL 61877/EAW025153 24-Jul-1949 © Historic England (Aerofilms Collection)

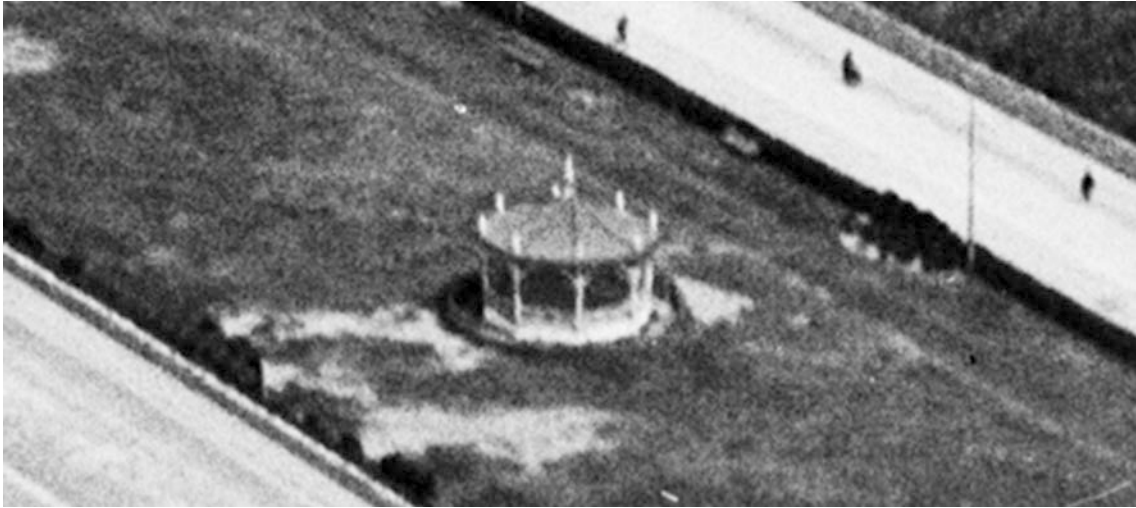
Figure 21 Bandstand on Beach Lawn 1920. Detail of AFL 60014/EPW001033 May-1920 © Historic England (Aerofilms Collection)

The Aerofilms photographs also show the development of the bandstand on Beach Lawn, opposite Ellenborough Park. The first bandstand was photographed in 1920 centrally placed on Beach Lawn (Fig 21). This appears to have been hexagonal in plan. It had distinctive uprights (presumably cast iron) that divide into three parts to support the roof. Finials are located around the edge of the roof and a single finial is at its centre. This bandstand was not depicted on any Ordnance Survey maps and map evidence combined with aerial photographs indicates that it was built between 1902 and 1920.

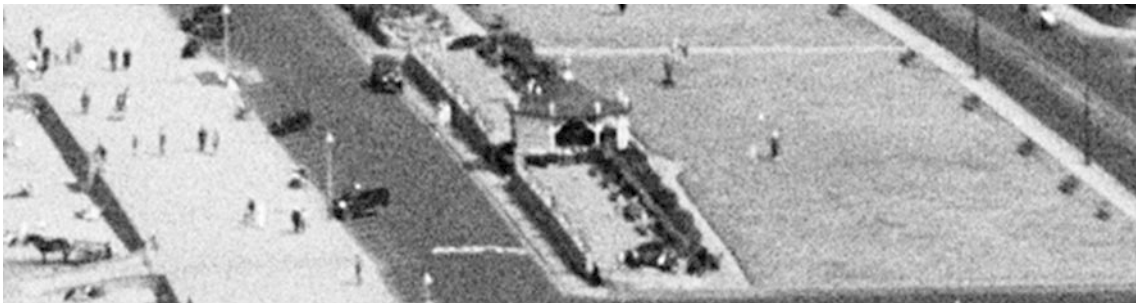
Figure 22 Repositioned bandstand on Beach Lawn seen in 1932. Detail of AFL 60818/EPW039935 Aug-1932 © Historic England (Aerofilms Collection)

By 1928 this bandstand had been dismantled and rebuilt closer to the coast on the edge of Beach Lawn. As part of this redevelopment, the bandstand was centrally placed on a broad raised walkway with railings facing the sea. Flowerbeds faced the lawn. Screens or walls had been built on the three seaward sides of the bandstand to offer some shelter to the musicians (Fig 22).

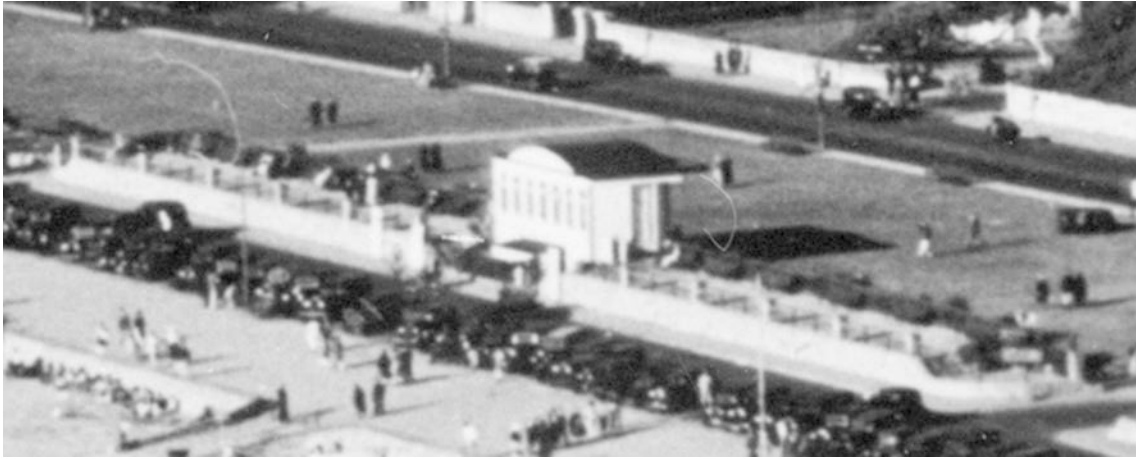
Figure 23 Replacement bandstand opposite Ellenborough Park 1936. Detail of AFL 60897/EPW051725 Aug-1936 © Historic England (Aerofilms Collection)

By 1936 this bandstand had been demolished and replaced by a new design (Fig 23). Although not identical to the 1930s bandstand on Marine Lake, it is clearly of a similar design (compare with Fig 19).

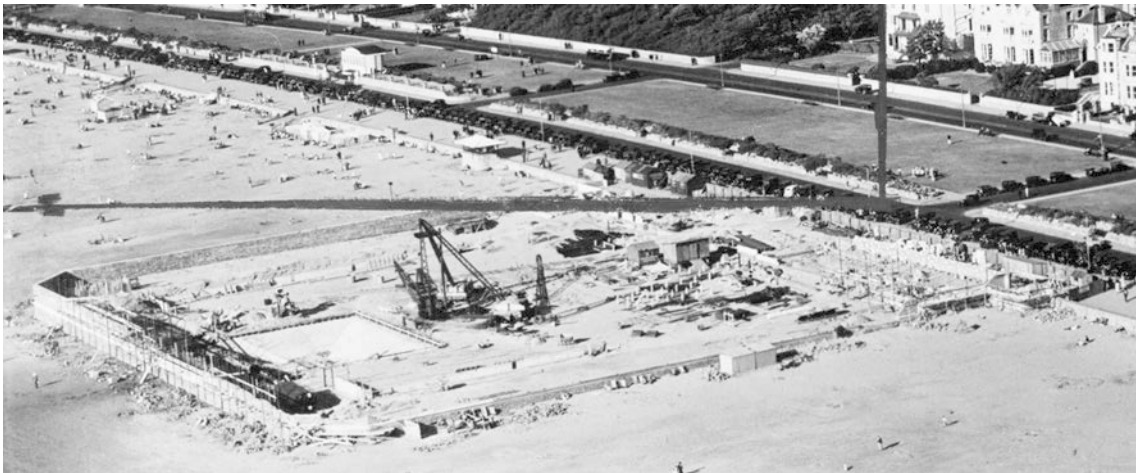
Figure 24 Swimming pool under construction in 1936. Note the deep depression on the left of the crane designed to hold sufficient water for diving. The dark lines across the top were drawn on the original print. Detail of AFL 60897/EPW051725 Aug-1936 © Historic England (Aerofilms Collection)

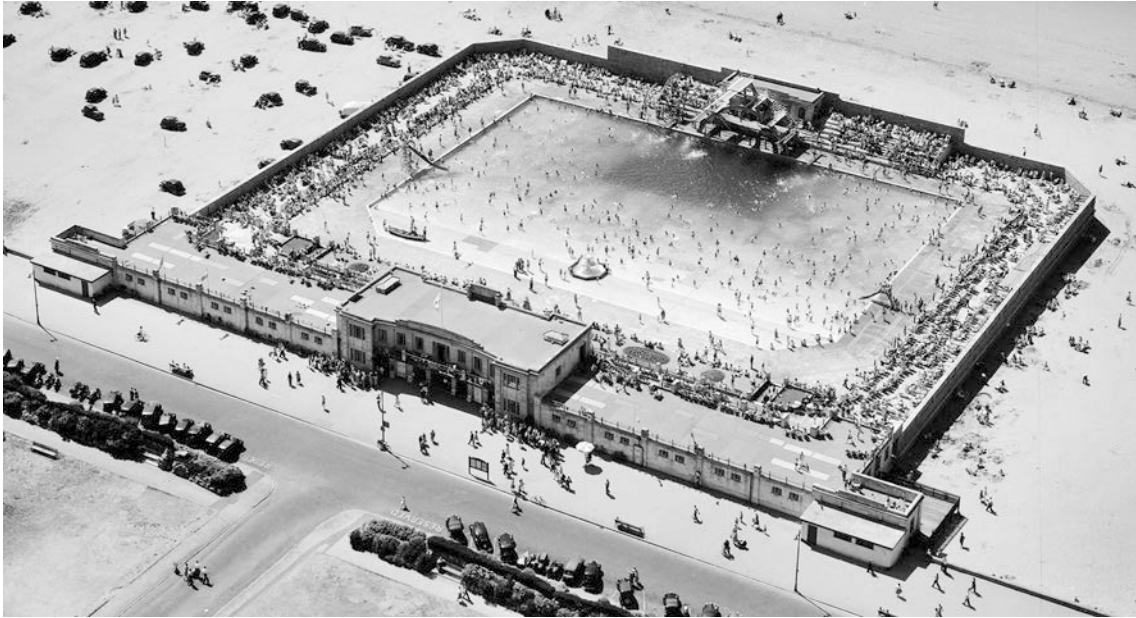
Figure 25 Called the Bathing Pool, it opened in 1937 and seen here in 1949. The entire central area contains water, but is darker where it is deepest. Detail of AFL 61877/EAW02515724-Jul-1949 © Historic England (Aerofilms Collection)

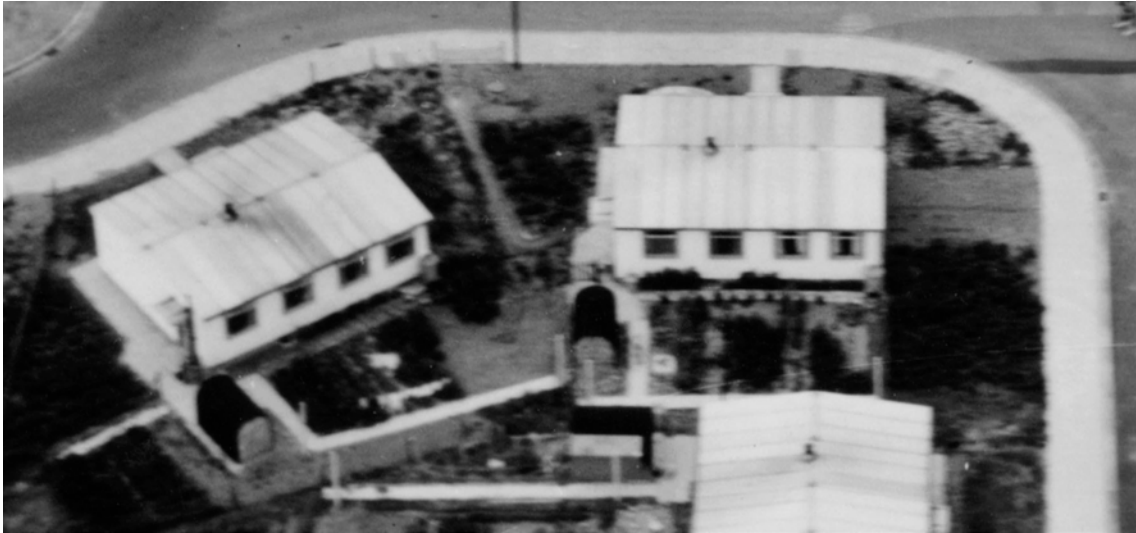
Figure 35 Prefabs on Selworthy Road, Bournville in 1948. Detail of RAF/541/99/PSFO-0059 16-JUL-1947 Historic England Archive (RAF Photography)

All the temporary prefabs built in Weston-super-Mare after the Second World War have since been demolished, but historic aerial photographs provide enough detail to identify the type of prefabs built (Fig 35). The prefabs have pitched roofs and are of four bays with four windows to the rear, a side door and a main elevation of three windows and front door under a porch. Each prefab was provided with a shed - possibly a surplus Anderson shelter repurposed for this role (Stevenson 2003, 69-70). Each shed is located in the back garden close to the prefab (on the left side when viewed from the rear).

This design of prefab was developed by the Aircraft Industries Research Organisation for Housing (AIROH) and is variously referred to as the AIROH, the 'Aluminium Bungalow' or simply the 'B2' (Stevenson 2003, 62). It was entirely manufactured in former aircraft factories on a production line (this included interior fittings and appliances) and it could be assembled on site in less than 24 hours (Stevenson 2003, 62-65). In common with all post-war prefabs, this was designed to have a relatively short lifespan (Blanchet 2014, 17).

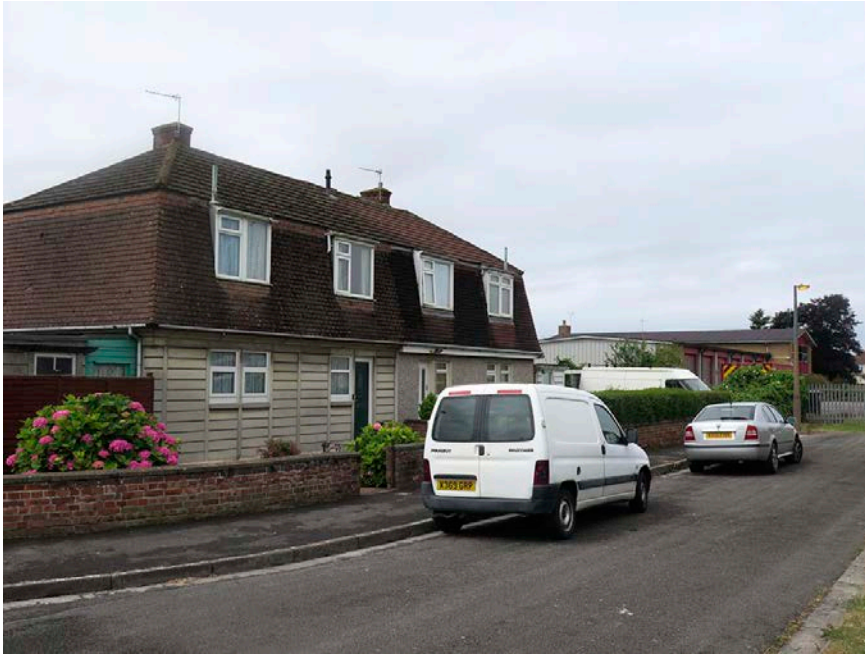
Figure 37 Cornish Unit in Summerlands Road with original concrete wall panels on the left. © Historic England

The Cornish Unit was a design of permanent, prefabricated buildings developed by the English China Clay Company. The house came in a variety of configurations, but all had a distinctive Mansard roof and concrete panel wall (Fig 37). The designs were finalised in 1946 and over the following 10 years more than 40,000 Cornish Units were built in Britain (Stratton & Trinder 2000, 137). The Cornish Units built in Weston-super-Mare survive, although some ground floor walls have been re-clad or rebuilt.

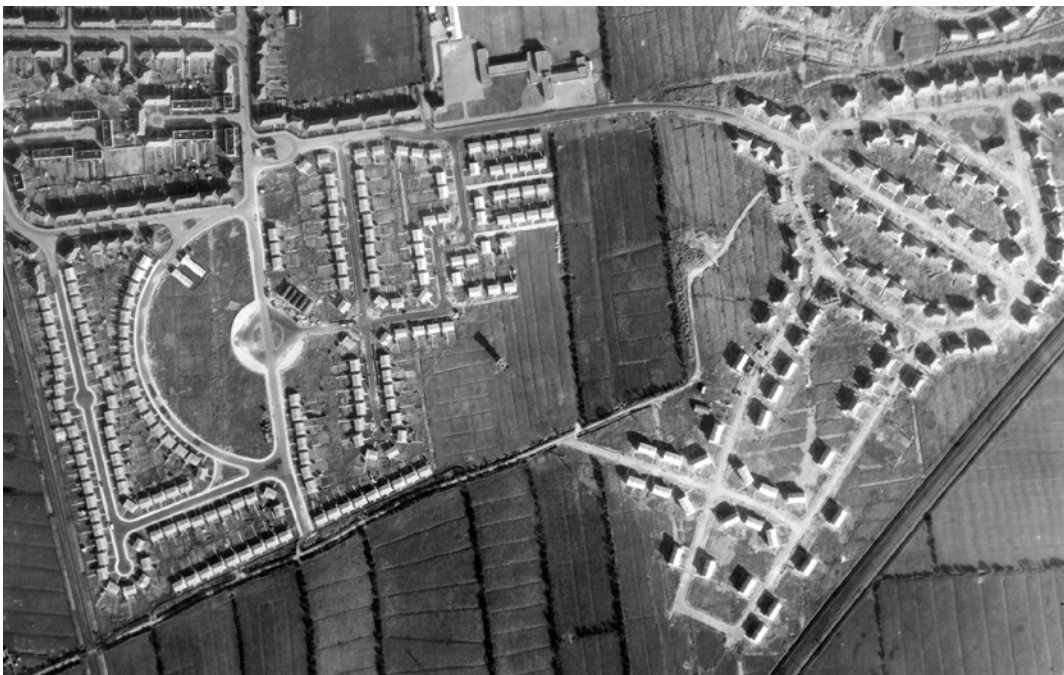
Figure 41 Bournville west (left) prefabs and Bournville east (right) with houses March 1948. Detail of RAF/CPE/UK/2489 V5011 11-MAR-1948 Historic England Archive (RAF Photography)

the initial housing stock built. As seen on photos taken on 11 March 1948, Bournville East consisted of permanent buildings whereas at Bournville West prefabs were initially erected (Fig 41).

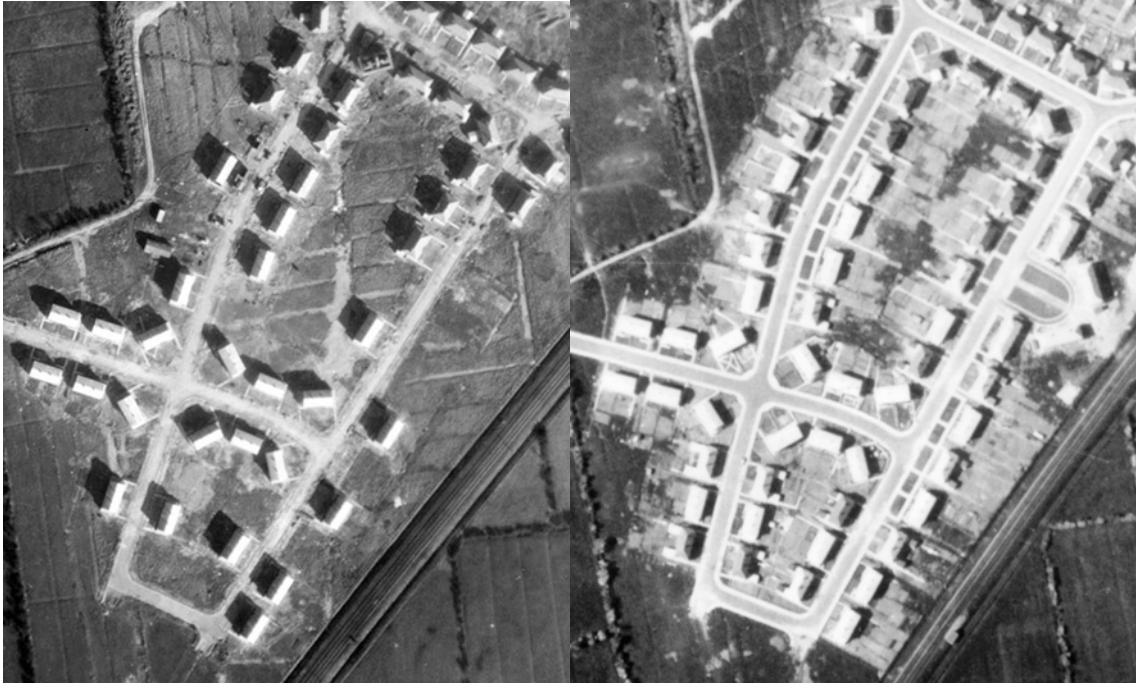
Figure 43 Bournville East in 1948 and 1950. Gaps between houses in 1948 filled with Cornish Units by 1950. Details of RAF/CPE/UK/2489 V5011 11-MAR-1948 and RAF/541/527 RP 3245 14-MAY-1950 Historic England Archive (RAF Photography)

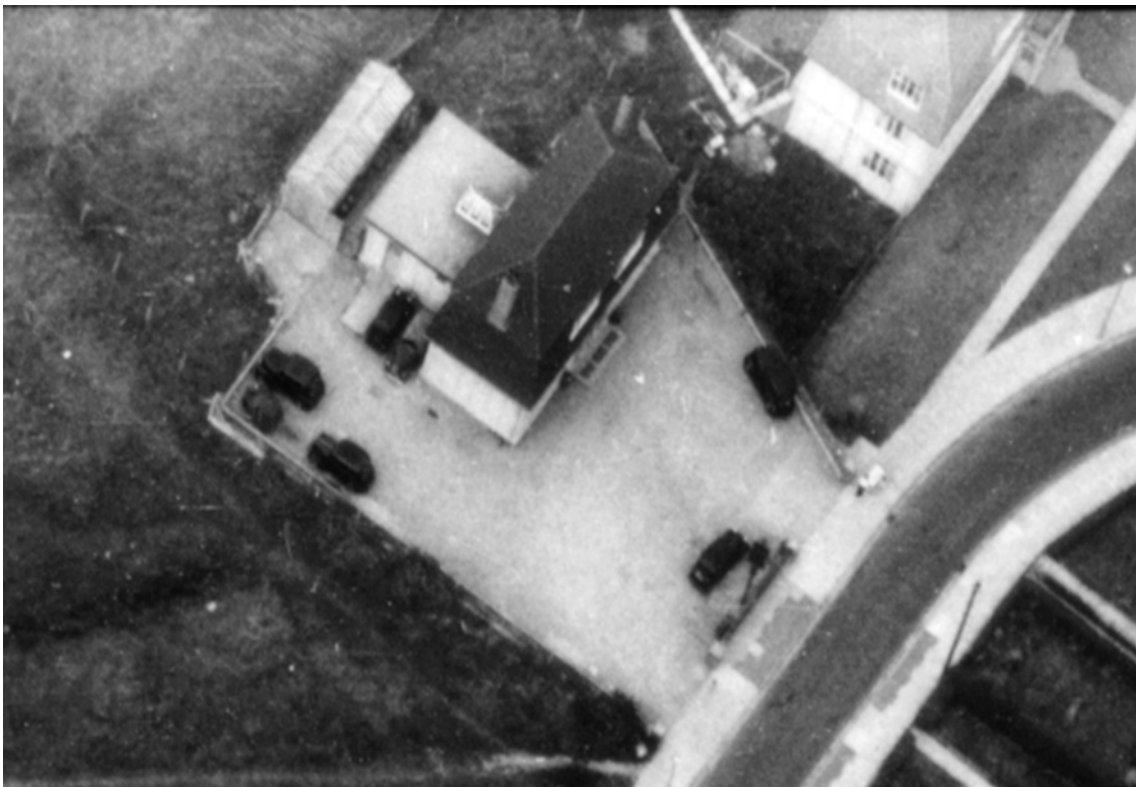
Figure 45 Windwhistle Inn, Cornish Unit pub in 1961. Detail of MAL/61484 V 93190 19-JUL-1961 Source: Historic England Archive

By 1954 Bournville east had been extended south-west and joined to Bournville west via Lonsdale Avenue (Fig 44). This phase largely consisted of short terraces of four houses but also included three story Cornish Units and a Cornish Unit pub on Chaucer Road named the Windwhistle Inn (Fig 45). This pub was identified as part of the Historic England project on post-war pubs (Cole, forthcoming). The following is a brief overview taken from the appendix of this post-war pubs project. The Windwhistle Inn was opened on 15 February 1954 and was claimed to be the first Cornish Unit public house. It consisted of two bars either side of a central servery. The single storey rear extension housed the beer store and toilets. This pub building was only intended to be temporary. It was replaced by a second Windwhistle Inn in 1963 and this was demolished 1999 (ibid).

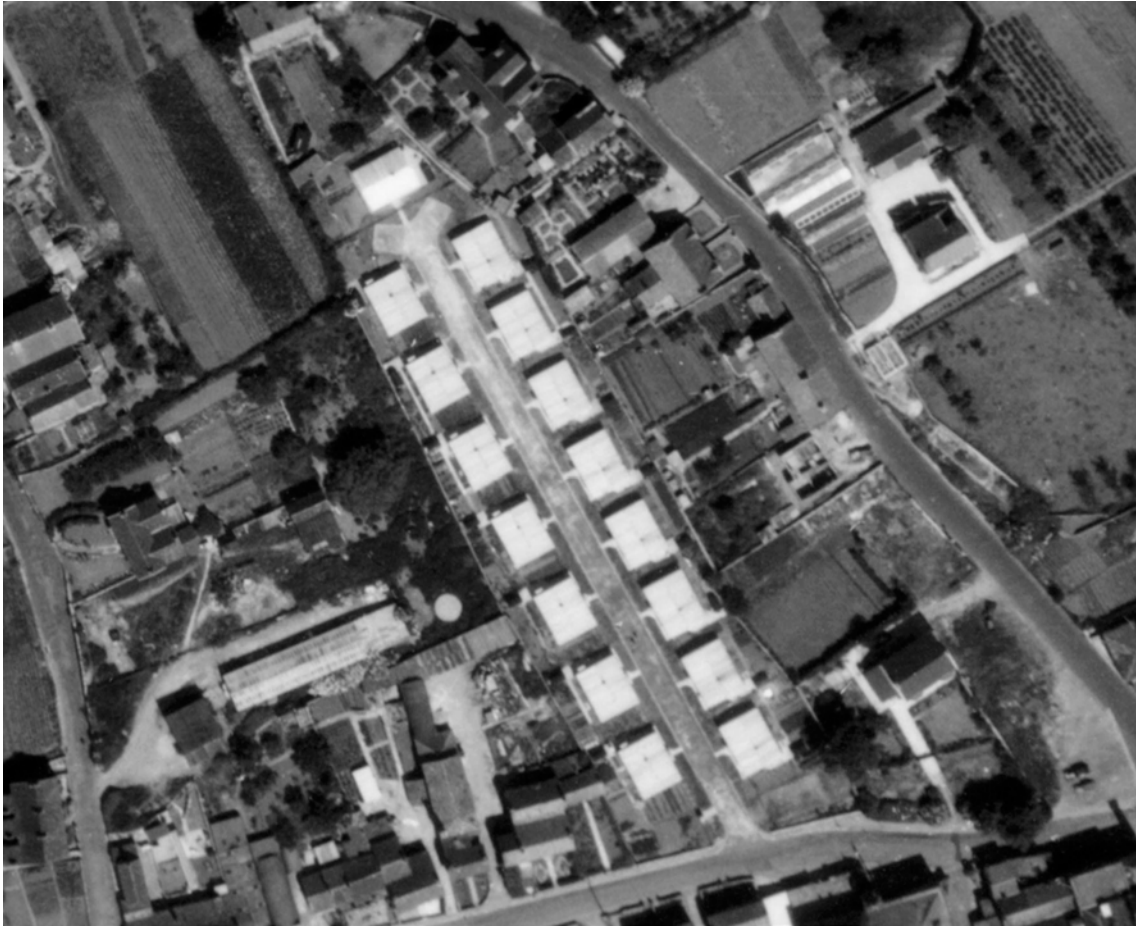
Figure 49 Prefabs in Worle. RAF/58/496 V508709-JUN-1950 Historic England Archive (RAF Photography)

By 1950, a small development of 16 prefabs had been built in Worle. A single road named The Maltings forming a cul-de-sac was laid out on a small narrow field extending north of the High Street. The same Aluminium Bungalow prefabs were built here as in Bournville, although at Worle each prefab was built on a much smaller plot of land (Fig 49). Based on Ordnance Survey map evidence these prefabs were demolished between 1962 and 1983. The name *Maltings* comes from a brewery on the opposite site of the High Street that was in use from 1795-1879 (J Roethe pers comm). The name continues in use for the road and the flats built there.

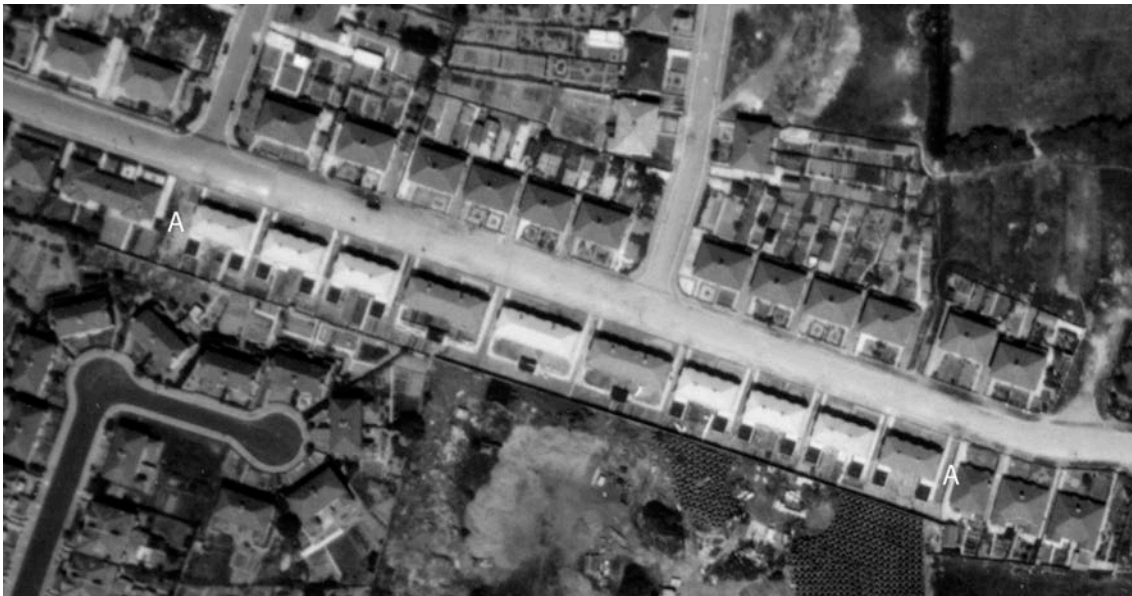
Figure 53 Cornish Units built in the late 1940s on the south side of Earlham Grove between A-A. All the other houses visible were built before the war. RAF/58/496 V 5131 09-JUN-1950 Historic England Archive (RAF Photography)

The 1942 aerial photograph shows a number of empty plots alongside the 1930s road layout. Based on aerial photographic evidence, houses were gradually built on these empty plots in late 1948/early 1949. The first of these, seen in June 1949, were ten semi-detached Cornish Unit houses erected in a gap between two groups of pre-war houses on the southern side of Earlham Grove (Fig 53). The Cornish Unit houses on Earlham Grove are of two designs of different sizes. The central three blocks are the largest with six bays, the remainder with four bays. These houses were all provided with an outbuilding. The smaller semi-detached houses have one each, the larger semi-detached houses appear to share what is presumably a subdivided outbuilding set on the boundary between the two properties

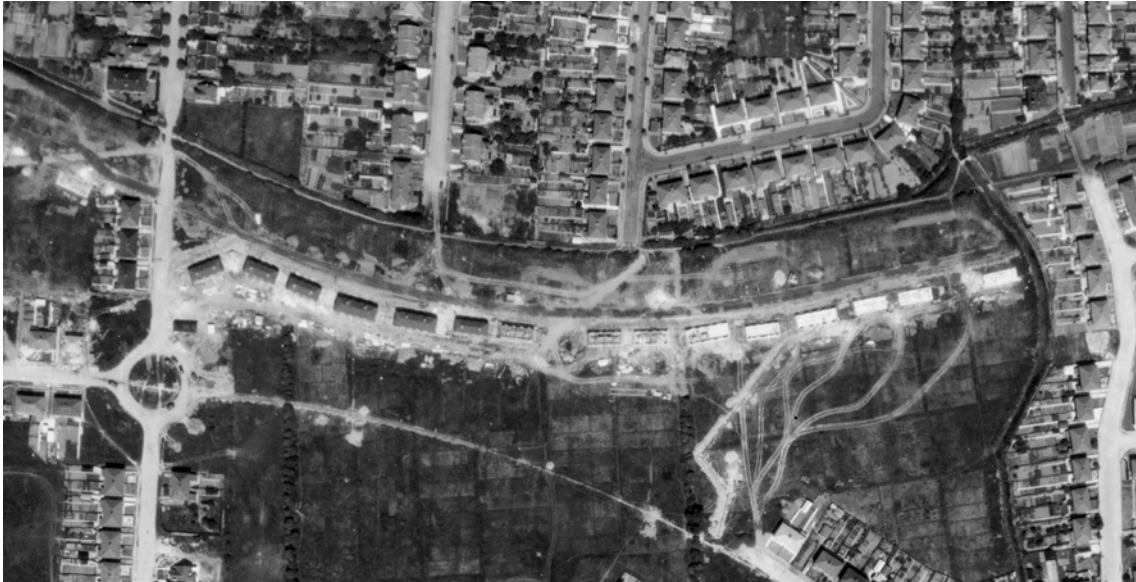
Figure 54 Cornish Units on Summerlands Road under construction. RAF/58/496 V 5132 09-JUN-1950 Historic England Archive (RAF Photography)

With the exception of six houses on Earlham Grove built using traditional techniques and materials, most houses built in Ashcombe in the late 1940s and early 1950s were Cornish Units. By 1950 the building work had progressed beyond infilling existing road frontage (although gaps remained) with the laying out of Summerlands Road. This road was laid out approximately 20m south of the line of WC&PLR - although the line had closed and the track removed in 1940 (Thomas 1966), (Fig 54).

A mixture of two and three bay semi-detached Cornish Units were built on the southern side of Summerlands Road occupying a plot approximately 20m deep. The similarity between the depth of the house plots and the gap left to the north of Summerlands Road suggest that the original intention was to build a line of houses on this strip of land. Although this scheme was never carried out, some houses have subsequently been built there. However, with the exception of a small group at the eastern end of Summerlands Road, these houses were all built facing north and incorporated into the streets linked to Milton Road.

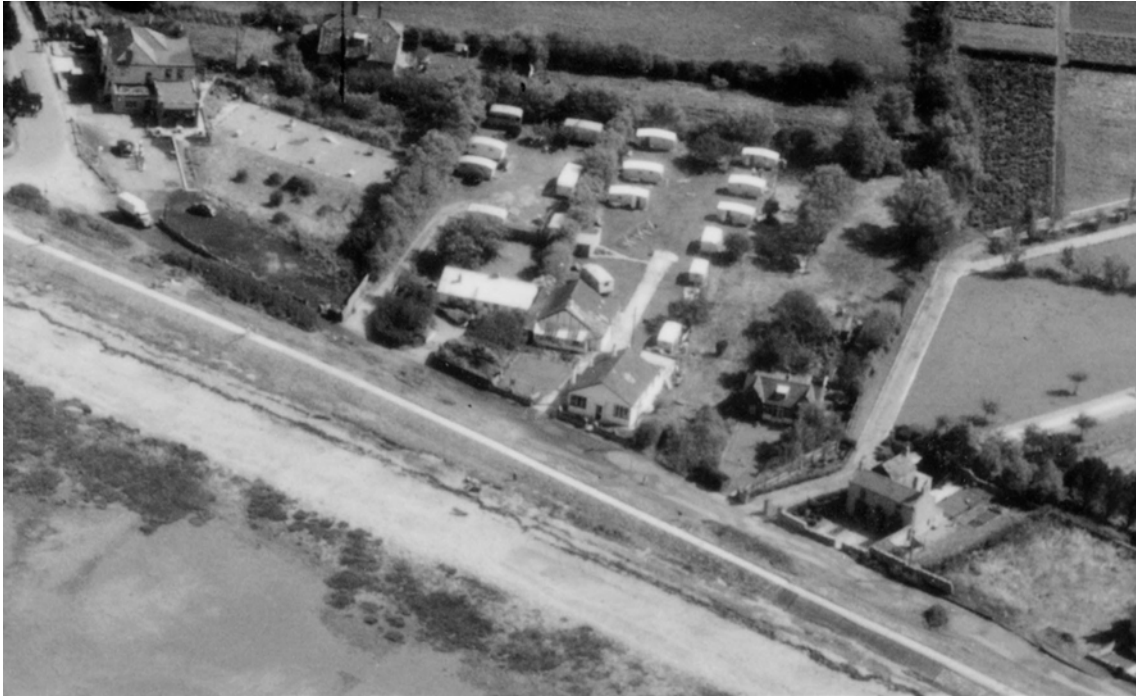
Figure 56 Caravans at Kewstoke in 1958 overlooking Sand Bay. RAF/58/2544/PSFO-P1-0014 25-AUG-1958 Historic England Archive (RAF Photography)

A number of caravan sites are present across Weston-super-Mare and the surrounding area to the north at Kewstoke and the south at Uphill (Fig 56). Some sites probably have their origins in the interwar period; others appear to have been established after the Second World War. Aerial photographs taken from the 1940s onwards show the establishment and development of some of these sites. These all appear to have begun for the use of holidaymakers, but some sites have evolved to residential sites.

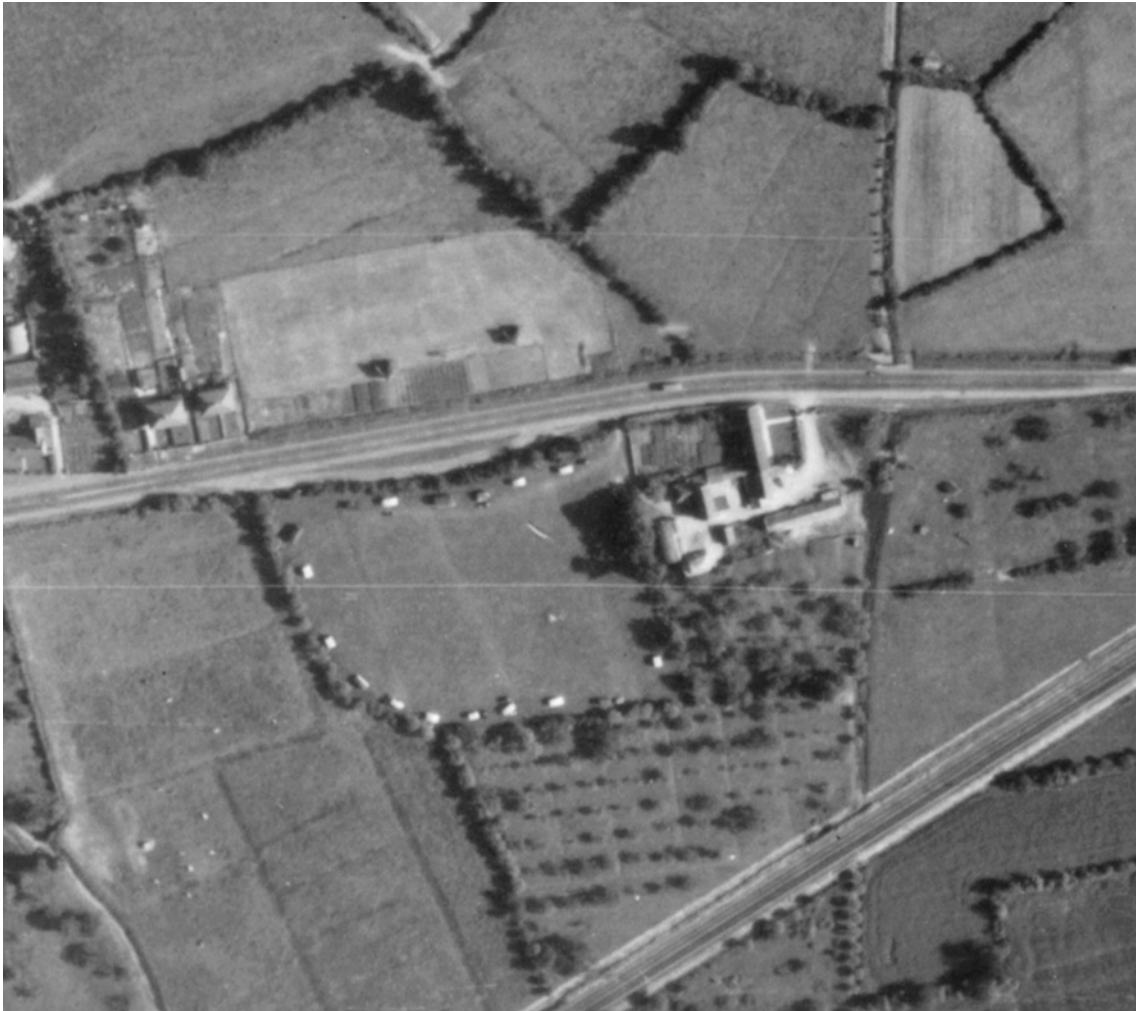
Figure 58 Westwick Farm in 1946. Caravans can be seen around the edge of the field to the left of the farmhouse. RAF/106G/1661 RP 3269 12-JUL-1946 Historic England Archive (RAF Photography)

Many of the caravan sites seen in the 1940s and 1950s survive today. Some of these sites are now occupied by static caravans that function as either holiday lets or permanent residences (Fig 58 & 59).

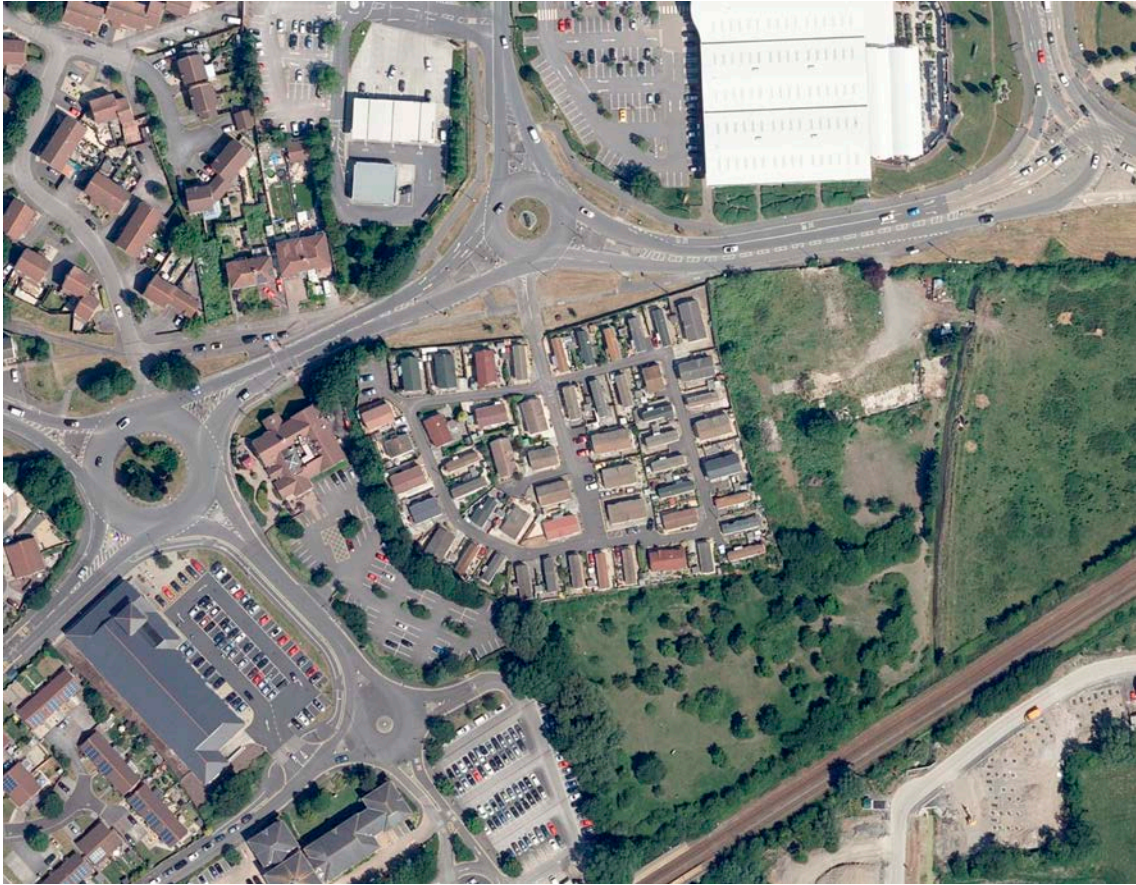
Figure 59 The same site in 2017, now occupied by static caravans. The farm buildings have been demolished and much of the surrounding areas built upon. The Queensway Centre retail park is to the top. Detail of ST3662 19-JUN-2017 RGB Aerial Photography - © Bluesky International/Getmapping PLC
